Exterior Lighting Assessment and Design Recommendations

**Grand Teton National Park**

Respectfully submitted by: Bryan Boulanger

July 26, 2022

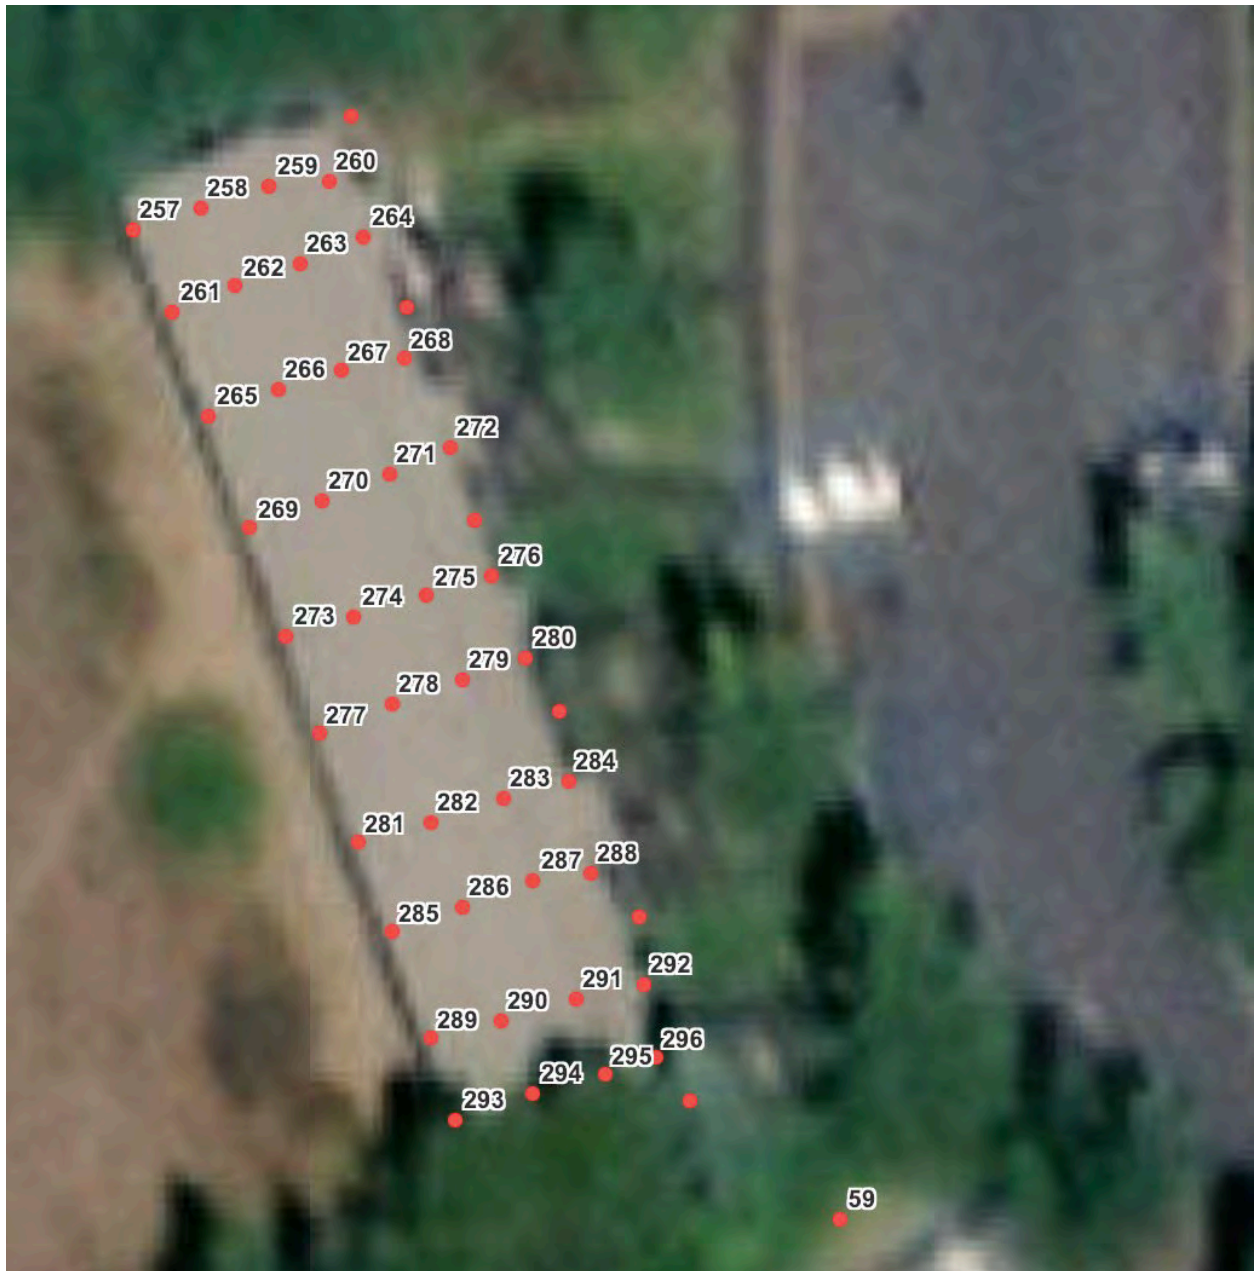
**Figure AVI-10. Fixture Locations and Compliance Assessment: Cabin Rooms 560 - 579.** Dark sky compliant lighting has a green marker and non-compliant lighting has a red marker. Numbers present above the dots indicate the fixture ID number whose characteristics are presented within the tables.

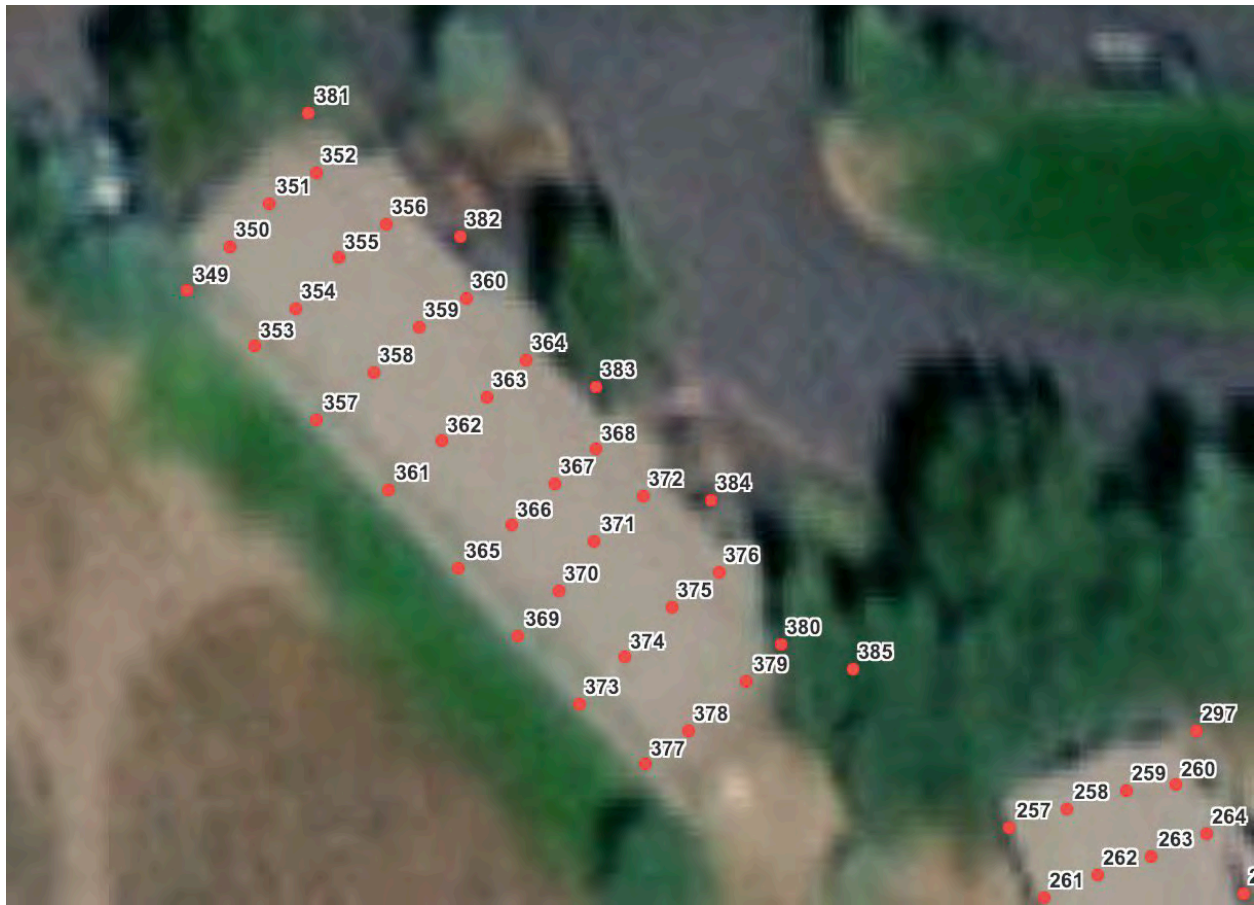
**Figure AVI-12. Fixture Locations and Compliance Assessment: Cabin Rooms 350 - 380.** Dark sky compliant lighting has a green marker and non-compliant lighting has a red marker. Numbers present above the dots indicate the fixture ID number whose characteristics are presented within the tables.

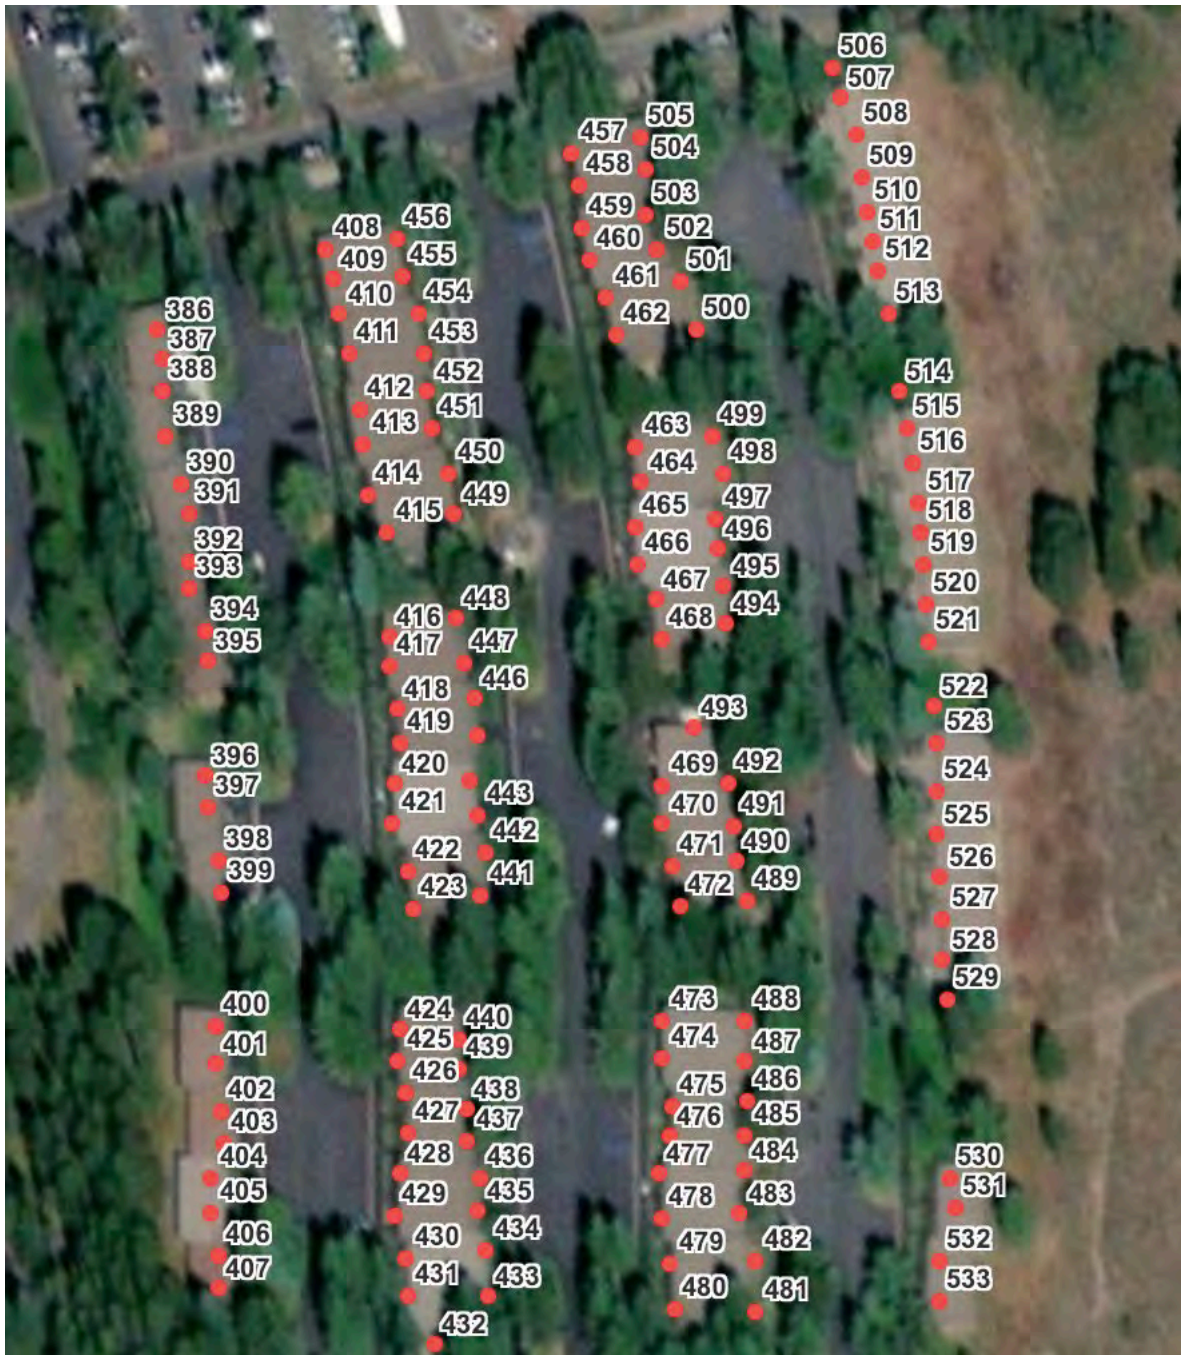
**Figure AVI-13. Fixture Locations and Compliance Assessment: Cabin Rooms South of Main Parking Area.** Dark sky compliant lighting has a green marker and non-compliant lighting has a red marker. Numbers present above the dots indicate the fixture ID number whose characteristics are presented within the tables.

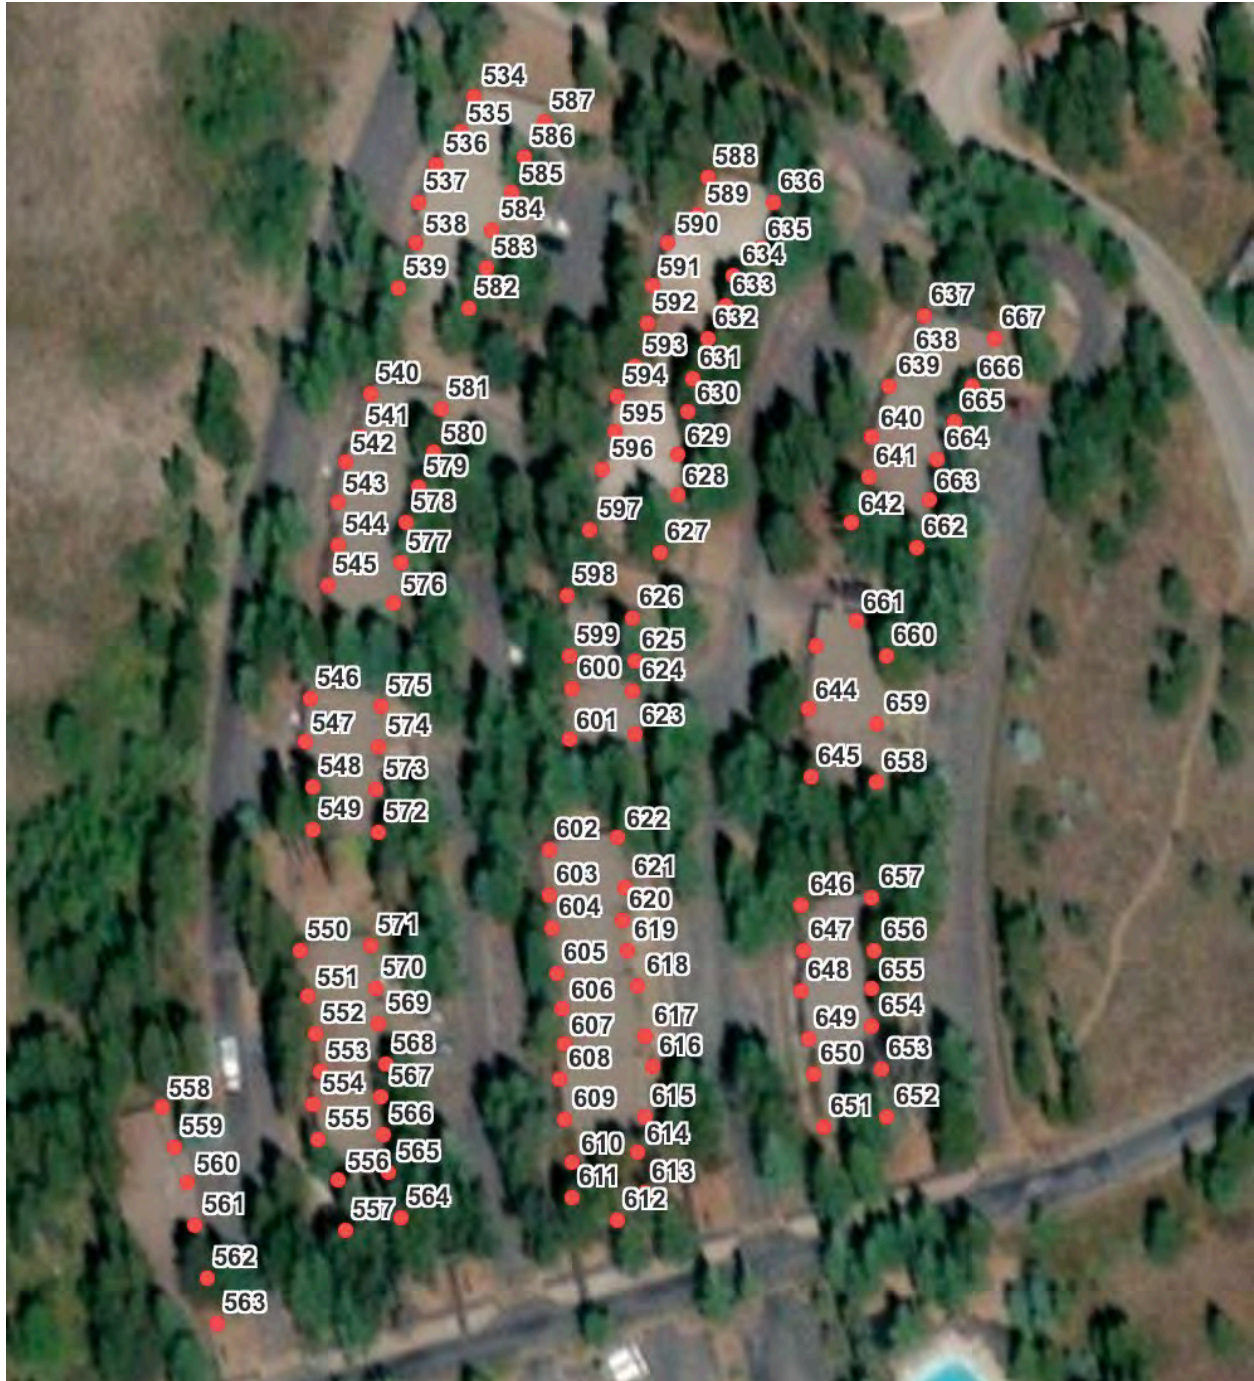
**Figure AVI-14. Fixture Locations and Compliance Assessment: Cabin Rooms North of Main Parking Area.** Dark sky compliant lighting has a green marker and non-compliant lighting has a red marker. Numbers present above the dots indicate the fixture ID number whose characteristics are presented within the tables.

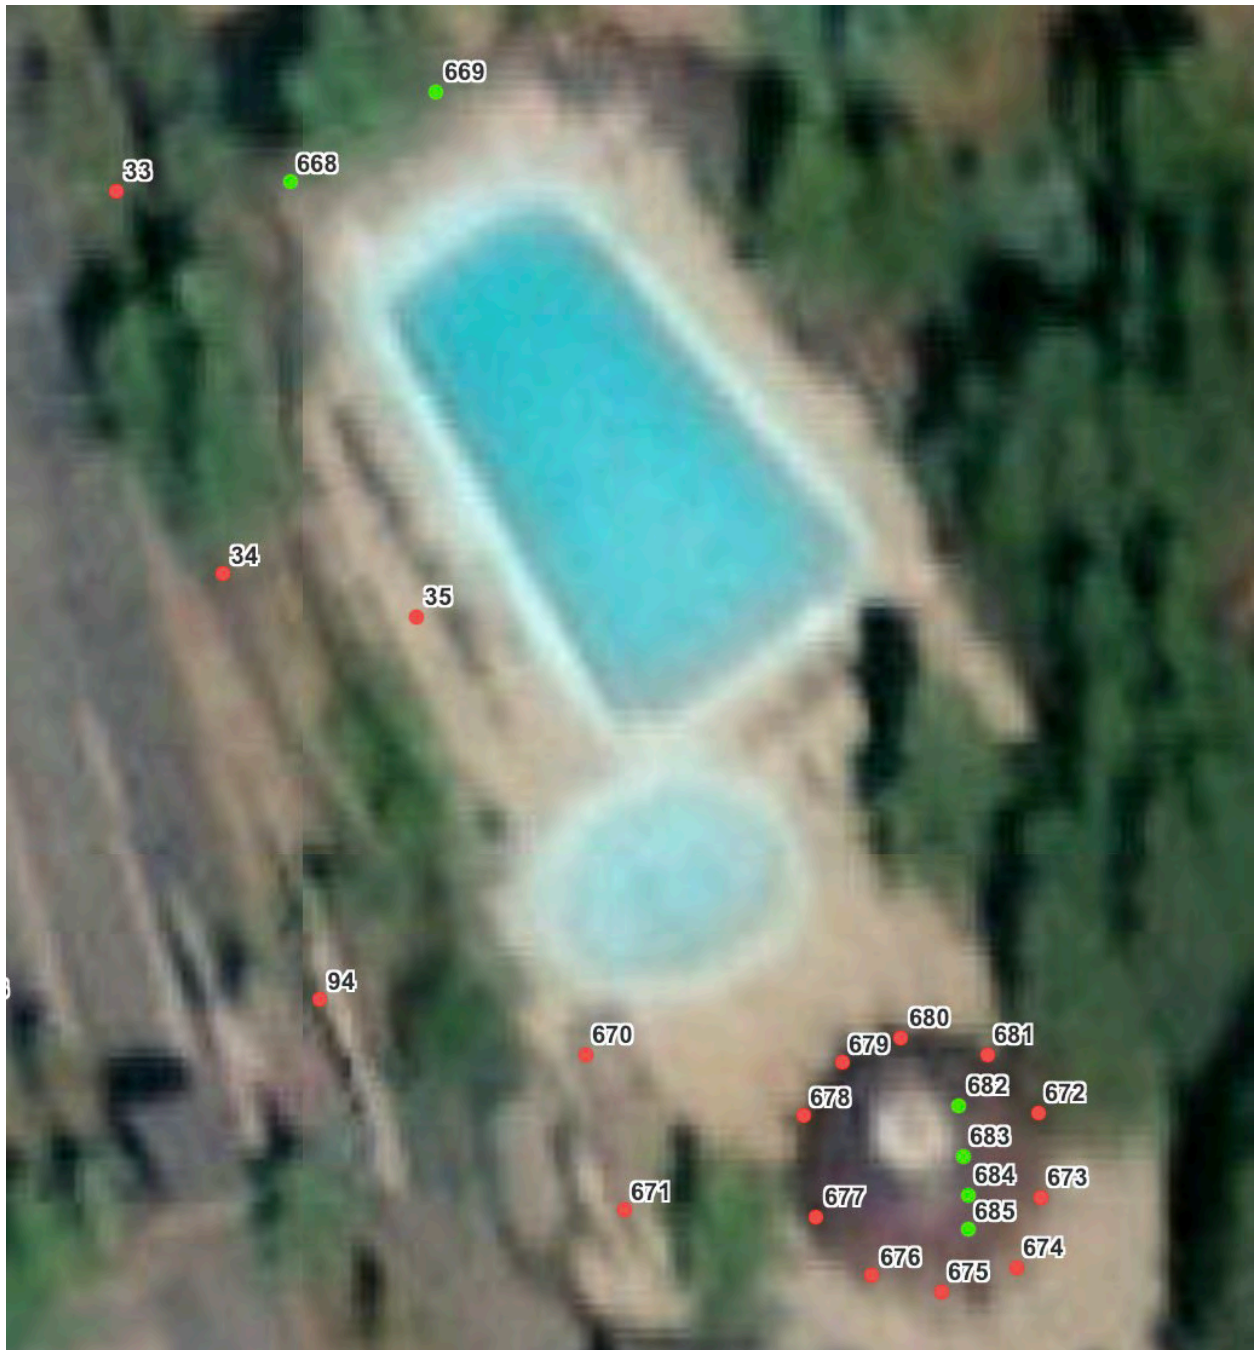
**Figure AVI-15. Fixture Locations and Compliance Assessment: Pool Area.** Dark sky compliant lighting has a green marker and non-compliant lighting has a red marker. Numbers present above the dots indicate the fixture ID number whose characteristics are presented within the tables.

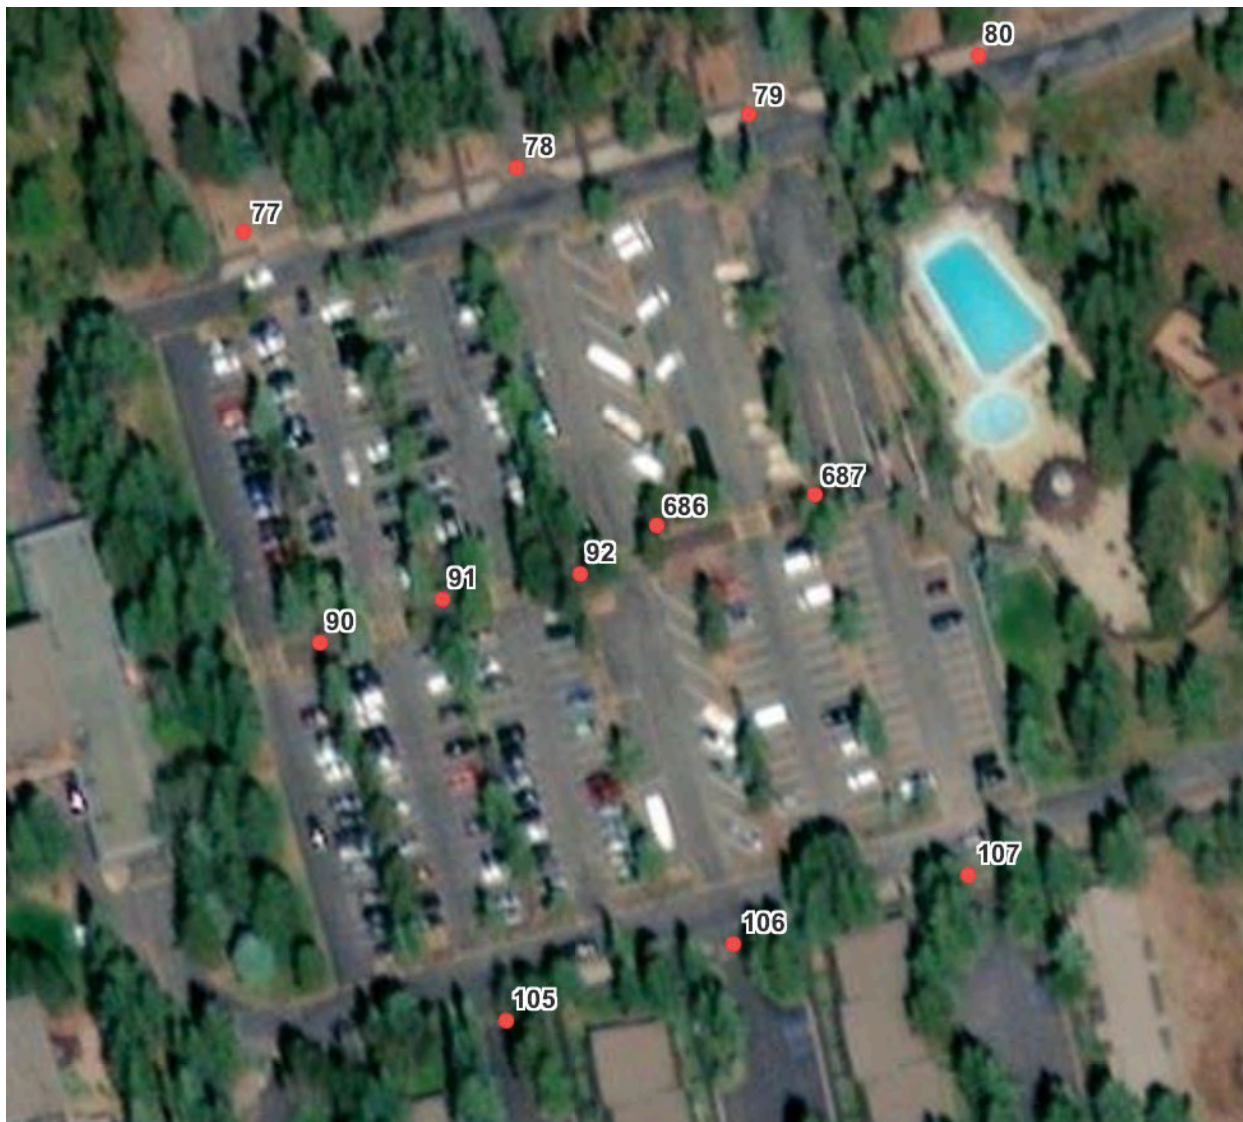
**Figure AVI-16. Fixture Locations and Compliance Assessment: Pathway Lodge Cabin Signs.** Dark sky compliant lighting has a green marker and non-compliant lighting has a red marker. Numbers present above the dots indicate the fixture ID number whose characteristics are presented within the tables.

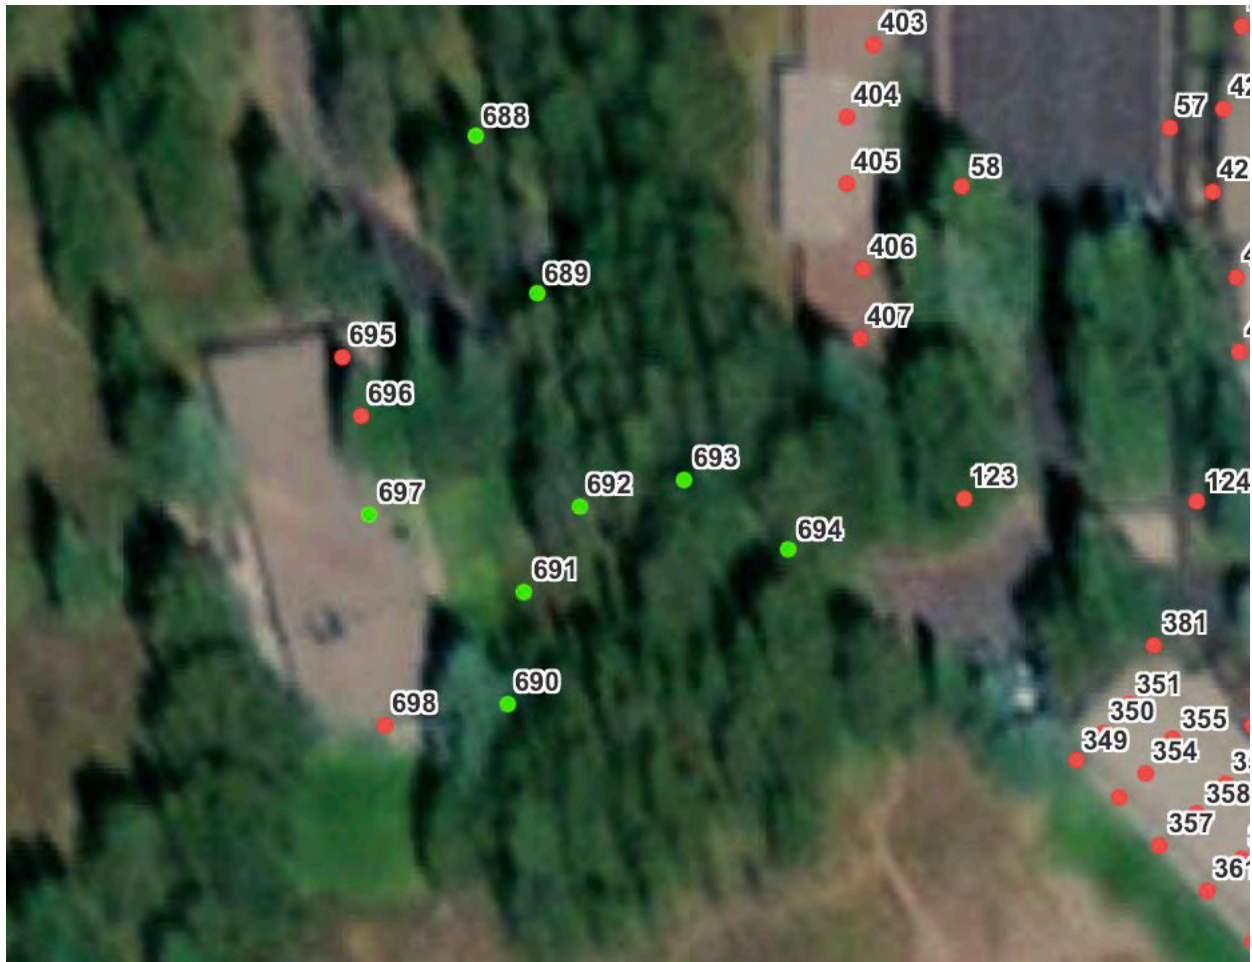
**Figure AVI-17. Fixture Locations and Compliance Assessment: Managers Residence.** Dark sky compliant lighting has a green marker and non-compliant lighting has a red marker. Numbers present above the dots indicate the fixture ID number whose characteristics are presented within the tables.

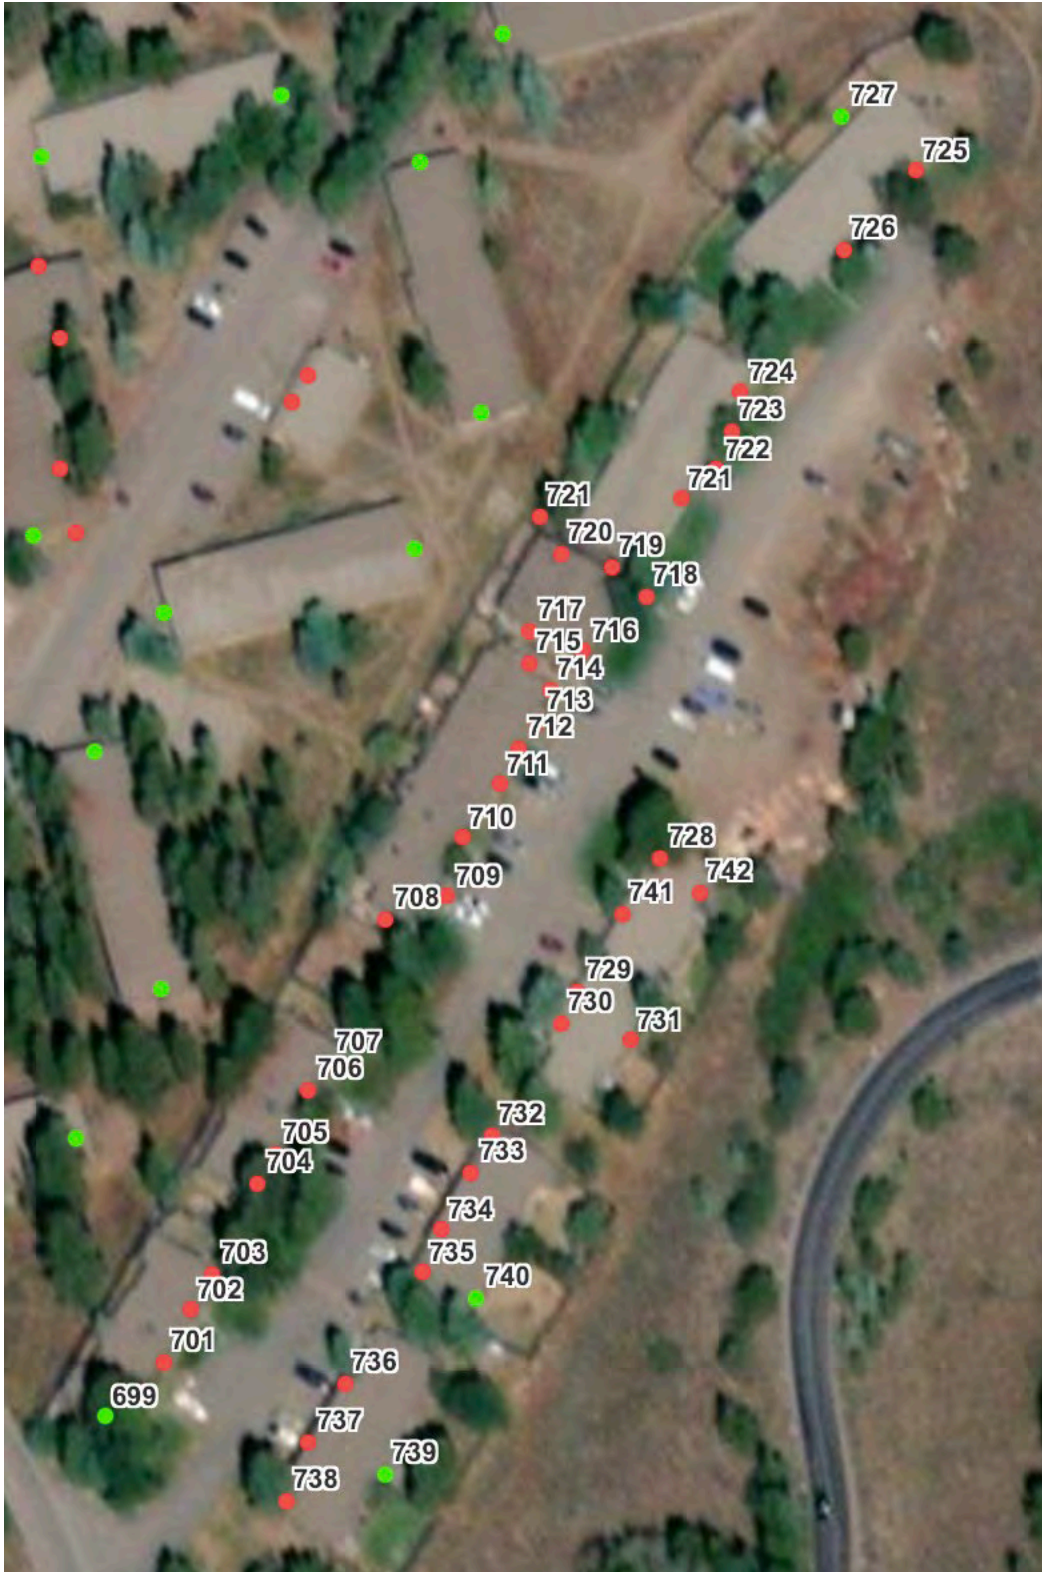
**Figure AVI-18. Fixture Locations and Compliance Assessment: Staff Housing #1 - #23.** Dark sky compliant lighting has a green marker and non-compliant lighting has a red marker. Numbers present above the dots indicate the fixture ID number whose characteristics are presented within the tables.

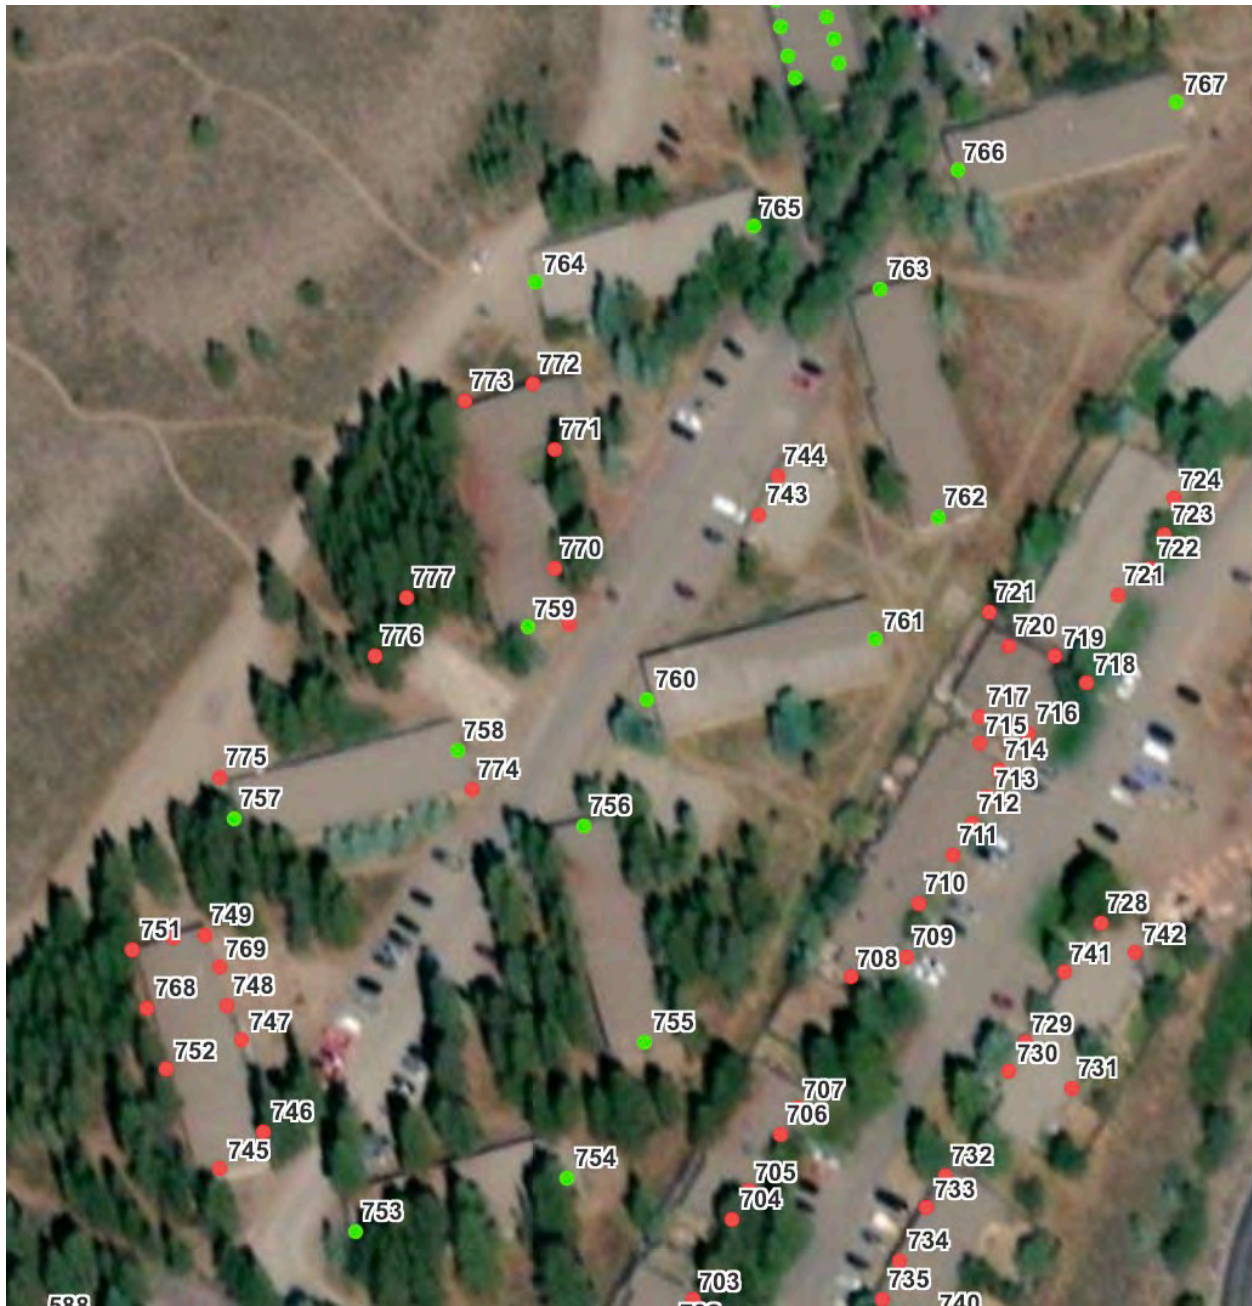
**Figure AVI-19. Fixture Locations and Compliance Assessment: Laundry/Information Buildings and Dorms 1 – 8 and 10 Building.** Dark sky compliant lighting has a green marker and non-compliant lighting has a red marker. Numbers present above the dots indicate the fixture ID number whose characteristics are presented within the tables.

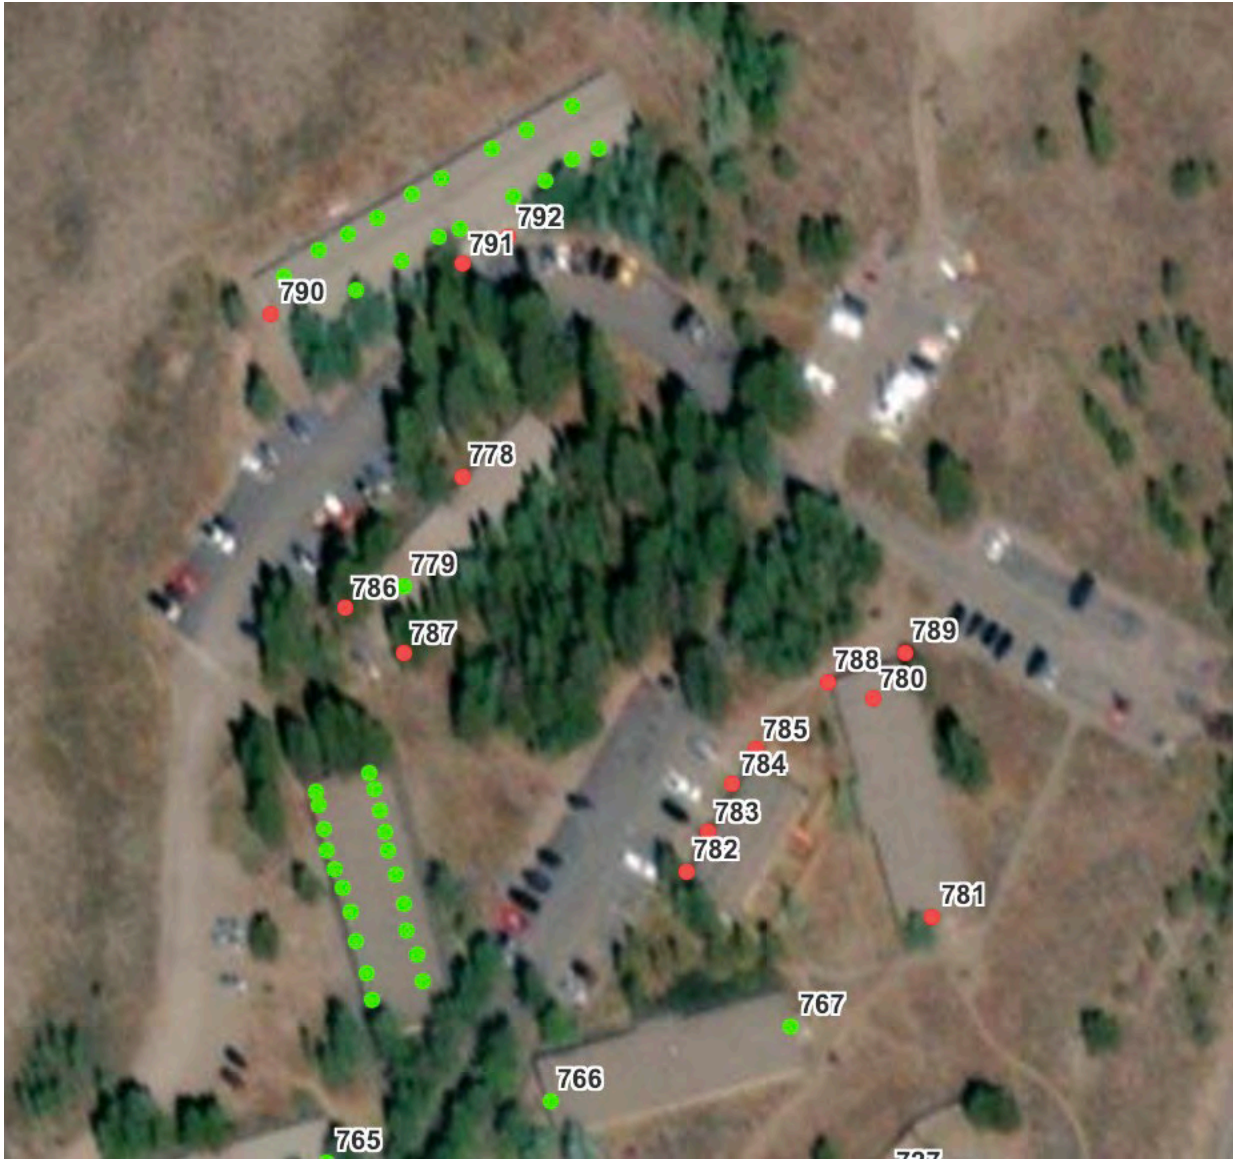
**Figure AVI-20. Fixture Locations and Compliance Assessment: Dorms 11 - 13.** Dark sky compliant lighting has a green marker and non-compliant lighting has a red marker. Numbers present above the dots indicate the fixture ID number whose characteristics are presented within the tables.

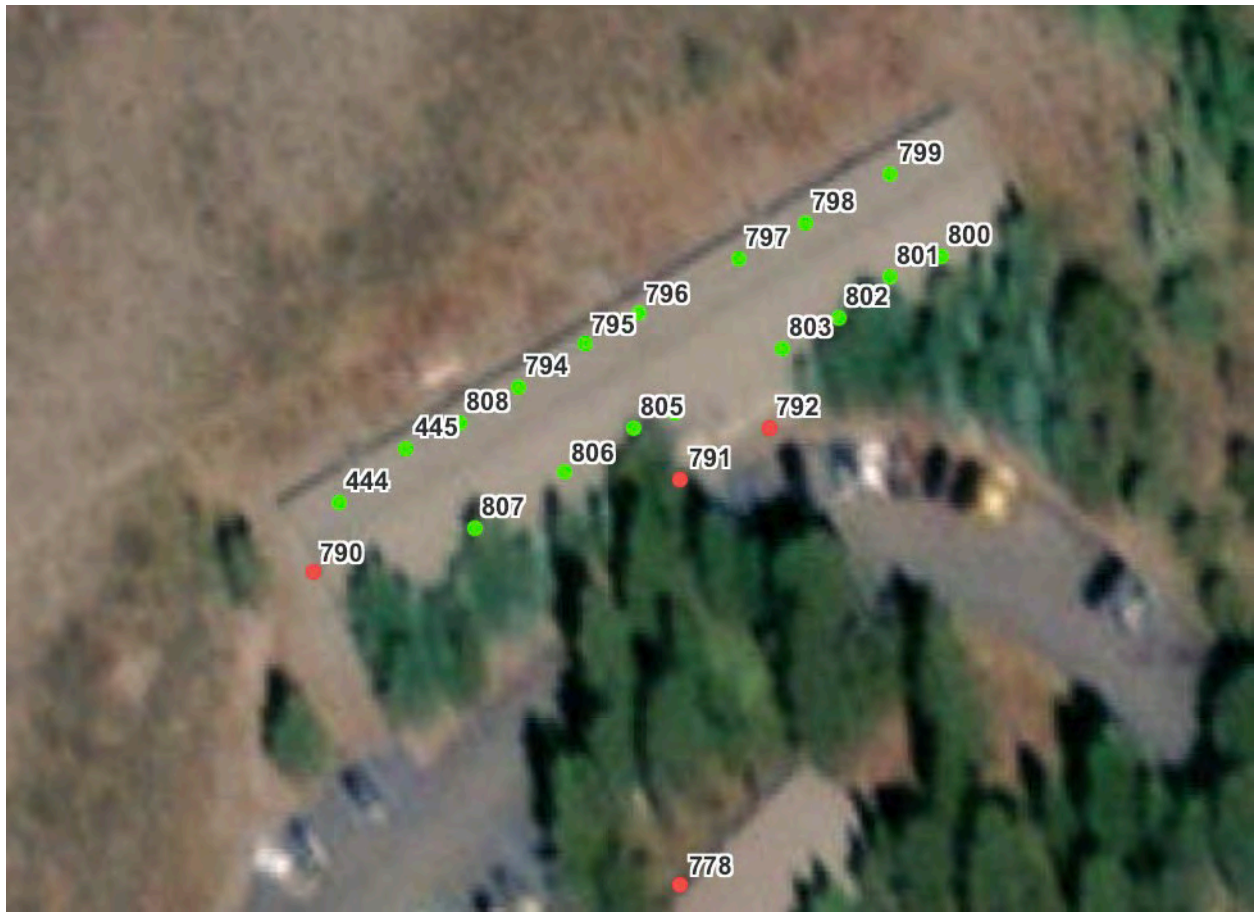
**Figure AVI-21. Fixture Locations and Compliance Assessment: Dorm 13.** Dark sky compliant lighting has a green marker and non-compliant lighting has a red marker. Numbers present above the dots indicate the fixture ID number whose characteristics are presented within the tables.

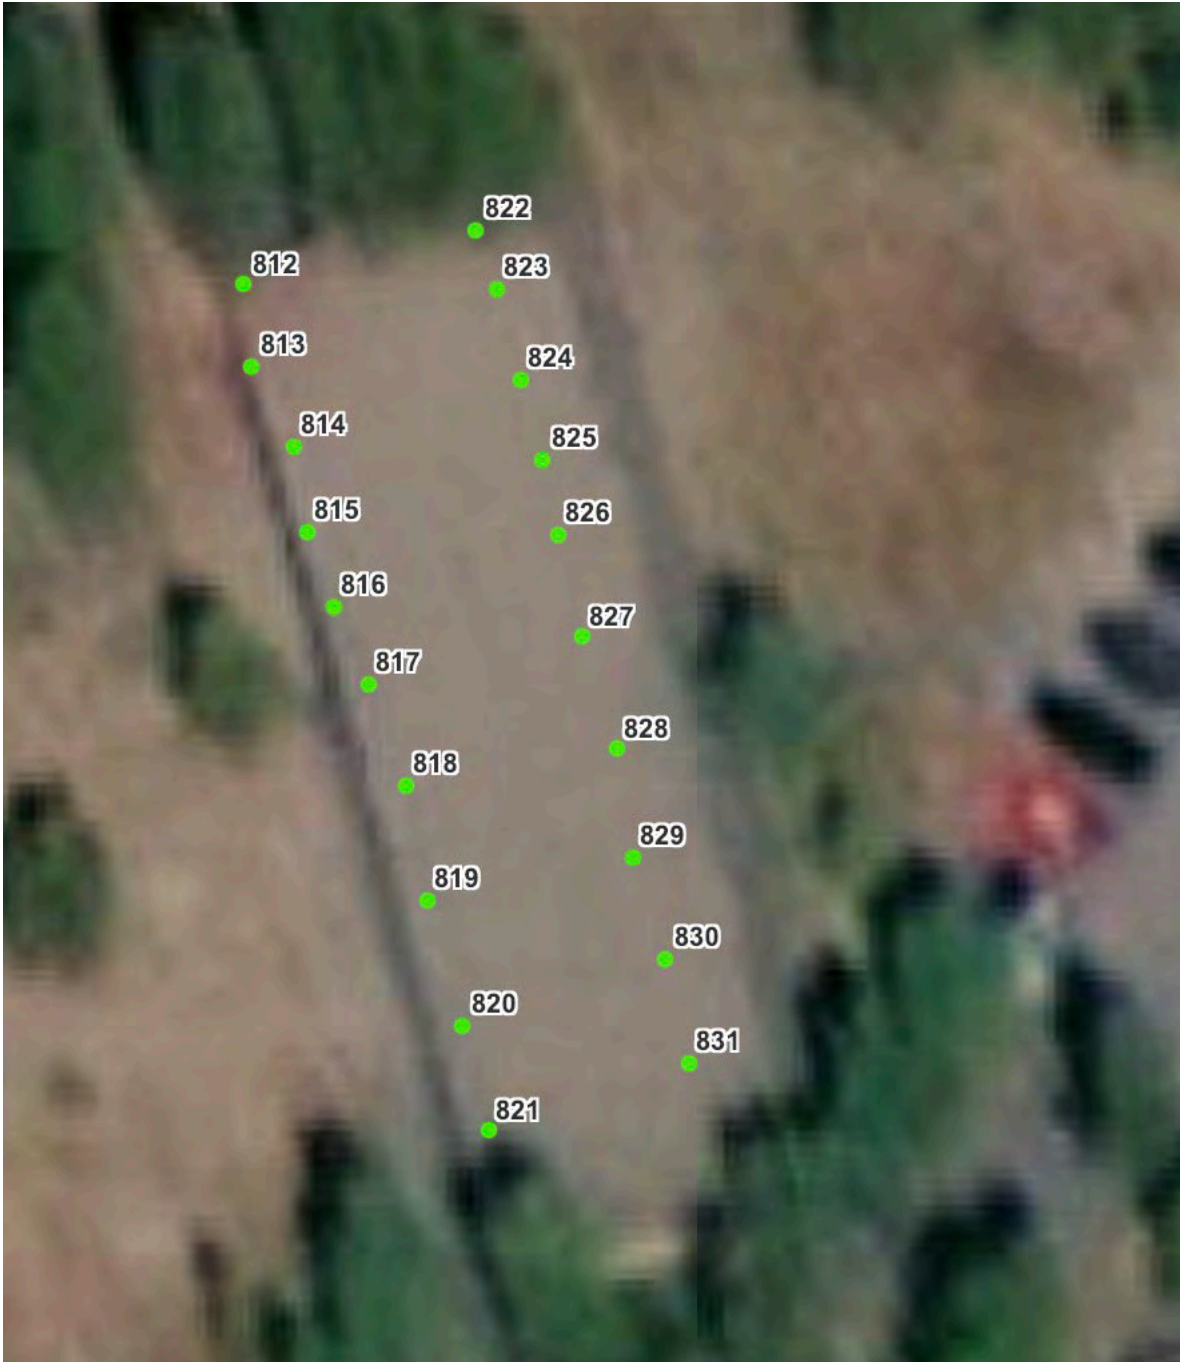
**Figure AVI-22. Fixture Locations and Compliance Assessment: Dorm 9.** Dark sky compliant lighting has a green marker and non-compliant lighting has a red marker. Numbers present above the dots indicate the fixture ID number whose characteristics are presented within the tables.

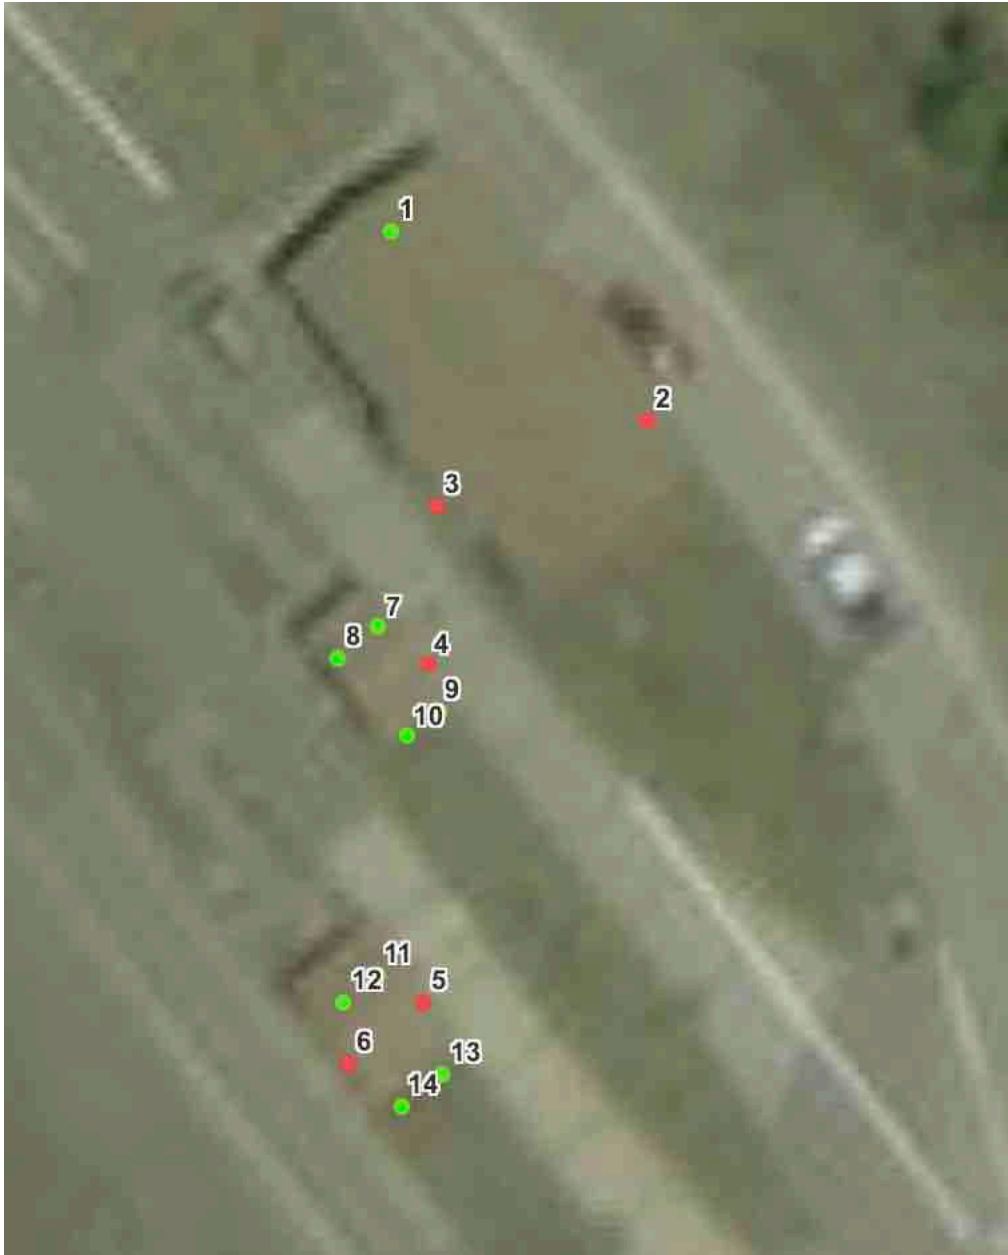
**Figure AVII-1. Fixture Locations and Compliance Assessment: Entrance Station.** Dark sky compliant lighting has a green marker and non-compliant lighting has a red marker. Numbers present above the dots indicate the fixture ID number whose characteristics are presented within the tables.

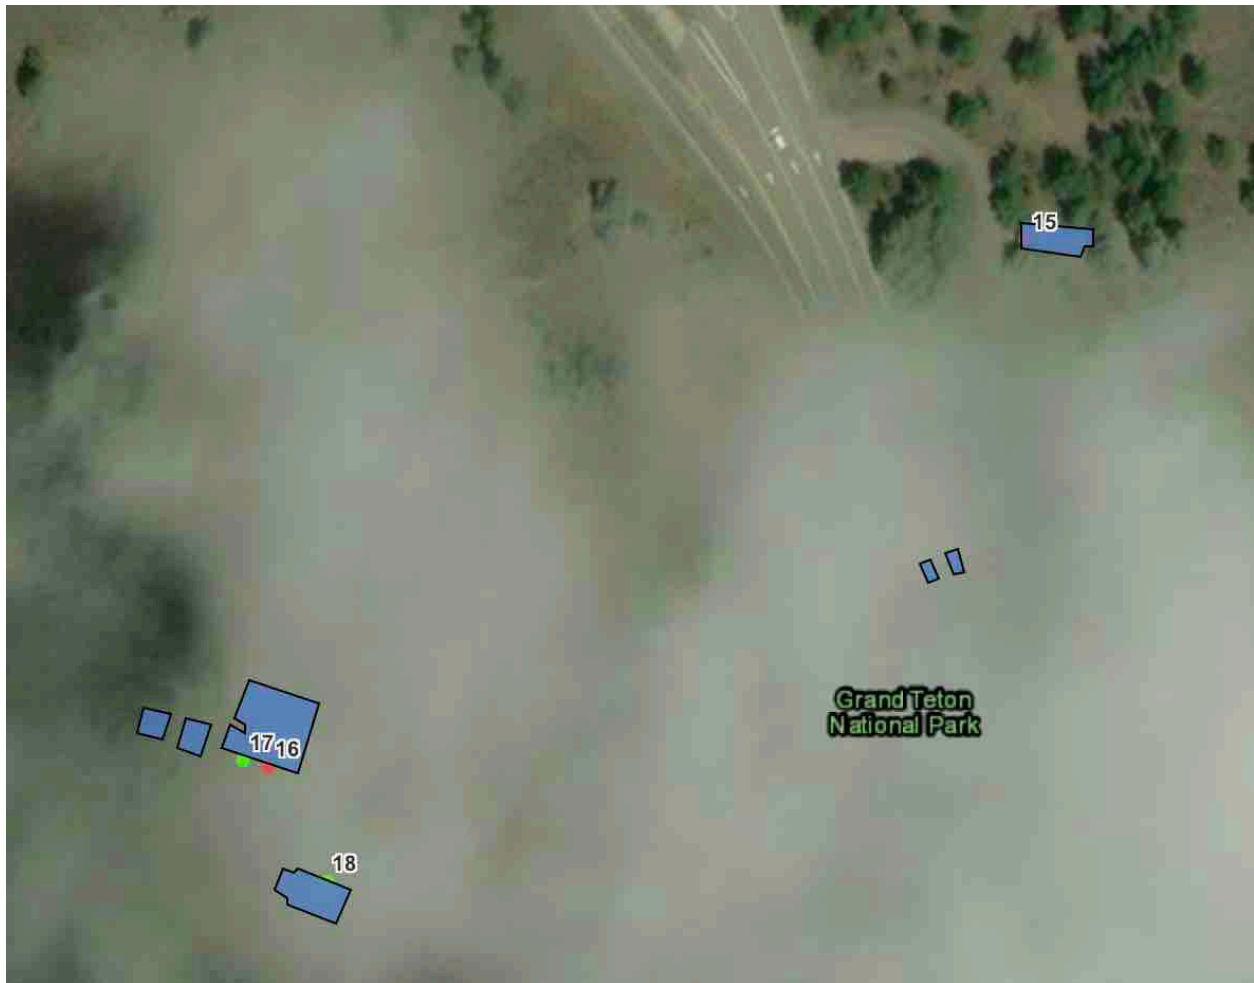
**Figure AVII-2. Fixture Locations and Compliance Assessment: Buffalo Fork Ranger Station, SLC Office, and Residence.** Dark sky compliant lighting has a green marker and non-compliant lighting has a red marker. Numbers present above the dots indicate the fixture ID number whose characteristics are presented within the tables.

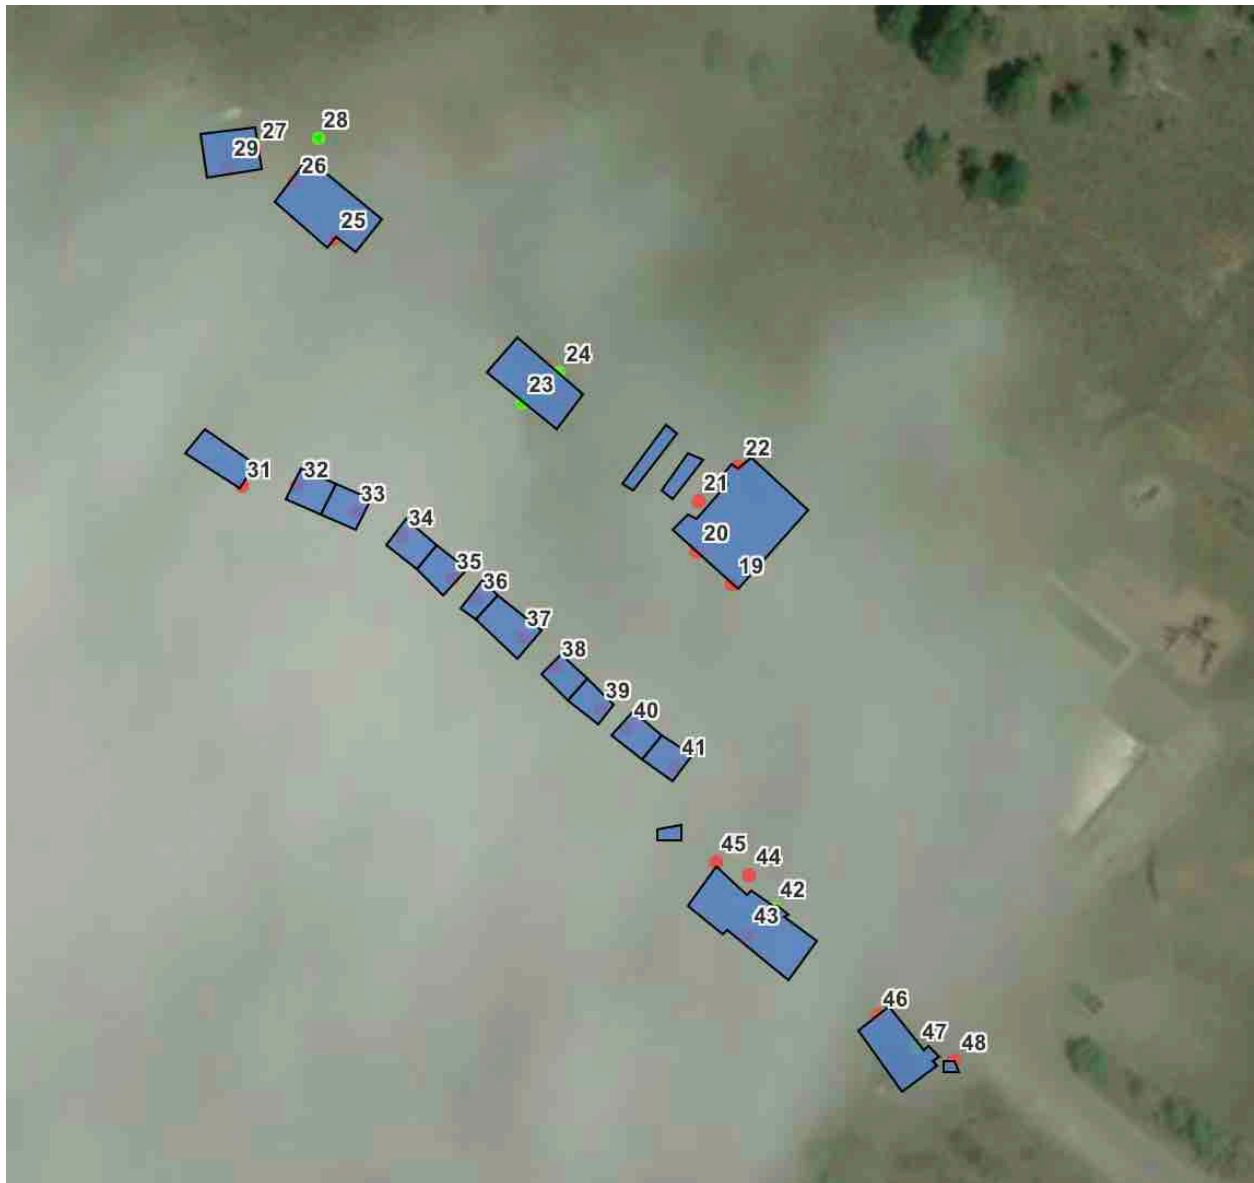
**Figure AVII-3. Fixture Locations and Compliance Assessment: Residential Area and Post Office.** Dark sky compliant lighting has a green marker and non-compliant lighting has a red marker. Numbers present above the dots indicate the fixture ID number whose characteristics are presented within the tables.
