Exterior Lighting Assessment and Design Recommendations

**Grand Teton National Park**

Respectfully submitted by: Bryan Boulanger

July 26, 2022

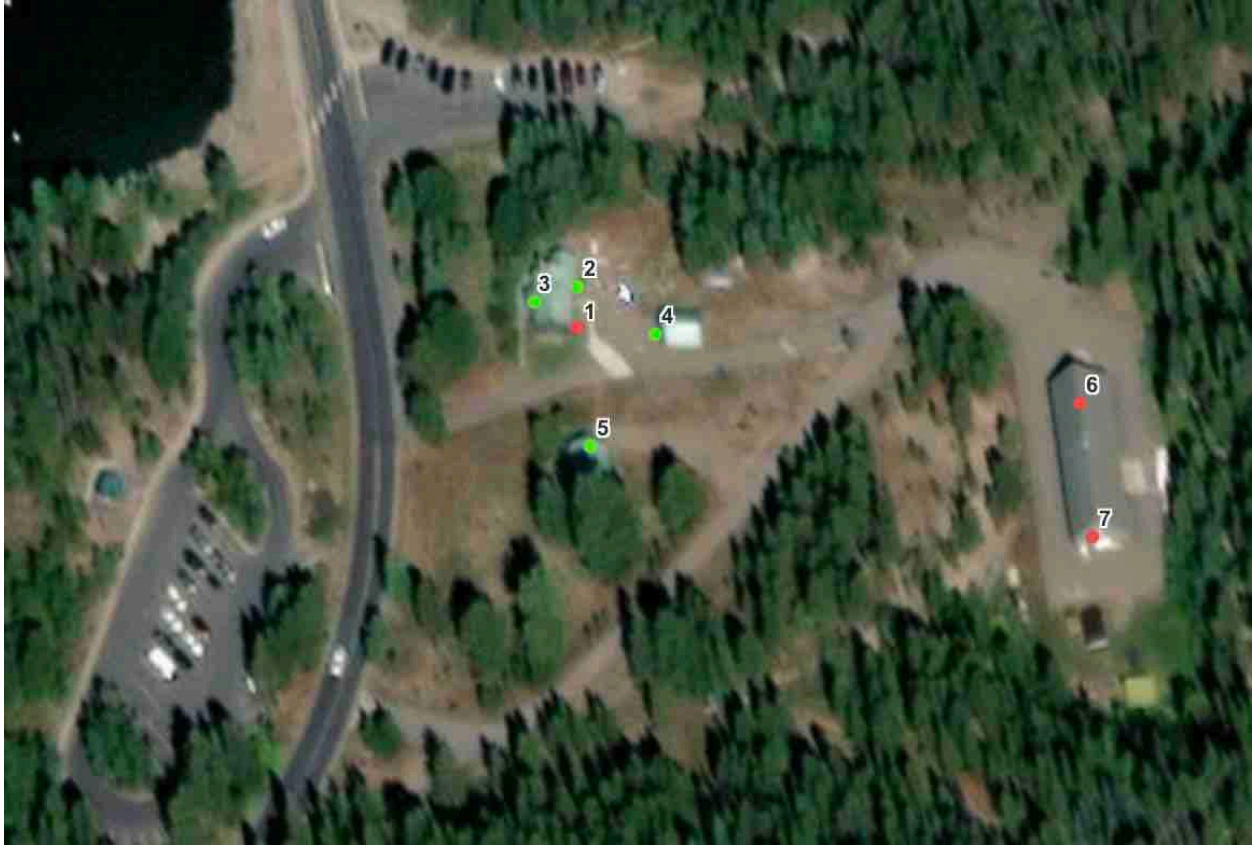
**Figure AVIII-1. Fixture Locations and Compliance Assessment: BLM Residences and Barn adjacent to Jackson Lake Dam.** Dark sky compliant lighting has a green marker and non-compliant lighting has a red marker. Numbers present above the dots indicate the fixture ID number whose characteristics are presented within the tables.

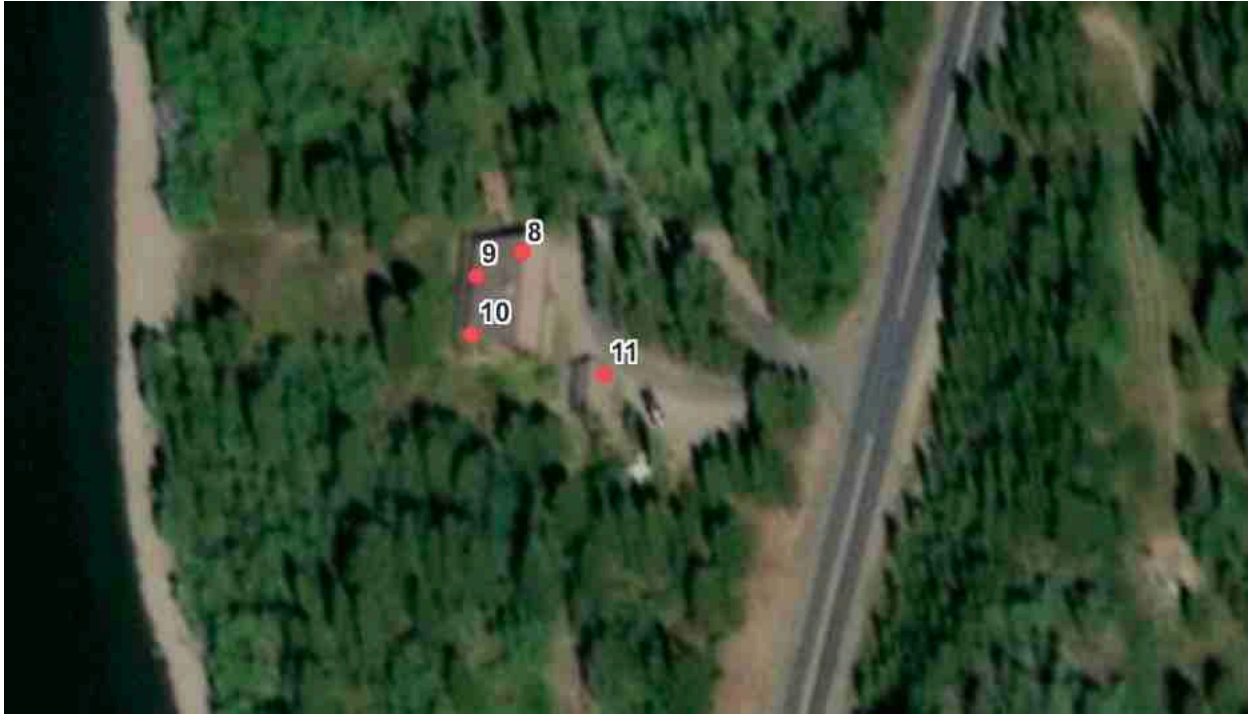
**Figure AVIII-2. Fixture Locations and Compliance Assessment: Brinkerhoff Property.** Dark sky compliant lighting has a green marker and non-compliant lighting has a red marker. Numbers present above the dots indicate the fixture ID number whose characteristics are presented within the tables.

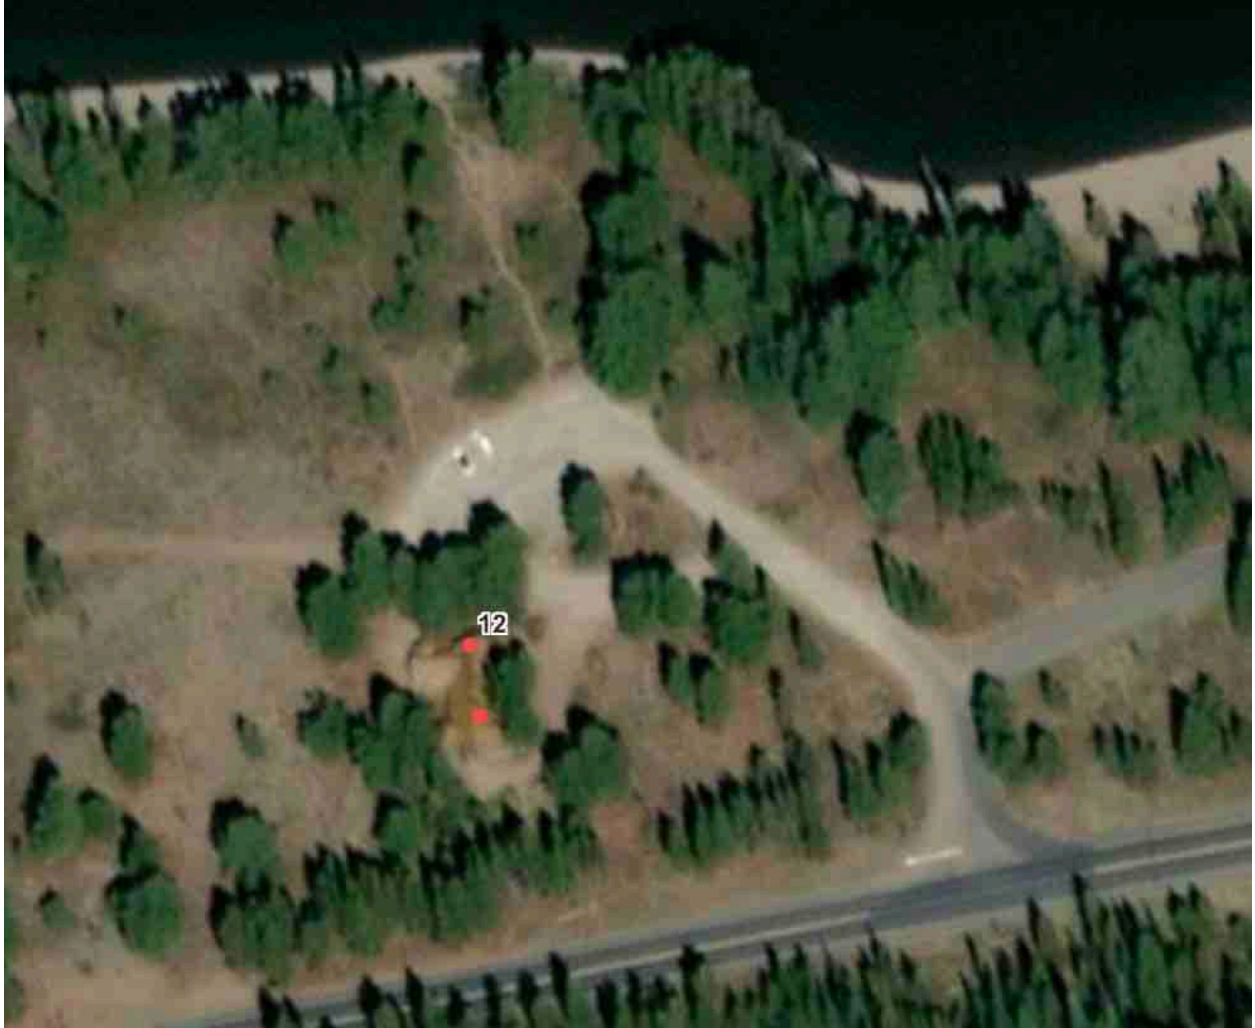
**Figure AVIII-3. Fixture Locations and Compliance Assessment: Chapel of the Sacred Heart.** Dark sky compliant lighting has a green marker and non-compliant lighting has a red marker. Numbers present above the dots indicate the fixture ID number whose characteristics are presented within the tables.

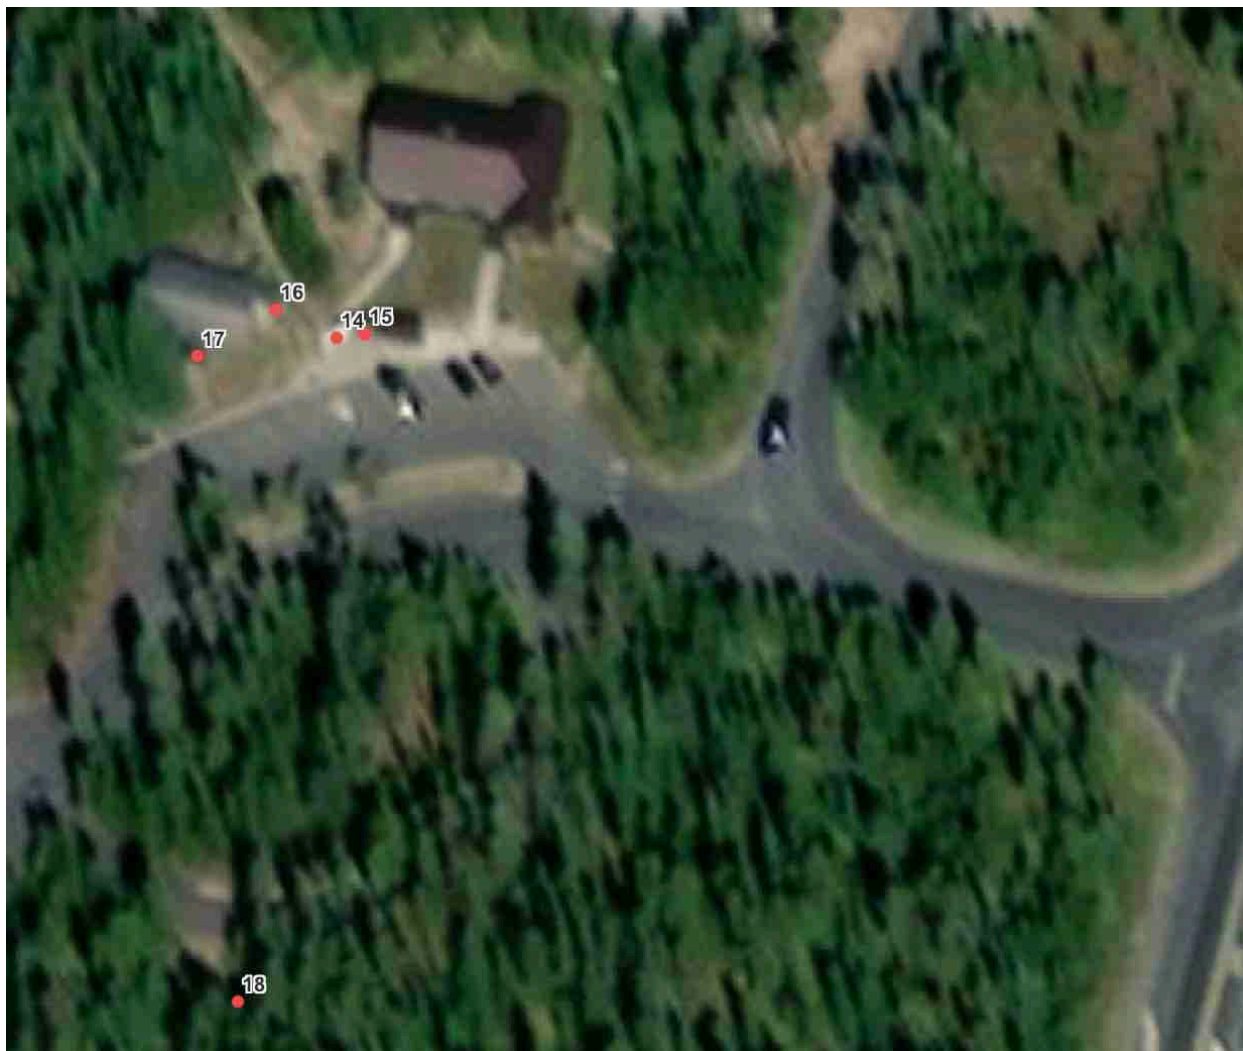
**Figure AVIII-4. Fixture Locations and Compliance Assessment: Ranger Station, Kiosk, and Pump House.** Dark sky compliant lighting has a green marker and non-compliant lighting has a red marker. Numbers present above the dots indicate the fixture ID number whose characteristics are presented within the tables.

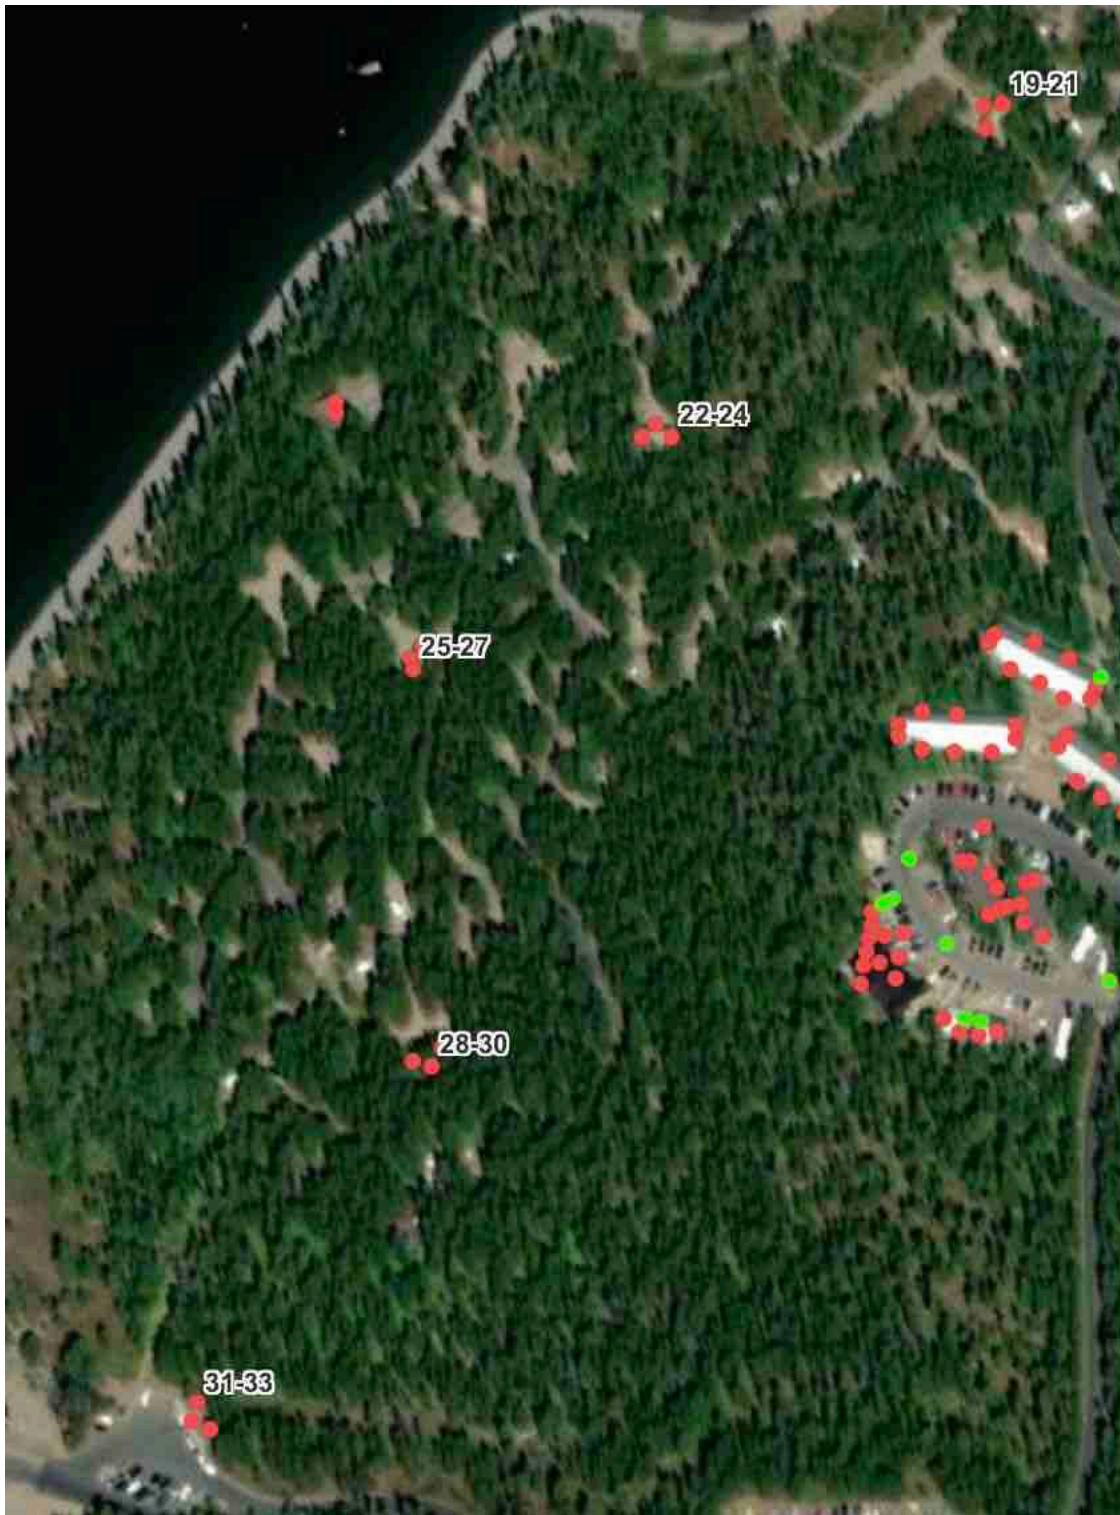
**Figure AVIII-5. Fixture Locations and Compliance Assessment: Comfort Stations.** Dark sky compliant lighting has a green marker and non-compliant lighting has a red marker. Numbers present above the dots indicate the fixture ID number whose characteristics are presented within the tables.

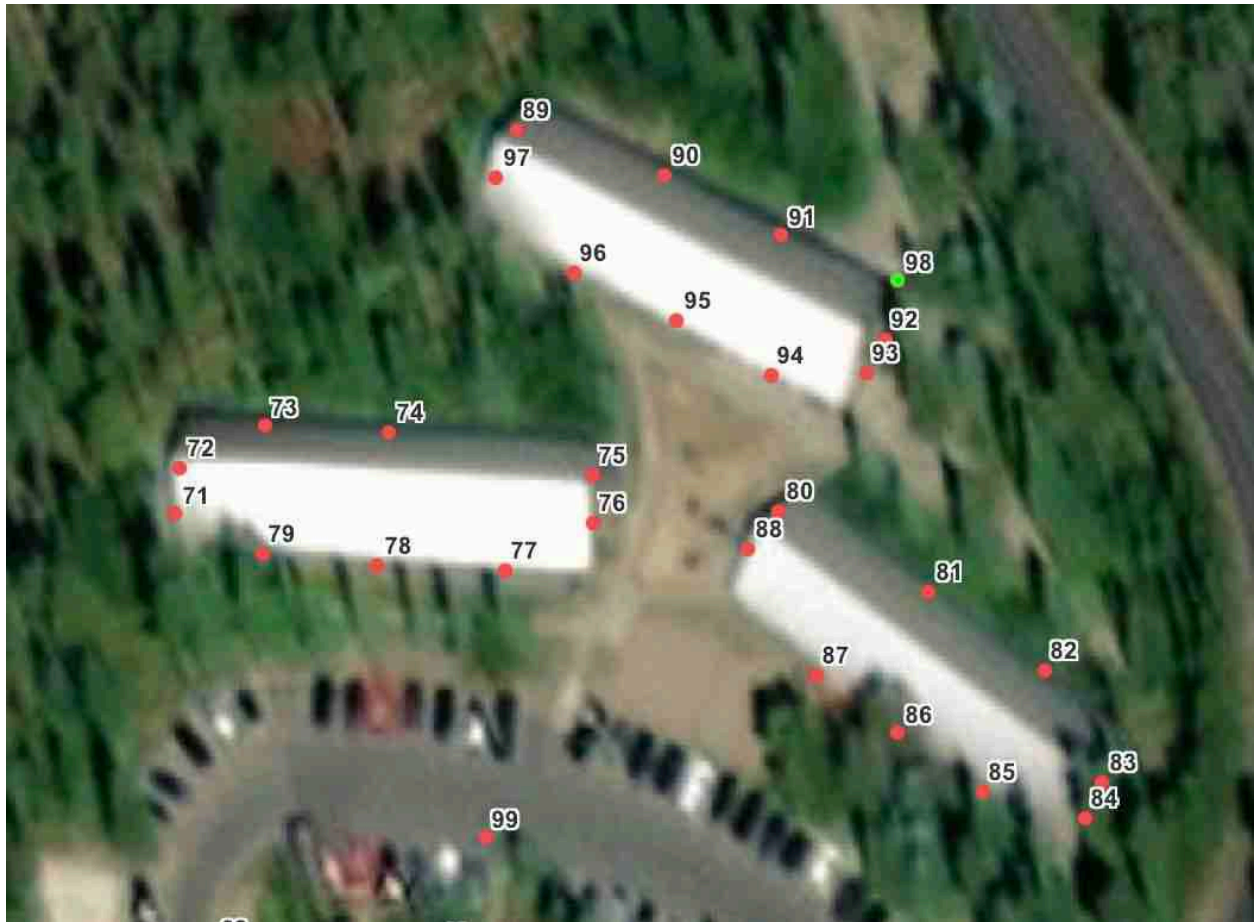
**Figure AVIII-8. Fixture Locations and Compliance Assessment: Dorms 1-3.** Dark sky compliant lighting has a green marker and non-compliant lighting has a red marker. Numbers present above the dots indicate the fixture ID number whose characteristics are presented within the tables.

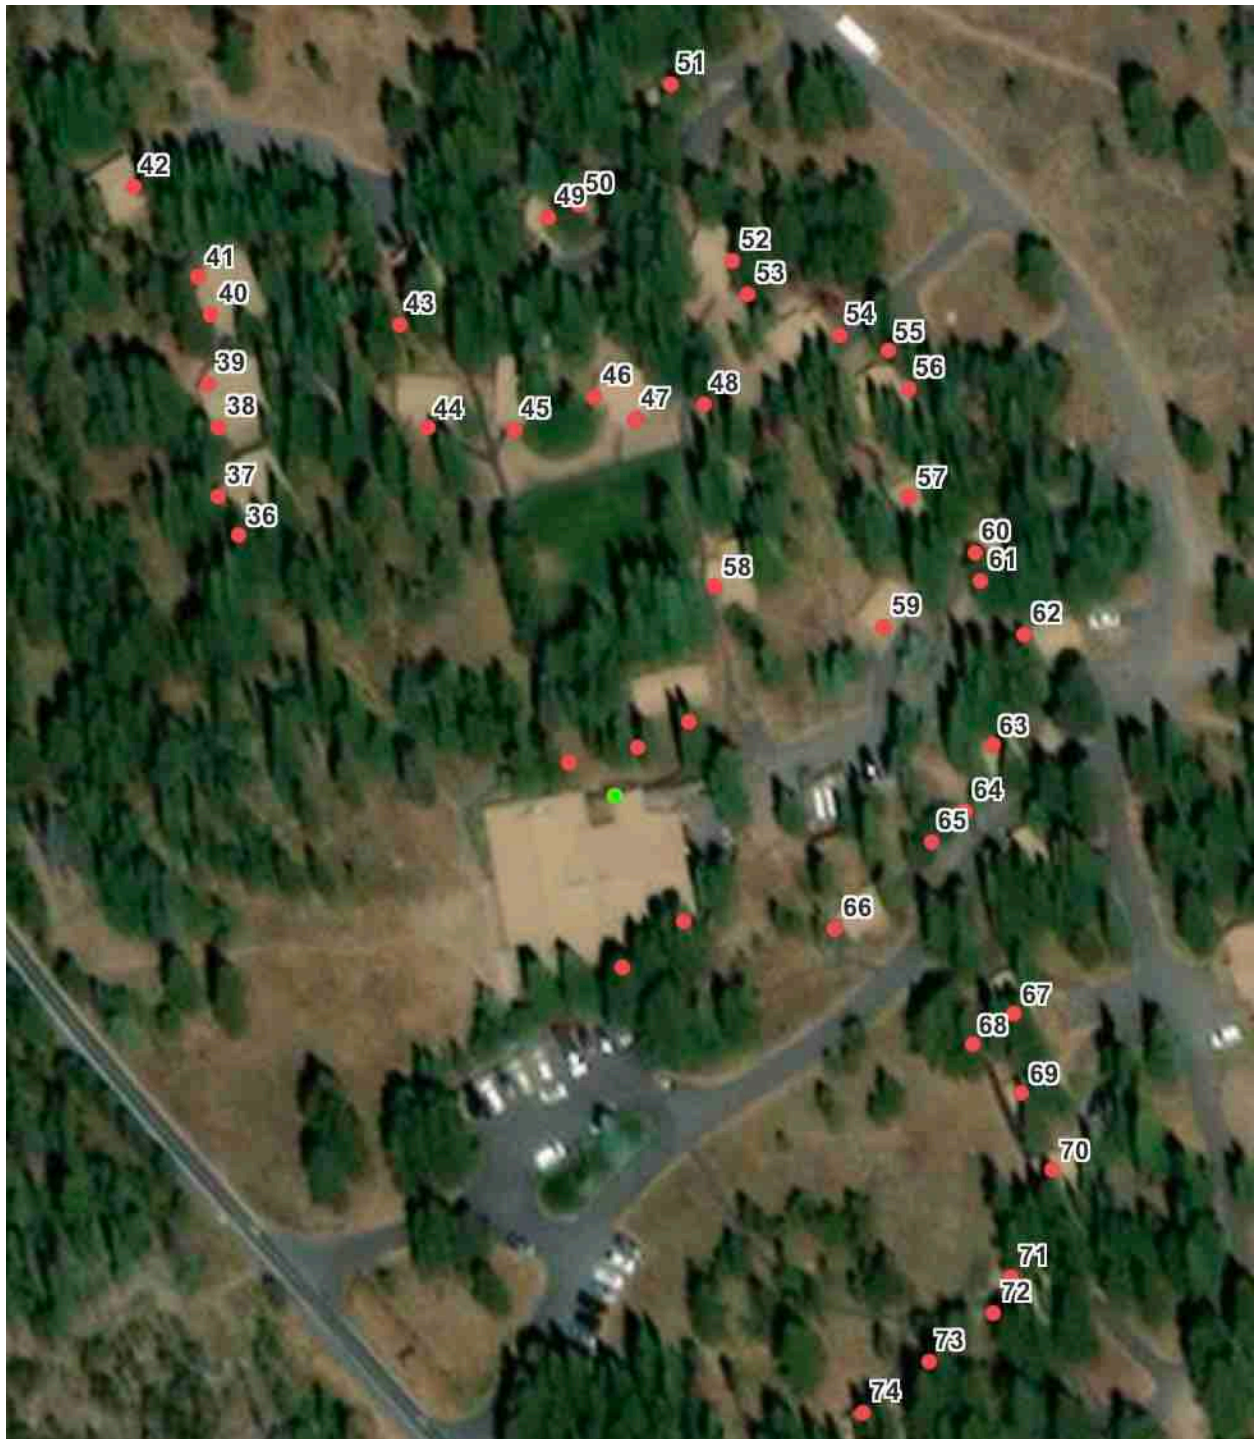
**Figure AIX-2. Fixture Locations and Compliance Assessment: Cabins.** Dark sky compliant lighting has a green marker and non-compliant lighting has a red marker. Numbers present above the dots indicate the fixture ID number whose characteristics are presented within the tables.

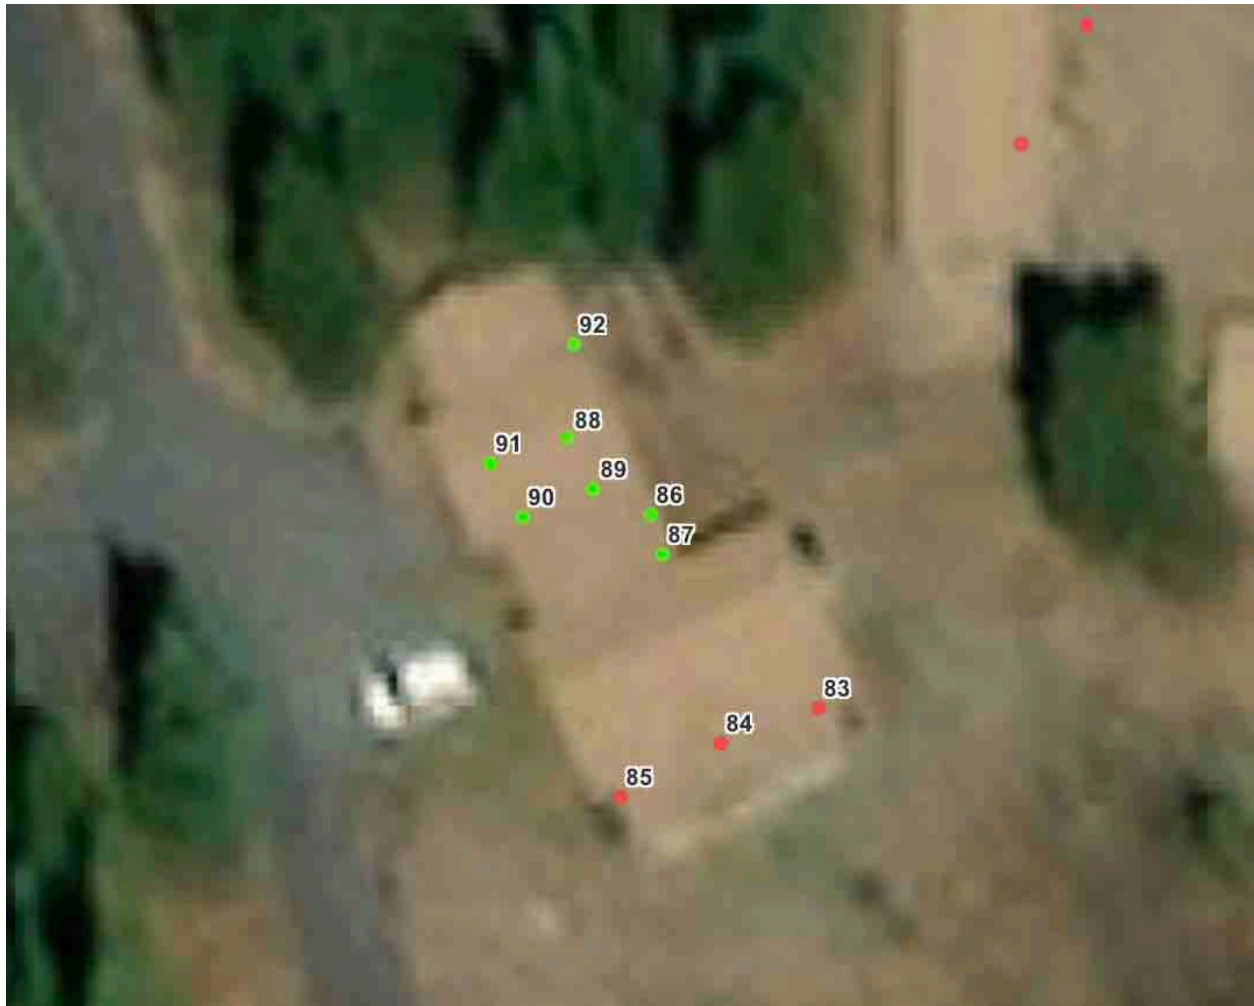
**Figure AIX-4. Fixture Locations and Compliance Assessment: Head House Keeping Residence.** Dark sky compliant lighting has a green marker and non-compliant lighting has a red marker. Numbers present above the dots indicate the fixture ID number whose characteristics are presented within the tables.

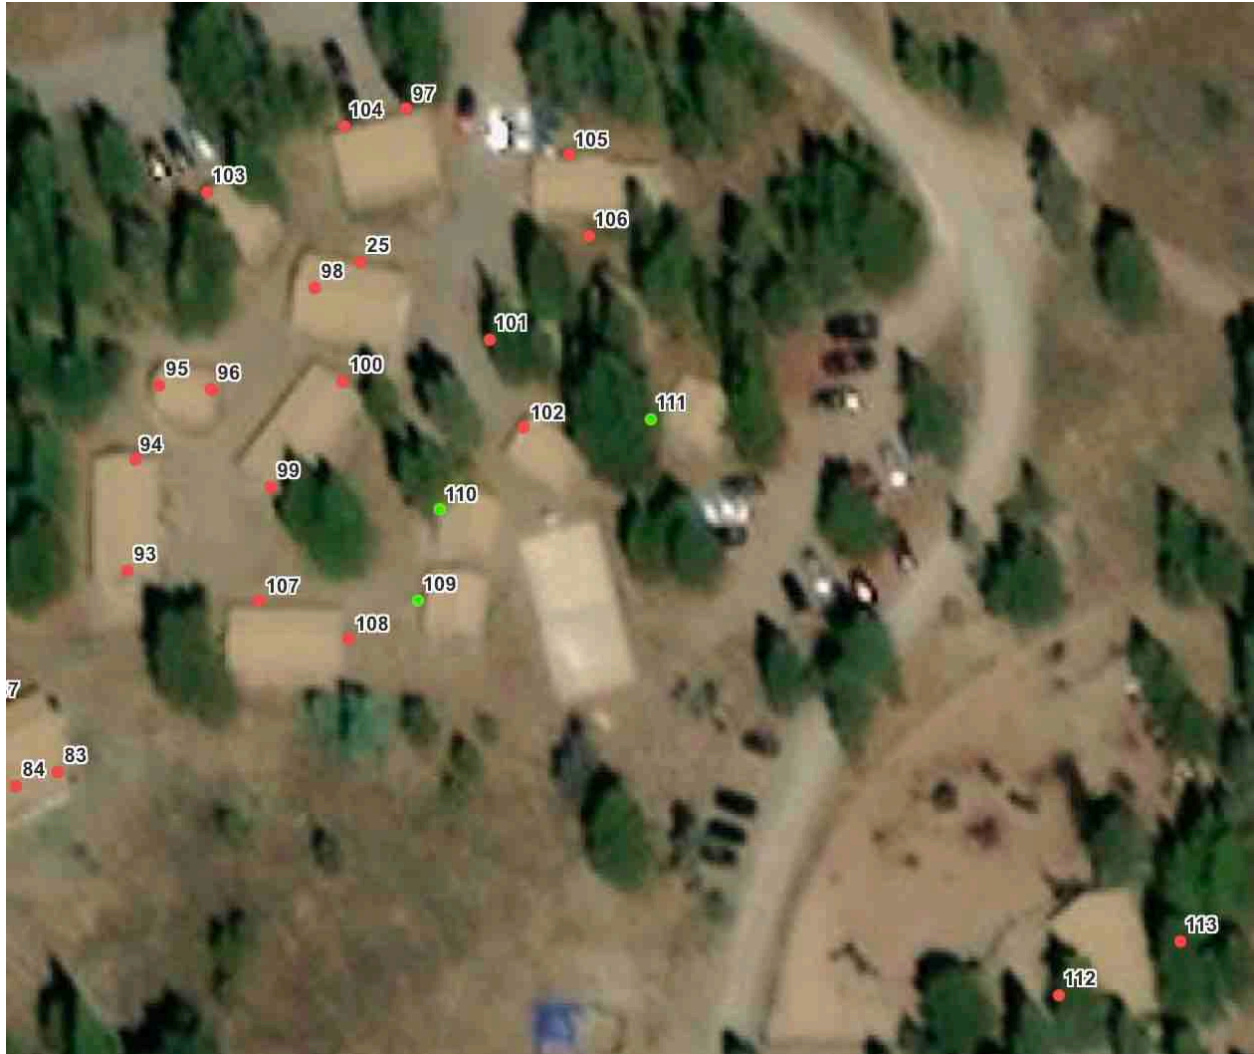
**Figure AIX-5. Fixture Locations and Compliance Assessment: Employee Cabins and Horse Stables House.** Dark sky compliant lighting has a green marker and non-compliant lighting has a red marker. Numbers present above the dots indicate the fixture ID number whose characteristics are presented within the tables.

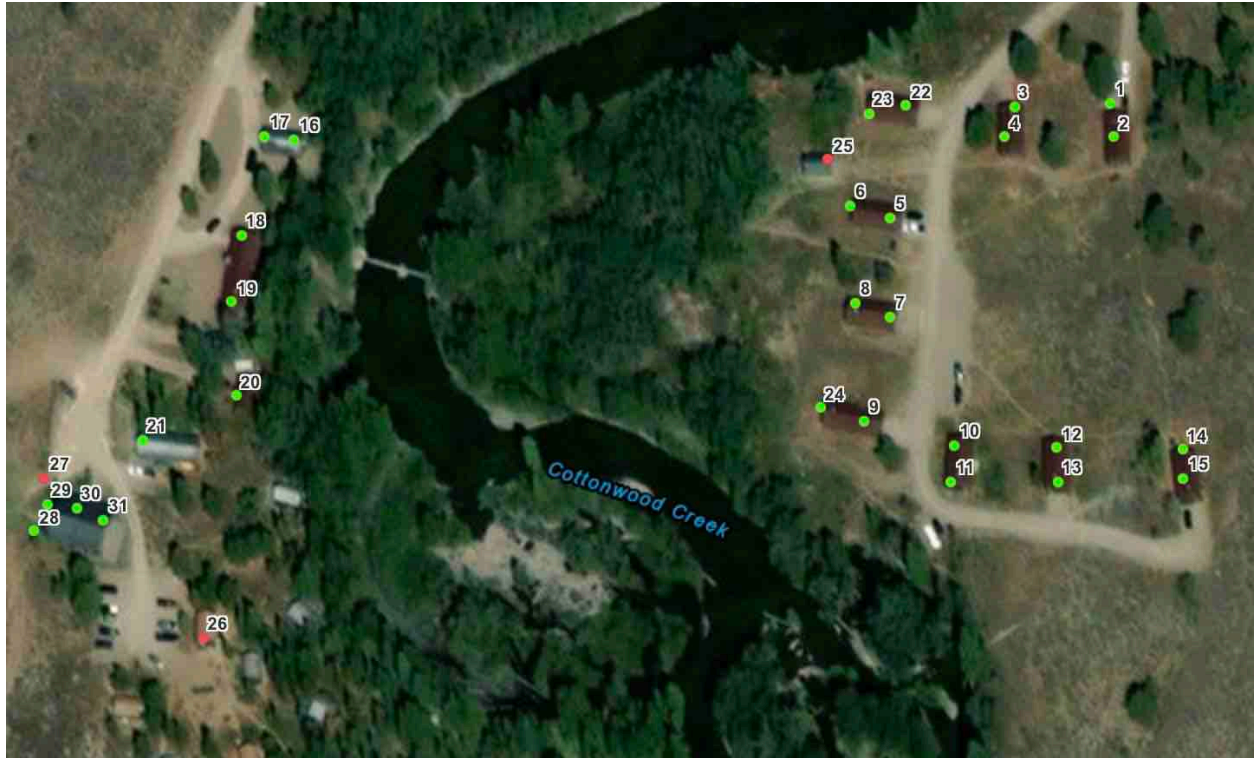
**Figure AXI-1. Fixture Locations and Compliance Assessment: Lupine Meadows.** Dark sky compliant lighting has a green marker and non-compliant lighting has a red marker. Numbers present above the dots indicate the fixture ID number whose characteristics are presented within the tables.

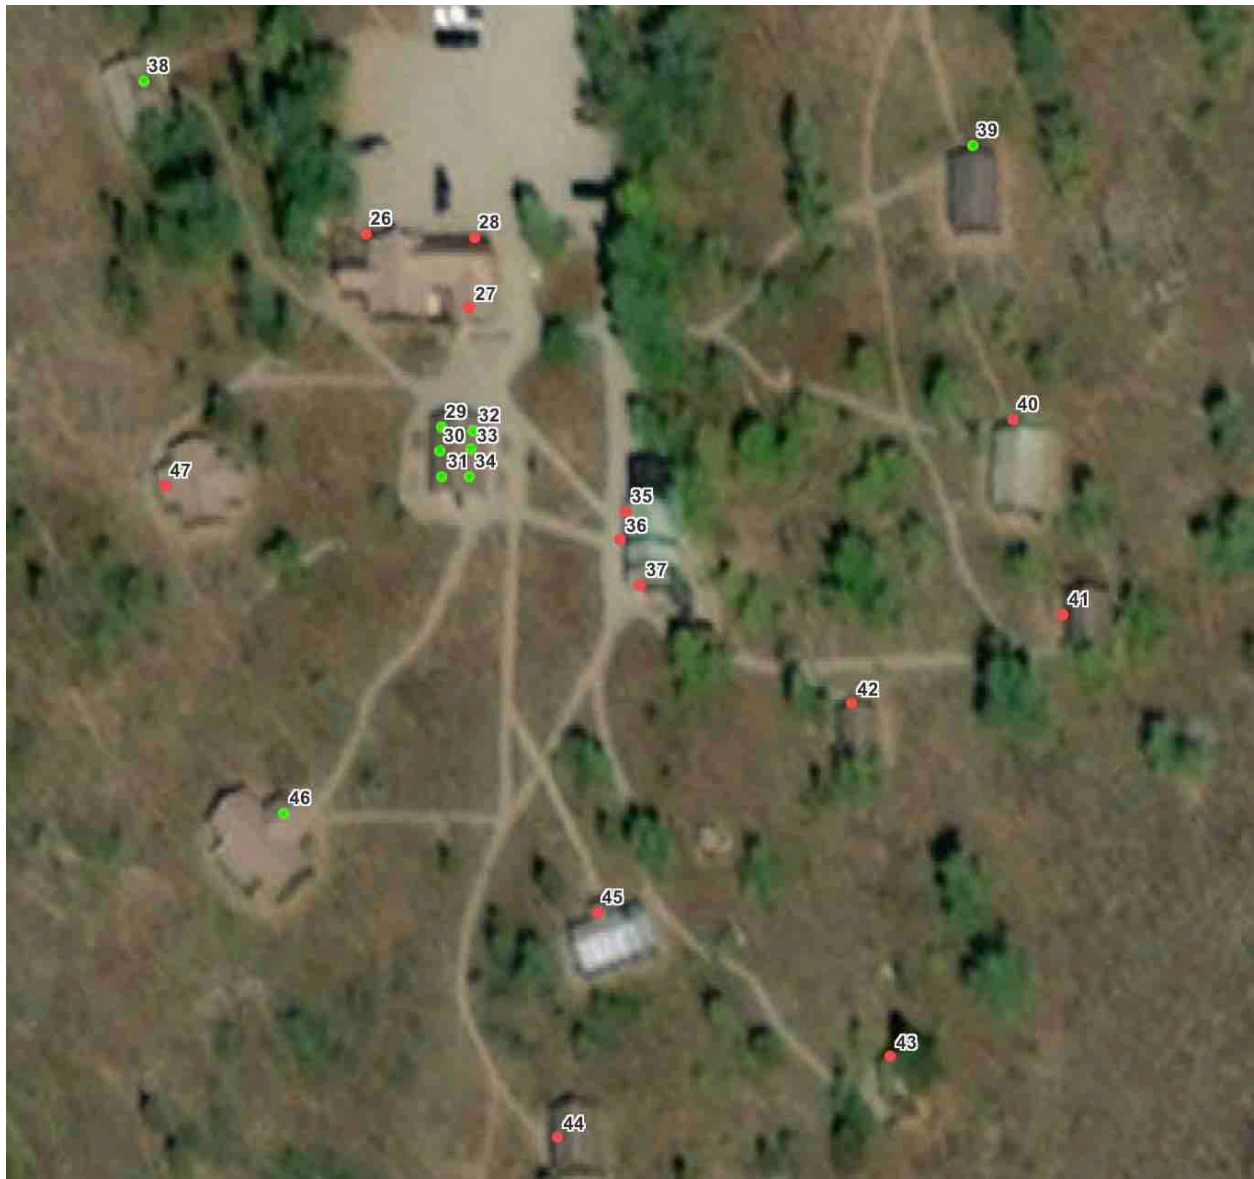
**Figure AXII-3. Fixture Locations and Compliance Assessment: Cabins.** Dark sky compliant lighting has a green marker and non-compliant lighting has a red marker. Numbers present above the dots indicate the fixture ID number whose characteristics are presented within the tables.

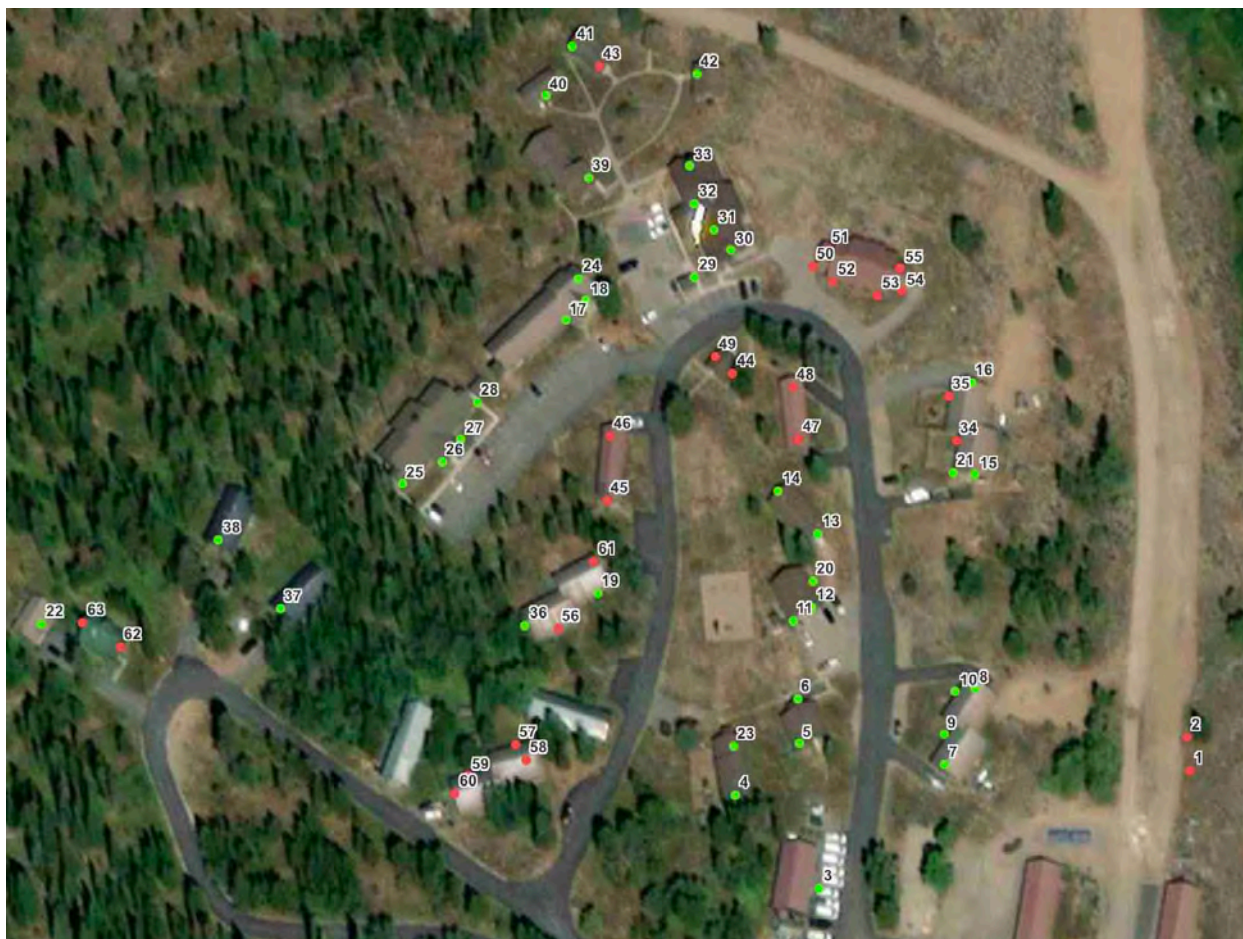
**Figure AXIII-1. Fixture Locations and Compliance Assessment: Pine Martin Drive Area.** Dark sky compliant lighting has a green marker and non-compliant lighting has a red marker. Numbers present above the dots indicate the fixture ID number whose characteristics are presented within the tables.

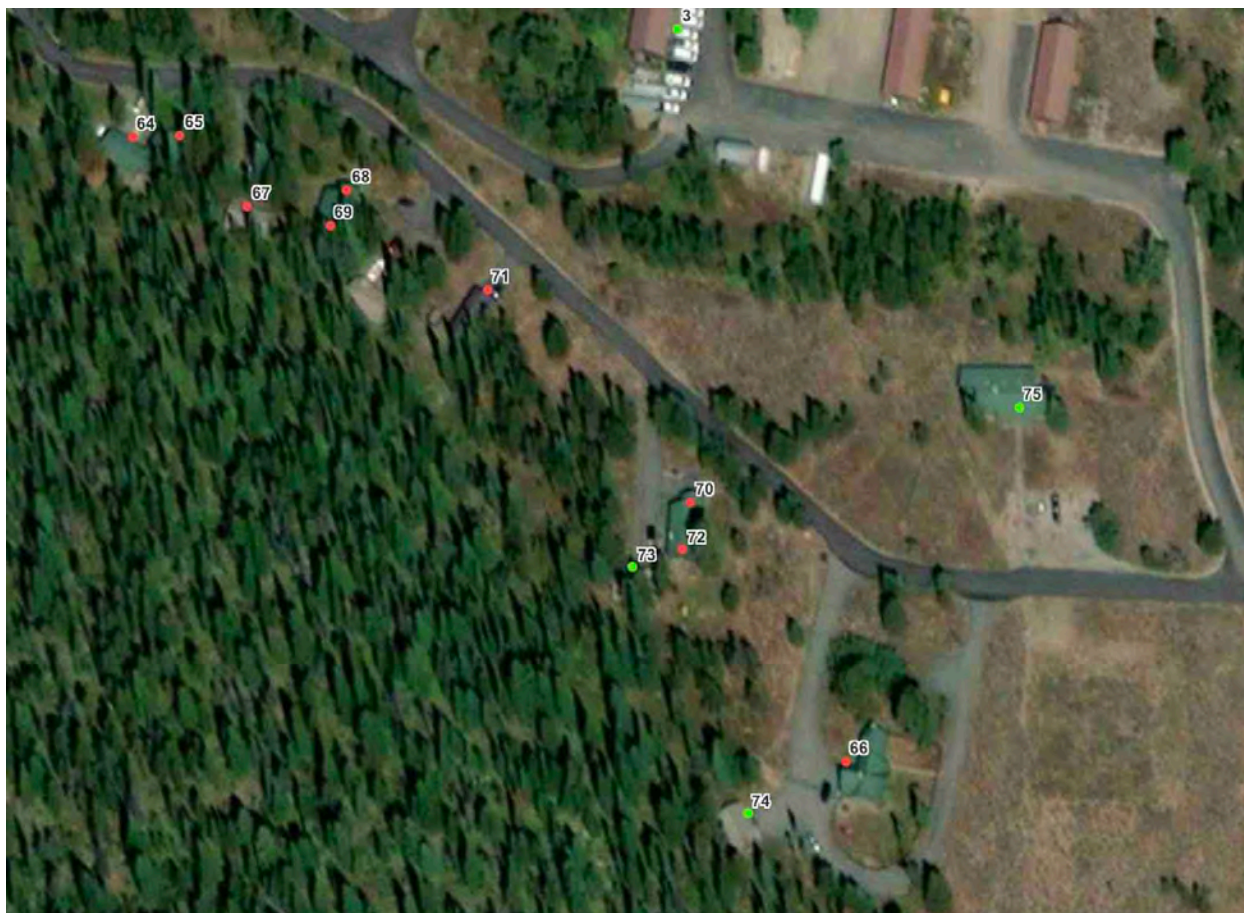
**Figure AXIII-2. Fixture Locations and Compliance Assessment: Beaver Creek Road Area.** Dark sky compliant lighting has a green marker and non-compliant lighting has a red marker. Numbers present above the dots indicate the fixture ID number whose characteristics are presented within the tables.

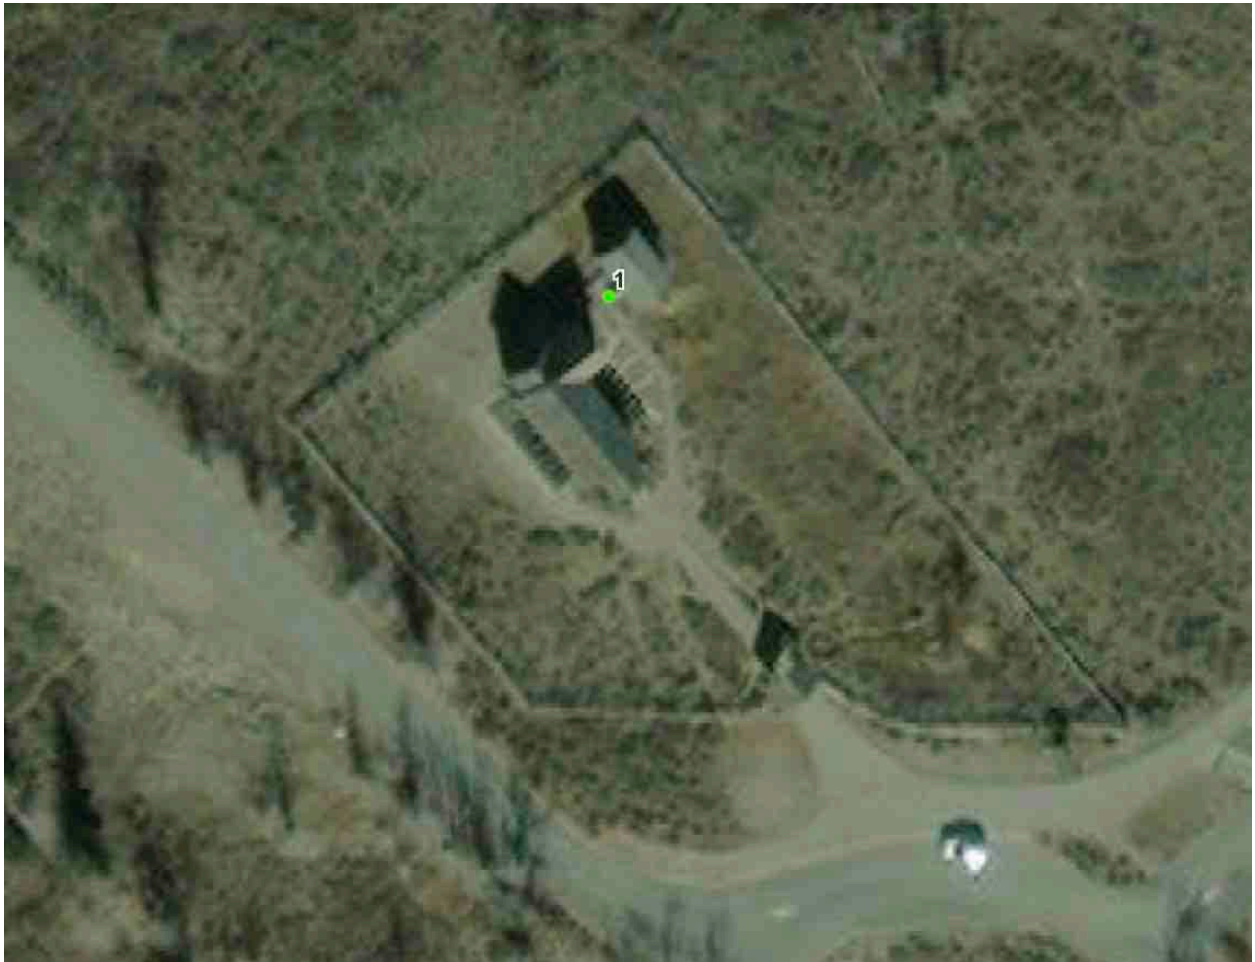
**Figure AXIV-1. Fixture Locations and Compliance Assessment: Chapel of the Transfiguration.** Dark sky compliant lighting has a green marker and non-compliant lighting has a red marker. Numbers present above the dots indicate the fixture ID number whose characteristics are presented within the tables.

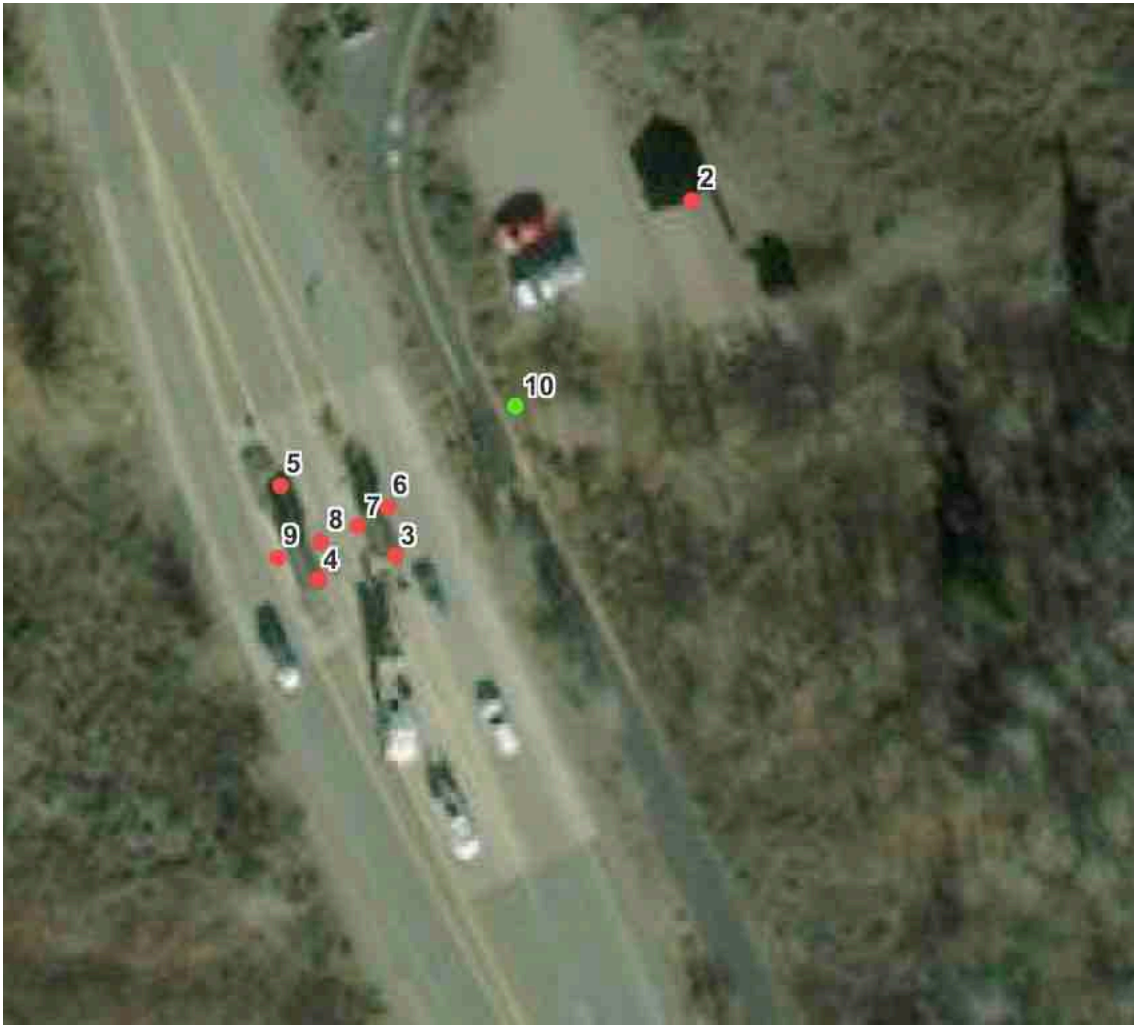
**Figure AXIV-2. Fixture Locations and Compliance Assessment: Entrance Station Area.** Dark sky compliant lighting has a green marker and non-compliant lighting has a red marker. Numbers present above the dots indicate the fixture ID number whose characteristics are presented within the tables.

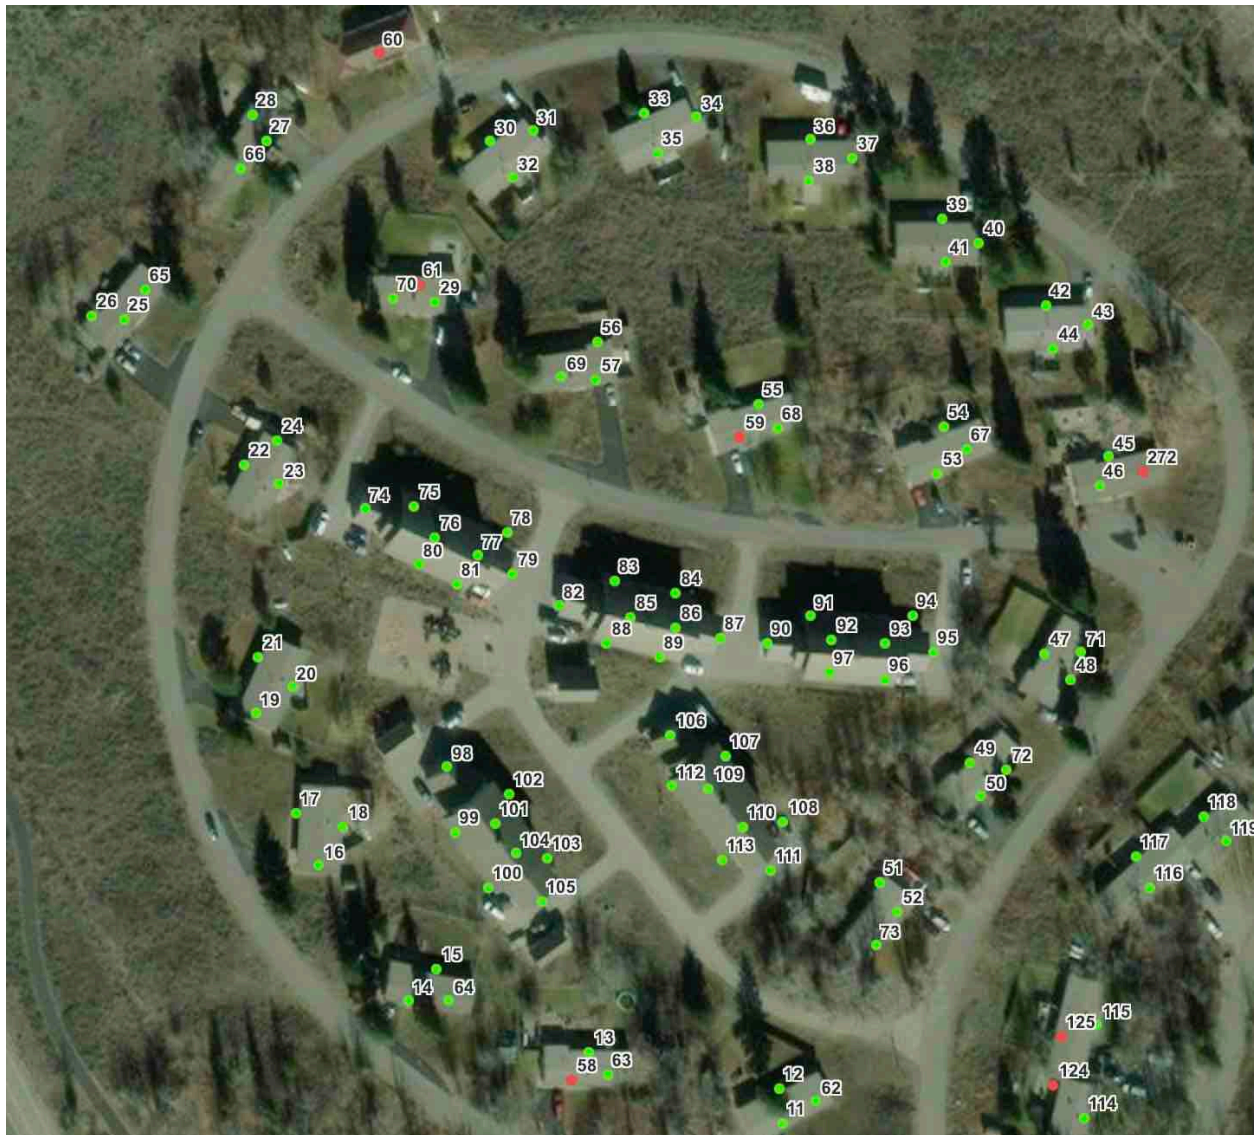
**Figure AXIV-3. Fixture Locations and Compliance Assessment: Mather Circle, Carncross Drive, and Burt Drive.** Dark sky compliant lighting has a green marker and non-compliant lighting has a red marker. Numbers present above the dots indicate the fixture ID number whose characteristics are presented within the tables.
