Exterior Lighting Assessment and Design Recommendations

**Grand Teton National Park**

Respectfully submitted by: Bryan Boulanger

July 26, 2022

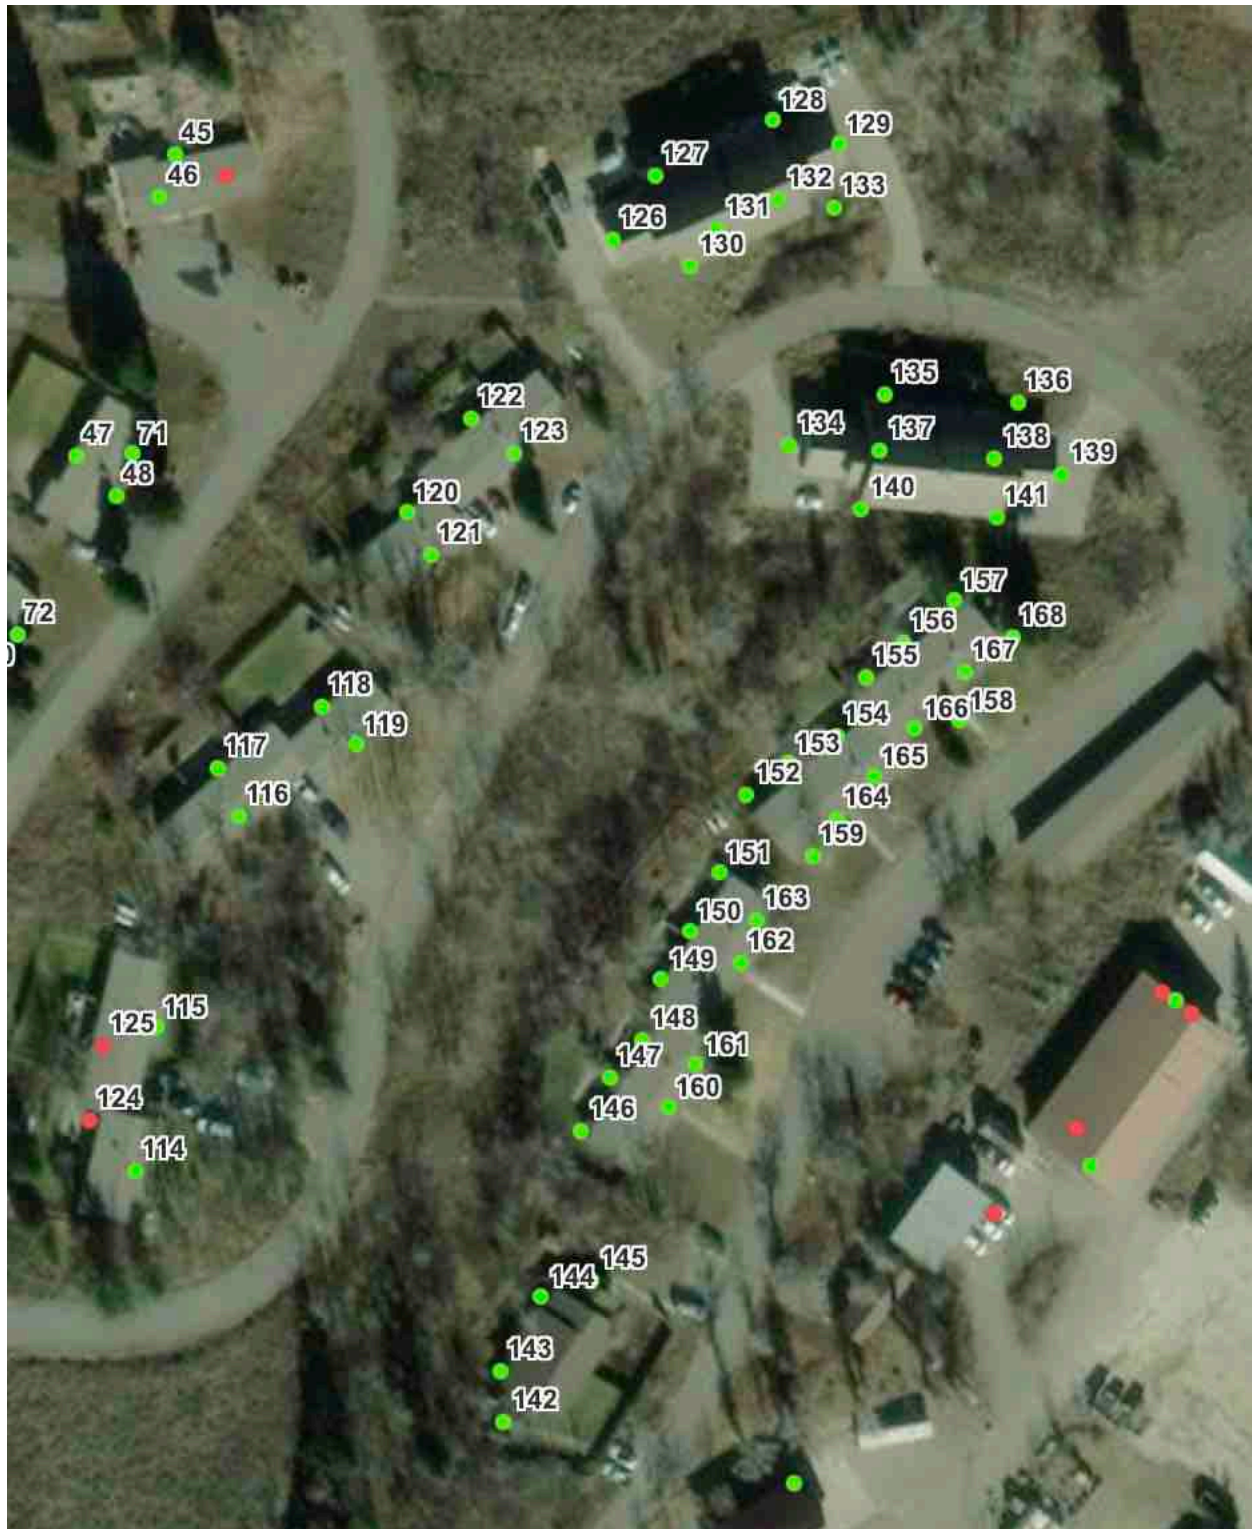
**Figure AXIV-4. Fixture Locations and Compliance Assessment: Noble Way and Headquarters Drive.** Dark sky compliant lighting has a green marker and non-compliant lighting has a red marker. Numbers present above the dots indicate the fixture ID number whose characteristics are presented within the tables.

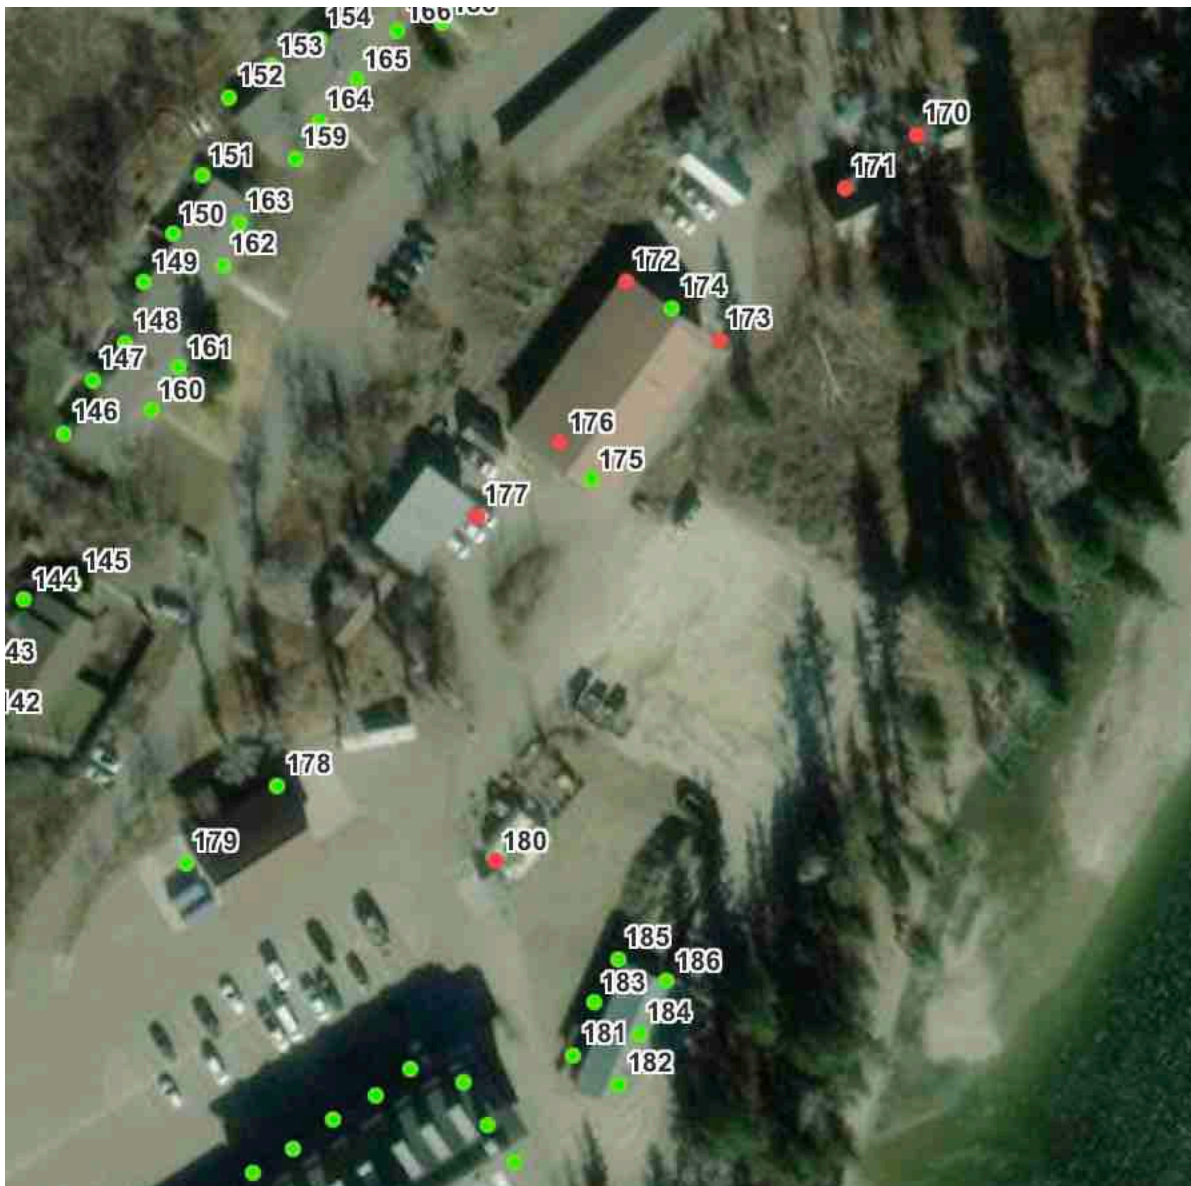
**Figure AXIV-5. Fixture Locations and Compliance Assessment: Hammond Road Maintenance Area.** Dark sky compliant lighting has a green marker and non-compliant lighting has a red marker. Numbers present above the dots indicate the fixture ID number whose characteristics are presented within the tables.

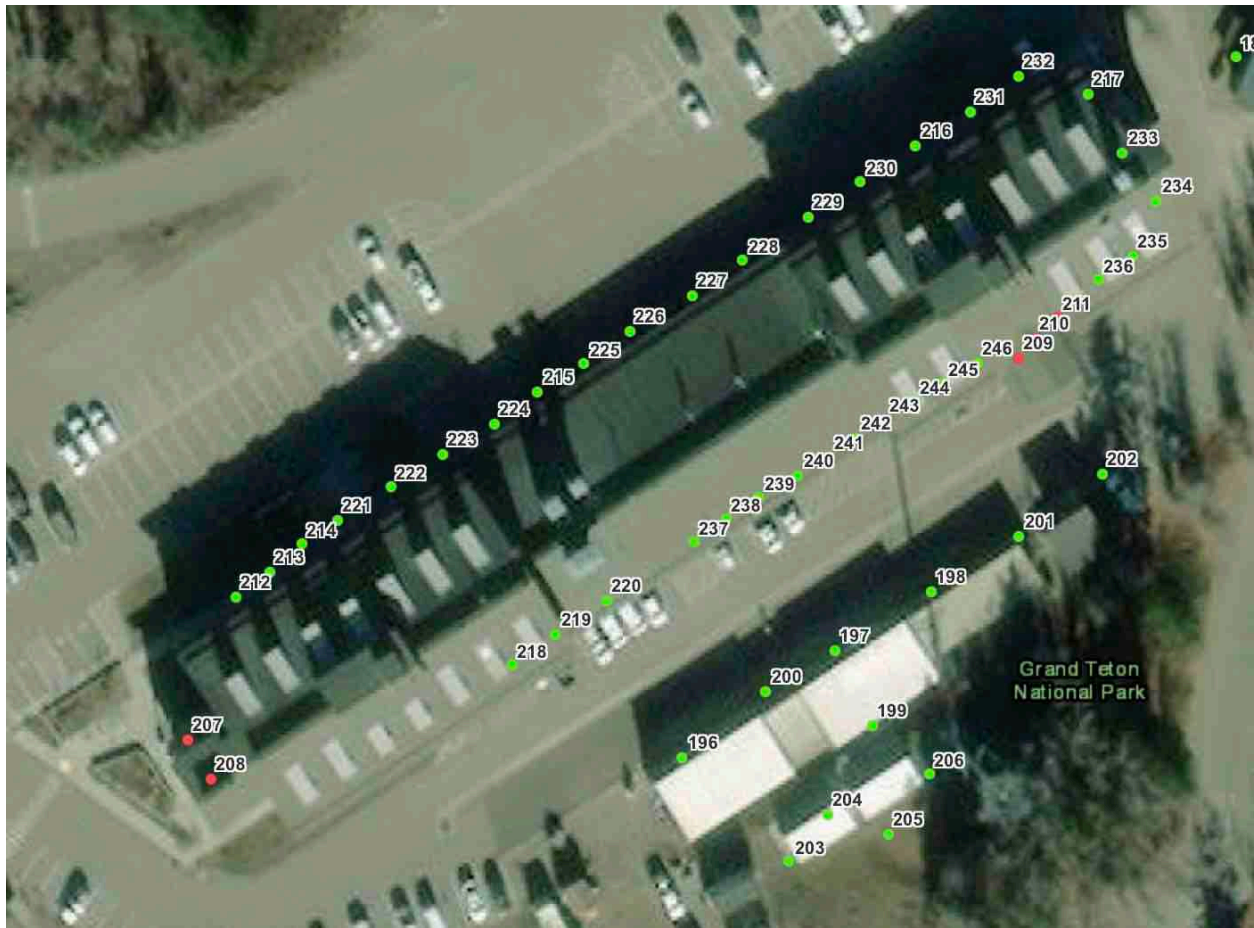
**Figure AXIV-8. Fixture Locations and Compliance Assessment: Headquarters Building.** Dark sky compliant lighting has a green marker and non-compliant lighting has a red marker. Numbers present above the dots indicate the fixture ID number whose characteristics are presented within the tables.

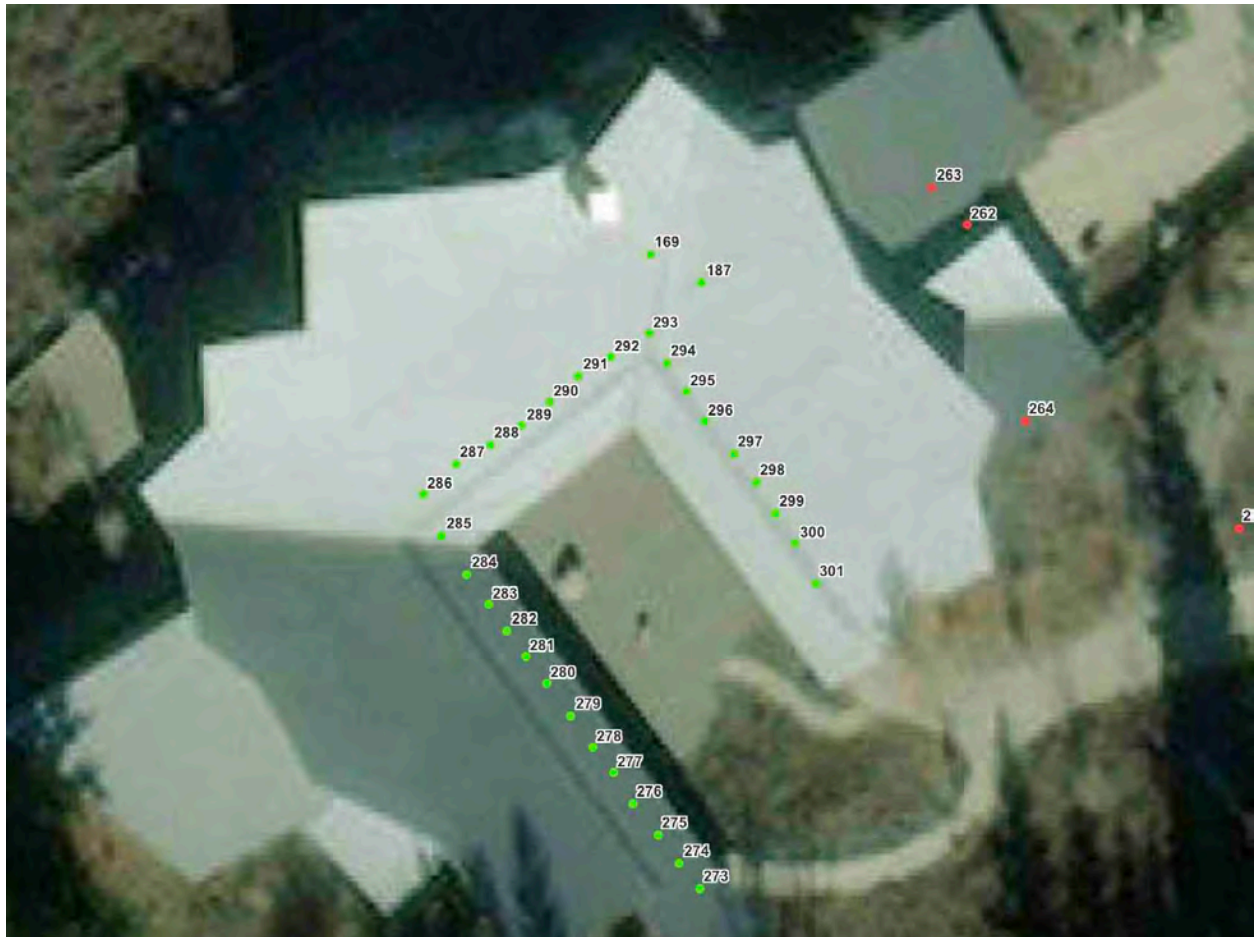
**Figure AXIV-10. Fixture Locations and Compliance Assessment: Visitor Center Building.** Dark sky compliant lighting has a green marker and non-compliant lighting has a red marker. Numbers present above the dots indicate the fixture ID number whose characteristics are presented within the tables.

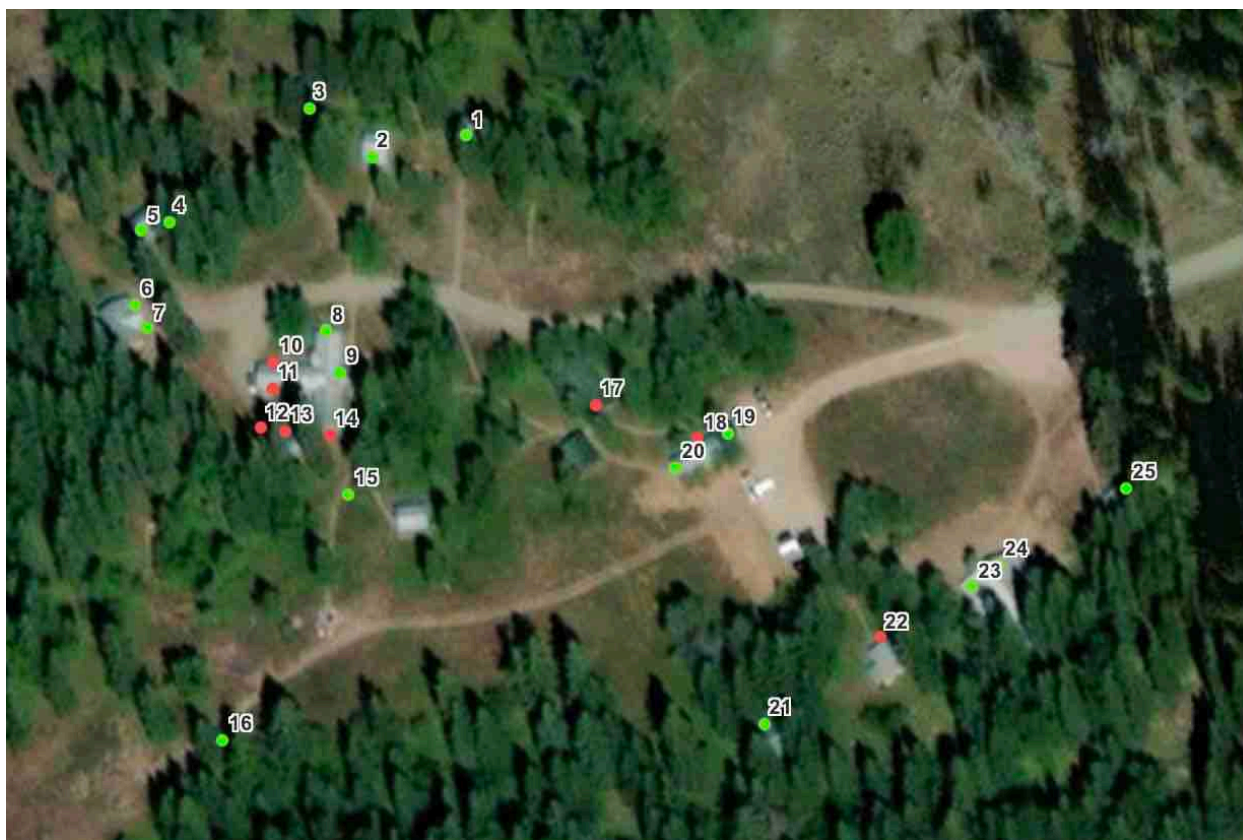
**Figure AXV-1. Fixture Locations and Compliance Assessment: Murie Ranch.** Dark sky compliant lighting has a green marker and non-compliant lighting has a red marker. Numbers present above the dots indicate the fixture ID number whose characteristics are presented within the tables.

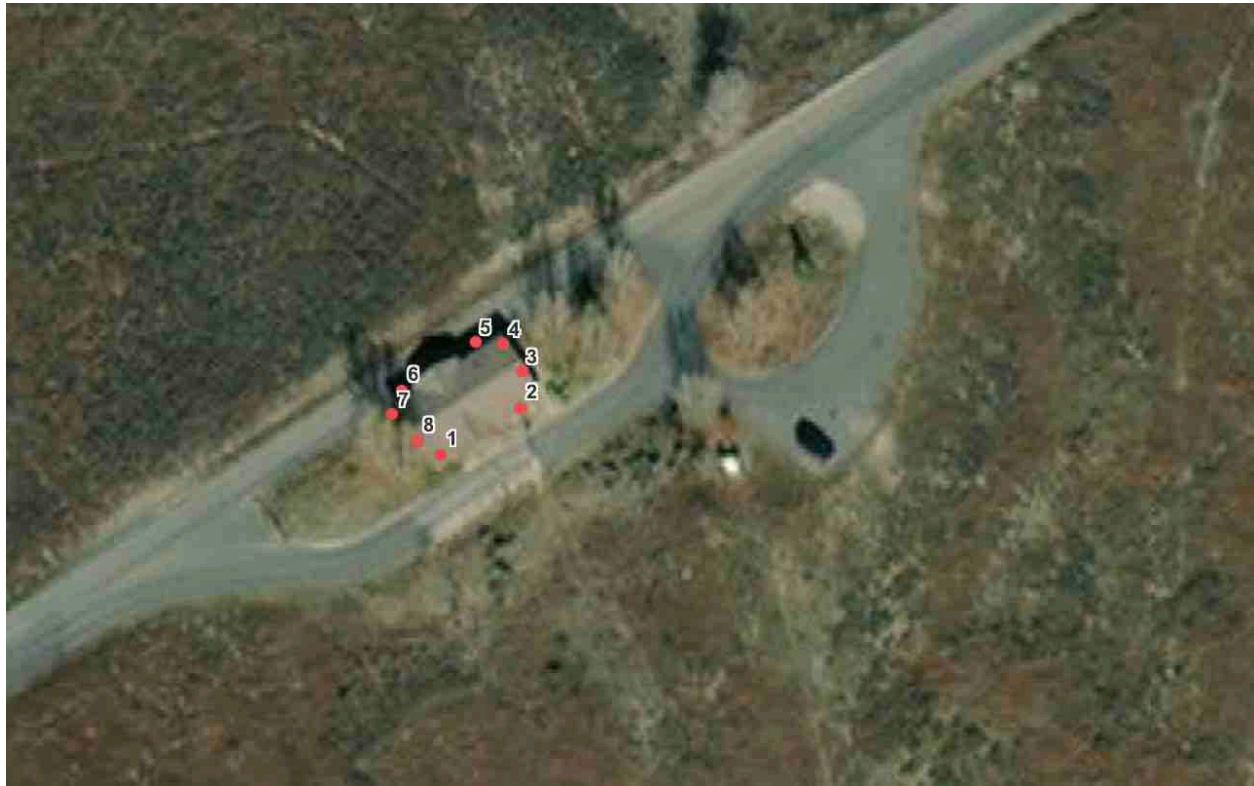
**Figure AXVI-1. Fixture Locations and Compliance Assessment: Entrance Station.** Dark sky compliant lighting has a green marker and non-compliant lighting has a red marker. Numbers present above the dots indicate the fixture ID number whose characteristics are presented within the tables.

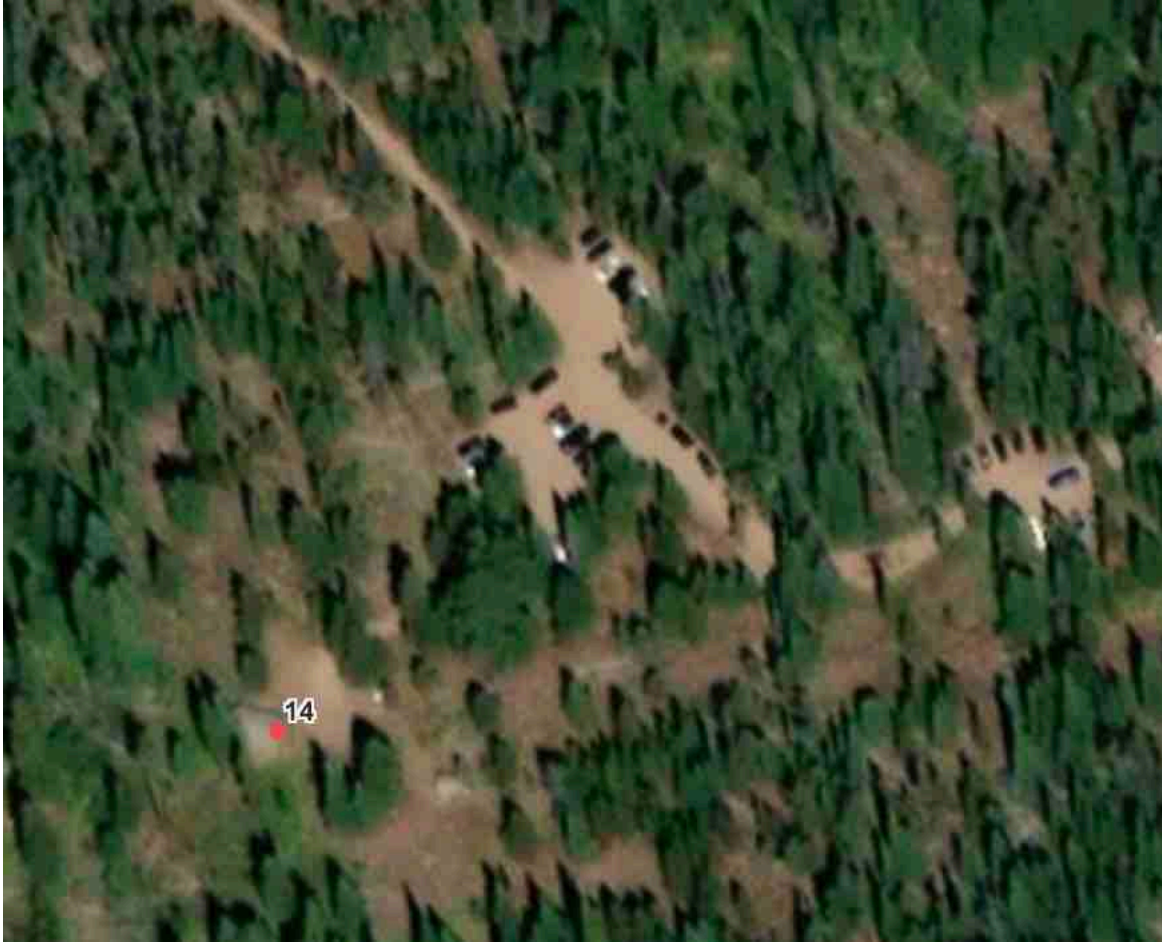
**Figure AXVI-3. Fixture Locations and Compliance Assessment: White Grass Ranger Station.** Dark sky compliant lighting has a green marker and non-compliant lighting has a red marker. Numbers present above the dots indicate the fixture ID number whose characteristics are presented within the tables.

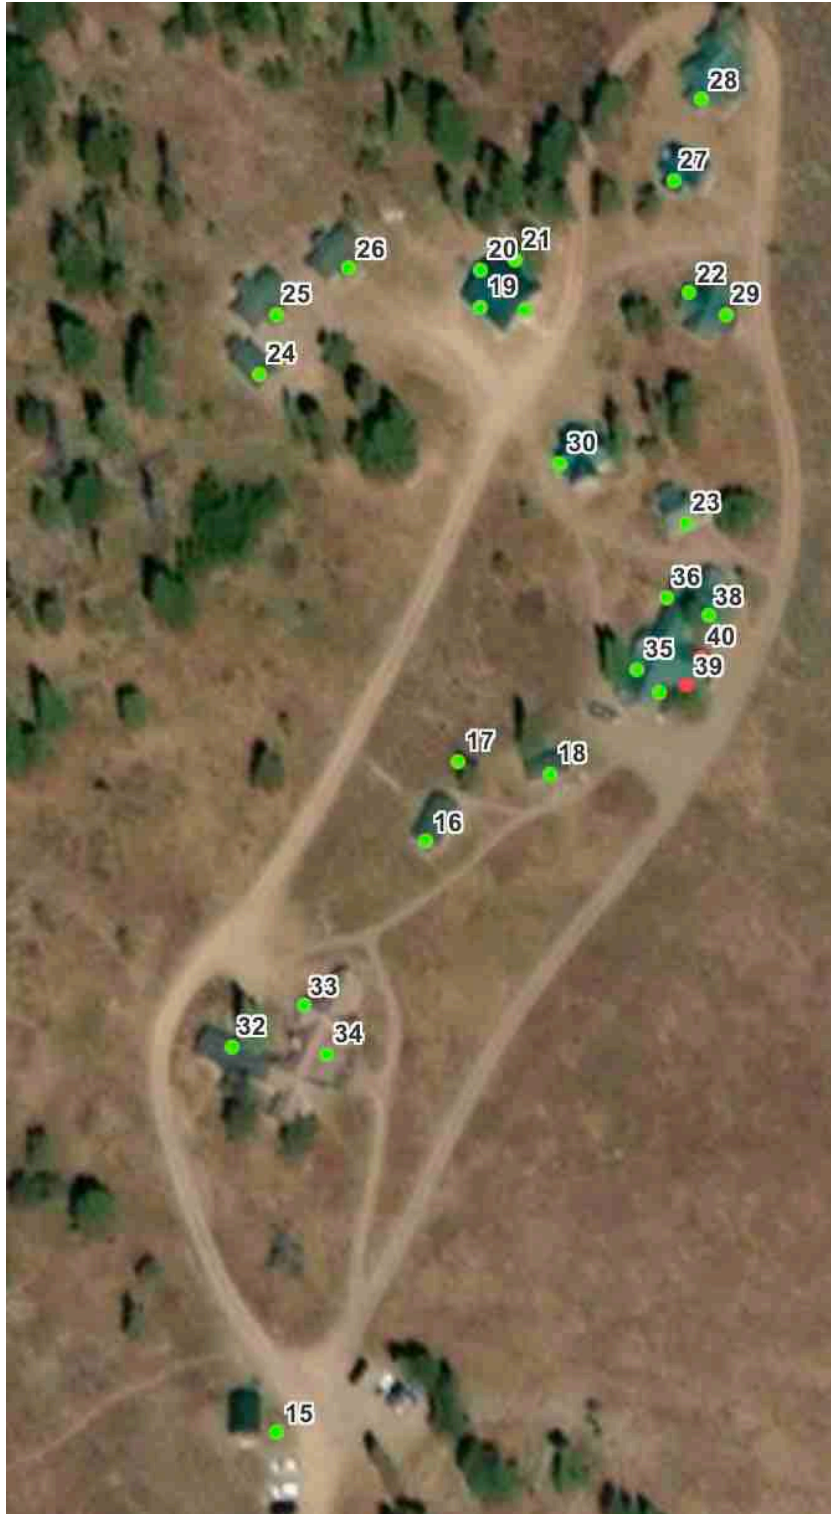
**Figure AXVI-4. Fixture Locations and Compliance Assessment: White Grass Cabin Area.** Dark sky compliant lighting has a green marker and non-compliant lighting has a red marker. Numbers present above the dots indicate the fixture ID number whose characteristics are presented within the tables.

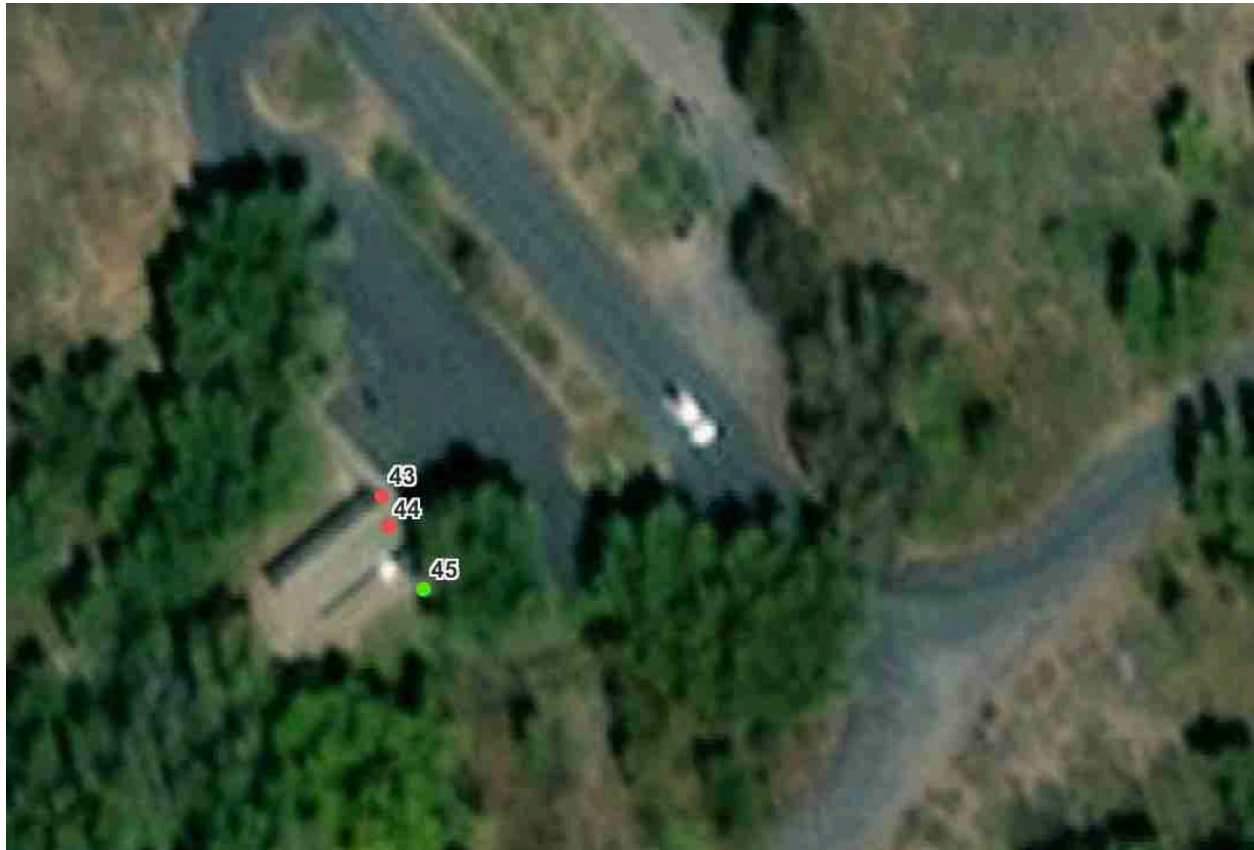
**Figure AXVIII-2. Fixture Locations and Compliance Assessment: Campground Office.** Dark sky compliant lighting has a green marker and non-compliant lighting has a red marker. Numbers present above the dots indicate the fixture ID number whose characteristics are presented within the tables.

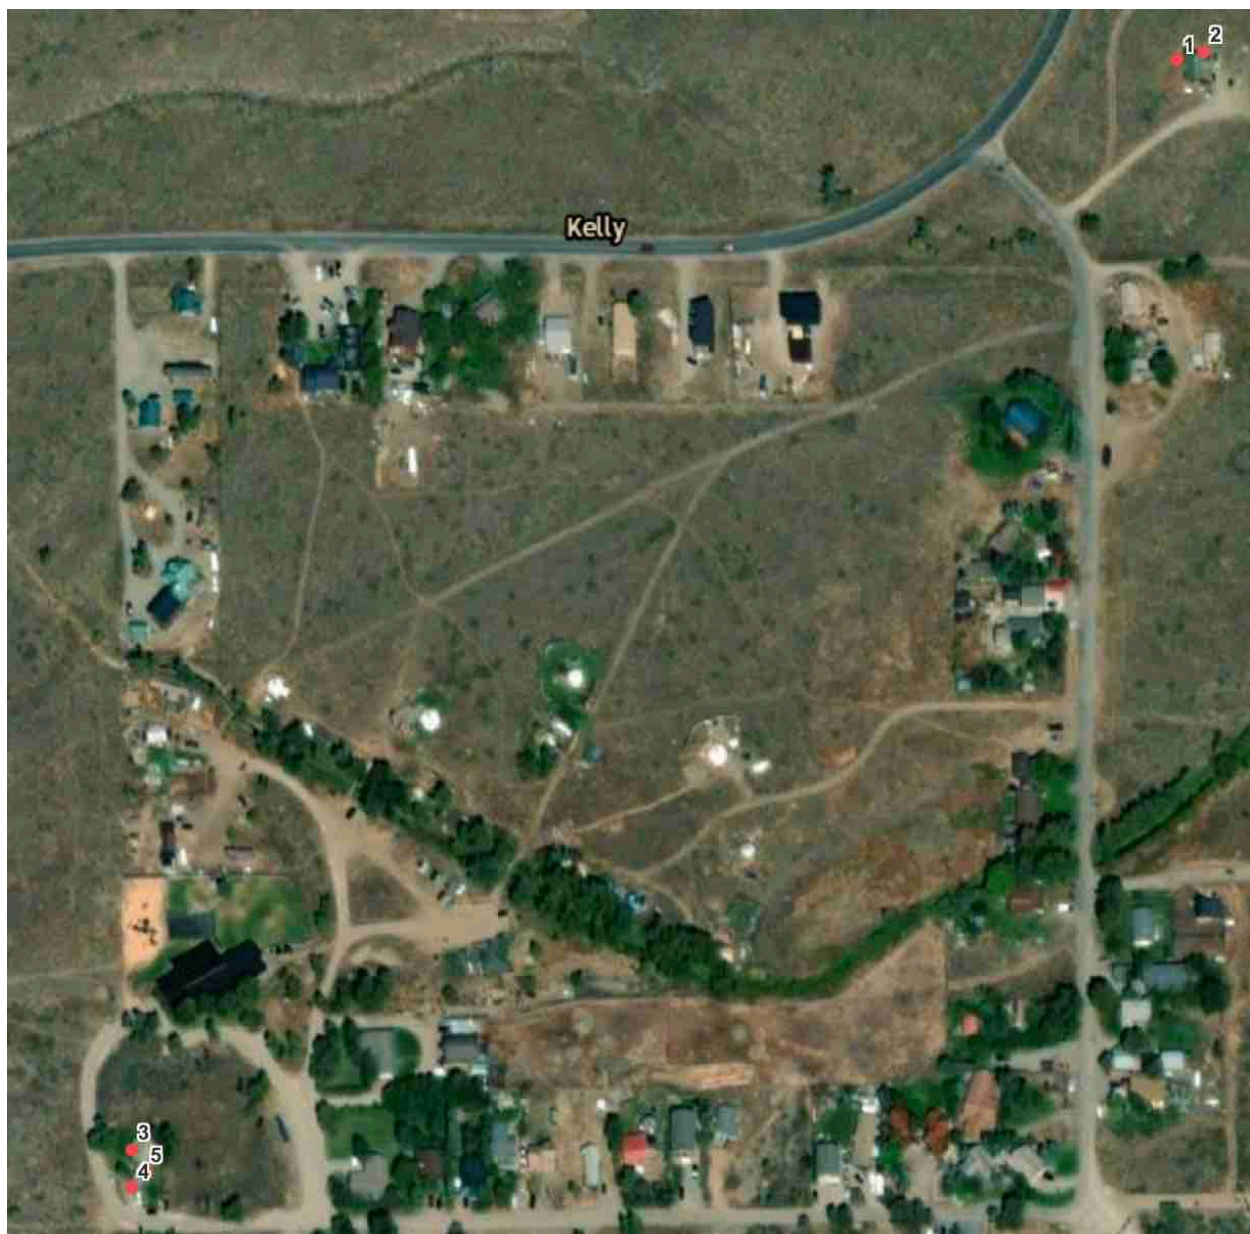
**Figure AXIX-1. Fixture Locations and Compliance Assessment: Kelly.** Dark sky compliant lighting has a green marker and non-compliant lighting has a red marker. Numbers present above the dots indicate the fixture ID number whose characteristics are presented within the tables.

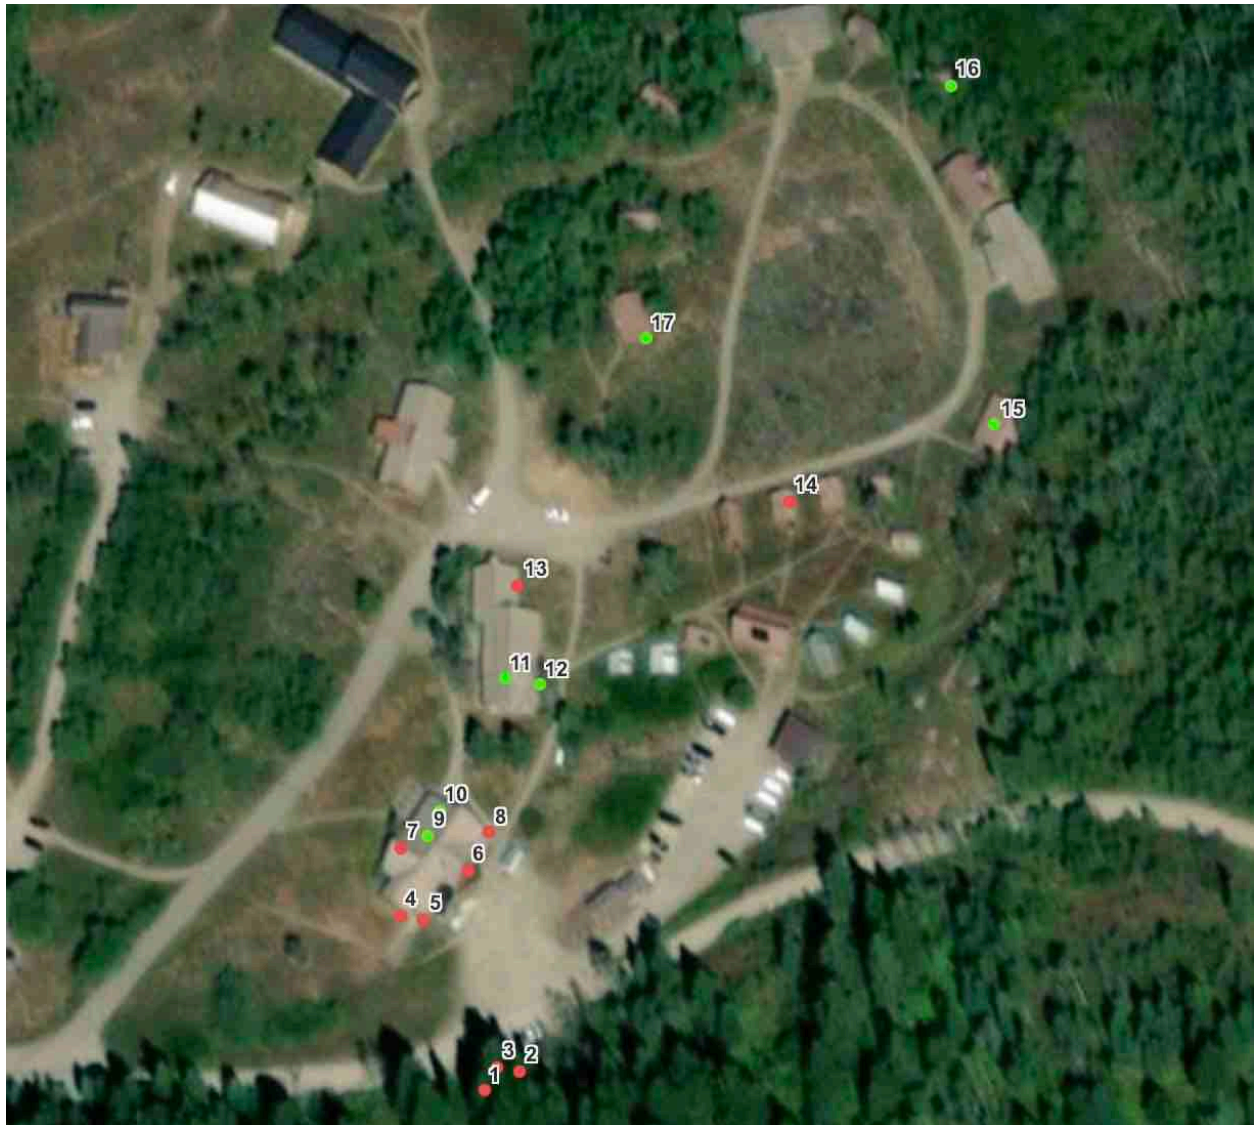
**Figure AXX-1. Fixture Locations and Compliance Assessment: Teton Science School Campus (Federal Buildings Only).** Dark sky compliant lighting has a green marker and non-compliant lighting has a red marker. Numbers present above the dots indicate the fixture ID number whose characteristics are presented within the tables.

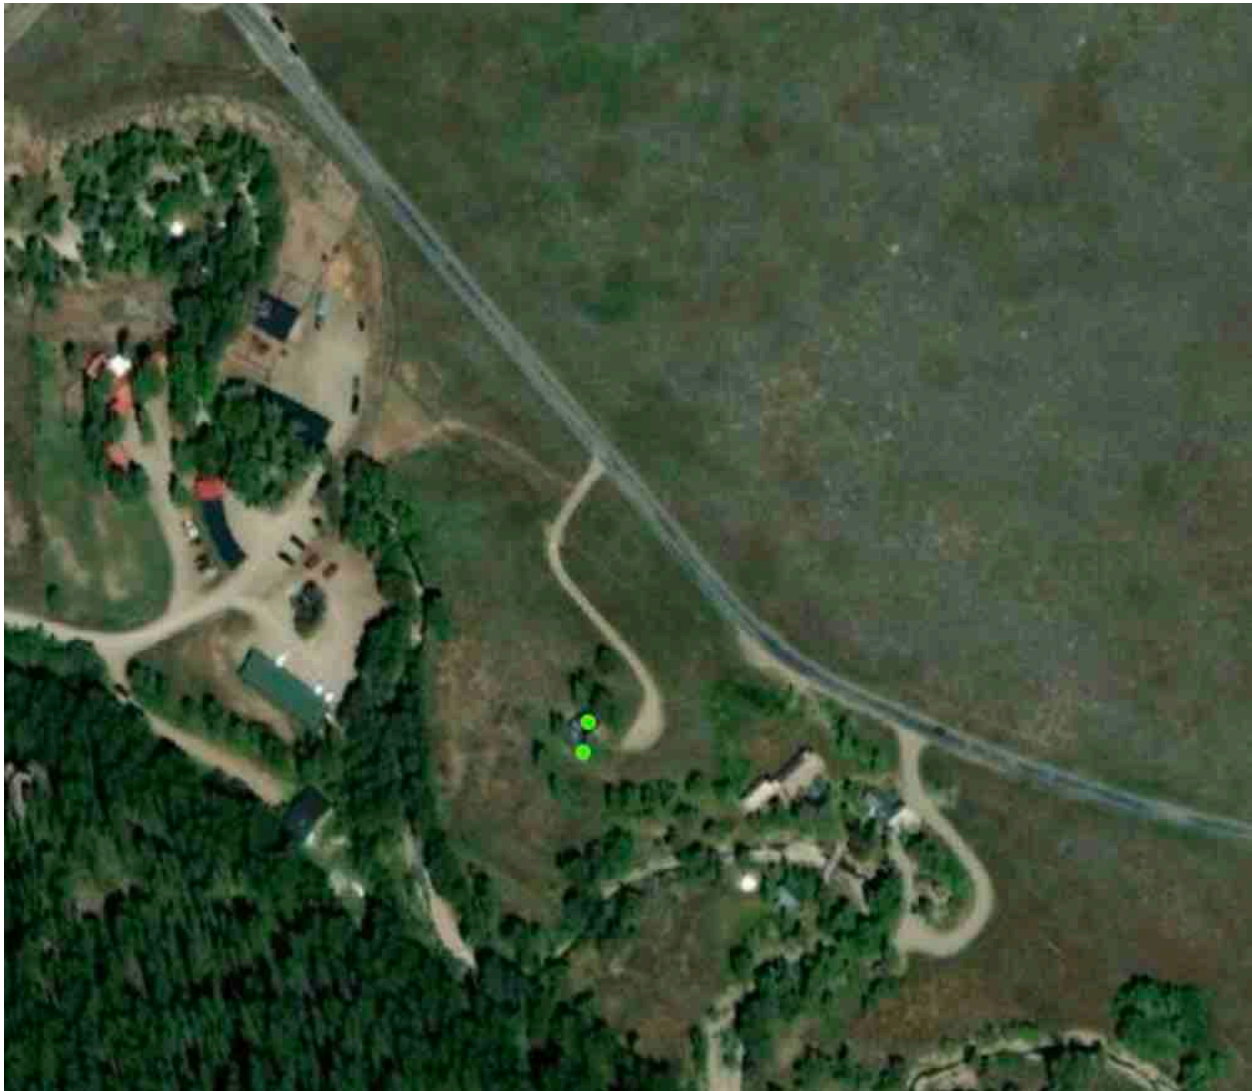
**Figure AXXI-1. Fixture Locations and Compliance Assessment: Reimer House.** Dark sky compliant lighting has a green marker and non-compliant lighting has a red marker. Numbers present above the dots indicate the fixture ID number whose characteristics are presented within the tables.

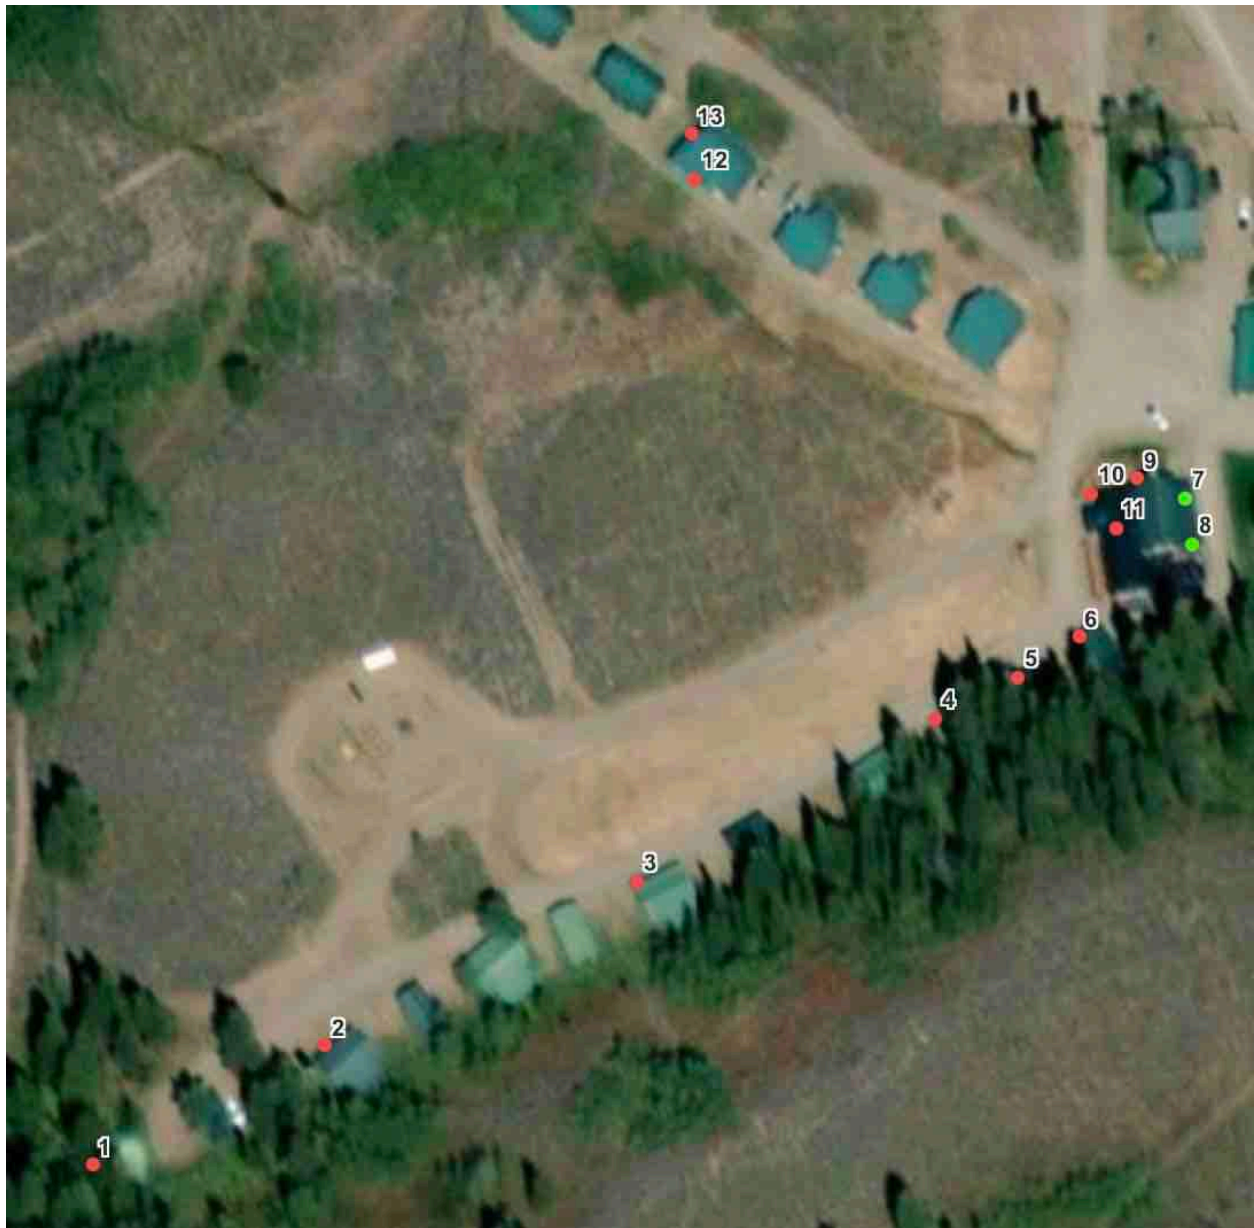
**Figure AXXII-1. Fixture Locations and Compliance Assessment: Cabins and Lodge.** Dark sky compliant lighting has a green marker and non-compliant lighting has a red marker. Numbers present above the dots indicate the fixture ID number whose characteristics are presented within the tables.

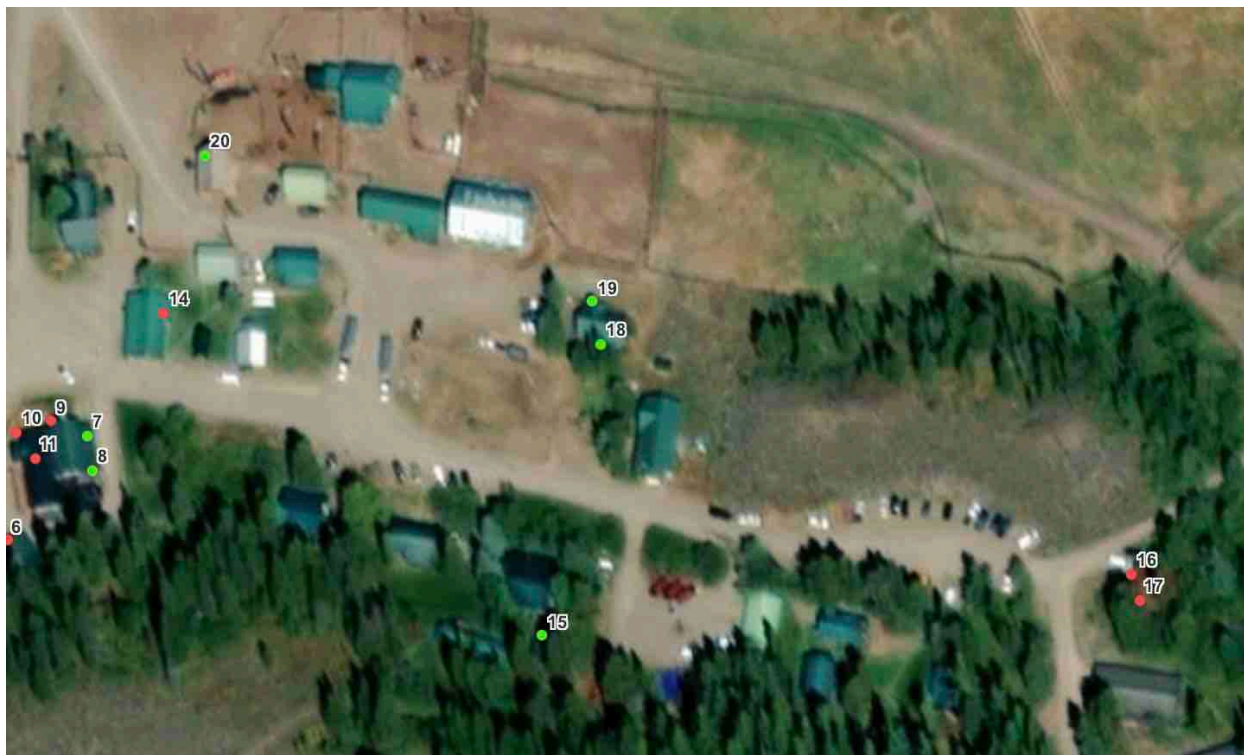
**Figure AXXII-2. Fixture Locations and Compliance Assessment: Employee Housing and Gift Shop.** Dark sky compliant lighting has a green marker and non-compliant lighting has a red marker. Numbers present above the dots indicate the fixture ID number whose characteristics are presented within the tables.
