FRIEDA FROMM-REICHMANN COTTAGE

National Historic Landmarks Nomination Form

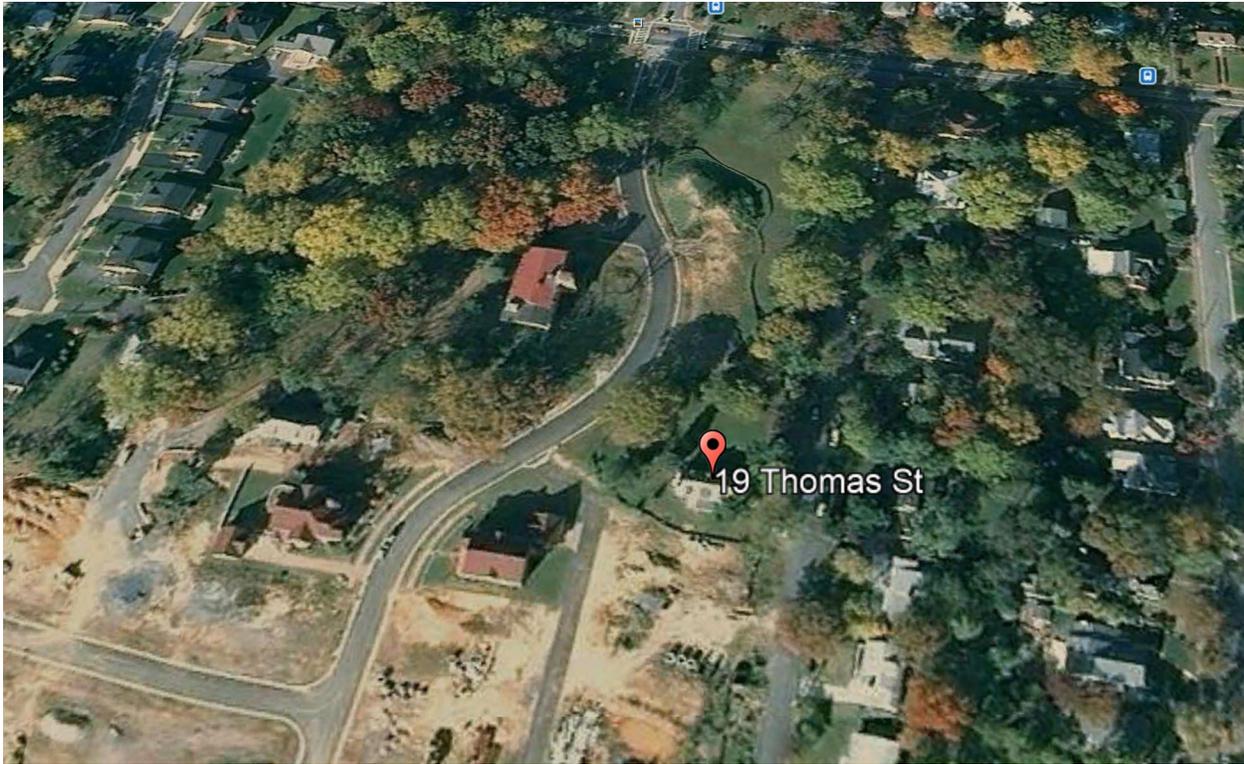
Figure 1. Aerial photo (2008) (with north toward the top of the page) shows Frieda’s Cottage at 19 Thomas Street and Chestnut Lodge northwest of the cottage. The Lodge was destroyed by fire in 2009. Scale: 100’ = ½”. Source: Google Earth.

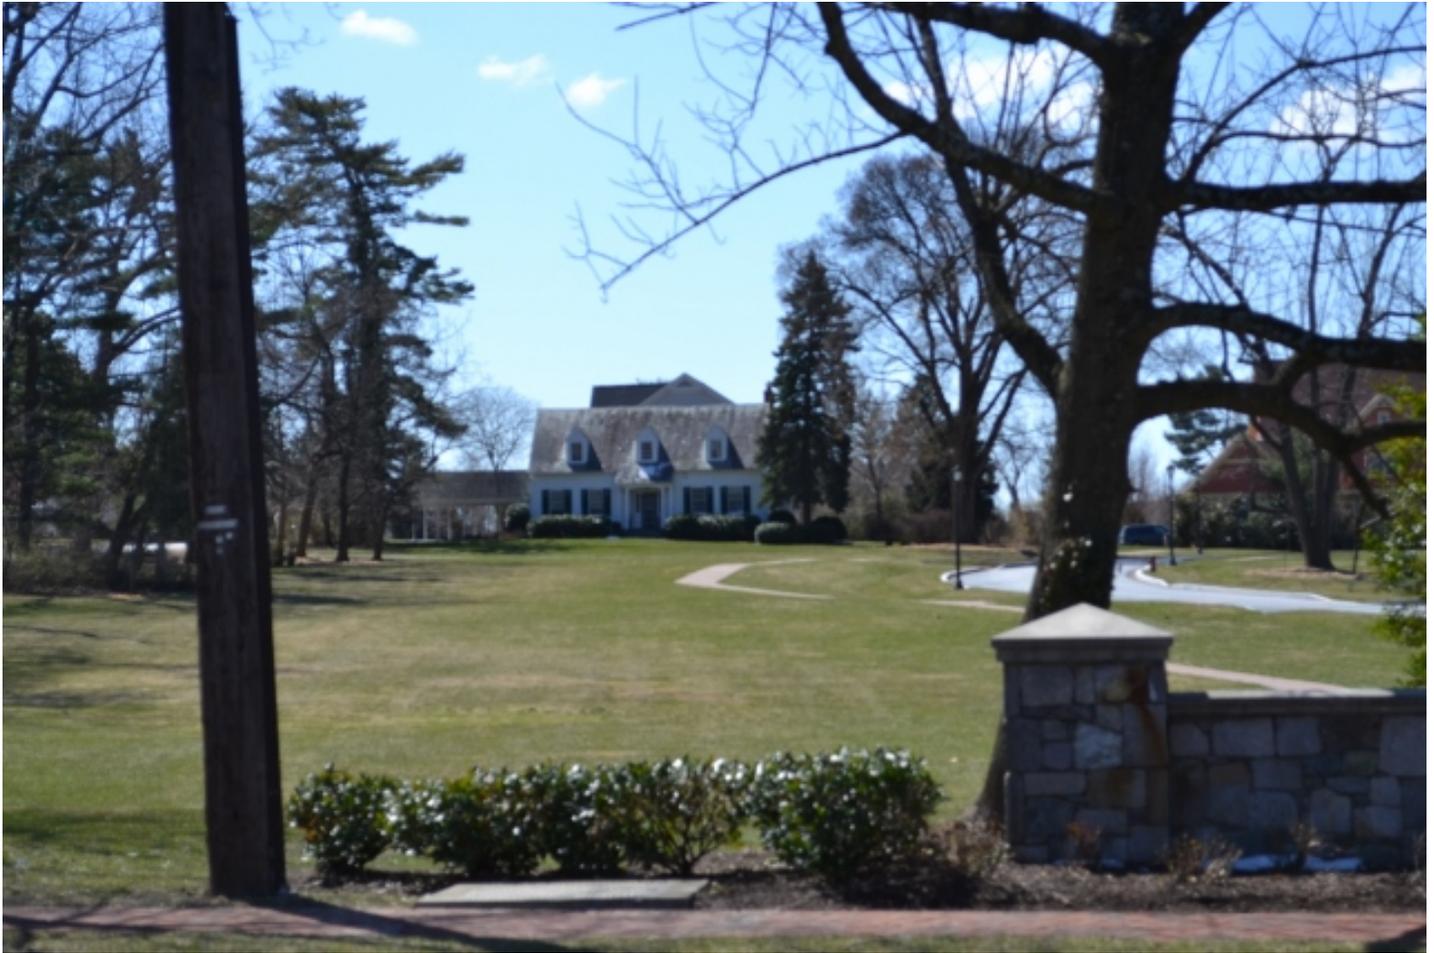
Photo 1. View looking south from Montgomery Avenue to front of cottage.

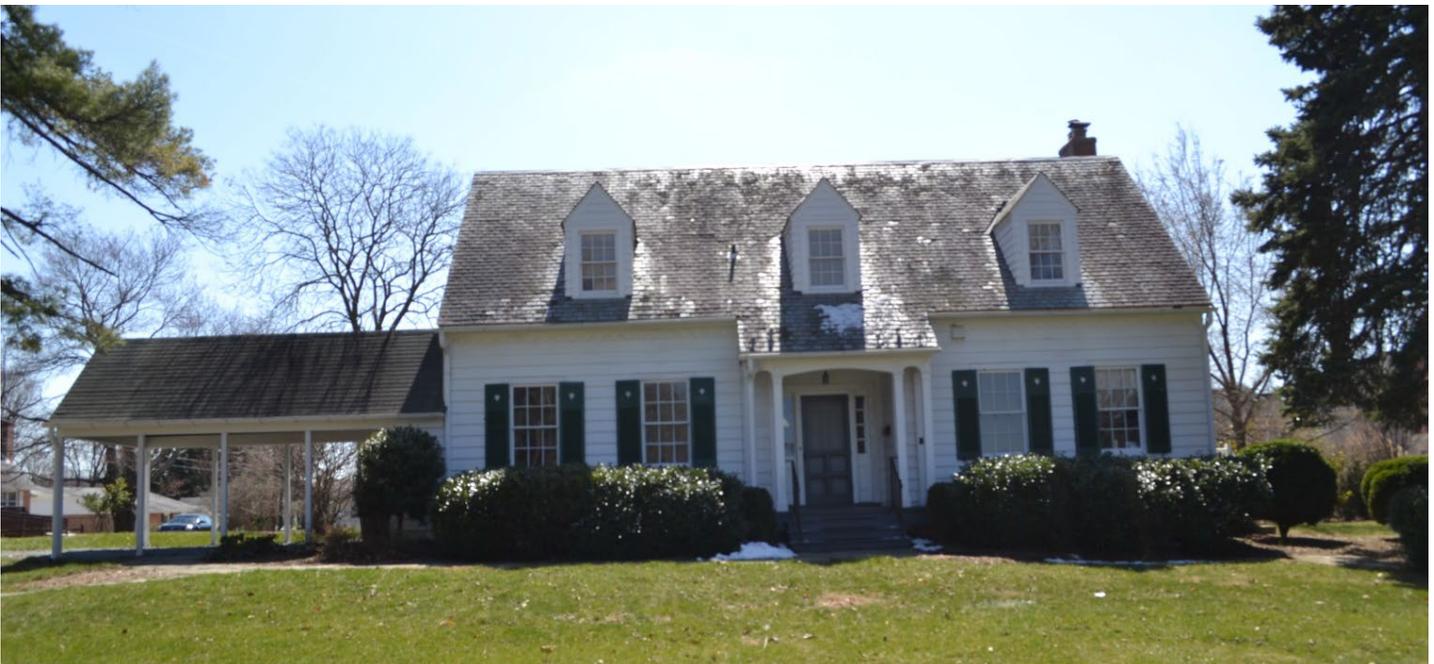
Photo 2. View of front of cottage with carport to the left.

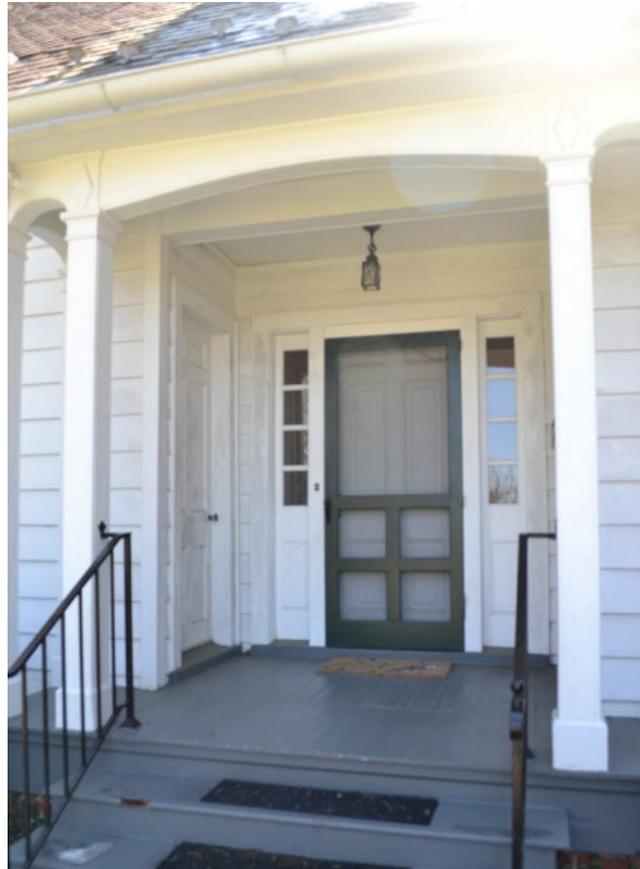
Photo 4. Close up view of front porch shows the primary door for visitors in the center and the secondary door for patients to the left.

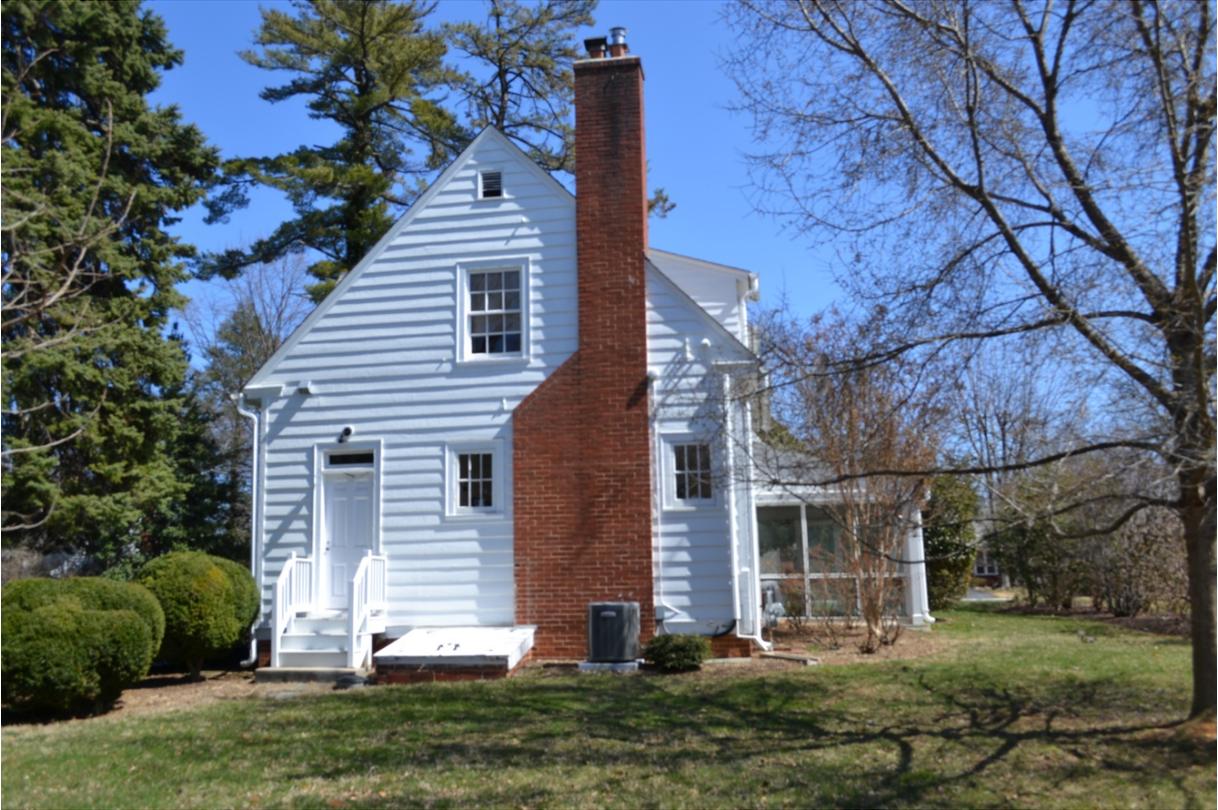
Photo 5. West side of cottage with entrance to the kitchen and the basement. The rear screen porch appears on the right.

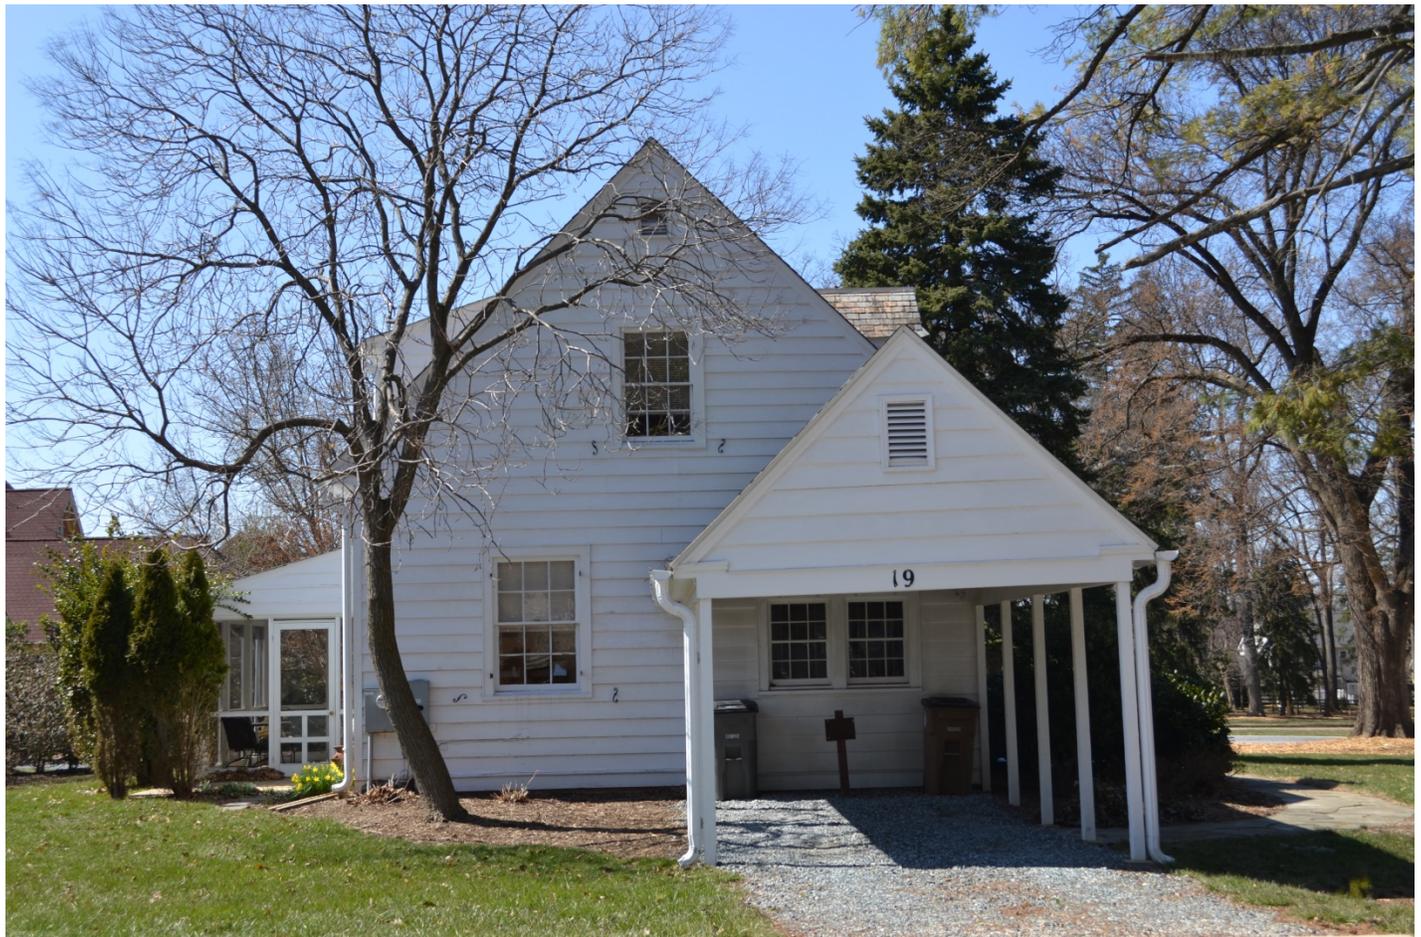
Photo 8. East side of cottage with carport. Windows on the wall below the carport appear to be the top half of a former double-door garage entry.

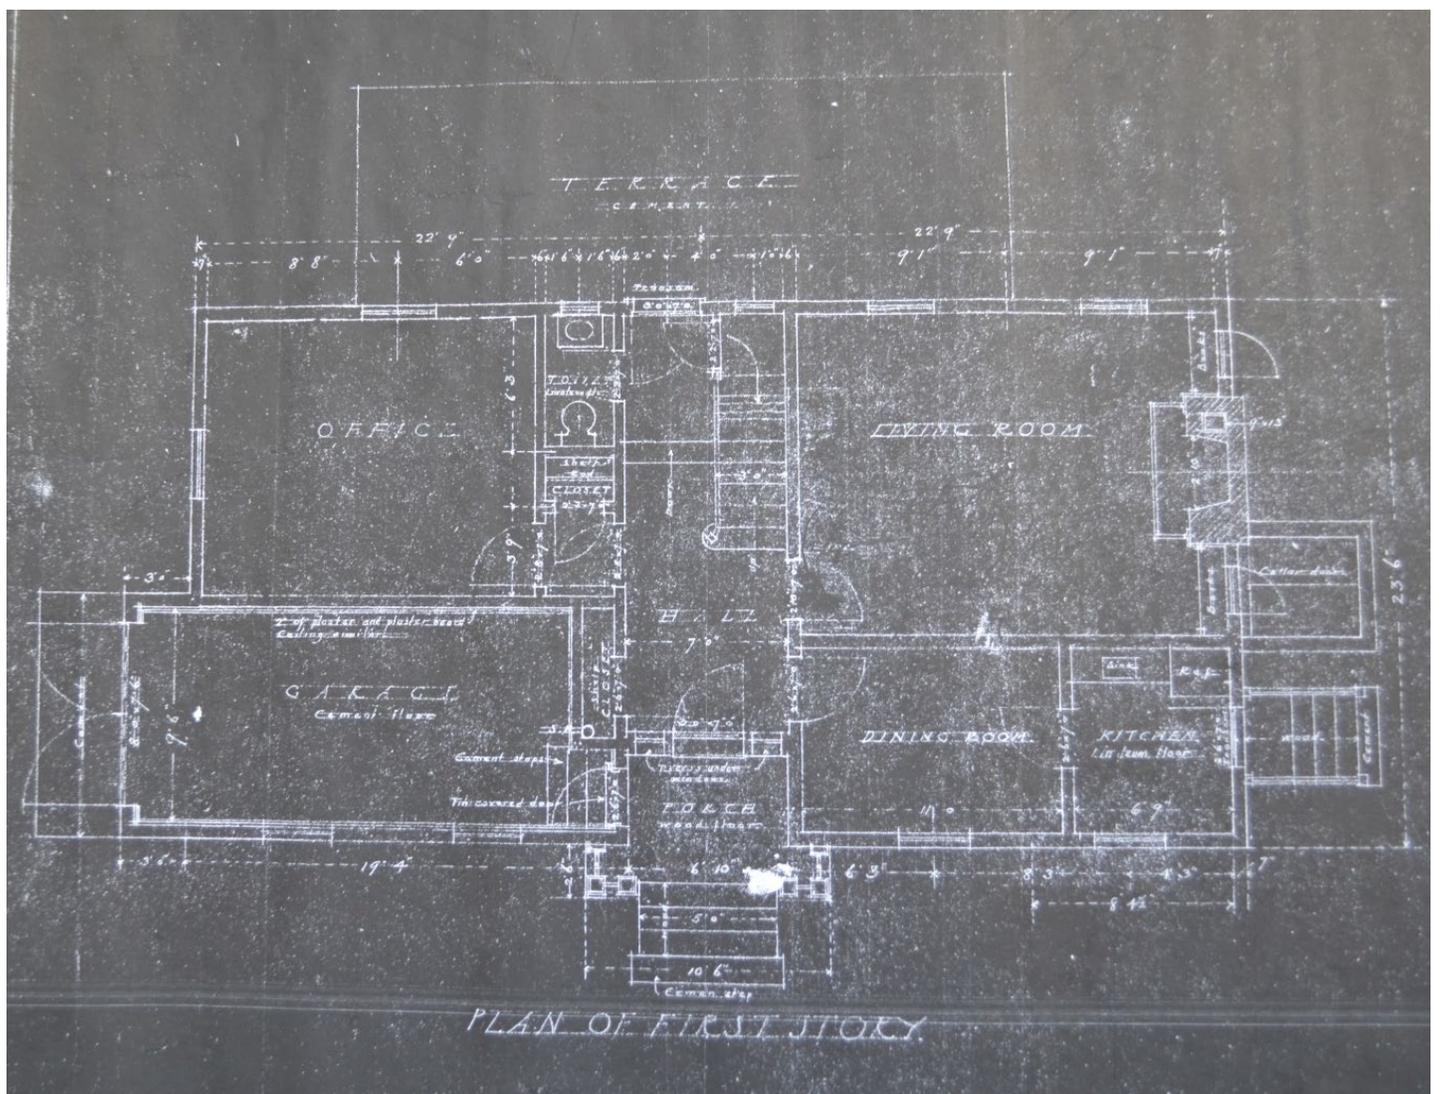
Figure 1. First floor cottage plan dated 1936 shows the garage inside the cottage, the office to the rear and the kitchen, dining and living rooms to the right of the hallway.

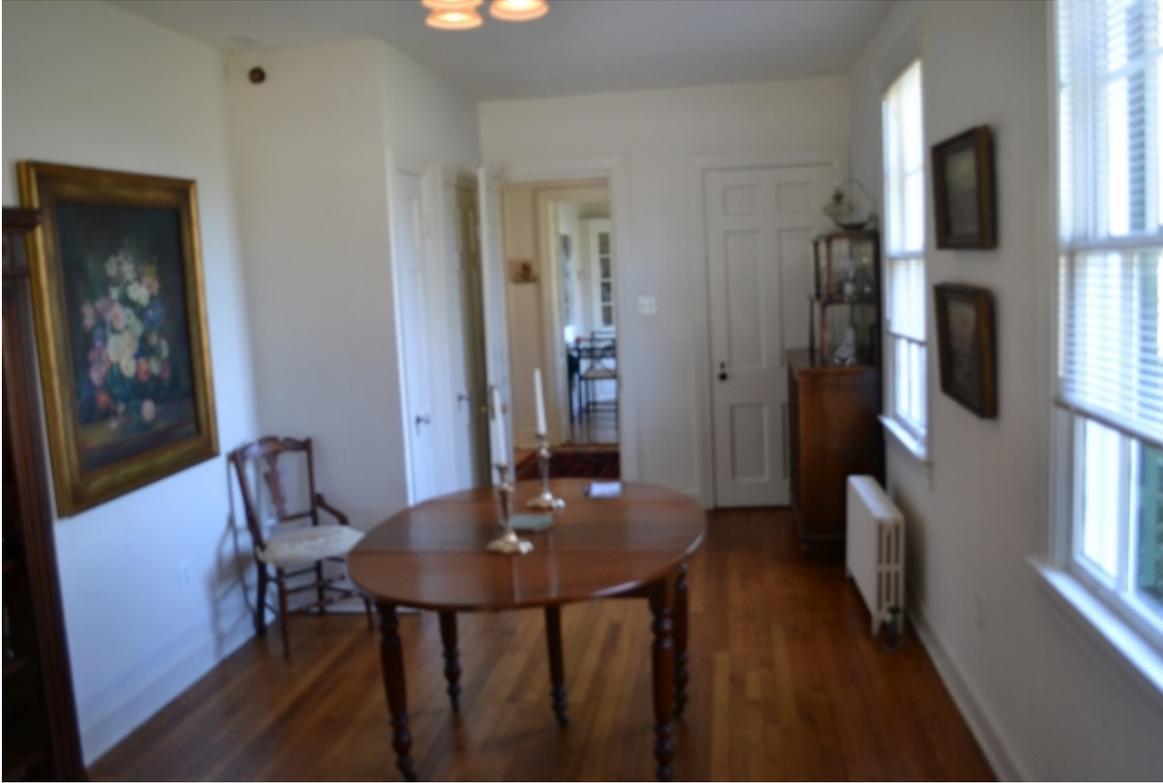
Photo 10. View west of the secretary/reception room that was formerly the garage. The closed door on the right was for patients entering the cottage. The center open door replaced a hallway closet. The closet to the left of the hall door inside the room appears to be a later addition.

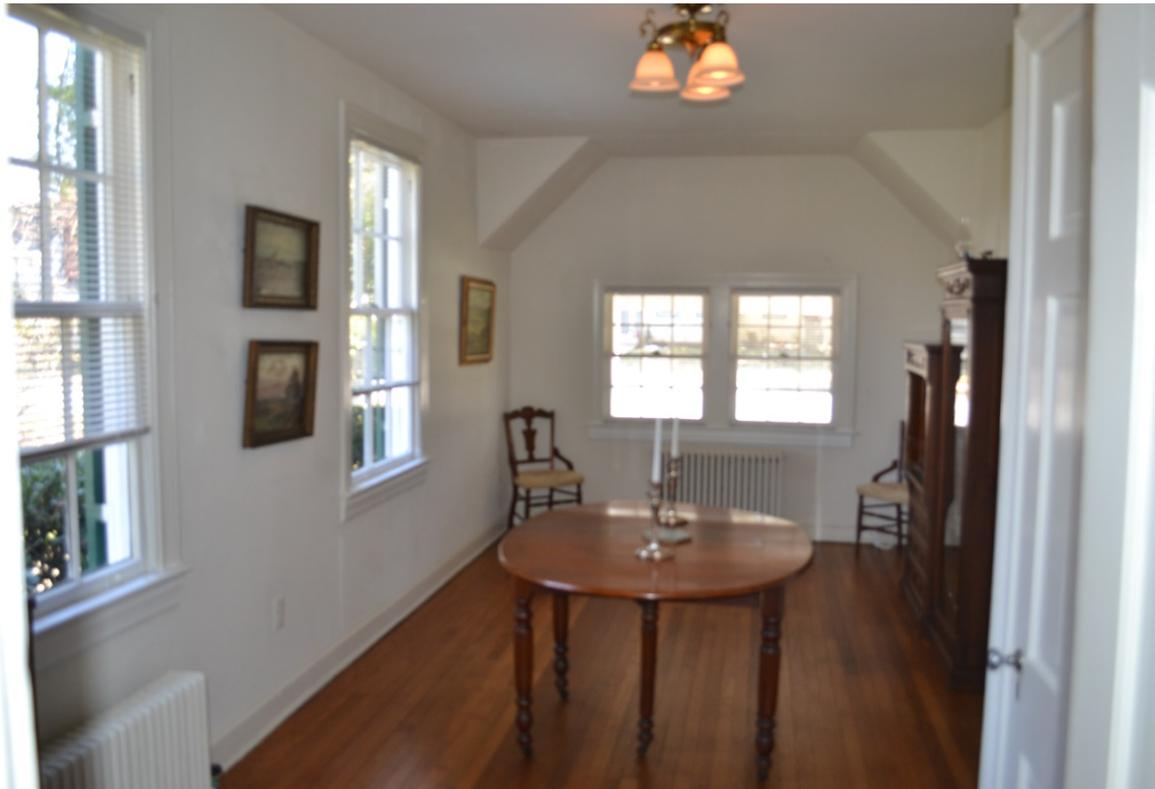
Photo 11. View east into the secretary/reception room. Former garage door windows are in the center.

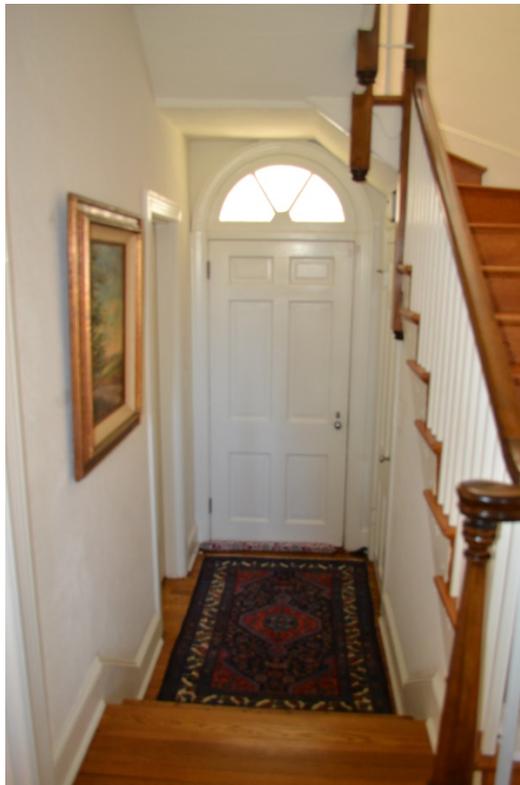
Photo 12. Hallway leading from front door to the screened porch. The office was on the left side of the hall.

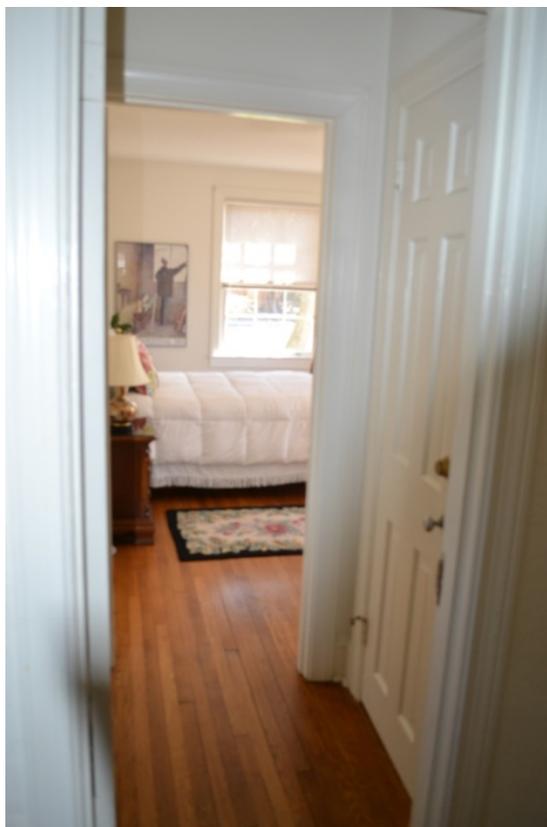
Photo 13. Entrance to the former office has two sets of doors, both open on the left, for privacy. One door is located at the hallway and the second at the bedroom with the closed closet door between.

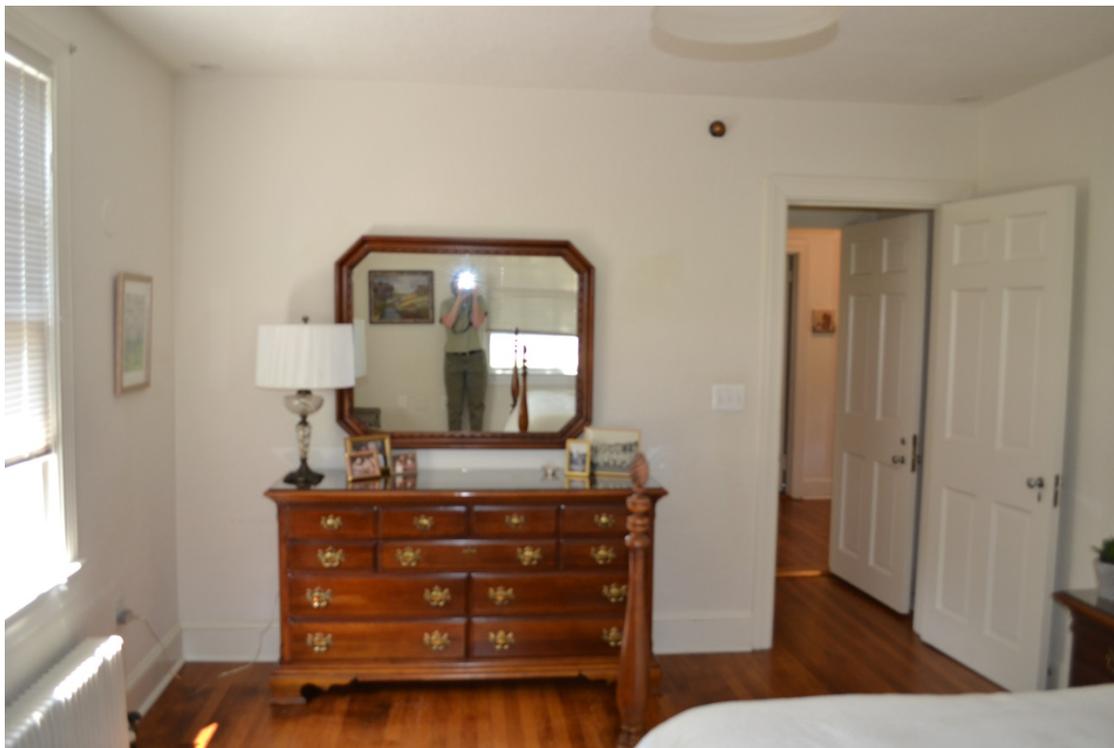
Photo 15. View northwest of former office looking toward the hallway shows the open double doorway used for privacy. Fromm-Reichmann's desk was located to the left of the entrance.

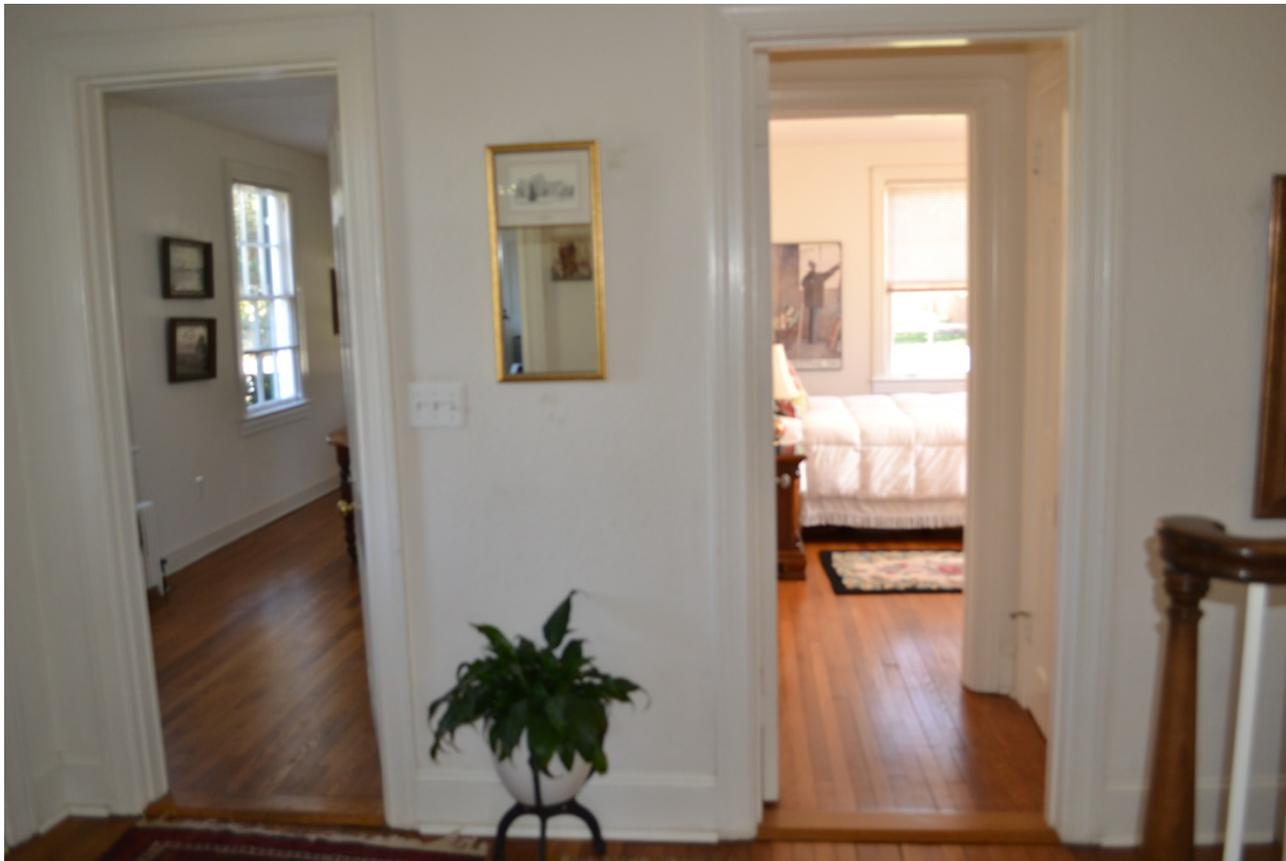
Photo 16. View east from the hall to the secretary/reception area (former garage) on the left and the office on the right. According to the original plan, no interior doorway existed to the garage, instead a closet was here.

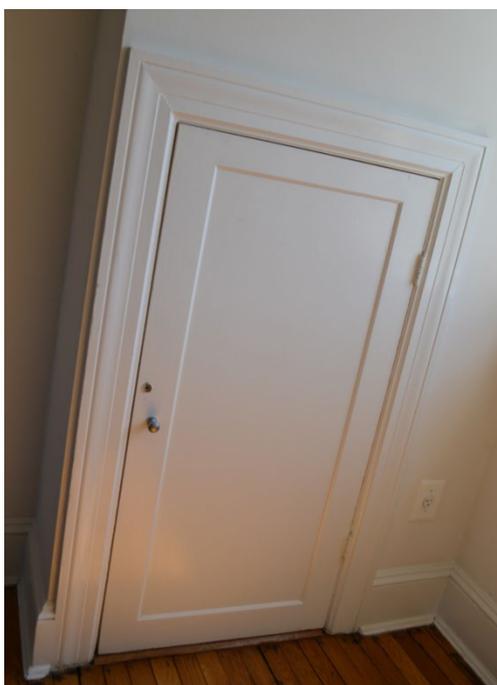
Photo 17. A typical locking cabinet for security on the second floor next to a dormer.
