SURF BALLROOM

Photos/Maps/Figures

National Historic Landmarks Nomination Form

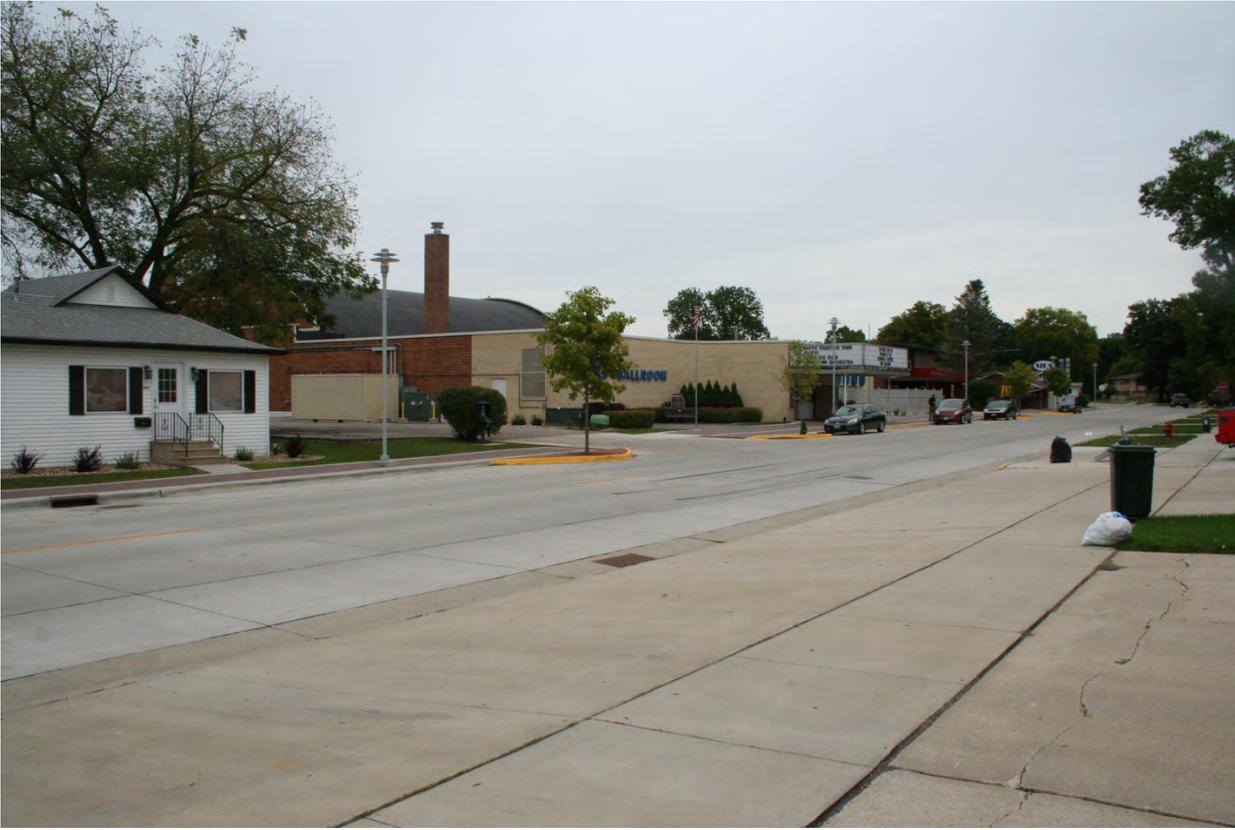
Photograph 1: Site View - Looking east along North Shore Drive. In this view, we can understand how the roof forms vary to accommodate interior functional spaces with the barrel roof indicating the ballroom and the flat roof marking all other interior spaces. (McDowell, 2018)

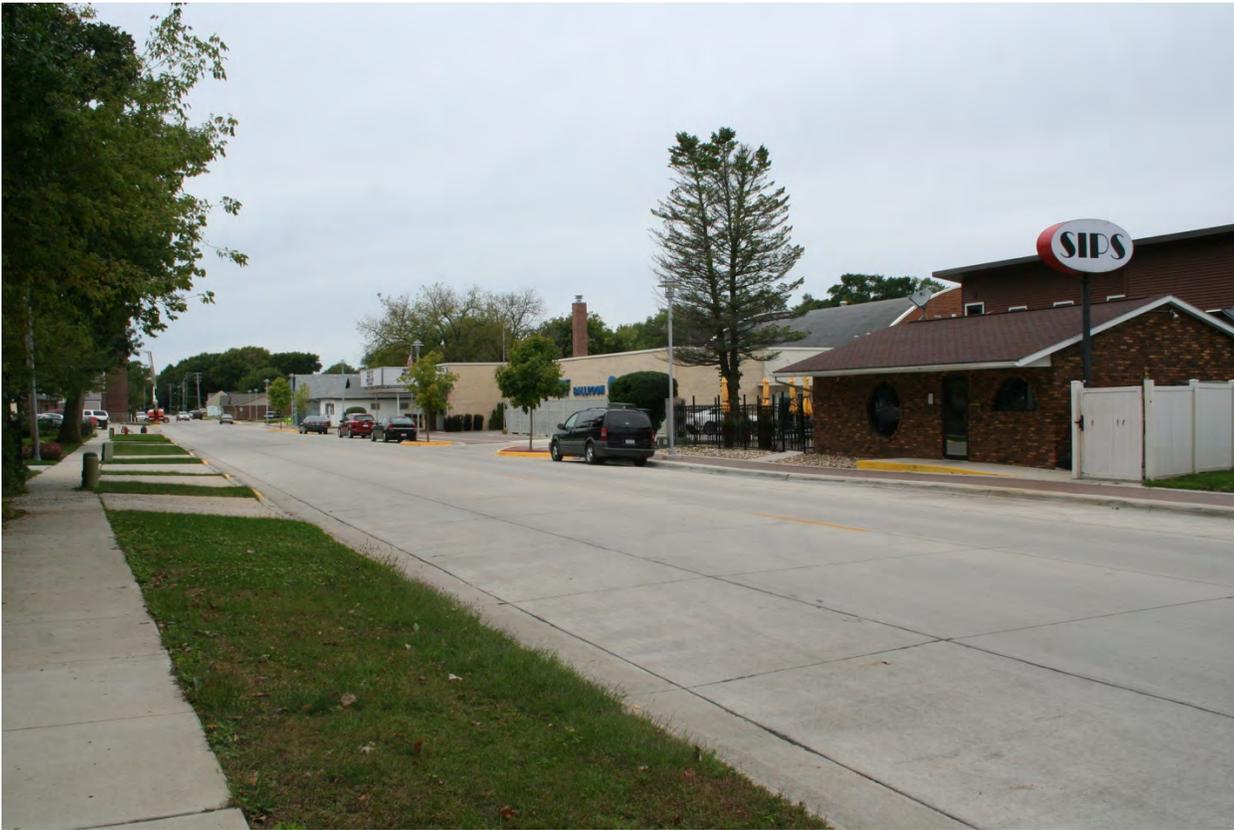
Photograph 2: Site View - Looking west along North Shore Drive. The lakefront site of the original Surf Ballroom is out of view on the left, immediately across the street from the 1948 ballroom. The original site has been occupied by single-family residences for many years. (McDowell, 2018)

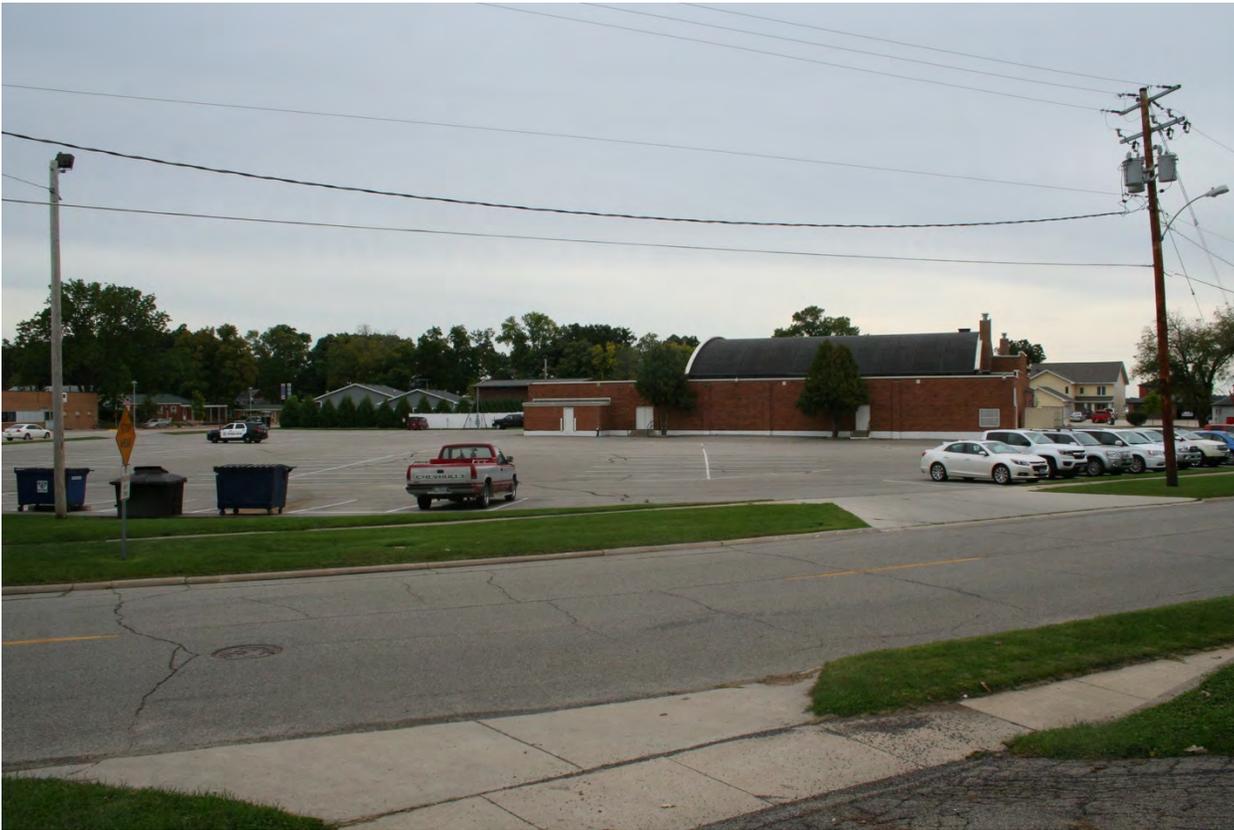
Photograph 3: Site View - Looking south. In this view, the barrel roof over the ballroom is in full view. A shallow section of roof at the west (right) end of the barrel roof marks the stage fly space. The property has included a large parking area from 1948, though the surfacing has been replaced multiple times. (McDowell, 2018)

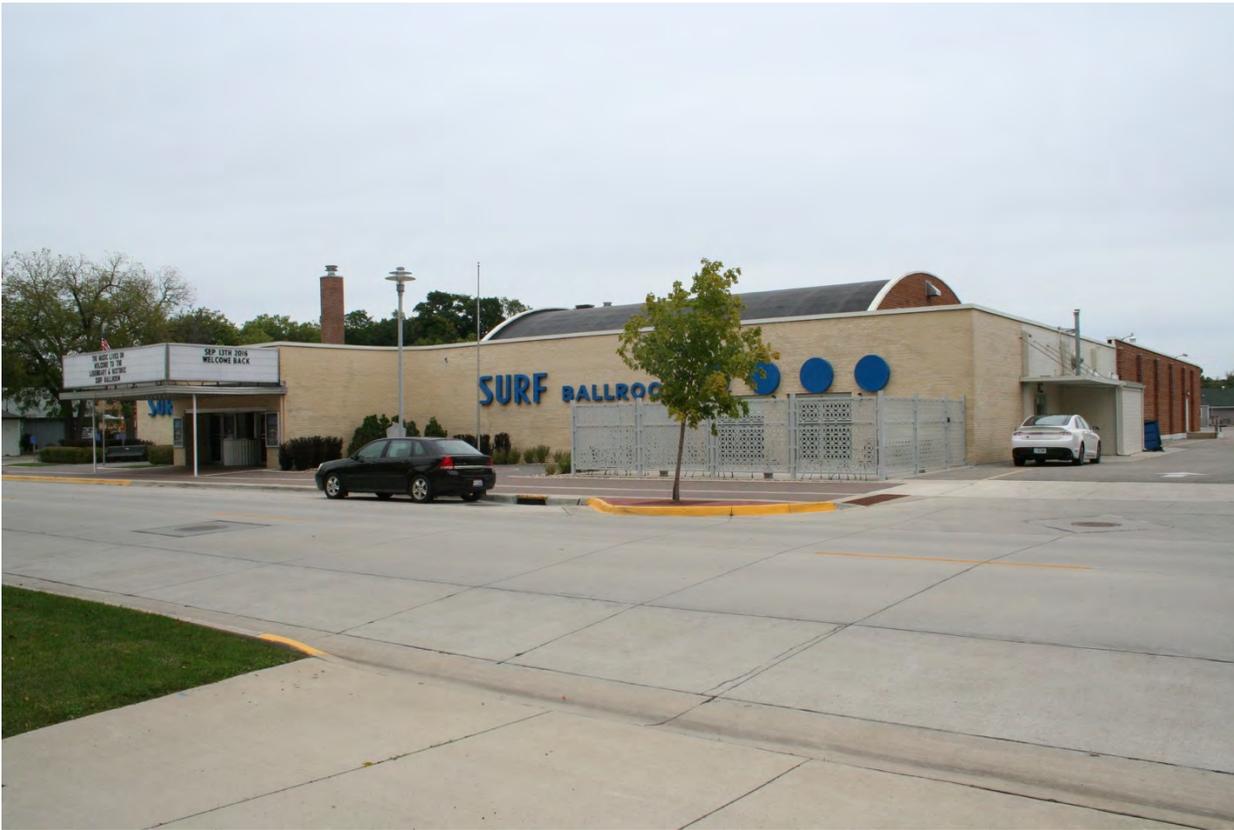
Photograph 4: Exterior - View of the façade (south) and east elevations, looking northwest. The lines of the Art Moderne style are apparent from this perspective. Although the canopy sign dates to ca.1963 (outside the period of significance), the stainless-steel canopy and ticket booth flanked by paired doors, and the mall-mounted signage are original to the building. The side (east) entrance is also original, though the brick adjacent to the entrance has been painted. (McDowell, 2018)

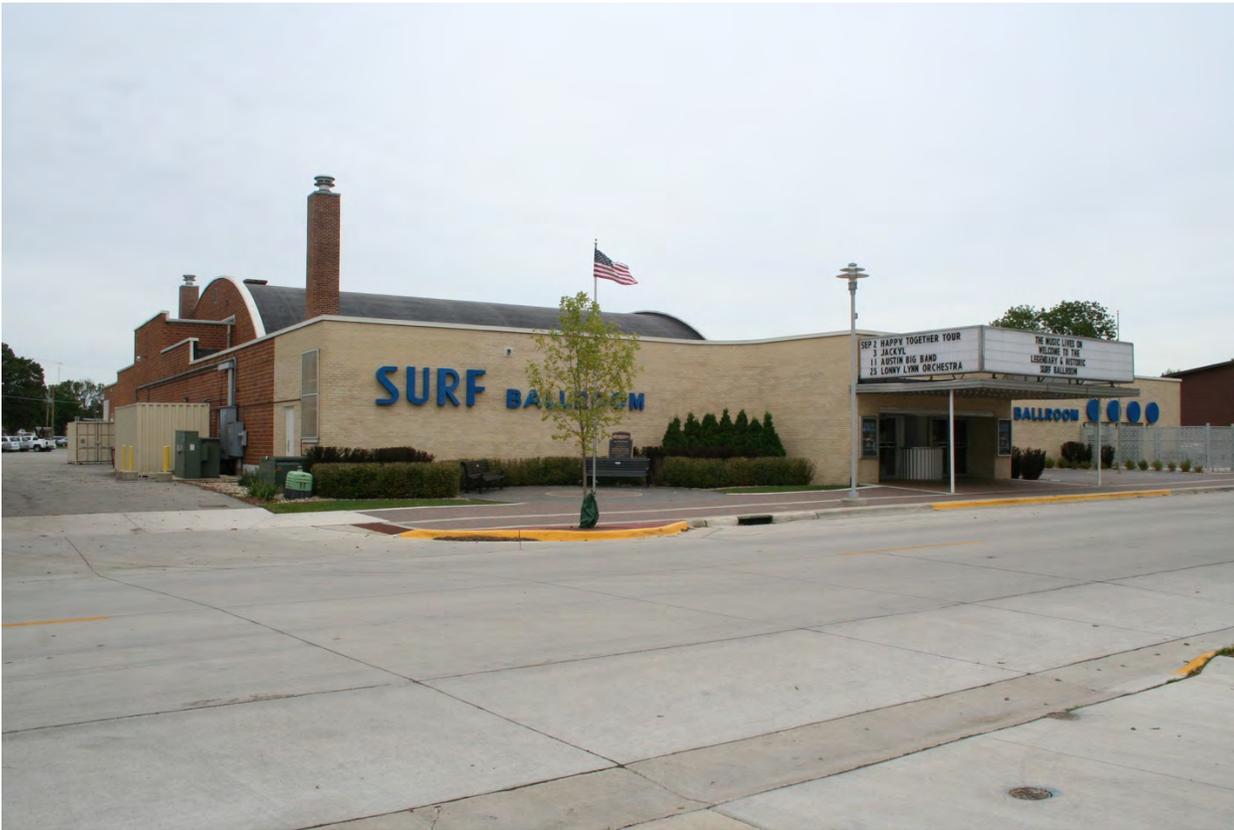
Photograph 5: Exterior - View of the façade (south) and west elevations, looking northeast. From this perspective, the juxtaposition of roof forms is well understood. The view also shows the 1994-era landscaping and the 2012 bronze marker commemorating the property's listing on the National Register of Historic Places. (McDowell, 2018)

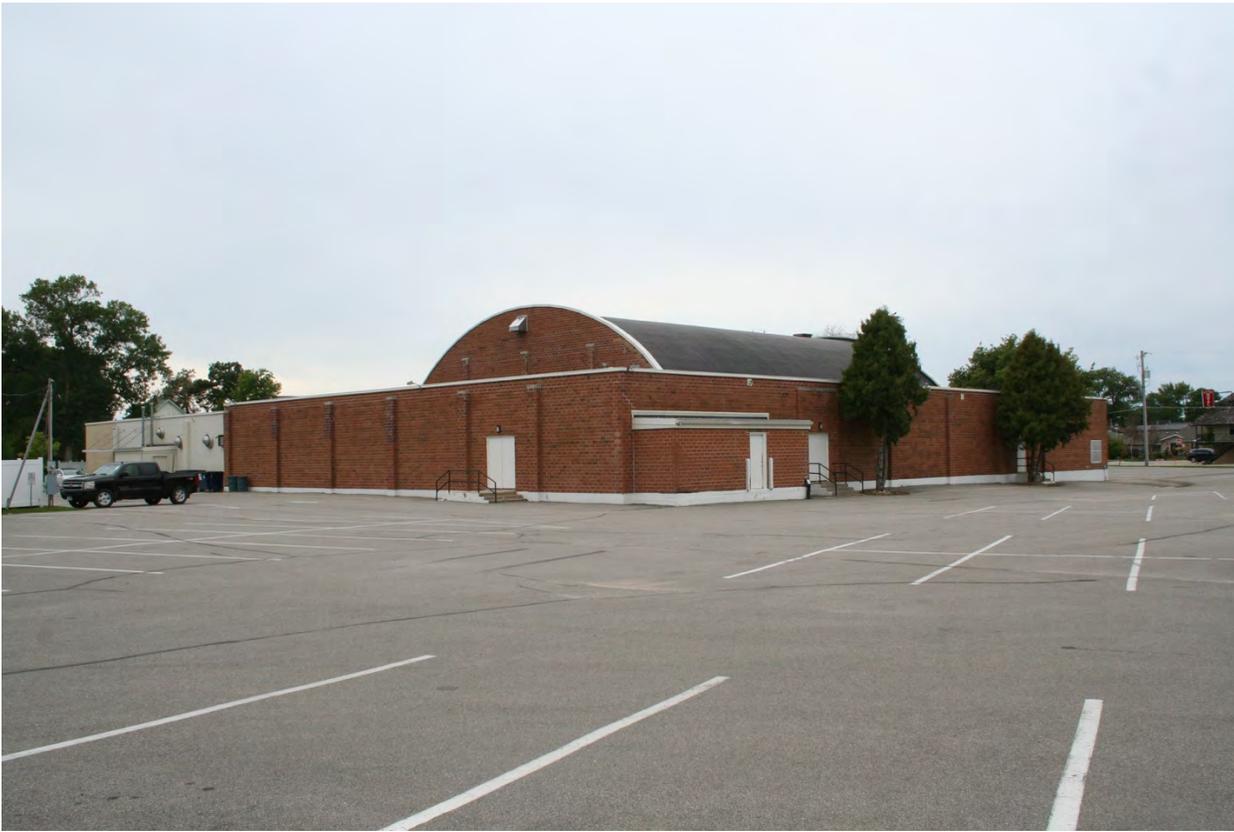
Photograph 6: Exterior - View of the north and west elevations, looking south. The barrel roof over the ballroom dominates the building from the rear perspectives. (McDowell, 2018)

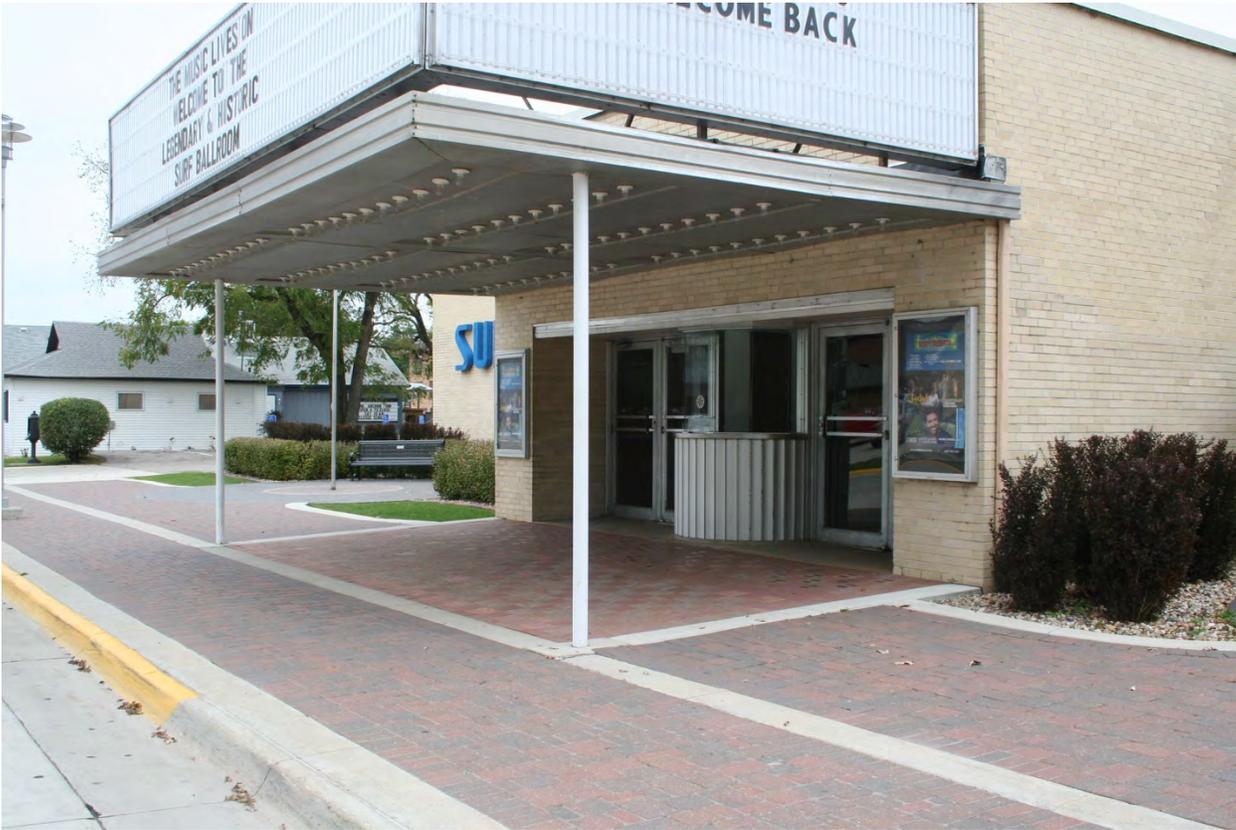
Photograph 7: Exterior Detail - Primary (south) entrance. The canopy with its steel post supports and exposed-bulb lights on the underside, the ticket booth, and the paired entrance doors are original to the building (1948). The three-sided marquee atop the canopy was added in ca.1963. The signboard cabinets flanking the entrance were in place by 1950. The brick pavers date to the 1994 historic rehabilitation; they were part of a fundraising effort for the property. (McDowell, 2018)

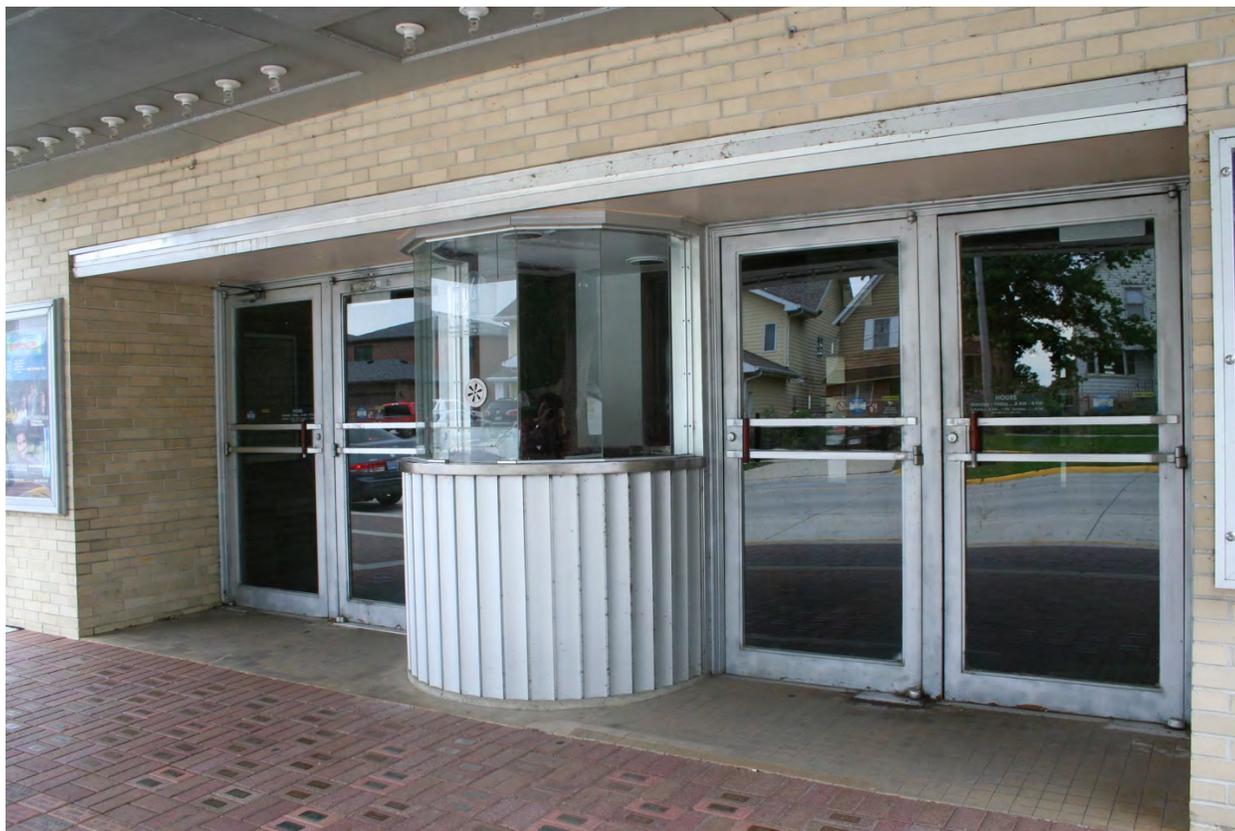
Photograph 8: Exterior Detail - Primary (south) entrance, ticket booth and doors. The ticket booth is accessed from the entrance vestibule and retains all original features. The doors retain Bakelite handles. The red pavers are non-historic alterations, but the buff-colored tile abutting the entrance doors is original. (McDowell, 2018)

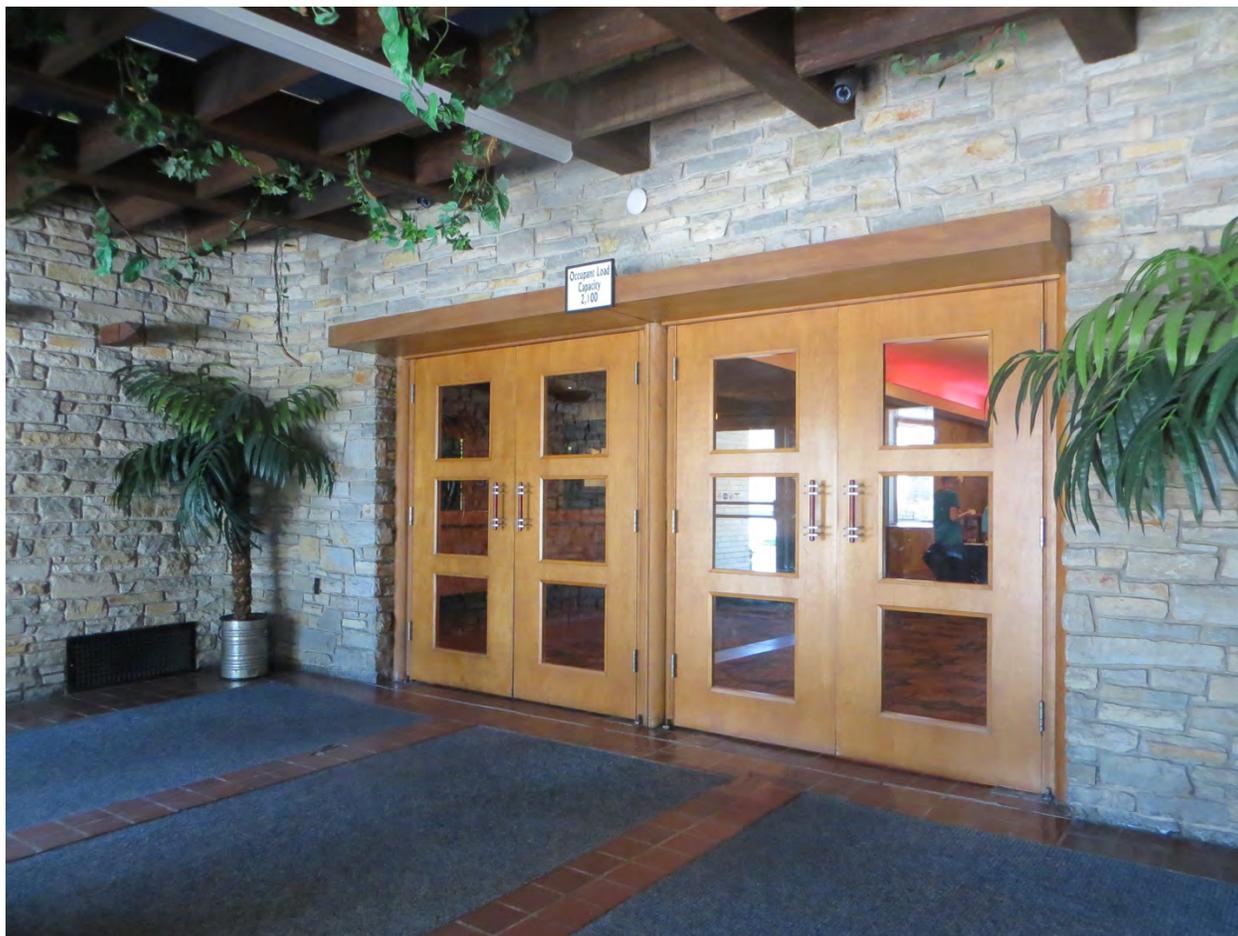
Photograph 9: Interior: Vestibule, looking northwest. The entrance vestibule retains original face-stone walls, timber beamed ceiling, glazed terra cotta tile floor, and paired, wood doors with Bakelite handles. A comparison with the 1948 historic photograph reveals no discernible alteration of the vestibule. (McDowell, 2018)

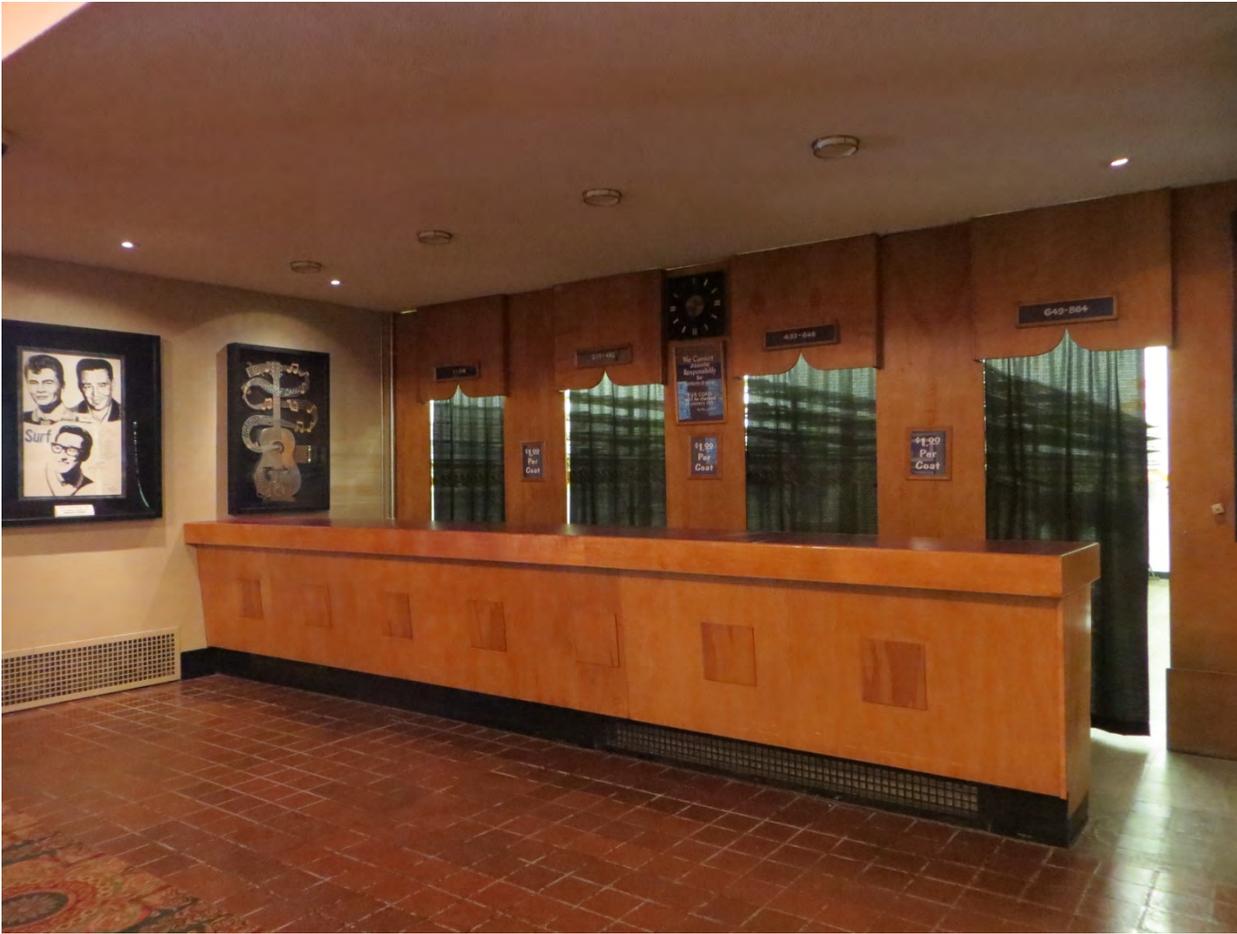
Photograph 10: Interior: Lobby – west coat-check, looking southwest. When constructed (1948) in during the period of significance, the Surf had two coat-checks; the east coat-check was removed as part of the 1994 rehabilitation. Historic drawings and photographs document its configuration and appearance as a match to the west coat-check above, which remains unaltered and in use. (McDowell, 2018)

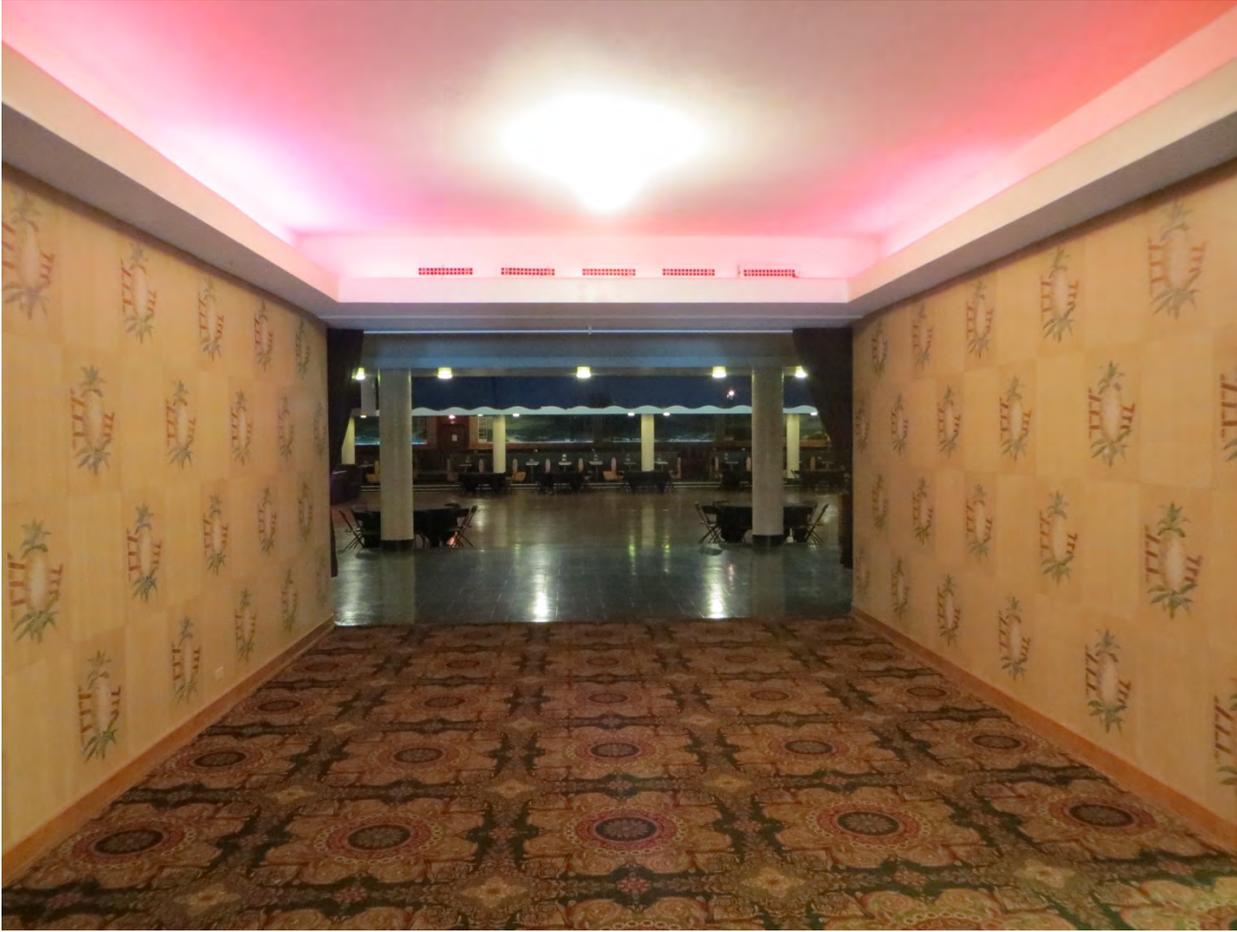
Photograph 11: Interior - Lobby promenade, looking north toward the dance floor. The walls of the lobby promenade were re-stenciled in 1994 historic rehabilitation, having been painted over at an undetermined time. In 2016, the walls were again re-stenciled, this time using additional documentation that allowed a replication that was more accurate in detail and palette. The carpet was replaced in 1994 and again in 2018 using historic photographs. The color of the cove lighting is not historically grounded. (McDowell, 2018)

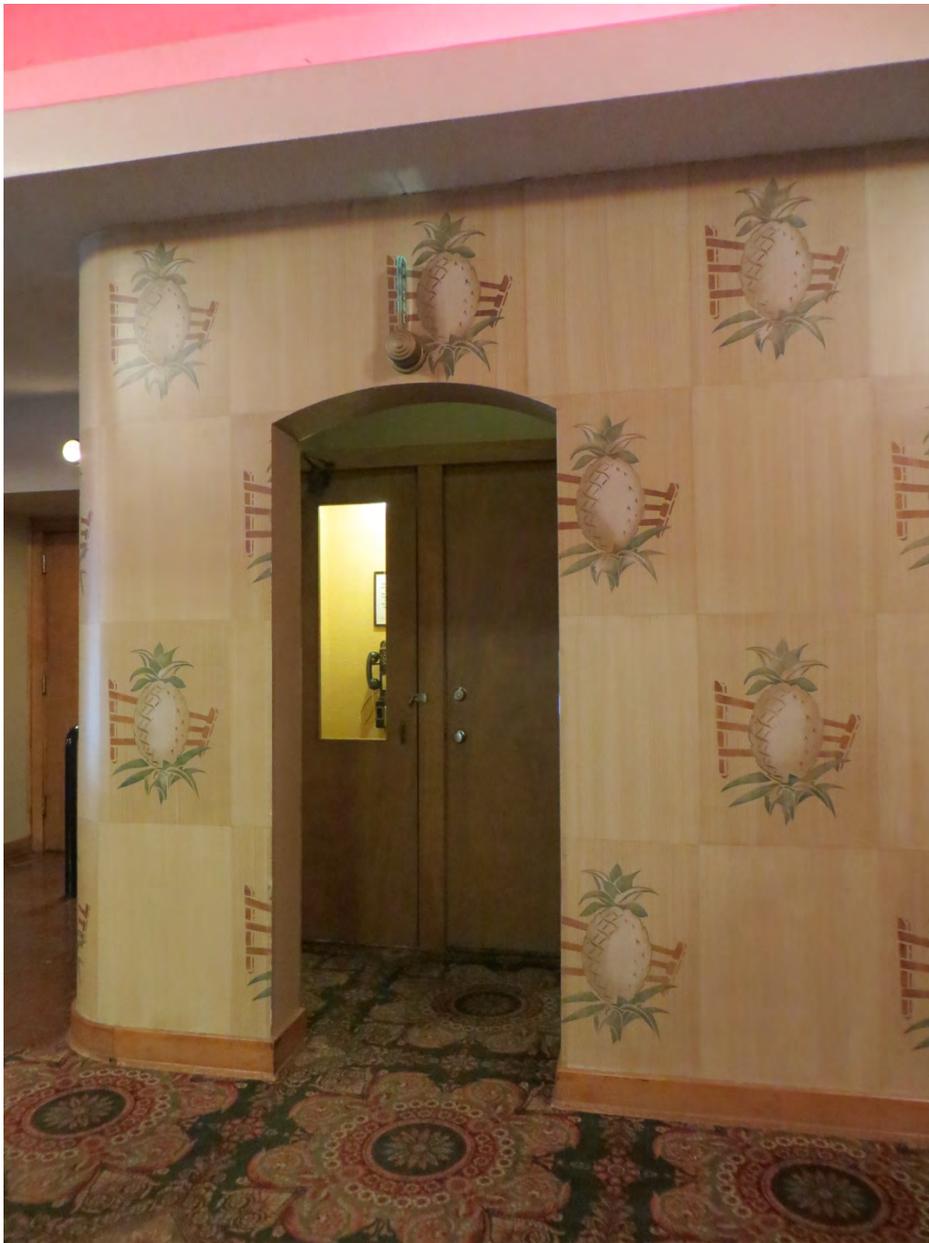
Photograph 12: Interior Detail - Lobby - Alcove with telephone booth. On the night of February 2, 1959, Buddy Holly and Ritchie Valens made telephone calls to their families in the hours before their deaths. The booth retains the original phone used for those calls. (McDowell, 2018)

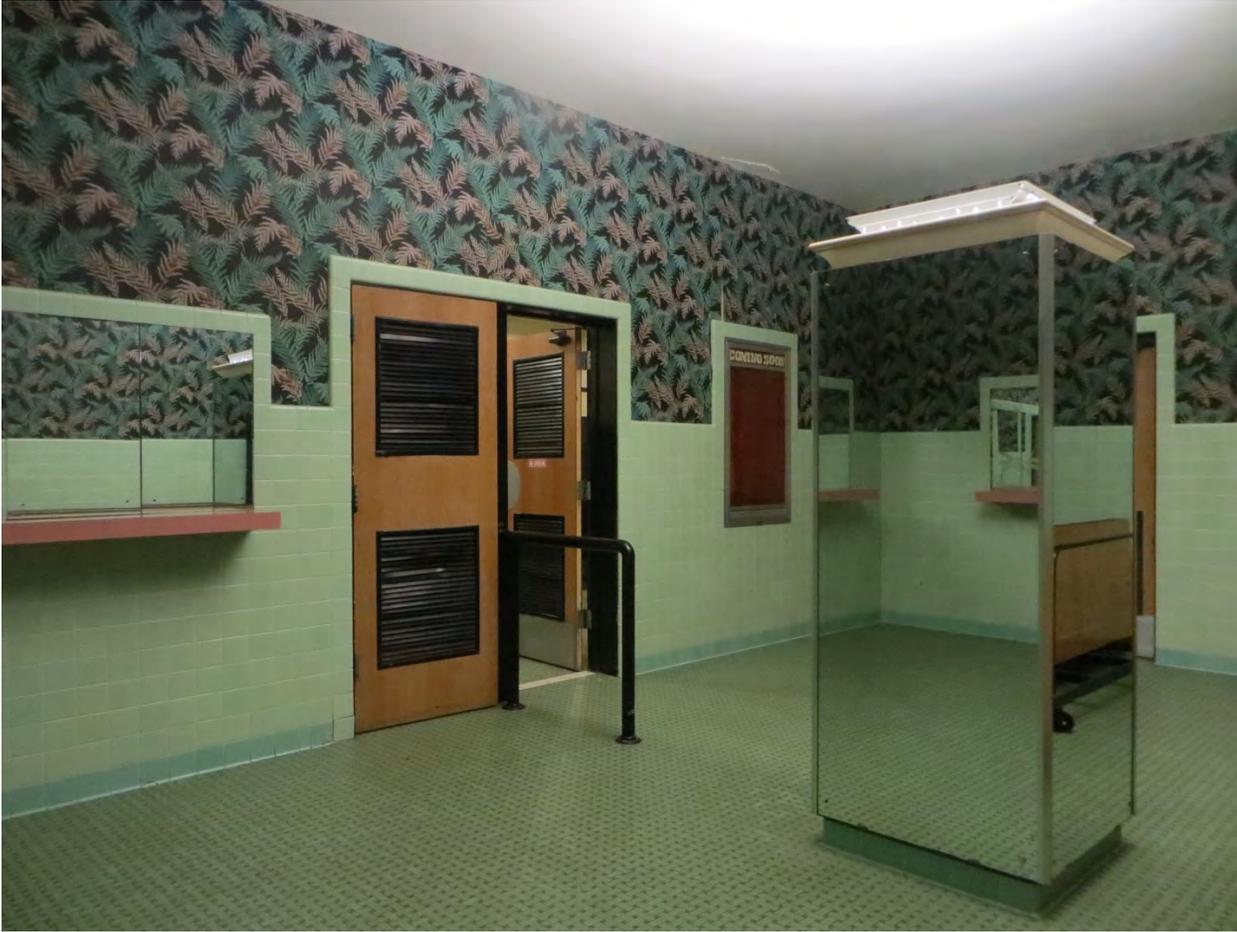
Photograph 13: Interior - Women's Lounge – View of the outer room, looking northwest. The tile on walls and floor is original to the building. The wallpaper in this image dates to the 1994 rehabilitation, its choice derived from the beach motif of the original building. The original wallpaper has since been replicated from a sample to replace that in both the women's and men's restrooms. (McDowell, 2018)

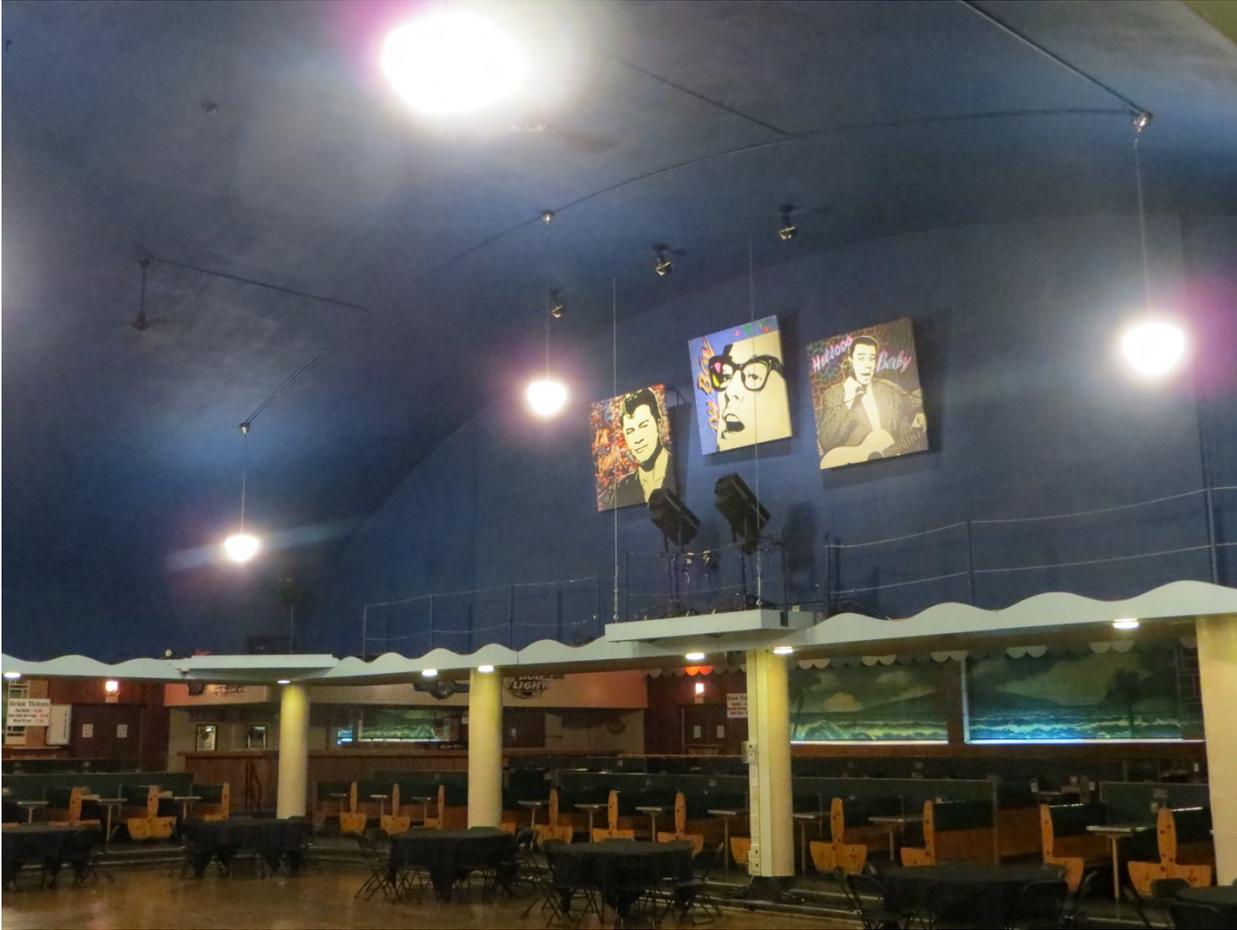
Photograph 14: Interior - Ballroom, looking northeast from the ballroom promenade to the east booths. The original, beach-themed murals (background, right) are visible in this view as are the booths that line the dance floor and the original bar with curvilinear soffit (background, center). The contemporary images of Ritchie Valens, Buddy Holly, and the Big Bopper are representative of the continued emphasis of the ballroom's place in the history of the three performers. (McDowell, 2018)

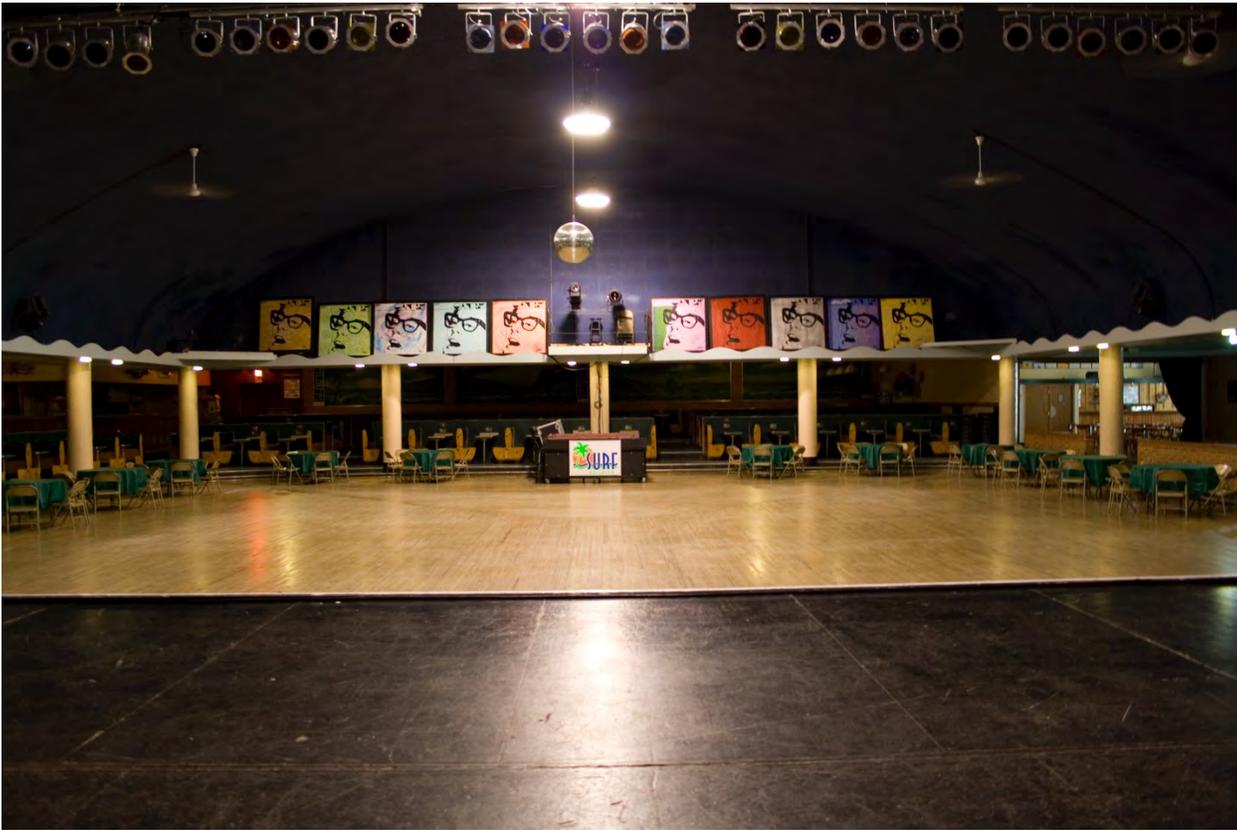
Photograph 15: Interior - Ballroom, looking east from the stage. Although the stage has been extended to accommodate the increasing size of bands and their equipment, the original stage form is discernible. In this view from the original portion of the stage, the scale of the dance floor is understood. The original wood floor, laid in a log cabin pattern, is retained. (McDowell, 2018)

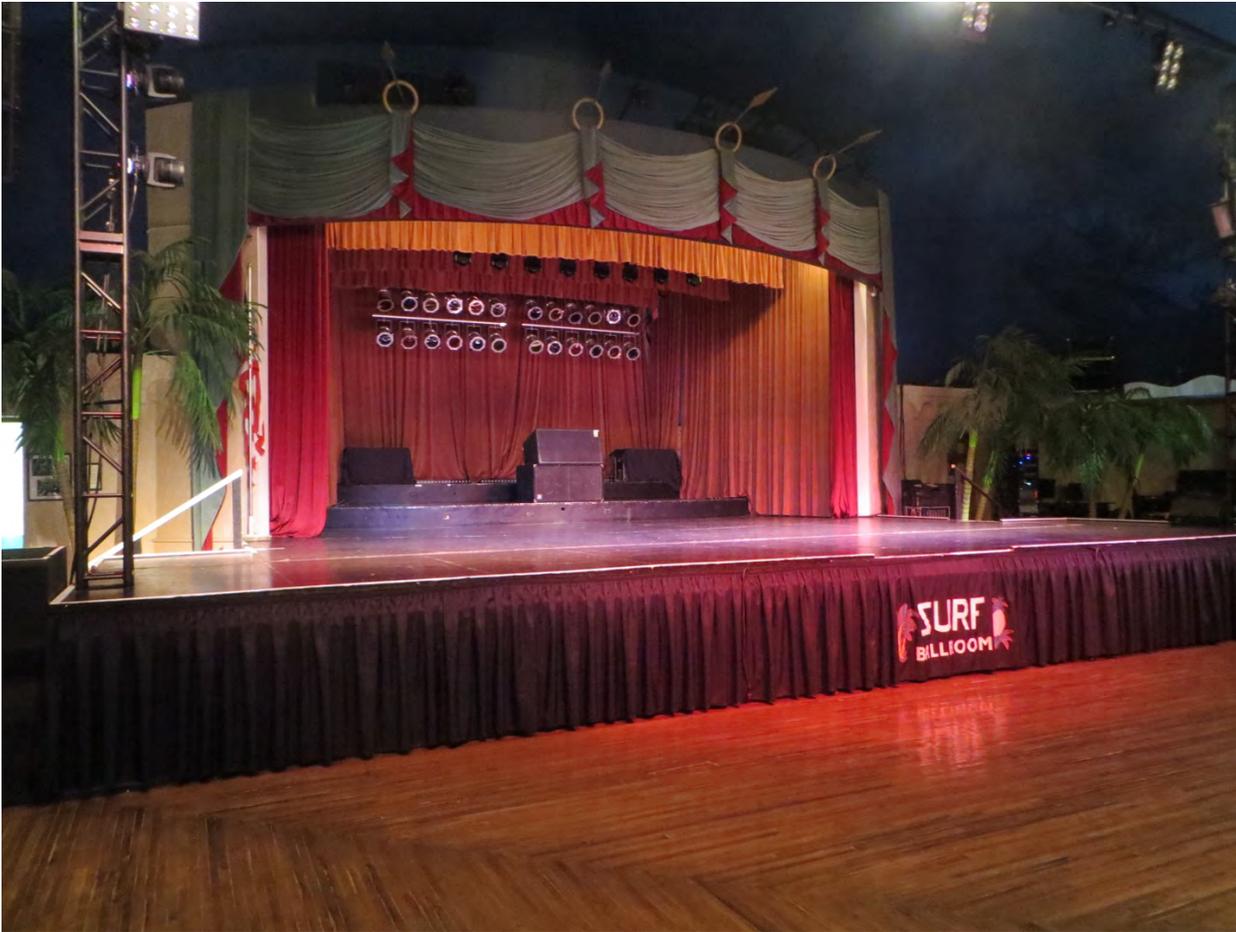
Photograph 16: Interior - Stage, looking north from dance floor level. From this perspective, the demarcation between the original stage and the later expansion is visible. The original stage footprint, including the rear portion, remains unaltered. The stage curtains were replicated from historic images as part of the 1994 historic rehabilitation. (McDowell, 2018)

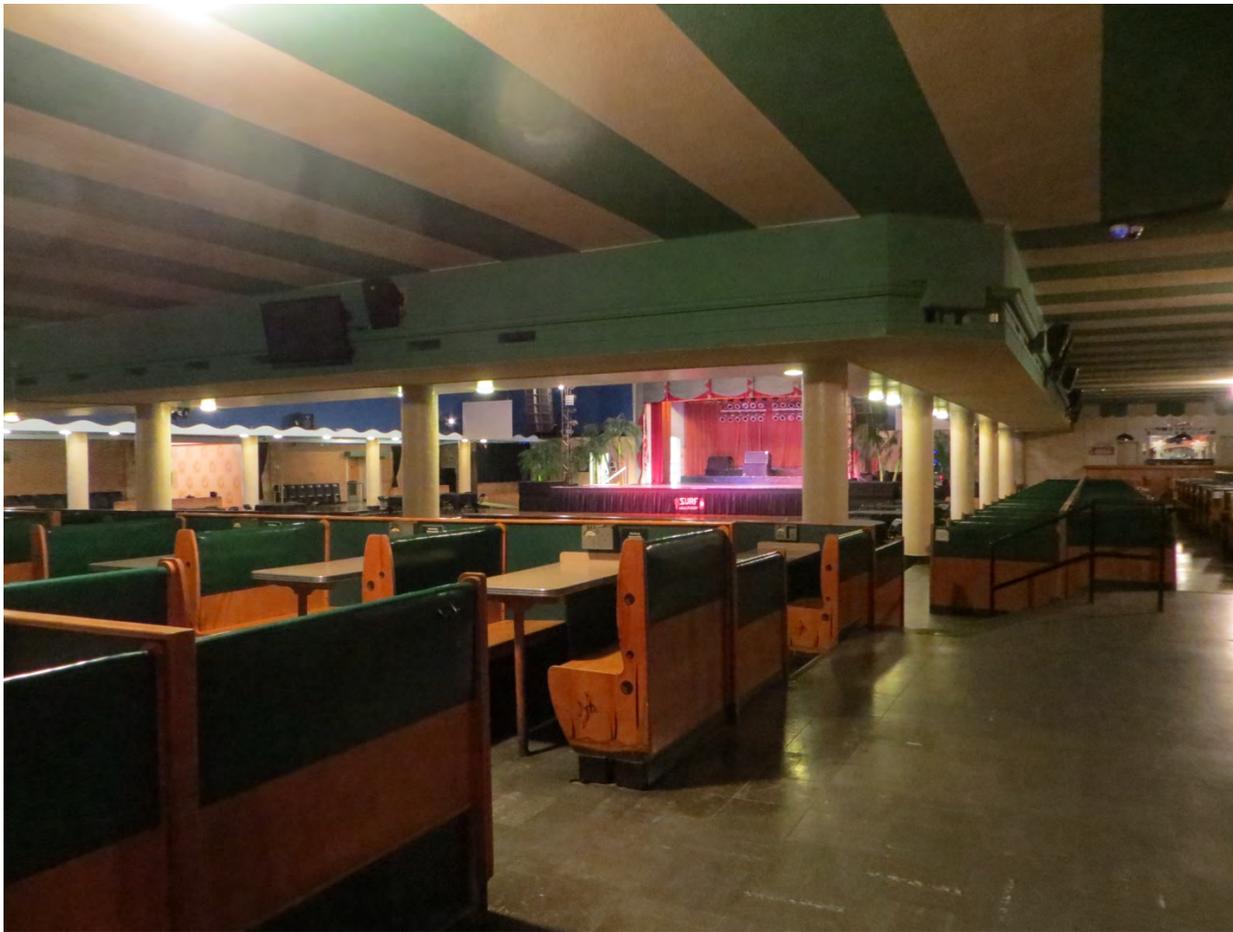
Photograph 17: Interior - Tiered booth seating, looking southwest toward the stage. When opened in 1948 and through the period of significance, the booths were intended to accommodate six. They are undersized for today's average person, but remain unaltered and in demand by concert-goers. The striped ceiling (representing a cabana awning) and flooring are also original. (McDowell, 2018)

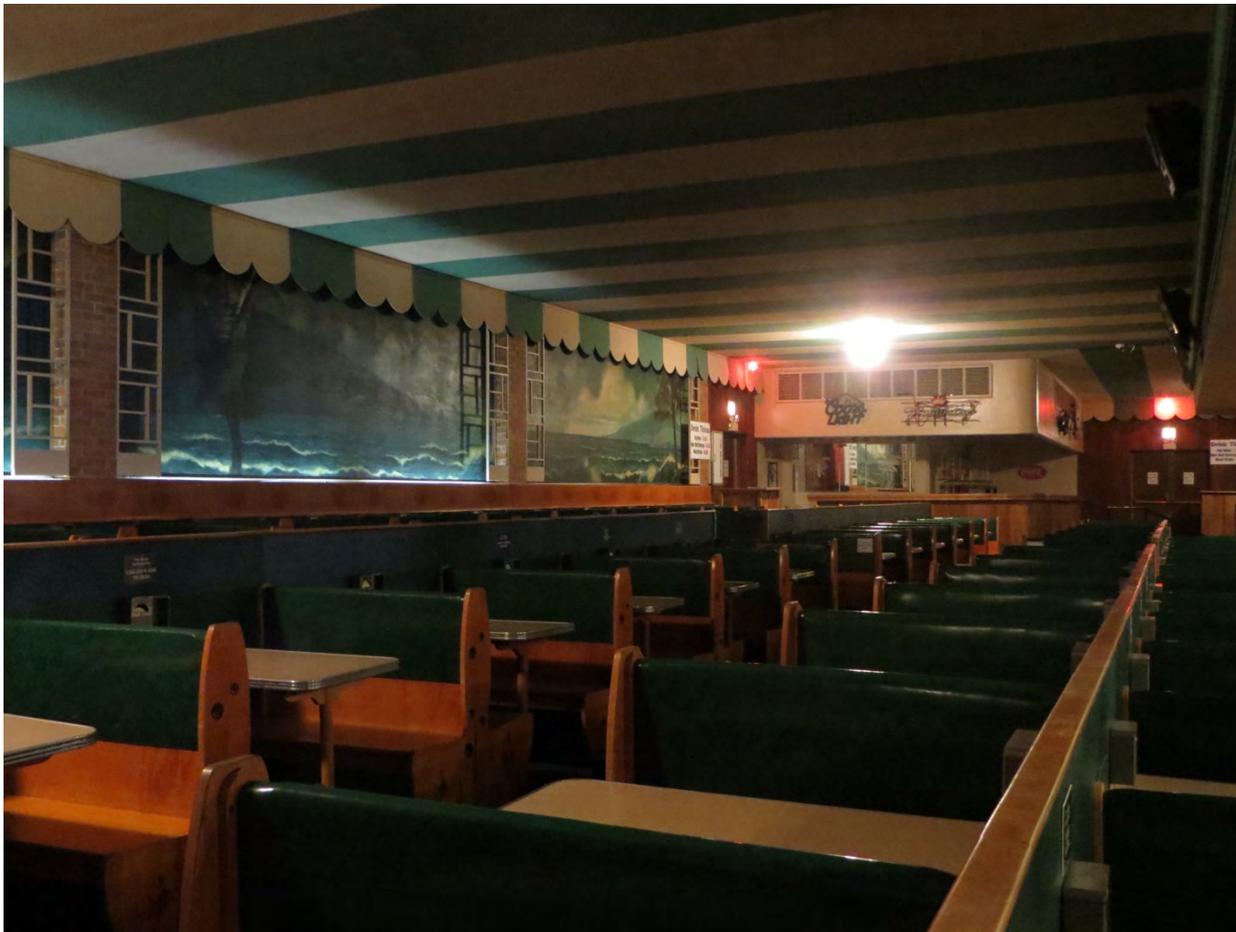
Photograph 18: Interior - Tiered booth seating, looking southwest toward the original bar. The original booths are arranged in tiers to maximize the view to the stage and access to the dance floor. The cabana awning gives way on the south (left) to the painted beach views. (McDowell, 2018)

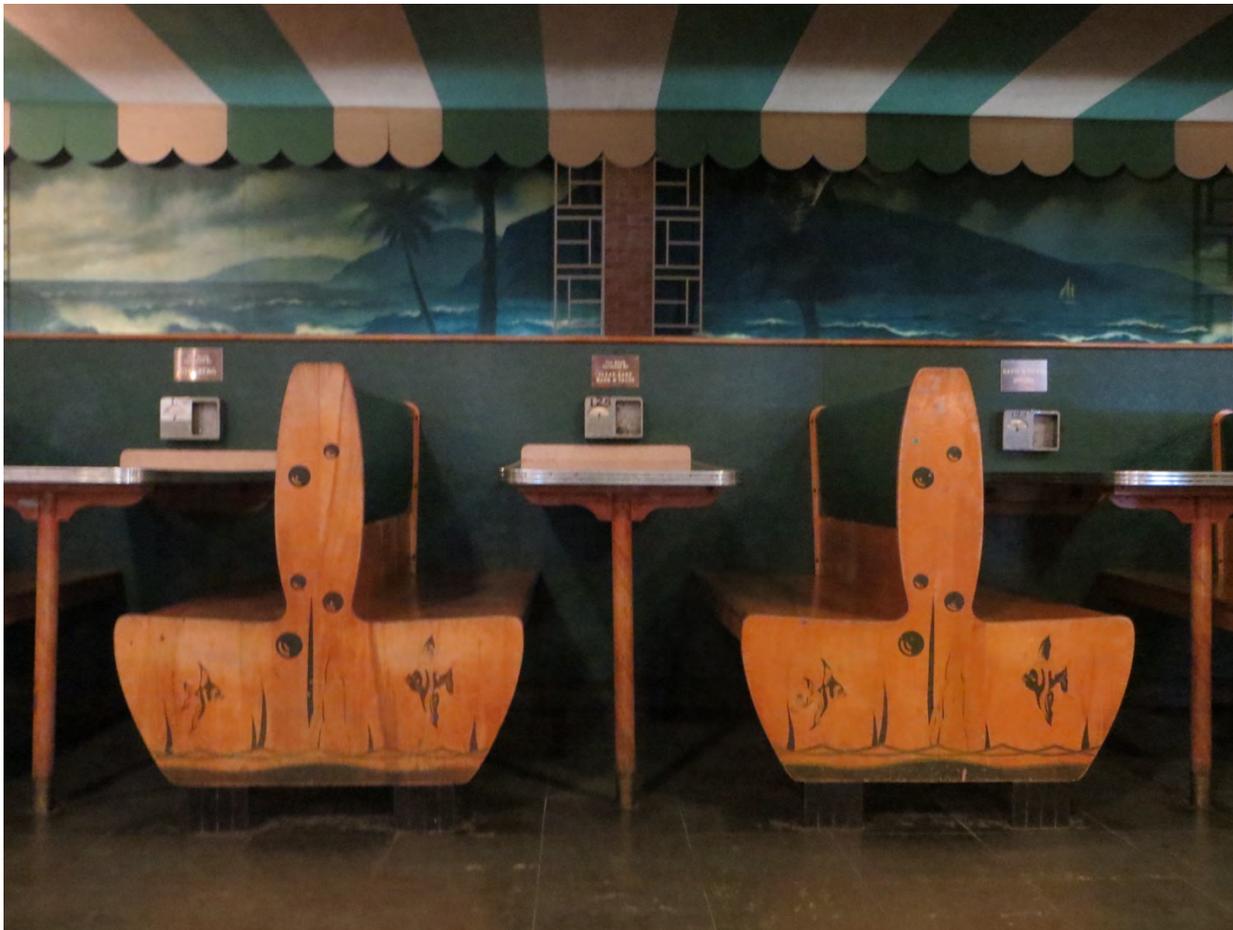
Photograph 19: Interior Detail - Original booths with stenciling representing an underwater motif. The booths remain unaltered from the period of significance. Although undersized for today's average person, reservations come at a premium due to high demand, particularly during the annual Winter Dance Party. (McDowell, 2018)
