SURF BALLROOM

Photos/Maps/Figures

National Historic Landmarks Nomination Form

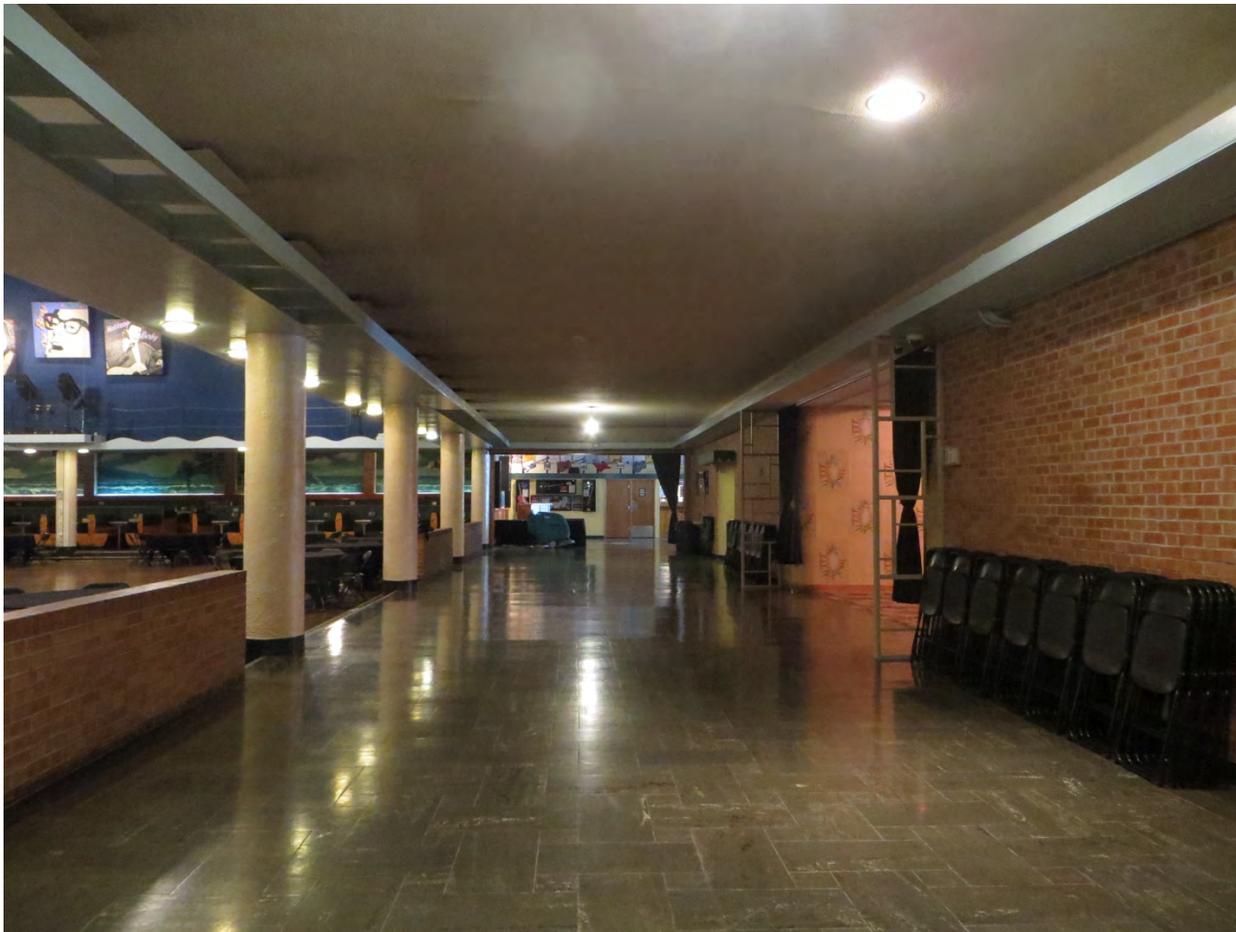
Photograph 20: Interior - Ballroom promenade, looking east with lobby opening at right and dance floor at left. The ballroom promenade remains unaltered from the original and through the period of significance, with plan and finishes retained. (McDowell, 2018)

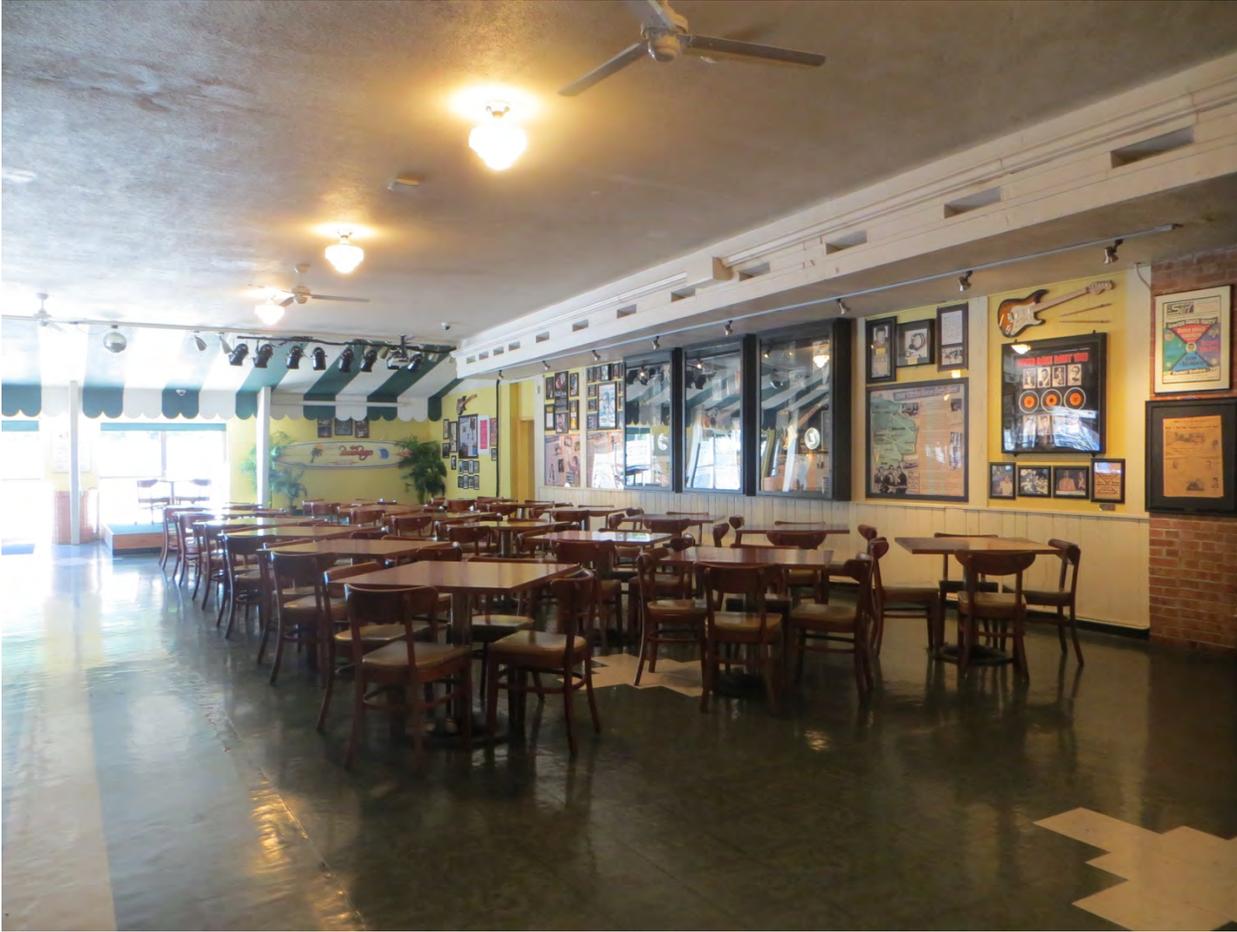
Photograph 21: Interior - Surfside 6 Café, looking south from near the ballroom promenade. The Surfside 6 Café is minimally altered from the period of significance. In 1964, two openings were cut in the south wall (background) with double-wide sliding glass doors installed to access an exterior patio. The openings were located between the canted piers without impacting the beach motif. The hallway from the café to the lobby was altered in 1994 (background, right). In the previous decade, the property has elevated its function as a museum, with professionally designed and installed displays located in the Surfside 6 Café. (McDowell, 2018)

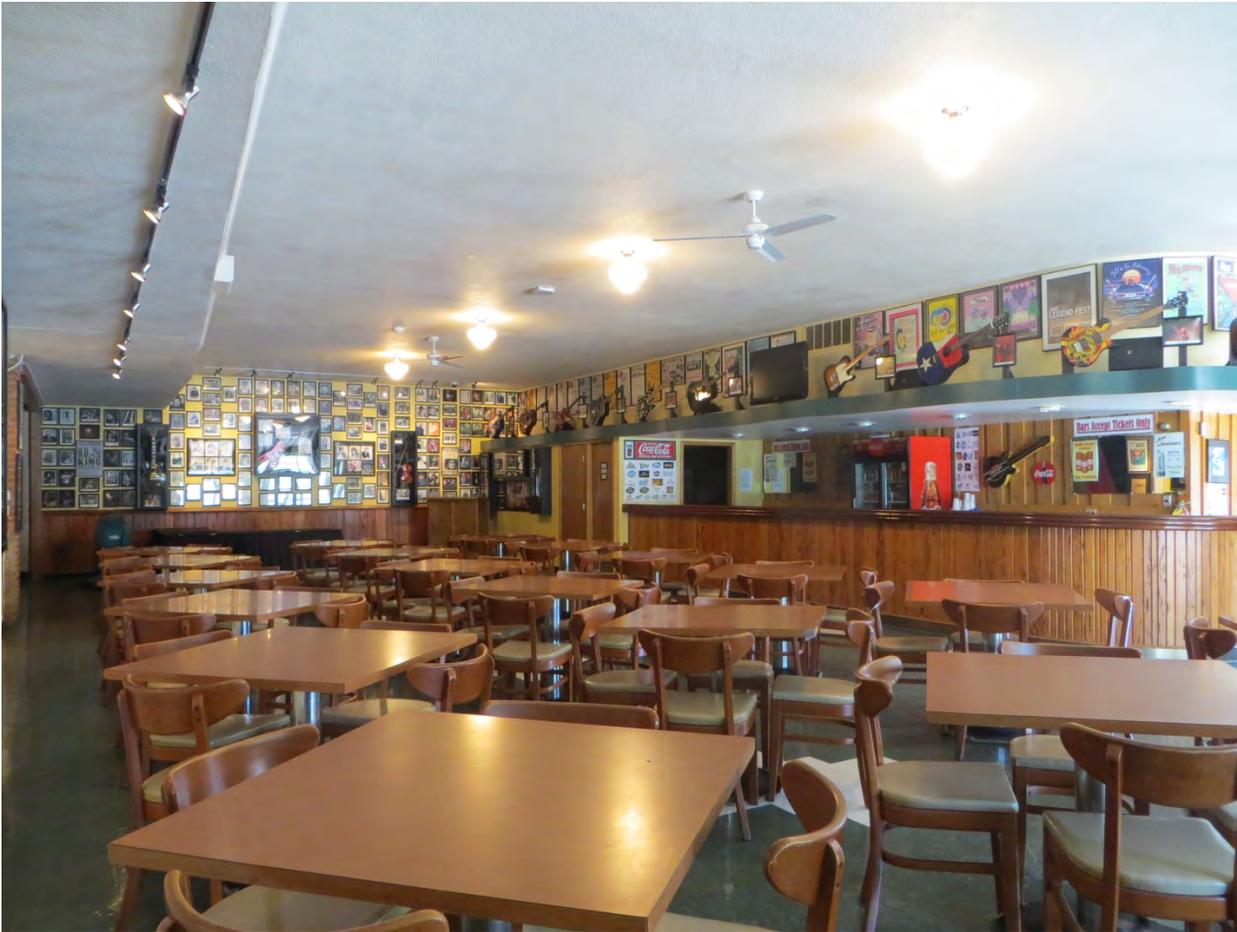
Photograph 22: Interior - Surfside 6 Café, looking northeast. The space retains the original streamlined bar with undulating soffit and its walls are lined with artifacts representing its long history. The families of Ritchie Valens, Buddy Holly, and J.P. Richardson have all gifted artifacts to the Surf so they are available to the many who visit the final performance site. (McDowell, 2018)
