Manual on Conservation Methodology for Historic Buildings and Structures: Puerto Rico and the Virgin Islands | 1997-07

A MANUAL ON CONSERVATION METHODOLOGY
FOR HISTORIC BUILDINGS & STRUCTURES
Puerto Rico and the Virgin Islands

Beatriz del Cueto, AIA
with the collaboration of Agamemnon Gus Pantel, Ph.D. and Roberto Garcia, M. Arch.

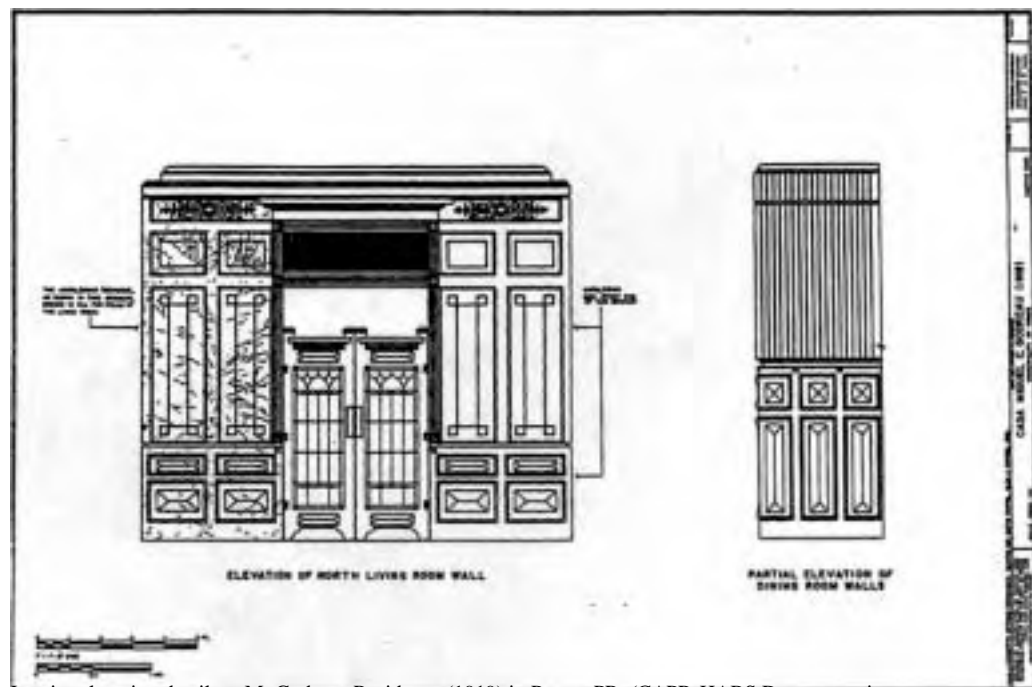
Interior elevation details at M. Godreau Residence (1919) in Ponce, PR. (CAPR-HABS Documentation Project 1985)

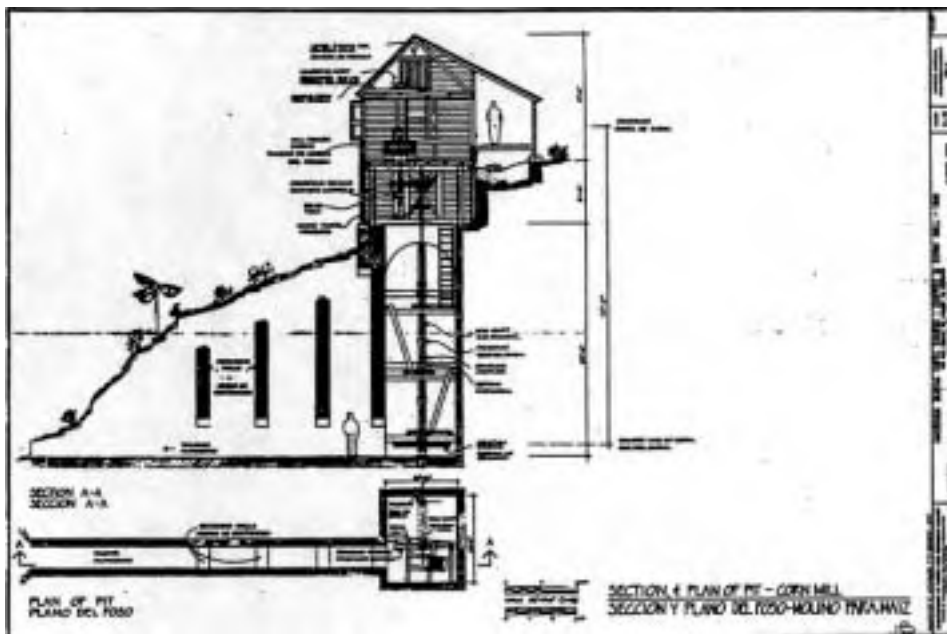
Corn Mill drawings of Hacienda Buena Vista (1851) in Ponce, PR. (HAER, 1977)

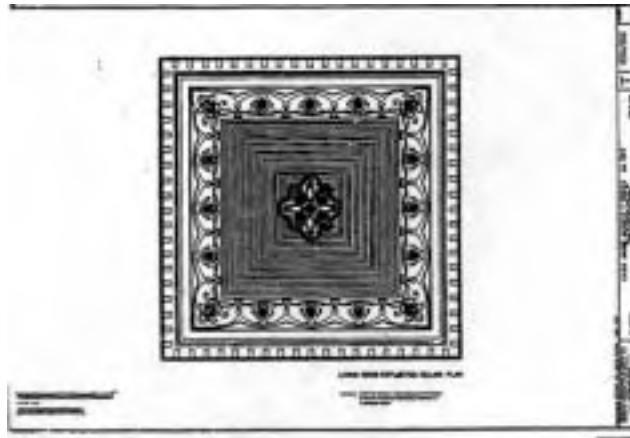
Reflected ceiling plan J. Acosta Forés Residence (1917) in San German, PR. (CAPR-HABS Documentation Project 1983)

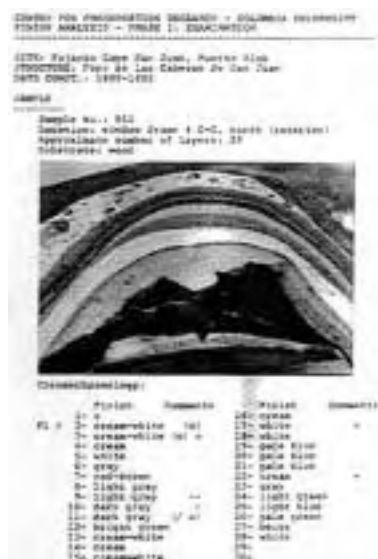
Color stratigraphies or chromochronologies as seen through a microscope. P3 gives the background color for a plaster surface while P12 gives the color of a wood window frame. Lighthouse at Las Cabezas de San Juan at Fajardo, PR (1988).

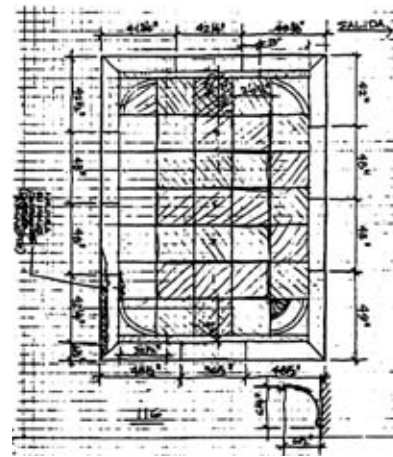
Existing condition field sketch of historic tin ceiling prior to restoration work. Colegio de Arquitectos de Puerto Rico (1992).

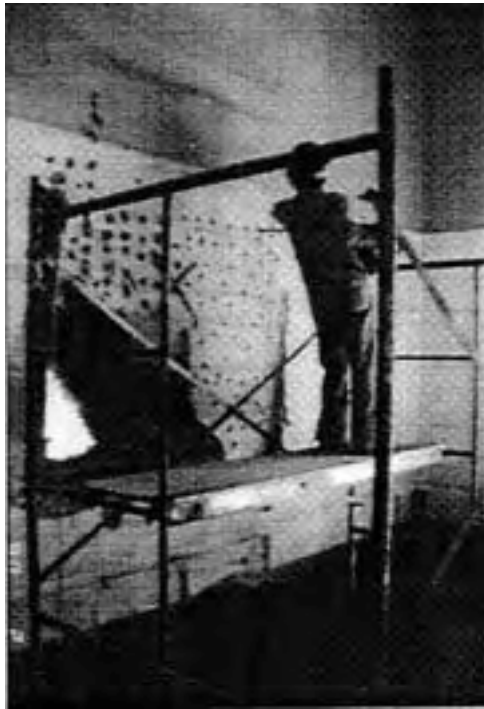
Drilling reinforced concrete wall before removal from adjacent historic fabric in Ballajá Military Barracks in Old San Juan, PR (1988).

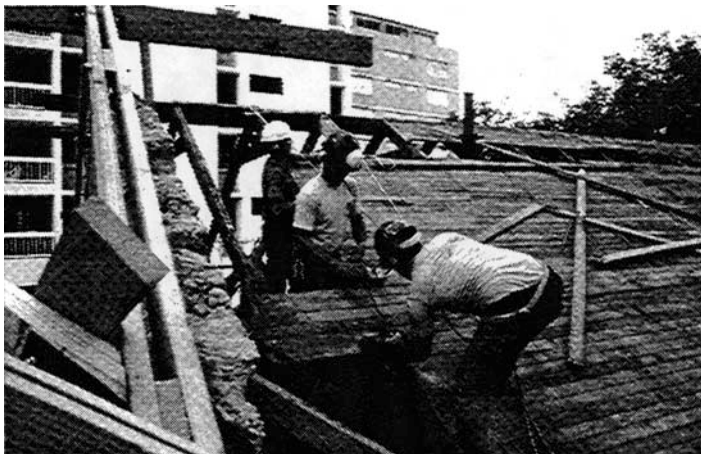
Cutting wood boards before dismantling original roof truss during Colegio de Arquitectos Headquarters restoration in Santurce, PR (19931).

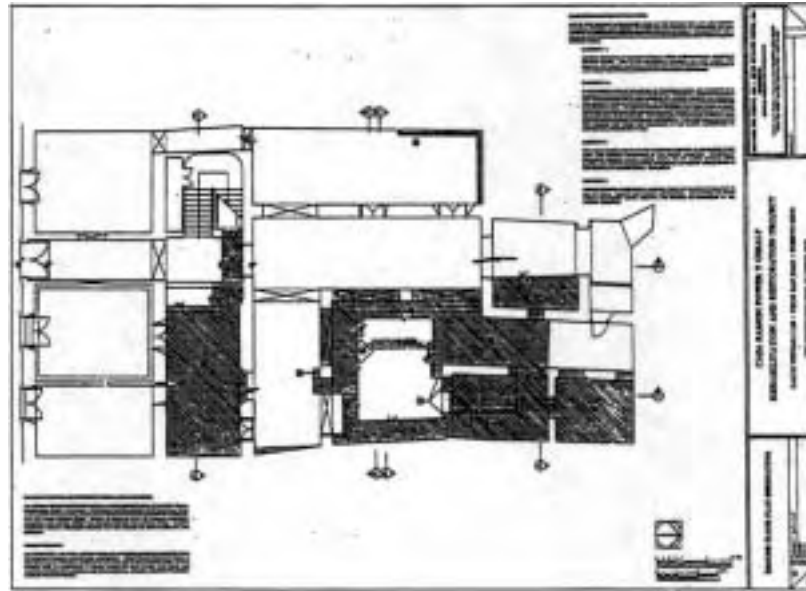
Selective demolition plan for Casa Ramón Power y Giralt as future headquarters for the Conservation Trust of Puerto Rico (1993).
