THE CONSERVATION AND PRESERVATION OF TABBY

A SYMPOSIUM ON HISTORIC BUILDING MATERIAL IN THE COASTAL SOUTHEAST

February 25–27, 1998
Jekyll Island, Georgia

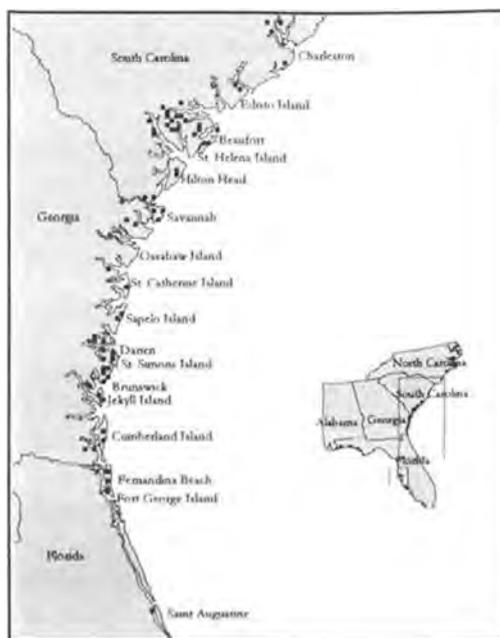
Selected extant tabby structures in the Southeastern United States

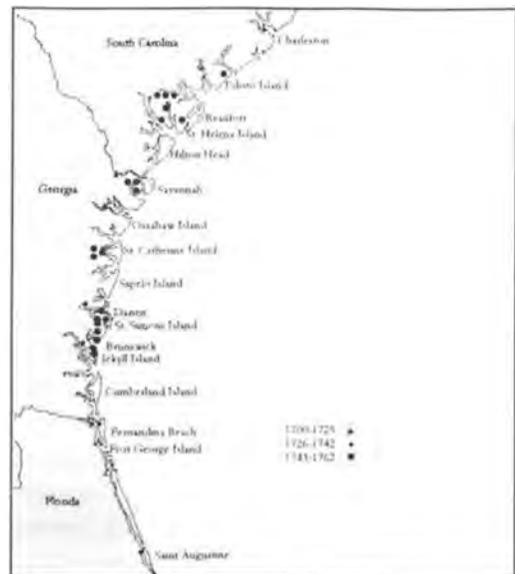
Tabby of British origin from 1700 to 1762.

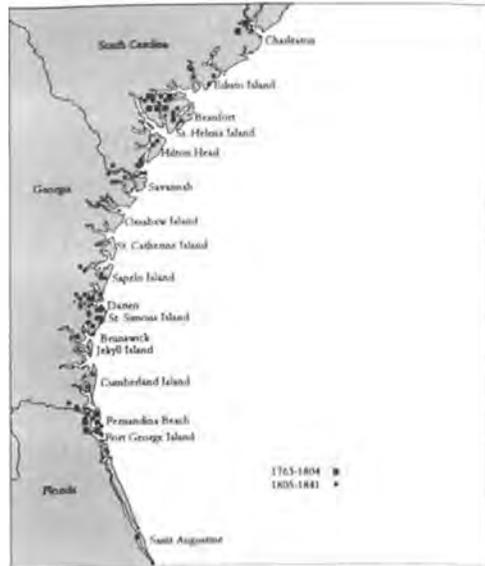
Tabby of British and American origin from 1763 to 1841.

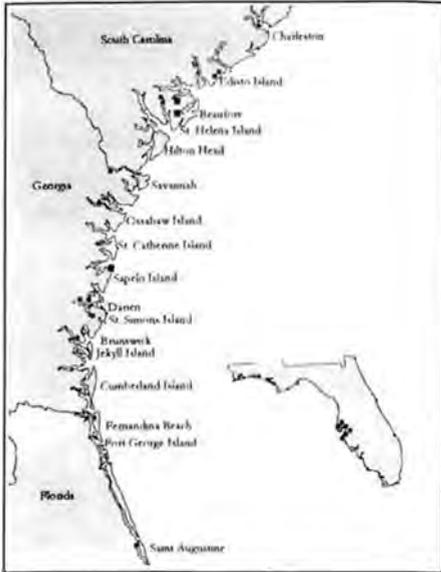
Tabby of American origin from 1842 to 1920.

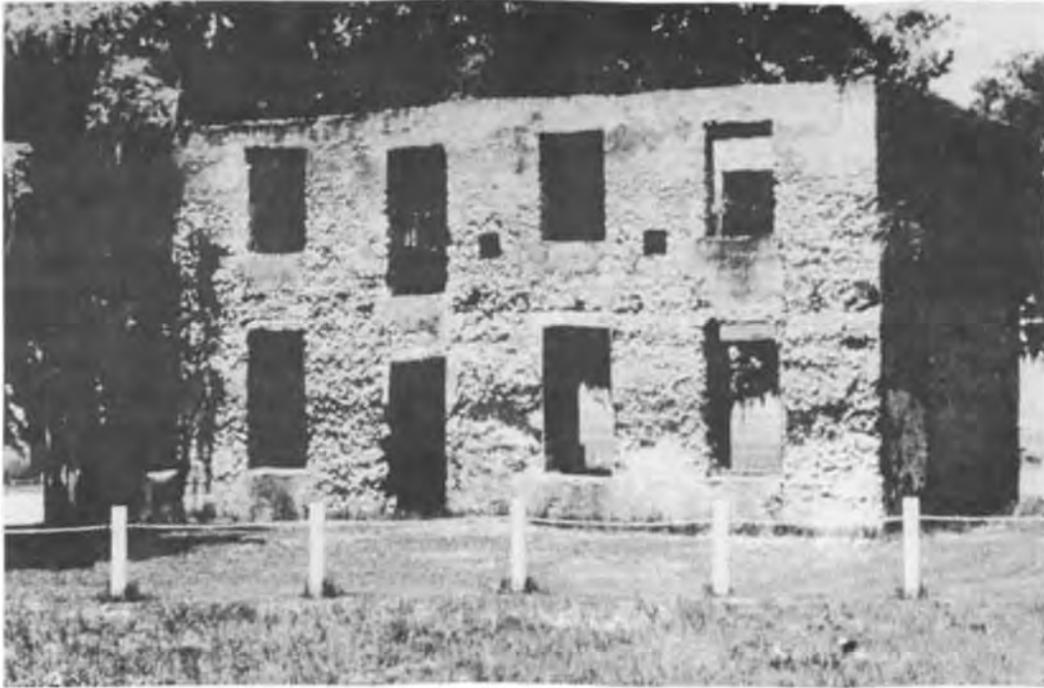
The Horton-DuBignon House on Jekyll Island (circa 1738) is one of the oldest intact tabby structures in Georgia.

There is one standing chimney on the west facade. The existing ruin is made up of three separate tabby constructions. Portions of tabby and the existing stucco date from the 1899 “restoration” of the structure by the Jekyll Island Club. It may have been during this period that steel rods were added for bracing. The second tabby pour, the age of which has not been determined, is evident along portions of the second-floor windows. The remaining portion, which is the majority of historic tabby, is identical in texture and consistency to that of the nearby ruins of the Horton Brewery, which date to the 1730s. A conjectural drawing done in a 1960s restoration plan depicts what the house may have looked like.

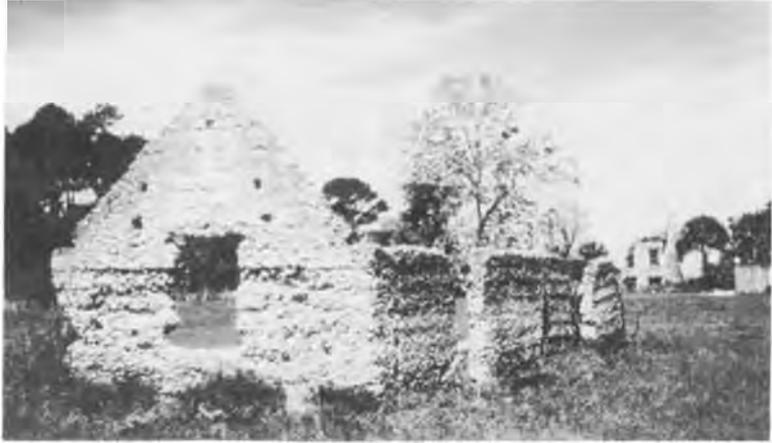
Chocolate Plantation on Sapelo Island in McIntosh County is believed to have been built sometime between 1812 and 1820. The site consists of over fifteen tabby structures, including the main house, individual slave cabins (above), storage buildings, an infirmary, and stables.

tures. Immediate structural stabilization of many of the walls is needed before much of this site is lost.

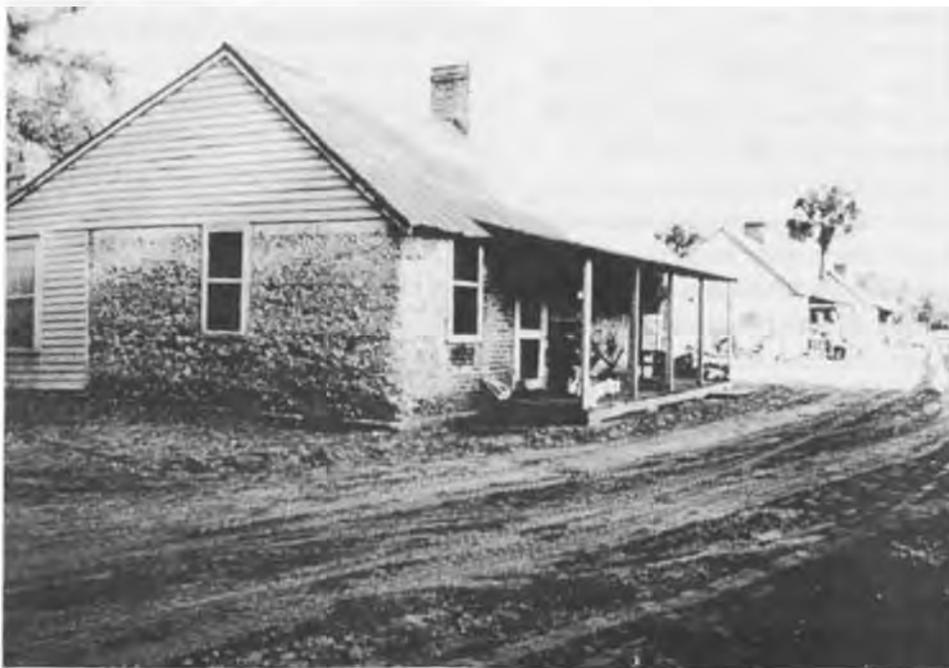
These two slave cabins are located on Hamilton Plantation, St. Simons Island in Glynn County. One of the cabins has a rear kitchen, but otherwise the overall forms of these two buildings remain intact.

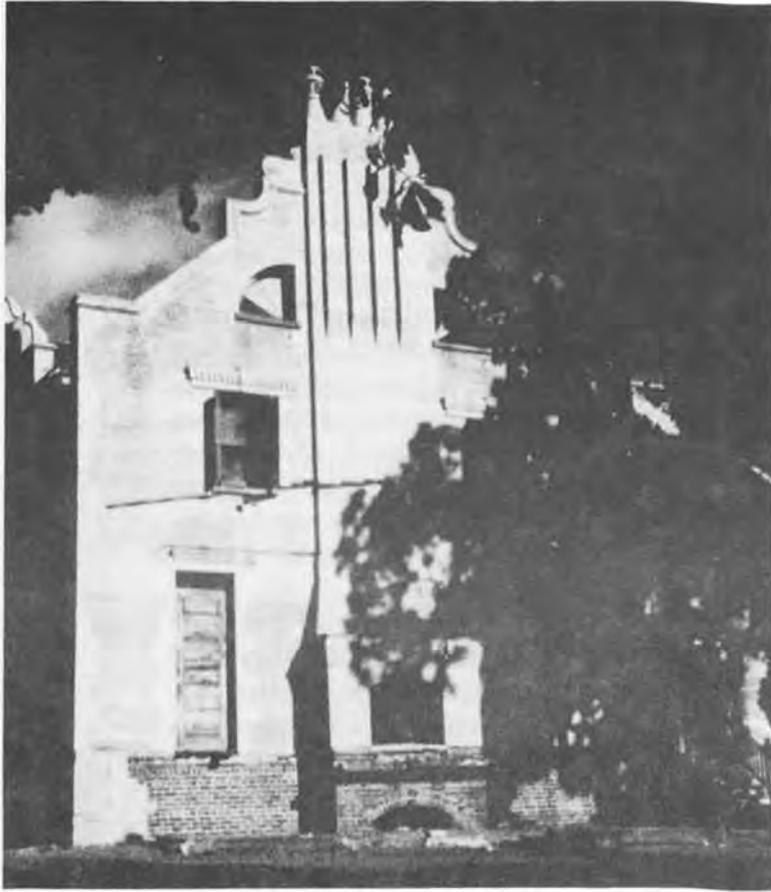
Hollybourne Cottage Jekyll Island, Glynn County

Hollybourne Cottage on Jekyll Island was built in 1890. The house is presently vacant and has numerous structural problems.

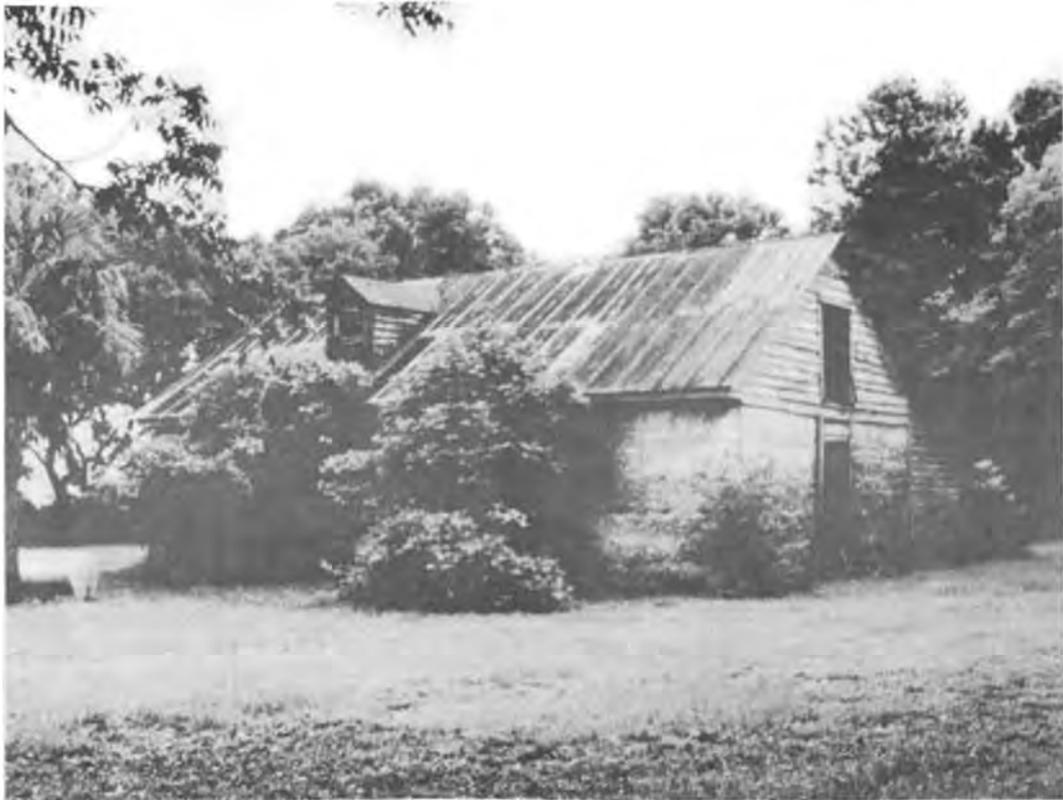
The tabby barn (circa 1800) at Frogmore Plantation is still in use.

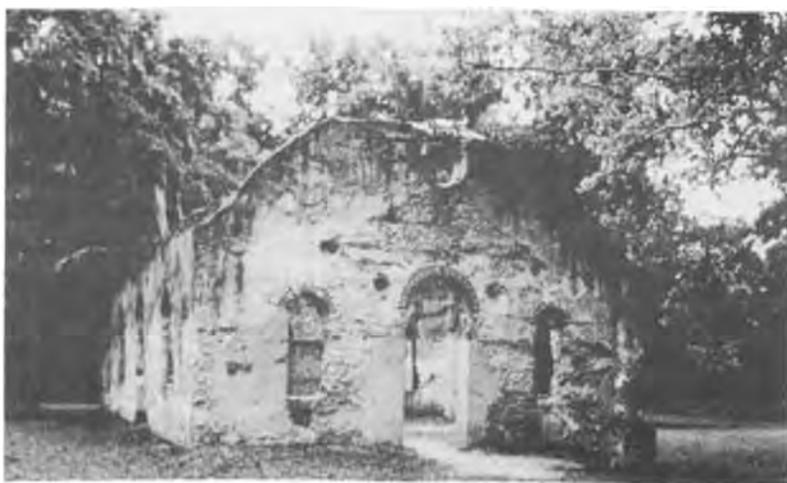
The Saint Helena Chapel of Ease (circa 1740) features tabby walls with brick columns and brick arches over the window openings.

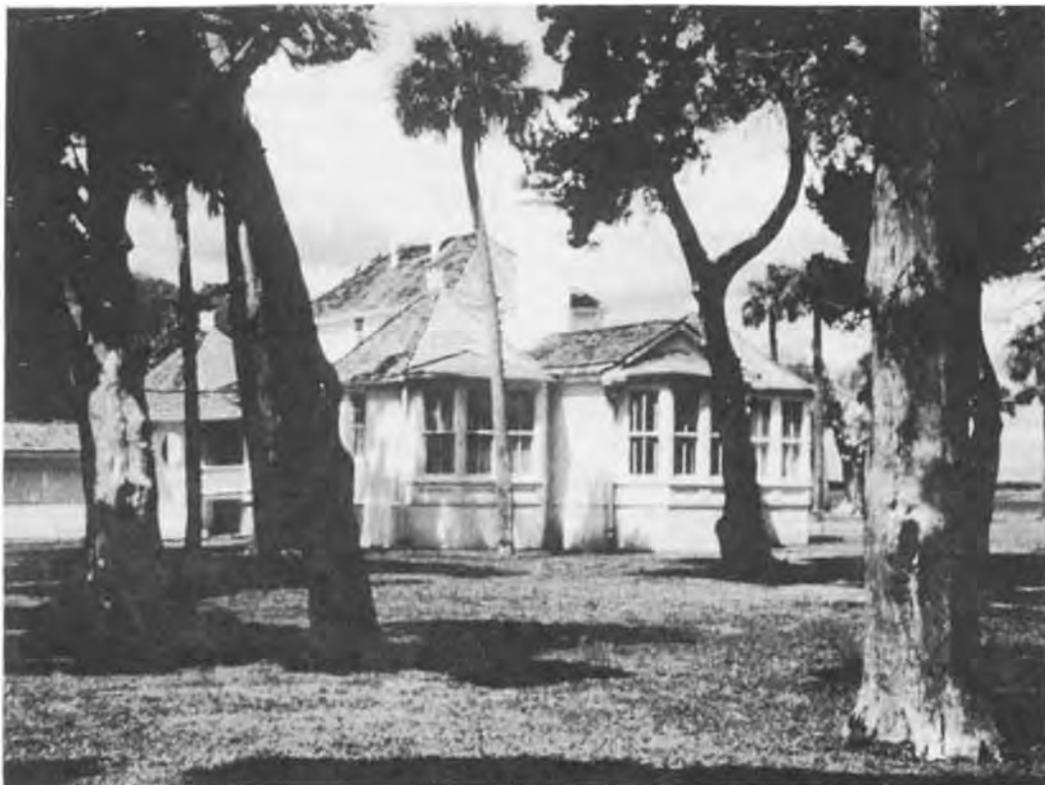
The Kingsley Plantation on Fort George Island north of Jacksonville features Florida's earliest examples of tabby. Above is the main house.

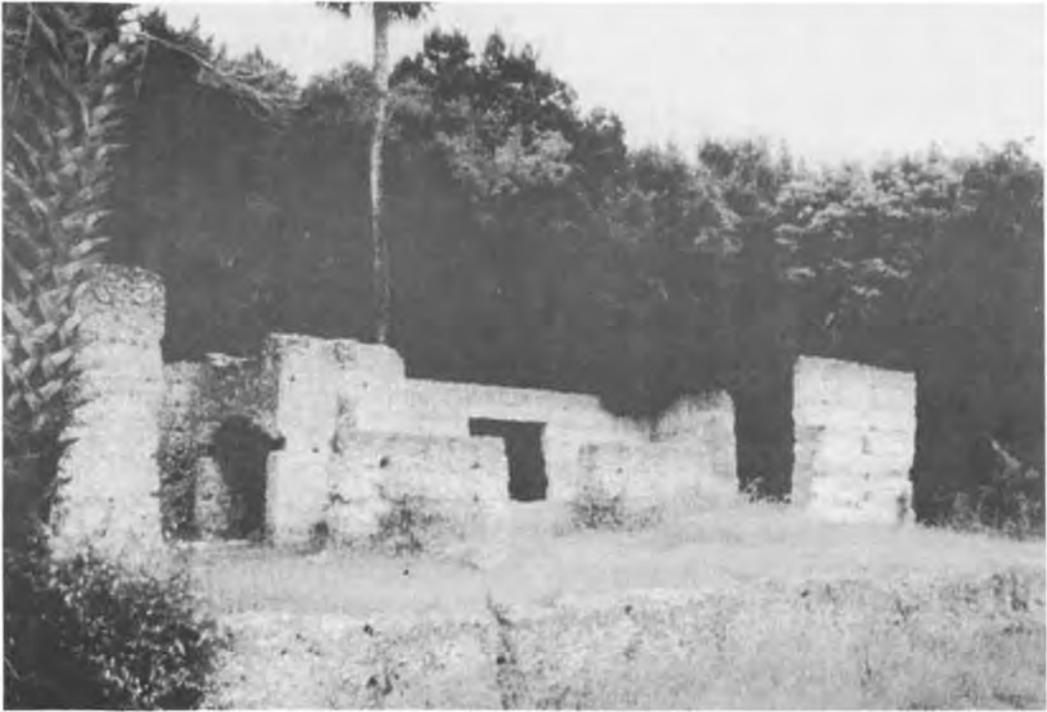
The ruins of the slave cabins at Kingsley Plantation are in remarkably good condition after almost two hundred years.

cast-in-place construction method with lifts ranging from nine-and-one-half to eleven inches. They have been most recently worked on in a 1996 training course sponsored by the Williamsport Center under the direction of Tom McGrath. With one reconstructed exception all remain roofless, with only the walls standing, and are in remarkably good condition after almost two hundred years, a lively demonstration of tabby's durability.

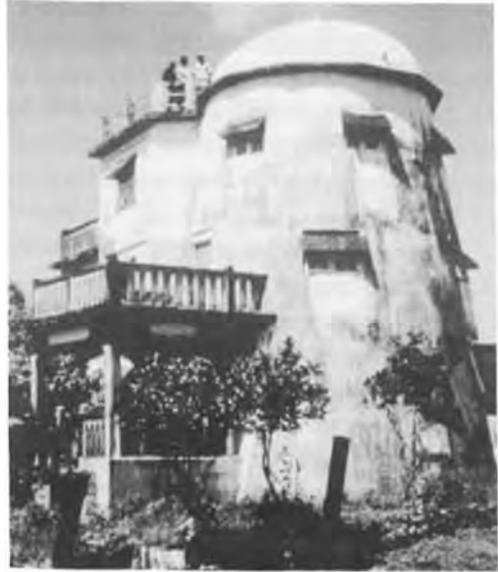
The Courland Great House/Mill is located near the town of Plymouth on the southwest side of the island of Tobago.

- **The Existing Great House.** The great house, as it is known today, consists of a modified windmill tower with a two-story addition on the southwest side of the tower. The age of the mill tower is unknown because of extensive twentieth-century modifications. Because of its location between the ruins of the estate house and the sugar factory, it is presumed to have been constructed contemporaneously with the factory.

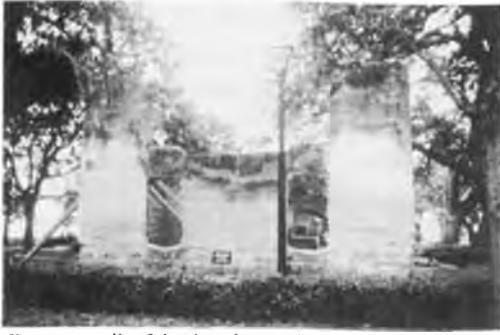
Exterior walls of the slave hospital at Retreat Plantation, Saint Simons Island, Georgia.

We used rectified photography to document the wall elevations. We accomplished this purpose by setting targets at an equal distance from the walls to a parallel plane from which photographs were taken. They were then enlarged to a given scale of one-quarter inch. These photos were traced onto mylar plastic sheets and drawn with technical barrel-type pens called Rapidographs. Floor footprints were measured and drawn showing the floor plan of these walls. Archaeologist Tom

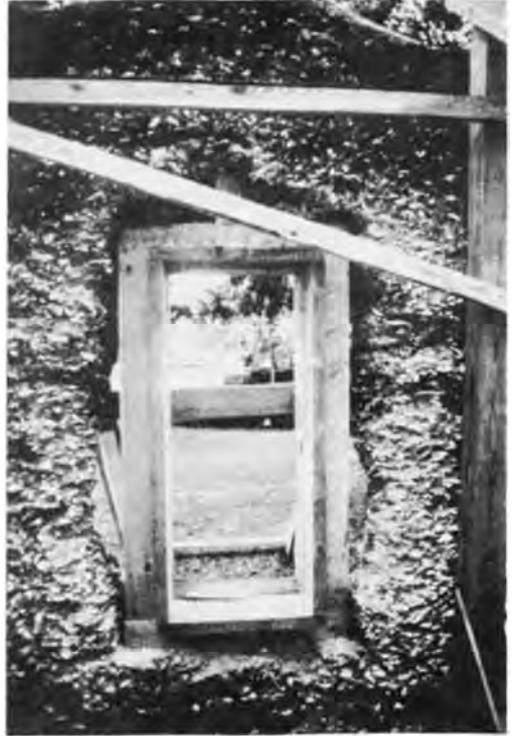
New wood framing at the slave hospital at Retreat Plantation, Saint Simons Island, Georgia.

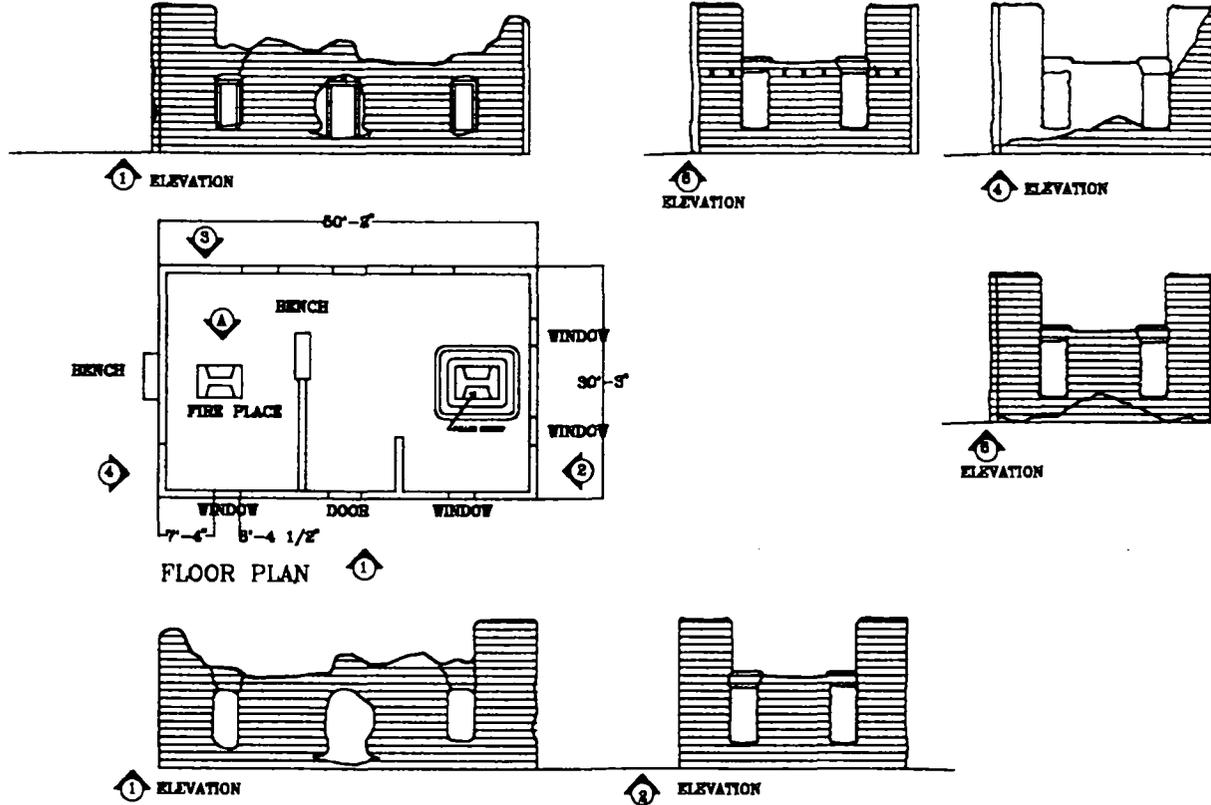
Tabby construction of the hospital at Retreat Plantation, Saint Simons Island, Georgia

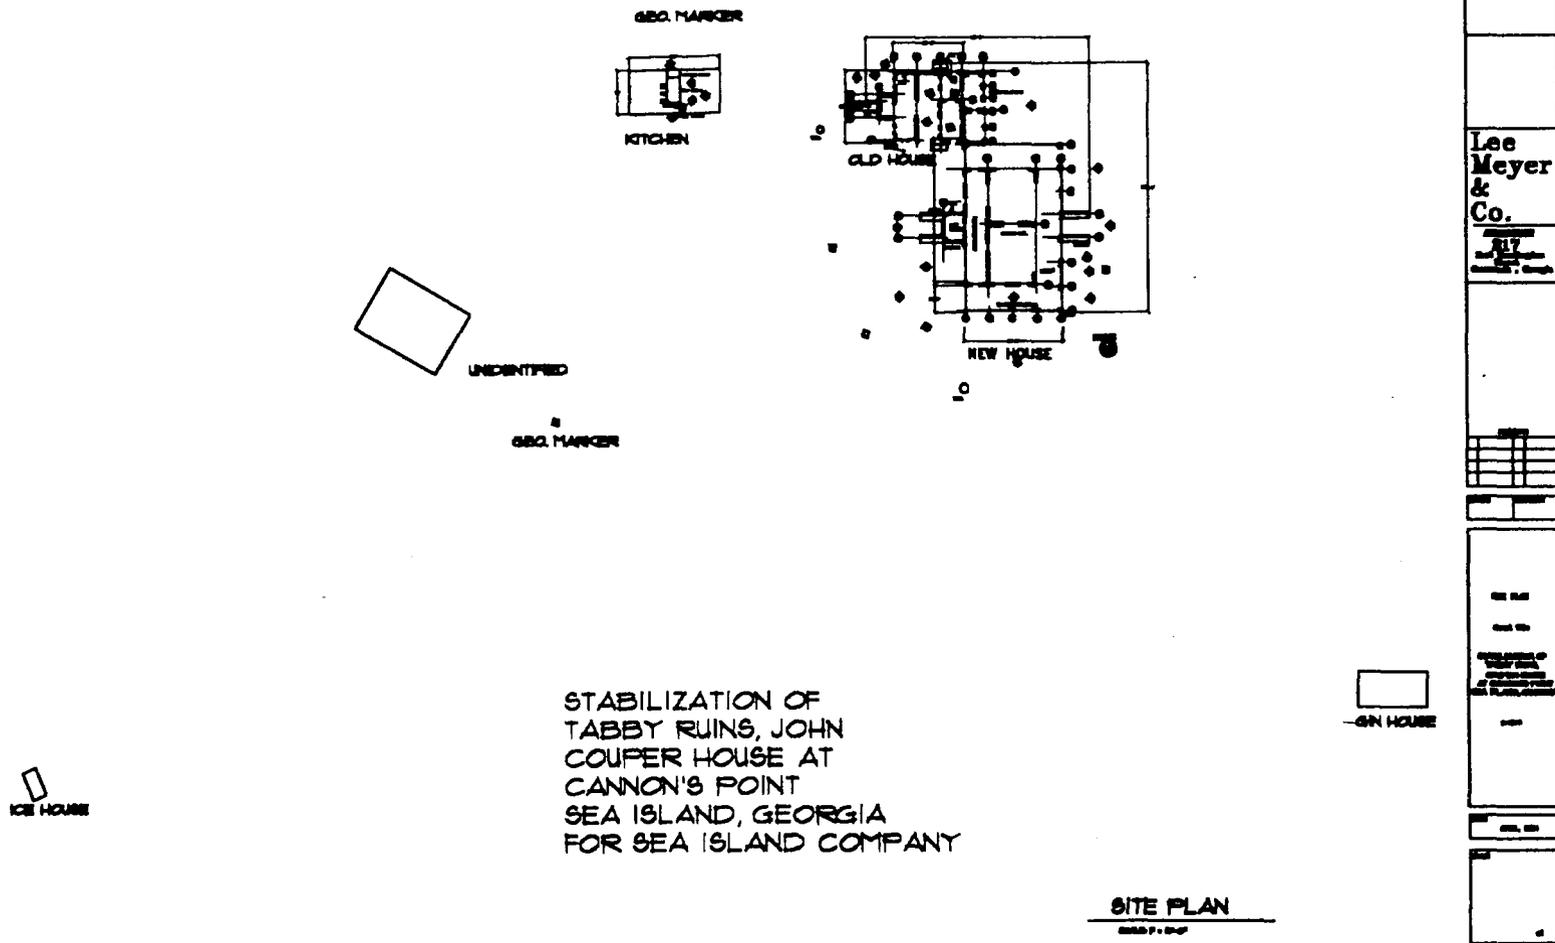
THE JOHN COUPER HOUSE AT CANNONS POINT AT SEA ISLAND GEORGIA
 FOR THE SEA ISLAND COMPANY SEA ISLAND, GEORGIA

at Cannons Point on Sea Island, Georgia. We photographed both from eye level and from a height of thirty feet from a bucket truck. We established a twenty-foot grid over the entire site. We also provided an additional north-south grid for each wall and column location. This allowed easy identification of each component. The purpose of this phase of the work was to identify the existing ruin and then to develop a program to stabilize and preserve it safely. The same technical data used at the slave hospital will be used for the work at the John Couper ruin.

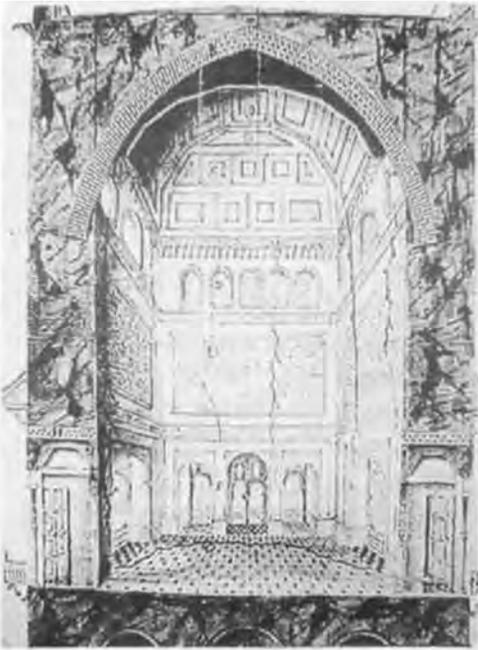
A 1686 drawing of the Torre de Comares at the Alhambra in Granada. Archivo General de Simancas.

The Torre de Comares, at the Alhambra, Granada, provides a memorable monument to such construction.²³ Erected circa 1340, this structure is about forty feet square and approximately seventy feet high and evidences numerous structural repairs. Post-medieval restorations are documented from 1588 down until the present time. A drawing dated 1686²⁴ is of unique interest, illustrating the structure riven by massive vertical cracks. Later records indicate that decayed, split, or otherwise impaired *tâbiyah* was gradually cut out and replaced with brick (a long-established practice documented at the Alhambra from 1590 onwards but known on other sites much earlier), the tower’s continued structural integrity depending upon intermittent reconstruction episodes. Today, it can be seen that much medieval fabric has been replaced, brick corner rein-

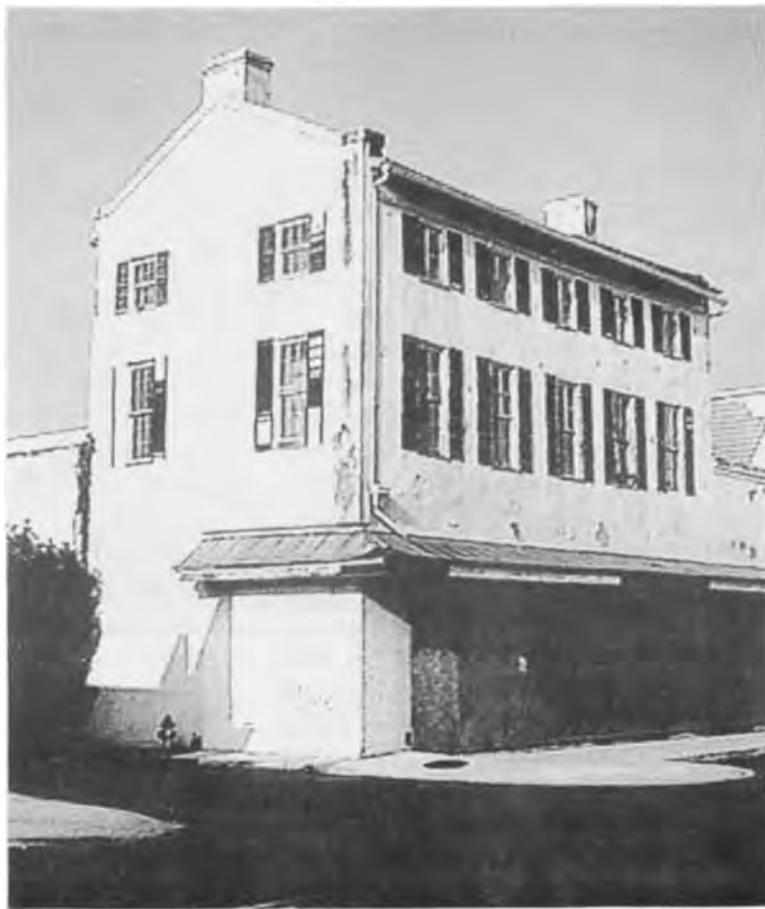
The Saltus/Habersham House (circa 1797) is located in Beaufort, South Carolina.

Upper portions of the old house were supported on steel joists, this highly hazardous exercise made more so by installation of undersized steel supporting members. While the two end facades with their internal brick chimney stacks still stand intact, steel beams carrying upper front and rear tabby walls have deflected as much as seven inches, tabby fabrics above tearing and splitting to a point where the entire building is endangered.

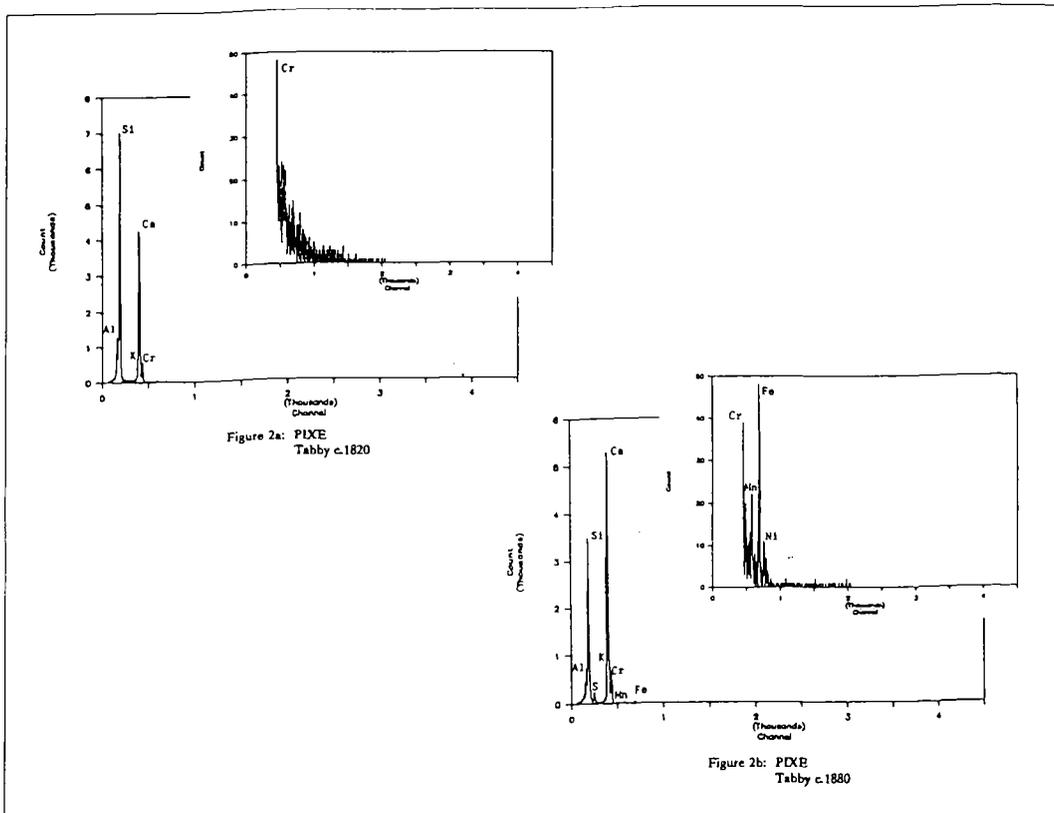
Taken from Lauren B. Sickels-Taves, Michael S. Sheehan, and Gary White, "Applications of Qualitative Trace Element Analyses: An Interdisciplinary Approach to Materials Conservation," *Materials Issues in Art and Archaeology* 5, Materials Research Society Proceedings 462 (1997): 328.

The three most outstanding tests—most useful in preparing the Tabby House for restoration—were particle-induced X-ray emission (PIXE), computer-assisted optical stereology, and ash analysis.

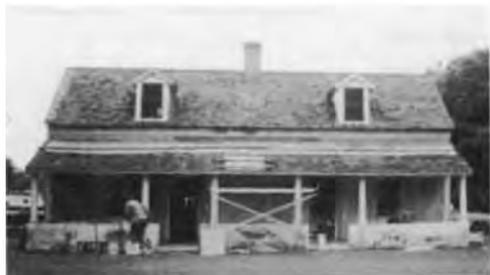
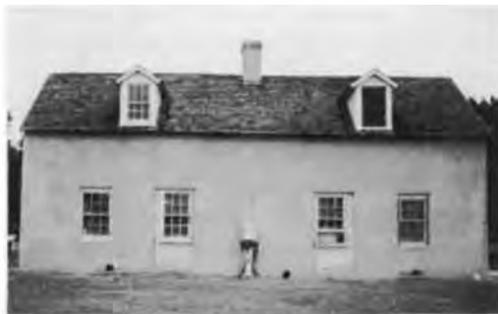
The Tabby House, front and rear elevations, nearing completion. The completed walls are drying to a uniform, warm, light brown color (Munsell Colour 10YR 8/1), closely matching the original color. Photographs by Melanie Taves.

The formula for original tabby, based on laboratory analysis, was a 1:3 lime:sand with wood ash, obtained during the lime burning, and oyster shell. This specific formula was one of two recommended by the Roman Vitruvius as early as 46–30
