# Corrosion Resistance Surface Treatment for Marble | 2013-07

**Project title:** Corrosion resistant surface treatment for marble

**Grant Number:** MT-2210-12-NC-08

**Date of Final Report:** August 12, 2013

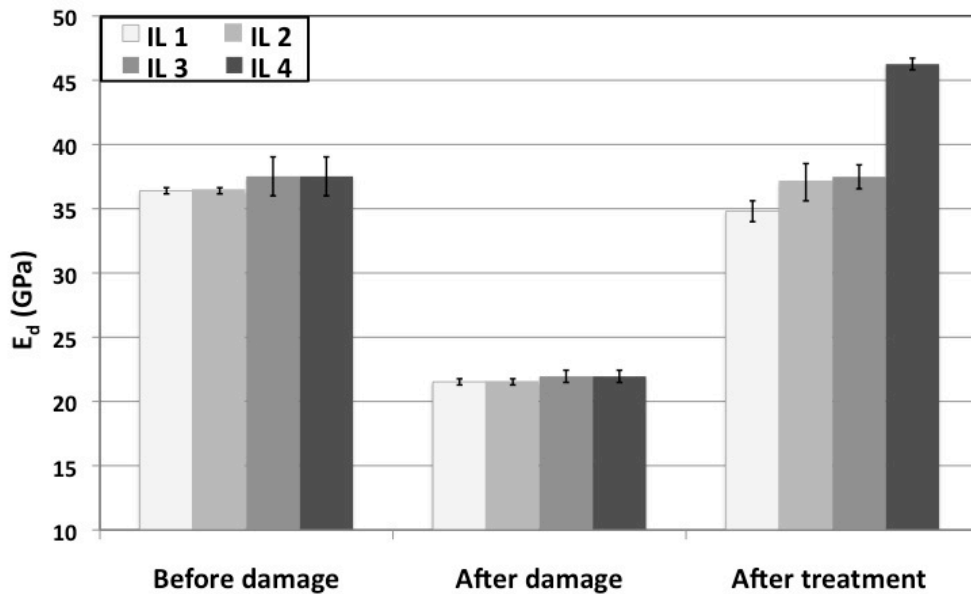
Figure 1. Dynamic modulus of DAP-treated IL samples. Error bars represent the values for the pairs of samples.

It was previously demonstrated (Sassoni et al. 2011) that treatment with DAP results in a film of HAP that fully restores the dynamic modulus of damaged limestone. In the present work, we compared the performance of the phosphate treatment with that of Conservare OH-100<sup>®</sup>, and also investigated the sequential application of those two consolidants. As shown in Figure 1, the heat treatment reduces the dynamic elastic modulus,  $E_d$ , by almost 50%, and a single treatment with DAP restores it completely, while a double treatment raises  $E_d$  above its initial value.

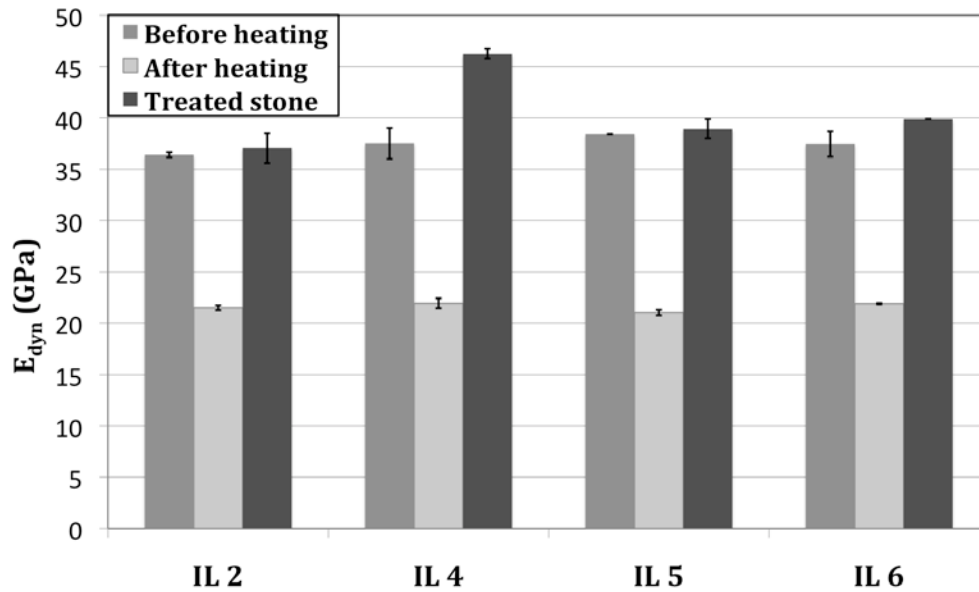
Figure 2.  $E_{dyn}$  comparison of different treatments. Error bars represent the values for the pairs of samples.

If the DAP treatment is followed by application of Conservare, there is very little improvement, as indicated in Figure 2. It was expected that HAP might act as a coupling agent

for the silicate to the carbonate, owing to the presence of OH groups in the crystal structure of HAP. However, spectroscopic analysis revealed no detectable OH groups on the surface of the HAP, possibly owing to carbonation of the surface. If a double treatment is to be applied, then it is much more effective to use DAP twice than to follow a single application of DAP with Conservare.

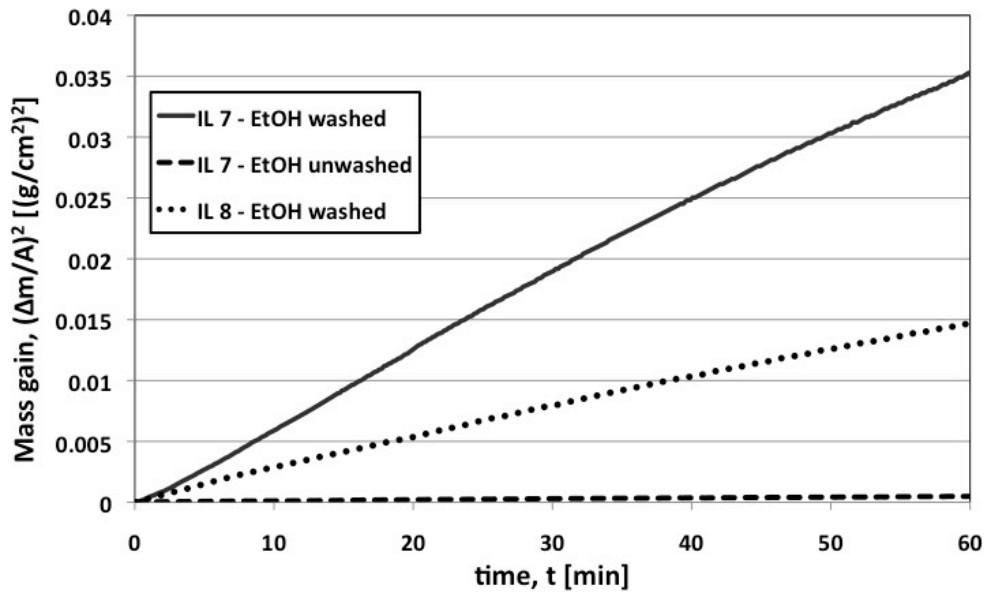
Figure 3. Initial water uptake of naturally cured Conservare-consolidated sample, pre- and post-rinsing with EtOH:H<sub>2</sub>O = 1:5.

In the course of this work, we discovered that the hydrophobicity of the Conservare-treated stone could be drastically reduced by rinsing the stone with a solution of water and ethanol (EtOH). The alcohol solubilizes the water, so that the solution readily penetrates the hydrophobic consolidated stone, and the water accelerates hydration of the tetraethoxysilane. Only a small proportion of alcohol is required, so we used a 1:5 (v/v) EtOH:H<sub>2</sub>O solution. The consolidated stone was immersed in the solution after 2 to 7 weeks of curing. As a result, the

sorptivity of the stone was dramatically increased, as indicated in Figure 3. This procedure will be very useful for conservators who need to retreat after application of a TEOS-based silicate consolidant.

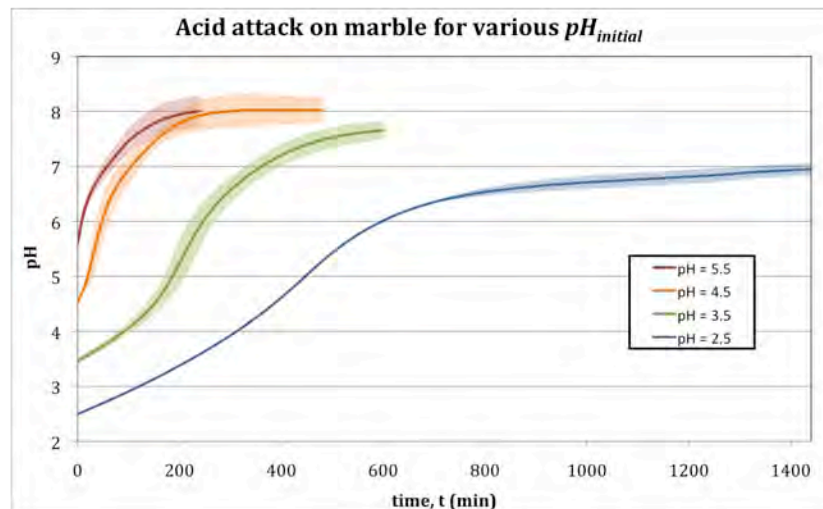
Figure 4. Acid attack profiles for uncoated marble at various initial pH values. Shading indicates the range of reproducibility of the results.

When marble is exposed to acid, the dissolution of calcium carbonate consumes protons in the solution, so the pH rises. The rate of change for bare marble is shown in Figure 4. When the stone is treated with DAP, the rate of attack is slowed, as indicated in Figure 5. Unfortunately, the benefit of the HAP coating is modest, in spite of the fact that the rate of dissolution of HAP is about 4 orders of magnitude slower than that of calcite. The problem is that the coating remains porous, so the acid can penetrate to the substrate.

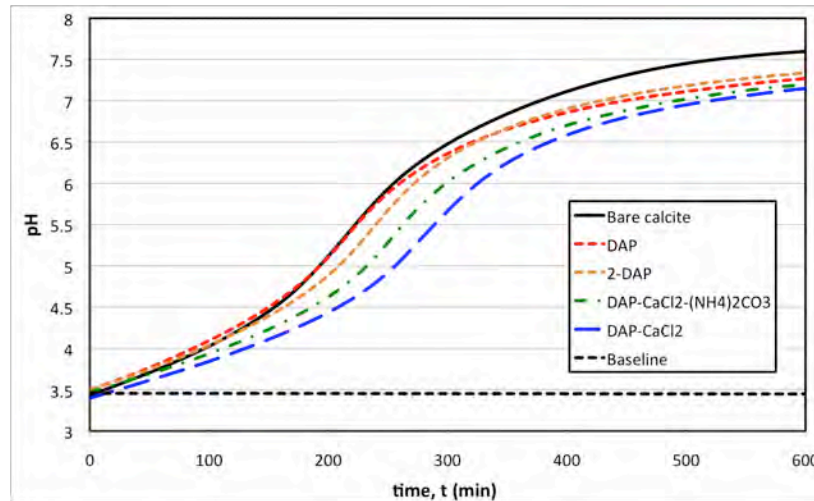
Figure 5. pH profiles for DAP-based treatments on marble: Bare calcite = uncoated marble; DAP = single treatment with 1 M DAP; 2-DAP = double treatment with 1 M DAP; DAP-CaCl<sub>2</sub>-(NH<sub>4</sub>)<sub>2</sub>CO<sub>3</sub> = single treatment with 1M DAP solution containing 1 mM CaCl<sub>2</sub> and 150 μM (NH<sub>4</sub>)<sub>2</sub>CO<sub>3</sub>; DAP-CaCl<sub>2</sub> = single treatment with 1M DAP solution containing 1 mM CaCl<sub>2</sub>; baseline shows the stability of the pH reading in the absence of a sample.

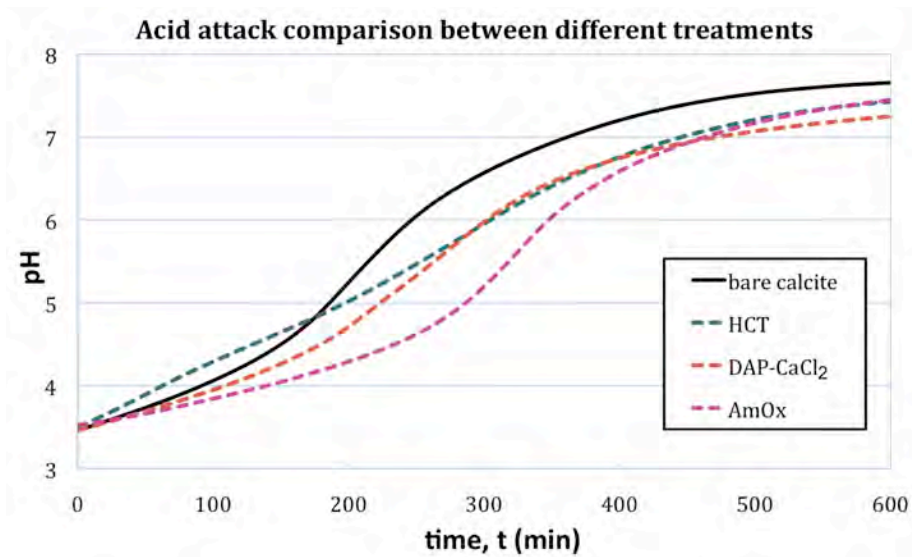
Figure 6. Comparison of the acid resistance of various coatings on marble: Bare calcite = uncoated marble; DAP-CaCl<sub>2</sub> = single treatment with 1M DAP solution containing 1 mM CaCl<sub>2</sub>; HCT = ammonium hydrogen tartrate; AmOx = ammonium oxalate

Treatment of marble with HCT results in large scattered crystals of calcium tartrate that do not constitute a coating, and which dissolve quickly, so that no protection is provided to the marble. In contrast, exposure to ammonium oxalate results in a uniform coating of small crystals that do retard the dissolution of marble, as shown in Figure 6, in spite of the relatively high solubility of calcium oxalate.

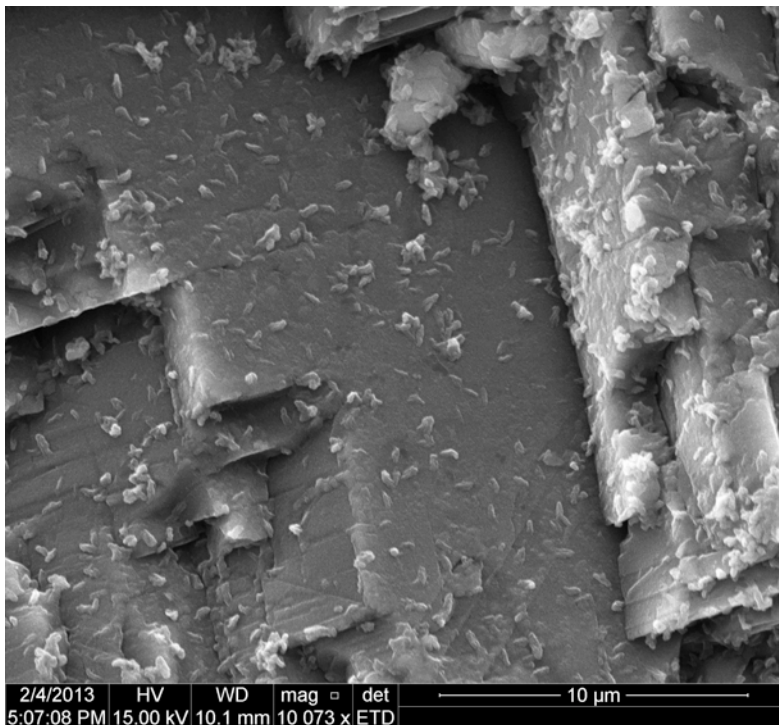
Figure 7. Surface of marble exposed to 1 M DAP + 1 mM CaCl<sub>2</sub> after ?? h. The small “rice grains” on the surface constitute the initial stage of growth of the phosphate film. This phase has not been identified, and may be non-crystalline.

The stages of nucleation and growth of the HAP film were observed in the SEM by interrupting growth at various intervals. The first phosphate phase to appear (as indicated by EDX) is in the form of small elongated grains shaped like grains of rice, as shown in Figure 7. It was not possible to identify the crystal phase using grazing incidence X-ray diffraction (GID), either because of the small amount present or because this material is non-crystalline.

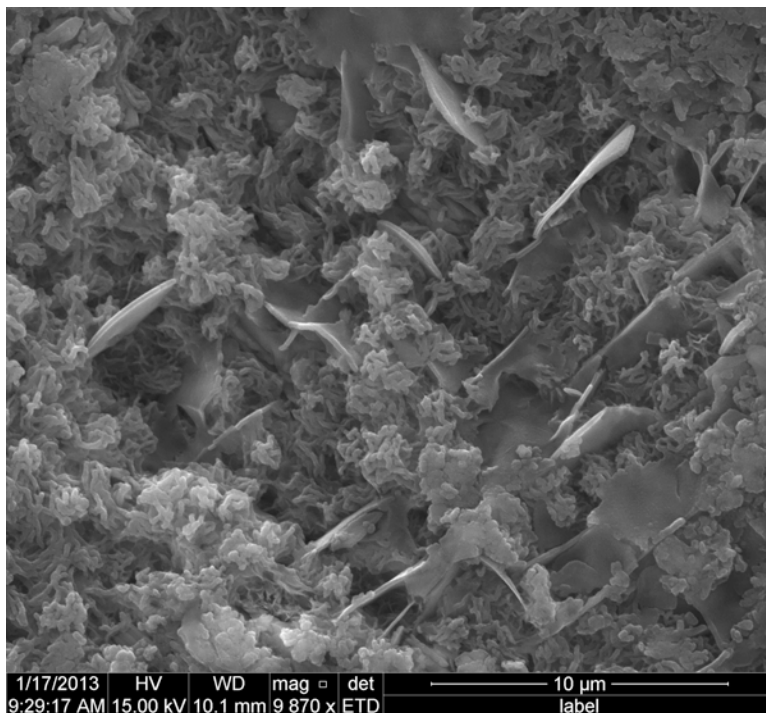
Figure 8. Surface of marble exposed to 1 M DAP + 1 mM CaCl<sub>2</sub> after ?? h. Flakes of octacalcium phosphate have begun to appear among clusters of the “rice grains”.

As shown in Figure 8, the “rice grains” gradually spread over the surface and pile up in clusters, and then large flakes of octacalcium phosphate (OCP) appear. The identification of this phase is based on the fact that samples treated only with DAP show no large flakes, and the only

phase detected by XRD is HAP; however, samples (such as that in Figure 8) treated with DAP + CaCl<sub>2</sub> do produce large flakes and show both HAP and OCP in the XRD pattern.

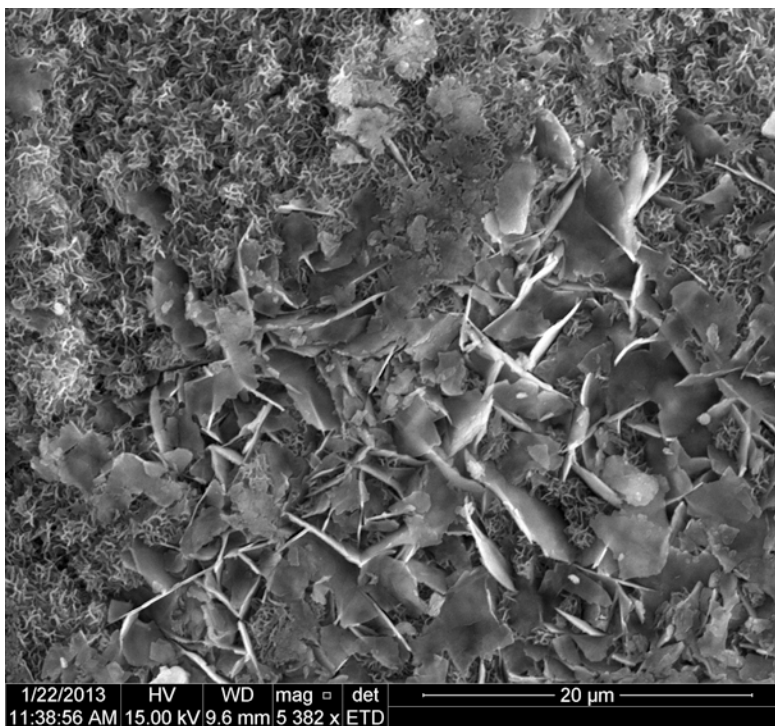
Figure 9. Surface of marble exposed to 1 M DAP + 1 mM CaCl<sub>2</sub> after ?? h. The “rice grain” structure has been replaced by flowery HAP crystals. The flakes of octacalcium phosphate will disappear (through burial in, or transformation to, HAP).

Figure 9 shows the structure at the beginning of the final stage of deposition, when the “rice grain” phase has transformed into a flaky, flowery form of HAP that gradually covers the surface and buries (or transforms) the OCP. Eventually, the HAP will cover the surface entirely.

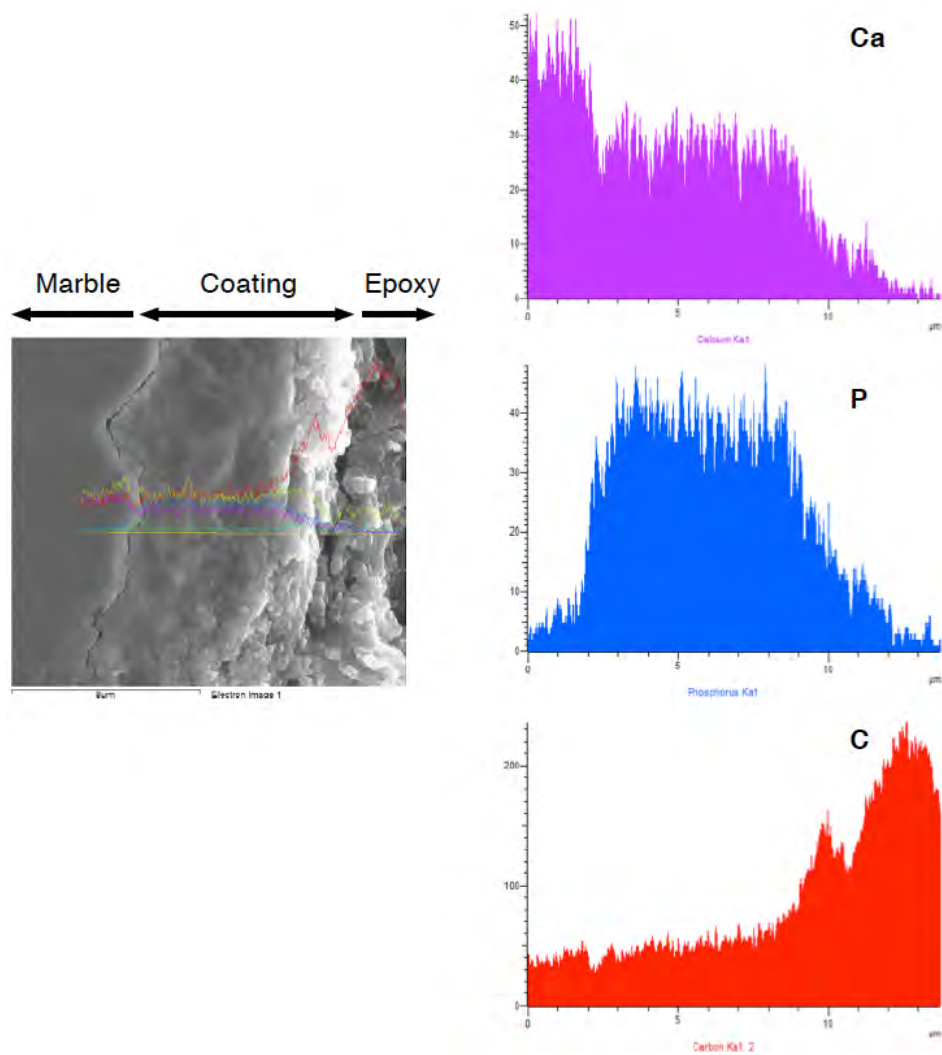
Figure 10. Cross-section of film deposited on marble from solution of 1 M DAP + 1 mM  $\text{CaCl}_2$  for 24 h. The EDX profiles show the phosphorous (P) localized in the film, and the calcium (Ca) in the film and the substrate; to the right, the epoxy potting compound is the only phase present.

Figure 10 shows a cross-section prepared by cutting through a marble substrate after 24 h of exposure to a solution of 1 M DAP + 1 mM CaCl<sub>2</sub>, then potting the sample in epoxy and polishing. From the phosphorus (P) EDX signal, the film is found to be about 8 microns thick. The calcium content steps down abruptly from its level in the CaCO<sub>3</sub> substrate to its level in the HAP layer. In contrast, the decay in the Ca and P signals at the outer surface is relatively gradual, reflecting the roughness of the surface, which allows the epoxy to penetrate a few microns into

the layer. These profiles must be interpreted with caution, because the width sampled by the electron beam is ~1-2 microns, so there would appear to be a gradual decline in concentration over that distance even if the concentration step were perfectly sharp. Nevertheless, the transition at the marble/film interface is clearly sharper than that at the film/epoxy interface, so the film is evidently porous, at least within a few microns of the outer surface. Near the substrate, it appears dense in the images, but the disappointing acid resistance indicates that the film is porous.

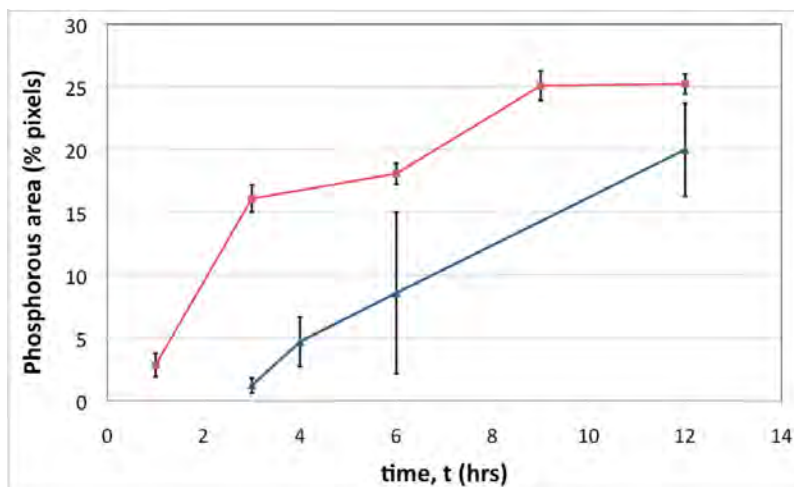
Figure 11. Effect of solution composition on the rate of HAP deposition, based on area scans by EDX. The area where P was detected was normalized by the count obtained on pure synthetic HAP. The lower (blue) curve is for growth from 1 M DAP, while the upper (red) curve is for 1 M DAP + 1 mM CaCl<sub>2</sub>.

To investigate the influence of solution chemistry on the rate of growth, samples of saw-cut marble were exposed to solutions of 1 M DAP with or without additions of 1 mM CaCl<sub>2</sub> or 150 μM (NH<sub>4</sub>)<sub>2</sub>CO<sub>3</sub>. The rationale for the latter additions is that we want to suppress dissolution of the substrate by raising the activity product of those ions above the equilibrium solubility of the calcite; the added calcium also feeds the growth of the HAP film. As shown in Figure 11, addition of calcium chloride accelerates nucleation and growth of the film, leading to much earlier coverage of the surface. Further addition of carbonate ions accelerates the early growth, but after 24 h the coverage is less than when carbonate is not added. This might be related to incorporation of carbonate ions into the HAP crystal, as such substitution is known to occur [Kamiya et al. 2004].
