Understanding Traditional and Modern Paints and Stains for Exterior Wood | 2014-01

Anthony & Associates, Inc. for Association for Preservation Technology International

Understanding Traditional and Modern Paints and Stains for Exterior Wood

NCPTT Grant No. MT-2210-11-NC-01

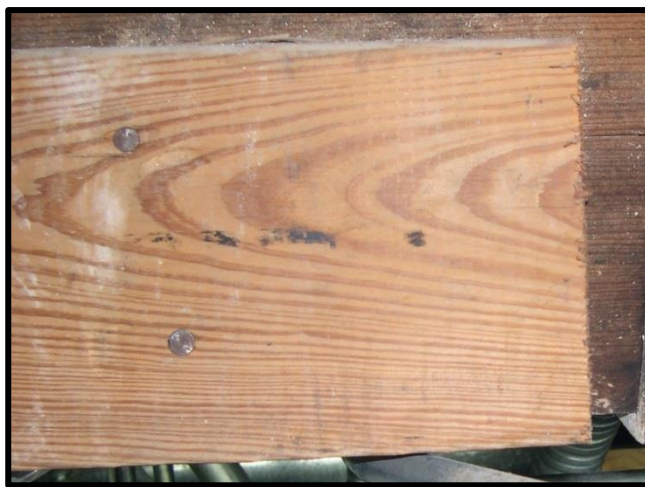
Figure 2.2. Flat-grained board with typical “U” shaped grain pattern.

Flat-grain lumber is wood that has been cut parallel to the tangential face of the log. This results in a pleasing characteristic “U” or “V” shaped grain pattern on the wide faces of boards and lumber (Figure 2.2). This cut is common because it maximizes the amount of useable material from the log. However, wood shrinks and swells the most in the tangential direction; therefore having large surface areas cut from the tangential faces of logs lead to boards and lumber that tends to cup, crown, bow, warp, and twist more than other cuts. This type of cut reduces the longevity of coatings due to greater shrinkage and swelling of the wood.

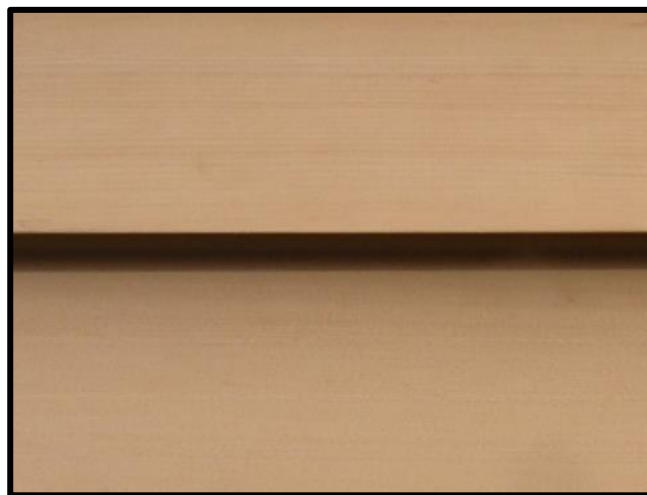
Figure 2.4. Tight vertical-grained Alaska yellow cedar siding with the wood fibers oriented parallel to the long axis of the boards.

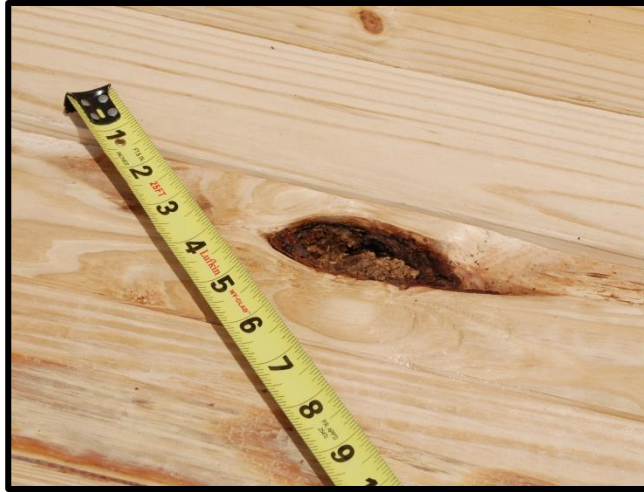
Figure 2.6. Bark Inclusions occur when a bark-covered branch or a separate stem becomes incorporated into the main trunk.

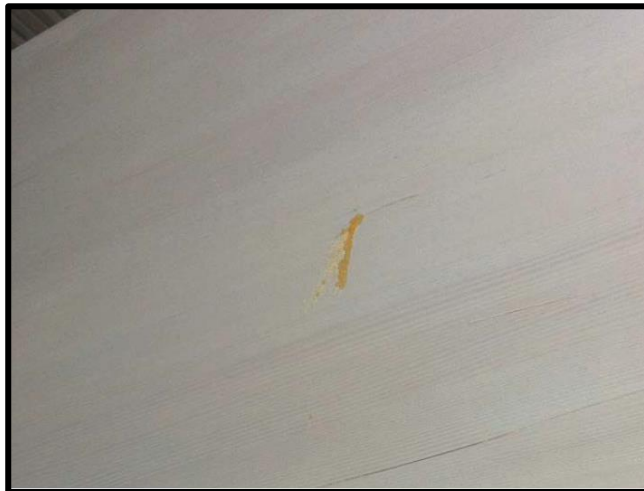
Figure 2.7. Although there is no visible evidence of a pitch pocket on the surface of the wood, the sap indicates the presence of one beneath the surface.

Knots, which are the remnants of branches, form areas of irregular grain and wood cellular structure that may not absorb a coating in the same manner as the surrounding wood (Figure 2.5a and 2.5b). Additionally, knotwood does not shrink or swell at the same rate as the surrounding wood fibers, thus leading to loose knots, knot holes, or cracks or splits in the surrounding wood fibers. Bark inclusions can behave in a similar manner, and also present rough patches that may be difficult to coat effectively (Figure 2.6). Pitch pockets, which are, as the name implies, pockets of tree sap or pitch that can seep out after coating, can lead to blisters or peeling (Figure 2.7).

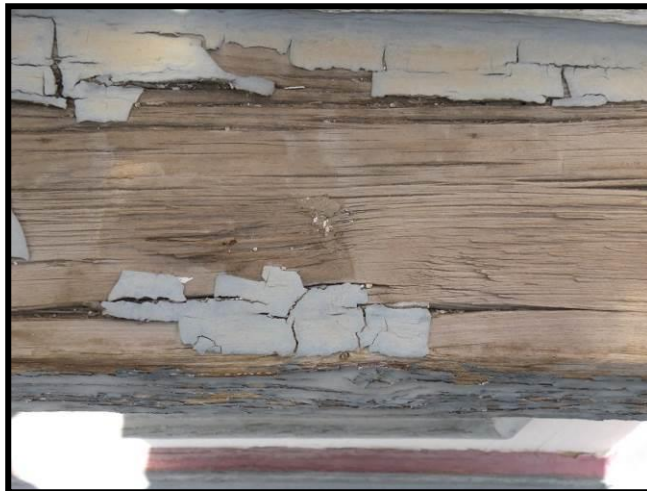
Figure 4.2. A window sill with failed paint and gray wood typical from UV exposure and weathering-caused cracks and checks that allow moisture penetration

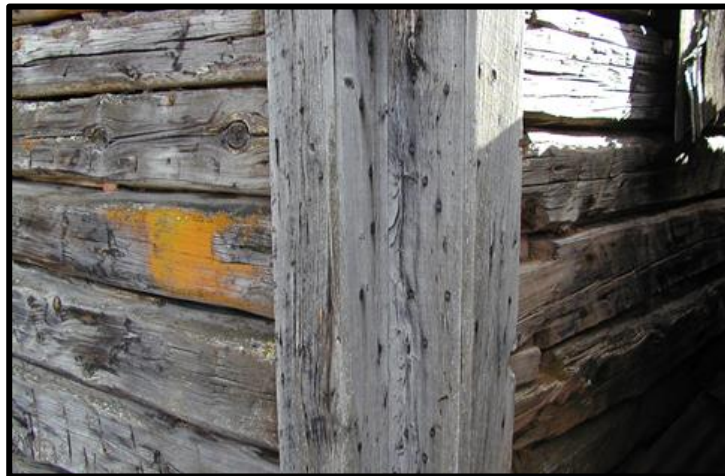
Figure 4.5. Lichens on the surface of a log structure.

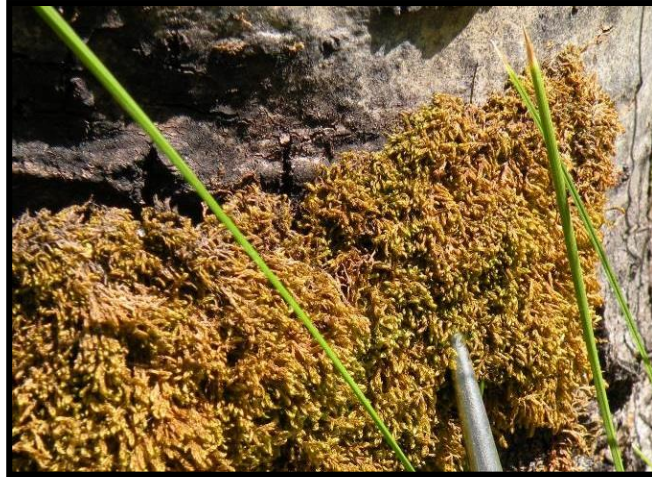
Figure 4.6. Moss growth on a wood substrate.

Mosses are non-vascular plants that can thrive on a variety of porous, moisture retentive surfaces (Figure 4.6). Mosses grow from spores and require near-constant high levels of moisture to survive. The presence of moss is an indication of a continuous high moisture environment, and the sponge-like composition of the moss traps moisture at the wood surface. If mosses are present on wood elements of a historic building, moisture levels are likely to be very high and decay fungi are probable. Moss can be easily removed with careful cleaning (Figure 4.7), but unless the favorable underlying conditions are altered, the moss will return. Mosses can be controlled by reducing the amount of available moisture and trimming trees and vegetation to increase sunlight exposure to enhance drying.

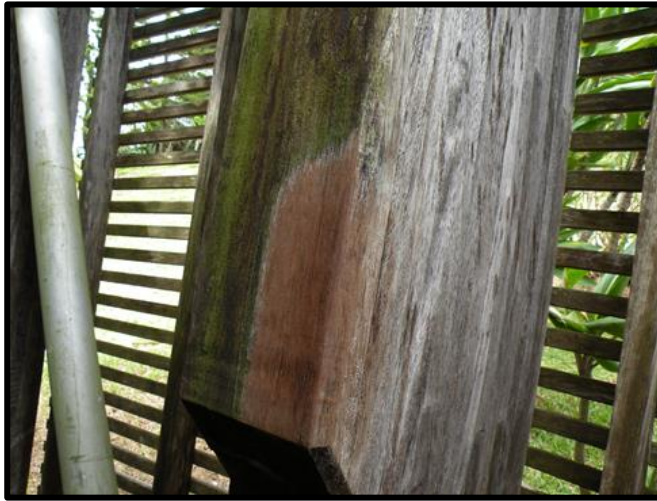
Figure 4.7. Biological growth and weathered patina, both of which can be removed through cleaning, as shown here.

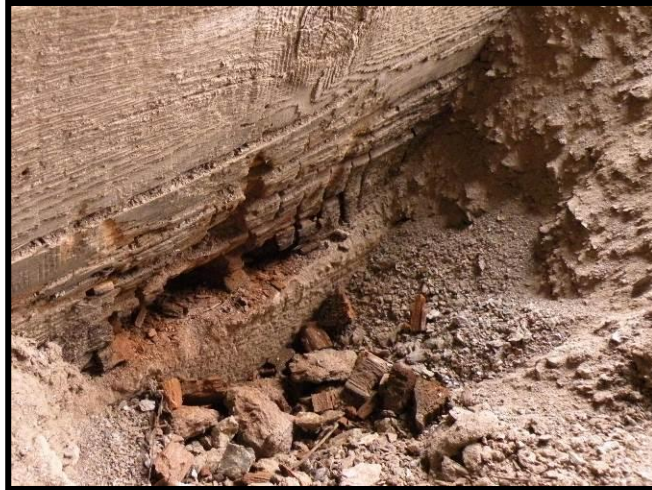
Figure 4.8. Deterioration of wood caused by wood-decay fungi.

All wood is subject to a variety of deterioration mechanisms, the most damaging throughout the U.S. of which is wood-decay fungi. Wood-decay fungi excrete enzymes that break down wood fibers, which can ultimately lead to a loss of integrity and the inability of the wood to perform its intended function. Most wood-decay fungi are only able to grow on wood with a moisture content greater than 20 percent (but require high moisture contents to initiate) and are unable to damage adjacent dry wood (Levy 1979). Evidence of typical decay of wood products can be identified by the dry, cubicle cracking that occurs in the wood substrate and/or by fungal fruiting bodies visible on the wood surface, although other patterns of deterioration can occur (Figures 4.8 and 4.9).

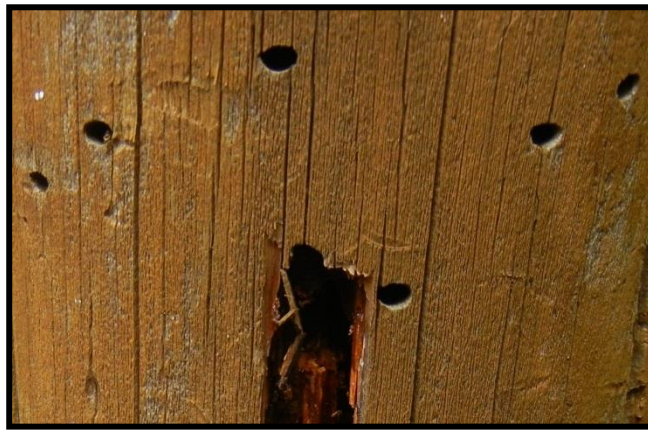
Figure 4.10. Bore holes in a stained column (also with deterioration by wood-decay fungi).

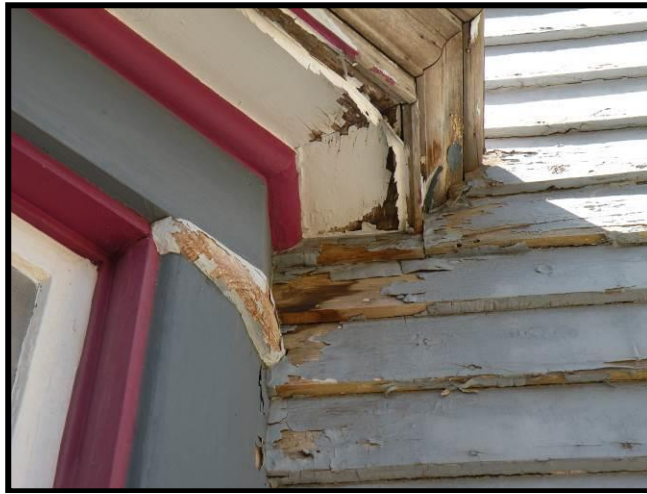
Figure 4.11. Coating failure near the end grain in an area where water flowed down the face of the exterior cladding, as evidenced by the moisture stains on the exposed wood.

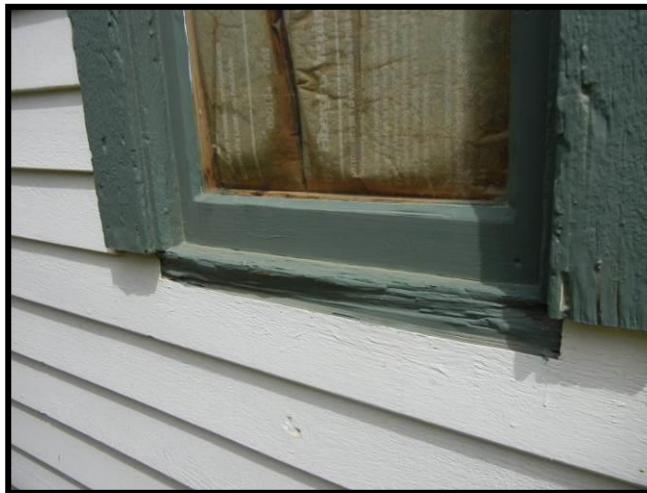
Figure 4.17. Missing window sill.

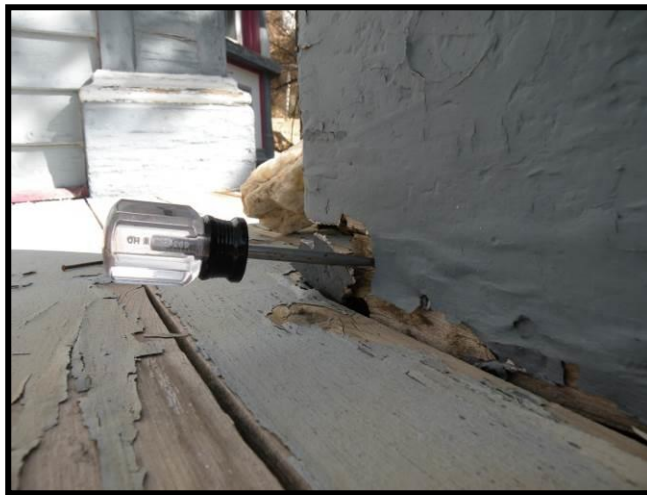
Figure 4.18. Probing at the base of a porch column with an awl reveals some deterioration.

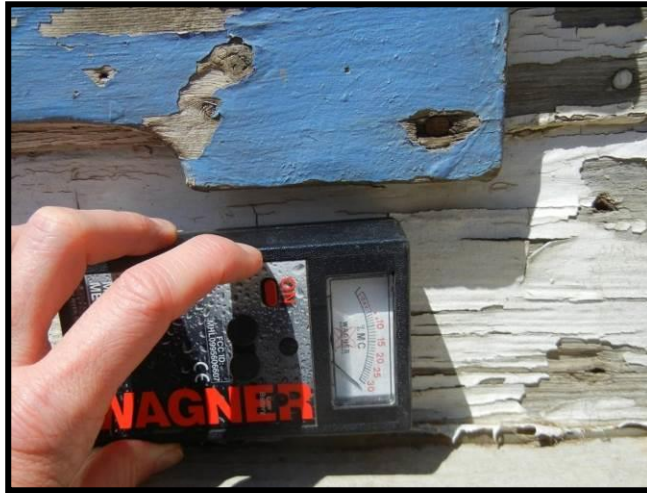
Figure 4.19. Use of a pinless (capacitance) moisture meter to determine the moisture content of siding.

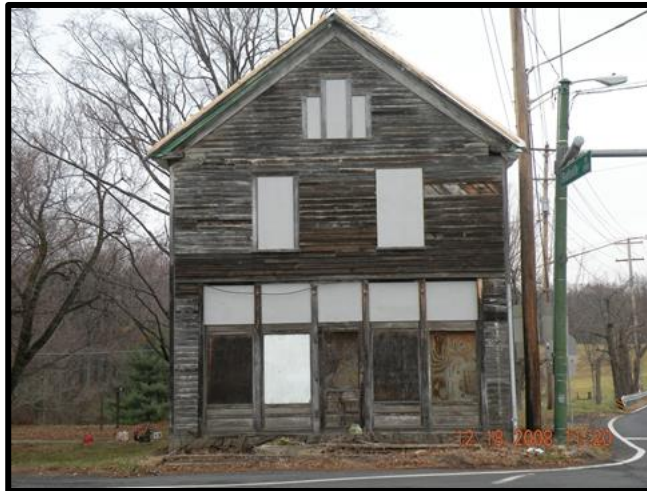
Figure 5.1 Weathered cladding from a naturally durable wood species that results in an appearance quite different than if it was painted.

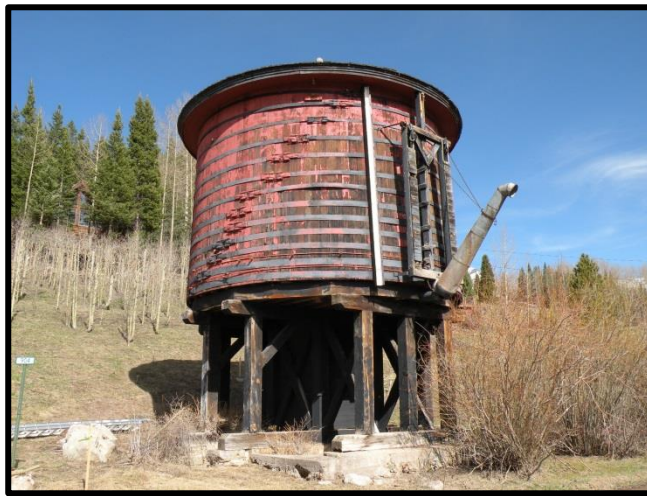
Figure 5.2. Deterioration of the staves of this water tank has resulted in friable wood surfaces that are delaminating. Given the fragile surface condition of many of the staves, repainting is not advised due to the potential damage that could result from removing the existing paint and properly preparing the surface for repainting; instead, replacement material can be painted to match the existing color, and the existing paint allowed to continue weathering.

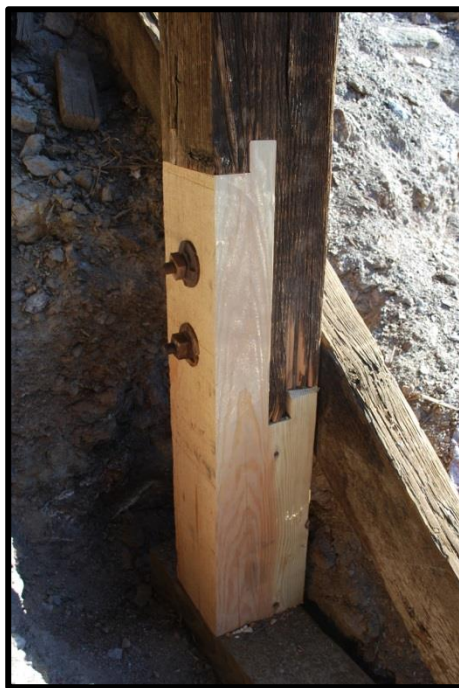
Figure 5.6. A Dutchman repair on an exterior column that had deteriorated in ground contact (courtesy of Douglas Porter, Conservation Associates).
