Understanding Traditional and Modern Paints and Stains for Exterior Wood | 2014-01

Anthony & Associates, Inc. for Association for Preservation Technology International

NCPTT Grant No. MT-2210-11-NC-01

February 2014

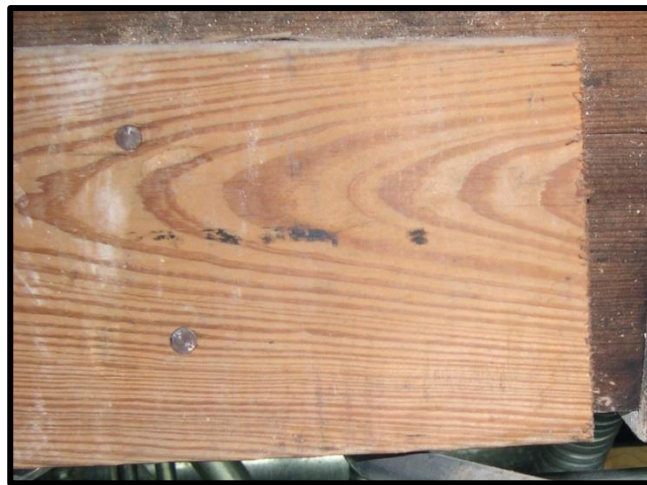
Figure 2.2. Flat-grained board with typical “U” shaped grain pattern.

Flat-grain lumber is wood that has been cut parallel to the tangential face of the log. This results in a pleasing characteristic “U” or “V” shaped grain pattern on the wide faces of boards and lumber (Figure 2.2). This cut is common because it maximizes the amount of useable material from the log. However, wood shrinks and swells the most in the tangential direction; therefore having large surface areas cut from the tangential faces of logs lead to boards and lumber that tends to cup, crown, bow, warp, and twist more than other cuts. This type of cut reduces the longevity of coatings due to greater shrinkage and swelling of the wood.

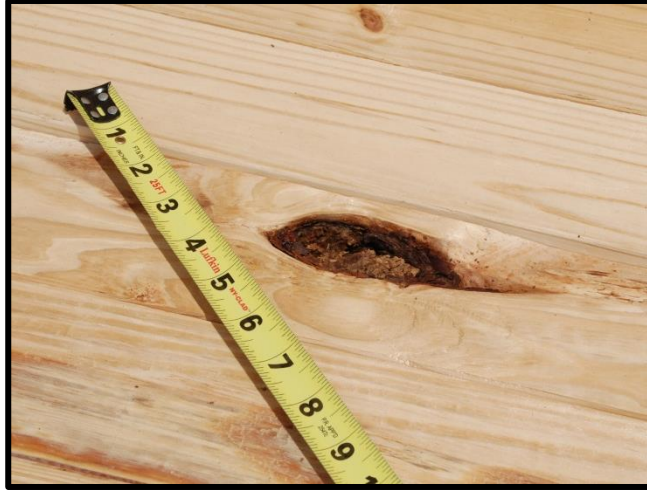
Figure 2.6. Bark Inclusions occur when a bark-covered branch or a separate stem becomes incorporated into the main trunk.

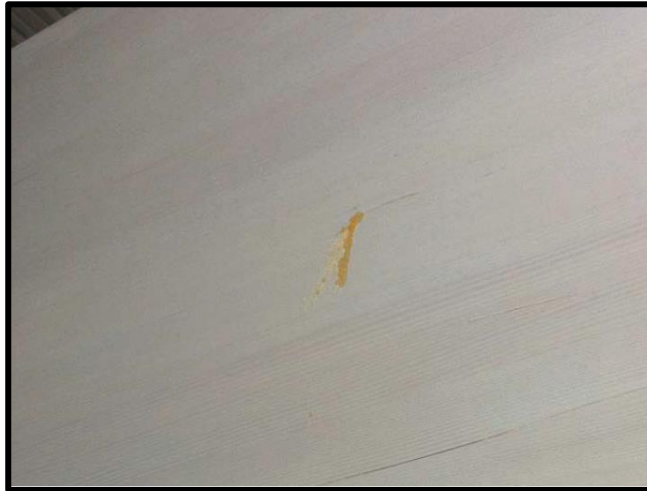
Figure 2.7. Although there is no visible evidence of a pitch pocket on the surface of the wood, the sap indicates the presence of one beneath the surface.

Knots, which are the remnants of branches, form areas of irregular grain and wood cellular structure that may not absorb a coating in the same manner as the surrounding wood (Figure 2.5a and 2.5b). Additionally, knotwood does not shrink or swell at the same rate as the surrounding wood fibers, thus leading to loose knots, knot holes, or cracks or splits in the surrounding wood fibers. Bark inclusions can behave in a similar manner, and also present rough patches that may be difficult to coat effectively (Figure 2.6). Pitch pockets, which are, as the name implies, pockets of tree sap or pitch that can seep out after coating, can lead to blisters or peeling (Figure 2.7).

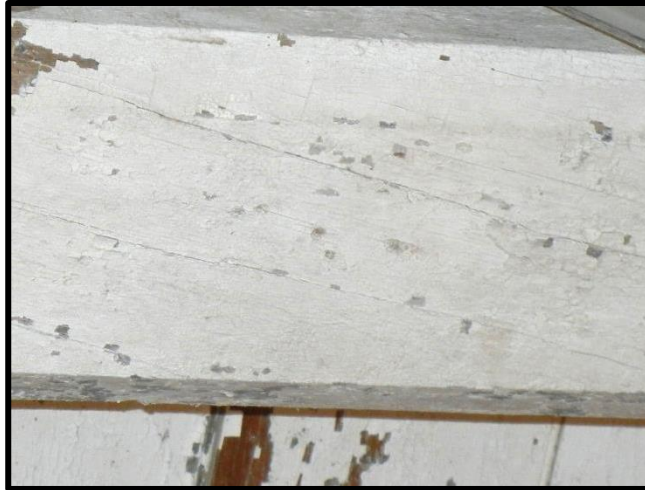
Figure 2.8. Slope of grain visible through the painted surface of a beam.

Slope of grain is the angle of the wood fibers relative to the long axis of the piece; wood with a high slope of grain tends to exhibit more checks, splits, and movement in service than wood where the grain runs parallel to the length of the piece. Checks and splits, which generally follow the slope of grain, usually develop as wood dries. Checks and splits make it difficult to seal the wood with the coating (Figure 2.8). Wood with splits and checks can allow for moisture intrusion, which in turn will increase movement in service and facilitate the development of additional and deeper checks and splits.

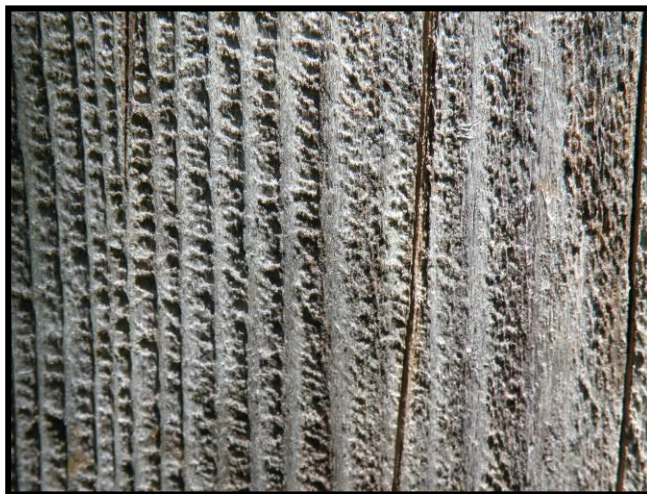
Figure 4.3. Detail of an uncoated wood substrate with erosion of the earlywood due to weathering.

In addition to the graying from UV exposure and swelling, shrinking, checking and splitting due to moisture intrusion, wind-blown debris erodes fibers on the exposed wood surface and collects in crevices, inhibiting drying and serving as a growth medium for wind-blown spores and seeds. For intact or partially intact coatings, UV exposure causes colors to fade and breaks down the surface layers of binder, leaving loose pigment particles on the surface, a condition known as chalking. As the weathering process continues, the coating erodes away. Areas of exposed wood experience differential weathering as the lighter-colored, less dense earlywood in the growth rings erodes faster than the darker, denser latewood bands, resulting in a rough surface texture (Figure 4.3).

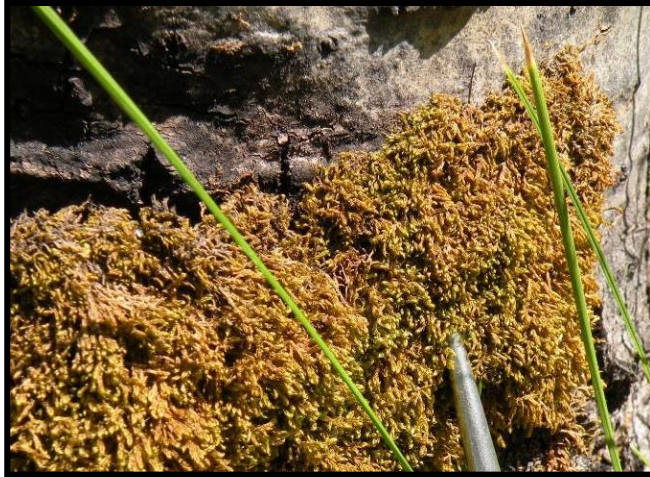
Figure 4.6. Moss growth on a wood substrate.

Mosses are non-vascular plants that can thrive on a variety of porous, moisture retentive surfaces (Figure 4.6). Mosses grow from spores and require near-constant high levels of moisture to survive. The presence of moss is an indication of a continuous high moisture environment, and the sponge-like composition of the moss traps moisture at the wood surface. If mosses are present on wood elements of a historic building, moisture levels are likely to be very high and decay fungi are probable. Moss can be easily removed with careful cleaning (Figure 4.7), but unless the favorable underlying conditions are altered, the moss will return. Mosses can be controlled by reducing the amount of available moisture and trimming trees and vegetation to increase sunlight exposure to enhance drying.

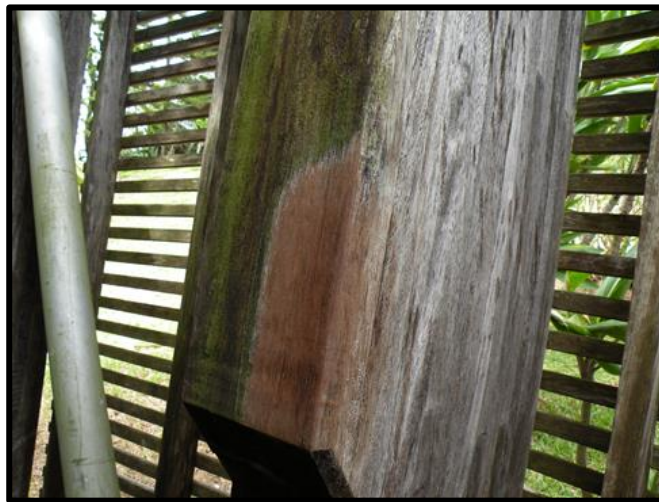
Figure 4.7. Biological growth and weathered patina, both of which can be removed through cleaning, as shown here.

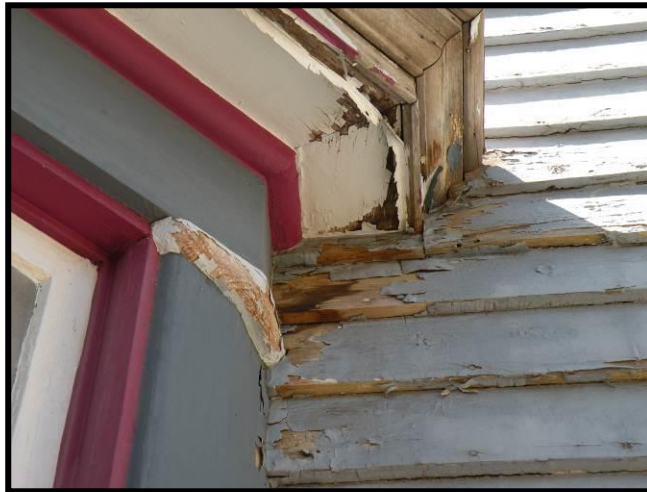
Figure 4.11. Coating failure near the end grain in an area where water flowed down the face of the exterior cladding, as evidenced by the moisture stains on the exposed wood.

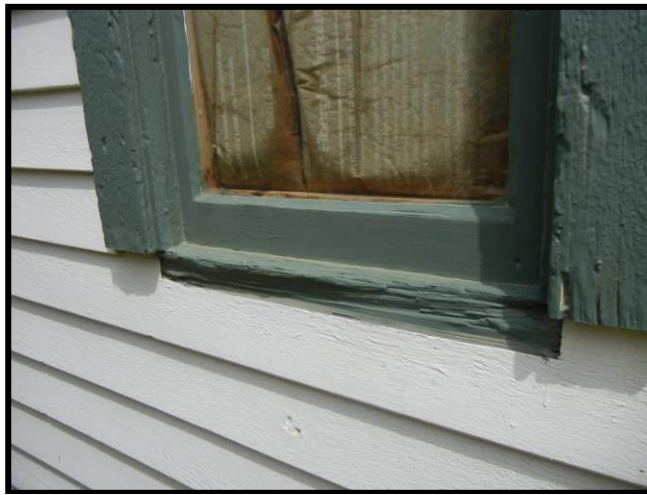
Figure 4.17. Missing window sill.

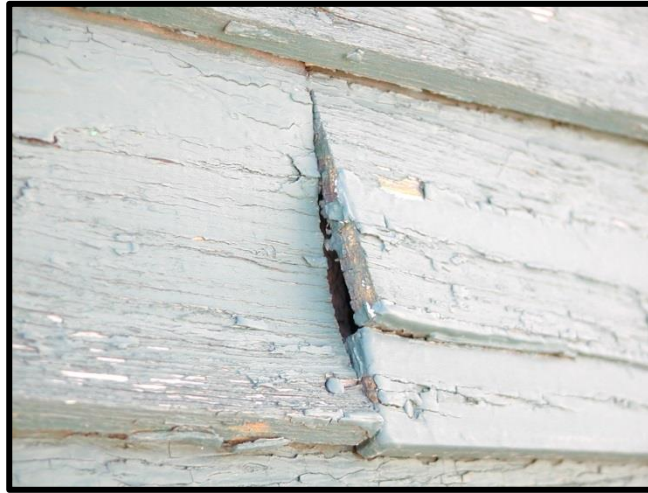
Figure 5.3. Cupping and splitting of boards on a historic theater building.

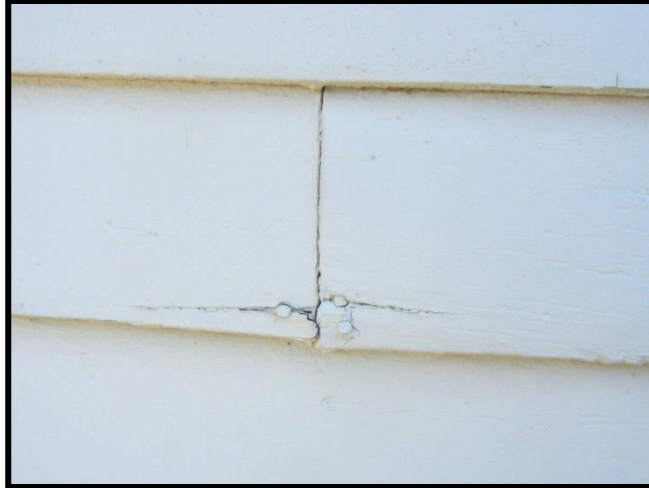
Figure 5.4. Horizontal siding with a butt joint. Note the siding has also been face-nailed in an attempt to prevent or minimize cupping. Face nailing tends to lead to board failure, as the wood is forced to move differentially, leading to splits, as shown here.

Typically scarf-joint or other types of wood joint repairs are preferable to butt-joints for both horizontal and vertical elements to increase the gluing surface area and holding power of the repair. Butt joints have square-cut end grain of two pieces of wood that are joined or “butted” up against one another (Figure 5.4). Scarf joints, in their most basic form, involve miter cuts across the end grain so that the two pieces of wood overlap, allowing for a greater cross section of wood to be used as the gluing surface and thus tending to form stronger joints than butt joints (Figure 5.5). However, scarf joints that are not tight will have more end grain exposed to potentially absorb moisture. Attention to the repair details is critical to prevent future problems associated with the repairs. Scarf joints on vertical elements should be angled up and towards the interior of the structure so that water will not be readily absorbed into the joint.
