HISTORIC AMERICAN TIMBER JOINERY

A Graphic Guide

II. Tying Joints: Tie at Plate

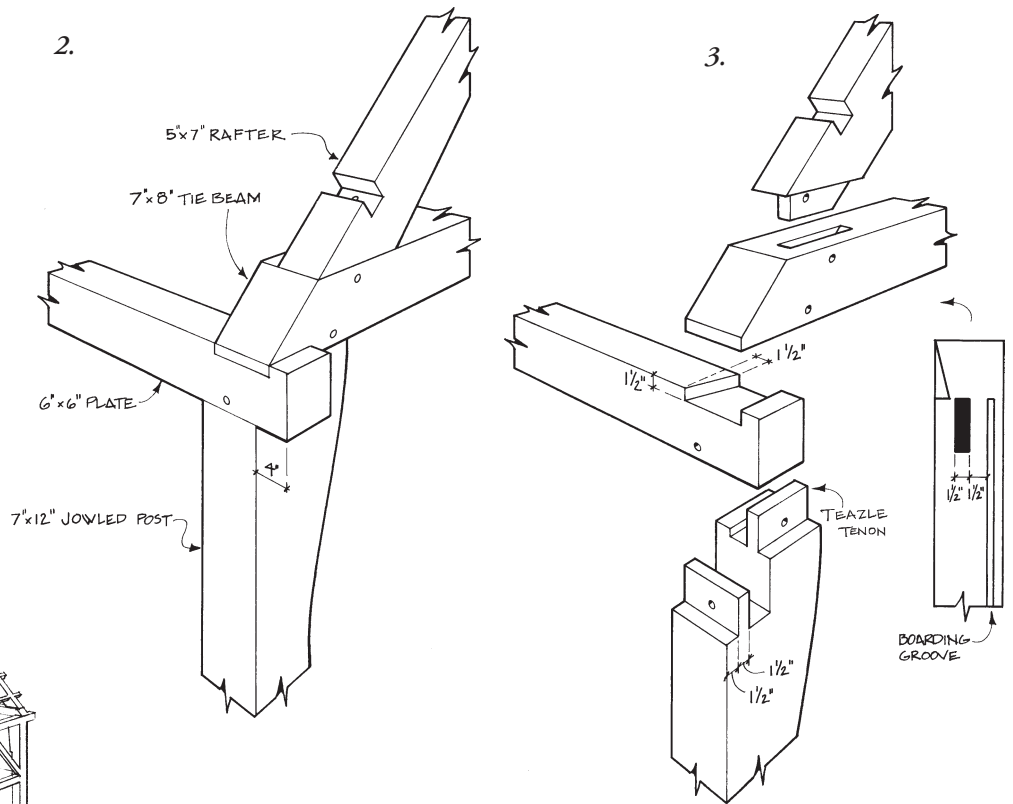
Figs. 1-3. Below, side-entrance, three-bay 23x32 barn in southeastern Massachusetts, ca. 1680. This barn has a steep 52-degree roof with 2x3 common purlins 24 in. on center trenched through rafters set about 6 ft. apart. A collar beam joins each pair. Unusually, one tie beam doesn't receive a rafter pair. At right, English tying joint with half-dovetail at the gable end. The plate, originally longer, now extends only 2 in. past the tie beam. A groove in the underside of the tie beam (Fig. 3) accepts the boarding.

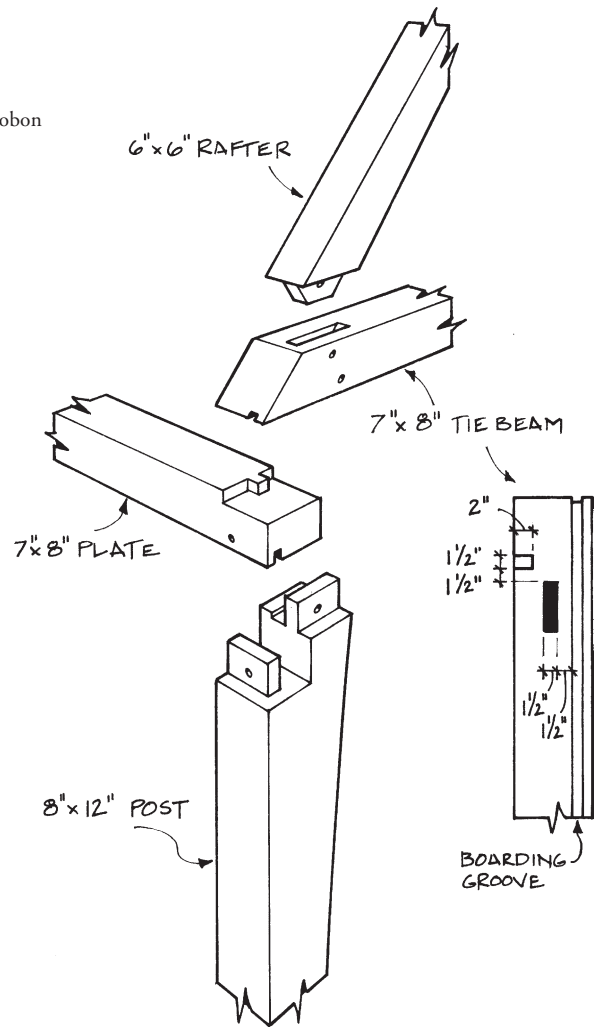
Fig. 5. In this corner tying joint from a 30x42 barn (1715) in Uxbridge, Massachusetts, a cog is used instead of a dovetail for the four corner tying joints to address the plate relish problem. Both plate and tie are grooved for vertical boarding.

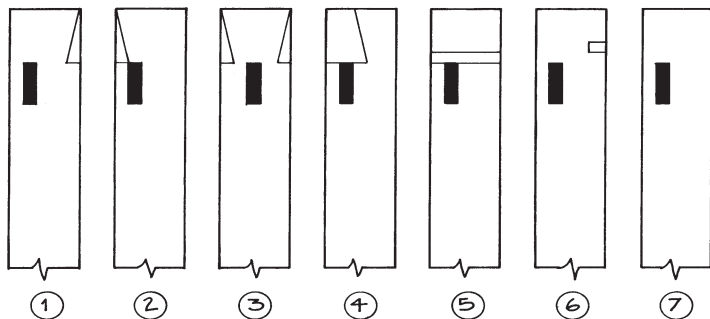
Fig. 6. Undersides of tie beam ends showing half-dovetails (1, 2, 4), full dovetail (3), cog types (5, 6) and one example (7) merely trenched across the plate.

inside edge of the tie beam, as far as practical (Fig. 6-4, overleaf). Or, instead of a dovetail, a cog was used that didn't require plate relish at all (Fig. 4). The cog also avoided another intrinsic problem of dovetails, namely shrinkage. In England, with its higher equilibrium humidity, shrinkage is likely less of a problem. But high initial shrinkage of the dovetail, exacerbated by American temperatures and humidity

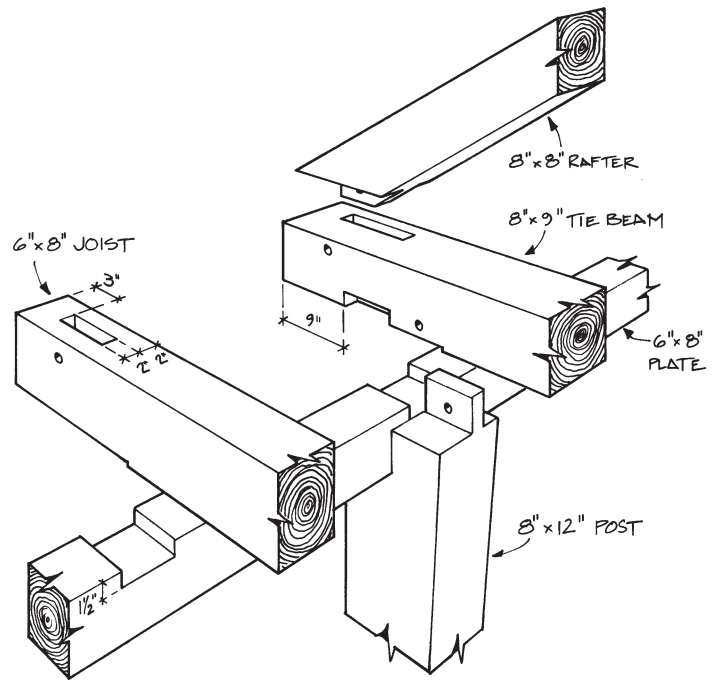
Fig 7. In this early 19th-century 32x40 two-story house in Washington, Massachusetts, the rafters tenon both into tie beams and joists, which extend 9 in. past the plate for a boxed-in cornice. The principal tie beams sit on tapered posts and are cog-lapped over the plate. The 6x8 joists do not run the full width of the house but frame into a central summer beam. They are notched through the plate without cogging. The roof has purlins framed between principal rafters and supporting the commons at mid-span.

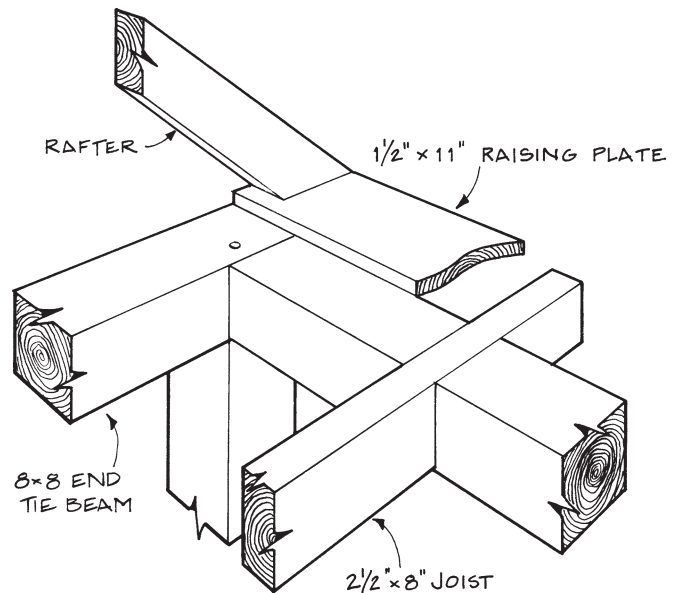
Fig. 8. A plank called a raising plate was nailed to both ties and joists, and rafters were nailed to it in turn. Attic floor boards butted to the plank. This arrangement was found in a 1791 house formerly standing in Cheshire, Massachusetts.

Other variations of these joints where ties and joists lap over the plate can be found in Tidewater Virginia. Here, the attic floor level is a few inches above the plate. The tie beams are lap dovetailed, and the joists simply notched to go over the plate. A raising plate, originally a timber but later a plank (Fig. 8), is nailed across the tie and joist ends for the rafters to bear on as in three of the flush lap examples described later. (See "The Eighteenth-Century Frame Houses of Tidewater Virginia," by Paul E. Buchanan, in *Building Early America*, ed. Charles E. Peterson, 1976. For additional New England variations, see Isham and Brown's *Early Connecticut Houses*, Cummings' *Framed Houses of Massachusetts Bay 1625-1725*, Kelly's *Early Domestic Architecture of Connecticut* and TF 36.)

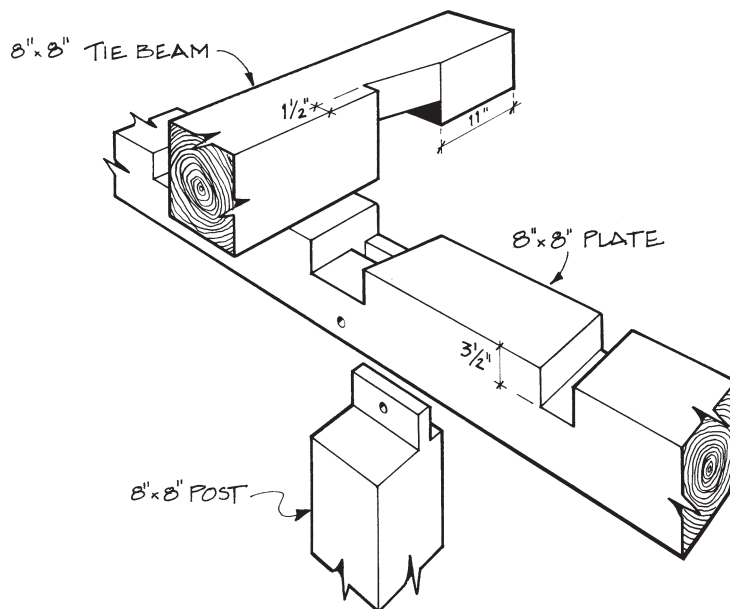
Figs. 11 and 12. In the 1791 Cheshire house, a 30x40 Cape, non-jowled posts terminated in a single top tenon. Tie beams and floor joists extended 11 in. at the front eave to support a boxed-in cornice. At the front corners (left), a combination of lap, tenon and overhanging tie avoided the plate relish problem. The two intermediate tying joints on the front wall (right) were lap dovetails. Curiously, one had the dovetail reversed: a mistake? Additionally, all the floor joists notched through the plate for additional tying. At the rear wall (not shown), there was no overhang. Instead of lap dovetails, the intermediate tie beams joined the plate with a straight-forward 4-in. deep horizontal mortise and tenon, and at the corners the joint was the same as at the front sans the 11-in. projection. See also photo of frame on back cover.

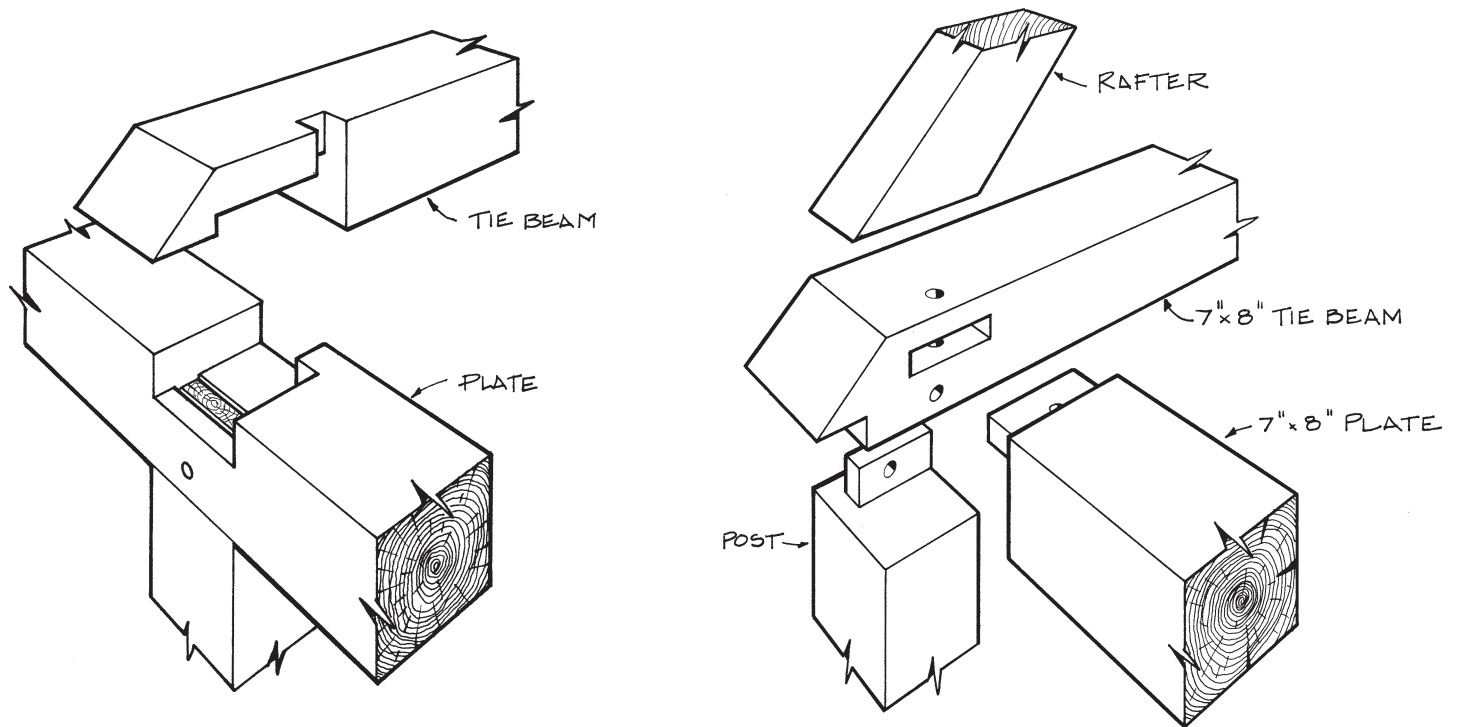
Figs. 13 and 14. A two-way cog was used in this lap joint in a 26x27 pre-1810 house in North Adams, Massachusetts. The tie beam end was notched on the bottom and the side to engage the plate. The cog measured 2x2½x3 in. The joists and ties extended about 7 in. to frame a cornice. At right, the end condition. A simple mortise and tenon is substituted for the lap.

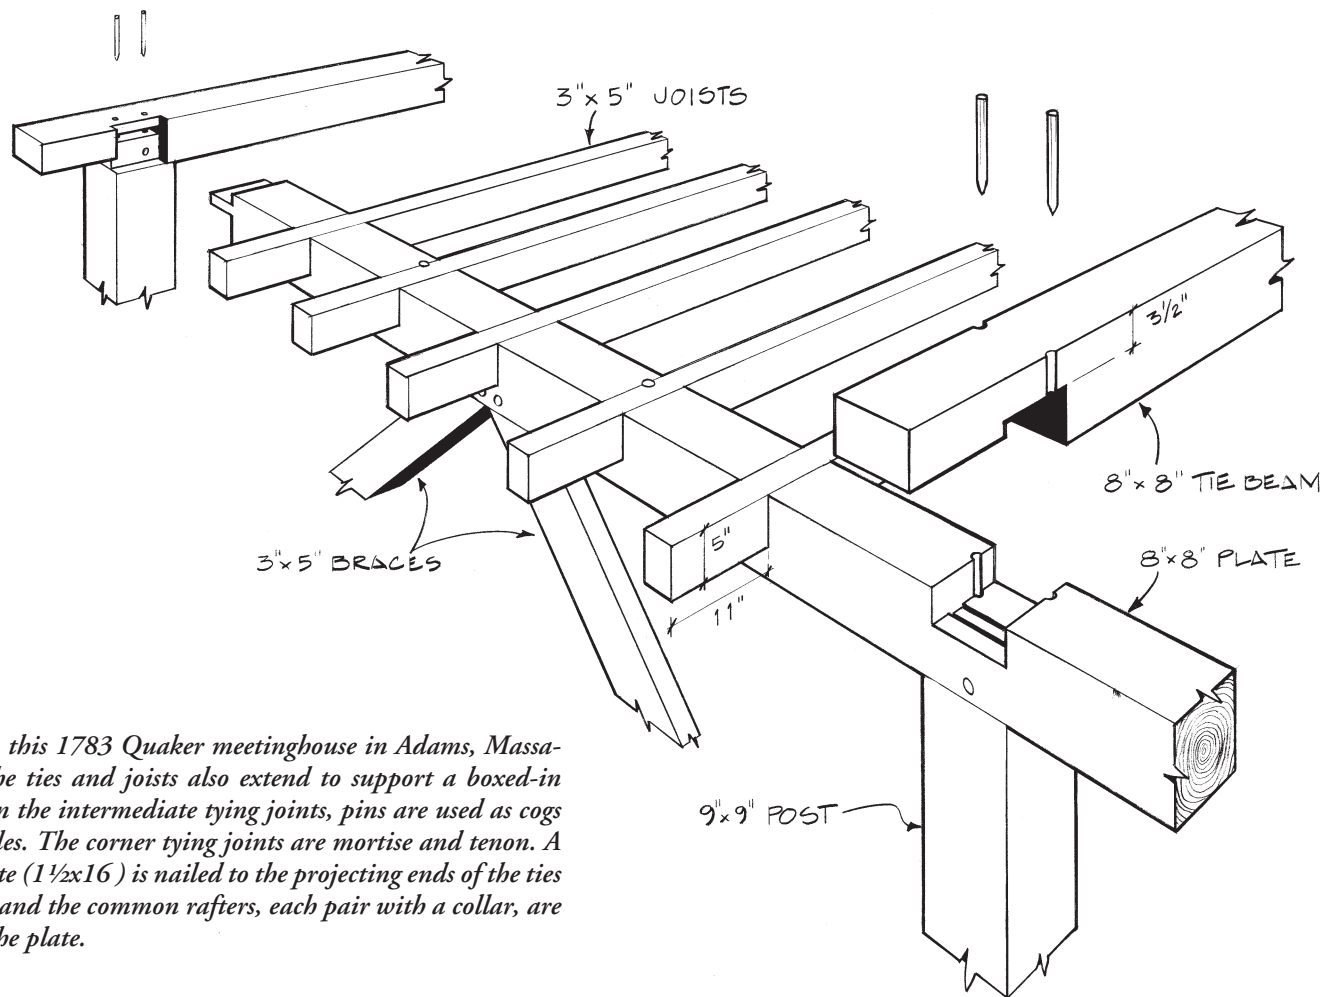
Fig. 15. In this 1783 Quaker meetinghouse in Adams, Massachusetts, the ties and joists also extend to support a boxed-in cornice. On the intermediate tying joints, pins are used as cogs on both sides. The corner tying joints are mortise and tenon. A raising plate (1½x16) is nailed to the projecting ends of the ties and joists, and the common rafters, each pair with a collar, are nailed to the plate.

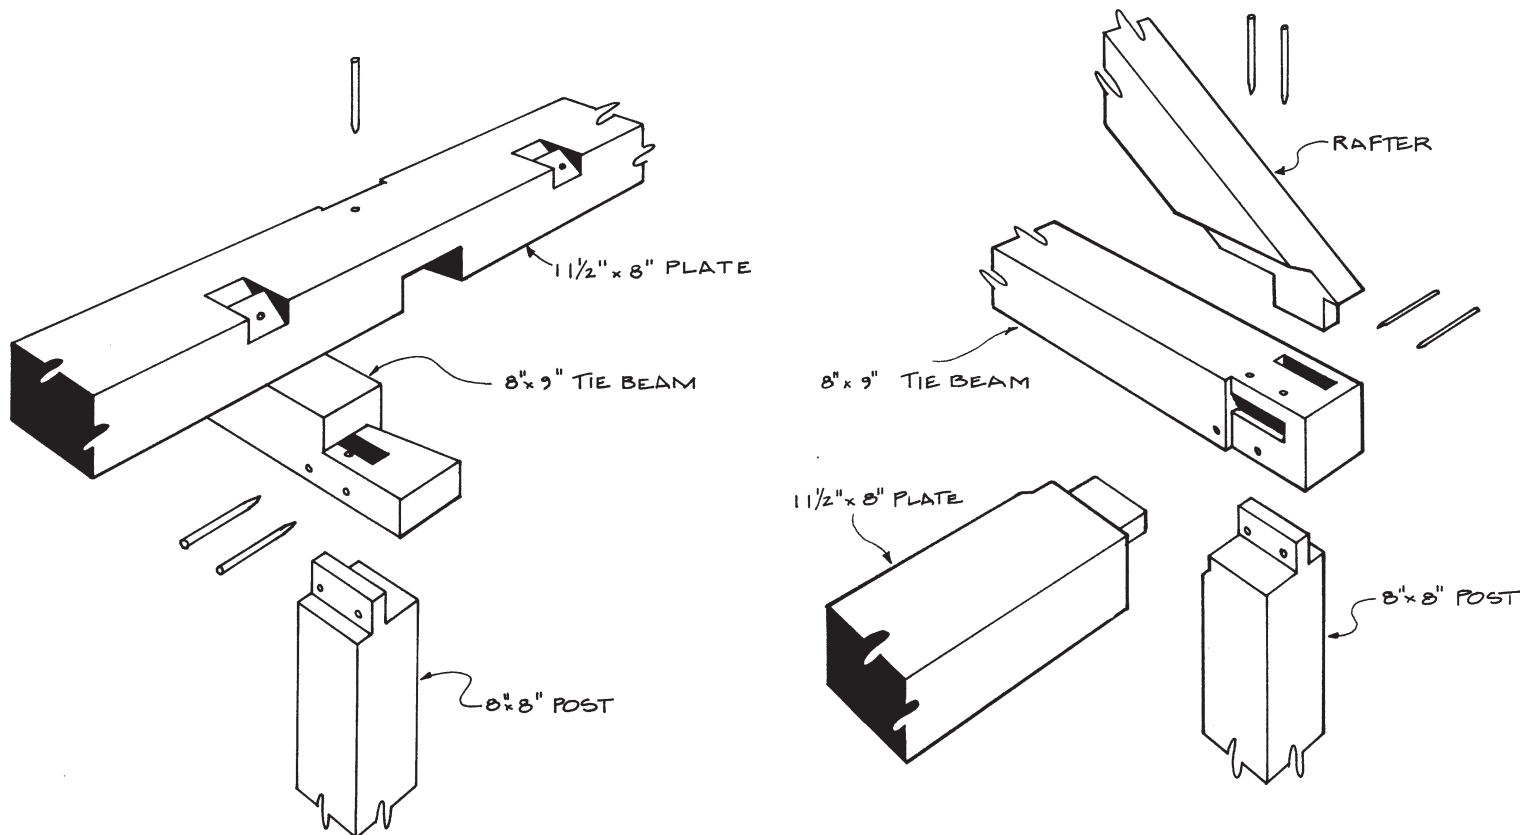
Figs. 18 and 19. In a Charlemont, Massachusetts, house, now dismantled, the front plate lapped over the dovetailed end of the tie beam. A single pin also resisted movement. The plate, together with the tie beam dovetail, projected 6 in. to become a solid cornice base. The rear plate (not shown) did not overhang and the rear tying joints on the intermediate tie beams relied on through mortises and two pins. The common rafters step-lapped into the plate, except at the front corners, as shown (note hewn rafter tenon). The back corners did not project.

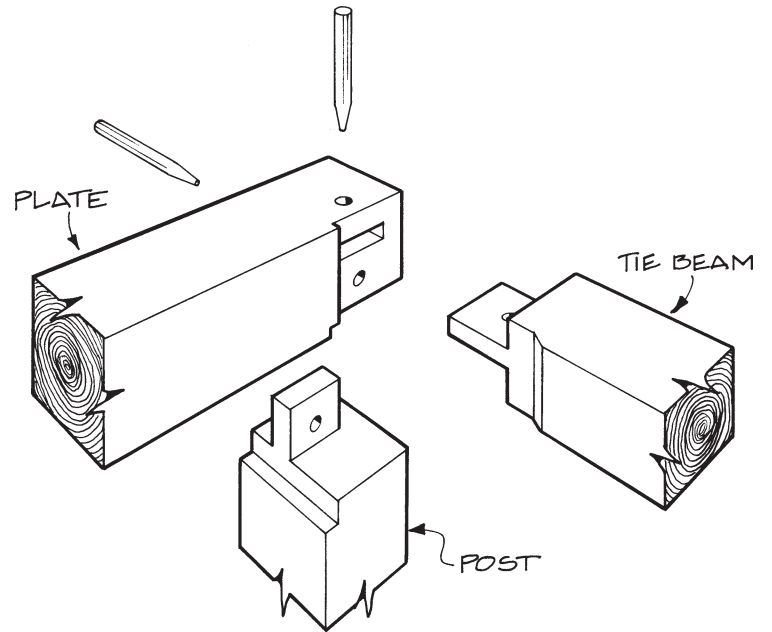
Fig. 21. This simple joint is found at the corners of a square rule barn in Huntington, Massachusetts.

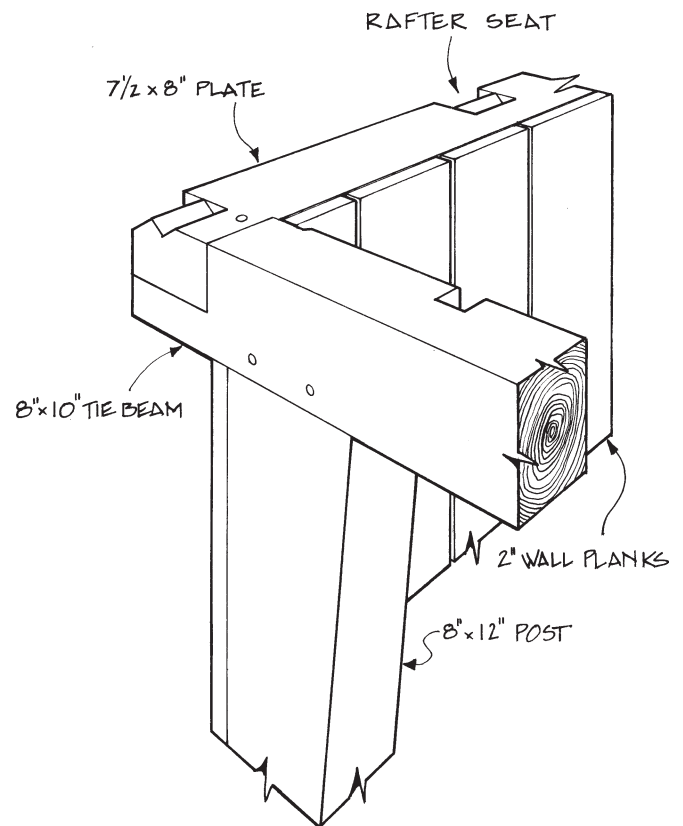
Fig. 22. In this Canaan, Connecticut, example (after 1810), now dismantled, the cantilevered plate projected enough to allow the wall planking to nail to the inside surface. The 6-in.-long tie beam tenons to the plate were secured by one pin at the corners and two pins on intermediate joints. The posts were tapered.

It is prudent to stagger joints whenever possible. There are several ways to accomplish this. First, the plate can project from the face of the building, creating a cornice. Thus the post is tenoned into the tie beam, not the plate (Fig. 22). The drawback here is that diagonal braces can't be framed from the post up to the plate, only down to the floor beams or sill. In some houses framed plank-on-timber, there were no braces. The wide planks, well fastened to sill and plate, braced the walls.

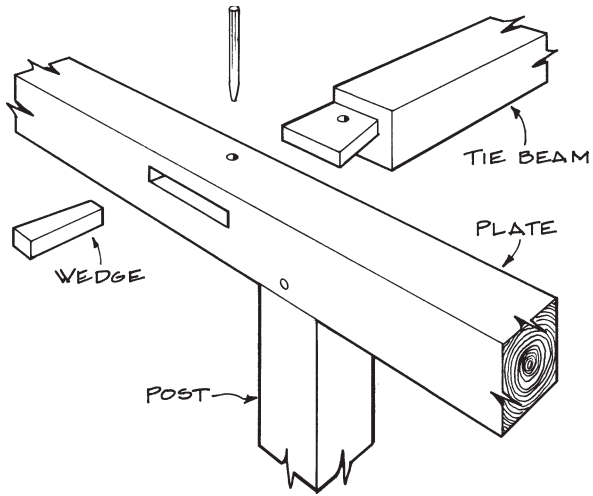
Fig. 23. This rugged offset tying joint, a wedged through half-dovetail mortise and tenon, is only used on intermediate tying joints.

Second, the tie beams can be offset from the posts. But end wall tie beams are outside of the plank wall and the plates cantilever out to support them. Again, braces can't be framed to them. On intermediate tying joints, a through tenon with two or more pins can be used or, better yet, a wedged through half dovetail (Fig. 23). Third, the plate can be raised and the tie beam deepened so that the post tenons into the tie beam instead of the plate. This tie to plate joint is an improvement over the normal mortise and tenon. Instead of the tie beam pins having two shear planes, they have three (Figs. 25-27). These mortise and tenon tying joints require a different raising technique. The plates must be slid horizontally onto their respective tenons and plate bracing is tricky to insert. A fourth method is to raise the tie beam above the plate (Fig. 24).

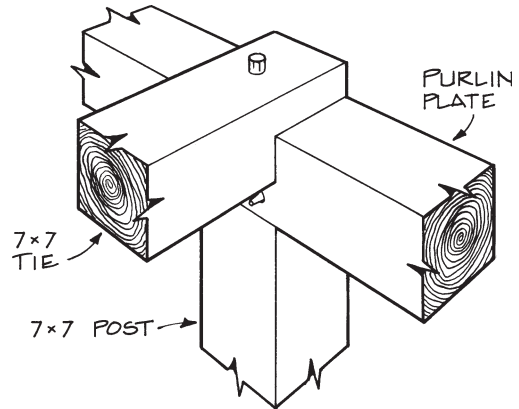
Fig. 24. This tenoned tie connects purlin plates in a barn in Goshen, Massachusetts. It also has an additional pin shearing plane in the tying joint.

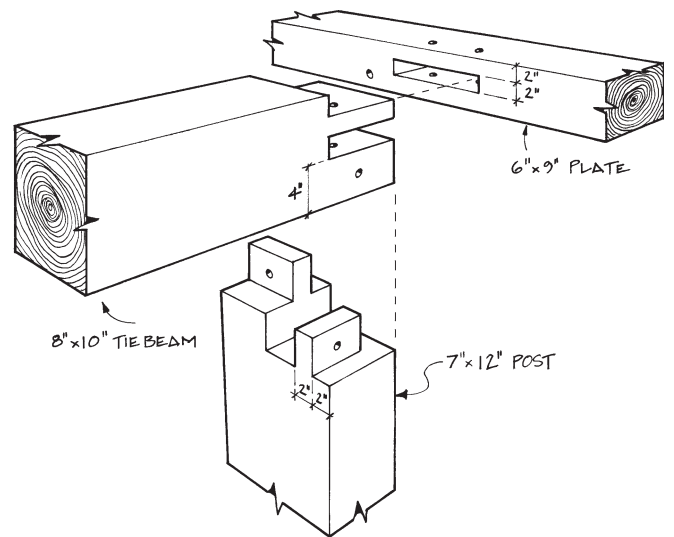
Fig. 30. A triple bypass joint in a 26x38 three-bay, side-entrance barn in Richmond, Massachusetts. All eight tying joints in the barn are of this type. End joints are of course provided with plate relish. The tying pins have an extra shear plane. This early scribe rule barn was framed before 1810.

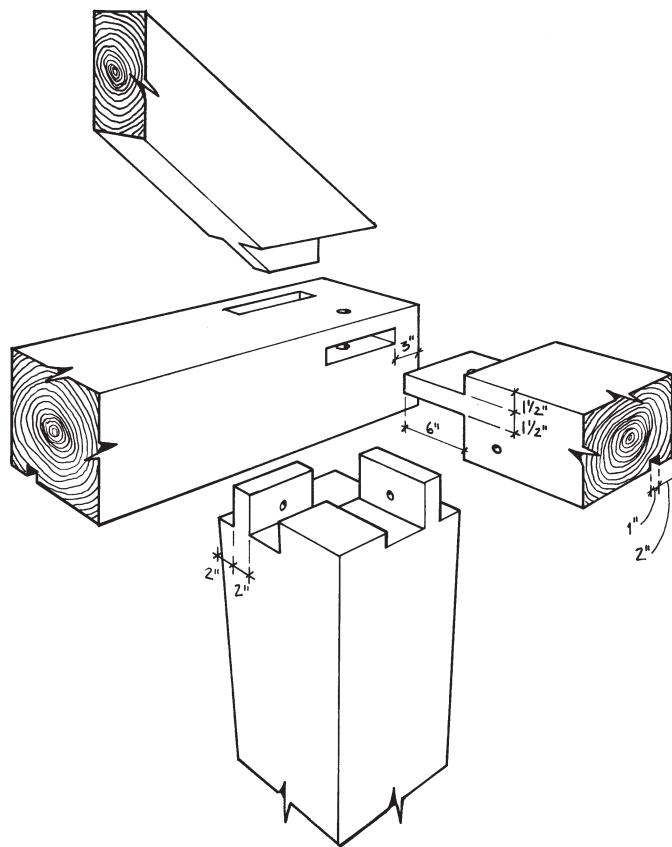
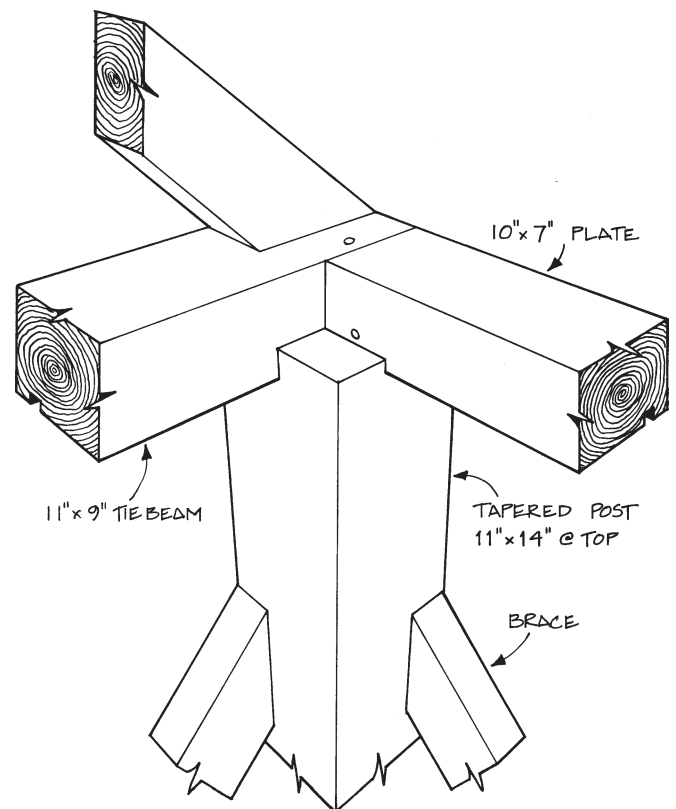
Figs. 28 and 29. This triple bypass corner tying joint was found in an early scribe rule (late 1700s) four-bay, side-entrance barn in Hoosac, New York. The 36x49-ft. barn appeared to be Germanic in origin, with purlin plates and a ridge beam. Intermediate ties were the dropped type. Long braces extended German-fashion from the sill up to the corner posts. These undoubtedly helped stabilize the structure during the setting of the plates. Boarding grooves were worked in both plate and tie. This barn was carefully dismantled but unfortunately burned while in storage.

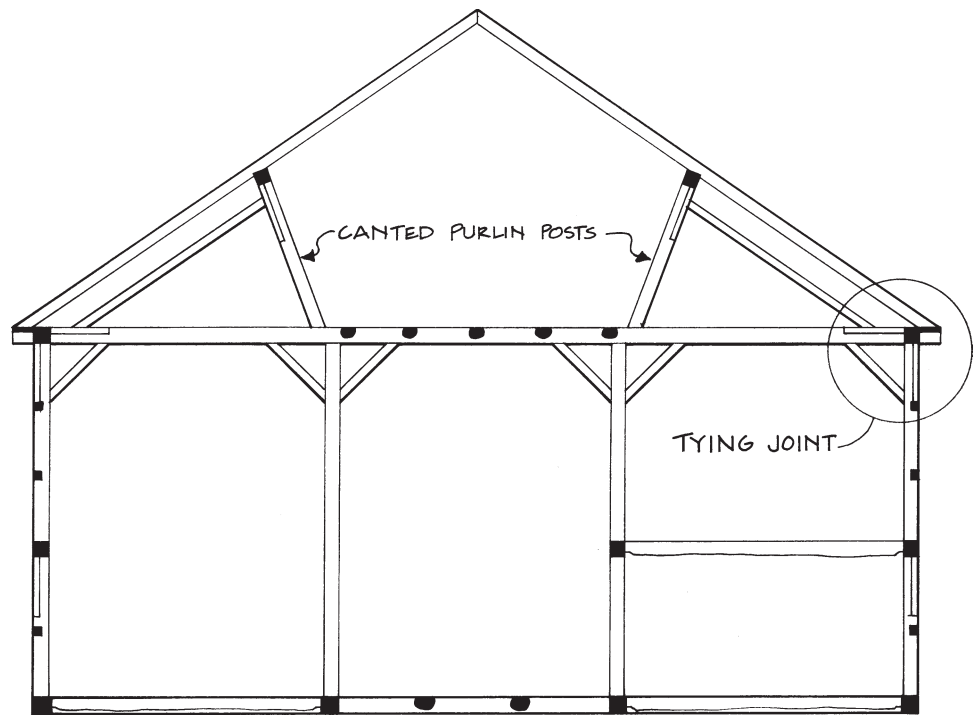
Figs. 31 and 32. This ca. 1850 barn, now rebuilt elsewhere, stood in Shrewsbury, Massachusetts. Measuring 37x50, it has canted purlin posts, continuous purlins and interrupted plates. All principal timbers are 7x7. To support a substantial Greek Revival cornice, the builder has inserted outriggers into the plates and secured them with nails (Fig. 32 below). A 2x11 raising plate is nailed to the outriggers, and the projecting tie beam ends stiffen the assembly and support the rafters. Braces in three planes reinforce the structure.

INTERRUPTED PLATE. In the early 19th century, a new barn type emerged in New England, a gable-entry, aisled barn that could vary in length from two to 10 bays (or more). Bays were typically 12 ft. Such barns were often built into side hills to allow access on more than one level. Figuring prominently in their design was a frame with interrupted plates. These shorter plates, tenoned between tie beams or posts, allowed standardized joints and components. A builder could vary the size without changing the design. Bents were raised and connected by plates and braces. As soon as two bents were connected, the frame was braced and stable. There were variations in this joint depending on cornice design. Some barns had two plates. One was in the normal position to receive the tops of the wall boards. The second tenoned between the projecting tie beam ends to support the fascia and soffit.

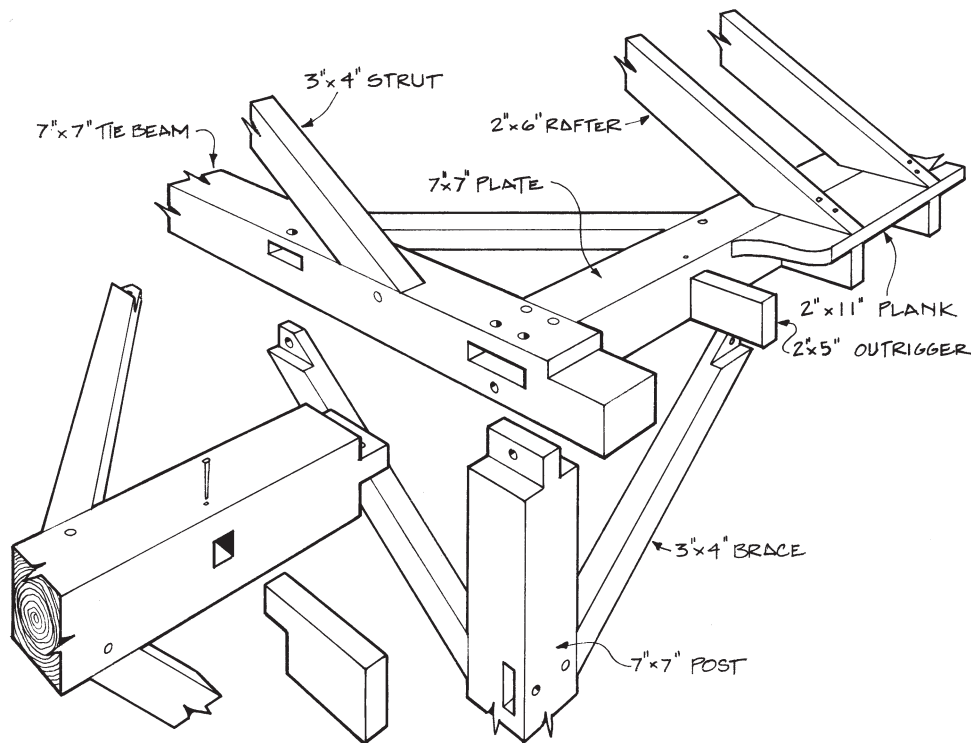
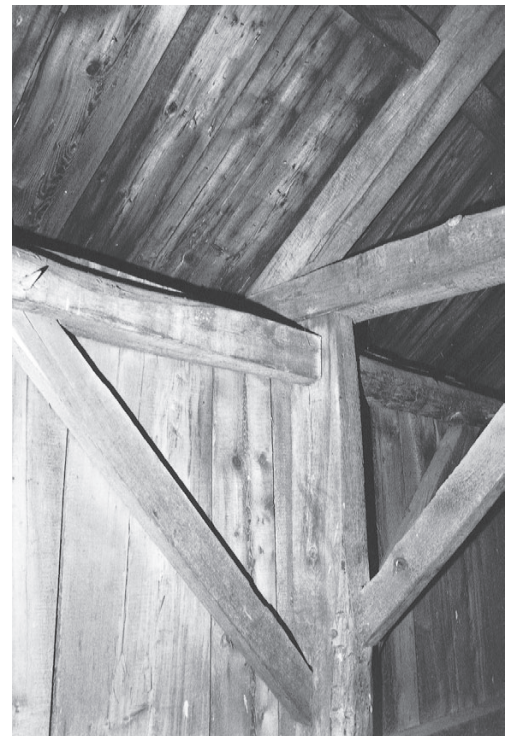
The English tying joint tradition lives on even with interrupted plates in this Newfields, Maine, aisled barn. The plates tenon into the side of the post and a flying plate (not visible) is supported by the tie beam ends.
