# HISTORIC AMERICAN TIMBER JOINERY

## A Graphic Guide

### III. Sill and Floor Joists

*THIS article is third in a series of six to discuss and illustrate the joints in American traditional timber-framed buildings of the past, showing common examples with variations as well as a few interesting regional deviations. The series was developed under a grant from the National Park Service and the National Center for Preservation Technology and Training. Its contents are solely the responsibility of the author and do not represent the official position of the NPS or the NCPTT. Previous articles, which appeared respectively in TF 55 and 56, covered Tying Joints: Tie below Plate and Tying Joints: Tie at Plate. Future articles in the series will cover Wall Framing, Roof Joinery, and Scarf Joints.*

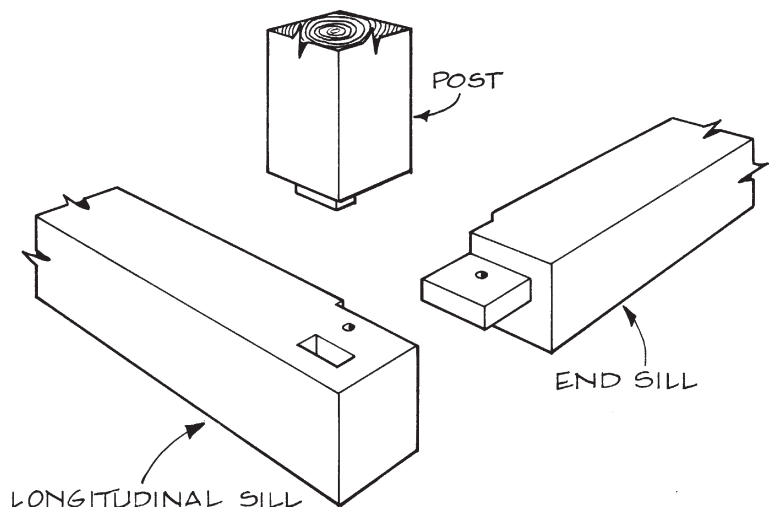
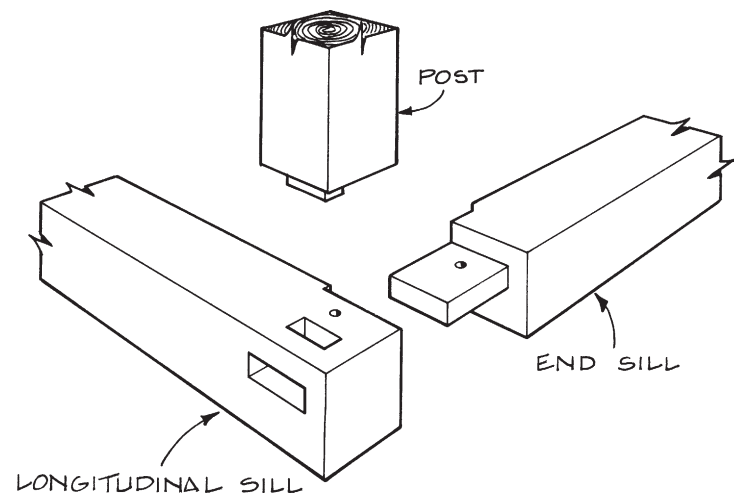
*Figs. 1 and 2. Blind (above) and through (below) mortise and tenon joints, both sized according to square rule layout.*

**Blind mortise and tenon.** Far and away, the most frequent sill corner joint is the blind mortise and tenon (Fig. 1). It combines simplicity with effectiveness. Both the sill and post mortises have relish to prevent horizontal displacement. The relish is usually equal to the tenon thickness, that is, 1 1/2 or 2 in. This design offers a modest amount of weather protection. Even though most American frames are covered by siding, wind-driven rain can penetrate. This joint has its origins in Europe where timber frames are often exposed to the elements. Usually one pin secures the two sills while the post bottom has a stub tenon. If the post has a longer tenon of, say, 3 in. (still without a pin), the sill mortise and tenon will be framed lower to avoid a conflict.

**Through Mortise and Tenon.** Much less common is this through mortise and tenon variety (Fig. 2). It occurs typically where sills are square in cross-section, or rectangular and set on edge, as the through joint increases tensile capacity for a narrow sill. Unfortunately, weather resistance is diminished compared with the blind joint, and the mortises are more likely to split open and the relish to fail.

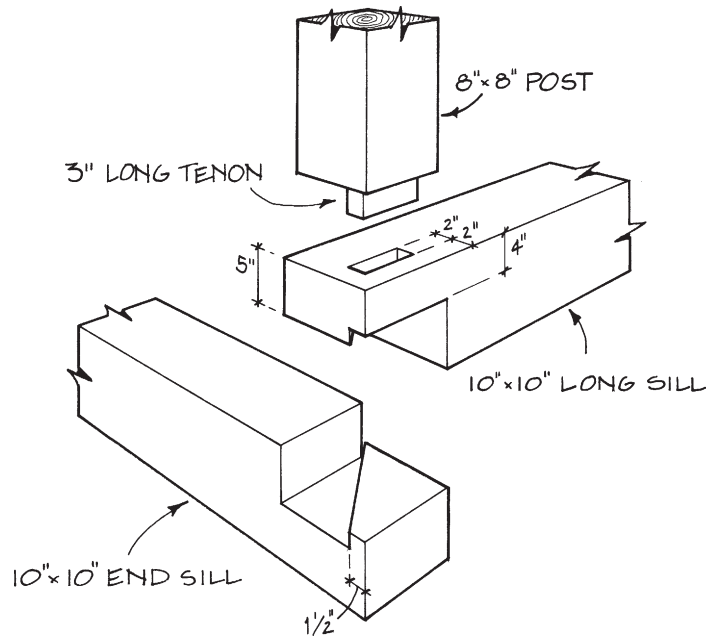
Fig. 3. Unique sloped and tabled corner lap, St. Johnsville, N.Y.

**Sloped Tabled Corner Lap.** Only one example of this joint has so far been found (Fig. 3), in a barn in St. Johnsville, New York. It appears to be of Germanic design. The dovetail-like lap prevents lateral displacement, but, unlike the mortise and tenon type, it must be sandwiched between the post and foundation to be effective. Otherwise, twisting from seasoning or subsiding of the foundation can render it ineffective.

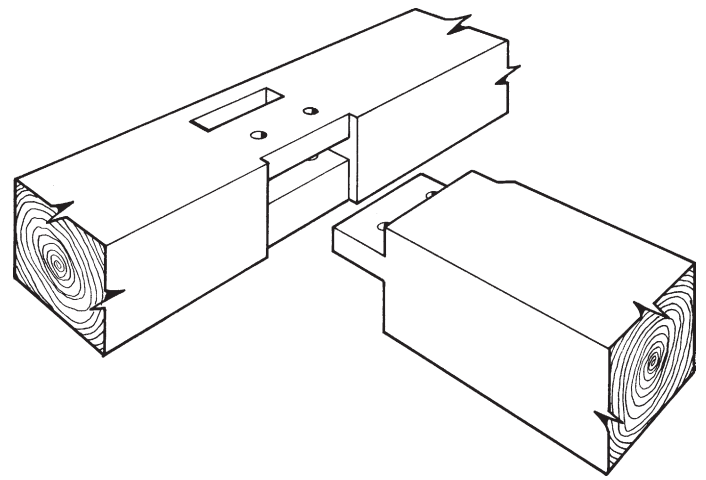
Fig. 4. Blind tenoned girder joint.

**Blind Mortise and Tenon.** Again this joint is the most common type (Fig. 4). Because there is no question of relish as at the corner, the tenons can be wider and typically are secured with two pins. This joint is moderately weather-resistant.

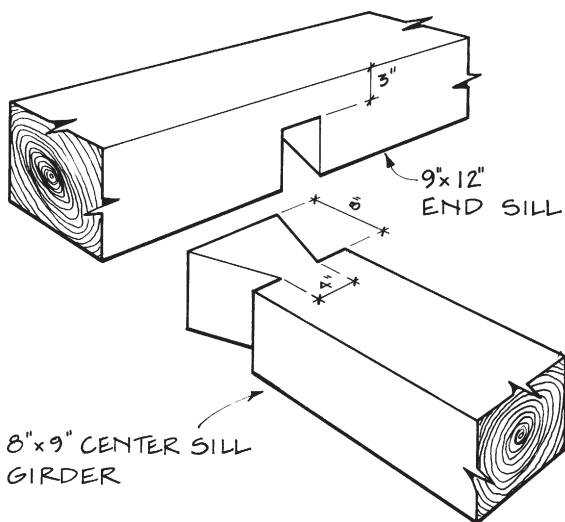
Fig. 5. Inverted lapped dovetail in Dutch barn moved from Guilderland to North Tarrytown, N.Y. The 47-ft. girder supports a 3-in. plank threshing floor and is well protected from weather. Assembled, the undersurface of the girder lies 2 in. below the undersurface of the sill.

**Inverted Lapped Full Dovetail.** Rarely, the bottom of the end wall sill receives the lap dovetail (Fig. 5). It is secured by being sandwiched between the foundation and the sill.

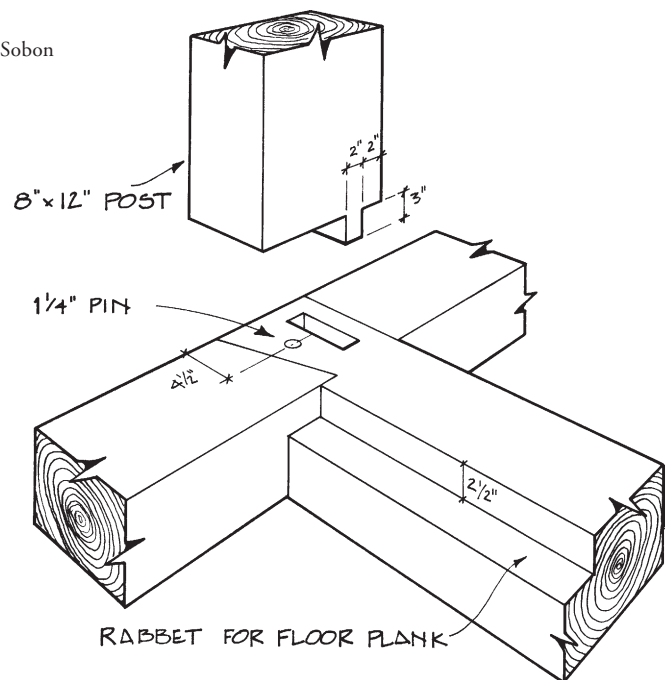
Fig. 6. Views of lapped half-dovetail girder joint in a pre-1820 scribe rule Dutch barn moved from Fort Plain to Altamont, N.Y. The interior sill is rabbetted for the 2 1/2-in. splined plank threshing floor.

**Lapped Half-Dovetail.** This simple joint (Fig. 6) is somewhat common in Dutch barns where the interior longitudinal sills for the posts join the end wall sills. The purlin posts are tenoned into the lap dovetail.

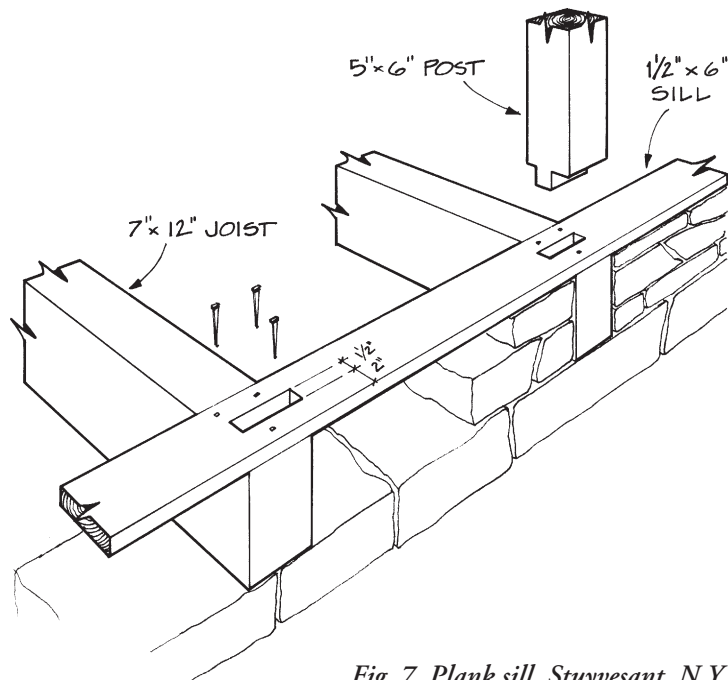
Fig. 7. Plank sill, Stuyvesant, N.Y.

**Plank Sill.** This unusual sill system has been seen on at least two scribe-rule-framed 18th-century New York Dutch houses, one standing in Stuyvesant (Fig. 7) and the other (now dismantled) formerly in Cohoes. Both houses, built with unfired brick infill between the posts, measure about 18 ft. wide, with full-span floor joists. Because of their long span and wide spacing (4-5 ft.), the joists are 12 in. deep. But a corresponding 12-in. sill is both impractical and unnecessary. With the plank sill system, the joists are set into the stone or brick foundation and a 2x6 plank is notched and nailed to secure them. The plank is through-mortised for the posts, and the mortise extends an inch into the joist as well. This design saved on material and joinery, and was probably also a time-saver during the scribe layout process. It has proved itself over time.

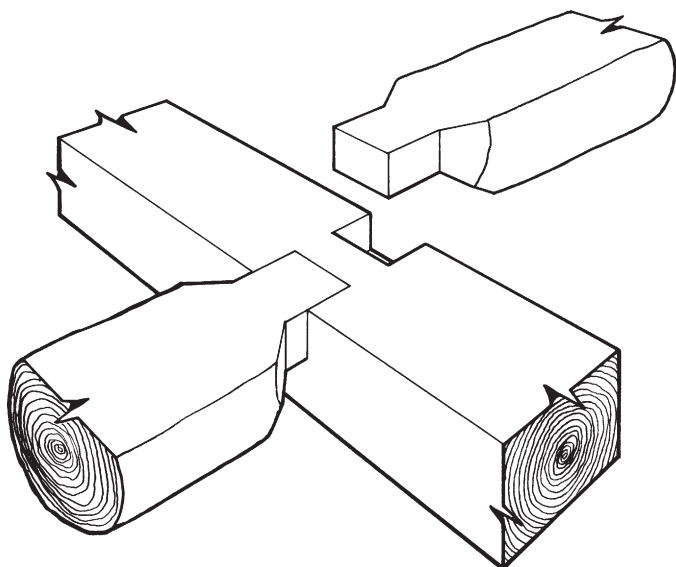
Fig. 8. Flattened log joists.

**FLOOR JOISTS AND GIRDER JOINTS.** In the days when most timber was hewn, considerable time could be saved by hewing some members only on faces that had to be flat to receive sheathing. Thus floor joists, especially ground floor and barn joists, were often hewn only on top. At the joint they were shaped to a rectangular cog (Fig. 8).

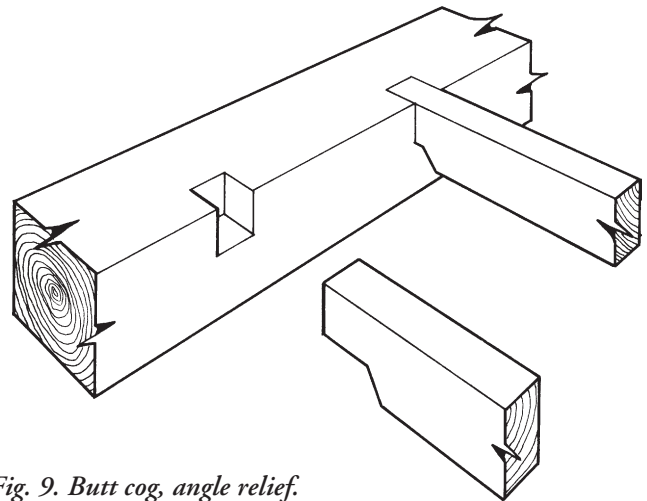
Fig. 9. Butt cog, angle relief.

**Butt Cog Joint.** The simplest joint to craft and insert, and consequently the most common, is the simple drop-in pocket or butt cog (Fig. 9). The full depth of the joist may be notched into the girder, or, more commonly, the joist is reduced in depth at the joint so as not to cut too much out of the girder. When the joist end is reduced in this way, the stiffness or bending strength of the joist is not affected, but its shear strength is diminished at the joint.

To avoid concentrating the shear stress at the notch, builders removed additional wood with an axe or adze, on an angle as shown. In a few frames, the joists were reduced in a graceful curve using the adze (Fig. 10).

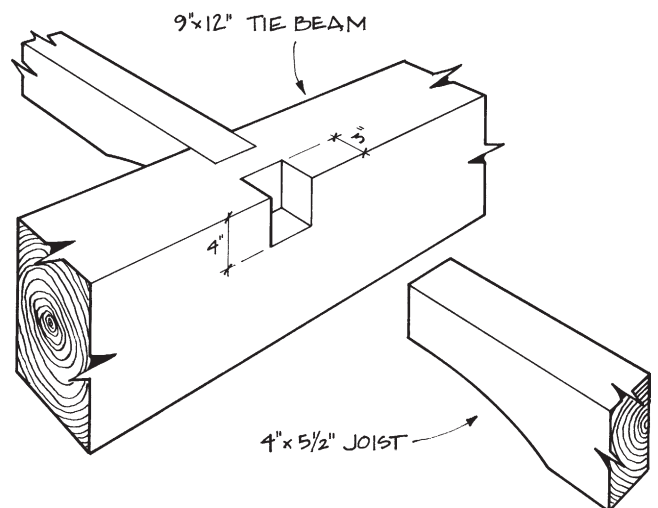
Fig. 10. Butt cog, curved relief.

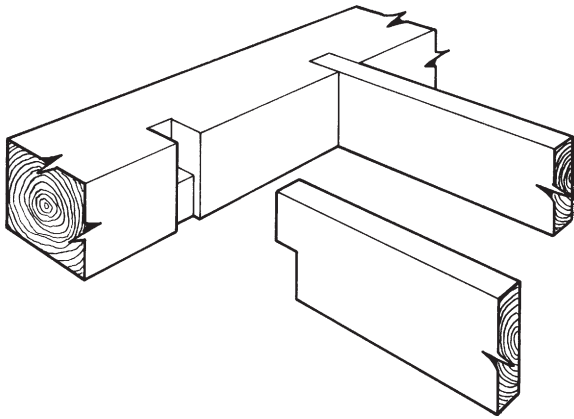
Fig. 11. Narrow full-depth joists with lower sizing housing.

If the bottoms of joists were to receive lath and plaster, then it was more convenient to use a squared notch at the girder. If the girder was also to be covered with lath and plaster, then the joist was typically notched to half its depth (Fig. 11). The square notch is considerably weaker than the angled or curved type and many old frames exhibit cracks or breaks at the notches.

In square rule structures, an additional gain was often cut in the girder below the notch, to size the girder to a consistent width so that all the joists could be cut to one length. The gain was usually a half-inch or less in depth so as not to unduly weaken the girder.

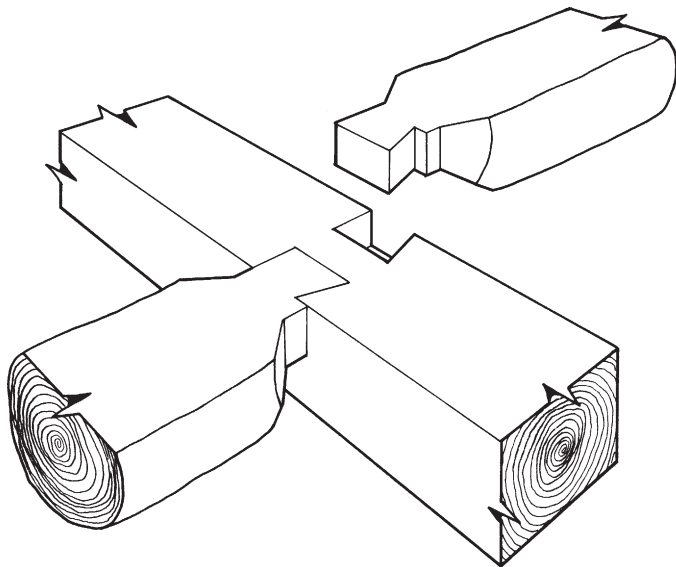
Fig. 12. Half-dovetail butt-cogged flattened log joists.

**T**YING JOISTS. Floor frames other than in the smallest buildings required one or two joists in each bay as tying joists to keep the girders or tie beams from spreading. Were they to spread, the cogged joists could withdraw and allow the floor to collapse. The most common tying joint was a half dovetail (Fig. 12).

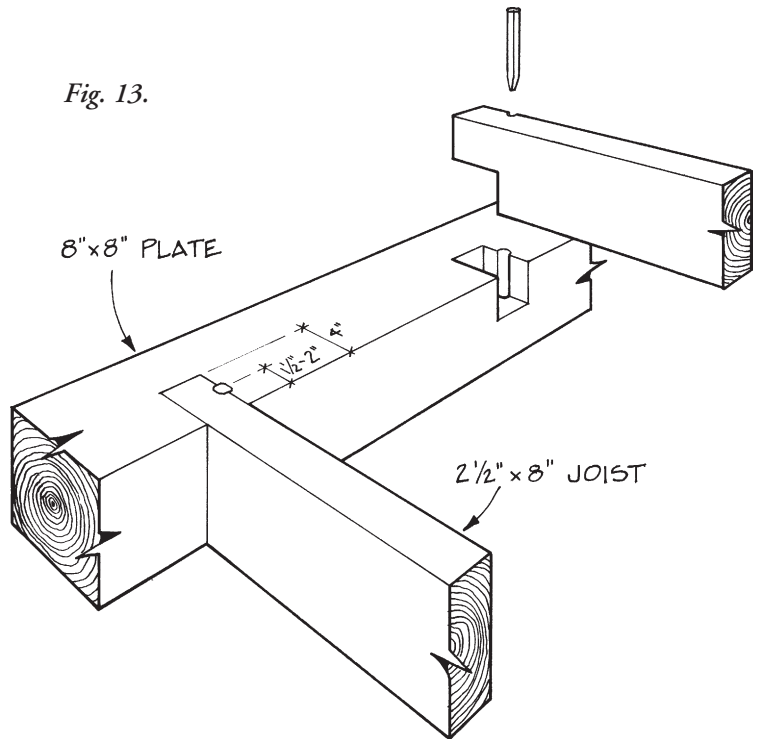
Fig. 13.

*Figs. 13-15. At top right (Fig. 13), butt-cogged tying floor joists with cogged pin, Cheshire, Mass., 1791. At middle right (Fig. 14), lapped half-dovetail on side aisle loft joist in a 1680s Dutch barn moved from Saratoga, N.Y., to Hancock, Mass., and since lost to fire. The opposite ends of these joists were vertically tenoned to wall posts. At bottom right (Fig. 15), through laps in side aisle loft joists of a Dutch barn in Westerlo, N.Y. (also lost to fire). The through lap, if simple, is quite effective as a tying joint.*

A variation was to bore a pin hole at the edge of a joist tenon after the joist was in place and drive a squarish pin that both wedged the joist tight against the opposite side and acted as a cog to prevent withdrawal (Fig. 13). On larger framing, the technique could be used on both sides. In framing where the top surface of the joist was elevated above the girder, a lap dovetail could be used (Fig. 14). If the joists were permitted to extend past the girder, the through lap (Fig. 15) was effective. Both of these joints can be found in the side-aisle lofts of Dutch barns.

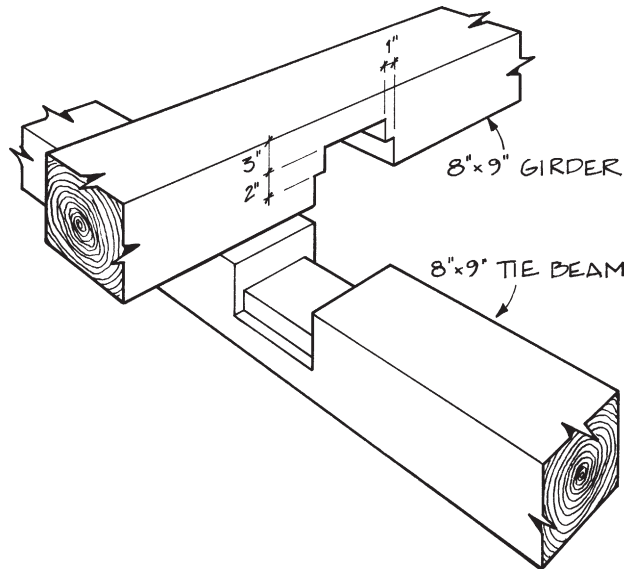
Fig. 16. Strengthened halving found in the attic floor of the 1783 Quaker Meeting House, Adams, Massachusetts. The 8x9 girder ran longitudinally and carried floor joists on both sides.

**Strengthened Halving.** This variation of the half-lap joint (Fig. 16) is configured to increase capacity for both members by adding bearing surfaces. The lower supporting beam has less material removed compared to a half-lap. The side housings provide better support for the upper girder and lessen shear problems. Examples are found in the attic floor of houses where a central spine beam runs the length of the house, lapping over the tie beams and carrying joists from both sides.

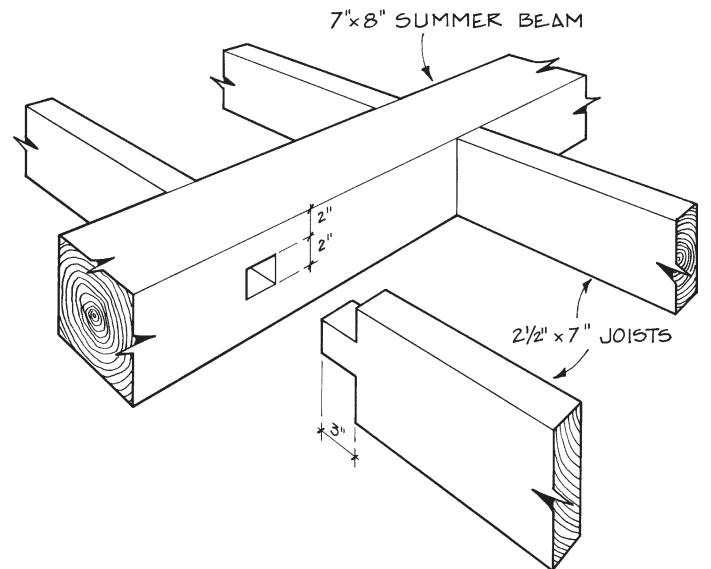
Fig. 17. Simple tenoned joists supported the second floor of a 1791 Cape-style house in Cheshire, Massachusetts.

**TENONED JOISTS.** The tenoned joint's structural advantage for connecting floor joists to a carrying timber is that in cutting the mortise, little or no wood is removed from the top or bottom surfaces of the carrying beam. Since these surfaces are under the greatest stress (compression in the top and tension in the bottom), a beam mortised in its side retains nearly all of its original strength. By contrast, a beam with a butt cog joint cut into each top edge loses 15 to 40 percent of its original strength. Another advantage is that by adding a pin, a tenoned joist becomes a tying joist. (However, a pin hole bored right through a beam reduces its strength. A tight-fitting pin may effectively replace the missing compression wood on top, but the pin cannot replace the tension wood on the bottom.) There is also a disadvantage to tenoned joists: they must be inserted from the side rather than the top. Thus joists are inserted in sets as each bent reaches vertical, or in the case of tie-at-plate examples, as each tie beam is set. Assembly requires careful work with many hands or temporary support structures. Alternately, joists may be tenoned at one end and merely seated on top of a beam at the other as in several 17th-century Massachusetts Bay houses. The simplest form of tenoned joist has the tenon bearing all the load (Fig. 17). The joint is simple to cut and removes a minimum of wood from the summer beam. It is common where closely spaced joists support a plaster ceiling and the joists and summer beam are the same depth. But the tenon is weak in shear.

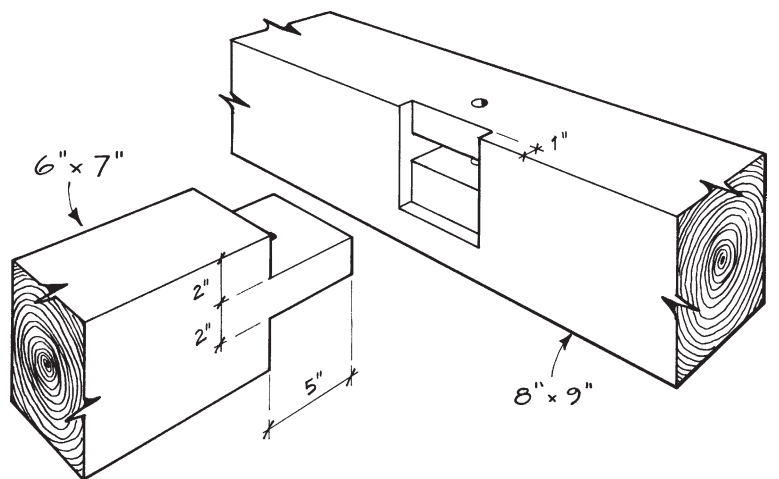
Fig. 18. Heavy aisle loft joist in a pre-1820 Dutch barn in Root, N.Y., part of a set spaced 5 ft. on center with their outboard ends tenoned to posts.

**Housed mortise and tenon.** A vast improvement in structural performance results from housing the entire joist end into the beam (Fig. 18). The shear problem is eliminated. However, the beam must be sufficiently deeper than the joist. This joint is more often seen on large joists spaced far apart and on headers. Fig. 19 shows a variation housed only below the tenon. This retains slightly more compression wood on the top of the beam while not reducing the shear capacity of the joist.

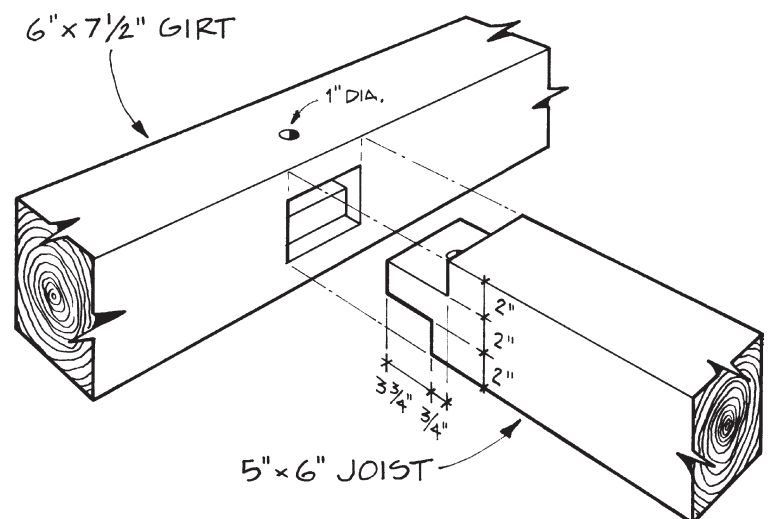
Fig. 19. Aisle loft joist in a Dutch barn, Warnerville, N.Y.

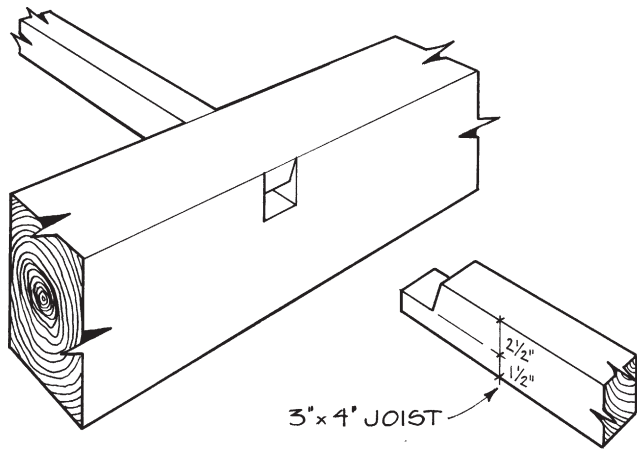
Fig. 20. Typical strengthened tenon, here without pin.

**Strengthened Tenons.** The ultimate tenoned joist has a sloped shoulder above the tenon (Fig. 20) that brings into bearing the entire depth of the joist while keeping intact the vital compression wood of the carrying beam. In 18th- and 19th-century builder's books it is the floor joint of choice. In ideal form, the underside of the tenon is continuous with the joist (and thus properly termed a soffit tenon, Fig. 20) and the mortise in the carrying timber is centered in the side of the beam.

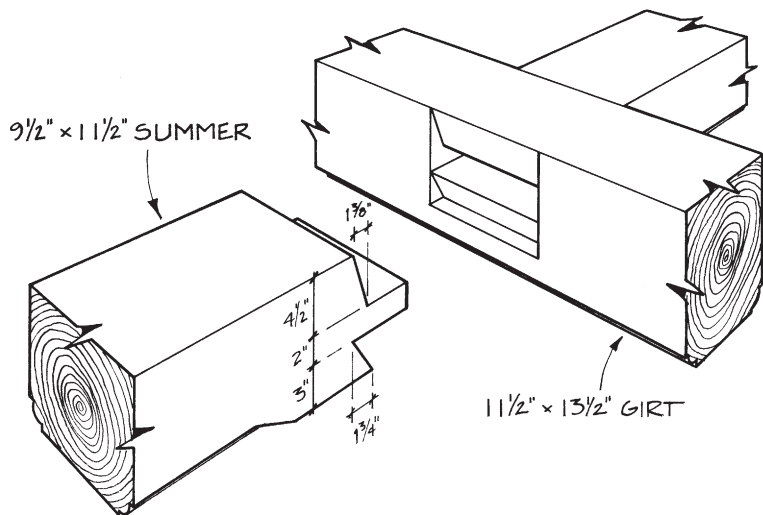
Fig. 21. Summer beam to girt connection in the 1665 Gedney House, Salem, Massachusetts. Both members have molded chamfers.

Occasionally the lower shoulder too was angled (Figs. 21 and 22) to form what Hewett called a spurred shoulder.

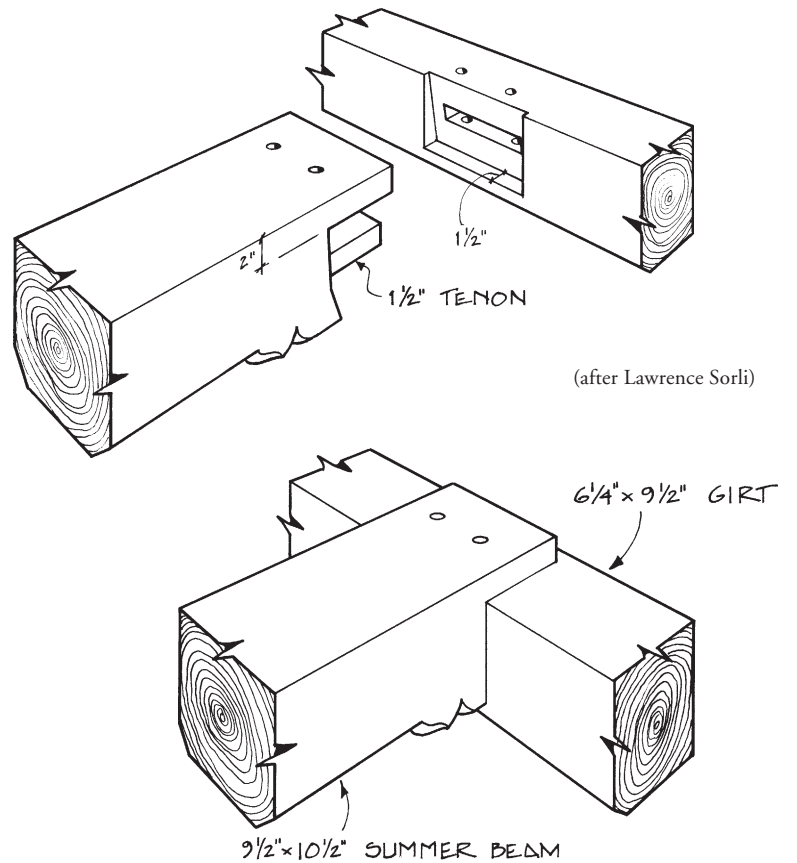
Fig. 22. Equal-depth summer beam and girt in the 1637 Fairbanks House, Dedham, Massachusetts. The summer is raised and lapped 2 in. over the girt to gain needed support at the bottom of the joint. Lack of congruency between housing and tenon shoulders is unexplained.

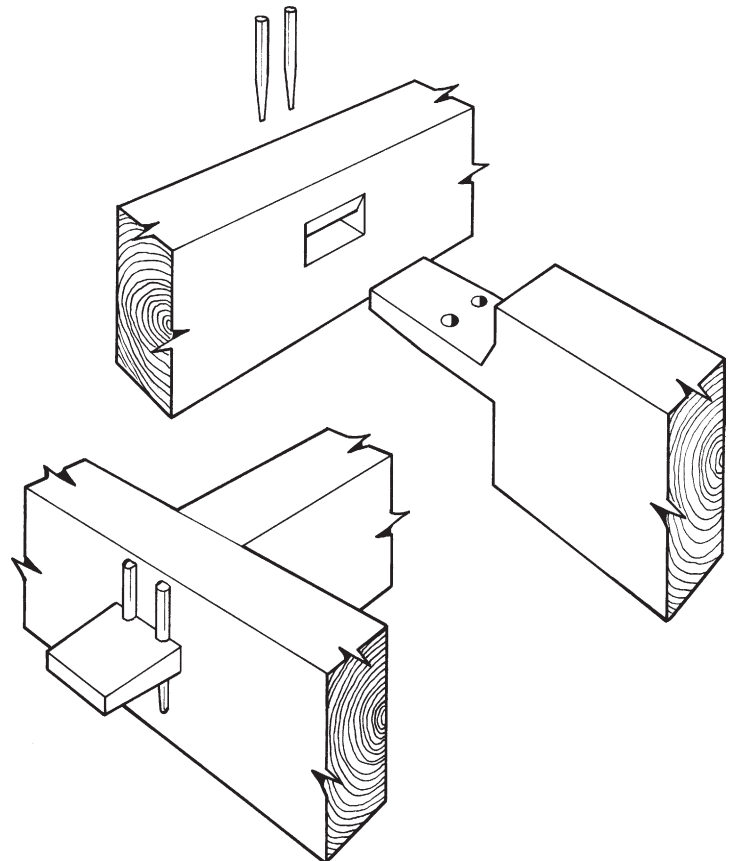
Fig. 23. Through tenon with outside wedges (pins flattened on a taper) in the attic floor of the Presbytere (1847), New Orleans.

**Other tenon forms.** Any joist tenon can become a through mortise and tenon with wedges to increase tensile capacity (Fig. 23). Especially deep members could have paired tenons (Fig. 24, overleaf).

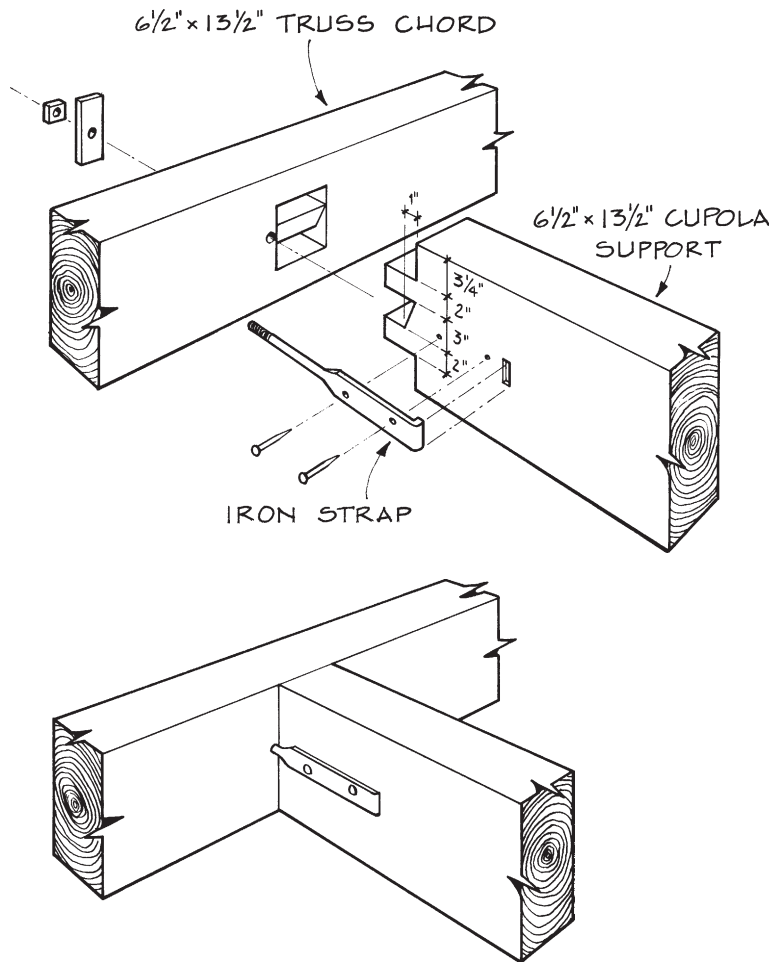
Fig. 24. Paired tenons, one strengthened, carry the ends of beams supporting cupola posts in the roof frame of the Cabildo, the original Spanish city hall in New Orleans (1796, 1849, 1992; see TF 21 and 24). A forged iron strap prevents spreading.

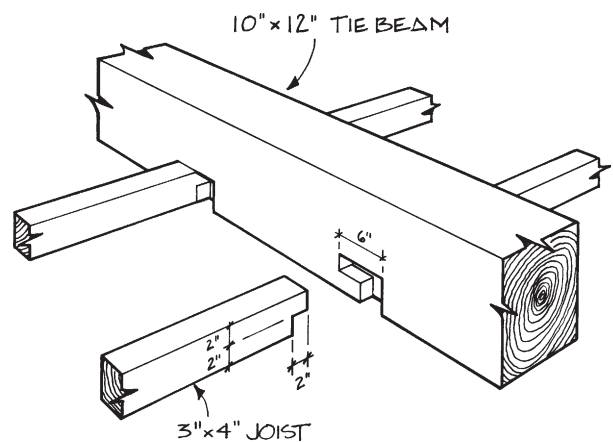
Fig. 25. An L-mortise in the 1829 Newbury, Vermont, Methodist Church. The building measures 45x60 with the ceiling joists spanning about 12 ft. and spaced at 30 in. on center.

**The L-Mortise.** This mortise allows the tenon to be lifted up and over (Fig. 25). Only one end of the joist has to be accommodated thus since the tenon on the other end of the joist can be inserted first (at a small angle to the horizontal) into a standard mortise. Though the L-mortises are shallow, they still cut into the bottom surface of the beam. Typically, only one side of each tie beam has these mortises.

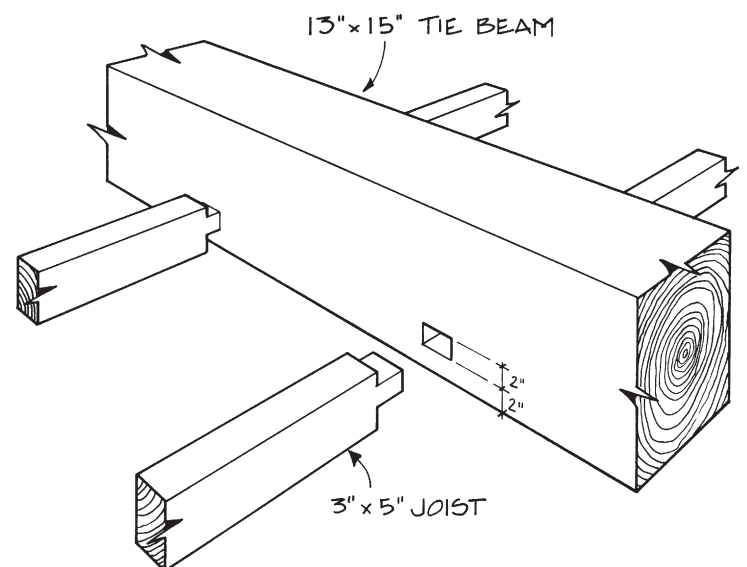
Fig. 26. Beech ceiling joists with shortened shoulders are secured from movement by a single cut nail in the Second Congregational Church, Newport, New Hampshire (1823).

**The Short Joist.** A joist with a shorter shoulder to shoulder length than the spacing between the tie beams can be inserted into one mortise an extra 2 or 3 in. deep, then swung into place and slid back until it bears an equal amount at each end (Fig. 26). Of course, the joist needs to be secured from future movement. Its main disadvantage is potential shearing of the tenon.

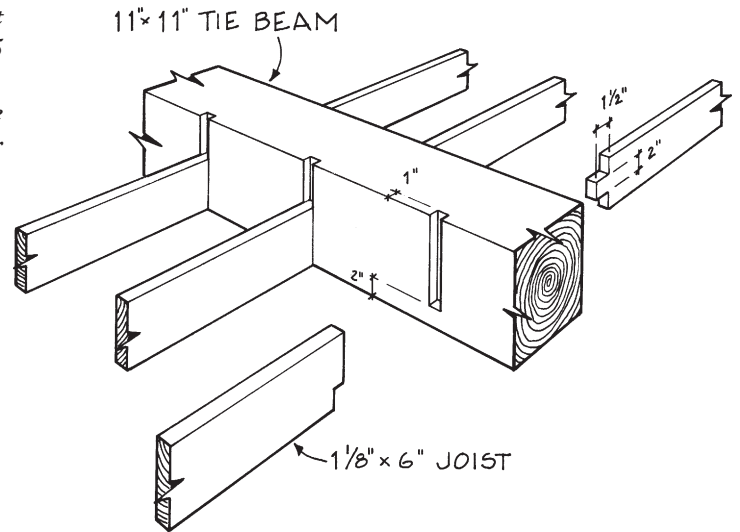
Fig. 27 (right). Board ceiling joists tenoned at one end and notched at the other drop into vertical chase mortises on the tie beams of the 1815 Methodist Church at Chenango Forks, New York (now dismantled). The bearing for the joist in the tie beam is only an inch deep. Close truss spacing of about 8 ft. permits the use of light boards. Similar joinery is found on an 1840 church in Brimfield, Massachusetts.

**The Vertical Chase Mortise.** One end is again inserted first, and the other swung down from above in a chase mortise (Fig. 27). Inserting joists from above is perhaps more convenient, but these

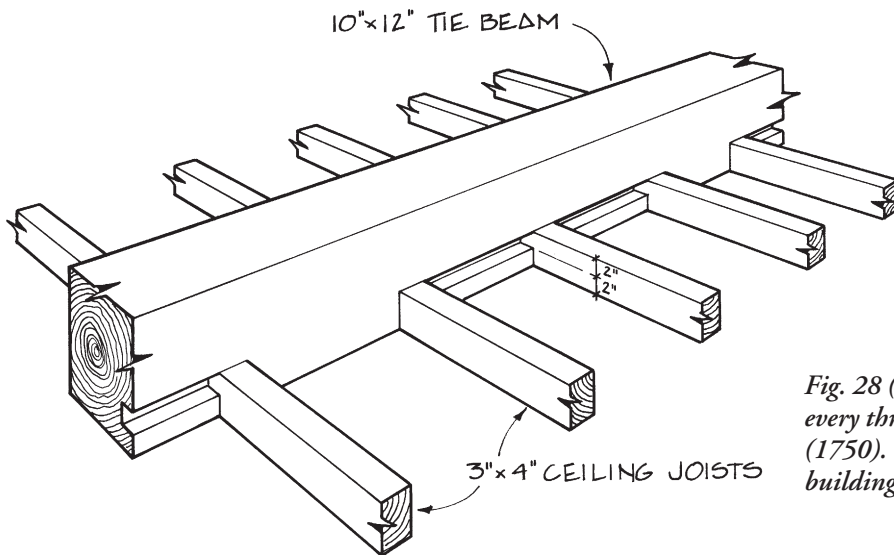
Fig. 28 (left). Long pulley (chase) mortises were cut in the tie beams for every three ceiling joists in the Hatfield, Massachusetts, Meeting House (1750). The opposite side of the ties had simple 2x3 mortises. This building was destroyed while being rolled to a new site in 1979.

**The Horizontal Chase Mortise.** In this variation, also called a pulley mortise, a continuous slot connects two or three joist mortises (Fig. 28). Thus multiple joists are maneuvered into place in the same slot.

With all these post-raising insertion types, the spacing of the tie beams, which are long and somewhat flexible, would be secured by at least one tying member near mid-span to prevent spreading of the beams and collapse of the ceiling. The lath would secure the spacing of the joists. Since the horizontal chase mortise does not remove wood from the bottom surface of the tie beam, it is the best solution structurally. However, it is more time consuming to craft than the first three.

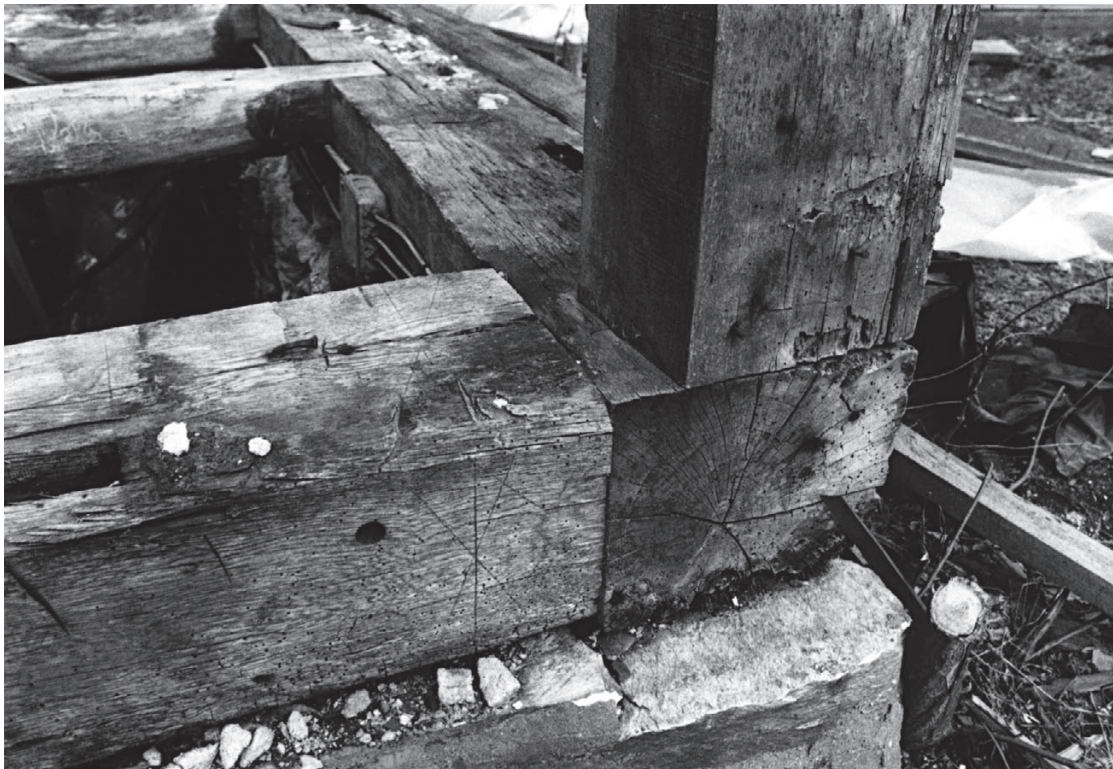
The typical blind sill corner joints on this house frame in Charlemont, Massachusetts, give little clue to their inner mortise and tenon configuration. The first joist to the rear, hewn flat only where necessary, joins the sill in a butt cog. Timber sills and girders, historically a natural part of the timber frame, have virtually disappeared from modern American work.
