# HISTORIC AMERICAN TIMBER JOINERY

## A Graphic Guide

### *V. Roof Joinery Excluding Trusses*

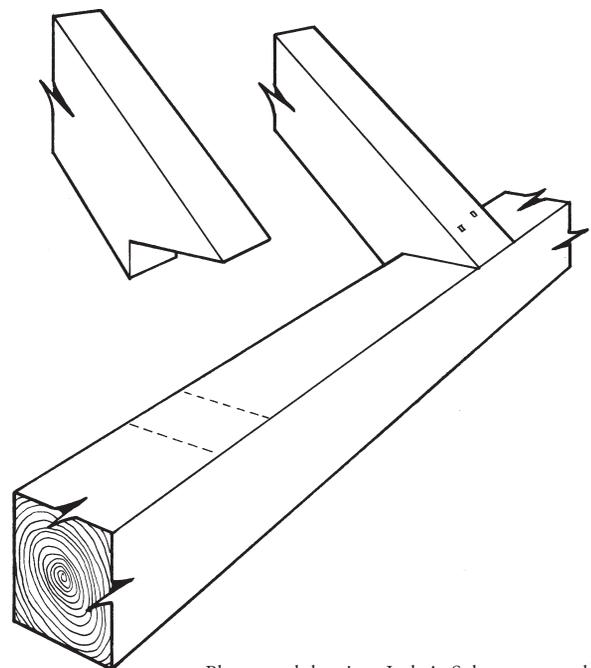
*Fig. 1. With a birdsmouth cut to fit the inside of the plate, roof thrust is adequately resisted. Here the joint is secured with nails.*

A better solution was to cut a *birdsmouth* in the rafter to bear against the inside edge of the plate (Fig. 1). This simple joint, named after its similarity to the open beak of a bird, could handle

the thrust without loading the nails or pins. Unfortunately, the roof thrust in tandem with the natural checking tendency of a boxed heart rafter causes a split to develop at the mouth that can be its ruin. The situation is further exacerbated by shrinkage. Acute angles on the ends of timbers become more acute as they season and shrink; thus the load is borne by the feathered extremes of the birdsmouth. The same weakness can be worsened by a waney or out-of-square plate.

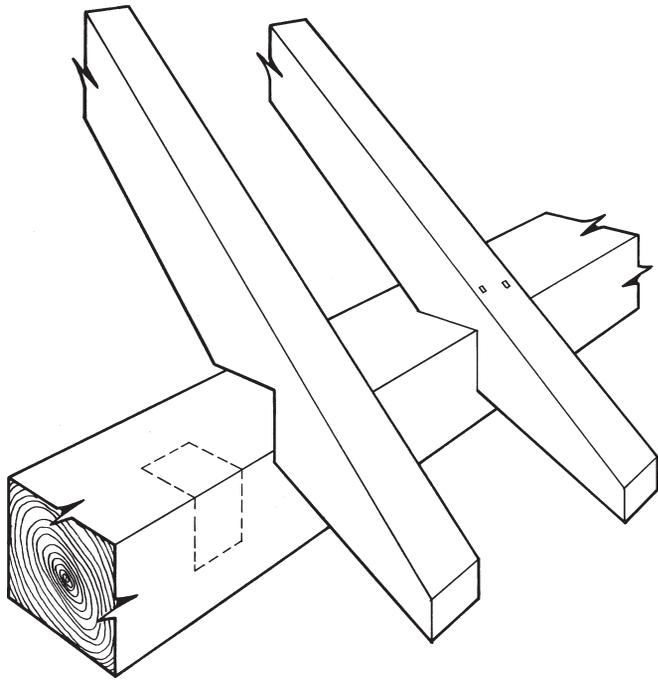
Fig. 2. As is popular today in conventional framing, the birdsmouth in this late 19th-century barn in Root, New York, is cut to fit the outside of the plate. Though the fastenings must resist thrust, there can be a substantial overhang.

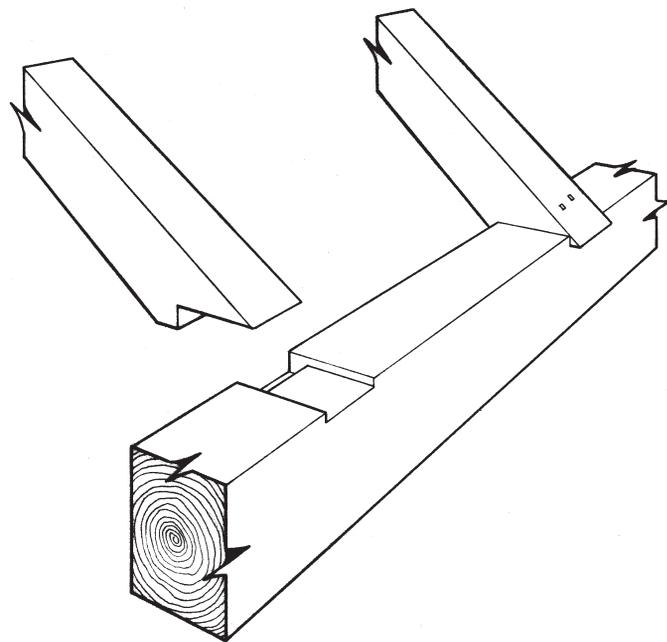
Fig. 3. The housed birdsmouth supports the lower side of the rafter and eliminates the tendency of the rafter to split up the mouth. This example is also housed into the top of the plate.

To counter these concerns, some builders used a *housed birdsmouth* joint (Fig. 3). The lower edge of the rafter is supported in a pocket, increasing its shear strength substantially. Occasionally, the top of the plate had a gain to receive the rafter. This may have been done to get a good bearing on a roughly hewn plate, or to increase the overhang slightly.

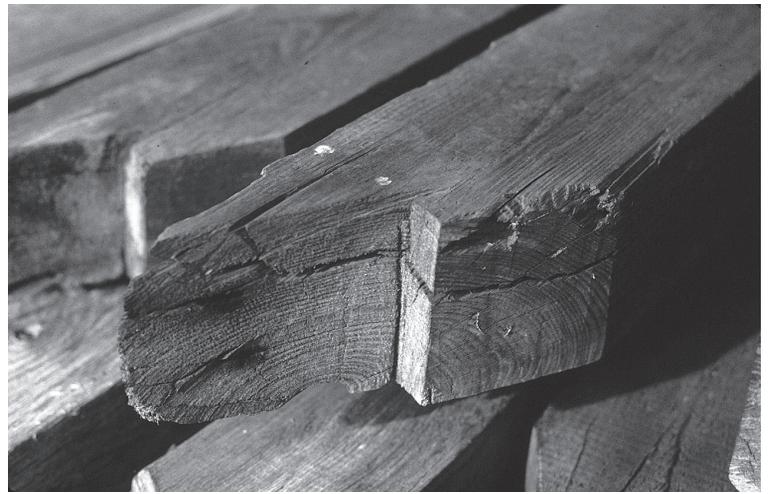
Rafters from a Great Barrington, Massachusetts, carriage shed showing a housed birdsmouth. This joint could be completely sawn.

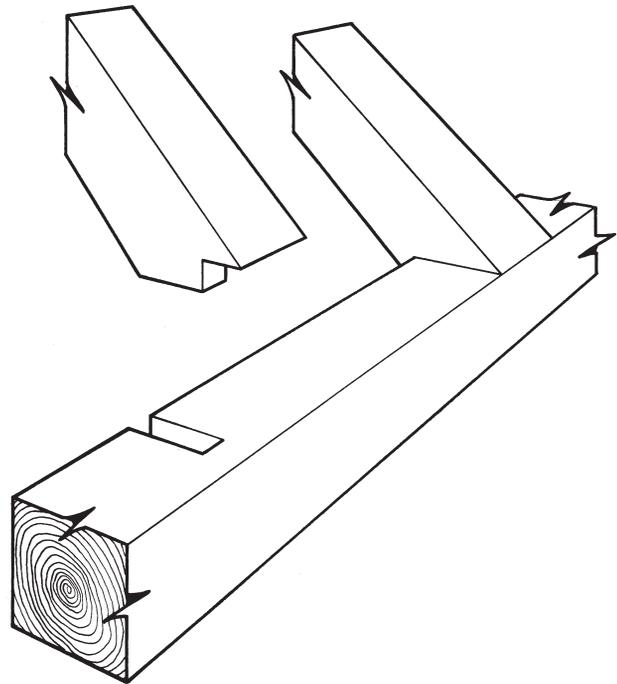
Fig. 4. On large Dutch barn rafters, a birdsmouth stub tenon is common. This example is barefaced.

In many New York State Dutch barns, the large-section (7x7, 8x8) rafters terminated in 2-in. stub tenons (Fig. 4). Sometimes they were barefaced (as shown), sometimes double-shouldered. Though the resulting mortise is strange (one expects a mortise to run parallel with the grain), the joint functions much like a housed birdsmouth. On the gable end rafters there can be relish between the mortise and the end of the plate. These joints often had no fastenings.

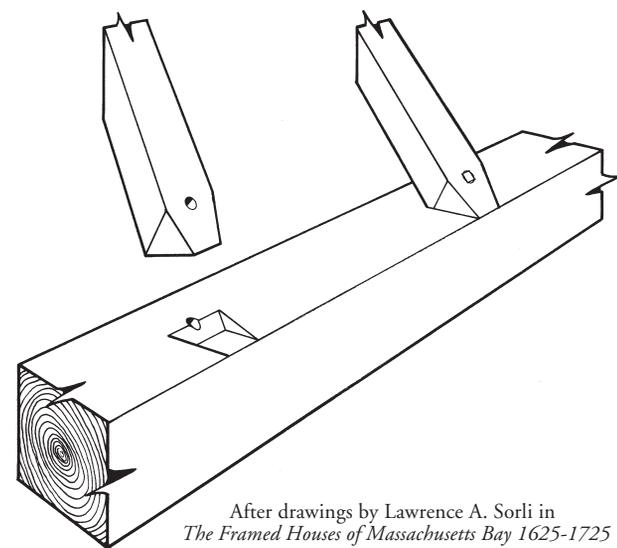
Fig. 5. Unusual rafter feet found in the ca. 1637 Fairbanks house in Dedham, Mass., and the Samuel Pickman house in Salem (before 1681). The dovetail matrix is apparently designed to resist roof thrust.

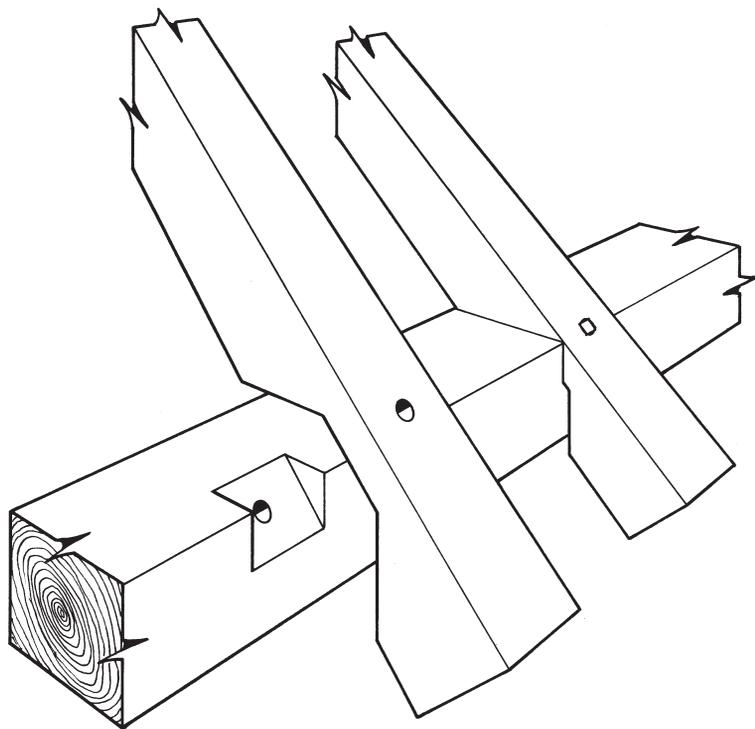
Fig. 6. In a mid-19th-century house in Shelburne, Massachusetts, the rafters have a level cut with a through tail to support a cornice.

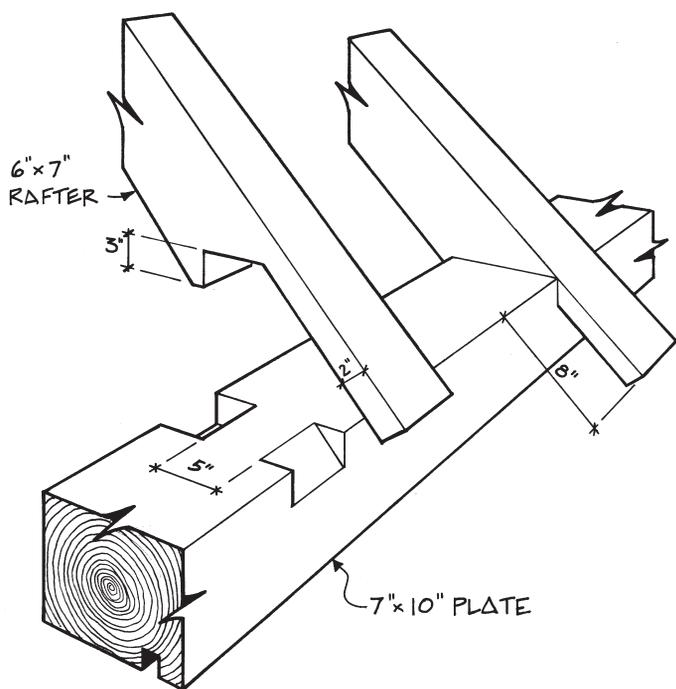
Fig. 7. These housed birdsmouth rafters with through tails were found in a well-crafted 18th-century barn formerly in Hoosac, New York. The rafters were supported at mid-span by a purlin plate and joined to a ridge at the peak. The groove in the underside of the plate was for vertical wall boarding.

A stronger solution is the *birds-mouth with through tail* (Fig. 7). This requires more notching in the plate but resists the roof thrust well. Its disadvantage is that the level cut on the rafter cannot be

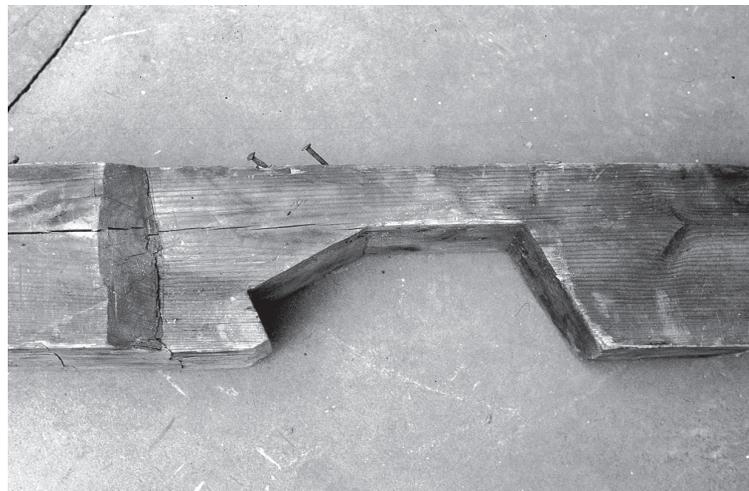
Rafter with housed birdsmouth and through tail from 18th-century Dutch house in Muitzenkill, New York. Three of the five cuts could be sawn; the other two had to be chiseled.

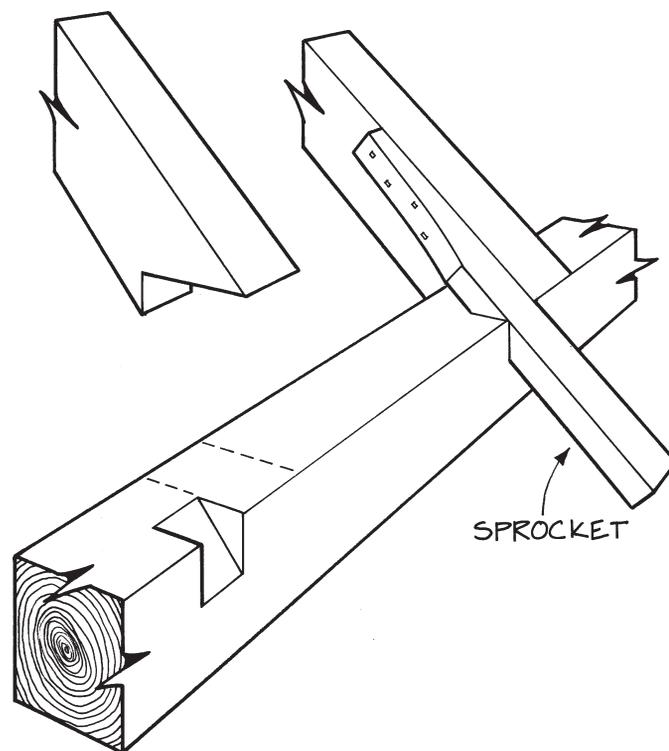
Fig. 8. Tails were often added to rafters to provide an overhang. These tails or sprockets are nailed or pinned in place. They can also be angled to provide a pitch change at the eave.

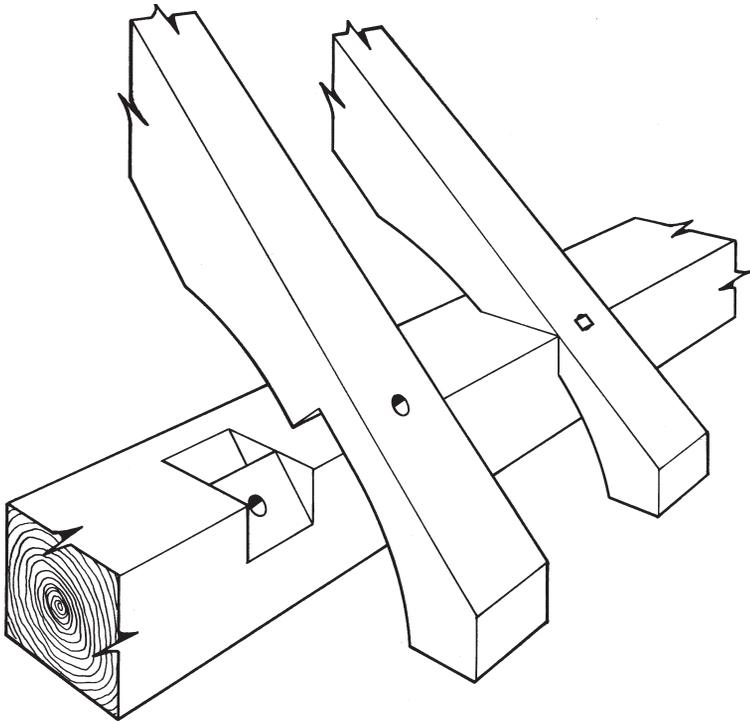
Fig. 9. The step-lap rafter can be shaped with an adze. Here the tail has a plumb and a level cut to support a cornice. A squarish pin through the tail secures it.

The best solution to connecting rafter and plate, at least to this author and builder, is the *step-lap rafter seat* (Fig. 9 facing page), the joint found more often than any other. It was used on one of England's oldest buildings, the Barley barn at Cressing Temple, ca. 1200 (see Cecil A. Hewett's *English Historic Carpentry*), and was a standard here in America. It performs well in all respects, including economy. Though it appears complex, it is fairly simple to fabricate. The rafter has only one sawcut (not including the end of the tail), and that at 90 degrees. The axe or adz can be used to swiftly shape the surfaces toward that sawcut. The plate notches involve sawing and chiseling but can be cut quickly, with the inner V-notch presenting the only difficulty. The step is usually either 1½ or 2 in. and the tail thickness the same. The shape of the tail varies depending on the cornice detail and the builder.

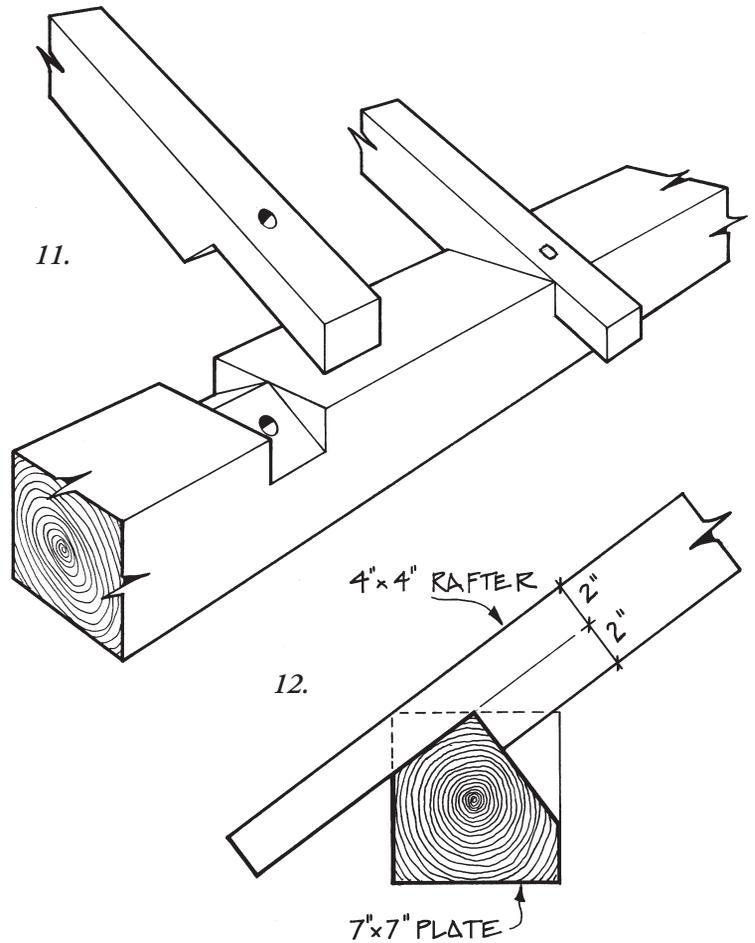
Figs. 11 and 12. The builder of a 19th-century South Lee, Massachusetts, barn (11) attempted to improve the step-lap seat by making it easier to cut. Here both parts of the seat could be sawed full depth. But the obtuse-angled rafter abutment tends to ride up and over the plate from the thrust of the roof. Fortunately, the roof loads in this 20x20 barn are small. The builder of a Rowe, Massachusetts, barn addition (12) also re-designed the rafter seat. Unfortunately, with its lower edge unsupported, the shear strength of the rafter is severely diminished, and the plate is also weakened, by losing its remaining upper arris.

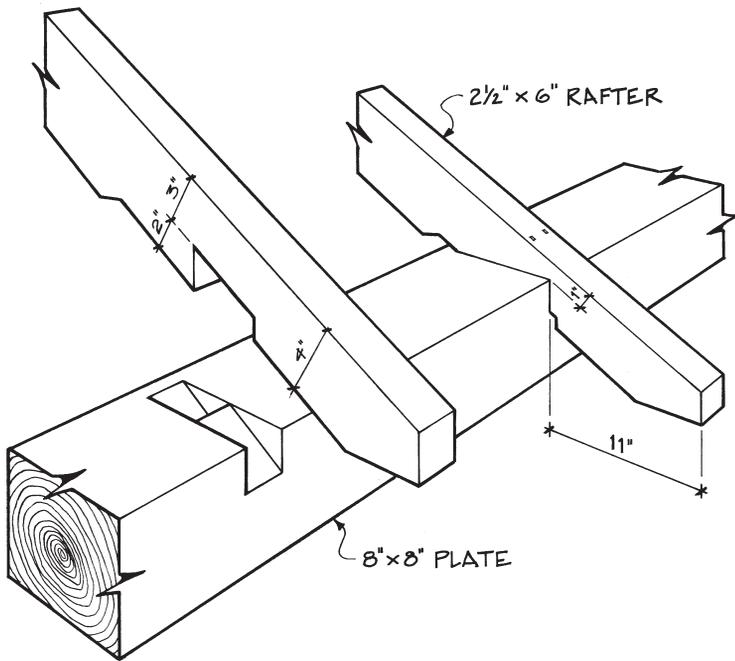
Fig. 10. Variation of the step-lap with plumb abutment. The roof plane is also elevated above the edge of the plate to increase the tail strength in this mid-19th-century carriage barn in Adams, Massachusetts.

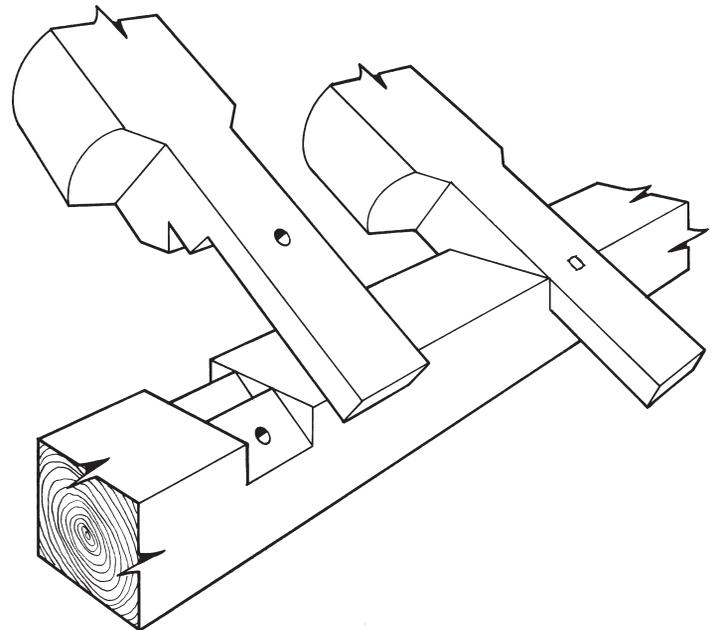
Fig. 13. The ultimate rafter-plate joint must be this example found in an 18th-century barn in Sheffield, Massachusetts. It combines the step-lap with the housed birdsmouth to create this magnificent but obviously time-consuming joint.

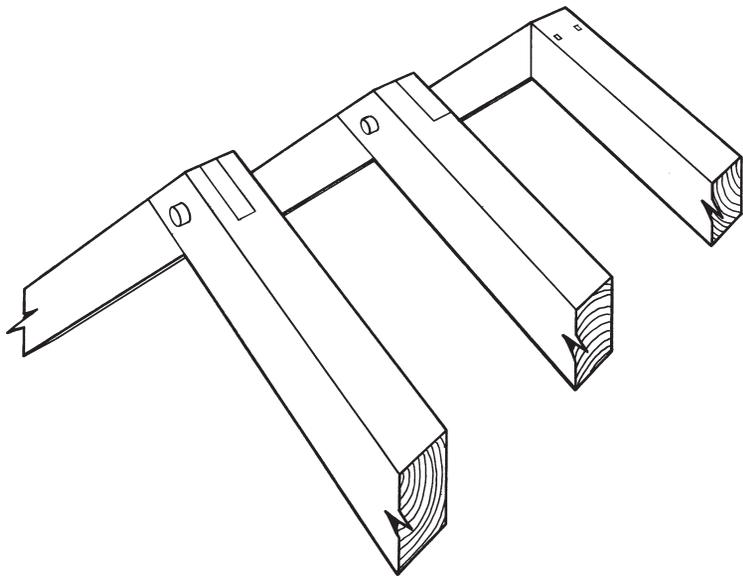
Fig. 14. Above, from left, three forms of joint for common rafters at the peak: open mortise and tenon, half-lap, butt.

**Rafter-to-Peak Joints.** Where common rafters reach the roof peak, they may be joined to each other or to a ridge beam or a ridge board. When joined to each other, they are butted and secured with nails, half lapped with a pin, or mortised (open or blind) and pinned (Figs. 14 and 15). Of these, the mortised joints perform the best but require the most time to execute.

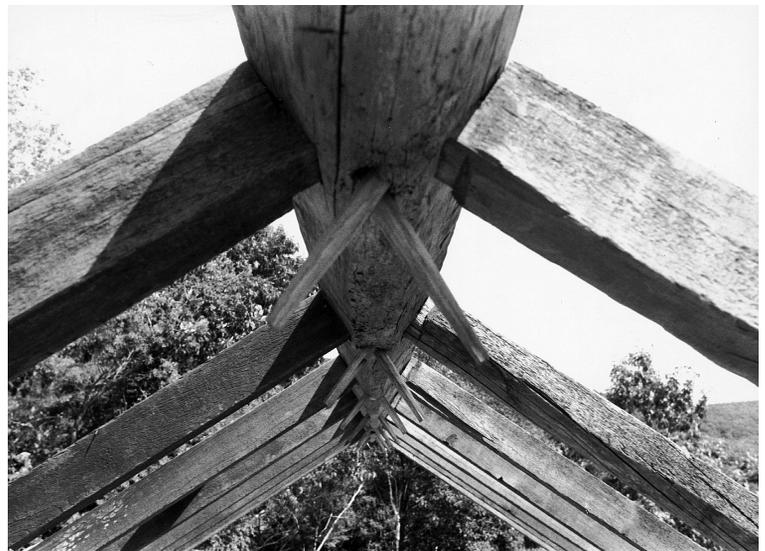
View down the ridge beam of a mid-19th-century 40x50 barn in Hinsdale, Massachusetts. The 3x4 rafters have barefaced tenons.

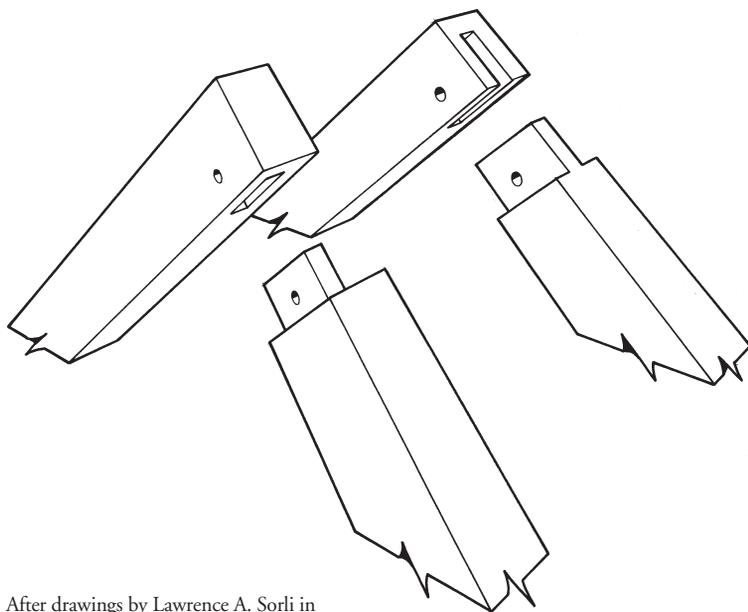
Fig. 15. On deeper section rafters, there may be some economy to these variations of the mortise and tenon. At left above, principal rafters in the ca. 1665 Gedney house, Salem, Massachusetts; at right, principal rafters in the Fairbanks house (1637), Dedham.

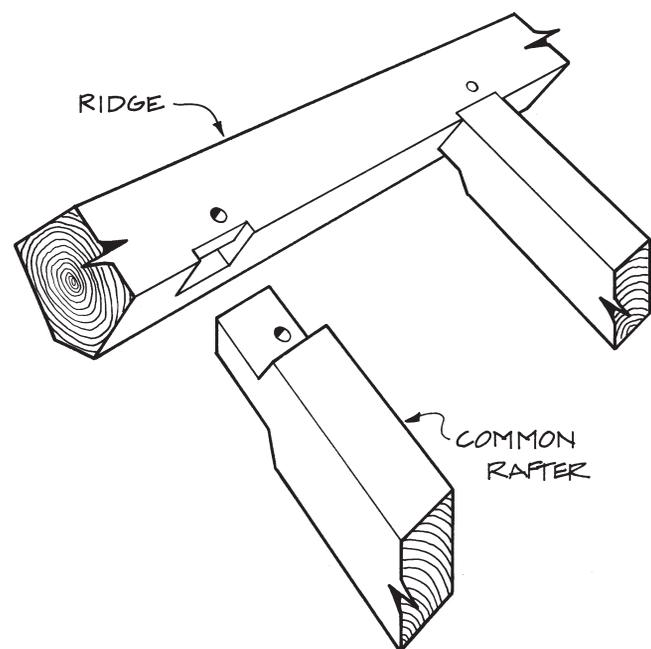
Fig. 16. The typical ridge beam, here a Square Rule example, is sized to accommodate the rafters. Pin holes are offset to avoid intersecting in material below mortises. The end of the tenon is cut plumb to provide maximum relish beyond the pin hole.

The sides of the ridge are perpendicular to the roof slope and, unless the roof pitch is 12/12, the cross-section usually ends up five sided (Fig. 16). Pin holes are offset toward one edge of the joint so they don't intersect the opposing ones. As a result, all rafters are

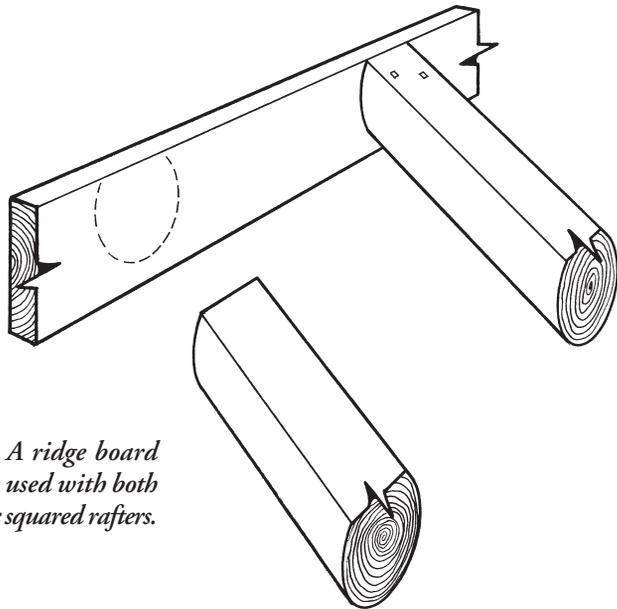
Fig. 17. A ridge board could be used with both round or squared rafters.

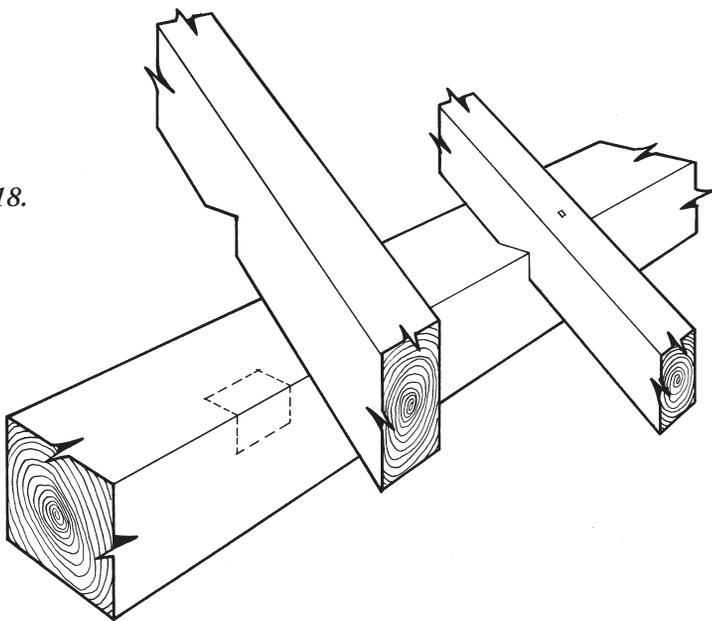
18.

Figs. 18 and 19. Above (18), a simple birdsmouth cut on the outside of the purlin plate is quite common in Dutch barns. A pin or spike is used to secure it. Below (19), rafters are reduced to a consistent, smaller size where they pass over the purlin plate. Only the pin resists thrust.

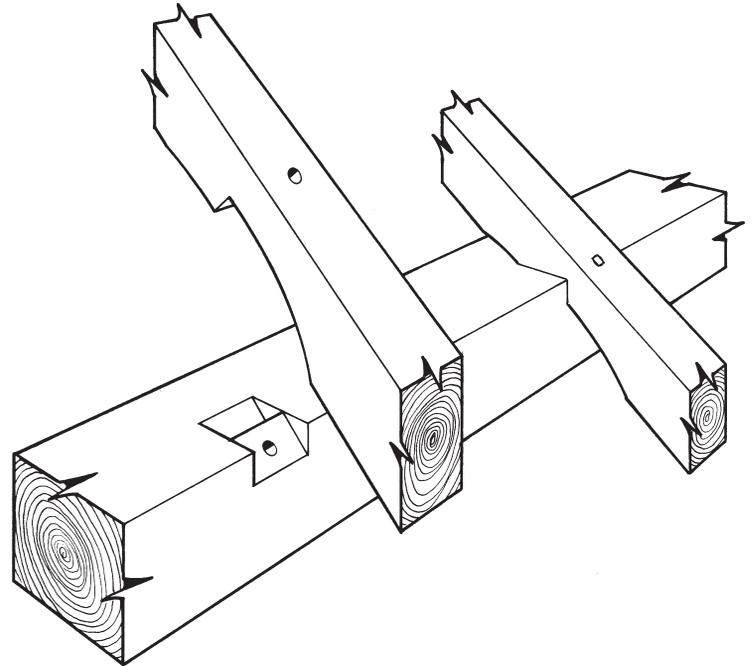
Fig. 20. The step-lap works equally well on purlin plates, but the rafter cross-section at the through point is thicker than the tail at the plate. Note how the rafter stands above the corner of the purlin plate.

In buildings with the step-lap rafter seat at the plate, the purlin plate will often have the same seat (Fig. 20). The rafter, however, is elevated above the corner of the purlin plate to maintain sufficient rafter thickness.

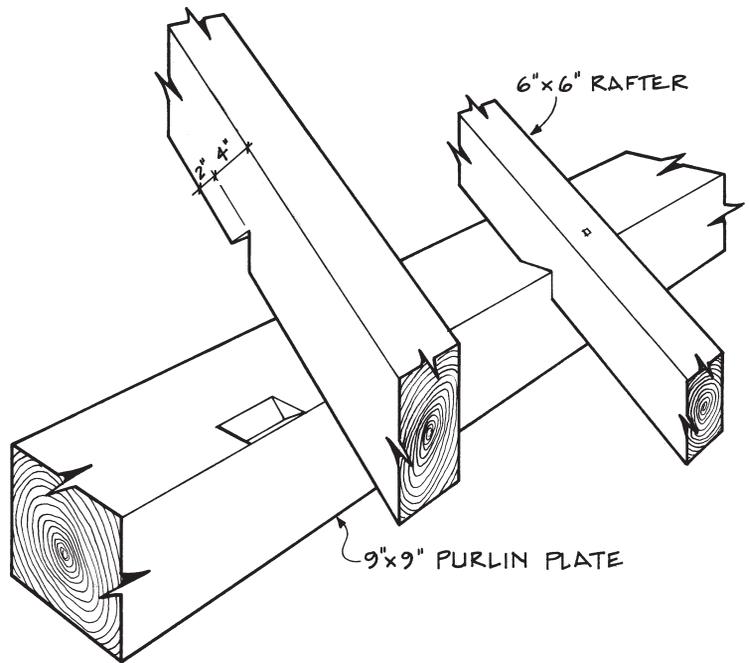
Fig. 21. This purlin plate joint was found in a 45-ft.-square barn in Middleburg, New York. It is simple and effective.

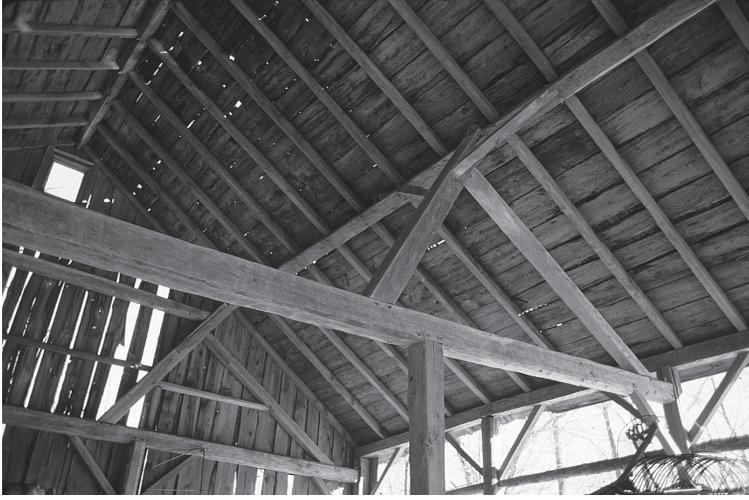
Mid-19th-century Hinsdale, Massachusetts, barn before dismantling. The continuous purlin plate assembly is canted perpendicular to the roof and the purlin plate is flush with the roof. The rafters tenon into both upper and lower faces of the purlin plate.

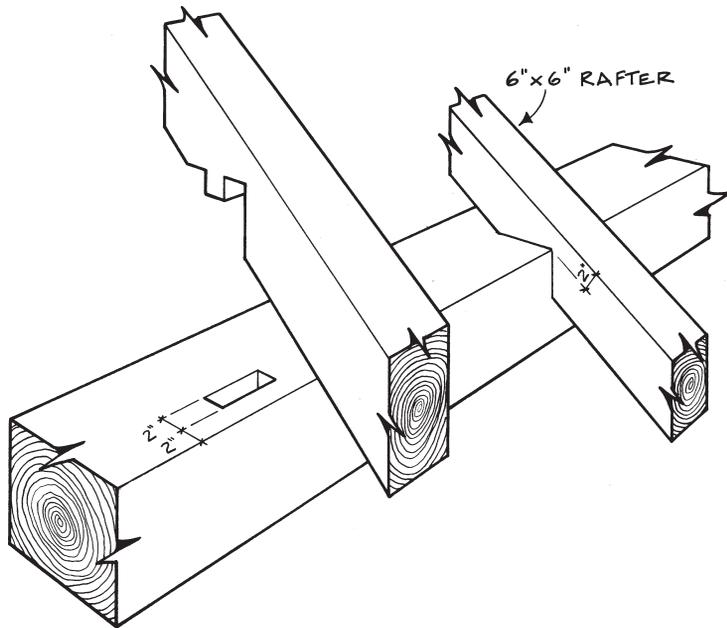
Fig. 22. A re-used rafter in a ca. 1825 Somerset County, N.J., barn implied this unusual purlin joint in its original location. Because of short grain in the tenon, its application would be best for roofs steeper than 45 degrees. The rafter section is reduced to one-third at the joint.

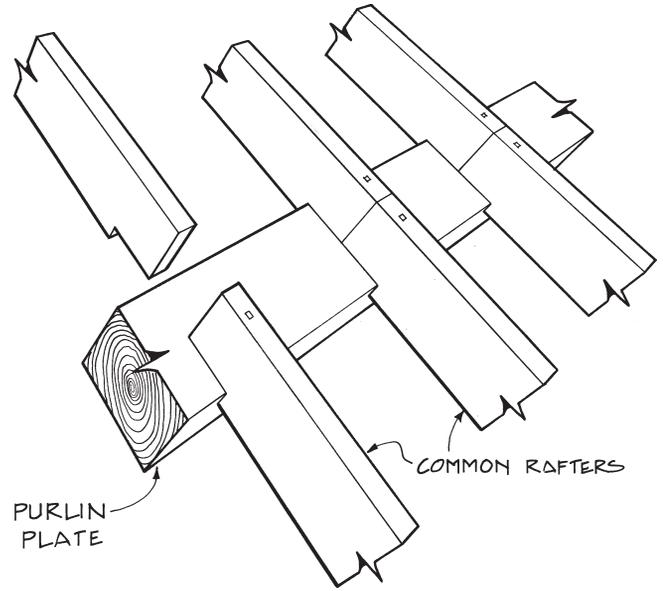
Fig. 23. Canted purlin plates eliminate considerable cutting since rafters (here sized and butted) can pass over the purlin plate.

In the mid-19th century, when purlin plates and their canted posts were framed perpendicular to the roof slope, as shown at top, the rafter joints were simplified. In many barns, rafters continued across the purlin plate undiminished and secured with nails. Often they were sized down to a consistent section, where a shallow square abutment increased thrust resistance (Fig. 23). Or, they could be two short rafters simply butted over the purlin plate.

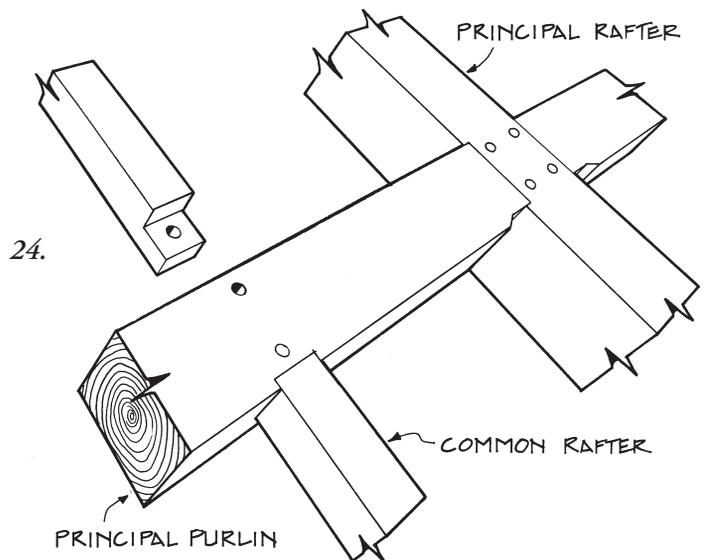
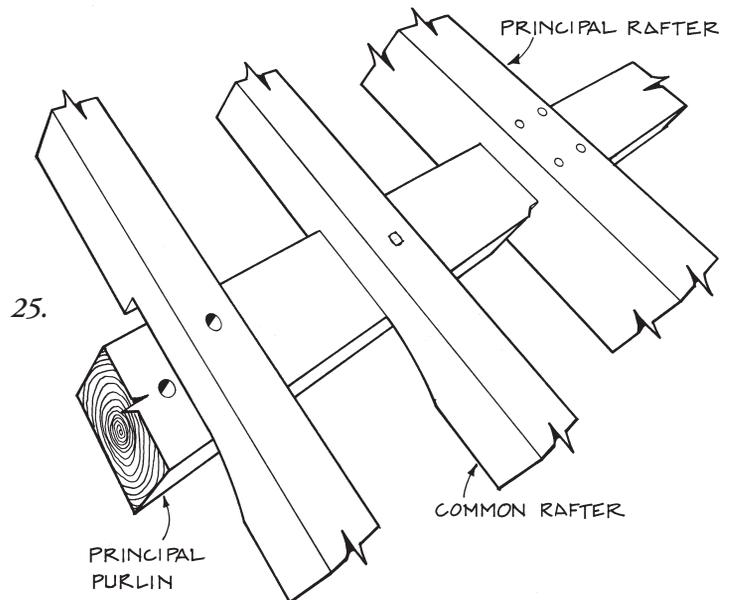
Figs. 24 and 25. Above (24), a flush principal rafter-principal purlin-common rafter roof, with rafters tenoned into the purlin, itself tenoned to the principal rafter. Below (25), purlin framed below principal rafter and through rafters notched where they cross the purlin.

**P** RINCIPAL RAFTER-PRINCIPAL PURLIN-COMMON RAFTER ROOFS. This most elaborate roof system includes purlins supported by principal rafters. The purlins may be tenoned between the principal rafters or run over them, and the common rafters then span between the principal purlins (Fig. 24), or run over them (Fig. 25). The advantages of such a design to warrant the extra cutting work are that the common rafters can be shorter and of lighter scantling, and bracing can be conveniently framed in to

The joinery that accompanies this roof type varies depending on whether all or some of the members are flush with the roof plane as seen in Figs. 24-27. Common rafter joints at plate and peak are unchanged from those already addressed.

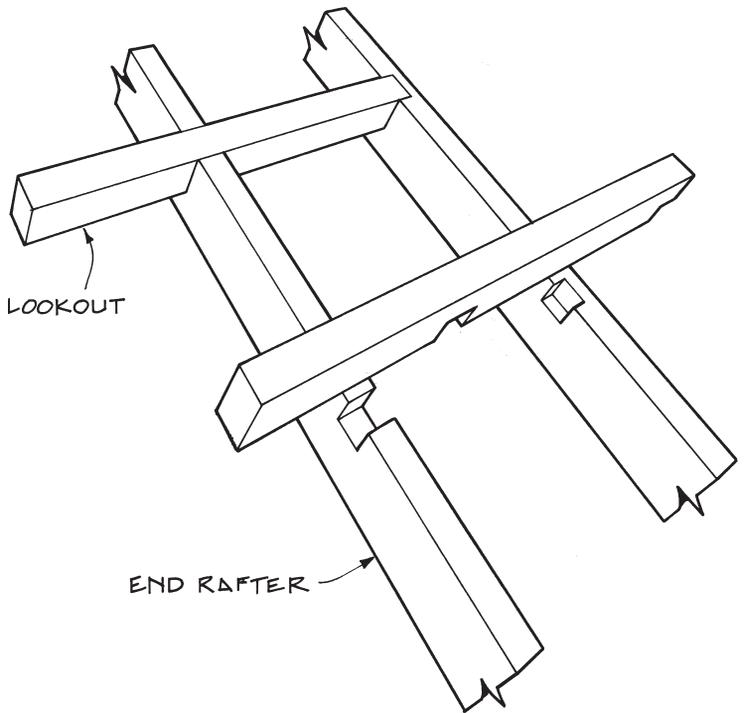
Fig. 28. In common-rafter roofs where a substantial rake overhang is required, "lookouts" are framed to cantilever out.

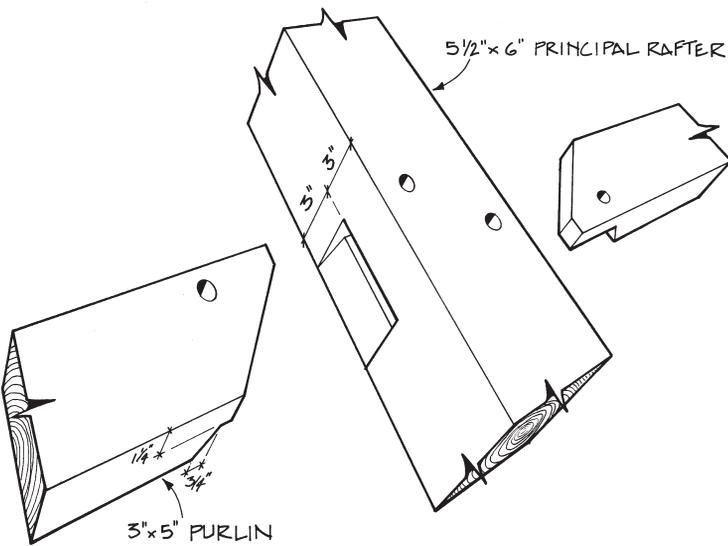
Fig. 26. This unique purlin-to-principal rafter joint appears in the 1668 Turner House (House of the Seven Gables) and the 1665 Gedney house, both in Salem, Massachusetts. Its advantage lies in the way a fairly narrow principal rafter could accommodate two purlin tenons with sufficient pin hole relief to be effective.

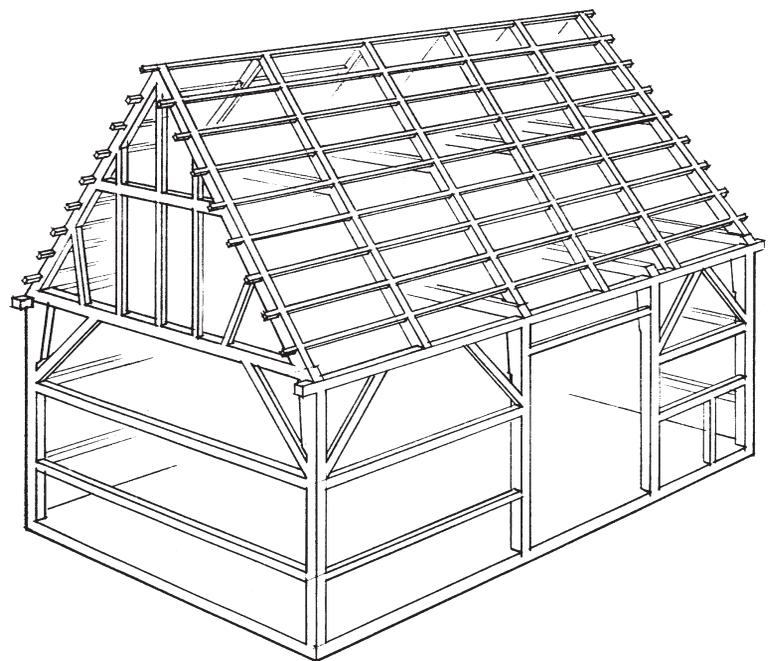
Fig. 29. This 17th-century barn in Seekonk, Massachusetts, has principal rafters spaced a little over 6 ft. apart with 2x3 common purlins spaced about 2 ft. on center. The purlins extend past the gable to provide an overhang.

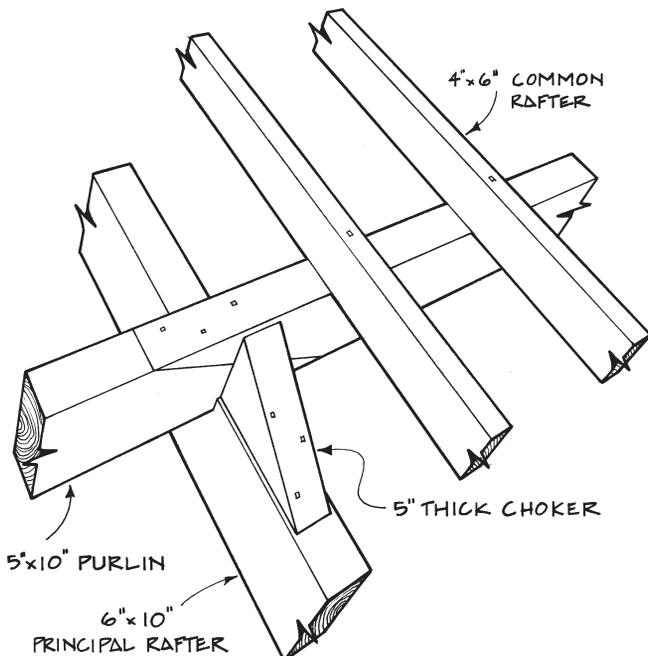
Fig. 27. In trussed roof buildings, the purlins may bear on top of the principal rafters, as shown here in the Cabildo in New Orleans. The deep-section cypress purlins are scarfed over the principal rafter in what the French refer to as a "whistle cut." The purlin end cut is then recycled as a sort of cleat, a "choker," to keep the purlin from rolling.

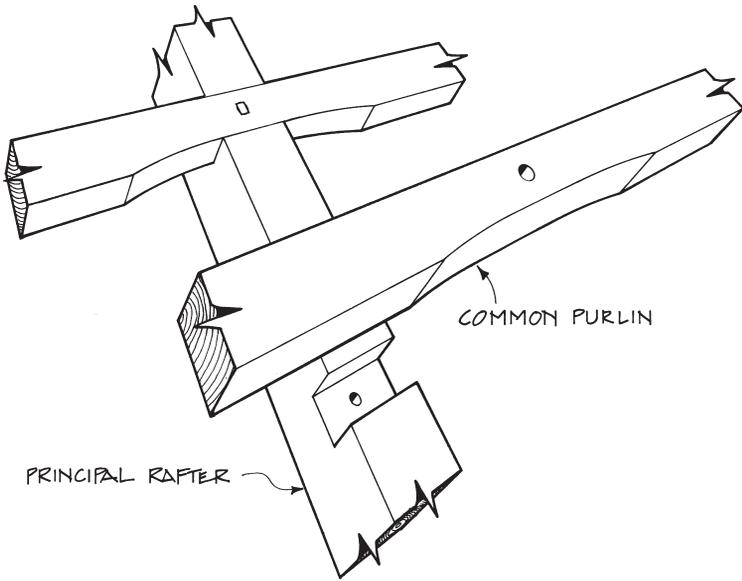
Fig. 30. Common purlins are typically trenched across the rafters and secured with a squarish pin. Here they are reduced to a consistent width with an adze.

The typical common purlin-to-principal rafter joint is a through trench in the rafter with a pin to secure it. The purlins may pass at full size or be reduced or halved in the trench (Figs. 30-34). Fig. 35 on the back cover shows the special case of a hip roof. Common purlins are often small (1½ in. x 2½ in. up to 3x5) and are usually laid flat.

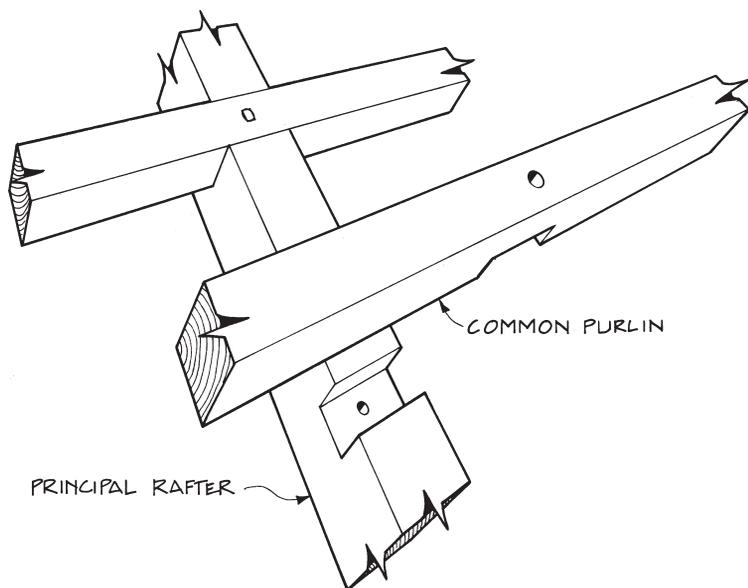
Fig. 31. To avoid unduly weakening principal rafters, deep-section purlins are notched or halved where they cross.

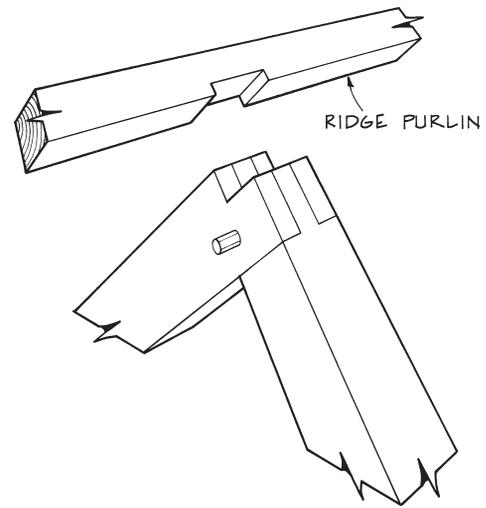
Fig. 32. The mortised rafter receives the notch for the ridge purlin.

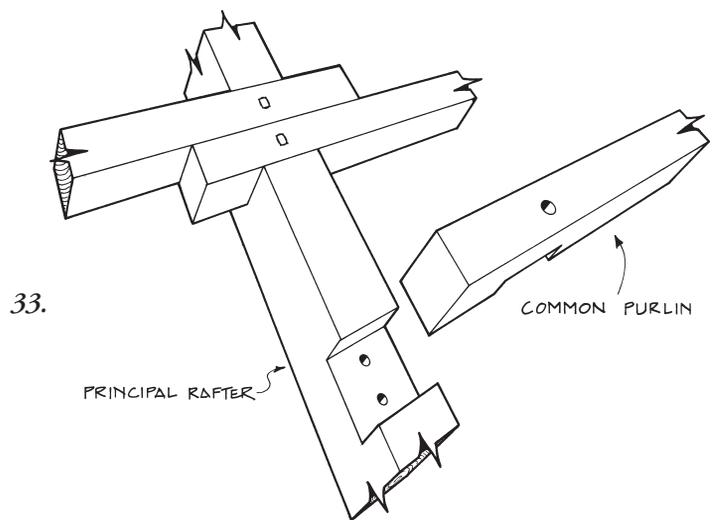
33.

Figs. 33 and 34. Above (33), many buildings have the purlins staggered to avoid scarfing. Here, purlin relish beyond the halving augments the pinned connection and ties the roof longitudinally. Below (34), purlins may be skived (scarfed) in line and secured with a pin.

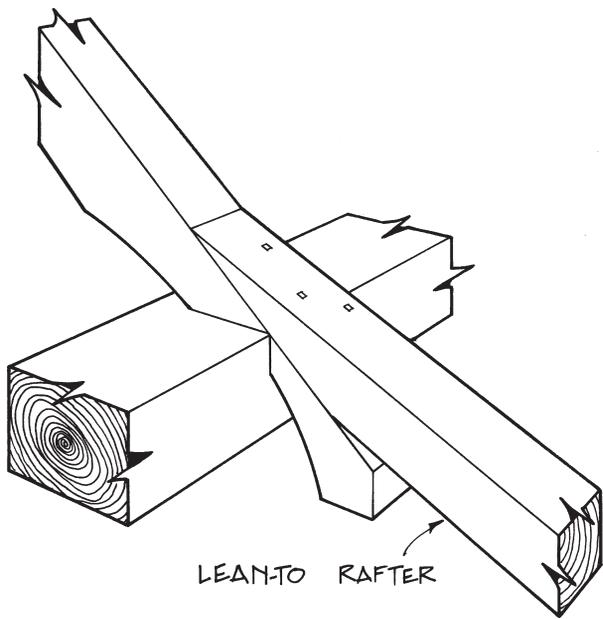
Fig. 36. Dutch houses often had “broken back” lean-tos, where the lean-to pitch was lower than the main roof pitch. A simple, effective solution was to bear the lean-to rafter on the back of the main rafters and secure the connection with a pin or nails.

**O**THER ROOF JOINERY. Lean-to-roofed additions are common on old structures, some built simultaneously with the main frame. By lessening the pitch of the lean-to roof—to produce a *broken back* roof—the rafter connections are simplified. The lean-to rafter can bear on the plate or on top of the main roof rafters (Figs. 36-38).

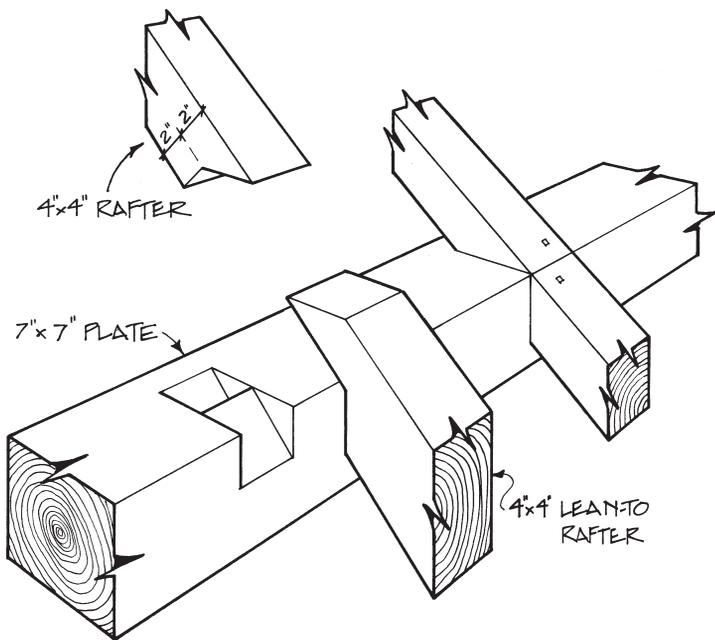
Fig. 37. In this early 19th-century Pittsfield, Massachusetts, house, the lean-to pitch matches the main roof pitch and the rafters are beveled in the step-lap seat.

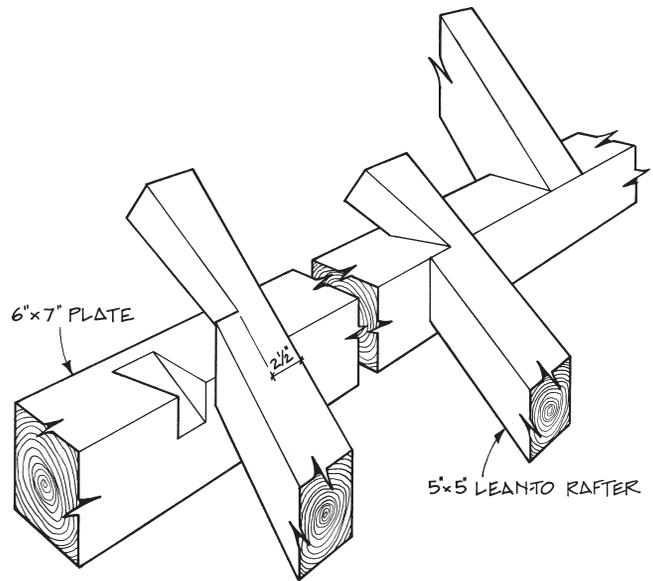
Fig. 38. In this ingenious and singular example from a barn in Seekonk, Massachusetts, the lean-to rafters are half-dovetailed in both width and thickness to lock into the main plate.

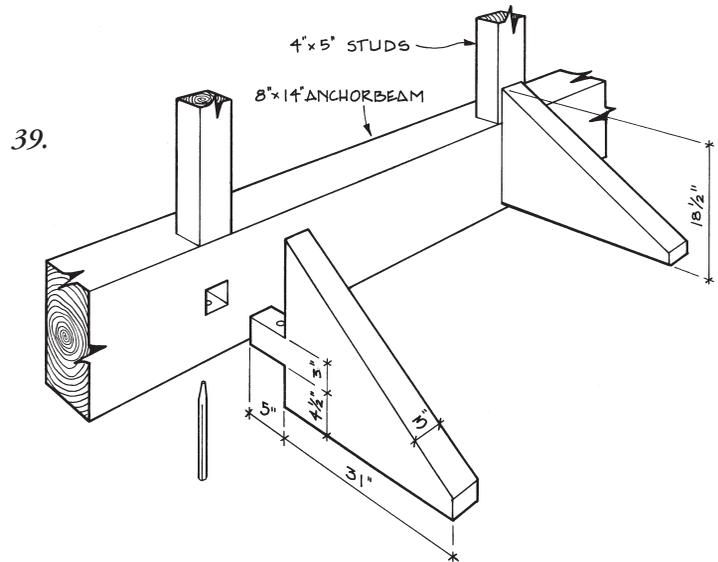
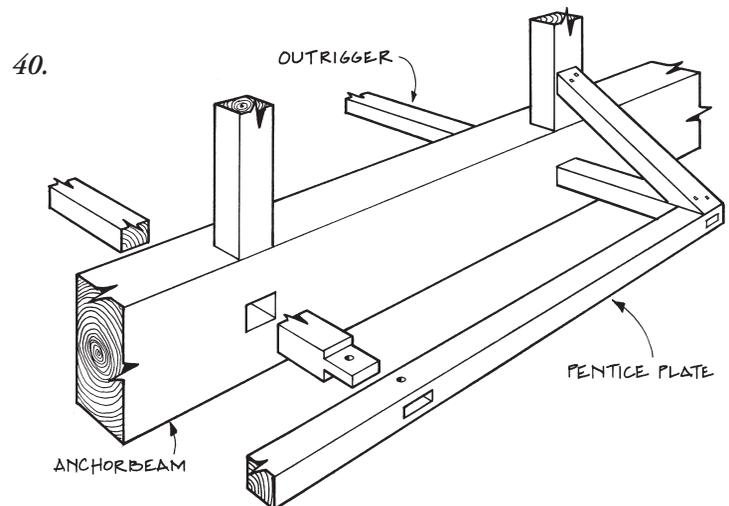
Figs. 39 and 40. Above (39), many end anchorbeams have tell-tale mortises, but only one example of this type has been found with all pentice parts intact, on a 44x45 barn that originally stood in Berne, N.Y. Though the 3x3 tenon 5 in. long would seem undersized, it worked for over 200 years. Below (40), many Dutch barns had cantilevered pentice arms mortised full-size through the gable anchorbeam. Four or five of these supported the pentice plate and rafters.

The Dutch and Germanic barns built in New York and New Jersey often had *pentice* roofs (see TF 43) over the main doors at each end and occasionally over the smaller side-aisle doors. Various techniques were used to support such a roof. In the simplest design, triangular blocks 1½ to 2 in. thick were nailed onto the sides of the studs over the doorway and supported board sheathing (tenoned variant, Fig. 39). In other designs, joists spanning the end bays cantilevered over or through the gable anchorbeam to support a plate and rafters (Fig. 40). These 2-ft. to 3-ft. pentice roofs protected the doors and sill below from the weather. —JACK A. SOBON
