HISTORIC AMERICAN TIMBER JOINERY

A Graphic Guide

VI. Scarf Joints

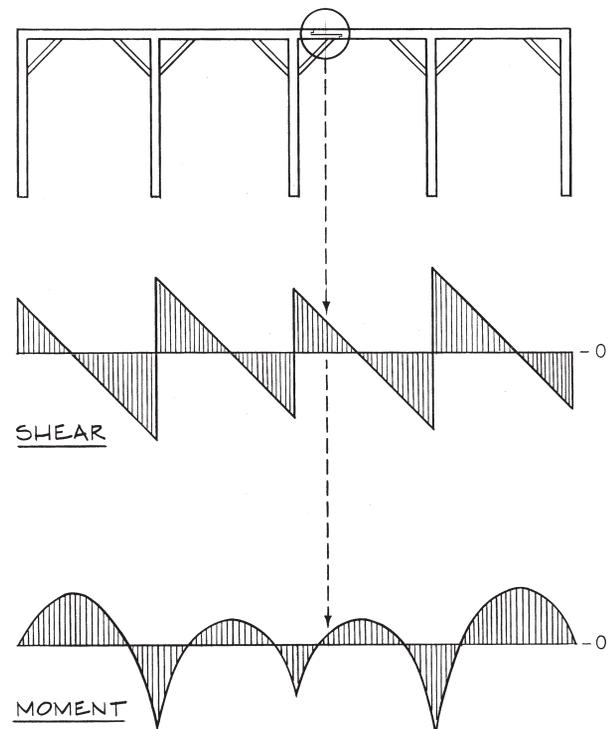
Fig. 1. Elevation of a plate continuous over five posts, showing a typical scarf location. Diagrams show resultant shear and moment values, both positive and negative, with horizontal line at zero force.

A member such as a plate or purlin plate that continues over multiple supports is much stiffer and stronger than one spanning between only two supports. The locations of the maximum and minimum moment (bending) forces are different in the continuous member. In a simple spanning member, the greatest moment occurs in the center of the span. In a continuous member, it occurs over the posts (Fig. 1, facing page).

Since it is difficult to create a scarf that handles bending forces as well as a solid timber, it makes sense to locate the scarf at a point where moment is the lowest. That is precisely where the majority of scarfs are located in old buildings. As in the illustration, the joint, additionally supported by the brace, is located where both shear and moment are low. Locating the scarf over the post, where stresses are at their maximum, would cause the plate to act like simple spanning members. Thus the plate would require a larger cross-section. Scarf location is also affected by available timber lengths and by the raising sequence of a building.

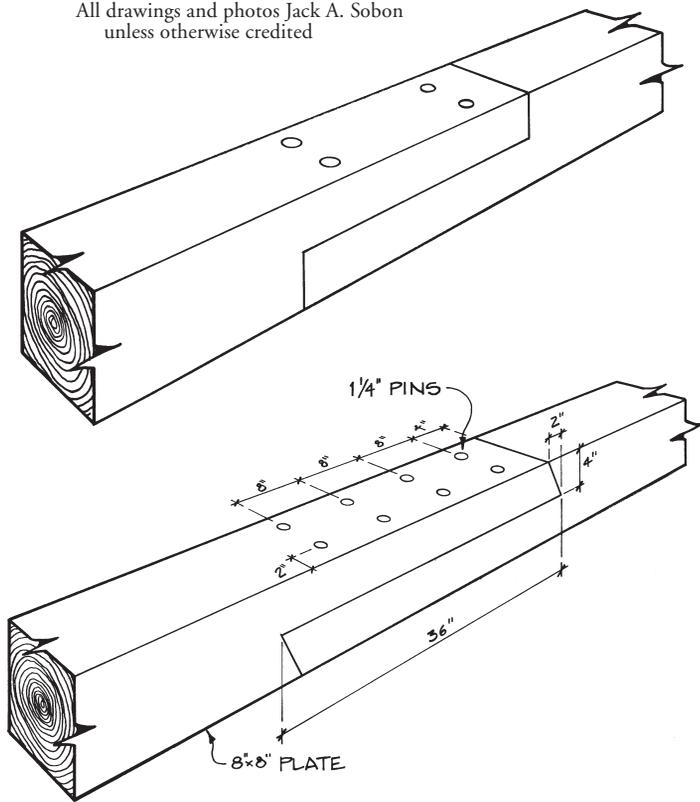
Figs. 2 and 3. At top (2), a halved scarf with four pins. Above (3), halved and undersquinted scarf found in an early-19th-century barn in Monterey, Massachusetts, the barn's only scarf; perhaps necessitated by some oversight in timber procurement. It has held up well despite its location in the center of the span. Note the 1-in-2 angle of the squint.

Halved Scarf. A basic halved scarf or half-lap (Fig. 2) is probably the simplest to fashion and thus the most abundant. It performs well in axial compression but depends solely on pins or bolts to resist tension and torsion. It has moderate shear strength but little

bending strength. It is often found where it receives continuous support, as in a sill, or where the carpentry is of the quickly executed variety, and many such joints open up over time. The half-lap is also commonly used in repairs made to buildings *in situ*.

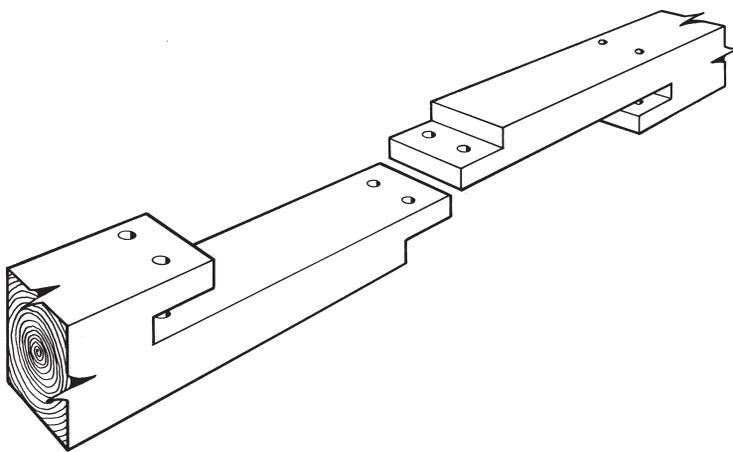
Fig. 4. Halved and bladed scarf with pinned tenons. Pins are often fitted additionally or alternatively in the central lapped portion.

Halved and Bladed. This common scarf is found in all periods and locales. Though most often used as depicted in Fig. 4, in early Massachusetts Bay frames it is frequently found on edge. The barefaced tenons prevent twisting and improve bending and tensile strength. Some builders added extra pins in the central lapped portion. Overall length is commonly four times the depth of the timber. Variations of this scarf may present stub tenons without pins or a shortened lapped portion. In one variation, the topmost and bottommost cuts are aligned vertically and the tenons lengthened (see Cummings, Fig. 86 and Hewett, Fig. 271). Tenons are typically 1½ in. or 2 in. thick, and 4 in. or 6 in. long.

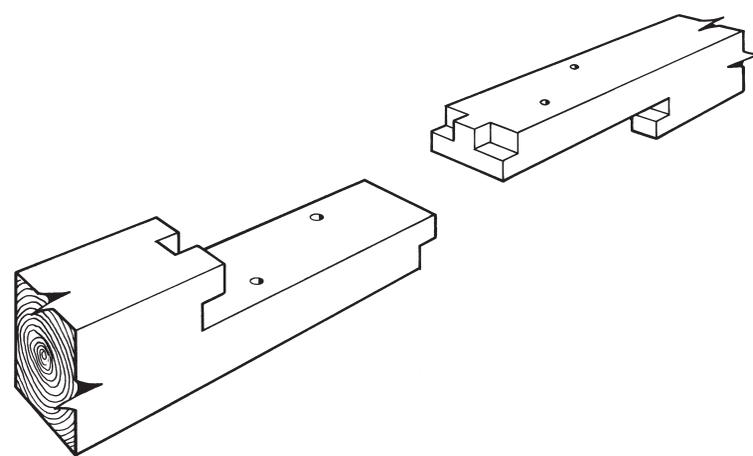
Fig. 5. Bladed and cogged scarf found in a barn along the Mohawk River in New York State. Drawn from memory.

Bladed and Cogged. In this unusual scarf (only one historic example found, though modern ones exist), a cog is provided in the T-shaped stub tenon (Fig. 5). This helps align the scarf and increases its bending strength against horizontal loads (such as rafter thrust), while adding some cutting time.

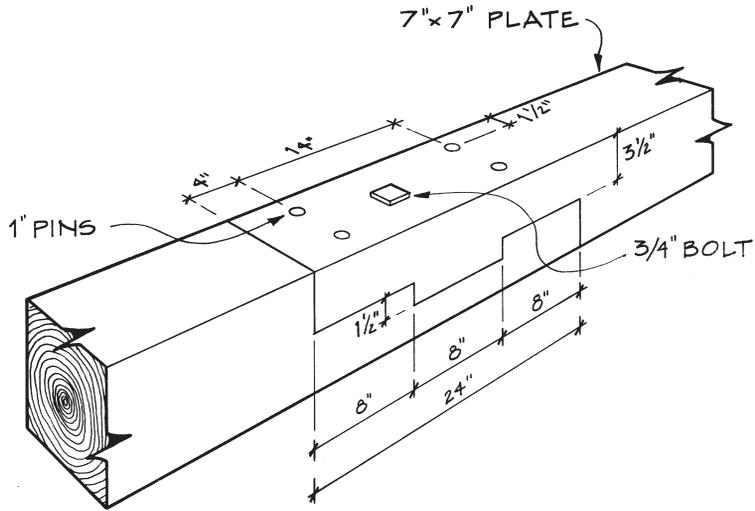
Fig. 6. Halved and tabled scarf in a 25x35-ft. three-bay 1860s barn in Windsor, Mass. This simple, effective joint relies on one bolt to keep it together.

Halved and Tabled. With its center “table,” this joint (Fig. 6) adds tensile capacity to the basic half lap. An iron bolt prevents twisting and displacement.

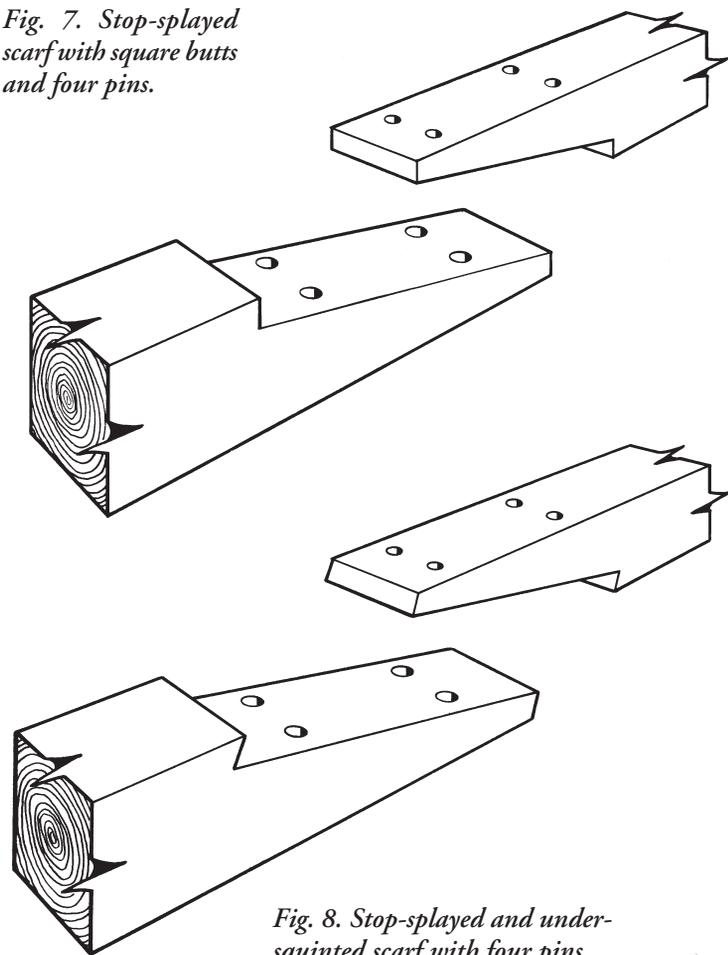
Fig. 7. Stop-splayed scarf with square butts and four pins.

Fig. 8. Stop-splayed and undersquinted scarf with four pins.

Splayed and Stop-Splayed. In its most basic form, this scarf is simply a pair of complementary straight sloping cuts secured to each other with pins, nails or bolts. Nicknamed the *whistle cut*, it works wonderfully in shear but relies upon fasteners for resisting axial loads and twisting. (See TF 59, page 13.) In its more common form, the sloped, lapped portion is stopped before it feathers out to nothing (Fig. 7). Compared with the half-lap, shear strength is vastly improved by the sloped surface. The square abutments, typically 1½ in. or 2 in., resist axial compression. The pins provide tensile and torsion resistance.

Stop-Splayed and Undersquinted. Again by undersquinting the butts, the stop-splayed scarf (Fig. 8) is made more resistant to twisting. This scarf performs well, considering its ease of cutting.

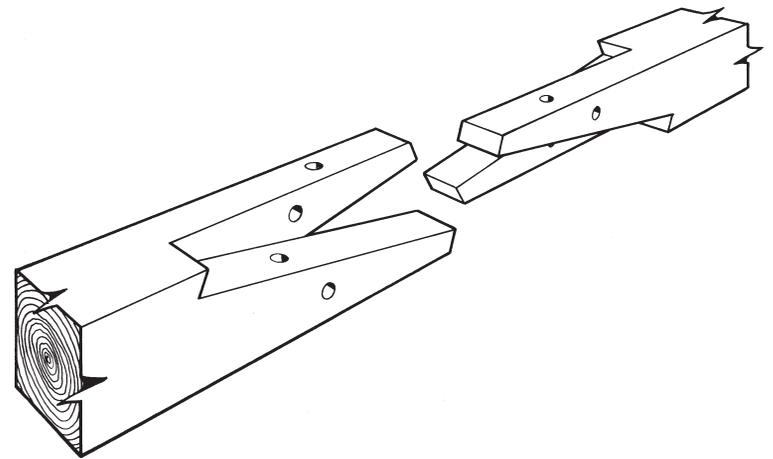
Fig. 9. Stop-splayed scissors scarf with two pins in each direction. The only known example is a 1927 repair to a house in Nantucket, Mass.

Stop-Splayed Scissors. While based on the stop-splayed and undersquinted scarf, this variation is much stronger (Fig. 9). However, it is disproportionately more time consuming to fabricate, which accounts for its rarity.

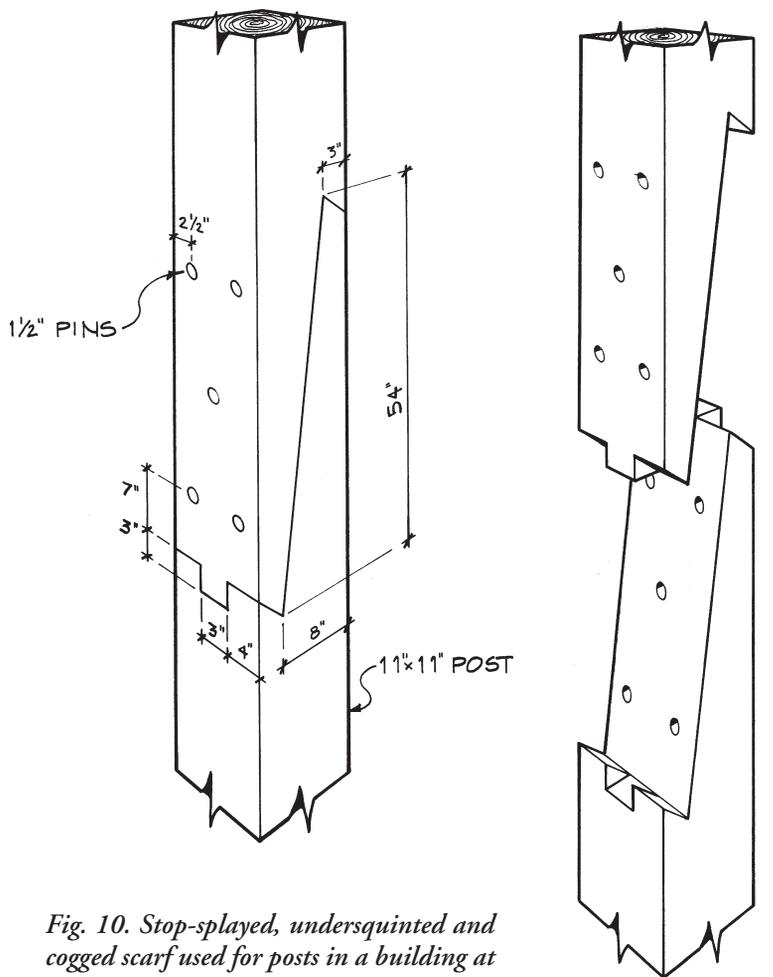
Fig. 10. Stop-splayed, undersquinted and cogged scarf used for posts in a building at Hancock (Mass.) Shaker Village, 1835. Apparently original, these joints are still tight. Note squint angle of 1 to 1.

Stop-Splayed, Undersquinted and Cogged. Adding a cog to the stop-splayed and undersquinted scarf improves its bending strength in the secondary direction (Fig. 10). Only one example has been found of this type.

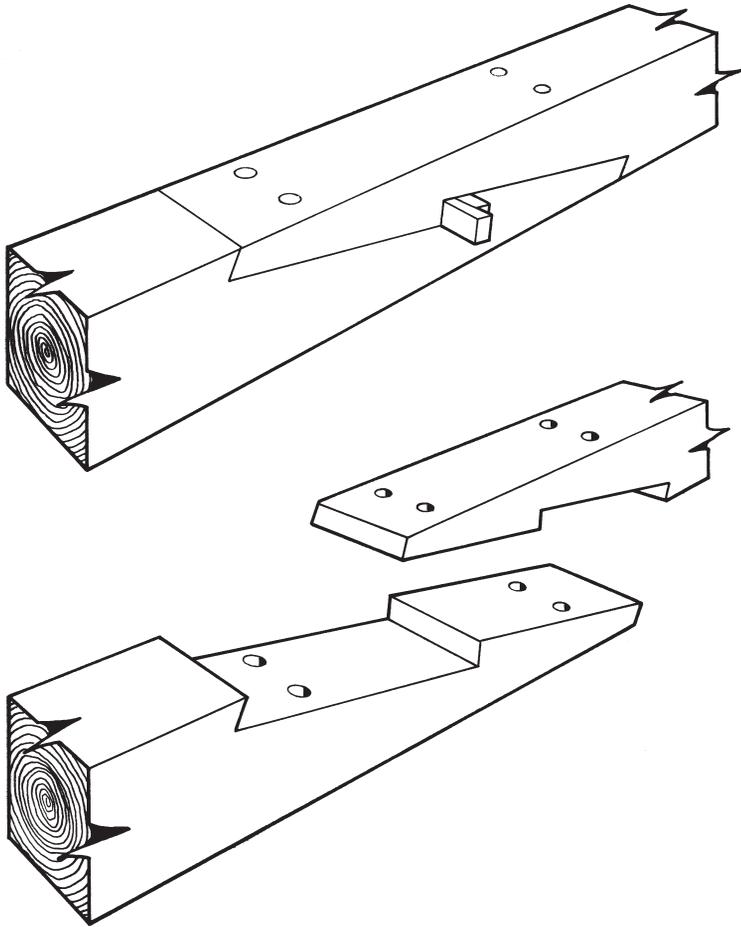
Fig. 11. Assembled and exploded views of stop-splayed, undersquinted and wedged scarf with four pins. Folding wedges pre-stress the joint.

Stop-Splayed, Undersquinted and Tabled with Wedges. A very strong scarf results when tabling and wedges are added (Fig. 11). The tensile capacity, torsion, and bending strength in both directions are greatly increased. The pins position the halves while the opposing wedges are driven and increase the joint's overall performance. The wedge thickness and the depth at the butts are usually the same, typically 1½ or 2 in. The butts need not be undersquinted. An example found at Jack's Valley, Nevada, has square butts, and bolts hold the scarf together.

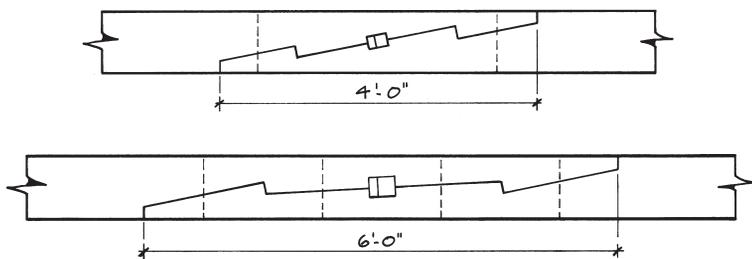
Fig. 12. Examples of the stop-splayed scarf with wedges and multiple tables, both taken from lower chords of trusses. The 4-ft. scarf was found on a late-19th-century building 40 ft. wide in Clayton, New York. The 6-ft. scarf was used in a ca.-1882 locomotive shop in Jamaica, N.Y., 64 ft. wide and 520 ft. long, and cut from 7½ x 9½ hard pine timber. Both scarfs use 1-in. bolts to keep the multiple bearing surfaces engaged. Both are designed for high tension loads.

Stop-Splayed with Wedges and Multiple Tables. By drawing out the scarf, additional tables can be added to increase tensile capacity (Fig. 12). The complexity of this scarf precludes its use except in members under great tensile loads, as in the lower chords of long-span trusses.

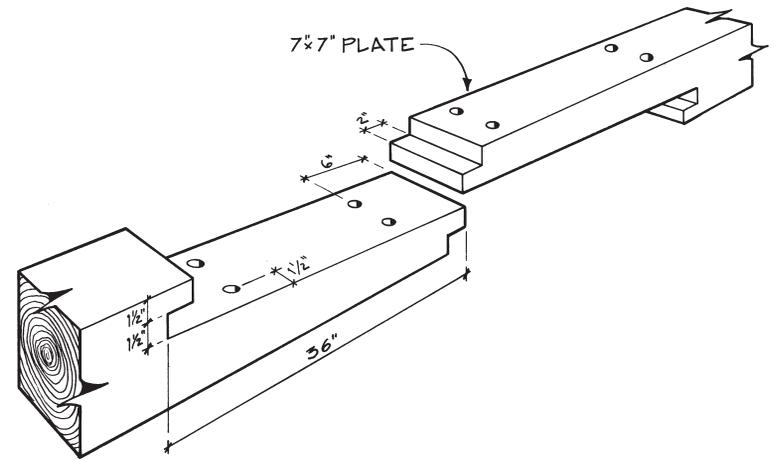
Fig. 13. Stop-splayed and bladed scarf in a late-19th-century 40x48-ft. barn in Windsor, Massachusetts, with stub tenons and four 1-in.-dia. turned pins. The slope of the splay is only 1 in 36.

Stop-Splayed and Bladed. By combining the bladed form with the splayed, the capacity of each is improved (Fig. 13). The tenons can be stub or long enough to be pinned. Compare Fig. 4.

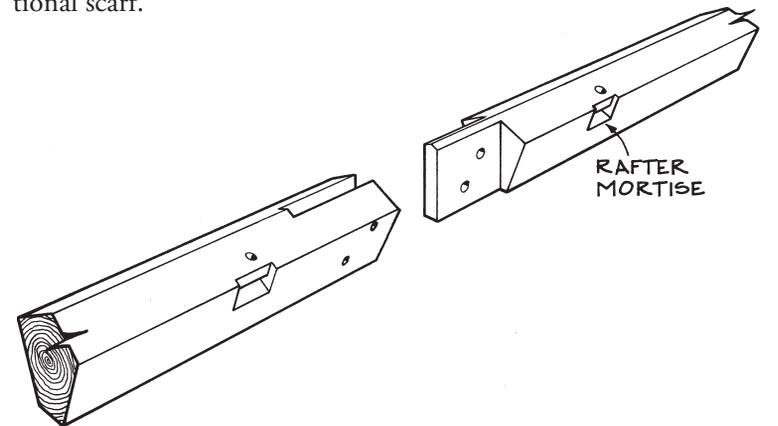
Fig. 14. Typical bridled scarf in a ridge beam. This short scarf works well where it receives frequent support from the rafters and must fit in the relatively short space between them.

Bridled. The simplest bridled joint is a tongue and fork or open mortise and tenon (Fig. 14). Though it doesn't handle loads other than axial particularly well, it still has advantages. Because it is typically fairly short, it uses less timber and can fit better between other joints. It is commonly found in ridge beam splices where the close spacing of the rafter mortises leaves little room for a conventional scarf.

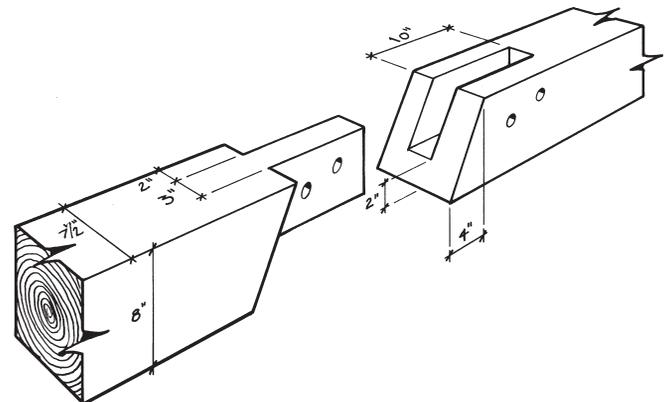
Fig. 15. Bridled and squinted scarf used (or reused) in the tie beams of the Harlow Old Fort House, Plymouth, Mass., ca. 1677.

Bridled and Squinted. The joint is improved by making the tenon blind on one edge and angling the abutment (Fig. 15). This

joint is also found where the abutment slopes the opposite way (see Cummings, Fig. 87), and in that form occurs in one of the oldest timber-framed buildings in England, as a sill scarf in the Barley Barn at Cressing Temple, ca. 1200 (see Hewett, Fig. 273). The use of this particular joint in the roof of Harlow Old Fort House in Plymouth, Mass., is odd: the scarfs, which do not perform well in bending, are located about 4 ft. from the ends of 27-ft. tie beams. But tradition says the house was framed of timbers taken from the original fort in the settlement, hence the scarfs.

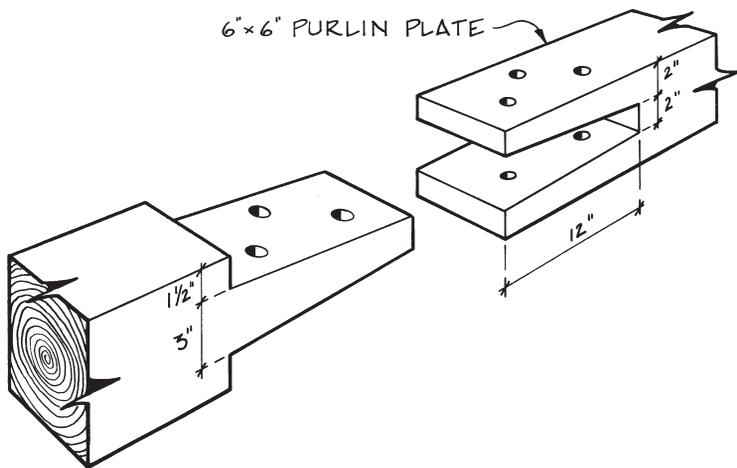
Fig. 16. Tapered bridle scarf in the purlin plates of a barn in Holliston, Massachusetts.

Tapered Bridle. This bridled scarf (Fig. 16), set flatwise, improves the shear capacity of the scarf. While it resists compression, moderate tension, and torsion, it is limited to locations where bending forces are minimal.

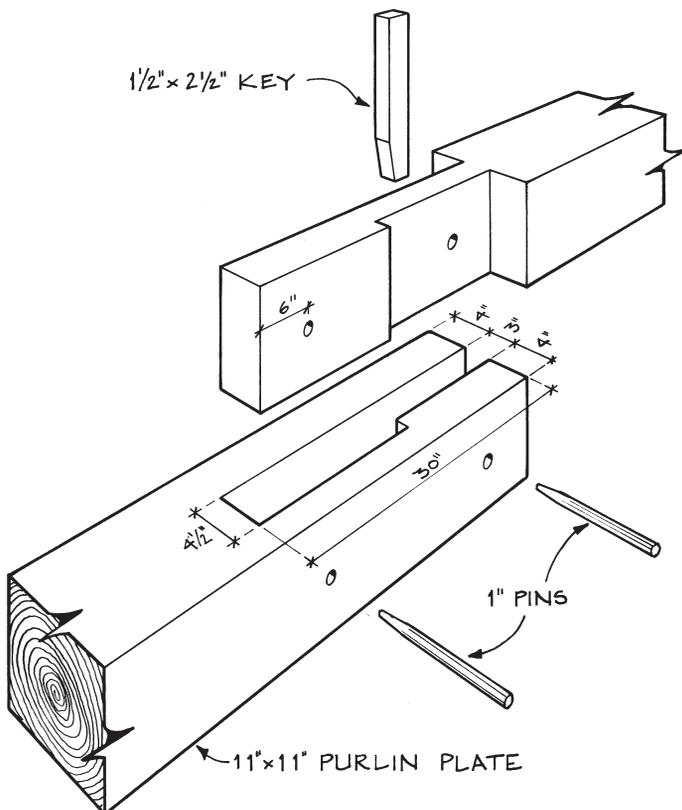
Fig. 17. Tabled and bridled scarf with key, 5-bay barn, 62x81 ft., Genoa, Nevada, ca. 1858.

Tabled and Bridled with Key. Lengthening the bridle to provide a table and key improves the tensile and bending performance of the scarf (Fig. 17). Its rarity seems to indicate that the extra strength is not sufficient to warrant the extra cutting work.

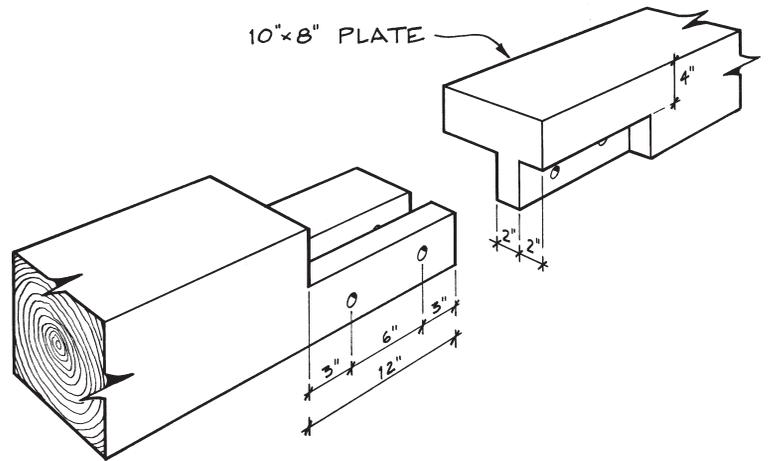
Fig. 18. Stop-Bridled Halving in a German barn, Myerstown, Penn. Located a very short distance from a post, it carried mostly shear force.

Stop-Bridled Halving. Only one example of this type (Fig. 18) has been located. Though it works moderately well in most conditions, weakness in bending limits its applications.

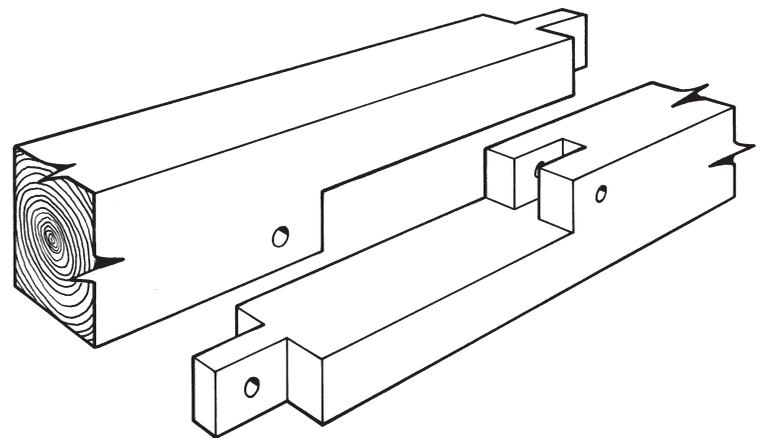
Fig. 19. A typical halved and bridled scarf. Additional pins may secure the lap.

Halved and Bridled. This not uncommon form (Fig. 19) works moderately well in all ways and yet is straightforward to fabricate and assemble. Undoubtedly there are splayed varieties of this scarf as well.

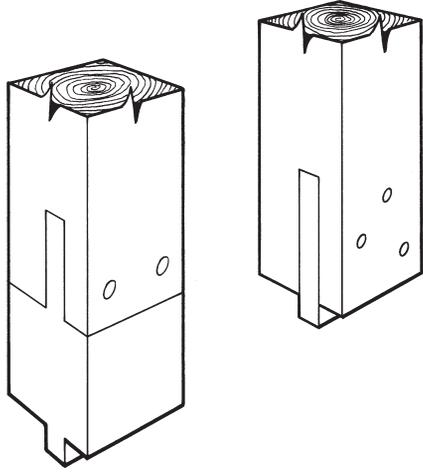
20.

Figs. 20-22. At top (20), post-bottom repairs: bridled scarf on left, free tenon on right. Middle (21), free tenon joins the posts of adjacent frames. Above (22), a stout pin kerfed and end-wedged does the same.

Bridled Repair Techniques. When early carpenters encountered posts with decayed bottoms, the simplest way to replace a short section of damaged wood was with the bridle. In this position, the joint was subjected to primarily axial compression. This short, easy to fabricate joint (Fig. 20, facing page), was more than adequate. If only the tenon was decayed, it could be replaced with a *free tenon* (Fig. 20), also called a slip tenon or faux tenon. The use of a free tenon also permitted members tenoned at both ends to be inserted into an already erect frame. In a few cases where a carpenter mistakenly cut a timber off at the shoulder rather than the end of the tenon, a free tenon allowed the piece to be saved.

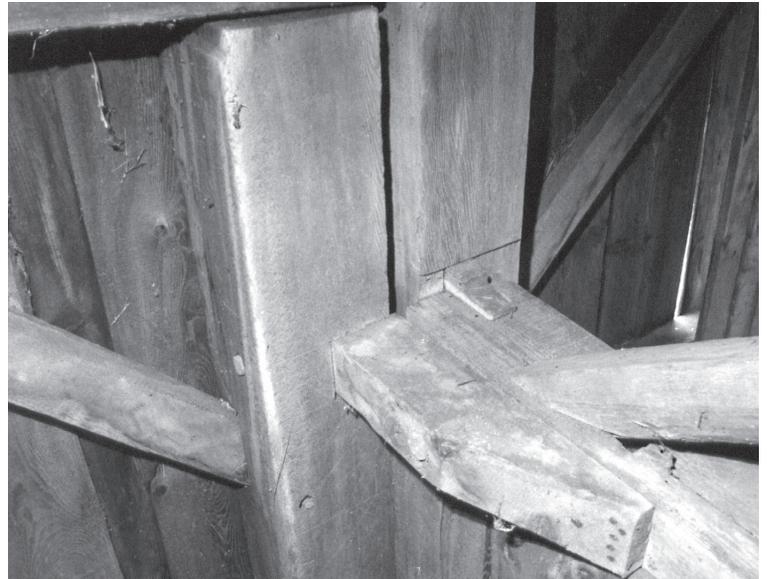
When the builder added to this barn in Savoy, Mass., he saved on a new 30-ft. tie beam by framing a piece into the post and pinning and nailing it to the existing barn's tie beam. Notice how the end is hewn down to permit better nailing.

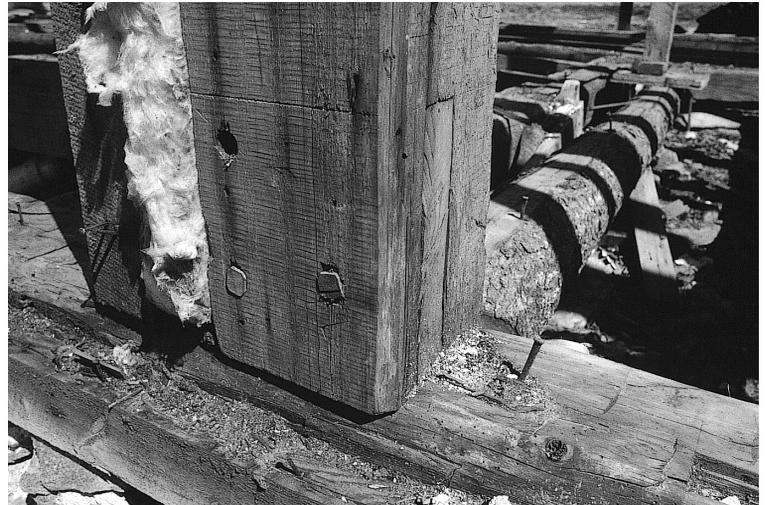
A free tenon in the bottom of a post in this house in Windsor, Mass., may be a repair or a fix for a mistake. Shadows are cast by joists above.

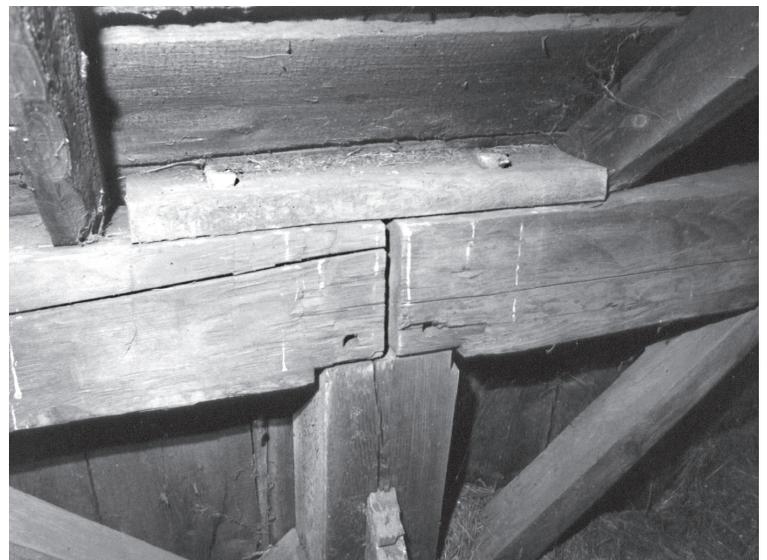
This strange arrangement in a barn in Rochester, Vermont, uses the post top tenon as a sort of free tenon to join the plates, though pins are invisible. The builder must have realized the inherent weakness of the connection and added the fish plate on top, secured with two pins.

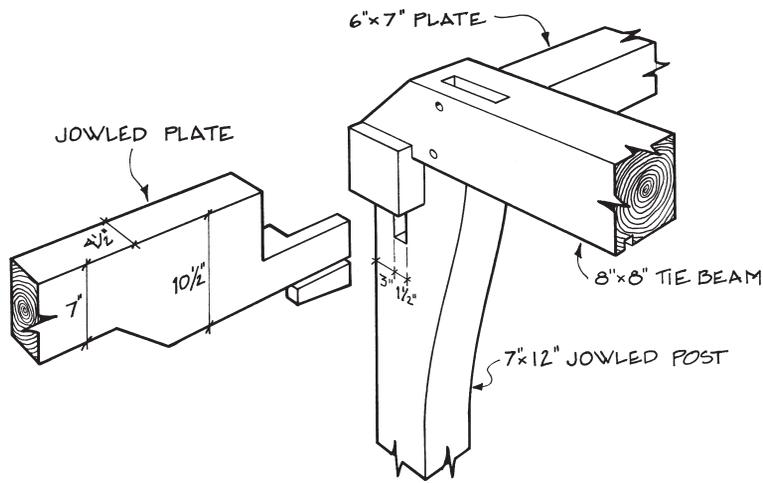
Fig. 23. Jowled plate of an early-18th-century addition to a barn in Seekonk, Mass. The mortise, offset in the post to avoid undercutting the post-to-plate tenon (hidden from view), was lengthened to allow easy insertion of the new plate tenon. The latter then was wedged up tightly under the existing plate. No pin was used.

If the plates and sills of the addition could be attached to the existing frame, then the builder saved the major expense of cutting an additional cross-frame. However, scarfing onto the end of an existing plate or sill was cumbersome and might compromise the original frame. The best solution was to utilize jowled members to offset the connection to an adjacent member (Figs. 23-25). The flared butt of the tree was retained during hewing or sawing. These jowled sills, plates and purlin plates required only simple mortises in the existing timbers, easily cut in place. Ten examples of such jowled members have been found in Massachusetts, New York and Vermont, from the early 18th century to the middle of the 19th.

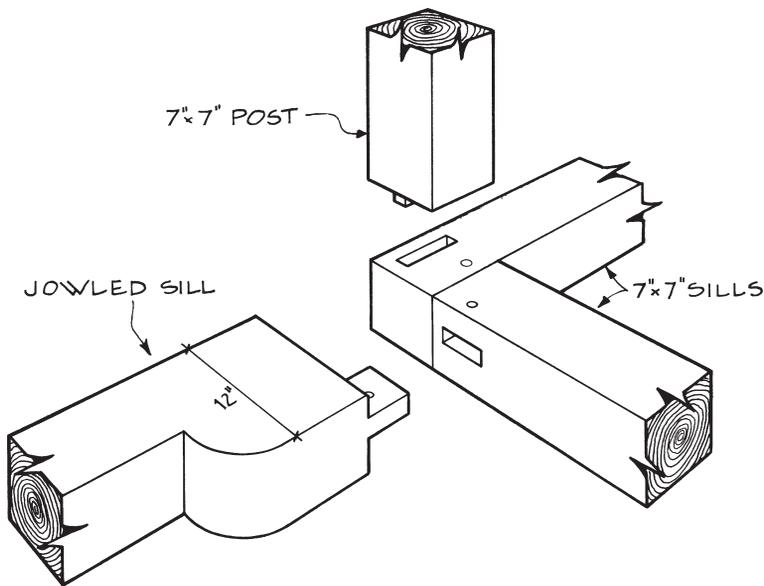
Fig. 24. In the same barn the sill was similarly jowled, but also pinned.

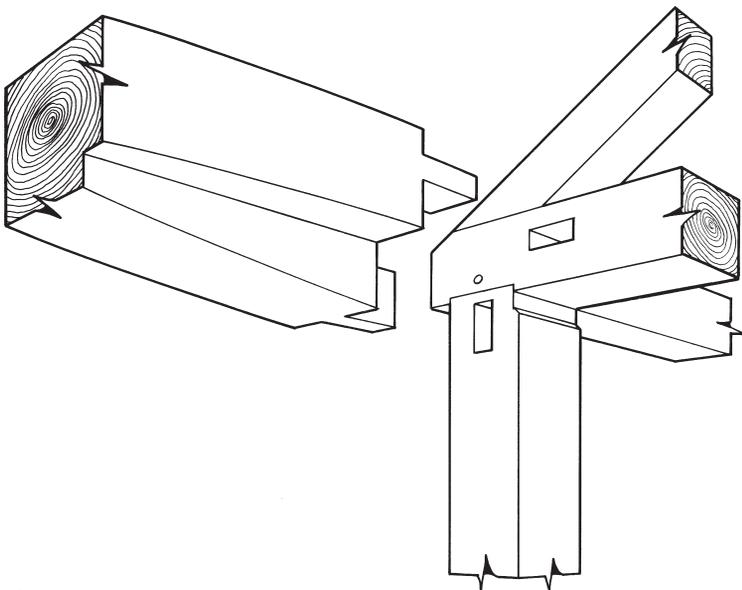
Fig. 25. A 9x9 plate, jowled in two directions to measure 12x13, joined an 1820-1860, 16x42-ft. carriage shed to a house in Rowe, Mass. The connections were unpinned and held in place by sheathing.

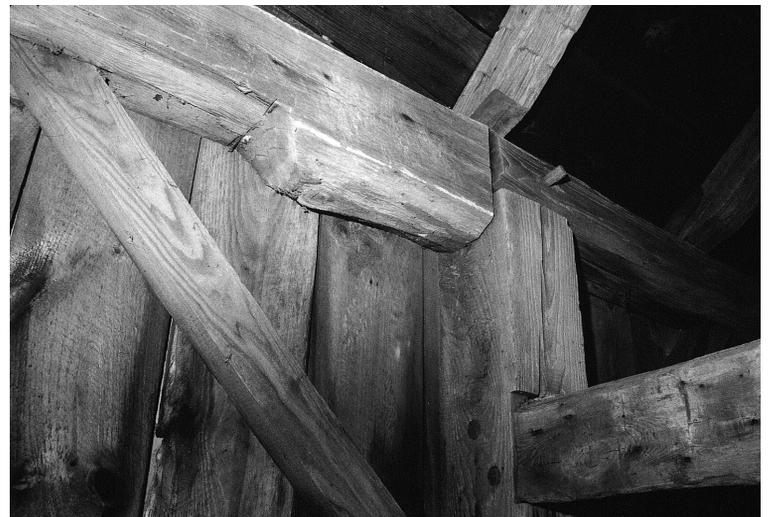
Jowled plate (one of six!) in a much-expanded 18th-century English-style barn, Huntington, Mass.

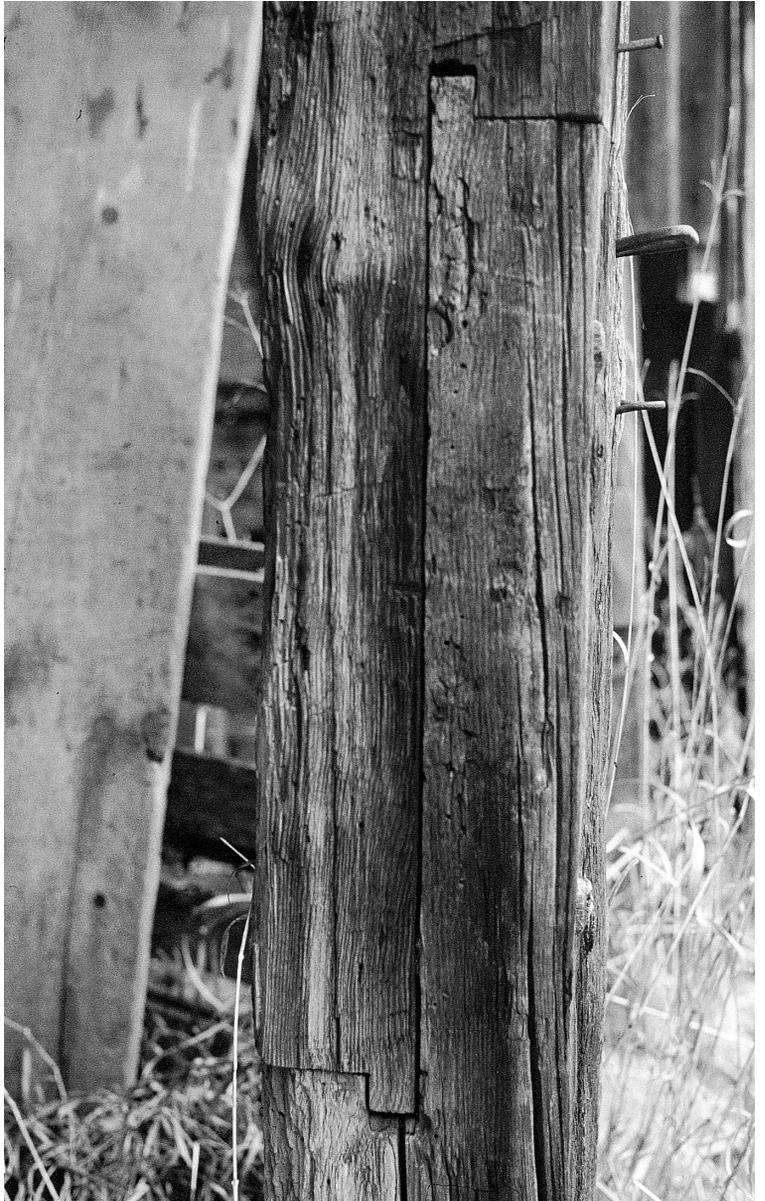
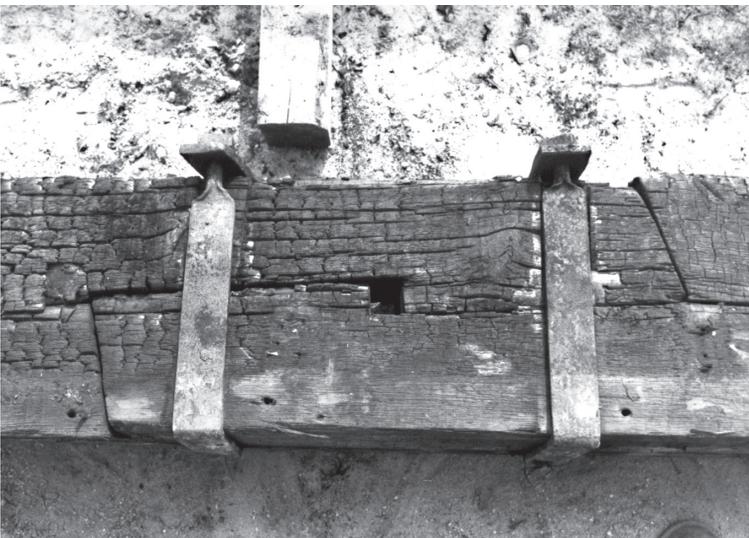
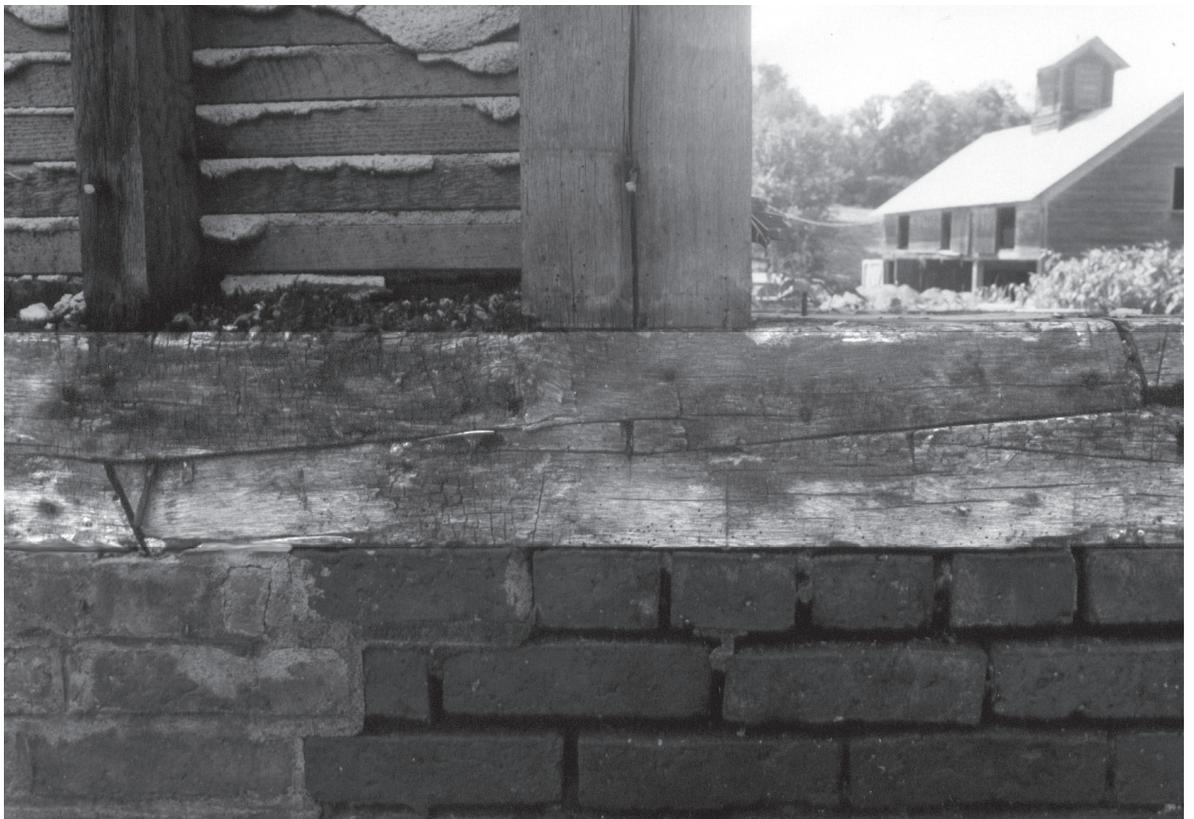
At top, bladed scarf with key, barn sill in Woodford, Calif. The sill is 8x8 Ponderosa pine, the scarf only 16 in. long. Top right, a bladed scarf used to repair a 7½ x 9½ post in a barn in Buskirk, N.Y. The tenons are 1 in. thick and 1 in. long, the scarf 23 in. long, with four pins. Above, a stop-splayed, undersquinted and tabled scarf with key used in a 6½ x 13 truss chord in the 1796 Cabildo in New Orleans (roof burned 1988, reconstructed 1992; see TF 21 and 24). There is barely a splay, and two forged iron straps still hold the joint together. At right, this unusual stop-splayed, undersquinted and tabled scarf in Pine Plains, New York, did not employ a key: the halves had to be slid together.
