Subject: Treatment of Interiors in Industrial Buildings

Applicable Standards: 2. Retention of Historic Character
5. Preservation of Distinctive Features, Finishes and Craftsmanship

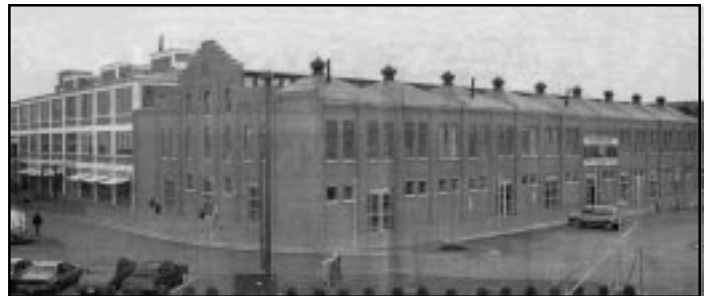
Tin can factory following rehabilitation.

Application 1 (Compatible Treatment): This 1895, three-story brick warehouse with its stepped gable façade, corrugated metal monitor roof and distinctive ventilators was originally built as a tin can manufacturing plant. The long vacant building was recently rehabilitated for use as research and office space for the world headquarters of a major manufacturing company. The creative design used in the rehabilitation for the interior underscored the building's industrial character by using materials, such as corrugated metal walls, steel beams and exposed wooden columns. Any required partitions were constructed to retain an open view of the character-defining latticed I-beams and metal trusses. The windows in the roof monitor over the center aisle were reopened and restored. The result is an open, contemporary office space that successfully retains the character of this utilitarian building.

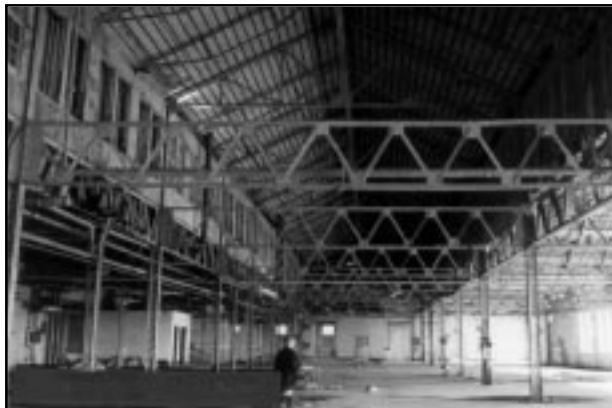
Second and third floor truss system before rehabilitation.

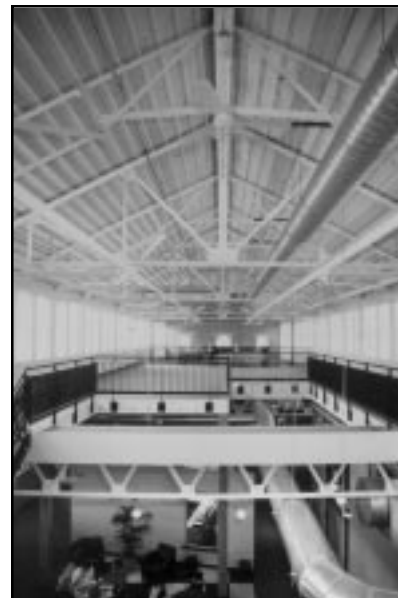
Interior following rehabilitation showing exposed latticed I-beams and metal trusses.

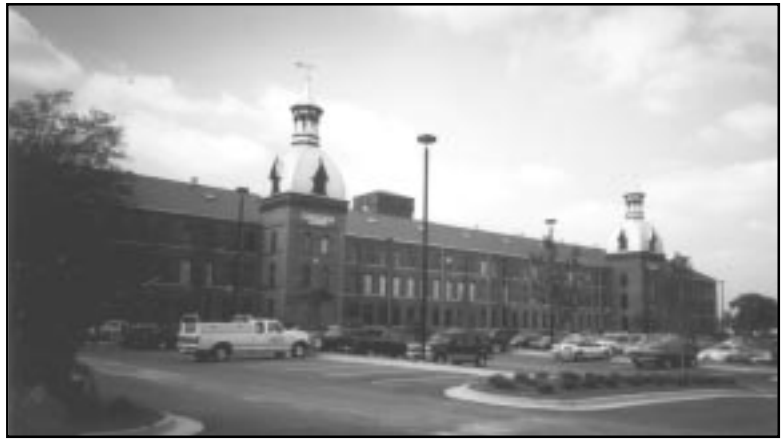
1878-1881 Textile Mill

This monumental, three-story mill building with its prominent four-story, mansard roofed stair towers is more than 400 feet in length. Constructed from 1878 to 1881, this building serves as the entry to a former flour/cotton mill complex. Recently, this mill building was rehabilitated as part of a mixed-use residential and commercial complex. While the exterior of this imposing building is highly ornamented, the interior was historically utilitarian manufacturing space characterized by exposed brick walls, wooden-chamfered posts, beams and planking, void of any decorative detail. The rehabilitation retained these character-defining features while accommodating the necessary subdivision of the large expanses of space for the new use. The large number of columns were retained by leaving some free standing in hallways and public spaces, while many remain visible engaged as part of partitions. The exposed beams, original flooring and exposed brick also preserves the industrial character of the mill's interior in the new use.

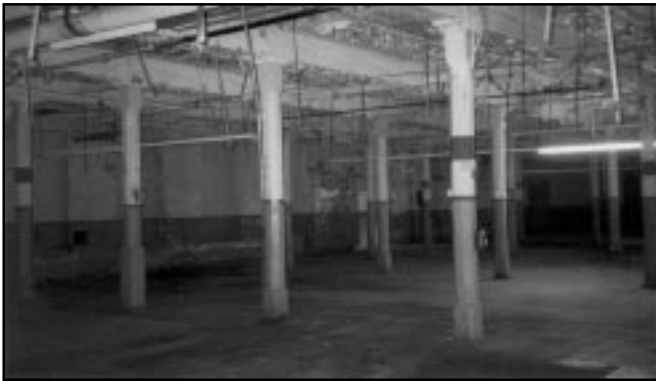
Exposed structure of the mill building prior to rehabilitation.

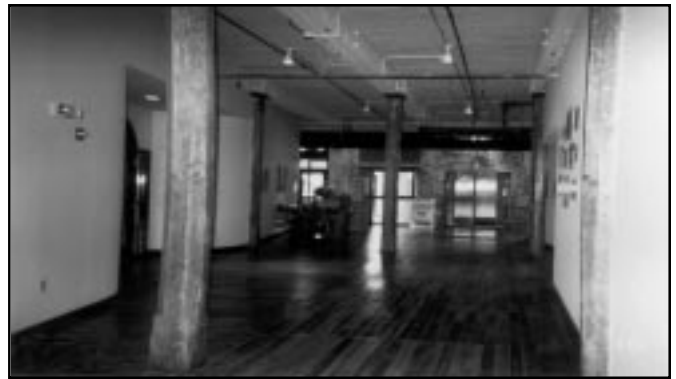
Interior after rehabilitation retains the exposed structure and finishes characteristic of the mill building with subdivision of the space for the new use.
