42 PRESERVATION BRIEFS

The Maintenance, Repair and Replacement of Historic Cast Stone

Richard Pieper

U.S. Department of the Interior
National Park Service
Cultural Resources
Heritage Preservation Services

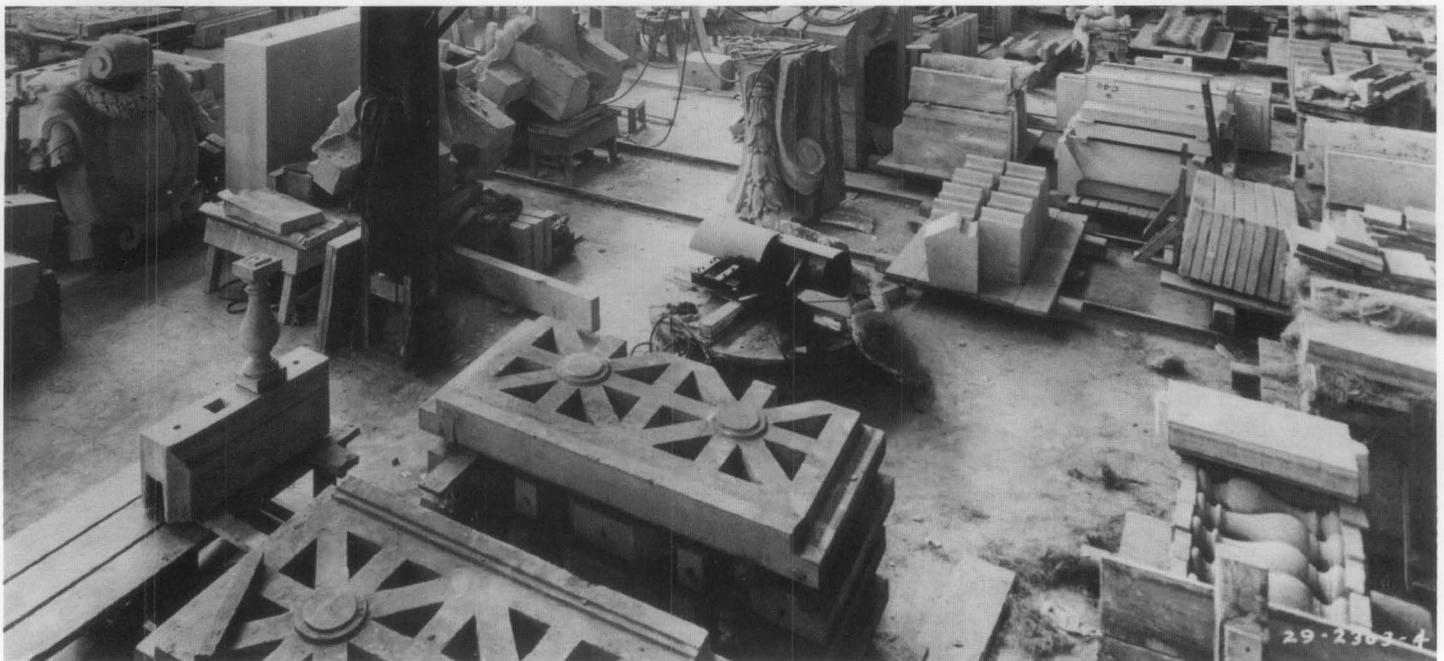
Figure 1. In the early 20th century, elaborate custom building ornament was frequently produced in cast stone. Here, at the Benedict Stone Company's plant in Chicago, cartouches, balustrade panels, railings, and balusters await finishing and shipment. Photo: Courtesy, National Building Museum.

The practice of using cheaper and more common materials on building exteriors in imitation of more expensive natural materials is by no means a new one. In the eighteenth century, sand impregnated paint was applied to wood to look like quarried stone. Stucco scored to simulate stone ashlar could fool the eye as well. In the 19th century, cast iron was also often detailed to appear like stone. Another such imitative building material was "cast stone" or, more precisely, precast concrete building units (Figs. 1, 2 and 3).

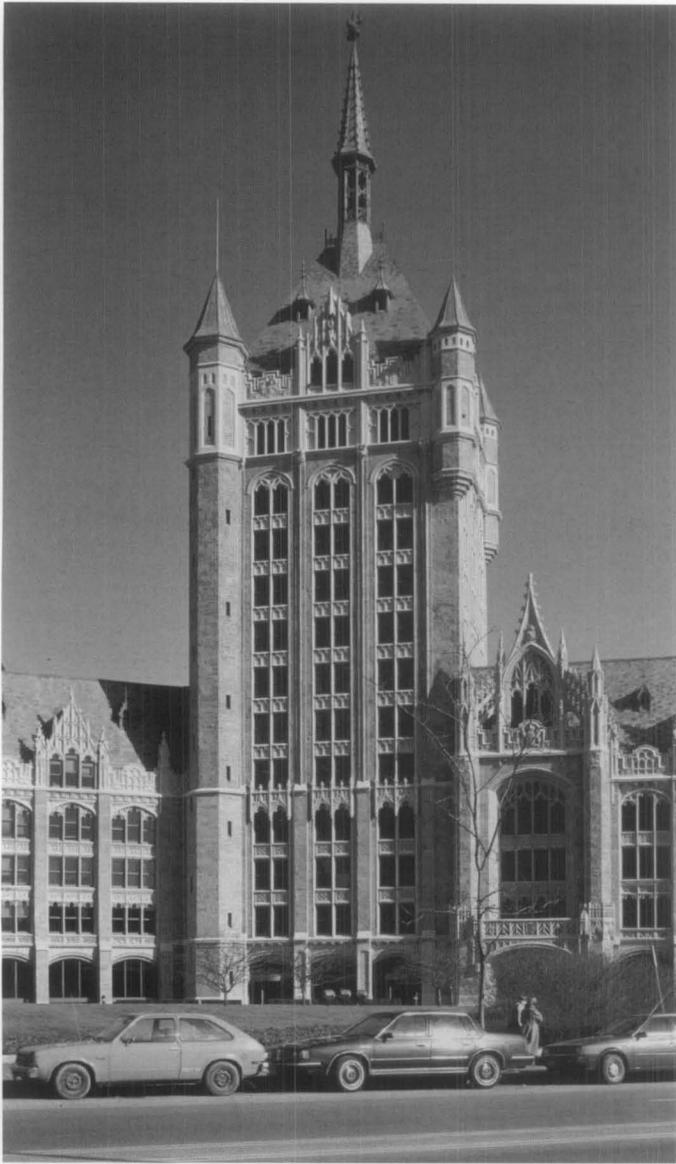
Figure 2. The prominent Delaware and Hudson Building in Albany, New York (1916) made extensive use of cast stone as trim combined with a random ashlar facing of natural granite. The elaborate gothic trim was produced by the Onondaga Litholite Company of Syracuse, New York.

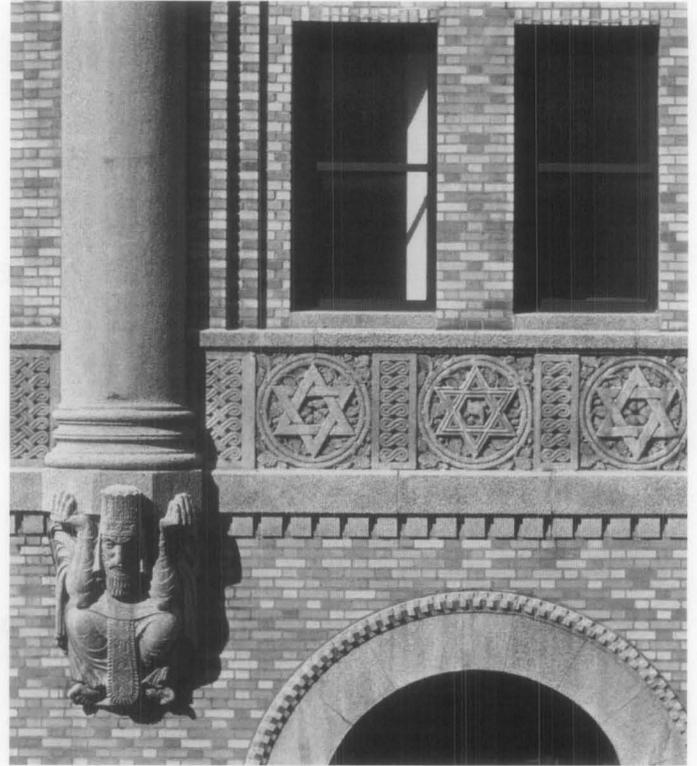
Figure 3. Sculptural ornament was frequently produced in cast stone. Repetitive detail, such as these banding course panels on the Level Club in New York City (1926), were produced much more economically than they could be in natural stone.

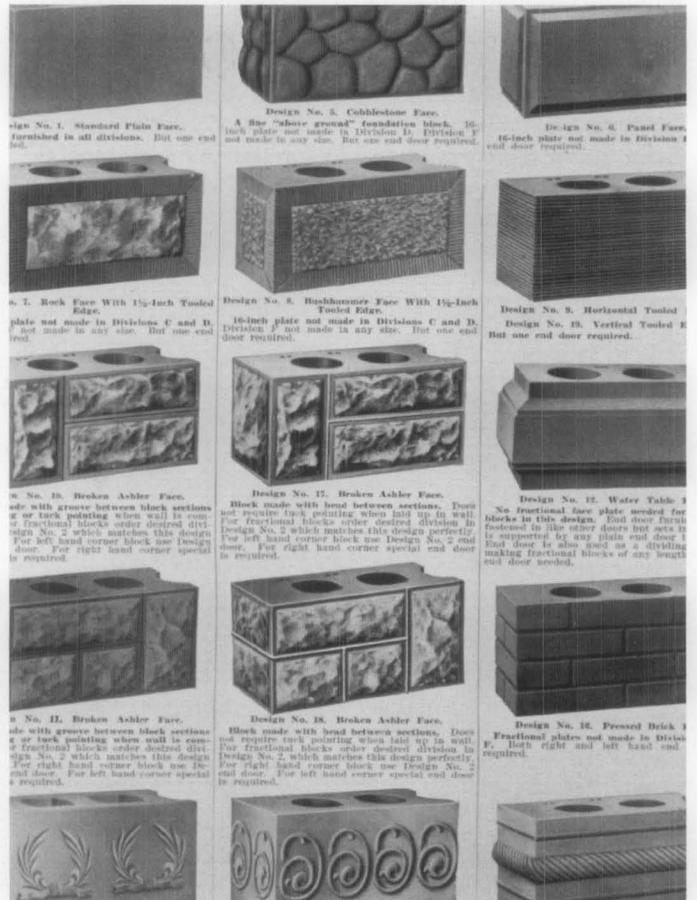
Figure 4. As shown in this Sears, Roebuck and Co. concrete machinery catalog, artistic concrete used standard concrete mixes to produce precast and cast-in-place concrete in molded forms, but made little effort to simulate natural stone.

States in the 19th century. These systems may be contrasted with "Artistic Concrete," decorative molded concrete construction, both precast and cast-in-place, which made little effort to simulate natural stone (Fig. 4).

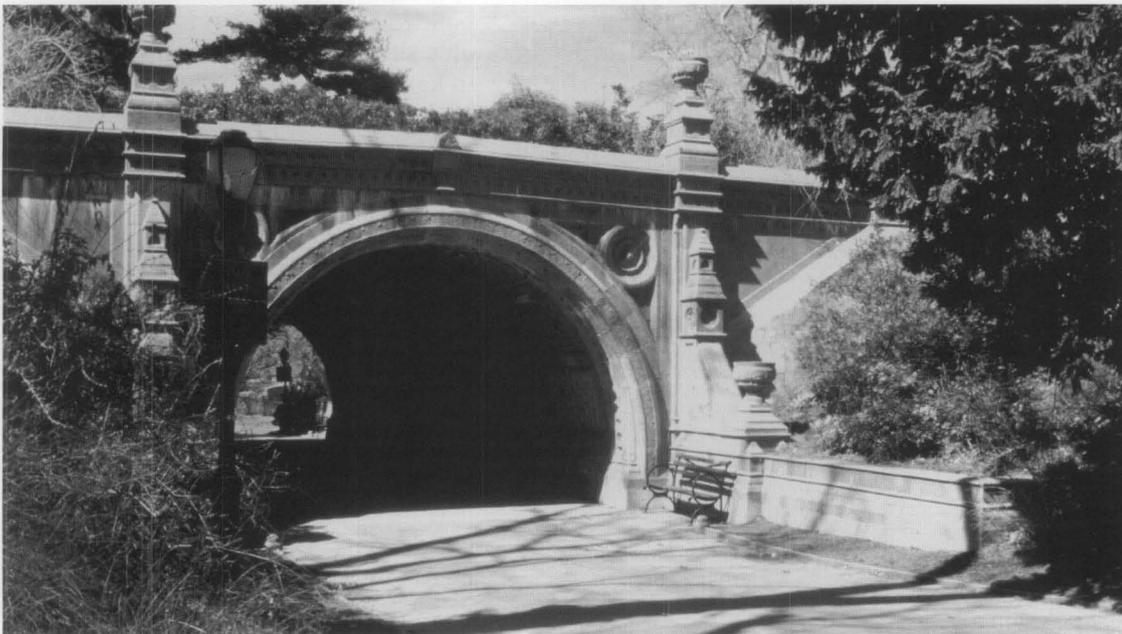
Figure 5. Constructed in 1868 of Beton Coignet, the Cleft Ridge Span in New York City's Prospect Park is one of the earliest extant cast stone structures in the United States.

the cast stone for one of the earliest extant cast stone structures in the United States, the Cleft Ridge Span in Prospect Park, Brooklyn, New York (Fig. 5).

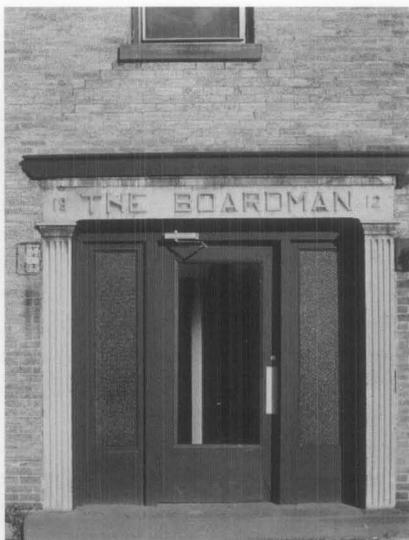
Figure 6. Cast stone was commonly used for molded trim in conjunction with brick or natural stone. This brick building in Rochester, New York, uses cast stone for the entry surround, and natural stone for unornamented window sills, thresholds, and water table units.

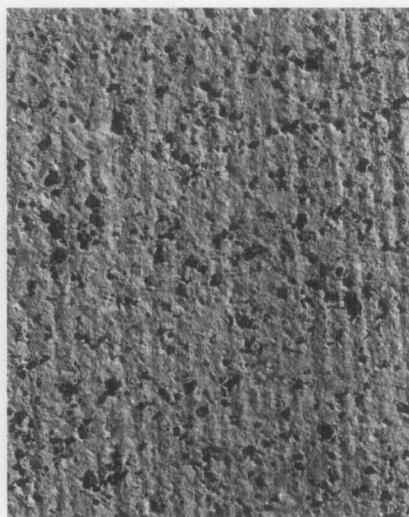
Figure 7. A combination of crushed white marble and black smelting slag was frequently used to give the appearance of a "white granite". The hammered finish on this early twentieth century cast stone would have been produced with a pneumatic chisel.

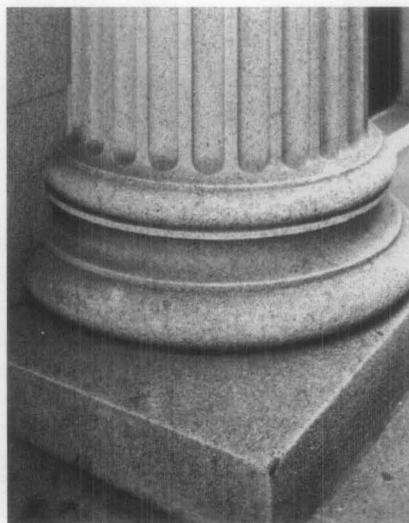
Figure 8. For this column, the appearance of a "pink granite" was simulated by using a pinkish matrix with white and black aggregate. Erosion of a tinted matrix results in a significant lightening of the cast stone surface.

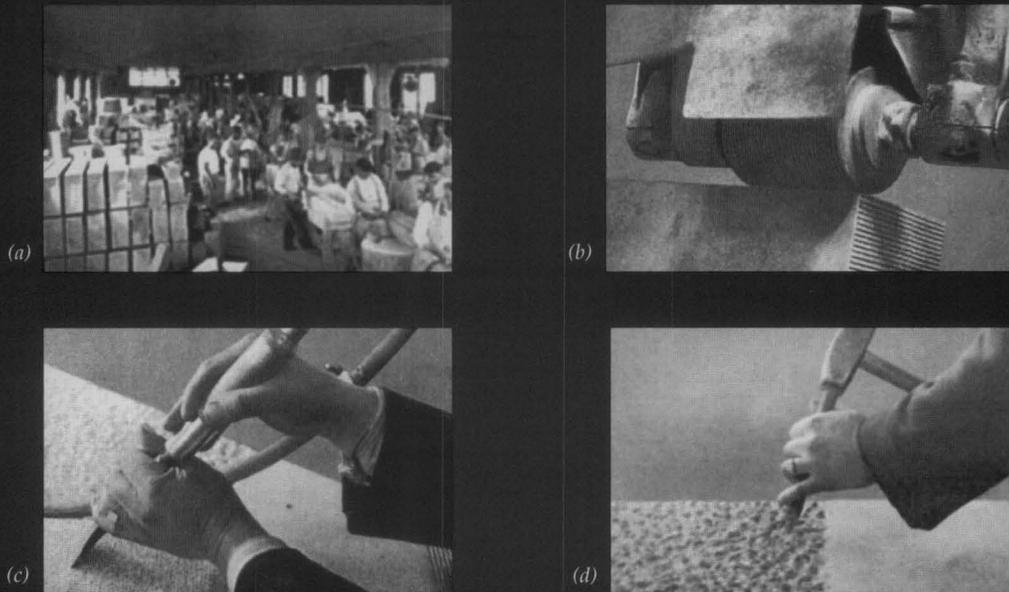
Figure 9. Onondaga Litholite Company Catalog: (a) Section of Hand-Finishing Department. (b) Tooling machines are set up with a series of carborundum wheels that grind grooves into the surface of the stone (c) Pneumatic hammers are used to produce six or eight cut finish (d) Point Finish is put on with a single pointed chisel. Courtesy, Collection of Michael F. Lynch.

High quality cast stone was frequently "cut" or tooled with pneumatic chisels and hammers similar to those used to cut natural stone (Fig. 9). In some cases, rows of small masonry blades were used to create shallow parallel grooves similar to lineal chisel marks. The results were often strikingly similar in appearance to natural stone. Machine and hand tooling was expensive, however, and simple molded cut cast stone was sometimes only slightly less costly than similar work in limestone. Significant savings could be achieved over the cost of natural stone when repetitive units of ornate carved trim were required.

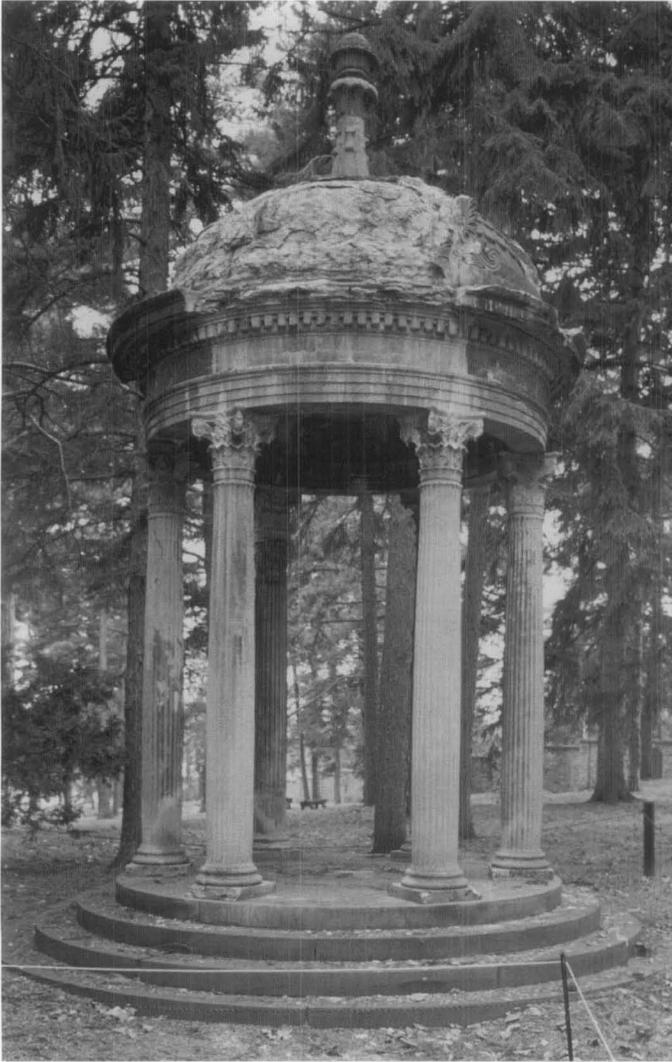
Figure 10. Scaling of cast stone units signals problems with the cementing mix and method of manufacture. Serious deterioration of cast stone, such as this, warrants replacement.

While it is relatively uncommon in twentieth century cast stone, serious deterioration of the cementing matrix can cause extensive damage to cast stone units (Fig. 10). A properly prepared cementing mix will be durable in most exterior applications, and any flaking of exterior surfaces signals problems in the cementing mix and in the method of manufacture. The use of poor quality or improperly stored cement, impure water, or set accelerators can cause cement problems to occur years after a structure is completed. Improper mixing and compaction can also result in a porous concrete that is susceptible to frost damage and scaling. Severe cement matrix problems may be impossible to repair properly and often necessitate replacement of the deteriorating cast stone units.

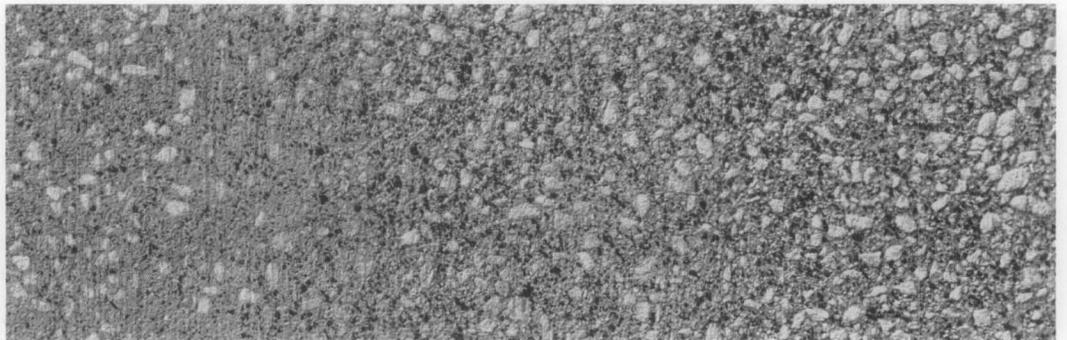
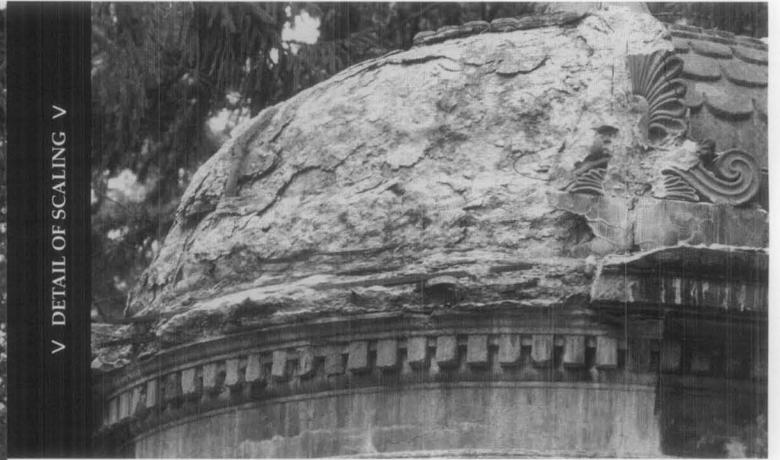
Figure 11. Erosion of the cementing matrix on the surface of cast stone is common in areas exposed to water runoff, such as window sills and copings. If no other deterioration is present, this condition does not warrant repair or replacement, but should be considered normal weathering. The unweathered surface at the left of this photograph shows the appearance of the original hammer-dressed finish. At right, the matrix has eroded, and the aggregate is much more prominent than on the unweathered surface.

More common and less serious than flaking or scaling caused by deterioration of the cementing matrix is the erosion of the matrix surface (Fig. 11). This usually occurs on surfaces of projecting features exposed to water runoff, such as sills, water tables, and window hoods. In these areas, the matrix may erode, leaving small grains of aggregate projecting from the surface. The resultant rough surface is not at all the intended original appearance. In some historic cast stone installations, the thin layer of cement and fine sand at the surface of the cast stone units was not originally tooled from the molded surface, but was finished with patterns of masonry pigments in a stylized imitation of highly figured sandstones or limestones (Fig. 12). Erosion of the pigmented surface layer on this type of cast stone results in an even more dramatic change in appearance.

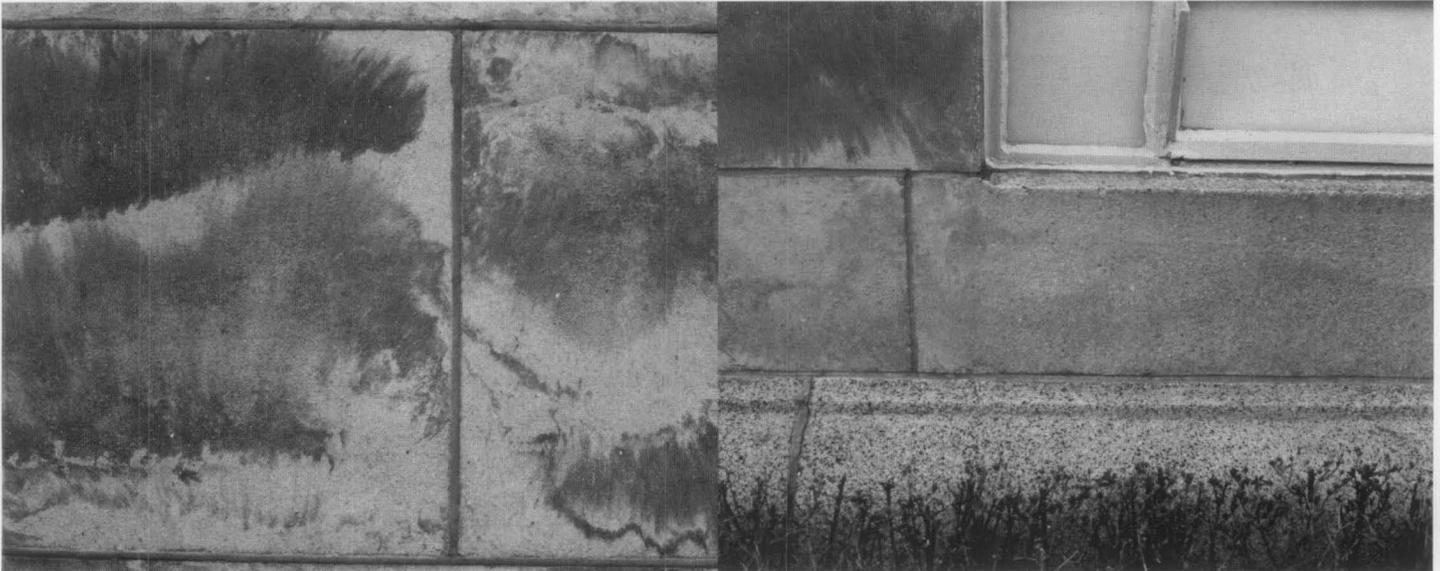
Figure 12. Elaborate pigmentation of the cementing matrix sometimes gave a rather stylized or unnatural appearance to the finished cast stone (left). Texts state that effects like this were sometimes produced by drawing strings dipped in masonry pigments across the surface of the uncured units. Cast stone, such as this, has its coloration only at the outer surface of the stone, and was not intended to be brushed or tooled to expose the aggregate. Erosion of the cementing matrix of this type of cast stone, as seen on the base of the wall (right), will result in a significant alteration of appearance.

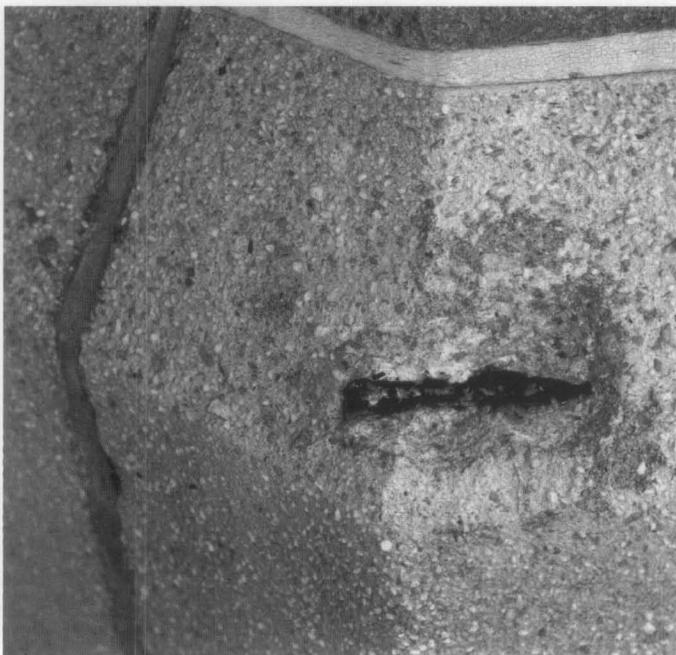
Figure 13. Rusting of reinforcement near the surface of the stone may result in spalling. Sections of reinforcement, such as this, may be cut out and the spall repaired with a matching composite mortar.

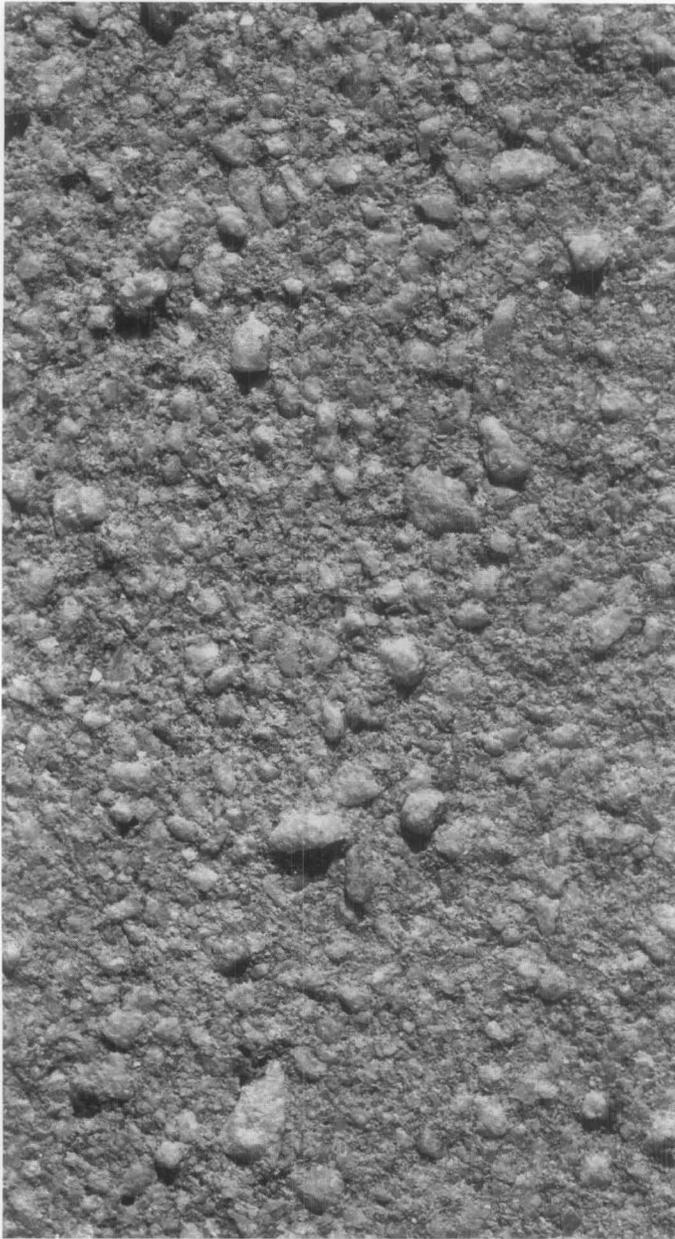
Figure 14. Sandblasting and wet grit blasting can seriously erode the surface and should not be used to clean cast stone surfaces.

Cast stone installations with marble or limestone aggregates may sometimes be cleaned with the same alkaline pre-wash/acid afterwash chemical cleaning systems used to clean limestone and other calcareous natural stones. If no marble or limestone aggregates are present, acidic cleaners, such as those used for natural granites and sandstones, may be used. In either case, dark particulate staining in protected areas may be persistent, however, and require experimentation with other cleaning methods. Some micro-abrasive cleaning techniques used under very controlled circumstances by skilled cleaning personnel can be appropriate for removing tenacious soiling. Ordinary sand blasting or wet grit blasting can seriously damage the surface of the cast stone and should not be used (Fig. 14).

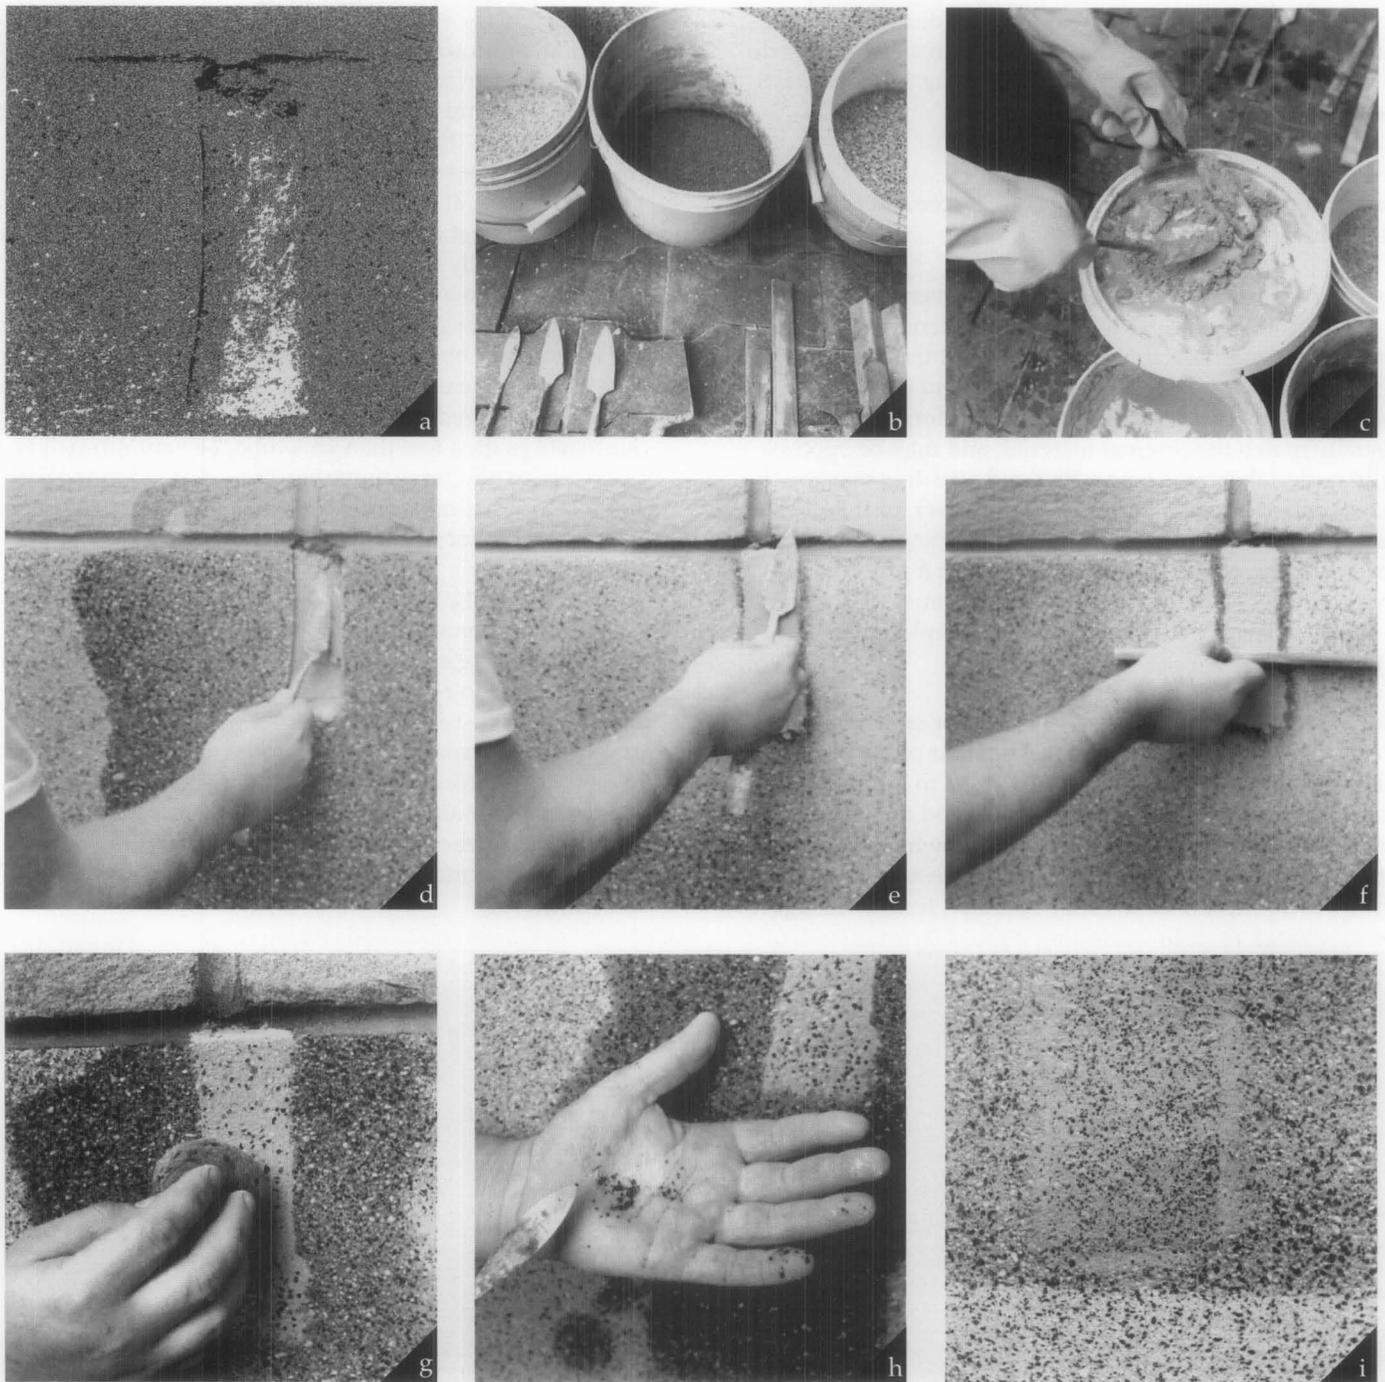
Figure 16. The (a) damaged area is cut out to create a shallow void of even depth, $\frac{1}{2}$ " or more. Undercutting the sides of the void may provide better adhesion while the composite is being applied. A small grinder fitted with a diamond blade may be used to prepare the void. (b) A range of aggregates matching those in the cast stone is required. Matching aggregate size and angularity is very important. Small spatulas and trowels are used for application of the composite. The aggregates are mixed to a ratio approximating that in the cast stone. (c) Matching the color of the cementing matrix may require numerous tests. Only small amounts are required for any one repair. Lime may be added to the mix for workability. (d) The composite mortar is applied to the void with a small spatula or trowel. An aggregate rich mix may not adhere properly, and it may be desirable to apply a more cement rich mix directly to the substrate. (e) The composite mix is pressed into the void, leaving the patch slightly proud of the surface. (f) The composite is struck flush with the adjacent surfaces. (g) Patting the patch with a moist sponge removes matrix and exposes the aggregate. (h) It may be desirable to impress additional aggregate into the surface of the patch to achieve a better match to surrounding surfaces. If so, the mix aggregate should be crushed to a smaller size. Laying in larger aggregate may result in a mosaic appearance which does not match adjacent surfaces. (i) This completed composite repair could have been improved by brushing to remove the matrix residue at the edges of the repair before the surface cured.

Where spalls have a feather edge, it will be necessary to cut back the repair area to a uniform depth (1/2" or more). As with natural stone composite repairs, a bonding agent may assist adhesion of the repair material to the original concrete. For unusually large or deep patches, mechanical anchoring of the repair with small nylon or stainless steel rods may be required. If the adjacent cast stone is tooled or weathered, it will be necessary to scribe or brush the repaired area to give it a matching surface texture. Adding enough coarse aggregate to match adjacent original material will sometimes interfere with adhesion of the composite, and it may be necessary to press additional aggregate into the applied patch prior to finishing. If this is not skillfully done, however, the surface of the patch may take on a mosaic appearance. For this reason, it is advisable to undertake test composite repairs in an unobtrusive location first (Fig. 16).

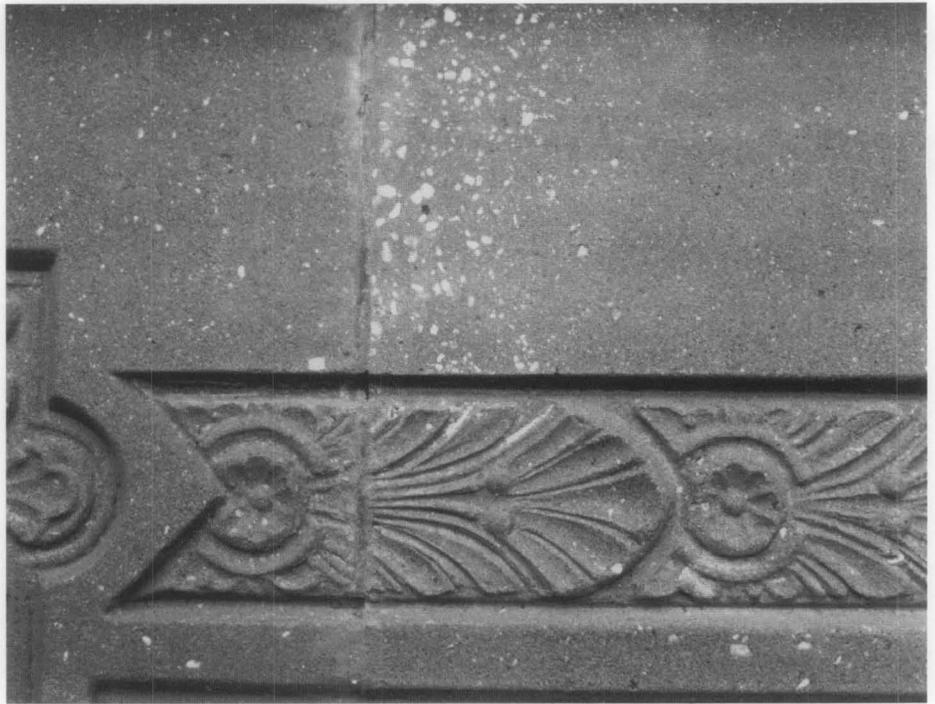
Figure 17. Unlike natural stone, cast stone generally may not be tooled in place to reduce lippage of uneven surfaces at joints. Tooling often exposes coarse aggregate from below the surface.

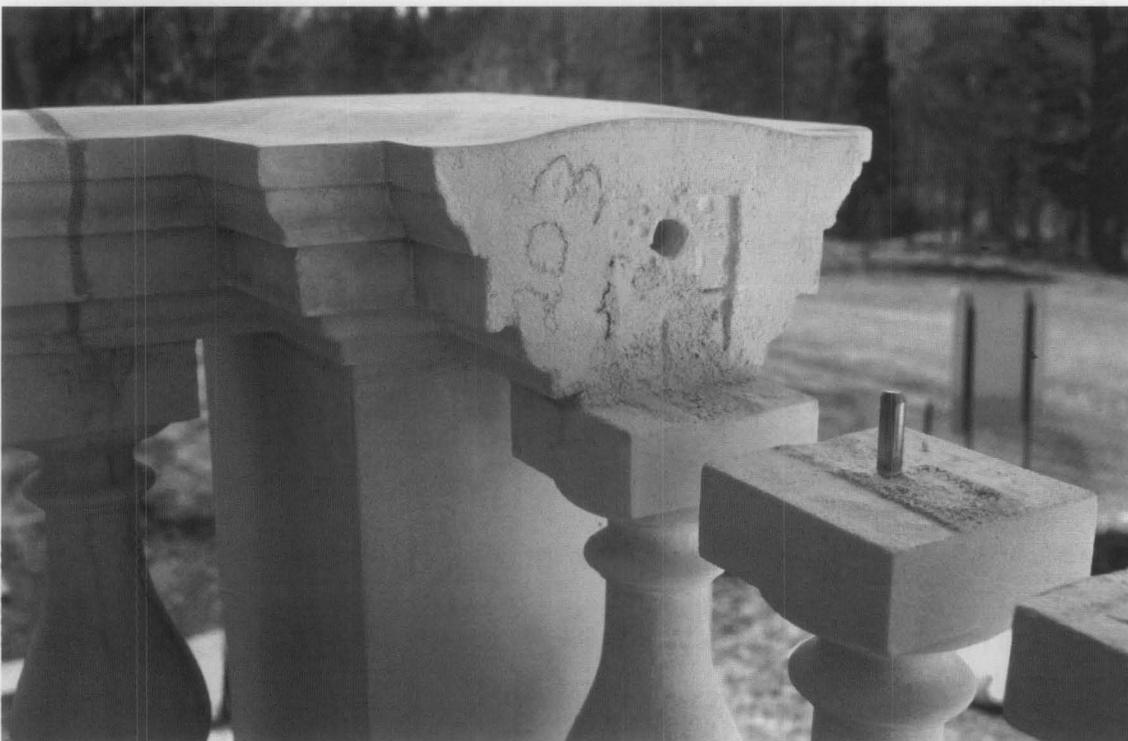
Figure 18. Long or thin cast stone elements require reinforcement. When possible, reinforcement of new cast stone should be made of stainless steel.

Individual cast stone units, which are subject to repeated wetting (such as copings, railings and balusters) and exhibit severe failure due to spalling or reinforcement deterioration, may require replacement with new cast stone (Fig. 18). Fortunately, a number of companies custom manufacture precast concrete units and can replicate deteriorated units in existing buildings (Fig. 19). The variables involved in manufacture are considerable, and it is wise to use a firm with experience in ornamental and custom work rather than a precast concrete firm which manufactures stock structural items, concrete pipe, or the like. Several trade organizations, including the Cast Stone Institute, the National Precast Concrete Association, and the Architectural Precast Association, have developed recommendations and/or guide specifications for the manufacture of cast stone and precast concrete. These specifications set standards for characteristics such as compressive strength and water absorptivity, and discuss additives such as air entraining agents and water reducing agents, which influence the longevity of new cast stone. Trade references and guide specifications should be consulted before contracting for replacement of historic cast stone.

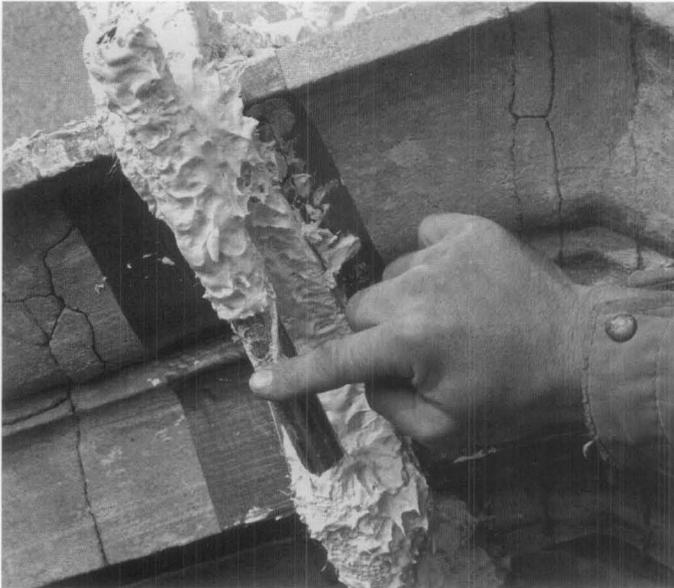
Figure 19. Molds for the replication of cast stone may be made on site using rubber materials and reinforcement. The molded profile of this window pediment will be used to run a plaster mockup, from which a production mold will be made. Photo: Michael Devonshire.

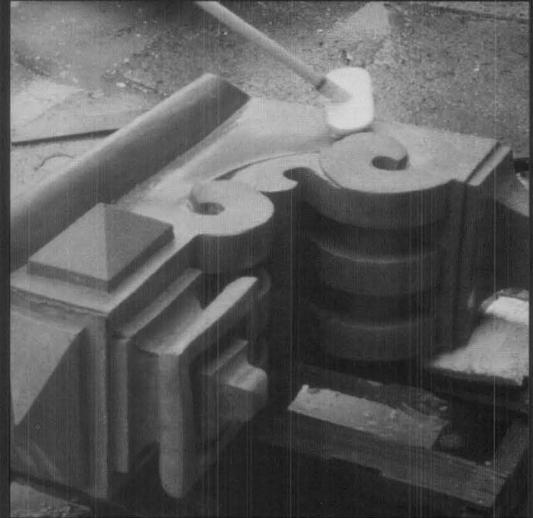
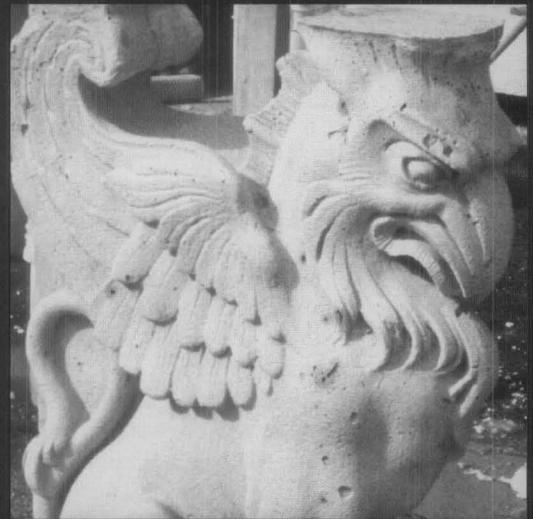
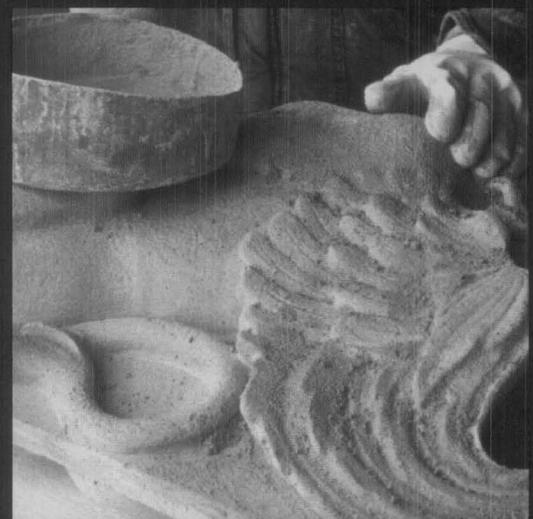
Figure 20. (top) After removal from the mold, new cast stone units are scrubbed, as shown, to remove surface paste and expose underlying aggregate. (middle) End cast pieces, such as columns or sculpture, may have numerous air bubbles at the surface. (bottom) The holes on the surface of the casting are filled with a mortar similar to the concrete mix used to cast the element.

when end casting long items such as columns or railings, where it is difficult to vibrate bubbles away from the finish surface of the unit (Fig. 20).

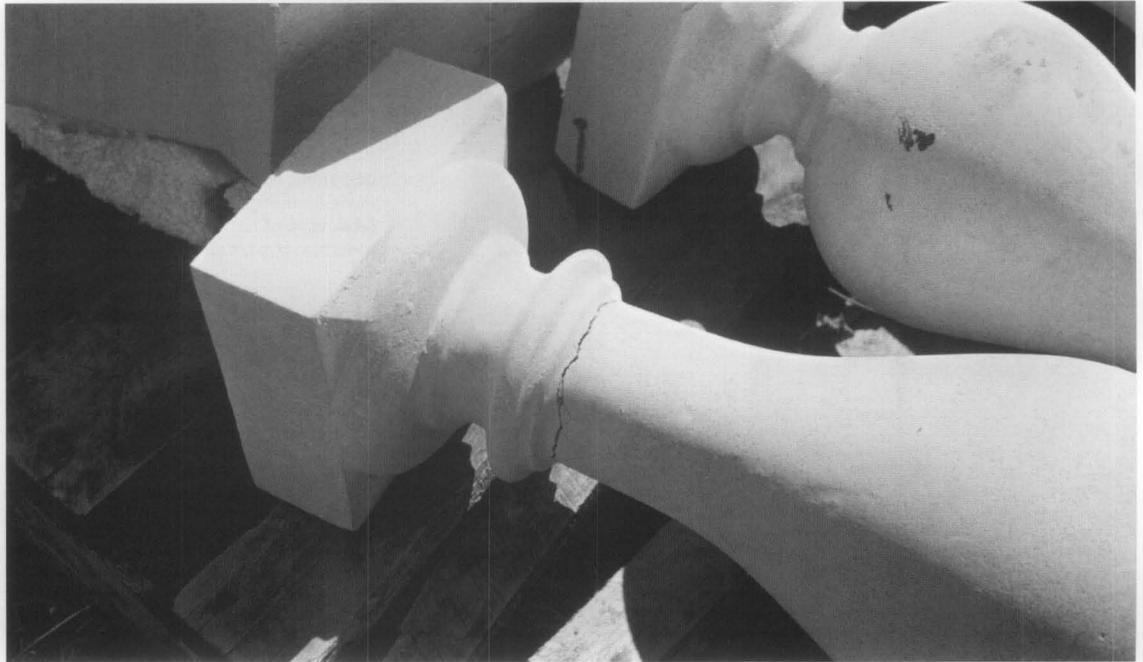
Figure 21. Surface cracking may reduce the durability of cast stone units. Cracking is often problematic on reinforced elements with thin "necks," such as balusters, unless curing is carefully controlled.

Surface cracking or checking. Overly wet mixes and insufficient moisture during curing can result in surface cracking of large castings, such as columns. Such cracking dramatically reduces the durability of new cast stone. Small reinforced elements, such as balusters, also frequently crack at thin "necks" in the castings (Fig. 21).

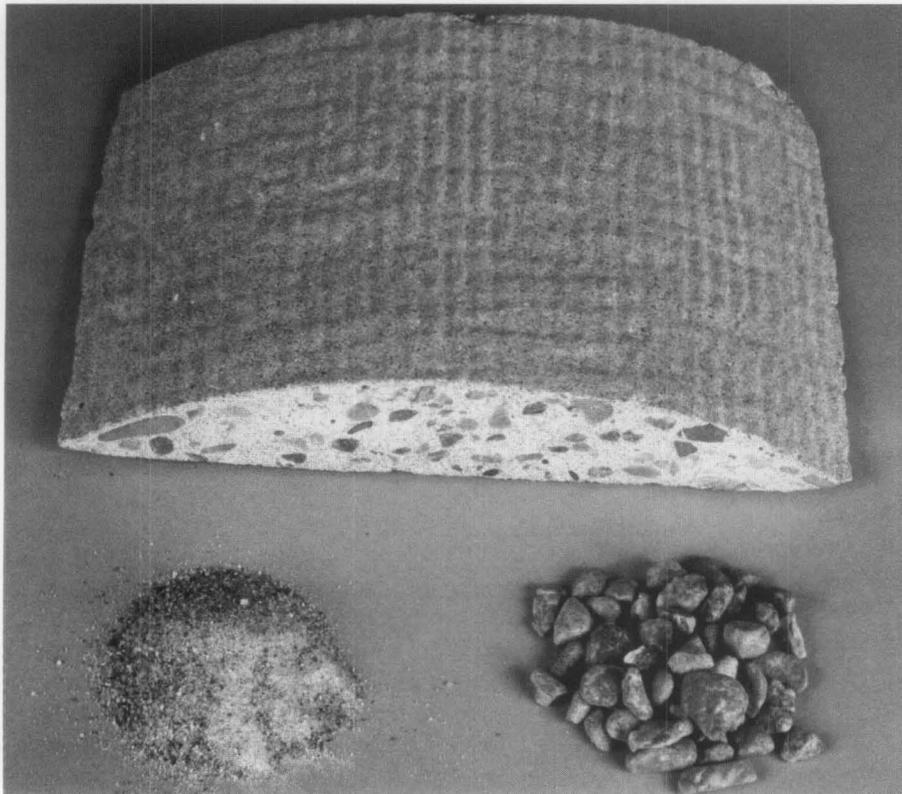
Figure 22. Most cast stone formulations use a mixture of coarse and fine aggregates. Coarse aggregates are not usually as visible from the surface, but may settle in end cast pieces.

Aggregate segregation. Cast stone formulations generally include a range of coarse aggregates (crushed stone) and fine aggregates (sand) (Fig. 22). When units are vibrated to assure compaction of the mix and liberate trapped air bubbles, coarse aggregates may begin to settle and separate from the paste of cement and sand. Aggregate segregation results in a visible concentration of coarse aggregate at one end of the casting. Segregation is more problematic when end casting long pieces, such as columns.

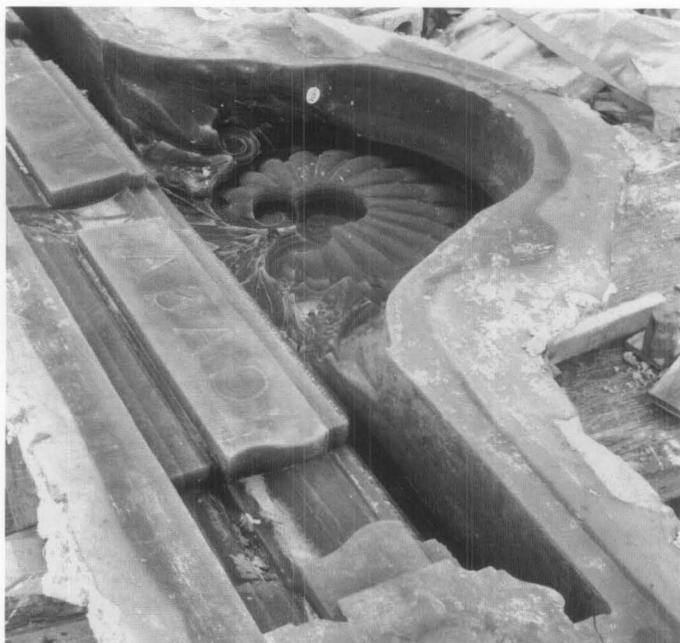
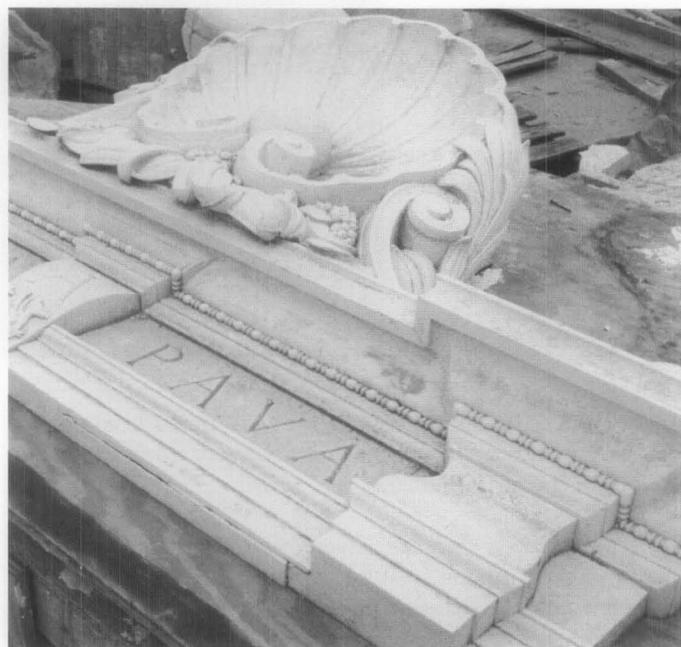
Figure 23. Production molds (left) made of durable rubbers backed with wood and plaster supports are used to fabricate new cast stone. Production molds may be made from original elements which have been repaired with epoxies and plaster, or from new plaster mockups. (below)

Surface rippling or irregularity. Production molds for fabrication are often made of rubber mold facings encased in larger "mother molds" of plaster and wood (Fig. 23). Vibration can loosen the rubber facing from the outer mold and result in rippling or irregularities on the surface of the finished casting (Fig. 24). Even when rippling is not noticeable, irregularity caused by mold movement can make it difficult to line up surfaces of adjacent units when assembling cast stone installations.

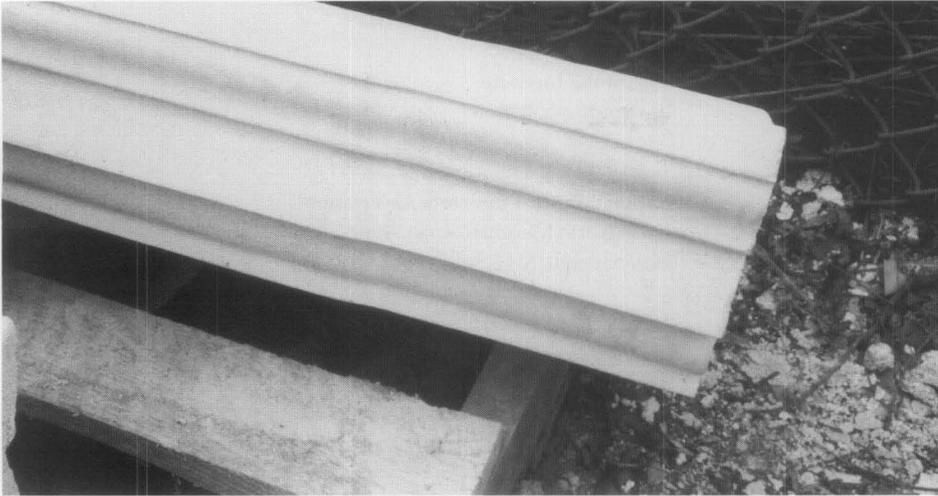
Figure 24. Separation of an interior rubber mold from a plaster mother mold during casting may result in rippling or irregularity of the completed casting.

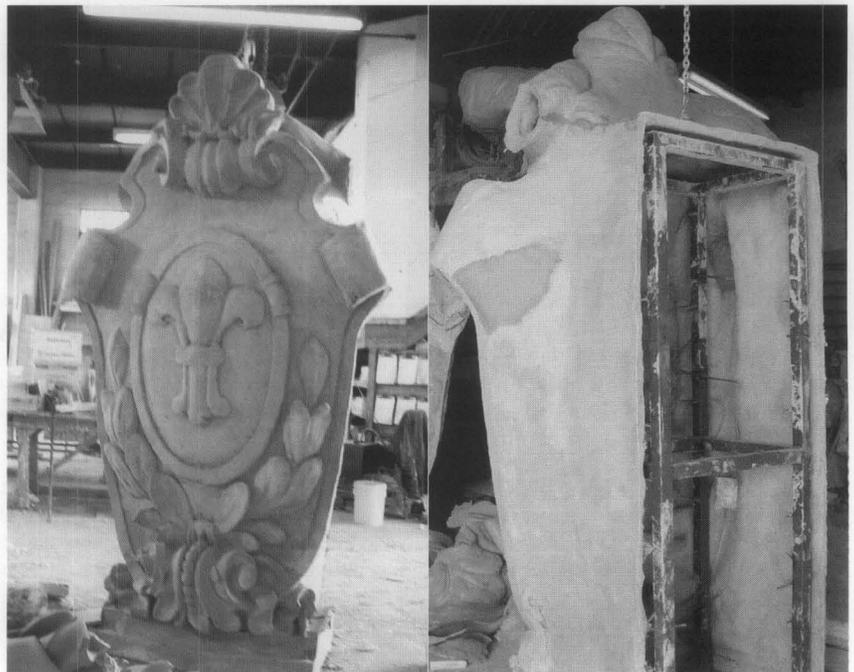
Figure 25. Glass Fiber Reinforced Concrete (GFRC) is sometimes used to replicate deteriorated elements of cast or fine grained natural stone. Because the GFRC element is a rigid, but relatively thin shell, it must be supported and attached with an interior framework of steel. The attachment hardware inside this GFRC cartouche (left) will not be visible when the unit is installed (armature visible at right). Photos: Towne House Restorations, Inc.

Glass fiber reinforced concrete (GFRC) is more and more frequently encountered in building rehabilitation and is used to replicate deteriorated stone and cast stone, and even architectural terra cotta (Fig. 25). This is a relatively new material that uses short chopped strands of glass fiber to reinforce a matrix of sand and cement. GFRC has become a popular low-cost alternative to traditional precast concrete or stone masonry for some applications. Fabricators use a spray gun to spray the mortar-like mix into a mold of the shape desired. The resulting concrete unit, typically only $\frac{3}{4}$ " thick, is quite rigid, but requires a metal frame or armature to secure it to the building substrate. The metal frame is joined to the GFRC unit with small "bonding pads" of GFRC.
