Tech Notes

HISTORIC INTERIOR SPACES

Preserving Historic Corridors in Open Office Plans

FIDELITY-PHILADELPHIA TRUST BUILDING

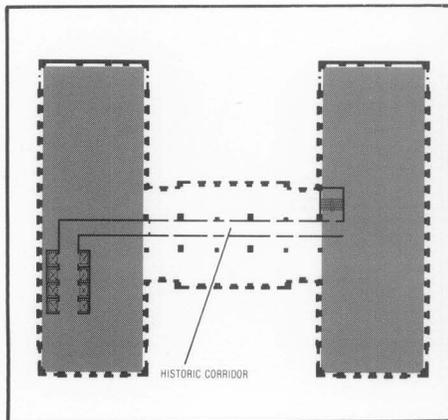
Figure 1. The double-loaded corridor, which forms the cross-bar of the H-shaped plan on each of the upper floors, is significant to the historic character of the building. Drawing: 2 Chris Henry.

The double-loaded corridor on each of the office floors, which forms the cross-bar of the H-shaped plan, is a significant feature of the interior, and these corridors are important surviving elements of the historic office plan (see figure 1). While various offices have been altered over time, the corridors retain a high degree of architectural integrity; their historic appearance and materials, including original light fixtures, marble floors and marble wainscoting, paneled doors, and wooden trim, have all survived largely intact.

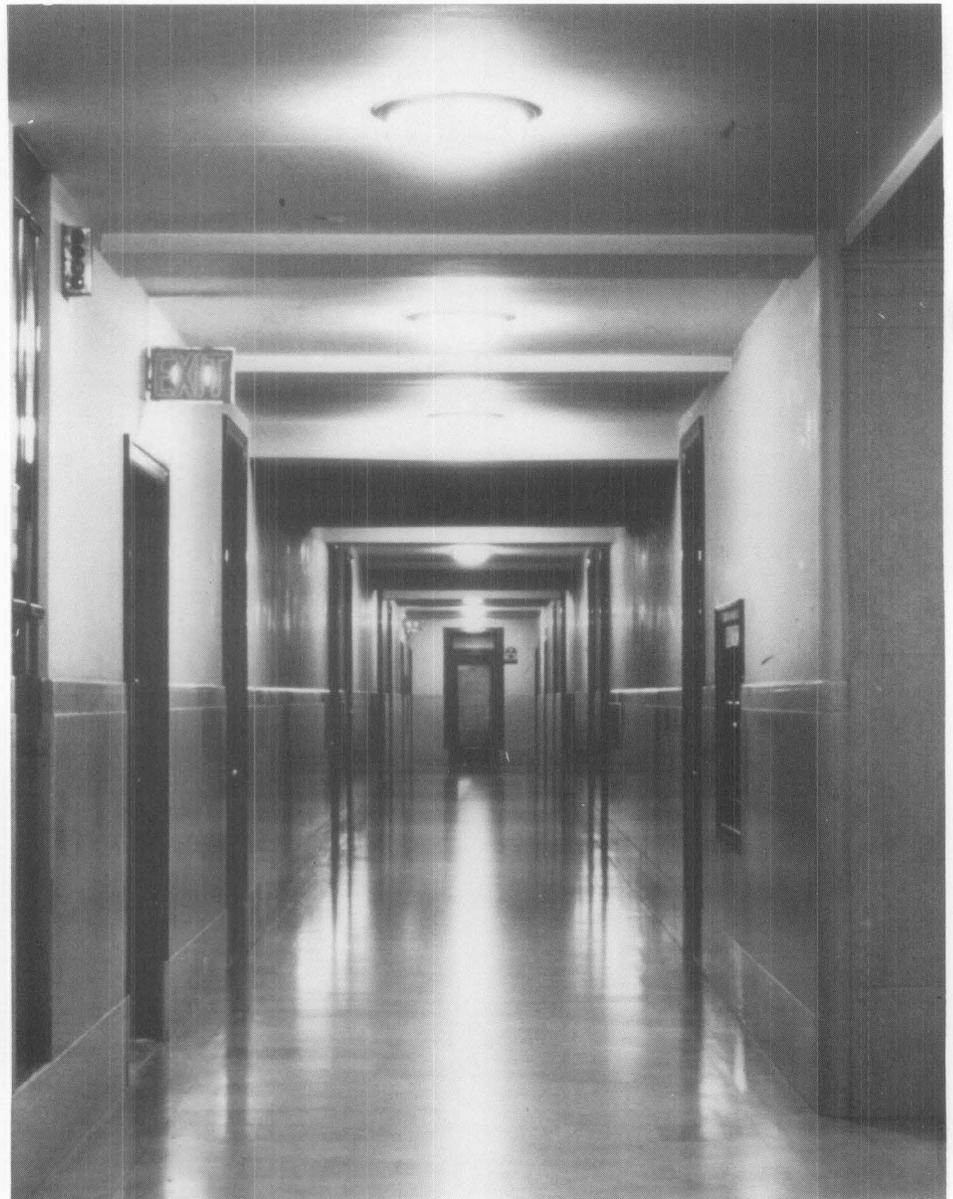
Figure 2. The central corridors, which help define the historic office plan, retain a high degree of architectural integrity, including the marble wainscoting and original light fixtures. Photo: Tom Crane.

Two factors were recognized quite early in the planning. First, any office plan selected would still require an ordered circulation spine from the elevator lobby to the far end of the hall where additional offices were located — a function currently served

by the historic corridor (see figure 2). Second, the design solution chosen would have to improve the lighting, since the halls, still lit by the historic fixtures, were considered too dim and the long windowless corridor created an extensive “tunnel” effect.

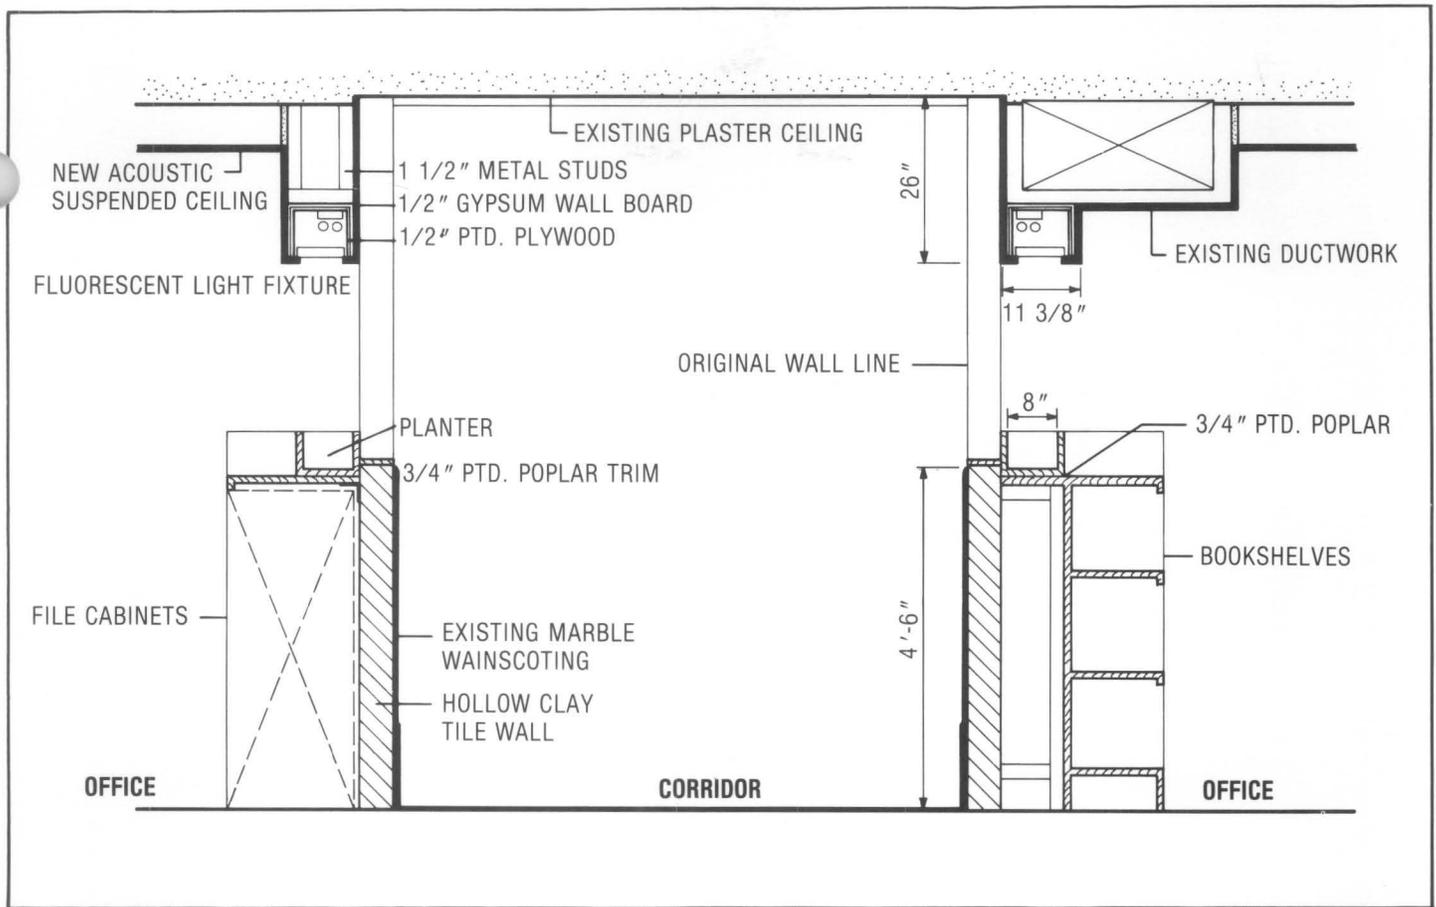
Figure 3. The innovative rehabilitation solution involved removing sections of wall above the marble wainscoting, leaving the historic floor frames and transoms in place, and constructing soffits above. Drawing: Chris Henry.

The innovative solution arrived at by the design team involved modifications that satisfied the concerns of the bank management and yet substantially preserved the central corridor. Along the corridor, sections of the plaster-covered clay tile wall were removed above the wainscoting and a soffit constructed above, leaving the historic door frames and transoms in

place, and forming a series of window-like openings which introduced visual continuity across the office floor (see figure 3).

Soffits were constructed, extending from the ceiling, directly above the new built-in file cabinets and bookcases (see figure 3). The soffits establish visual continuity along the upper wall of the corridor, horizontally connecting the door frames and

The soffits are simple boxes constructed of poplar and plywood faced with drywall. The soffits located beneath the 18" high duct on one side are 11 3/8" deep and 8" high. On the opposite side the soffits are 26" high so that the visual appearance of the two sides along the corridor is identical (see figure 3). Since the soffits are set back from the corridor wall line, a 6" gap in the corridor ceiling had to be patched.

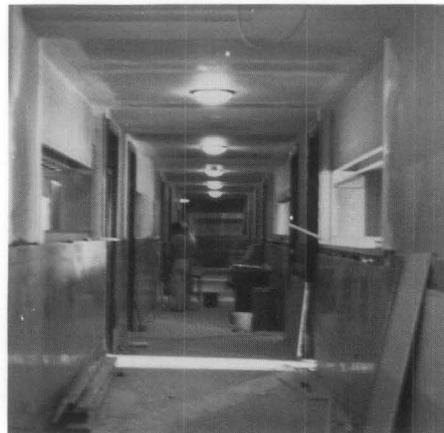
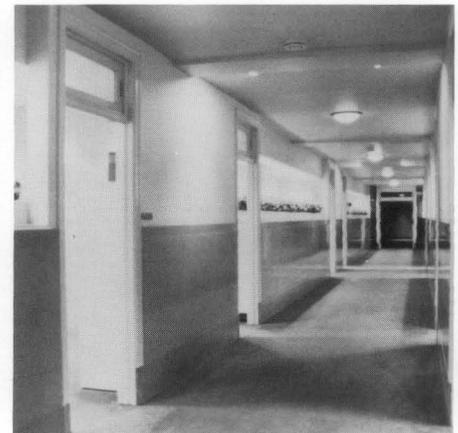
Figure 4. The window-like openings introduced by the wall removal greatly reduced the "tunnel" quality of the corridor and noticeably opened up the office spaces. Photos: Chris Henry.

Window-like openings were created by removing selected sections of the existing plaster-finished 6" thick walls while retaining many of the significant hall features and preserving a sense of the historic corridor (see figure 4). The 4'-6" height of the historic marble wainscoting which was being retained in place determined the height of the lower wall sections. To finish off the lower wall section, the marble cap along the upper edge of the wainscoting served as a trim piece (see figure 3). During

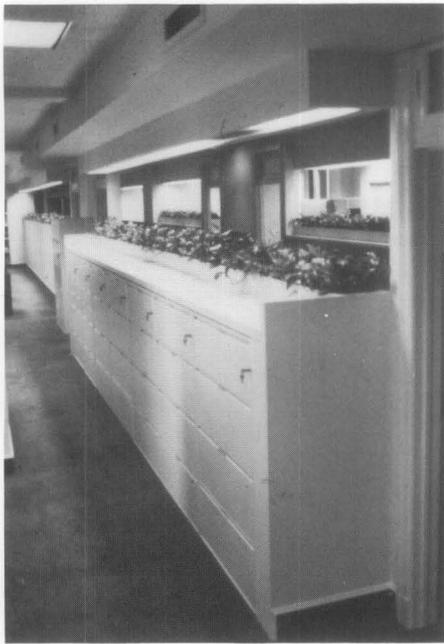
Figure 5. Banks of file cabinets and shelving were set flush against the existing wall and enclosed on the sides and tops.
Photo: Nelson & Associates.

Flush to the existing corridor wall, on the office side, file cabinets and bookcases were installed, enclosed on the sides and tops with poplar in order to give a more uniform appearance (see figure 5). Planters were constructed on top of the built-in units flush to the back side of the existing corridor wall and extending approximately 5" above the height of the wainscoting. The built-in planters provide screening so that employees working at desks near the wall would not be distracted by corridor traffic and so that their workspaces would not be readily visible from the hallway. The planter boxes, 6" deep and 8" wide, were constructed of poplar and have a waterproof liner. For the boxes, heart-leaved philodendron plants were selected because of their low height, fullness and ease of care. As a final step, the stored marble pieces were replaced and the historic marble cleaned with a mild detergent.

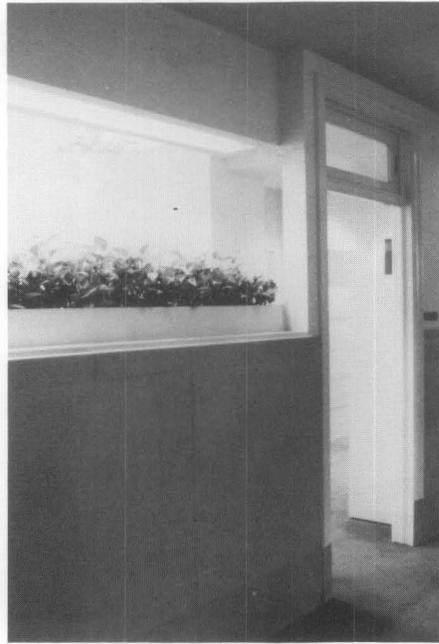
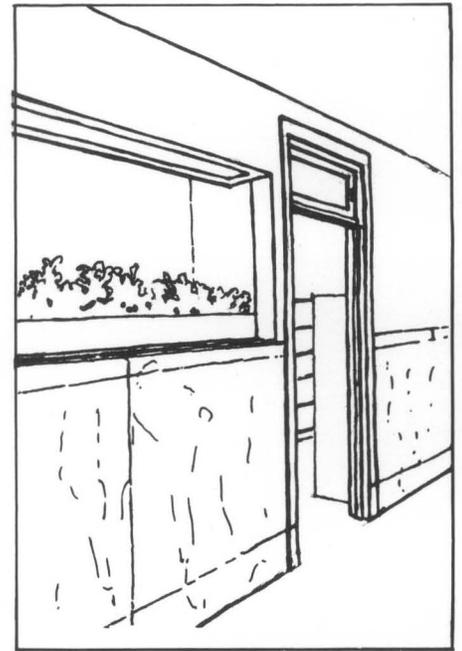
Figure 6. An alternate detail retaining the soffit at the original corridor wall plane would achieve a greater visual continuity of the historic walls, ceilings and doorways.
Photo and Drawing: Chris Henry.

An alternate design solution for the soffit that might be considered in similar situations involves aligning the soffit with the plane of the historic marble wainscoting rather than setting it back from this wall (see figure 6). By retaining the historic wall plane in the corridor, the necessity for extensive repair of the ceiling could be avoided. In addition, the upper frames of the doors would not project as they do in the Fidelity Building and there would be greater

visual continuity between the half and full wall sections as they are perceived down the hall.

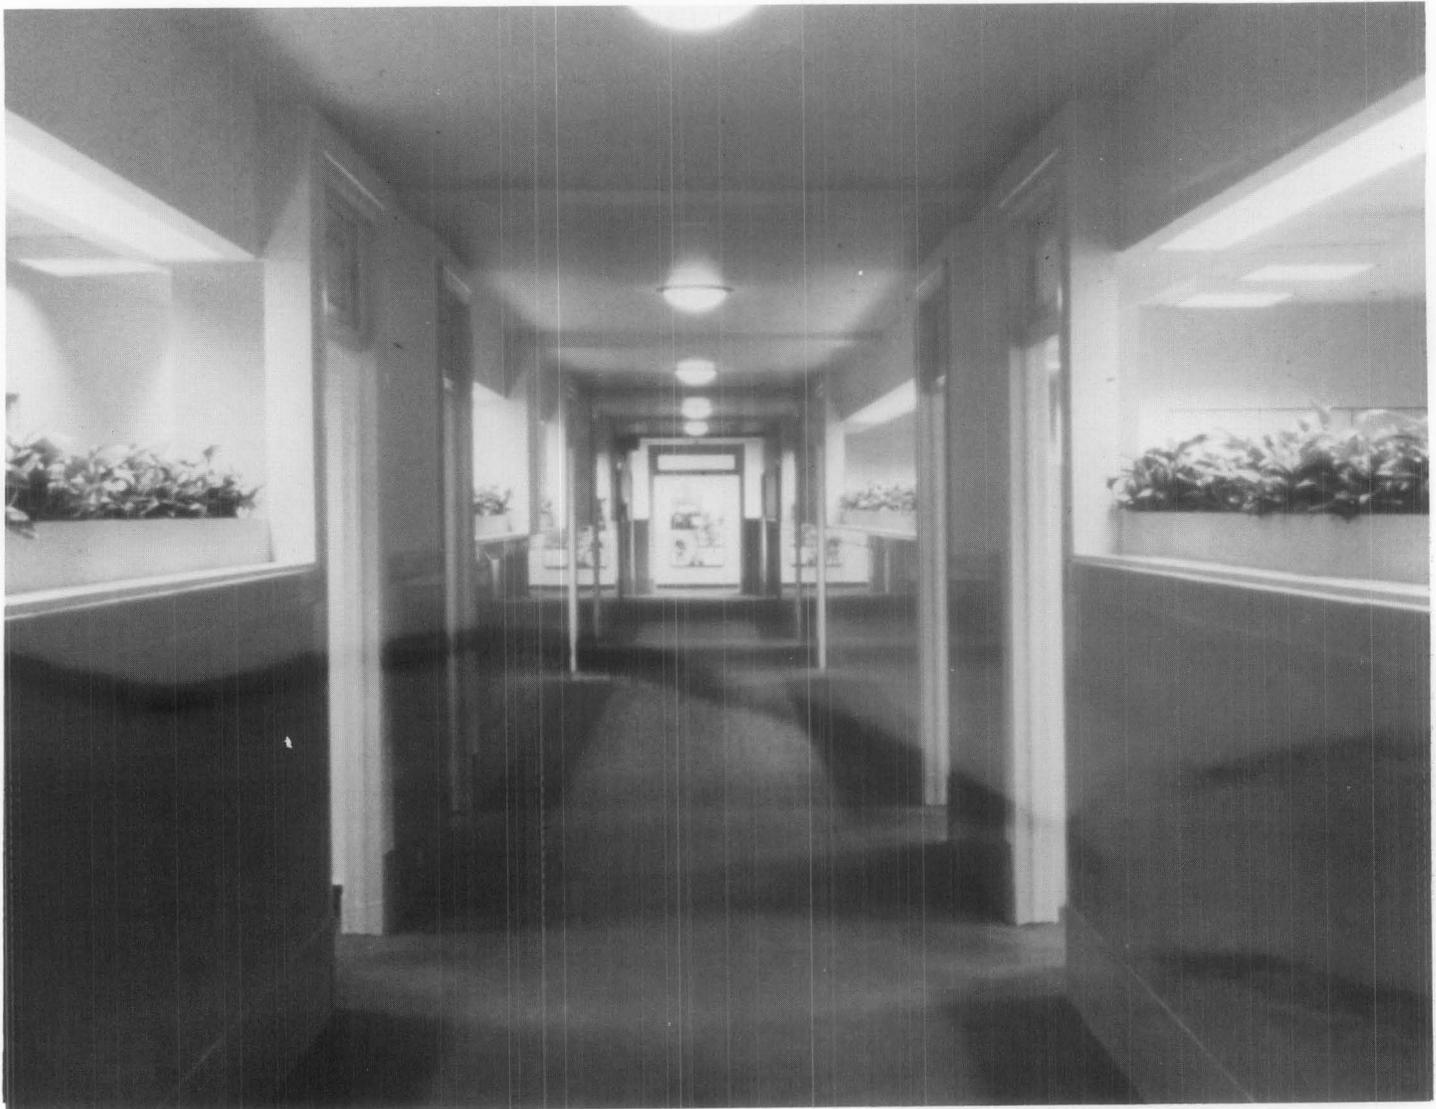
Figure 7. The historic double-loaded corridor plan, most of the hallway's significant features and sense of space have been retained while utilizing an innovative design to achieve a more open, flexible office plan. Photo: Tom Crane.

nificant, the hall detail is richer, or the historic office space off the corridors is finer, such a design solution as described may not be appropriate, because the significance of such features would warrant more complete preservation. The conditions present at the Fidelity Bank, however, lent themselves to some alteration work. The successful results can be attributed to sensitive planning and a willingness of the bank management to explore innovative design solutions appropriate to their needs and to those of the historic building (see figure 7).
