Subject: Removing Interior Plaster to Expose Brick

- Applicable Standards:**
- 2. Retention of Historic Character
 - 6. Repair/Replacement of Deteriorated or Missing Features Based on Evidence

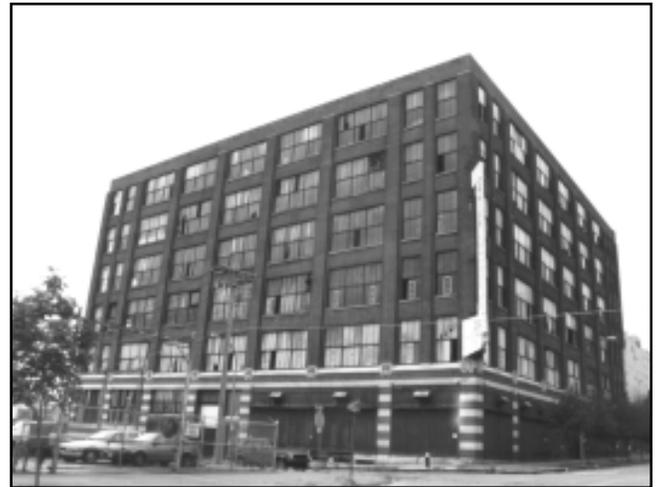
Built in 1916, this light industrial structure is a typical example of utilitarian industrial buildings constructed in the early 20th century.

The masonry walls were historically left unfinished. Exposed brick would therefore be an appropriate treatment for the rehabilitation of this building.

On the other hand, industrial buildings, e.g. warehouses and factories, are a building type where interior brick walls were not traditionally finished but rather were left exposed or merely painted. The walls were usually left unfinished to suit the utilitarian function of the building, as well as to limit the initial construction costs. In this case, the unfinished interior brick is a significant architectural feature contributing to the historic character of the structure. Thus, keeping the brick exposed preserves the character, and is an appropriate rehabilitation treatment for this historic building type.

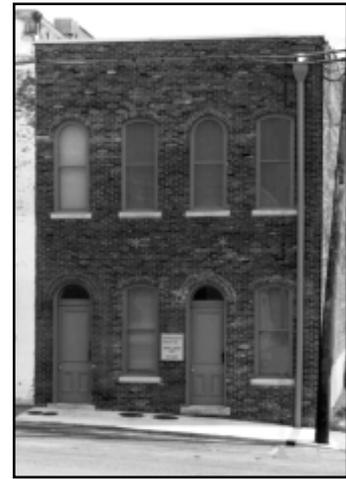
Built in 1879, this commercial/residential structure is an example of a building type where exposed brick is not an appropriate interior wall treatment.

Application (*Incompatible treatment*): This two-story mid-Victorian commercial building was built in 1879 by a lawyer to house his law office on the first floor with living space on the second floor. It underwent a number of renovations in 1910, 1936, and 1958, and was abandoned in 1982. The recent rehabilitation restored it for commercial/residential use. While the rehabilitation retained most of the character defining interior features, including the Italianate fireplace surround, deep molded baseboards, articulated stairway, and paneled doors, the equally significant plaster was removed from the interior masonry walls leaving the brick inappropriately exposed. Although popular as a current decorating trend, exposing traditionally plastered interior masonry walls is not appropriate for this historic building type. In order to bring this project into compliance with the Standards, remedial work was required. Since it was documented in the “before” photographs that the plaster was deteriorated, the owner was given the option of either replastering that masonry or replacing it with a modern material to approximate the original finish (e.g. gypsum drywall).

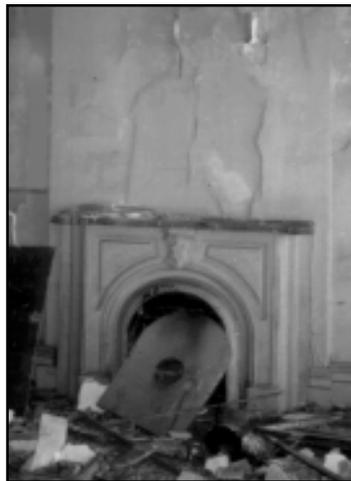
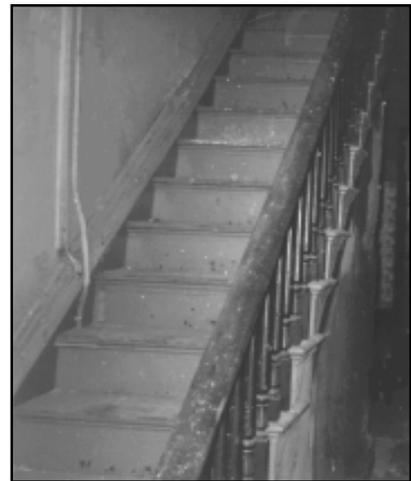
Before Rehab...

Before photographs document the original finished quality of the stairhall and second floor with plastered walls, an Italianate cast iron fireplace surround, and deep molded baseboard.

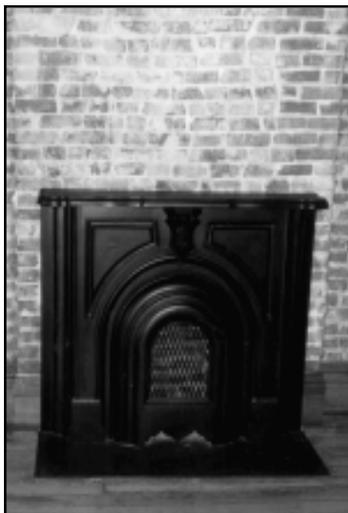
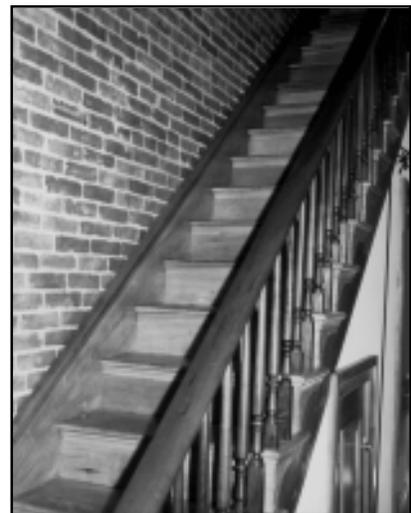
After Rehab...

The removal of plaster to expose brick walls historically finished is however a wholly contemporary practice that gives the spaces affected a new character incompatible with the historic one. To bring the project into conformance with the Standards, the walls will be replastered or covered with gypsum wallboard.
