Subject: Installing New Systems in Historic Corridors

Applicable Standards: 2. Retention of Historic Character

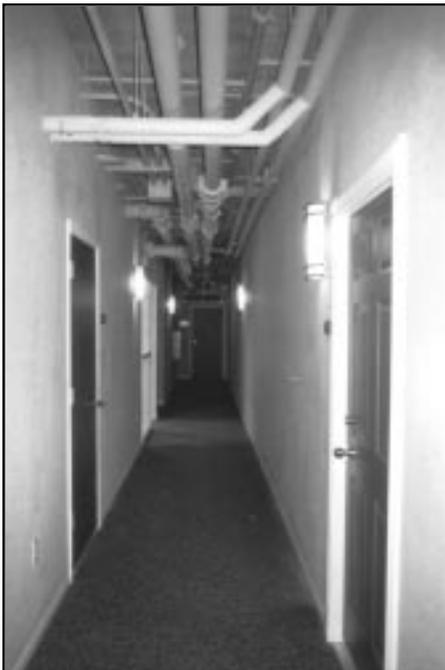
Left: The exposed pipes give the corridor, although quite plain, an unfinished appearance which is not compatible with the historic character of this 1926 bank building.

Application 1 (*Incompatible treatment*): The tangle of pipes along the corridor of this 1926 bank building, which was rehabilitated into apartments, creates a sharp visual distraction. Given the straightforward detailing of this corridor, installing a new ceiling to hide the overhead pipes would have been the preferred treatment, even if it meant lowering the original height of the ceiling. Where there is insufficient room in the corridor space to drop a new ceiling without significantly altering the volume of the space or interfering with existing features such as door transoms, trim, or other features, other solutions are required.

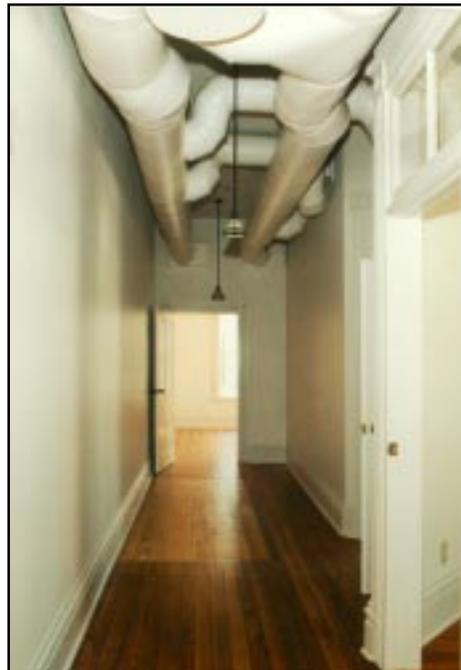
Right: These ducts should have been installed in a secondary space since lowering the corridor ceiling would have concealed the transoms.

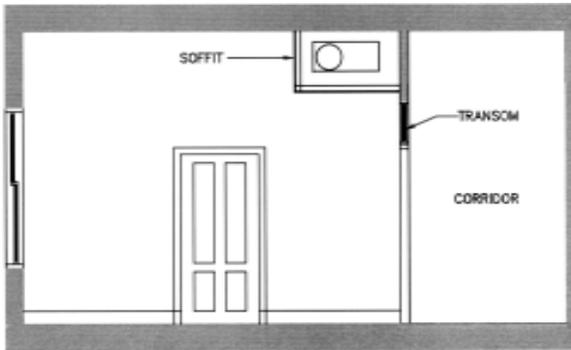
Routing HVAC and other systems along spaces on either side of corridors is a more sensitive approach that often works well in rehabilitations of historic office buildings.

Application 2 (*Incompatible treatment and suggested remedial treatment*): A new dropped ceiling would have not been the appropriate solution for hiding the large ducts in the corridors of this 1886 commercial building. Dropping the ceiling height low enough to conceal the ducts above would have required the ceiling to drop below the door transoms. In this case, if the ducting could not be reduced in size, a possible treatment could entail routing the ductwork parallel to the corridor in less significant interior spaces. The first drawing illustrates a scheme in which the ductwork is encased by a soffit above the existing transom. When the ceiling height does not allow sufficient room above the transom, other compromises might be required, such as the one depicted in the second drawing. In this case, the new mechanical equipment was also installed parallel to the corridor, but the lack of clearance between the top of the door transom and the existing overhead structure requires that the new soffit cover the transom behind the corridor wall. Although obscuring existing historic features is generally not recommended, when such alterations cannot be avoided, it is preferable to limit these treatments to less significant or secondary service areas such as closets, bathrooms, or kitchens inside new offices or apartments to avoid altering more significant public spaces such as corridors.

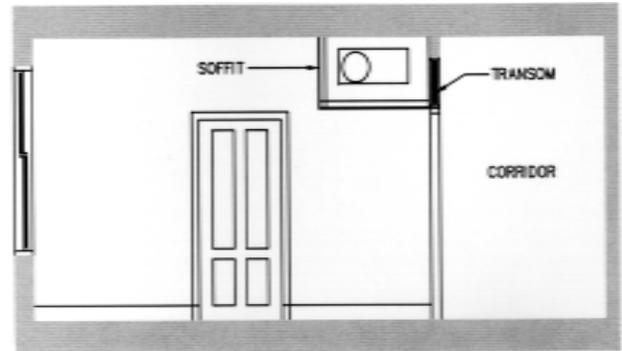
Although obscured on one side, the transom can be retained on the more visible corridor side.

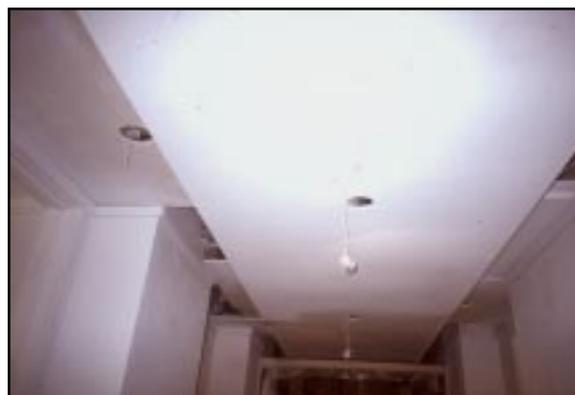
A partial ceiling can cover new systems in a corridor without obscuring existing historic features.

Application 3 (*Compatible treatment*): Another possible approach is illustrated in the conversion of this 1925 office building into a hotel. The design of this new floating ceiling allows covering new HVAC systems without obscuring or damaging existing features along the corridor walls. Holding the ceiling back away from the walls allows the existing trim and other details to be retained and kept visible.
