This poster details the results of a Historic Structure Assessment Report completed by the Historic Preservation Training Center (HPTC) for Monocacy National Battlefield (MONO). The project consisted of documentation of extant conditions; condition assessment, treatment recommendations for exterior and interior preservation, and the development of a context study to assist in the understanding of the uniqueness of the Best Farm Stone Barn in Frederick County, MD.

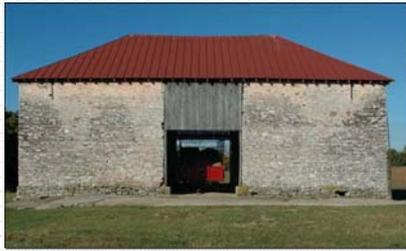
Best Farm Stone Barn – East Elevation (08/07) Note saq at ridge line.

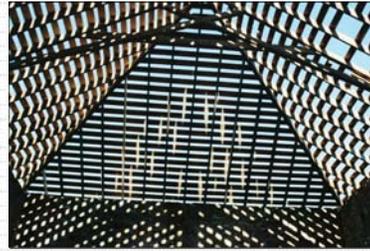
Photo Taken in 1997 by NPS employee during reroofing of the barn. The hip rafters are used to support the over-stressed normal rafters which make up the bulk of the roof frame. Rafters are undersized for the span and have minimal bearing and connections. Roof lathe has provided lateral support not given by other roof members.

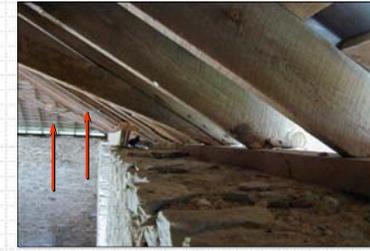
View of Top of Wall with Rafter Plate perched at exterior line of wall. Minimal connections between rafter plate and stone wall and rafters and rafter plate have allowed outward movement of roof frame and resulting saq in roof frame.

Two lateral cable ties (see arrows) have been used in an unsuccessful attempt to prevent outward movement of rafter plates.
