Restoration Guide for Historic Log Buildings on the Trail of Tears National Historic Trail

National Park Service
Trail of Tears National Historic Trail
MTSU Center for Historic Preservation

February 2015

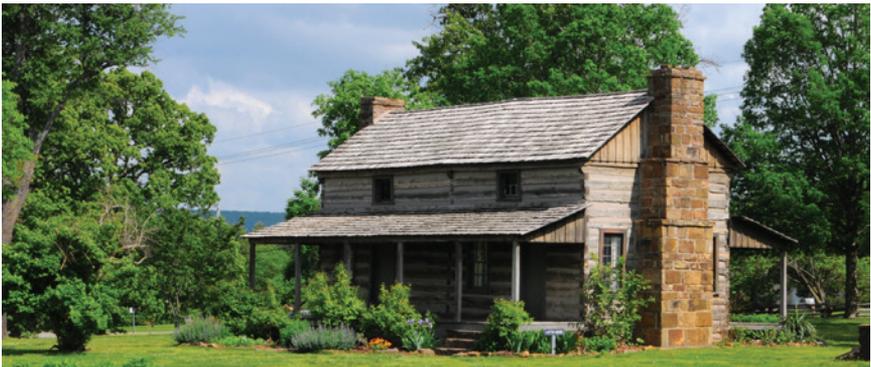
The Bell detachment disbanded near the ca. 1834 Latta House (Vineyard Post Office) on January 7, 1839. The two-story, double-pen log house was moved from its original location to the Prairie Grove Battlefield State Park in Washington County, Arkansas, in 1958.

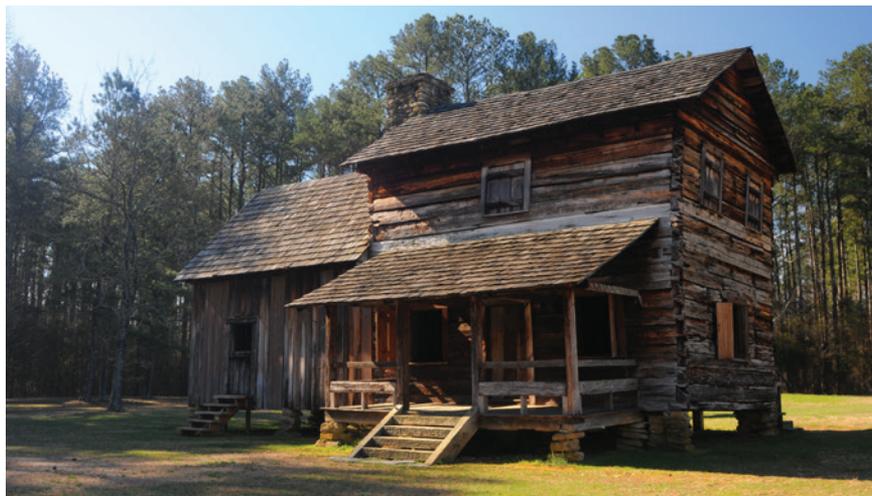
Cherokee James Vann built this two-story hand-hewn log tavern around 1805. It has a single room on the first floor and three rooms on the second floor accessible by an external staircase at the rear. A one-story board-and-batten room was added to the east side at a later date. The tavern was moved to the New Echota State Historic Site in Gordon County, Georgia, in 1955.

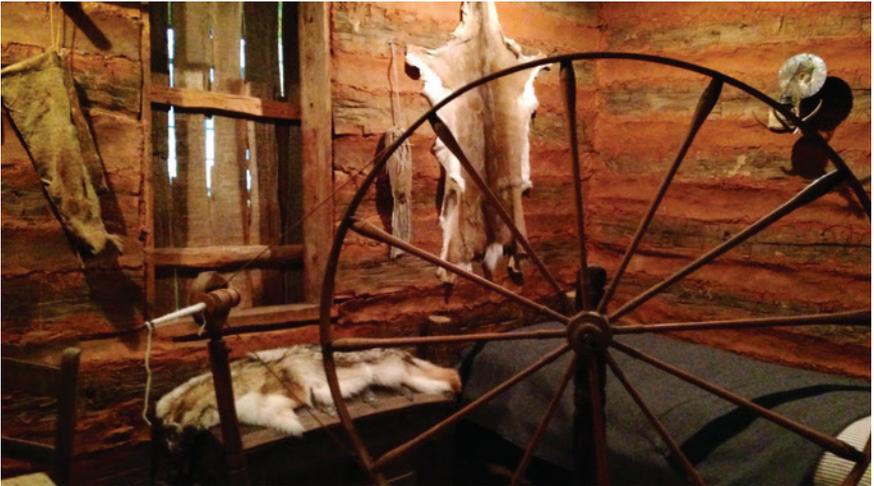
Born in Tennessee, Sequoyah, the creator of the Cherokee syllabary, built this single-pen hand-hewn log house in 1829 in present-day Sequoyah County, Oklahoma.

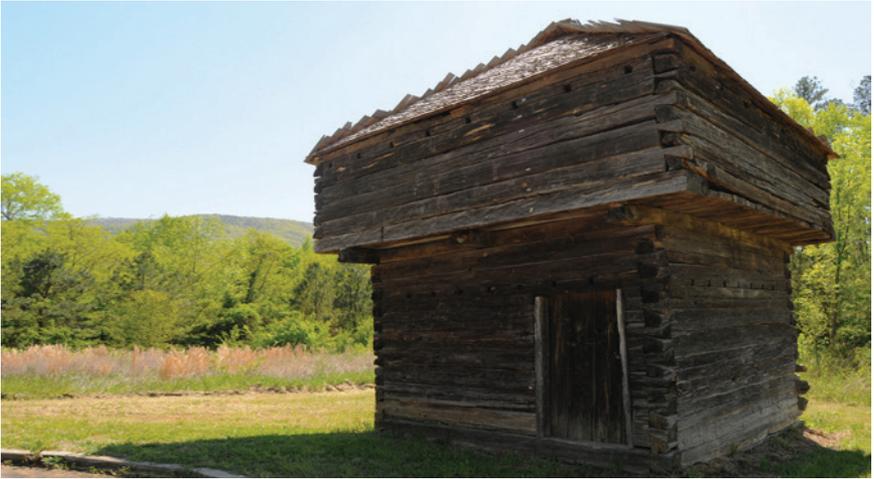
The Fort Morrow Blockhouse in Polk County, Tennessee, is the only known example of cantilevered log architecture on the Trail of Tears.

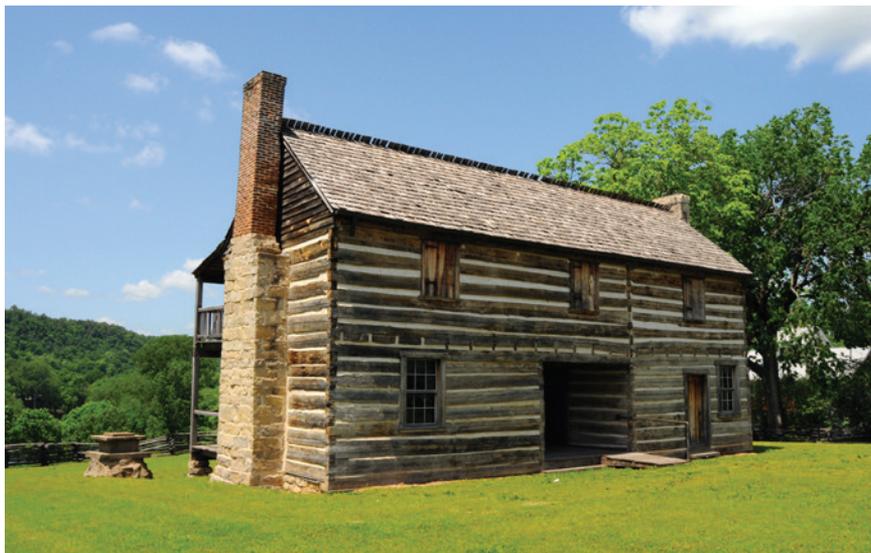
The Wolf House in present-day Norfolk, Arkansas, was built in 1829 and is an excellent example of a two-story dogtrot log building. It was the first permanent courthouse for Izard County in Arkansas Territory. Those traveling with Bengé's detachment would have seen this building on their way to Indian Territory.

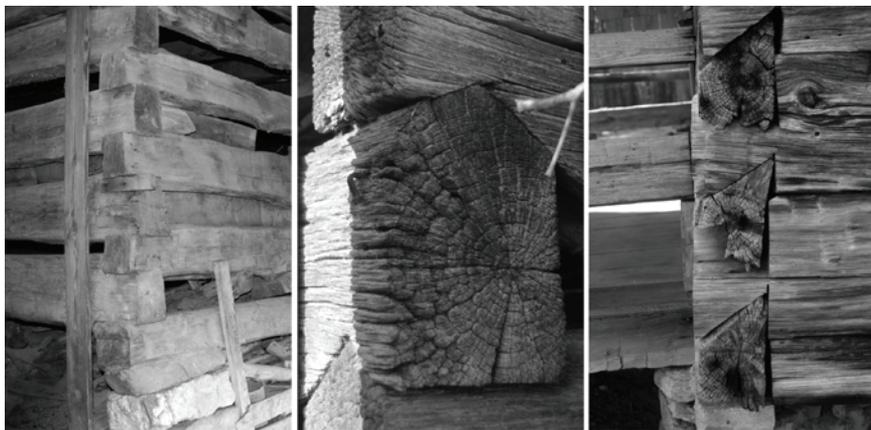
(Left) Square notch, ca. 1836 corn crib at the Crider Tavern Complex in Caldwell County, Kentucky; (center) V-notch, ca. 1810 outbuilding at the George A. West Complex in Robertson County, Tennessee; (right) Half-dovetail notch, ca. 1805 Vann's Tavern in Gordon County, Georgia.

One of the most distinguishing features of a log house is its corner notch. Notches locked the logs in place, thus ensuring the structure's stability. The most commonly seen notch types on log buildings along the Trail of Tears National Historic Trail are square, V, and half-dovetail. Half-dovetail notches offer the most stability of the three. The square notch offers the least, as it does not allow the logs to lock in place; structures built with this notch type are significantly less stable and more susceptible to collapse.

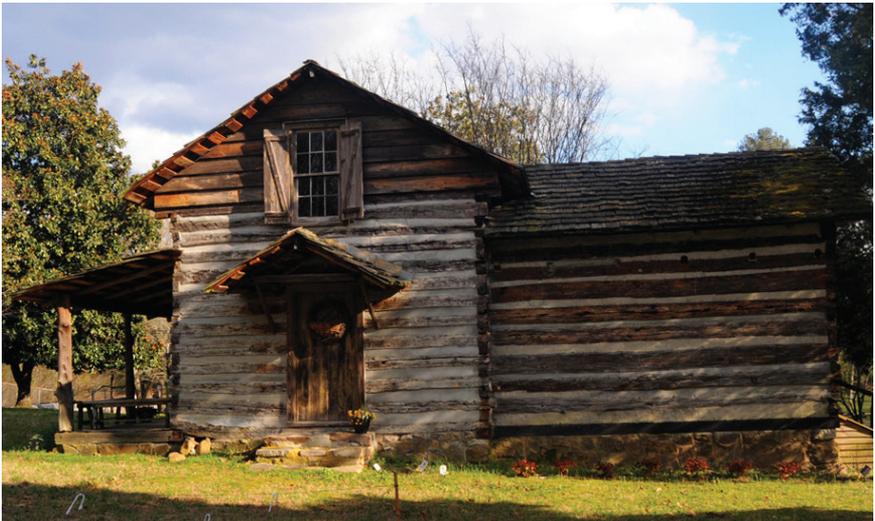
Log structures in warm climates were set on piers in order to allow air to circulate underneath. This air circulation kept the house cooler and helped keep wooden components (particularly sills and joists) from rotting. If infill was added between the piers air circulation decreased, making deterioration of the sills, joists, and lower logs more likely.
