Replicating a Prehistoric Masonry Room at Tuzigoot National Monument

Matt Guebard
Lucas Hoedl

Montezuma Castle/Tuzigoot National Monument
National Park Service

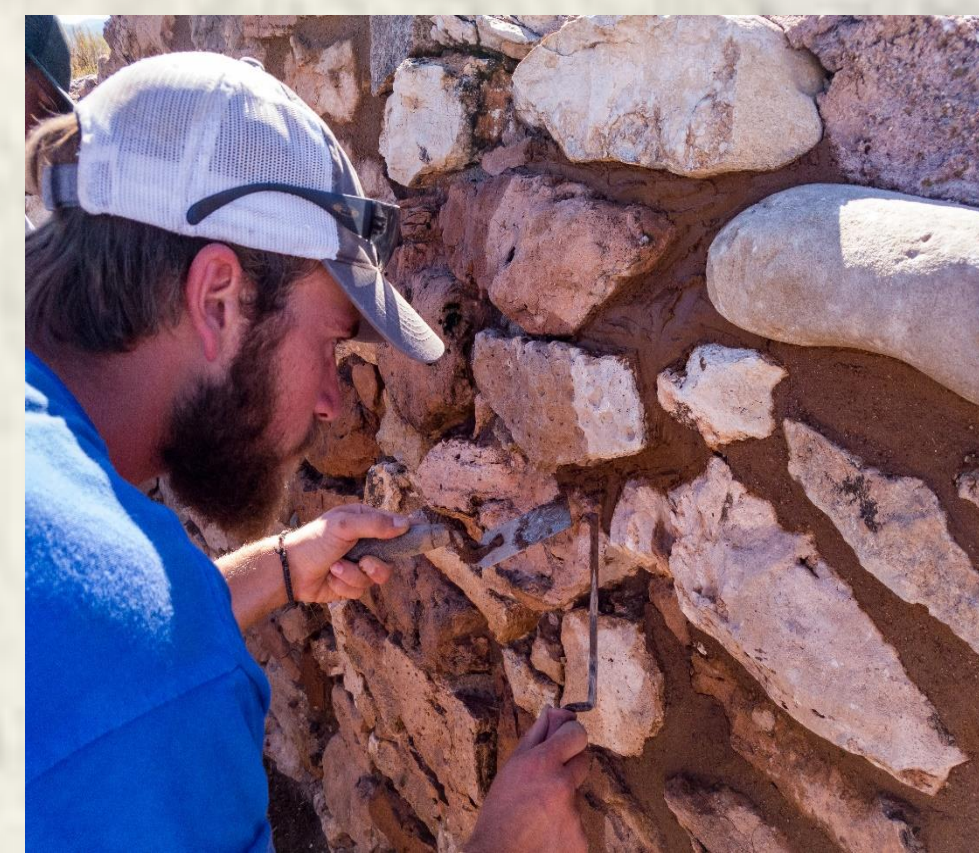
During stabilization using the technique of tuck pointing.

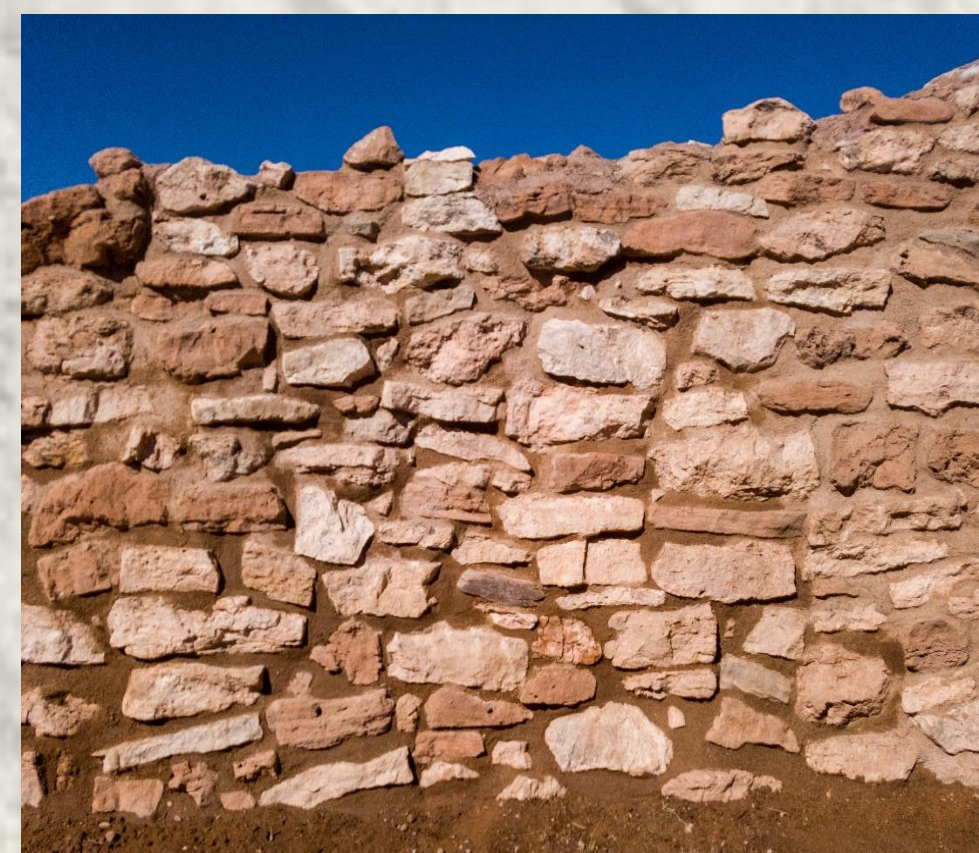
After stabilization using the current mortar mix at Tuzigoot National Monument.

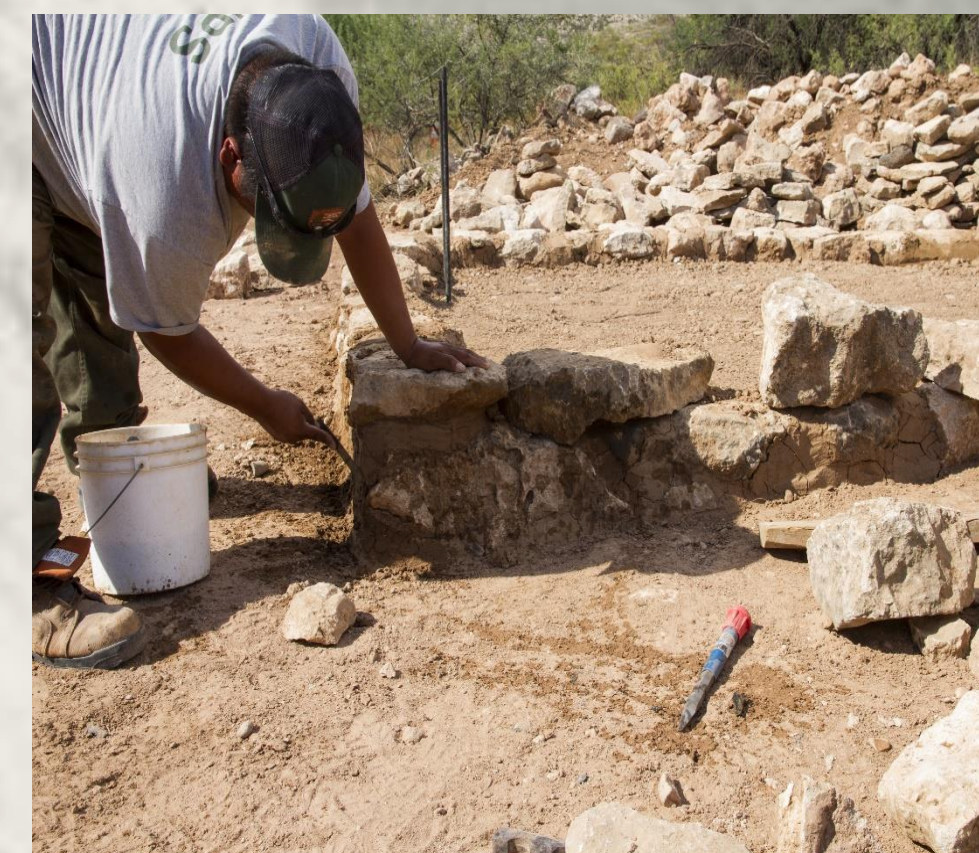
Using a tuck pointer to push in the mortar. During the construction of the Replica pueblo.

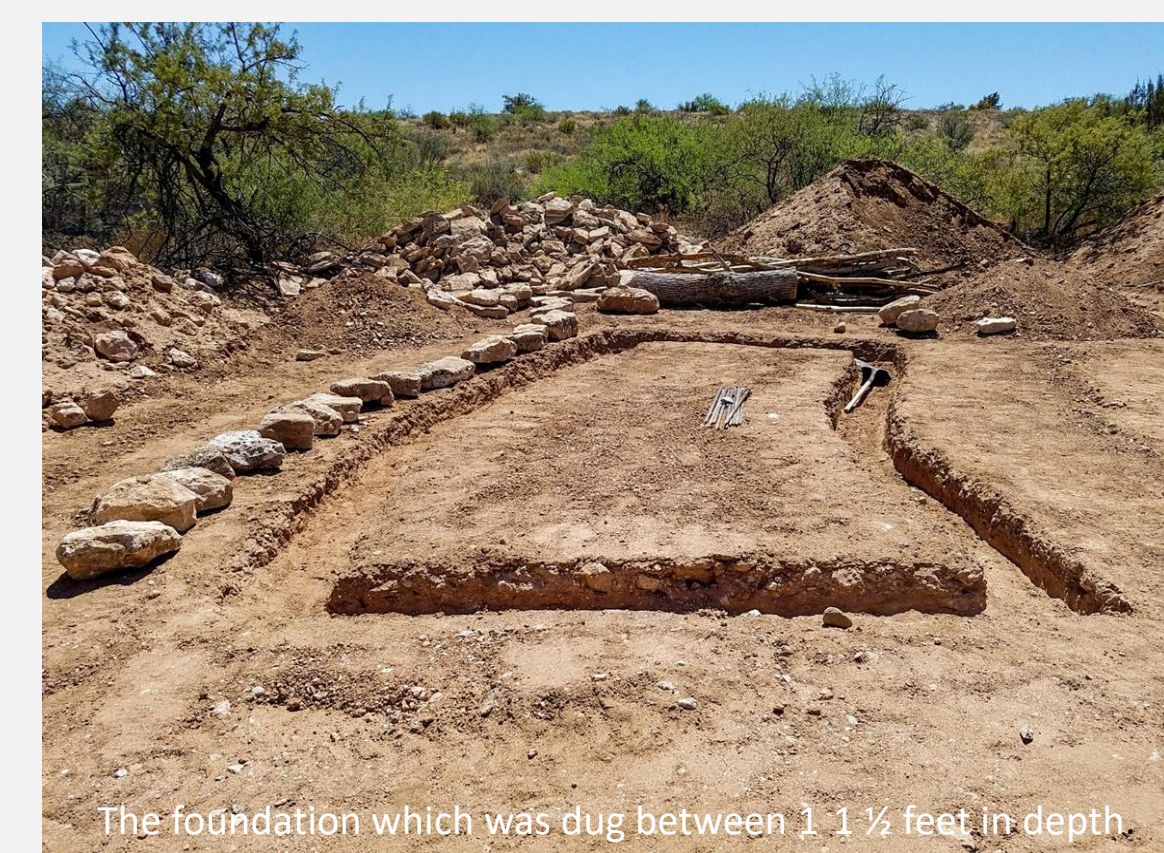
The foundation which was dug between 1-1 1/2 feet in depth.

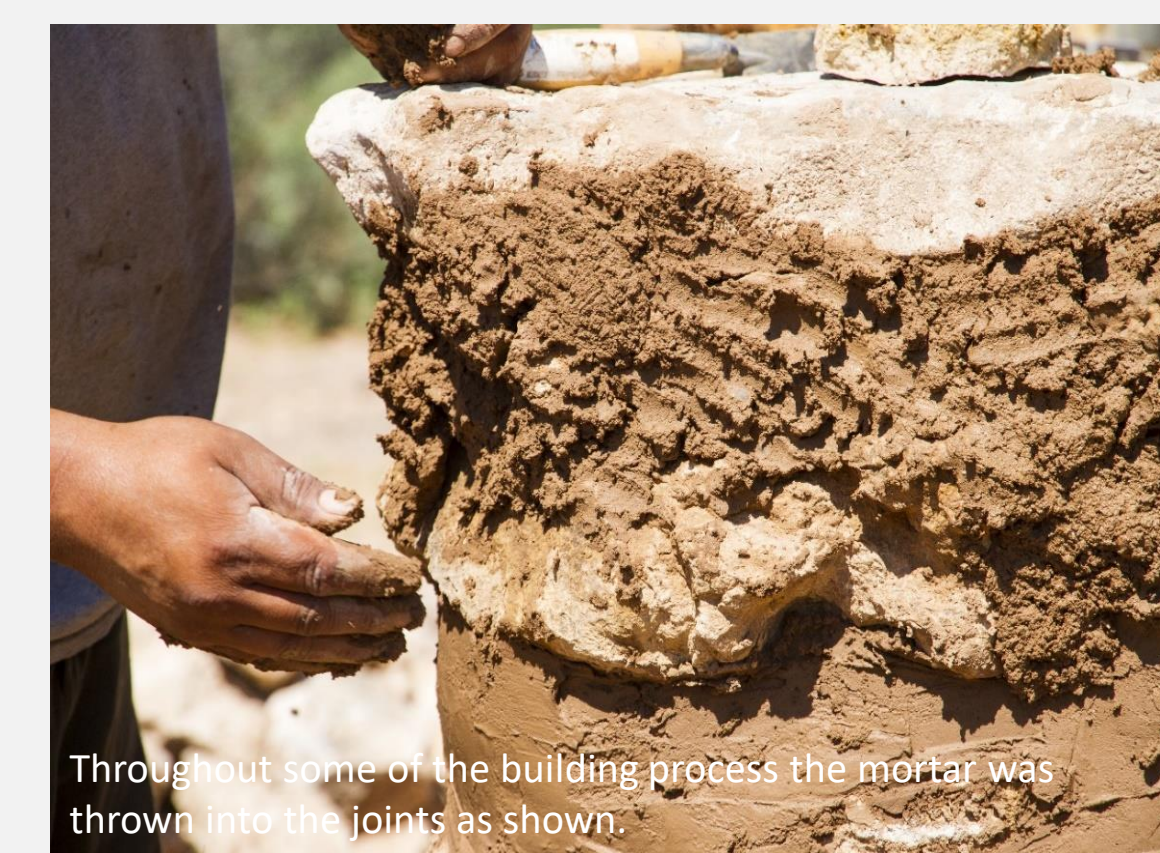
Throughout some of the building process the mortar was thrown into the joints as shown.

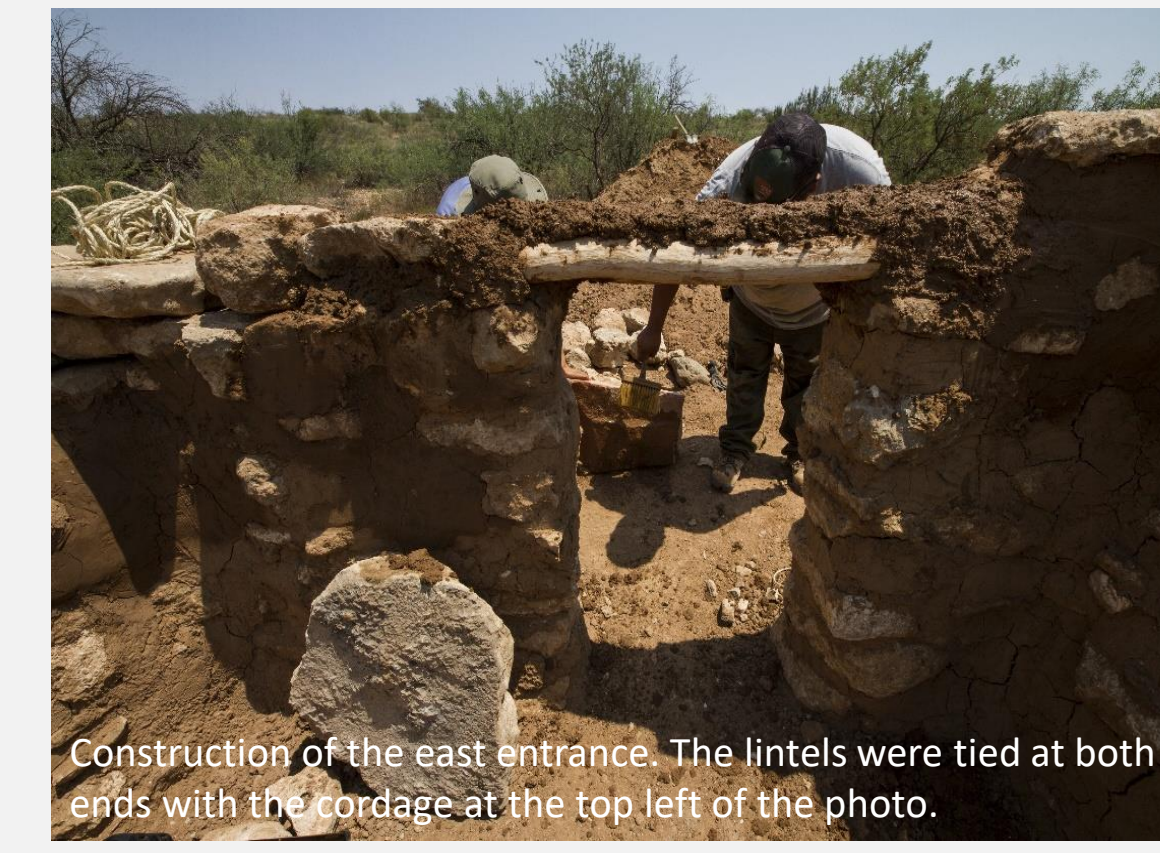
Construction of the east entrance. The lintels were tied at both ends with the cordage at the top left of the photo.

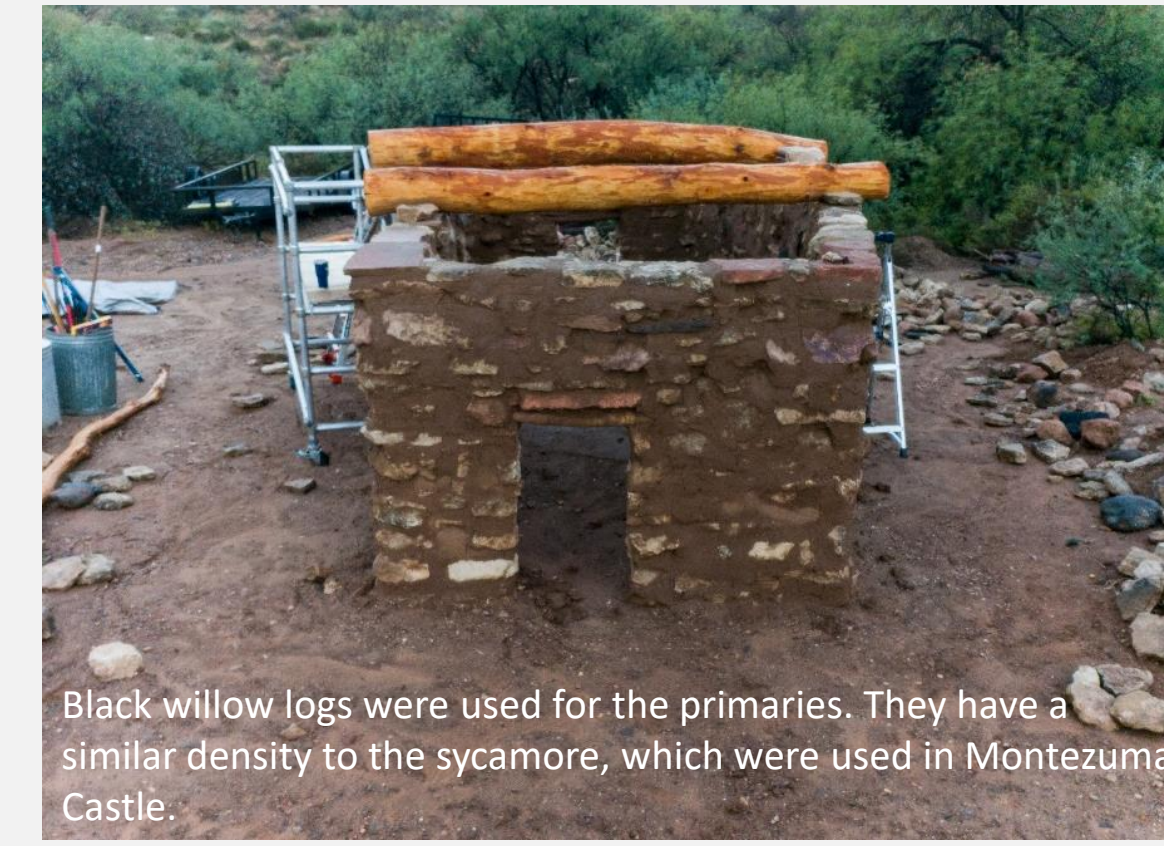
Black willow logs were used for the primaries. They have a similar density to the sycamore, which were used in Montezuma Castle.

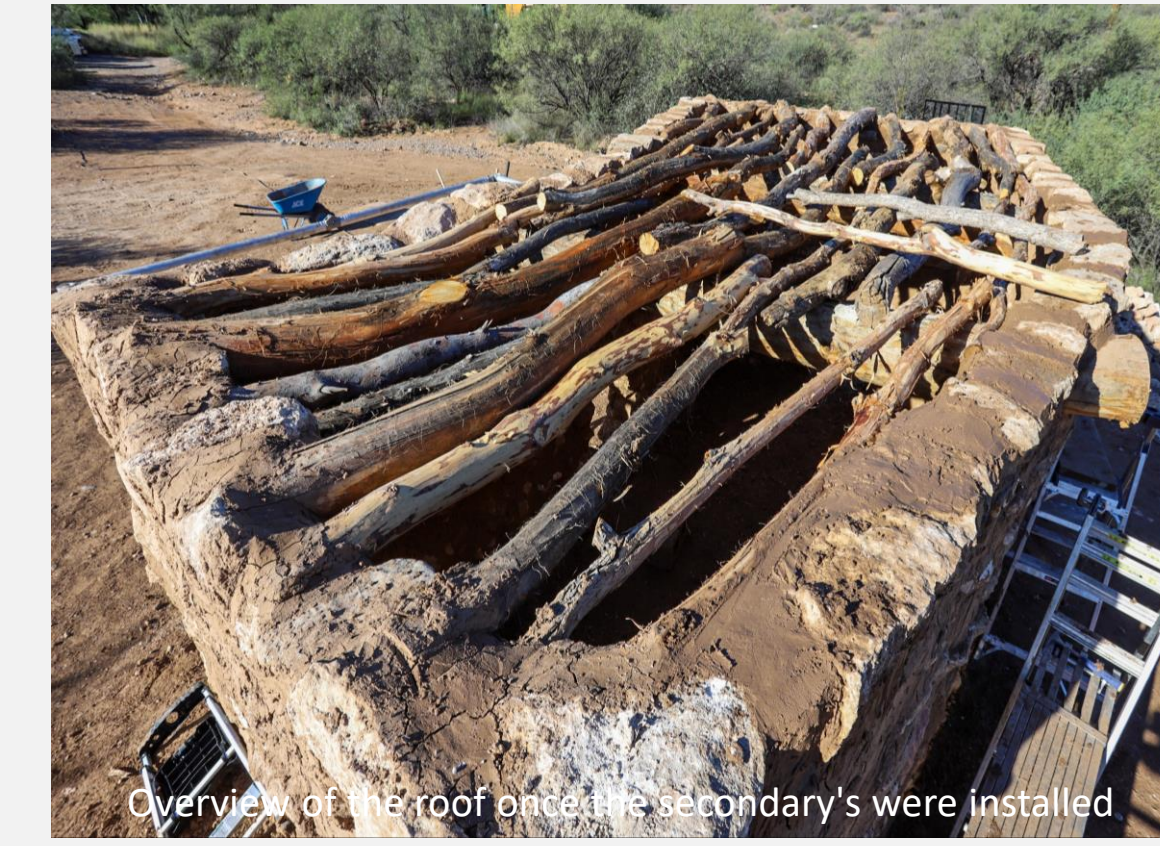
Overview of the roof beams. The secondary's were installed.

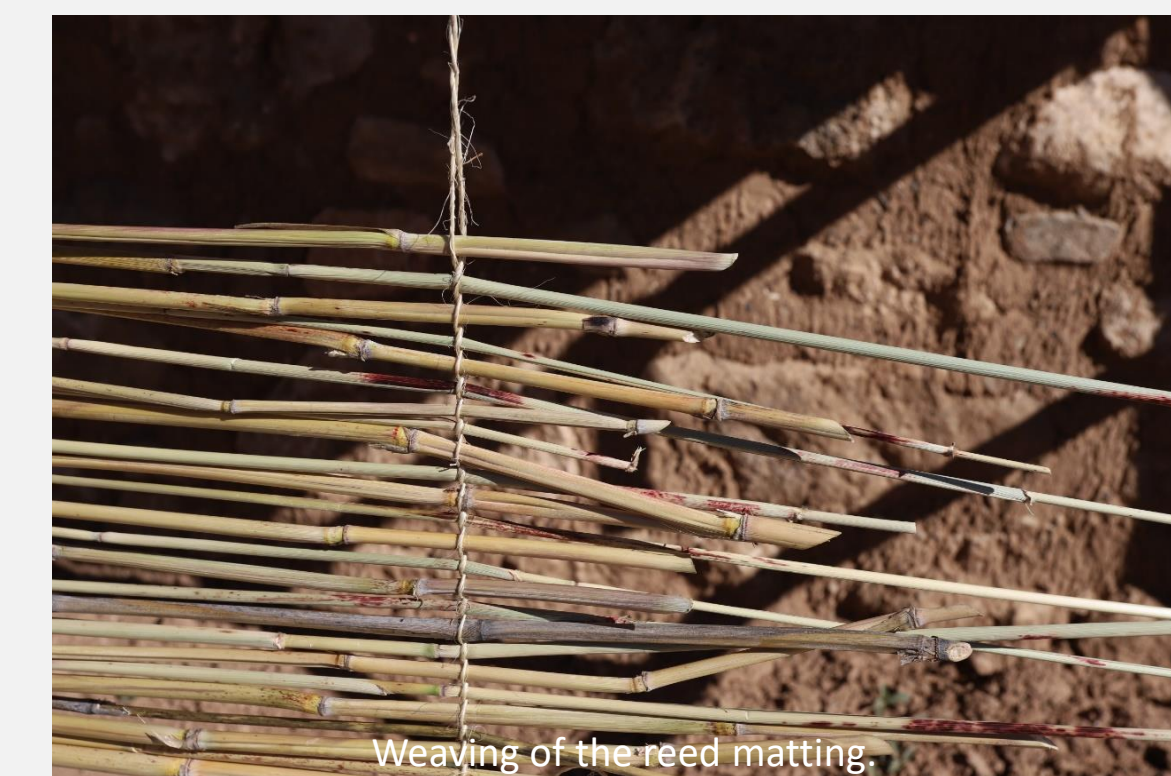
Weaving of the reed matting.

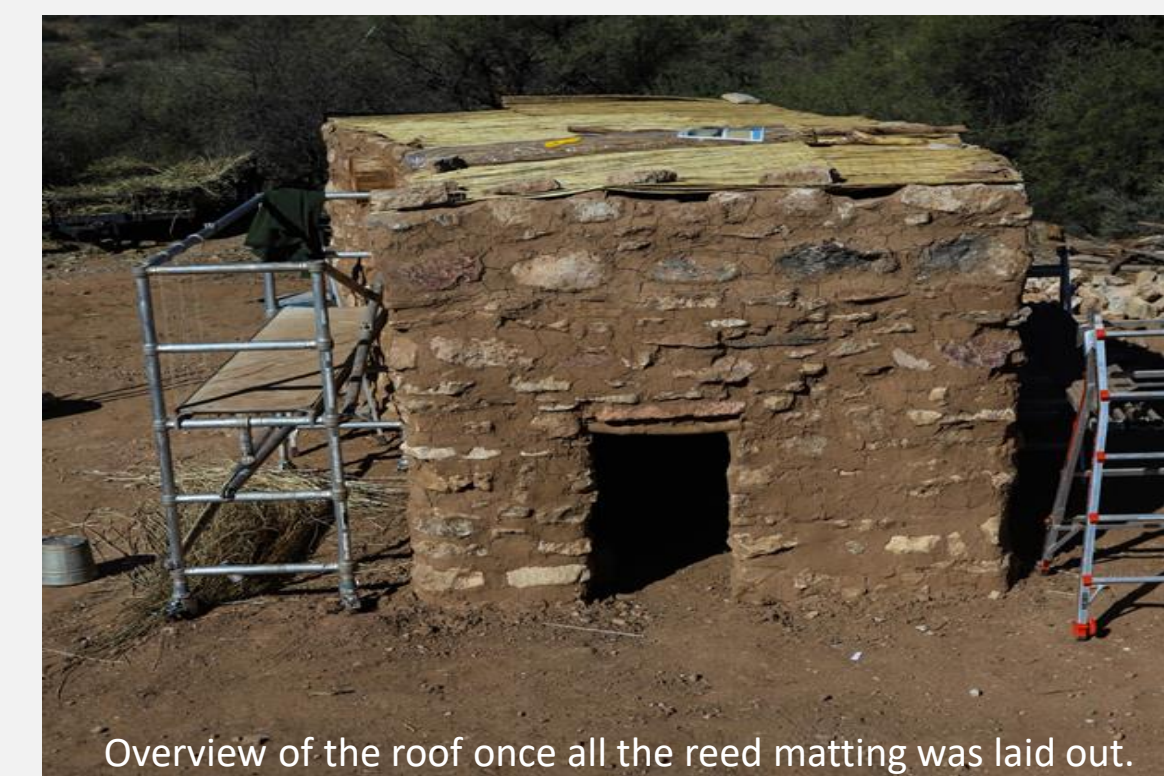
Overview of the roof once all the reed matting was laid out.

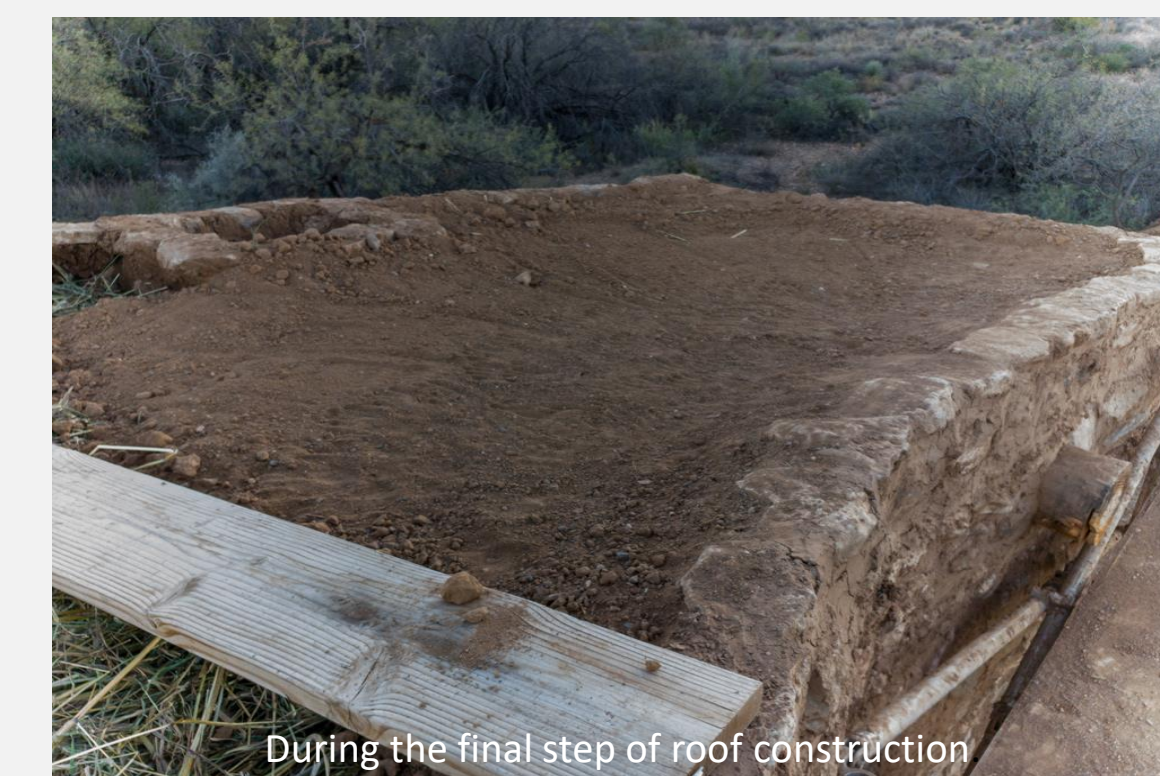
During the final step of roof construction.

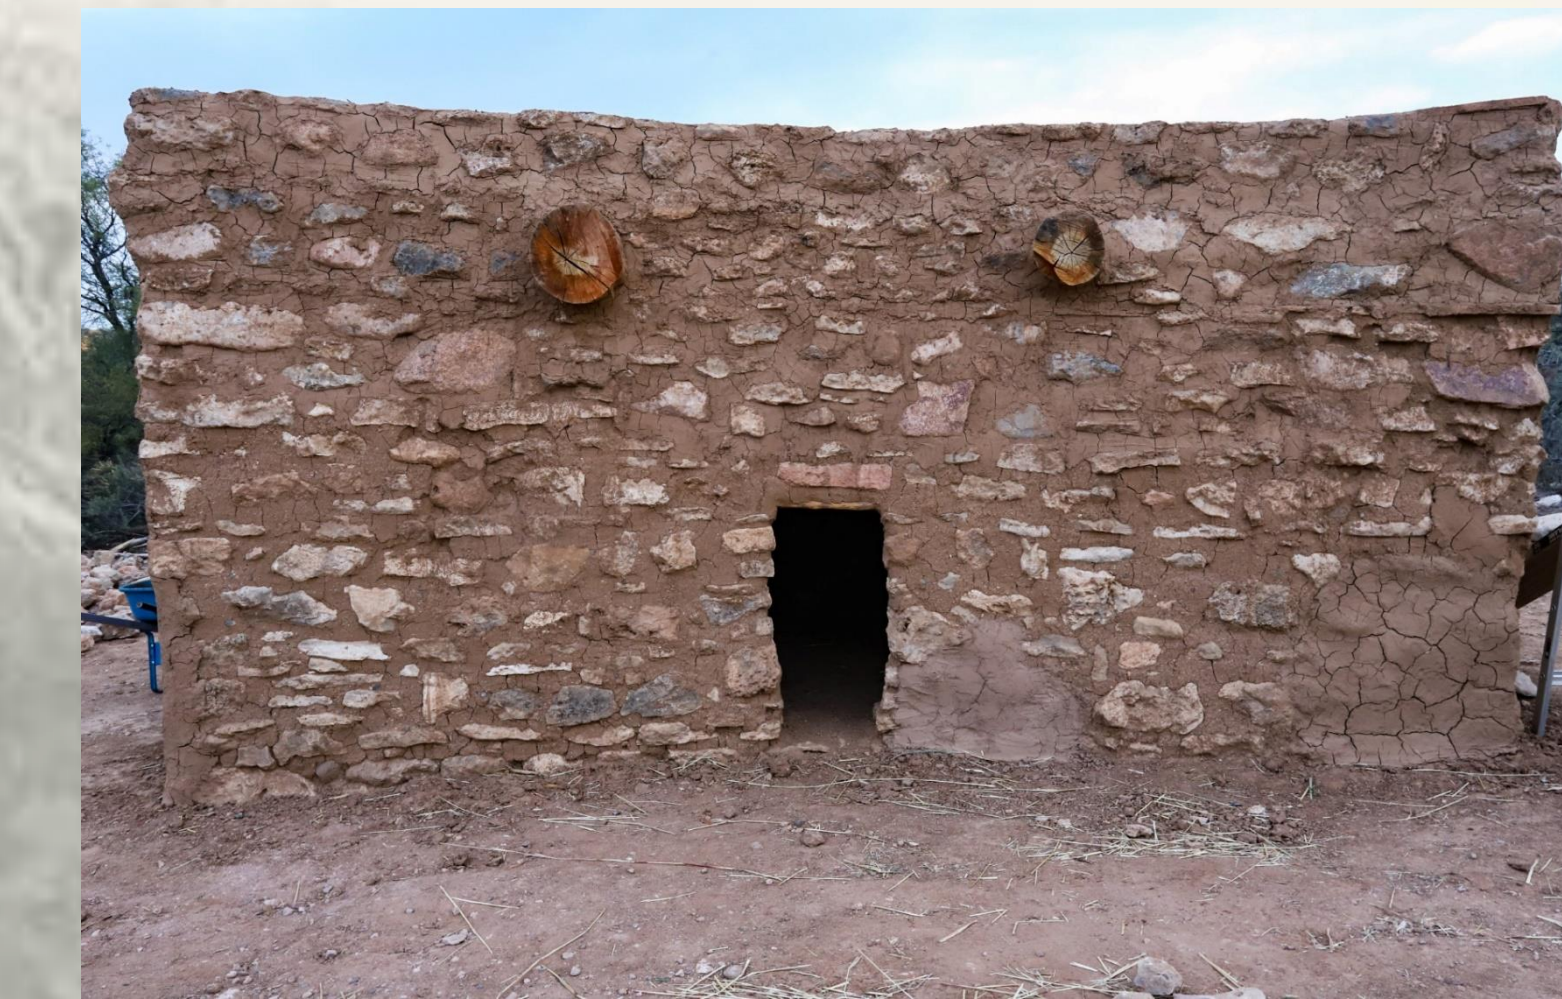
Prior to any plastering, many tests were conducted. Notice the two test patches at the east side of the entrance and at the corner.

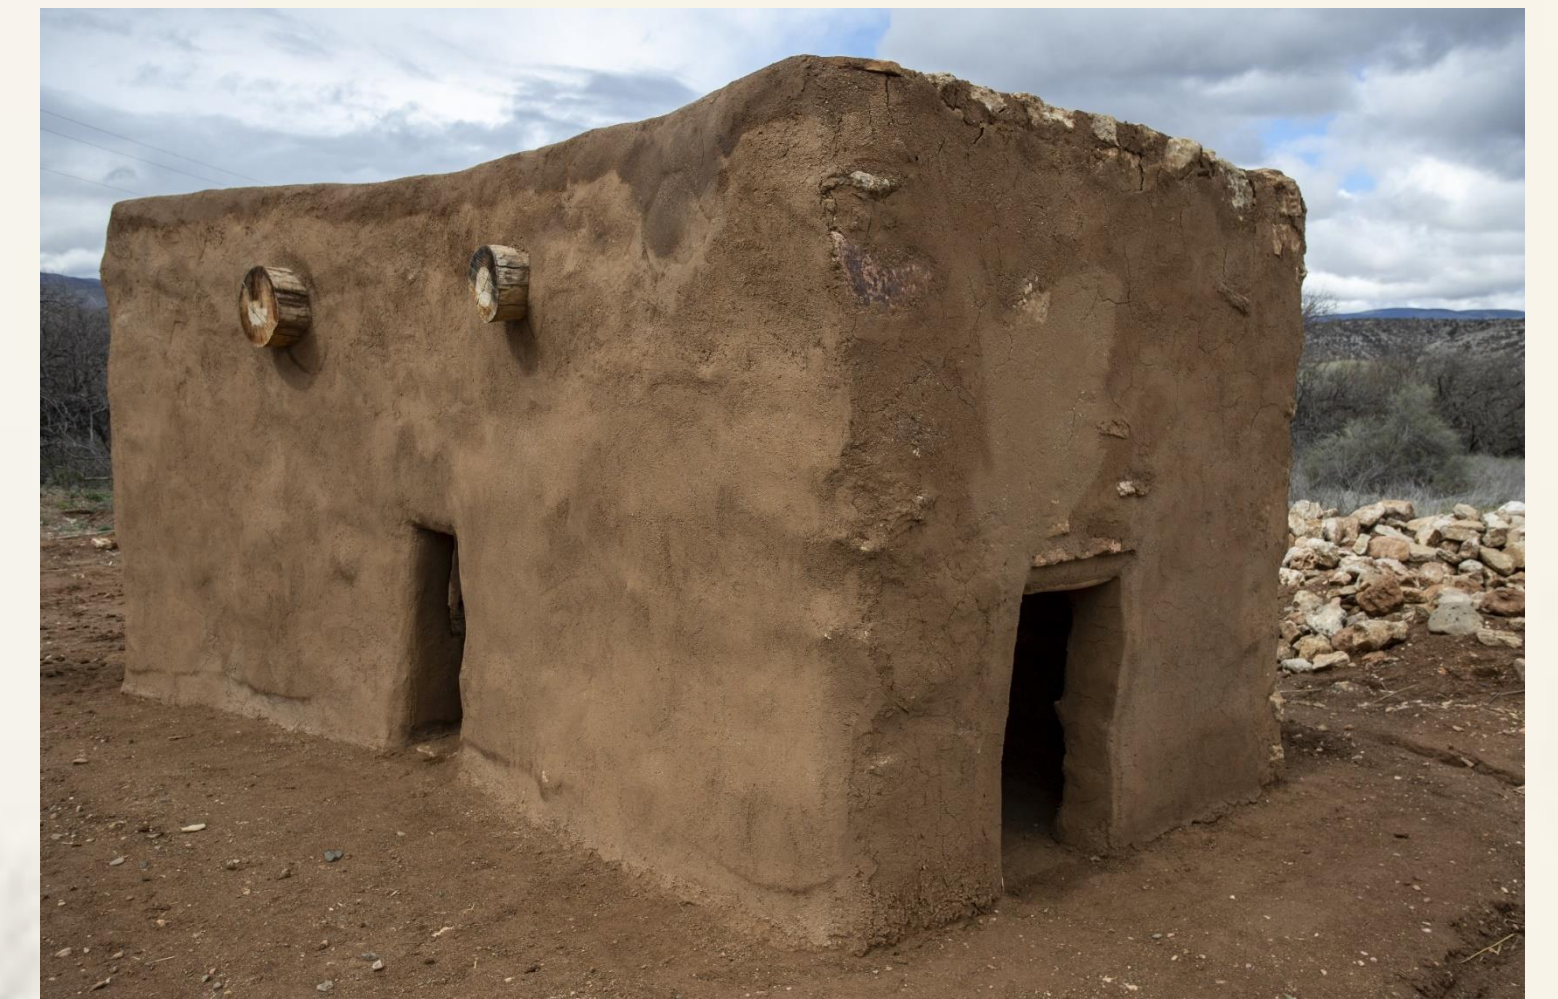
After the final layer of finishing plaster was applied.

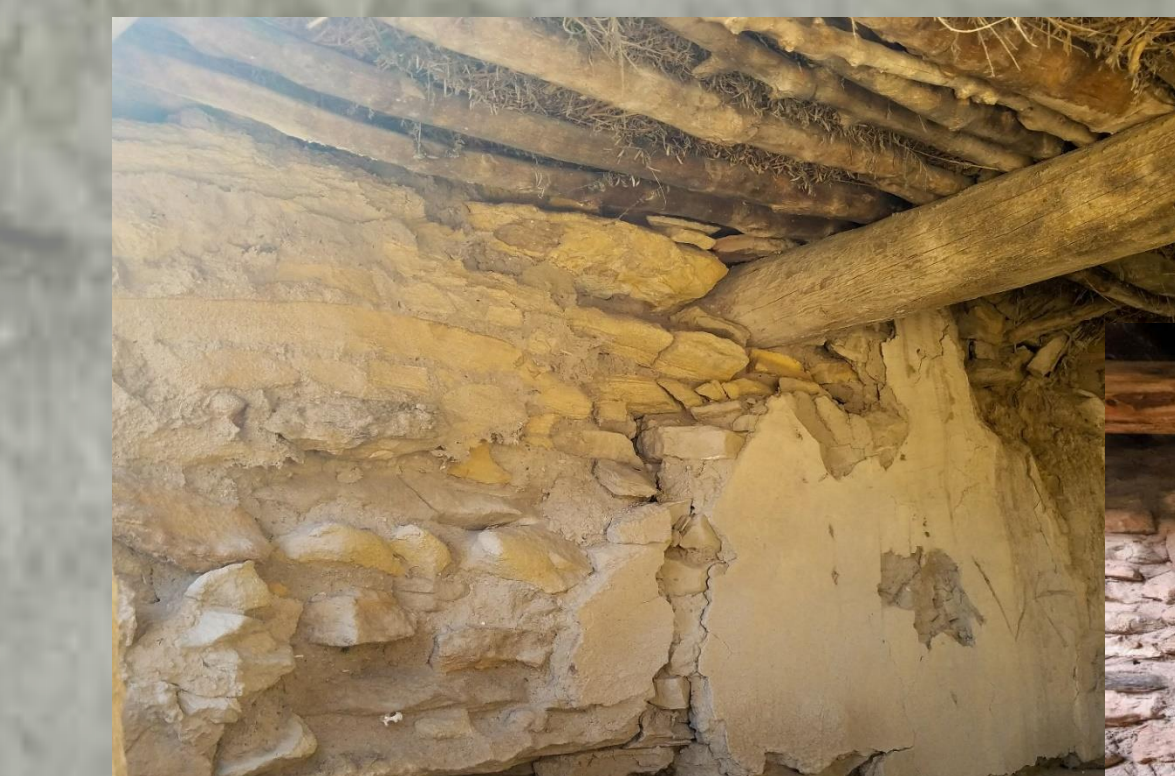
The masonry construction from a room at Hopi.

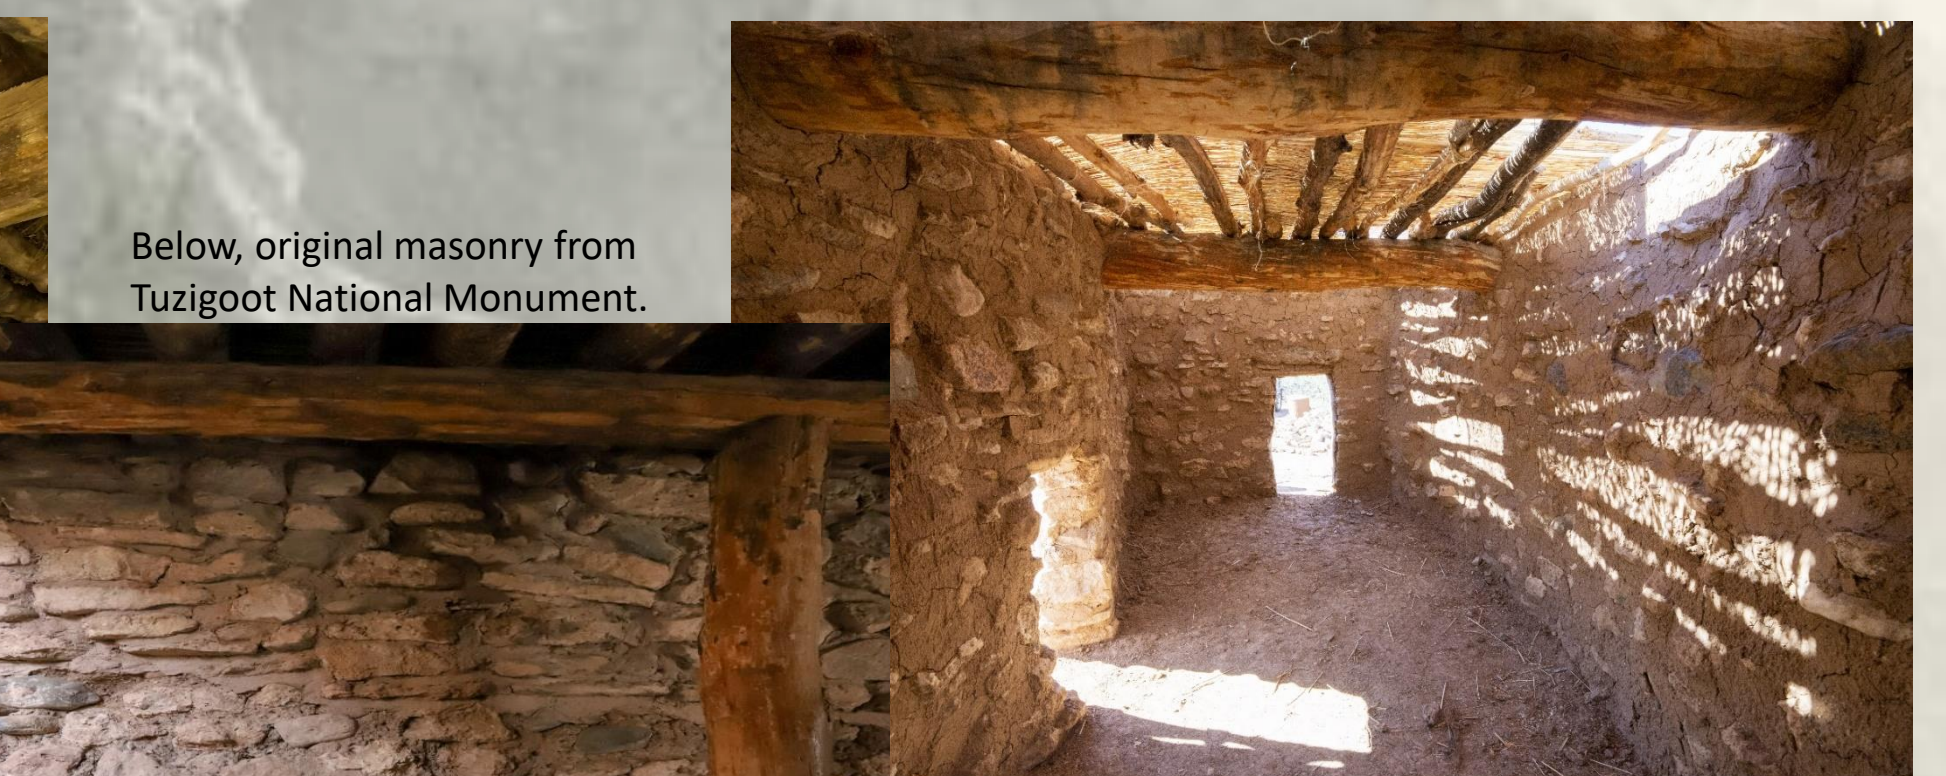
Masonry from the replica room.

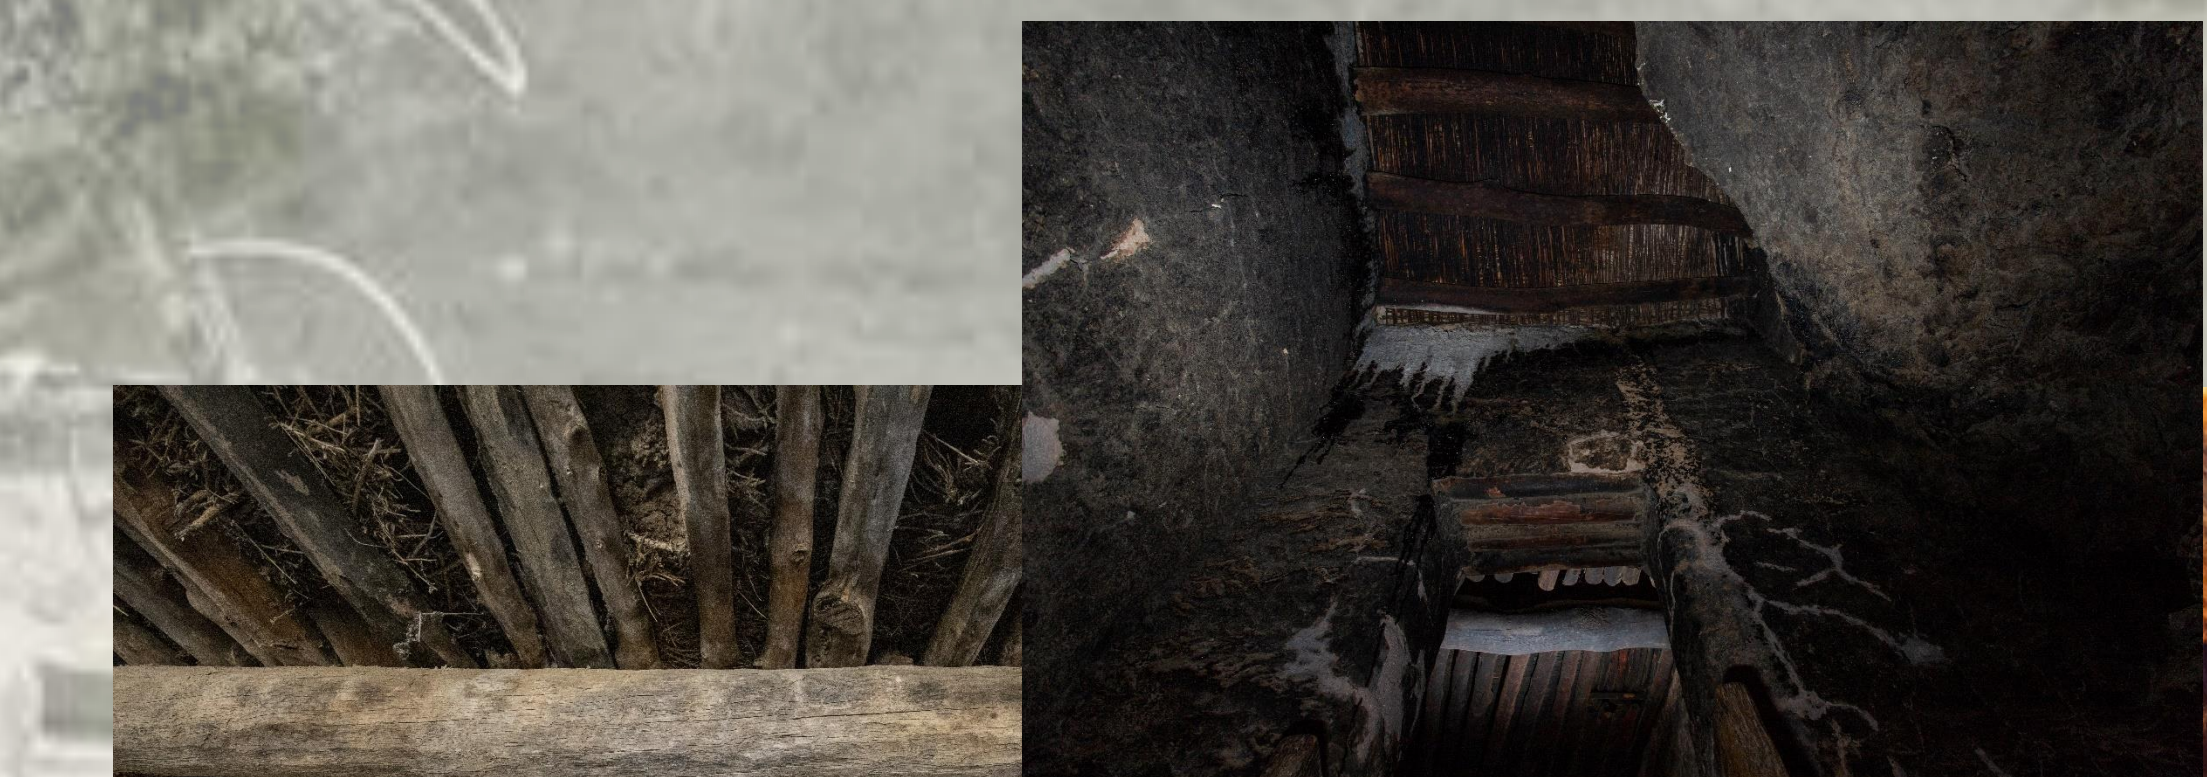
The traditional roof construction out at Hopi.

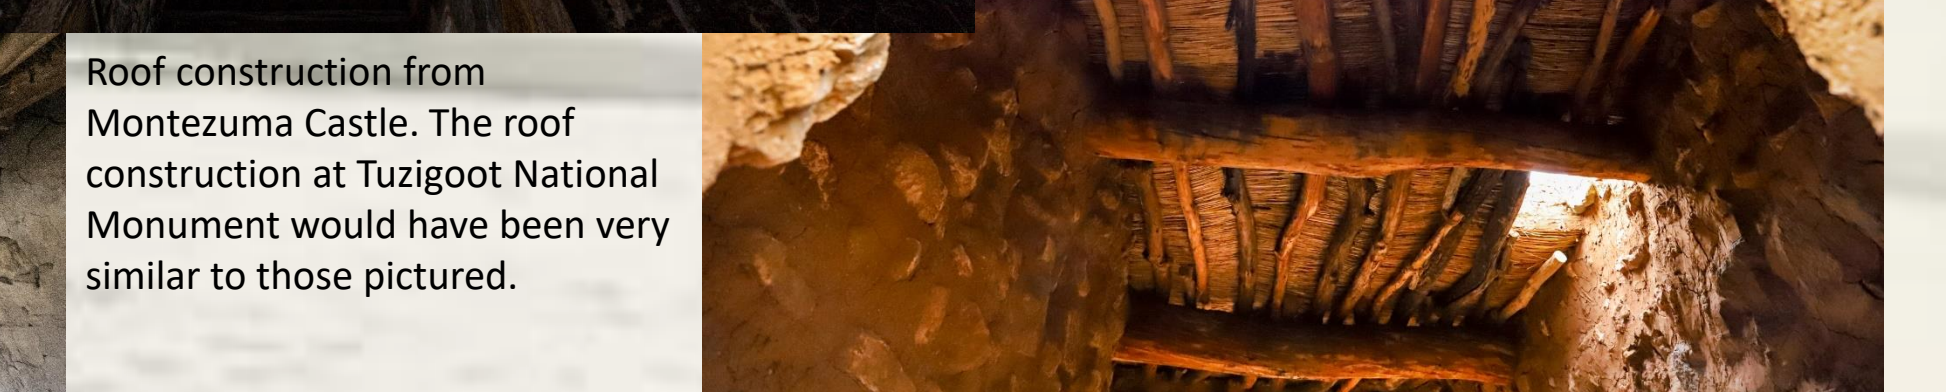
Roof construction from Montezuma Castle. The roof construction at Tuzigoot National Monument would have been very similar to those pictured.
