Analysis and Evaluation

Comparative Analysis of Existing and Historic Conditions

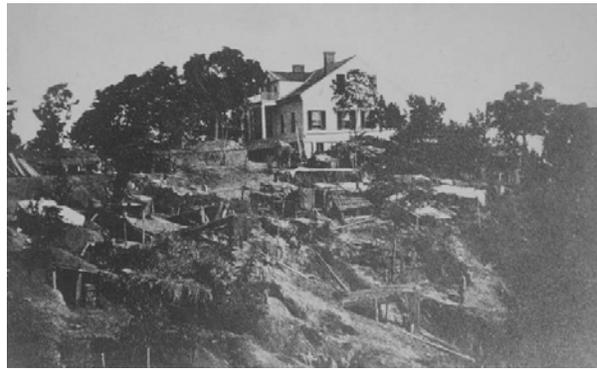
FIGURE 184. Shirley House shebangs, looking northeast, 1863. During the Civil War siege of Vicksburg, artillery shelling was a constant fact of life. Union soldiers camped near the Third Louisiana Redan established tent sites by digging into the hillside near the Shirley House.

FIGURE 186. The same view, 2007. The historic view in Fig. 184 was compared with similar later views, Fig. 185 and Fig. 186. The later views indicate that evidence of the shebangs does not survive, and that woody vegetation obscures the viewpoint of these features.

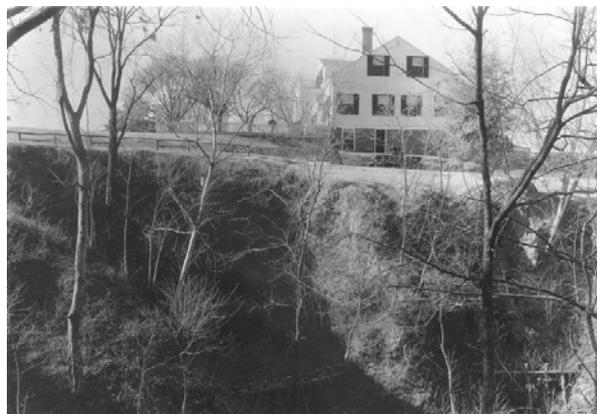
FIGURE 185. A similar view, 1935. Note the erosion control measures in place on the steep slope in the foreground.

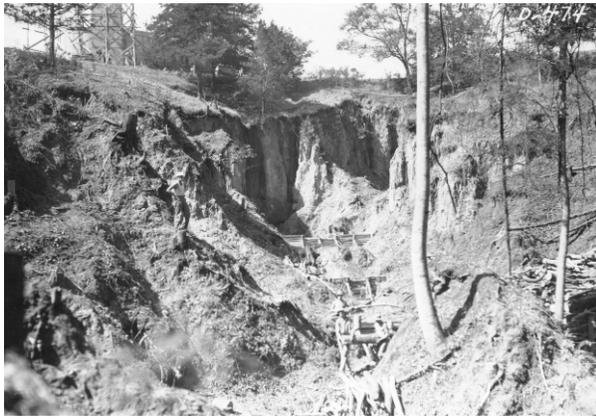
FIGURE 187. View looking northwest toward the Missouri State Memorial of slope erosion, October 11, 1934.

FIGURE 189. View looking northwest toward the Missouri State Memorial showing completed slope, November 7, 1935. These 1930s photographs illustrate the filling, grading, and sodding efforts conducted by the CCC. These images are an example of the many similar efforts conducted in numerous locations around the park at the time to correct erosional problems threatening roads and monuments. Agricultural activities had led to a lack of vegetative cover to protect against the loss of soil due to overland flow of stormwater. The CCC worked to protect the soil from further erosion through filling, grading, and sodding.

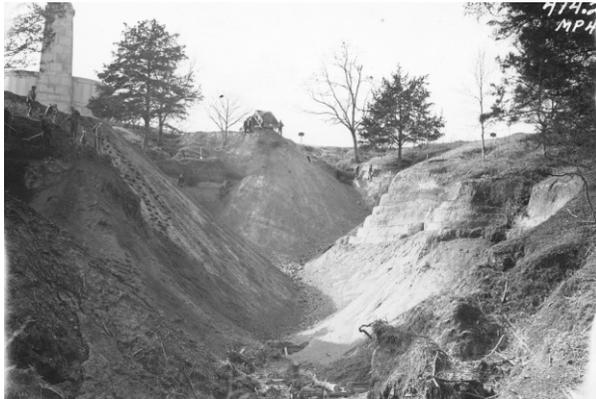
FIGURE 188. View looking northwest toward the Missouri State Memorial of filling operations, February 1935.

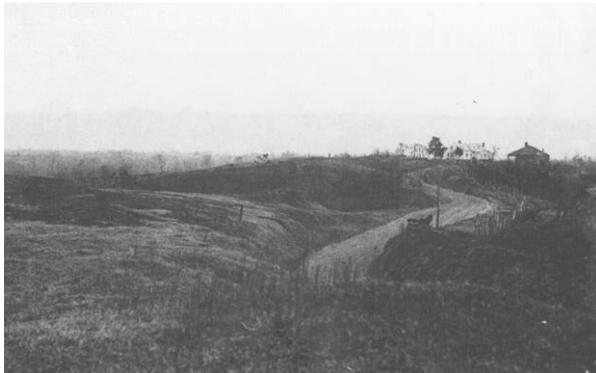
FIGURE 190. View looking northeast from the Third Louisiana Redan toward the Shirley House, circa 1899. This photograph predates construction of the Illinois State Memorial, which was dedicated in 1906. It indicates the existence of Jackson Road and the Shirley House at the time.

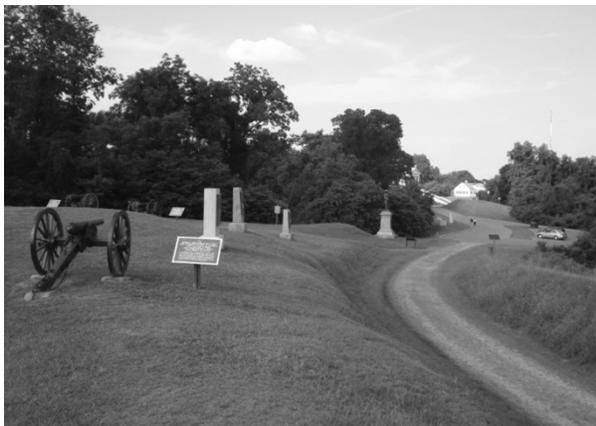
FIGURE 192. The contemporary view indicates the addition of cannon, tablets, and monuments marking the Civil War events that occurred in this area. A hard-packed earth road in the historic view, Jackson Road is paved in the 2007 view. Although partially visible due to tree cover, the Illinois State Memorial can be seen in the center of the historic photograph.

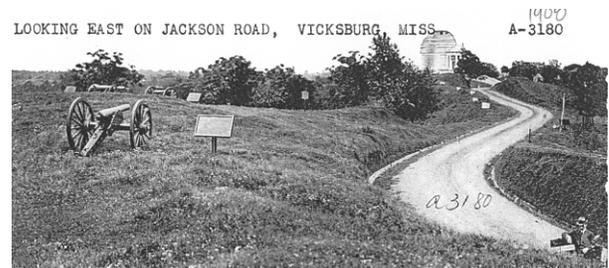
FIGURE 191. A similar postcard view from the vicinity of the Third Louisiana Redan, 1908. This view shows the historic site after construction of the Illinois State Memorial and the placement of tablets and cannon.

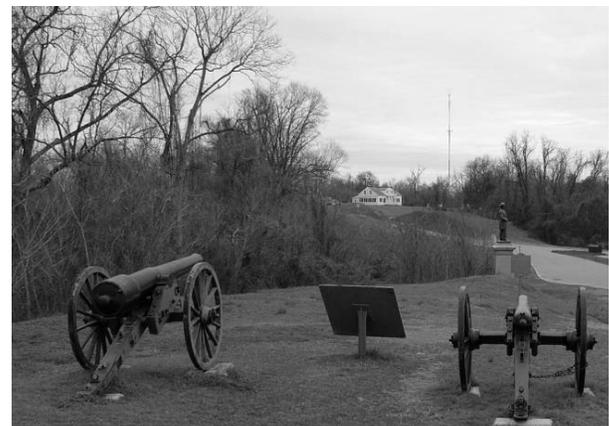
FIGURE 193. Comparison with a similar view in 2007 indicates that a parking area has been added below the redan and tree cover is far more extensive in 2007 than it was historically.

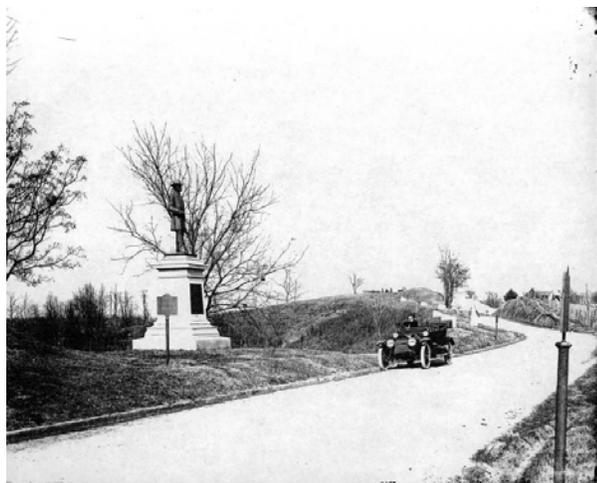
FIGURE 194. View looking northeast along Jackson Road toward the Illinois State Memorial, circa 1912.

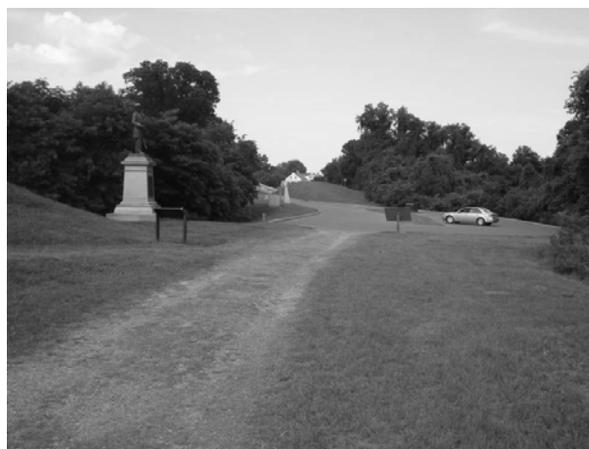
FIGURE 195. The same view, 2007. These two views indicate that the road corridor pavement has been altered, and the degree of the tree cover between the monument shown and the Shirley House in the background has increased.

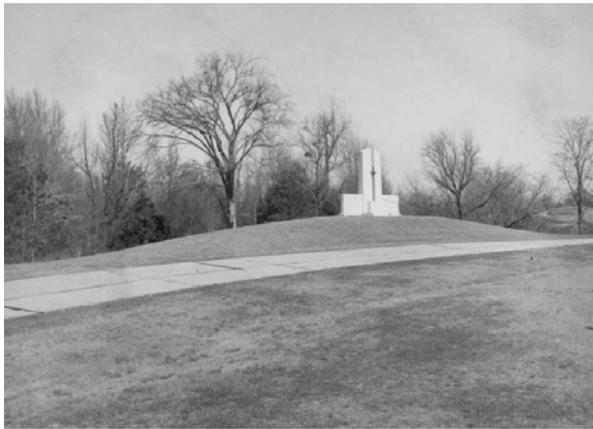
FIGURE 196. View looking north along Confederate Avenue toward the Arkansas State Memorial, circa 1950s. This photograph of the road corridor after construction of the memorial in 1954 shows the historic concrete road surface and a view to the memorial.

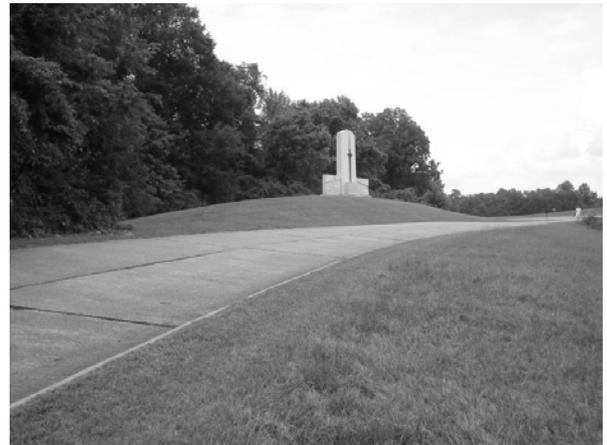
FIGURE 197. A similar view photographed in 2007 indicates that the scene remains much the same, although once again the degree of tree cover behind the monument is greater in 2007 than in the historic photograph.

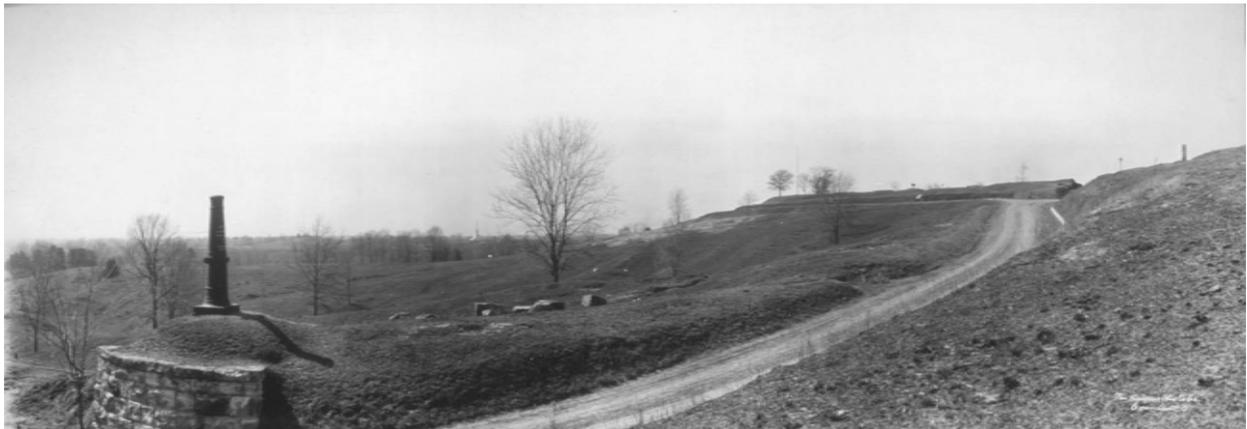
FIGURE 198. View west from the Surrender Interview site along Pemberton Avenue, circa 1910.

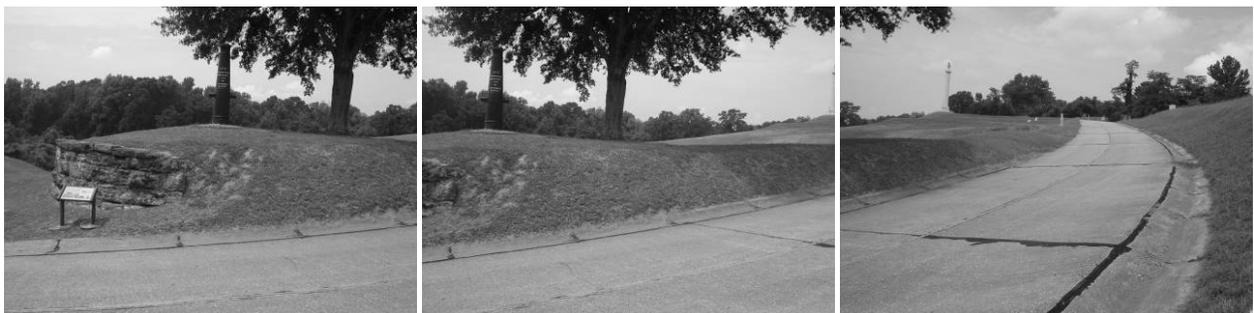
FIGURE 199. The same views, 2007. Comparison of the images indicates that regrading was conducted in this area after the 1910 image was taken. Images of the CCC efforts to correct erosion at the park show the work that was conducted along Pemberton Avenue to correct erosion at its intersection with Confederate Avenue. Comparison of these two images reveals that the Louisiana State Monument had not yet been constructed. A circle drive referred to as Louisiana Avenue is known to have afforded visitors the opportunity to view the monument from all sides between construction of the monument in 1920 and the CCC regrading effort that changed the intersection of the circle, Pemberton Avenue, and Confederate Avenue.

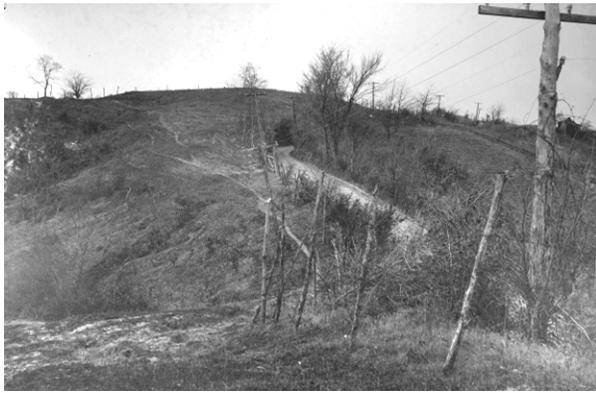
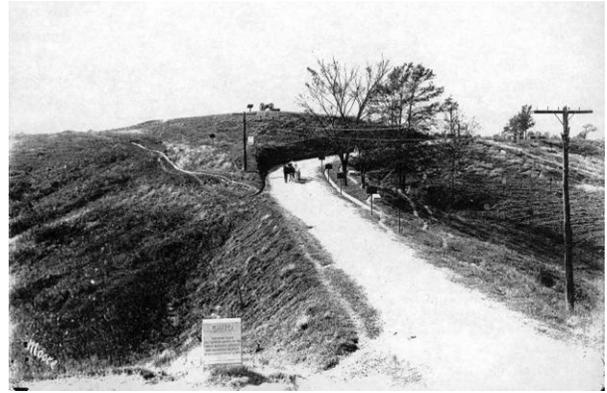
FIGURE 200 and FIGURE 201. Views west along Graveyard Road toward Stockade Redan, 1899 and circa 1908. These two historic views of Graveyard Road looking west toward Stockade Redan illustrate the landscape during the early park development period.

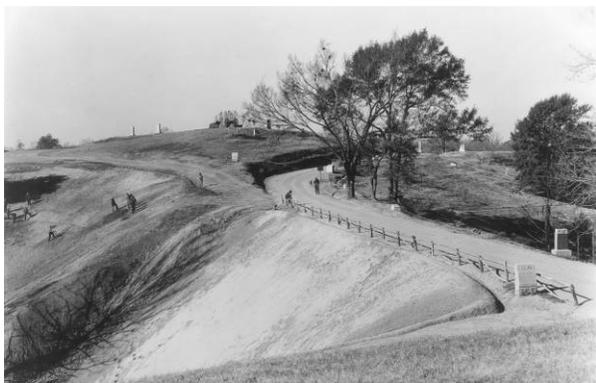
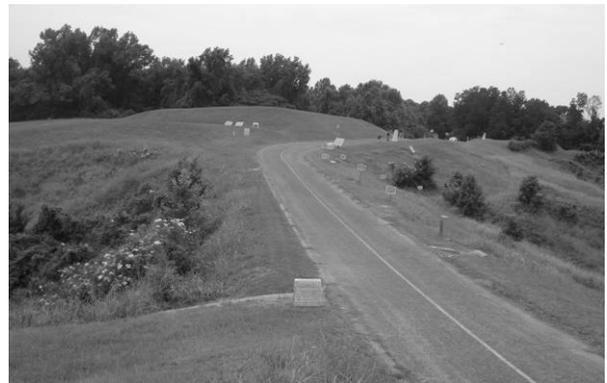
FIGURE 202 and FIGURE 203. A similar view, 1935 and 2007. The image at left shows this location during the Civilian Conservation Corps (CCC) period. The images illustrate the character of Graveyard Road as it evolved from a hard-packed earth road to a paved road corridor. These images indicate that severe erosion along the road margins was corrected by CCC filling and regrading efforts. Telephone poles visible in the 1908 view had been removed by the 1930s. Rustic wooden guard rails installed during the 1930s are also now gone, as are trees that once edged the road to its north. Woody vegetation in the background of the photographs is far more extensive in 2007, however.

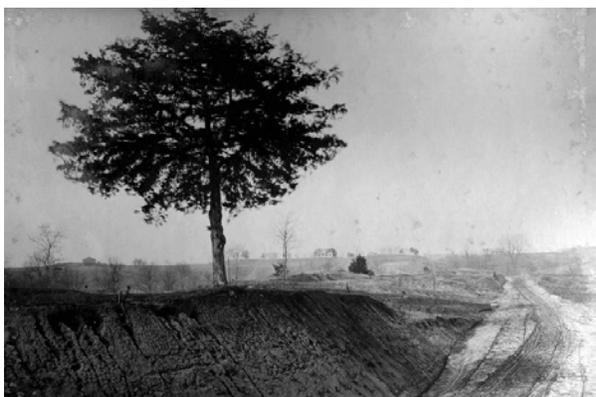
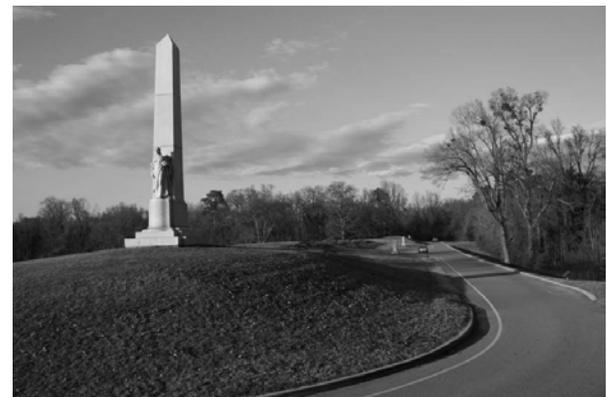
FIGURE 204 and FIGURE 205. Left: View looking north along Union Avenue of the site of Battery De Golyer, circa 1902. The historic image illustrates the open character of the landscape, with exposed earth undergoing erosion in the foreground, Battery De Golyer and a few trees scattered in the middle ground, and the Shirley House and another unidentified building in the background. Right: The same view, 2007. In the contemporary view, a tree growing in the foreground has been replaced with the Michigan State Memorial, Union Avenue has been paved with asphalt, curbing occurs along the downhill sides of the road to conduct stormwater, and the earthen slopes are protected under turf grass. Battery De Golyer is still visible in the middle ground. Heavy tree cover has grown up in the background and to the east of the road corridor, obscuring the historic view of the Shirley House.

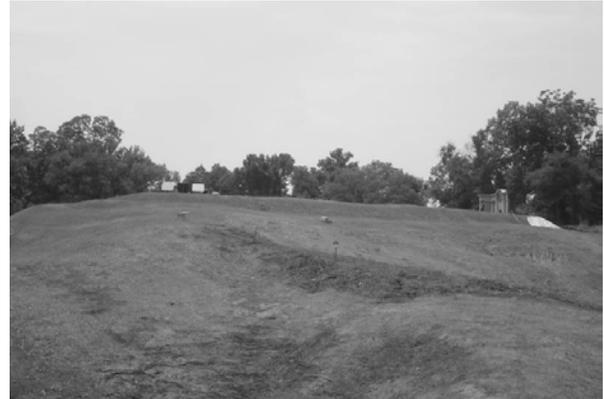
FIGURE 207. The same view, 2007. The redoubt survives, continues to be associated with a series of tablets and monuments, and can be viewed across open ground from a nearby road corridor. Recently cleared of woody vegetative cover, the landcover fronting the redoubt appears to be in the process of stabilizing as turf grass becomes established over the area cleared of trees. Evidence of recent erosion is present in the photograph, however. Tree cover behind the earthwork is more extensive today than in the historic photograph.

- The Old Administration Building along Pemberton Avenue was formally planted with trees and shrubs around the parking area and building foundation.
- Ornamental and shade plantings of trees and shrubs are associated with the 1968–1970 visitor center.
- Battlefield restoration during the late twentieth and early twenty-first century has focused on removing woodland cover in association with important fieldworks and their fields of fire (Fig. 206 and Fig. 207).

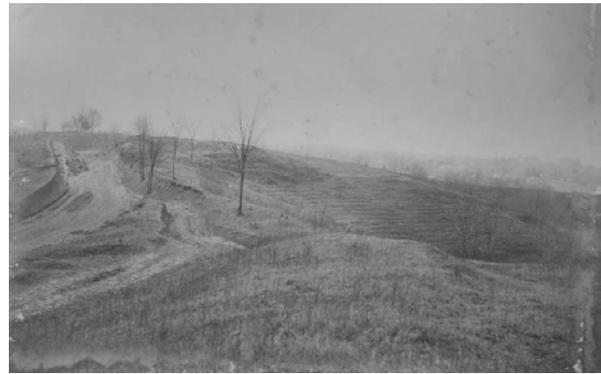
FIGURE 208. View looking southwest from the Illinois State Monument toward the Third Louisiana Redan, circa 1900. The historic image predates construction of the Illinois State Monument. The landscape is almost entirely open in the photograph. Visible is the earthen corridor of the historic Jackson Road and terraced slopes that likely indicate agricultural use of the ridgeline.

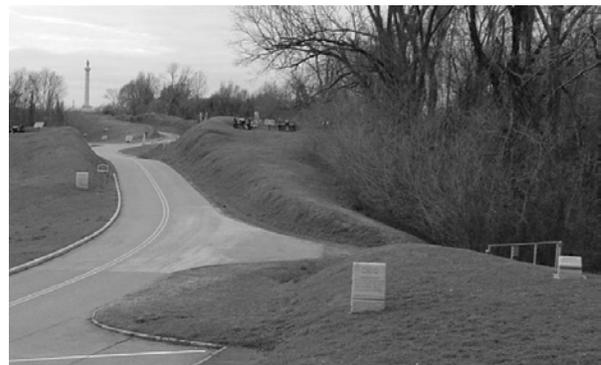
FIGURE 209. The same view, 2007. The contemporary view indicates the numerous changes that have occurred within this area of the park, including the paving of Jackson Road, construction of the 1920 Louisiana Monument in the distance, establishment of numerous smaller monuments, markers, and tablets, and an increase in tree cover and turf grasses. The photograph was taken from the steps of the Illinois State Monument, which did not exist at the time the historic photograph was taken.

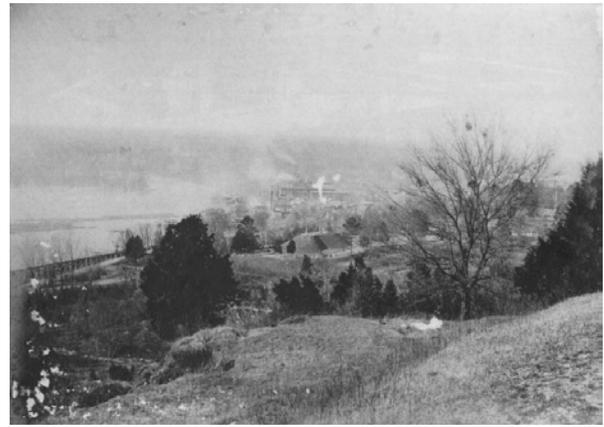
FIGURE 210. View looking north from Fort Hill toward Vicksburg National Cemetery and the Yazoo River Diversion Canal, first decade of twentieth century.

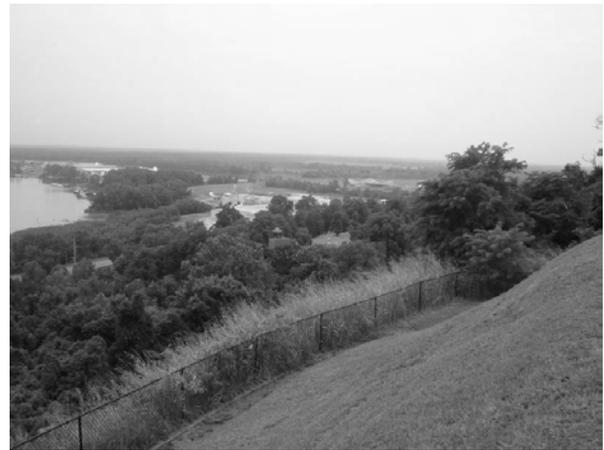
FIGURE 211. A similar view, 2007. Generally, the view continues to include a glimpse of the former river bed, and features of the national cemetery are visible from the elevated landform, but woody growth is far more extensive in 2007 and serves to obscure much of the view.

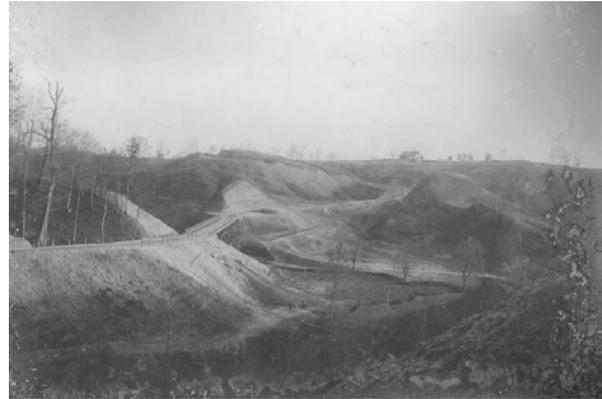
FIGURE 214. View south along Union Avenue and a historic bridge crossing Glass Bayou toward the Shirley House on the ridgeline beyond, circa 1903.

FIGURE 215. The same view, 2007. A comparison of the two images is difficult due to the extent of woody vegetation blocking views of the bridge and Shirley House. The bridge shown in the early photograph was replaced with a contemporary bridge in the 1970s. The Shirley House survives, but is no longer visible from this vantage point.

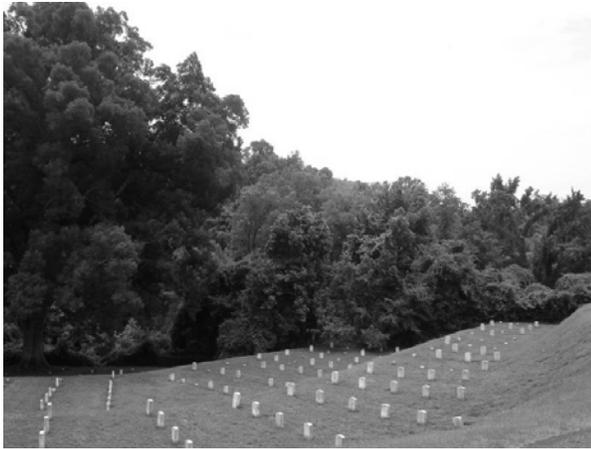
FIGURE 213. A similar view, 2007. The primary change in the landscape since the early twentieth century is the degree of tree cover which obscures the view of the hillside from the mound. The cemetery also appears slightly less manicured and planted with ornamental specimens and flower beds in 2007.

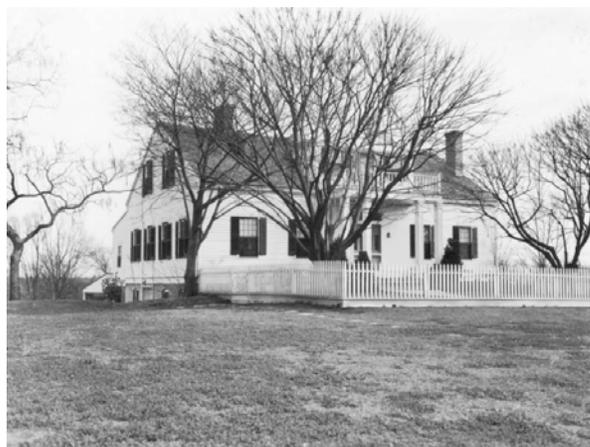
FIGURE 216. The Shirley House, looking northeast, undated, circa 1930s. The historic photograph indicates that the house was formerly surrounded by a wooden picket fence painted white, which was edged by shade and ornamental trees. Turf lawn extended from the house precinct toward Jackson Road.

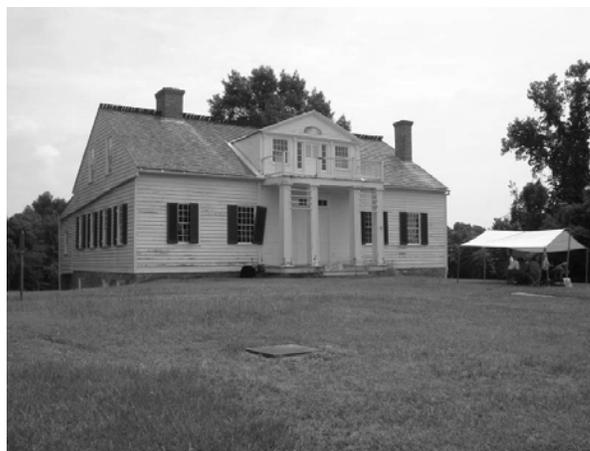
FIGURE 217. The same view, 2007. The fence and shade and ornamental trees are no longer extant, but the turf grass survives.

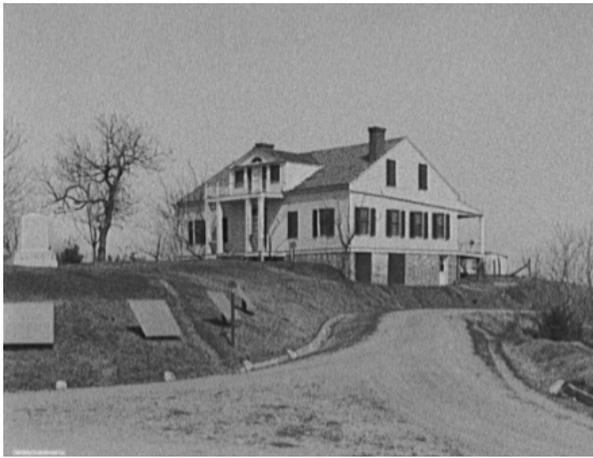
FIGURE 218. The Shirley House, looking northwest, from the intersection of historic Jackson Road and Union Avenue, circa 1910–1920.

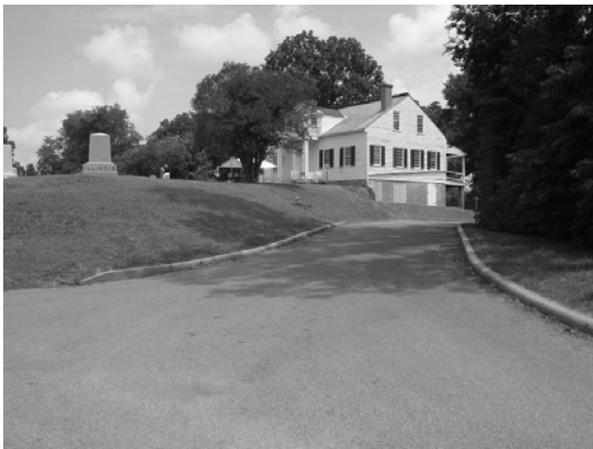
FIGURE 219. The same view, 2007. The 2007 view indicates that removal of the tablets along the road, which occurred in 1942 as part of a World War II metal drive, the changes that have occurred to the road corridor including paving, curbing, and widening, and growth of trees along the right hand side of the road and behind the house since the historic photograph was taken
