CULTURAL LANDSCAPE REPORT
FOR WEIR FARM
NATIONAL HISTORIC SITE

VOLUME II: UPDATED TREATMENT PLAN AND RECORD OF TREATMENT

RIDGEFIELD AND WILTON, CONNECTICUT

Olmsted Center for Landscape Preservation
National Park Service, Boston, Massachusetts, 2013

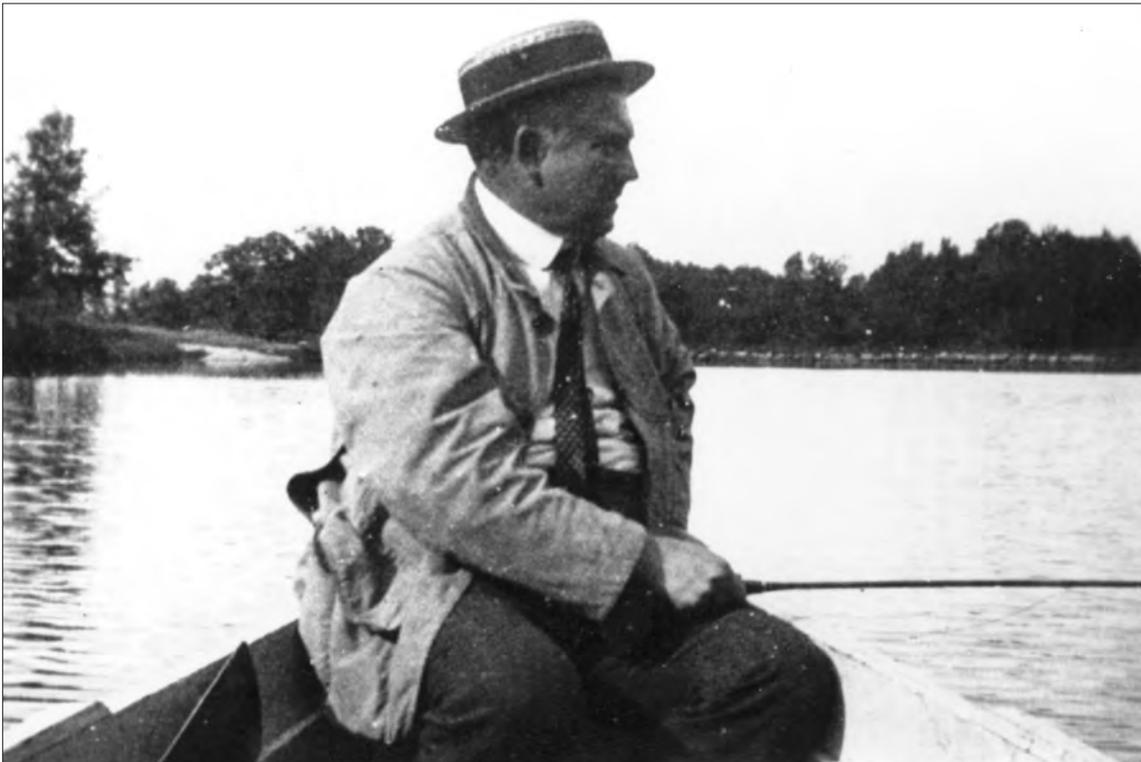
Figure 4. Julian Alden Weir fishing on the pond he had constructed in 1896. A linear band of stones in the background mark the crest of the dam used to retain the pond. View looking north, circa 1900 (WEFA HP 22).

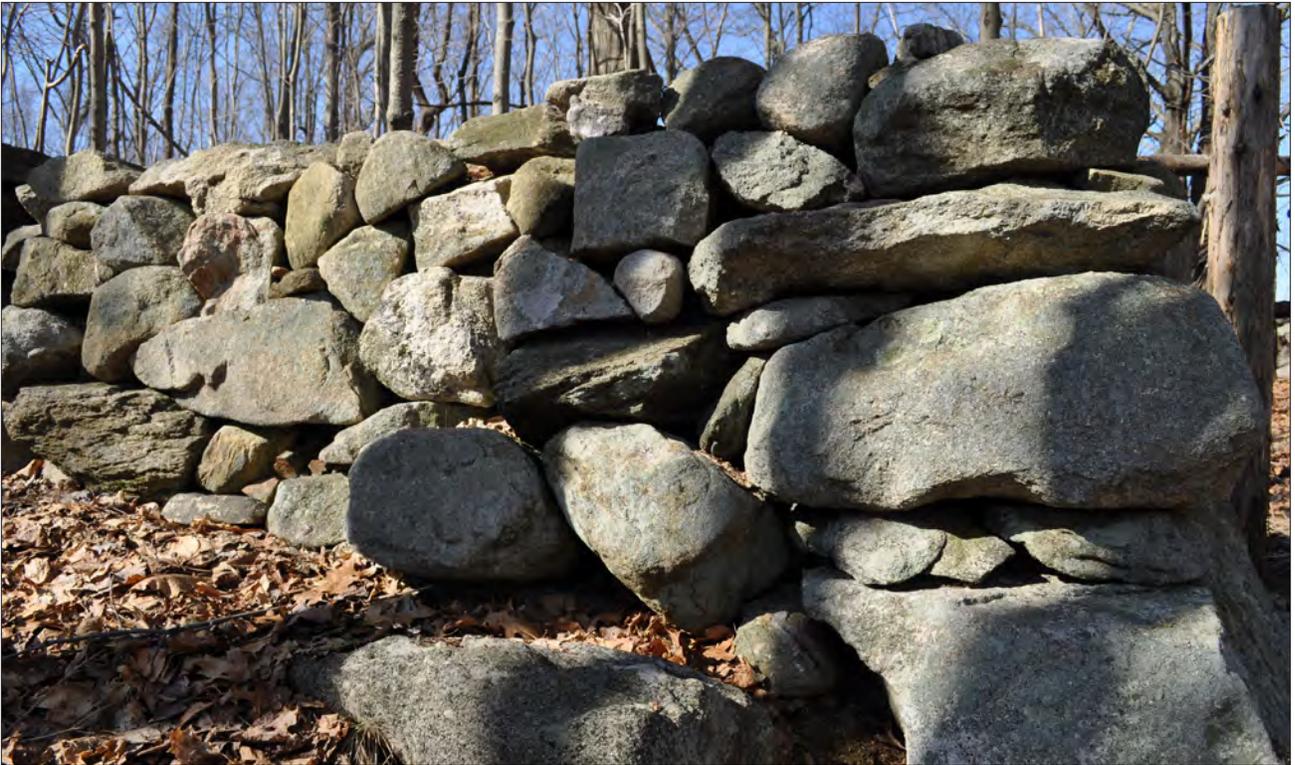
Figure 19. Stone walls to be preserved park wide including the repair of deteriorated sections to match of the character of the existing wall. View looking southwest in the Burlingham Complex, 2010 (OCLP).

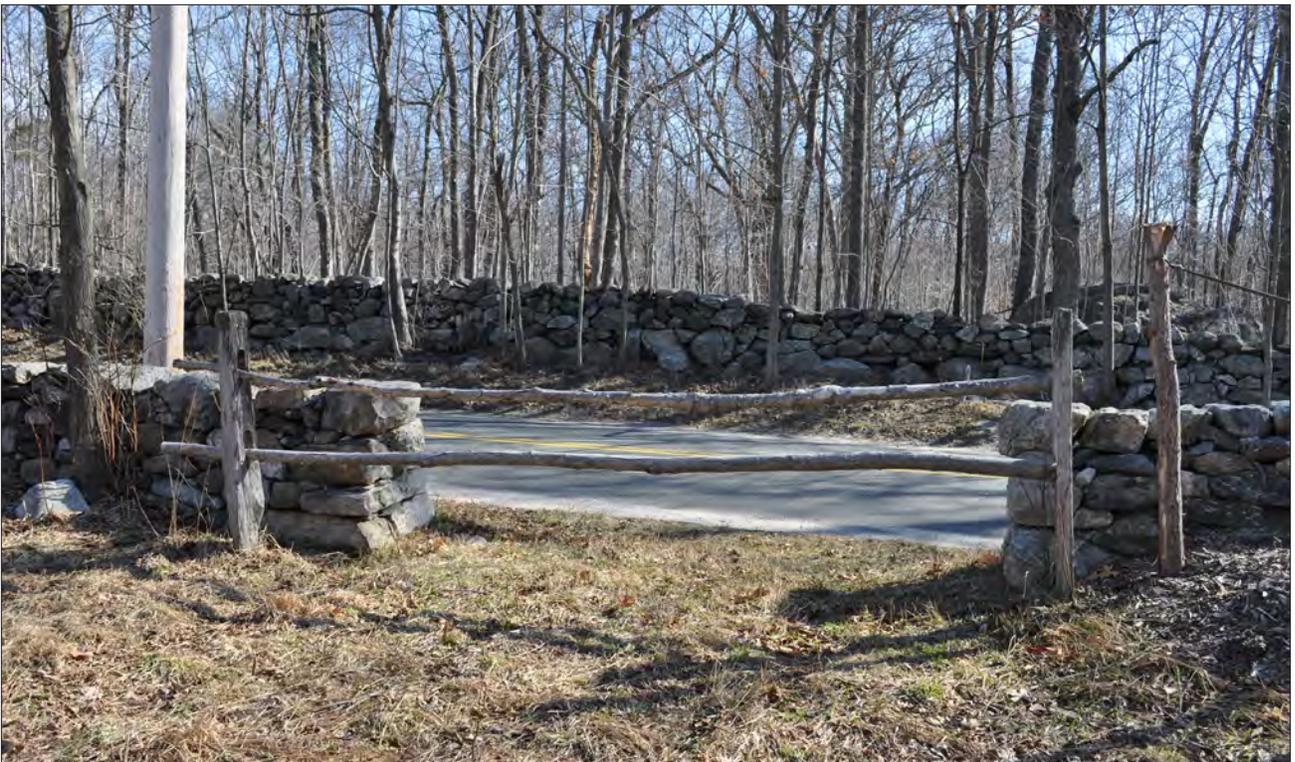
Figure 20. Barway gates to be preserved park wide including replacing in kind deteriorated fence posts, rails, and fixtures. View looking east in the Burlingham Complex, 2010 (OCLP).

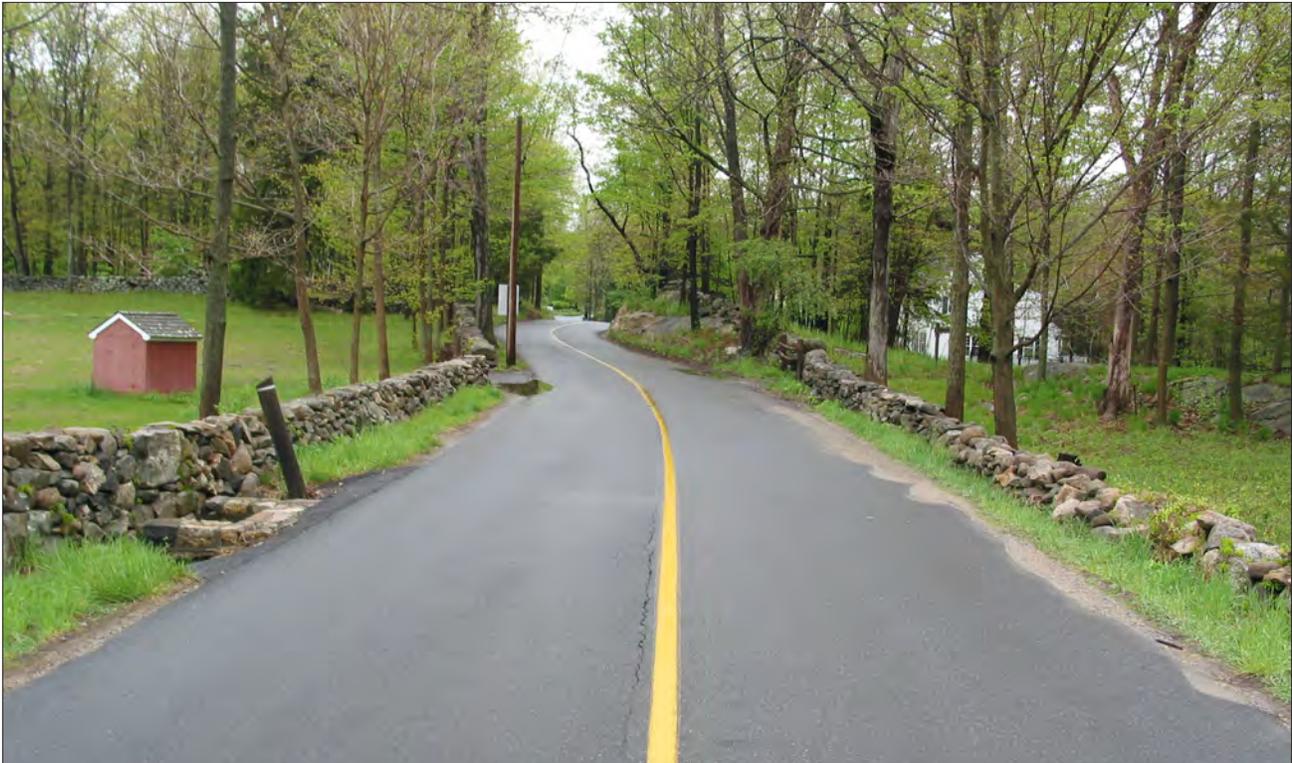
Figure 21. Vegetation character along public roads to be preserved park wide including mature deciduous trees and the lack of manicured vegetation along the road shoulders. View looking north on Nod Hill Road, 2010 (OCLP).

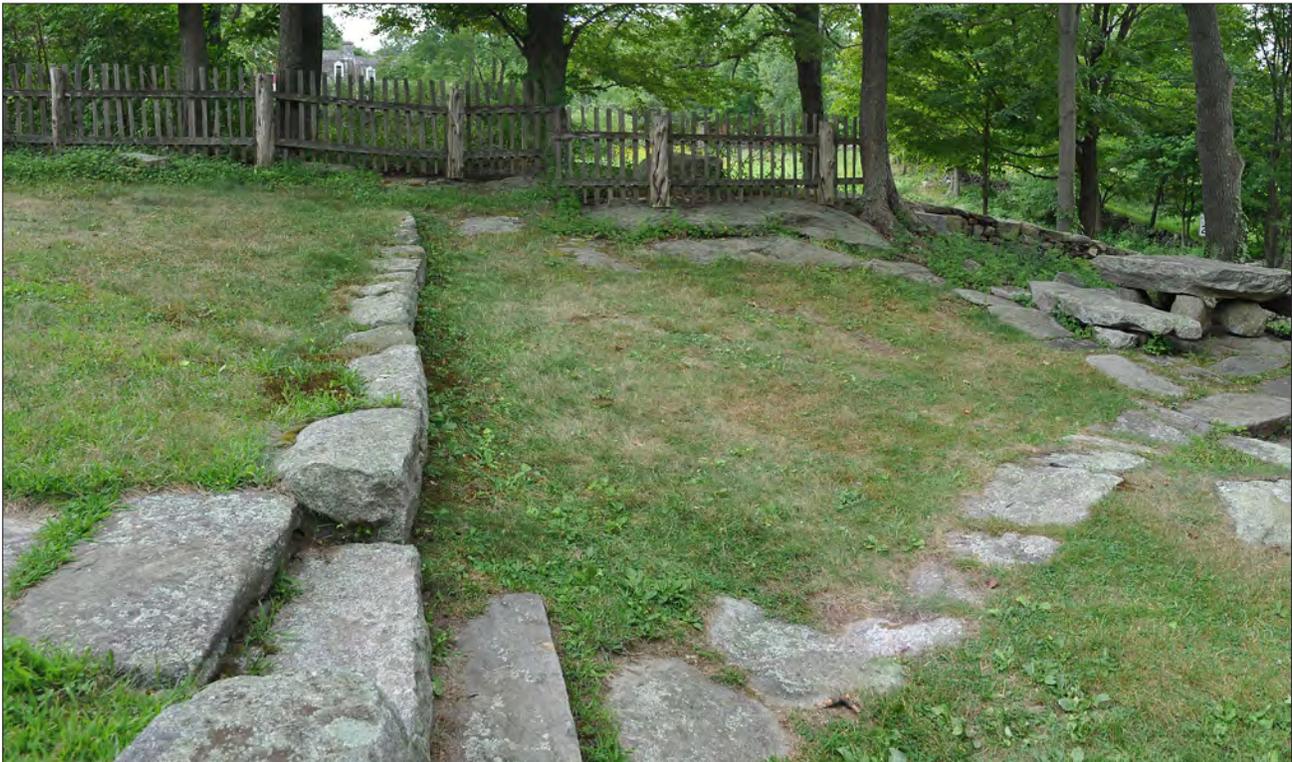
Figure 22. Domestic lawns to be renovated park wide to address conditions such as broadleaf weeds, moss, and shallow soil depth. View looking south from the Weir House, 2011 (OCLP).

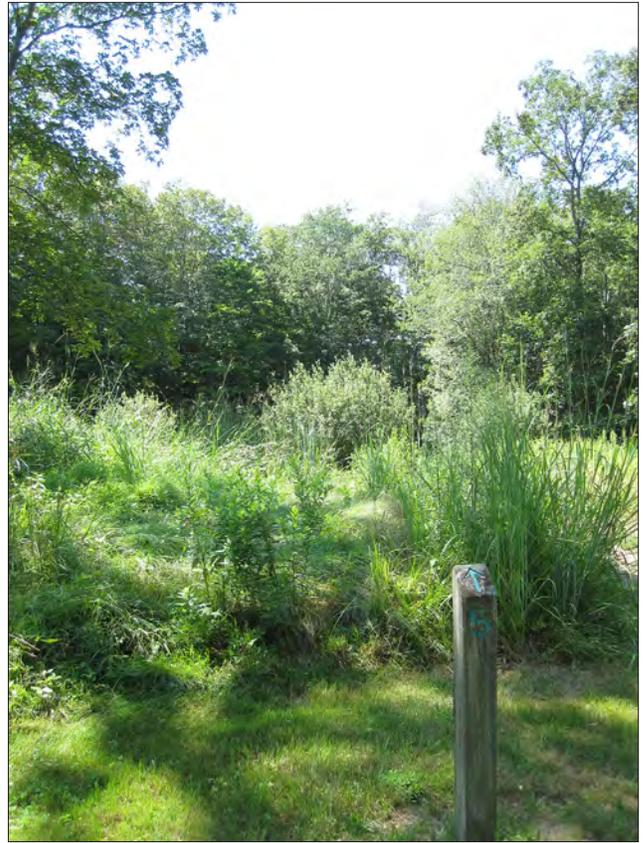
Figure 23. Meadow turf to be rehabilitated park wide. View looking west from painting site #5 toward the Weir Orchard, 2011 (OCLP).

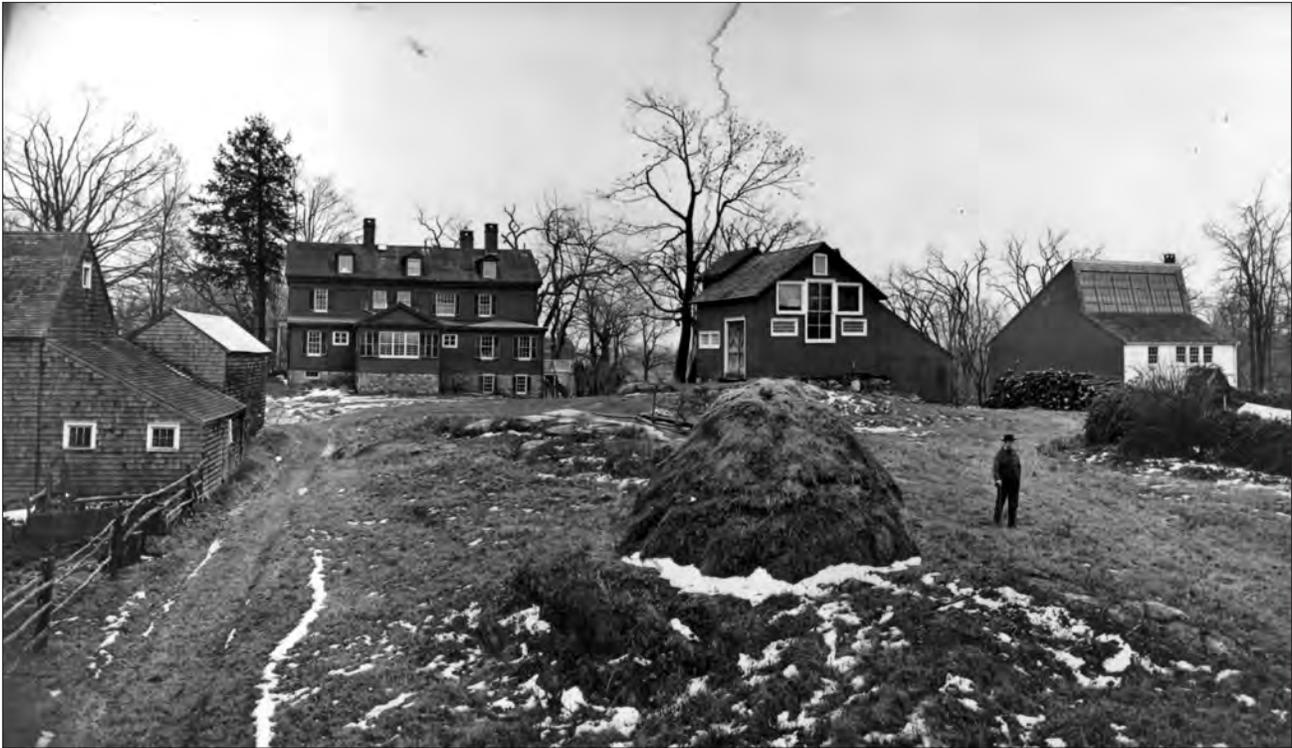
Figure 25. Planking for the deck is visible on a stacked stone wall extending from the Weir Studio, the second building from the right. View looking south from the Chicken House, circa 1942 (WEFA, HP 150).

Two cast iron stoves heated the Young Studio and remained operational in the building when the National Park Service acquired the property.¹⁵ A circa 1942 photograph of the barn, house, and two studios shows firewood neatly stacked and stored between the Weir and Young studios (see Figure 25). Fieldwork performed in 1995 documented an extant wood pile between the two studios but currently, the wood pile is not present.

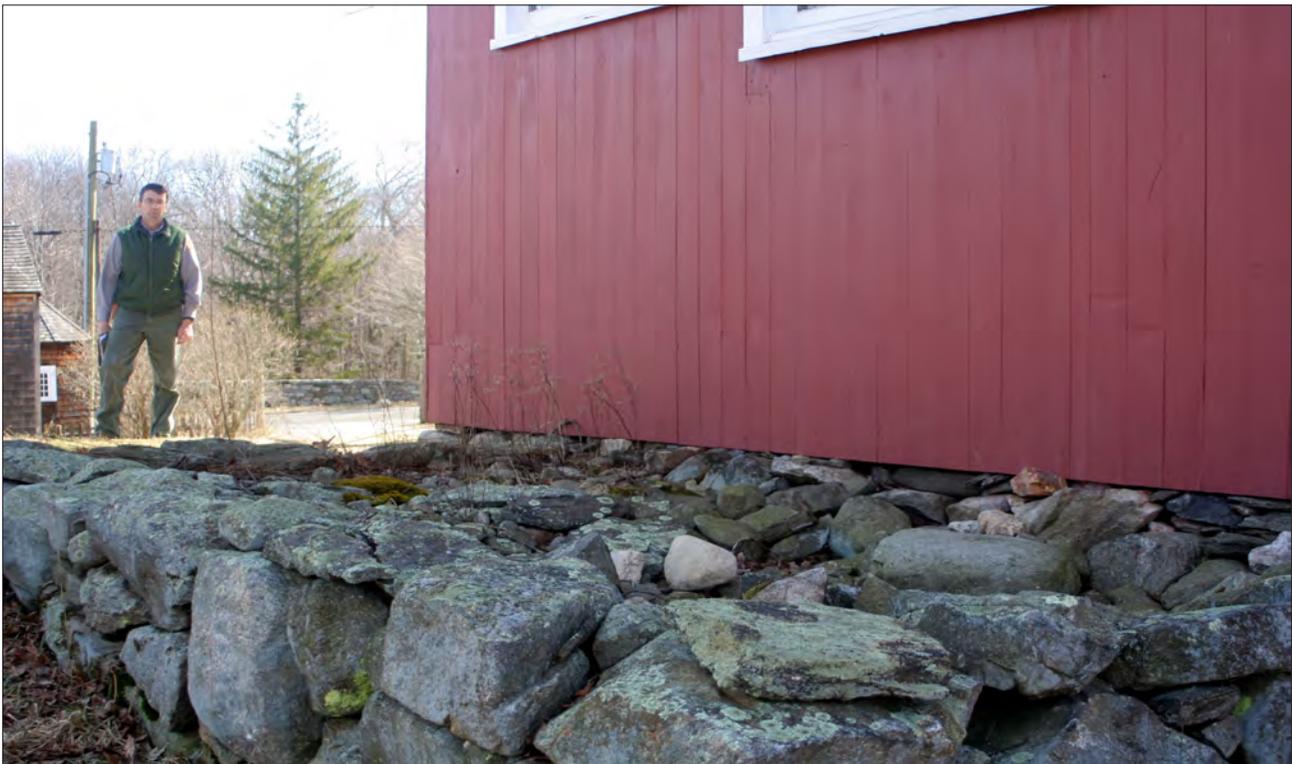
Figure 26. Weir Studio deck to be restored including resetting loose stones, adding wood joists on top of the stone base, and attaching decking to the joists. View looking southeast, 2010 (OCLP).

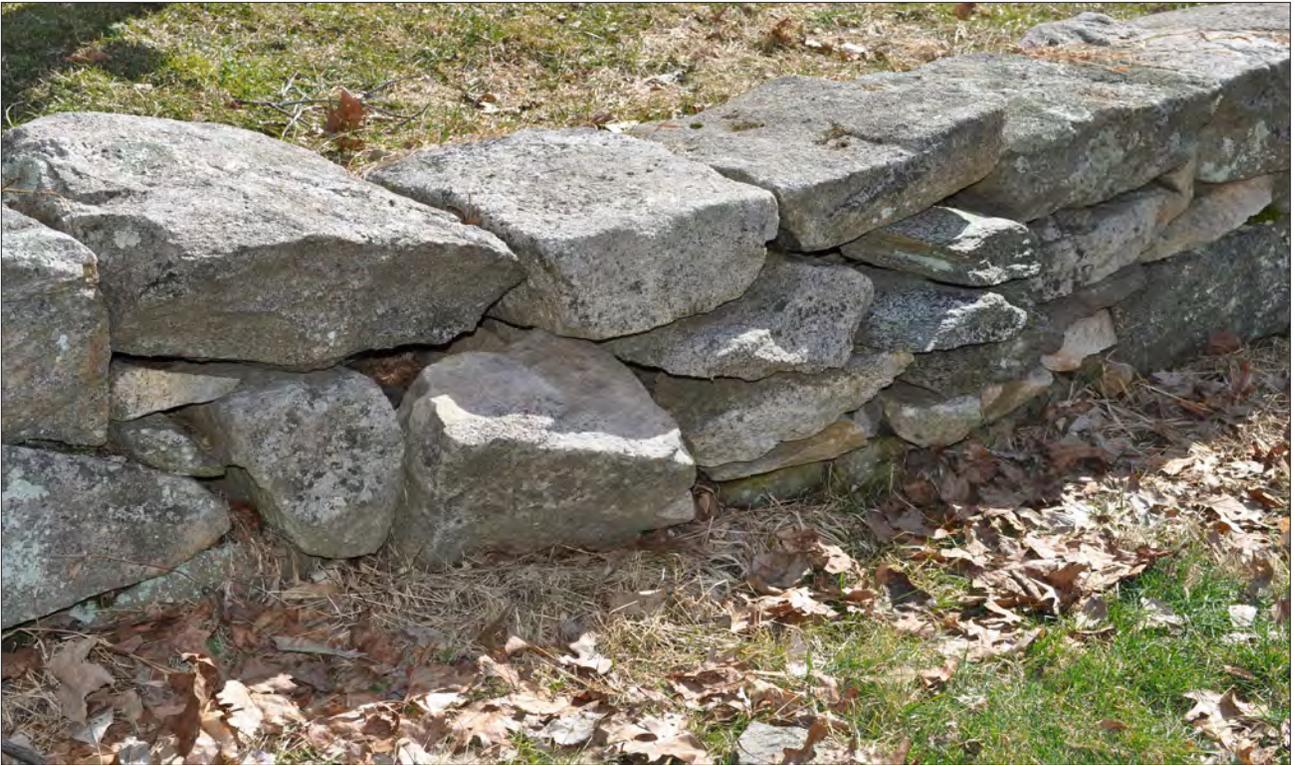
Figure 27. Weir vegetable garden terrace walls to be stabilized. View looking southeast, 2010 (OCLP).

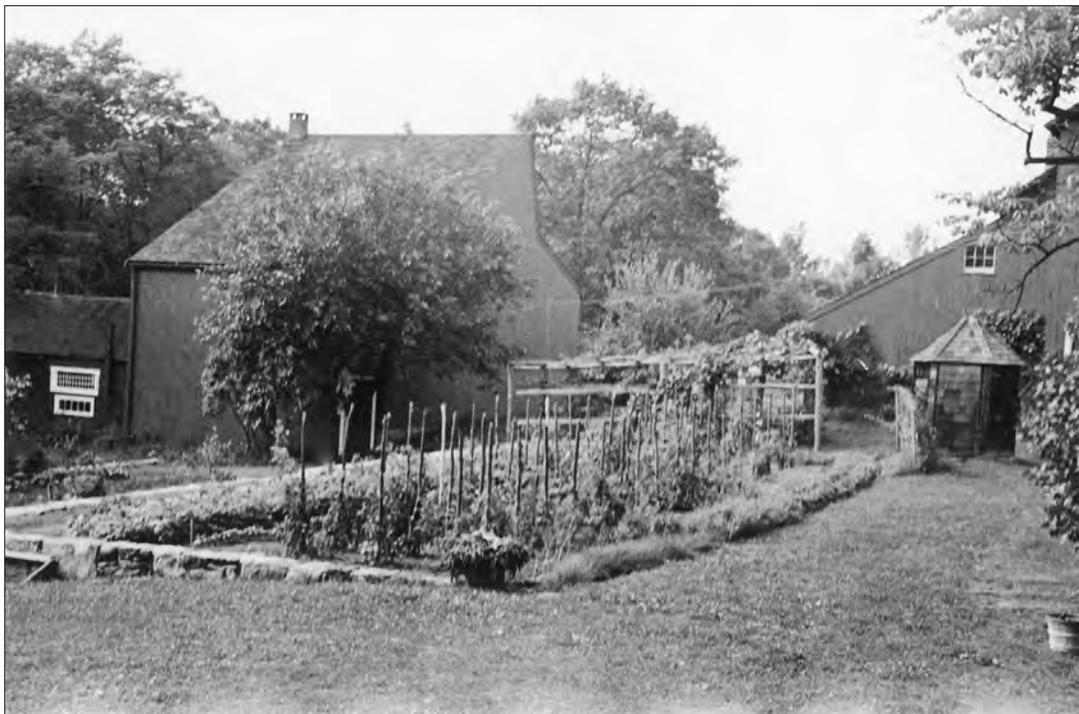
Figure 29. The upper vegetable garden terrace contained rows oriented in a north-south direction with low herbs bordering the eastern edge, peas or pole beans comprising a large portion of the garden, and grapes growing on a rustic arbor at the northern end of the terrace. View looking northwest, circa 1945 (Lewis Iselin, WEFA).

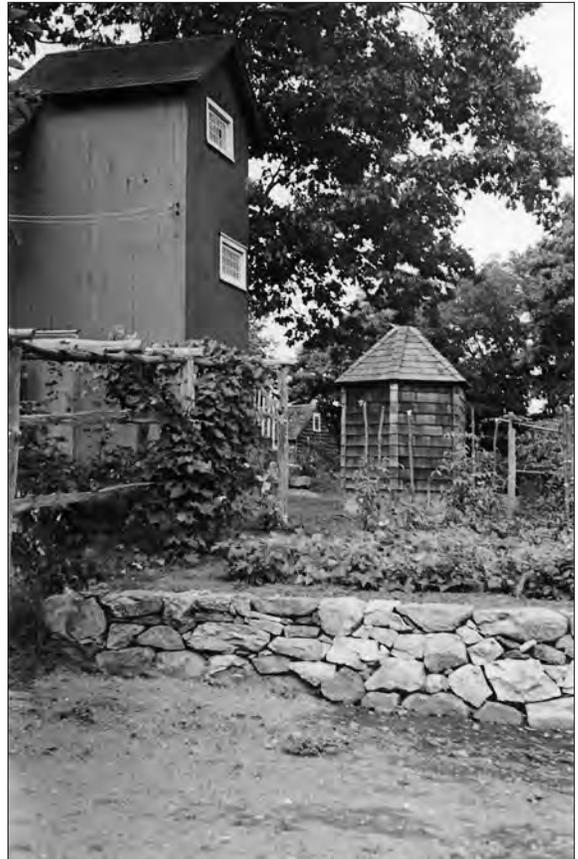
Figure 30. The lower vegetable garden terrace, foreground, lacked the extensive planting seen in the upper terrace. View looking east, circa 1945 (Lewis Iselin, WEFA).

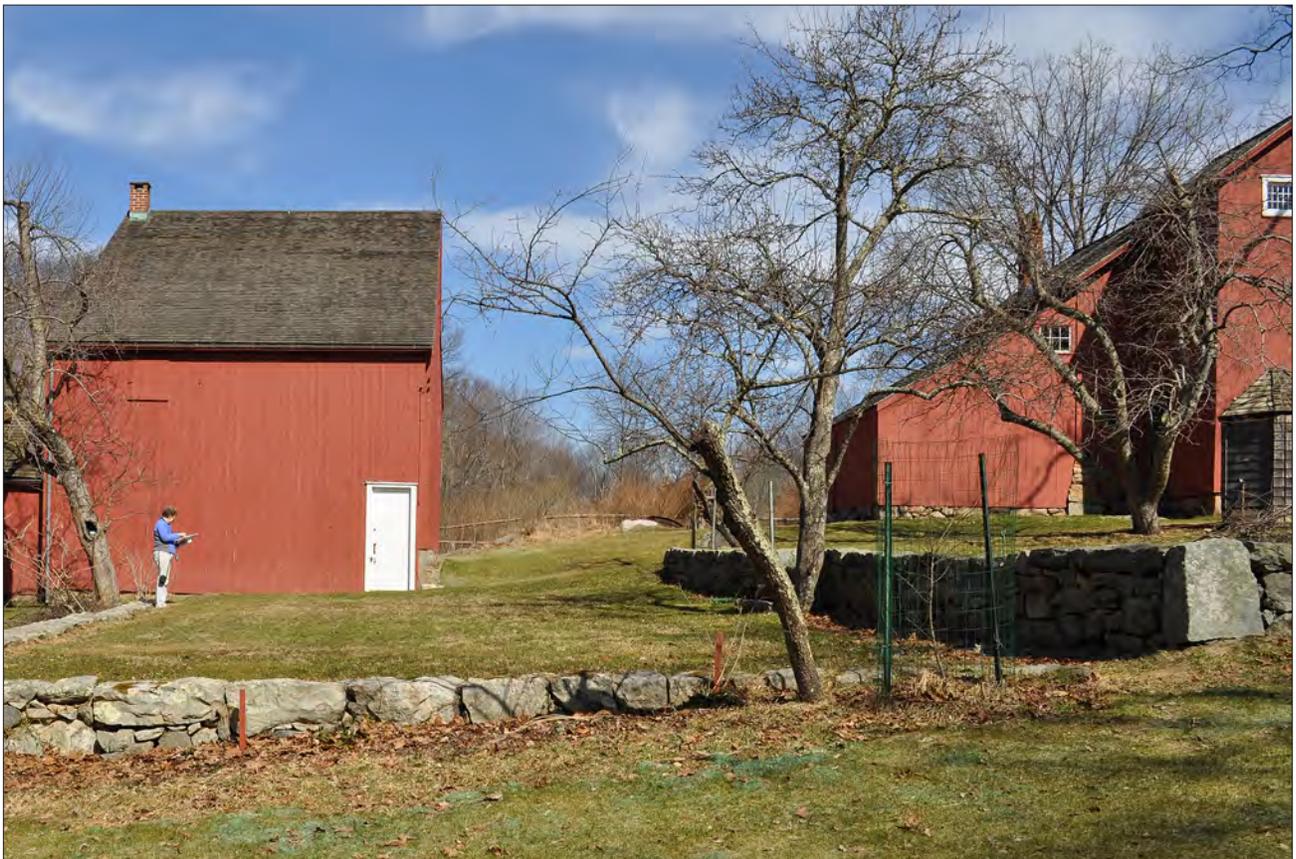
Figure 31. Install stabilized soil surface on the lower vegetable garden terrace and plant with a lawn turf mixture that matches the surrounding domestic lawns. View looking north, 2010 (OCLP).

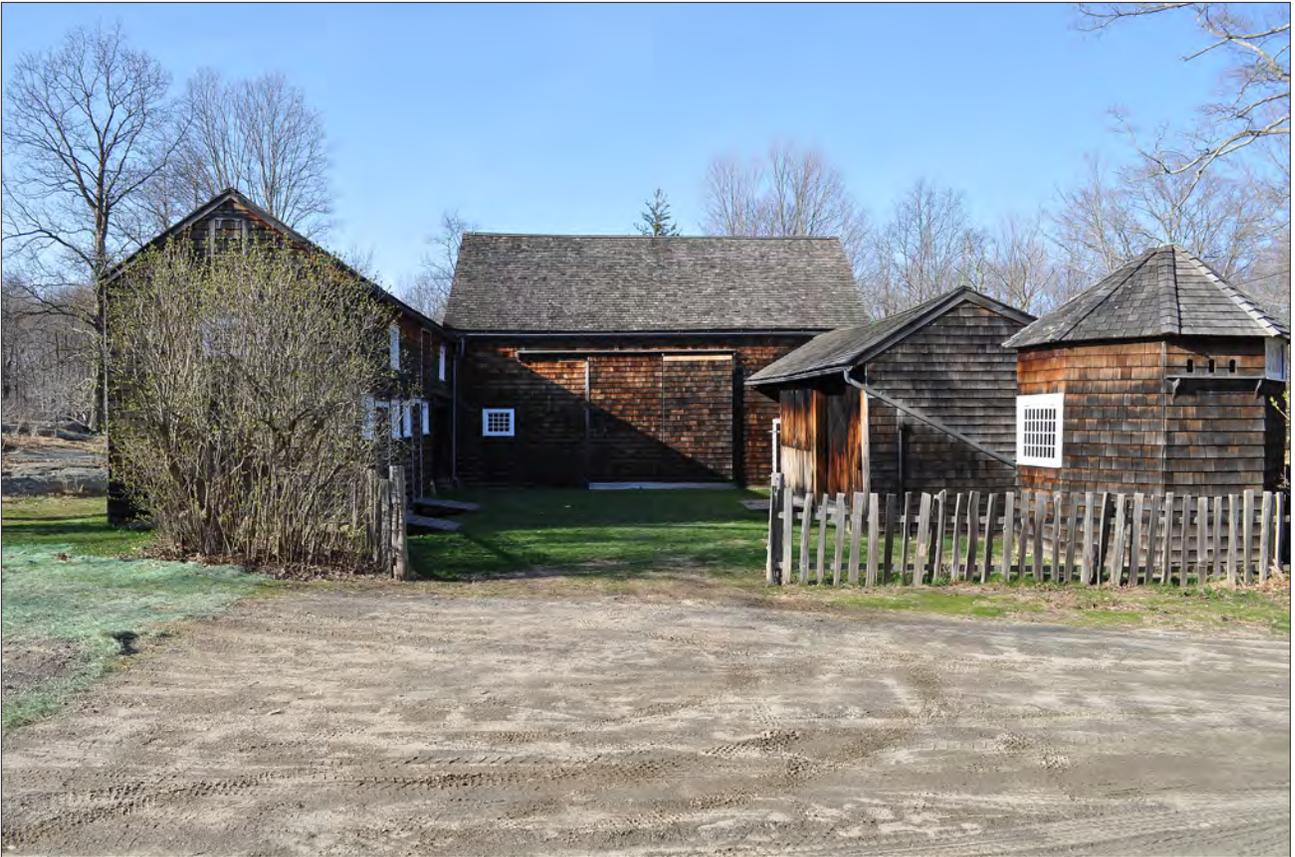
Figure 34. Current driveway surface of compacted earth and lawn throughout the south barnyard to be installed with a compatible and appropriate surface. View looking north, 2010 (OCLP).

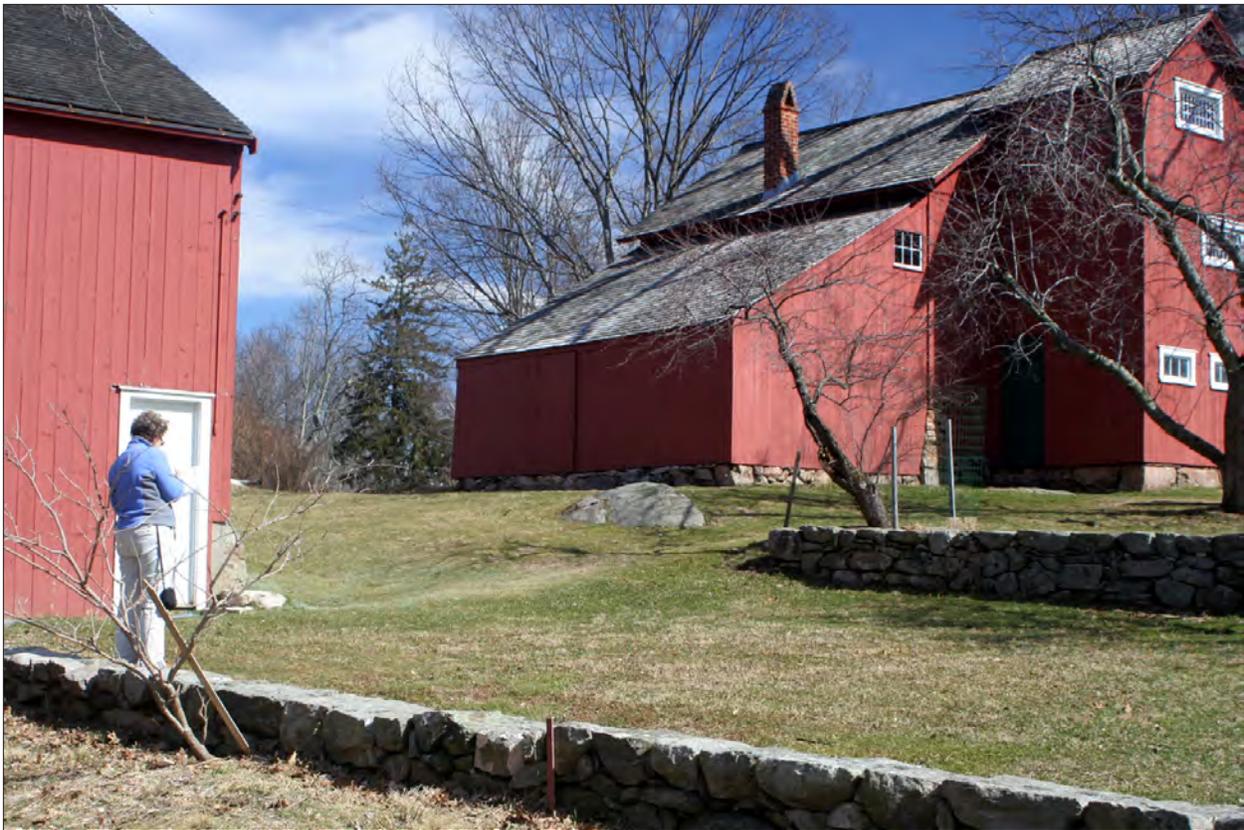
Figure 36. Install informal service route to Young Studio to improve existing grades that vary between ten and fourteen percent. View looking northeast across the lower vegetable garden terrace, 2010 (OCLP).

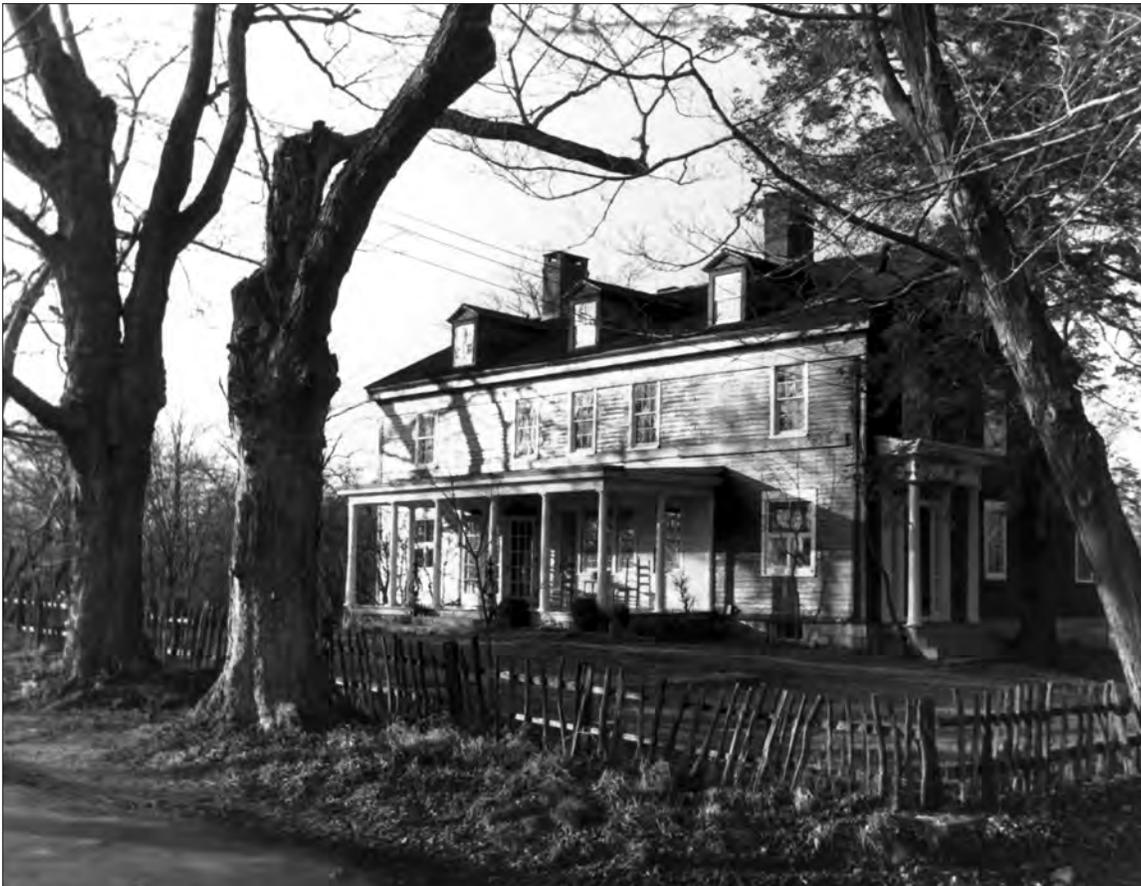
Figure 39. Historic pair of sugar maples to be replaced in kind at the stone walk leading to the Weir House. View looking northwest, circa 1960s (WEFA HP 260).

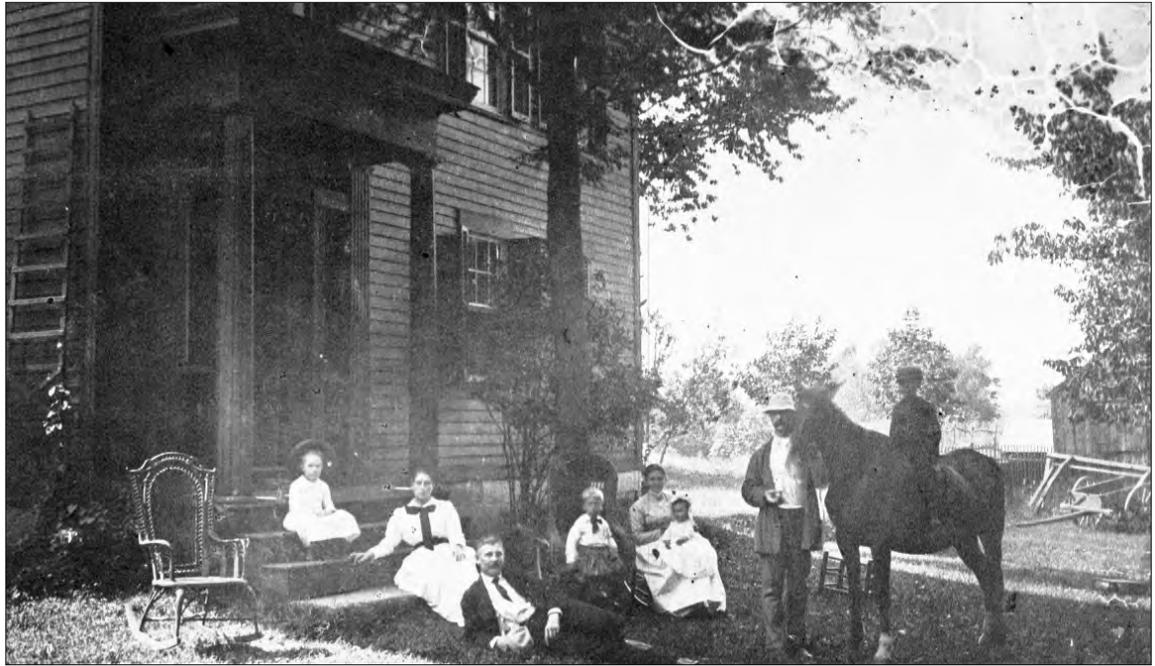
Figure 40. Historic Canadian hemlock to be replaced in kind north of the steps along the Weir House east facade. View looking northwest, 1889 (WEFA HP 233).

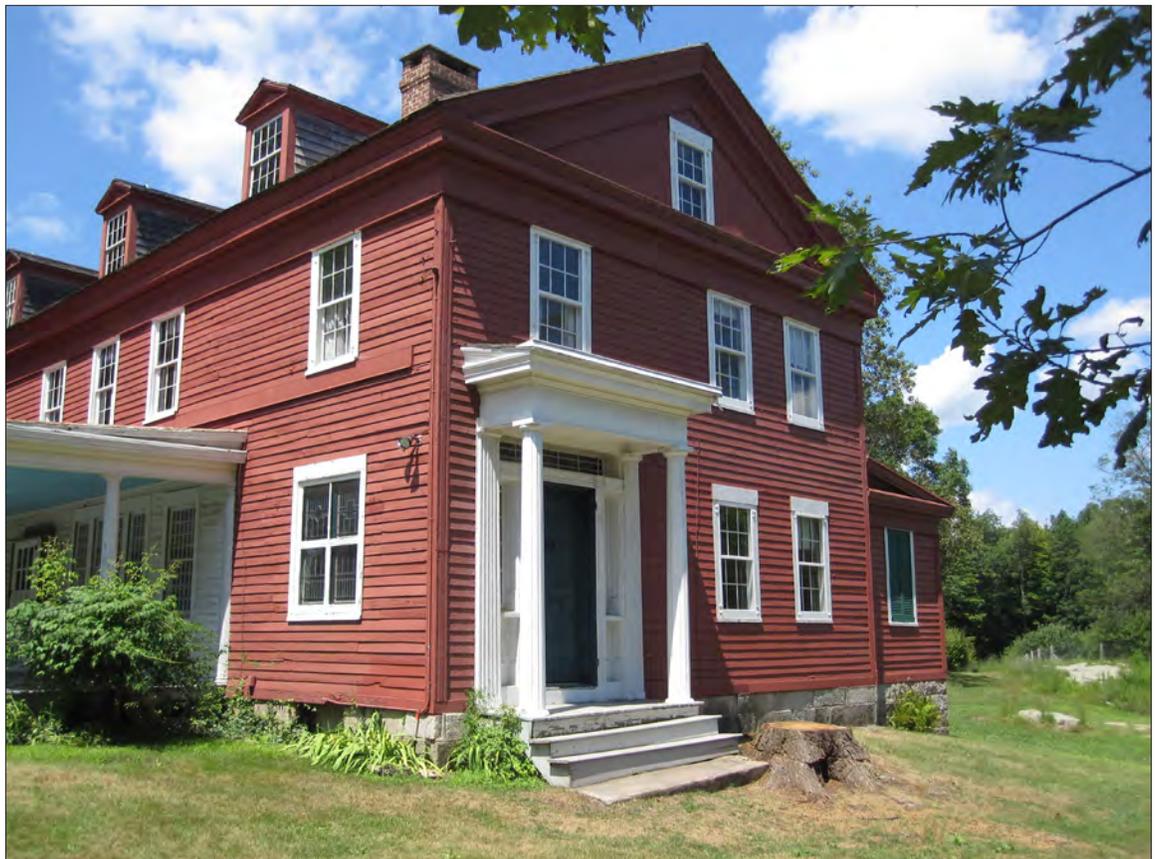
Figure 41. Historic Canadian hemlock to be replaced in kind north of the steps along the Weir House east facade. The hemlock's advanced age required the that park remove the tree to limit impacts on the Weir House. View looking northwest, 2011 (OCLP).

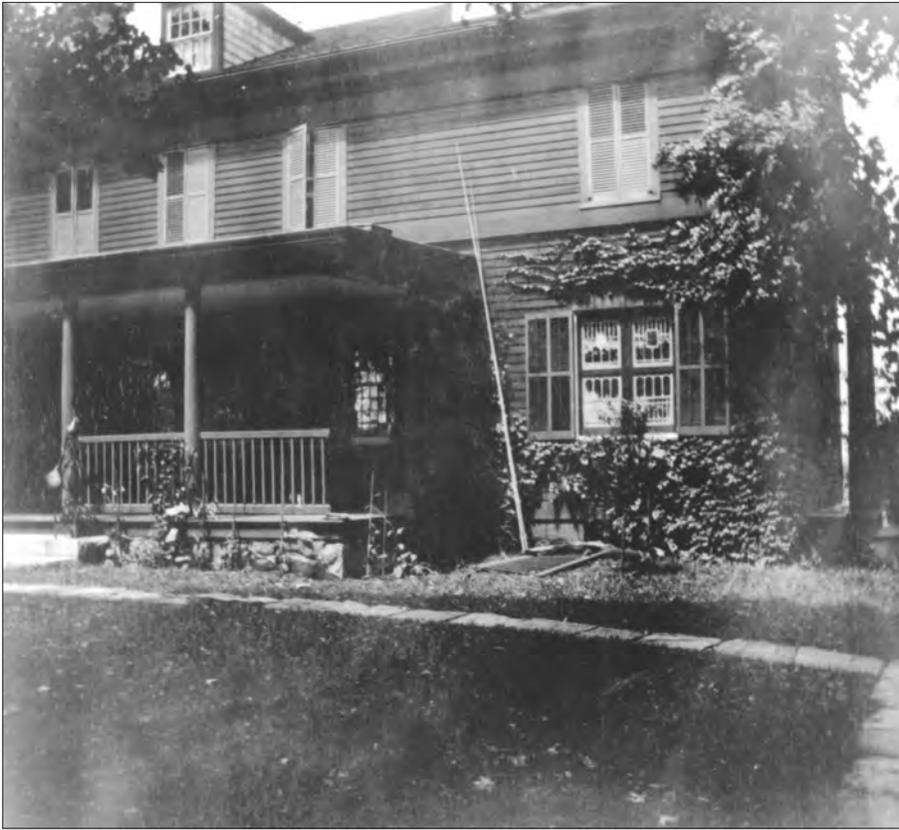
Figure 42. Foundation plantings in narrow beds along the south facade of the Weir House including Boston ivy and autumn clematis trained on support structures east of the entry steps. View looking northeast, post-1901 (WEFA HP 347).

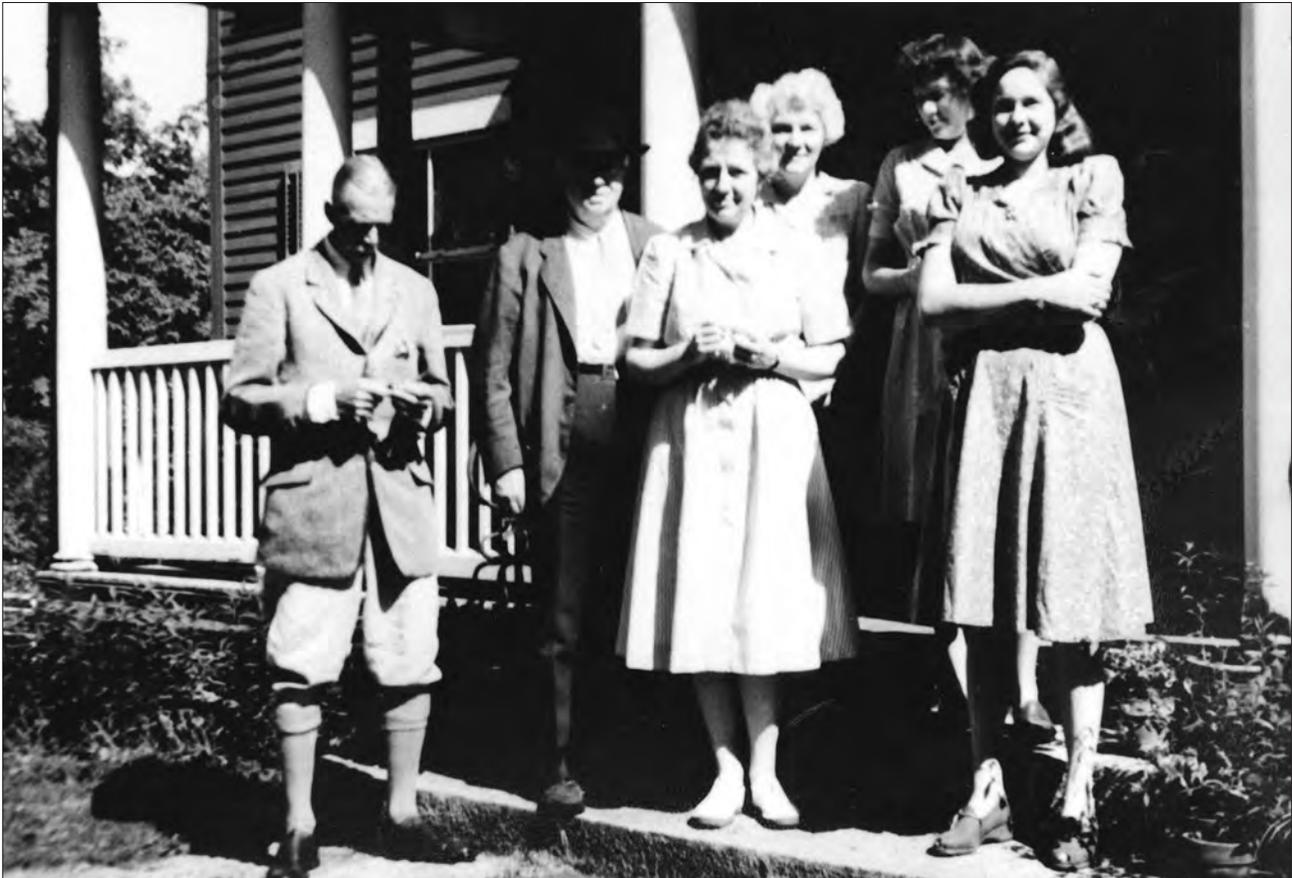
Figure 43. Foundation plantings left of the granite steps maintained below the height of the porch decking and small clay pots containing annuals present on the granite steps. View looking northwest, circa 1940 (WEFA HP 95).

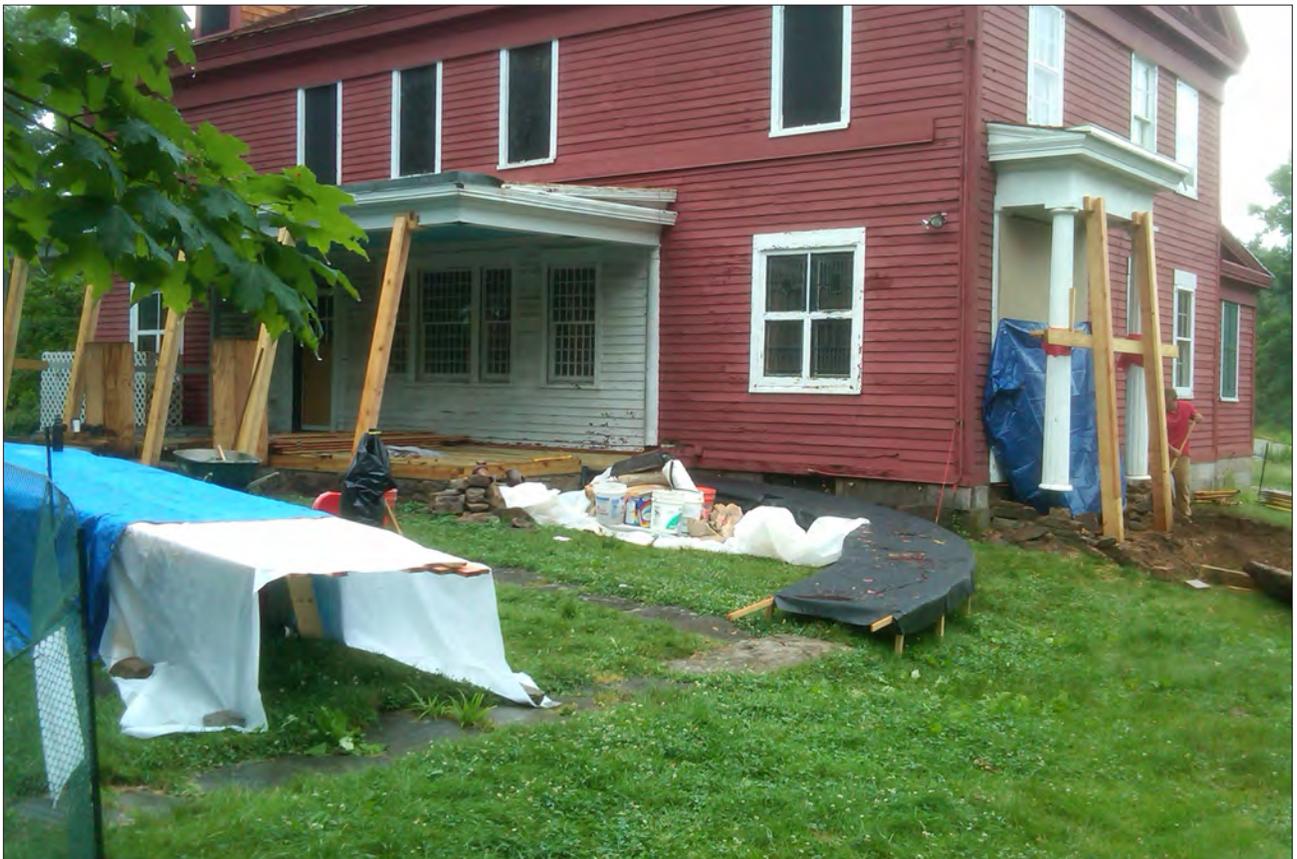
Figure 45. Replant missing foundation plantings at the Weir House after completing building restoration work that includes utility upgrades and universal access. View looking northwest, 2012 (OCLP).

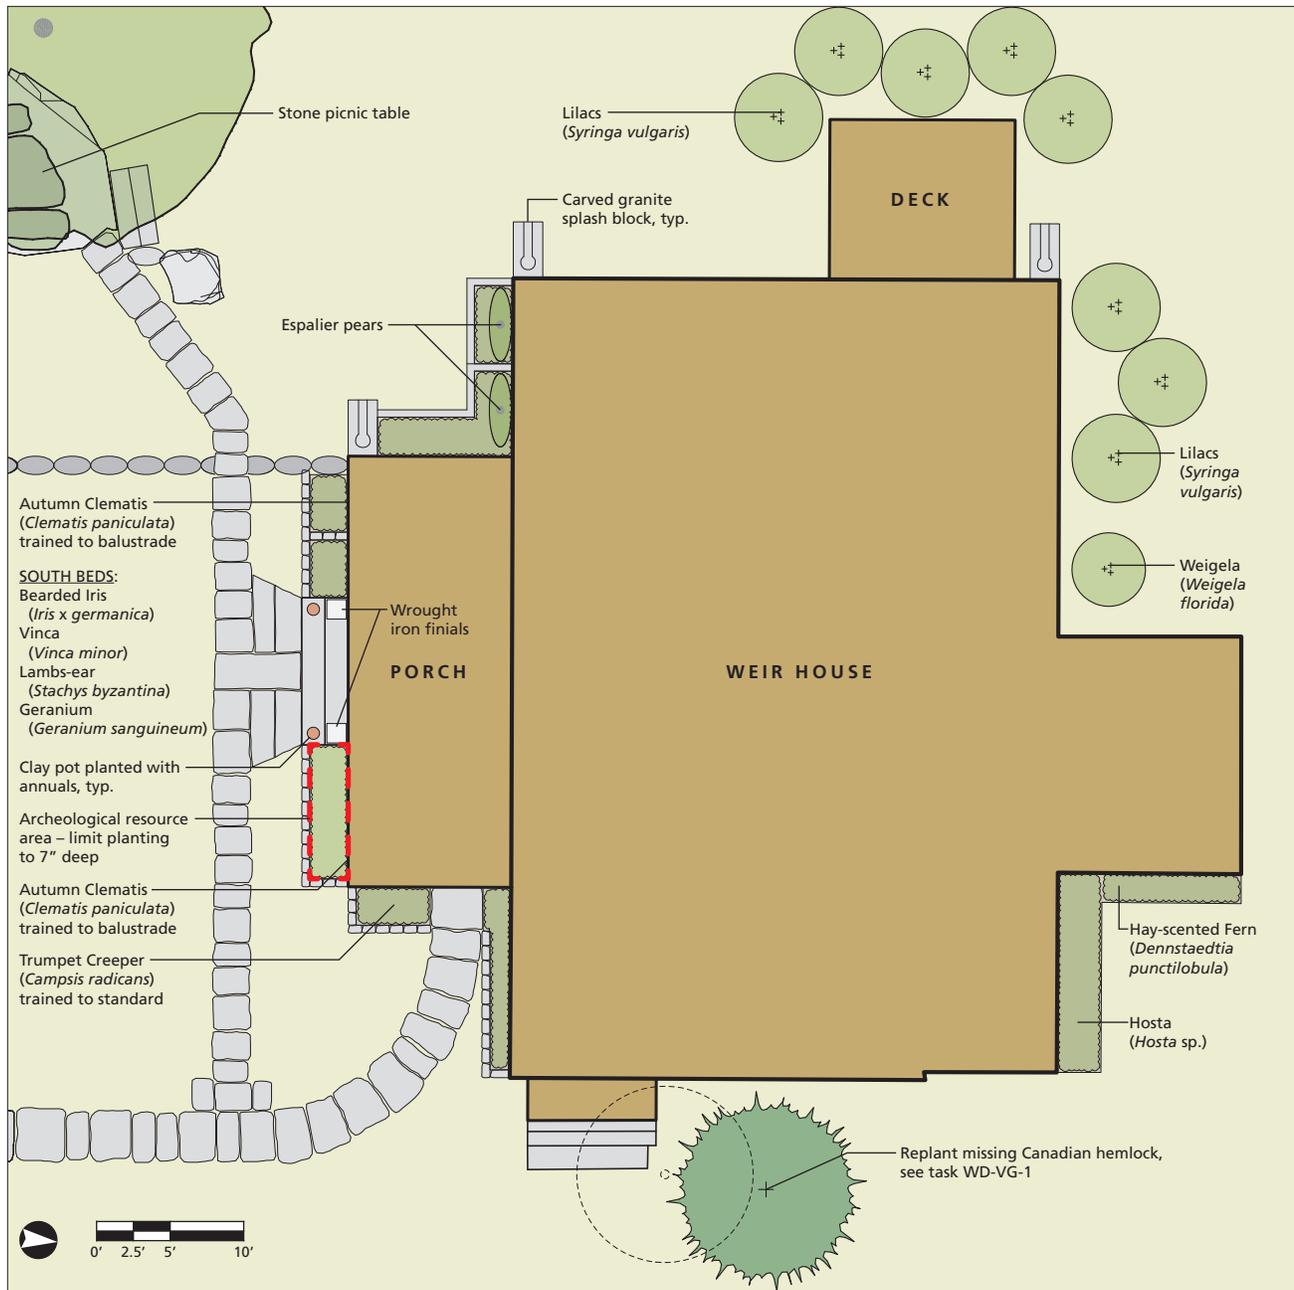
Figure 46. Diagrammatic plan showing replanted foundation plantings at the Weir House, 2012 (OCLP).

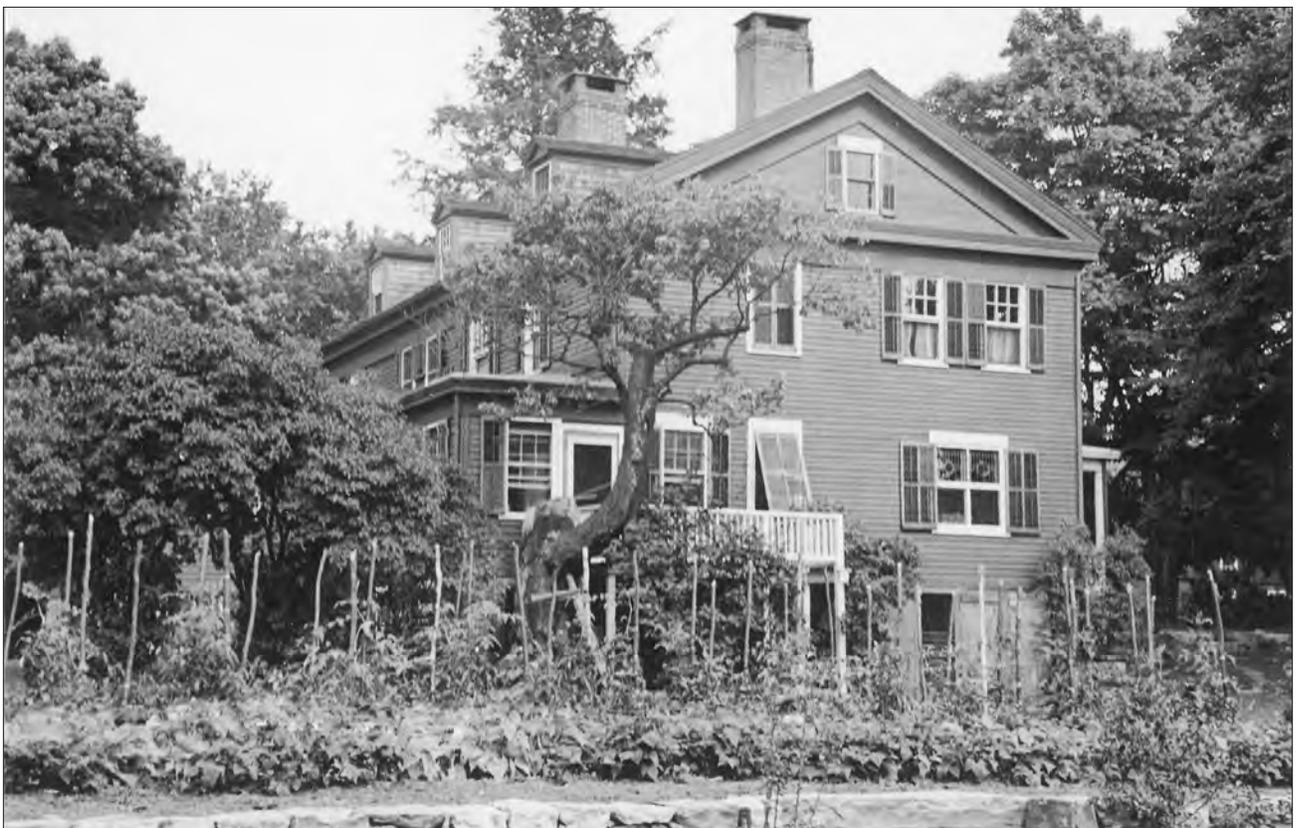
Figure 48. Seasonal vegetable plantings at the upper terrace featuring an earthen path on the west side of the terrace along the stone wall, foreground, and unmilled wood poles to support vegetables. View looking southeast, circa 1945 (Lewis Iselin, WEFA).
