CULTURAL LANDSCAPE REPORT
FOR WEIR FARM
NATIONAL HISTORIC SITE

VOLUME II: UPDATED TREATMENT PLAN AND RECORD OF TREATMENT

RIDGEFIELD AND WILTON, CONNECTICUT

Olmsted Center for Landscape Preservation
National Park Service, Boston, Massachusetts, 2013

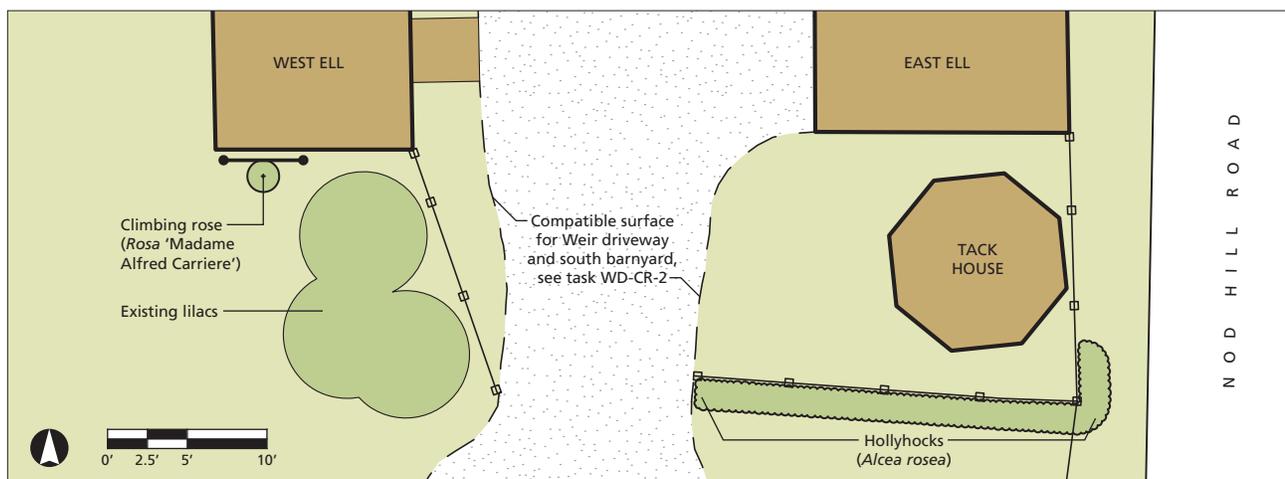
Figure 53. Diagrammatic plan showing perennials to be planted at the Weir Barn trellis and rustic picket fence, 2012 (OCLP).

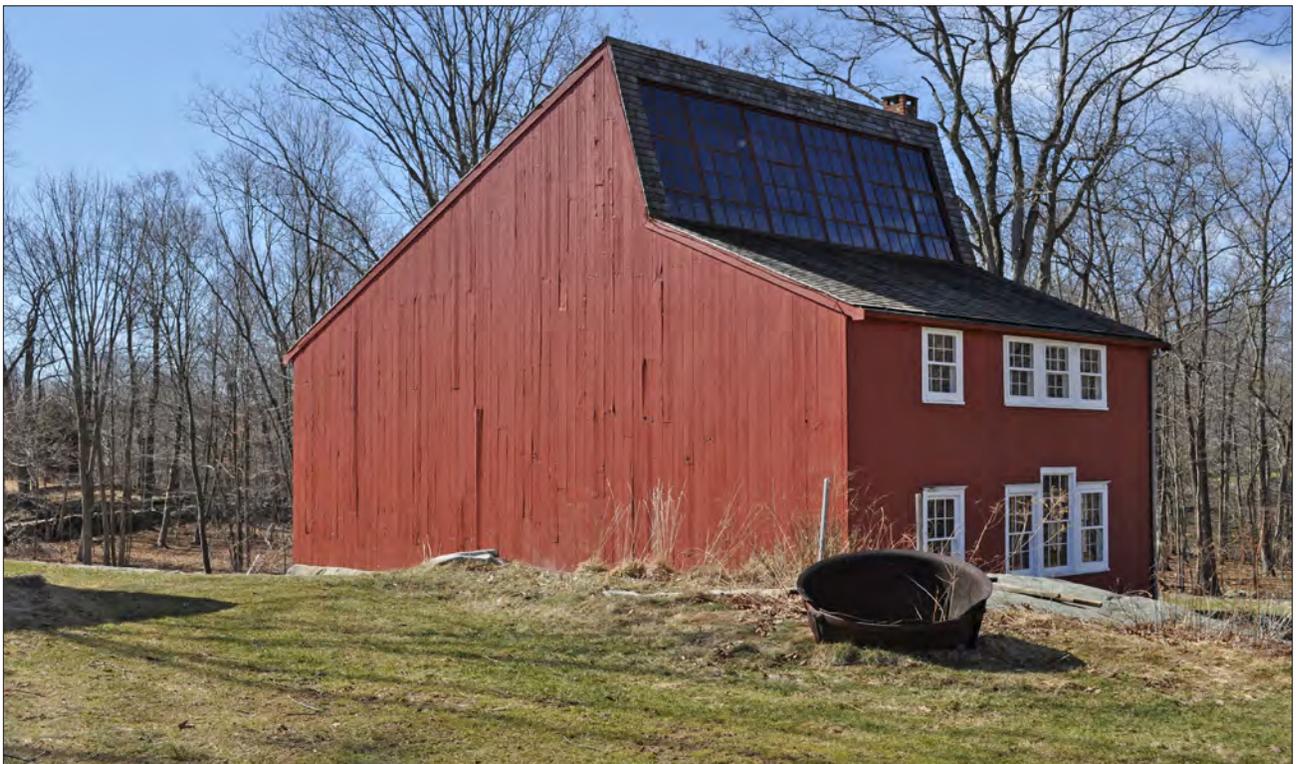
Figure 55. Scalding vat to be relocated to an area south of the reconstructed Wagon Shed. View looking southwest, 2010 (OCLP).

The Bass family, who tenant farmed and served as caretakers at the property during the Young tenure, used a large cast iron kettle as a scalding vat to prepare slaughtered hogs for butchering. In an interview, Charlie Bass recalled setting the vat on rocks over a fire in an area south of the Wagon Shed. The vat held a boiling mixture of water, wood ash, and lye. Charlie's father slaughtered the hogs near the Wagon Shed and then he and his brothers dunked each hog in the vat before scraping the hides free of hair. The family then transported the hogs to a butcher in Georgetown.¹⁶ Photographs of the Wagon Shed show that by circa 1960, the scalding vat had been moved to an undetermined location (Figure 54). Fieldwork performed in 1995 documented the scalding vat located between the Weir and Young studios and presently, the vat remains in a similar location on a level area of ground roughly ten feet away from the northeast corner of the Young Studio (Figure 55).

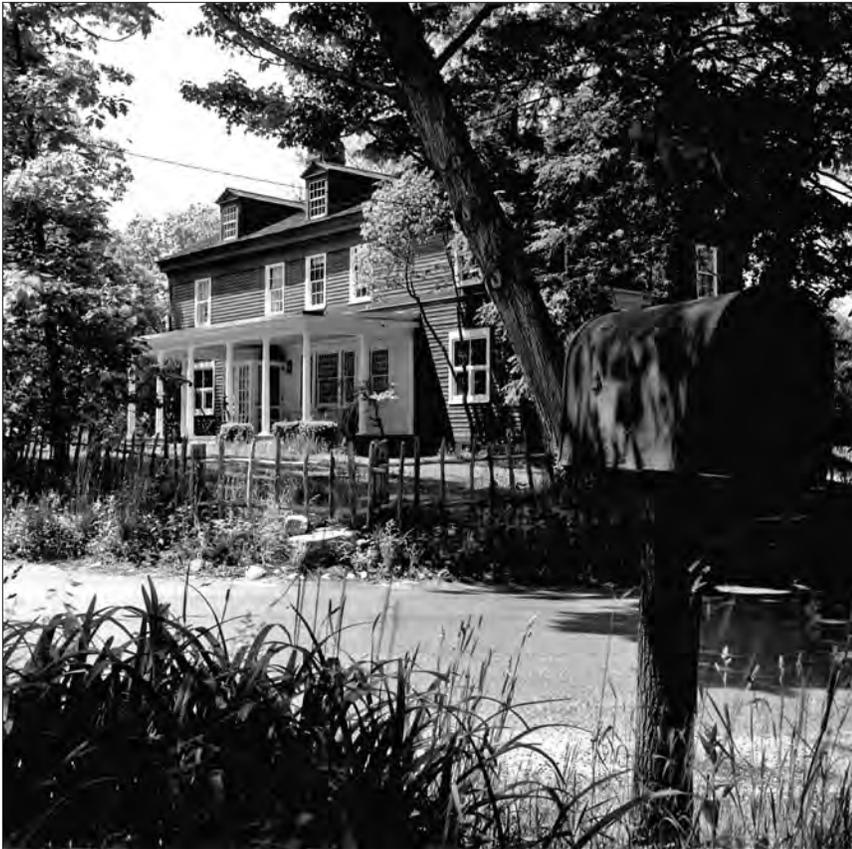
Figure 56. Weir mailbox to be replaced. The mailbox captured in the foreground of this photograph is presently stored in the park's maintenance shop and should be replaced with one matching the materials, size, and finish of the original. View looking northwest, 1995 (OCLP).

Existing conditions documentation in 1995 recorded two mailboxes along the eastern side of Nod Hill Road near its intersection with Pelham Lane. One mailbox was located near the driveway to the Caretaker's House and to the north a second mailbox was installed for the Weir House (Figure 56). Both mailboxes were U- or tunnel-shaped rectangles constructed from steel. Both featured signal flags on the right side of the box and were mounted on unpeeled wood posts set into the ground. The mailbox associated with the Caretaker's House is currently extant and the mailbox for the Weir House is safely stored in the park's maintenance shop.

The park should continue to store the Weir mailbox and install a replacement mailbox that matches the materials, size, and finish of the original. Replacing this small-scale feature enhances the historic character of the landscape when Weir Farm served as a residence and received rural mail service. To help maintain the replacement mailbox, the door should be screwed or riveted shut since the park receives mail at the Burlingham House and this replacement mailbox is not needed for functional service. Finding a replacement mailbox that matches the original in materials, size, and finish will be difficult given the increasing use of electronic communications instead of carrier mail service. When a source has been identified, multiple mailboxes should be acquired as future replacements.

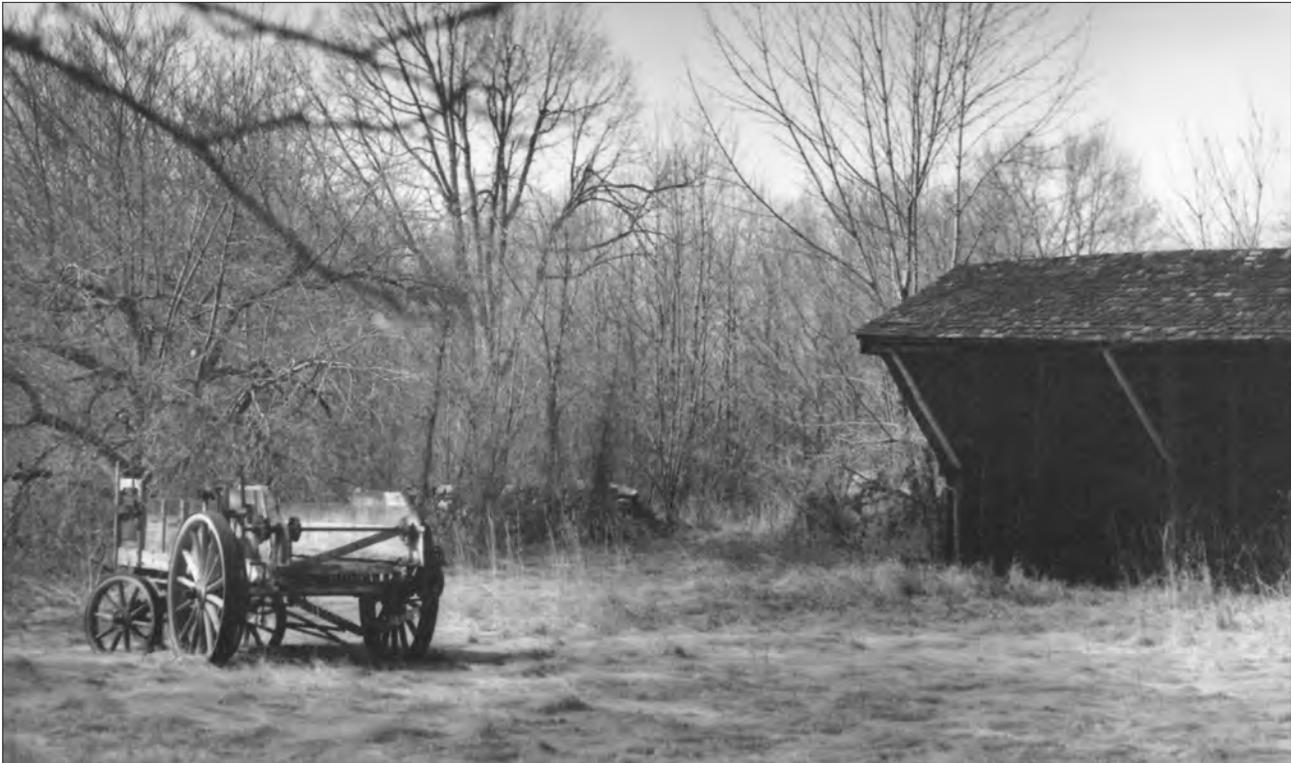
Figure 57. Wagon Shed to be reconstructed featuring four open bays on its south facade and a wood shingled roof. Unmilled logs were used for posts and framing members and the roof extended south of the interior posts. View looking northwest, circa 1960 (WEFA HP 1148).

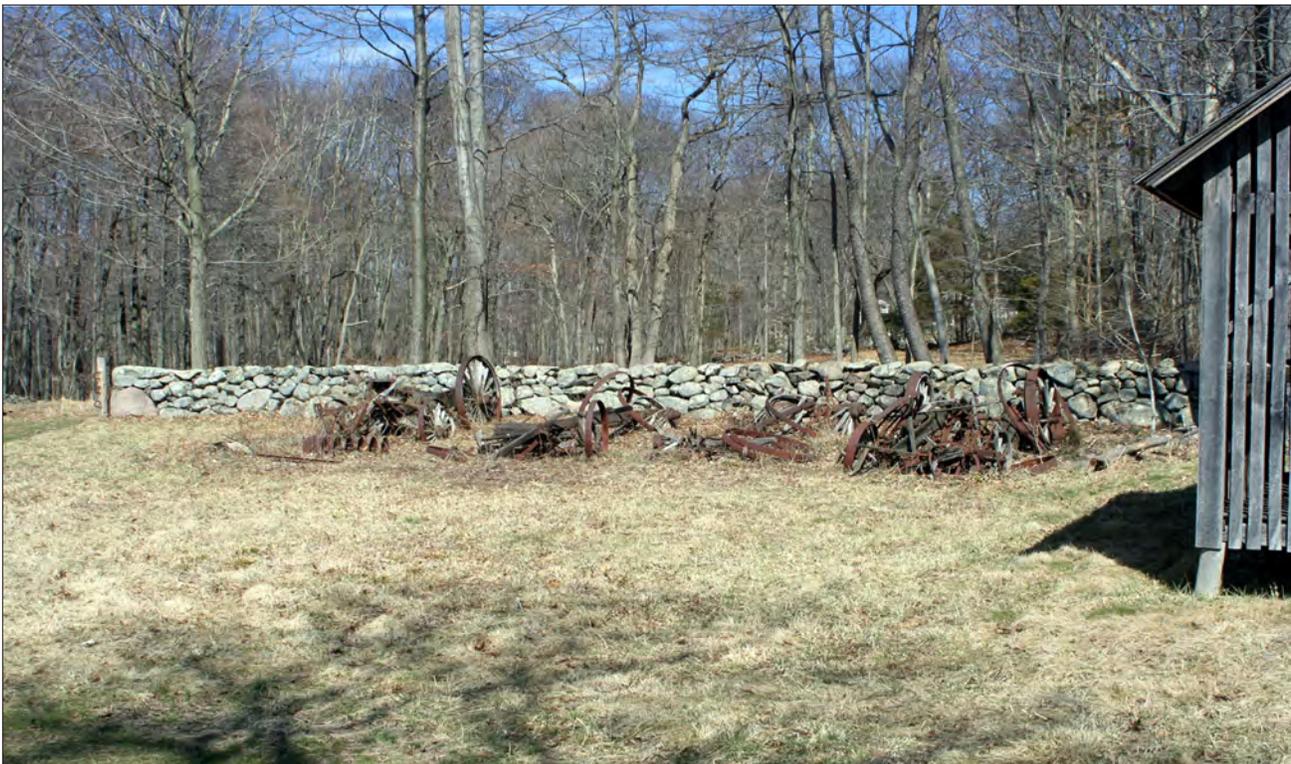
Figure 58. Site for the Wagon Shed to be reconstructed. Four piles of farm machinery help mark the four open bays of the former Wagon Shed. A closer examination of the area reveals the remnants of stone foundations and post holes that define the footprint of the missing structure. View looking north, 2010 (OCLP).

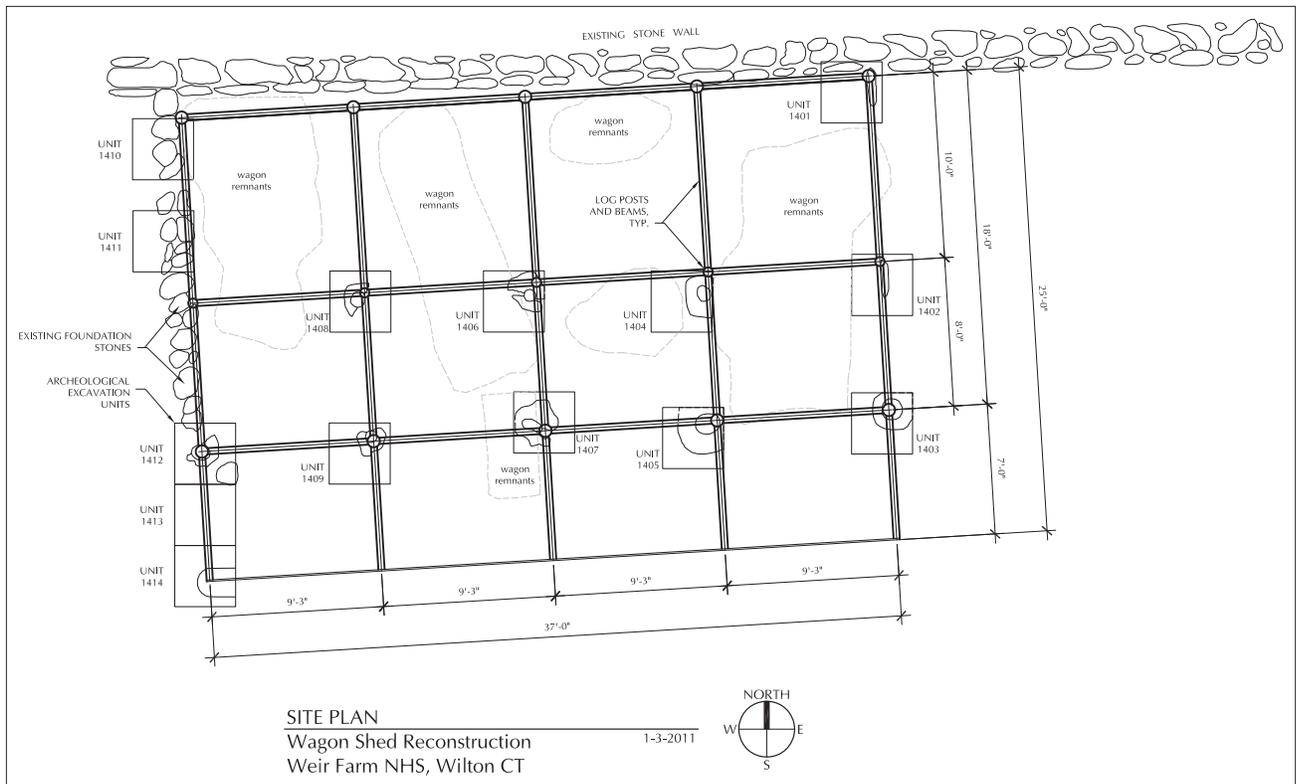
Figure 59. Site plan for the Wagon Shed reconstruction. Based on archeological investigations and historic photographs, the Historic Preservation Training Center prepared a plan for reconstructing the Wagon Shed, 2011 (Historic Preservation Training Center, hereafter HPTC).

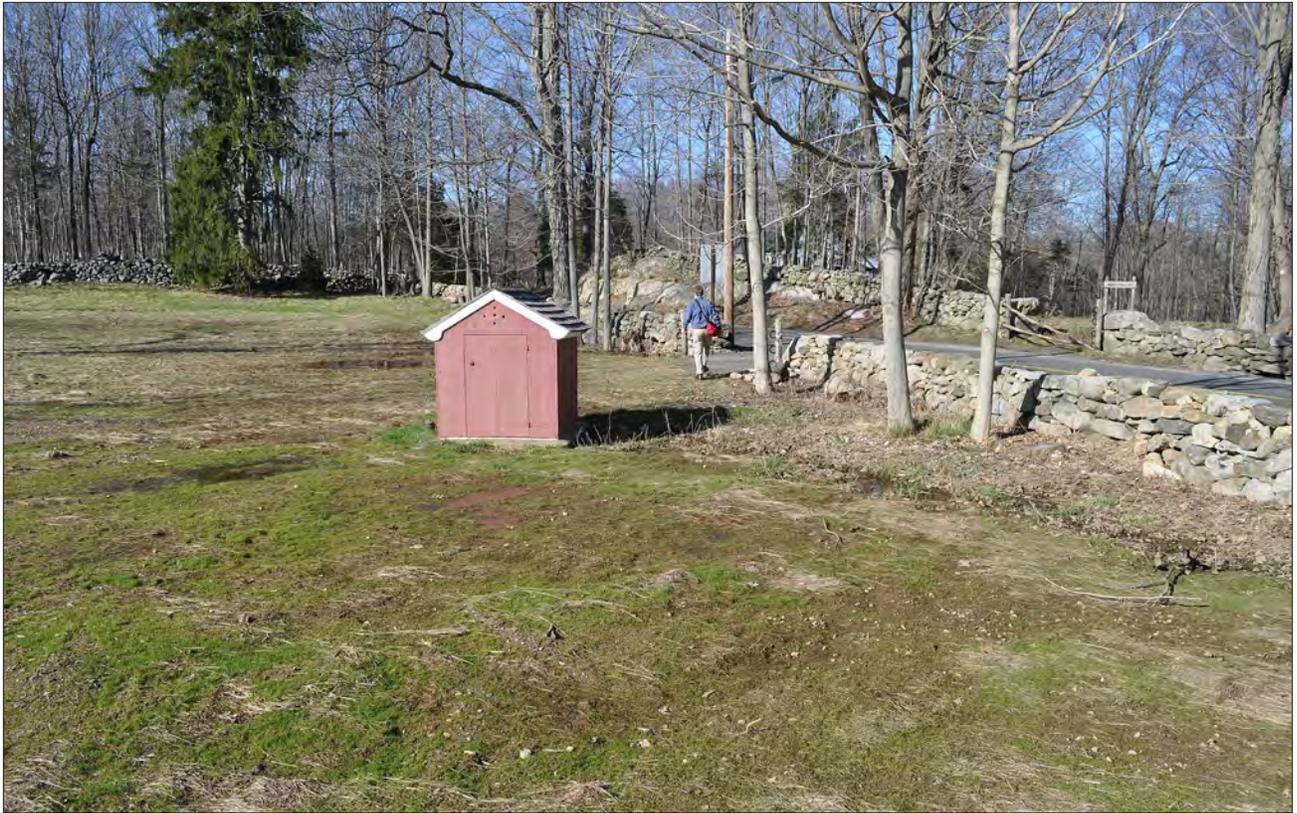
Figure 61. Area around Pump House to be fine graded. View looking northeast, 2010 (OCLP).

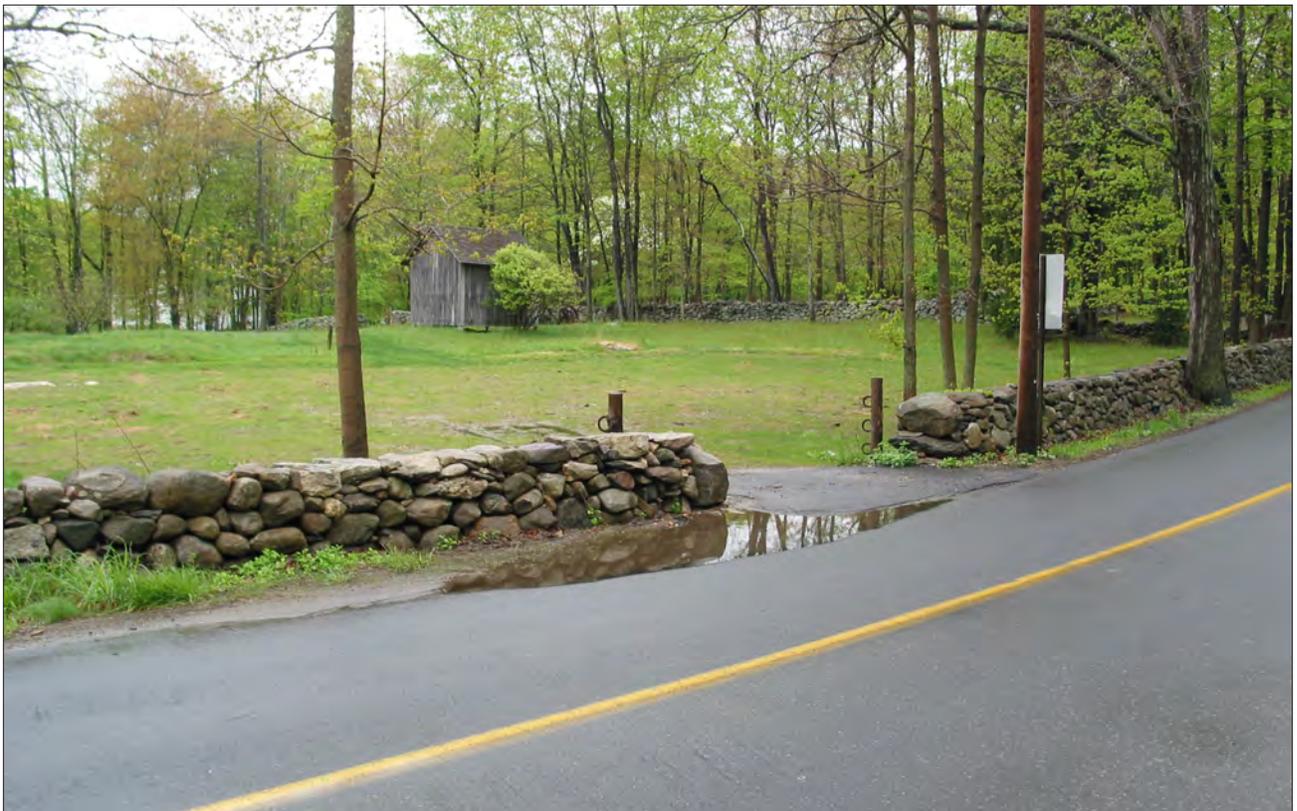
Figure 62. West shoulder of Nod Hill Road to coordinate with Town of Ridgefield on adding a drainage structure. View looking northwest, 2010 (OCLP).

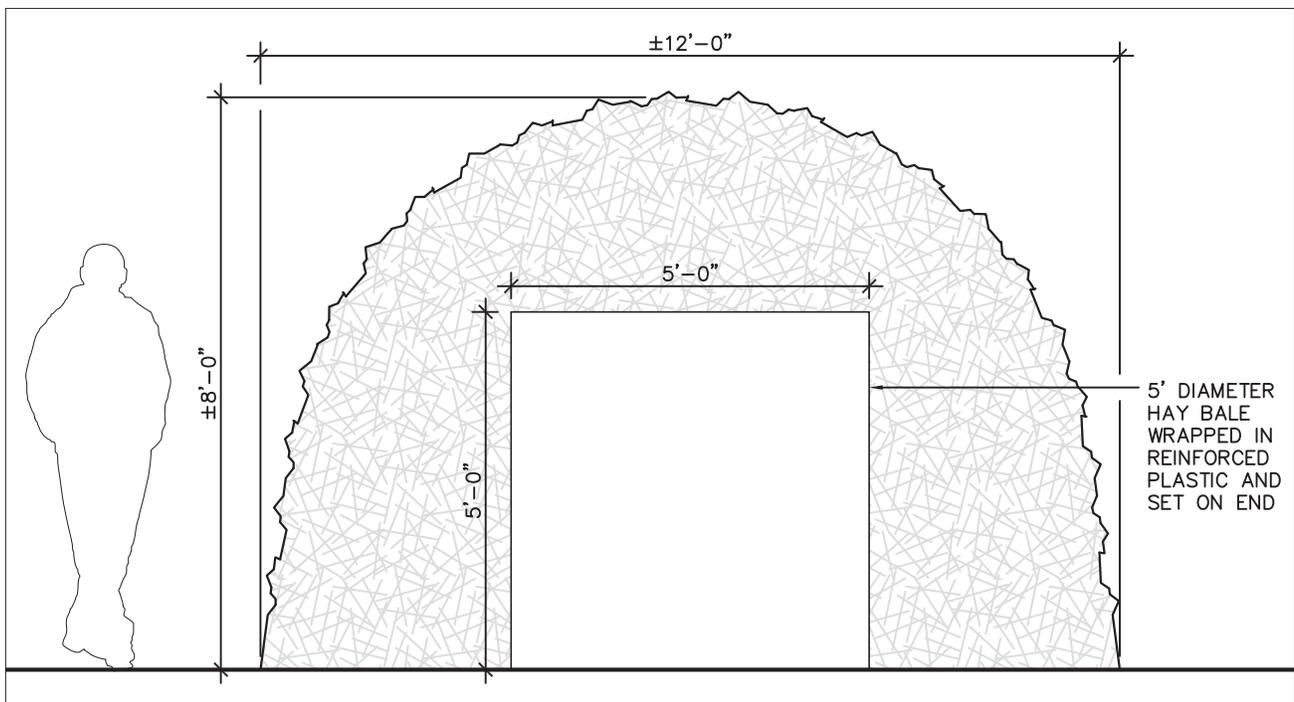
Figure 64. Diagrammatic section showing missing haystack to be restored. To limit the amount of hay needed for restoring this feature, a core should be created using a 5-foot diameter round hay bale, 2012 (OCLP).

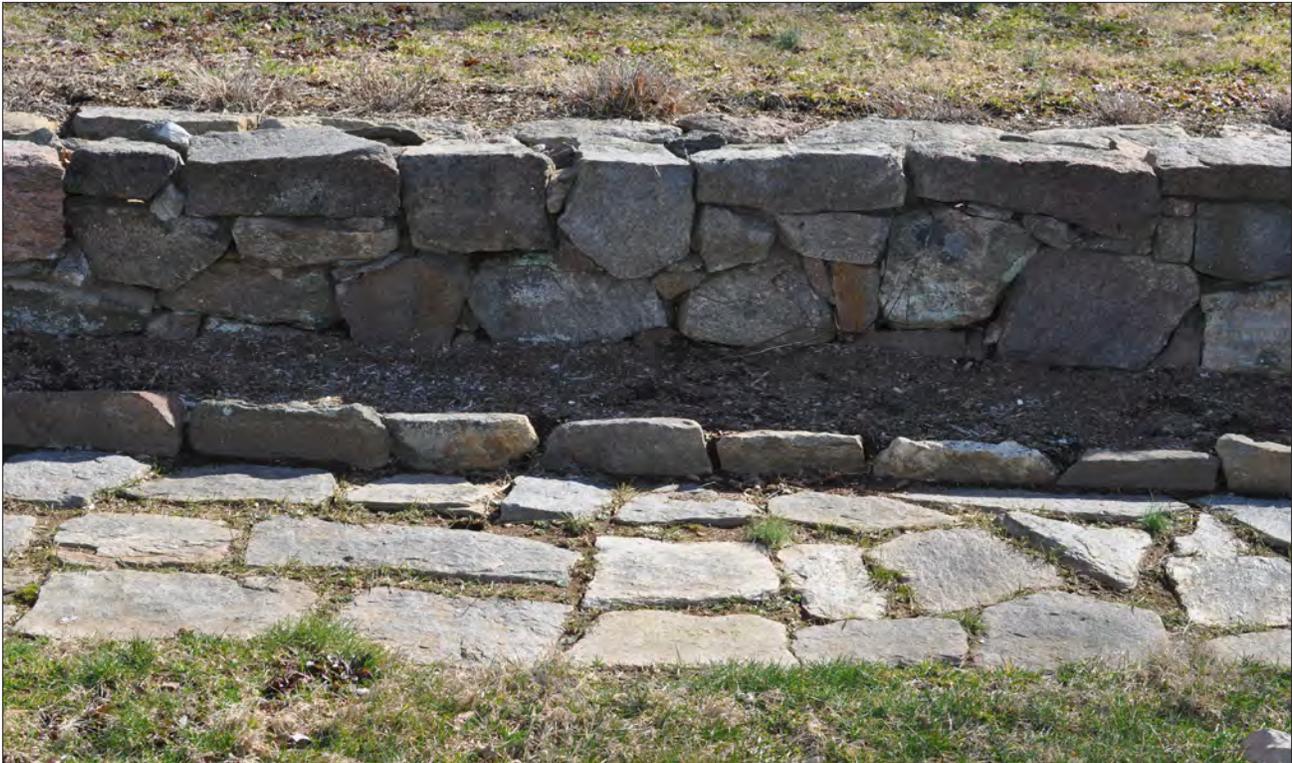
Figure 65. Stone-lined beds and irregular stone flagging in the South Garden terraces. Planting beds in the South Garden terraces extend from the terrace walls and are defined by stone edging and a band of irregular stone flagging approximately two feet wide. View looking east in the middle terrace, 2010 (OCLP).

In the South Garden, the eastern perimeter of the lower and middle terraces feature planting areas defined by stone edging. The stones are set into the ground on their narrow edge and installed approximately eighteen to twenty-four inches away from the base of the terrace walls. West of the stone edging is a band of irregular stone flagging approximately two feet wide (Figure 65).

As a component of preserving and enhancing the South Garden terraces, the park should rehabilitate the stone-lined beds and irregular stone flagging. Loose stones should be reset and missing stones should be replaced with ones that match the existing in size, texture, and color range. Accumulated soil and vegetation growing on the irregular stone flagging should be removed and the walkway maintained free from new deposits (Figure 66). In conjunction with rehabilitating the stone work, the park should install one-quarter inch mesh hardware cloth in the planting beds to discourage voles. The mesh should be installed one foot below the finish surface of the bed and wrapped up six inches following the sides of the stone edging or walls. At these depths, the mesh will be hidden from view. While initially involving more effort, the park should consider resetting the flagging and on a stonedust setting bed installed over a compacted aggregate base. Installation with a setting bed and compacted base will reduce future maintenance requirements by lessen the chances of settling and limiting coverage by sediment and vegetation.

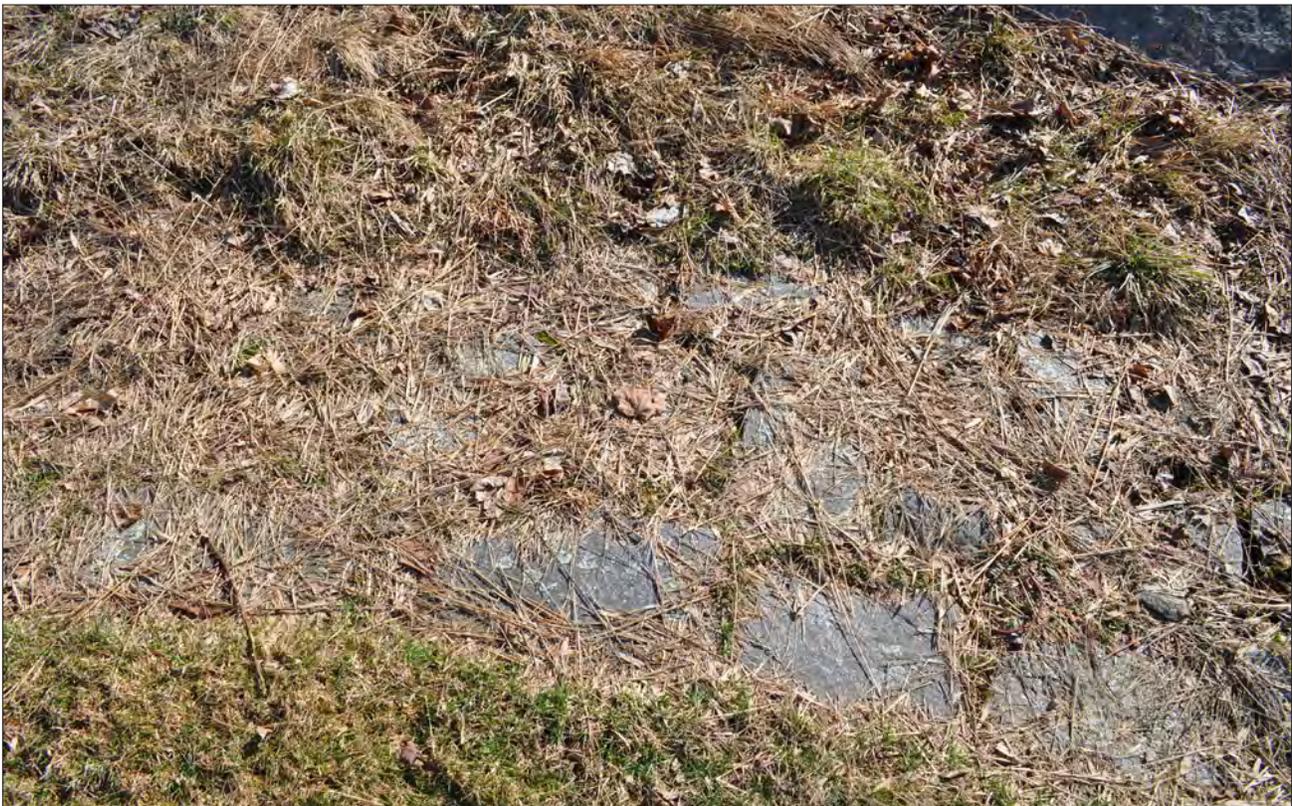
Figure 66. Stone-lined beds and irregular stone flagging in the South Garden terraces to be rehabilitated including the removal of accumulated soil and vegetation. Detail of stone flagging in the middle terrace, 2010 (OCLP).

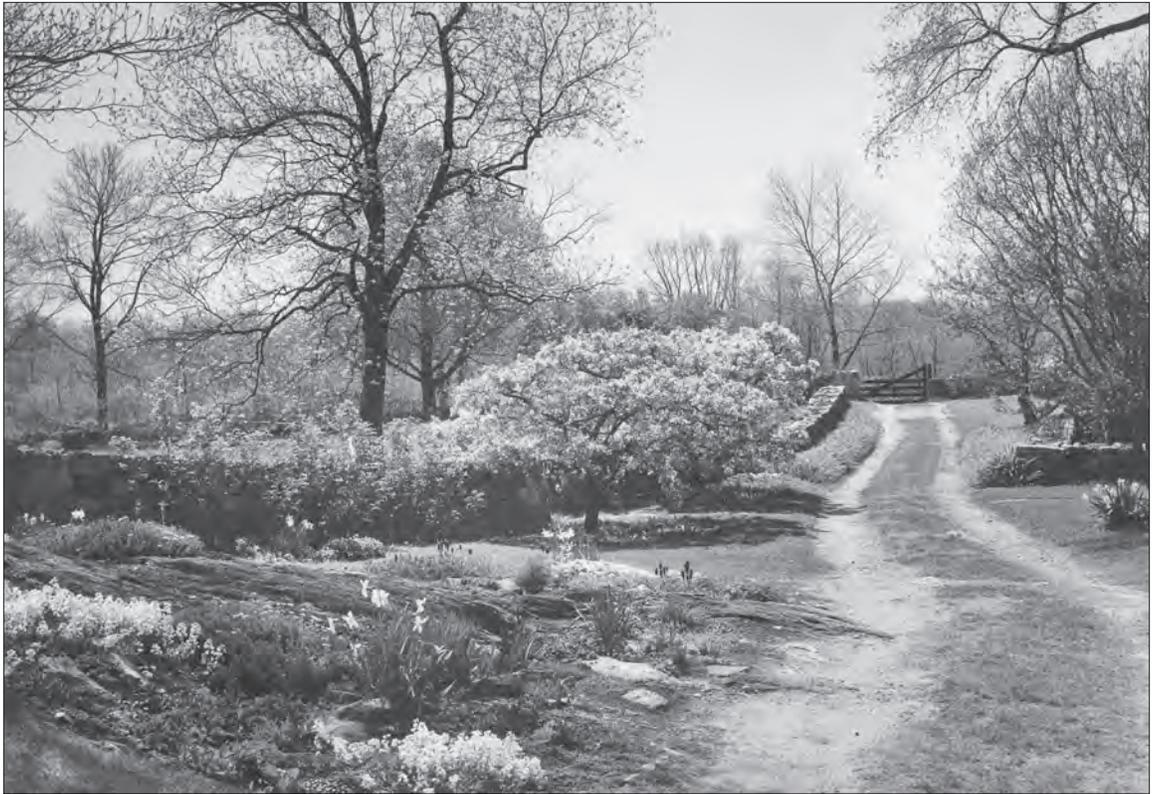
Figure 67. The Burlingham driveway consisted of two parallel tracks separated by a higher, vegetated median during the historic period. View looking west, circa late 1930s–1950s (WEFA HP 1123).

driveway comprised of two parallel tracks separated by a higher, vegetated median. The tracks are surfaced with a mixture of crushed stone and soil and the vegetated median features an array of lawn and broadleaf weed species (Figure 67).

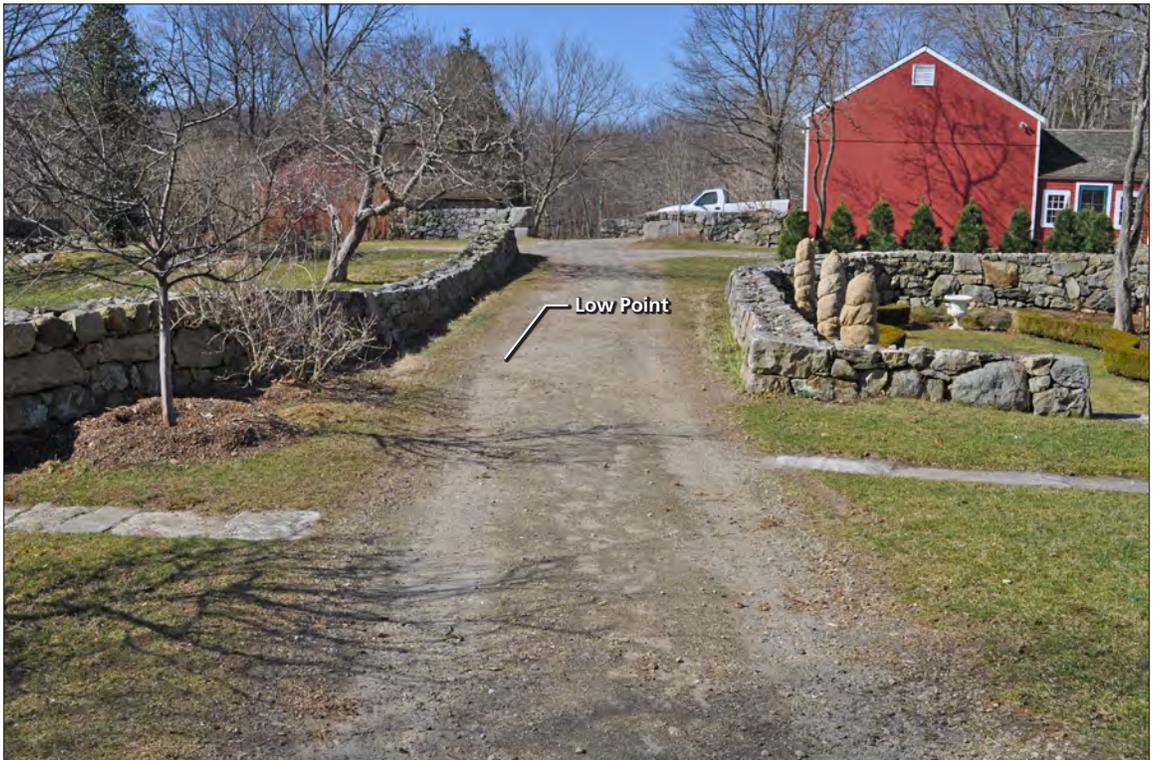
Figure 68. The Burlingham driveway to be rehabilitated with drainage deficiencies corrected. The driveway passes between two stone walls and pitches to a low point that traps water in a large puddle. View looking west, 2010 (OCLP).

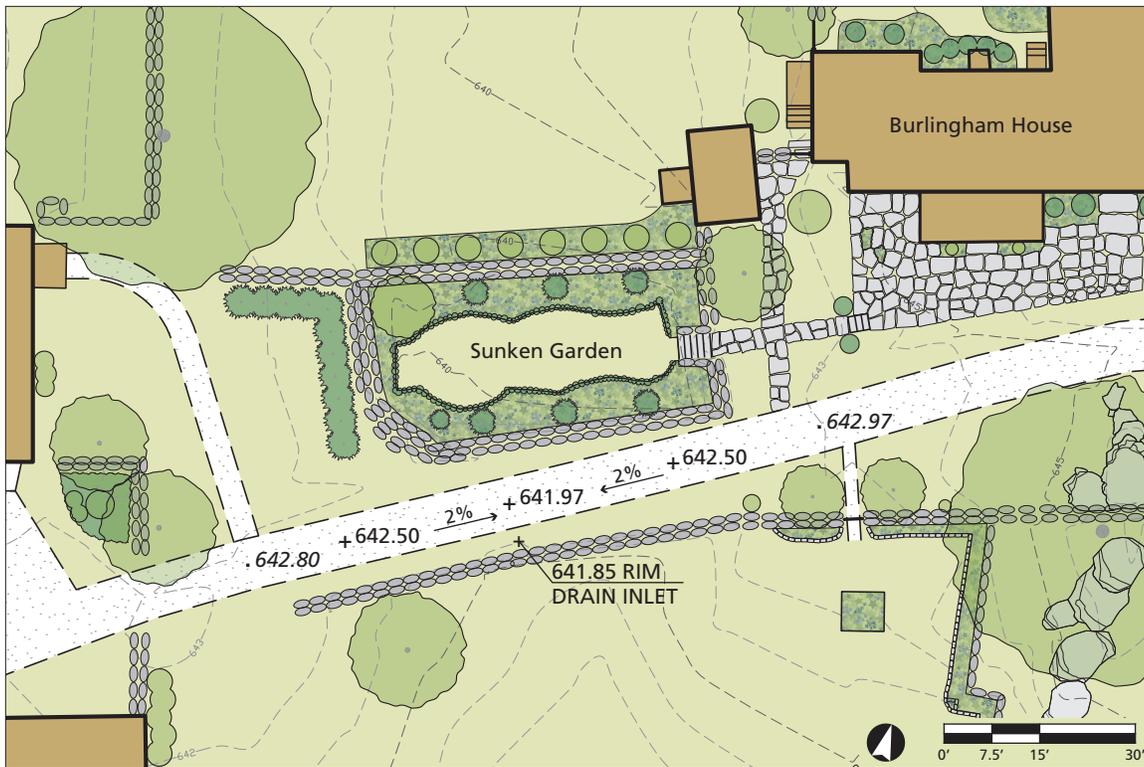
Figure 69. Schematic plan showing rehabilitated and improved drainage at the Burlingham driveway. The longitudinal slope of the driveway should be increasing in the area between the Sunken Garden and south meadow, 2012 (OCLP).

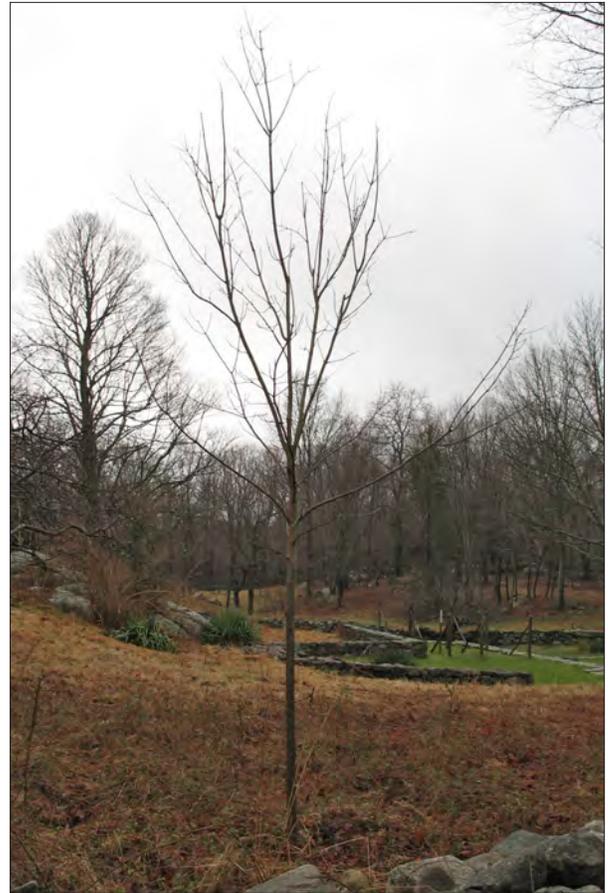
Figure 71. Replaced in kind sugar maple, Burlingham Complex domestic grounds. Trees that date to the historic period should be replaced in kind when they reach the end of their lifecycle. View looking south, 2012 (Greg Waters, WEFA).

In 2010 the park removed a large sugar maple (*Acer saccharum*), inventory number BT-1-15, that stood along Nod Hill Road during the historic period. The tree was nearing the end of its life and since it posed a hazard, its removal was necessary. The sugar maple stood in close proximity to a corner formed by the stone wall along Nod Hill Road and the Burlingham driveway stone wall. In order to minimize potential damage to the walls from tree roots and maintain the character of large deciduous trees along Nod Hill Road, the park planted a replacement maple six feet south of the Burlingham driveway wall in 2012 (Figure 71). The distance west from the edge of Nod Hill Road to the new planting remained the same as the historic location. In addition to the sugar maple, the 1998 inventory of existing trees and shrubs recorded a pear (*Pyrus* sp.), number BT-2-4, in poor condition to the west of the South Garden terraces. The pear has been removed and should also be replaced in kind (Drawing 6). Other trees identified in the 1998 inventory that date to the treatment period should be replaced in kind when they reach the end of their lifecycle.

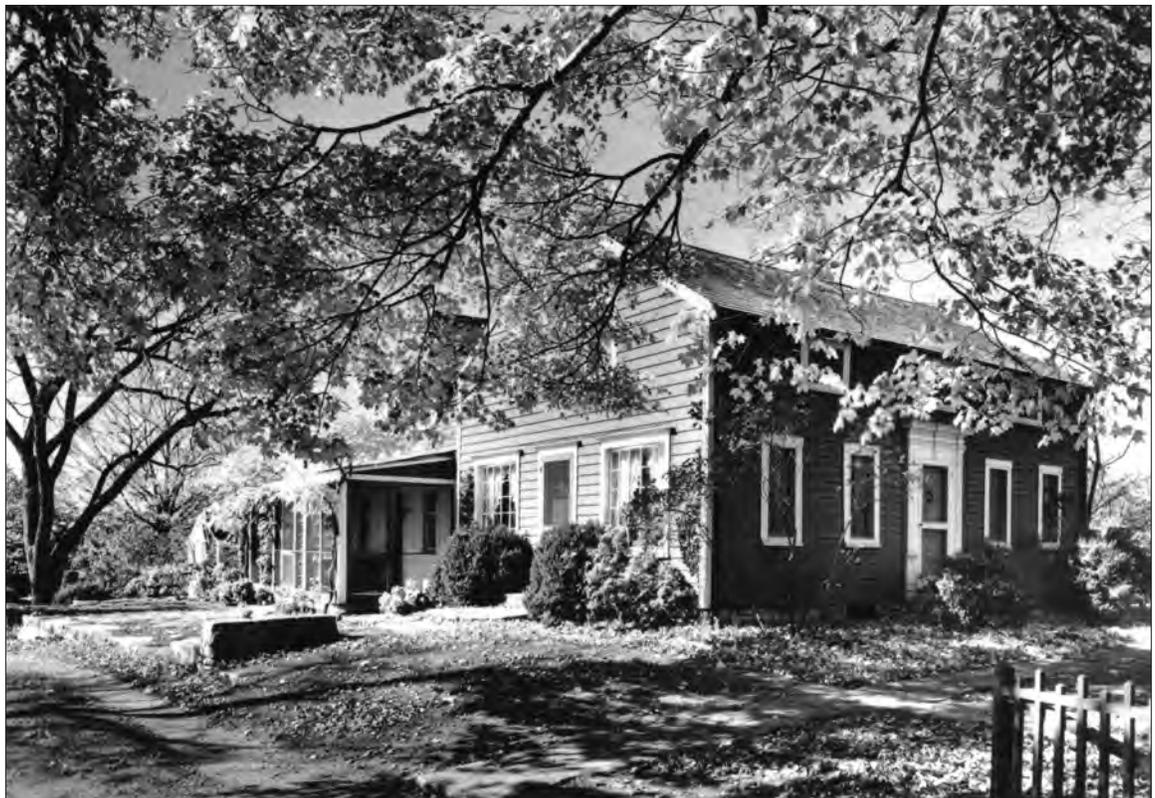
Figure 72. Foundation plantings at the Burlingham House during the historic period. Note the single clump of lilacs at the southeast corner and evergreen shrubs flanking both doorways. View looking northwest, circa late 1930s–1950s (WEFA HP 673).

Burlingham directed major alterations to the house and by the mid-1930s, the structure extended west with the additions of a new dining room and kitchen. The additions shifted the main entry of the house from the east elevation along Nod Hill Road to the newly elongated south elevation. Cora Burlingham, an avid gardener, also added foundation plantings surrounding the renovated house. Photographs from the 1930s to the 1950s document the architectural additions and foundation plantings (Figure 72).

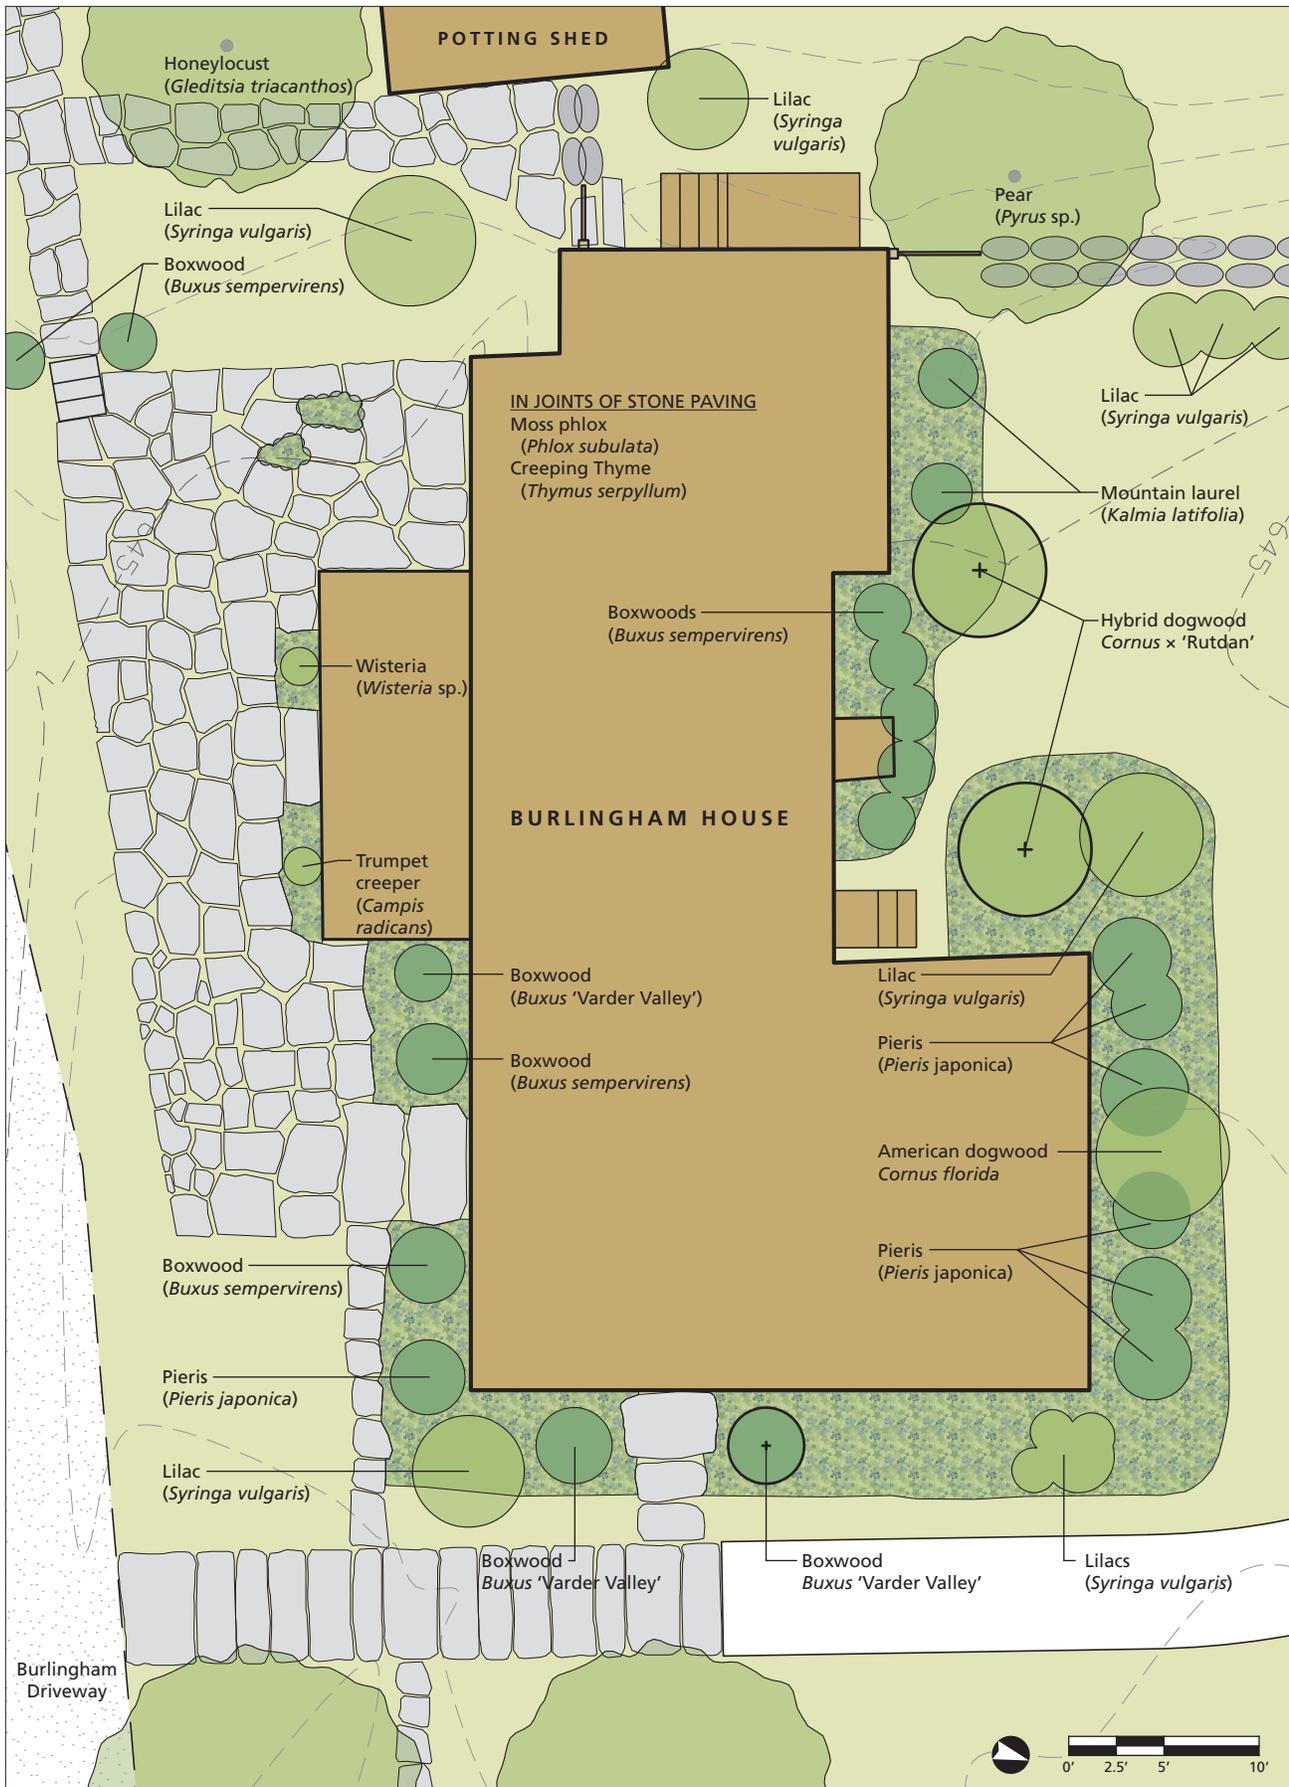
Figure 73. Diagrammatic plan showing missing foundation plantings to be replanted at the Burlingham House, 2010 (OCLP).

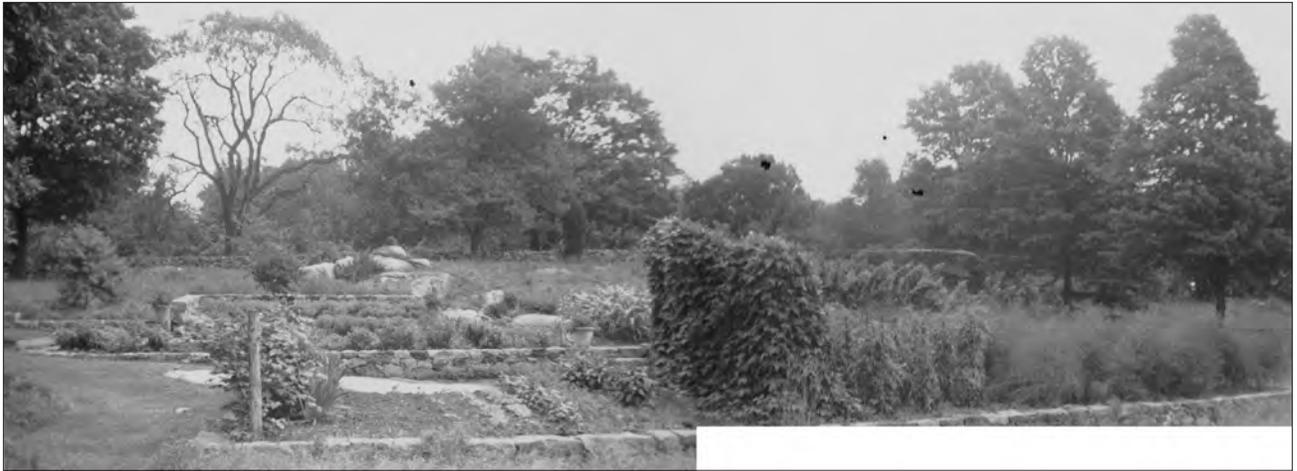
Figure 74. Plantings in the South Garden terraces during the historic period. View looking east, circa late 1950s–early 1960s (WEFA HP 1128 and 1129).

The garden terraces in the meadow directly south of the Burlingham House were constructed after the end of World War II, when Cora Burlingham abandoned her Victory Garden north of the house. Her son, Charles Burlingham, recalls that after the war, his mother became more interested in growing small fruits such as raspberries and strawberries in this new garden rather than vegetables. The garden contained three terraces defined by dry-laid stone walls. Starting with the lower terrace on the west, the terraces rose in elevation heading east and included the middle terrace and the upper terrace. The small meadow surrounding the garden terraces also included limited other plantings such as an asparagus bed, pear trees, and a small grape trellis (Figure 74).

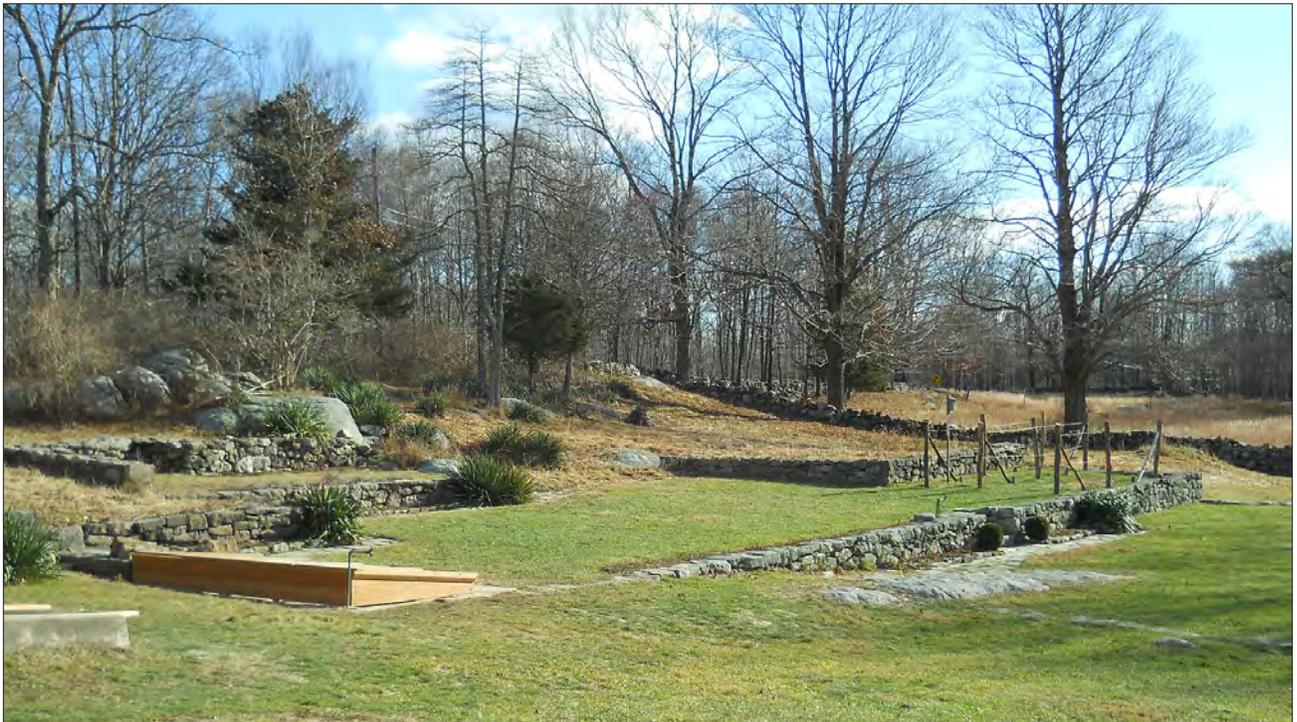
Figure 75. Plantings in the South Garden terraces added based on the 2001 garden treatment plan. The addition of plant material has greatly enhanced the character of the South Garden terraces, however, plants are missing from the middle and upper terraces. View looking southeast, 2010 (OCLP).

The addition of plant material called for in the 2001 plan has greatly enhanced the character of the South Garden terraces. Presently, the South Garden terraces are in good to fair condition with missing plant material in the middle and upper terraces (Figure 75). The park should replant the missing plantings in the South Garden terraces continuing to follow the 2001 plan (Figure 76).

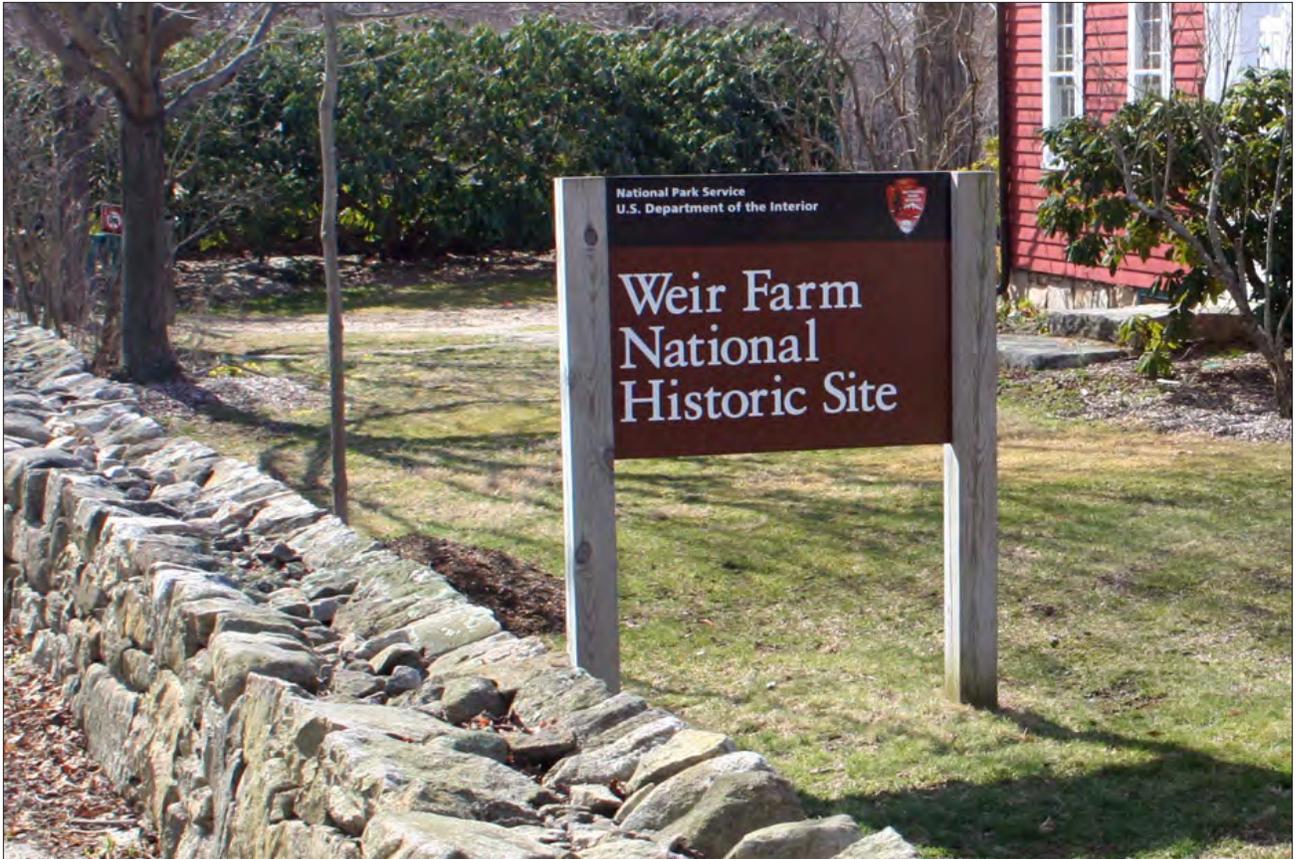
Figure 77. Park entrance sign to be developed with mounts or surrounds consistent with the site's artistic tradition. View looking southwest, 2010 (OCLP).

Presently, the park entrance sign stands east of the Burlingham House near a stone wall bordering Nod Hill Road. The sign is supported by two 8-inch square pressure treated wood posts anchored into the ground (Figure 77). Elements of the park’s mission indicate the desire to enhance public understanding of the site’s cultural and natural heritage and to perpetuate its artistic tradition. Physical elements relating to these traditions may be creatively recombined in an entrance sign of a representational nature such as easels, palettes, or frames. The *Park and Facility Identity Sign Design Standards* offers considerable latitude in the design of park entrance signs allowing variations in structure and materials to reflect the character of the park and the sign’s setting.²⁸ For Weir Farm National Historic Site’s entrance sign, special mounts or surrounds should be designed that reflect the interpretive themes of a park (Figure 78).
