CULTURAL LANDSCAPE REPORT
FOR WEIR FARM
NATIONAL HISTORIC SITE

VOLUME II: UPDATED TREATMENT PLAN AND RECORD OF TREATMENT

RIDGEFIELD AND WILTON, CONNECTICUT

Olmsted Center for Landscape Preservation
National Park Service, Boston, Massachusetts, 2013

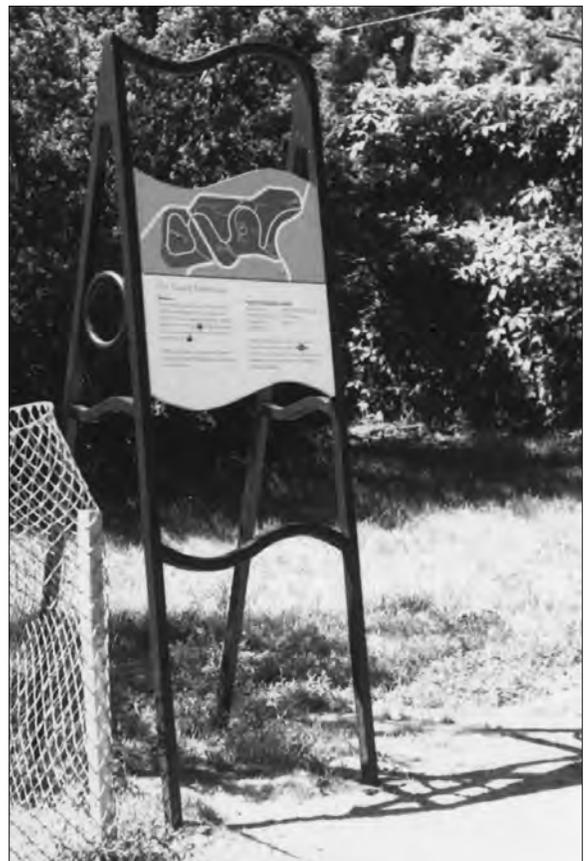
Figure 78. Precedent image of a park sign mounted on a representational easel. The Arnold Arboretum, 1997 (OCLP).

Presently, the park entrance sign stands east of the Burlingham House near a stone wall bordering Nod Hill Road. The sign is supported by two 8-inch square pressure treated wood posts anchored into the ground (Figure 77). Elements of the park’s mission indicate the desire to enhance public understanding of the site’s cultural and natural heritage and to perpetuate its artistic tradition. Physical elements relating to these traditions may be creatively recombined in an entrance sign of a representational nature such as easels, palettes, or frames. The *Park and Facility Identity Sign Design Standards* offers considerable latitude in the design of park entrance signs allowing variations in structure and materials to reflect the character of the park and the sign’s setting.²⁸ For Weir Farm National Historic Site’s entrance sign, special mounts or surrounds should be designed that reflect the interpretive themes of a park (Figure 78).

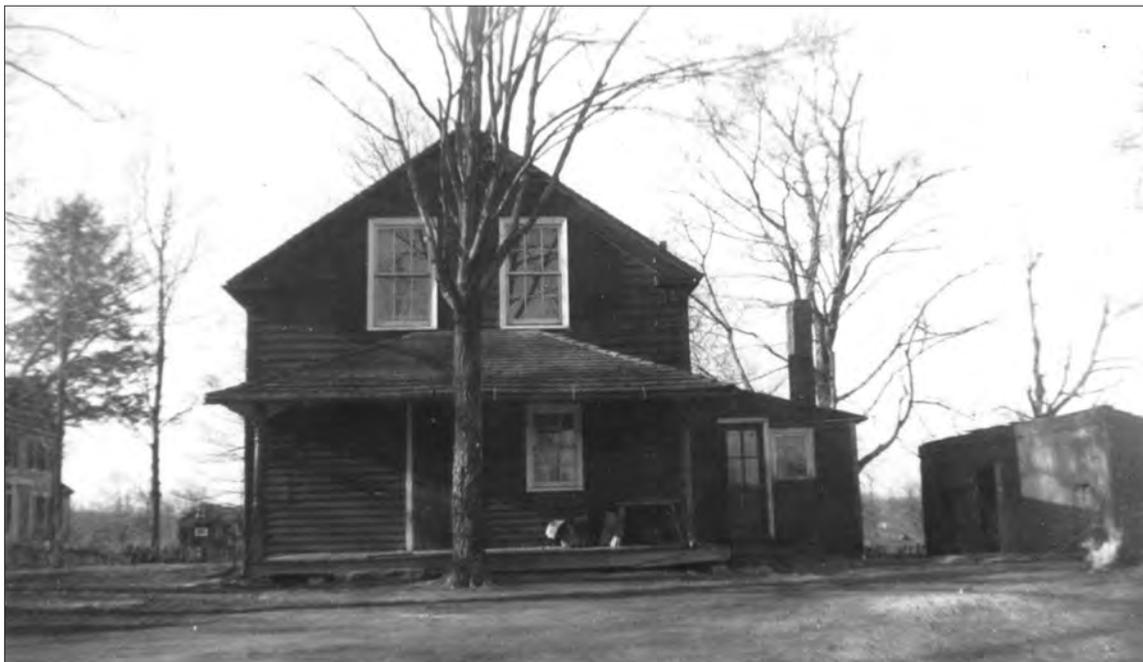
Figure 82. Minimal foundation plantings at the Caretaker's House during the historic period. View looking north, circa mid-1930s (WEFA HP 1111).

Mahonri Young also captured images of the Caretaker's House in sketches prepared during his tenure at the property. Two Young sketches from the 1940s show the north facade of the Caretaker's House with limited foundation planting and a rustic, wood picket fencing north of the building (Figures 80 and 81). Photographs from the Bass family, who served as caretakers and lived in the house during the Young tenure, also show minimal foundation planting (Figure 82).

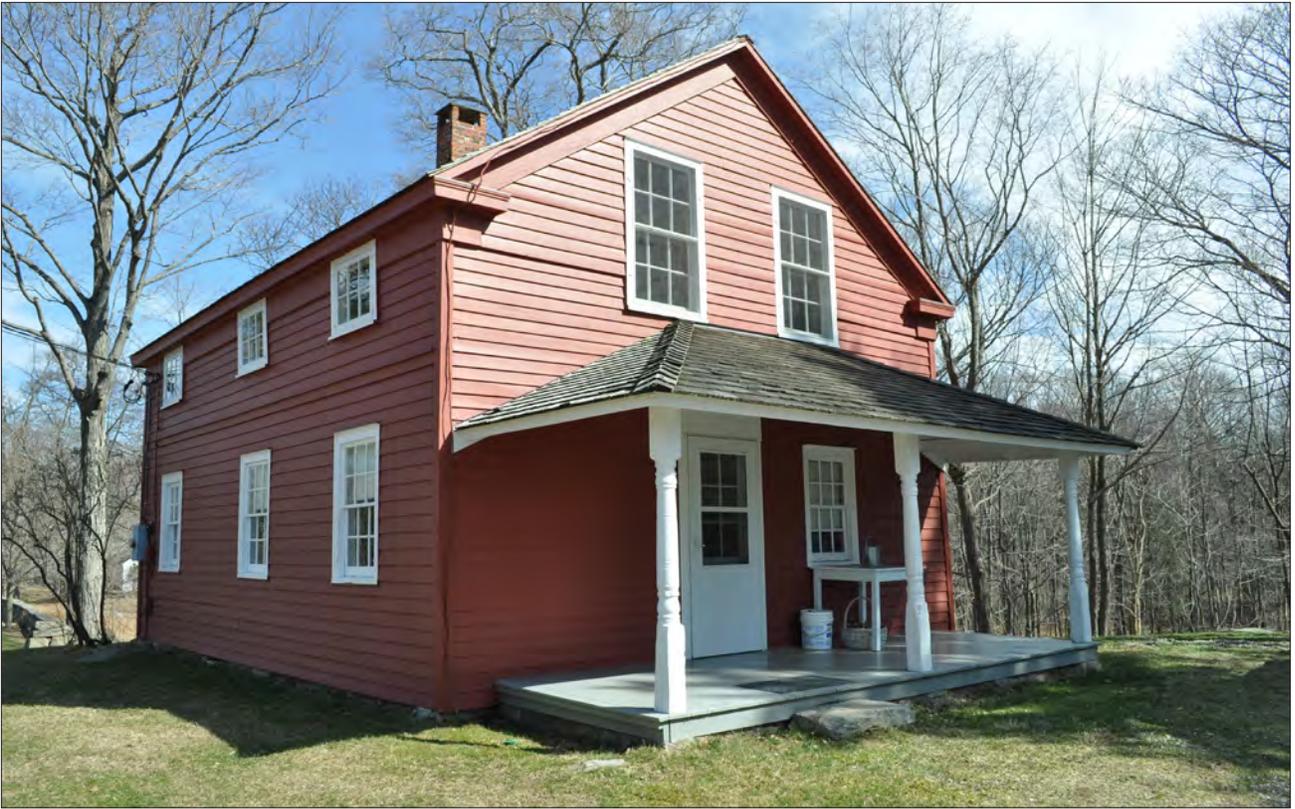
Figure 83. Missing foundation plantings at Caretaker's House to be replanted. View looking northeast, 2010 (OCLP).

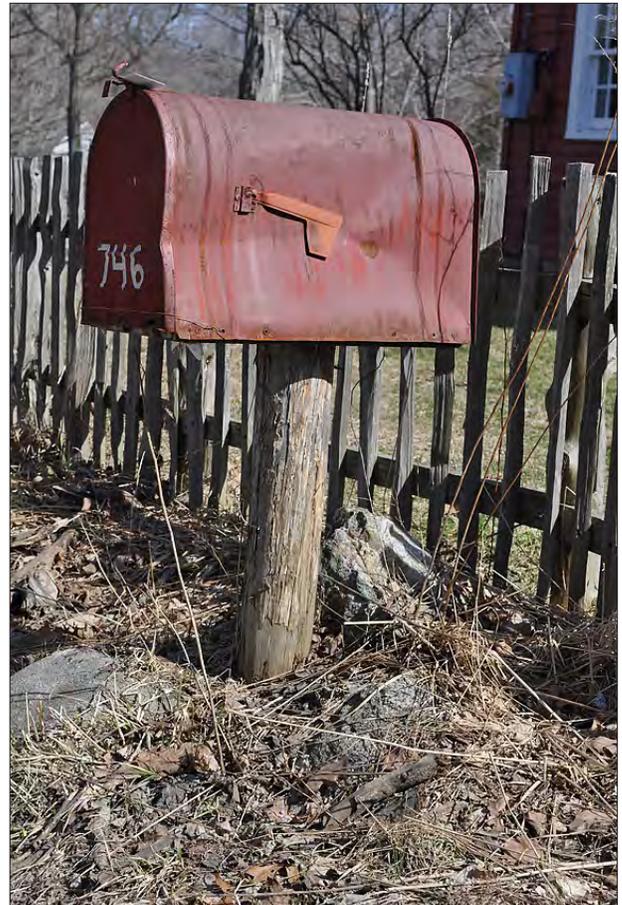
Figure 84. Caretaker's mailbox to be preserved. View looking northeast, 2010 (OCLP).

A large steel mailbox stands north of the driveway to the Caretaker's House along Nod Hill Road. The mailbox is mounted on an unpeeled wood post set into the ground (Figure 84). The size of the mailbox, larger than ones currently commercially available, is indicative of residences that received rural mail service and contributes to the character of Weir Farm National Historic Site.

The park should preserve the Caretaker's mailbox by maintaining the paint finish to match the existing color. The park should also screw or rivet shut the door since this operational feature is not needed. In conjunction with replacing the Weir mailbox (see task WD-SSF-2), the park should find a replacement mailbox for the Caretaker's House that matches the existing in materials, size, and finish. The replacement mailbox should be acquired and stored for future use.

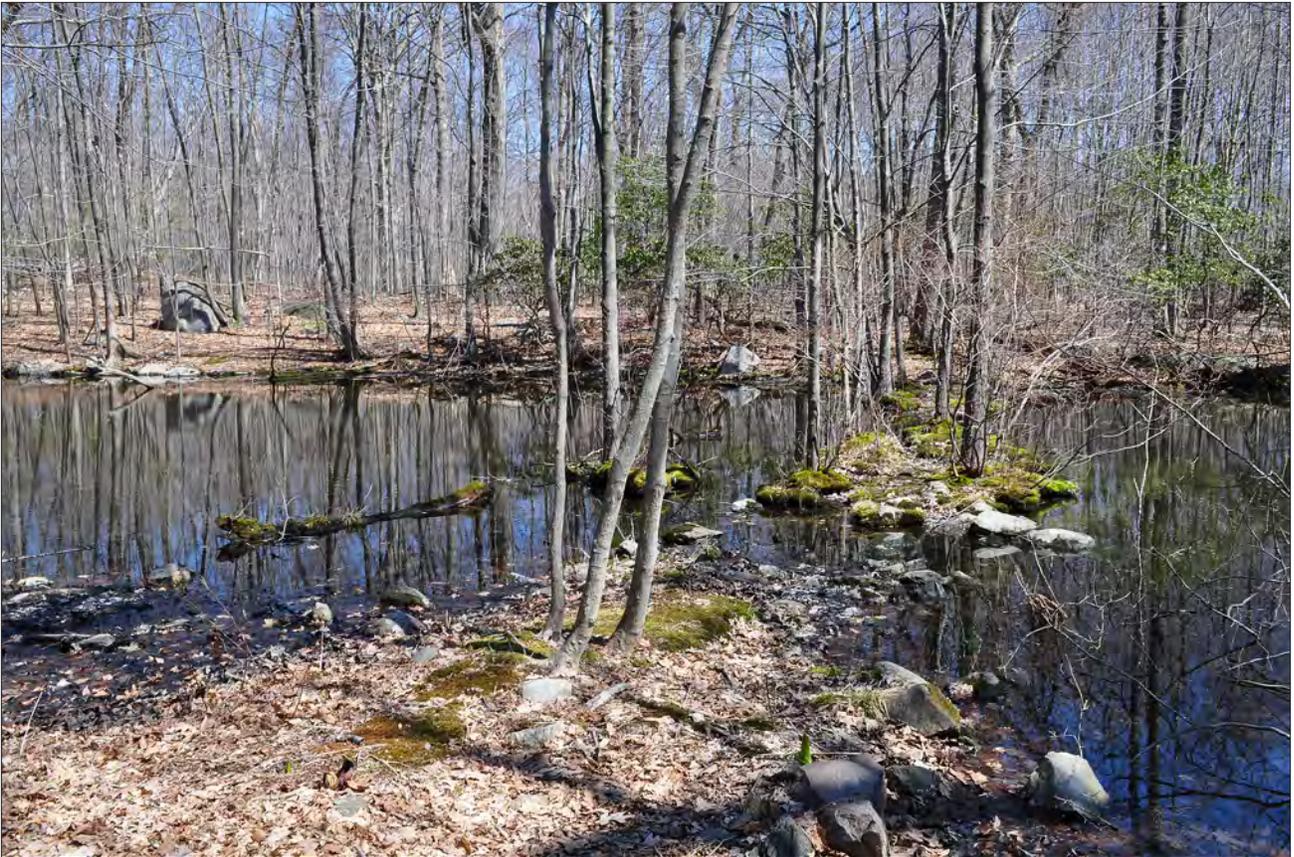
Figure 85. Vegetation on historic stone causeway to be managed. The stone causeway pre-dates Julian Alden Weir's purchase of the property and is presently in poor condition due to trees growing among the stones. View looking north, 2011 (OCLP).

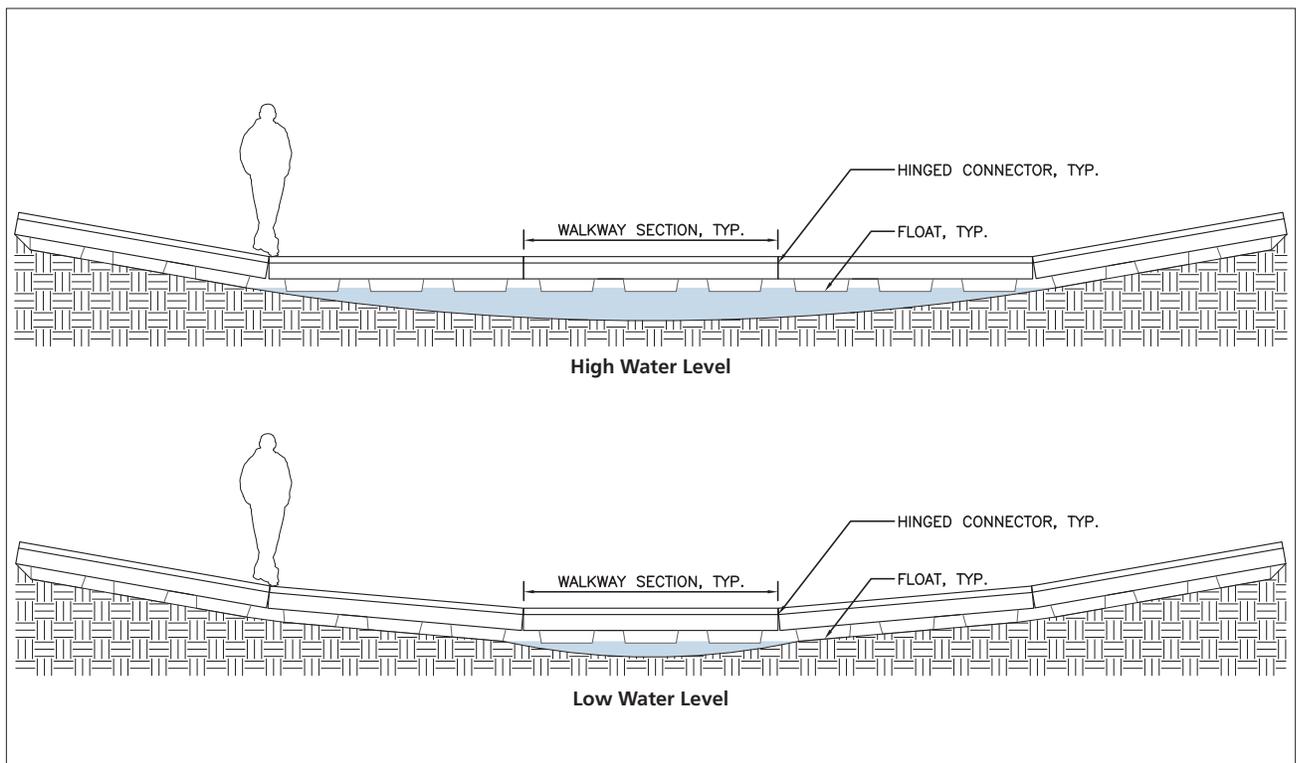
Figure 86. Diagrammatic section showing wetland crossing to be installed adjacent to historic stone causeway. The new wetland crossing is constructed from sections of wood or synthetic decking attached to polyethylene floats underneath, 2012 (OCLP).

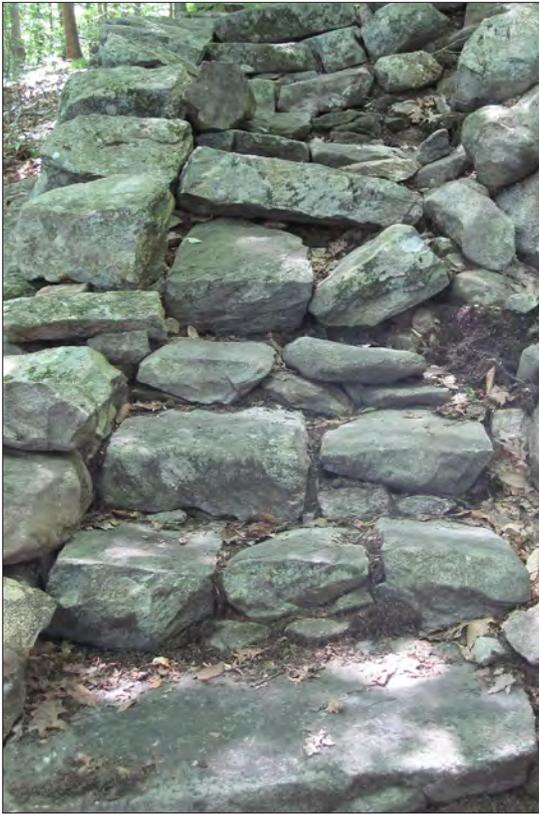
Figure 87. Fieldstone steps to be reset leading from Ridgetop Meadow to Weir Pond. The stones should be reset so the treads provide a level and consistent walking surface. View looking west, 2011 (OCLP).

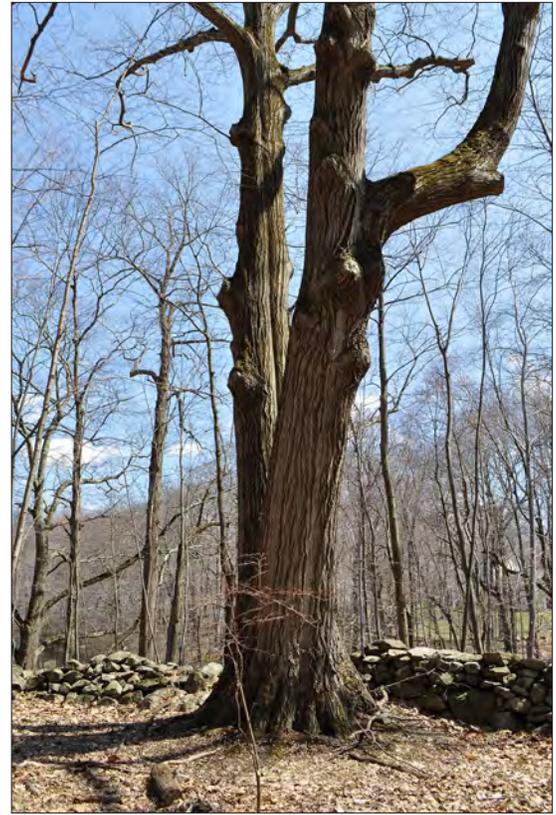
Figure 89. Large “wolf tree” to be preserved during the removal of successional woody vegetation from the Triangular and Ridgetop meadows. View looking east along the perimeter of the Ridgetop Meadow, 2011 (OCLP).

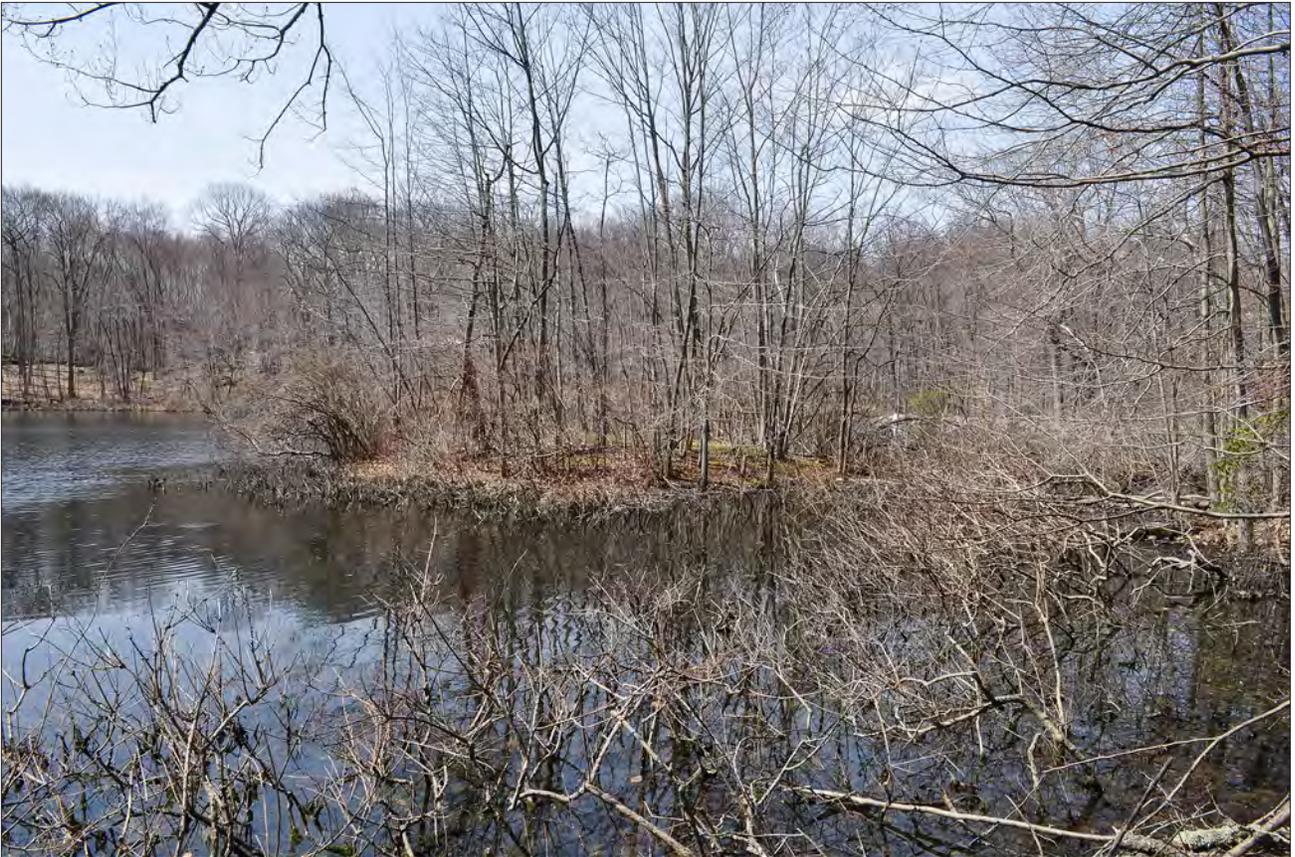
Figure 93. Semi-submerged shrubby vegetation to be removed along the island's perimeter. The current vegetation obscures a clear edge that defines the intentionally constructed island. View looking north, 2011 (OCLP).

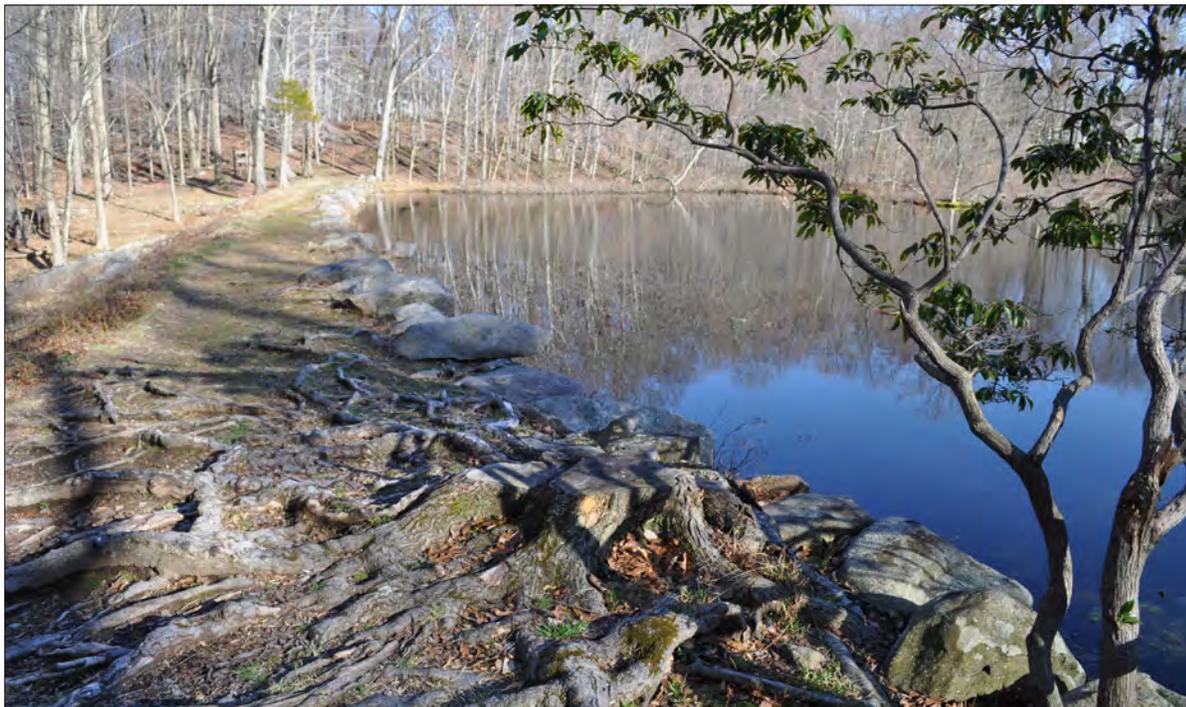
Figure 95. Weir Pond and dam to be rehabilitated. The earthen dam crest serves as a footpath that is part of a trail system around the pond. In the foreground, a stump remains from a tree removed from the crest. View looking southeast, 2010 (OCLP).

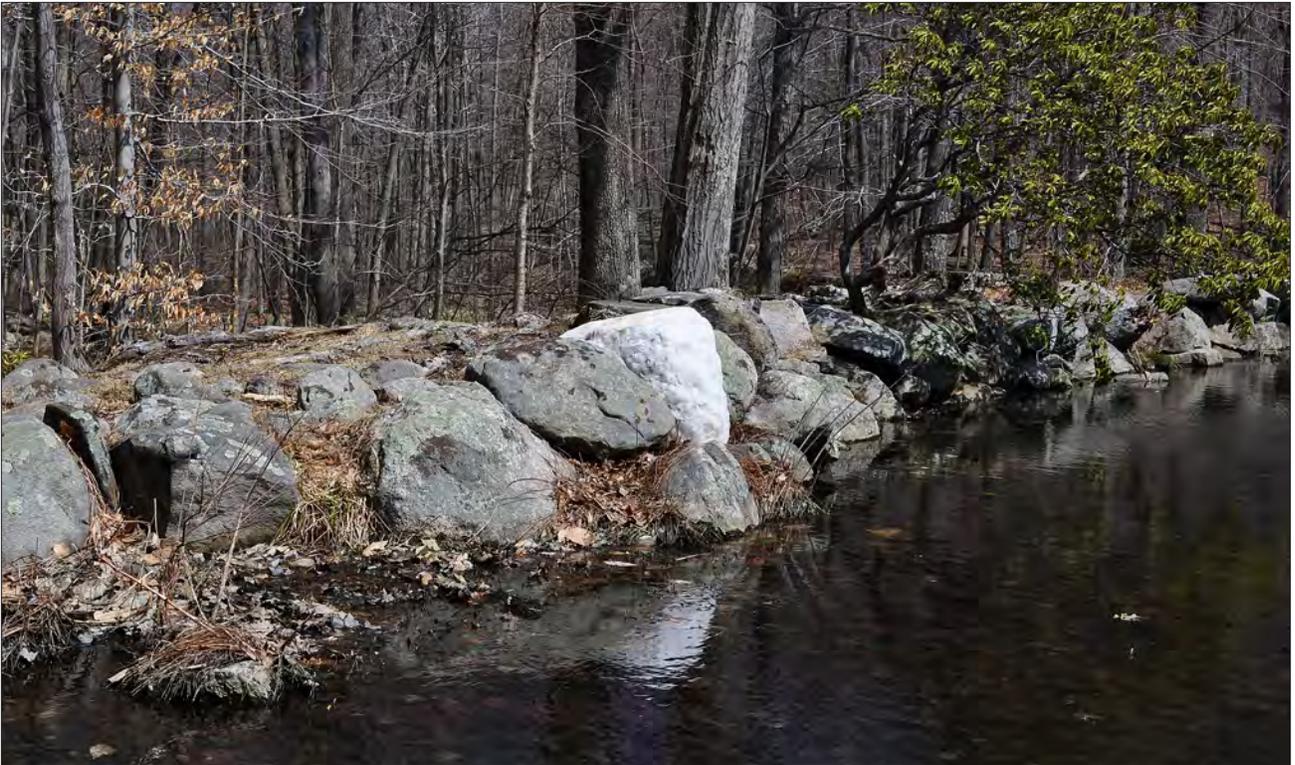
Figure 96. White quartz boulder to be preserved in its current location during the rehabilitation of Weir Pond and dam. View looking northeast at the western end of the dam, 2011 (OCLP).

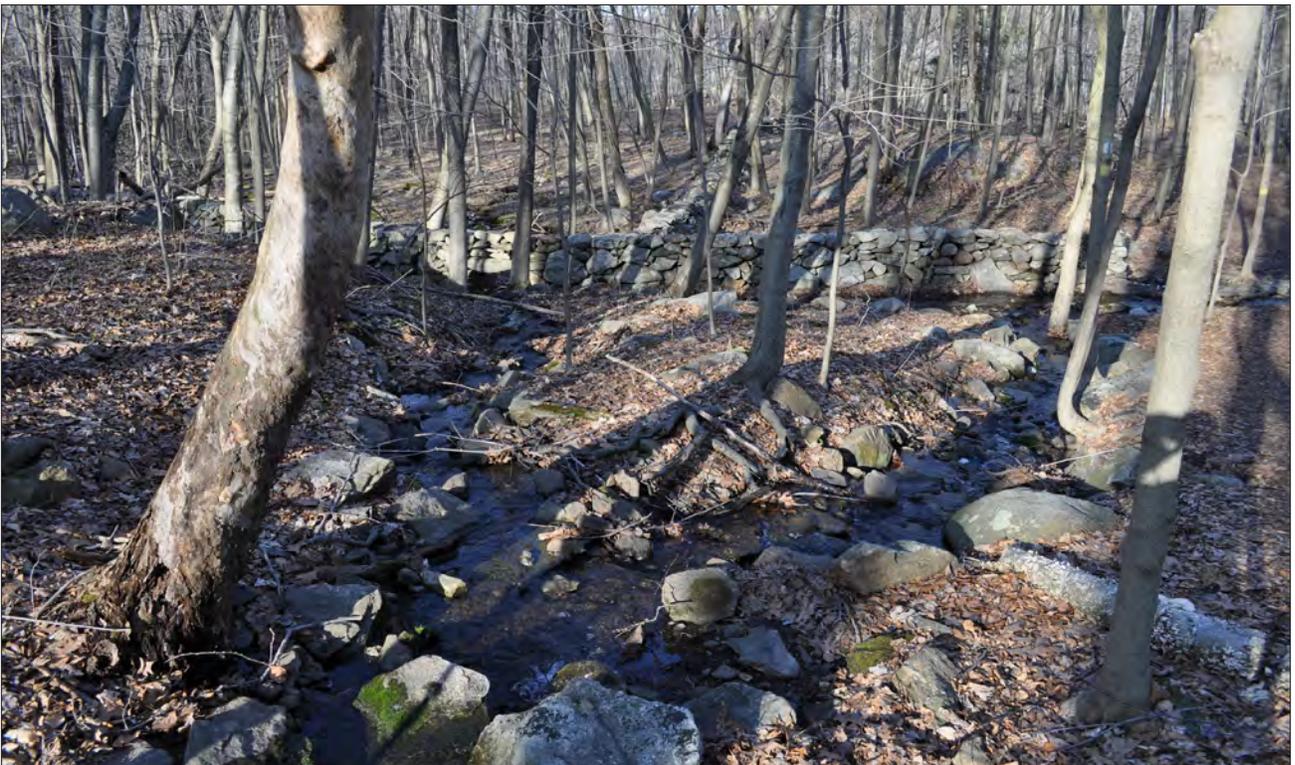
Figure 97. Stone-lined water diversion system to be rehabilitated including resetting collapsed stones and removing debris from the system's water channel. View looking east, 2010 (OCLP).

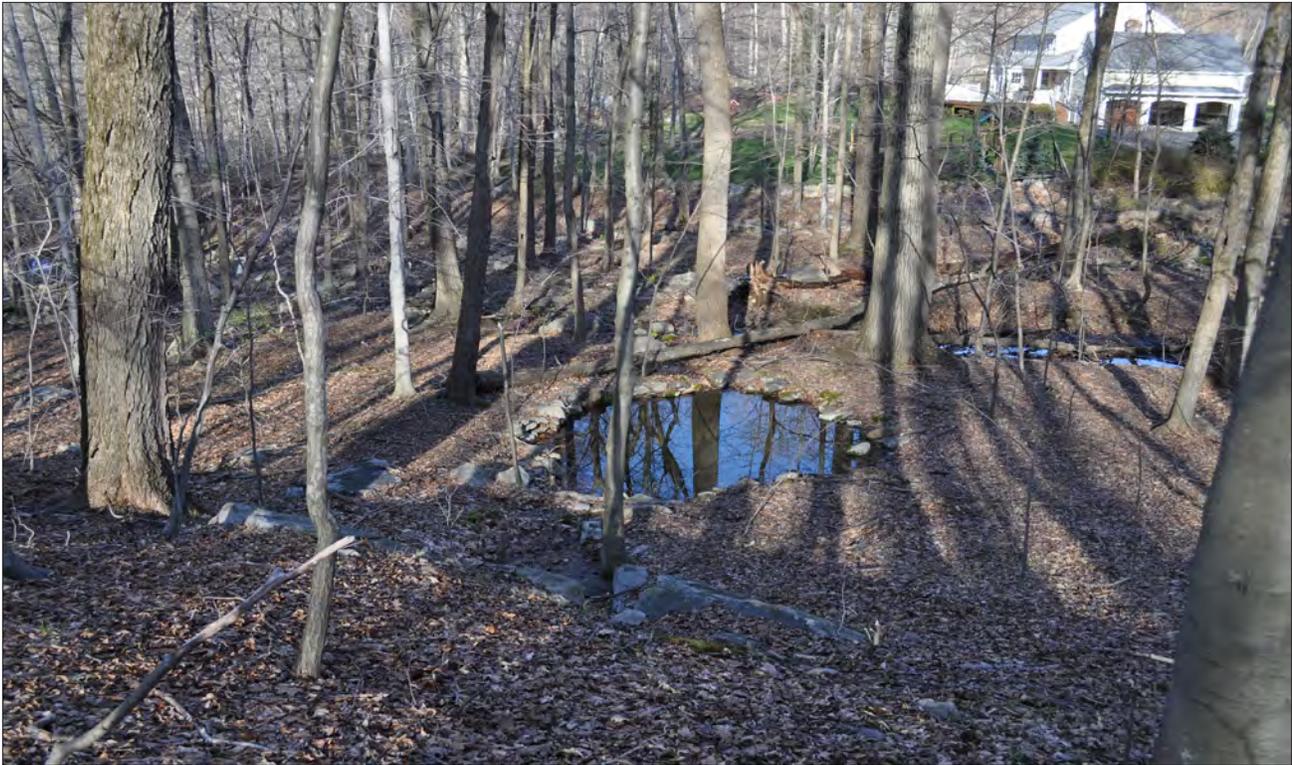
Figure 98. Spring box and circular pool to be rehabilitated including the clearing of sediment and debris. View looking east, 2010 (OCLP).

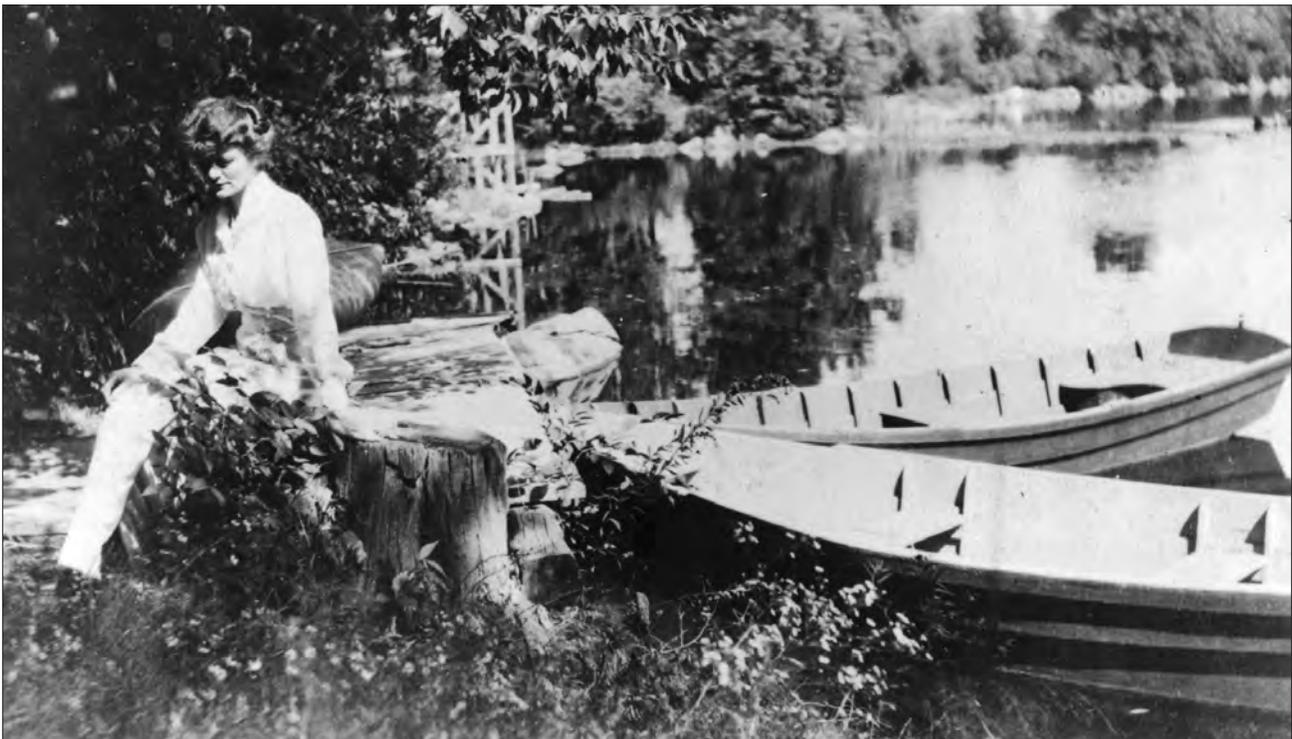
Figure 99. Complete archeological research of Boathouse site prior to erecting interpretive marker. An open, wood frame Boathouse is visible in the background of this photograph and restoring the structure is not recommended since sufficient information is not available. View looking northeast, circa 1915 (WEFA HP 167).

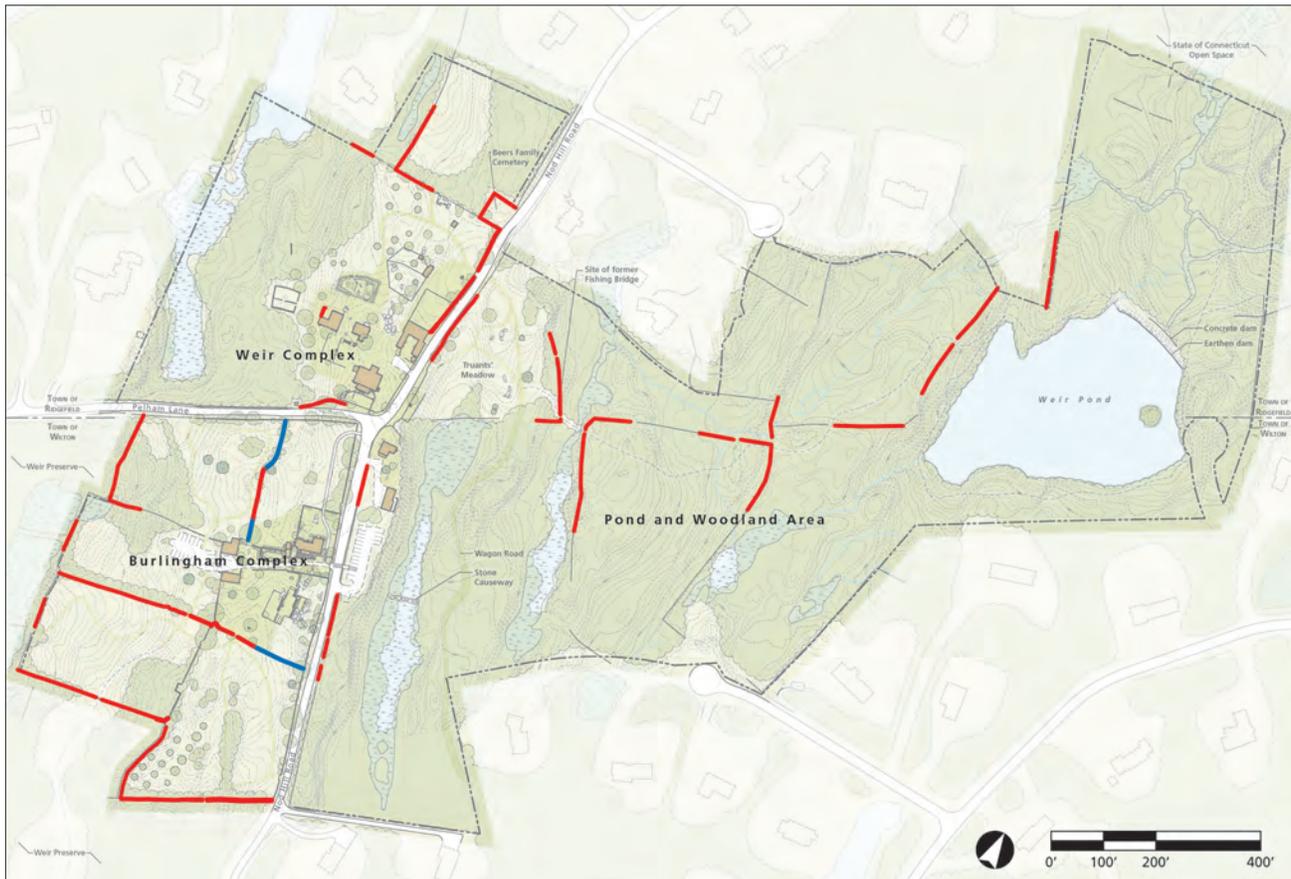
Figure 100. Stone walls repaired and restored site wide. Red lines designate repairs or restorations completed between 1997 and 2012 and blue line show stone wall control samples that should remain unaltered. The graphic does not include garden terrace walls, the stone pig pens, or work completed by contractors since these projects are covered in separate record of treatment sections, 2012 (OCLP).

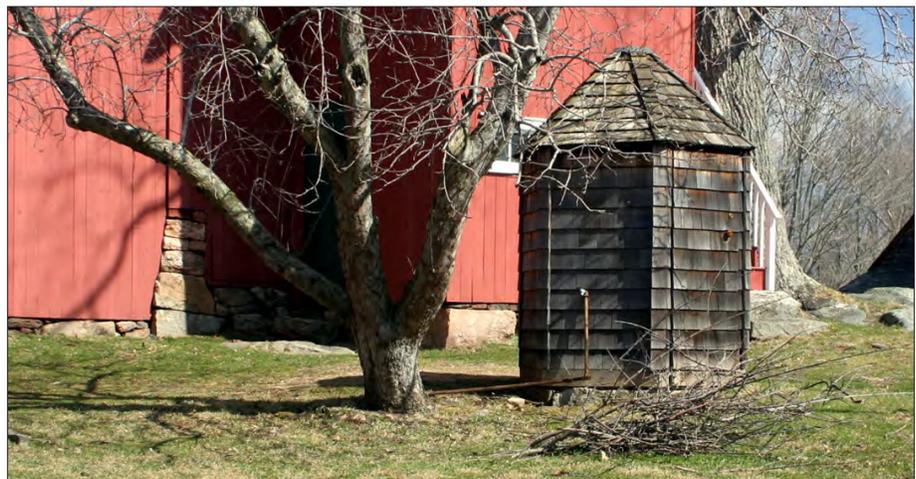
Figure 102. Stabilized Tool Shed. View looking northeast, 2010 (OCLP).

Located northwest of the Weir House and east of the vegetable garden, the Tool Shed was built sometime between 1900 and 1930. The Tool Shed's construction likely occurred in concert with the building of the rustic gate structures at the Secret Garden. Late 1930s sketches by Mahonri Young show the octagonal building and circa 1945 photographs by Lewis Iselin record the Tool Shed was extant during the circa 1940 treatment period (Figure 101). Similar to many wood framed outbuildings at Weir Farm National Historic Site, the Tool Shed was in declining condition due to a failing foundation and deteriorating wood members. The park entered into a cooperative agreement with the Institute for Preservation Training and in 1999, the Institute completed work to stabilize the Tool Shed. The work performed included foundation repairs, replacing in kind the deteriorated sill, floor framing, and flooring, and installing new cedar roof shingles, side-wall shingles, and flashing to match the historic materials (Figure 102).¹

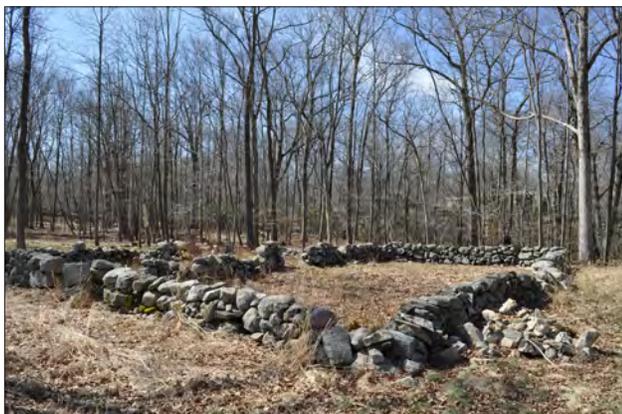
Figure 104 (bottom left). Pig pens to be stabilized. View looking southwest, 2010 (OCLP).

The pig pens are located about sixty feet west of the Young studio and feature two to four feet high stone walls forming two rectangular pens. During a March 2010 review, the pig pens appeared in poor condition with fully collapsed sections and gaps created by missing stones (Figure 104). In the autumn of 2010, the Dry Stone Conservancy, Inc., stabilized the pig pens by repairing approximately 220 linear feet of collapsed or unstable stone wall. Workers completed all repairs using extant stones from the collapsed or unstable sections (Figure 105).

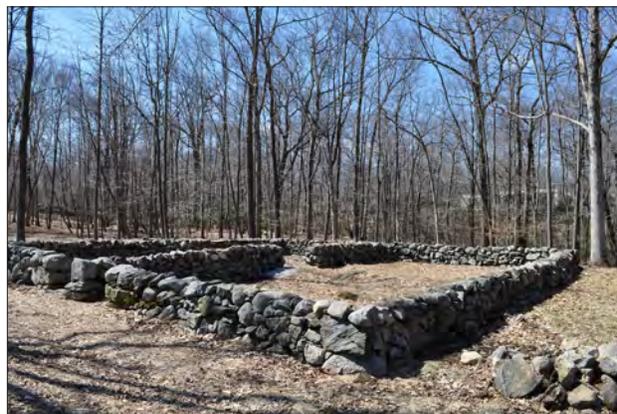
Figure 105 (bottom right). Stabilized pig pens. View looking southwest, 2011 (OCLP).

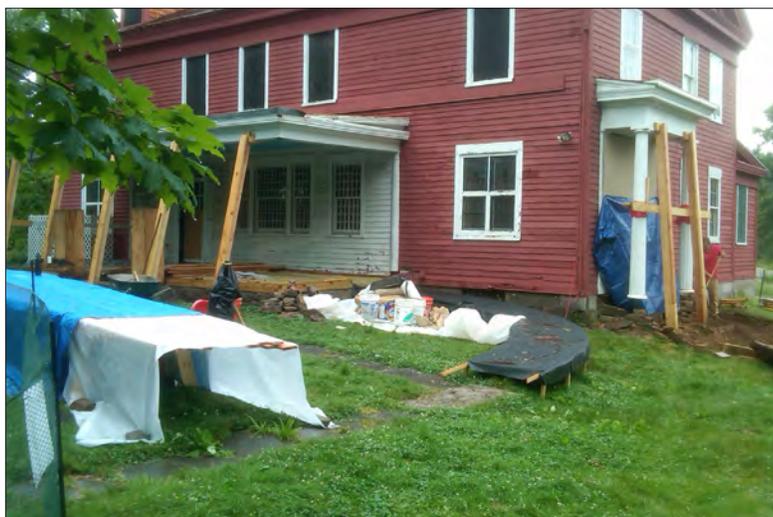
Figure 107 (top left). Weir House Accessible Walk. Plan view, 2012 (OCLP).

In August 2012, the park completed a universally accessible route to the Weir House. The route began off of Pelham Lane and proceeded north through a gate in the rustic picket fence. The apron section to the gate was finished with a chip and seal or rolled stone surface set on an asphalt base. From the gate, the route changed to a walk of new granite pavers and began a gentle rise in grade with the slope not exceeding five percent. The new granite replaced historic granite pavers too narrow for an accessible route. The new granite matched the old in color and composition and exposed surfaces were natural cleft finish instead of sawn. Irregularities in the cleft surface were bush hammered and the combination of the cleft surface and hammering created a rough, flaked texture that more closely resembled naturally weathered granite. The new granite pavers varied in width from 37 to 40 inches and varied in length from 18 to 48 inches. Workers set pavers of different sizes next to each other with joints varying from 3/8 to 3/4 inches to create a meandering edge and a walk consistent with the character of the historic granite pavers (Figure 107). The new granite walk then turned in a consistent radius to the west and continued to rise with the slope not exceeding five percent to meet the east edge of the Weir House porch. At the porch, a section of inset decking, roughly 7 feet 6 inches in length, rose approximately 4 inches and made a flush transition with the surrounding decking (Figure 108).

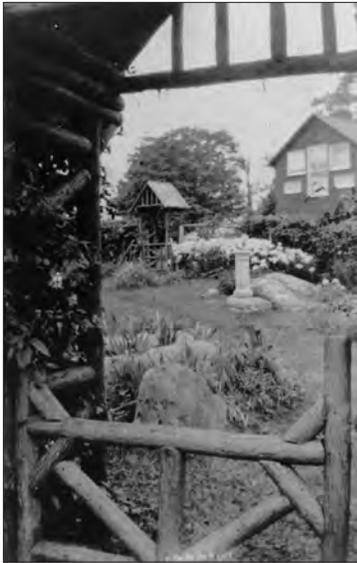
Figure 109 (above). The Secret Garden during the Weir tenure. View looking southeast, circa 1915 (WEFA HP 162).

By circa 1915, a series of photographs indicate that the Weir family expanded a garden north of the Weir Studio to include extensive perennial planting, a perimeter hedge, a fountain, a sundial, and two rustic roofed gates (Figure 109).⁴ Flower gardening was not an area of intense interest for Mahonri and Dorothy Weir Young and during their tenure at Weir Farm the plantings, particularly the perimeter hedge, became overgrown. Obscured by the perimeter hedge, the Youngs christened the garden the “Secret Garden.”⁵ Between the late 1930s and early 1940s, Mahonri Young prepared several sketches that included the Secret Garden. The sketches confirm that in addition to the hedge, the fence, roofed gates, and sundial continued as defining elements of the garden during the circa 1940 treatment period (Figure 110). The garden’s wood fence and roofed gates came down some time following Dorothy Weir Young’s death in 1947.⁶

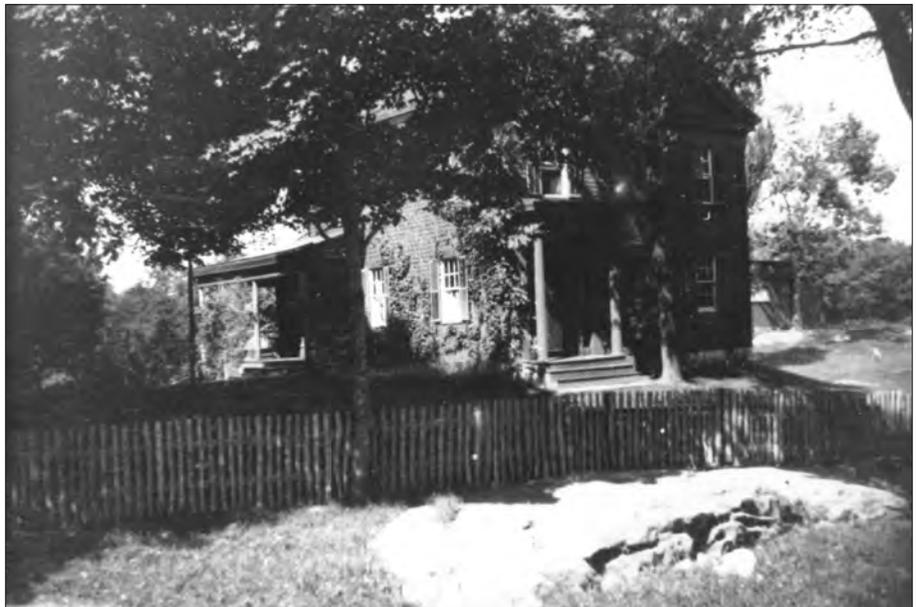
Figure 117. Rustic picket fencing at the Weir House. View looking west across Nod Hill Road, pre-1900 (WEFA HP 27).

Rustic picket fencing lined a portion of Nod Hill Road and Pelham Lane in front of the Weir House and was historically used as a consistent motif to unite the house, Barn, and Caretaker's House across Nod Hill Road. In the early 1900s, Weir had the rustic fence installed to replace a more classically designed fence that featured white painted pickets made of sawn lumber (Figure 117). Both the earlier painted fence and the rustic fence featured wrought iron pins set into the exposed stone ledge to provide support for the vertical posts. Two historic photographs dating to the 1940s reveal that rustic fencing with split, triangular pickets was retained through the historic period.⁷

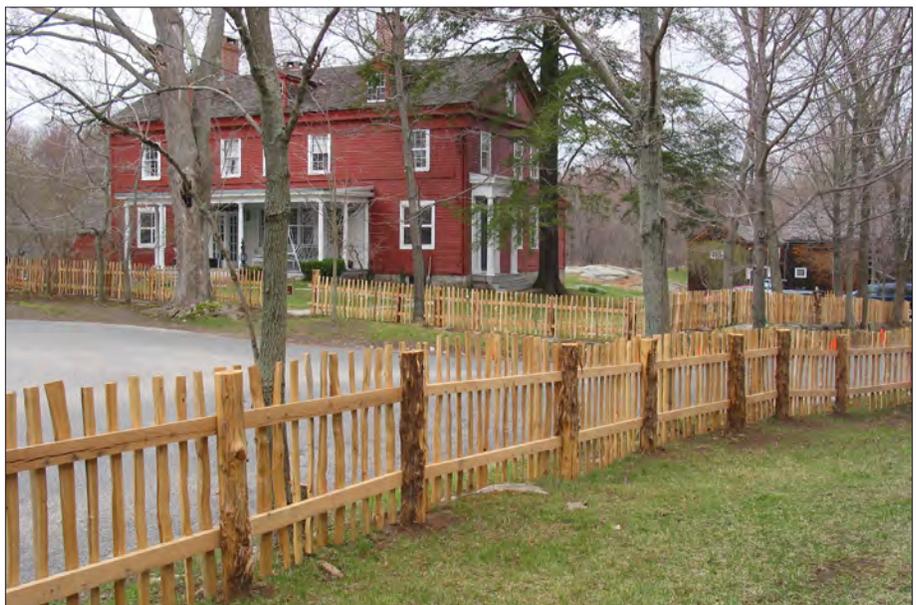
Figure 118. Restored rustic picket fencing at the Weir House. View looking northwest across the Nod Hill Road and Pelham Lane intersection, 2003 (OCLP).

In April 2003, the park installed rustic picket fencing at the Weir House following restoration plans prepared by the Olmsted Center (Figure 118). Identical

fencing was installed along Nod Hill Road at the Caretaker’s House, however, fence sections north of the house were not added as part of the 2003 project. The Olmsted Center determined the layout for fence posts based on surviving iron pins and drill holes present in the exposed stone ledge. New fence posts were cut from eastern red cedar (*Juniperus virginiana*) logs approximately 6 inches in diameter. Horizontal rails were selected from rough sawn white oak (*Quercus alba*) and the rustic pickets were crafted from split Atlantic whitecedar (*Chamaecyparis thyoides*). Each picket varied in width from 1-3/4 to 2-1/4 inches and was attached to the rails at 4-1/2 inches on center (Figures 119 and 120).

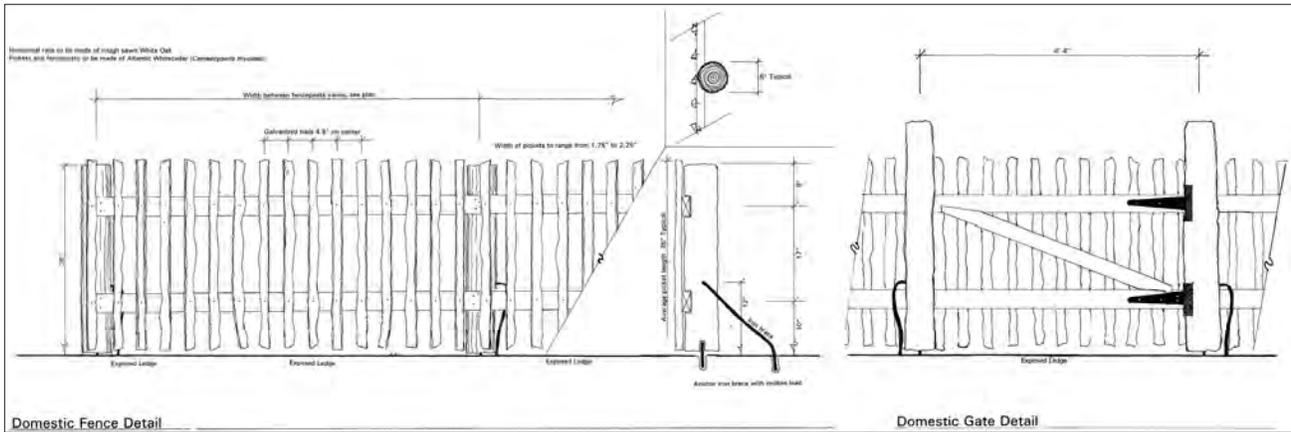
Figure 119. Elevation of rustic picket fence and gate for the Weir House, 1996 (OCLP).
