CULTURAL LANDSCAPE REPORT
FOR WEIR FARM
NATIONAL HISTORIC SITE

VOLUME II: UPDATED TREATMENT PLAN AND RECORD OF TREATMENT

RIDGEFIELD AND WILTON, CONNECTICUT

Olmsted Center for Landscape Preservation
National Park Service, Boston, Massachusetts, 2013

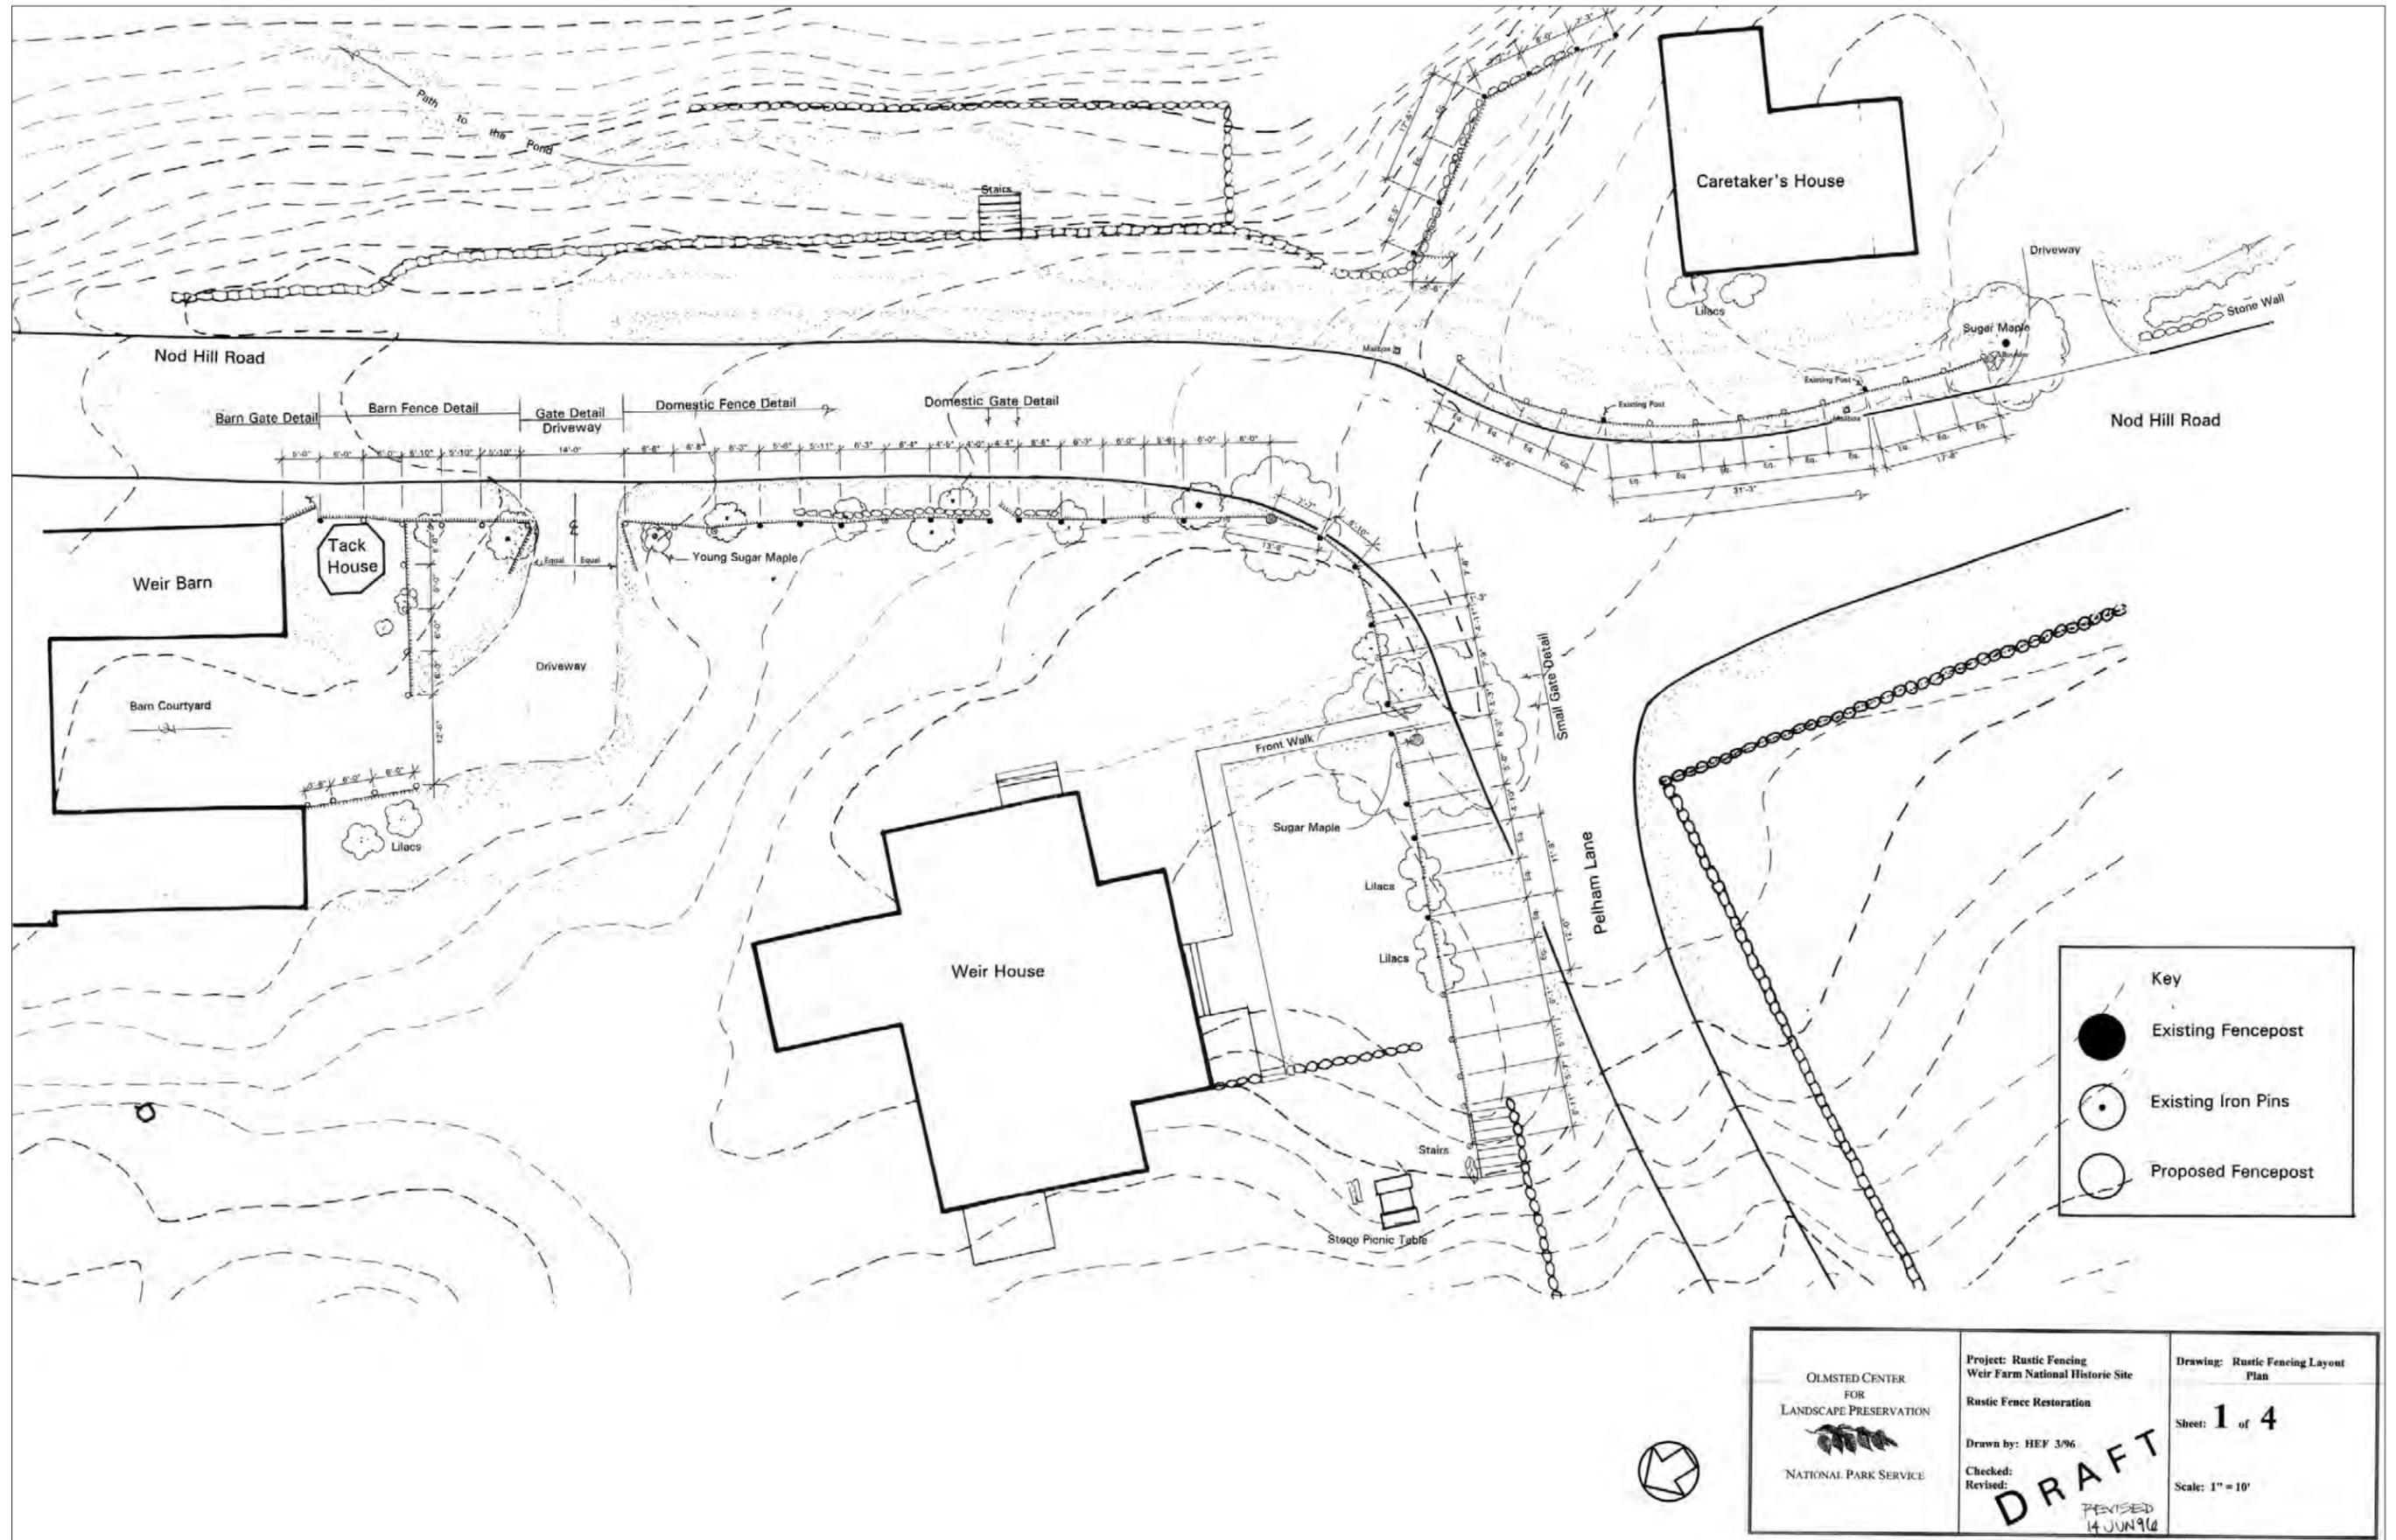
Figure 120. Layout plan of the rustic fence and gates, 1994 (OCLP).

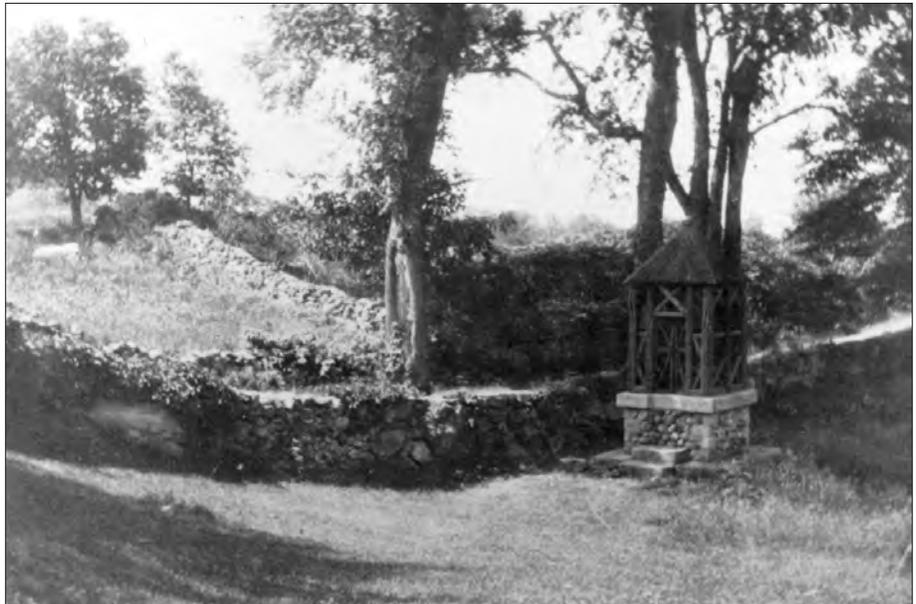
Figure 121. Stone well house with Adirondack-style twig-framed canopy. View looking southwest, no date (WEFA HP 284).

Between 1890 and 1905, a stone well house was built west of the Weir House and near Pelham Lane. The well house featured an Adirondack-style twig-framed canopy attached to a stone cover (Figure 121). According to interviews with Bill Young, Mahonri Young's son from his first marriage, it is uncertain that the canopy survived into the 1940s. Interviews with Doris Andrews indicate that when she and her husband purchased the Weir property in 1958, the canopy was not present. Since it is uncertain the canopy survived to the circa 1940 treatment period, the park has not restored this feature. Instead, the park replaced the deteriorated stone cover in 2005 and securely fastened the new cover to the well house (Figure 122).⁸ For the cover, the park selected a salt-and-pepper granite two inches thick. The granite featured saw cut edges and measured three foot square in size.

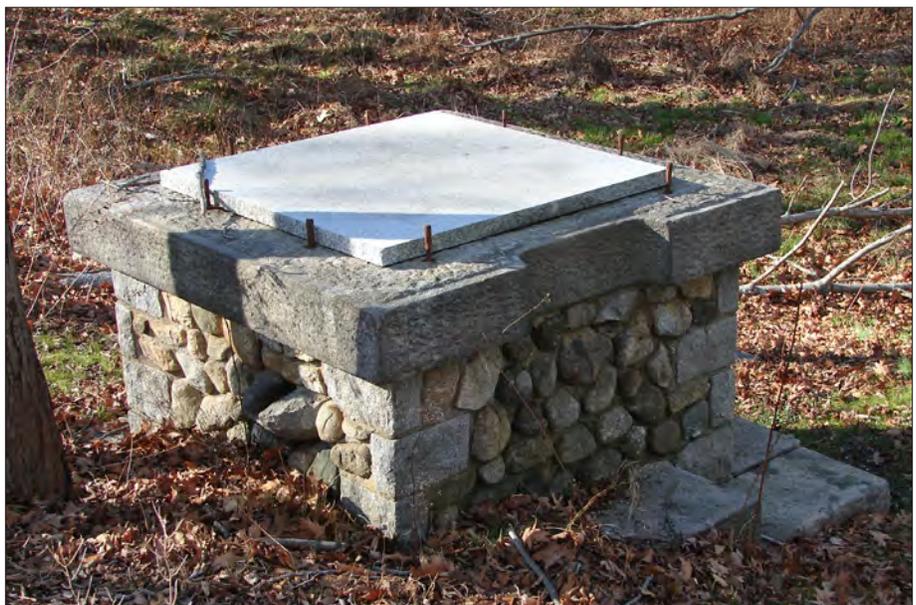
Figure 122. Stabilized well cover. View looking northwest, 2010 (OCLP).

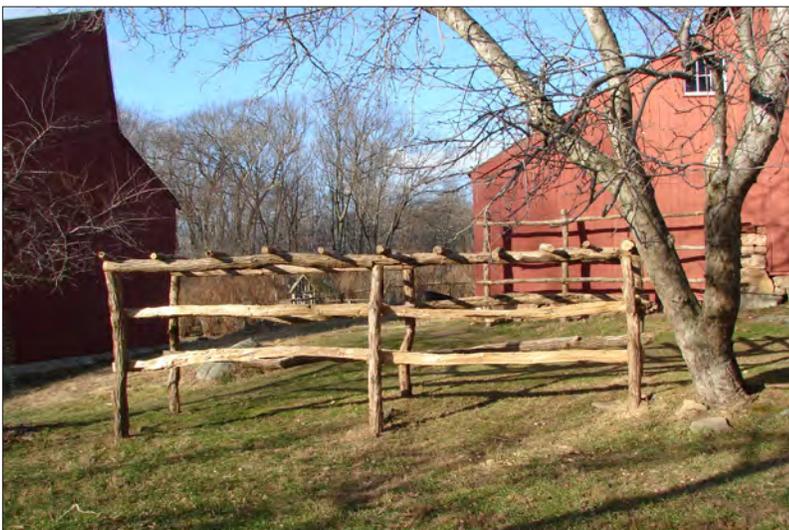
Figure 124 (bottom). Restored Garden Arbor. View looking north, 2010 (OCLP).

To better convey Weir Farm National Historic Site as the rural home of two artists, the Historic Preservation Training Center restored the arbor in the fall of 2010 (Figure 124). The arbor’s wood posts and rails were prepared from naturally rot-resistant black locust. The new pieces were treated with Tim-Bor Professional™, a water-soluble borate powder that provides additional protection against wood decay and insect damage. The borate application does not affect the finish color and the locust pieces will naturally weather. Based on the historic images and existing stone pieces, the posts were set at eight feet on center forming an overall length of sixteen feet. The arbor’s height was set at approximately five feet, below the roof line of the existing Tool Shed to the east, and its width at approximately four feet (Figure 125).

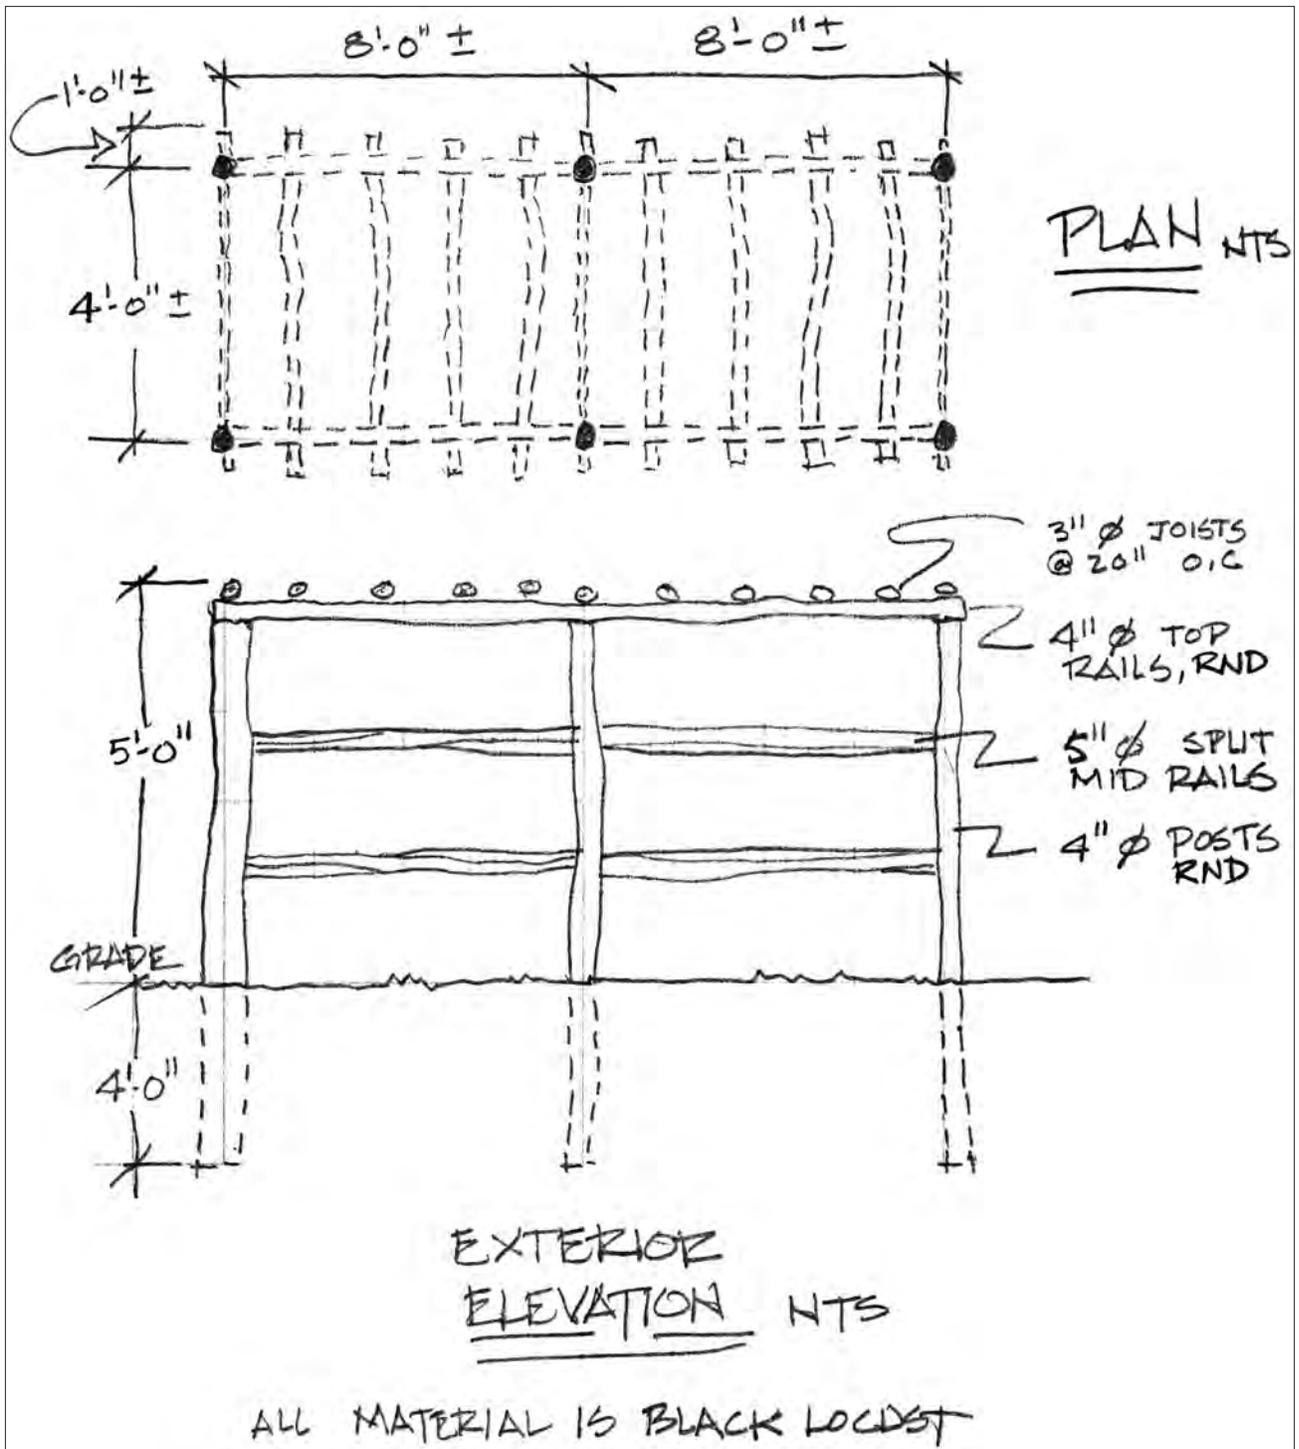
Figure 125. Restored Garden Arbor plan and elevation, 2010 (HPTC).

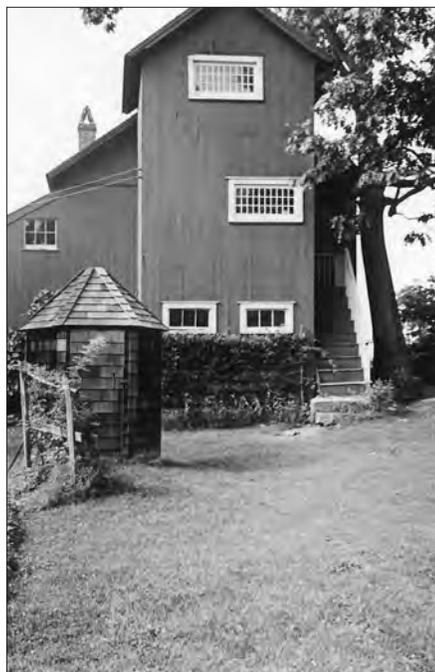
Figure 126 (left). Rose Arbor, Tool Shed, and Weir Studio. View looking north, circa 1945 (Lewis Iselin, WEFA).

The Mahonri Young sketches and Lewis Iselin photographs document a second, smaller arbor in the vicinity of the upper terrace. Southwest of the Tool Shed, a simple Rose Arbor stood constructed from two posts and two rails (Figure 126 and see Figure 123). In conjunction with the restoring the Garden Arbor, the Historic Preservation Training Center restored the Rose Arbor in the fall of 2010 (Figure 127). The arbor posts were black locust logs, approximately 5 inches in diameter. Black locust was also used for the two rough sawn rails. The top rail consisted of 2x3 lumber and was set at a slope as indicated in the historic images. The southern end of the top rail was attached at a lowered elevation than the northern end. A piece of larger 2x6 lumber was installed as the bottom rail. All the locust components were treated with Tim-Bor Professional™ (Figure 128).

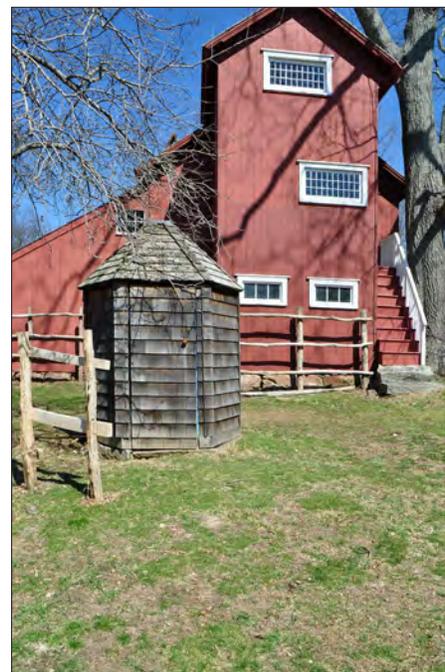
Figure 127 (right). Restored Rose Arbor. View looking north, 2011 (OCLP).

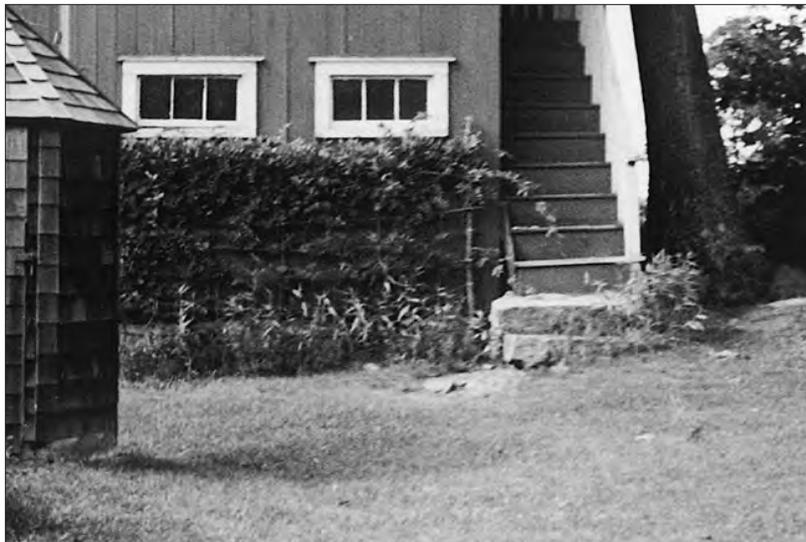
Figure 129 (top). Weir Studio water tower, trellis, and vines. Detail of view looking north, circa 1945 (Lewis Iselin, WEFA).

Historic images from the Young tenure show vines growing on the south facade of the Weir Studio. Specifically, Young's sketches from the late 1930s show vines on the lean-to addition of the Weir Studio (see Figure 123). The vines on the addition remained during the circa 1940 treatment period and are documented in circa 1945 photographs by Lewis Iselin (see Figure 101). The Iselin photographs also document vines under the windows of the projecting water tower and reveal the vines were trained on to trellises constructed from narrow, unmilled wood poles

set perpendicular to each other (Figure 129).

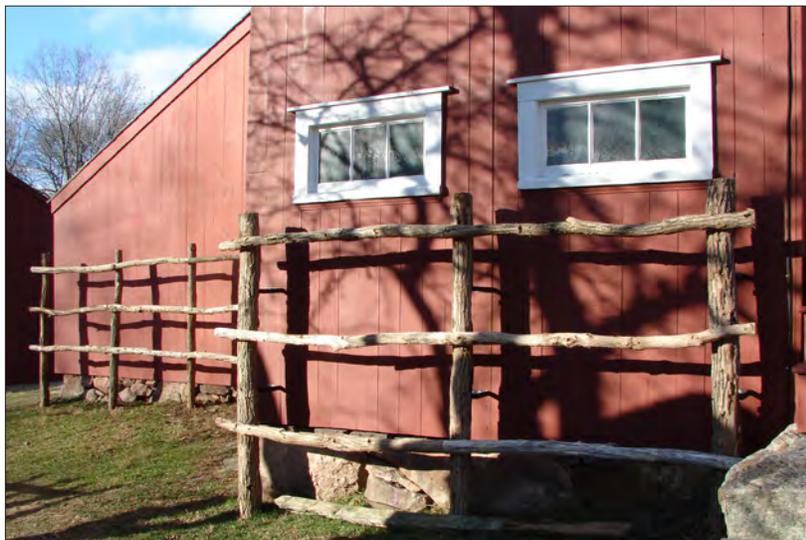
Figure 130 (bottom). Restored trellises on the Weir Studio. View looking northwest, 2010 (OCLP).

Working with the Historic Preservation Training Center, the park restored the trellis on the lean-to and on the water tower of the Weir Studio in the fall of 2010 (Figure 130). The trellises were constructed from black locust logs for both the posts and rails. The posts measured ± 4 inches in diameter and the rails measured ± 3 inches diameter. All the locust components were treated with a water-soluble borate powder sold as Tim-Bor Professional™. Due to concerns about encountering utility lines near the Weir Studio, the posts were not set into the ground but attached to the studio with inconspicuous "L" brackets. Workers at Woodbury Forge in Woodbury, Connecticut, fabricated the brackets and finished them with a black exterior paint. The Historic Preservation Training Center mortised the brackets into the back of each post and secured the brackets to the Weir Studio with 2-1/2 inch stainless steel screws (Figure 131).

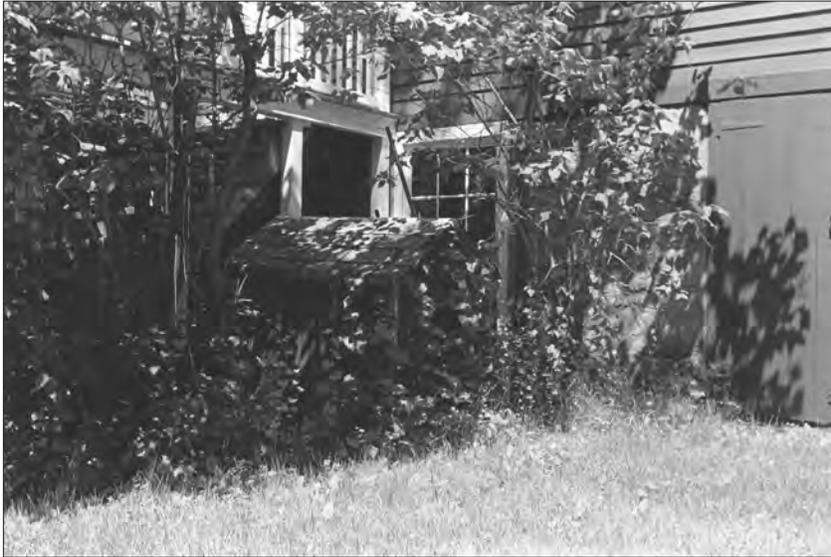
Figure 132 (top). Dog house near the Weir House deck. View looking north, 1995 (OCLP).

Mahonri Young sketches from the late 1930s and early 1940s show dog houses in various locations around the Weir House.¹⁰ The dog houses are small in size, simple wood construction, and may have been moved to various locations around the house during the circa 1940 period. Fieldwork performed in 1995 documented a dog house located south of the Weir House deck concealed among clumps of lilacs (Figure 132). The origin of the dog house near the deck is unknown and the feature is no longer extant.

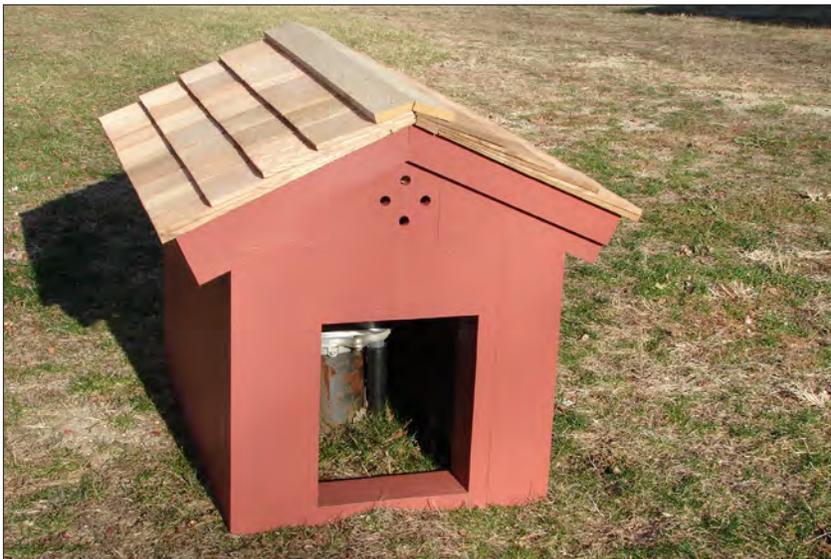
Figure 133 (bottom). Reproduction dog house. View looking northeast, 2010 (OCLP).

The park completed major utility and infrastructure upgrades in 2009 that required excavations around the Weir House and with this activity completed, the Historic Preservation Training Center constructed a reproduction dog house in the fall of 2010 (Figure 133). The reproduction dog house assists in restoring the domestic character of the circa 1940 landscape that included small-scale features in the Weir Domestic Complex. The dog house measures 25 inches wide, 37 inches long, and 32 inches high. The frame was constructed out of pressure treated 2x4 lumber and clad with 5 inch wide mahogany boards for the siding. The siding was painted to match the red exteriors of the Weir House and the two studios. The roof was covered with cedar shingles featuring a 4-1/2 inch exposure. The Historic Preservation Training Center placed the open frame dog house over a protruding well head northwest of the Weir House.

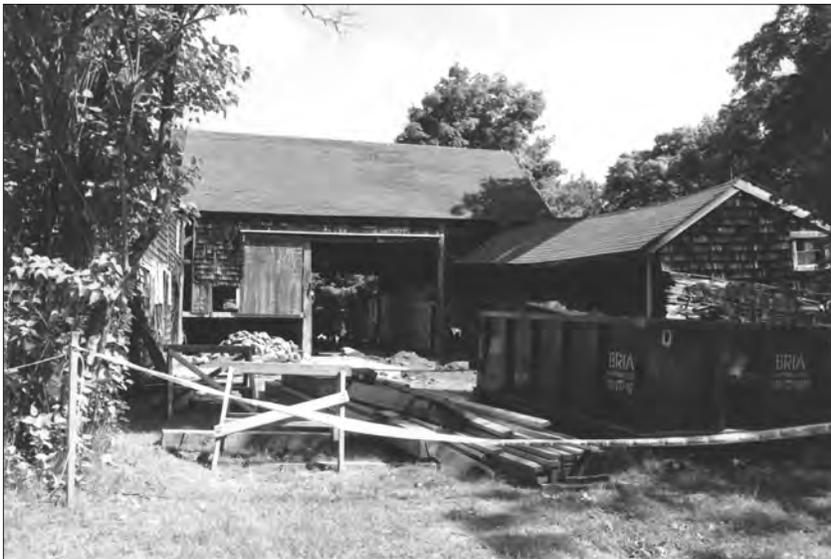
Figure 134 (top). Restoration of the Weir Barn and Tack House. View looking northeast, 1995 (OCLP).

and installed temporary structural supports to prevent the Barn from collapsing (Figure 134). In 1996,

the park completed restoration work on the Weir Barn and Tack House. Foundations and rotted sills

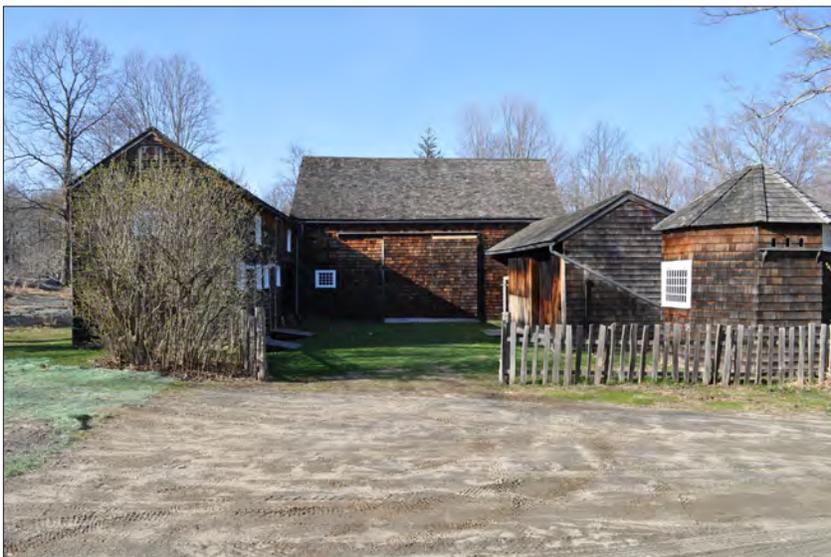
Figure 135 (bottom). Restored Weir Barn and Tack House. View looking north, 2010 (OCLP).

were repaired and replaced where necessary. Five non-historic maple trees, growing in close proximity to the

two structures' foundations, were also removed. Restoration work included finishing the buildings' exterior walls

and roofs with unpainted wood shingles and painting all window trim white (Figures 135 and 136).¹¹

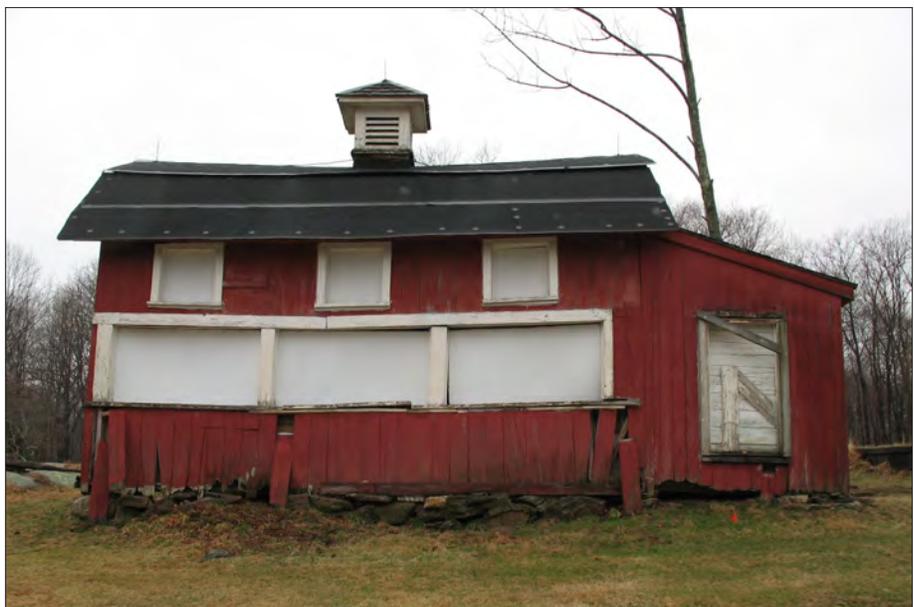
Figure 137. Chicken House to be stabilized. View looking west, 2008 (Greg Waters, WEFA).

During the Weir tenure, the family directed the construction of an ice house in circa 1891. Mahonri and Dorothy Weir Young continued to use the ice house during their years at the farm. However, around 1941, the Youngs converted the structure to a chicken house because they were at the property more frequently, could use a contemporary electric refrigerator, and wanted to increase the size of their flock pending rationing for World War II. When Weir Farm became a unit of the National Park Service, the Chicken House rested on a deteriorated stone foundation with rot affecting the wooden sills and vertical board siding (Figure 137). In 2008, the park stabilized the Chicken House by repairing the foundation and replacing the rotted sills and siding (Figure 138).¹²

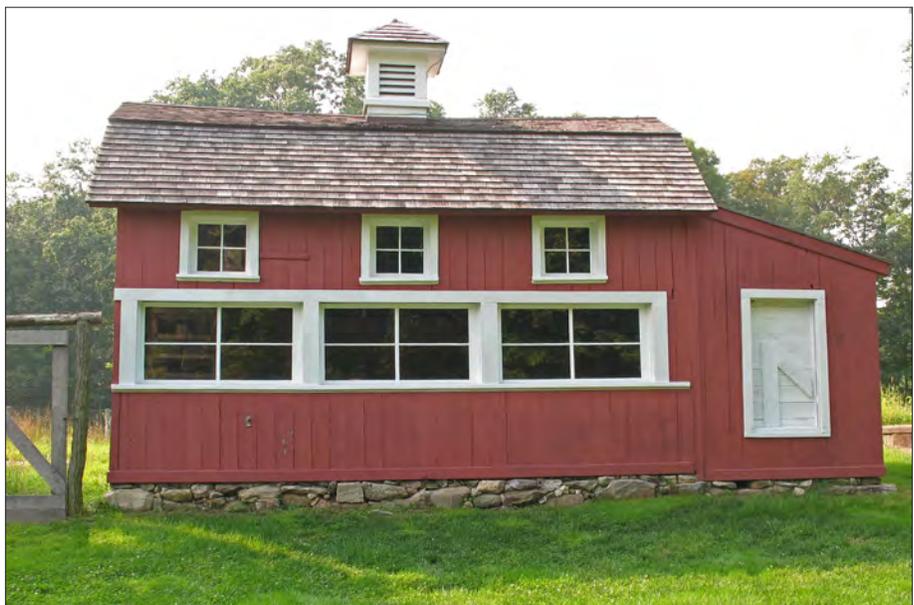
Figure 138. Stabilized Chicken House. View looking west, 2013 (Greg Waters, WEFA).

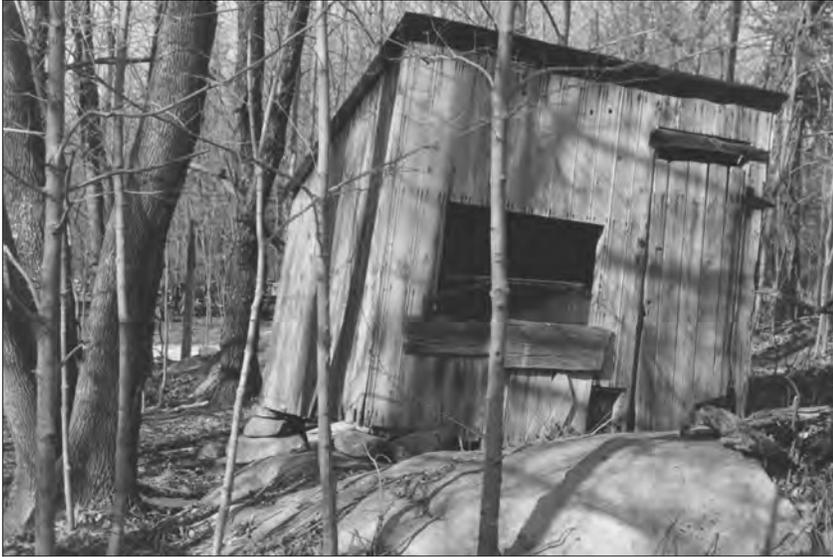
The Animal Shelter is thought to have been built circa 1932 to replace a chicken coop removed by the construction of the Young Studio. It appears that the Animal Shelter served as a chicken coop until the early 1940s when the nearby Ice House was converted for use as a chicken house. Fieldwork performed in 1995 recorded the Animal House in very poor condition and teetering on an inadequate

Figure 139 (top). Animal Shelter in very poor condition. View looking northeast, 1995 (OCLP).

foundation (Figure 139). In 1998, the Institute for Preservation Training stabilized the Animal Shelter by salvaging original fabric and replacing in kind other material. Institute workers reset the dry-laid stone footings at each of the structure's four corners and constructed a new floor platform consisting of 4x4 white oak sills and 2x4 pressure treated pine joists. The platform was covered with a layer of wire screening and finished with new southern yellow pine flooring. Original and replacement lumber were used to reframe the walls and roof and the exterior received new vertical board siding. Workers installed roof sheathing using random width, 1-inch thick white oak boards and topped the sheathing with red cedar shingles laid at a 5-1/2 inch exposure. New wire screening was installed over window and vent openings, and on the south facade, plexi glass was secured behind the wire to better seal a window opening 2 feet 5-1/2 inches high by 3 feet 4 inches wide (Figure 140).¹³

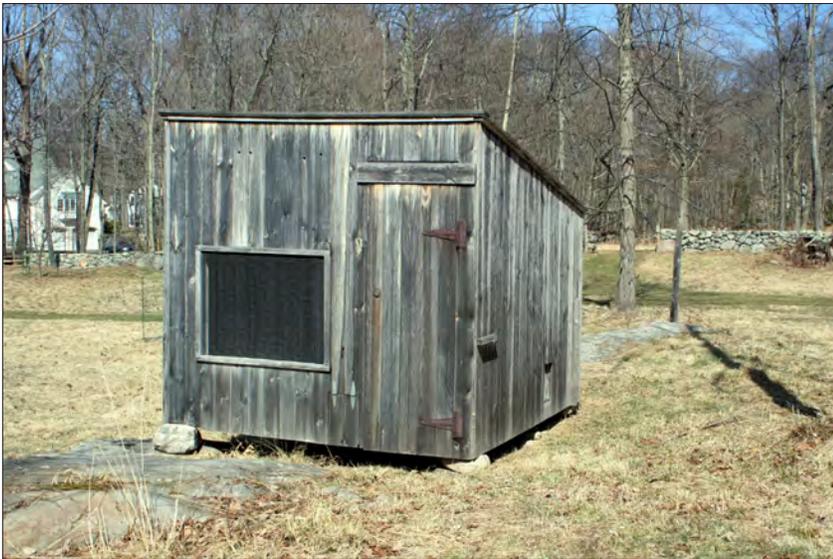
Figure 140 (bottom). Stabilized Animal Shelter. View looking northwest, 2010 (OCLP).

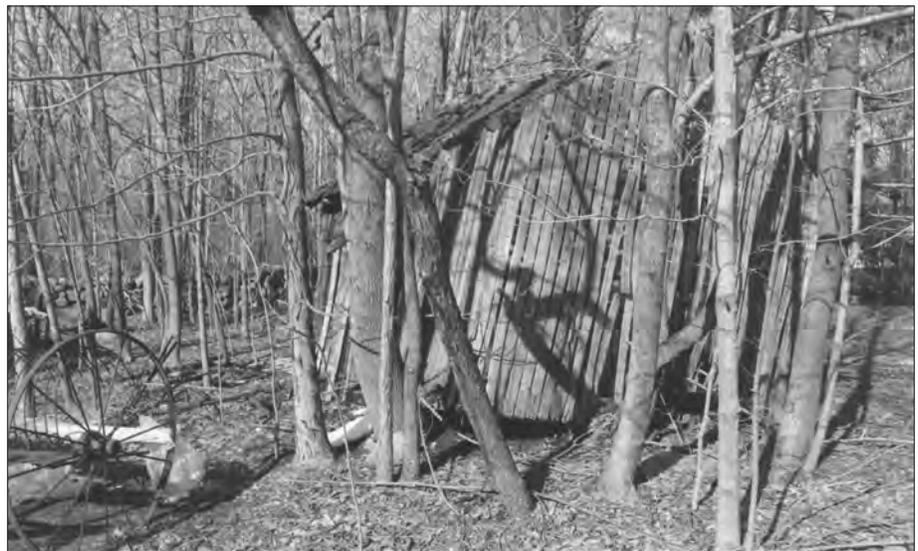
Figure 141. Corn Crib in very poor condition. View looking north, 1995 (OCLP).

Following Julian Alden Weir's death in December 1919, property tax records prepared in 1920 recorded a corn crib along with several other agricultural outbuildings.¹⁴ Additional information on the construction of the Corn Crib during the Weir tenure has not been discovered. In 1932, Mahonri Young prepared a drawing entitled "Shingling the Corn Crib" that depicts two men nailing shingles to a roof and shows the east and south exterior walls of a small building. Fieldwork performed in 1995 reported the Corn Crib in such poor condition that the structure posed a safety hazard to park visitors (Figure 141). In 1996, park staff installed temporary bracing to prevent the structure's imminent collapse and pursued plans to restore the Corn Crib. The park entered into a cooperative agreement with the Institute for Preservation Training and in 1998, the Institute completed the restoration (Figure 142). The extremely poor condition of the structure necessitated that approximately ninety percent be replaced in kind including sills, joists, framing, flooring, and siding (Figure 143).¹⁵

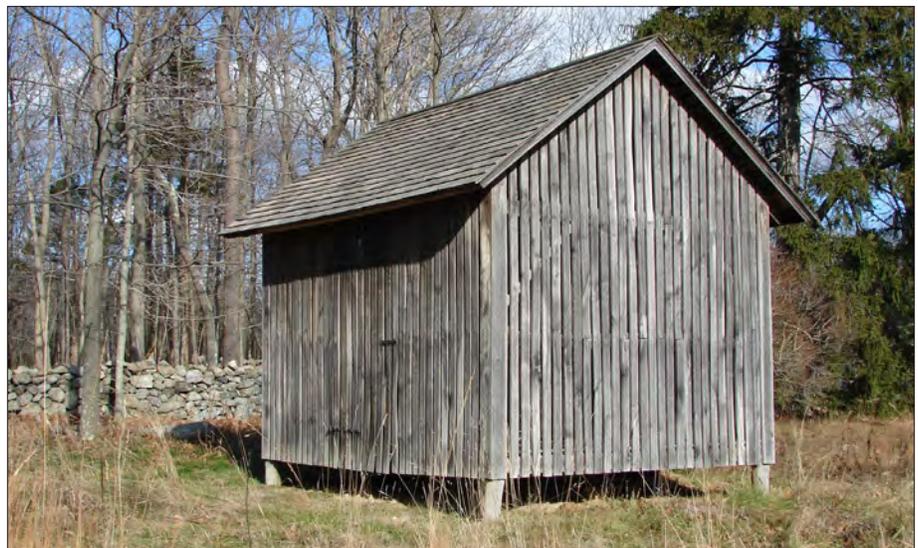
Figure 142. Restored Corn Crib. View looking northeast, 2010 (OCLP).

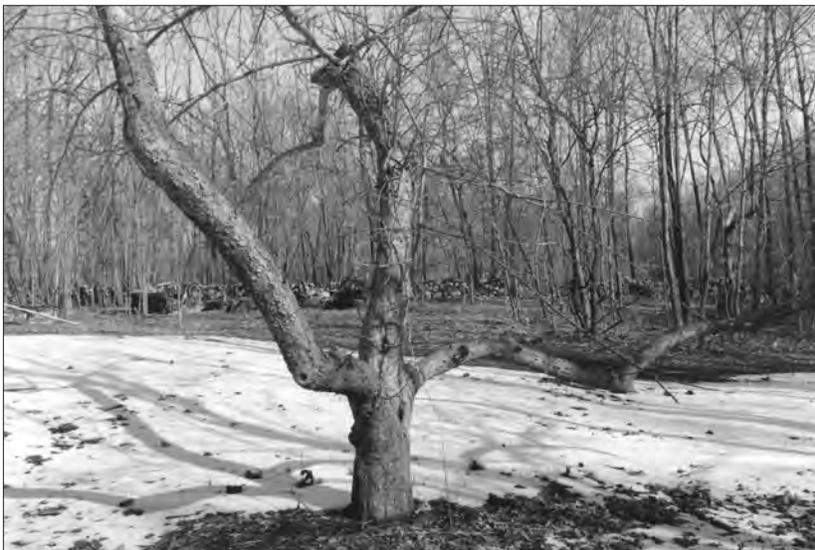
Figure 144 (top). Apple tree in the remnants of the Weir orchard. View looking north, 1995 (OCLP).

Following the park's enabling legislation, staff recorded the orchard's condition and documented only five surviving apple trees (Figure 144). In addition, staff mapped stumps and declining apple trees so that future replacements could be planted accurately. In 1994, staff collected cuttings from the five surviving trees in order to propagate replacement trees from the historic plant material. One of the surviving trees was identified as Newtown Pippin and another as Baldwin. Varieties for the remaining three trees were not determined and in subsequent

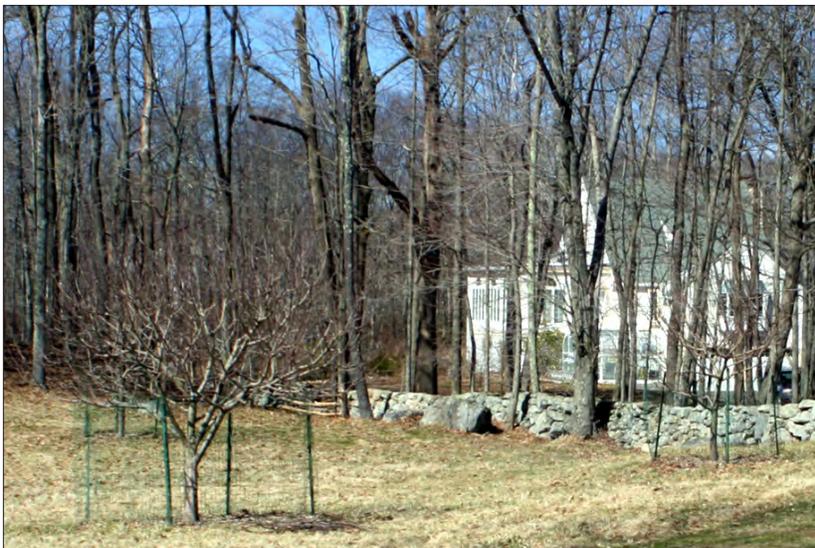
Figure 145 (bottom). Stabilized Weir orchard featuring fencing installed around the trees in order to protect them from deer. View looking northwest, 2010 (OCLP).

years, have not been identified. Park staff shipped the cuttings to the Arnold Arboretum in Jamaica Plain, Massachusetts, and the arboretum's staff raised the propagules. Fieldwork conducted in 1995 recorded only five surviving apple trees and in 1998, the park and the Olmsted Center's preservation maintenance team stabilized the orchard (Figure 145). Work performed included the removal of young woody vegetation from the orchard and planting nine propagated trees in the exact location of former trees. The nine propagated trees arrived in three sets of three each from the Arnold Arboretum and have the accession numbers AA# 124-94, AA# 125-94, AA# 127-94, AA# 128-94, and AA# 129-94.¹⁶ In order to be prepared for future replacement needs, the park planted additional propagated trees from the Arnold Arboretum in the Burlingham Orchard. In 2007, the park transplanted three trees from the Burlingham Orchard to replace trees in the Weir Orchard that had declined (Figure 146).

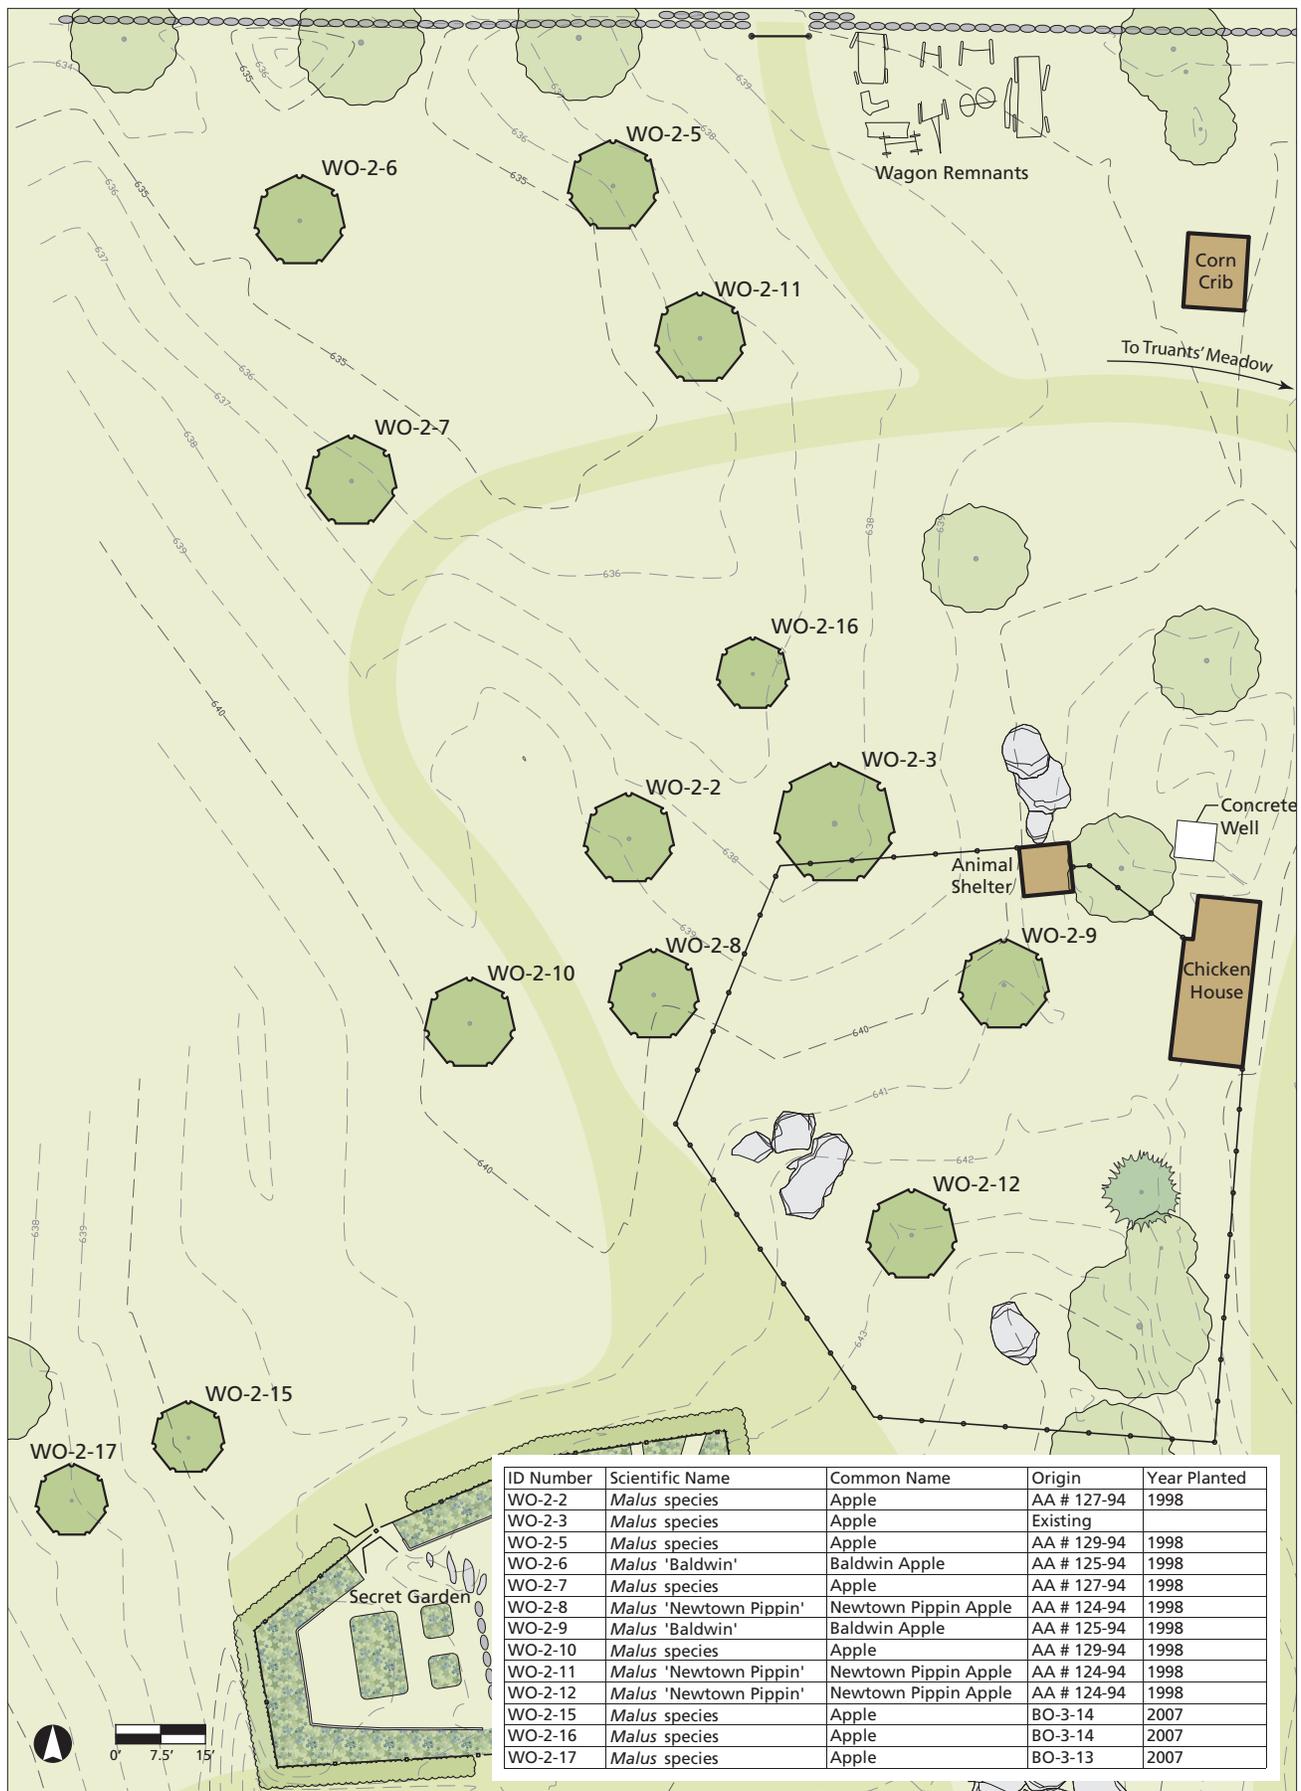
Figure 146. Weir orchard existing conditions plan, 2012 (OCLP).

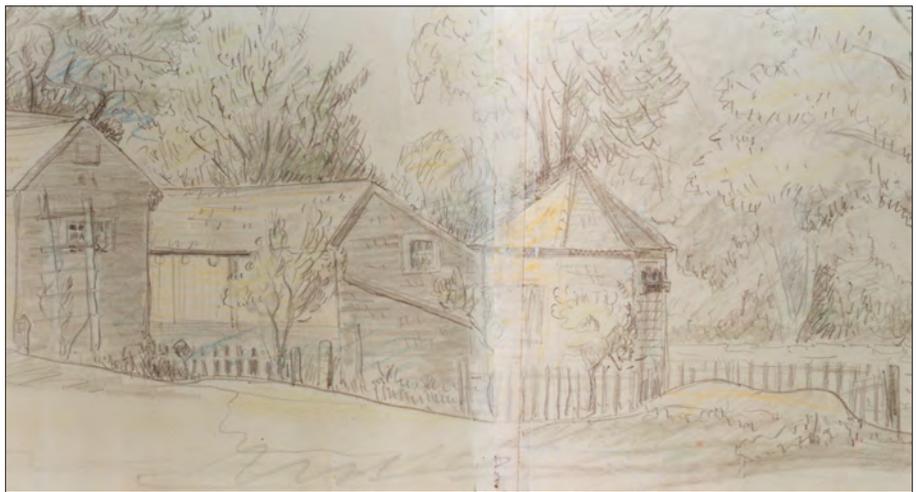
Figure 147. Rustic picket fence at Weir Barn in detail of Mahonri M. Young sketch, circa 1940 (WEFA 306).

Photographs from the Weir family's tenure show fencing south of the Weir Barn similar to the rustic picket fencing found on the site along Nod Hill Road and Pelham Lane. A circa 1940 panoramic sketch by Mahonri Young shows the barn and the rustic fencing with its distinctive slats in place during the circa 1940 treatment period (Figure 147). As a component of the fence restoration project in April 2003, the park installed a rustic picket fence south of the Weir Barn utilizing wider triangular split pickets. The larger pieces create a fence with a coarser appearance than is seen in the historic documentation (Figure 148). The new fence posts were cut from eastern red cedar (*Juniperus virginiana*) logs approximately 6 inches in diameter. Horizontal rails were selected from rough sawn white oak (*Quercus alba*) and the rustic pickets were crafted from split Atlantic whitecedar (*Chamaecyparis thyoides*). Each picket varied in width from 2-3/4 to 3-1/4 inches and was attached to the rails at 7 inches on center (Figure 149 and see Figure 120).¹⁷

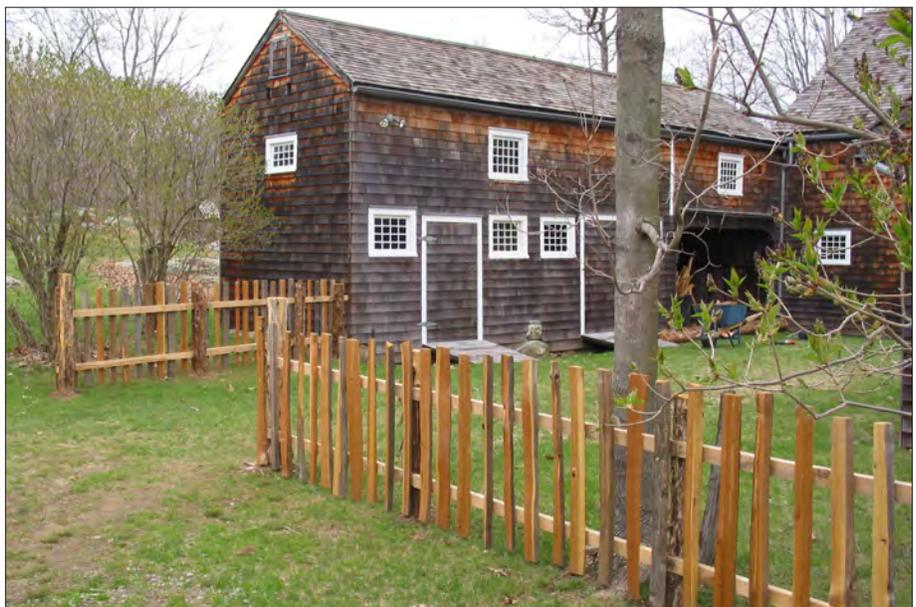
Figure 148 (right). Restored rustic picket fence at the Weir Barn. View looking northwest, 2003 (OCLP).

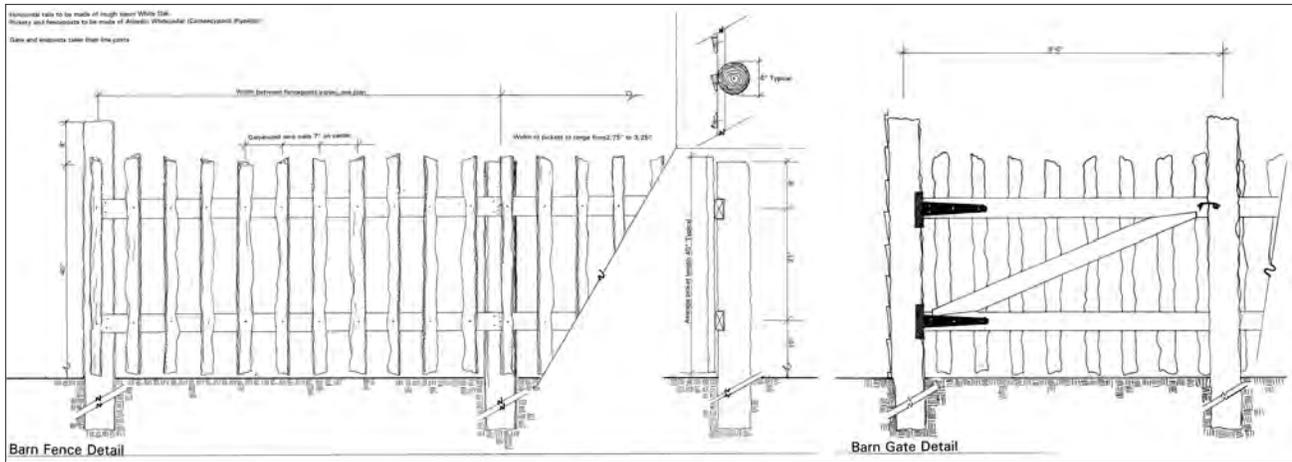
Figure 149. Restored rustic picket fence and gate at the Weir Barn. Elevation, 1996 (OCLP).

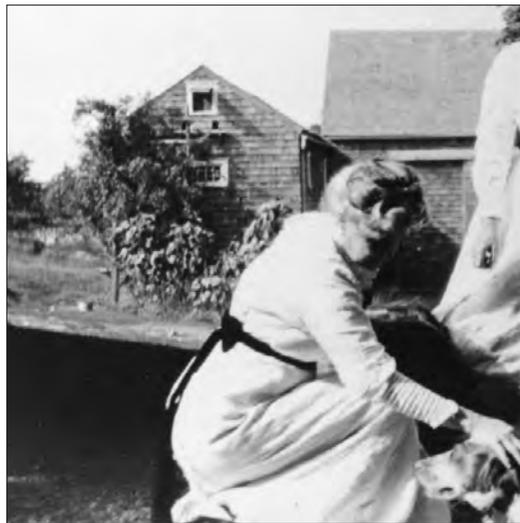
Figure 150 (left). Trellis on the west ell of the Weir Barn. View looking north with Weir family members in the foreground, circa 1900 (WEFA HP 297).

Prior to Julian Alden Weir’s purchase of the property in 1882, a barn stood immediately west of Nod Hill Road. U-shape in plan, the barn consisted of a main block at the north end and two wings or ells that extended south. During Weir’s tenure, photographic documentation shows a simple, ladder-like wood trellis supporting vines on the west ell of the barn (Figure 150). A Mahonri Young sketch from circa 1940 demonstrates that the trellis remained on the west ell near the conclusion of the historic period (Figure 151). The trellis on the west ell, similar to other small-scale carpentry features in the Weir Complex, was not present when the National Park Service acquired the property.
