CULTURAL LANDSCAPE REPORT
FOR WEIR FARM
NATIONAL HISTORIC SITE

VOLUME II: UPDATED TREATMENT PLAN AND RECORD OF TREATMENT

RIDGEFIELD AND WILTON, CONNECTICUT

Olmsted Center for Landscape Preservation
National Park Service, Boston, Massachusetts, 2013

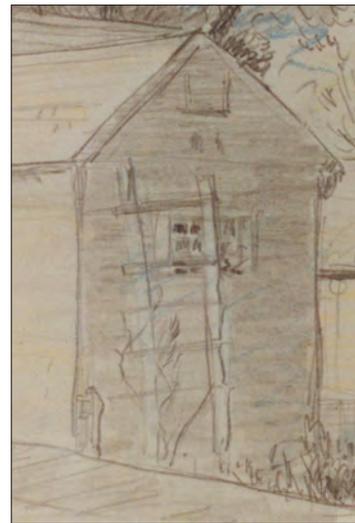
Figure 151 (right). Detail of Mahonri M. Young sketch, circa 1940 (WEFA 306).

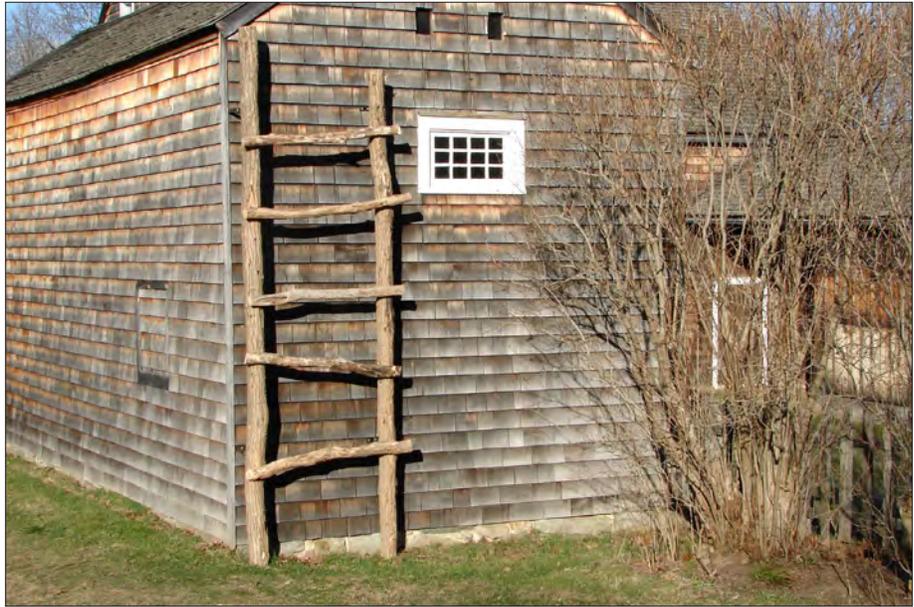
Figure 152. Restored trellis on the west ell of the Weir Barn. View looking northeast, 2010 (OCLP).

Based on the historic images, the Historic Preservation Training Center restored the trellis on the west ell of the Weir Barn in the fall of 2010 (Figure 152). Constructed from black locust, ±5 inch diameter posts were erected as the vertical members of the trellis and spanned by five, ±3 inch diameter horizontal rails. The black locust pieces were treated with Tim-Bor Professional™, a water-soluble borate powder that provides protection against wood decay and insect damage. The borate application does not affect the finish color and the locust pieces will

naturally weather. The overall height of the trellis was set just below the eave of the west ell's roof and the posts were attached to the structure with inconspicuous "L" brackets. Workers at Woodbury Forge in Woodbury, Connecticut, fabricated the brackets and finished them with a black exterior paint. The Historic Preservation Training Center mortised the brackets into the back of each post and secured the brackets to the Weir Studio with 2-1/2 inch stainless steel screws (Figure 153).

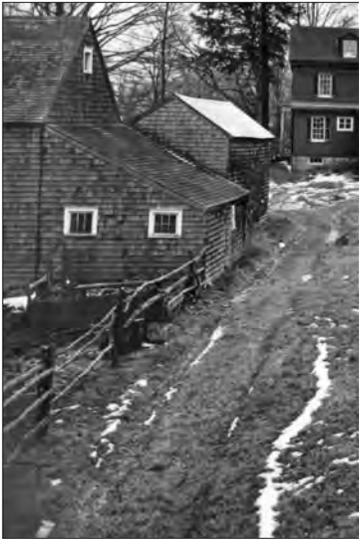
Figure 154. North barnyard sapling fence extending north from Weir Barn. View looking south from the Chicken House, circa 1942 (WEFA HP 150).

North of the Weir Barn, animals grazed in an enclosed, rectangular area defined by the north facade of the barn, the stone wall along Nod Hill Road, and a sapling fence. The sapling fence originated at the northwest corner of the barn and extended approximately eighty feet to the north before turning ninety degrees and proceeding east to the stone wall. The fence is documented in a circa 1942 photograph of Mahonri Young walking between the barn and the Secret Garden (Figure 154). The photograph shows the fence comprised from larger-diameter wood posts set into the ground with smaller-diameter sapling rails set perpendicular to the posts. The saplings attach to the posts in an alternating fashion with one set of three rails on the inside of the barnyard and the next set on the outside. Some sections in the photograph have a double rail—mounted on inside and outside—near the top of the fence.

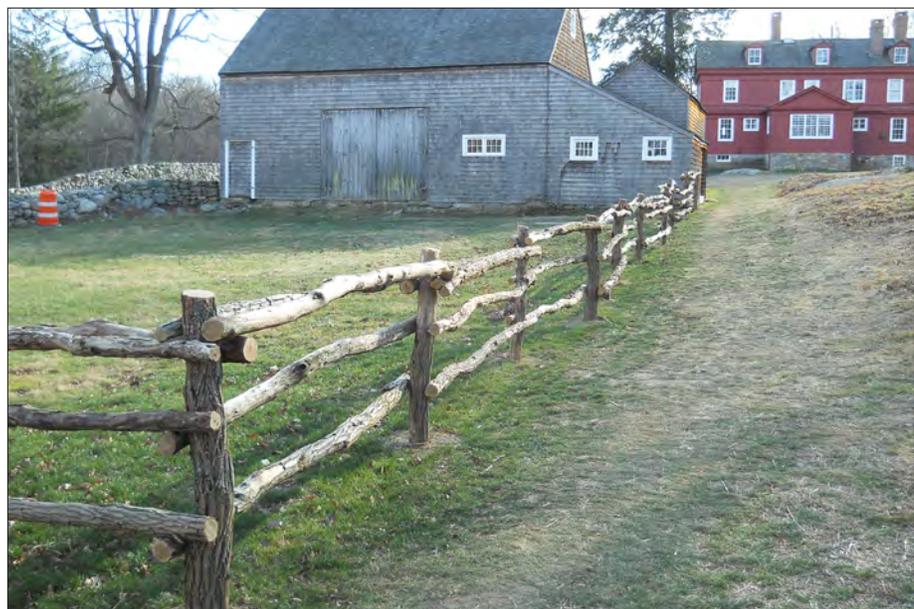
Figure 155. Restored north barnyard sapling fence. View looking southeast, 2010 (OCLP).

As one of several of carpentry tasks completed at Weir Farm National Historic Site, the Historic Preservation Training Center restored the north barnyard sapling fence in the fall of 2010 (Figure 155). Black locust logs were used for both the fence posts and rails. Workers erected ± 5 inch-diameter posts at approximately 10 feet on center. Three rails, each ± 3 inches in diameter, were attached to the posts with a vertical spacing of 12 inches on center. All the locust posts and rails were treated with a water-soluble borate powder sold as Tim-Bor Professional™ (Figure 156). In order to enter the barnyard, the Historic Preservation Training Center attached a section of rails with horseshoes driven into the posts as brackets. This technique is identical to the system used on some of the park's barways and allows a person to create a temporary opening by sliding the rails through the horseshoes.

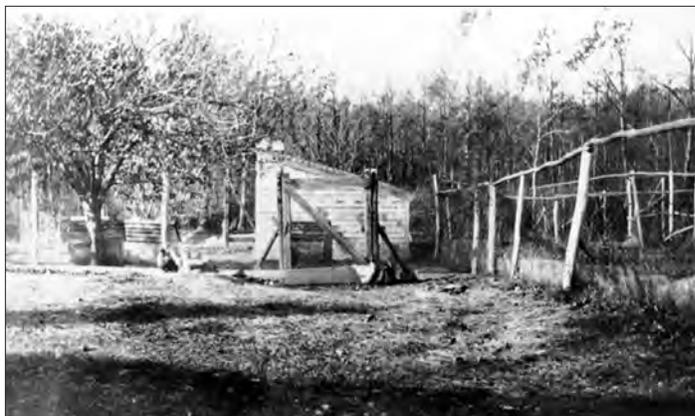
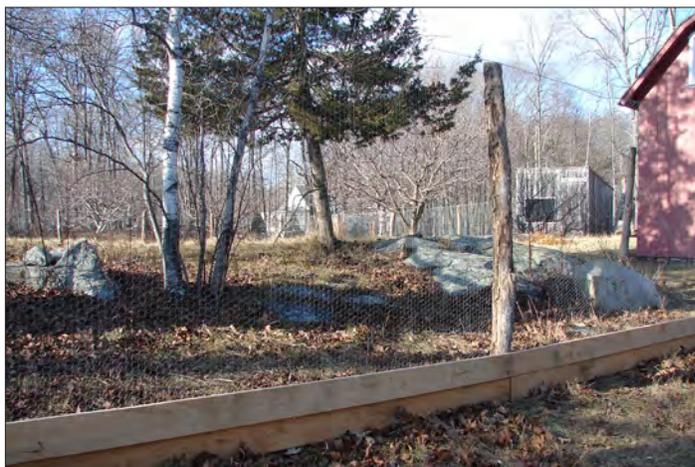
Figure 158 (bottom). Restored poultry fencing. View looking northwest, 2010 (OCLP).

The poultry fencing is an important small-scale feature associated with agriculture activities in the Weir Complex. As part of the restoration treatment of the Weir Complex, the Historic Preservation Training Center restored the poultry fencing in the fall of 2010 (Figure 158). The Historic Preservation Training Center used ± 6 inch-diameter black locust logs for the posts and installed them at 12 feet on center. The black locust was treated with Tim-Bor Professional™ to help prevent wood decay and insect damage. Workers attached galvanized chicken wire to the outside of the posts. The top of the chicken wire was tensioned with a galvanized wire and the bottom was reinforced with two rows

of 1x4 pressure treated lumber (Figure 159). Following installation, differential settling and the natural expansion and contraction of the wood has resulted in gaps between the ground and 1x4 lumber along the bottom of the fence. The park should correct gaps by removing pieces of 1x4 lumber and either reattaching sound pieces to a lower position or replacing warped pieces with new material.

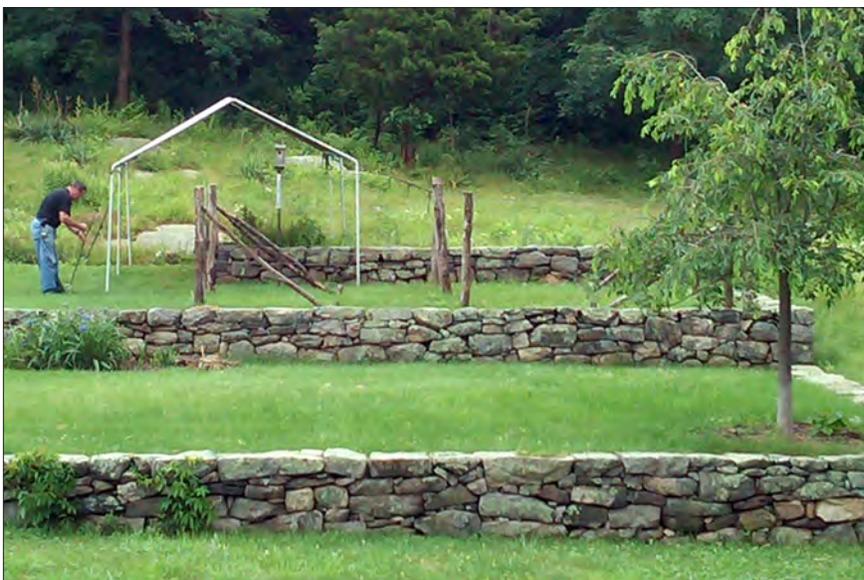
Figure 161 (bottom). Stabilized South Garden terrace walls. A mason is disassembling a shade structure following completion of the work. View looking east, 2012 (OCLP).

South of the Burlingham House, Cora Burlingham directed the construction of the South Garden terraces which were completed by about 1946 or 1947.¹⁹ The South Garden is divided into three terraces laid out from east to west at three different heights. Each terrace is framed by dry-laid stone walls. Furthest east is a narrow upper terrace bounded by exposed ledge on its south side. To the west is a wider and longer middle terrace. In the center of the middle terrace, a set of monolithic stone steps descend to the west to the lower terrace (Figure 160). All three terraces are presently in good condition, however, individual stones and short sections of walls are displaced due to frost heave, wash out, and visitors walking on top of the structures. In 2012, the Dry Stone Conservancy,

Inc., stabilized the South Garden terrace walls (Figure 161). Workers from the Dry Stone Conservancy incrementally dismantled individual stones and short sections of displaced walls. The dismantled stones were sorted according to size and the wall rebuilt to match the composition of adjacent sections in terms of stone sizes, shapes, colors, and patterning.

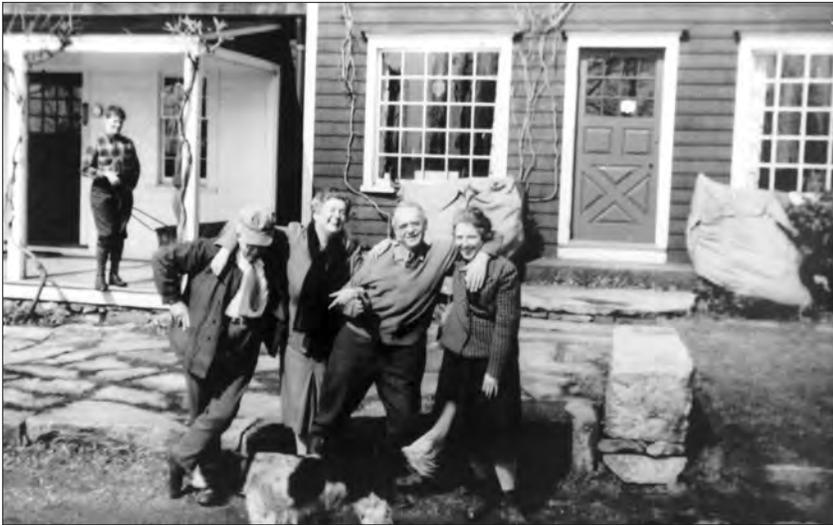
Cora Weir and Charles Burlingham directed the construction of a stone paved terrace south of their home between 1933 and 1938. The paving consisted of irregular, rough-faced granite slabs with wide, soil-filled joints to support the growth of aromatic herbs. Near the Burlingham House's porch, larger planting pits were created for vines to establish and climb up the porch's columns. Along the terrace's south perimeter, the

paving was supported by a low stone retaining wall that varied in height from six to eighteen inches above the grade of the Burlingham drive (Figure 162).

Figure 162 (top). Stone paved terrace at the Burlingham House. View looking northwest, circa 1940s (WEFA HP 124).

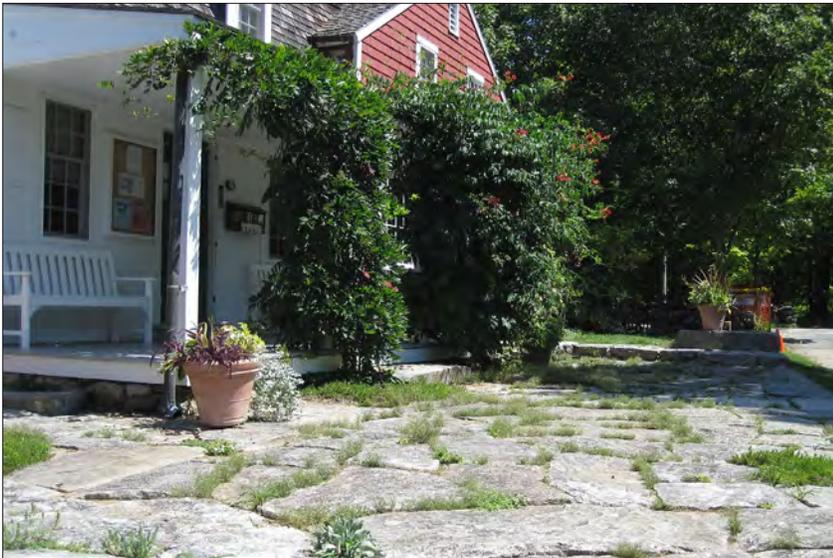
The stone paved terrace was extant when the National Park Service acquired the property, however, annual freeze-thaw cycles and settling had greatly shifted the stones. In some instances, a two-inch difference in elevation occurred between stones and presented a significant tripping hazard. In 2001, the park completed repairs to the stone paved terrace with assistance from an Acadia National Park masonry team. Masons reset individual stones to provide for positive drainage and to create as even a walking surface as possible. At the terrace's south perimeter, workers removed an approximate two-foot wide band of paving stones adjacent to the stone retaining wall. The base material below the paving stones was removed, a layer of filter fabric was installed, and sand fill was added to reduce expansion against the retaining wall and provide a consistent bed to reset the paving stones. Masons reset loose stones in the retaining wall and filled large voids with appropriately-sized stone flakes called chinks. Throughout the repairs, the wide joints between paving stones and the planting pits were retained (Figures 163 and 164).²⁰

Figure 163 (middle). Repaired stone paved terrace. View looking northeast, 2011 (OCLP).

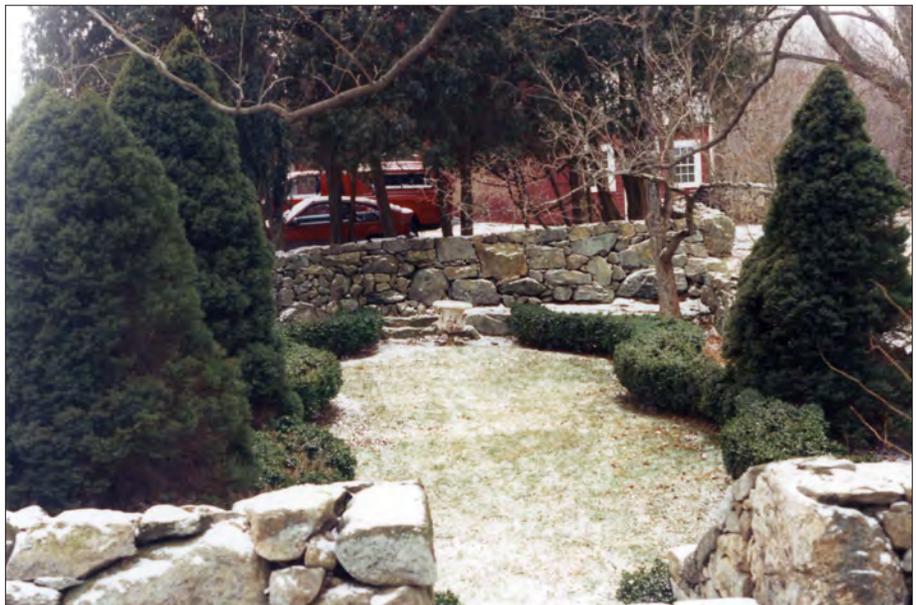
The Sunken Garden continued as a defining feature in the Burlingham Complex during the National Park Service administration, however, the shrub plantings were overgrown and few perennials remained (Figure 166). Based on plans prepared in 1997 by Norma Williams, the park rehabilitated the Sunken Garden. The rehabilitation reused as much of the existing plant material as possible

Figure 166. Sunken Garden. View looking west, late 1990s (Greg Waters, WEFA).

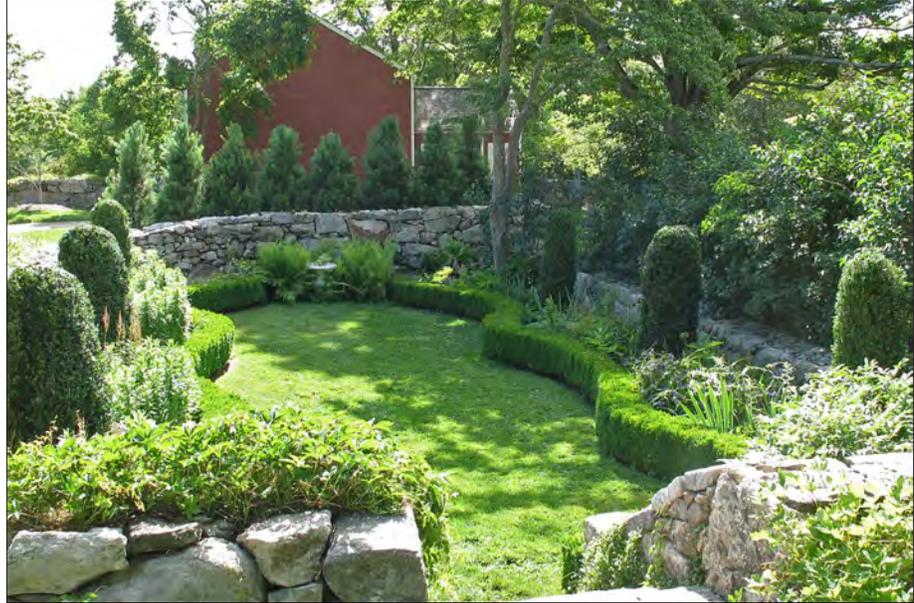
Figure 167. Rehabilitated Sunken Garden. View looking west, 2012 (Greg Waters, WEFA).

and incorporated new plants specified in the 1969 plan of the garden (Figure 167). Where it was determined unwise to use plants because of maintenance requirements or potential deer damage, other plants of similar form and color were substituted consistent with the rehabilitation approach selected for the entire Burlingham Complex (Figures 168 and 169).²²

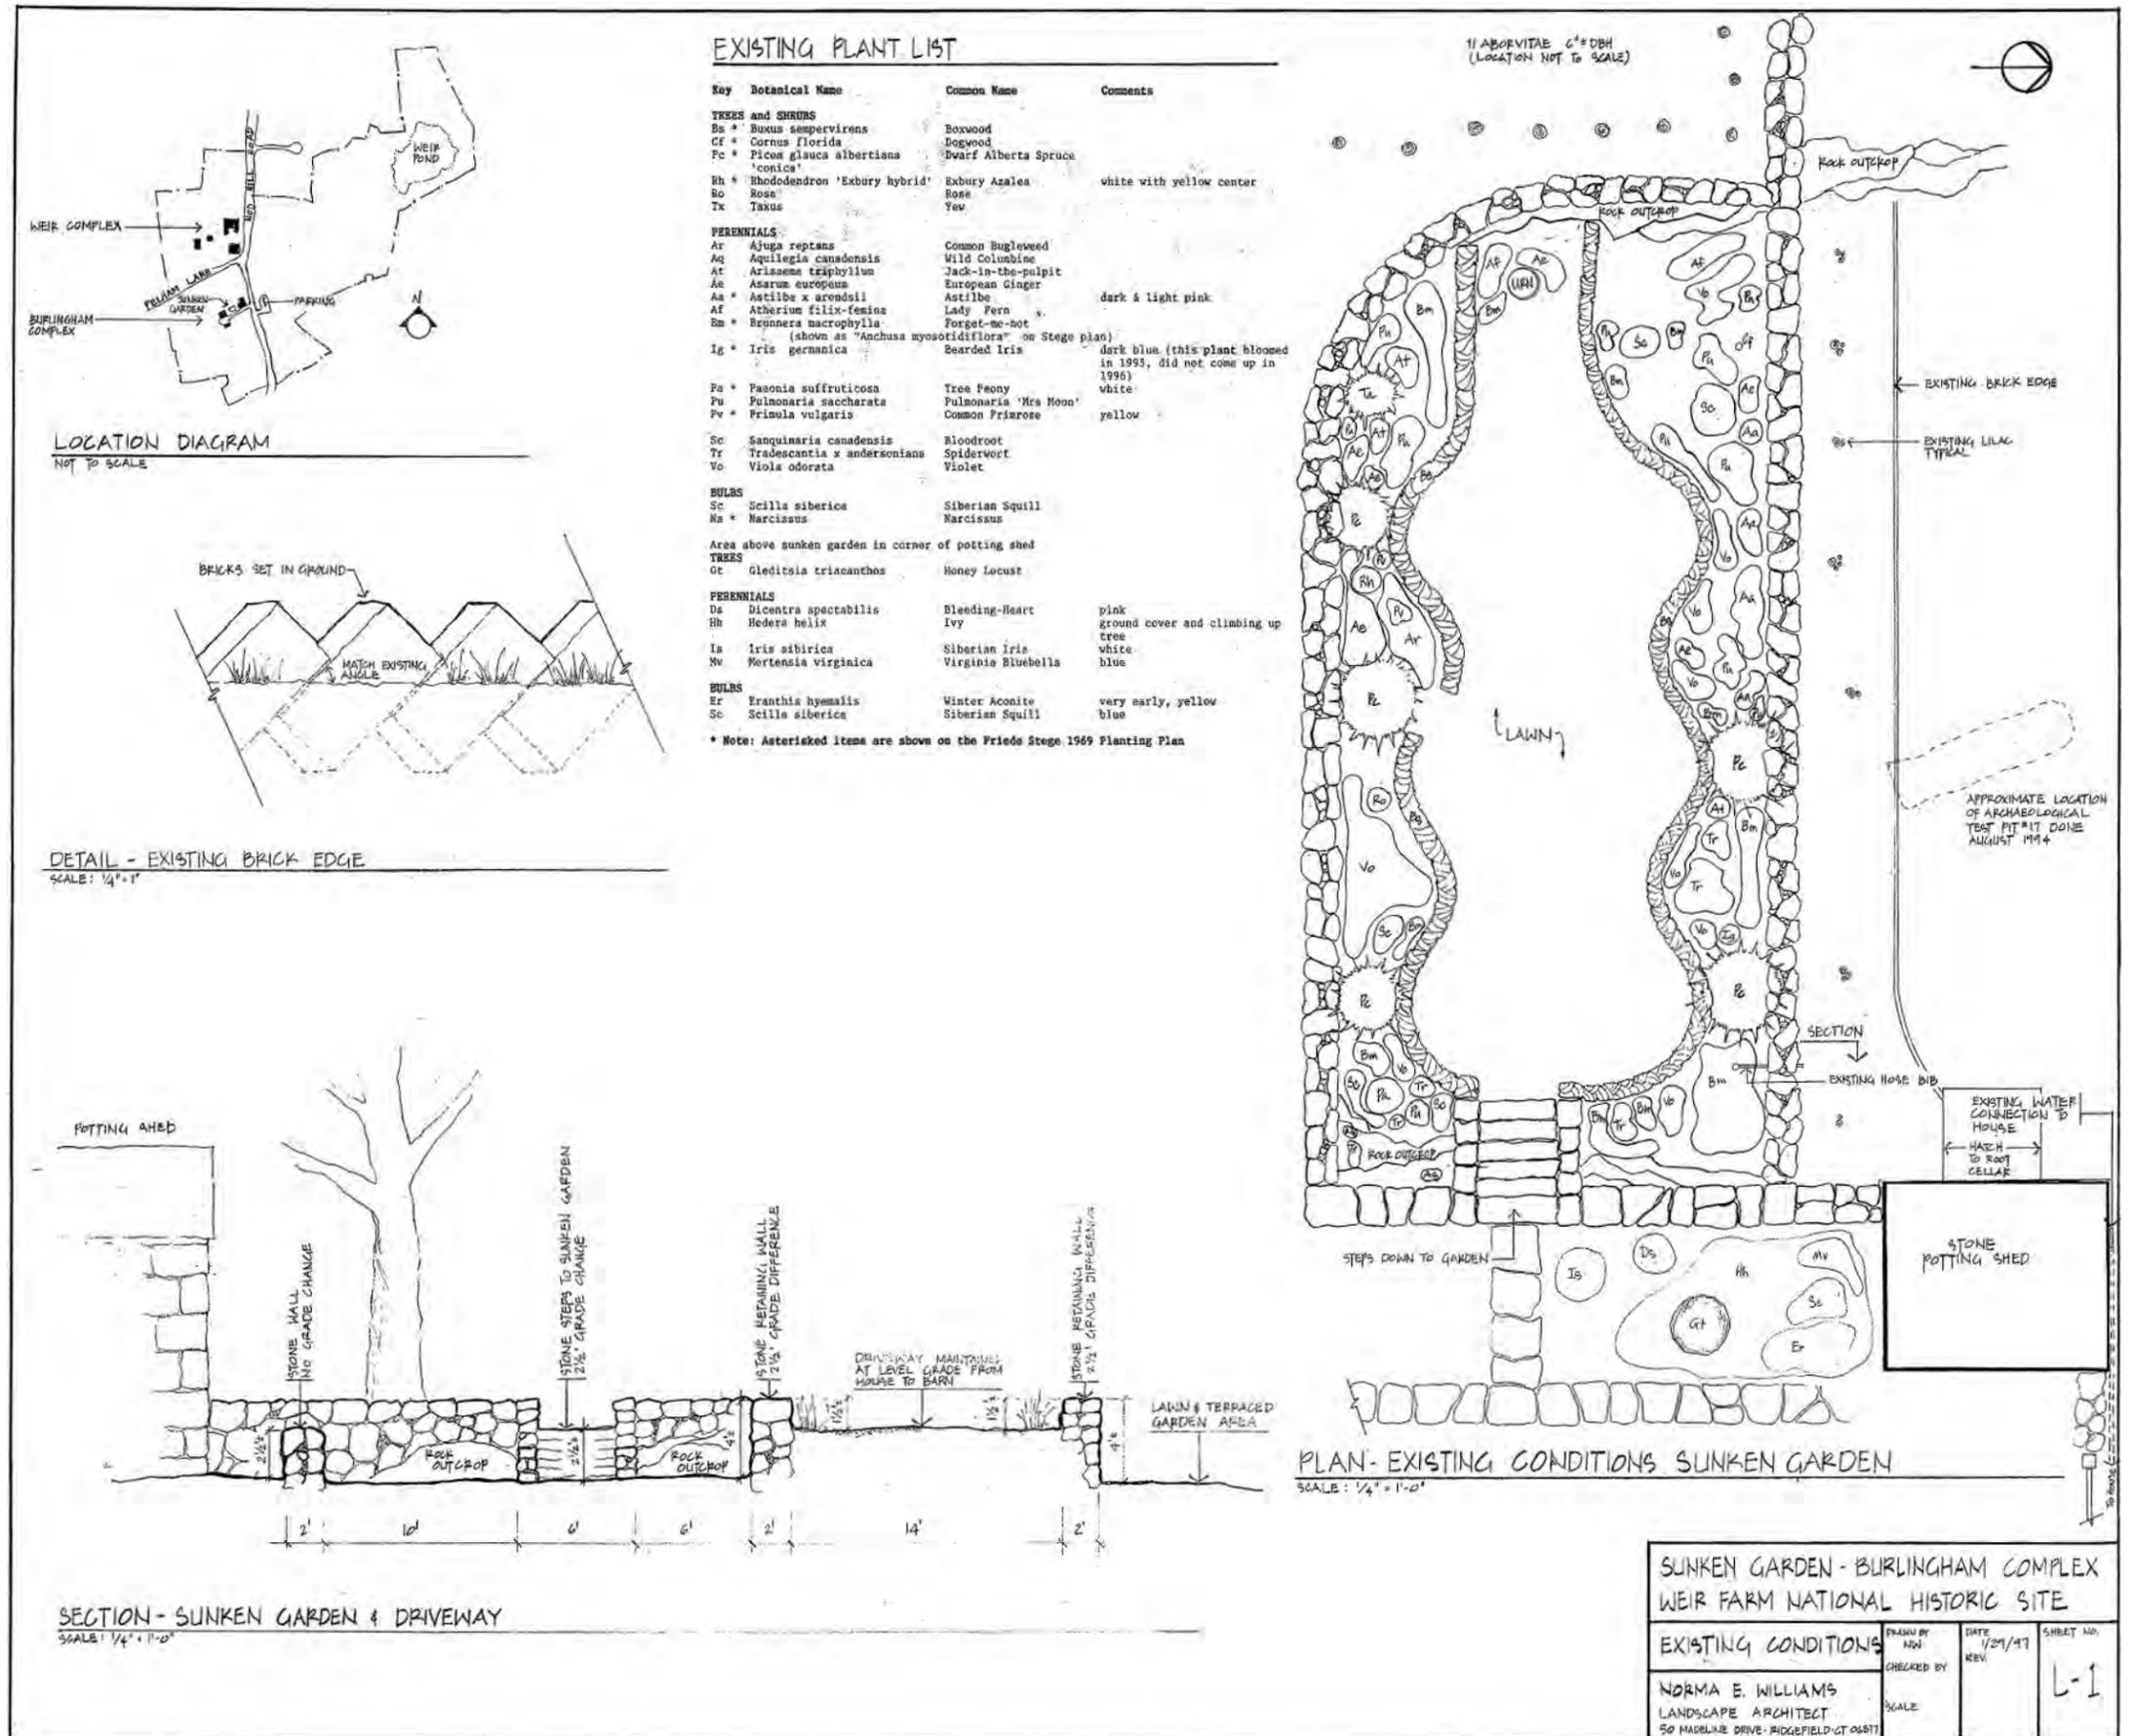
Figure 168. Sunken Garden existing conditions plan, 1997 (Norma Williams).

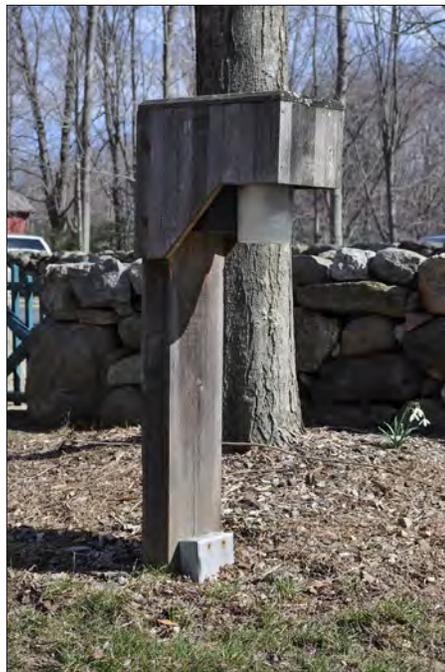
In conjunction with constructing the visitor parking lot in 1993, the park installed outdoor light fixtures to illuminate a pedestrian route from the lot to the Burlingham House. The fixtures extended above the stone walls along Nod Hill Road and were too visually prominent in the landscape (Figure 171). In 2011, the park completed installation of new fixtures that are lower in height, use a smaller light source, and a design that directs the light to the ground (Figure 172). Sladen Feinstein Integrated Lighting, based in Boston, Massachusetts, designed the new fixtures. The fixtures feature a wedge-shaped downlight purchased from Bega Lighting, Carpinteria, California, and mounted into a 6-inch round cedar post. The cedar posts were not treated and will weather naturally. Each post was set into the ground and extends 2 feet above the finish grade. Lighting contractors mounted the top of the wedge-shaped downlight at a height of 32 inches. The catalog number for the wedge-shaped downlight is 2228 LED BRZ. This catalog number references Bega's downlight using a 3.4-watt LED luminaire in a bronze finished housing (Figure 173). Following installation, contractors added a hammered copper sheet over the top of each post for better weather protection.

Figure 171 (left). Outdoor light fixture to be modified. View looking east, 2010 (OCLP).

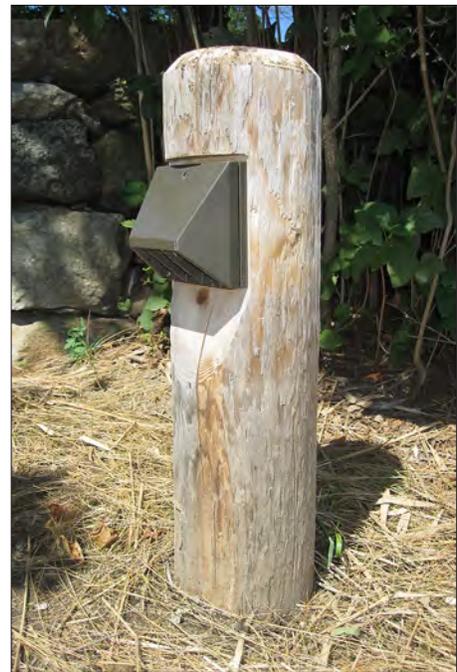
Figure 172 (right). Modified outdoor light fixture. View looking northeast, 2011 (OCLP).

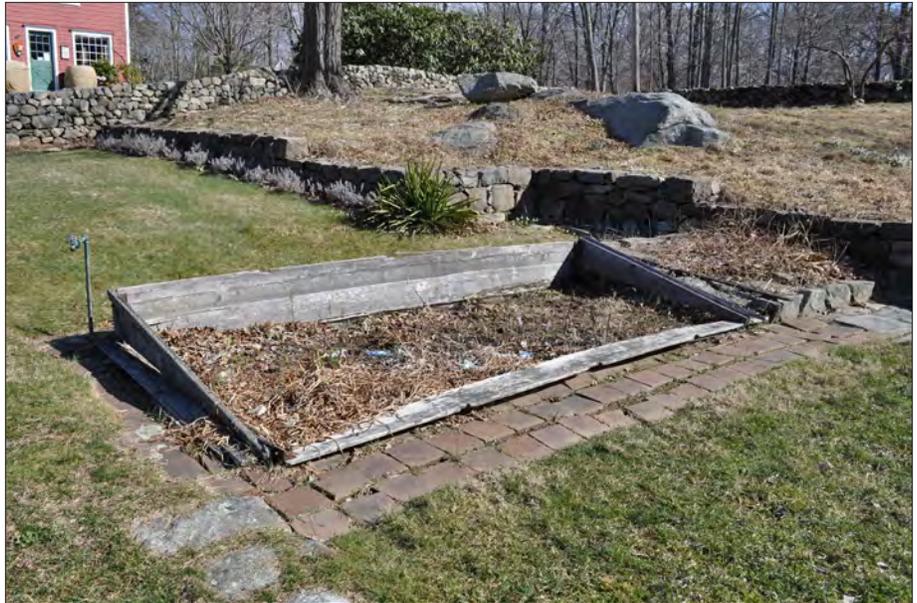
Cora Weir Burlingham, an avid gardener, directed the construction of two cold frames north of the South Garden terraces. She used both cold frames to grow and harden off plants for transplanting (Figure 174). Fieldwork performed in the spring of 2010 recorded a wood cold frame, measuring four feet wide by twelve feet long, located immediately north of the South Garden's middle terrace (Figure 175). The wood components were in a deteriorating condition and the sashes were not present. In the fall of 2010, the Historic Preservation Training Center replaced the wood cold frame in kind.

Figure 175 (bottom). Wood cold frame to be replaced in kind. View looking northeast, 2010 (OCLP).

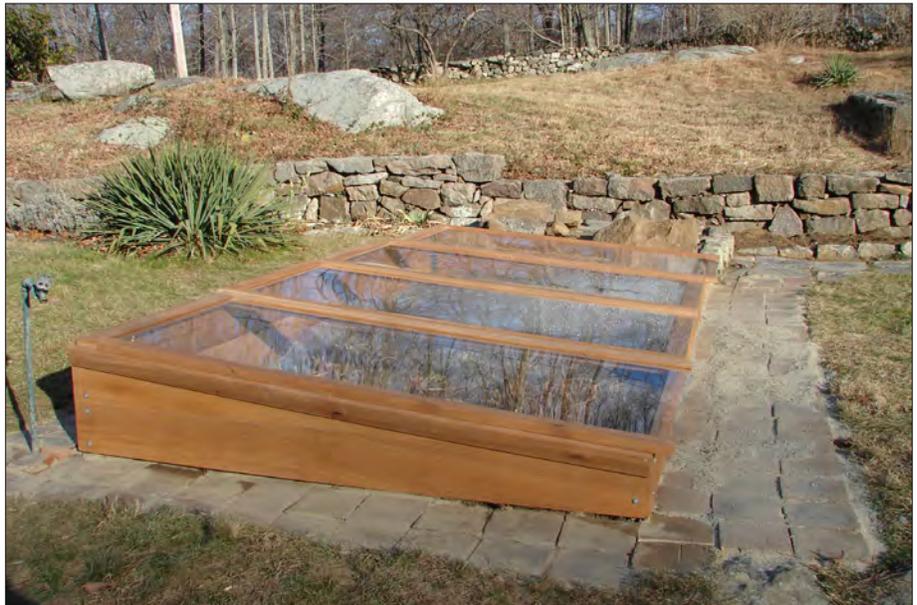
Figure 176. Wood cold frame replaced in kind. View looking east, 2010 (OCLP).

The Historic Preservation Training Center assembled the wood frame using 1-1/8 inch thick mahogany lumber. The north end of the cold frame consists of two boards stacked on top of each other to achieve an overall height of 14-1/4 inches. The bottom board is 6-1/2 inches high and the top board is 7-3/4 inches high. A single board, 7-1/2 inches high, was installed at the south end. The connecting west and east ends feature two stack boards with the top board cut to form a taper from the higher north end to the south. On both sides, the bottom board is 6-1/2 inches high and the top board is 7-3/4 inches high at the north end and 1 inch high at the south end. The four corners were connected using angle irons and hardware that matched the original connectors present on the cold frame. Four sashes were constructed from 1 inch thick mahogany and fitted with 1/4-inch thick plexi glass. The plexi glass over hangs the frame at the bottom by 1/2 inch and acts as a drip edge. Each sash measures 3 feet-3/4 inches wide by 6 feet long. The long pieces of each sash are held in rectangular recesses notched into the cold frame's north and south boards (Figure 176).

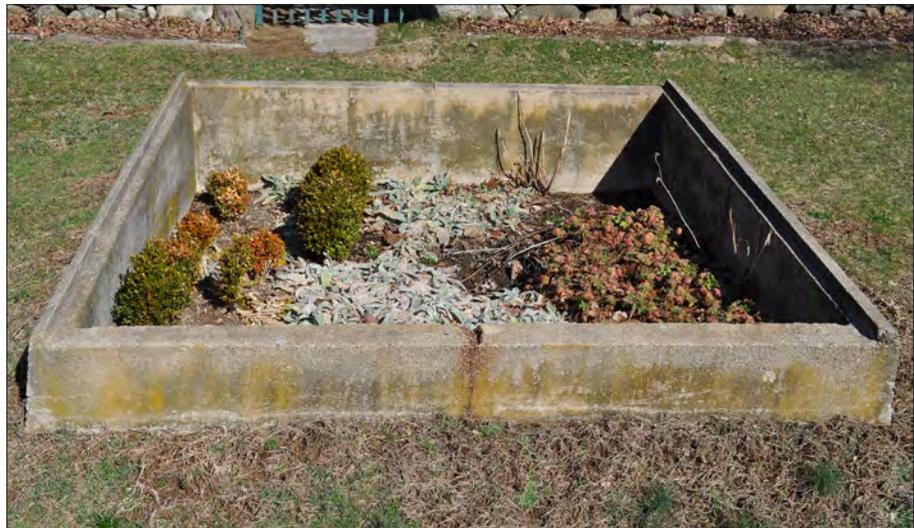
North of the wood cold frame, a concrete cold frame stands that measures five feet square (Figure 177). The concrete is in fair condition, however, the cold frame lacks sashes to cover plant material and provide additional protection during marginal weather. In addition to restoring the wood cold frame, the Historic Preservation Training Center restored sashes to fit over the concrete cold frame in the fall of 2010. The Historic Preservation Training Center constructed the two sashes, each with a 1 inch thick mahogany frame, and fitted them with 1/4-inch thick plexi glass. The plexi glass over hangs the frame at the bottom by 1/2 inch and acts as a drip edge. Each sash measures 3 feet wide by 6 feet long and are supported in the center of the cold frame by an iron bracket. The bracket rests in recessed slots on the north and south edges of the concrete and spans the length of the structure (Figure 178). Park staff report that the plexi glass sashes are flimsy and difficult to move. The park should replace the plexi glass with double-walled, hollow channeled polycarbonate sheets that are more rigid and still provide good light transmission.

Figure 177. Concrete cold frame without sashes. View looking north, 2010 (OCLP).

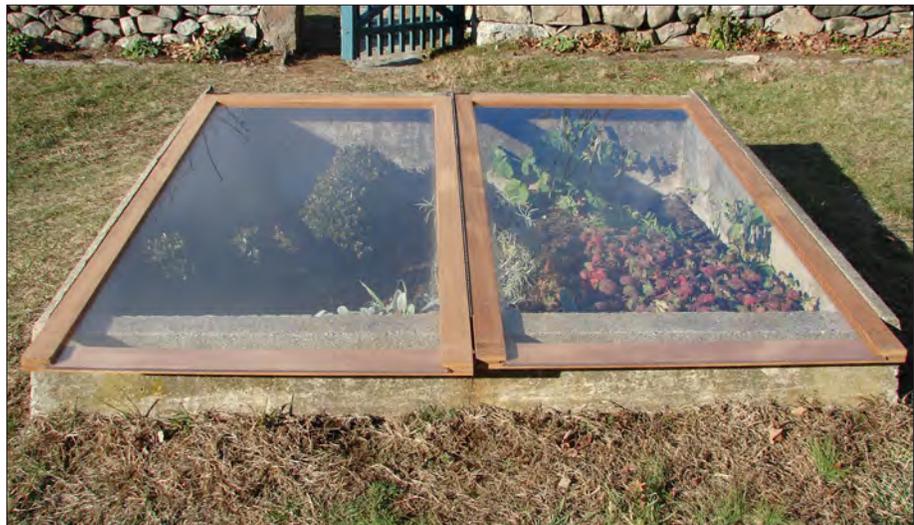
Figure 178. Restored sashes on the concrete cold frame. View looking north, 2010 (OCLP).

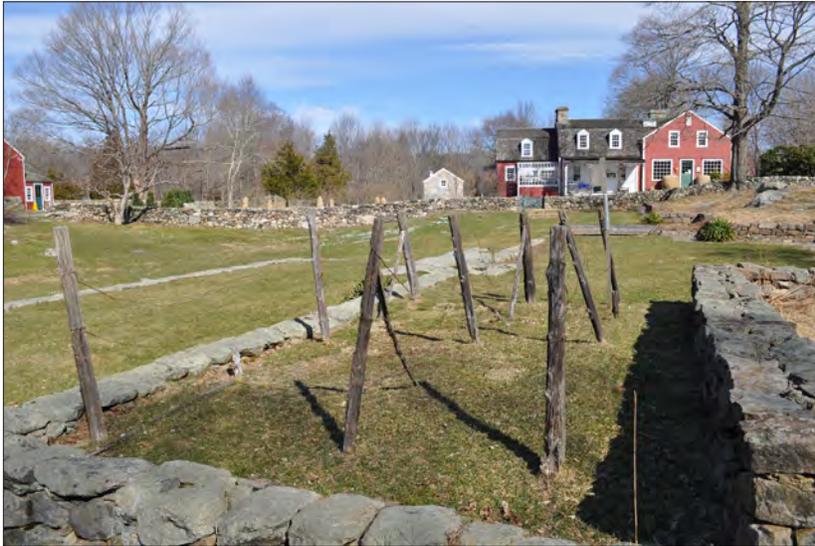
Charles Burlingham, Cora Weir Burlingham's son, recalled that after World War II his mother became more interested in growing small fruits such as raspberries and strawberries in the South Garden versus vegetables in her Victory Garden.²³ Photographs from the 1950s and 1960s show wooden poles supporting plants in the middle terrace and remnants of this wire trellis system survived in fair to poor condition through the National Park Service's administration (Figure 179 and see Figure 174).

Figure 179 (top). Raspberry arbor to be restored. View looking north, 2010 (OCLP).

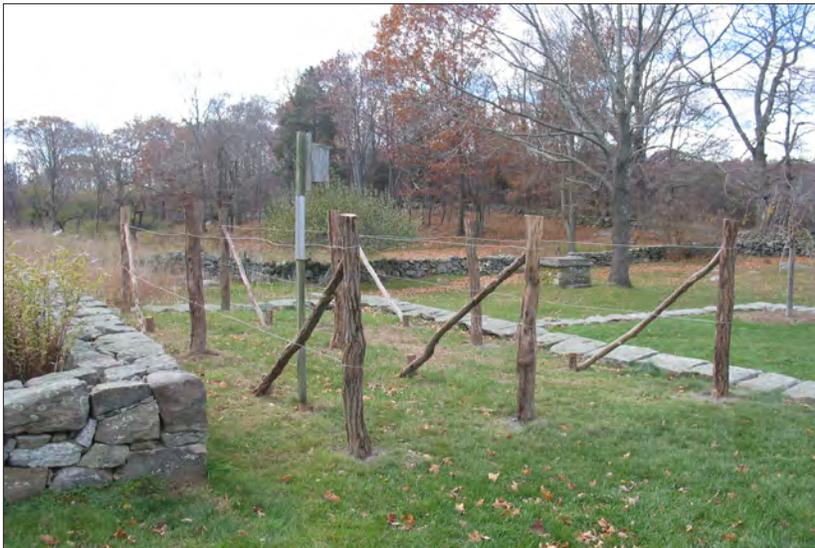
Figure 180 (bottom). Restored raspberry arbor. View looking southwest, 2010 (OCLP).

As a component of preserving and enhancing the South Garden terraces, the park worked with the Historic Preservation Training Center to restore the raspberry arbor in the fall of 2010 (Figure 180). The existing wood posts, braces, and stakes were removed and replaced with naturally rot-resistant black locust logs. Three rows of three posts each were installed in the holes of the removed posts. The posts measured ± 5 inches in diameter. The six end posts were braced with ± 2 inch-diameter logs. A small notch was cut into each end post and the narrower brace was set at a diagonal into the notch. The end of each diagonal brace was attached to a stake driven into the ground. All the black locust pieces were treated with Tim-Bor Professional™, a water-soluble borate powder that provides additional protection against wood decay and insect damage. Workers completed the raspberry arbor by stringing 12-gauge galvanized wire between each set of posts. The galvanized wire was looped and twisted around each end post and secured with galvanized staples.

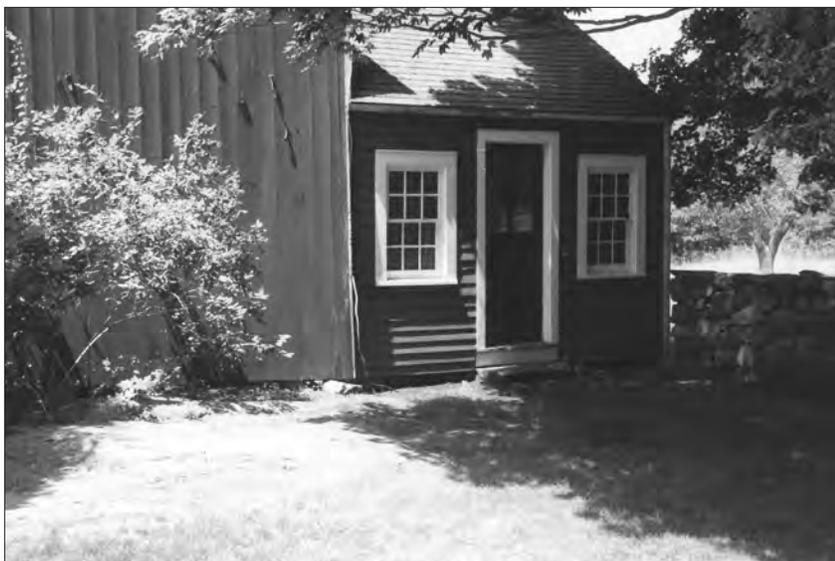
Figure 181 (top). Burlingham Barn annex. View looking northwest, 1997 (OCLP).

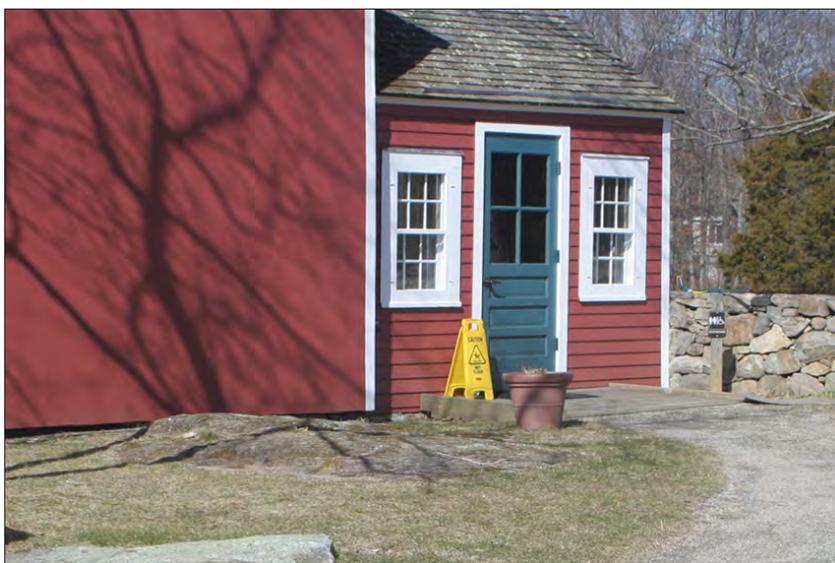
Figure 182 (bottom). Rehabilitated Burlingham Barn annex. View looking northwest, 2010 (OCLP).

The 1995 General Management Plan identified rehabilitating the Burlingham Barn to support visitor and educational programming at Weir Farm National Historic Site. The rehabilitation plans included accessible restrooms in the small annex extending off the north side of the barn since universally accessible restrooms were not then available at the park (Figure 181). The park rehabilitated the Burlingham Barn between 2002 and 2004. Originally added to the barn as a shed, rehabilitating the annex included the addition of partition walls to define two restrooms and an interior corridor to provide passage to the main room of the barn. The northern restroom measured approximately 10 feet long by 6 feet

wide and located fixtures to meet the clearance, maneuvering, and reach requirements for an individual in a wheelchair. The southern restroom measured approximately 7 feet long by 6 feet wide and at its western end, featured a secured door for park staff to access a janitor's closet. All newly installed exterior and interior doors in the barn and annex provided a minimum clear width of 3 feet. To provide exterior access to the annex, the park used imported soil to create a subtle incline along the east facade. The graded incline terminated at a roughly 6-foot long wood ramp. Finished with wood decking, the top of the ramp matched the finish floor elevation of the annex. The ratio of the new incline and wood ramp was less than 1 foot vertical per 5 feet horizontal and therefore did not have to be designed as an accessible ramp with visually intrusive handrails (Figure 182).²⁴ The wood ramp replaced irregular stone paving and a stone cheek wall in the design drawings (Figures 183 and 184).

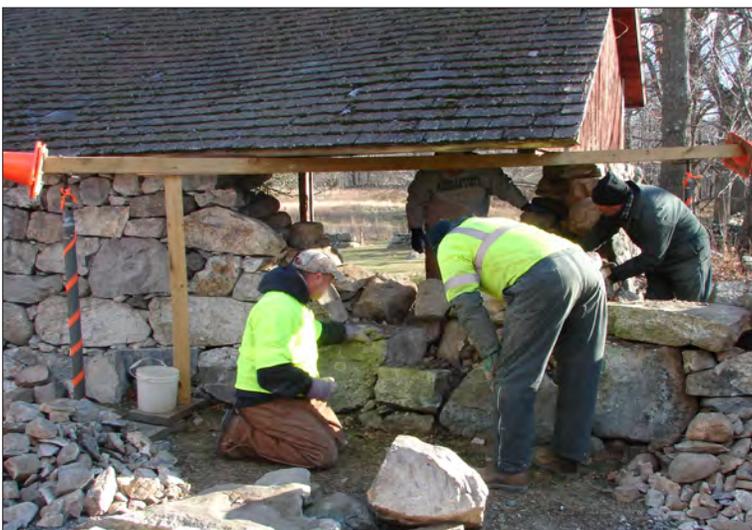
Figure 186. Repairs to the Burlingham Woodshed. View looking southeast, 2010 (OCLP).

Along the Woodshed's west facade and at the northwest corner, the dry-laid stones have shifted and resulted in a bulging section approximately seven feet

long. In the fall of 2010, the Dry Stone Conservancy, Inc., repaired the west facade and northwest corner (Figure 186). Workers braced the Woodshed's roof and incrementally removed the bulging section until structurally sound stonework or a stable footing was identified. The removed stones were cleaned and sorted for reuse according to their original location in the wall. The Dry Stone Conservancy rebuilt the wall using the original stones and matching the alignment and batter of the adjacent sections. No new stones were incorporated into the rebuilt wall and masons reset the sorted stones to match the existing appearance of stone sizes, shapes, colors, and patterning. To improve the structural integrity of the rebuilt wall, masons added tie stones at regular intervals. A tie stone has a smaller exposed face and extends through the width of the wall to help hold adjacent face stones into the wall interior. The Woodshed's northwest corner was rebuilt using slightly larger stones than the west facade with longer and shorter stones alternating from course to course.

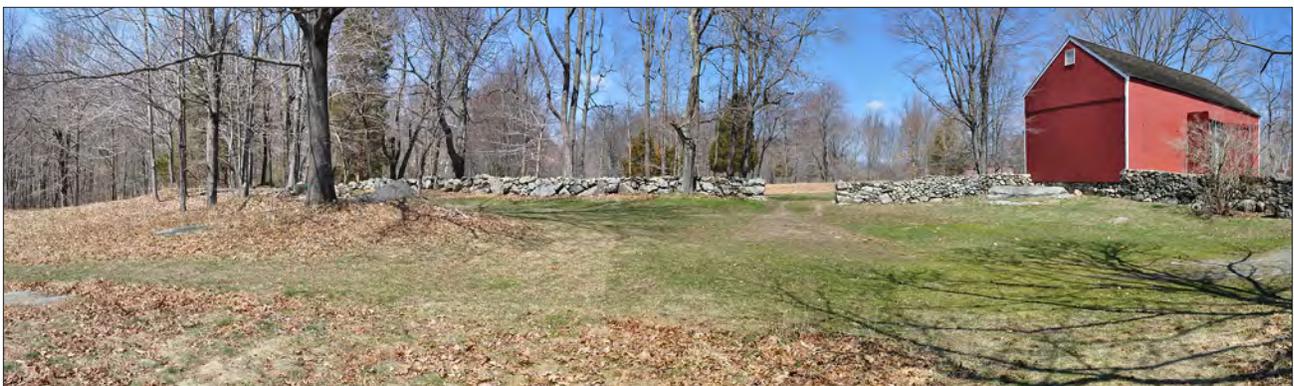
Figure 187. Proposed limited staff parking area west of the Burlingham Barn. View looking north, 2011 (OCLP).

In order to alleviate a parking demand on the visitor lot, the park installed a limited staff parking area west of the Burlingham Barn in 2011. Working with the Olmsted Center to produce schematic designs, the area west of the Burlingham Barn was selected due to favorable topography, an existing access route, and screening created by existing buildings, walls, and vegetation. The relatively flat area had existing vehicular access via the Burlingham driveway and constructing an additional access route to this location was not required. In addition, the area west of the Burlingham Barn was free from major surface obtrusions of ledge and standing water and plant species associated with wetlands. The area was also screened by the Burlingham Barn, the Woodshed, and existing vegetation to the north and south (Figure 187).

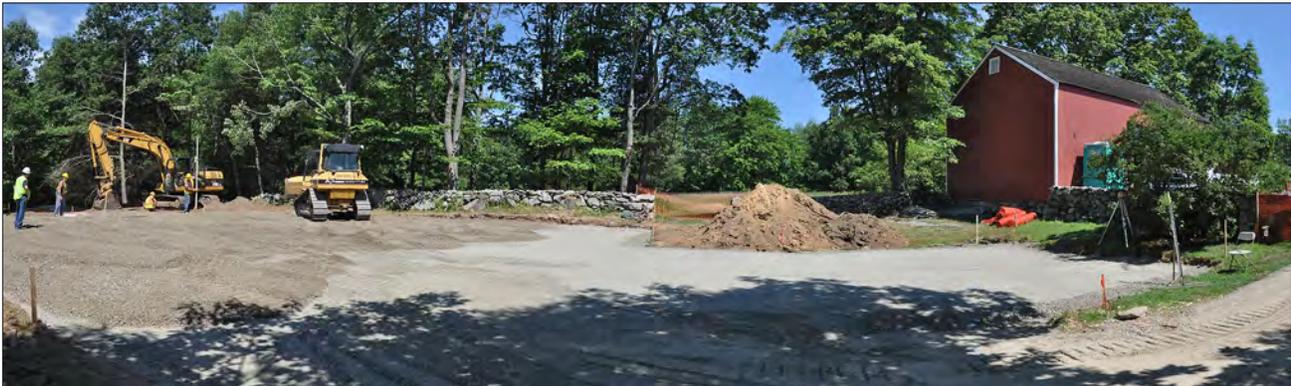
Figure 188. Construction of the limited staff parking area west of the Burlingham Barn. Crews are spreading a ¾-inch crushed stone aggregate, darker material on the left, over a compacted aggregate base. View looking north, 2011 (OCLP).

In September 2010, archeologists excavated thirty-one shovel test pits across the proposed area for limited staff parking. Tests in the western portion of the proposed area revealed twentieth-century fill activities over exposed ledge and bedrock. A mixture of recovered artifacts included contemporary items such as plastic, Styrofoam, and a light bulb. Tests in the southern and eastern portions of the proposed area terminated at either bedrock or sterile subsoil and contained few artifacts. The archeological investigations concluded that the twentieth century fill had no additional research value and no further work was recommended for the parking area.²⁹ In 2011, the park contracted with Watermark Environmental, Inc. for design/build services to install the parking area. Three stalls for the parking area were set perpendicular to the stone wall off the northwest corner of the Burlingham Barn. An additional twelve stalls, six on each side, were laid out to the west along a twenty-four foot wide central aisle. From the northeast corner to the southwest corner, the parking area slopes at 3.3 percent and was surfaced with a ¾-inch crushed stone aggregate (Figures 188 and 189).

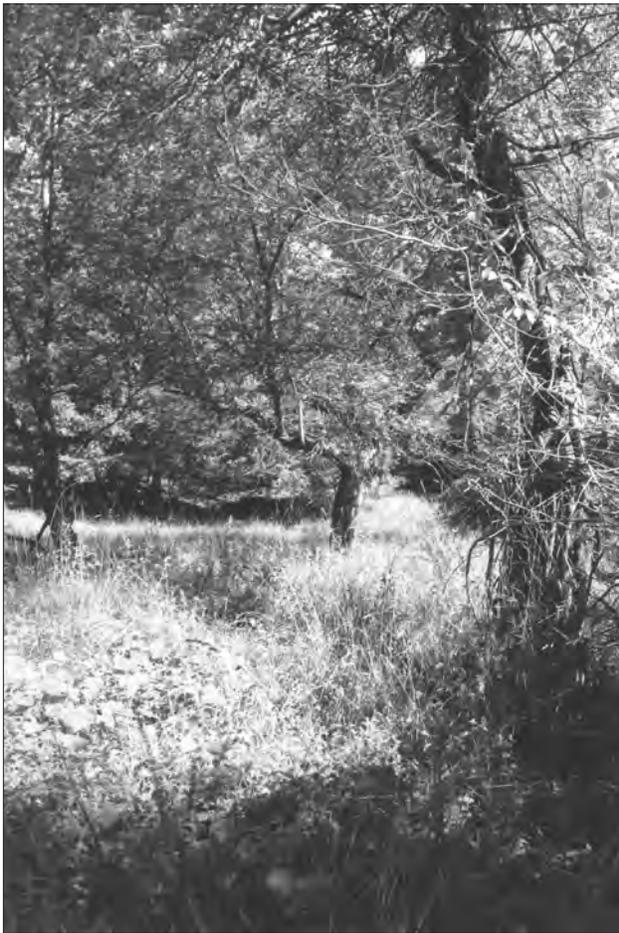
Figure 190. Burlingham orchard. View looking southwest, 1997 (OCLP).

BA-VG-RT-1: Rehabilitate Burlingham orchard

Historic aerial photographs from 1941 and 1951 indicate a geometrically arranged orchard that contained ten to thirteen trees in the southeast portion of the Burlingham Complex. An existing conditions inventory prepared for the Volume 2 report recorded five extant apple trees in this area with all five being in poor condition (Figure 190). In 1998, the park rehabilitated the Burlingham orchard by first removing volunteer trees and vines that encroached upon the orchard. Existing trees received rejuvenative pruning to decrease their overall height and stimulate bud development and growth on their lower branches. Staff established a regular mowing regime and using propagated trees from the nearby Weir orchard, additional trees were planted in the exact locations of missing trees to complete the geometric arrangement of the orchard (Figure 191). The Arnold Arboretum raised the propagated trees and six of the Burlingham orchard trees share the accession number AA# 33-99. Three additional trees are identified as AA# 124-94, AA# 127-94, and AA# 128-94 (Figure 192).³⁰
