CULTURAL LANDSCAPE REPORT
FOR WEIR FARM
NATIONAL HISTORIC SITE

VOLUME II: UPDATED TREATMENT PLAN AND RECORD OF TREATMENT

RIDGEFIELD AND WILTON, CONNECTICUT

Olmsted Center for Landscape Preservation
National Park Service, Boston, Massachusetts, 2013

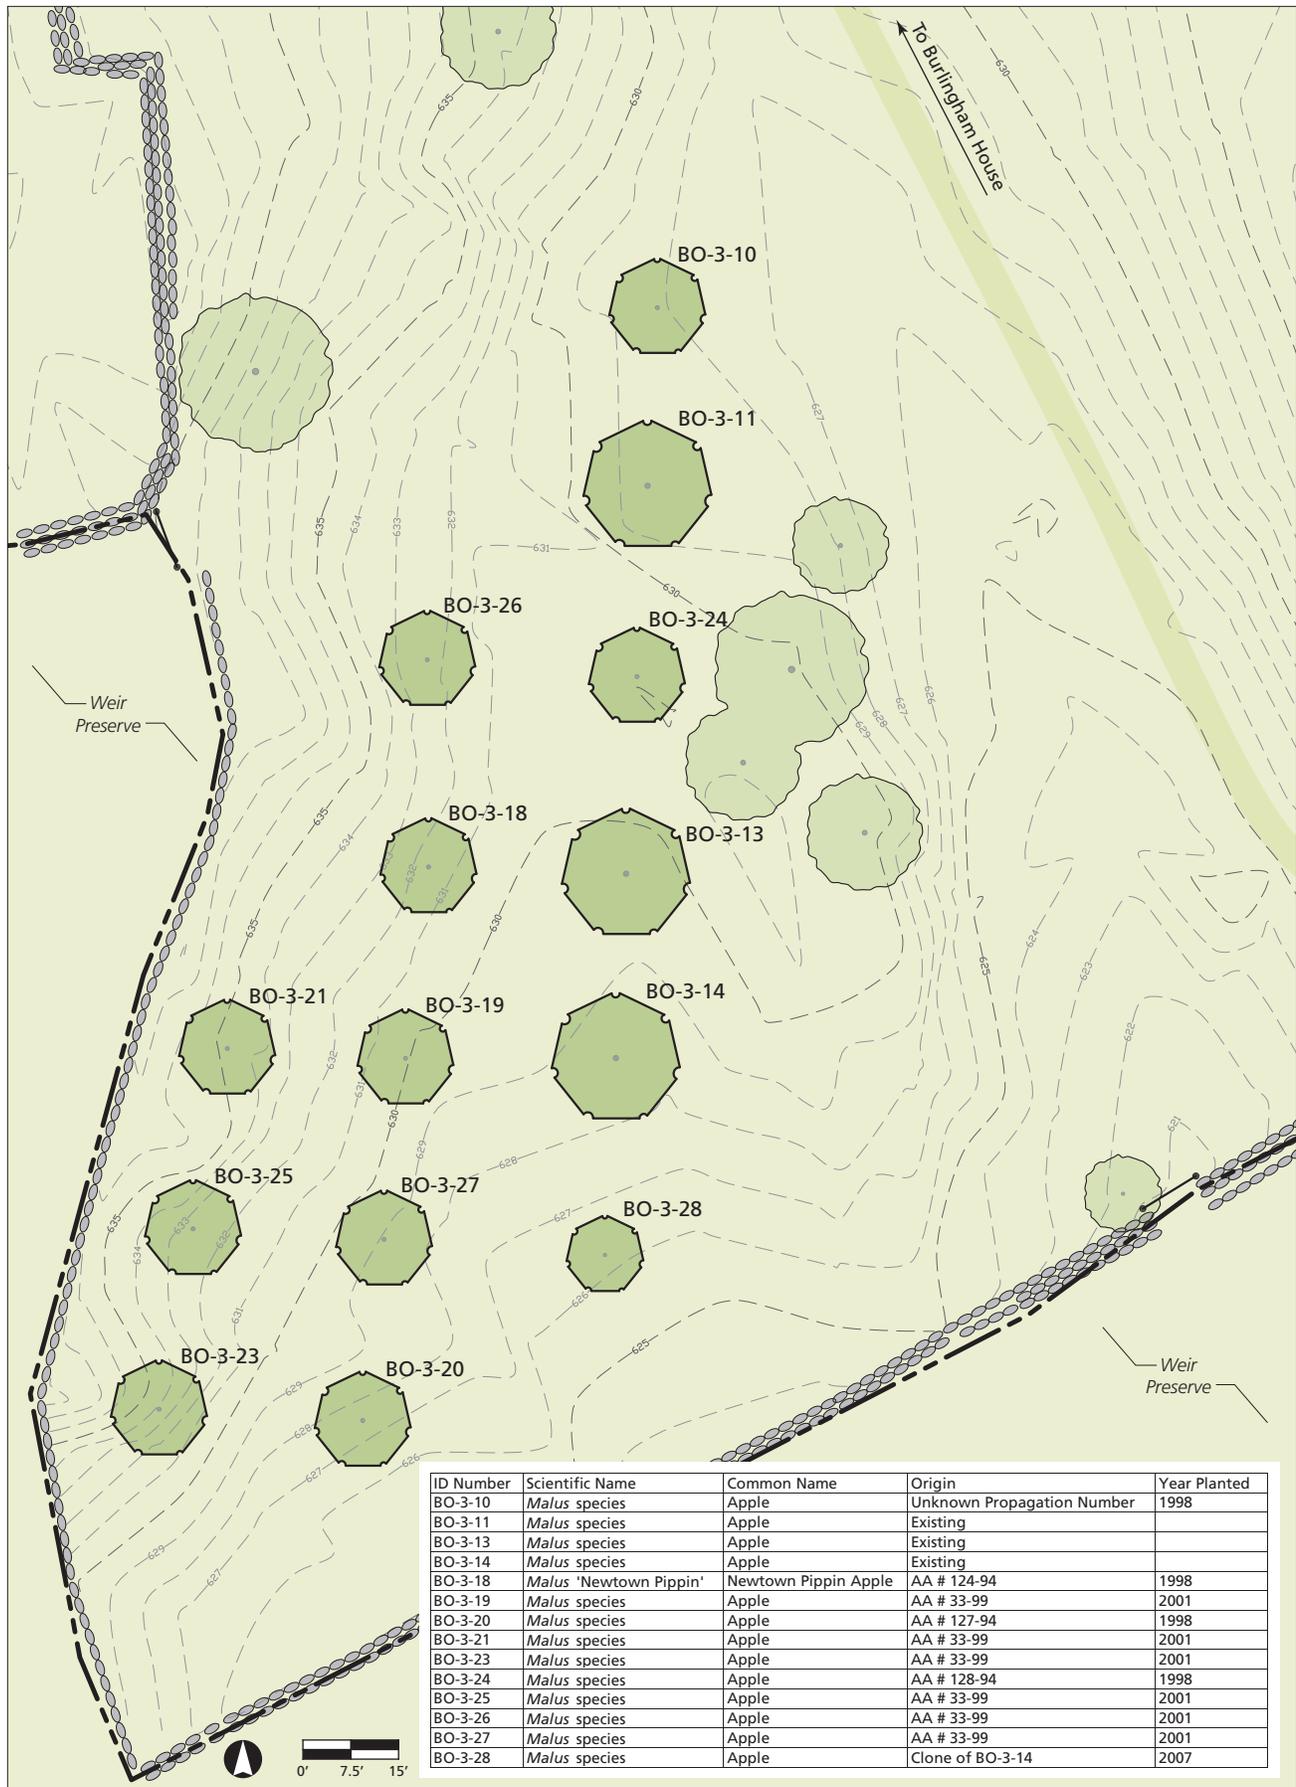
Figure 192. Burlingham orchard existing conditions plan, 2012 (OCLP).

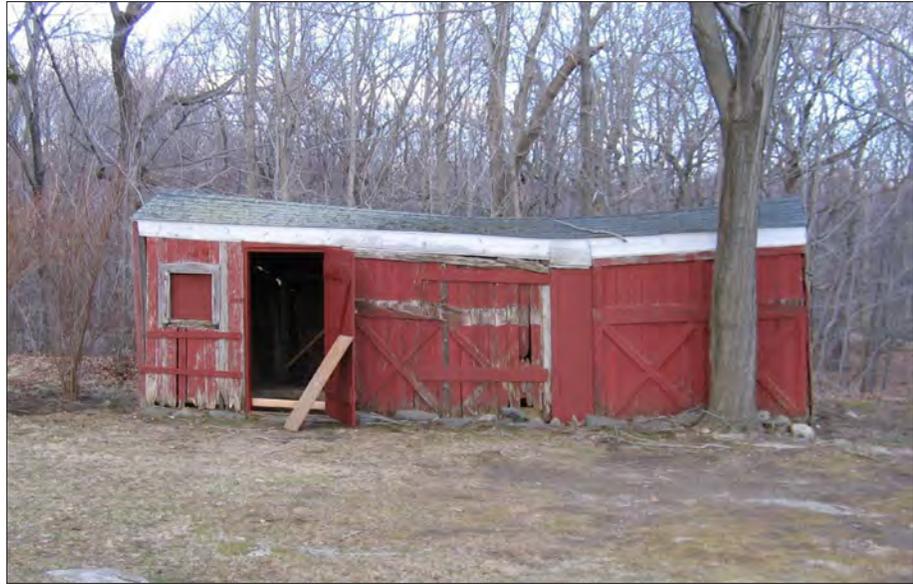
review of aerial photographs, the carriage house was demolished between 1970 and 1975.³³ The three-bay garage remained as a freestanding structure and by the mid-1990s, was in poor condition with a bowed ridgeline and failing exterior cladding (Figure 194).

Figure 194. Caretaker's Garage to be rehabilitated. View looking east, 2006 (*Historic Structures Report* vol. II- B, 2008).

The park's General Management Plan outlined rehabilitating the Caretaker's Garage and adding to it a compatible, new addition to serve the needs of the park's artist-in-residence program. The addition would occupy the footprint of the carriage house removed in the 1970s. The park began design and project compliance in 2005 and in 2009, completed the rehabilitation of Caretaker's Garage (Figure 195). The rehabilitated garage and new artist's studio are open in plan with the garage approximately 25-feet long by 19-feet wide. The studio

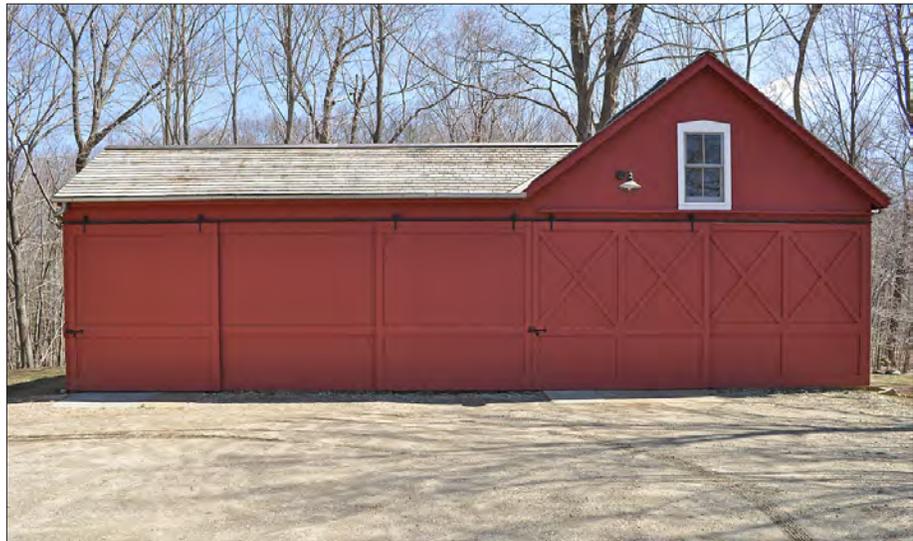
Figure 195. Rehabilitated Caretaker's Garage and artist's studio. View looking east, 2011 (OCLP).

measures approximately 23-feet long by 21-feet wide and opens along its east facade on to a 6-foot wide cut stone terrace. The west facade of both buildings features wood garage doors on sliding tracks. The north and east facades of the garage are clad in cedar shingles with a 6-inch exposure. The studio exterior is finished with 1x8 tongue-and-groove vertical cedar siding punctuated by a bank of windows on the east facade. The roofs of both buildings were finished with cedar shingles featuring a 5-inch exposure (Figure 196).

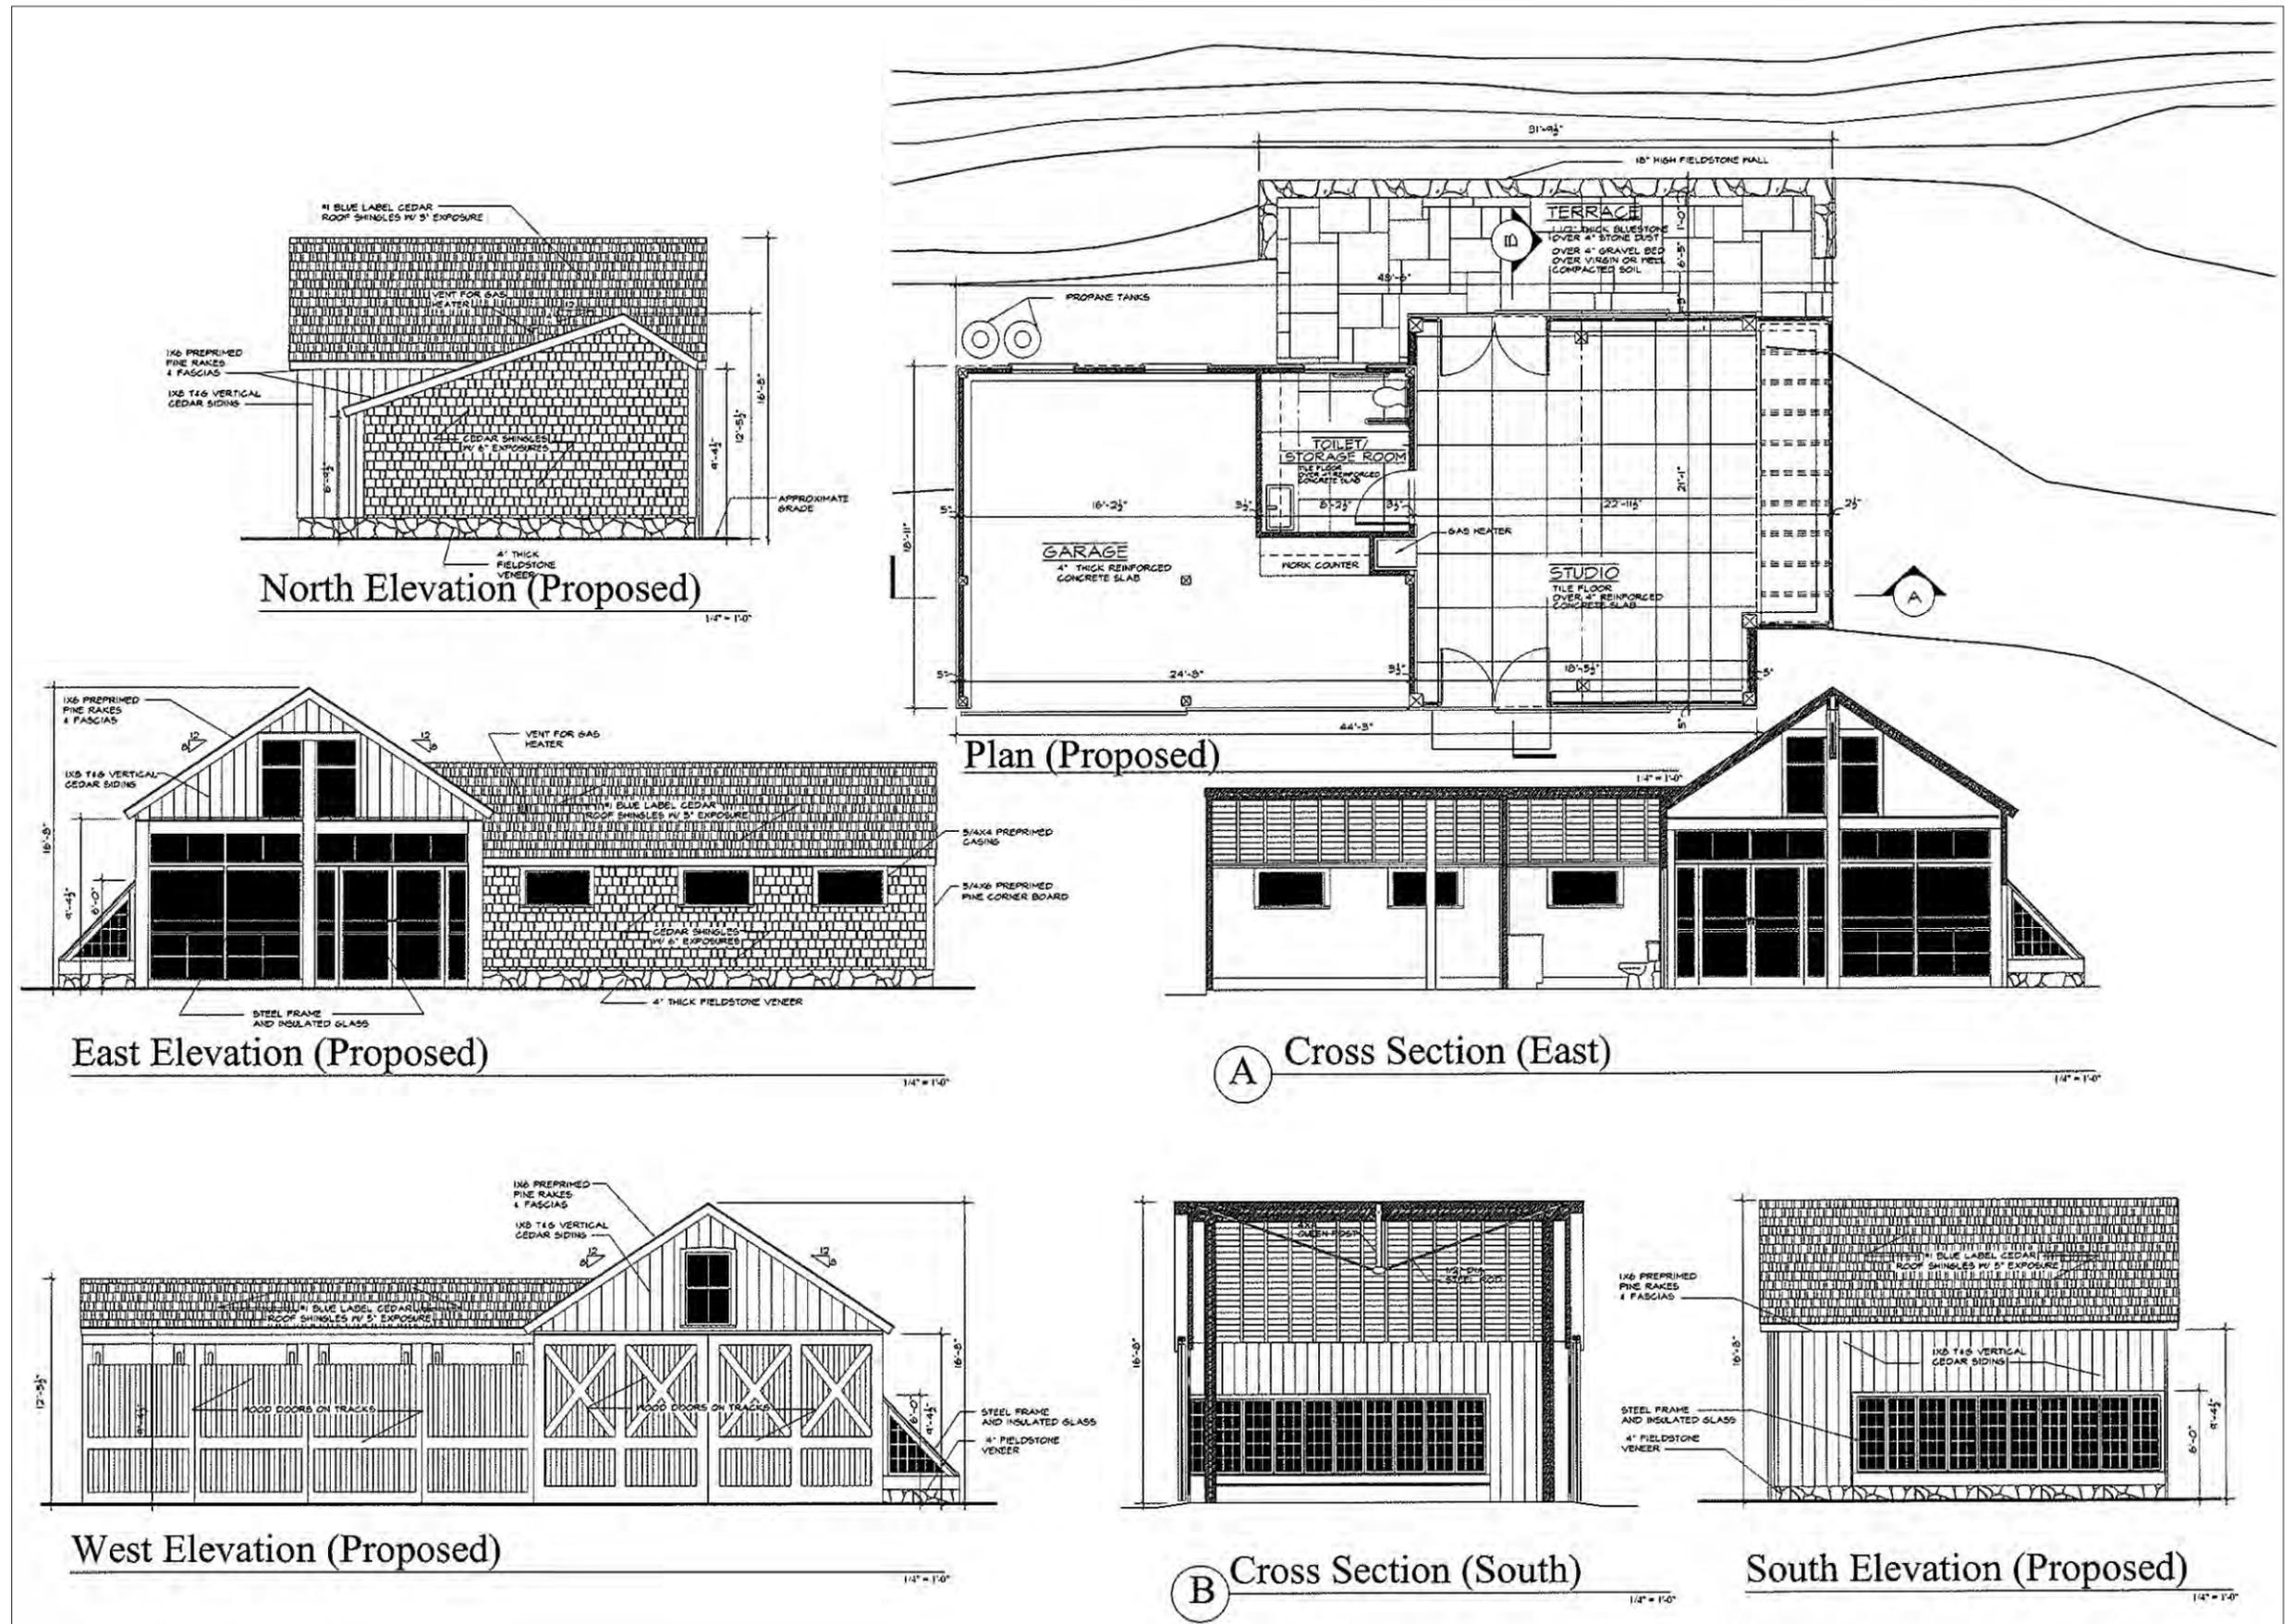
Figure 196. Plan, sections, and elevations of the Carriage House and Caretaker's Garage (Fasey Smith Architects, PC).

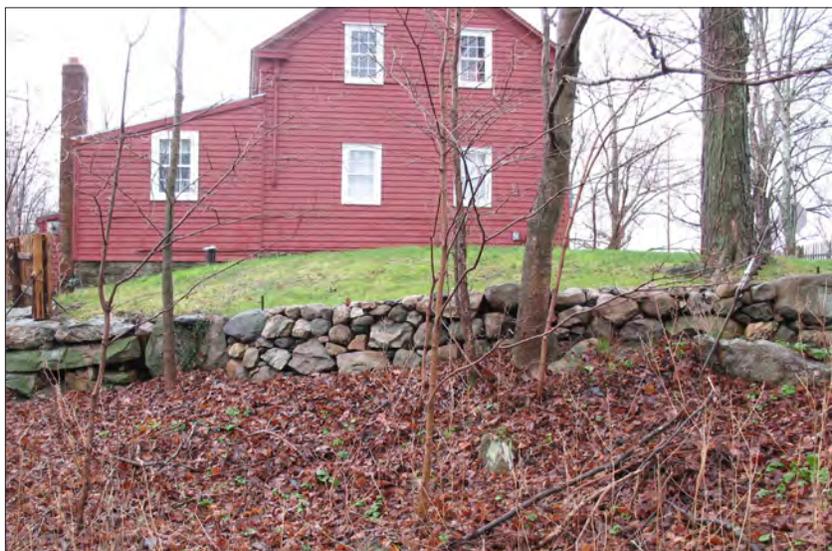
North and east of the Caretaker's House, a steep embankment descends to a low-lying, wetland area. Approximately twenty feet north of the house, a dry-laid stone wall retains a lawn area that slopes away from the house. The wall may have been installed in conjunction with the original construction of the Caretaker's House or be associated with modifications Julian Alden Weir directed shortly after purchasing the property in 1882. A Mahonri Young sketch from circa 1940 shows the wall in place and topped with a rustic, wood picket fence (Figure 197). In 2010, an approximate twenty-five foot section, extending east from Nod Hill Road, appeared severely deteriorated with large stones displaced and strewn down the embankment.

Figure 198 (bottom). Repaired retaining wall north of Caretaker's House. View looking south, 2012 (Greg Waters, WEFA).

In December 2010, the Dry Stone Conservancy, Inc., repaired the deteriorated wall section using only extant stones from the collapsed or unstable sections. Workers incrementally dismantled unstable sections of the wall until reaching a stable footing or base. The collected and dismantled stones were sorted according

to size and the wall rebuilt to match the composition of adjacent sections in terms of stone sizes, shapes, colors, and patterning (Figure 198).

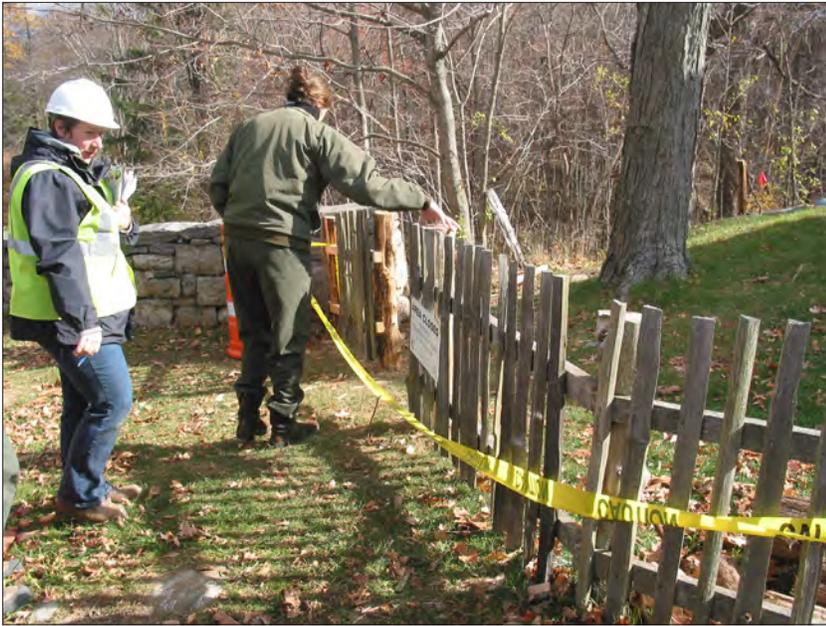
Figure 199 (top). Restored rustic picket fence at the Caretaker’s yard. View looking southeast, 2010 (OCLP).

was not restored. Working with the Historic Preservation Training Center, the park restored two sections of rustic picket fencing at Caretaker’s yard in the fall of 2010 (Figure 199). The Historic Preservation Training Center project did not restore an approximate twenty-five-foot section of fencing due to pending repairs of the stone retaining wall north of the Caretaker’s House. The wall repairs have been completed and the remaining section of fence will be restored in a future project (Figure 200).

The rustic picket fencing completed in the fall of 2010 utilized new fence posts that were cut from eastern red cedar (*Juniperus virginiana*) logs approximately 6 inches in diameter. Horizontal rails were selected from rough sawn white oak (*Quercus alba*) and the rustic pickets were crafted from split Atlantic whitecedar (*Chamaecyparis thyoides*). Each picket varied in width from 1-3/4 to 2-1/4 inches and was attached to the rails at 4-1/2 inches on center (see Figure 120).

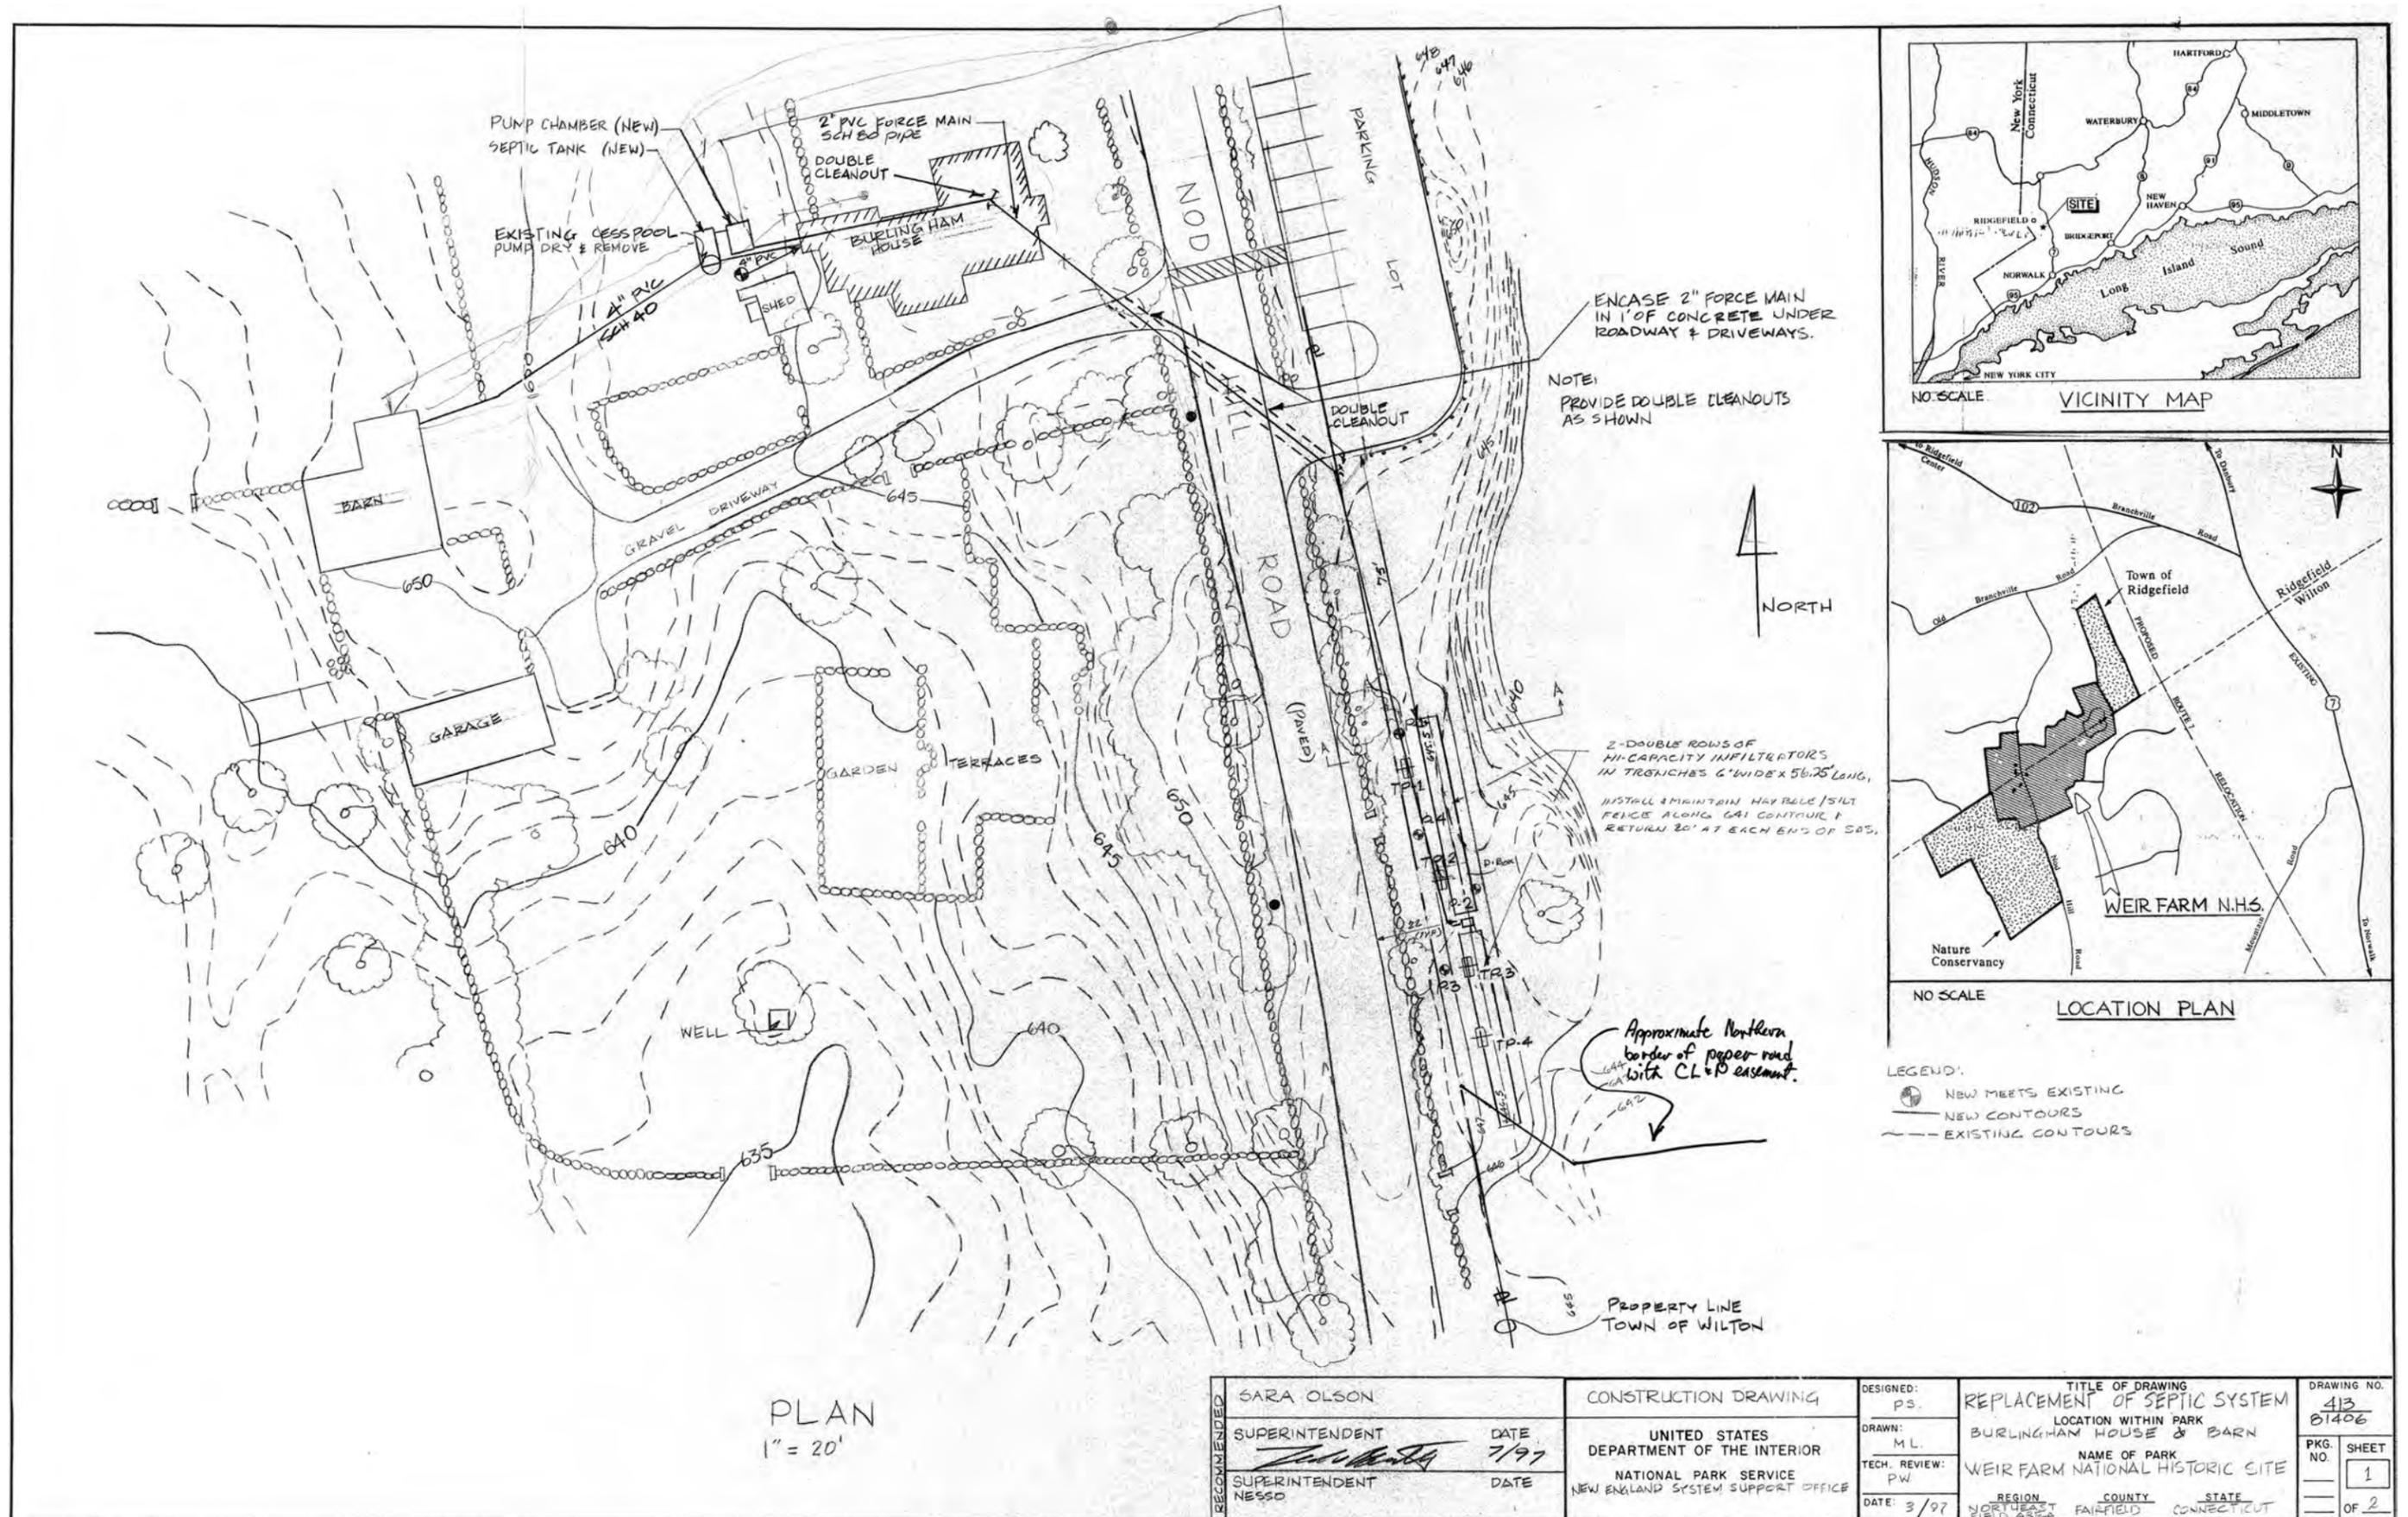
Figure 201. Plan of replacement septic system for Burlingham House and Barn with leach field installed south of visitor parking lot (e-TIC, WEFA_413_81406 [id95777]).

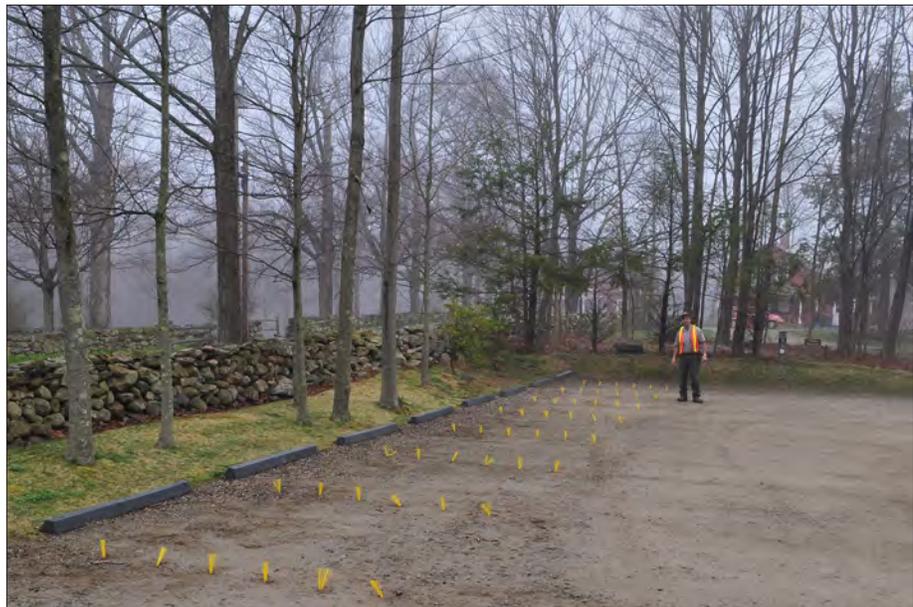
Figure 204. Delineated parking stalls at the visitor parking lot featuring yellow marking whiskers. View looking northwest, 2012 (OCLP).

Following completion of a resurfacing project in 2011, the park installed marking whiskers to clearly delineate the parking stalls (Figure 204). Marking whiskers are tufts of brightly colored nylon attached to a metal clip that are used in surveying and construction. Vehicles can drive over the nylon tufts without damaging them and the markers are a preferable environmental and longer-term alternative to painting the ground. For the visitor parking lot, staff attached a six-inch nail to each marker's metal clip and drove six markers into the lot to form a line for one stall. Yellow markers were used to delineate the stall lines and blue markers, along with signage, were installed to designate the parking lot's one van accessible handicap spot.

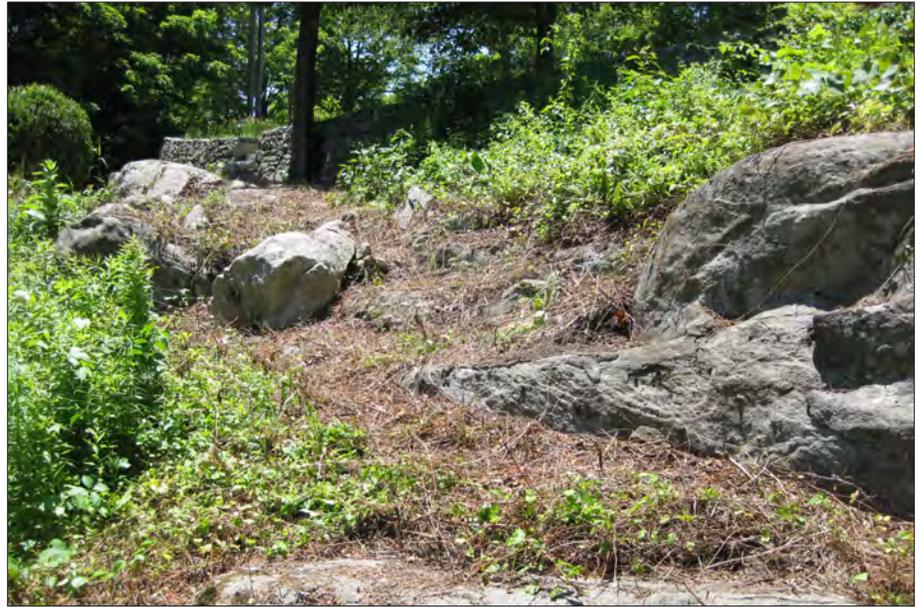
Figure 205. Sloped area for stone steps and connecting trail to be installed. View looking southwest, 2012 (Greg Waters, WEFA).

On the east side of Nod Hill Road opposite the Weir House, a series of seven monolithic granite steps lead through a dressed stone wall and down to a lawn terrace. From the terrace, visitors choose their own route down a steep grade change that leads to a mown path through the Truants' Meadow (Figure 205). The park needed a dedicated route, utilizing stone steps for consistent footing down the existing grade change, that connected the terrace and mown path through the Truants' Meadow. In September 2010, archeologists completed fieldwork in the proposed area for the stone steps and trail and reported no deposits or features. Consequently, the archeologists recommended no further archeological investigations in this area.³⁵

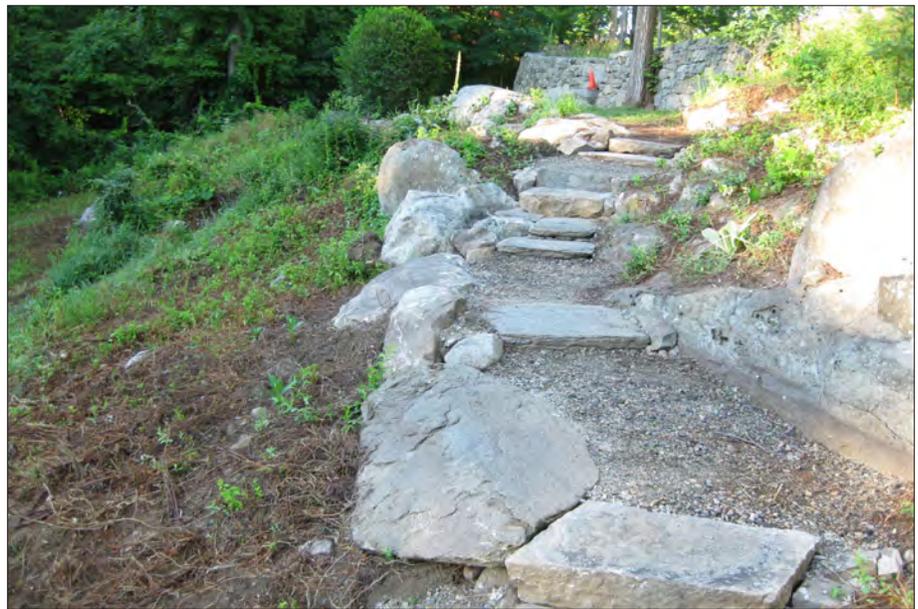
Figure 206. Installed stone steps and connecting trail. View looking southwest, 2012 (Greg Waters, WEFA).

In 2012, the park completed the installation of the stone steps and connecting trail. The trail, roughly two feet wide, extended north from the terrace and connected to four sets of stone steps. Each set of steps consisted of native stone slabs, approximately three feet long, two feet wide, and between two and six inches thick, that were set on a mixture of compacted earth and aggregate. Workers repositioned existing boulders on the downhill side of the trail to retain the trail bed and create a level surface. The trail was surfaced with a mixture of compacted earth and aggregate (Figure 206).

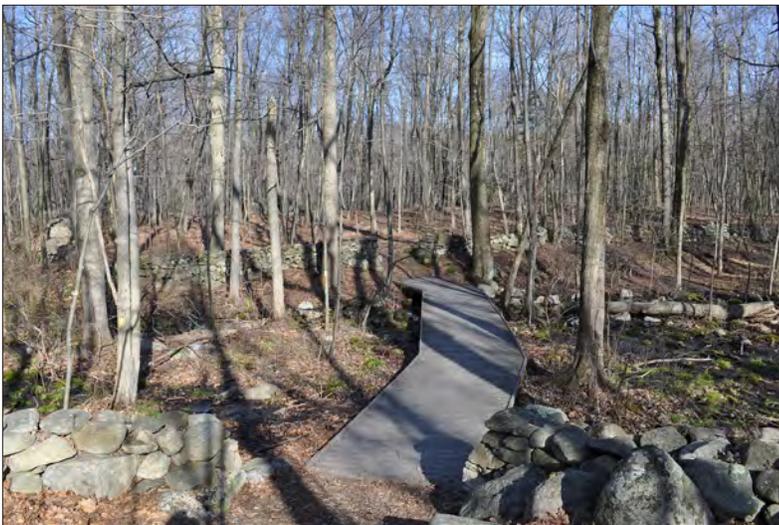
Figure 208 (bottom). Constructed wetland crossing. View looking east, 2010 (OCLP).

Restoring the Fishing Bridge was not recommended due to safety issues raised by the narrow walking surface and single handrail. Instead, the park constructed a low and wide boardwalk across the wetland to the south of the Fishing Bridge site (Figure 208). The non-historic boardwalk permits access to and from the pond, allows the stone remains at the Fishing Bridge site to be interpreted, and keeps pedestrians out of the wetland. Park staff constructed the boardwalk using pressure treated lumber for the posts, beams, and joists and a synthetic lumber product for the decking. The boardwalk rests on 4x4 posts driven into the ground with the span between the posts reinforced by 2x6 beams. Workers attached 2x8 joists to the beams and secured 2x6 plastic decking to the joists. The outer edges of the boardwalk were delineated by 2x4 plastic toe boards attached to the decking (Figure 209).³⁶

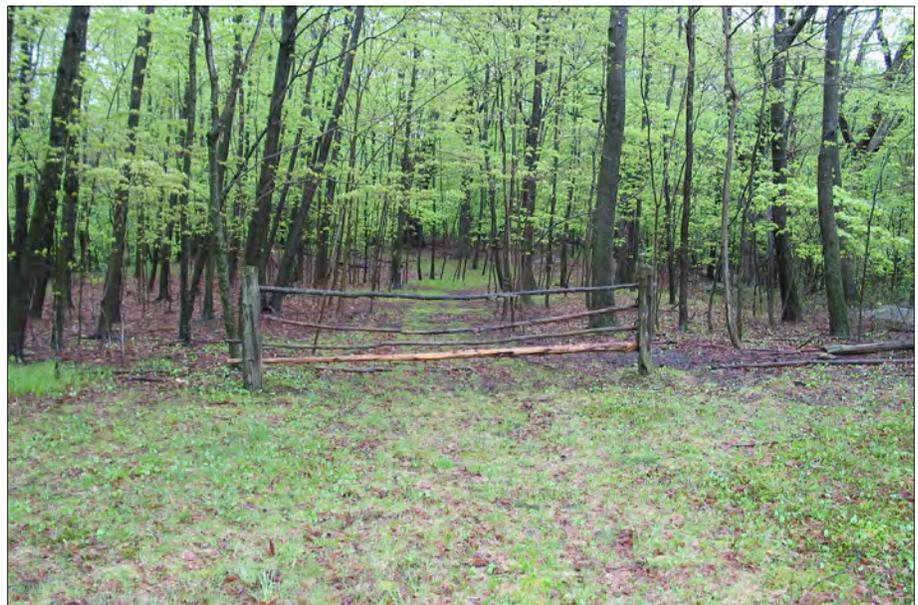
Figure 210. Preserved Wagon Road. View looking southeast, 2010 (OCLP).

During Weir's tenure and very likely before, repeated trips from the house to the fields and pond east of Nod Hill Road created a circulation feature known as the Wagon Road. The road, a compacted earth trace, began near the northwest corner of the Truants' Meadow at a barway entrance from Nod Hill Road. The road continued along the eastern edge of the meadow and entered the woodland area to the south. Regular use of the Wagon Road decreased after the Young family's tenure and as a result, woody vegetation has encroached on the edges of the route and emerged from the roadbed. In 1999 and periodically since, park staff preserves the Wagon Road by removing small trees less than twelve inches diameter at breast height to a distance of five feet on either side of the road's centerline (Figure 210).³⁷

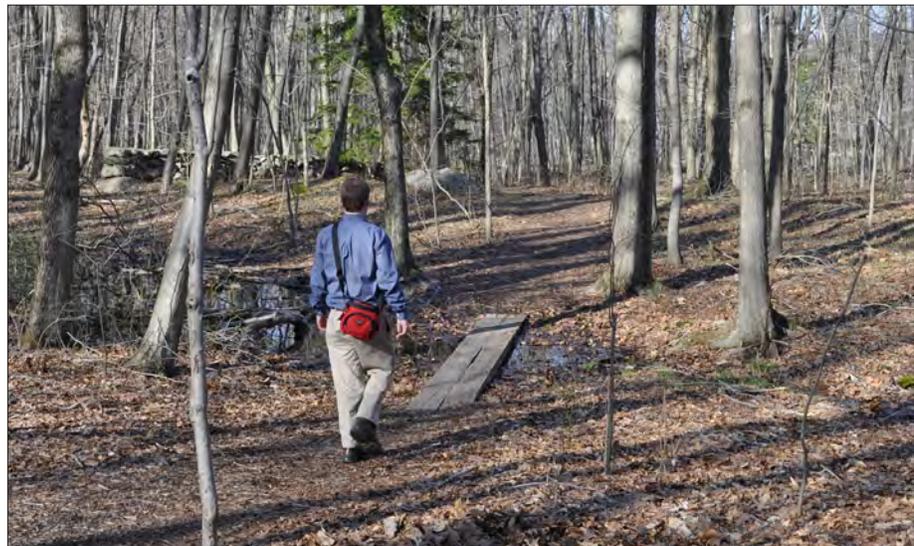
Figure 212. Installed bogwalk along the trail to Weir Pond. View looking east, 2010 (OCLP).

Photographs taken during the Weir family tenure document tree limbs and simple bridge-like fixtures used for dry passage over narrow, wet areas in the Pond and Woodland complex (Figure 211). These ephemeral features were not present when the National Park Service acquired the property, however, seasonally wet areas persisted in the Pond and Woodland Area. Visitors and staff seeking a route to and from the pond had to cross several wet areas and as a result, the park supported two Eagle Scout projects that installed bogwalks in 1998 and 2003 at necessary points (Figure 212). The scouts constructed the bogwalks from rot-resistant black locust (*Robinia pseudoacacia*) logs. Bed logs, a minimum of 2 feet long, were cut and partially buried into the ground. In order to provide a level walking surface tread logs, roughly 8 to 12 feet long, were sawn to create one roughly milled face. The rounded base of the tread logs was notched at either end and the recessed area placed over the bed logs. The tread logs were secured to the bed logs with galvanized spikes (Figure 213).³⁸

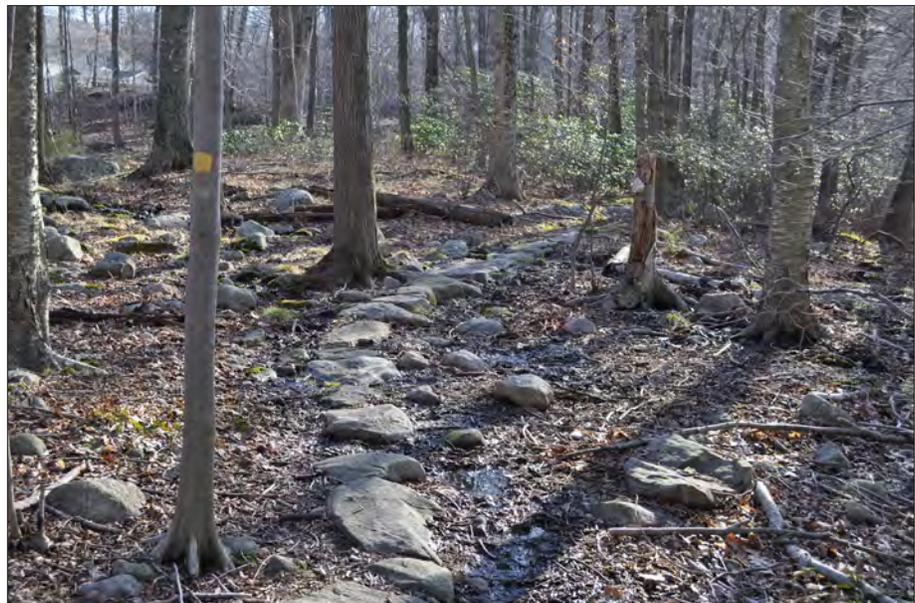
Figure 214. Rehabilitated path around Weir Pond. This section of the path, near the southeast edge of Weir Pond, features stepping stones that cross a seasonally wet area. View looking southwest, 2010 (OCLP).

Following the construction of the dam and pond in 1896, Weir added a Summerhouse on the pond's island and a separate Boat House along the western bank to support the family's recreation activities. With the pond and these additional amenities drawing people to this portion of the property, it is likely that a circumferential path was created over time by persistent pedestrian traffic. When the National Park Service acquired Weir Farm, the path around the pond, similar to other circulation features in the Pond and Woodland Area, was obscured by young woody vegetation. The park rehabilitated the path around Weir Pond by removing the volunteer vegetation to define a dedicated route (Figure 214). Working with a trails team from Acadia National Park, the park

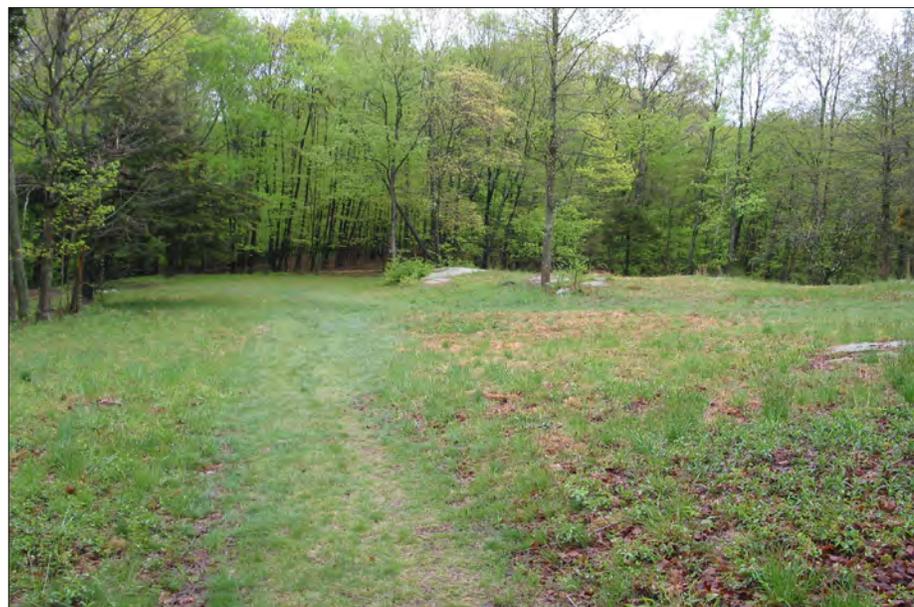
Figure 216. Removed young woody vegetation in the Truants’ Meadow. View looking southeast, 2010 (OCLP).

A meadow area east of the Weir House and Barn served as the setting for Julian Alden Weir’s 1895 painting “The Truants.” In the painting, two youngsters hide in a low pocket of the meadow beyond a stone wall. The painting won first prize at the Boston Art Club the following year and with the prize money, Weir purchased ten acres east of his current property and constructed the “Boston Art Club Pond” on the newly acquired land. Aerial photographs from the 1940s show the meadow depicted in “The Truants” remained open through the circa 1940 treatment period. Following the Young family’s tenure, young woody vegetation emerged in the meadow. By 2004, the park removed the woody vegetation in the Truants’ Meadow and established a regular mowing regime to maintain its historic character (Figure 216).⁴⁰
