**WEIR FARM
HISTORIC STRUCTURES REPORT**

**Weir Farm National Historic Site
Wilton, Connecticut**

**VOLUME I
The Site and the Weir Complex**

APPENDICES

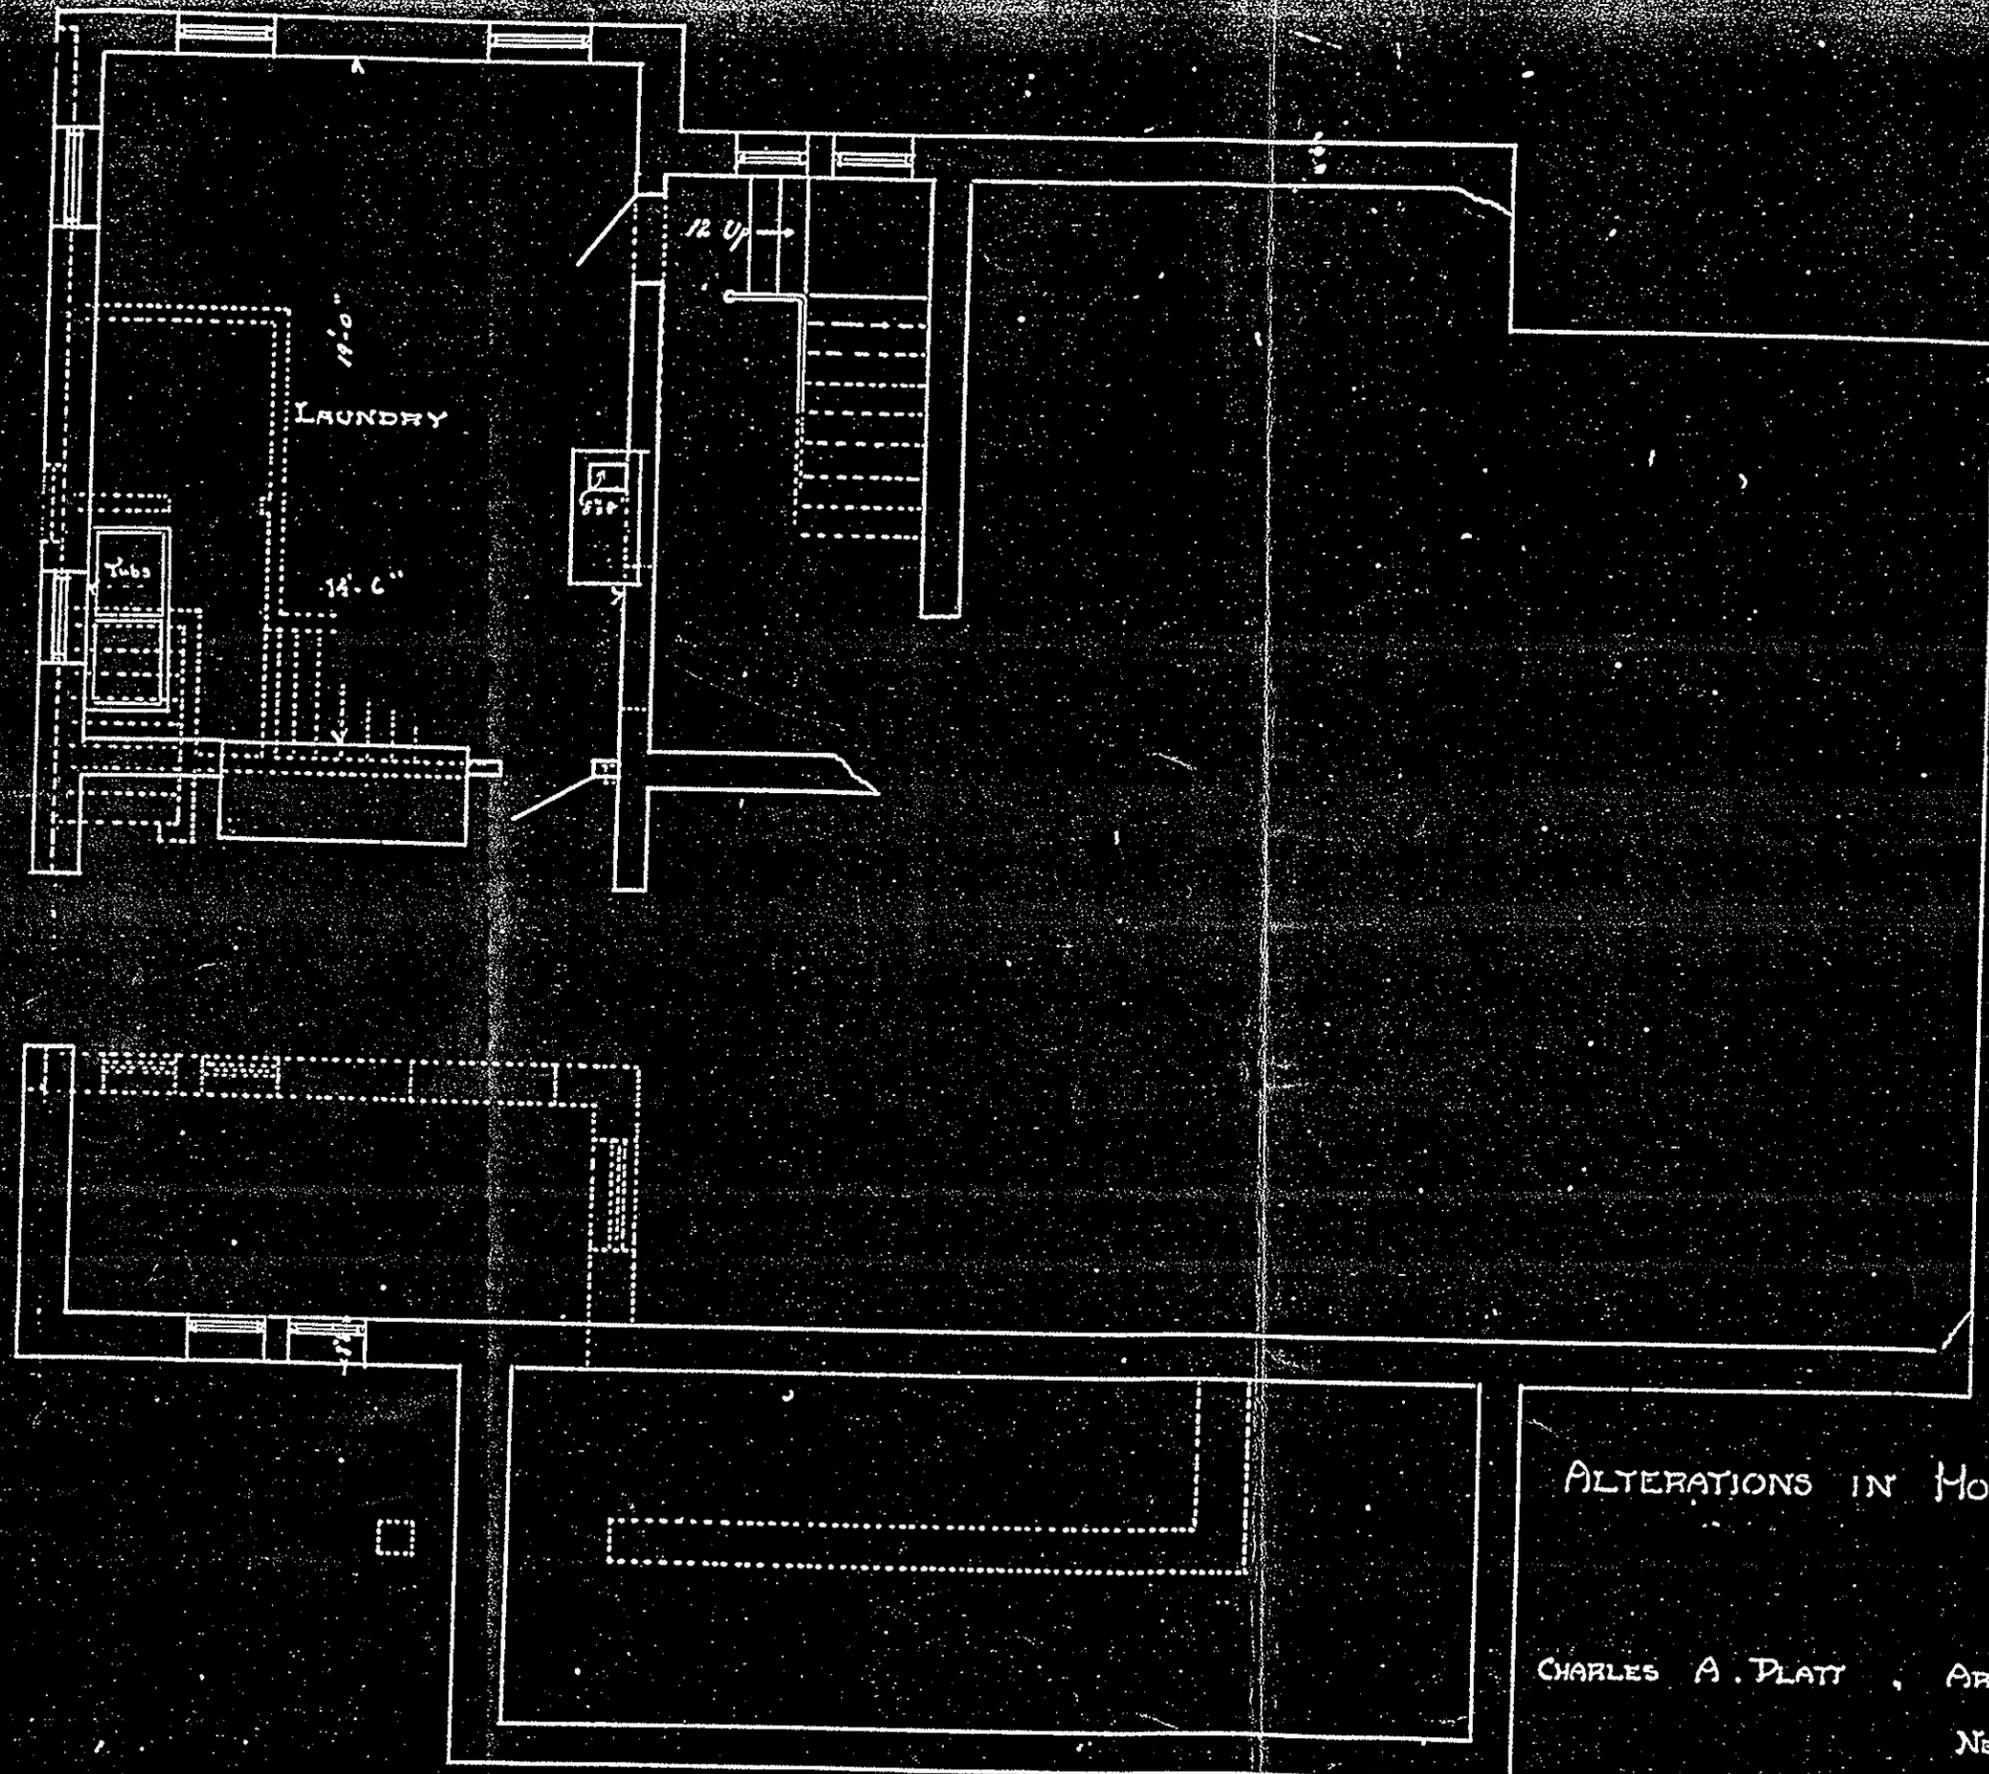
BASEMENT PLAN
Note :- Dotted Lines indicate Old Construction

ALTERATIONS IN HOUSE OF
MR . J . ALDEN WEIR
CHARLES A . PLATT , ARCHITECT
NEW YORK
BRANCHVILLE , CONN
1/4" = 1'-0"

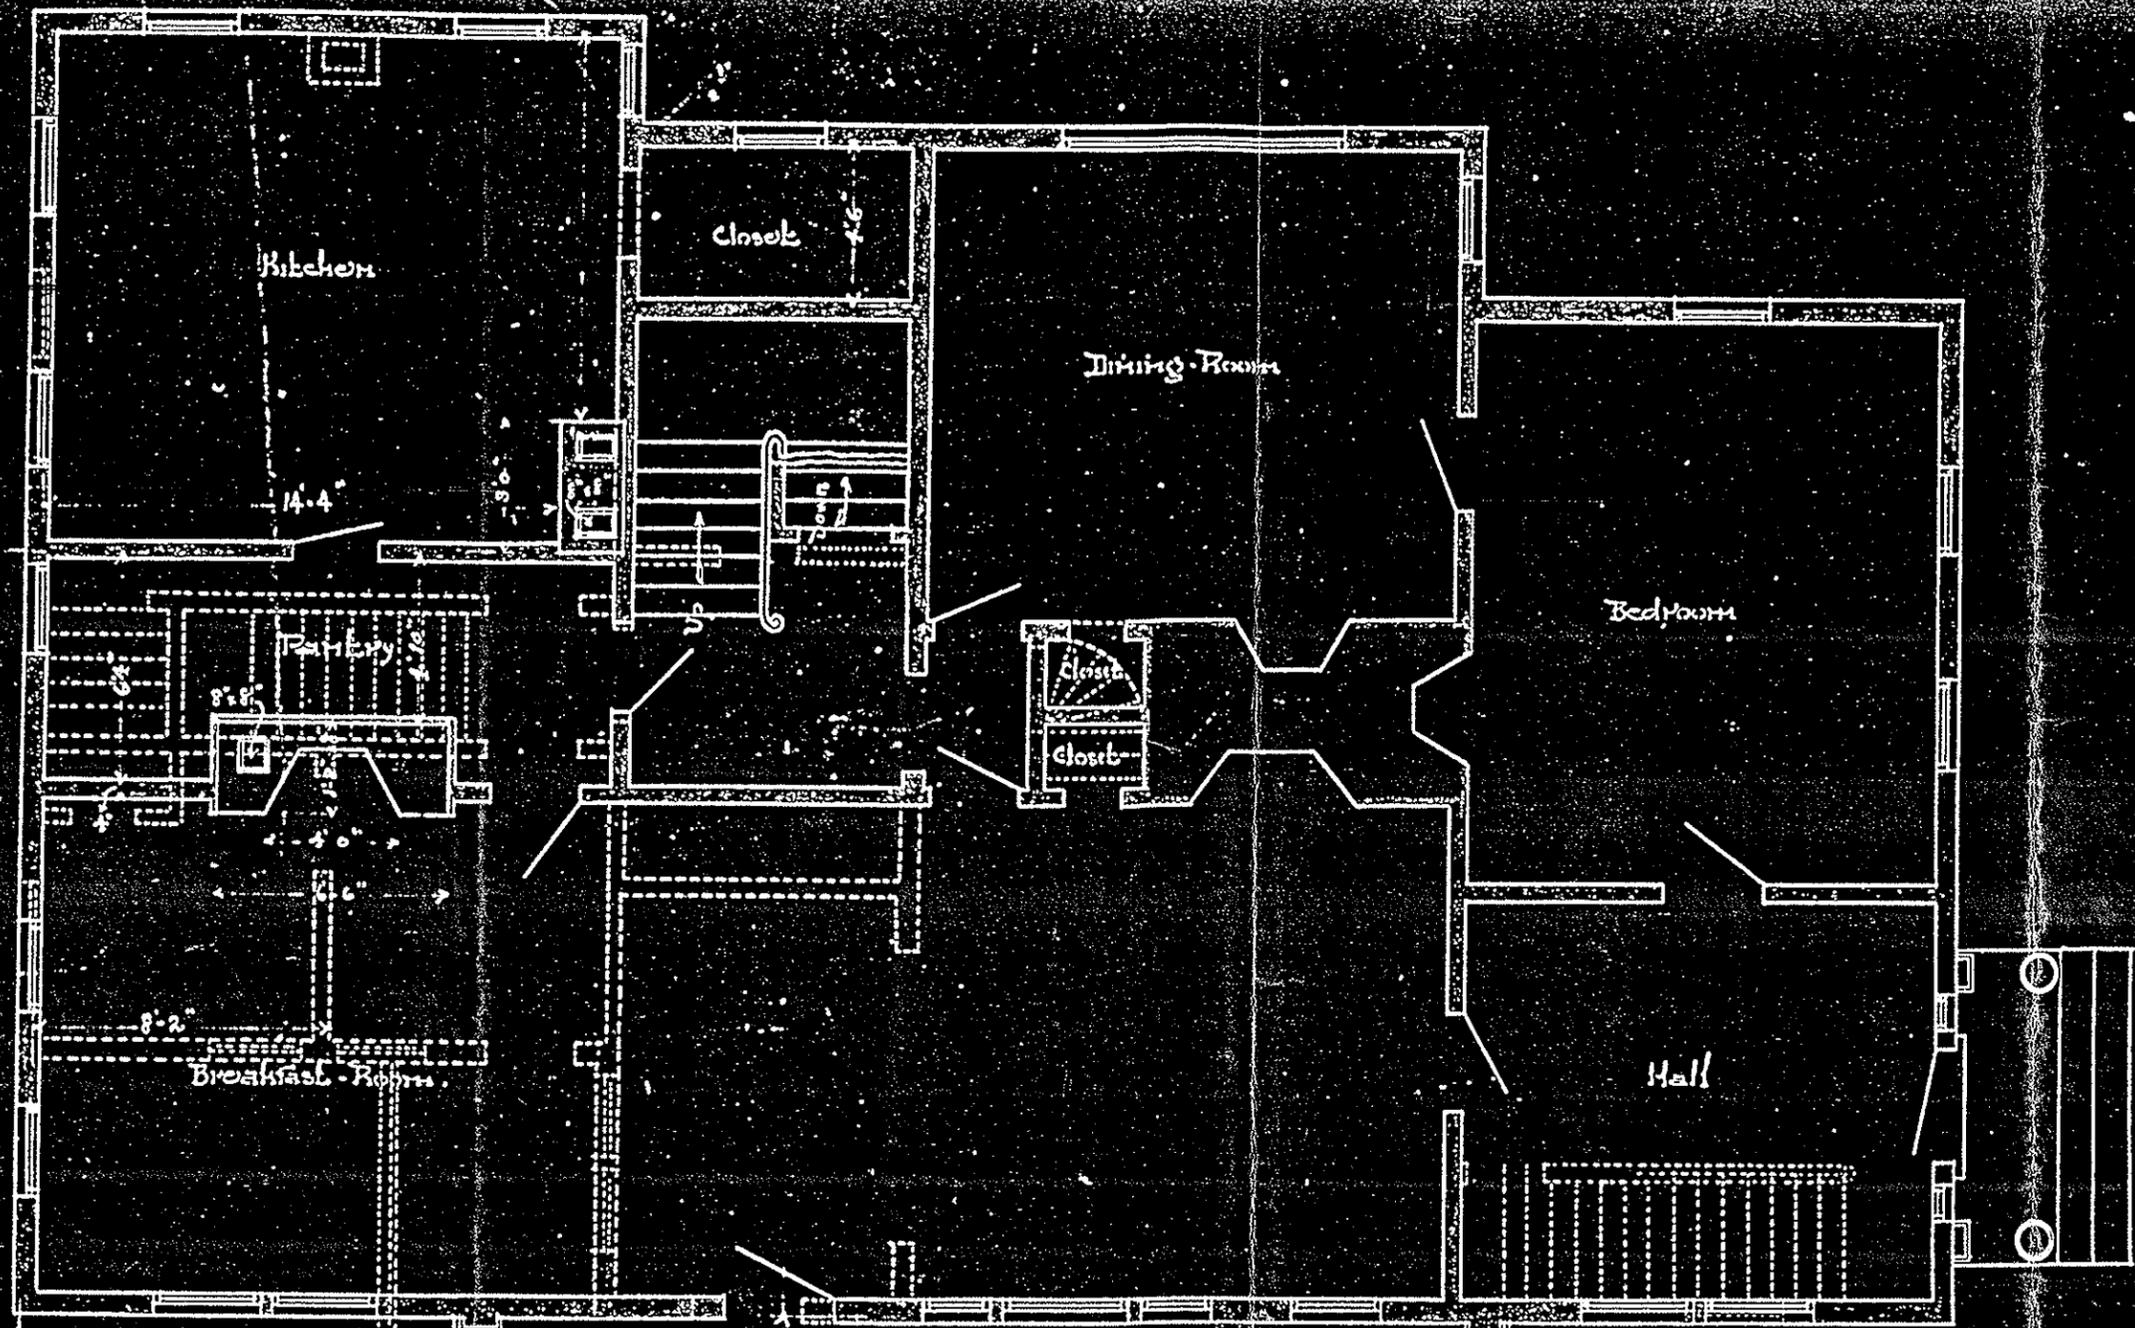
FIRST FLOOR PLAN

Note: Dotted Lines indicate Old Construction

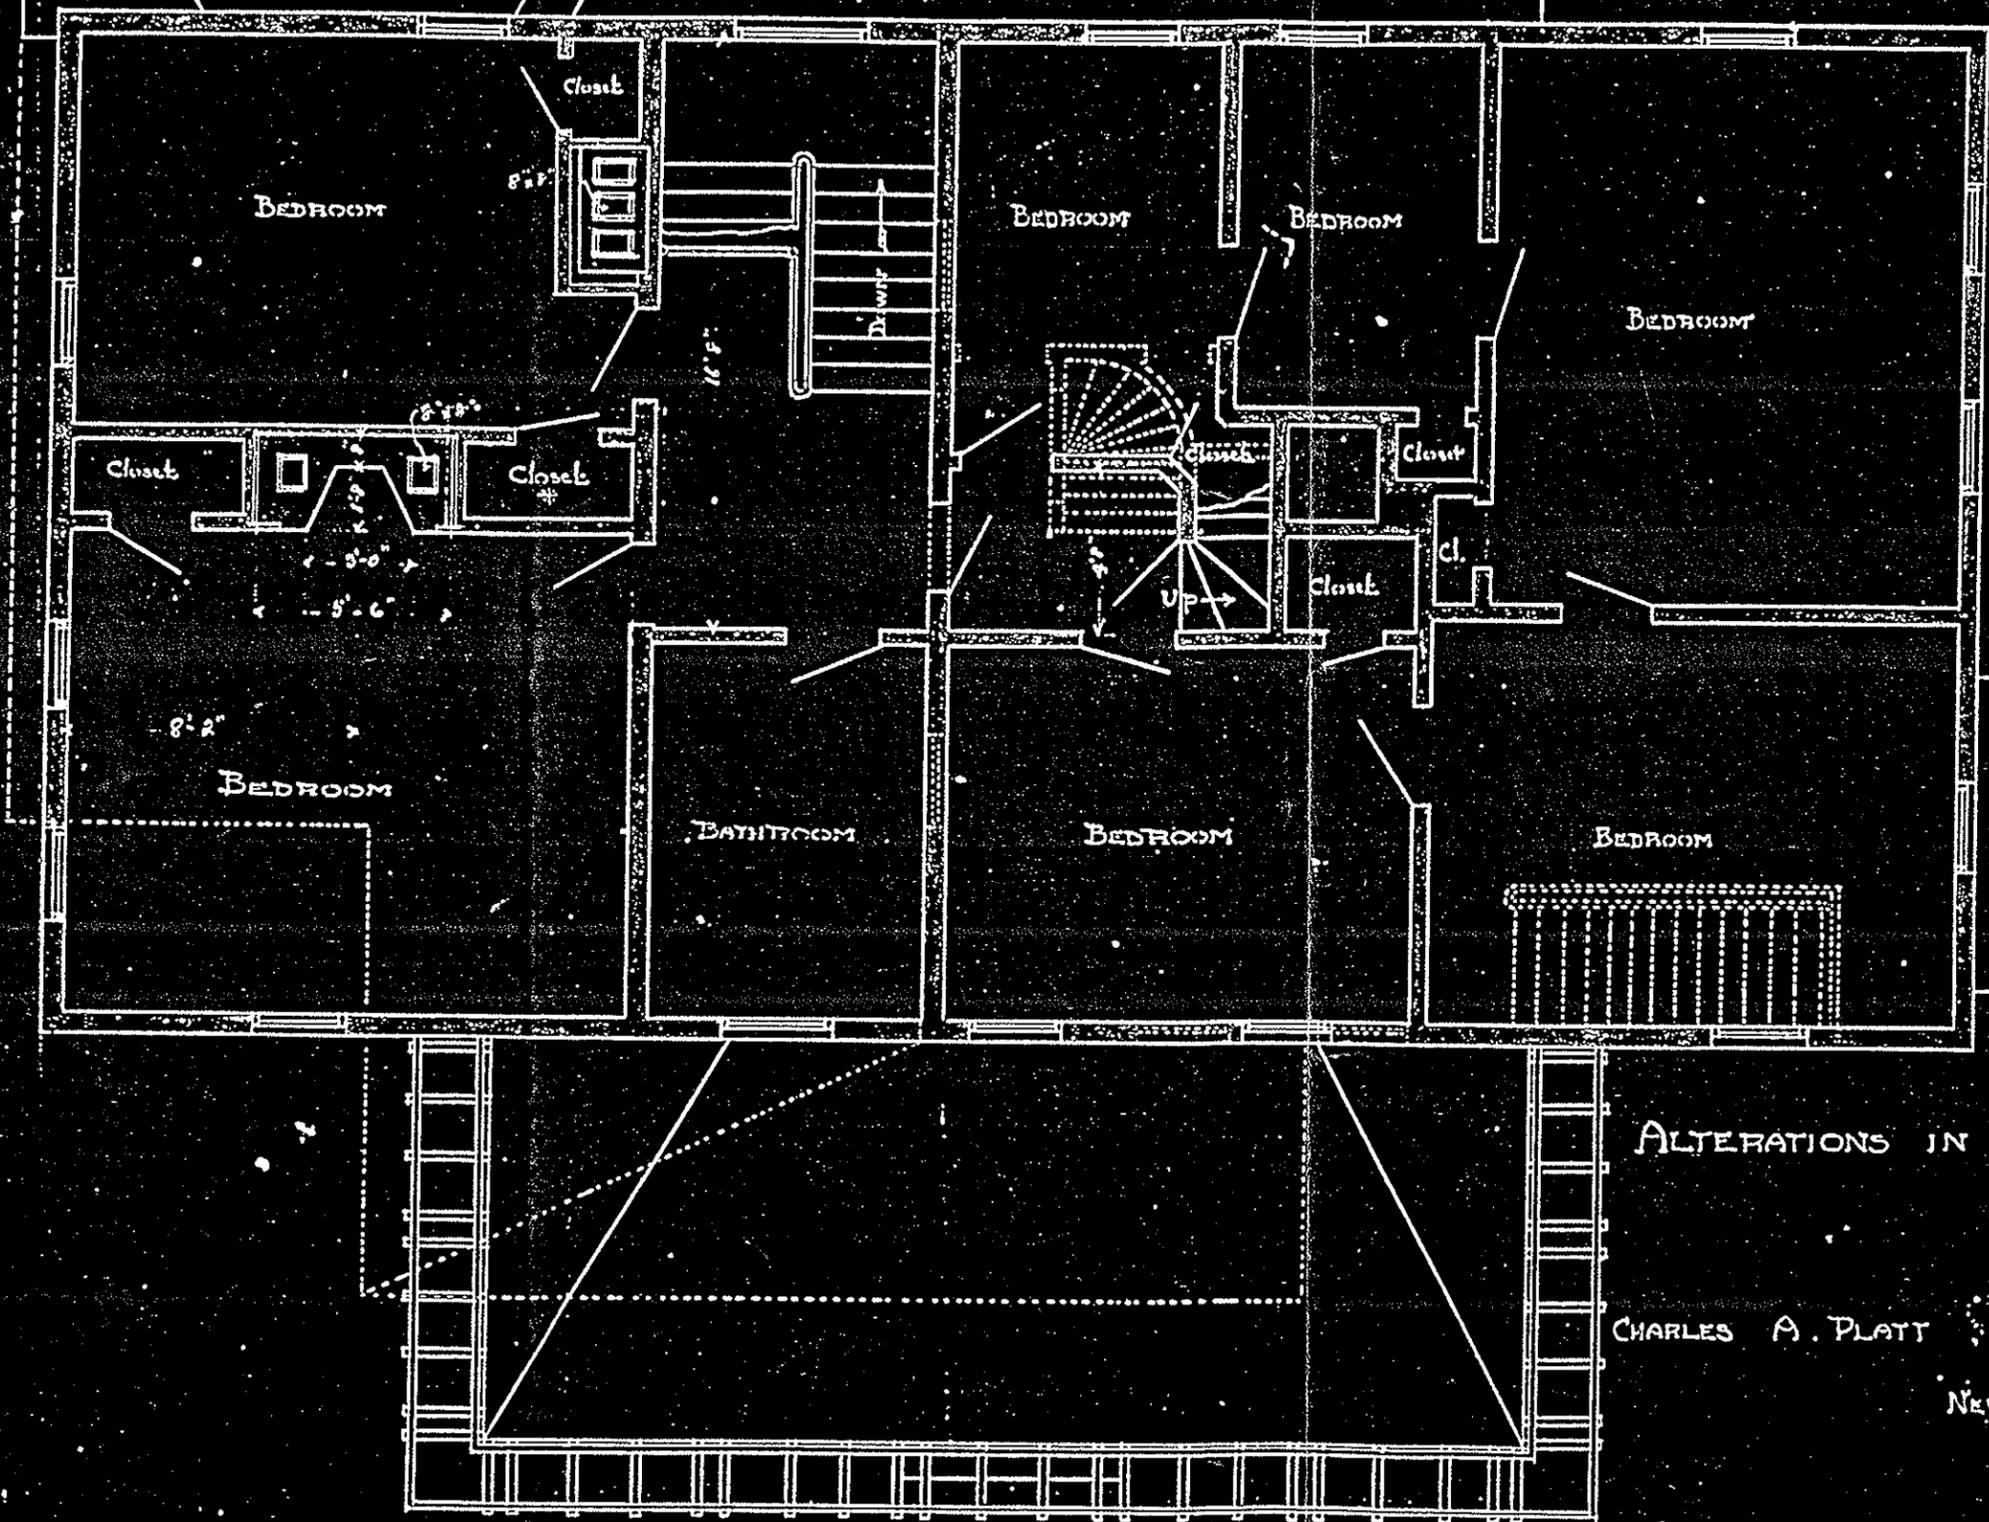
SECOND FLOOR PLAN
 Note: Dotted Lines indicate Old Construction

Note: Dotted Line over
 * Bedroom Closet shows position of
 Water-Tank in Attic

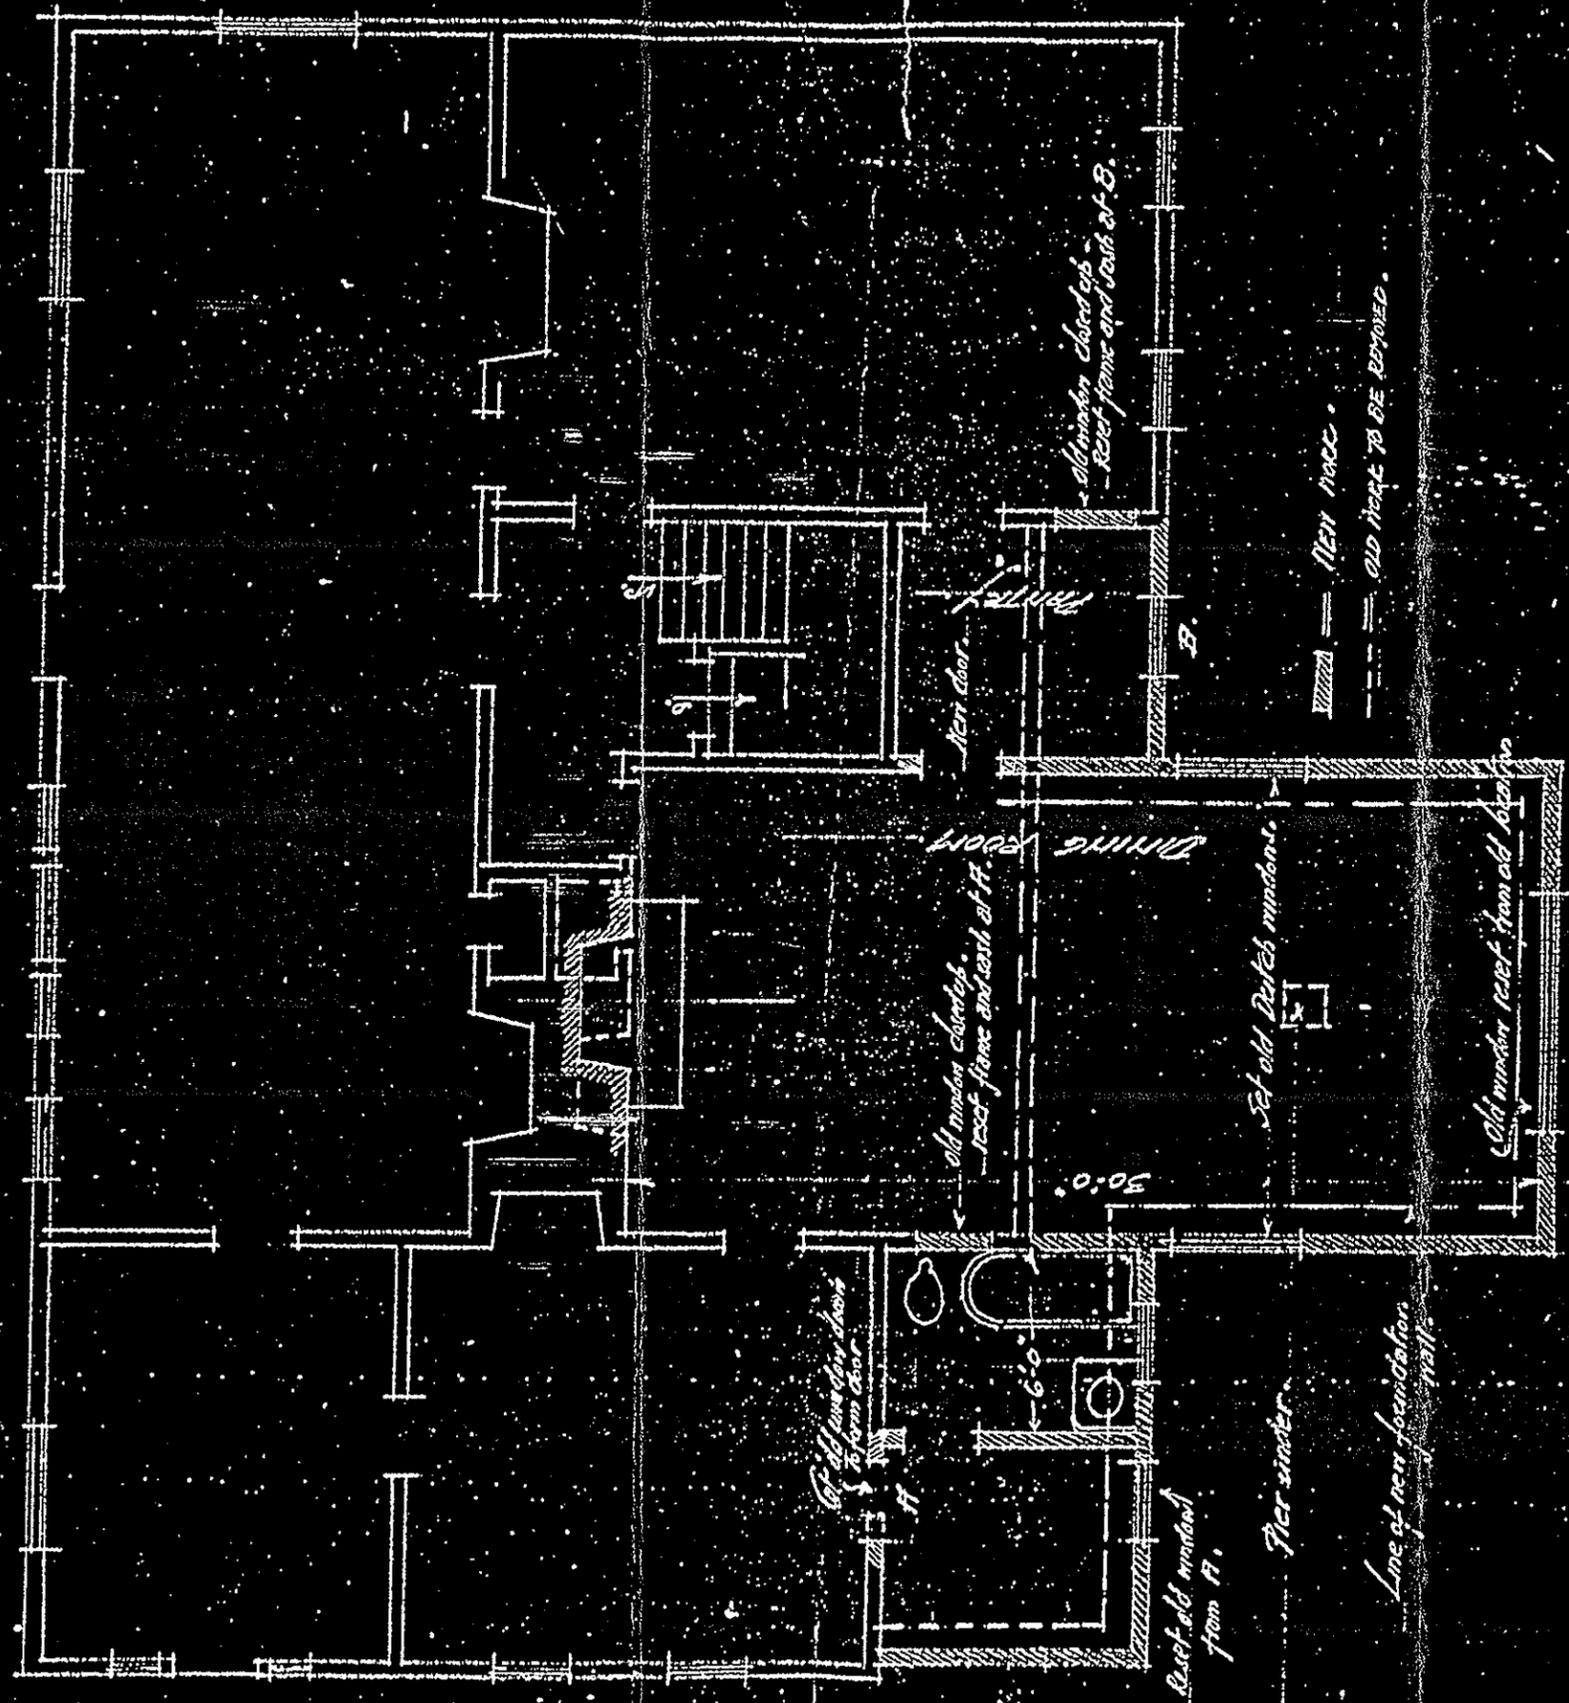
FIRST FLOOR PLAN. FOOTING TO HAVE THE JARVIS WARE, ETC.
 Scale 1/4" = 1'-0"
 BRANCHVILLE, CONN.

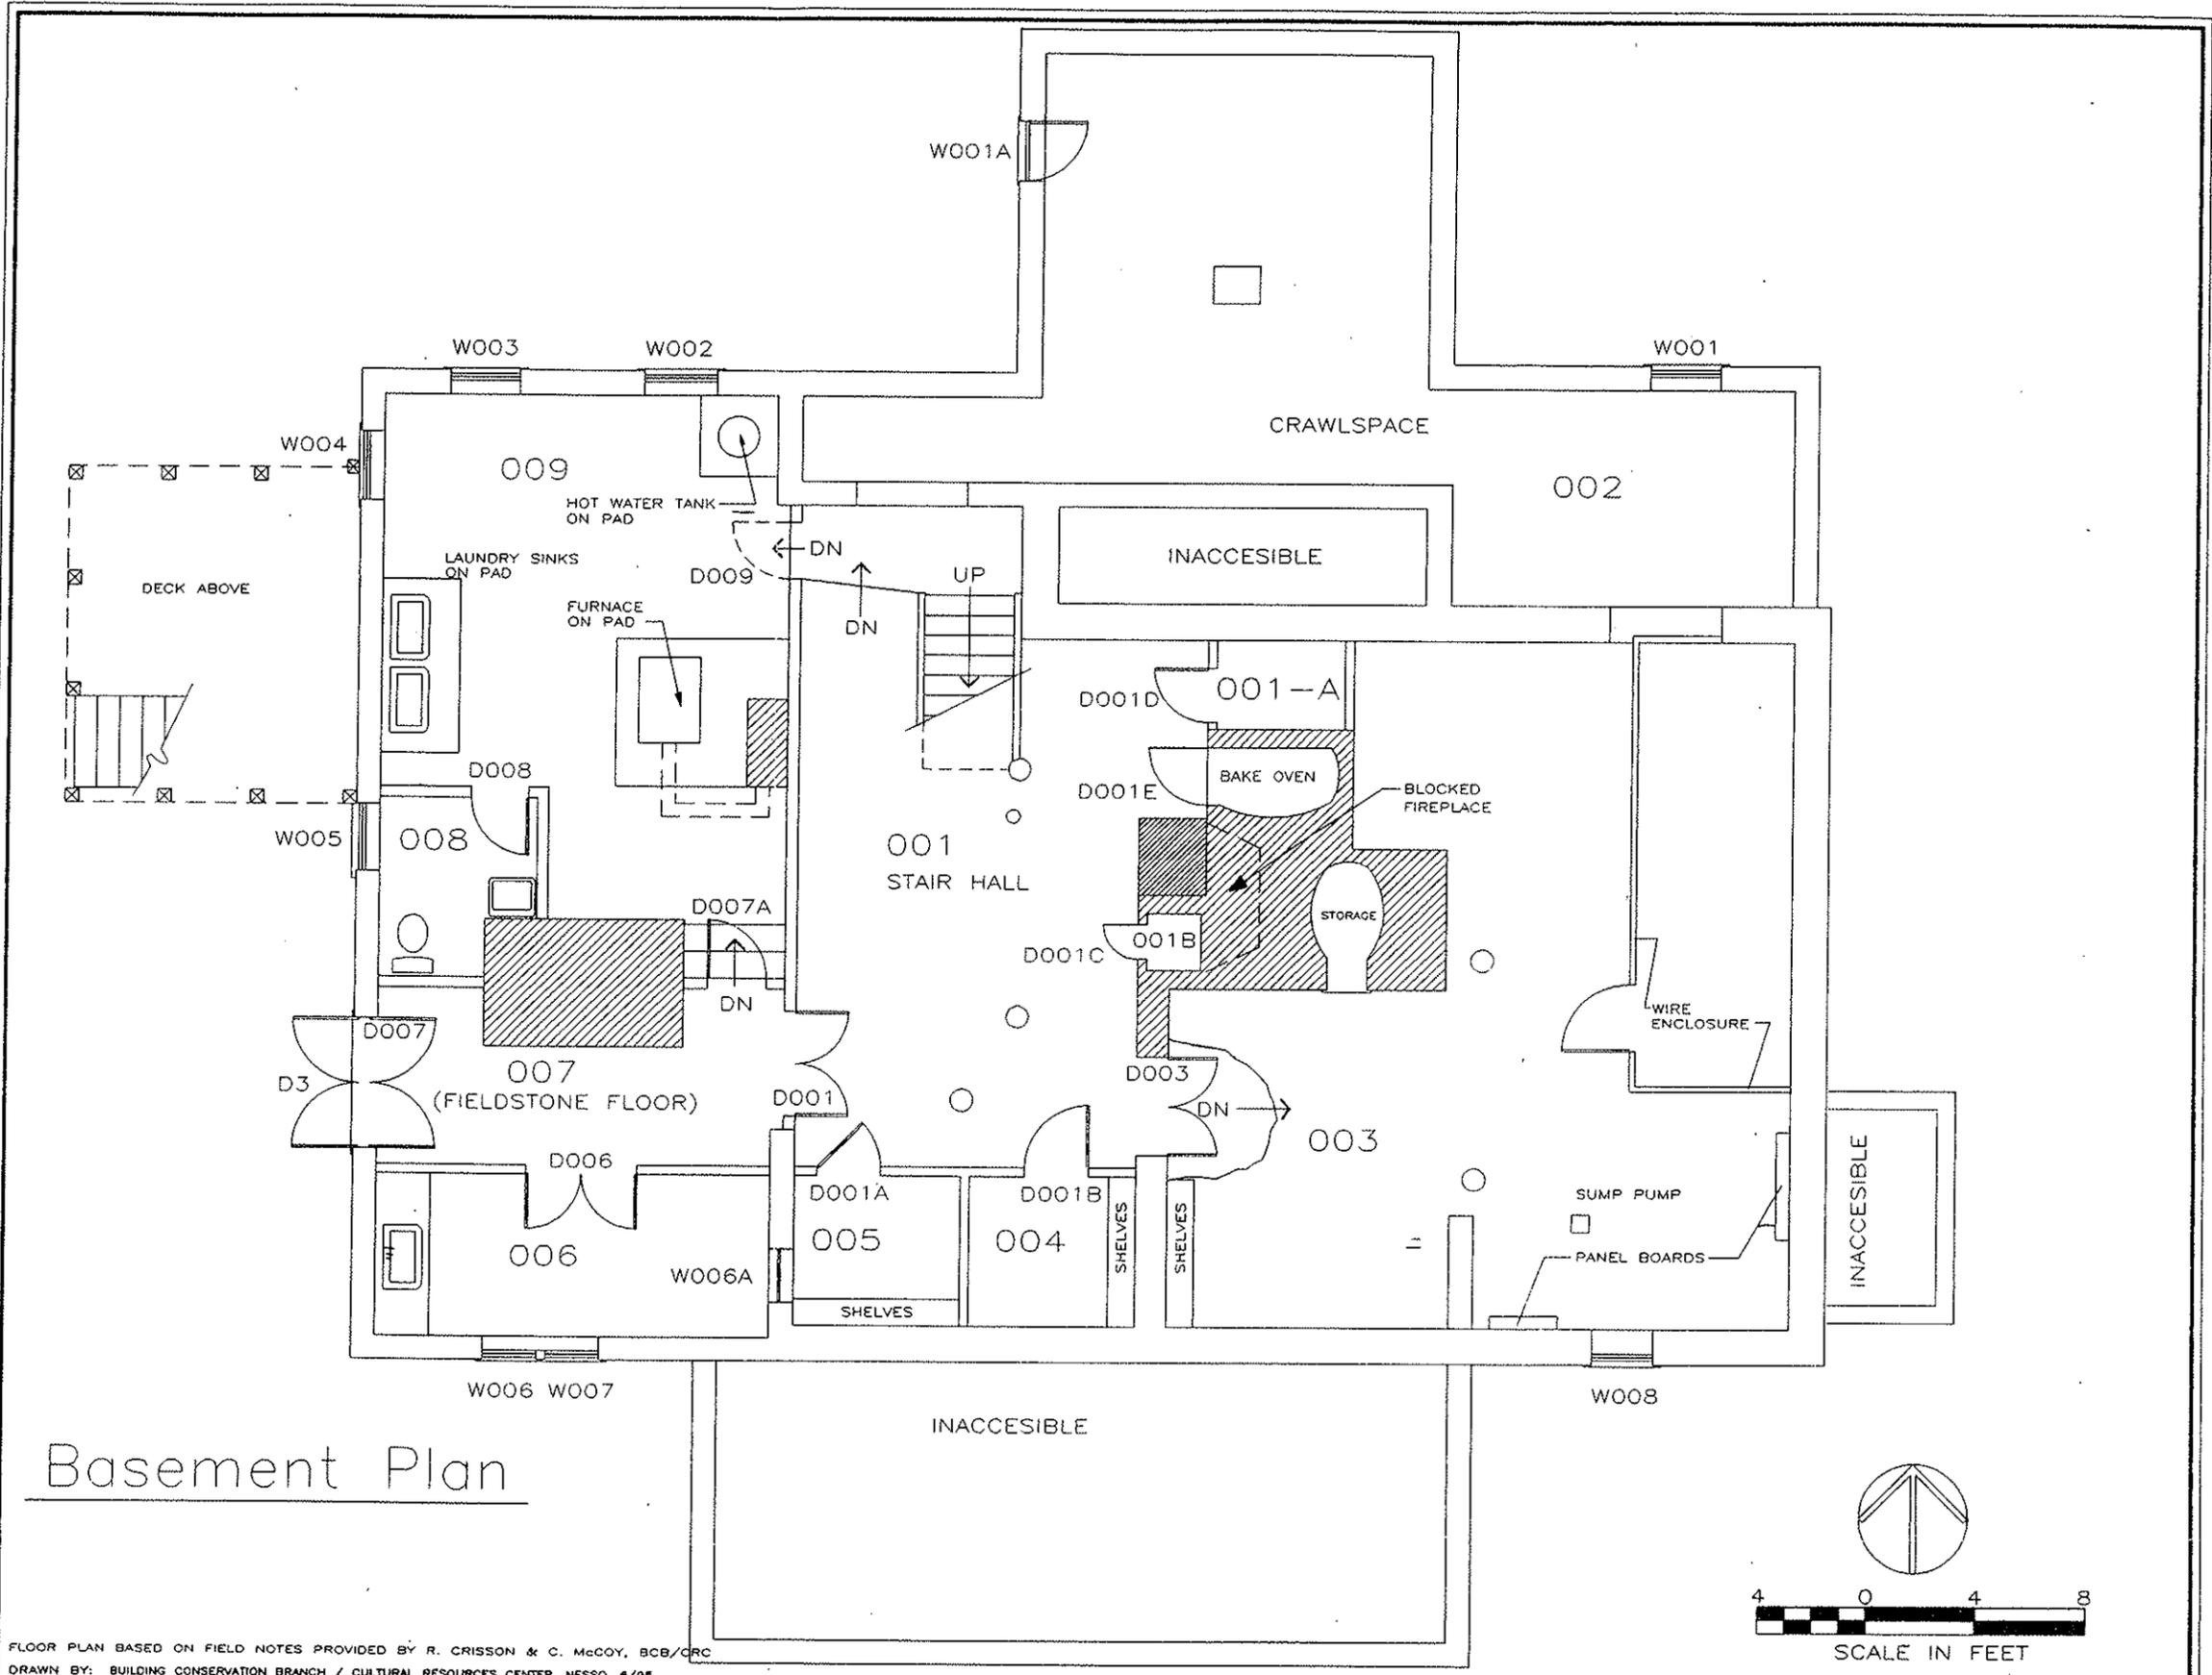
Basement Plan

FLOOR PLAN BASED ON FIELD NOTES PROVIDED BY R. CRISSON & C. MCCOY, BCB/CRC
 DRAWN BY: BUILDING CONSERVATION BRANCH / CULTURAL RESOURCES CENTER, NESSO, 6/95

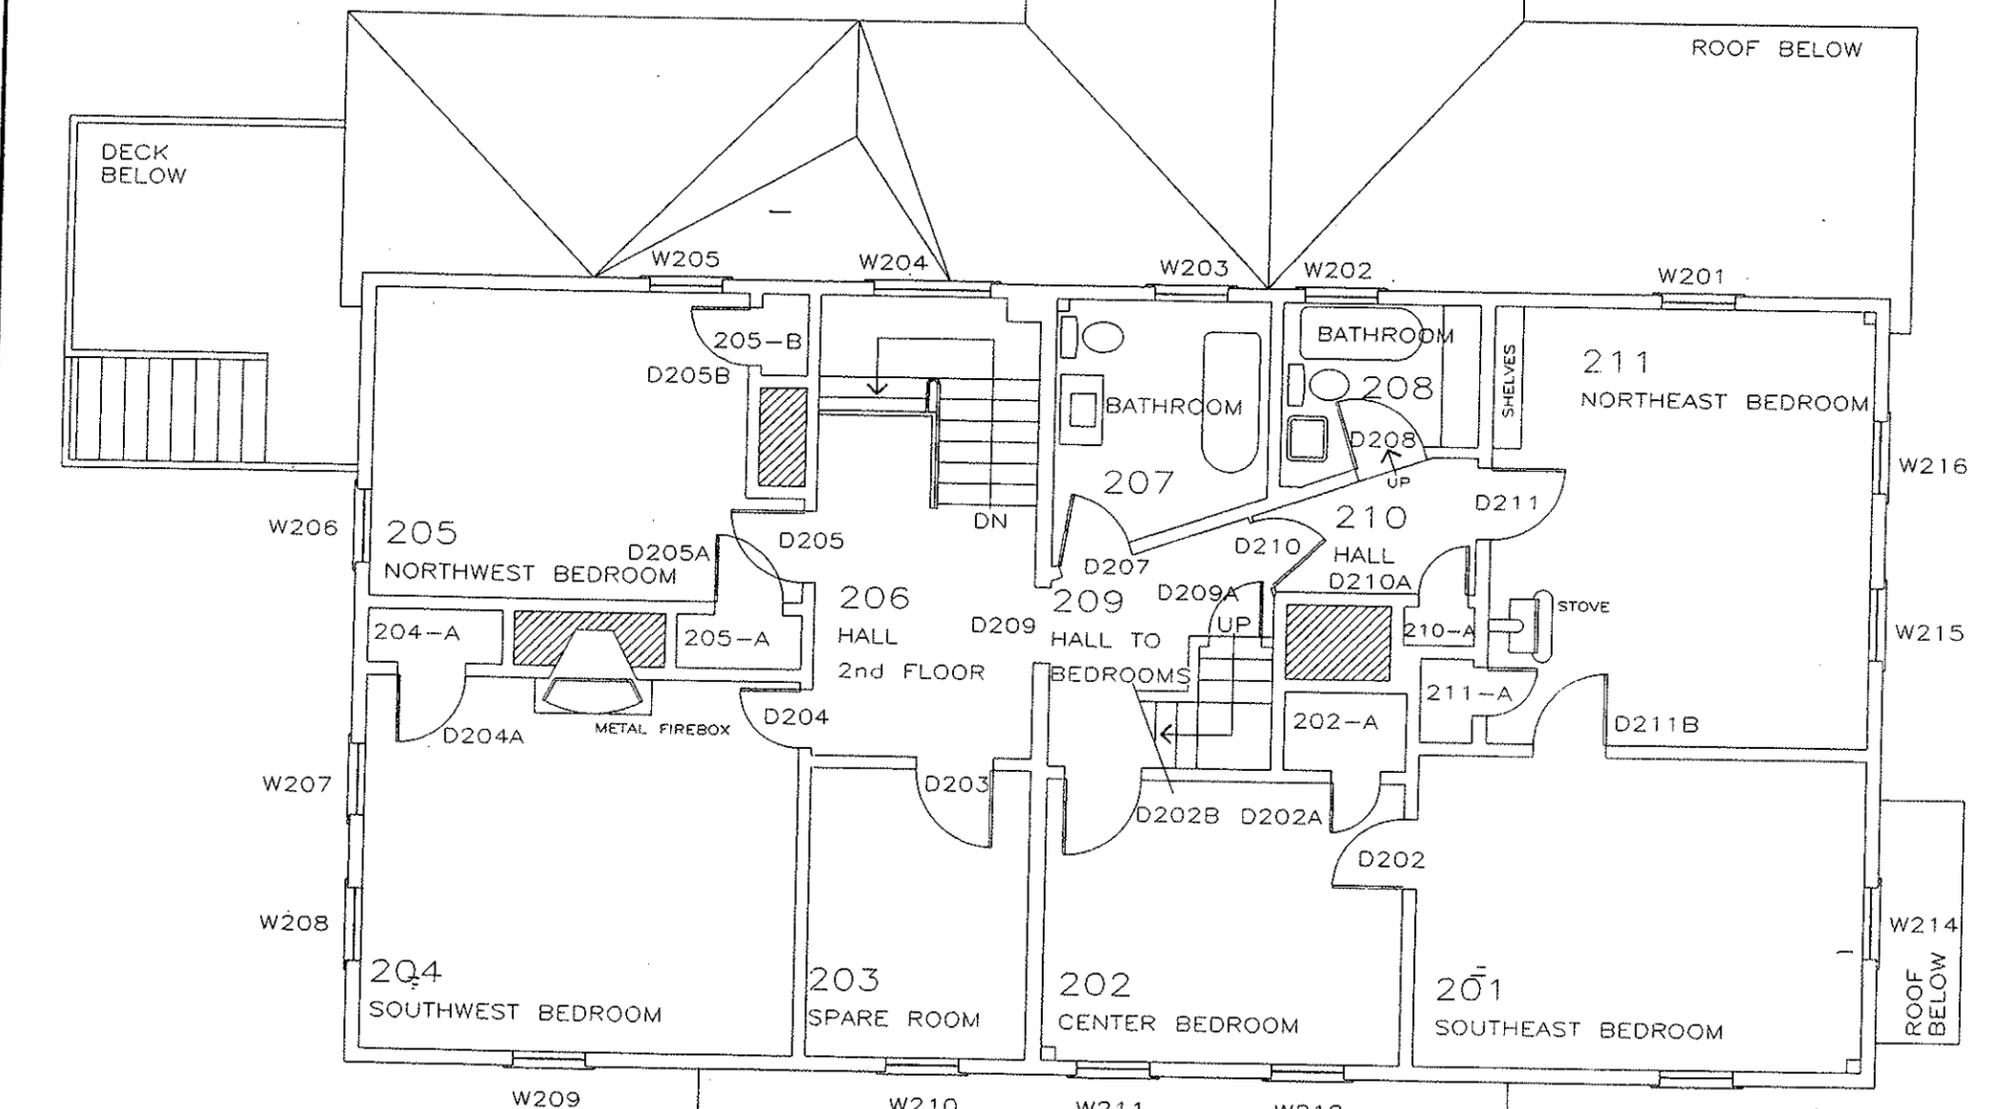
Second Floor Plan

FLOOR PLAN BASED ON FIELD NOTES PROVIDED BY R. CRISSON & C. MCCOY, BCB/CRC
 DRAWN BY: BUILDING CONSERVATION BRANCH / CULTURAL RESOURCES CENTER, NESSO, 6/96

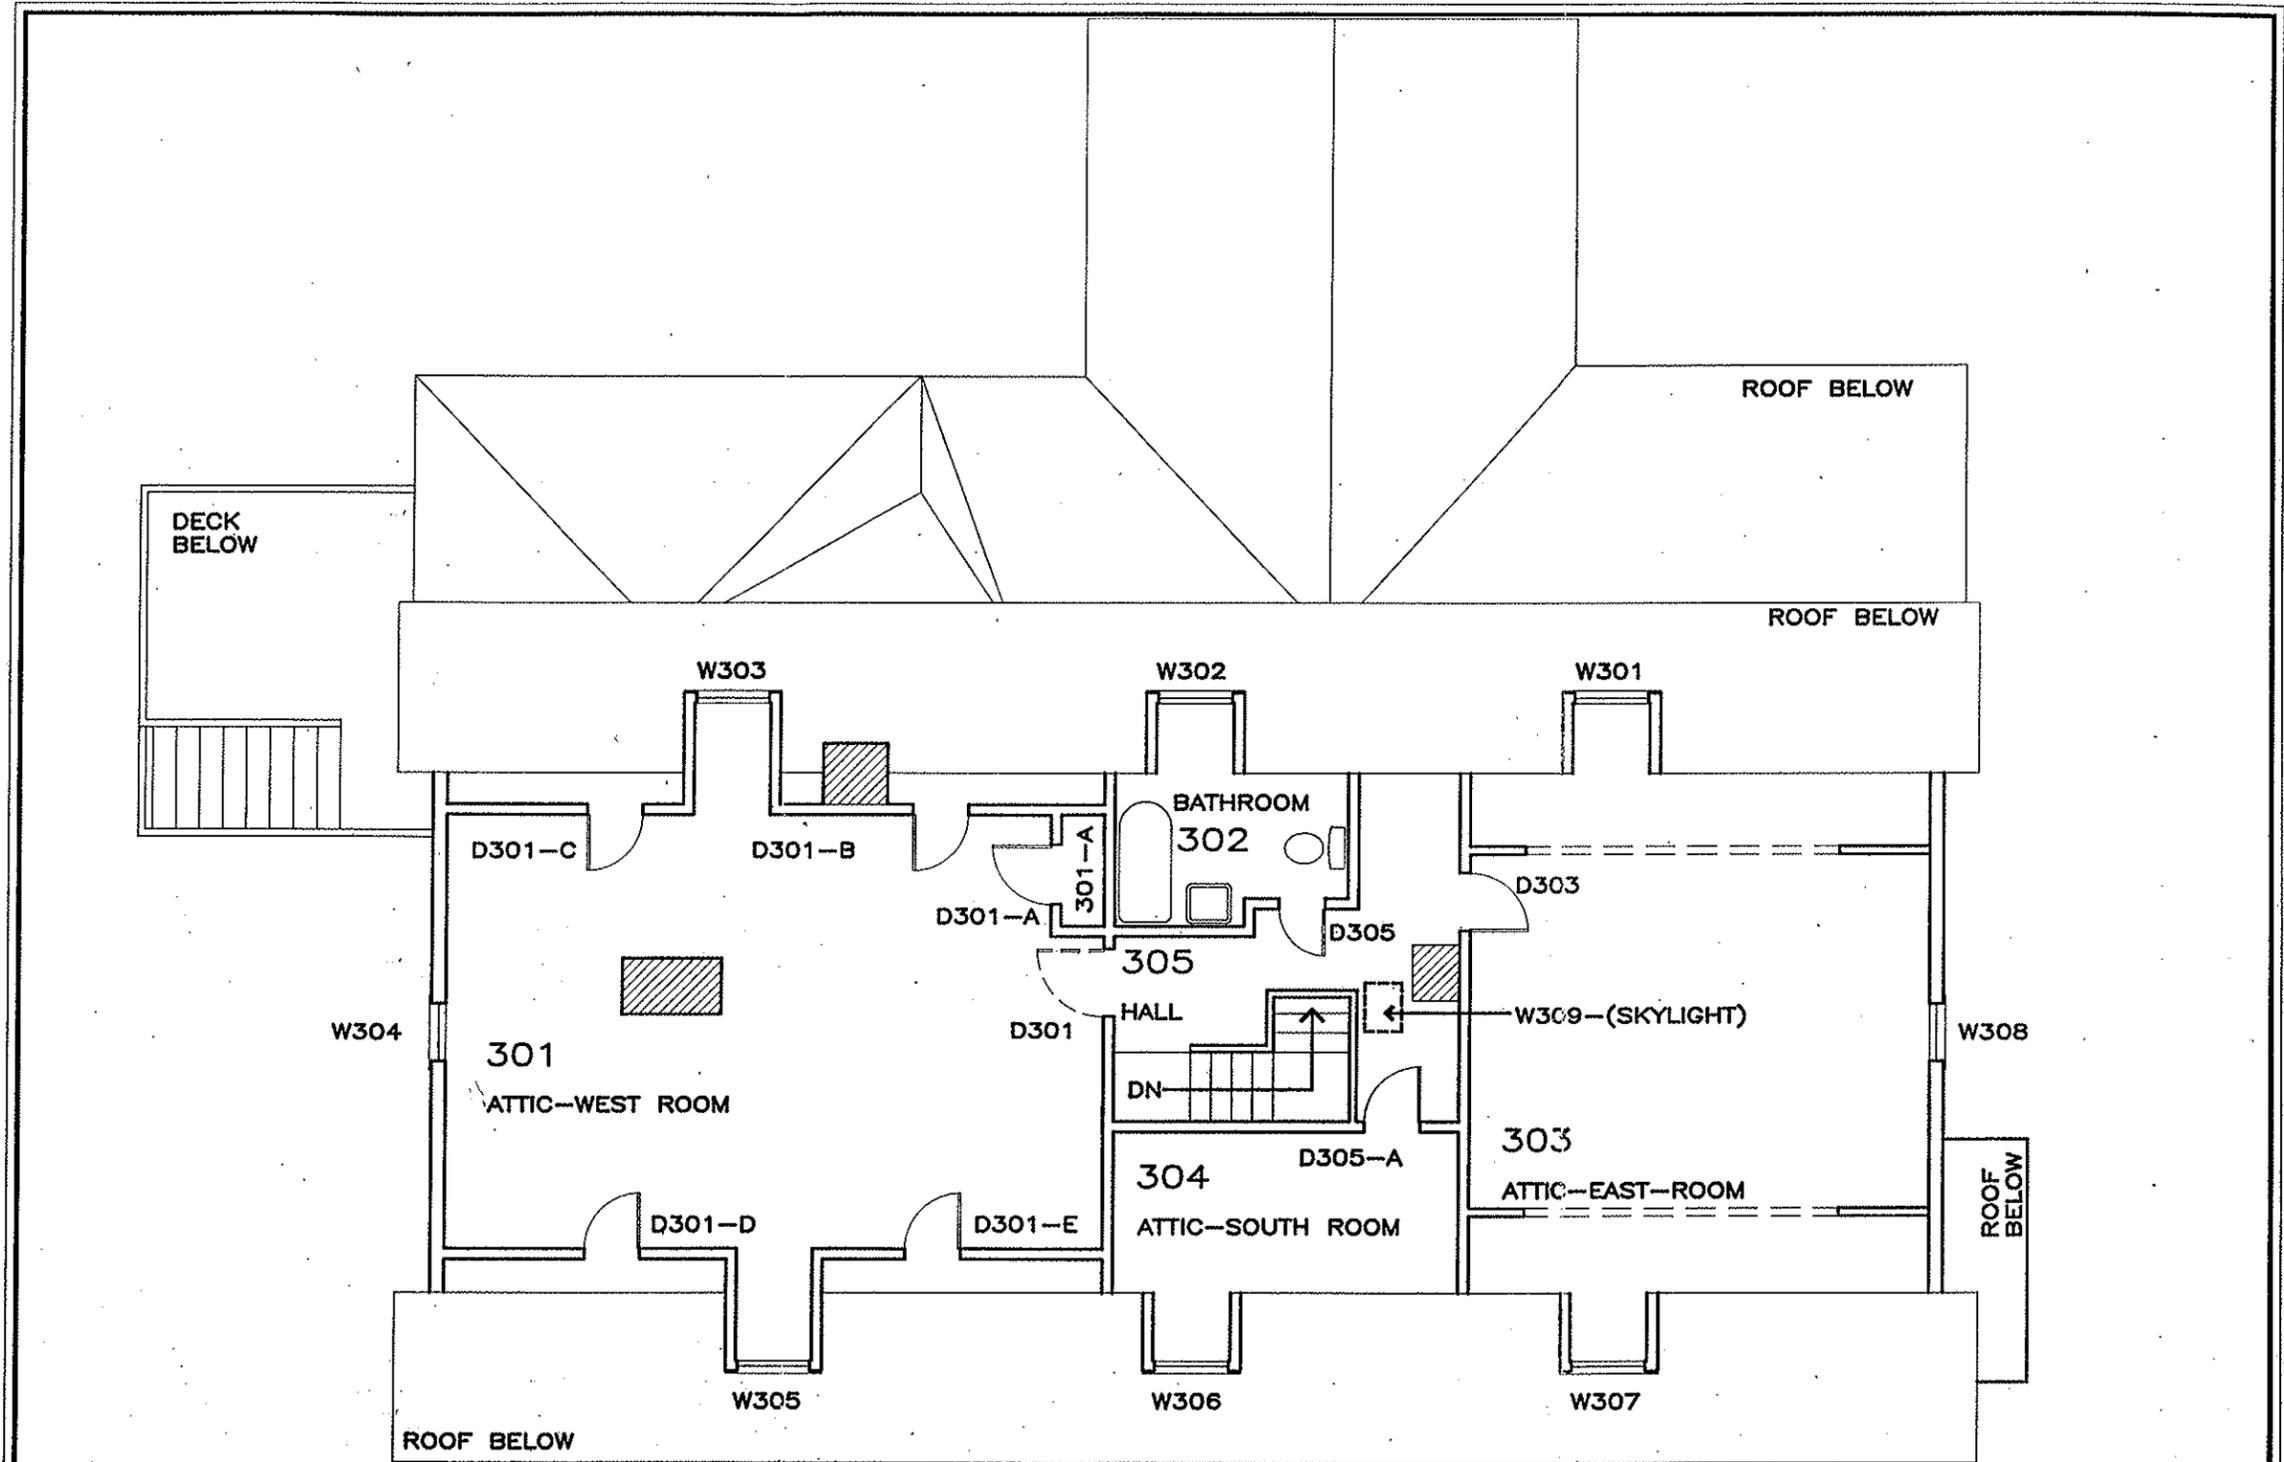
Attic Floor Plan

FLOOR PLAN BASED ON FIELD NOTES PROVIDED BY R. CRISSON & C. MCCOY, BCB/CRC
 DRAWN BY: BUILDING CONSERVATION BRANCH / CULTURAL RESOURCES CENTER, NESSO, 6/95
