**WEIR FARM
HISTORIC STRUCTURES REPORT**

**Weir Farm National Historic Site
Wilton, Connecticut**

**VOLUME I
The Site and the Weir Complex**

APPENDICES

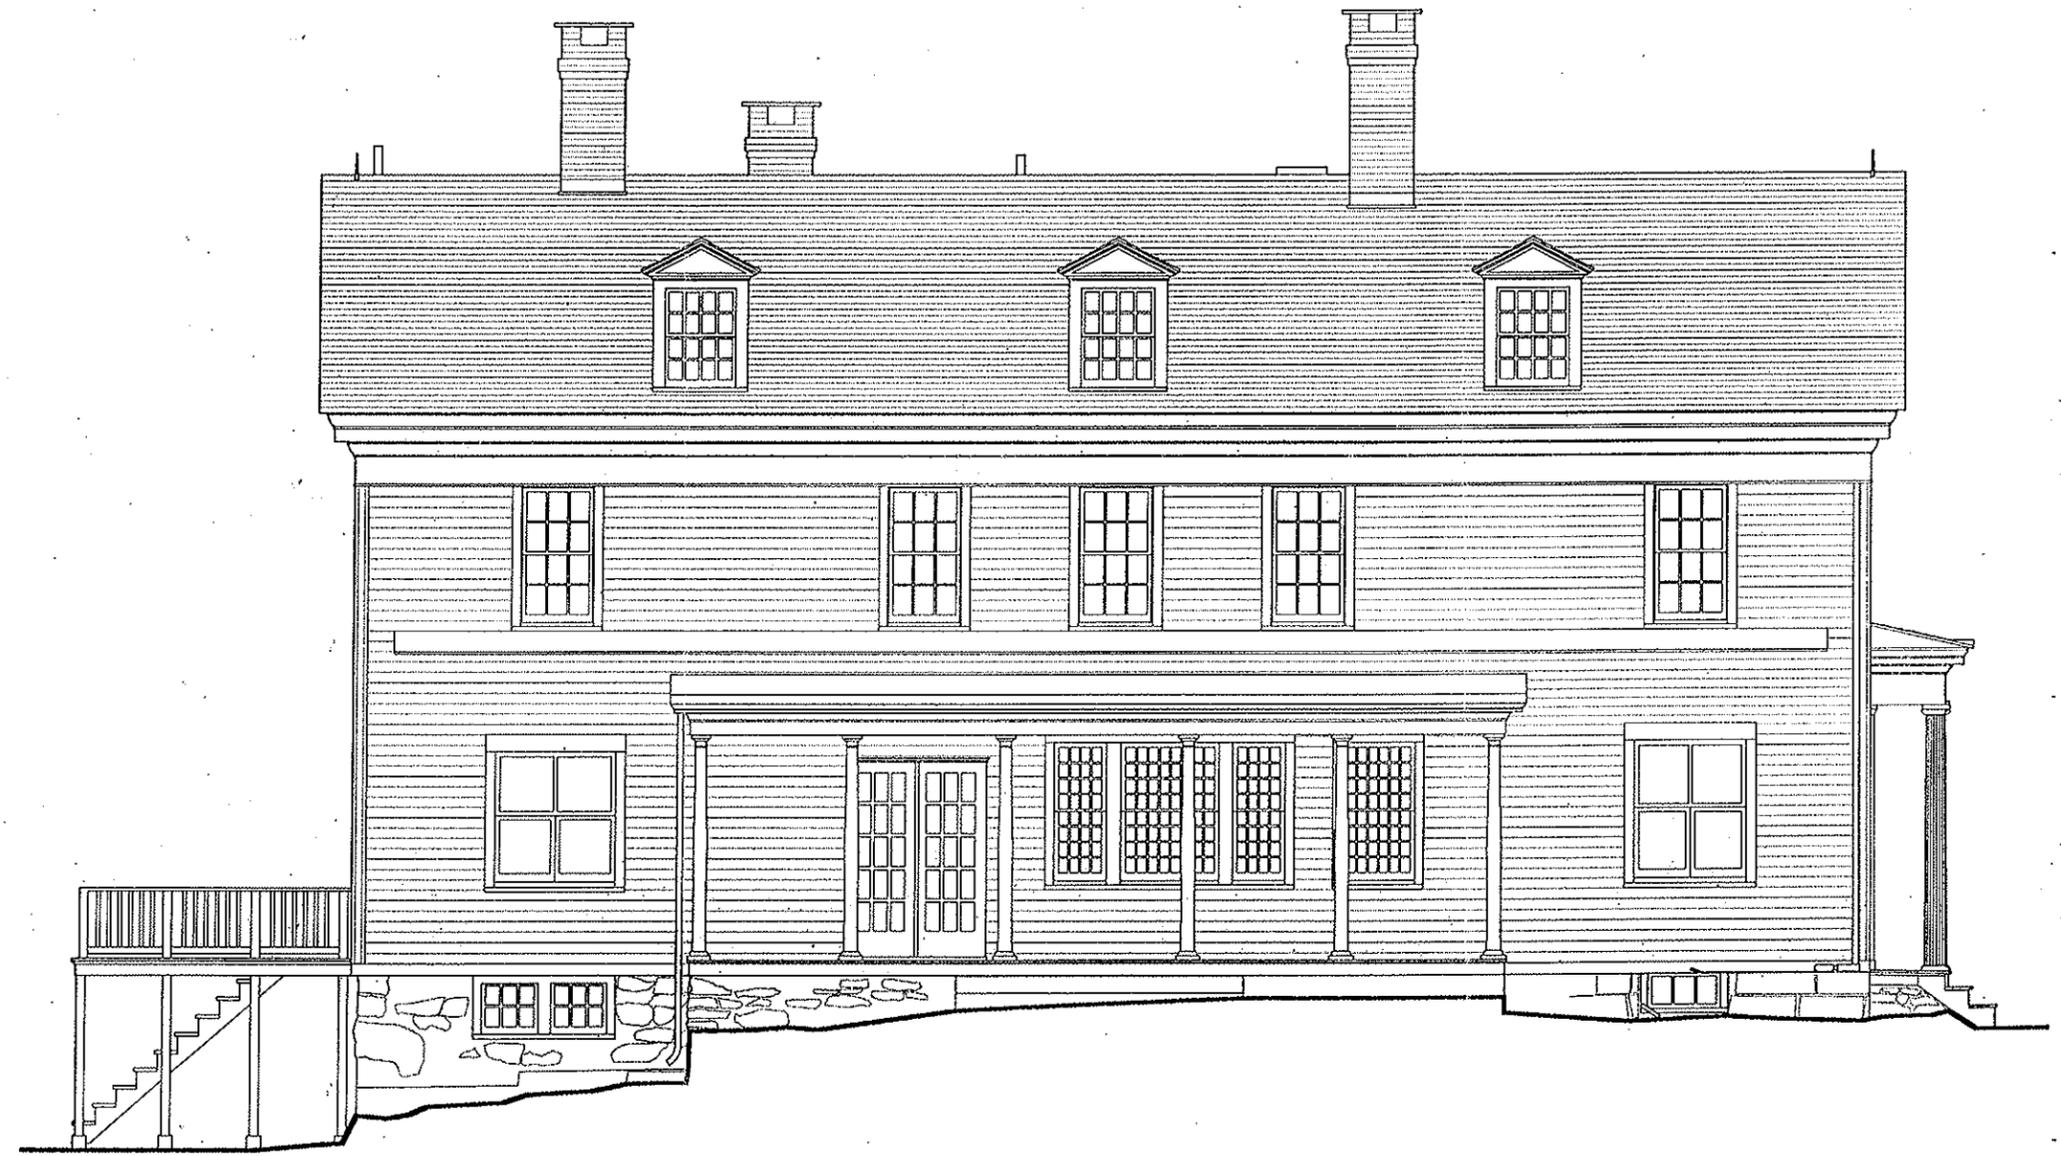
South Elevation

9'10" 54'4.5" 2'9"

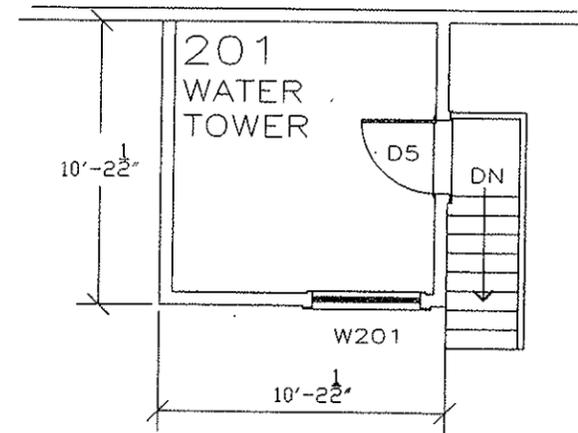
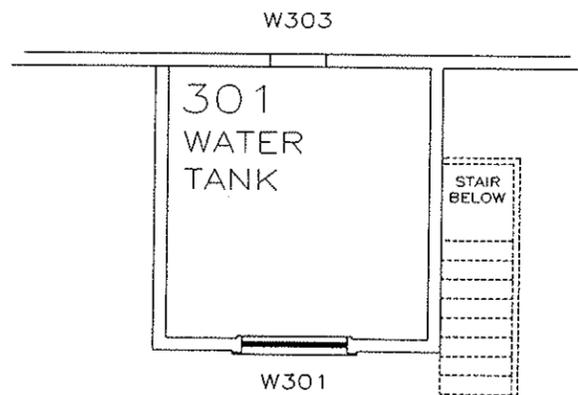
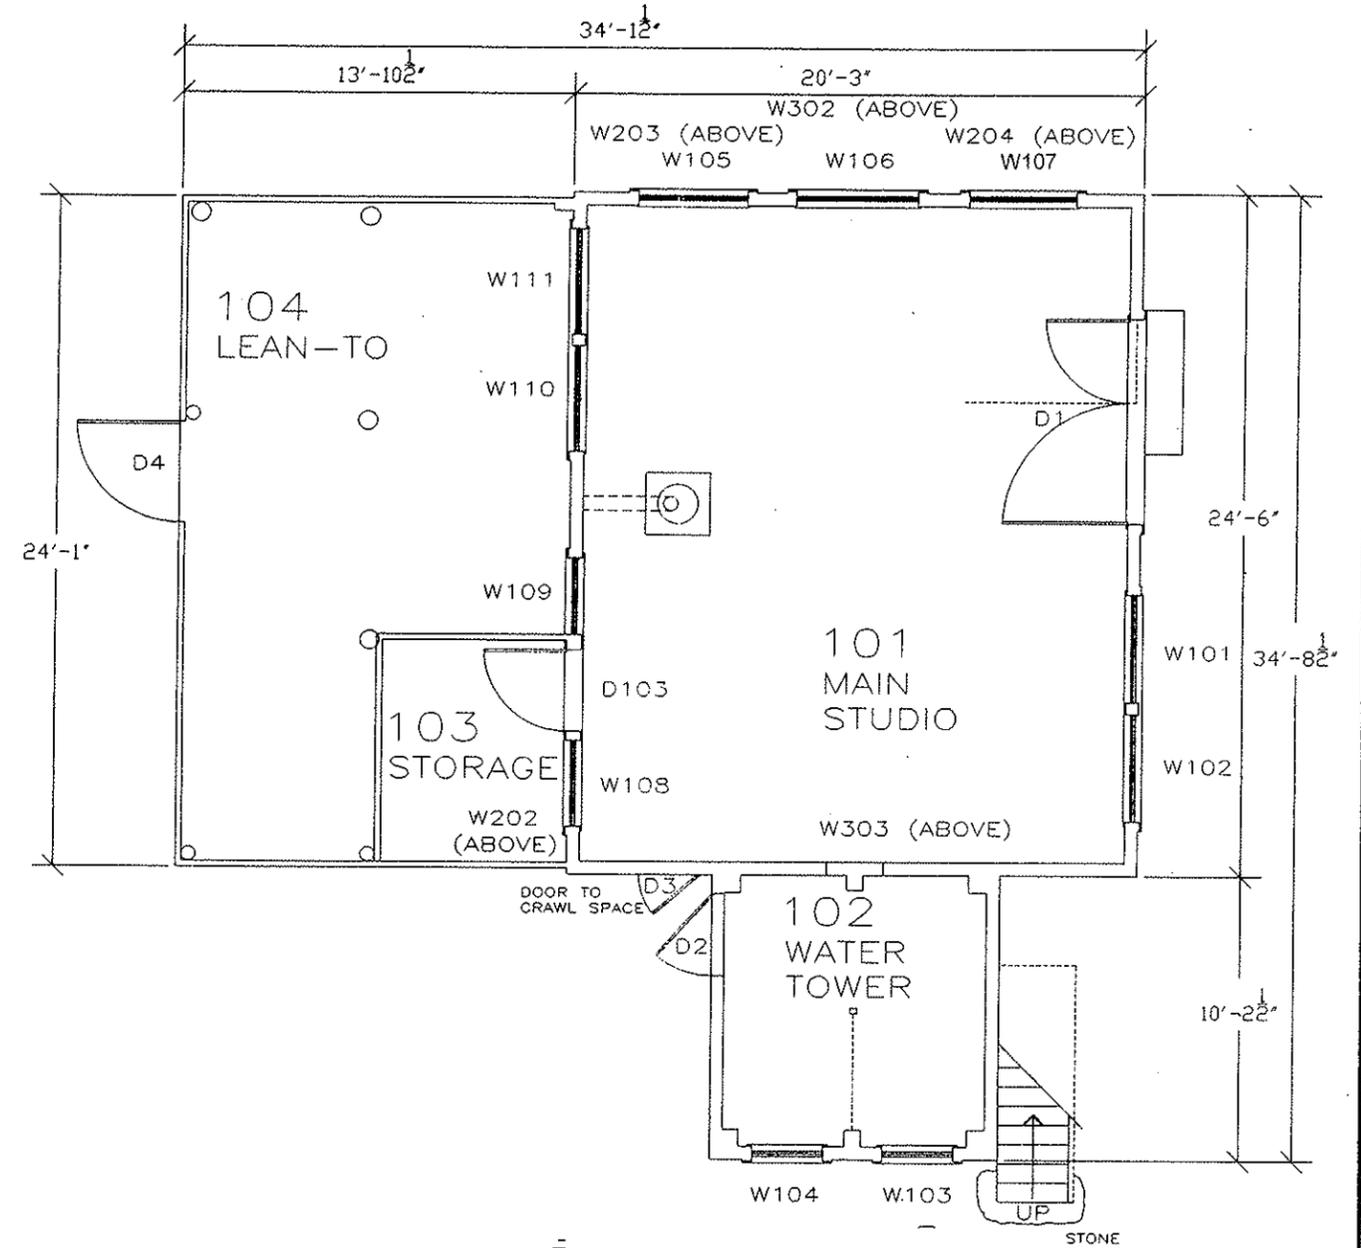
Water Tower:
2nd & 3rd Floor Plan

First Floor Plan

FLOOR PLANS BASED ON FIELD NOTES PROVIDED BY R. CRISSON & C. MCCOY, BCB/CRC
DRAWN BY: BUILDING CONSERVATION BRANCH/ CULTURAL RESOURCES CENTER, NESSO, 8/95

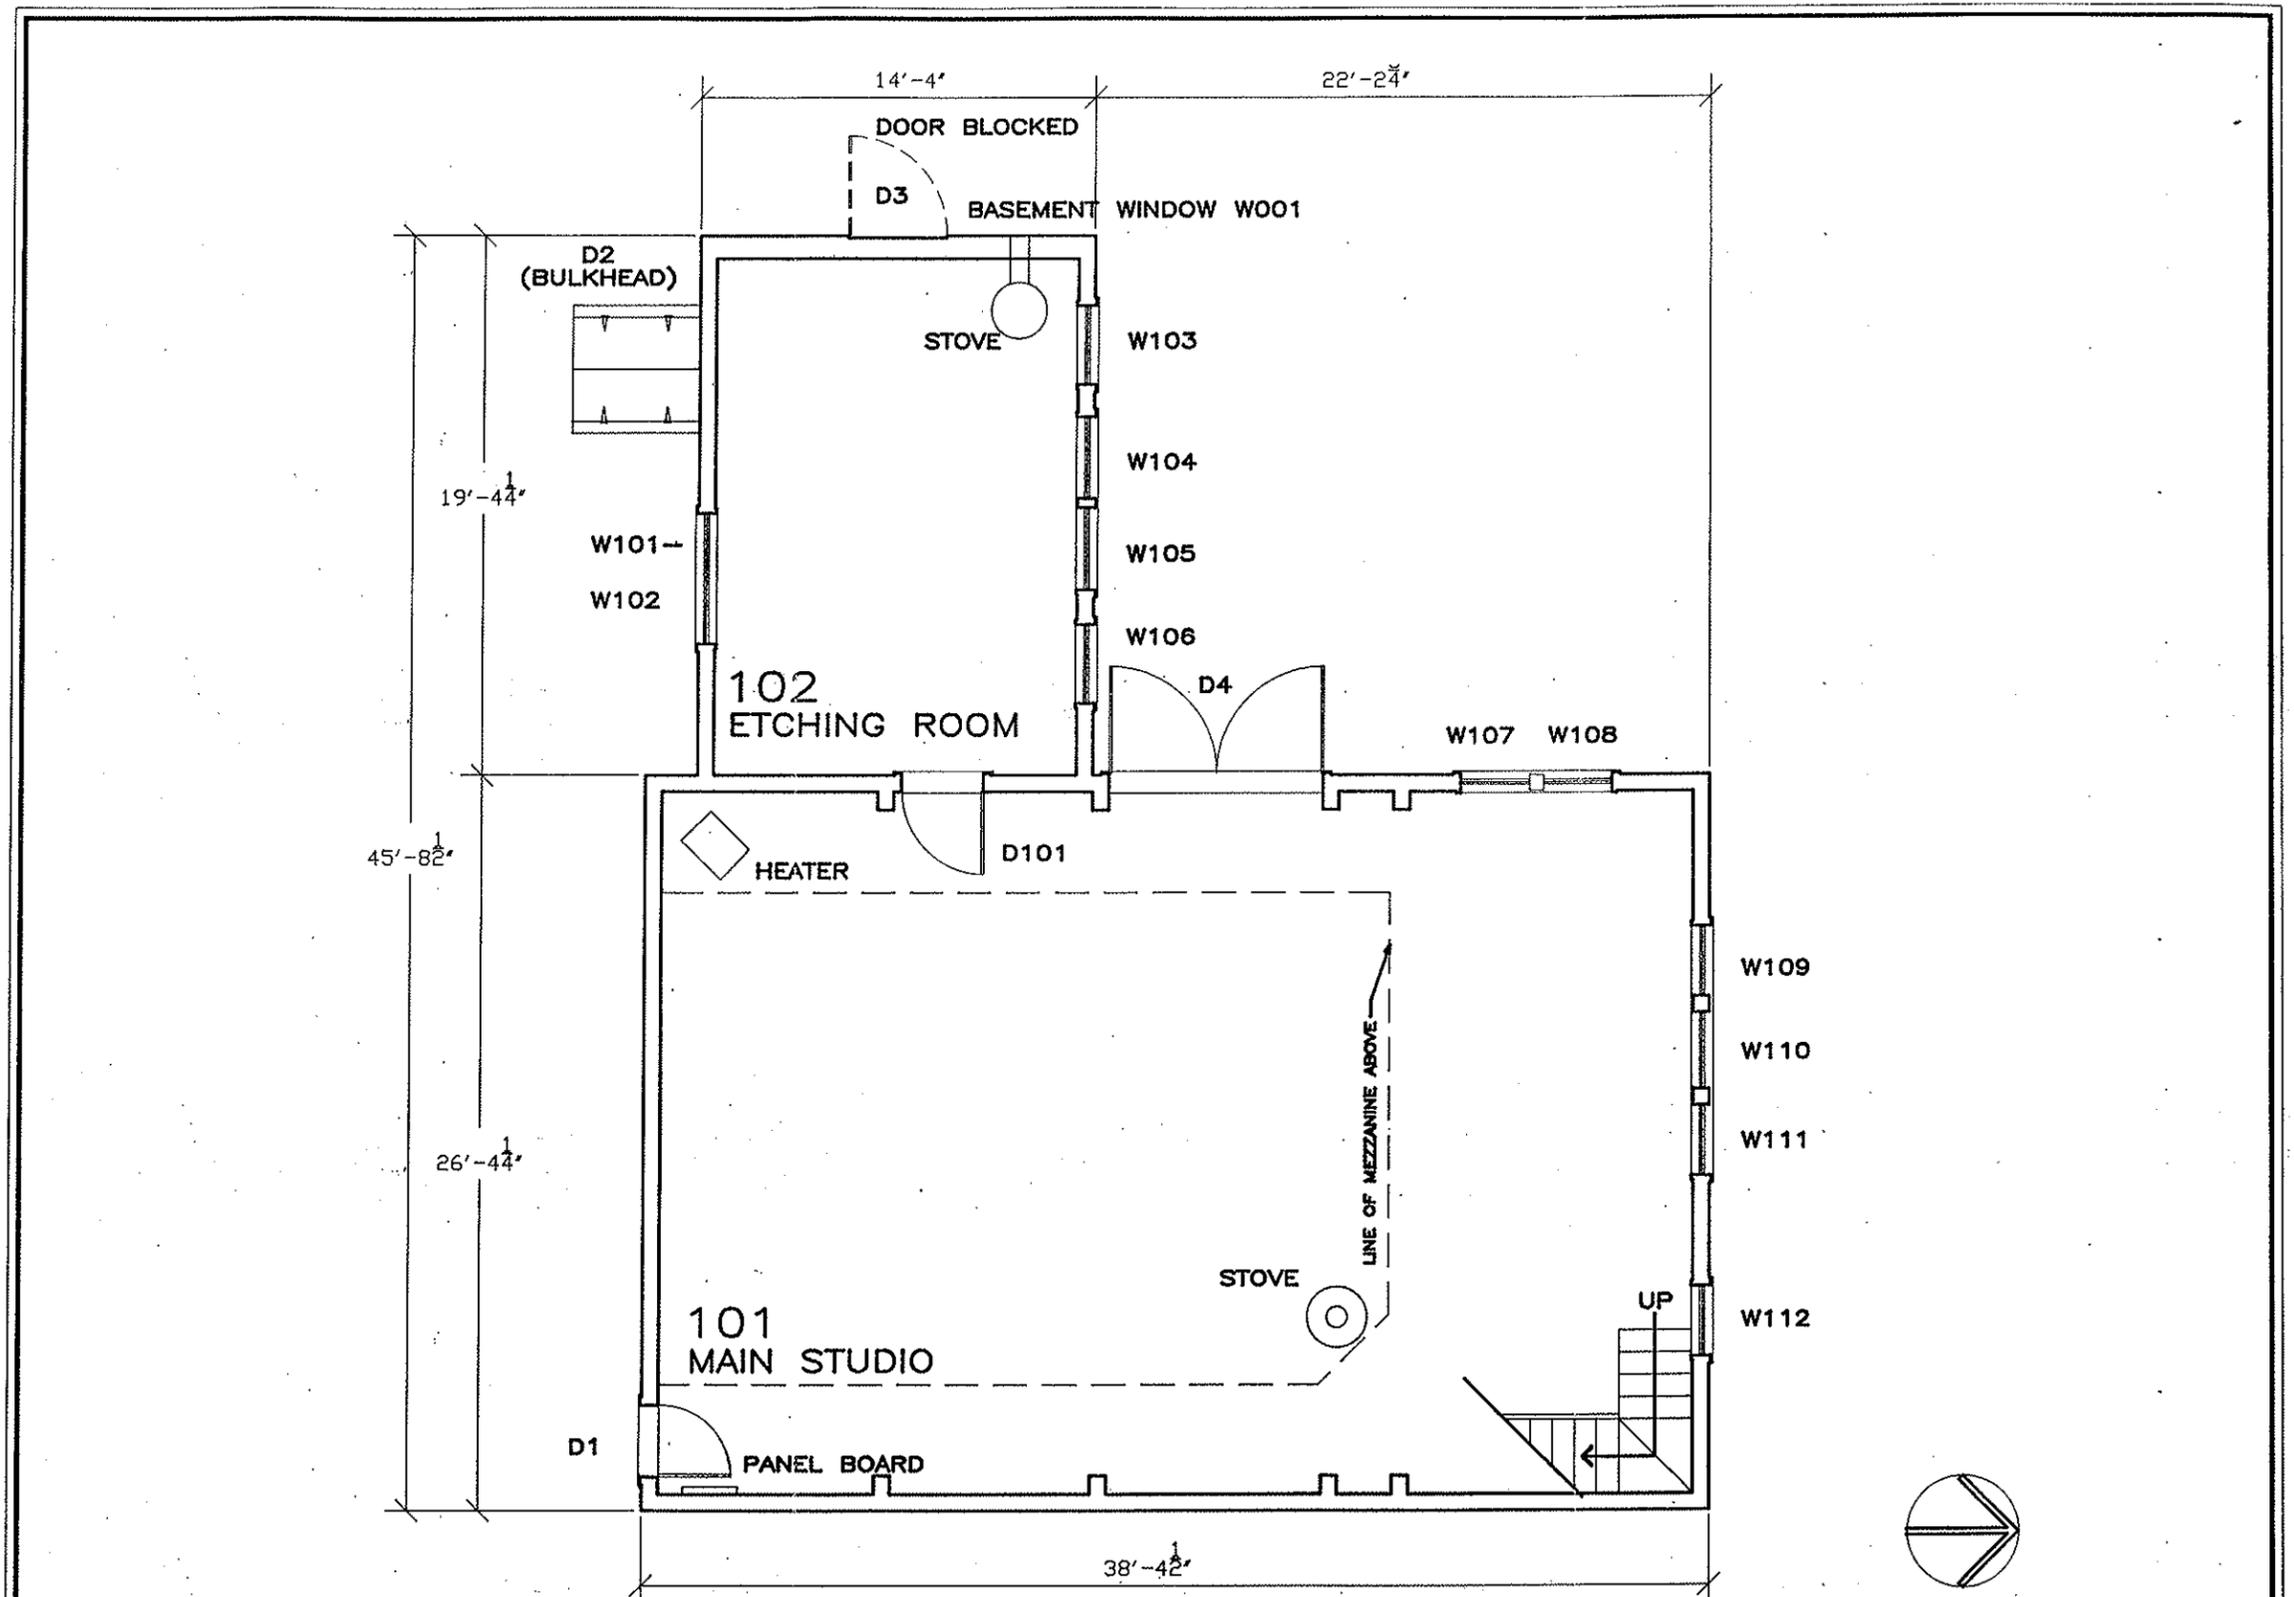
First Floor Plan

FLOOR PLAN BASED ON FIELD NOTES PROVIDED BY R. CRISSON & C. MCCOY, BCB/CRC
 DRAWN BY: BUILDING CONSERVATION BRANCH/CULTURAL RESOURCES CENTER, NESSO, 6/95

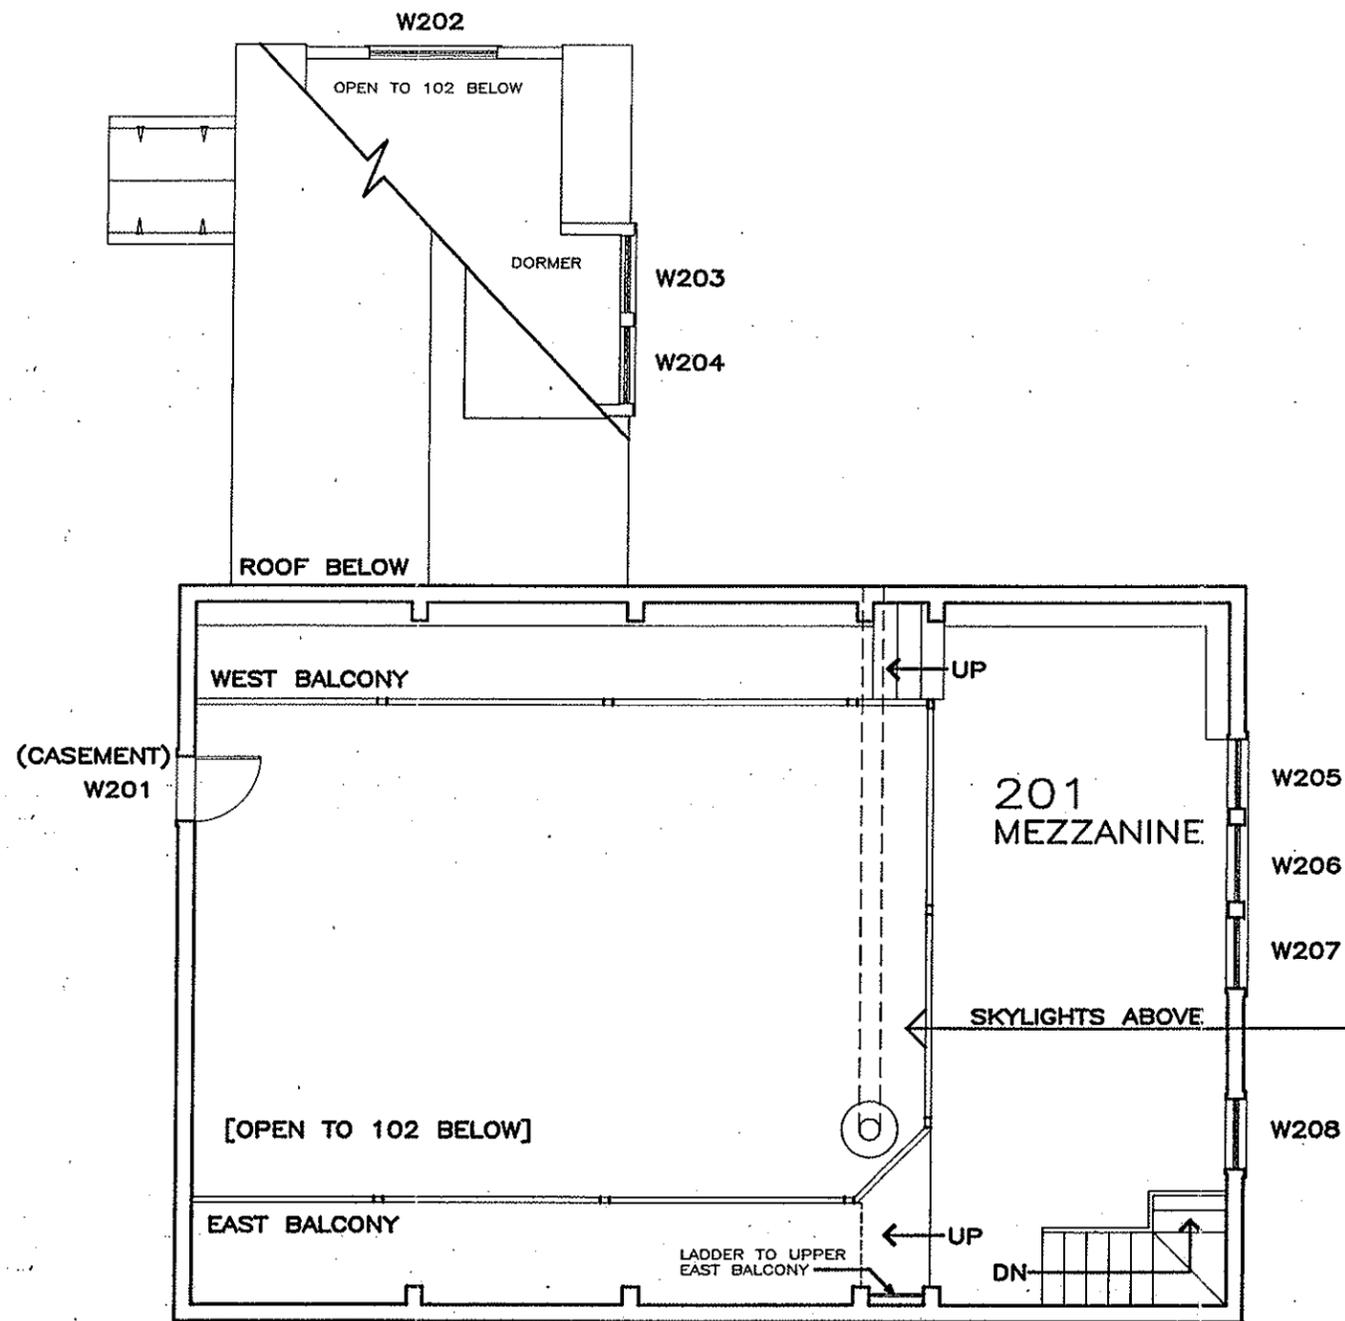
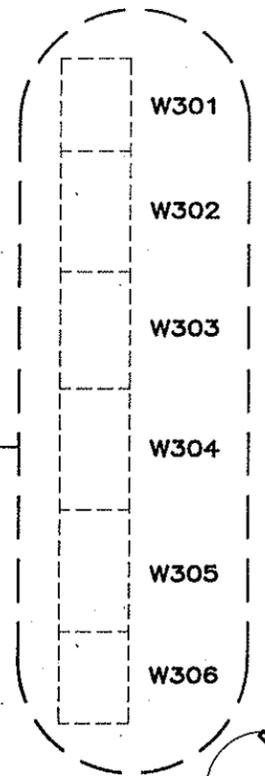
Second Floor Plan

FLOOR PLAN BASED ON FIELD NOTES PROVIDED BY R. CRISSON & C. MCCOY, BOB/CRC
 DRAWN BY: BUILDING CONSERVATION BRANCH/CULTURAL RESOURCES CENTER, NESSO, 6/95

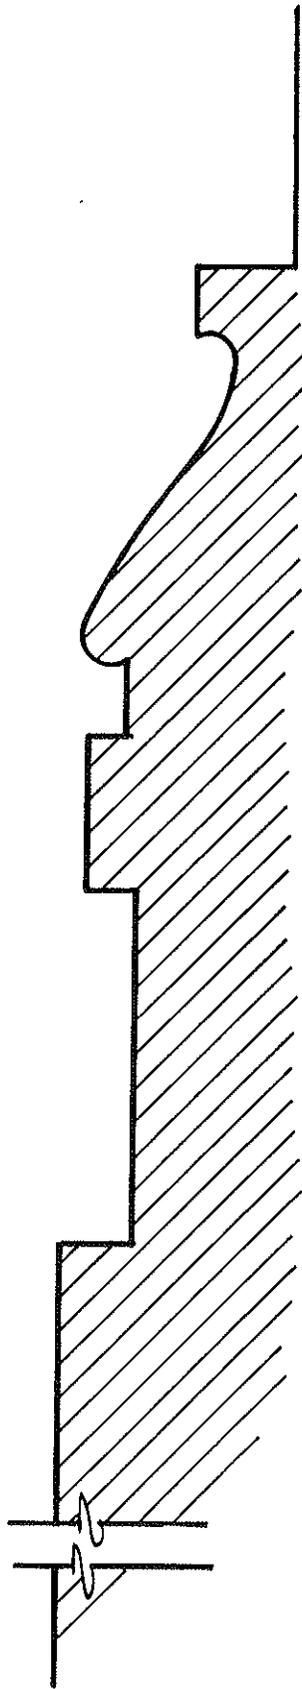
Baseboard Profile
Type BB-A

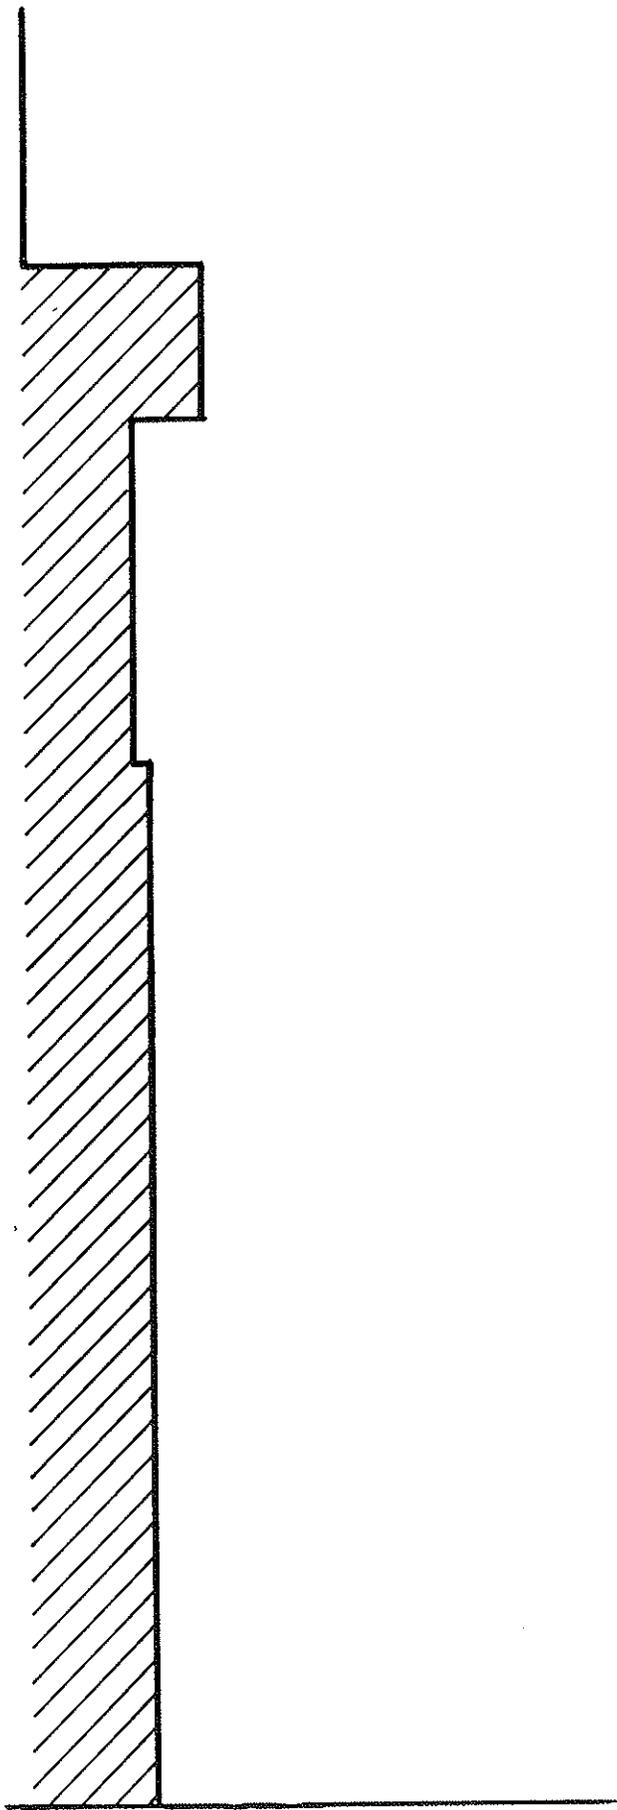
Baseboard Profile
Type BB-C

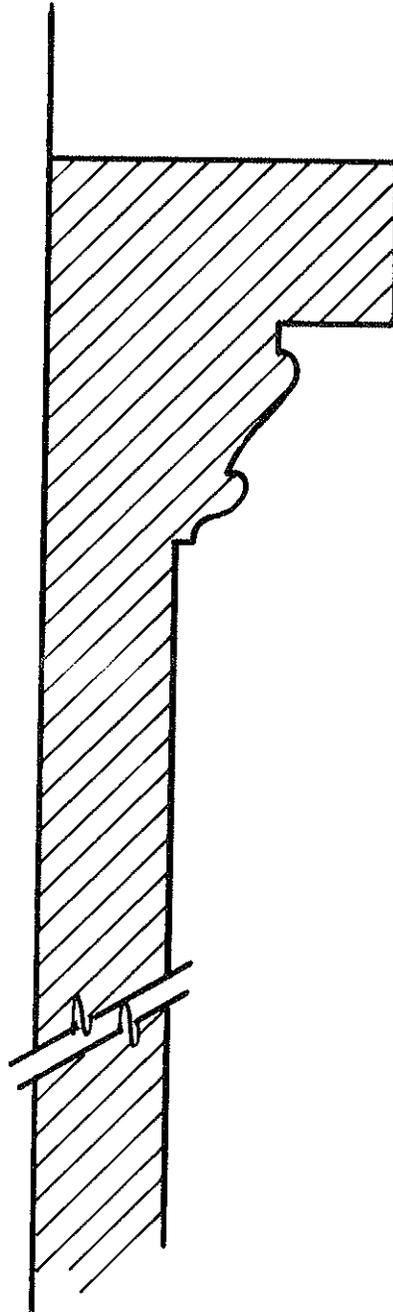
**Wainscot and Chairrail
Profile Type WC-A**

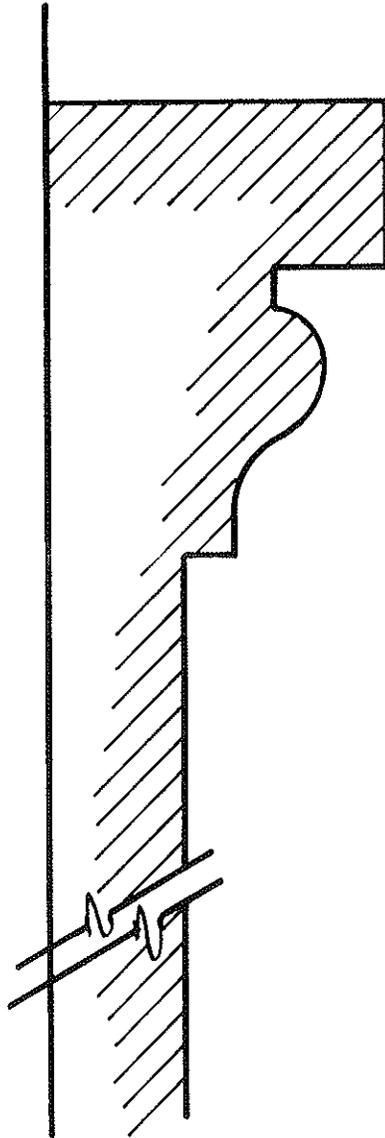
**Wainscot and Chairrail
Profile Type WC-B**

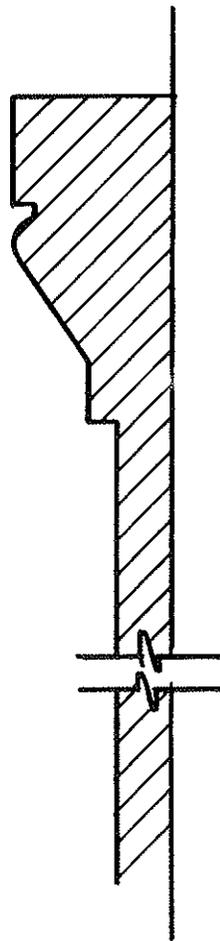
Corner Board
Profile Type CB-A

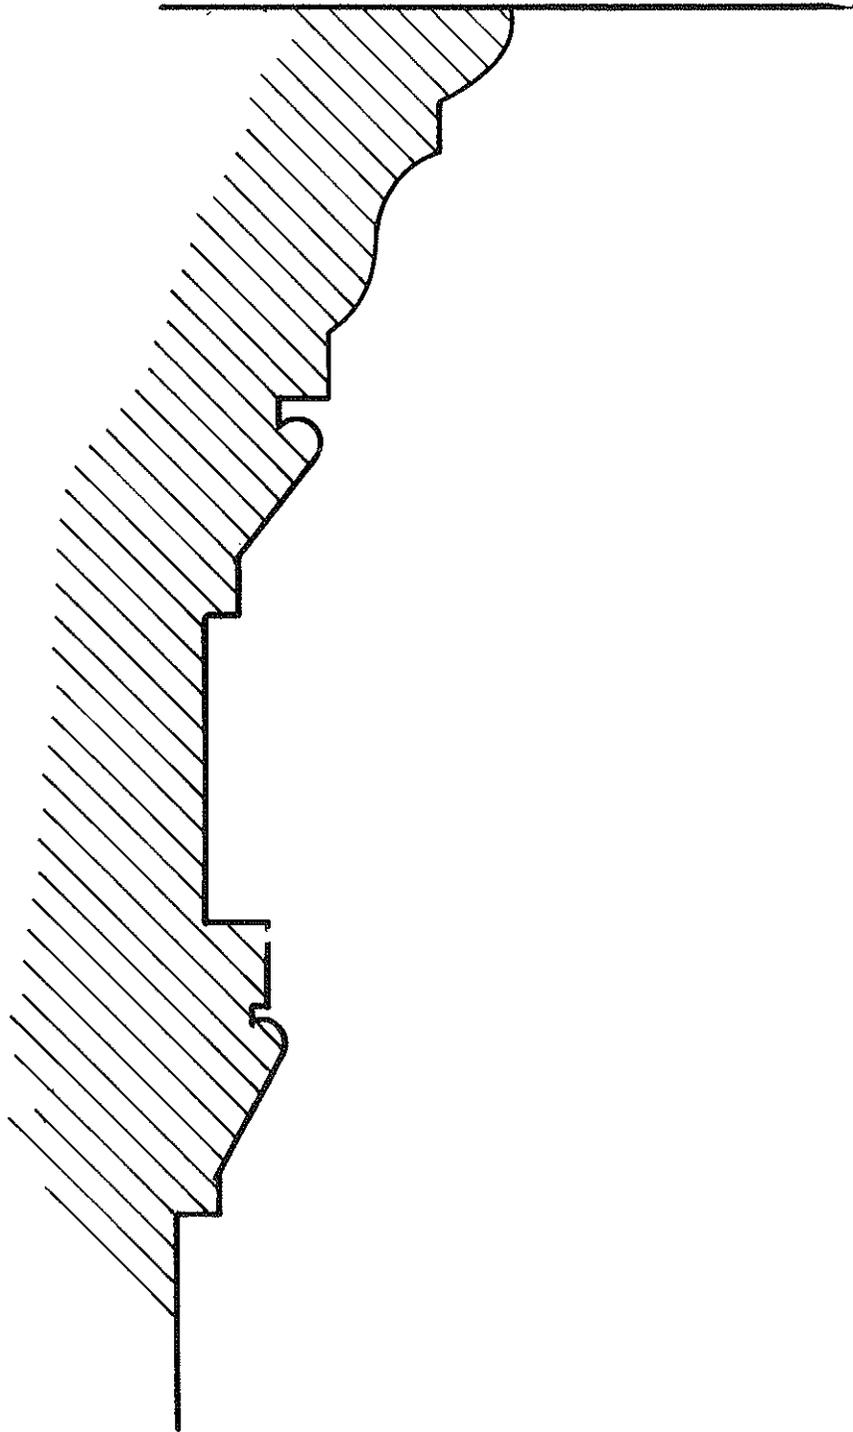
Crown Molding - Room 101
Profile Type CM-A

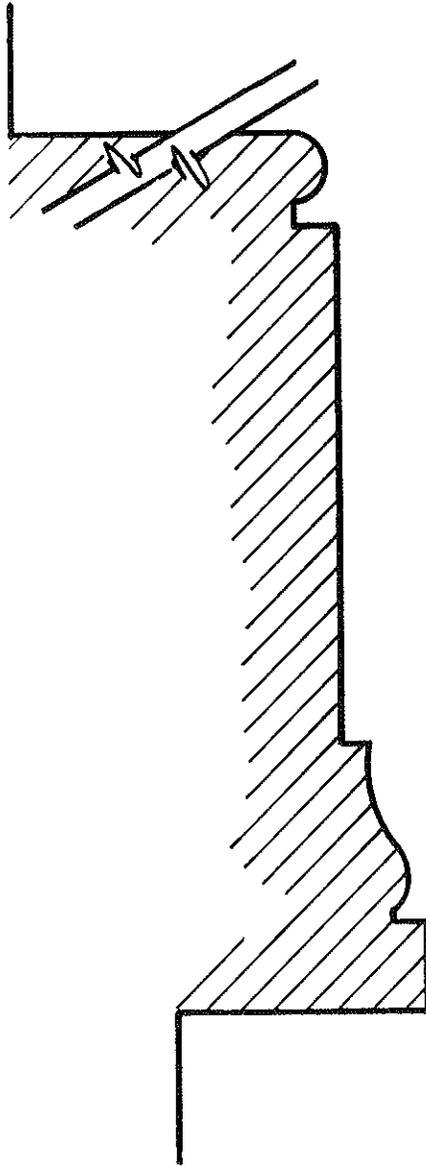
**Doorway Surround
Profile Type DF-A**

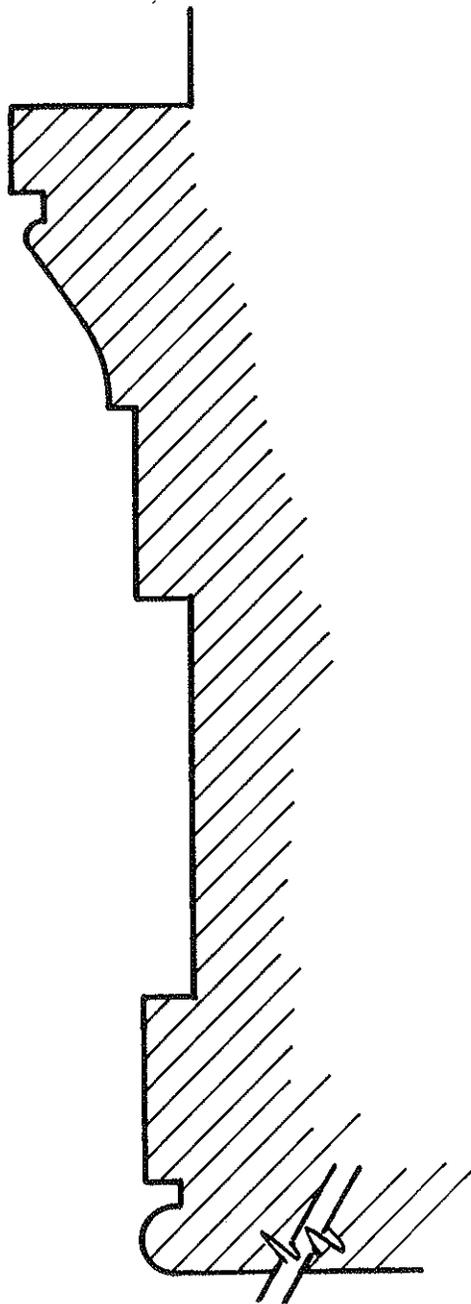
**Doorway Surround
Profile Type DF-B**

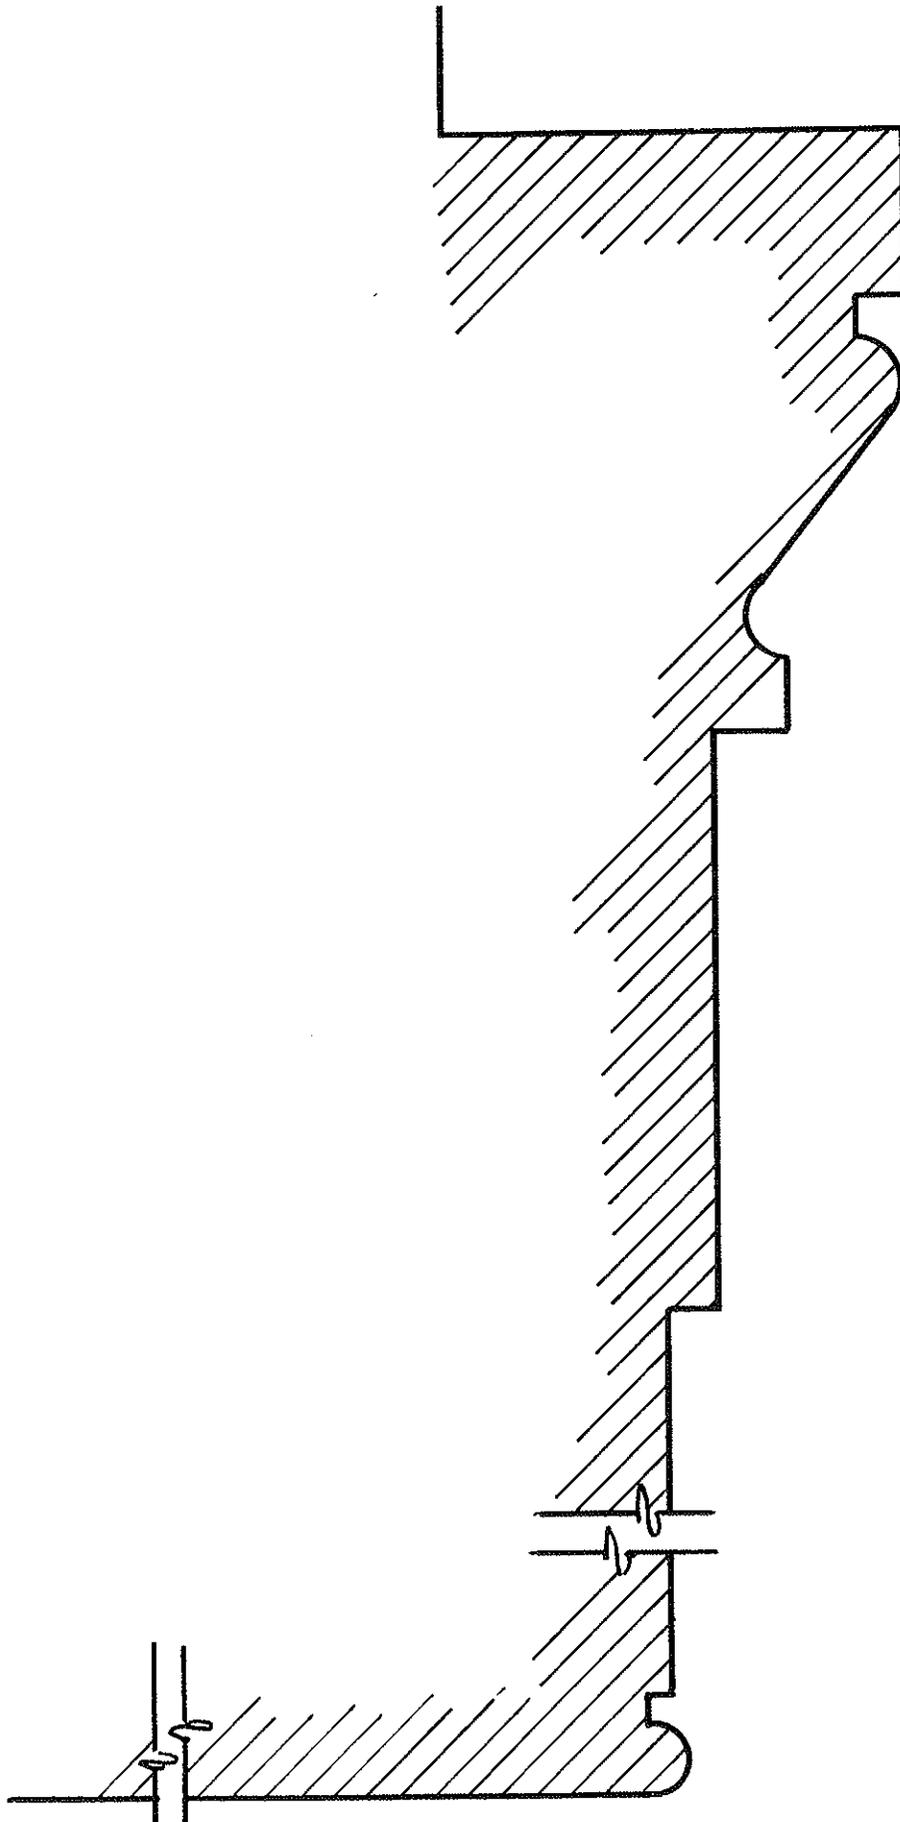
Doorway Surround
Profile Type DF-C

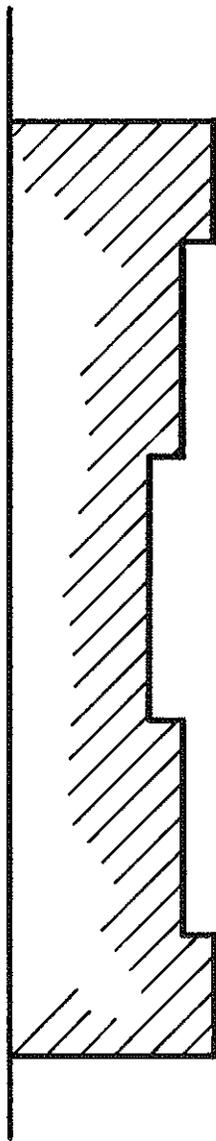
**Doorway Surround
Profile Type DF-D**

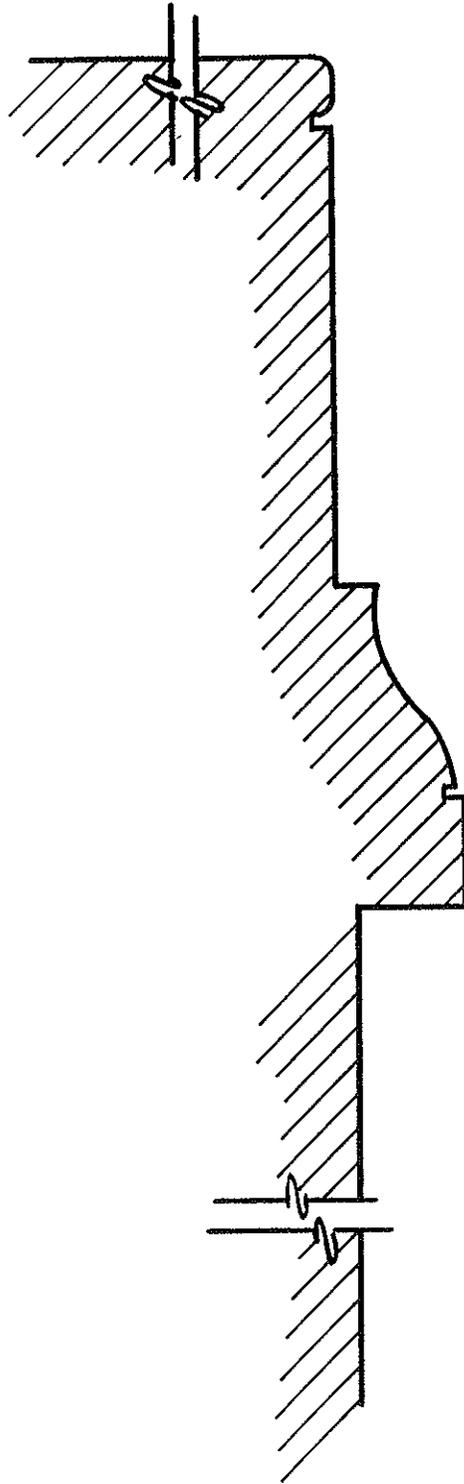
**Doorway Surround
Profile Type DF-E**

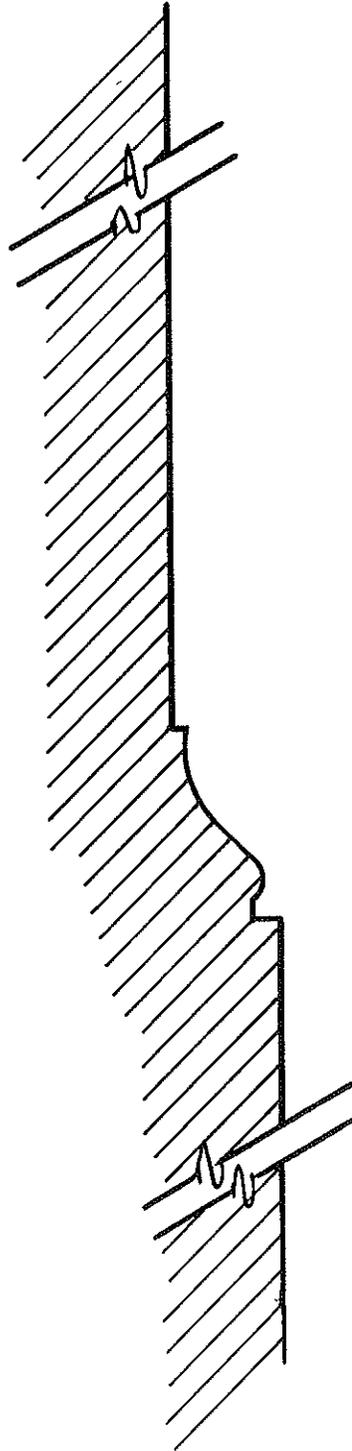
**Door Panel - Interior
Profile Type DP-A**

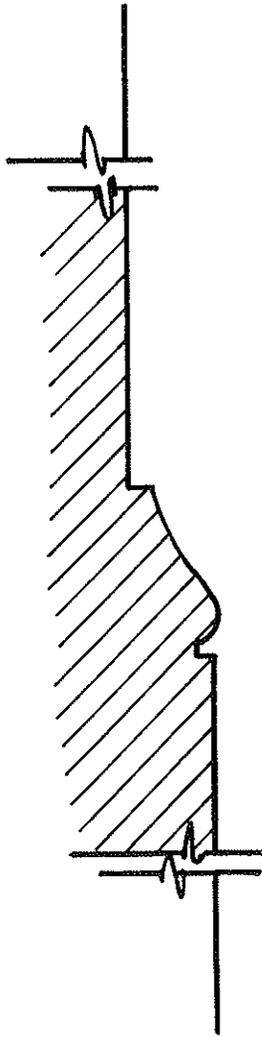
**Door Panel - Interior
Profile Type DP-B**

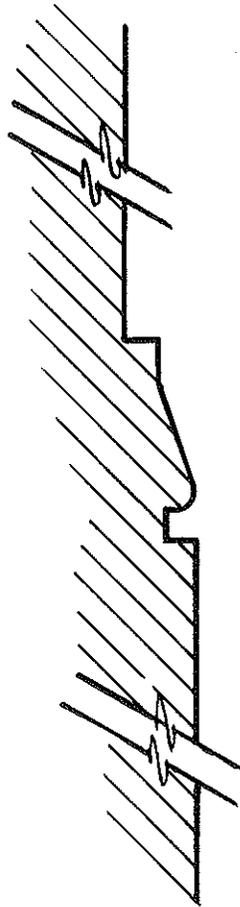
**Door Panel - Interior
Profile Type DP-C**

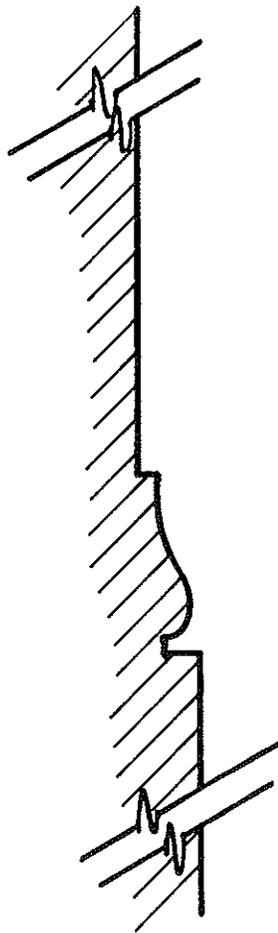
**Door Panel - Interior
Profile Type DP-D**

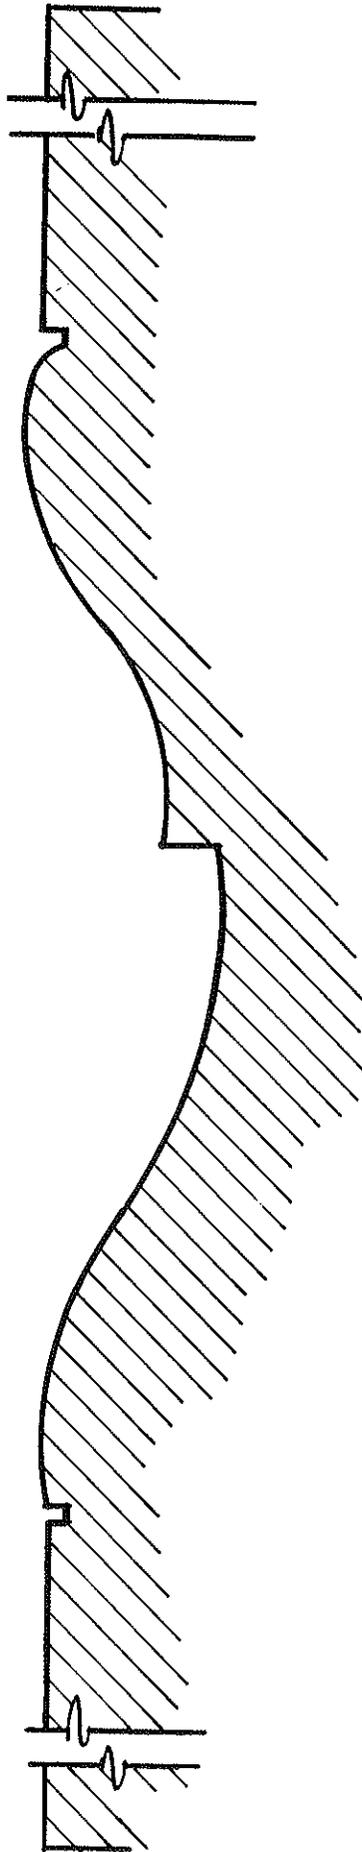
Exterior
Door Panel

Profile Type DP1-A

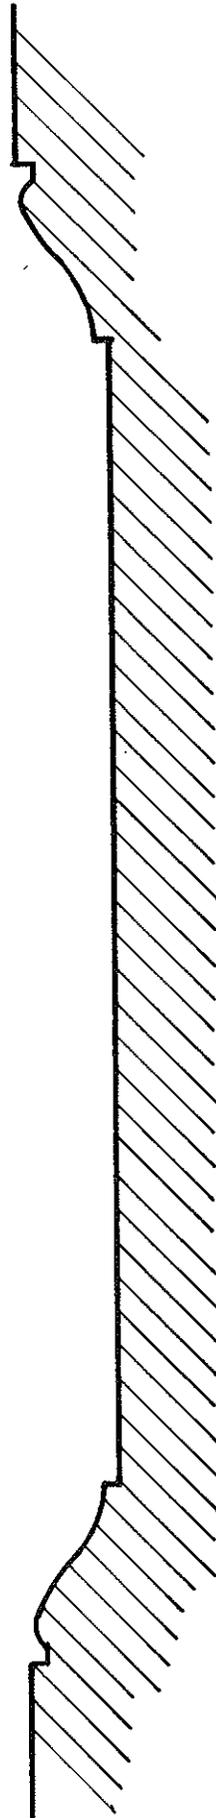
**Exterior
Door Panel**

Door Panel Profile Type DP2-A

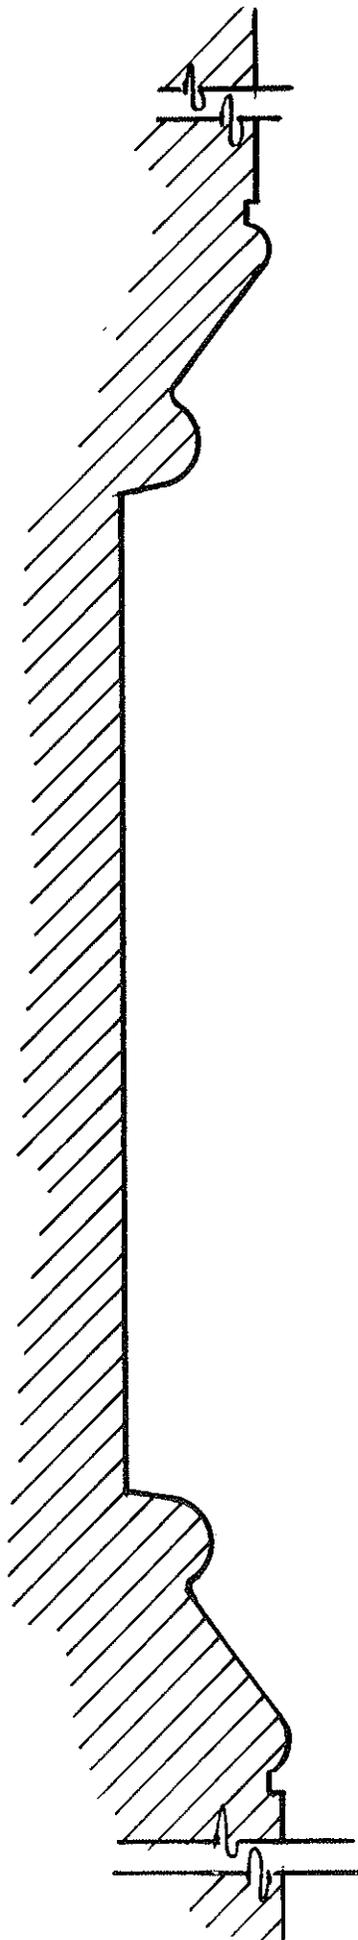
**Exterior
Door Panel**

**Door Panel
Profile Type DP4-A**

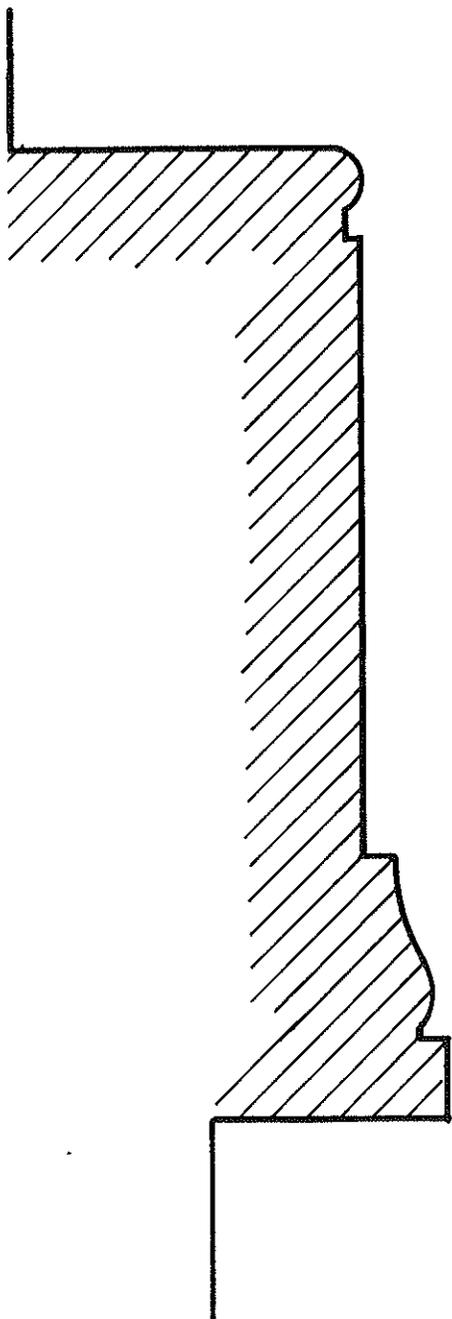
**Window Surround
Profile Type WF-A**

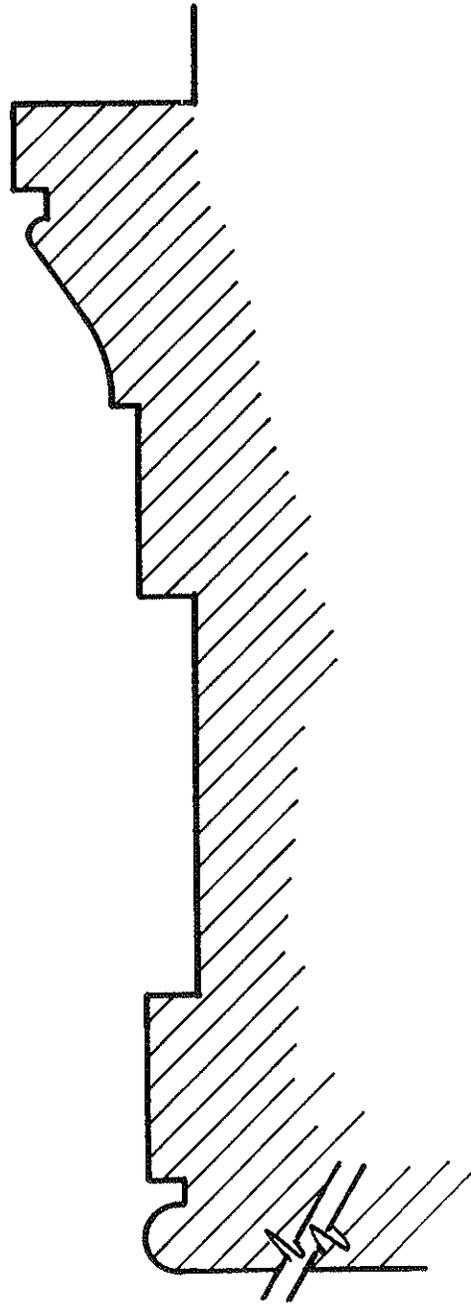
**Window Surround
Profile Type WF-B**

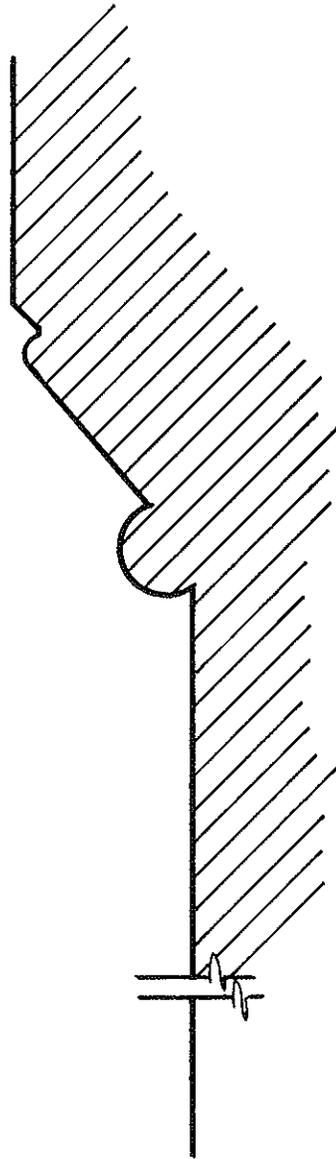
**Window Apron
Profile Type WA-A**
