**WEIR FARM
HISTORIC STRUCTURES REPORT**

**Weir Farm National Historic Site
Wilton, Connecticut**

**VOLUME I
The Site and the Weir Complex**

APPENDICES

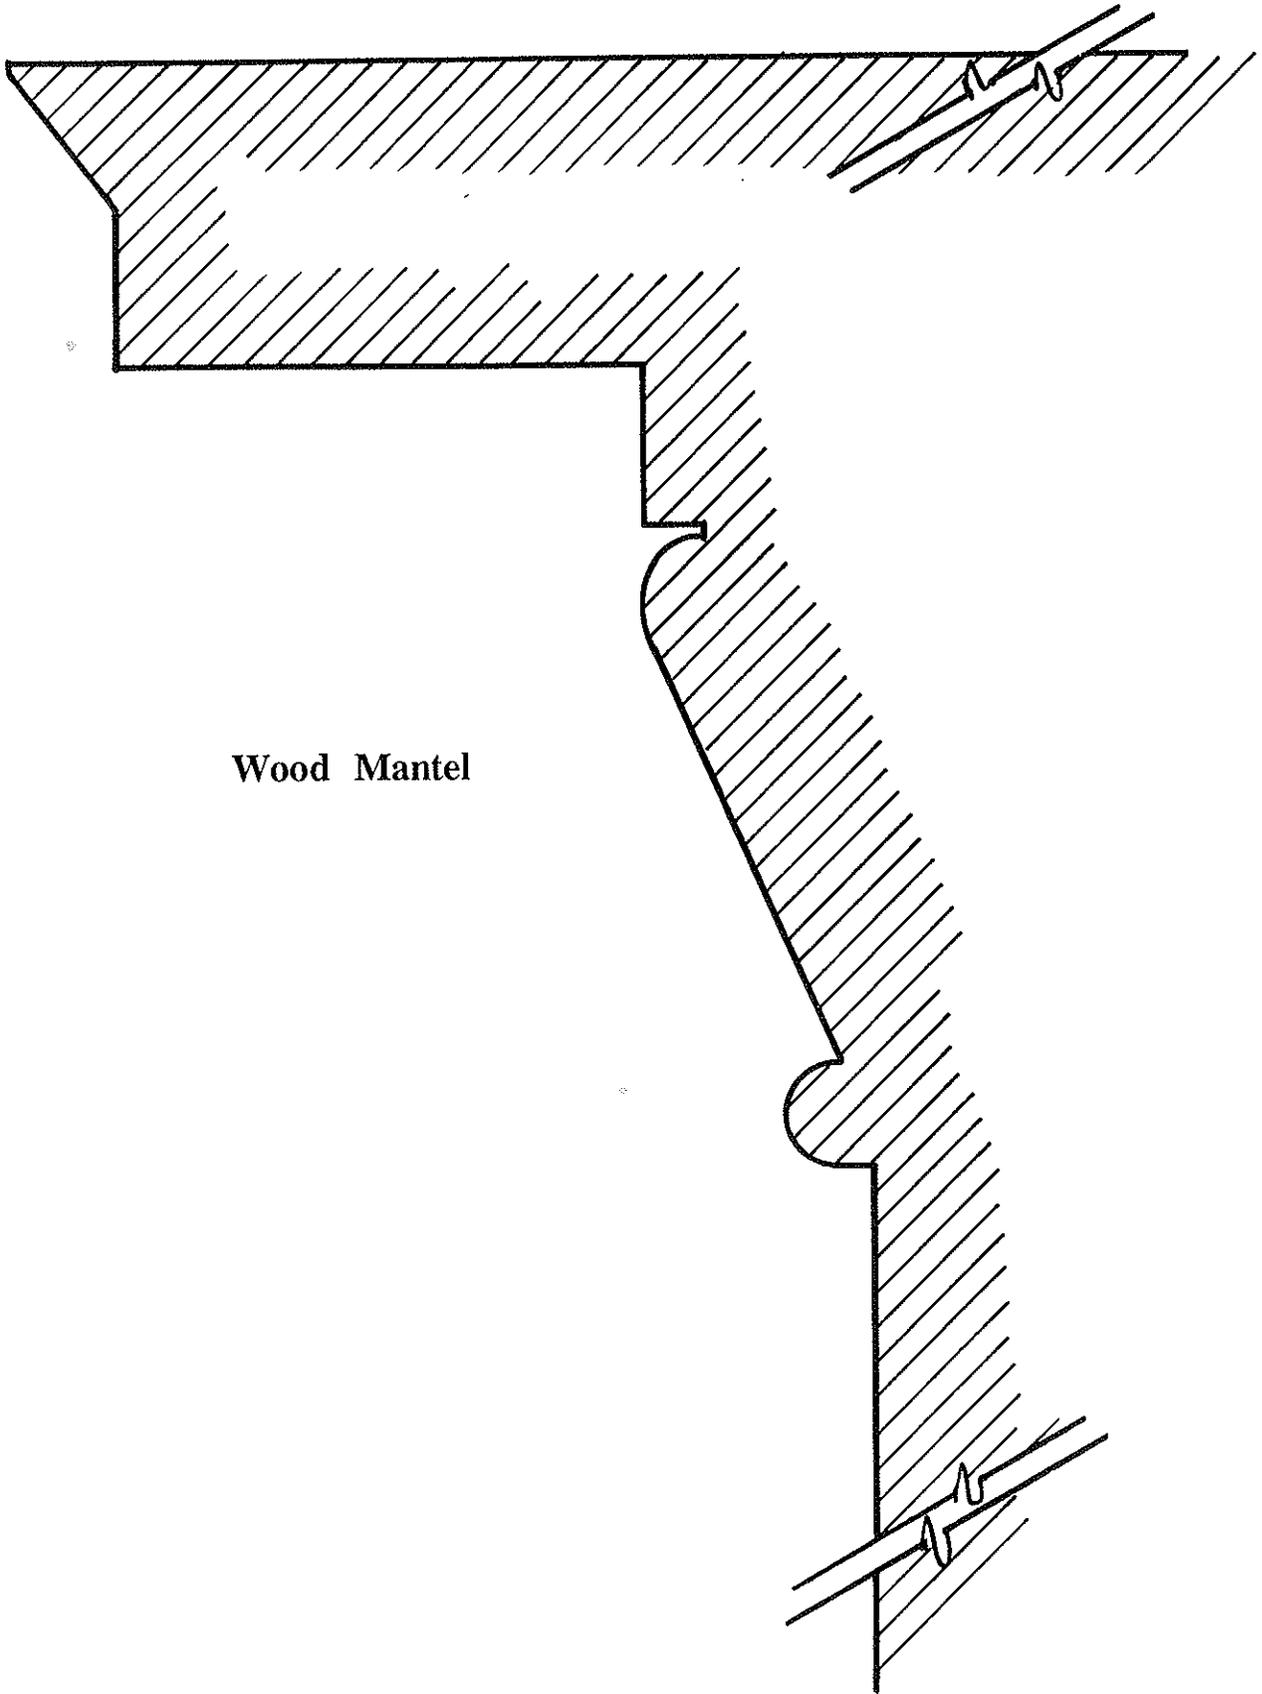
Wood Mantel

Profile Type FM-A (Upper)

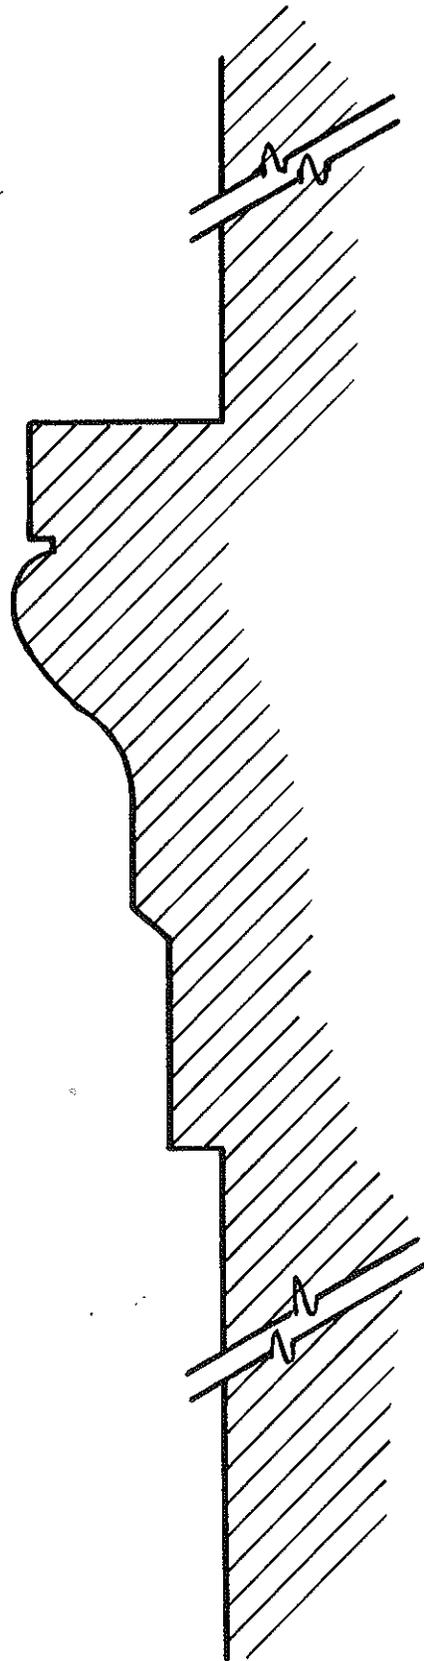
Wood Mantel

Profile Type FM-A (Lower)

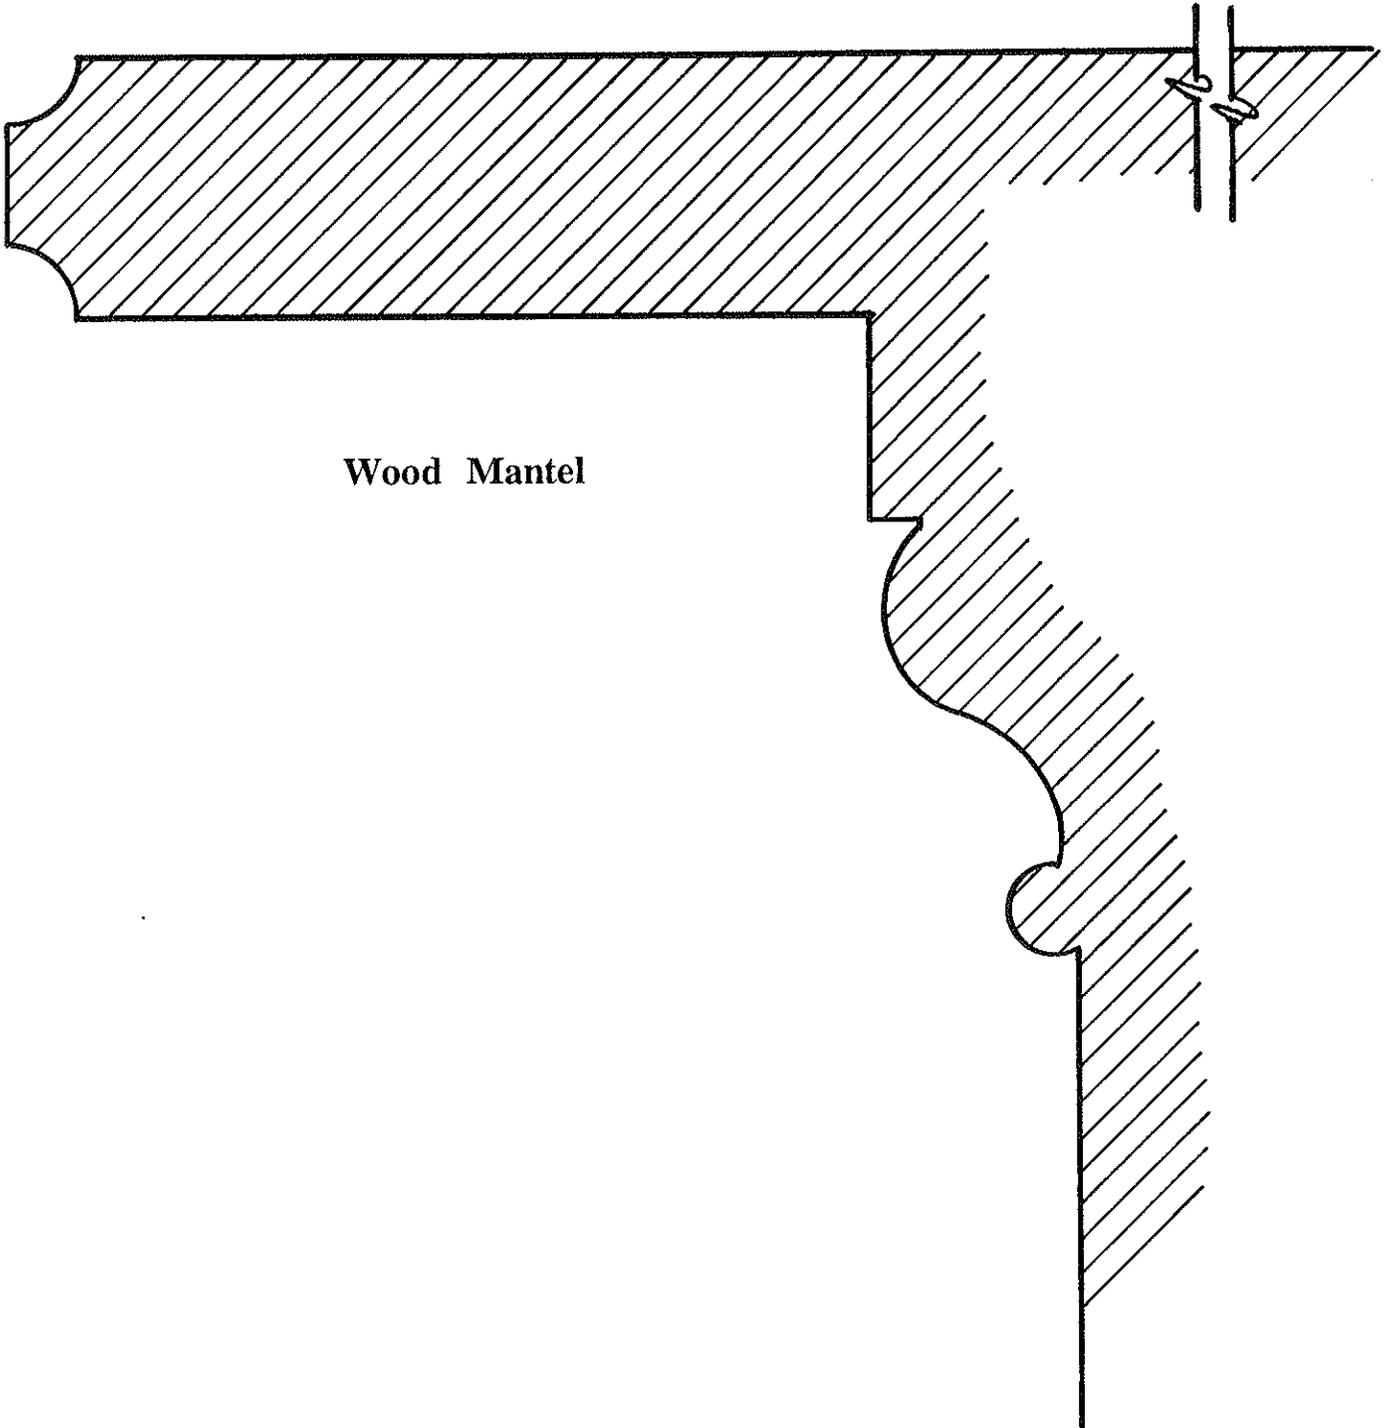
Wood Mantel

Profile Type FM-B (Lower)

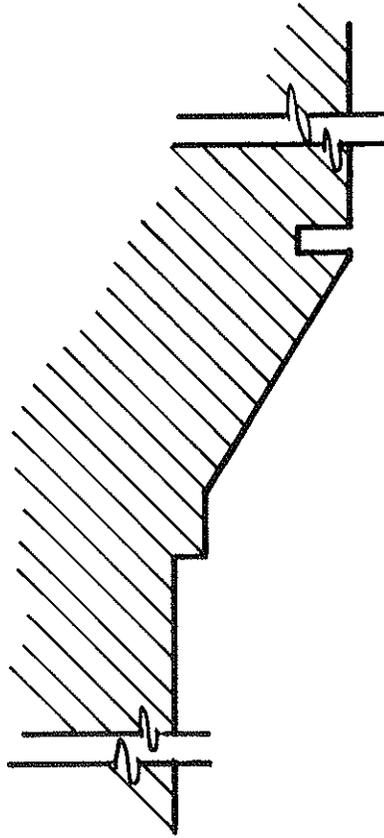
**Wood Mantel
Profile Type FM-C**
