**WEIR FARM HISTORIC STRUCTURES REPORT
VOLUME I**

**Weir Farm National Historic Site
Wilton, Connecticut**

The Site and the Weir Complex

Building Conservation Branch
Northeast Cultural Resources Center
National Park Service, U.S. Department of the Interior
Lowell, Massachusetts

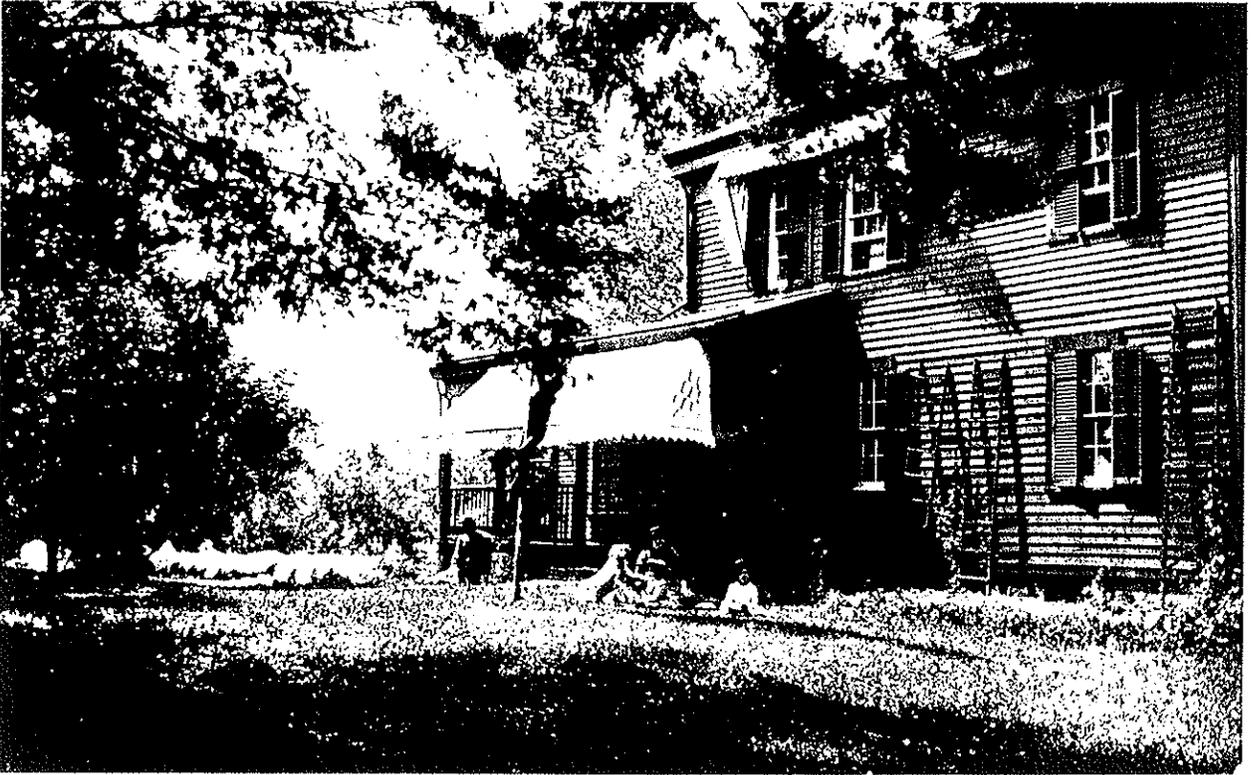
Figure 17. Weir House - South Porch (Circa 1888).

The west addition that the Weirs made to the house in 1888 is visible in historic photographs of the house. In **figure 17** it can be seen that the south porch has been extended to the west and now has an additional column. The photograph also shows that the awning is now too short for the south side of the porch roof. Upon close examination of the photograph, it can be seen that the west window on the south wall has been replaced by the south entry doorway and a new window installed to the west of the new door. A portion of the new addition is visible in the background. Laundry is hanging out to dry on the west lawn, indicating a laundry room was on the west side of the house. In a Weir painting, *The Laundry, Branchville, 1894*, the one-story west addition is visible, and the west lawn is depicted as the laundry yard (**fig. 18**).

The first floor of the 1888 house is most clearly depicted in the Platt 1900 first floor plan, where old construction is indicated by dotted lines (see **APPENDIX A**), and in **figure 17**, which shows that the doorway on the south facade has been moved westward. This change created a one-story entry foyer that led east to the parlor. A doorway in the north wall of the parlor opened to a central hallway, in which two doorways opened to the dining room to the north and to cellar stairs and to the kitchen area to the west. The new west entry, the central hallway, the kitchen, and the north end of the dining room were all one story high. The kitchen was a long room with two small rooms (possibly a pantry and a breakfast room) at the south end; the southeast room opened to the west side of the wrap-around porch. Under the one-story kitchen wing was the laundry, which had a high foundation due to the westward slope of the terrain. This room may have also functioned as a summer kitchen as well. The east side of the house appears to have been unchanged. The circa-1830 staircase on the south wall of the front entry hall that led to the second floor can be seen through the easternmost window in **figure 17**.

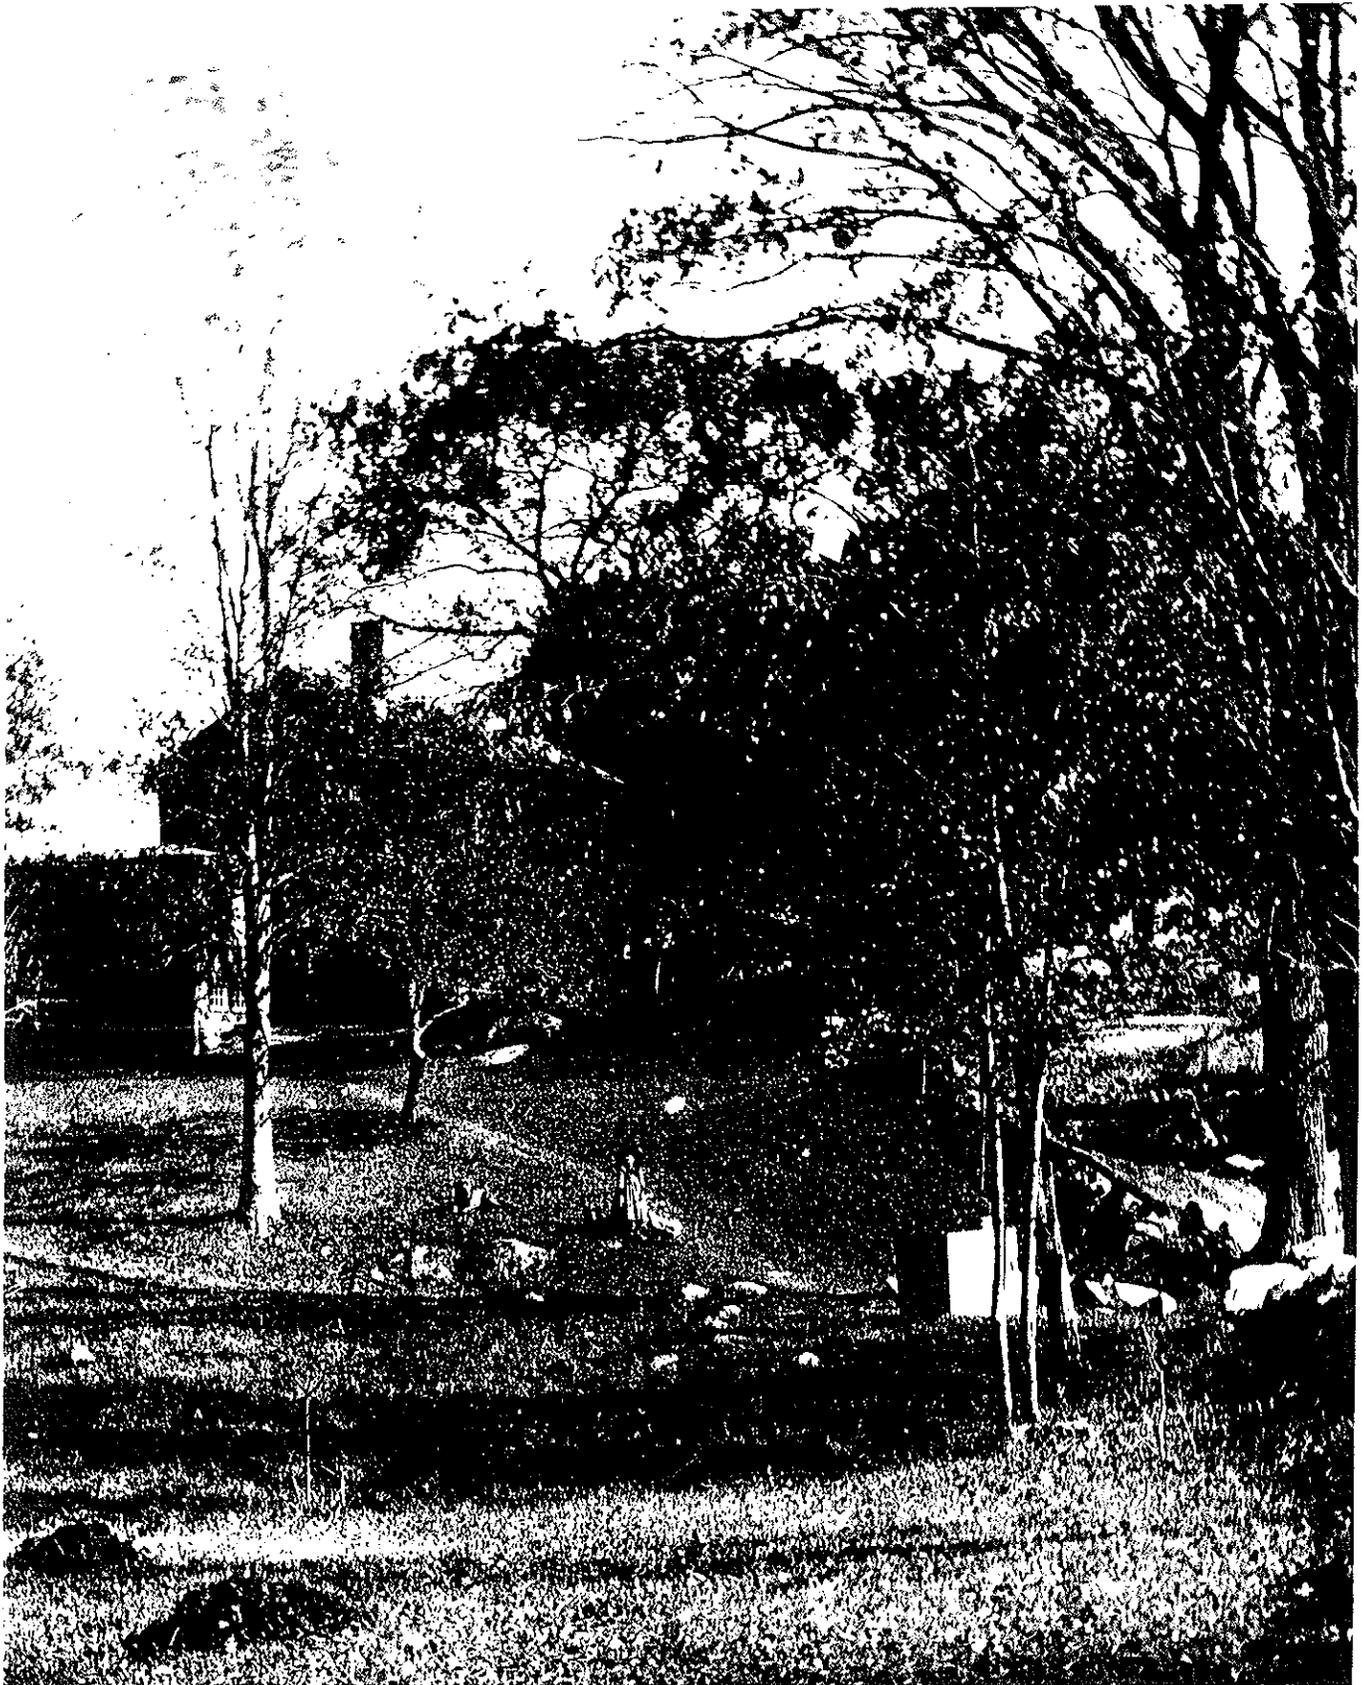
Figure 20. Weir House - West Side of House and Lawn, Looking Northeast (After 1888).

of the house after the 1888 addition was completed (**fig. 20**). A corridor was thus formed (Room 007) and a door was added at the west (see **fig. 18**), from which laundry could be carried out. This resulted in three doors in regular succession connecting the basement rooms from east to west. These are board and batten doors whose paint and hardware indicate that they are the original doors in these locations.

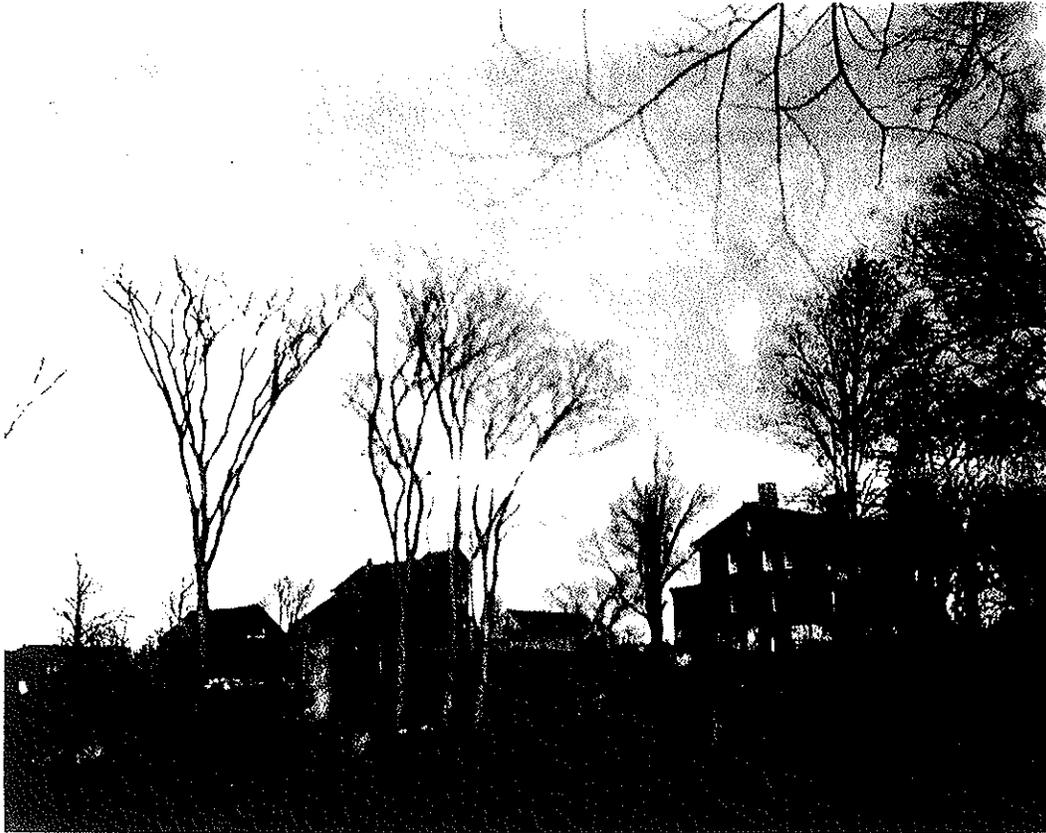
Figure 21. Weir Complex - View from the Southwest (Circa 1901-1911).

The Weir house as it appeared after the 1900 alterations can be seen in a circa 1901-1911 photograph of the Weir complex (**fig. 21**). The 1900 alterations expanded the house westward to a total depth of 54 feet. The most dramatic change on the exterior was the Platt "signature," the colonnaded veranda on the **south facade**. By extending both the first and second stories westward, adding regularly-placed windows and dormers, and building the veranda in the center, a classical symmetry on the south facade was achieved. The south entry gained new prominence, highlighted by two large cast-iron finials that were placed on the top granite steps of the veranda (**fig. 22**). It was also probably at this time that Stanford White painted the epigram over the front (south) door mentioned above. The extant physical and documentary evidence indicates that the cross-buck balustrade pattern shown on the 1900 south elevation drawing was not built, but that straight vertical balusters were used instead. The veranda ceiling was plastered and its roof covered with roofing canvas.

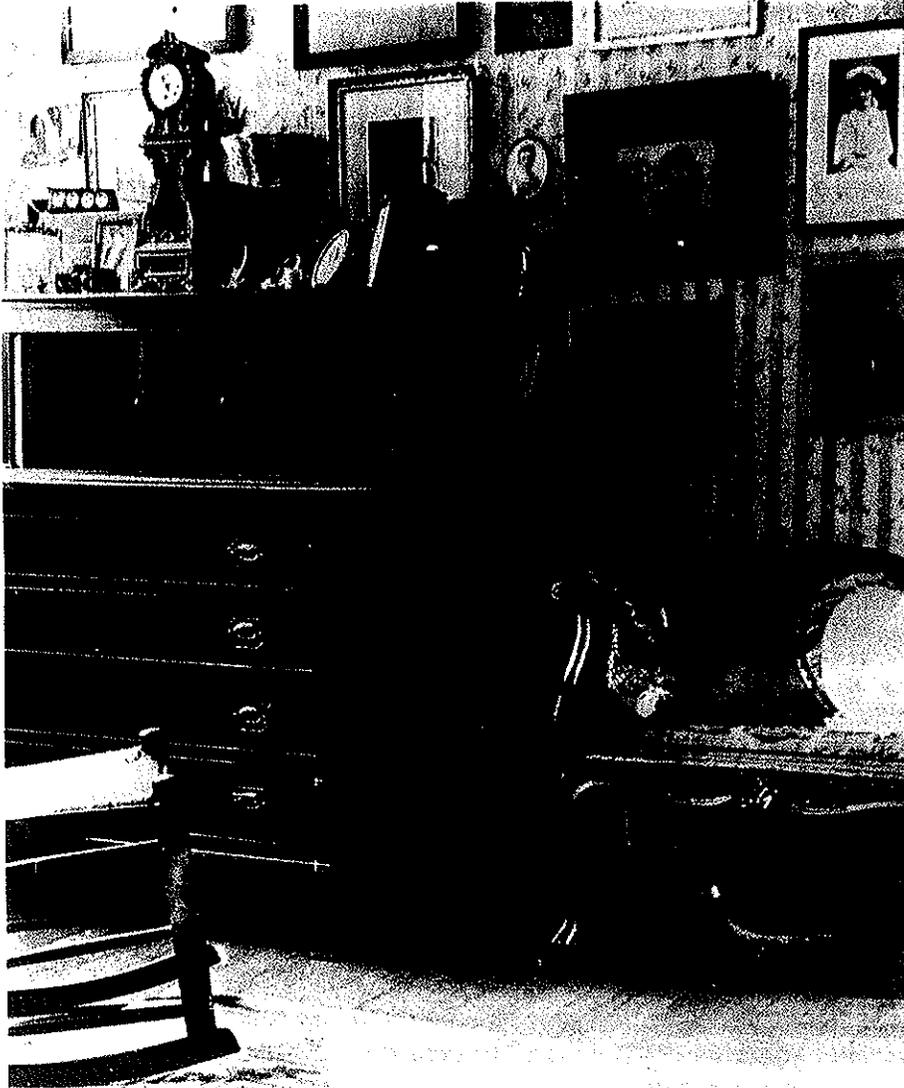
Figure 27. Weir House - Cora Weir's Bedroom (Circa 1900-1905).

A series of photographs in the Weir NHS archives that dates to circa 1900-1905 were taken of Cora Weir's bedroom (Room 201). The views show that the walls in the room were covered with wallpaper that had stripes decorated with floral sprigs (**fig. 27**). It is likely that, as with the living room and east entry hall downstairs, several of the bedrooms were wallpapered at the time of the 1900 Platt alterations. The northeast bedroom (Room 211), which was the master bedroom in 1900, displays today a Morris-style wallpaper that may date to that period (see **figs. 92 & 93**).

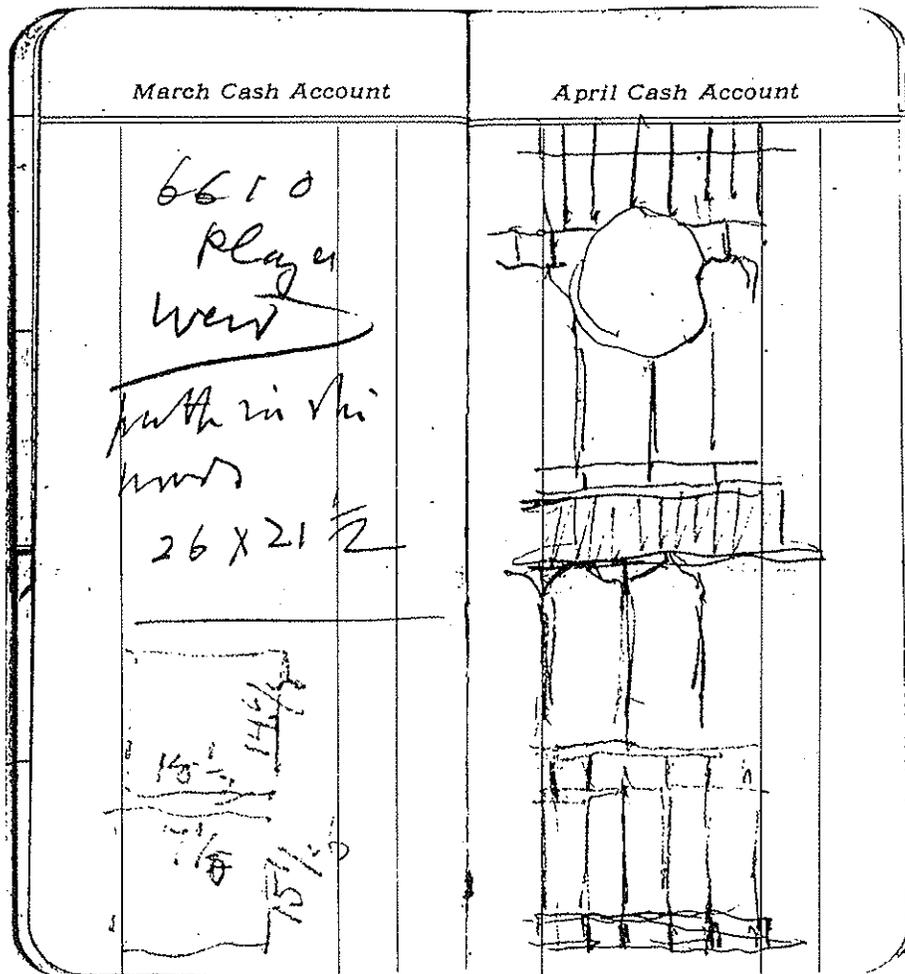
Figure 30. Sketch by J. Alden Weir of 1900 Leaded Casement Window (1911).

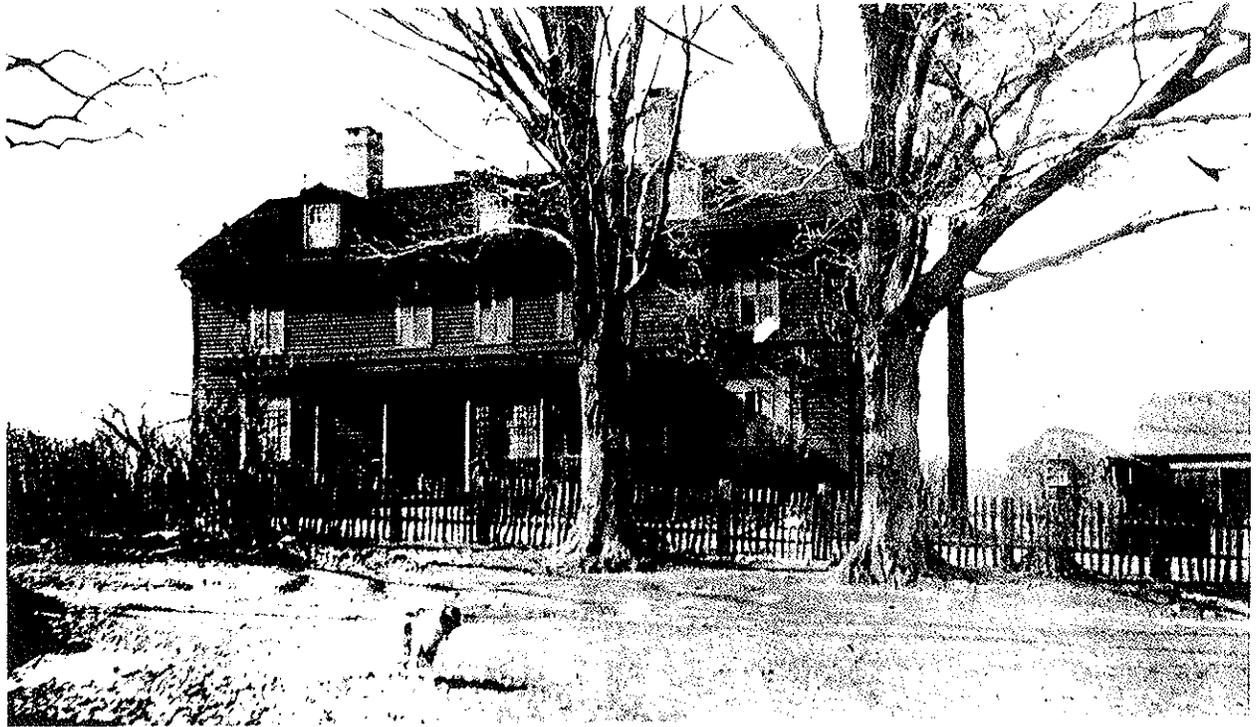
Figure 31. Weir House - South Elevation (Circa 1915).

of the Weir house between circa 1915 and 1918. In the first photograph, which dates to circa 1915, the entire south facade is shown in bright sunlight with the exterior shutters on the first and second stories closed (**fig. 31**). In the second photograph, which dates to circa 1915-1918, Weir is shown standing in front of the southeast corner of the house (**fig. 32**). Both photographs indicate (and paint analysis confirms) that the exterior color scheme of dark red siding and dark green trim on the house was constant throughout Weir's life. In the circa-1915 view the sashes in the dormers can be seen as painted a light color -- probably the usual white. By the time the circa-1915-1918 photograph was taken the window sashes appear to be painted a dark color instead of white. This dark sash color was not confirmed by the paint analysis (see **APPENDIX E**).

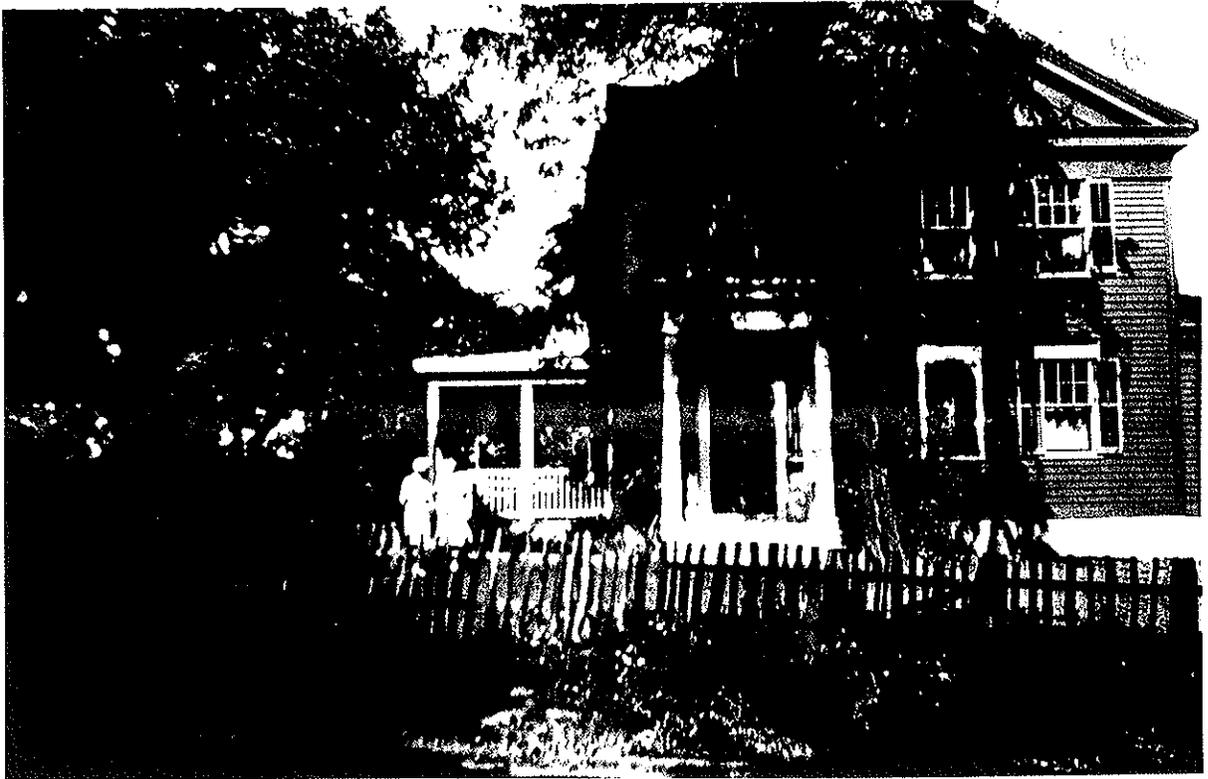
Figure 35. Weir House - View From East (Circa 1940s).

white trim in porches & around windows as an innovation".¹⁰⁷ A circa-1940 photograph of Cora Burlingham and Dorothy Young standing on the east side of the south porch (**fig. 35**) shows the white porch columns, balusters, and trim and the white surround of the east entrance.

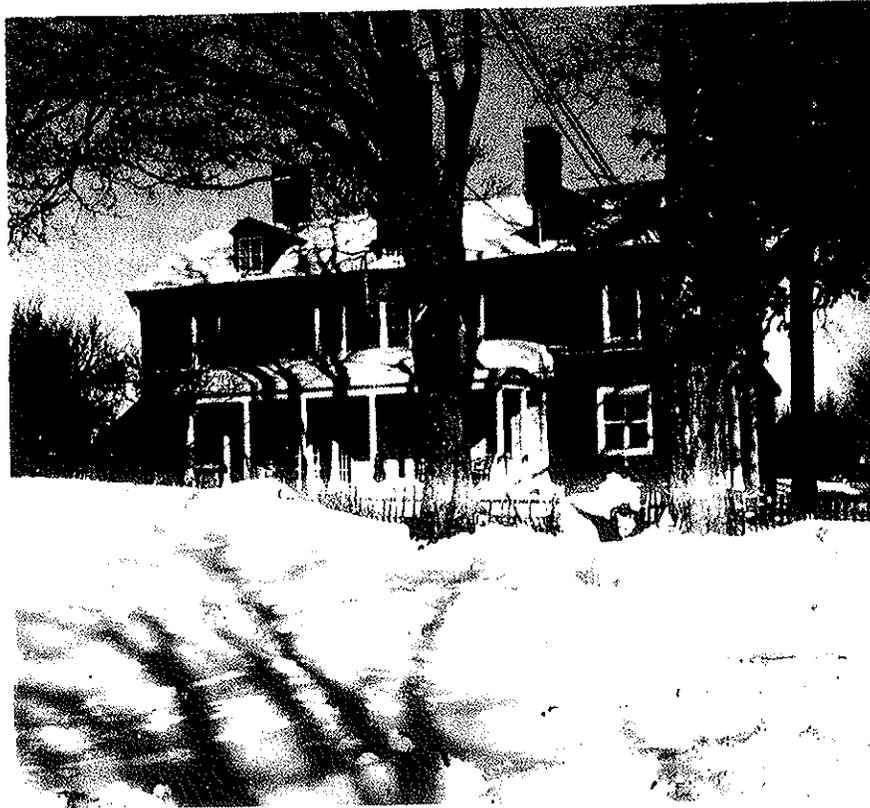
Figure 40. Weir House - South Elevation (After 1958).

Figure 40 is a view of the house as it has appeared since circa 1958. The uses of the house and its various rooms have been reasonably consistent between the Young period and the Andrews period.

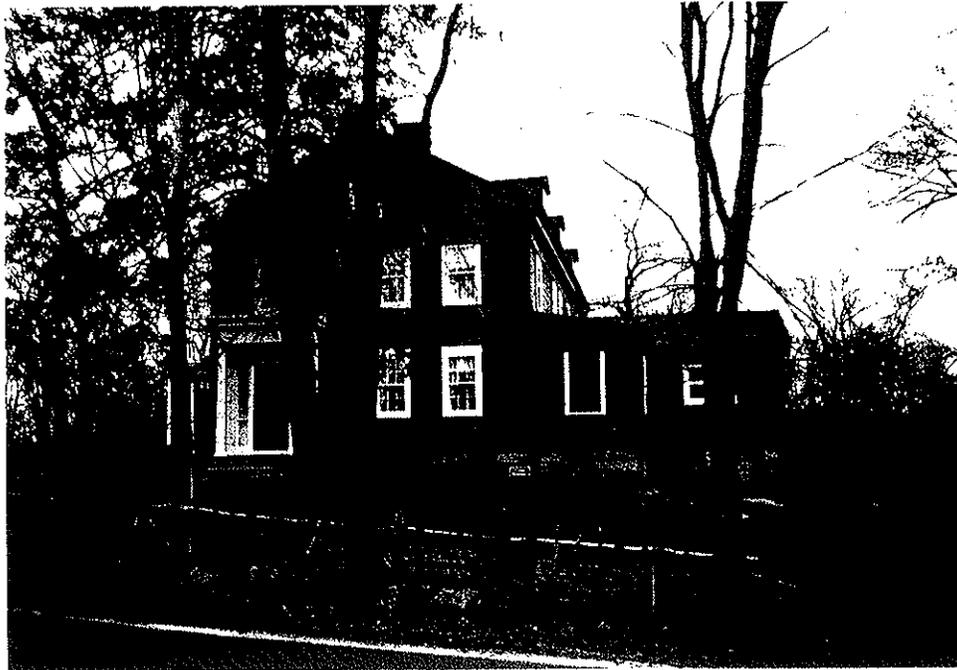
Figure 41. Weir House - East Elevation (1994).

A one-story porch visible at the south end of, and set back from, the east facade is a 1900 addition. Although it is a larger colonnaded porch, the formality of the south porch remains secondary to that of the east entry. Gates in the fencing on both the east and south sides of the lawn around the house accentuate the function of both the east facade and south elevation as entrances. The one-story wings that project on the north side of the east facade date to 1911.

The existing exterior paint color scheme of red clapboards and white trim has existed since the Dorothy Weir/Mahonri Young period. During J. Alden Weir's lifetime the trim was dark green. Prior to Weir's occupancy, the house was white with white trim and black wooden blinds. Evidence of pre-1883 white siding paint exists in isolated locations under the red paint.

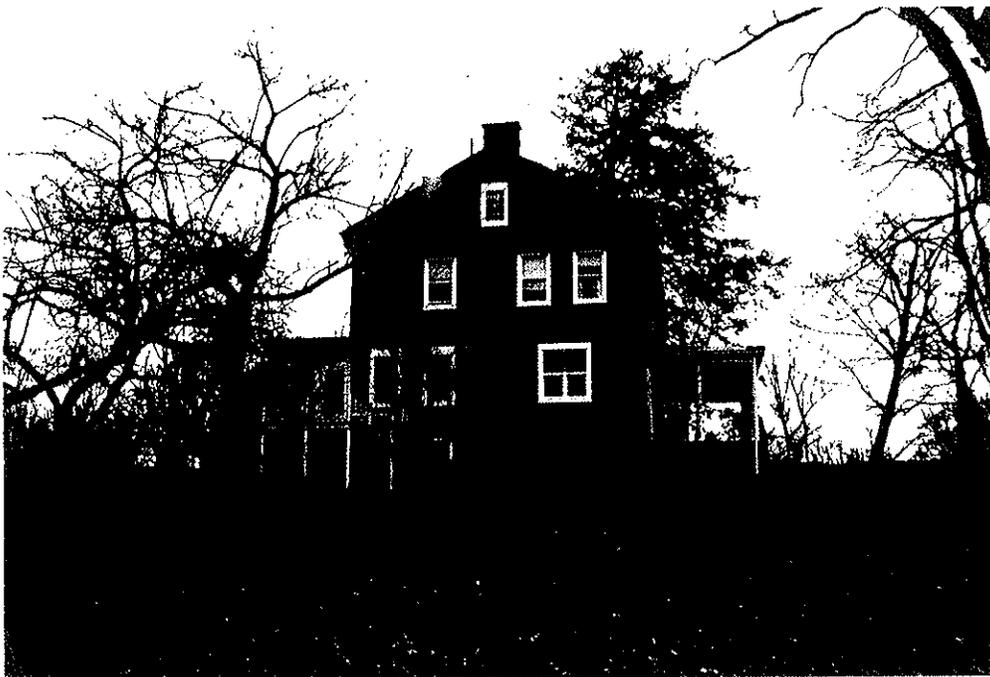
Figure 45. West elevation (1994).

The west elevation, like the east facade, is composed of a two-story and attic main structure with one-story wings extending to the north and a one-story porch to the south. The most notable features on the west elevation are the Greek Revival pedimented gable end that was relocated from the circa-1830 gable end during the 1900 renovations, the 1900 veranda visible at the south, the circa-1888 one-story short kitchen wing on the north, and the 1911 one-story wing also on the north, set back from the plane of the west elevation. A small open porch deck at the first-story entrance has a straight run of steps leading down to the west lawn. Because of the low grade on this elevation, the deck is built on stilts, and the house foundation is higher than on the other three elevations, allowing for full, double-hung windows and a double doorway with tongue-and-groove vertical-board doors at the basement level.

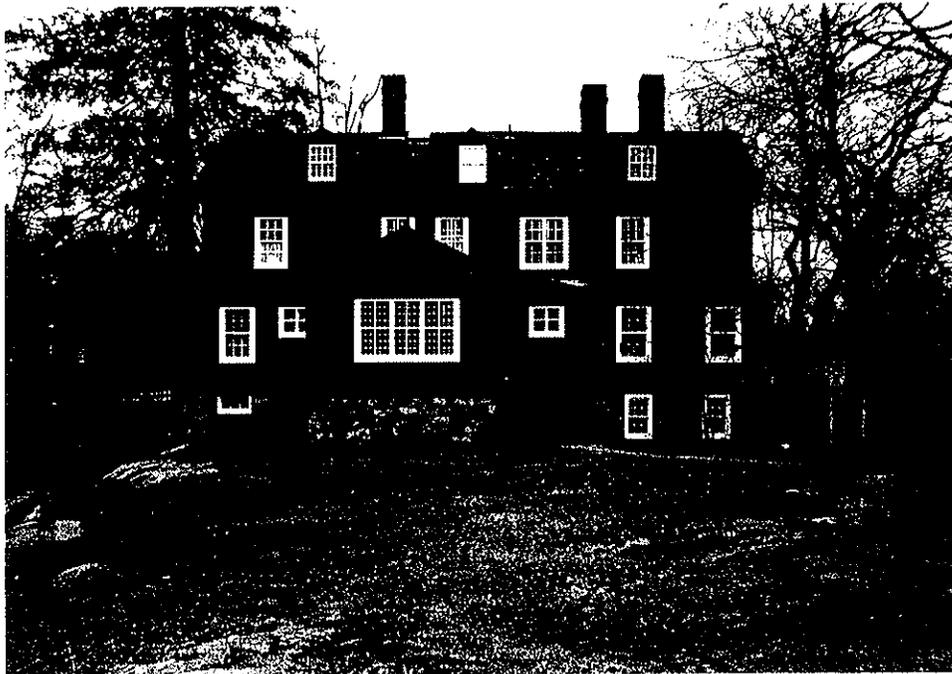
Figure 47. Weir House - North Elevation (1994).

The north elevation consists of the 1900 two-story and dormered attic main house and the later one-story additions that run along the entire north elevation. The projecting center addition is the 1911 dining room. Also visible are the north elevations of the small covered entry on the east (circa 1830) and the open-deck porch on the west (1911). The east and center dormer windows date to 1900, while the west dormer was added in 1911. All three chimneys on the house are visible; the east chimney is original to the house, but may have been re-bricked during the 1900 renovations; the west chimney and the northernmost chimney date to 1900. The gable and cornice trim on the one-story additions is in visual harmony with the earlier Greek-Revival roof cornice. Window placement around the gable-end addition is symmetrical. The decline of grade from east to west allows for two full-size double-hung windows at the west end of the foundation.

The range in pattern of the ashlar granite foundation can be fully observed on this elevation, starting with the more formal regularly coursed units at the east, moving westward to a random pattern at the rear of the house.

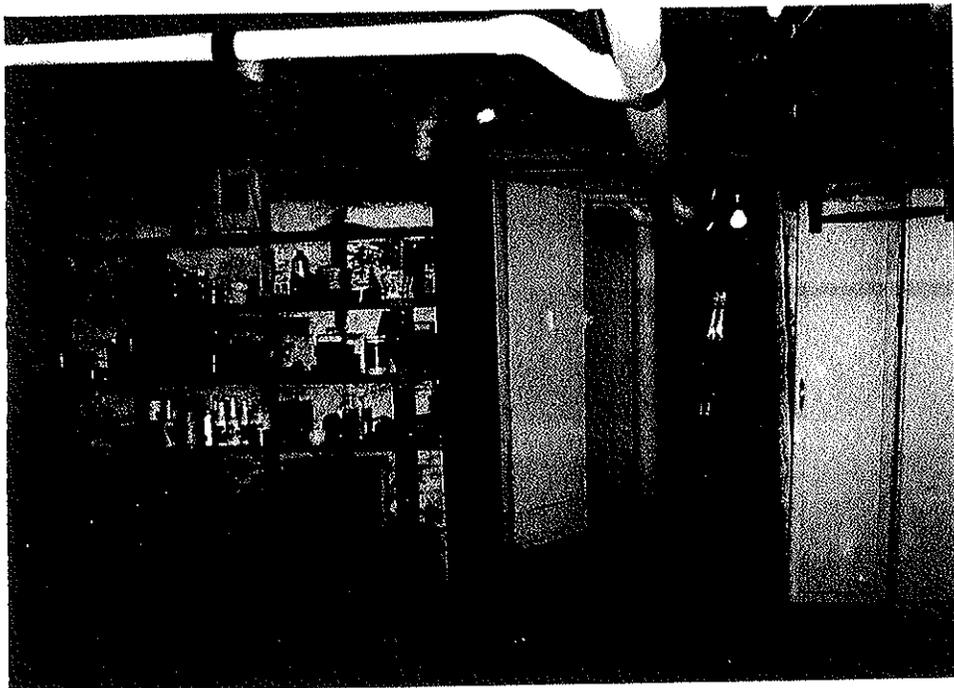
Figure 51. Weir House Basement - Southeast Room [Room 003], Looking West (1994).

The southeast room (Room 003) is the earliest basement room and dates to the original eighteenth-century construction of the Weir house. A short stone half-wall abutting the south wall is thought to have separated a crawl space at the east from the excavated area containing the central chimney mass at the west. Most of the visible structural evidence for the original house exists in this room (see **PHYSICAL DESCRIPTION of EXISTING ELEMENTS - Structural Elements**, above.) An original basement window, located at the east end of the north wall, is now blocked due to the construction of the 1911 addition. An opening in the first-floor framing in the southeast corner of the room marks the former location of a staircase that had led up to the first floor.

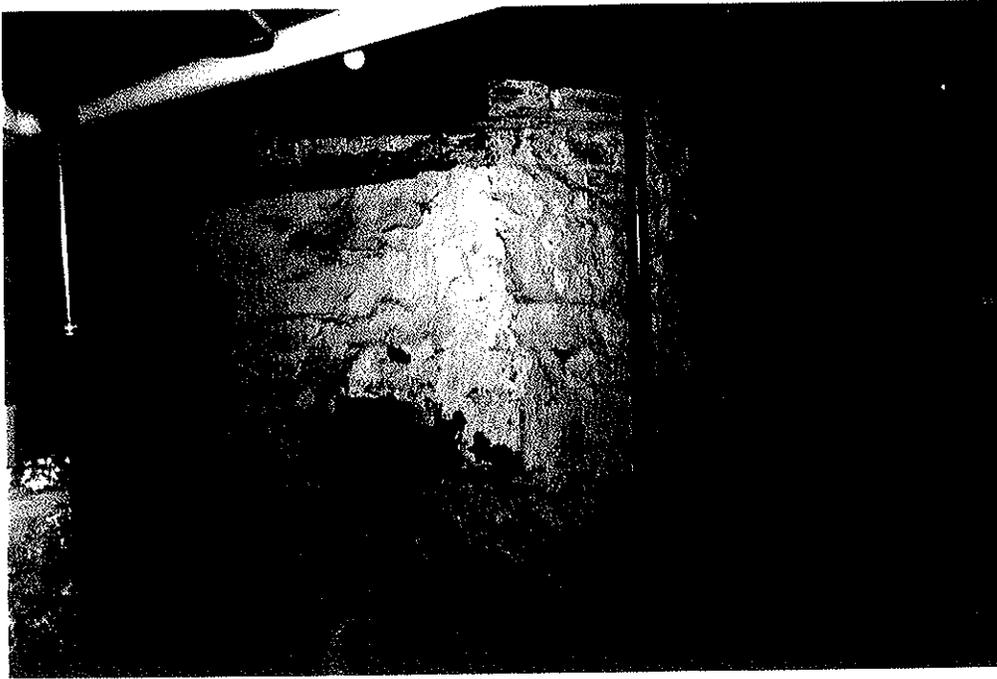
Figure 52. Weir House Basement - Southeast Room [Room 003], West Wall, Doorway D003 (1994).

•WEST WALL	<ul style="list-style-type: none"> • D003 to Room 001 has double batten doors each constructed of 2 wide vertical boards with horizontal battens on R003 side; wrought-iron latch; cutout in north door leaf for east/west pipes. 	<p>D003: R003 face - whitewash R001 face - black paint</p>
•NORTH WALL	<ul style="list-style-type: none"> • None 	
WINDOWS		
•EAST WALL	<ul style="list-style-type: none"> • None 	
•SOUTH WALL	<ul style="list-style-type: none"> • W008 with wood, 3-light, hopper sash that is modern replacement - see Exterior 	<p>North-wall opening to R002 was c. 1830 window; sash removed in 1911.</p>
•WEST & NORTH WALLS	<ul style="list-style-type: none"> • None

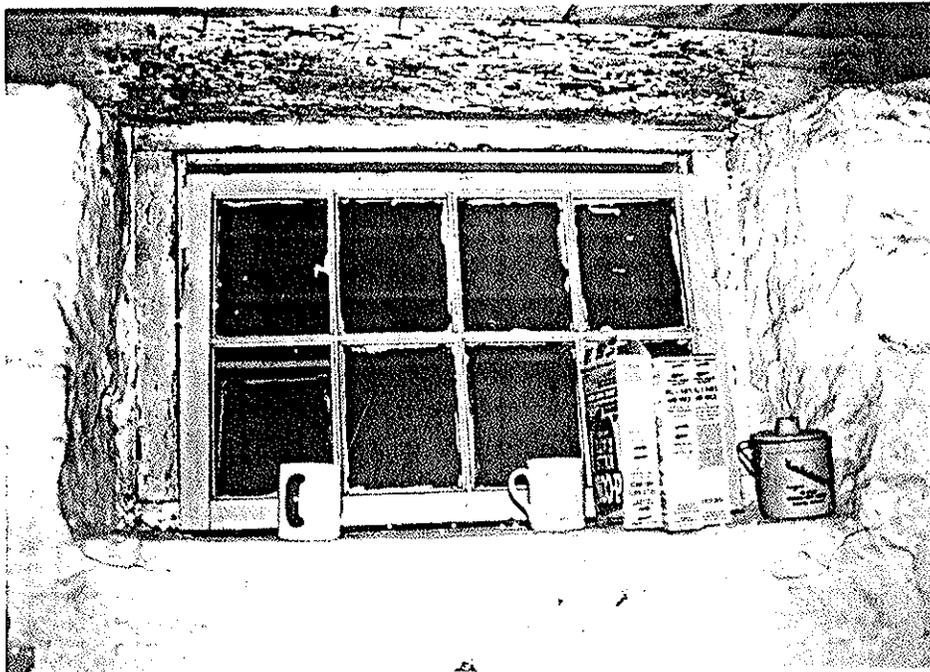
Figure 56. Weir House Basement - Storage Room [Room 005], Upper Southwest Corner (1994).

The west wall of Room 005 was the exterior west foundation wall for the circa-1830 lean-to cellar and later for the 1888 addition. The wall is now enclosed within the 1900 part of the basement. The original window (W006A) in the circa-1830 west wall is extant at the south end of the wall.

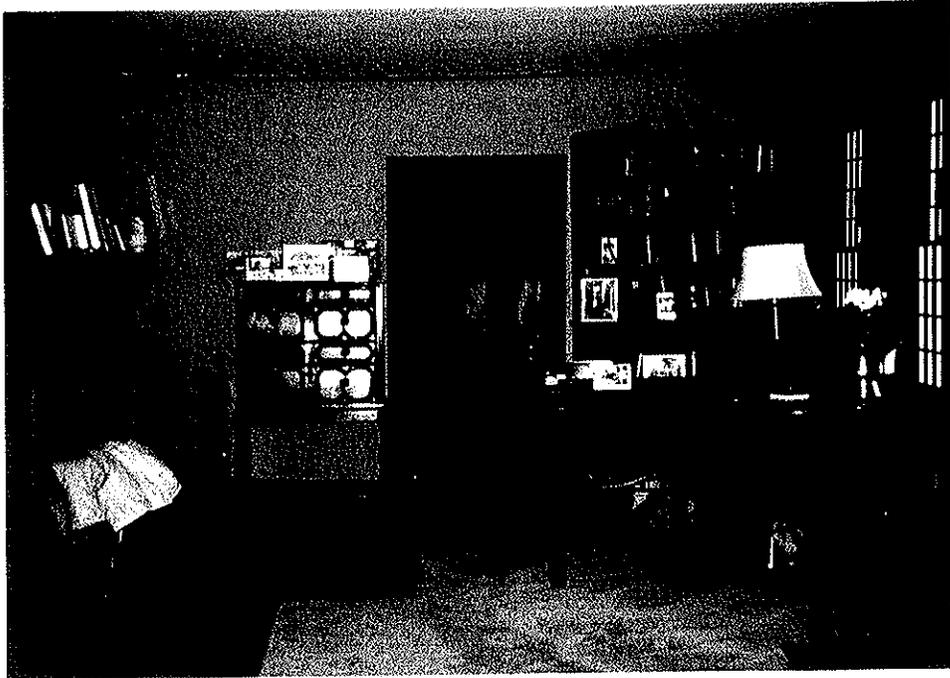
Figure 66. Weir House - Living Room [Room 102], Looking East (1994).

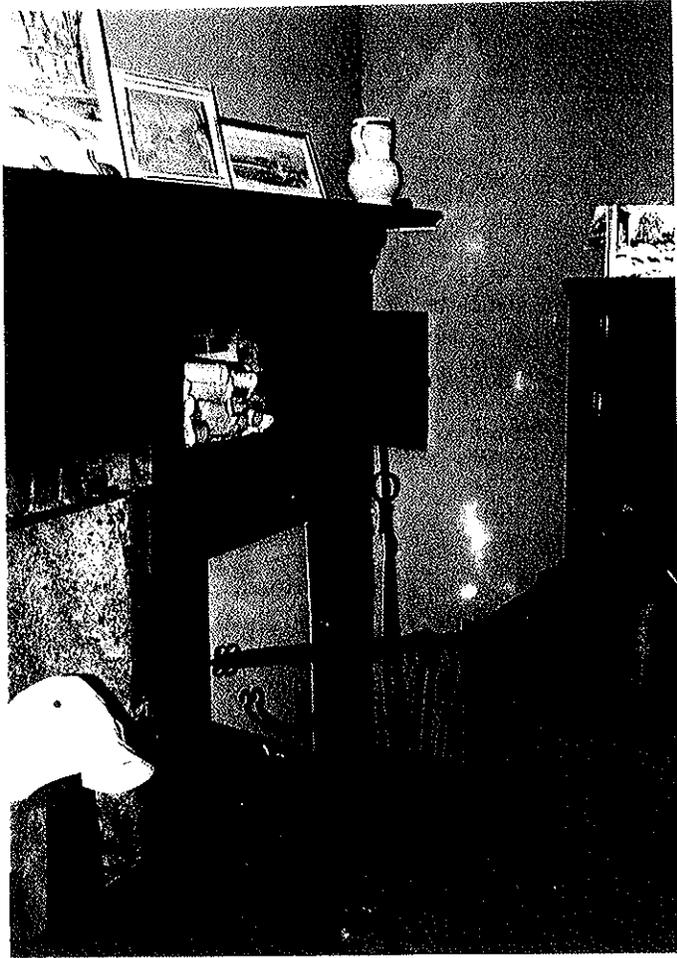
Figure 69. Weir House - Living Room [Room 102], Northeast Corner, Detail of East Fireplace (1994).

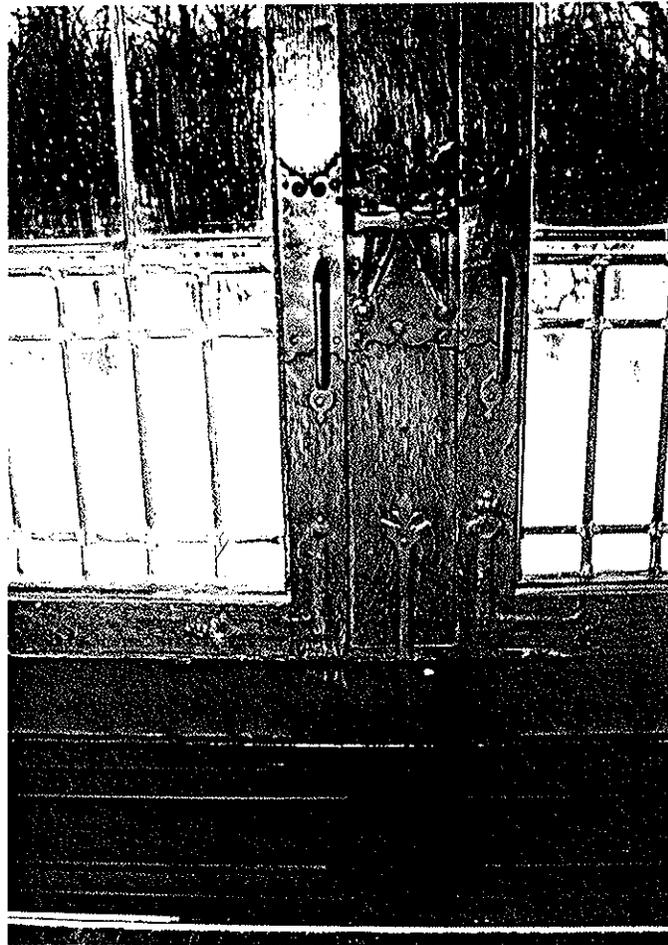
Figure 71. Weir House - Living Room [Room 102],
West Wall, Window W112 Latch Detail (1994).

The living room windows are all unusual or ornate. Two ornamental double-casement windows are located in the room - on the west wall (W112 - **figs. 67 & 71**) and one at the west end of the south wall (W113 - **fig. 70**). The sashes in both of these windows have inserts of the small German stained-glass panels that Julian and Anna Weir bought in Italy in 1883; the bottom sashes in window W113 have written in lead cane Ella Weir's initials ("EBW") in the left-hand corner and the date of installation ("1900") in the right-hand corner (**fig. 70**). Three double-hung multi-light windows on the south wall look onto the porch.

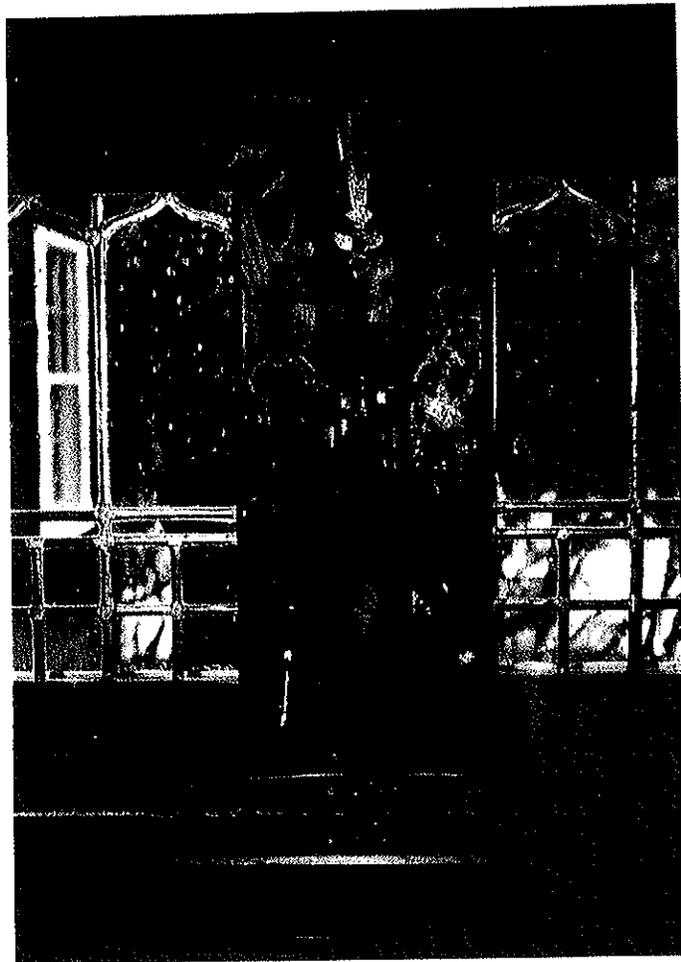
Figure 81. Weir House - Dining Room [Room 107], West Wall, Detail of Window W105 (1994).

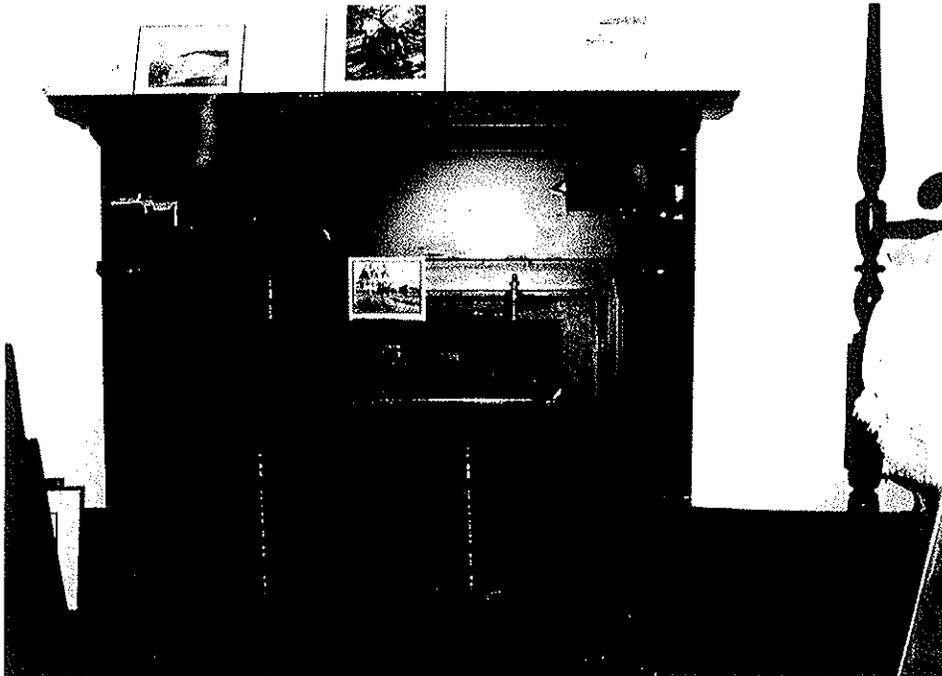
Figure 85. Weir House - Downstairs Bedroom [Room 108], West Wall, Fireplace (1994).

The downstairs bedroom (Room 108) was at one time called the "Ryder Bedroom" because Henry Pinkham "Pinky" Ryder slept here when he visited the Weirs.¹²² Located on the east side of the first floor, it was part of the original eighteenth-century house. There is a fireplace on the west wall (**fig. 85**), with its flue connected to the central chimney that is fitted with a metal stove insert with an elaborate design. A doorway on the north wall opens to a dressing room (D108A), and one on the south wall opens from the library (D108). During the Weir/Young period the walls in Room 108 were papered with a Morris-type bold blue floral wallpaper. This wallpaper was removed sometime after 1958 and the walls were then painted white. This room retains its original circa-1830 Greek Revival-style woodwork, among the most elaborate in the house. The wood paneling on the wall below the windows on the east wall (W119 & W120) is repeated in the adjacent 1911 dressing room.

FEATURE	DESCRIPTION	FINISHES/NOTES
SPECIAL FEATURES		
•WEST WALL	•Fireplace with wood mantel Type FM-A with projecting shelf; fitted with cast-iron, coal-burning stove insert with elaborate design; brick hearth & firebox.	Black paint Mantel c. 1830
CLOSETS		
	•None	
UTILITY SYSTEMS		
•ELECTRICAL	•Double-switch West of doorway D108; two wall sconces on South wall adjacent to D108, each with round mirror set in tooled metal, single electric candle; baseboard outlet receptacles - 1 at East wall & 1 at North wall.	
•HEATING	•Floor-mounted cast-iron radiator at East wall adjacent to window W120; exposed pipes at Northeast corner for 2nd-story radiators.	Black paint
•PLUMBING	•None	
•MISCELLANEOUS	•None

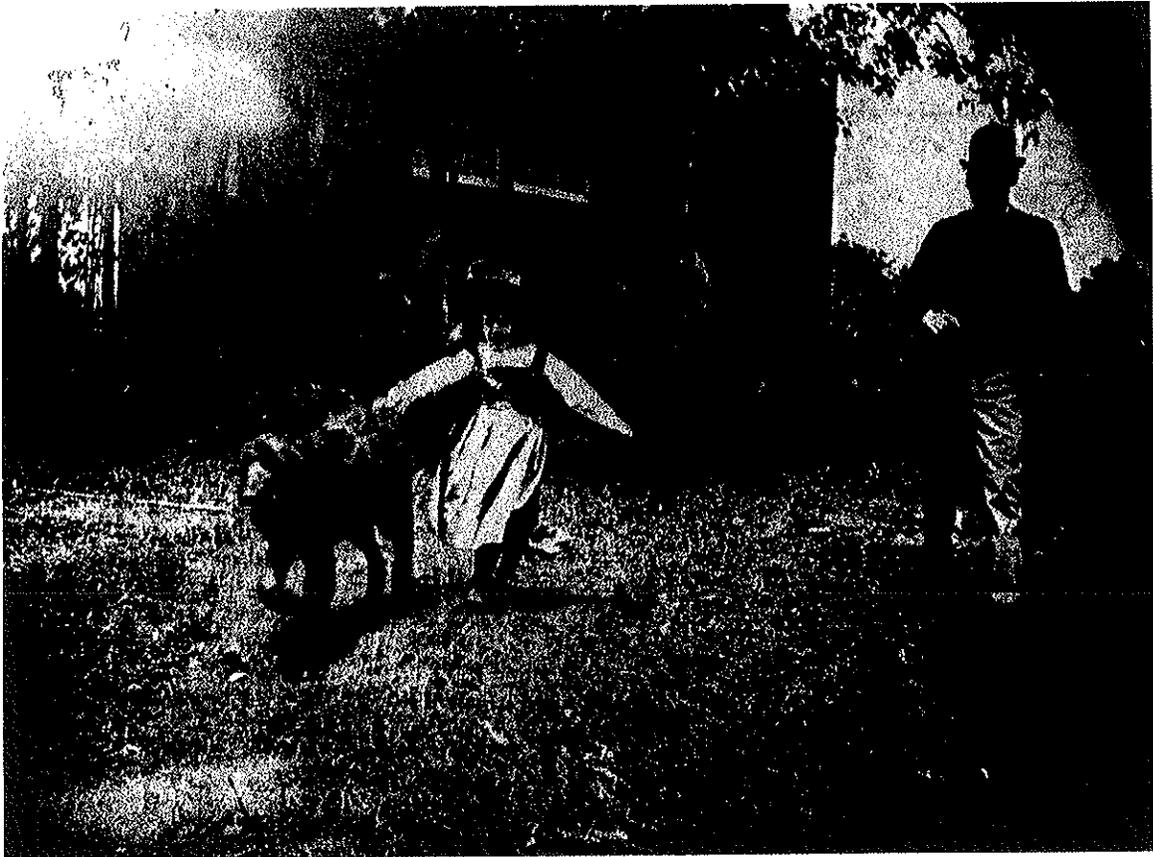
Figure 100. Weir Studio - East Facade (Circa 1888).

J. Alden Weir's studio was built in 1885 near a clump of small trees on a rocky outcropping northwest of the Weir house and to the west/southwest of the Weir barn. On July 7, 1885, Weir wrote a letter to his sister-in-law Ella Baker, saying "My studio is now finished."⁷ Shortly after, Anna Weir wrote to Ella, "Julian's studio is finished, and is as comfortable as possible."⁸ The original studio is loosely depicted in a Weir painting dated 1888-90 (*Early Spring at Branchville*, see **fig. 3**), but while the studio appears in the painting with other outbuildings on the farm, the Weir barn has been omitted (presumably for "artistic license") and this painting cannot be relied upon to show the actual appearance of the studio in 1888-90. Some aspects of the original building are, however, well documented; a special point of interest at the farm, the studio is the background in several photographs of family or friends frolicking on the grass in front of the new studio building (**figs. 99 & 100**).

On the south elevation, although there are no clear views of this aspect of the studio it is known that this wall had at least two small windows at the first-floor level. These openings are barely visible in a circa-1888 photograph of the east facade of the studio (**fig. 100**). There was also an opening with fixed wood louvers at the south gable peak similar to the opening on the north gable. On the west elevation were four windows with wood canopy shades. There are no historic photographs which show the west elevation before the lean-to was built against that side, but the blocked window openings are extant and visible on the interior west wall of the studio and on the interior east wall of the lean-to later built on the studio's west wall. The wood canopy shades are still in place

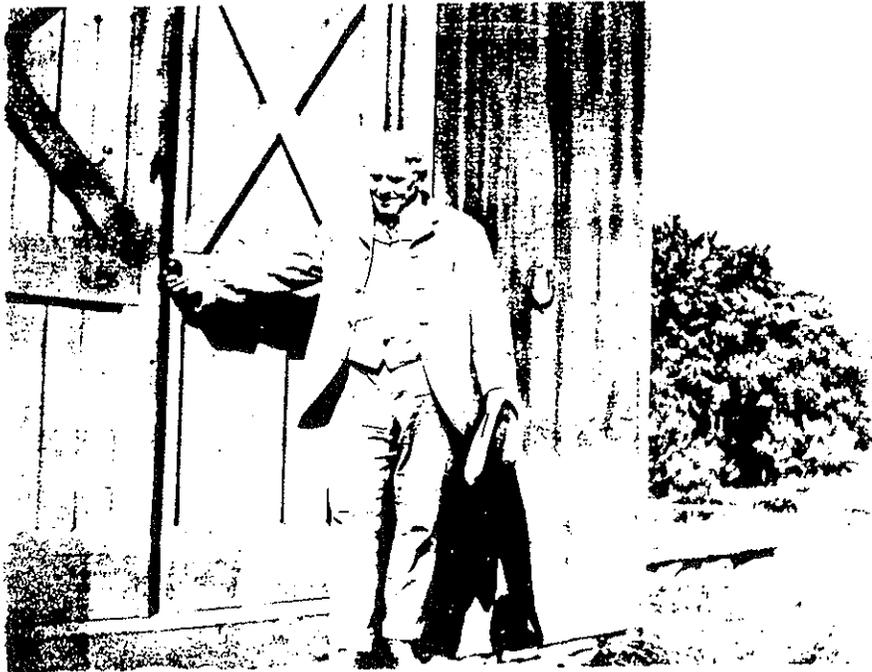
Figure 103. J. Alden Weir at East Doorway of Weir Studio (Circa 1915).

Sometime before 1919, a wood platform laid on stones was constructed outside the north wall of the studio. The platform can be seen on the lower right-hand side in a photograph of Weir standing in front of his studio entry door (**fig. 103**). It is thought the structure was an outdoor painting deck, and that it may have been built in conjunction with the garden behind the studio. Although the platform is now gone, the stone base still exists.

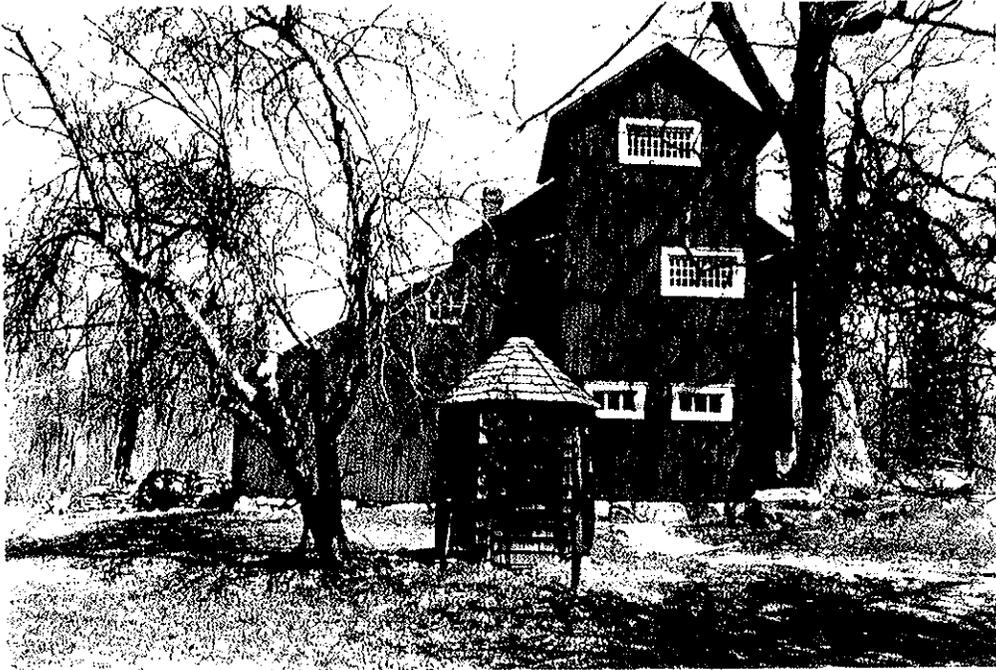
Figure 111. Weir Studio - South Elevation, Water Tower Stairs Removed (1994).
