**WEIR FARM HISTORIC STRUCTURES REPORT
VOLUME I**

**Weir Farm National Historic Site
Wilton, Connecticut**

The Site and the Weir Complex

Building Conservation Branch
Northeast Cultural Resources Center
National Park Service, U.S. Department of the Interior
Lowell, Massachusetts

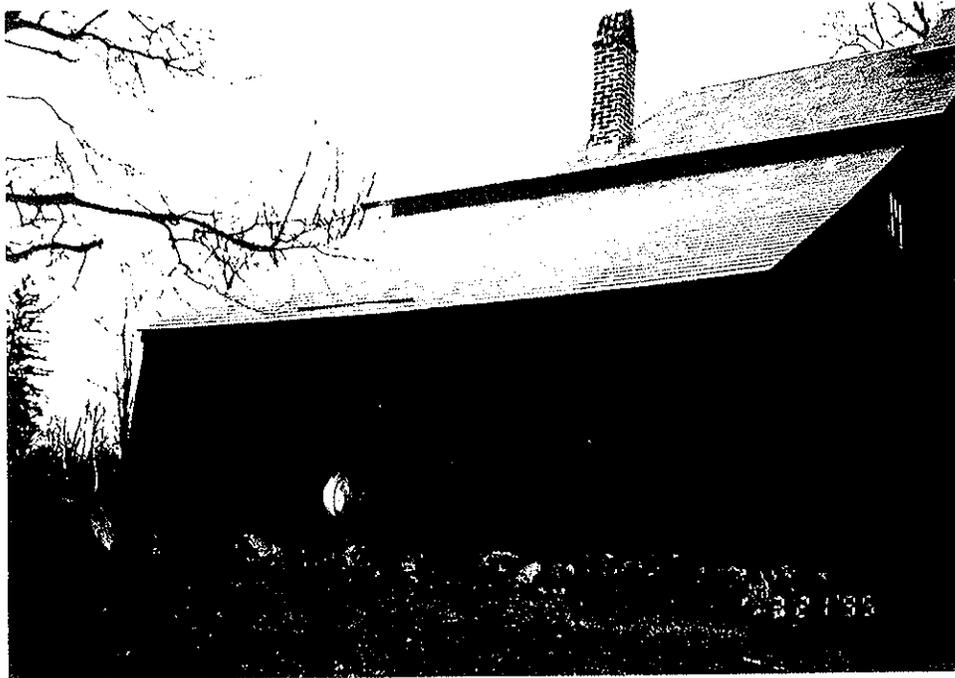
Figure 113. Weir Studio - West Elevation, Restored Wood-Shingle Roof (1994).

The west elevation of the Weir studio is the rear of the building and includes the west elevation of the water tower and lean-to, the steeply-sloping lean-to roof, the west roof slope of the studio, and the studio chimney (fig. 113). Visible in figure 113 is a doorway (D4) to the north (left) of center that leads to the woodshed (Room 104). A doorway on the water tower (D2) leads to the tower's first-floor room (see fig. 112). Both photographs of the studio's west elevation were taken in 1994 after siding was replaced, the studio was reroofed with wood shingles, and the chimney was rebuilt.

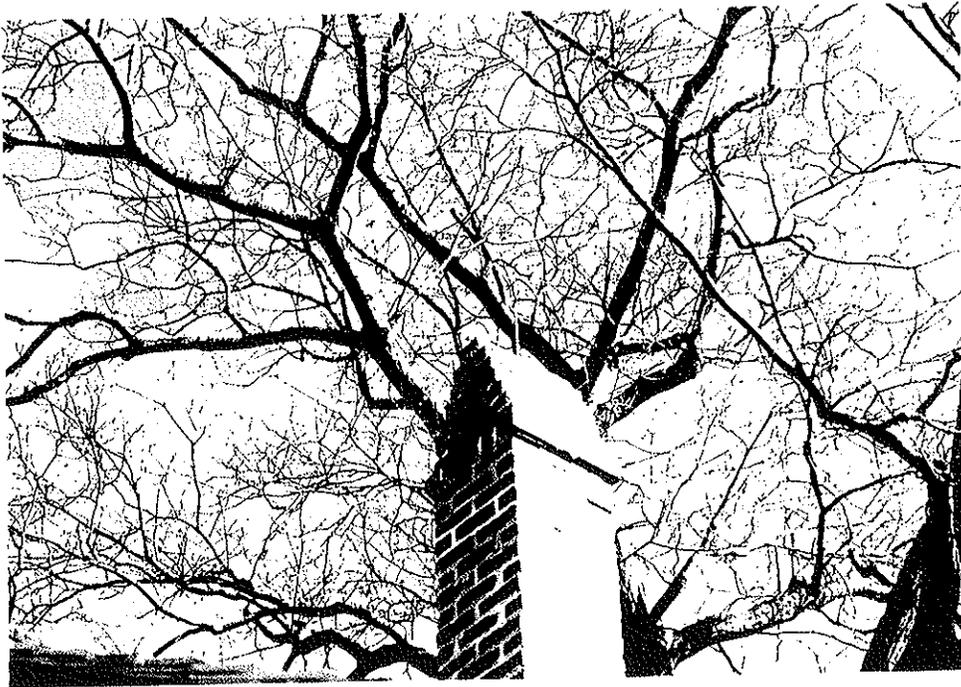
Figure I14. Weir Studio - West Elevation, Detail Showing Rebuilt Chimney (1995).

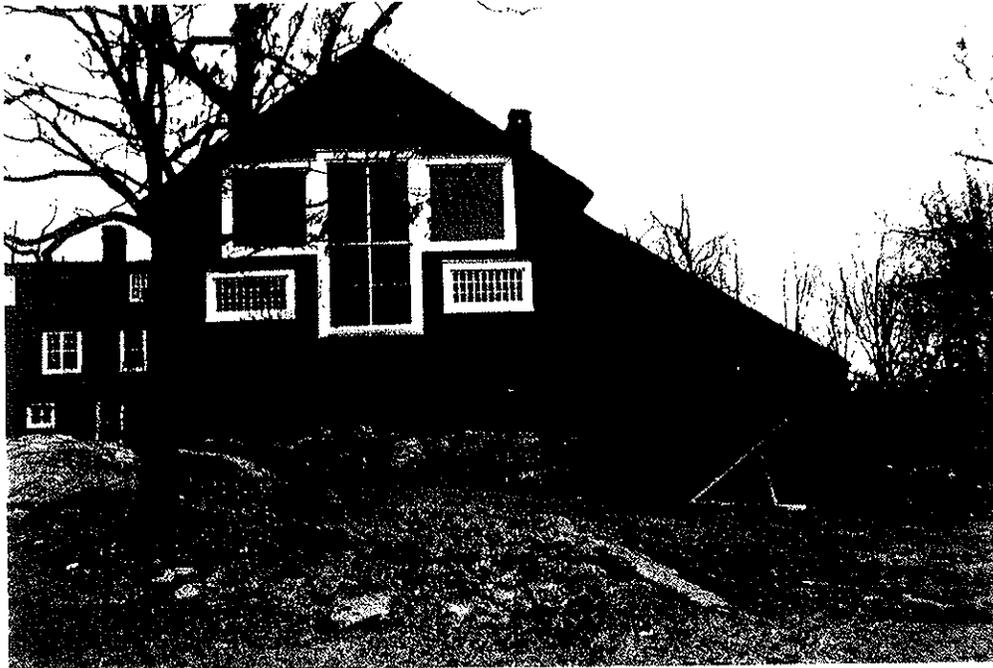
Figure 115. Weir Studio - North Elevation (1994).

The tight squeeze of the windows in the gable resulting from the addition of new single-pane windows in 1899 can be seen in **figure 115**. The windows probably appeared less tightly spaced in Weir's lifetime when the frames were painted the same red color as the siding and only the sashes were painted white.

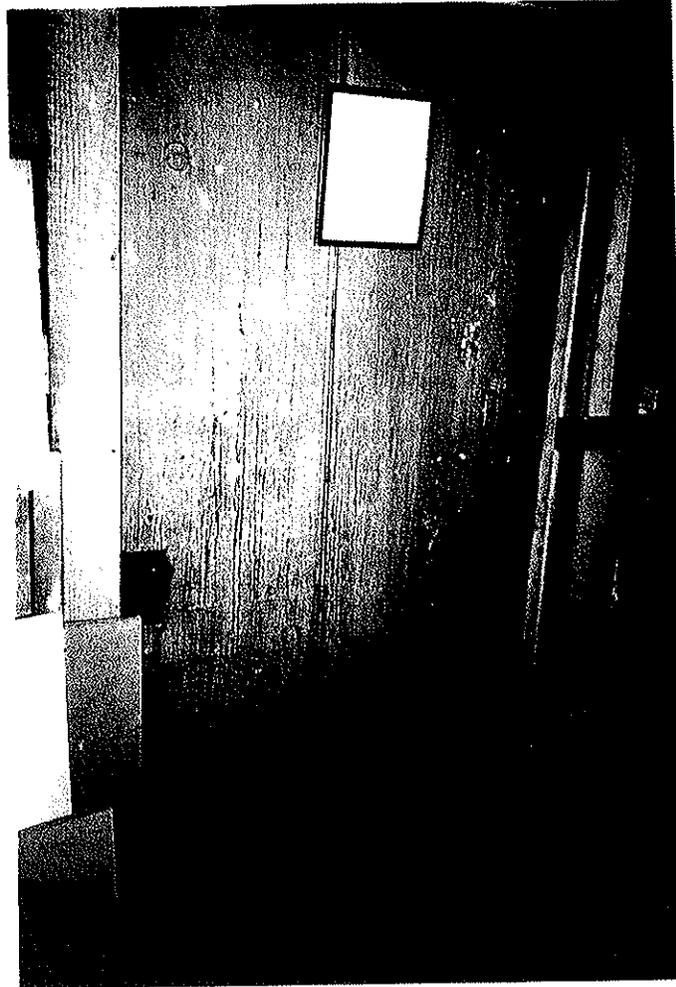
Figure 123. Weir Studio - Studio [Room 101], West Wall, Doorway D103 (1995).

The interior of the lean-to shed was divided into two rooms. A small storage room was carved out of the southeast corner that was accessed by a doorway (D103) from the studio. This doorway was fitted with a door comprised of two thin door panels attached back-to-back; two, vertical, beaded boards faced the studio side and six raised panels faced the storage room. Both faces of the door were given a wood-grained finish (see **figs. 123 & 127**). What remained of the lean-to space was a large "L"-shaped room that was used for wood storage. There was no communication between the two lean-to rooms.

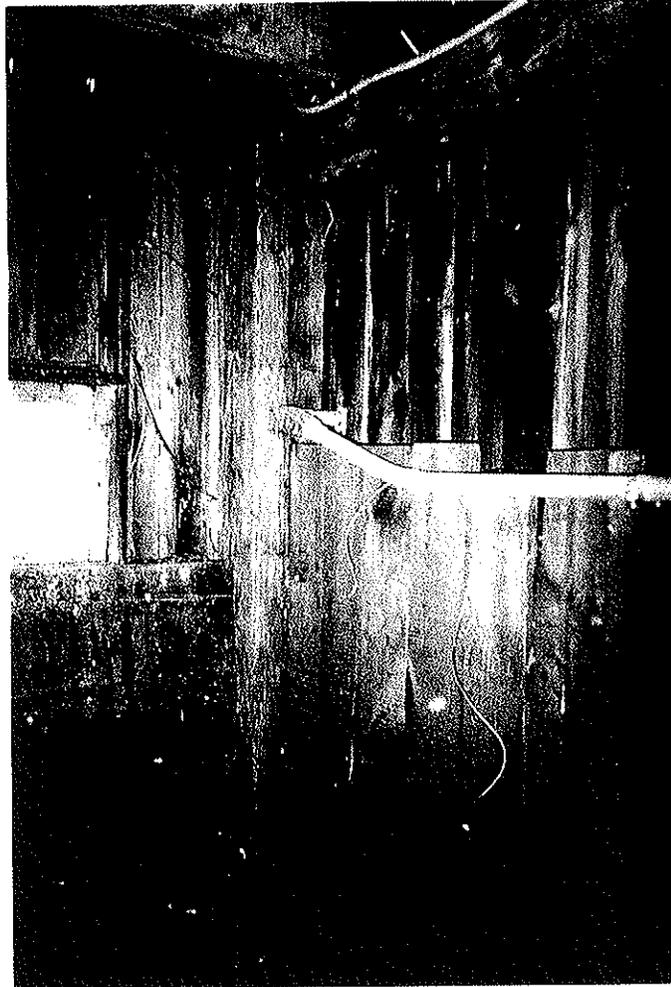
Figure 125. Weir Studio - Water Tower First Floor [Room 102] - Southwest Corner (1994).

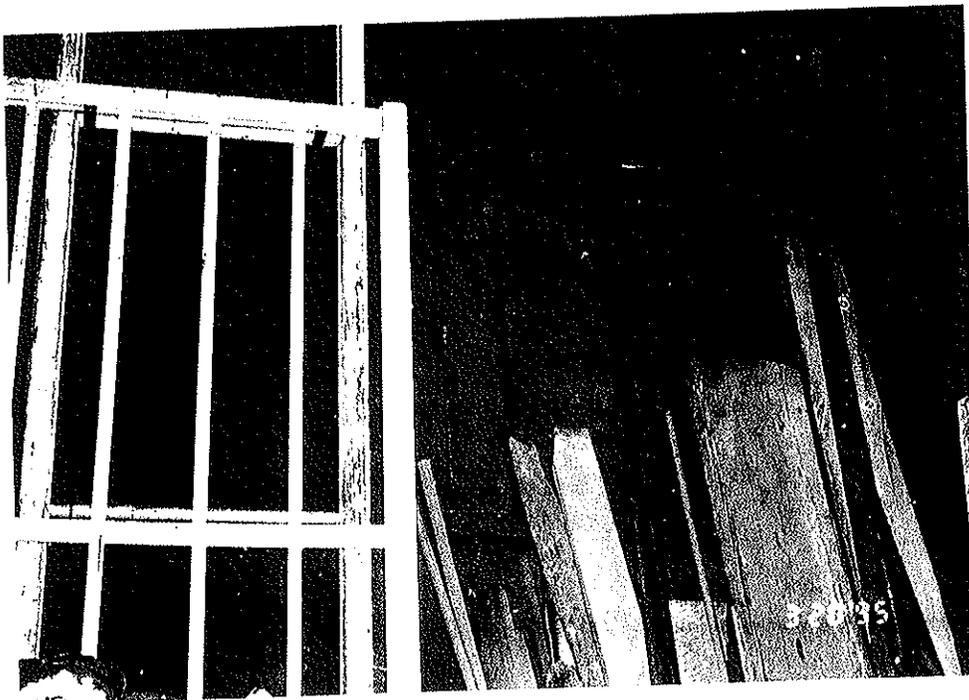
Figure 128. Weir Studio - Woodshed [Room 104], East Wall (1995).

The woodshed is currently filled with scrap lumber, building parts, and split logs. Stacked against the east wall are building remnants, including porch columns from earlier periods on the Weir house. A small balcony area at the north holds odd pieces of furniture that appear to have been there for a number of years. In the southwest corner are stored other miscellaneous pieces of scrap wood and logs, as well as numerous building remnants from the Weir farm structures. Among these are porch columns and porch balustrades thought to have come from the south porch of the Weir house.

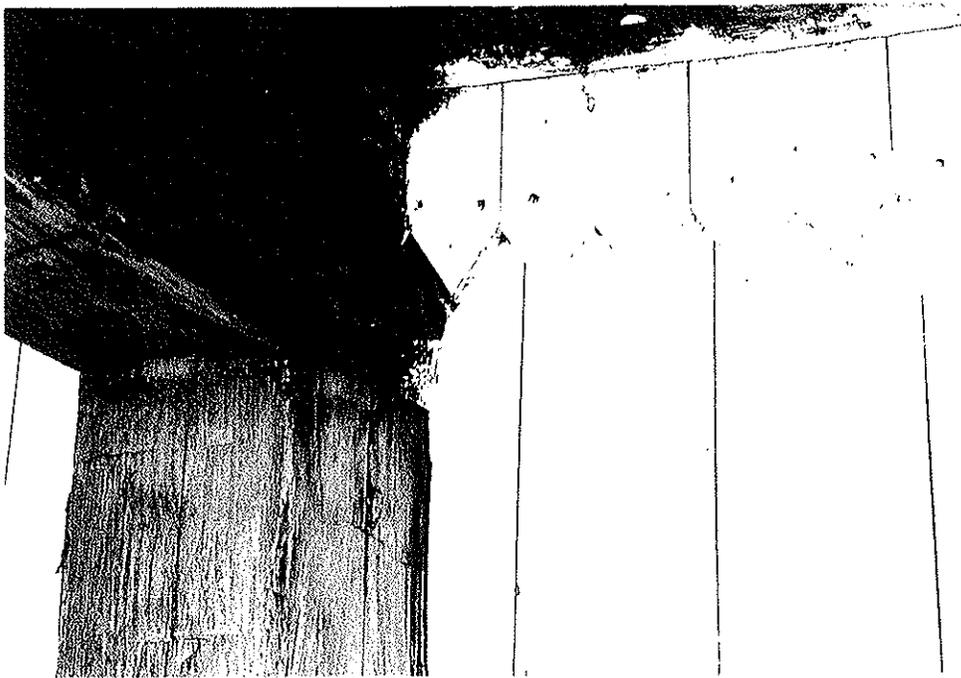
Figure 130. Weir Studio - Water Tower Second Floor [Room 201], North wall, Detail Showing Pegged Post-and-Beam Construction (1995).

Room 201 occupies the second floor of the water tower. This room is almost square, measuring approximately 9 feet 3 inches by 9 feet 6 inches, and is the landing for the exterior stairs along the east wall that lead to the east-wall entry doorway (D5). The room has tongue-and-groove pine flooring. Three of the interior walls consist of the exposed framing and exterior siding. The north wall is composed of the former exterior south-wall of the 1885 studio; the upper saw-tooth siding of the original studio's south gable is extant (fig. 130). A window (W201) with a multi-pane sash is installed on the south wall.

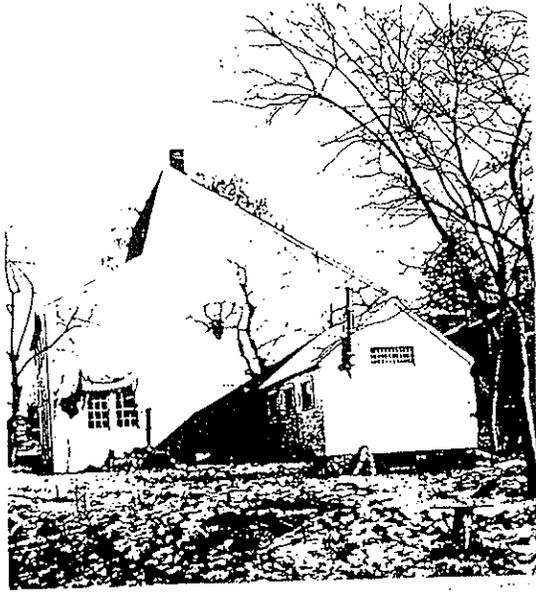
Figure 135. Weir and Young Studios - View from the South (1993).

The Young studio was built thirty feet to the west of Weir's studio. The juxtaposition of the two studios is shown in a circa-1936 sketch by Mahonri Young, *Studios and Tool House, B'ville* (fig. 134) and in a recent photograph of both buildings taken from the south (fig. 135). In the 1936 sketch, the east wall of Young's studio is painted white, and a fence visually connects the two studios. The sketch also depicts the Weir garden tool shed near the Weir studio. A local firm, "Charles Meyer Builders" of Wilton, Connecticut, did the construction work on the Young studio. ⁴⁰ The large, 2 1/2-stories-high, one-room studio was built as a modified A-frame shape, with a towering roof punctured by an expansive six-section skylight and an oversized double doorway through which to transport the large works of art that Young planned to execute.

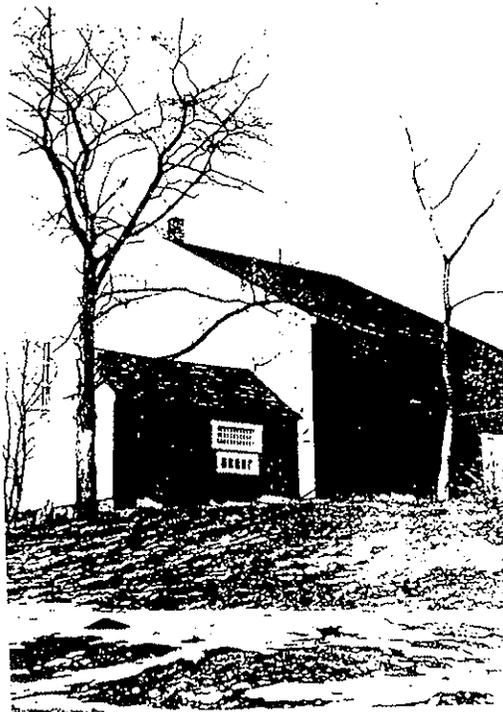
Figure 136. Young Studio - West Elevation (Circa 1932).

Photographs taken of the studio circa 1932 show that a small pre-existing structure, said to have originally been a bindery used by Weir's daughter Caro, was attached as an ell to the west elevation of the main building at the time of the Young studio's construction (figs. 136 & 137). ⁴¹ Although it is not known when the bindery was originally built, the building is thought to date to 1915 or before, since it had windows with horizontal multi-pane sashes similar to those used in the Weir studio and on other buildings on the farm between 1885 and 1915. The configuration of these sashes suggests that they were originally used on the original exterior west wall of the Weir studio, which was blocked circa 1899 by the construction of its lean-to. The one room in this building was used by Young for his etching process.

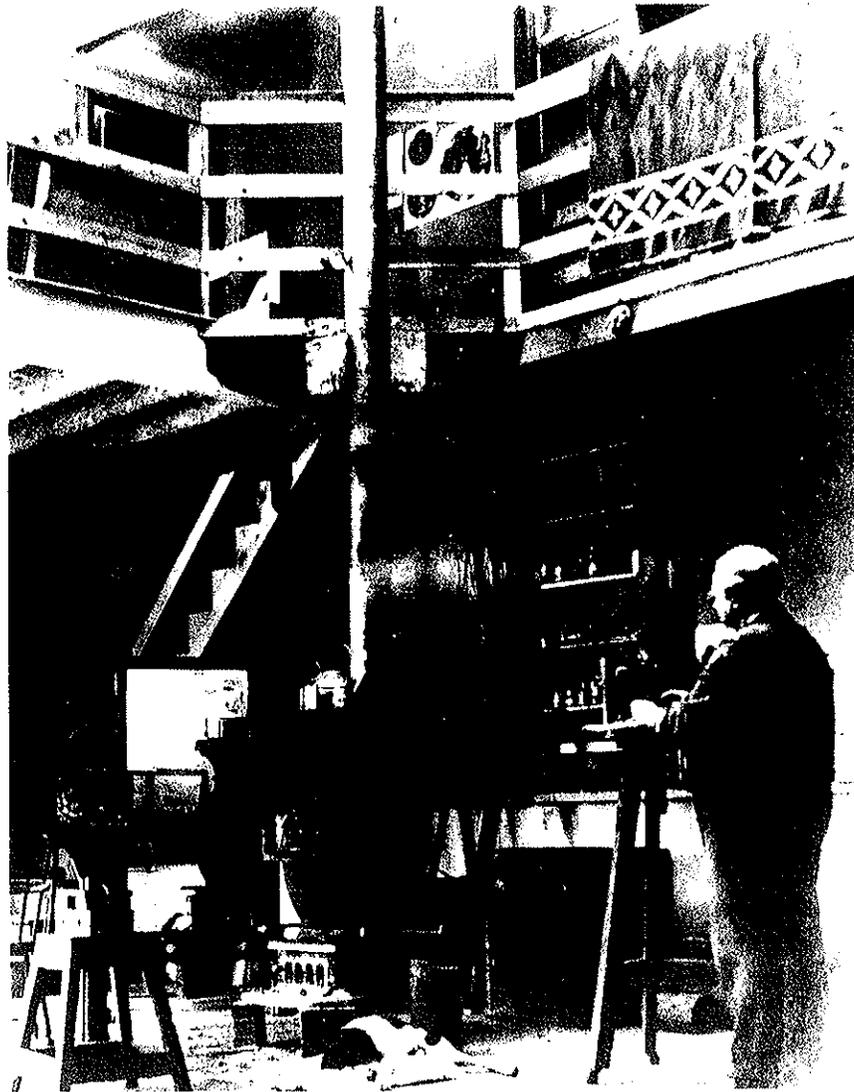
Figure 138. Mahonri Young in Young Studio (After 1932).

Several photographs have survived that show Young in his studio shortly after it was completed (**figs. 138-143**). A major portion of the interior of the new studio was comprised of one great open space (**figs. 138 & 139**). The etching room and a cozy mezzanine floor at the north side of the studio provided more intimate areas (**figs. 140 & 141**). Bill Young described the "balcony" (or mezzanine) as a secluded spot which Mahonri Young used as his study and library.⁴⁵ In the mornings Young worked on the large first floor with clay and plaster, making use of a sink with running water in the southwest corner and a bathtub in which he kept his damp clay.⁴⁶ The sink and tub were illustrated in a circa-1938 Young sketch (**fig. 142** - water had been piped to the studio soon after it was completed).⁴⁷ In the afternoons he worked upstairs where it was clean and quiet. It is said that Mahonri Young wrote his autobiography in his studio⁴⁸ **Figure 141** shows Young at his desk in the mezzanine study shortly after the studio was built. There were narrow balconies with ladders on the east and west walls to reach the many shelves of **books (figs. 139 & 143)**.

Figure 140 shows Young at his press in the etching room. Visible in the view are the tongue-and-groove pine-board flooring, which was continued from the studio (**fig. 138**), and the interior walls and ceilings, which were covered with fiberboard, a beaded narrow-board paneling, and wider-board paneling. Ray Meyer described the fiberboard as "Celotex," an insulating cane board made by the Celotex Company of Chicago.⁴⁹ The interior walls of the studio were covered with the same fiberboard.

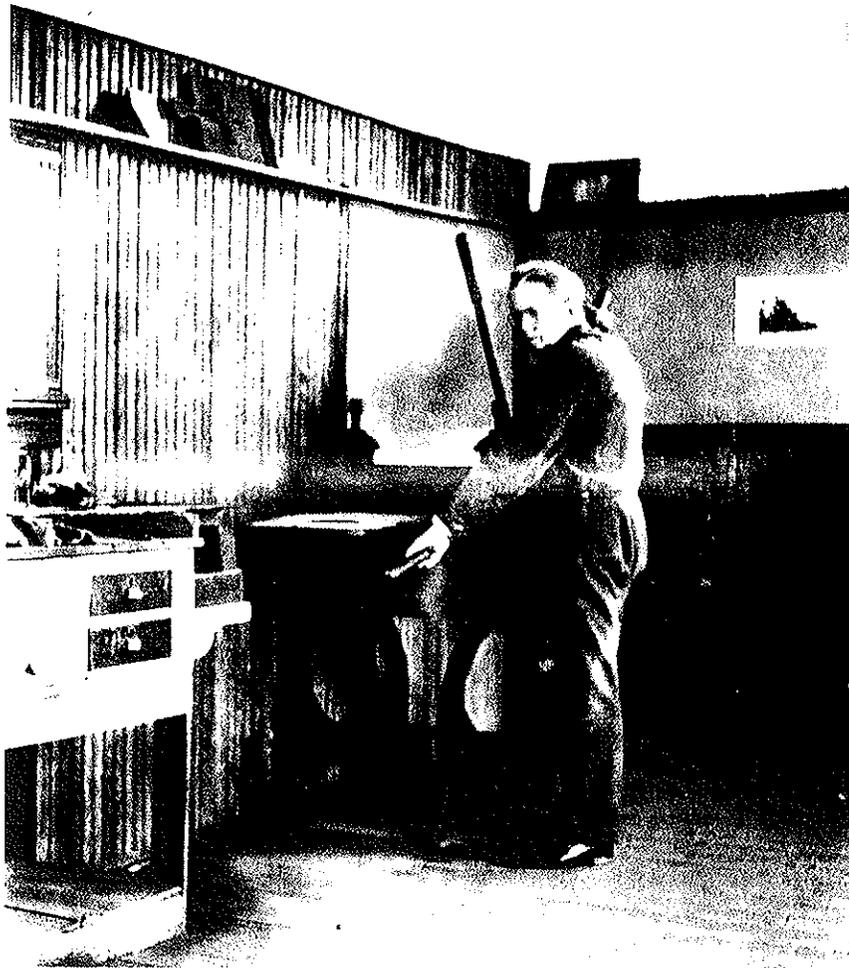
Figure 139. Mahonri Young in Young Studio - View of Northeast Corner (After 1932).

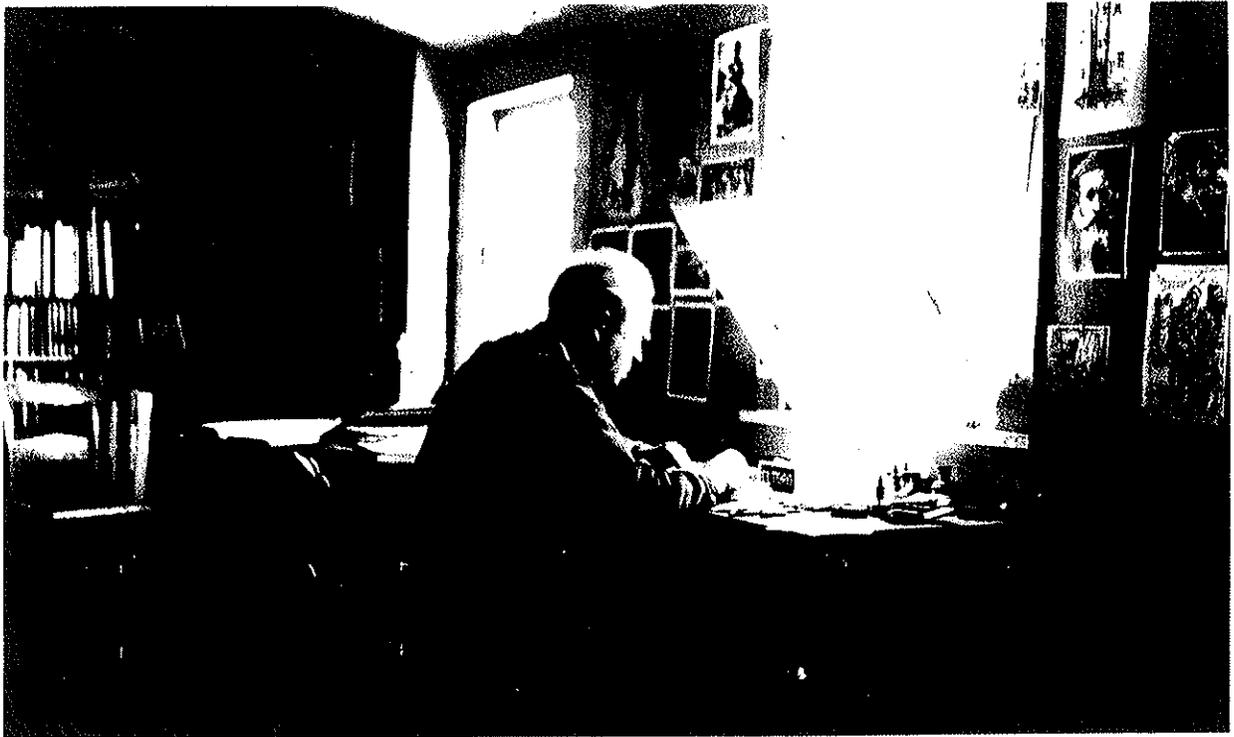
Figure 140. Mahonri Young in Etching Room of Young Studio - View of Southwest Corner (After 1932).

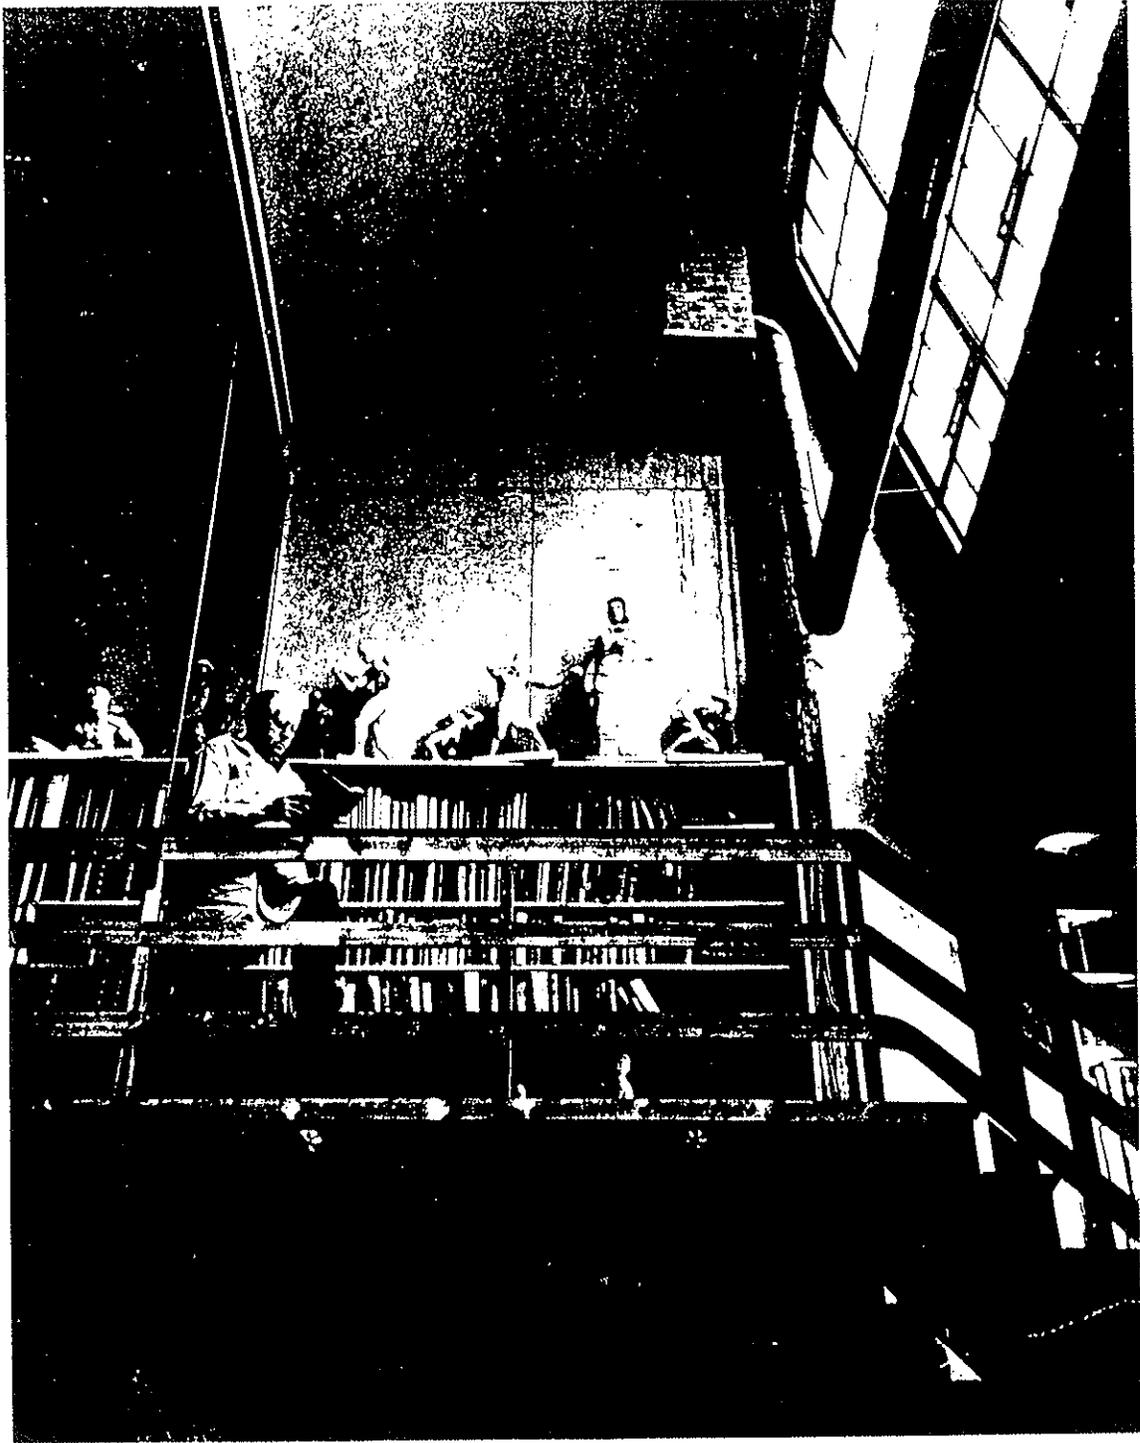
Figure 142. Mahonri Young, Untitled Sketch Showing Young's Assistants Working in Studio (Circa 1938).

Presently there is no interior plumbing in the Young studio. However, physical evidence of former plumbing exists in the form of capped water pipes and a drain at the southwest corner of the main studio, behind the new temporary furnace. Historic photographs and a circa-1938 Young sketch (**fig. 142**) indicate that there was a wall-mounted porcelain sink with a high splashboard and a high arched faucet in this location that was used by Young and his assistants. Sometime after 1938 the sink was removed; the original water pipes are presently capped and the drain is fitted with the propane supply for the furnace. In this same area on the exterior at the south end of the west wall is an outdoor faucet projecting from the ground. This faucet may be attached to a remaining section of the pipe that once fed the sink.

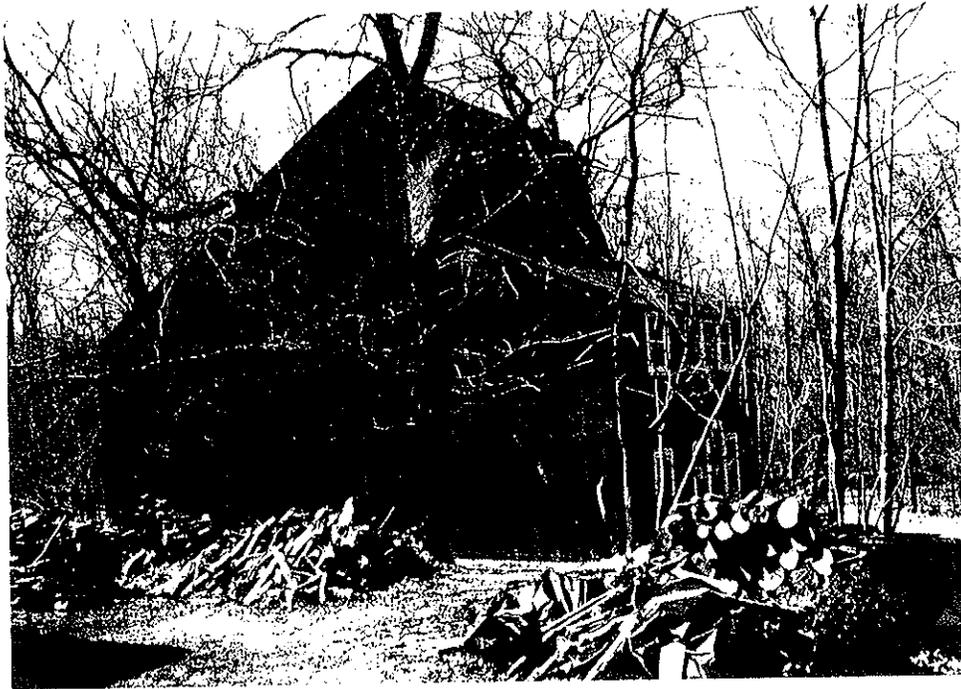
The east elevation of the Young studio illustrates the modified A-frame shape and tall roof of the main building. This side of the studio, which faces the Weir studio, barn, and Nod Hill Road to the east, has no windows or doorways. It characteristically has always had a woodpile in front (see **fig. 144**).

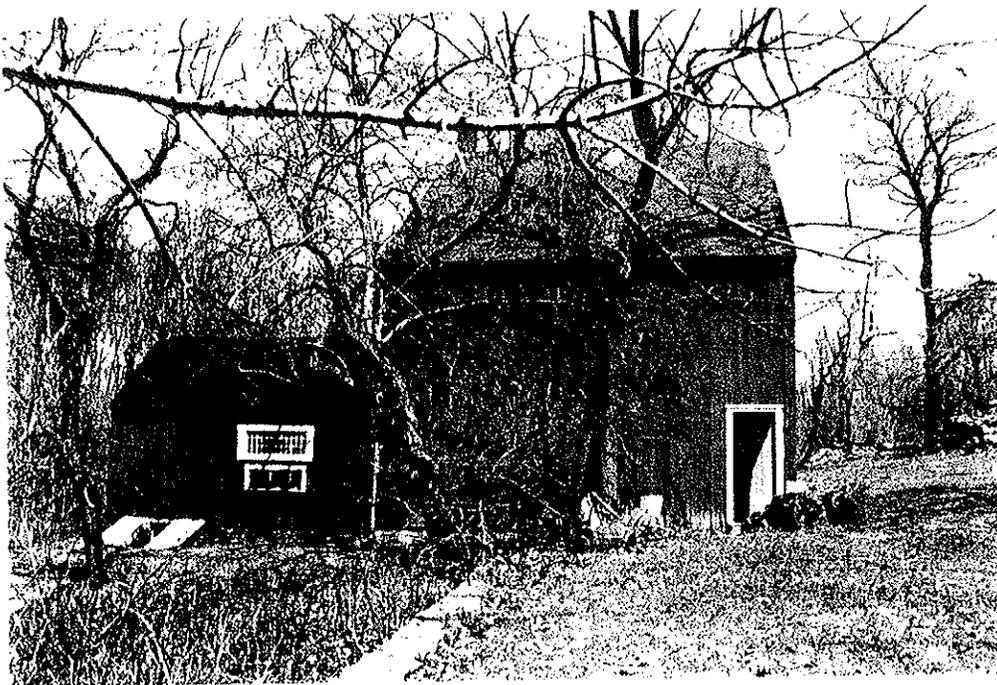
Figure 146. Young Studio - South Elevation (1994).

The south elevation includes both the main building and the ell. The main entry doorway (D1) to the studio is at the east end of the main building; a bulkhead door (D2) to the etching room basement is at the west end of the ell. Two windows placed one over the other (W101 & W102) are on the south elevation of the ell, and an opening with a vertical-board casement sash is located on the second-story level of the main building just under the eave.

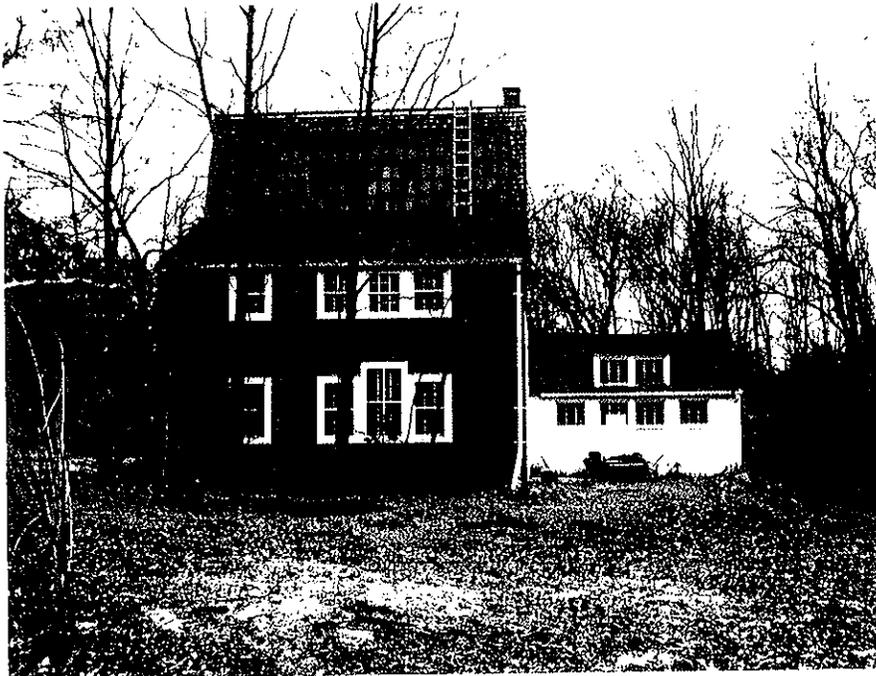
The west elevation illustrates the different roof heights of the main building and the ell attached to its south end. A doorway (D3) on the ell west wall is walled off on the interior but has retained its door on the exterior. An oversized double doorway with double transom doors above (D4) is located on the west wall of the main studio to the left (north) of the junction with the ell. A double-sash window (W107 & W108) is located at the north end of the main building and a multi-pane single-sash window (W202) is positioned over the blocked doorway on the ell.

Figure 147. Young Studio -West Elevation (1994).

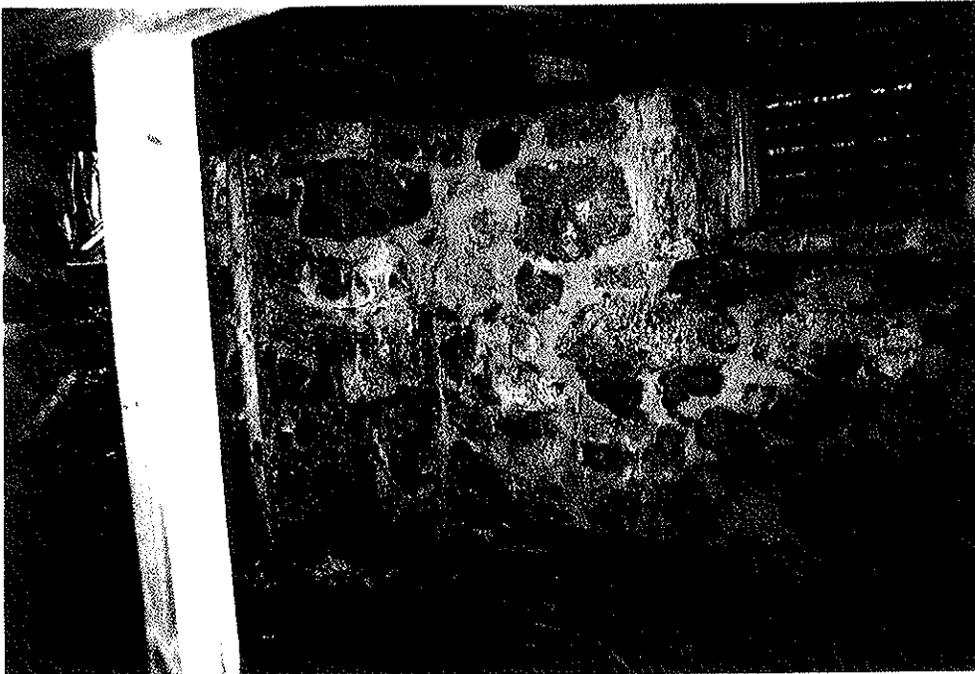
Figure 149. Young Studio - Basement [Room 001], Southwest Corner (1993).

The basement measures approximately 12 feet 6 inches wide by 18 feet long. A bulkhead door (D4) is located on the south wall (fig. 150), and a louvered window (W001) is on the west wall (fig. 149).

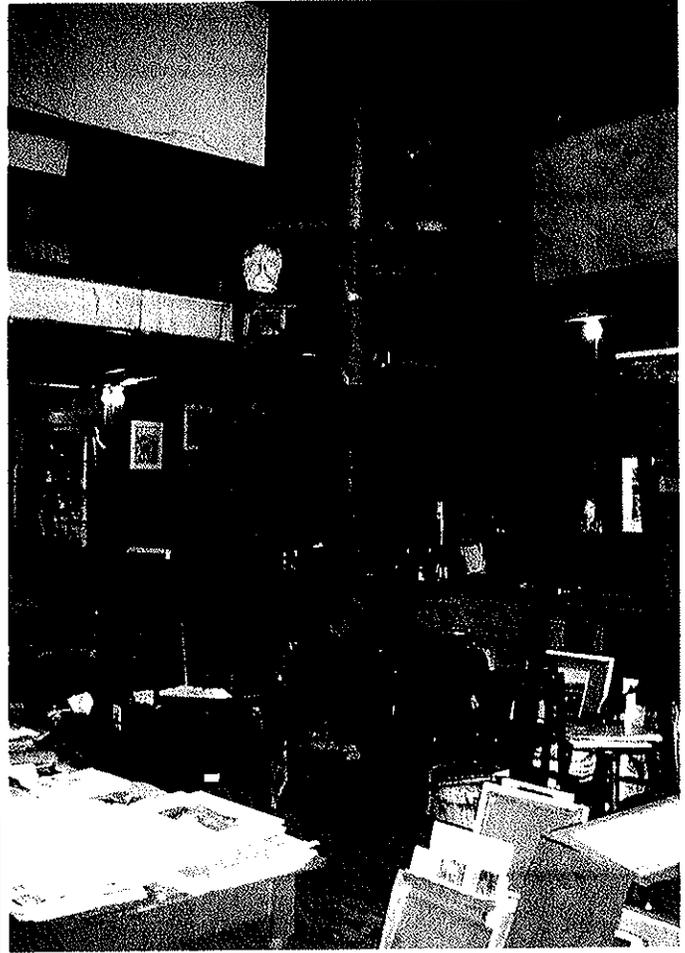
Figure 152. Young Studio - Studio [Room 101], Looking South (1993).

The studio (Room 101) was Mahonri Young's primary work space for sculpting and painting. The room measures 25 feet wide by 37 feet long with its ceiling open to the roof ridge two and a half stories above. A mezzanine on the north wall and balconies on the east and west walls are visible from the floor. Tables and work surfaces line the northwest corner walls, over which are located a double-sash window (W107/W108) on the west wall and a triple-sash window (W109/W110/W111) on the north wall (**fig. 151**). A single-sash window (W112) is located at the east end of the north wall over the beginning of a staircase that doglegs up the mezzanine. A large six-sash skylight (W301-W306) fills the north slope of the ceiling above and to the south of the mezzanine. A 1932 heating stove sits in the northeast area of the room under the outer corner of the mezzanine and east balcony (**figs. 153 & 154**). An exterior doorway (D1) is located at the east end of the south wall. A double-door exterior doorway with a double-door transom (D4), used to transport large works of art in and out of the studio, is located on the west wall. An interior doorway (D101) is located on the west wall to the south (left) of the double doorway and opens into the etching room.

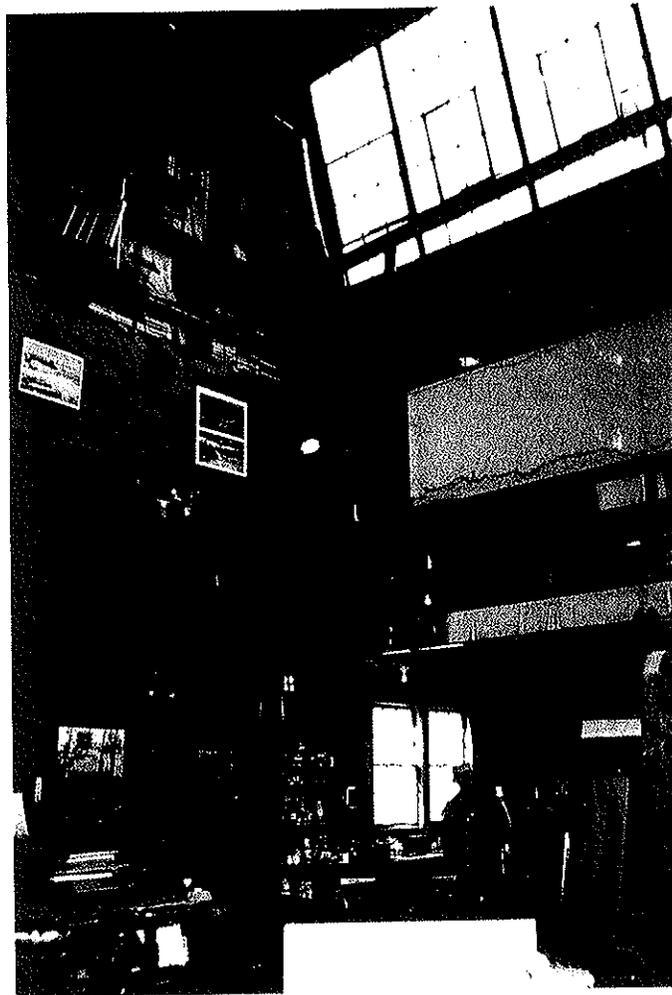
A mezzanine (Room 201) is located at the north end of, and overlooks, the studio (Room 101). It was in the mezzanine that Mahonri Young spent his quiet hours writing and reading. The room measures 25 feet wide by 10 feet 6 inches deep. Four windows (W205-W208) are located on the north wall of the room. A staircase from the first floor is located in the northeast corner. A bannister runs along the south edge of the mezzanine, and steps at each end of the bannister lead up to the balconies on the east and west walls.

Figure 158. Young Studio - Mezzanine [Room 201], Looking West (1994).

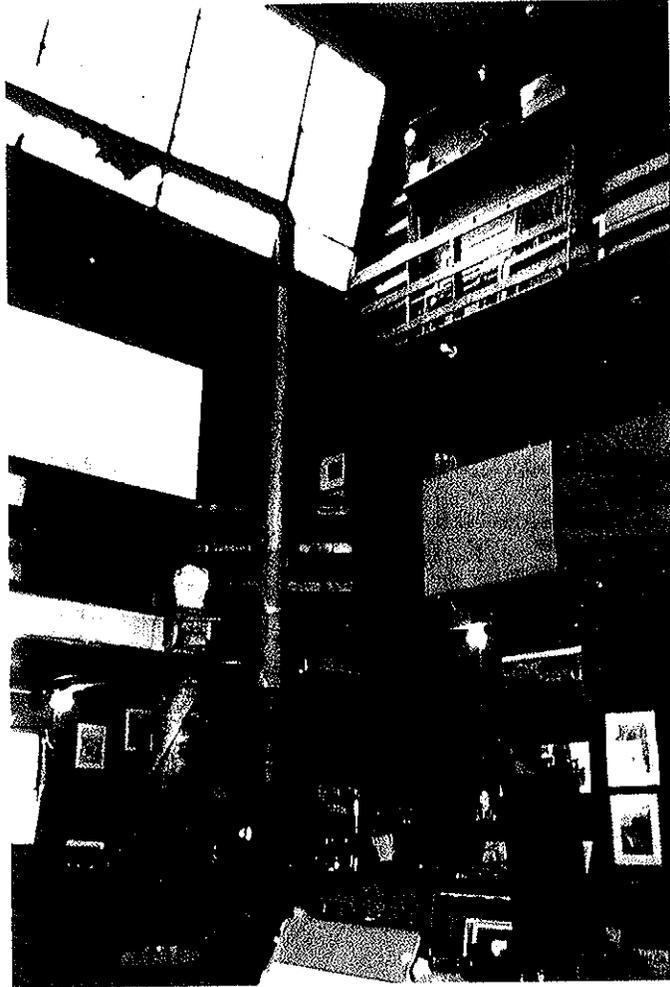
A west balcony (Room 201A) and an east balcony (Room 201B) run along the west and east walls of the studio on a level a few steps up from the mezzanine. These balconies date to the 1932 construction of the Young studio. The balconies each measure 3 feet 6 inches deep by approximately 26 feet 6 inches long and are reached by a few steps at each end of a bannister that runs along the south edge of the mezzanine. A ladder attached to the wall at the north end of the east balcony leads up to the upper east balcony (Room 201C), thought to have been built after 1958. A bannister runs along the outer edge of each of the three balconies.

Figure 159. Young Studio - West Balcony [Room 201A], North End (1994.)

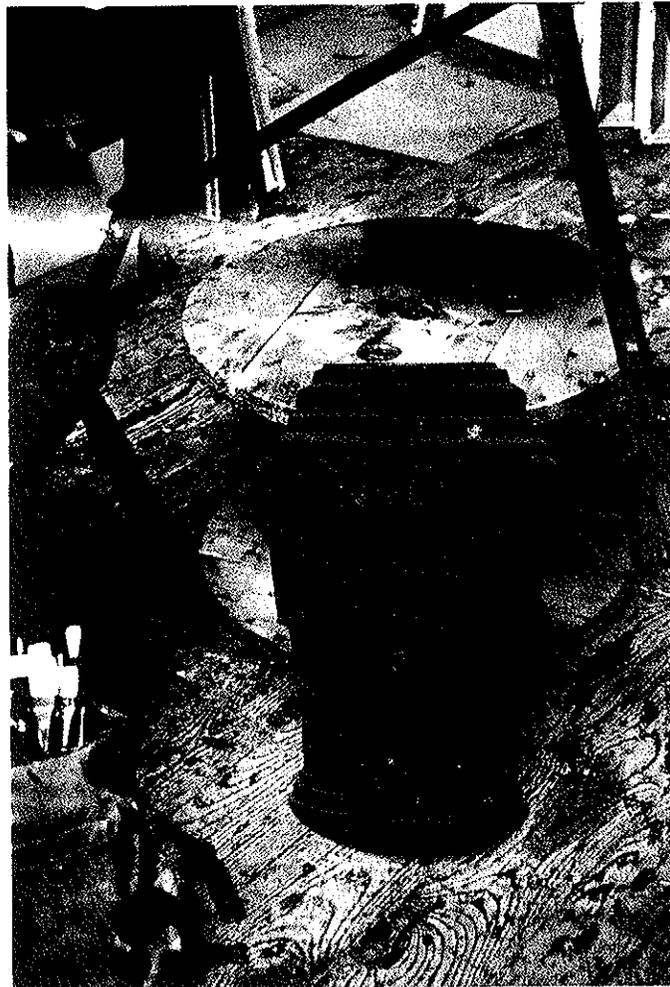
Figure 161. Young Studio - Remnant of Cast-Iron Stove Stored in Room 101 (1994).

The existence of the stored stoves and stove parts is recorded here for future reference. The provenance of the stoves is not known, although, according to Sperry Andrews, one may be the original stove used in the Weir studio (see discussion in **HISTORICAL BACKGROUND and ARCHITECTURAL EVOLUTION - WEIR STUDIO**, above).
