Subject: National Register Nomination for Crane Flat Fire Lookout, Yosemite National Park

NATIONAL REGISTER OF HISTORIC PLACES REGISTRATION FORM

historic name Crane Flat Fire Lookout
other names/site number Building 6202

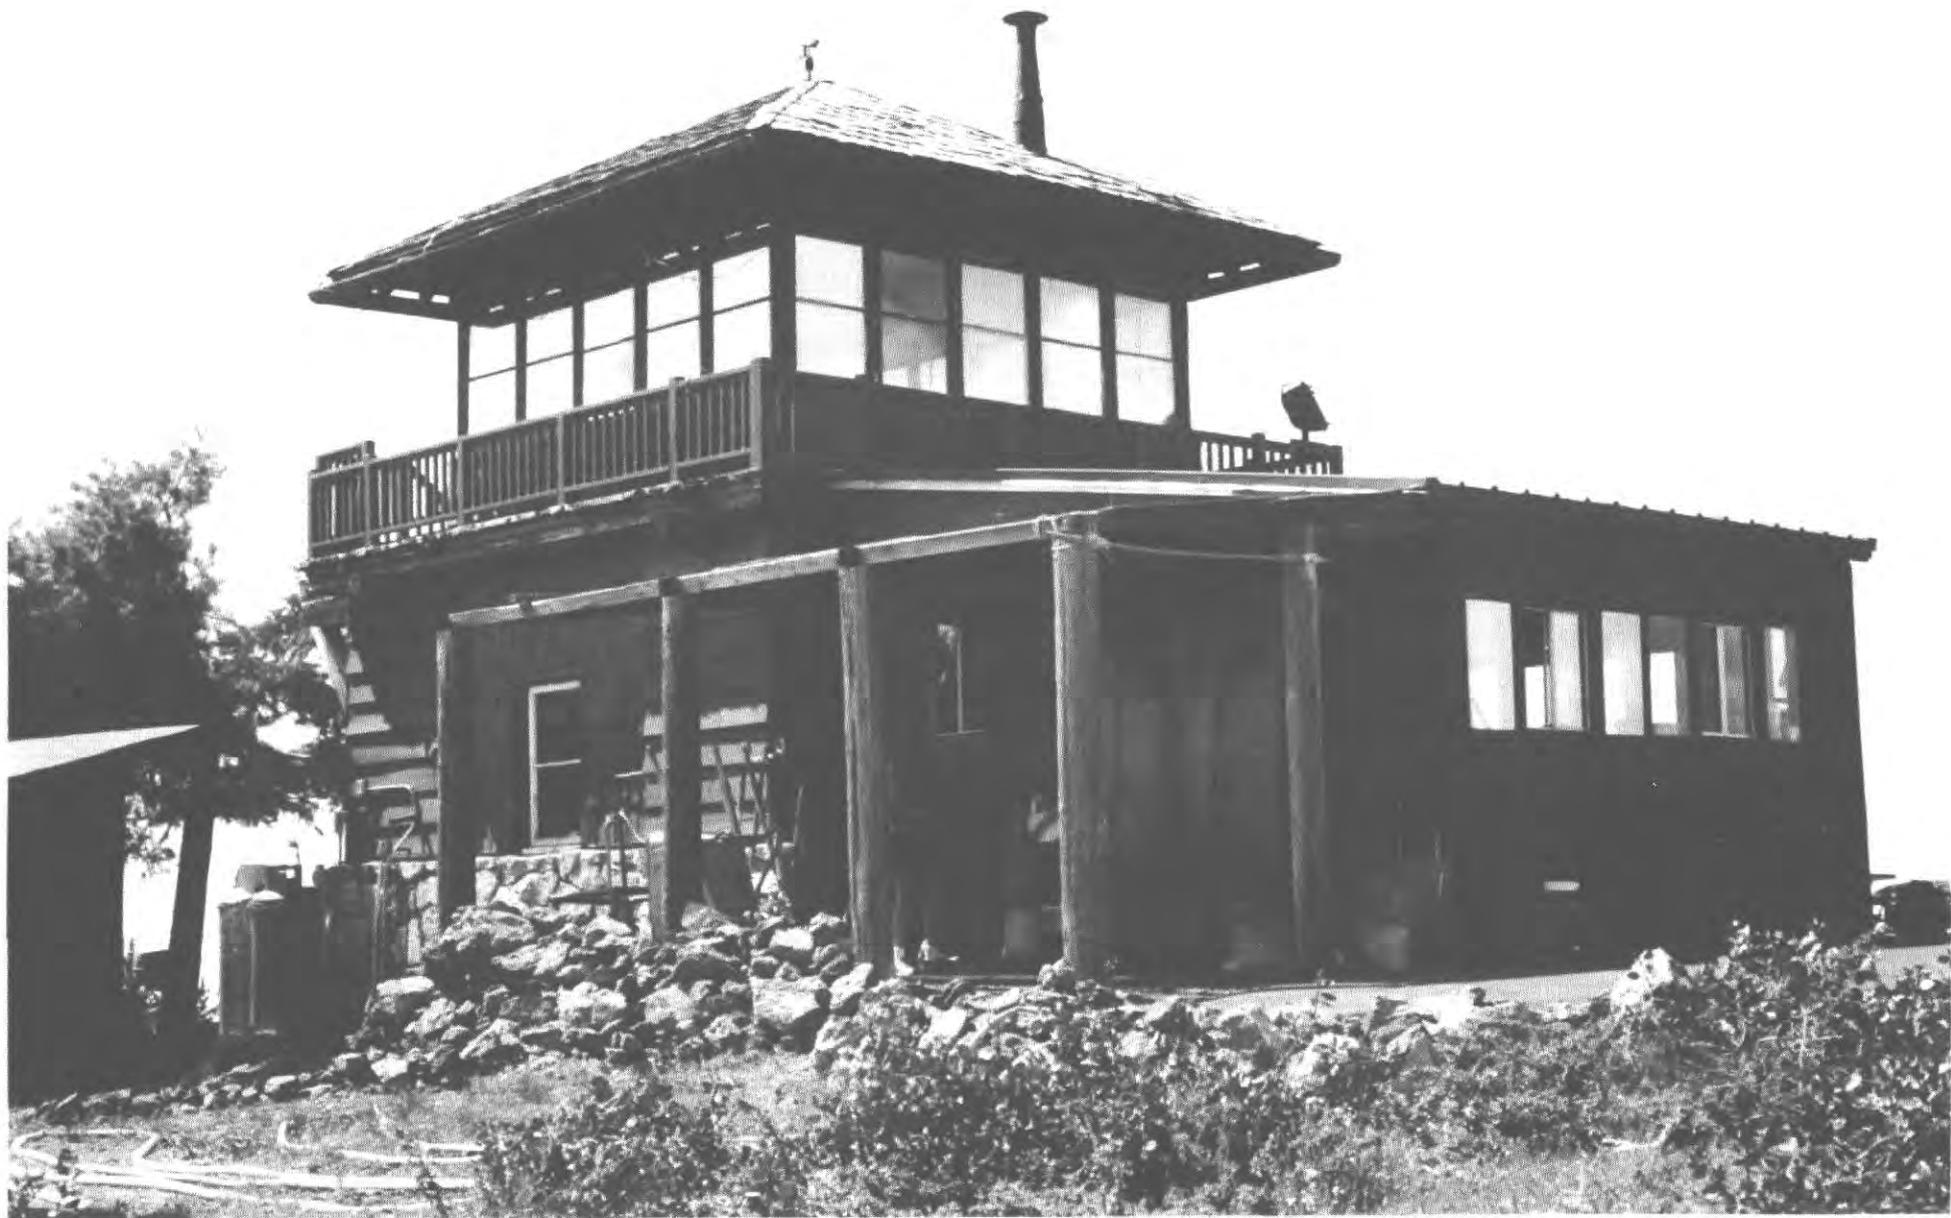
Photo # 1

Looking southeast

The Crane Flat fire lookout, though unusual in having a garage on the ground story, was nonetheless typical of fire lookout design in the 1930s, particularly in its utilization of a glass wall, cat walk and overhanging roof. The addition and lean-to are scheduled to be removed and the lookout is scheduled for complete restoration, much as was recently done with the Henness Ridge fire lookout. Once this work is completed, the Crane Flat lookout will have regained all its structural integrity.

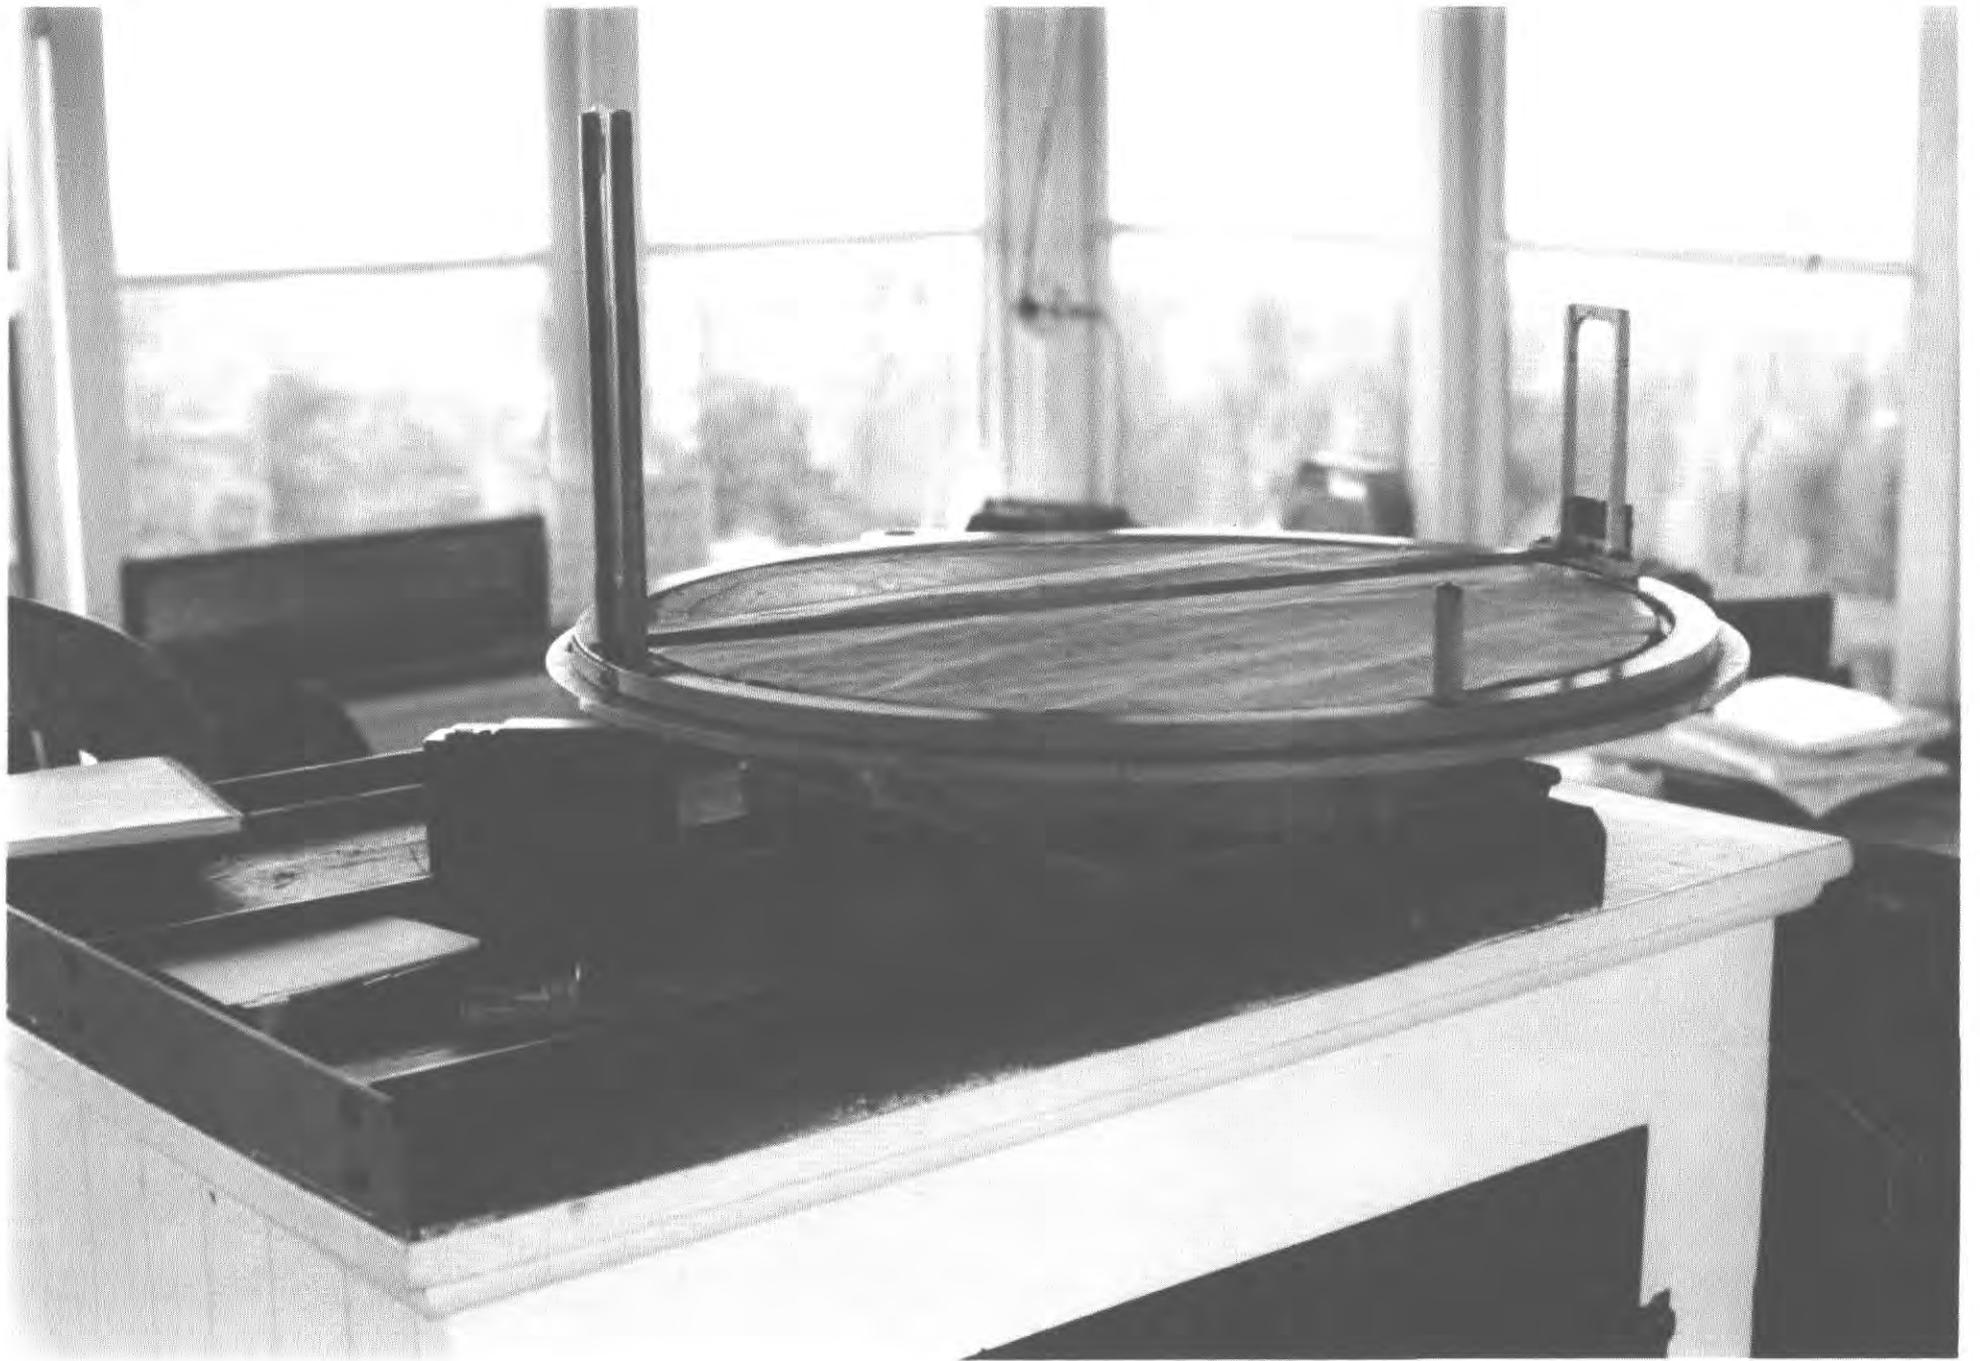
Photo #3

Interior, Fire Finder
