National Park Service
Cultural Landscapes Inventory
2007

Glacier Point Road
Yosemite National Park

CULTURAL LANDSCAPES INVENTORY (CLI) 2007

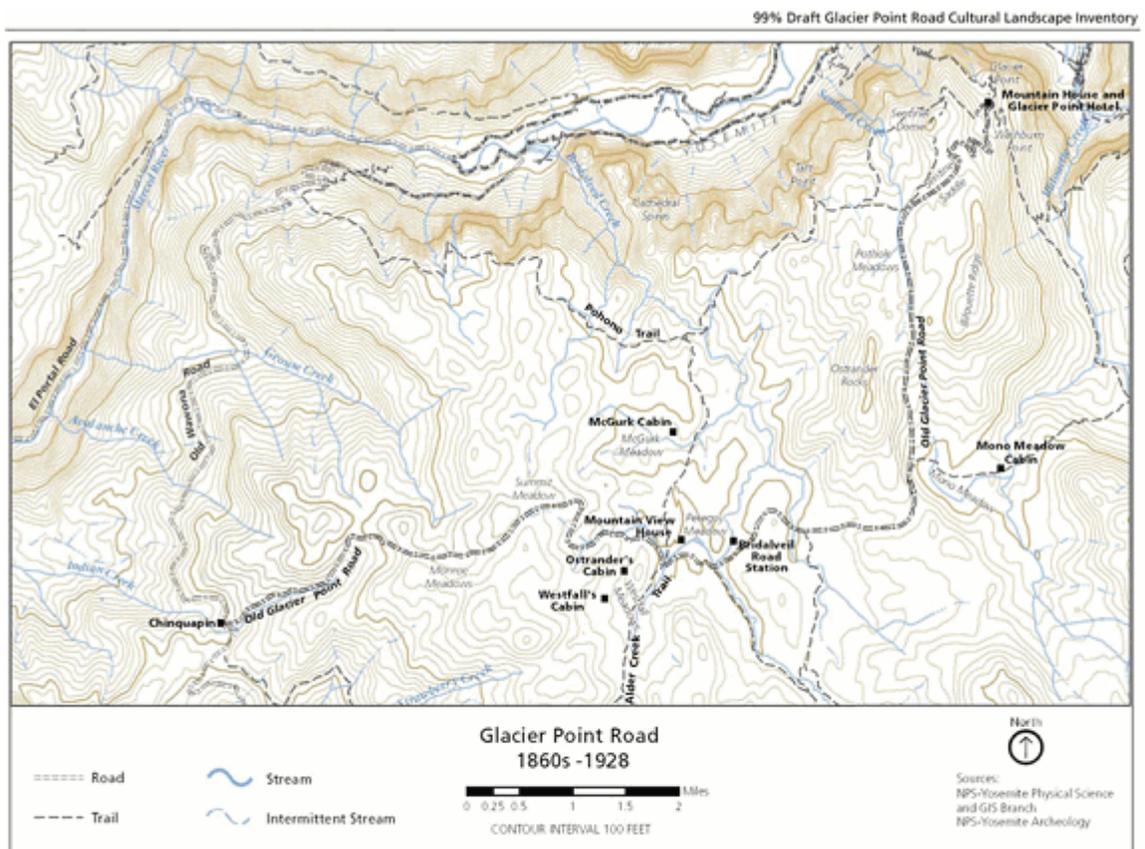
Figure 3. Map of Glacier Point Road Landscape, 1860s-1928

History Figure 1. Map of Glacier Point Road Landscape, 1860s-1928.

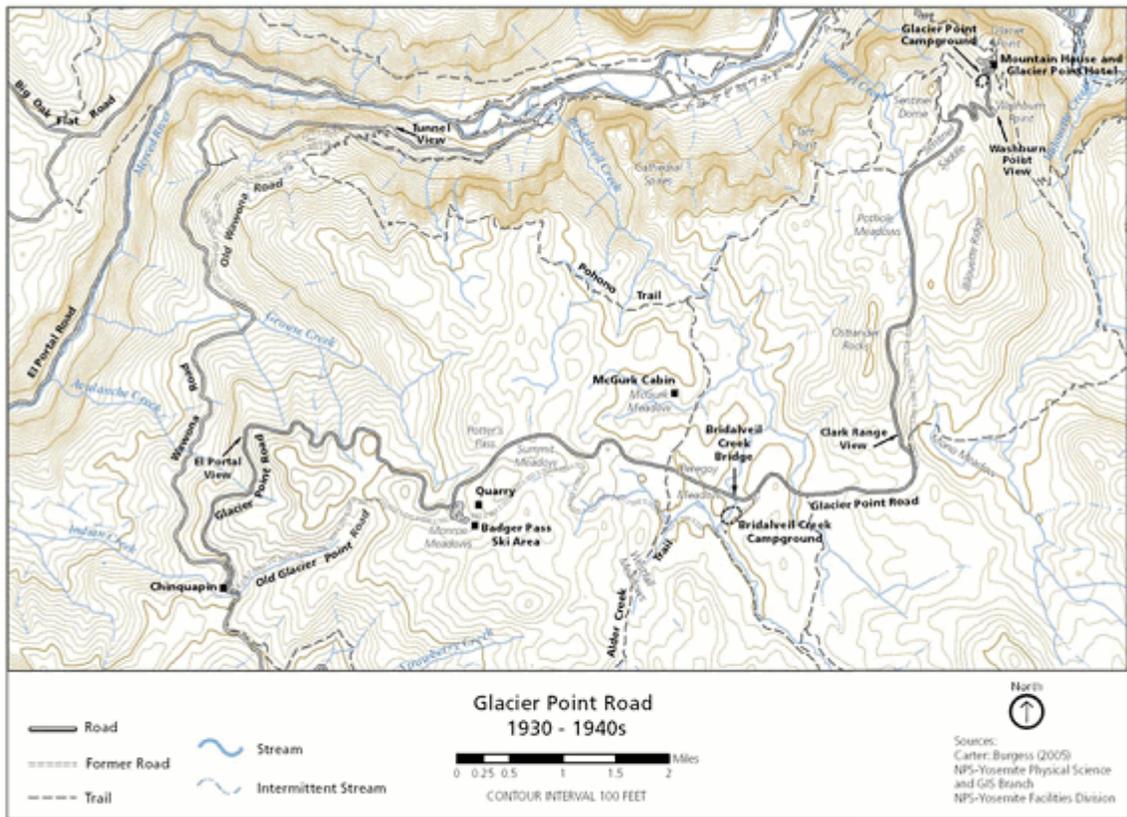
Figure 5. Map of Glacier Point Road Landscape, 1930-1940s

History Figure 3. Map of Glacier Point Road Landscape, 1930-present.

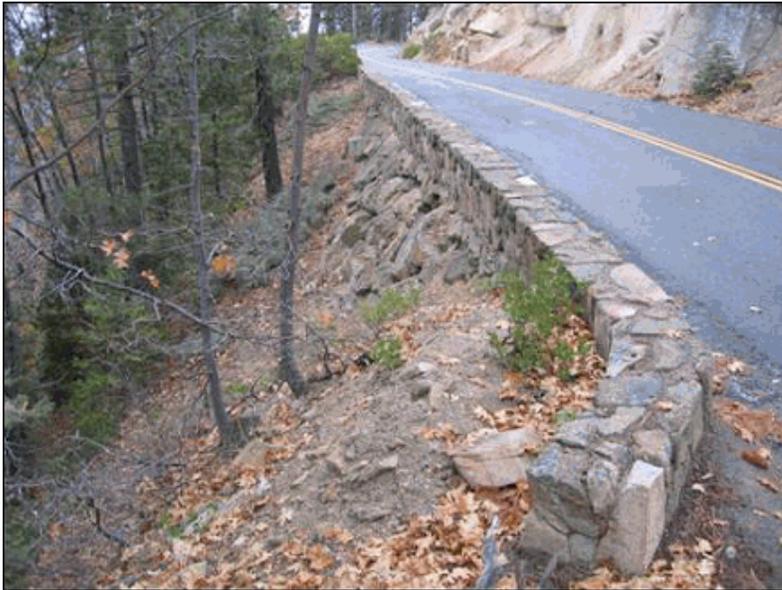
*Guardwall and Embankment at Mile 1.9, Showing Rock Cut and Steep Fill Slope
Photo by Clare Sandy, NewFields, 2005*

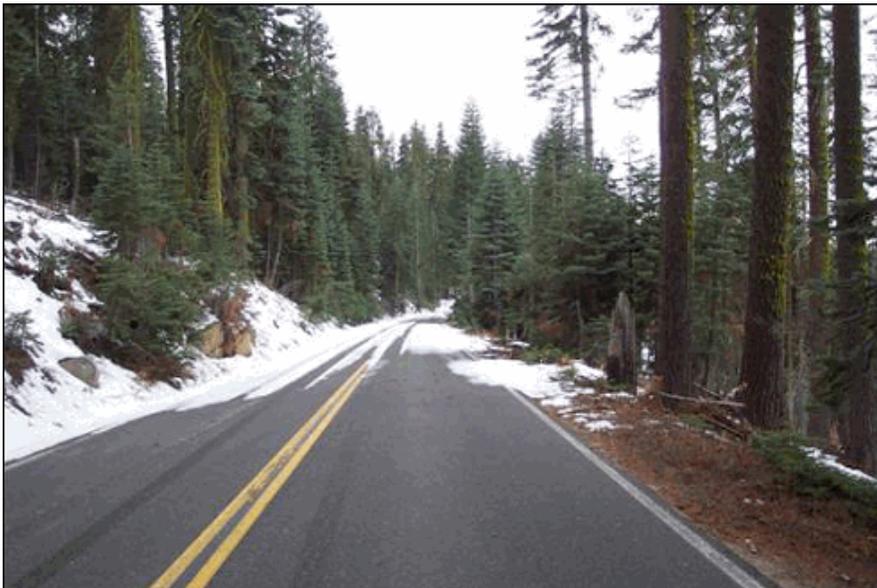
*Example of Cut and Fill at Mile 5.5
Photo by Clare Sandy, NewFields, 2006*

Cuts and fills, integral to the geometry of an engineered road, are found along the entire length of Glacier Point Road. A typical cut and fill construction consists of one travel lane carved into a slope. The material that was cut from the slope is then used to fill the adjacent, downslope travel lane. The ratio of the amount of cut to fill is equal throughout most of the roadway. Cut and fill is predominant in the Chinquapin to Potter's Pass segment, where the road traverses a fairly steep slope and dramatically climbs in elevation (Mile 5.5, Figure 9, for example). While traveling east in this segment, the road traverses a right-to-left side slope with the cut side of the road on the right and the fill on the left at a fairly equal ratio. Examples of cut and fill are also found in the Potter's Pass to Mono Meadow segment (at Mile 6.8 and 7.4), and the Ostrander Rocks segment (Mile 10.5). Significant examples of cut and fill are found as Glacier Point Road descends to Glacier Point through a series of steep winding curves cut into the hillside in the Switchbacks segment. In some areas of significant uphill cuts into earth or rock, the fill is used to construct a turnout on the fill slope as well as the roadbed, for example, at Mile 7.0. For this reason, there are many more turnouts on the left side of the road than the right from Chinquapin to Badger Pass. NPS standards were used for cut and fill slope ratios and rounding (Roach 1933: 4-7).

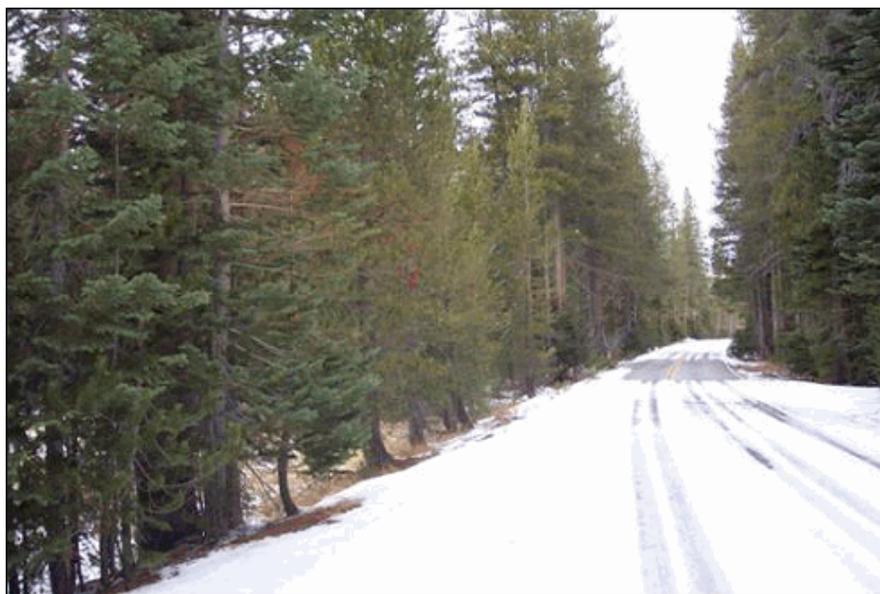
*Example of Immature Trees Grown Up Along Roadway at Pothole Meadow
Photo by Devon Rothell, NewFields, 2006*

Unregulated growth of vegetation along Glacier Point Road over many years has allowed some of the intended character of vegetation along the roadway to become obscured. The intended vegetation scheme along the road was not one of unlimited natural growth, but a carefully planned naturalistic atmosphere that emphasizes the road corridor and viewpoints, and was manipulated to blend in with the surrounding environment. Nonetheless, the overall pattern of species and types of vegetation, as well as individual specimens, are intact today along the road, and contribute to the historic setting of the Glacier Point Road landscape. The changes to the vegetation patterns and design along the road could be reversed through careful vegetation management, and historic patterns could be restored.

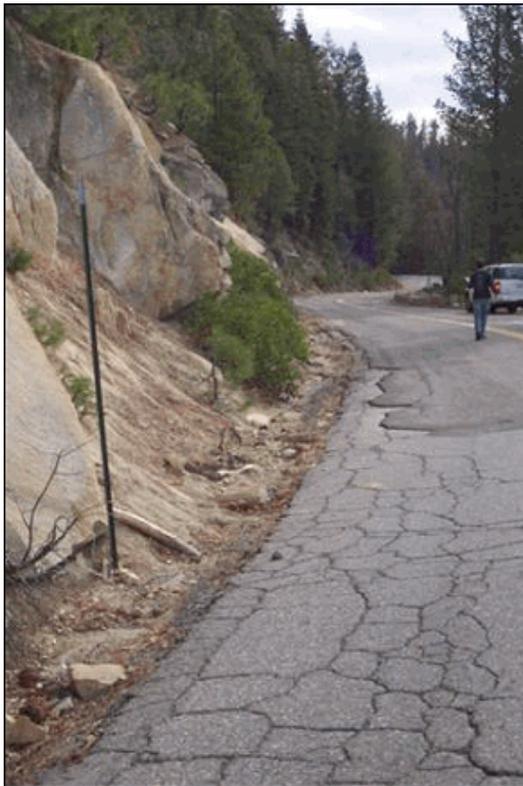
Example of Typical Curving Roadway, Chinquapin to Potter's Pass Segment, No Shoulder Striping

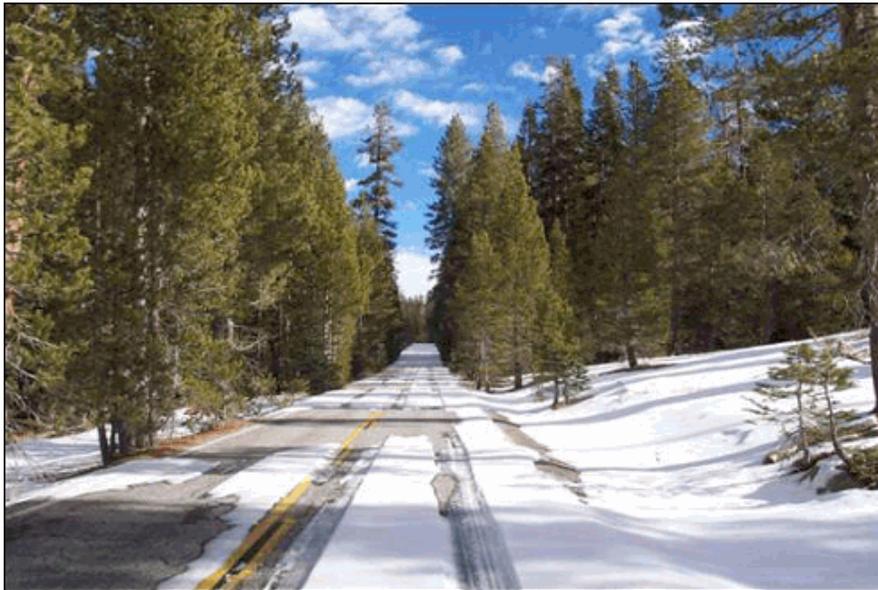
*Example of Typical Roadway in Area of Moderate Topography, Note Lack of Shoulder
Photo by Devon Rothell, NewFields, 2006*

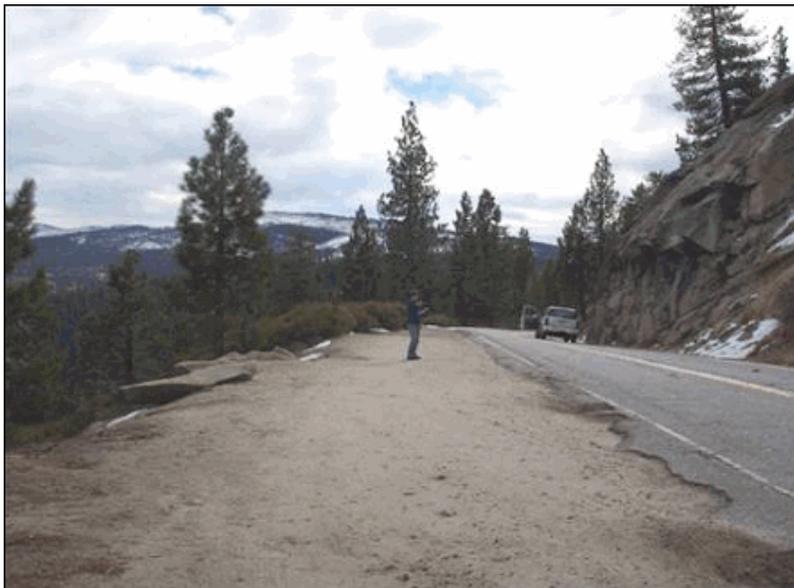
*Previously Paved Historic Turnout, Eroding Road Shoulder, at Mile 10.9
Photo by Devon Rothell, NewFields, 2006*

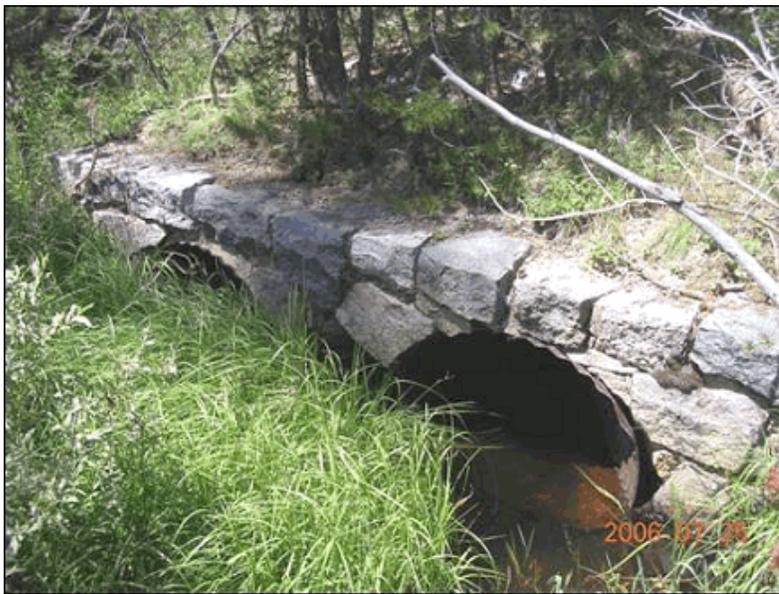
Example of Double 36-inch Pipe Culvert Headwall (at East Fork Bridalveil Creek, Mile 9.05)

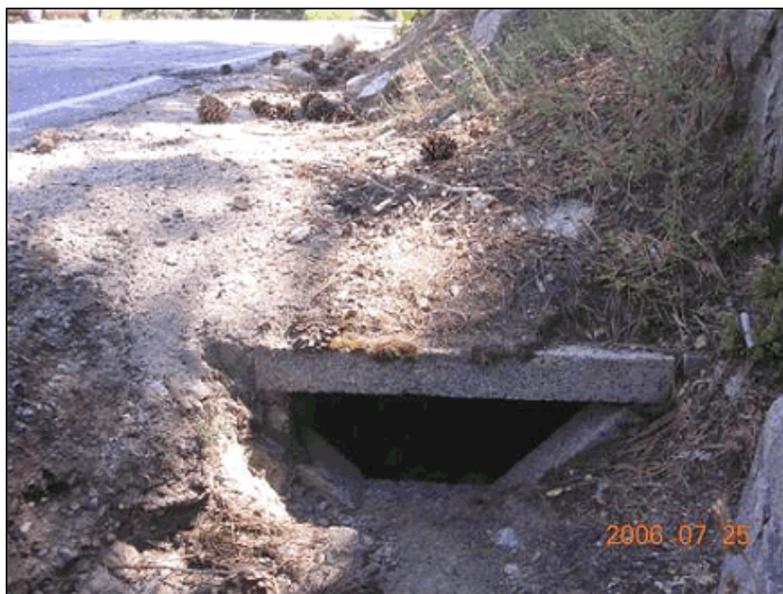
*Example of Concrete Slab Drop Inlet (at Mile 10.69)
Photo by Schuyler Greenleaf, NewFields, 2006*

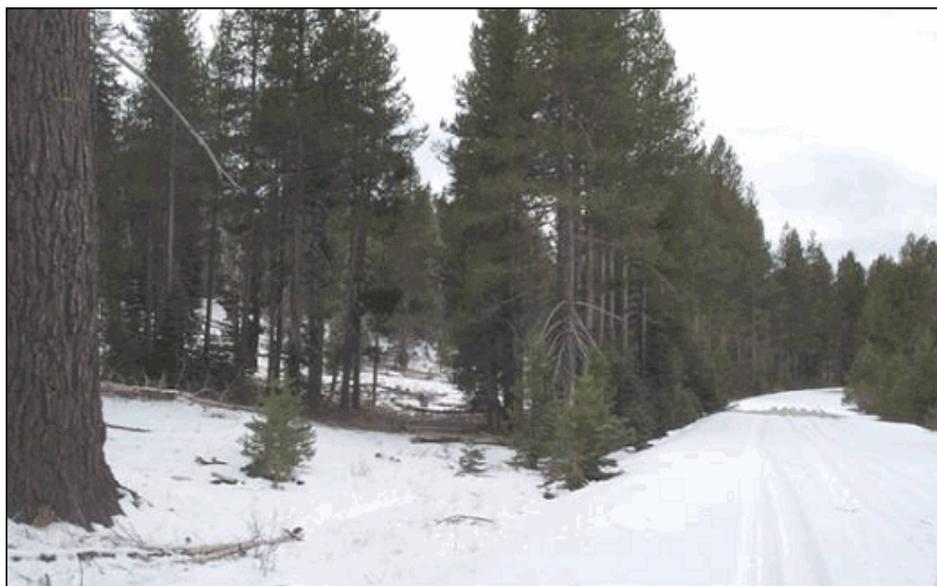
*Photograph Showing Old Glacier Point Road Trace (at center) and Glacier Point Road (at right), View to Southwest, near Mile 9.5
Photo by Devon Rothell, NewFields, 2006*
