National Park Service
Cultural Landscapes Inventory
2004

Cultural Landscape Inventory Level II:
Mariposa Grove
Yosemite National Park

MARIPOSA GROVE
YOSEMITE NATIONAL PARK

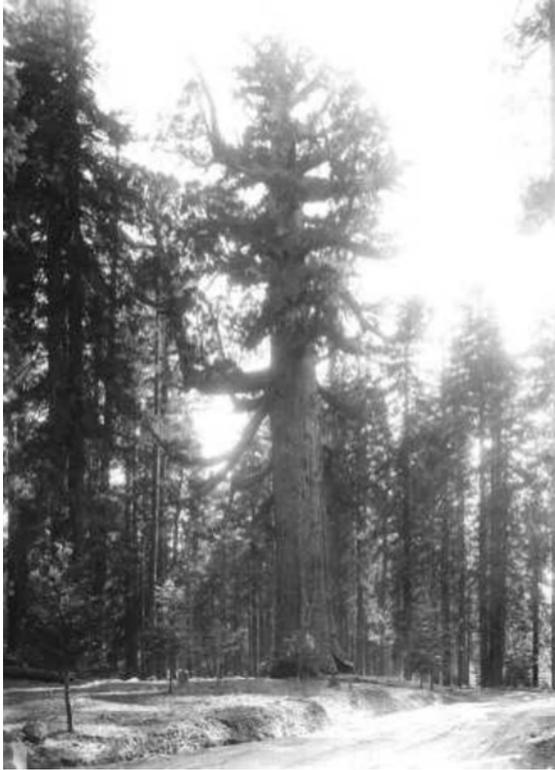
Figure 6. Photograph of the Grizzly Giant showing road and drainage ditches on north side of tree. YRL Photo No. RL-979447-7.

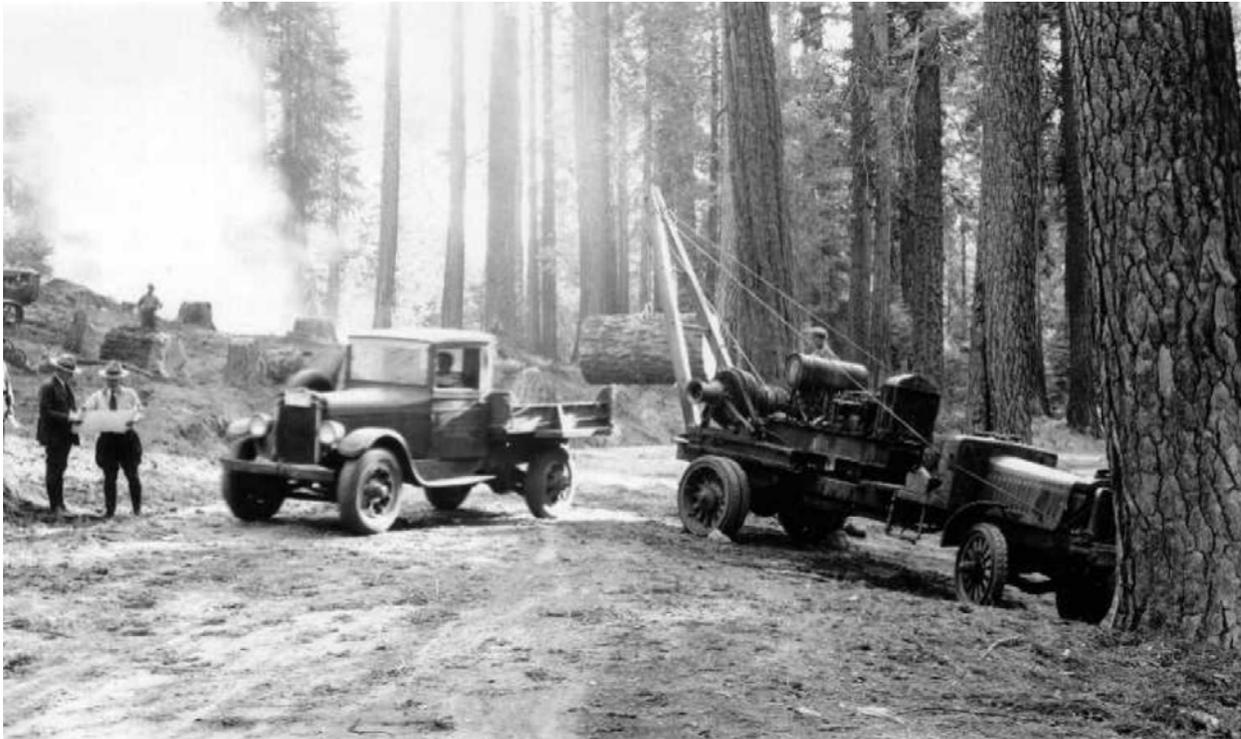
Figure 8. Rerouting the road around the Grizzly Giant. [Photo scanned from Thomson 1932 "Final Report, Grizzly Giant Road", Office of the Chief of Maintenance, El Portal, CA.]

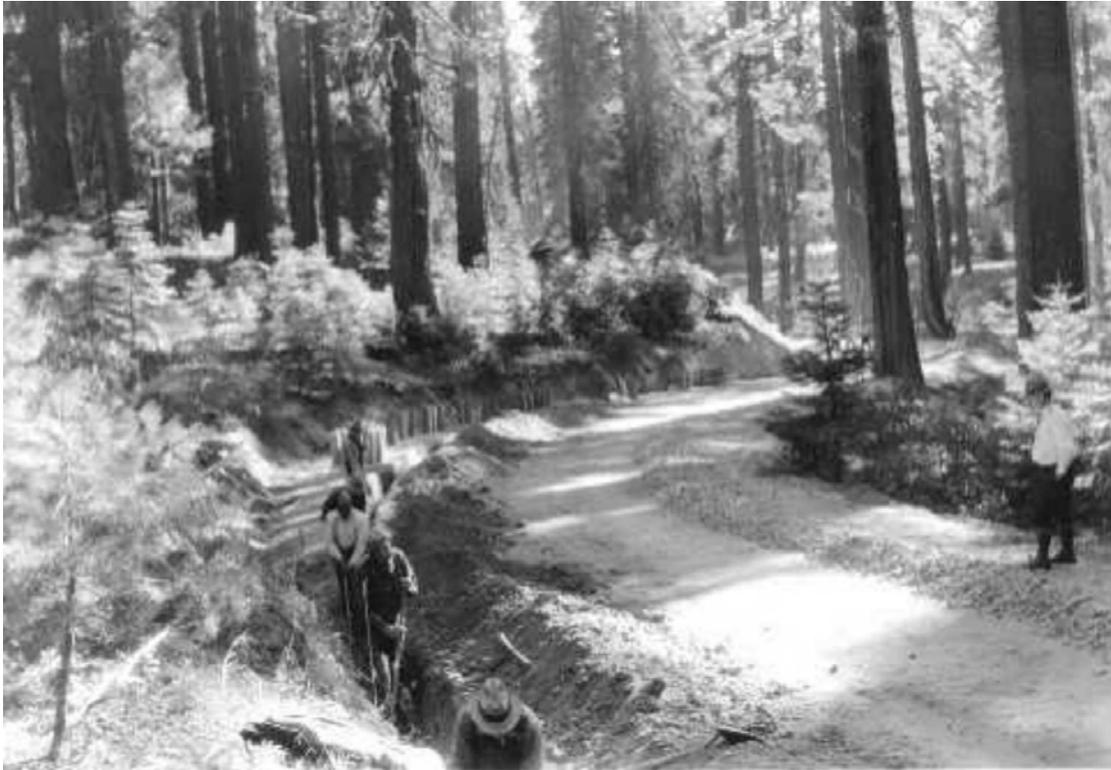
Figure 15. "Installing 6-inch drain tile..." [Scanned from Thomson 1934 "Preliminary Report – Armor Coat Paving Mariposa Grove Road F.P.#238.8 Account No. 521", Office of the Chief of Maintenance, YOSE, El Portal, CA.]

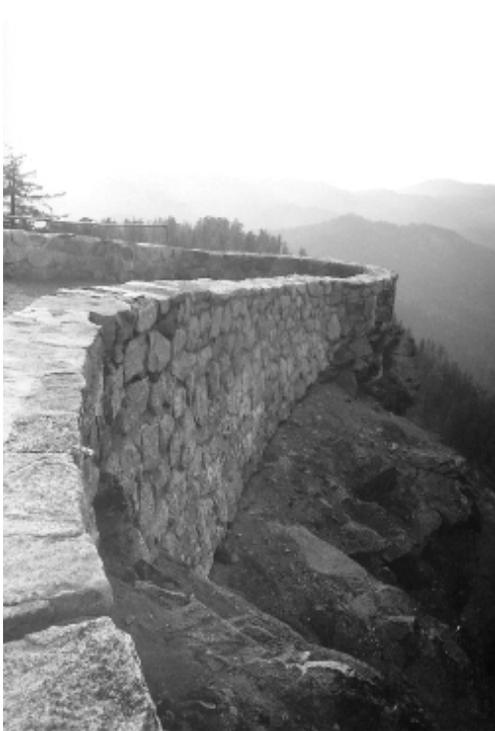
Overview of mortared stone retaining wall at Wawona Point Lookout. 11/1999, HRA

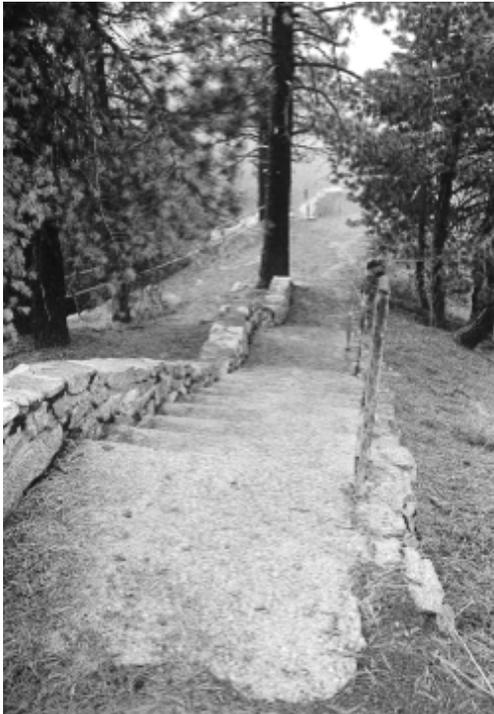
Sairway to north lookout platform at Wawona Point Lookout. Note that original stone stairs have been replaced with concrete. HRA, 11/1999.

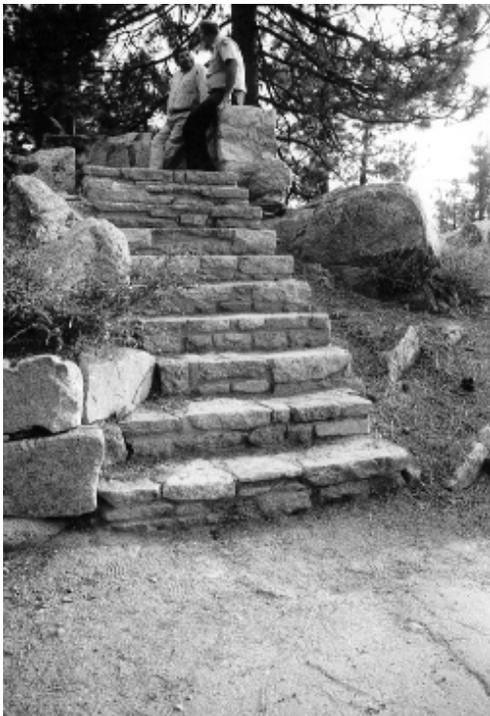
Stone stair to south lookout platform. Note original stone steps. HRA, 11/1999.

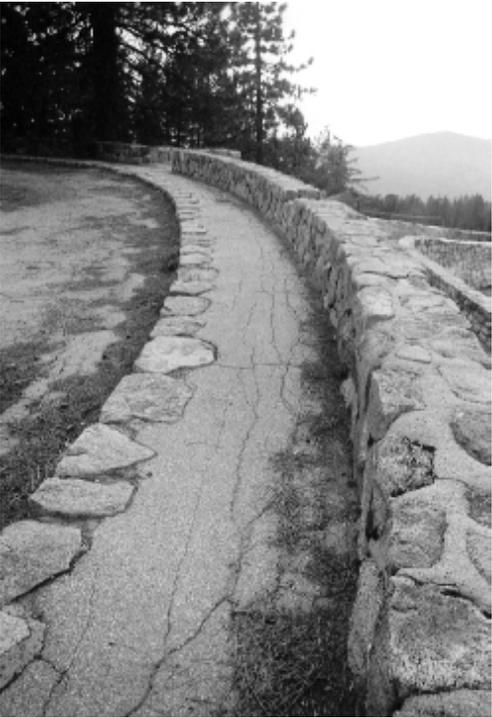
Parapet guardrail and stone-lined walk at Wawona Point. HRA, 11/1999

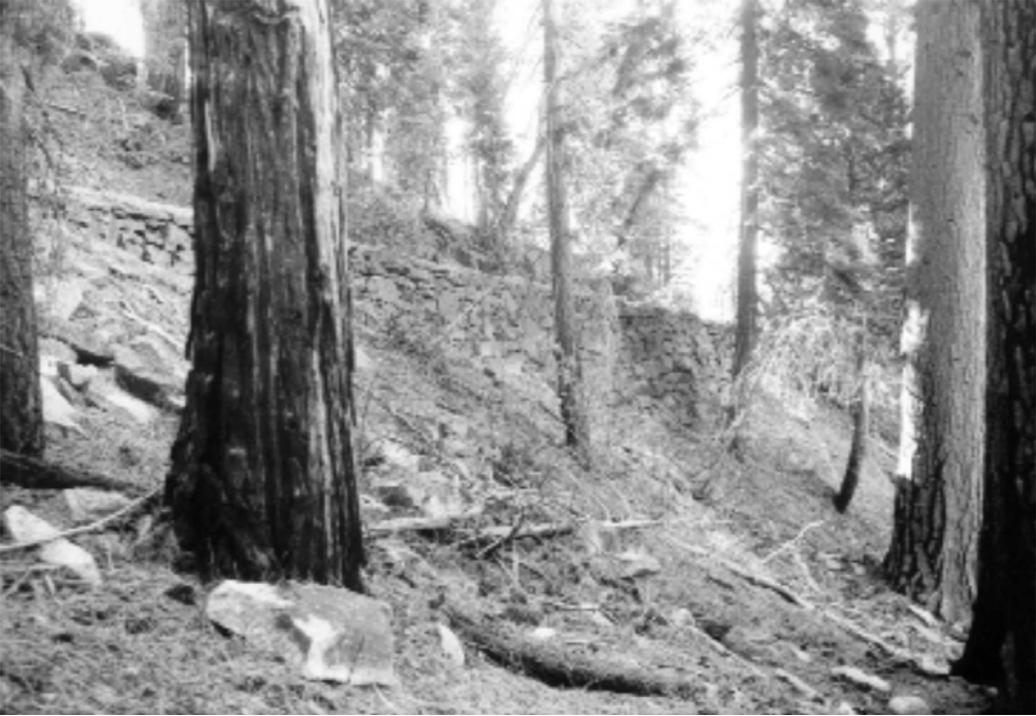
Dry-laid stone retaining wall stabilizing fill section in main vehicular road. HRA, 11/1999

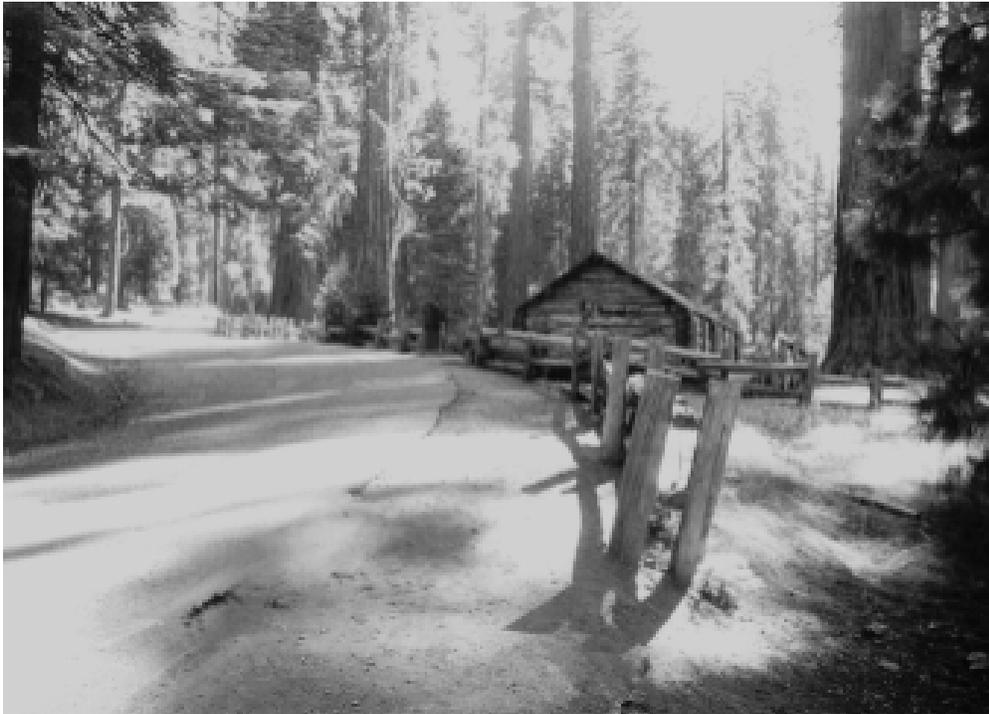
Looking southeast along road to museum. Note the raised grade in this vicinity, designed to cushion sequoia roots. Fencing is modern. HRA, 11/1999.

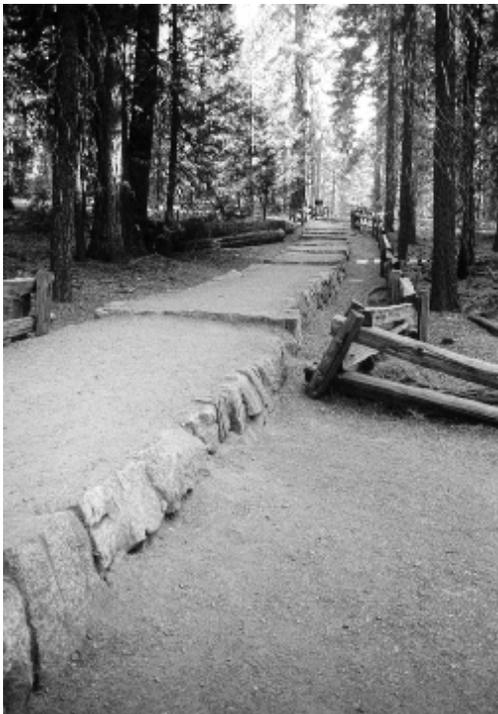
Looking northeast along the 1986 raised grade trail to the California Tree. These modern trails are noncontributing features. HRA, 11/ 1999

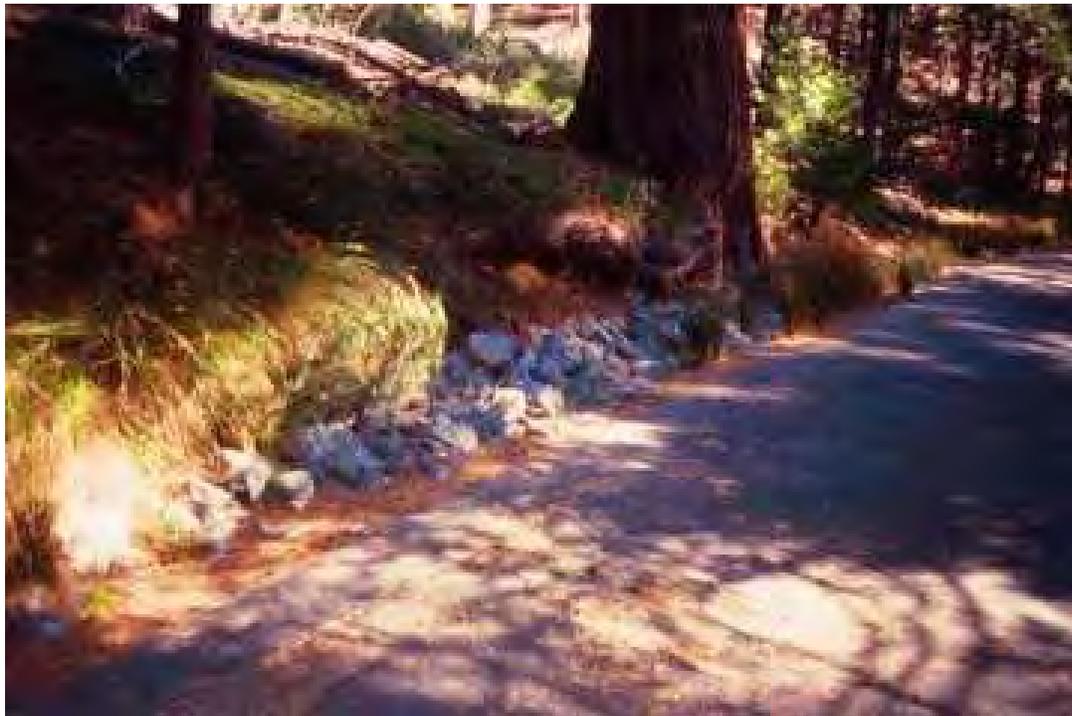
Drainage along the Mariposa Grove road continues to be a problem, especially during flood events. In some instances, attempts to halt erosion in road-side ditches have resulted in the application of inappropriate materials, which detract from the appearance of the road. An example of this is the light colored rip-rap laid in the road-side ditches during the 1997 flood.

Example of riprap applied to ditches to prevent erosion during 1997 flood. HRA, 11/1999.

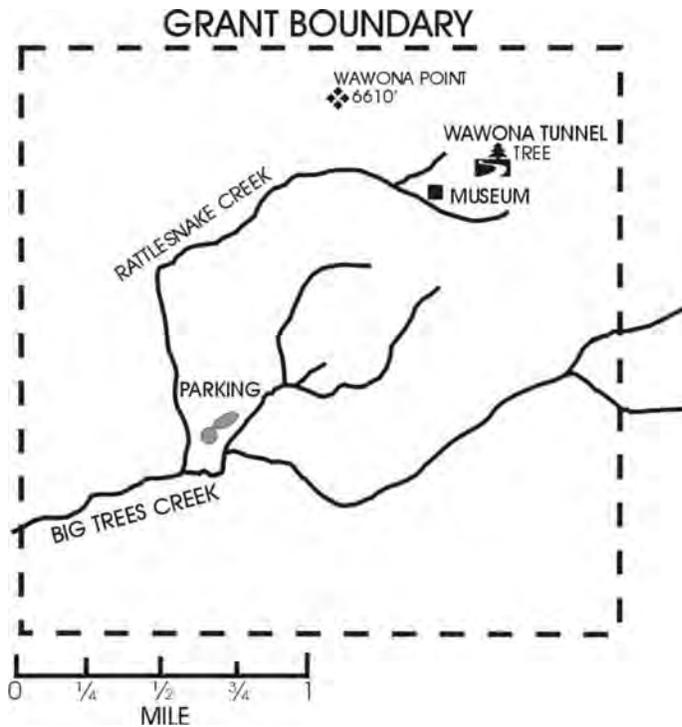
Schematic drawing showing the major drainage systems within the Mariposa Grove.
