Self Evaluation and Transition Plan

Yosemite National Park

Accessibility Program

May 2010

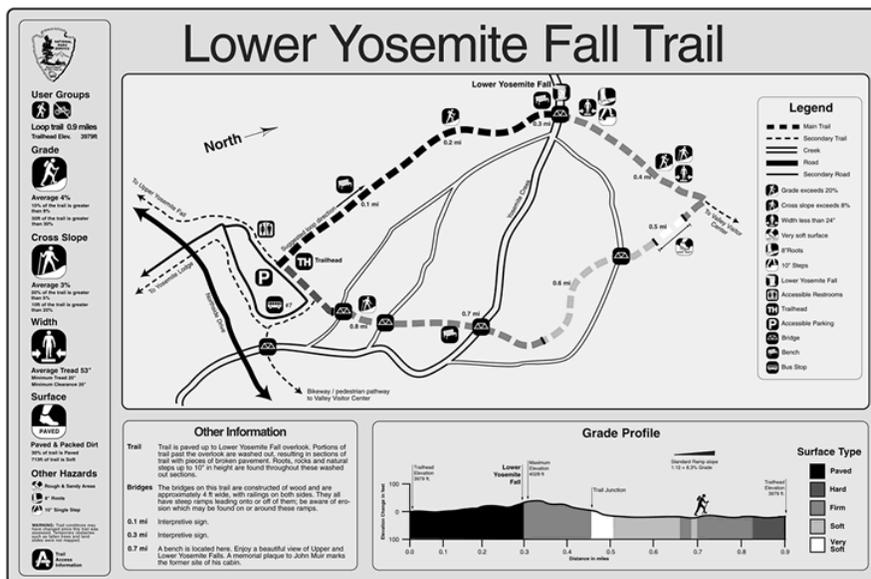
This is sample of full trailhead signage that would be printed in full color and could be placed at the beginning of the trail. It could also be formatted to fit into a fold up pocket guide.

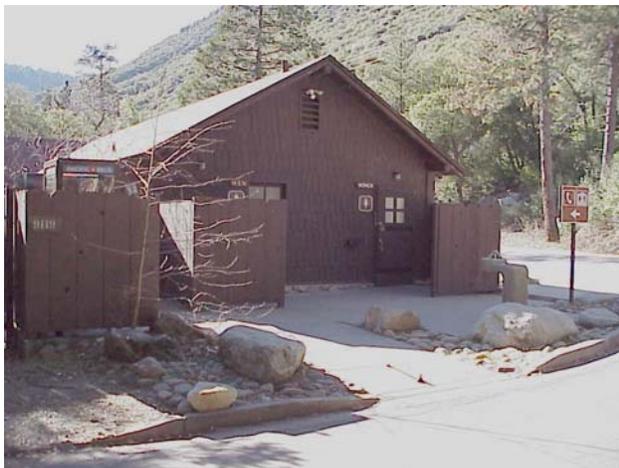
Arch Rock Entrance Station – Restrooms

Improvements to the Arch Rock ranger's office and entrance station kiosk were underway at the time of publication. Though these are "employee-only" areas, the fact that the kiosk and ranger station are utilized to distribute information about the accessible features of the park to disabled visitors supports enhancing the accessibility of these features.

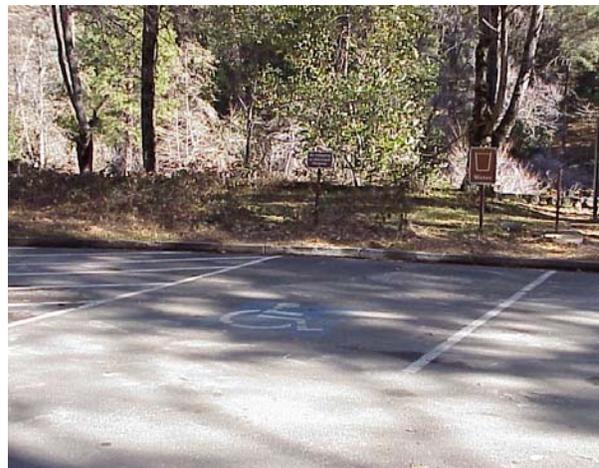
Arch Rock Entrance Station – Parking Space

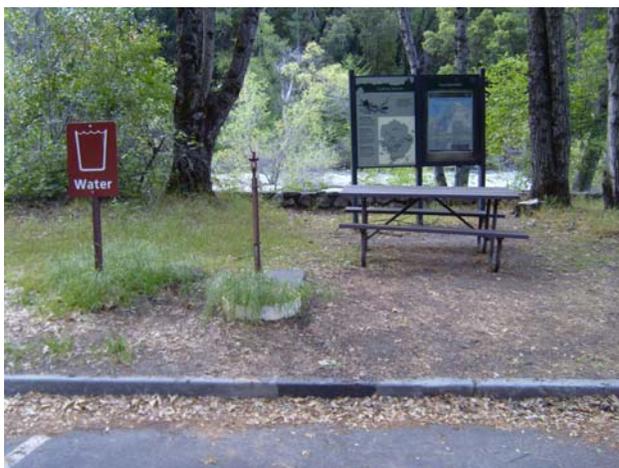
Arch Rock Entrance Station – Picnic Area

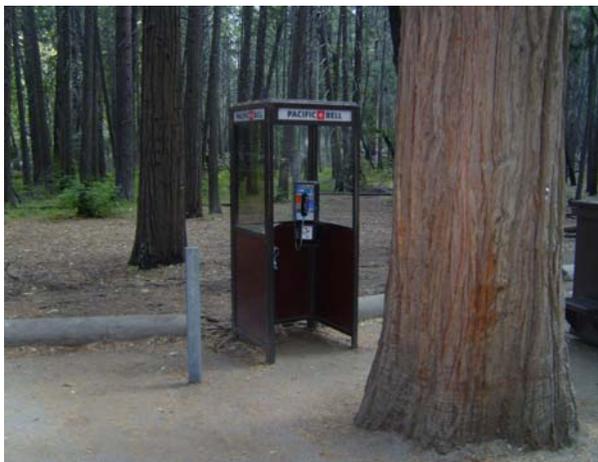
Bridalveil Fall Parking/Trailhead – Telephone

An accessible wayside exhibit is being fabricated and installed during the summer of 2010. Signage along the road that directs visitors to the area will need to be replaced with a compliant sign meeting NPS best practices and other regulations. The existing waterless restroom will be improved by posting the ISA (International Symbol of Accessibility or “wheelchair symbol”) and moving the toilet paper dispensers.

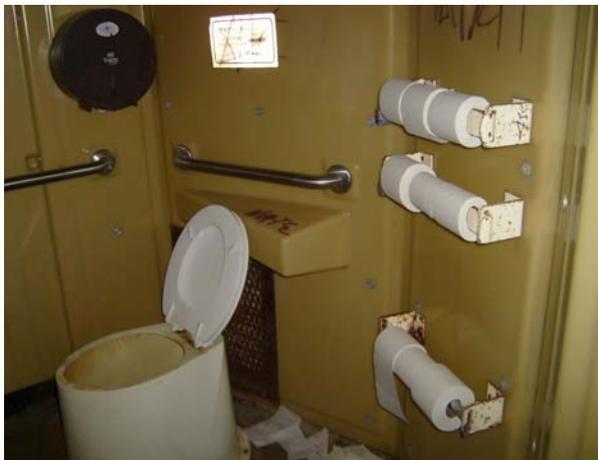
Bridalveil Fall Parking/Trailhead – Waterless Restroom

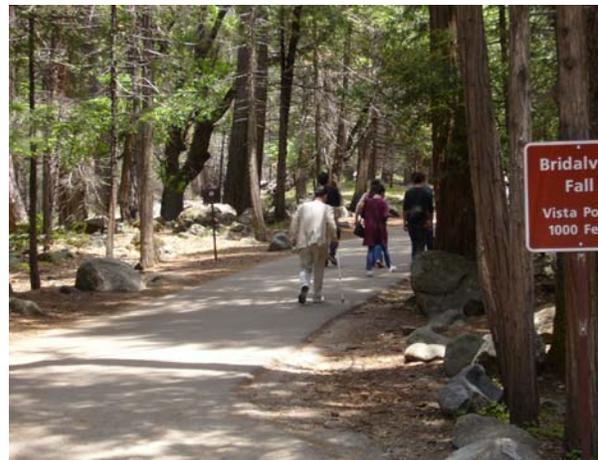
Bridalveil Fall Parking/Trailhead – Start of Trail

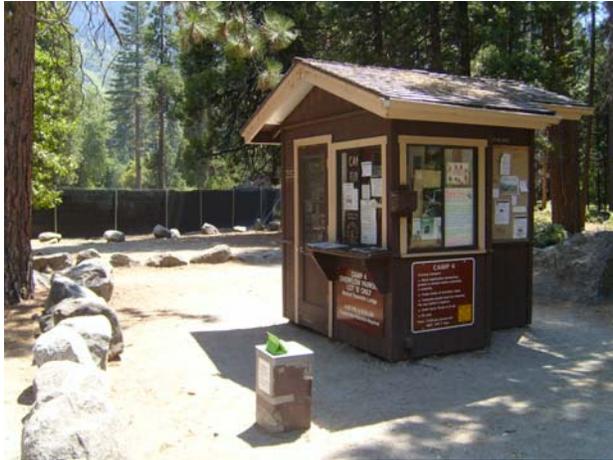
Camp 4 – Registration Booth

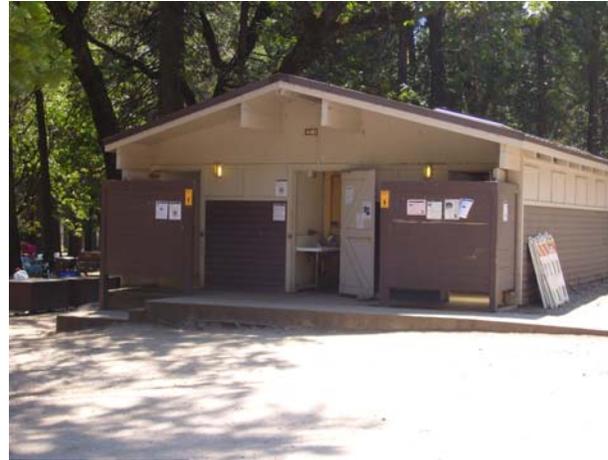
Camp 4 – Restrooms

Item	Barrier	Action	Corrective Action
Camp 4 Walk-In Campground			
Parking	Van-accessible parking not provided.	Provide a van-accessible parking space and sign (ABA F 208.2.4).	Long Term
ORAR	An ORAR is needed to connect site features.	Provide an ORAR to connect site features (PG T 204; PG T 304).	Important
Campsites	Accessible campsites not provided.	Provide compliant campsites (PG T 218; PG T 318). Provide an accessible bear box, accessible grill (PG T 208; PG T 308), fire ring (PG T 207; PG T 307) and picnic table (PG T 206; PG T 306). Connect site features with an ORAR (PG T 204; PG T 304).	Critical
Restrooms	The restrooms are inaccessible.	Update the restrooms and paths around them to accessibility standards (ABA F213).	Critical

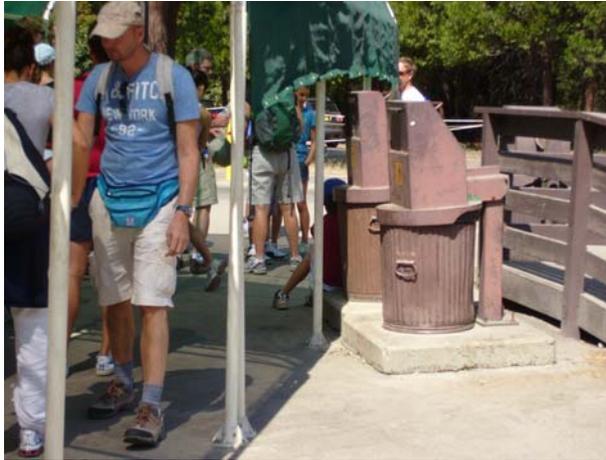
Camp 6 Parking Area – Access to Cans Barred by Support Poles for Shade Structure

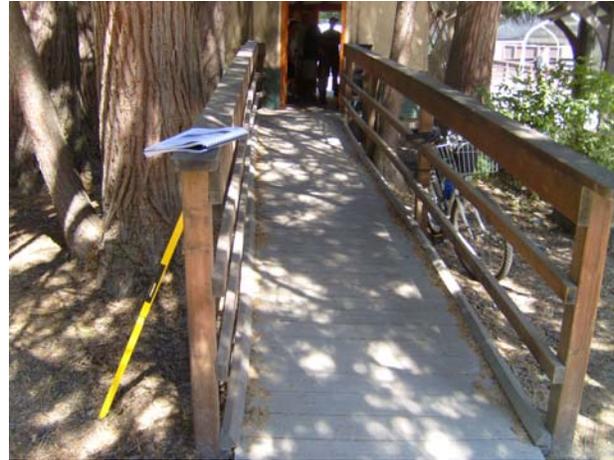
Camp 6 Parking Area – Ramp to Information Center

Item	Barrier	Action	Corrective Action
Camp 6 Parking Area			
Sign	Restroom sign is needed at Camp 6 restrooms.	Post ISA sign at restrooms (ABA F 216.8).	Long Term
Information Center Ramp	Ramp has slope > 5% and has no accessible handrails.	Install accessible handrails at the appropriate height (ABA 505.4)	Critical
Information Center Ramp Entrance	Threshold has 3/4" vertical change in level and a 2" beveled change in level.	Replace the threshold to meet accessibility standards (ABA 303.2).	Important

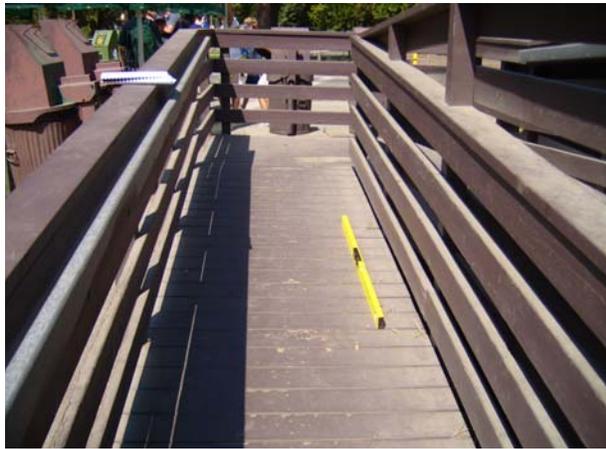
Camp 6 Parking Area – Ramp to Restrooms

Item	Barrier	Action	Corrective Action
Camp 6 Parking Area			
Restroom Ramp Handrail	Ramp handrail is not an accessible style.	Replace with an acceptable style (ABA 505.2; 505.7).	Important
Restroom Mirrors	Mirrors are too high.	Lower one of the mirrors to accessibility standards (ABA 603.3).	Important

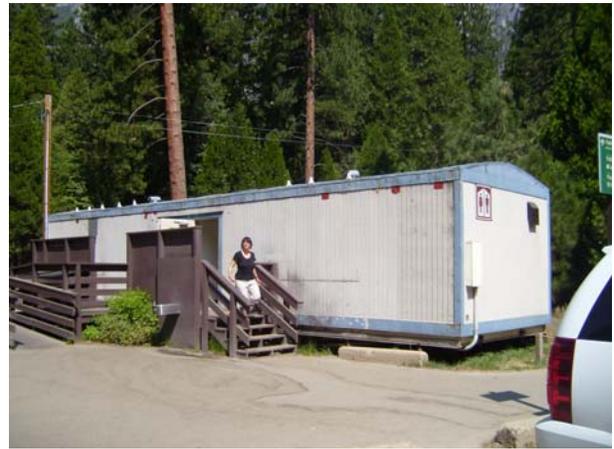
Camp 6 Parking Area – Restrooms

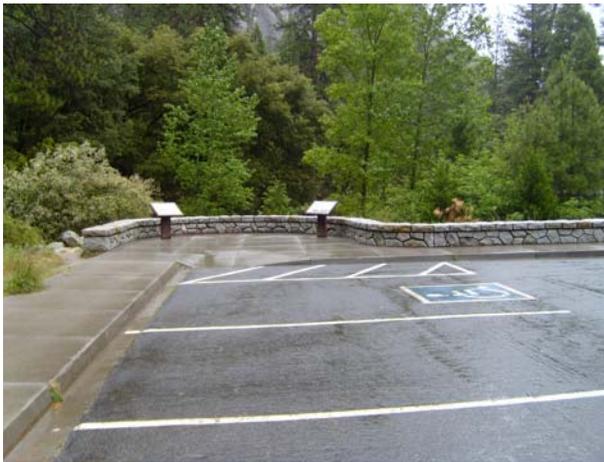
This site provides visitors the opportunity to park and enjoy the surroundings of the waterfall known as the Cascades. The site has an accessible viewing area and wayside exhibits, but modifications to the parking and curb cut are needed to correct excessive slope.

Cascades Viewing Area – Parking

Item	Barrier	Action	Corrective Action
Cascades Viewing Area			
Parking	The parking area has a slope of over 4 %.	Provide a major asphalt overlay to correct the slope deficiencies (ABA 502).	Important
Curb Ramp	Current curb cut slope is 9.1% and could pose a problem for persons with disabilities.	Consideration should be taken into changing the slope to be no greater than 1:12 or 8.33% (ABA 405.2).	Important

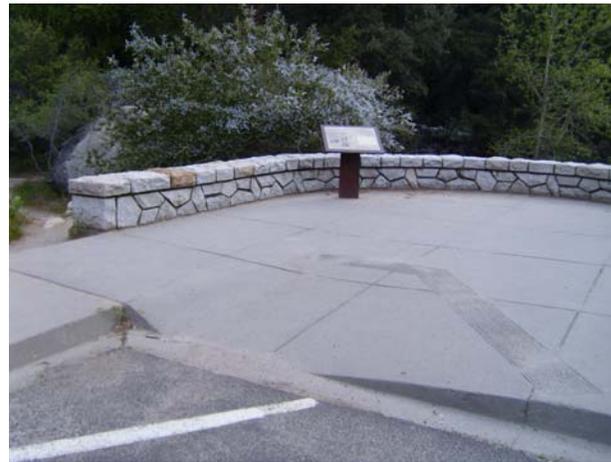
Cascades Viewing Area – Exhibits

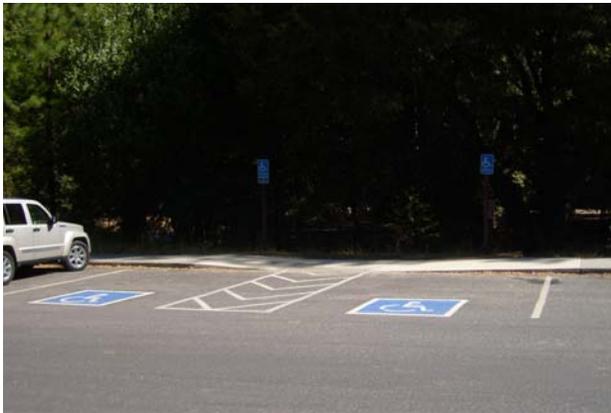
Cascade Creek Picnic Area – Parking Area

The location needs to be improved by the addition of a van accessible parking sign and a standard accessible parking sign for the appropriate spaces. The path of travel from the parking lot to the picnic area will need to be improved to meet ORAR standards.

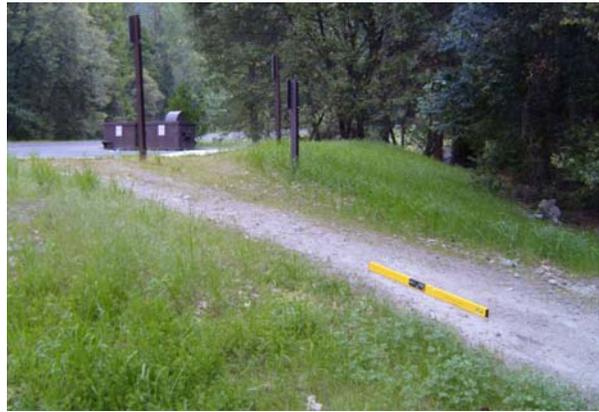
Cascade Creek Picnic Area – Route to Picnic Area

Item	Barrier	Action	Corrective Action
Cascades Creek Picnic Area			
Accessible Routes	There is no accessible route to the picnic area or the beach of the Merced River.	Create an accessible route from parking to picnic area and beach (PG T 204; PG T 304).	Critical

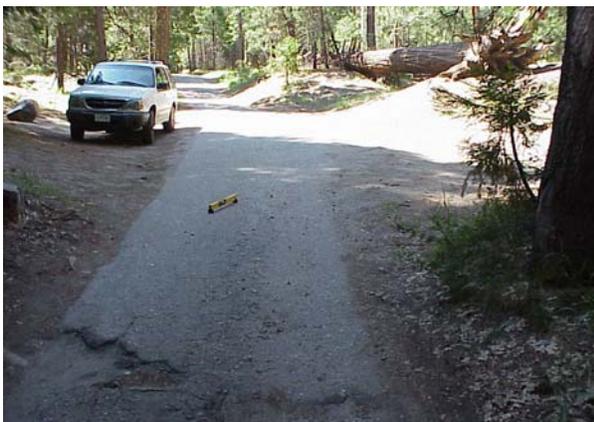
Cathedral Beach Picnic Area – Entrance Road, Route to Toilet

Improvements to this picnic area include providing van accessible parking near site features, placement of the ISA outside the waterless restroom, relocation of the toilet paper dispensers, beveled access to the waterless restroom, and directional signage throughout the area. An access route will also be needed to provide an equal opportunity for beach recreation. The designated picnic areas will be made accessible by adding accessible tables and grills, and an ORAR connecting these site features.

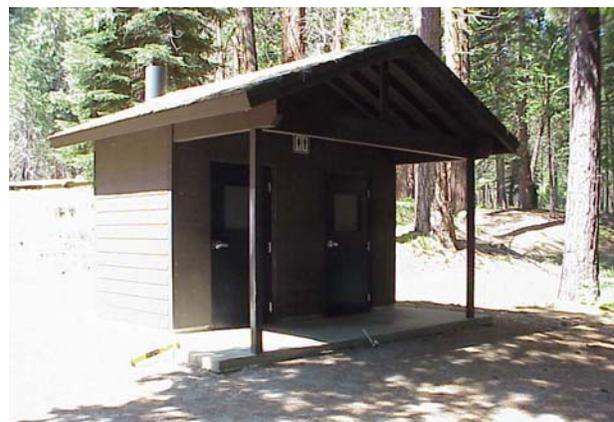
Cathedral Beach Picnic Area – 4” Step from Ground to Pad

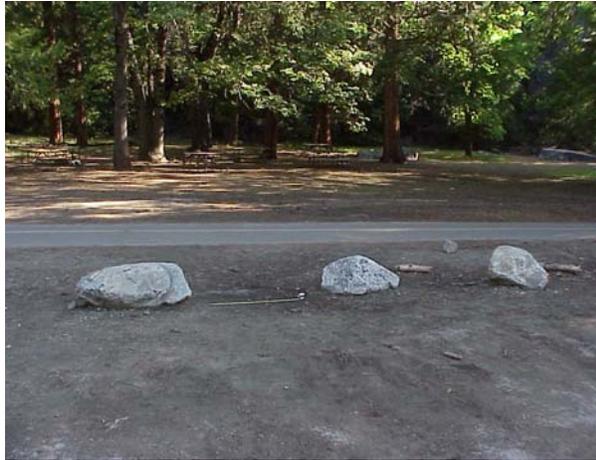
Church Bowl Picnic Area – Parking Area Access to Picnic Area

This unique area was used for various group activities such as religious services and seminars but is now primarily a picnic and gathering place. Improvements required for accessibility include the addition of a van-accessible parking space, the stabilization of an ORAR to connect site features, and the reduction in change of level at the entrance to the waterless restroom facility. The picnic tables are not of the accessible type and will also need to be replaced.

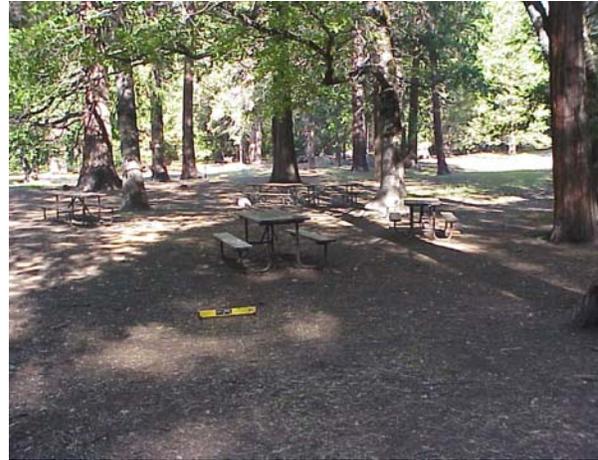
Church Bowl Picnic Area – Slope at Accessible Table

Item	Barrier	Action	Corrective Action
Church Bowl Picnic Area			
Portable Toilet	Accessible waterless restroom has a drop-off at the entrance.	Fill the entrance to the waterless restroom or create a transition plate (ABA 206.2.2).	Important
ORAR	An ORAR is needed to connect parking space to picnic area and waterless restroom.	Add an ORAR to connect site features (PG T 204; PG T 304).	Important
Parking	A van-accessible parking space is needed at the picnic area.	Provide a van-accessible parking space on an accessible pad, and sign (ABA 208.2.4).	Critical
Picnic Tables	No accessible picnic tables present.	Replace 50% of the tables with the accessible model (PG T206.2.2).	Critical

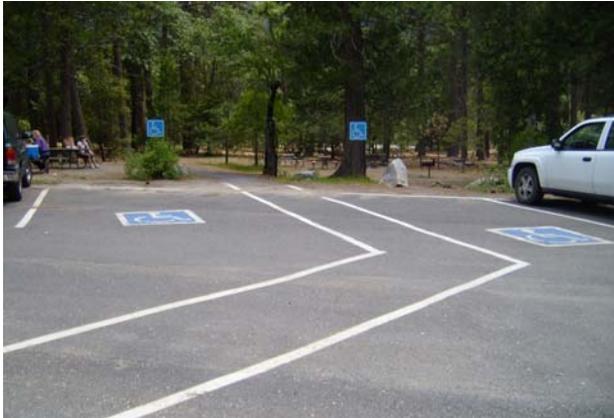
El Capitan Picnic Area – Accessible Parking with Access Route to and from Waterless Restrooms

There are several accessible characteristics at this picnic area, but they are in need of a makeover. There is an accessible route at the site, but the pavement around the picnic area is in need of repair, and tree branches hang to low over the pathway to the waterless restrooms. The waterless restrooms lack accessible characteristics and will need to be replaced with a newer accessible waterless restroom model. Two accessible parking spaces are available, but they too will need to be updated with appropriate striping and compliant signs. One of these should be designated as van accessible.

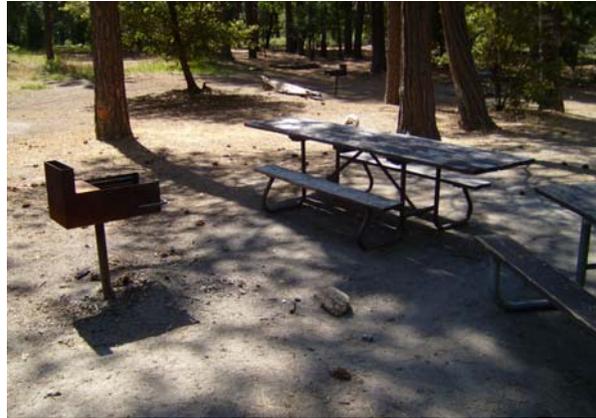
El Capitan Picnic Area – Accessible Picnic Area

Item	Barrier	Action	Corrective Action
El Capitan Picnic Area			
Accessible Route	Route through the picnic area has areas with over 5% slope and does not connect all features, such as waterless restroom, table, and grill.	Update the accessible route that connects the picnic areas with parking and waterless restroom (ABA F206).	Important
Parking	Accessible spaces provided are not compliant.	Re-stripe and post signs for car and van-accessible spaces (ABA F 208.2.4).	Important
Picnic Area	The accessible picnic area needs designation and clear maneuvering space.	Designate the accessible picnic area with an ISA placard and clear asphalt pad of rocks, debris, etc.	Important
Waterless Restroom	Waterless restroom lacks appropriate sign and toilet paper is out of reach.	Move toilet paper dispenser and post ISA sign (ABA F 216.8; ABA 604.7).	Long Term
Protruding Object	The trees along the path to the waterless restroom hang over the required clear space.	Prune tree limbs to create required clear space over the route (PG T322.1).	Important

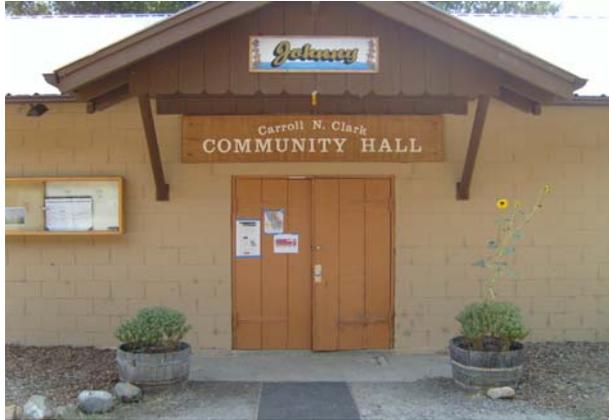
Clark Community Center – Entrance

Item	Barrier	Action	Corrective Action
El Portal Clark Community Center			
Parking	No accessible parking.	Provide a van accessible parking space (ABA F208).	Critical
Front Entrance	2 ½-inch change in level at door.	Reduce the change in level (ABA 303.2).	Critical
Front Doors	Door hardware is not compliant.	Replace hardware with U-shape or lever action hardware (ABA 404.2.7).	Important
Stage	No accessible route to the stage.	Provide an accessible route up to the stage (ABA F202.2.1).	Important

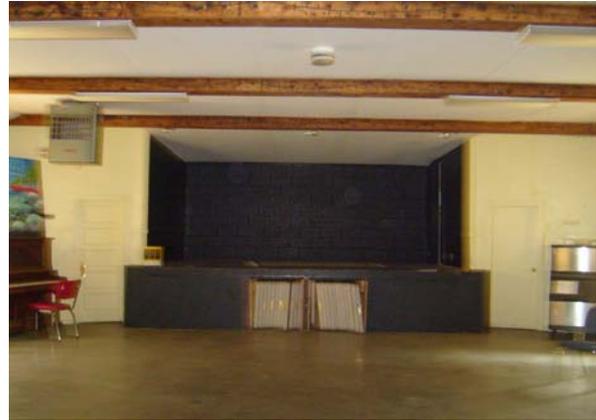
Clark Community Center – Stage

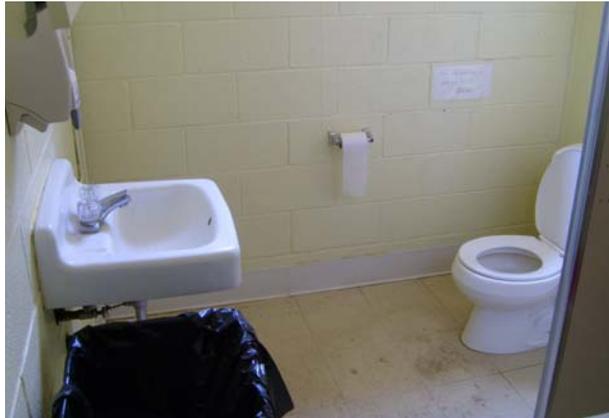
Clark Community Center – Women's Restroom

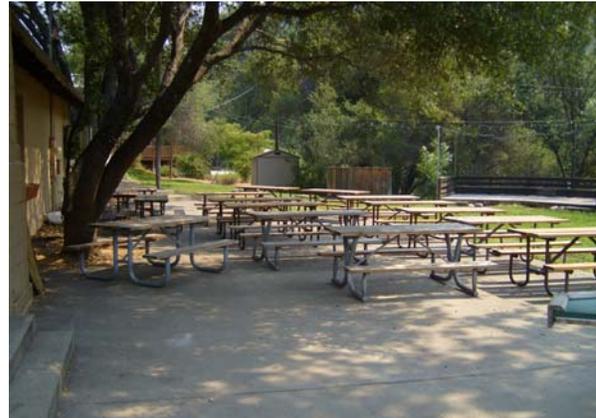
Clark Community Center – Picnic Area and Outdoor Stage

Item	Barrier	Action	Corrective Action
El Portal Clark Community Center			
Back Door	Steps are inaccessible and have no handrails.	Provide handrails at the stairs and install an accessible ramp or other route to picnic area (ABA 504.6; ABA F202.2.1).	Important
Picnic Area	There are 17 picnic tables available and none are accessible.	Replace at least half of the tables with accessible models (T 206.2.2).	Long Term
Outdoor Stage	The outdoor stage has no accessible route.	Create a route to and onto the stage (ABA F202.2.1).	Long Term
Restrooms	Both men's and women's restrooms are inaccessible.	Update restrooms to accessibility standards (ABA 603).	Critical
Kitchen	Kitchen is inaccessible.	Update kitchen to accessibility standards (ABA 804.2.2).	Long Term
Kitchen Outside Entrance	Route to entrance has a slope of 6.8% and a 2-inch change of level at door threshold.	Reduce slope and change in level at entrance (ABA 303.2; ABA 403.3).	Important

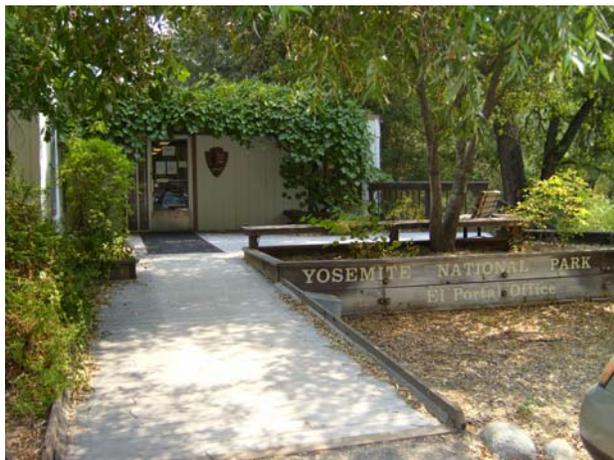
El Portal Fiscal Office – Front Entrance

Located just west of the El Portal post office, this site is specifically an office building, but because of the nature of services provided, public traffic does occur. Future improvements include an accessible parking space, stairs, and a restroom.

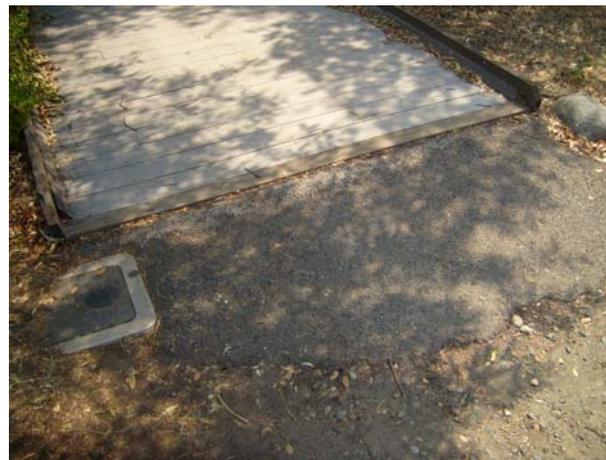
El Portal Fiscal Office – Transition from Parking to Ramp

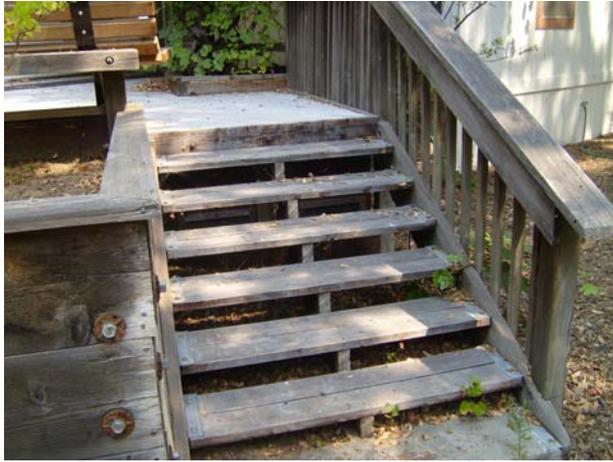
El Portal Fiscal Office – Open Risers at Stairs

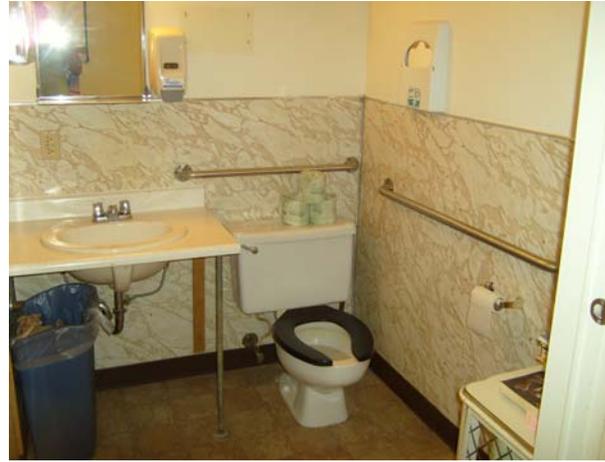
El Portal Fiscal Office – Men's Restroom

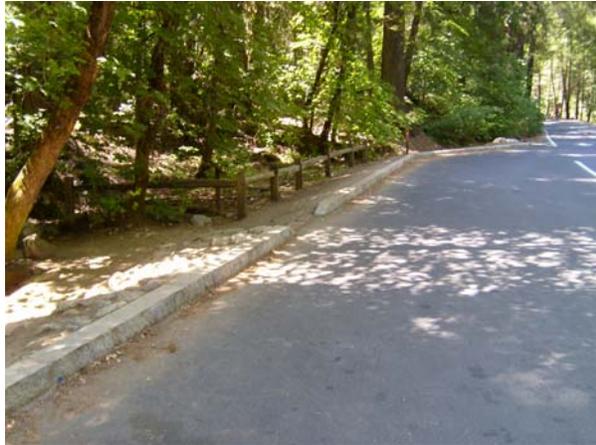
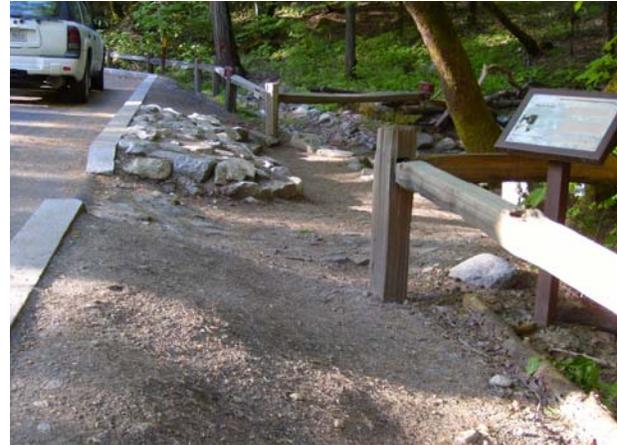
This site just east of the Pohono Bridge is the location of a natural spring which bubbles up out of the ground year round. This location has seen extensive restoration efforts since the last transition plan and is a beautiful place to stop along Southside Drive. Because of its modifications, the site should be made accessible in accordance with ABA F201 standards. Modifications for accessibility include an accessible route to the wayside exhibit or the relocation of the exhibit to an accessible route. An accessible parking space should be considered for this location as well.

Item	Barrier	Action	Corrective Action
Fern Spring Wayside			
Parking	An accessible space is needed.	Designate an accessible parking space (ABA F 208.2.4).	Long Term
Parking	Parking area has slope > 2 percent.	Reduce parking area slope to 2% or less (ABA 502.4).	Important
Accessible Route	Site exhibit not accessible from parking.	Provide an accessible route or relocate the exhibit sign to an accessible location (ABA F206.2.2).	Critical

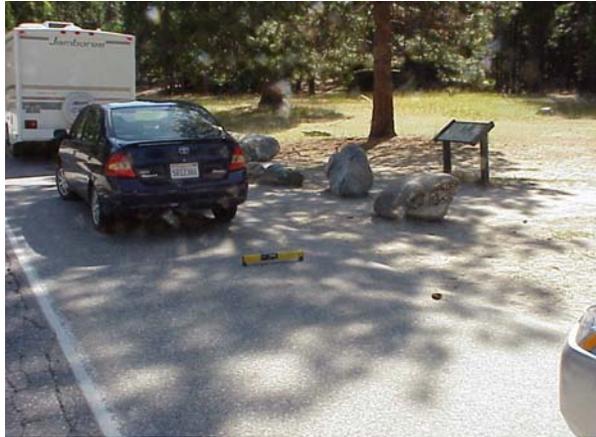
Four Mile Trail Wayside – Prior to Modifications

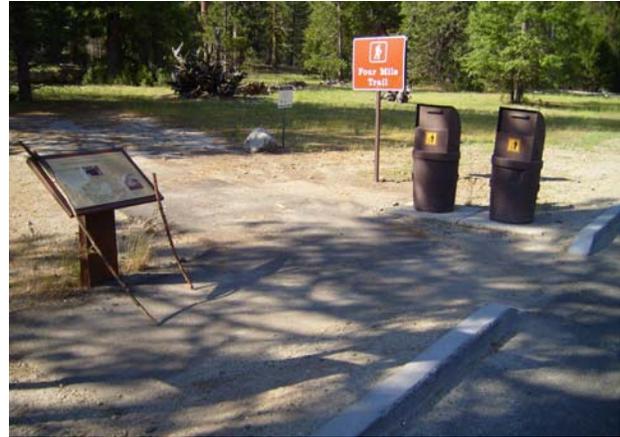
This is the site of the first hotel in Yosemite Valley, and the original location of Yosemite Village. It is also the start of one of the park’s more popular trails, which retraces the original mule trail up to Glacier Point. This area has been improved by a newly paved pullout and curb cut for better accessibility to the trailhead. Future improvements include the addition of a van-accessible parking space.

Four Mile Trail Wayside – After Modifications

Item	Barrier	Action	Corrective Action
Four Mile Trail Wayside and Trailhead			
Parking	Parallel parking is available on both sides of the roads, and there are no designated accessible spaces.	Provide a van-accessible parking space and sign (ABA F 208.2.4).	Important

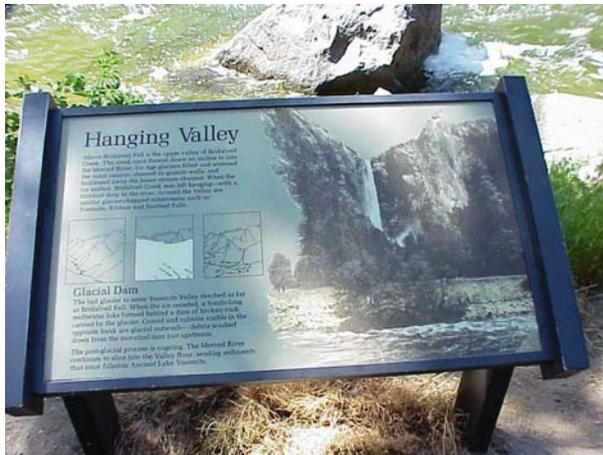
Hanging Valley Wayside – Visual Contrast on the Wayside

This wayside area provides visitors with an extended view of Bridalveil Fall and information on its geologic history. The site will be altered by providing a van-accessible parking space, adjusting the slope at the ends of the route, and providing a curb-cut ramp from the parking area. The current exhibit is being replaced during summer 2010 with an accessible wayside exhibit and should be located on an accessible route.

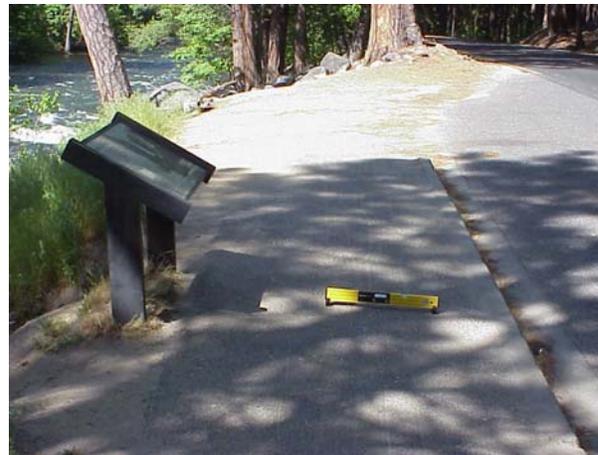
Hanging Valley Wayside – Cross Slope at Sign Exceeds 2%

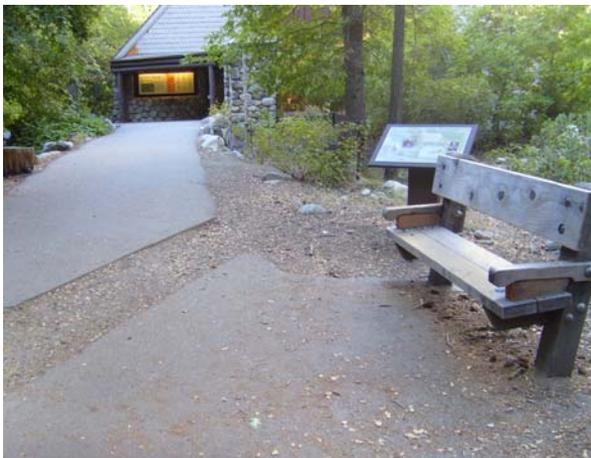
Happy Isles Nature Center and Parking Area – Route to Entrance

The slope and cross slope along the path of travel to the facility will become accessible by re-paving the route. The clear ground space near the bench (for wheelchair users to sit beside a companion) will be stabilized and an accessible bench will be added. Directional and other signs will be replaced with accessible signs that meet ABA standards. Route to exhibits will be connected to the main accessible route.

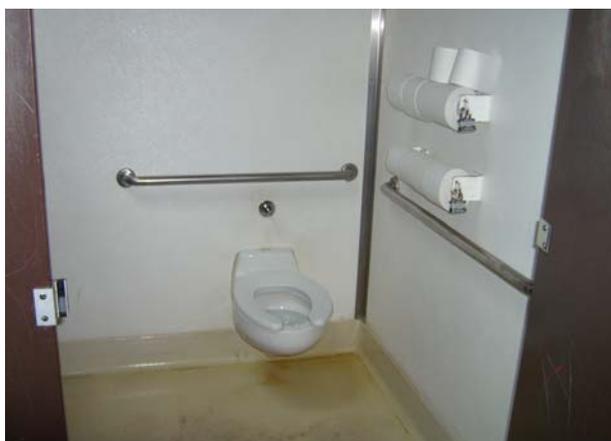
Happy Isles Shuttle Bus Stop and Restrooms – Toilet Paper Dispensers

Needed improvements here include the lowering of the service window at the concession stand, the retrofitting of the restrooms to comply with ABA standards, and the installation of a van-accessible parking space.

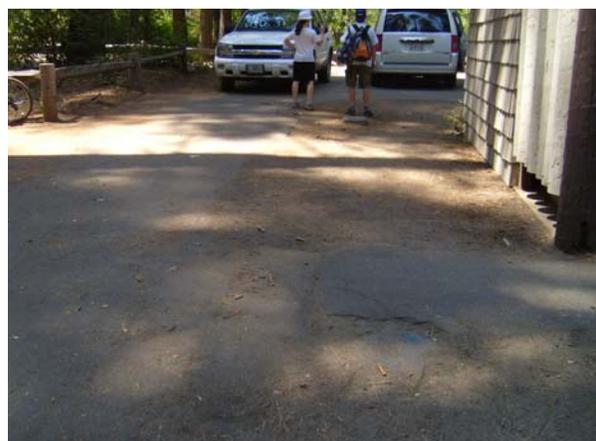
Happy Isles Shuttle Bus Stop and Restrooms – View of Route from Accessible Parking Space

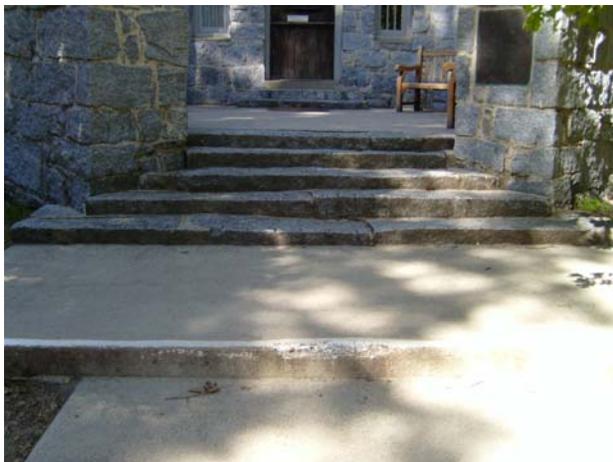
LeConte Memorial Lodge – Steps Leading up to Entrance

This area will be improved by providing an accessible route from the transit stop to the LeConte Lodge, a bench with companion seating and accessible information. An accessible entrance is needed as well as an accessible route from the parking to that entrance. In addition, an accessible interpretive sign should be installed on an accessible route.

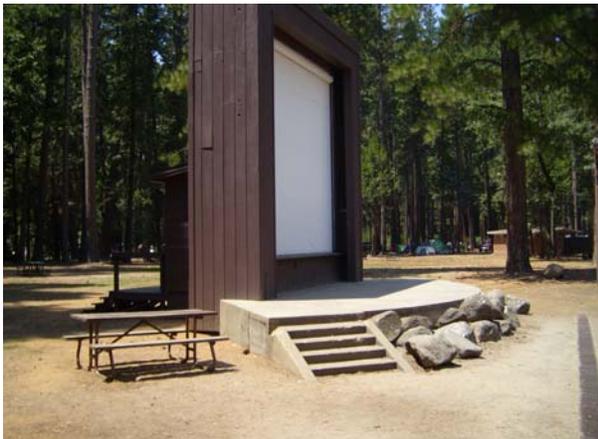
Lower Pines Amphitheater – Steps at Amphitheater Stage

This facility is used for evening interpretive programs, Yosemite Institute programs, and religious services on Sunday mornings. The amphitheater requires various alterations for access enhancement. An ORAR will be needed to connect accessible features. Wheelchair seating will also need to be dispersed as well as companion seating. An accessible route is needed to connect parking with site features, and a ramp from the access route to the stage will be provided.

Item	Barrier	Action	Corrective Action
Lower Pines Amphitheater			
Amphitheater Seating	Wheelchair seating spaces and companion seating spaces are needed in the amphitheater.	Disperse wheelchair seating spaces and companion seating throughout the amphitheater (ABA 802).	Important
Accessible Route	An accessible route is needed within the amphitheater to connect accessible spaces.	Provide an accessible route to connect the site features (ABA F 206.2.2).	Important
Path	Path from parking to amphitheater has a slope of 11.5 percent.	Provide an accessible route from the parking area to the amphitheater with the correct grade (ABA F 206.2.2)	Critical

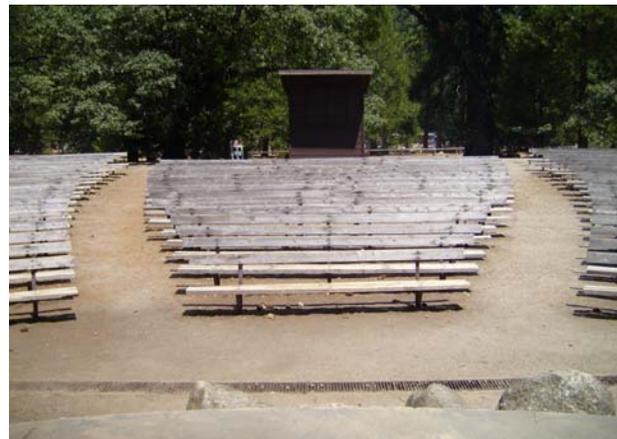
Lower Pines Amphitheater – View from Stage

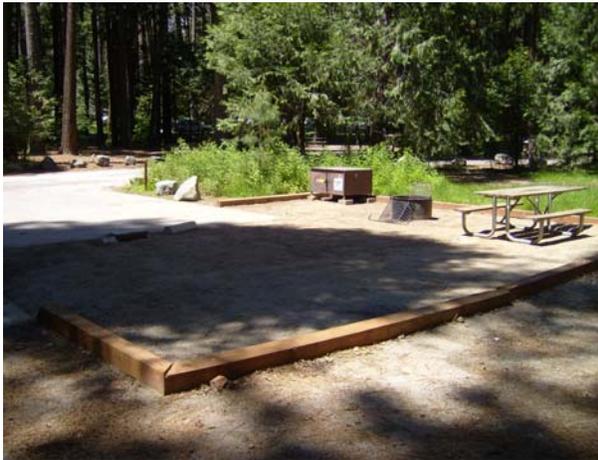
Lower Pines Campground – Accessible Campsite #7

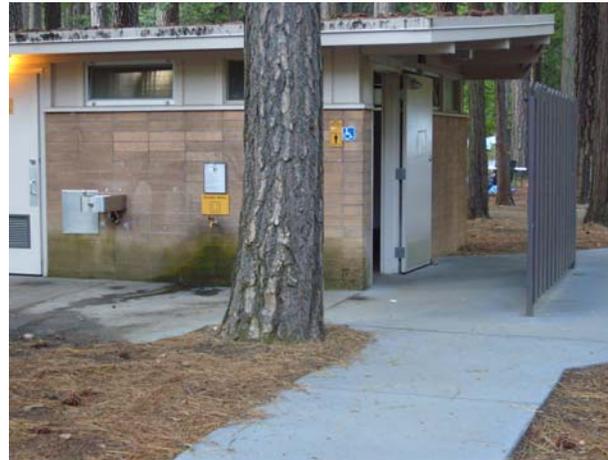
Lower Pines Campground – Restrooms

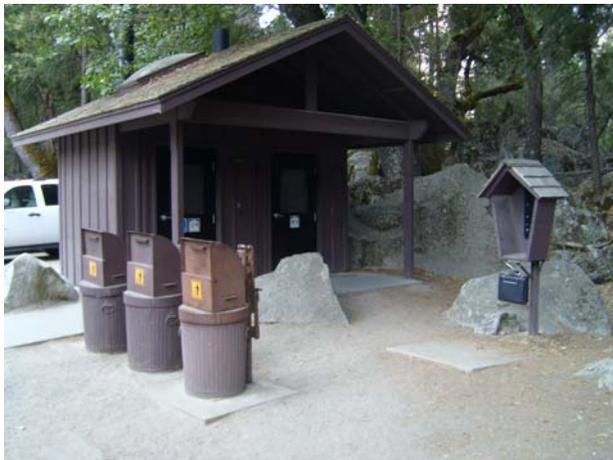
Mirror Lake – Vault Toilets at Lower Pool

The waterless restrooms at Mirror Lake will be retrofitted to comply with ABA standards. An accessible interpretive trail has been designated and publicized, but the trail needs to be re-graded to make it truly accessible. The telephone at the Lower Pool restrooms has been removed and will not be replaced; the housing unit is still there and should be removed as well. A compliant trailhead sign will also be added along the ORAR at an accessible location.

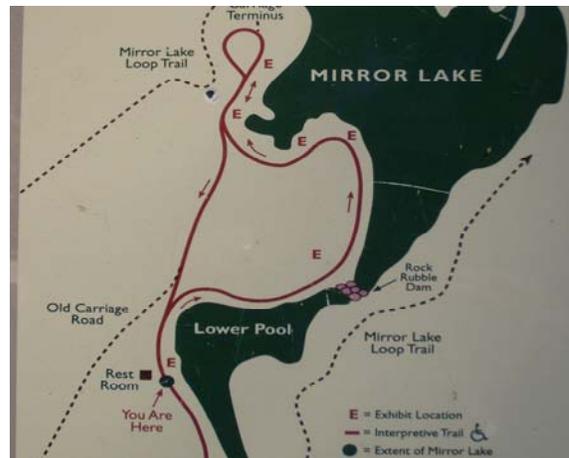
Mirror Lake – Exhibit Showing Accessible Path

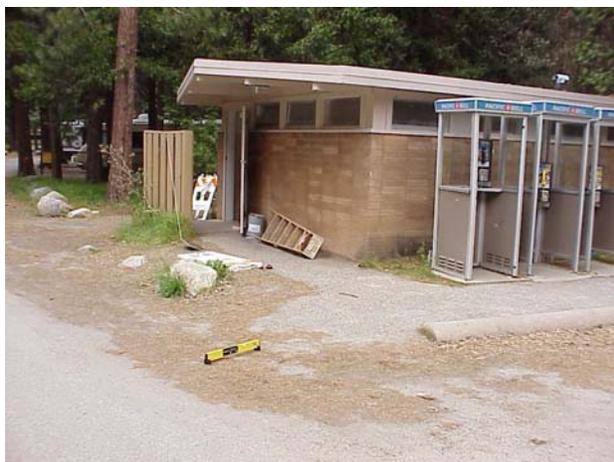
North Pines Campground – Restroom path of travel (Before)

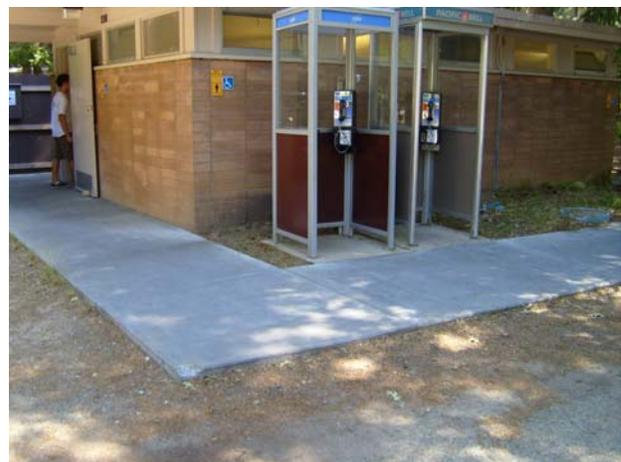
North Pines Campground – Restroom path of travel (After)

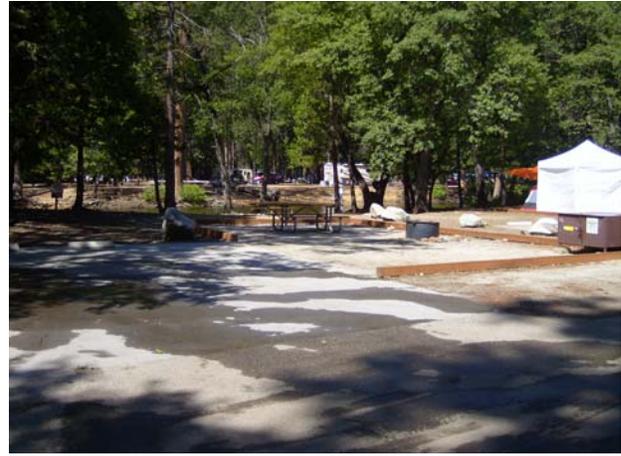
North Pines Campground – RV Accessible Campsite

Item	Barrier	Action	Corrective Action
North Pines Campground			
Pay Telephone	The pay telephones for the camping area are not on an accessible route and are not accessible design.	Provide accessible pay telephone on the accessible route. (ABA 704.2.1)	Long Term
Protruding Object	Branches hang over sidewalk and have a clearance of <80 inches.	Trim the tree branches at path near restrooms to maintain a clearance of 80 inches (PG T322.1)	Long Term

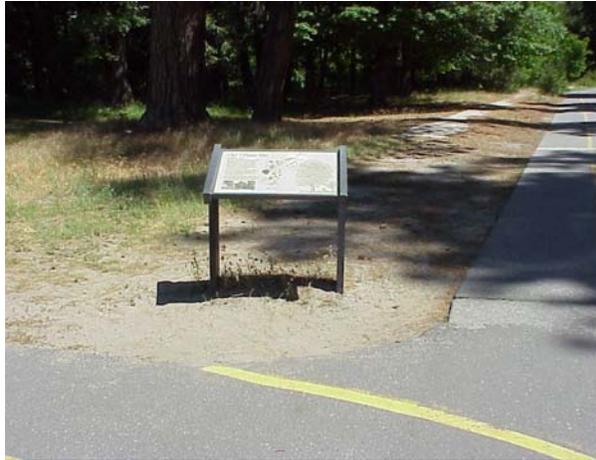
This wayside exhibit relates some history of this location as the Old Village Site. This area will be improved through the stabilization of the route from the picnic site to the portable toilet. The exhibit area is currently located off the bicycle path that demonstrates significant changes in level. A concrete pad should be poured in order to create an accessible approach to the exhibit area or the exhibit relocated to an accessible location.

Old Village Site Wayside – Area Around Wayside Not Compliant

Item	Barrier	Action	Corrective Action
Old Village Site Wayside			
Accessible Route	No stabilized route exists from the picnic site to the portable toilet.	Stabilize route or pour concrete route to connect accessible areas (ABA F 206.2.2).	Long Term
Wayside Exhibit	Wayside exhibit is not on an accessible surface.	Pour a concrete pad for accessible approach to the wayside exhibit (ABA F 206.2.2) or relocate to an accessible location.	Long Term
Wayside Exhibit	Sign lacks visual contrast.	Replace exhibit with accessible sign with appropriate contrast (ABA F 216.3).	Long Term

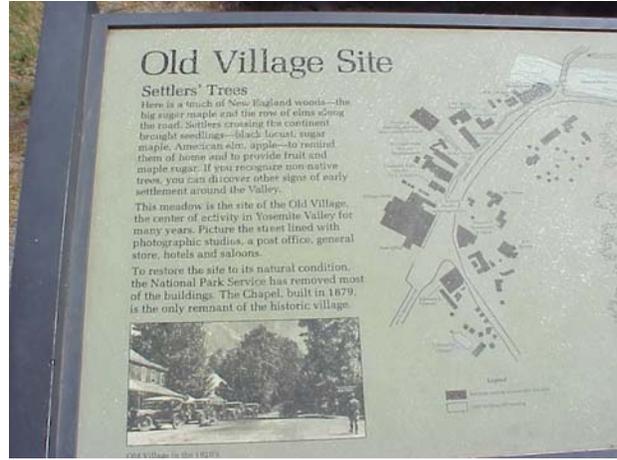
Old Village Site Wayside – Visual Contrast Not Compliant

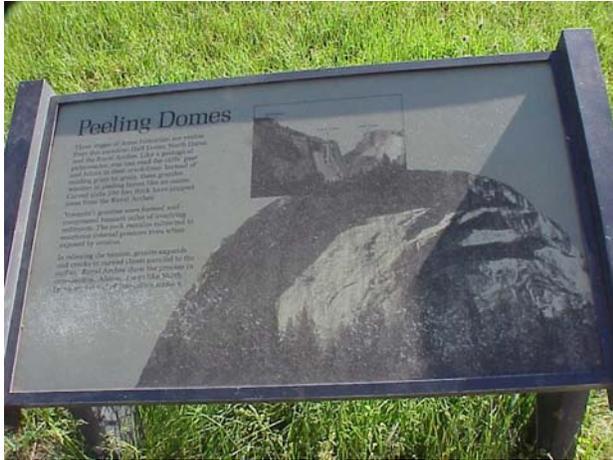
"Peeling Domes" – Sign Lacks Visual Contrast

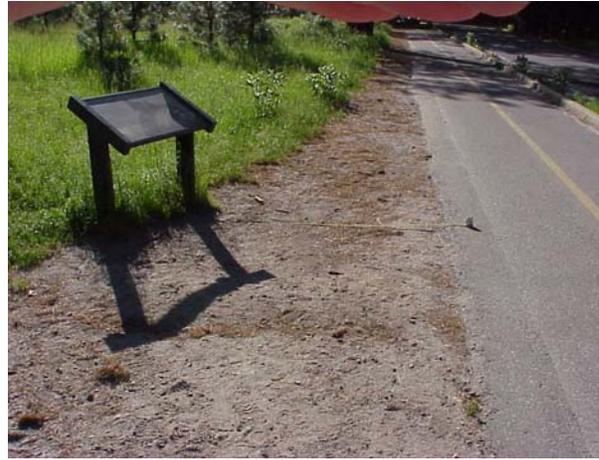
This bicycle path exhibit provides information on how Half Dome, North Dome, and Royal Arches were formed. Exhibit signs will be relocated to an accessible route or a concrete pad will be created around the sign with sufficient clear space to access the exhibit. Replacement of the wayside exhibit with a compliant sign with appropriate contrast is in process and the new sign will be installed in summer 2010.

"Peeling Domes" – Stoneman Bridge Drive Wayside

Item	Barrier	Action	Corrective Action
Peeling Domes Wayside			
Exhibit	A drop-off over 2" prohibits access to the exhibit.	Move sign to accessible route or create a pad around the sign with 60" x 60" clear space (ABA F 206.2.2).	Long Term
Exhibit	Exhibit does not comply with standards for contrast.	Replace exhibit with accessible sign with appropriate contrast (ABA F 216.3).	Long Term

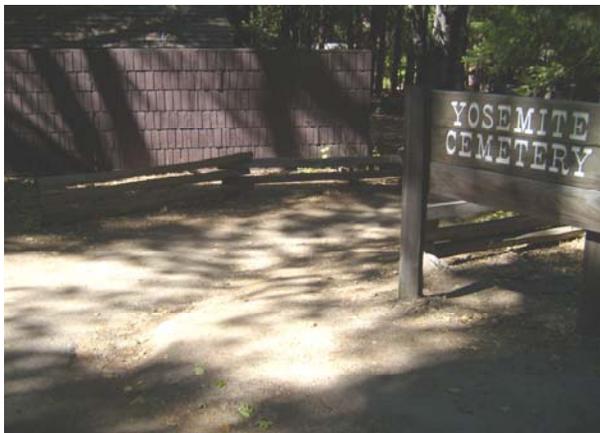
This area contains the Valley's historic pioneer cemetery and will be improved through the addition of an accessible route from the parking area to the historic site.

Pioneer Cemetery – Slope from Road to Cemetery

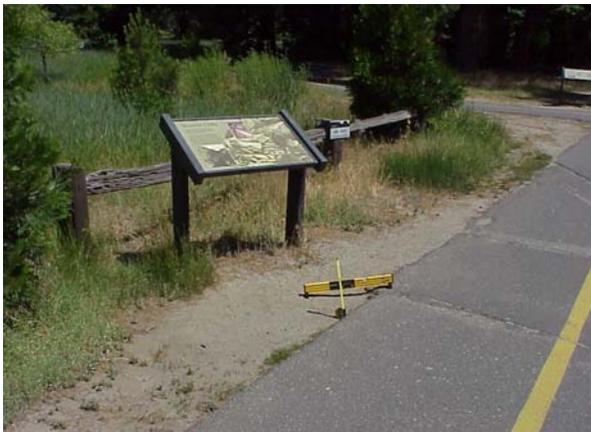
Scarred Cliffs Wayside – Slope, Drop-Off, and Location

The exhibit is currently located off the bicycle path and not accessible. This exhibit is scheduled for removal. If not removed, needed improvements here include moving the sign to the accessible route or to a concrete pad with sufficient space, and the replacement of the exhibit with a compliant wayside.

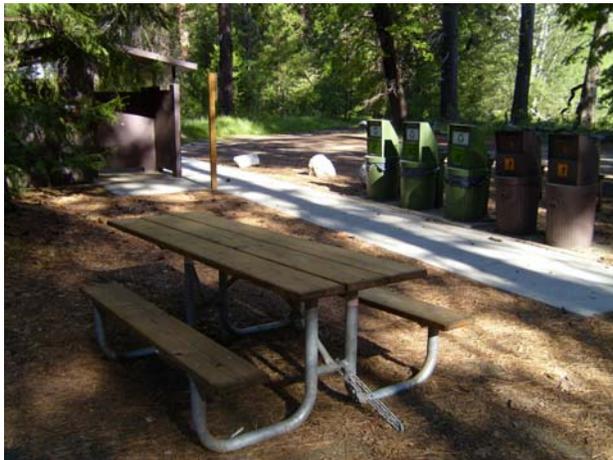
environment for visitors with disabilities. There is also a DNC-operated river rafting “take-out” with a bus loading area for rafters. Picnic Area 2 will be improved by the construction of a beach access route.

Sentinel Beach Picnic Area

Item	Barrier	Action	Corrective Action
Sentinel Beach Picnic Area			
Picnic Area 2 Route	No accessible route exists from parking to the beach area.	Designate an accessible route to site facilities (ABA F 206.2.2).	Important

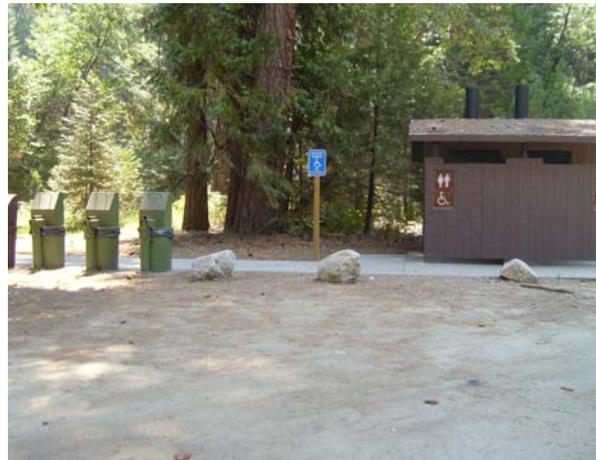
Sentinel Beach Picnic Area – Parking

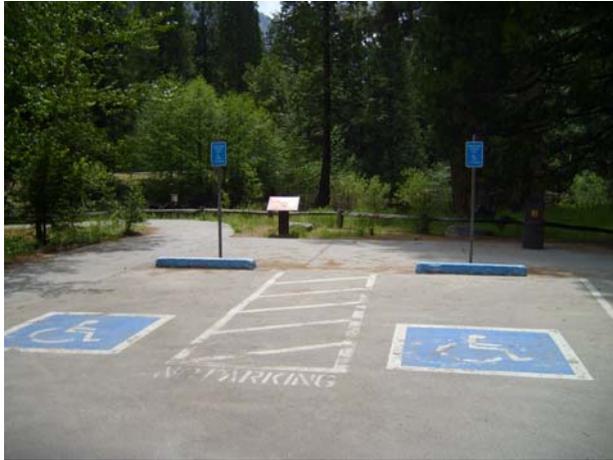
Accessible parking is available at the site, but lacks a designated van-accessible parking space. The exhibits along the sidewalk will also need to be filled in at their base in order to make the cement contiguous with the pathway. Additionally, an advisory sign warning visitors of the slope will be added to the route over the bridge.

Sentinel Bridge, Waysides and Parking Lot

Item	Barrier	Action	Corrective Action
Sentinel Bridge Waysides and Parking Lot			
Sign	Sidewalks on the bridge have areas of excessive slope.	Post an advisory sign to advise visitors of areas of excessive slope (NPS Best Practices).	Long Term
Parking	No van accessible designated parking available at the waysides.	Add one van-accessible space and one standard accessible parking with signage (ABA F 208.2.4).	Long Term
Wayside Exhibit	Wayside exhibits are not on the accessible route.	Stabilize area around wayside exhibits (ABA F 206.2.2).	Long Term

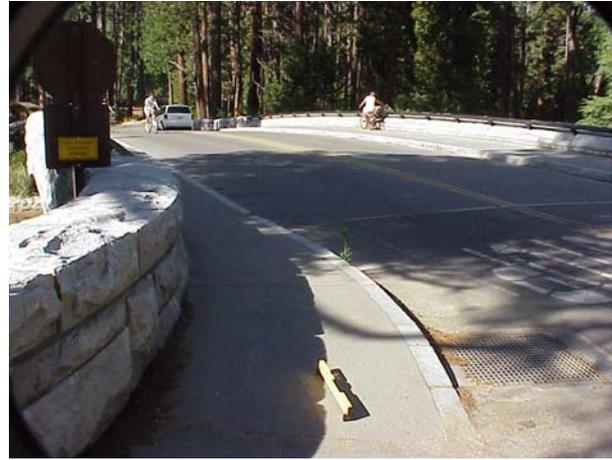
Sentinel Bridge, Waysides and Parking Lot – Slope on Western Side of Southside Drive

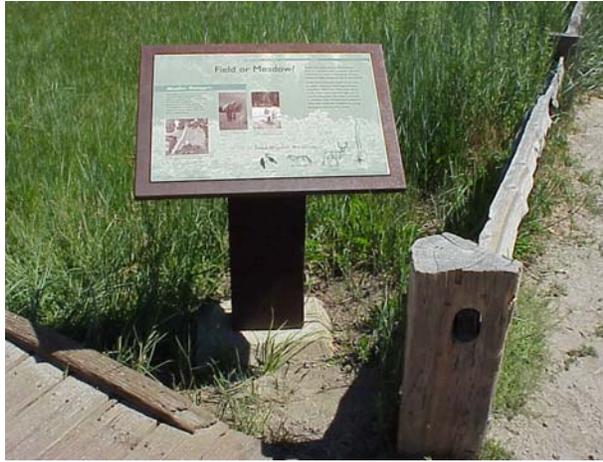
Sentinel Meadow Interpretive Boardwalk – Drop-Off to Wayside
