Self Evaluation and Transition Plan

Yosemite National Park

Accessibility Program

May 2010

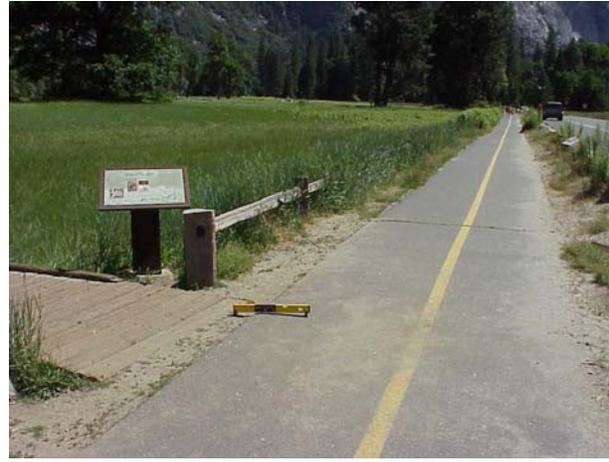
Sentinel Meadow Interpretive Boardwalk – Gap at Bicycle Path

Item	Barrier	Action	Corrective Action
Sentinel Meadow Interpretive Boardwalk			
Wayside Exhibit	Wayside exhibits are not on accessible route.	Stabilize area around wayside exhibits (ABA F 206.2.2).	Important
ORAR	An ORAR is needed from parking to the boardwalk.	Connect all features with an ORAR (PG T204).	Important
Parking	A van-accessible parking space is needed at the interpretive walk.	Provide a van-accessible parking space and sign (ABA F 208.2.4).	Important
River Access	Route to the river is interrupted by steps.	Provide an access route to the river bank (PG T 205; PG T 305).	Long Term
Sign	Meadow Damage sign is not located on the accessible route.	Relocate the Meadow Damage sign to the accessible route (ABA F 216.1).	Long Term

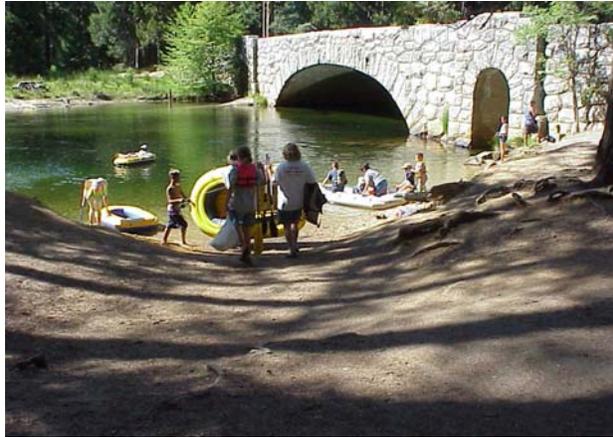
This wayside exhibit provides information about the Merced River, raft launching, and fishing. This area will be improved by the addition of an ORAR to the riverbank, as well as an accessible surface from the road to the wayside exhibit.

Stoneman Bridge Wayside – Route from Wayside to River

Item	Barrier	Action	Corrective Action
Stoneman Bridge Wayside			
Wayside Exhibit	Wayside exhibit is not on an accessible surface.	Provide an ORAR from road to wayside exhibit (PG T 204; PG T 304).	Long Term
River Access	Route to the river is interrupted by steps.	Provide an access route to the river bank (PG T 205; PG T 305).	Long Term

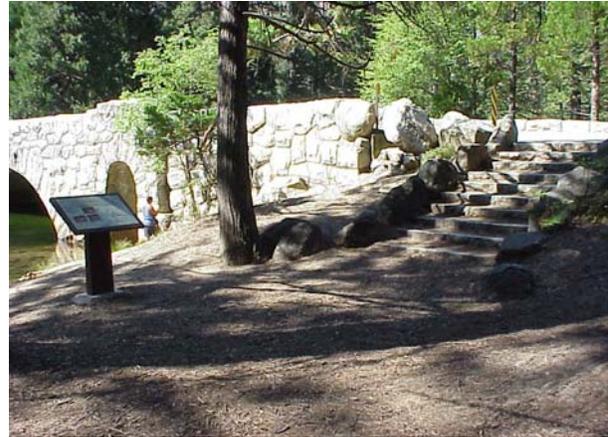
Stoneman Bridge Wayside – Steps Down to Wayside & River

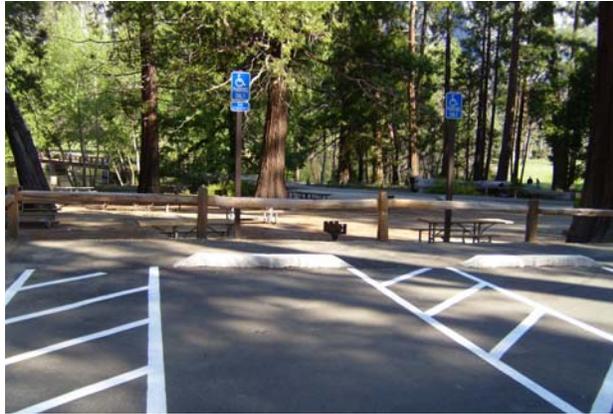
This picnic area is a quiet place to enjoy the scenic Merced River as it passes through Yosemite Valley. Van-accessible parking spaces and newly designated accessible picnic spaces have greatly enhanced this picnic area. An accessible route has been created in order to connect accessible parking spaces to the waterless restroom, and an ORAR now connects all accessible site features.

Swinging Bridge Picnic Area – Van Accessible Parking Spaces

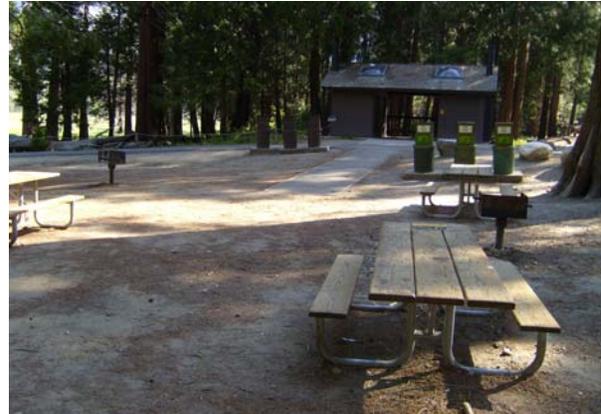
Swinging Bridge Picnic Area – Accessible Tables and Grills

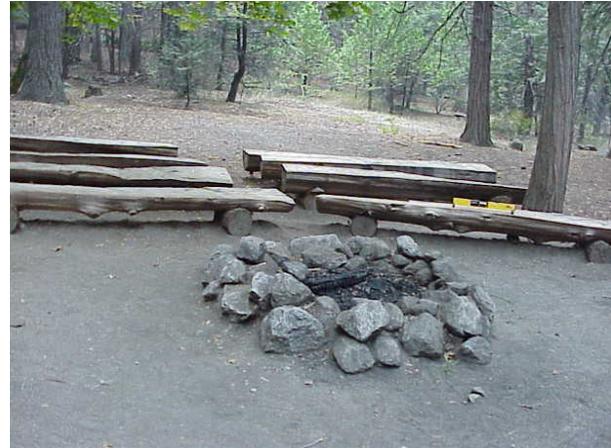
The Fen – Benches and Campfire Circle

Item	Barrier	Action	Corrective Action
The Fen Marsh Area and Amphitheater			
ORAR	An ORAR is needed to the Fen from parking.	Provide an ORAR from parking to the Fen (PG T 204; PG T 304).	Important
Trailhead Sign	Lack of compliant trailhead sign.	Install a compliant trailhead sign at an accessible location along the ORAR (PG T 221; PG T 321).	Important
Accessible Route	A boardwalk is needed to the amphitheater from parking.	Provide an accessible boardwalk to the amphitheater from parking (ABA 206.2.2).	Important
ORAR	An ORAR is needed in the fire circle / amphitheater.	Provide an ORAR in amphitheater area connected to boardwalk (PG T 204; PG T 304).	Important
Amphitheater Seating	Wheelchair seating spaces and companion seating spaces are needed in the amphitheater.	Disperse wheelchair seating spaces and companion seating throughout the amphitheater (ABA 802).	Important

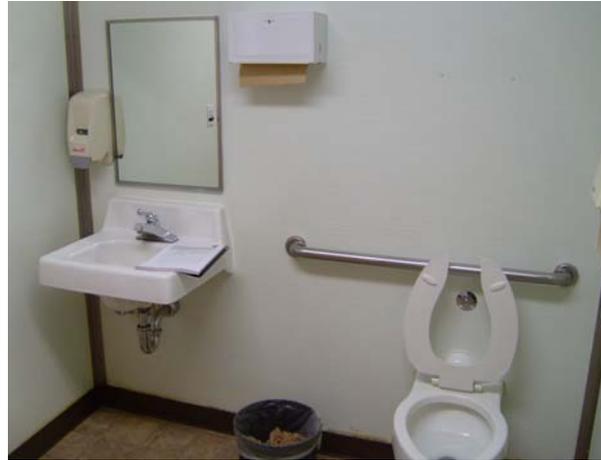
The United States District Court in Yosemite Valley is very accessible with compliant parking, metal detector, seating, and restroom. The only issue that needs to be corrected is the height of the paper towels in the restroom to a lower location.

United States District Court – Restroom

Item	Barrier	Action	Corrective Action
United States District Court			
Restroom	Paper Towels positioned too high from floor surface.	Lower the paper towels (ABA 606.1).	Long Term

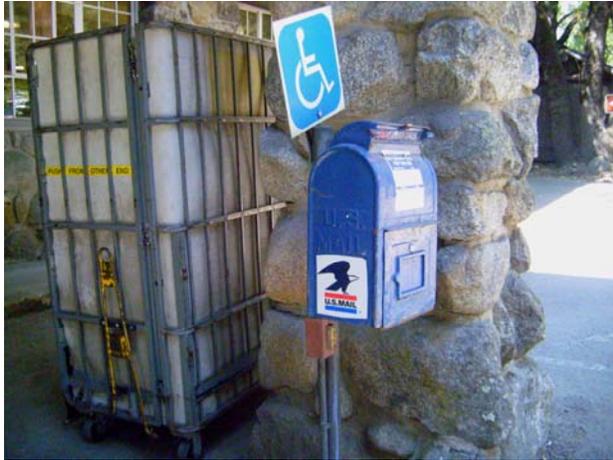
U.S. Post Office – Backdoor & Mailbox with Help Button

Item	Barrier	Action	Corrective Action
United States Post Office – Yosemite Village			
Directional Sign	Accessible parking is located in the rear of the post office.	Post directional sign to accessible parking and call button (ABA F 216.3).	Critical
Call Button for Service	The call button for car side services is in an inaccessible box.	Provide an accessible call button on the accessible route (ABA F 205).	Critical
Entrance/Door	The door at the post office lacks a kick-plate and a door sign. The rock wall prevents easy conversion for clear floor space and maneuvering space.	Install a kick-plate at the entrance to the post office and post the ISA sign at the entry. Install an automatic door opening device (ABA 404).	Critical
Parking	A van-accessible parking space is needed at the post office.	Provide a van-accessible parking space and sign (ABA F 208.2.4).	Critical
Transaction Counter	A lowered section of the transaction counter is needed for access.	Lower a section of the counter or provide an alternate area to provide services that is accessible (ABA 904.3.2).	Critical

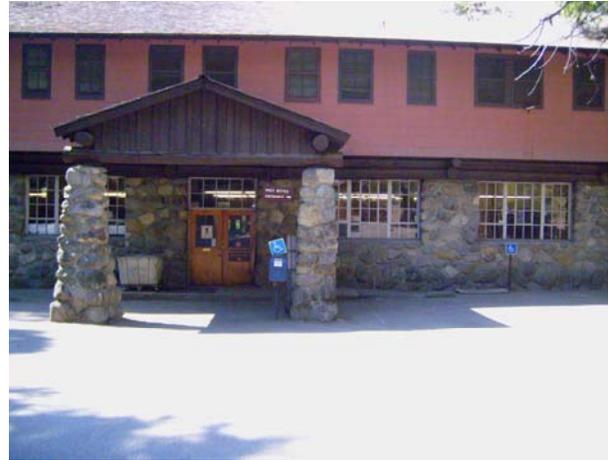
U.S. Post Office – Accessible Parking Space

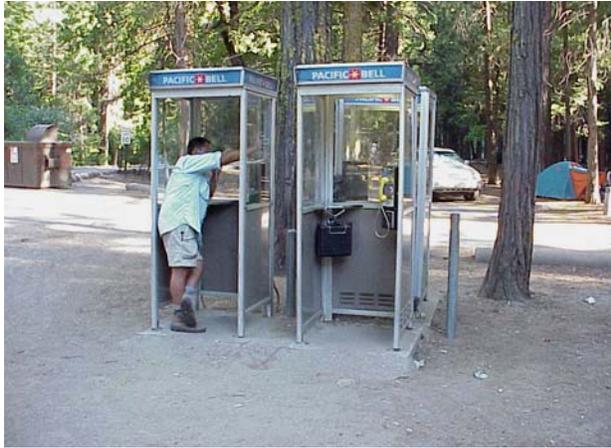
Upper Pines Campgrounds – Phone Booths

Item	Barrier	Action	Corrective Action
Upper Pines Campground			
Pay Telephone	Pay telephones are not accessible.	Provide an accessible pay telephone on the accessible route (ABA F 217).	Long Term

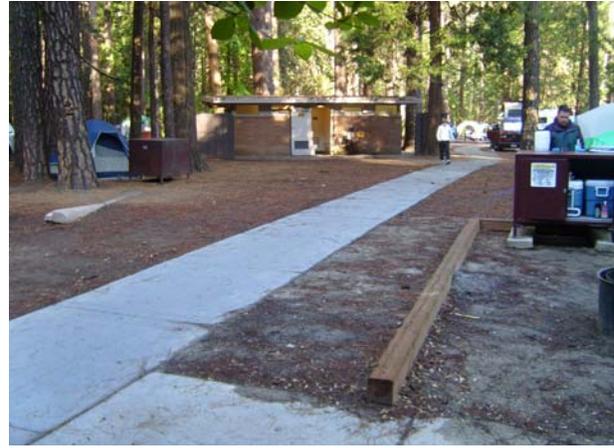
Upper Pines, along with Lower and North Pines Campgrounds, was designed and constructed in 1965-66, during the Mission 66 Initiative. Camping will be improved by the adding additional accessible campsites. The additions need to include access routes to and from campground facilities (restrooms, telephones, etc.). Loop A and Loop B restrooms have been remodeled to include accessible features.

Upper Pines Campgrounds – Route From Accessible Campsite

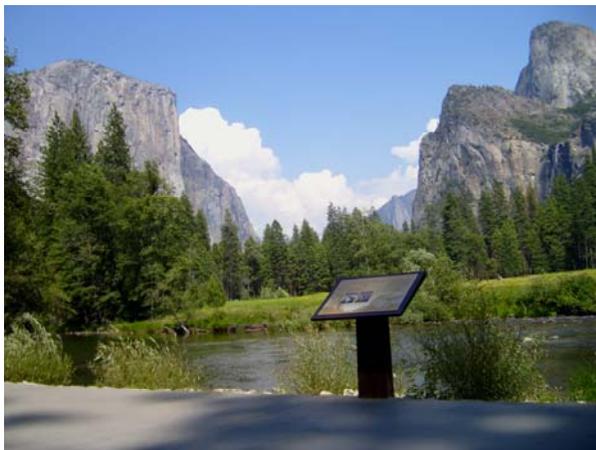
Valley View Wayside – Signage Without Sufficient Contrast

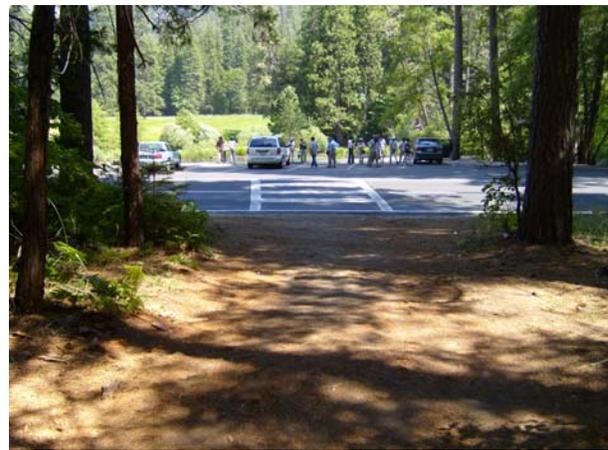
This wayside provides parking, a waterless restroom, and a wayside exhibit. Improvements to the parking and exhibit area are making this one of the most pleasant and scenic pullouts on the Valley floor. The waterless restroom across the street is along a path with excessive slope and lacks accessible qualities. Future modifications should include an accessible route to the waterless restroom.

Valley View Wayside – Route From Toilet to Wayside

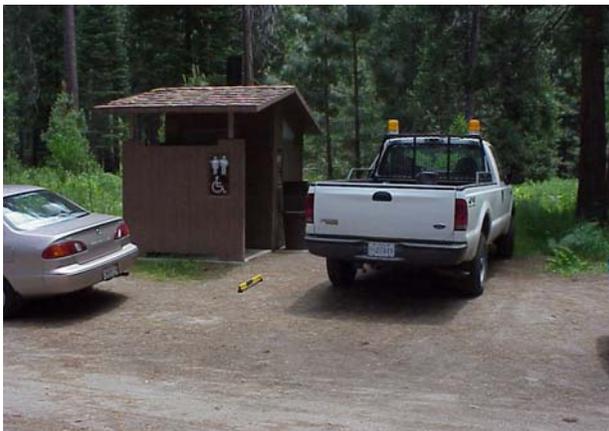
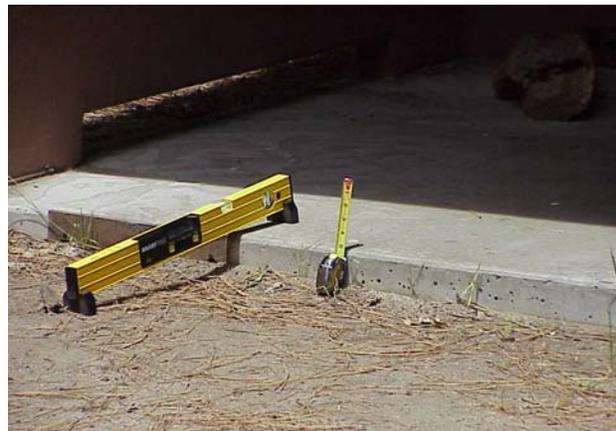
This campground provides campsites for volunteer groups that come into the Park to work as volunteers (i.e. scouting troops, business groups, etc.). Loop A parking will be improved through the addition of a van-accessible parking space. Waterless restrooms will be upgraded and connected to other site features on the accessible route. Accessible picnic tables will be added as well as an ORAR to connect all site features.

Yellow Pines Campground – Waterless Restroom Loops C & D

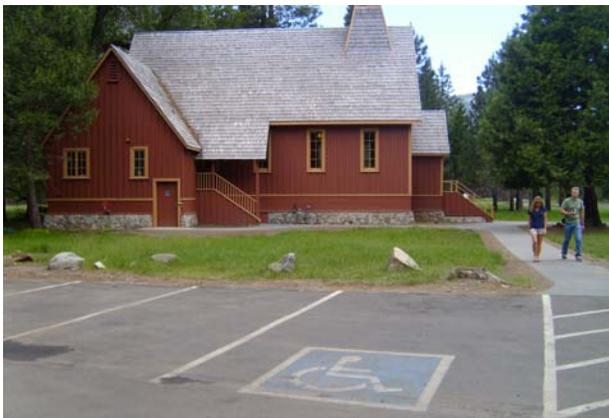
Yosemite Chapel is a non-denominational church that offers Sunday worship and wedding services. The accessible route from the parking lot to the wheelchair lift was recently repaved to correct any changes in level that previously were present. An ISA is currently located on the lift door, but is in the wrong location according to ADA and ABA standards.

Yosemite Chapel – Route from Parking Lot to Chapel

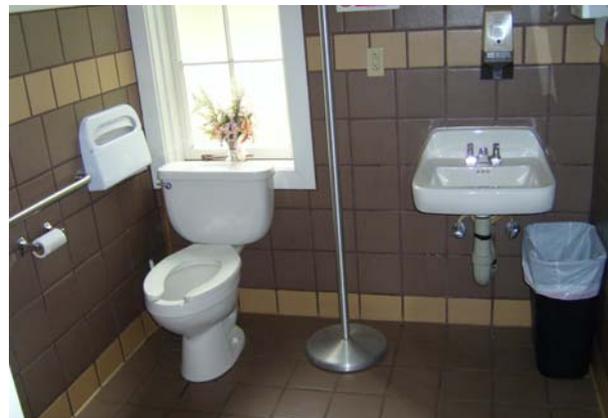
Yosemite Chapel – Less Than Full-Access Restroom

In order to improve access to the chapel and surrounding areas, the sign on the elevator door will be relocated and the outdoor bench will be replaced with an accessible model. The restrooms will also be altered in order to comply with ABA standards.

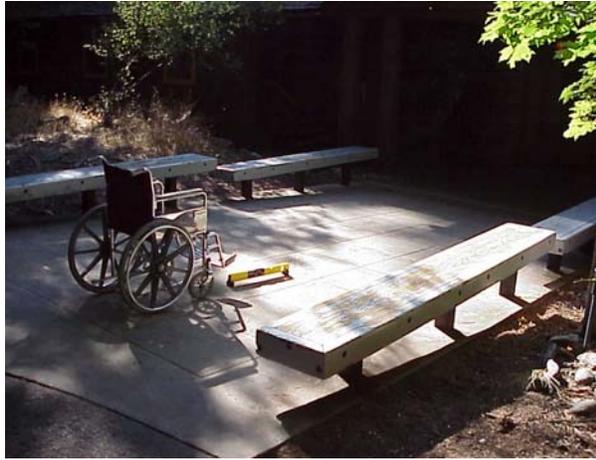
Valley Museum/Research Library – Slope at Rear of Museum Building from Indian Village

Item	Barrier	Action	Corrective Action
Yosemite Museum, Indian Village of Ahwahnee, and Research Library			
Ramp	The route to the museum has excessive slope and changes in level.	Ramp areas of route with excessive slope and add handrails and a smooth transition through the door (ABA 405).	Critical
Accessible Route	The route from the back door of the museum has a slope over 5 %.	Convert route to a more gradual slope or create a ramp with handrails (ABA F 206.2.2).	Critical
Door Hardware	The door hardware on both doors is inoperable with a closed fist.	Replace inaccessible door hardware (ABA F 216.3).	Critical
Audio Tour	Audio information not is provided to interpret the information at the museum.	Provide audio description of exhibits and a Braille guide.	Important
Exhibit Labels	Exhibit lacks Braille labels.	Label exhibits with Braille tags.	Important
Entrance/ Door	Doors require more than 5 lbs. of force to operate.	Adjust the door closer at front and back of building to under 5 lbs. of pressure or install door openers (ABA 404).	Critical

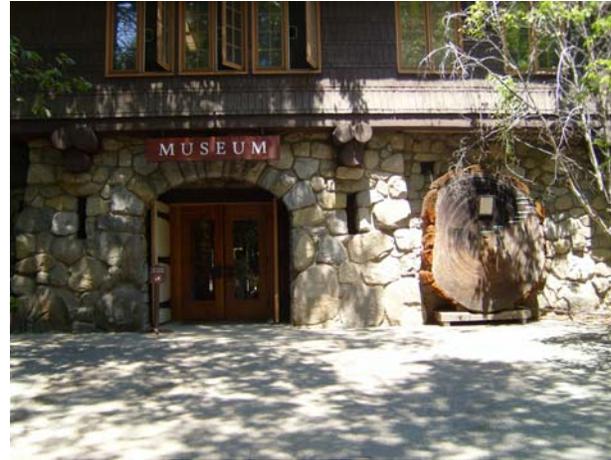
The front and back doors to the museum will be improved through the addition of accessible door hardware, reduced operating pressure and the installation of the ISA. The research library is currently on the second floor and will require either: (i) the installation of an elevator or (ii) the program being made accessible through relocation to an accessible facility or through program means such as assigning a research assistant to people with disabilities or digitization of the collection.

Valley Museum/Research Library – Front Entrance

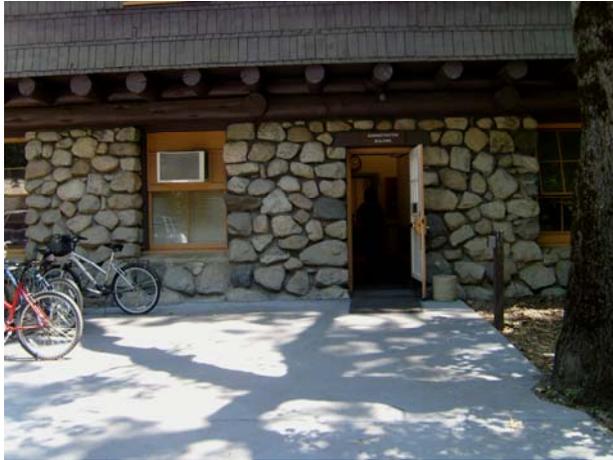
Newly designated accessible parking is now available with a new sidewalk and curb cut in place, which acts as an accessible route to the building. The superintendent’s office will undergo minor modifications to demonstrate accessibility. The visitor check-in area will also have the door hardware replaced with compliant hardware and maneuvering space will be provided.

Valley Administration Building – Accessible Entrance

Item	Barrier	Action	Corrective Action
Yosemite Valley Administration Building			
Restrooms	Restrooms located upstairs and are inaccessible.	Construct an accessible restrooms on main floor (201.1)	Critical
Sign	The accessible entrance to the building lacks an ISA sign.	Post the ISA on the latch side of the accessible entrance to the building (ABA F 216.3).	Long Term
Visitor Check-in	Door hardware is not operable with one closed fist. Door swing does not allow clear maneuvering space.	Replace door hardware with accessible lever or paddle-style handles. Hang door oppositely to allow clear floor space on the pull-side of the door (ABA 404).	Critical

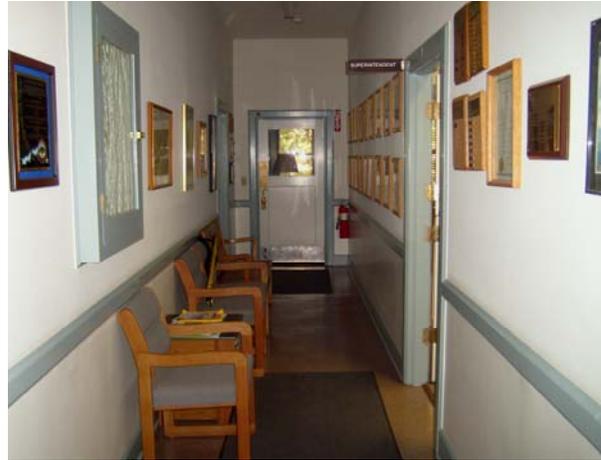
Valley Administration Building – Hall to Superintendent’s Office

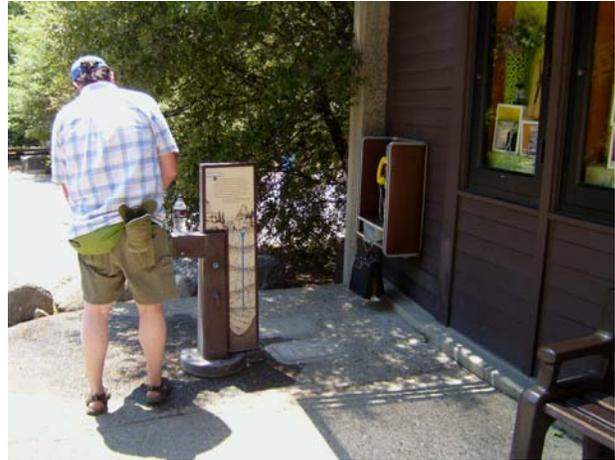
Yosemite Valley Visitor Center – Drinking Fountain and Phone

Item	Barrier	Action	Corrective Action
Yosemite Valley Visitor Center			
Accessible Route	Ground slope inside Valley Visitor Center has areas with slopes between 5 and 6 percent.	Adjust slope to < 5% inside the visitor center (ABA 403).	Critical
Sign	The ISA is not posted at the north and south entrances to the Visitor Center.	Post the ISA sign at the north and south entrances to the Visitor Center (ABA F 216.3).	Long Term

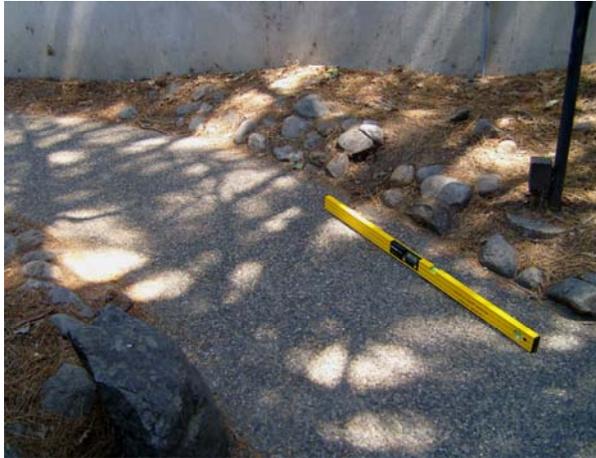
Yosemite Valley Visitor Center Restrooms – Slope of 6.4% from Visitor Center to Comfort Station

The main deficiency at the site is the route from the restroom to the back of the visitor center, auditorium, and theater. This route is designated as an accessible route and requires alteration to create a barrier-free path of travel. The bench located outside of the restrooms also needs to have clear ground space for wheelchair users.

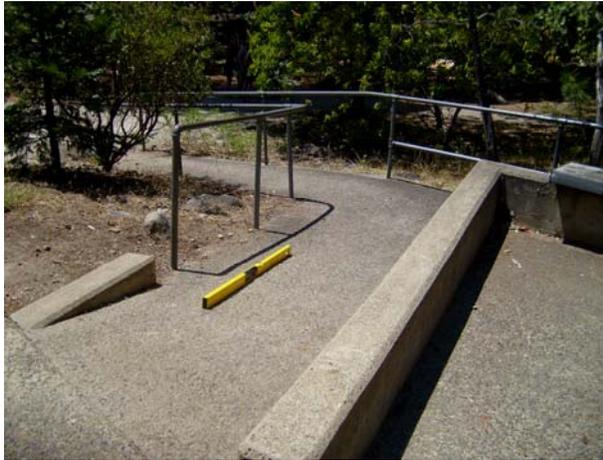
auditorium will need compliant handrails on both sides to compensate for the excessive slope. Plans are in the works to improve the ramp. Both the theater and the auditorium are presently accessible via the accessible route through the visitor center exhibit hall.

Valley Visitor Center Auditorium and Theater – Ramp to Theater

Item	Barrier	Action	Corrective Action
Yosemite Valley Visitor Center Theater and Auditorium			
Entrance/ Door	The door hardware at the auditorium is inoperable with a closed fist and requires more than 5 lbs. of force to operate.	Replace door hardware and adjust the door closer (ABA 405).	Critical
Picnic Table	Picnic tables are not the accessible design with clear knee space for wheelchair users.	Provide one accessible picnic table at the west side of the theater (PG T 206; PG T 306).	Critical
Sign	No ISA sign is posted on the entrance to the theater and auditorium.	Post the ISA sign on the entrance to the building (ABA F 216.3).	Long Term
Ramp	Handrails are not compliant for ramp slope requirements.	Install compliant handrails (ABA 505.2; 505.3).	Critical
Benches	Located off the pavement and are not accessible.	Replace with accessible benches at accessible locations (ABA 903).	Long Term

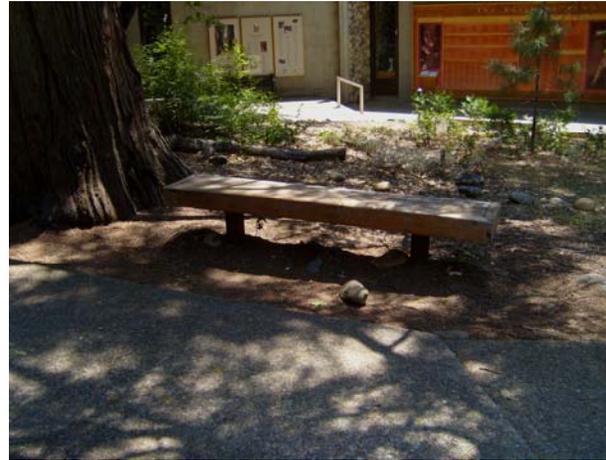
Valley Visitor Center Auditorium and Theater – Benches in Dirt

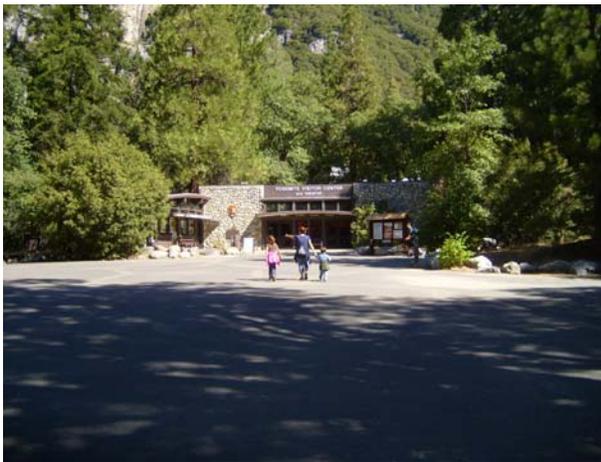
Village Mall – Slope from Transit Stop to Plaza

adjacent to this space. Visitor orientation and ranger-led walks originate within this site and the area links to six shuttle stops. The space in front of the visitor center is used occasionally for press conferences, speeches, concerts, and outdoor exhibitions. Currently, the routes in the mall have excessive slope and the Plan calls for a new accessible route that will connect all public use areas in the plaza. New benches will be added throughout the plaza to add companion seating space and old information boards will be replaced with signs that have appropriate text and contrast.

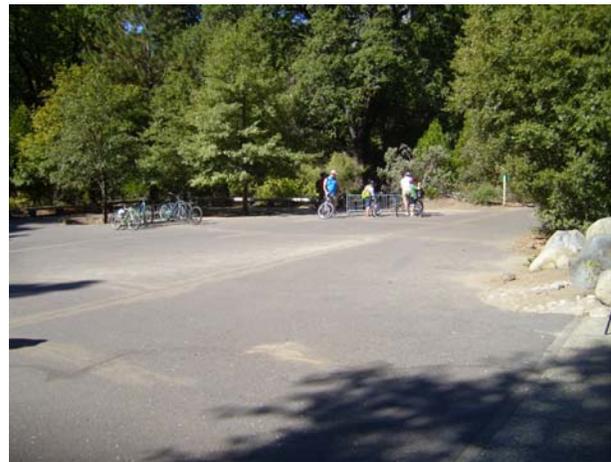
Village Mall – Bicycle Racks

Item	Barrier	Action	Corrective Action
Yosemite Village Pedestrian Mall			
Bench	Benches do not have arm and back rests or companion seating space.	Add new benches with companion seating space throughout the mall (ABA 903.1).	Important
Sign	Areas of the plaza have excessive slope.	Post sign at parking warning of excessive slope as an interim procedure (ABA F 216.3).	Important
Accessible Route	Paths throughout the Plaza have excessive slope.	Provide an accessible route connecting all areas of use at the mall (ABA F 206).	Important
Information Boards	Information signs at visitor center and parking area are not accessible.	Provide compliant information signs with appropriate text and contrast (ABA F 216.3).	Important

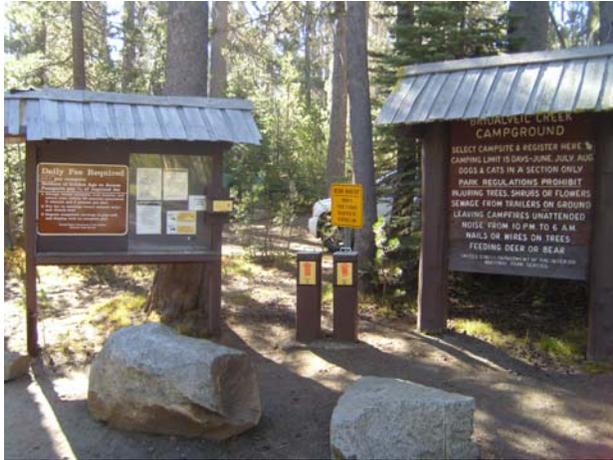
Bridalveil Creek Campground – Info Boards and Pay Station

Item	Barrier	Action	Corrective Action
Bridalveil Creek Campground			
Campsites	Accessible campsites not provided in the stock users' campground or family campground.	Provide 7 accessible campsites including RV accessible sites (PG T 218; PG T 318). Provide an accessible bear box, accessible grill (PG T 208; PG T 308), fire ring (PG T 207; PG T 307) and picnic table (PG T 206; PG T 306). Connect site features with an ORAR (PG T 204; PG T 304).	Critical
Restrooms	Restrooms are inaccessible.	Retrofit or replace restrooms with accessible restroom facilities (ABA F 213).	Critical
ORAR/ Amphitheater Route	ORAR to the amphitheater is not provided.	Provide an ORAR linking accessible campsites to amphitheater. (PG T 204; PG T 304). As an interim procedure provide an accessible parking space at the amphitheater (ABA F 208; ABA F 206).	Important
Benches/ ORAR in Amphitheater	Amphitheater lacks accessible benches.	Install accessible benches at amphitheater (PG T 213; PG T 313). Stabilize ORAR within amphitheater area (PG T 204; PG T 304).	Important

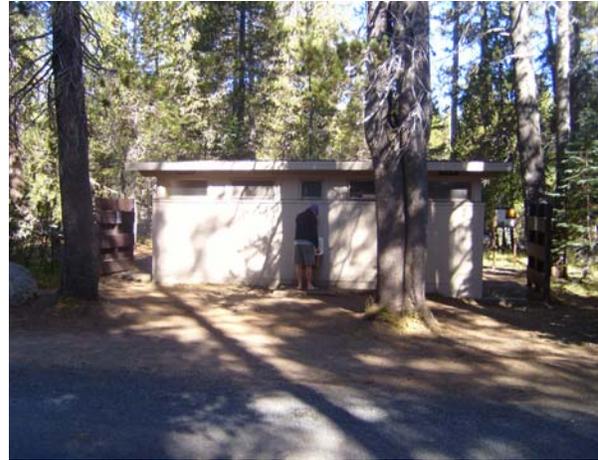
Bridalveil Creek Campground – Restrooms

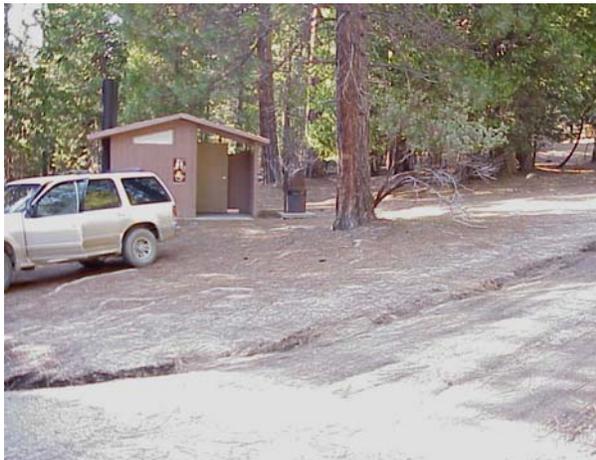
Chilnualna Fall Trailhead – Route to Waterless Restrooms

This trailhead will be improved by the addition of a van accessible parking space near the waterless restrooms and an accessible route from the parking to the restrooms. In addition, an accessible trailhead sign will be placed along the accessible route near the parking.

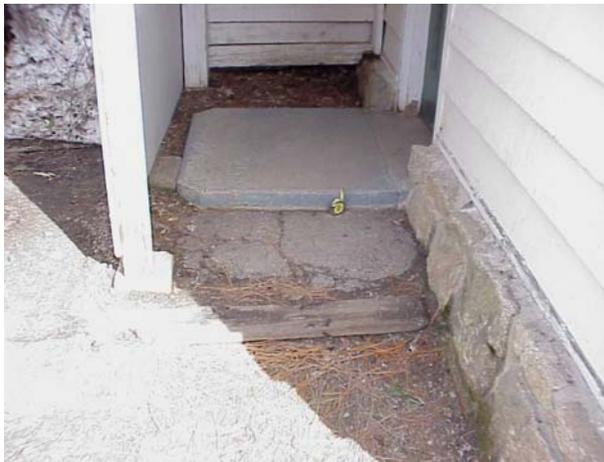
Chinquapin Restrooms – Entrance to Women’s Restroom

Item	Barrier	Action	Corrective Action
Chinquapin Restrooms and Parking			
Accessible Route	Route from parking area to comfort station and pay telephone exceeds slope requirements and is obstructed by a curb.	Provide an accessible route to comfort station and pay telephone (ABA F 206.2.2).	Critical
Parking	Van-accessible parking space not provided.	Provide a van-accessible parking space and sign (ABA F 208.2.4).	Critical
Restrooms	Restrooms lack accessible entry, restroom sign, door hardware, accessible toilet stall configuration and grab bars.	Retrofit the restroom to comply with ABA standards (ABA F 213).	Critical

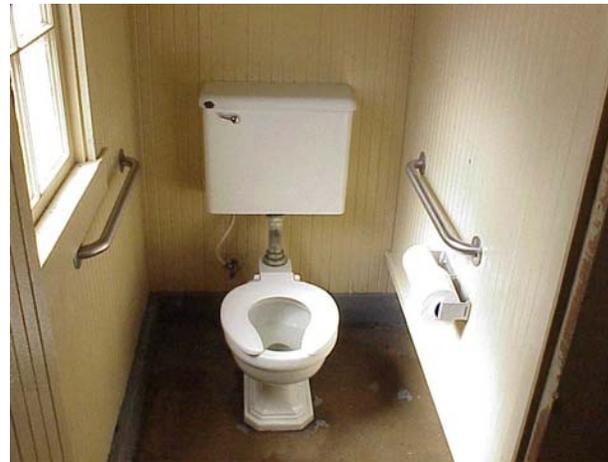
Chinquapin Restrooms – Stall Interior in Men’s Restroom

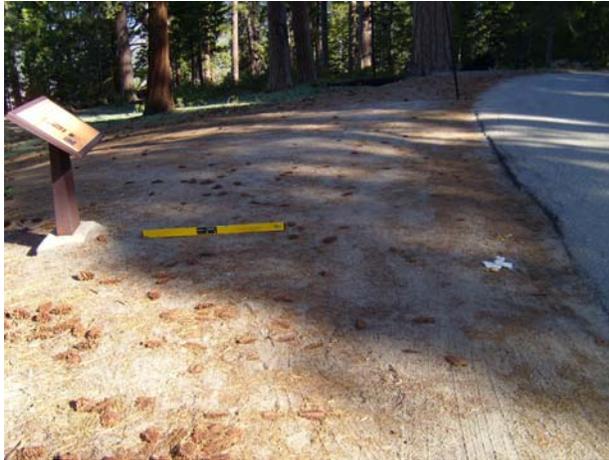
Fire Wayside – Change in Level at Wayside

The site will be improved by reducing the change in level between the asphalt and dirt, or relocating the wayside exhibit to an accessible location.

Item	Barrier	Action	Corrective Action
Fire Wayside			
Accessible Route	Change in level greater than 1 inch.	Reduce the change in level (PG T304.5).	Long Term

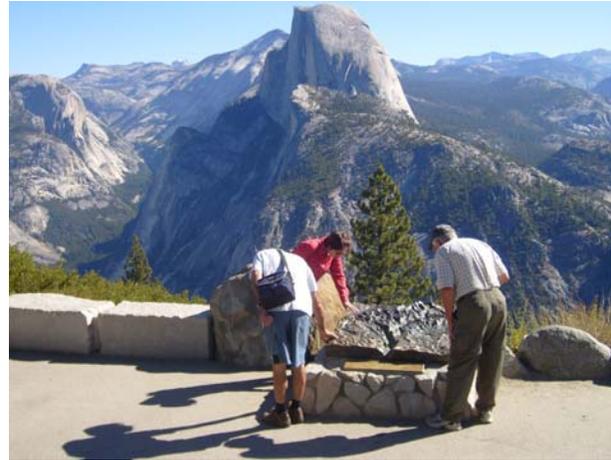
Due to the constraints of the terrain, the geological exhibit is not on an accessible trail and a plan is needed to make this feature accessible. A bronze tactile map has been installed at the lower viewing area, but is scheduled for relocation during the summer of 2010. Several small improvements need to be made to facilities such as restrooms, phone, benches, and parking lot, but overall this site is mostly accessible in its physical layout.

Glacier Point – Lower Viewing Area

Item	Barrier	Action	Corrective Action
Glacier Point			
Trailhead Sign	The Four Mile Trail/Glacier Point trailhead sign is not accessible.	Install a compliant trailhead sign at an accessible location along the ORAR to the trail (PG T 221; PG T 321).	Long Term
Restrooms	Restroom signs are not displayed correctly. Lavatories have non-compliant faucets and lack sufficient knee space.	Post the ISA properly and replace lavatory or remount with clear knee space (ABA F216.2; ABA F213.3.4).	Critical
Accessible Route	Route to the geology exhibit has excessive slope.	Reroute path to follow areas with the lowest slope and connect to exhibit (ABA F 206.2.2).	Important
Amphitheater	The amphitheater does not have designated seating for wheelchair users.	Provide dispersed seating for wheelchairs and companion seating (ABA 802.3).	Important
Benches	Benches do not have arm and back rests or companion seating space.	Retrofit 50% of the benches to be accessible (ABA F 213; PG T 313).	Important

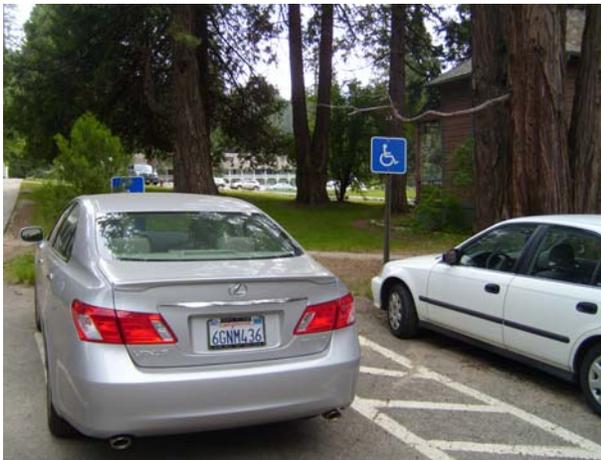
Hill's Studio – Non Compliant Parking Signs and Spaces

This summer visitor contact center, which already demonstrates many accessible features and a high degree of usability, will be enhanced to provide more accessible parking, and a fully accessible restroom.

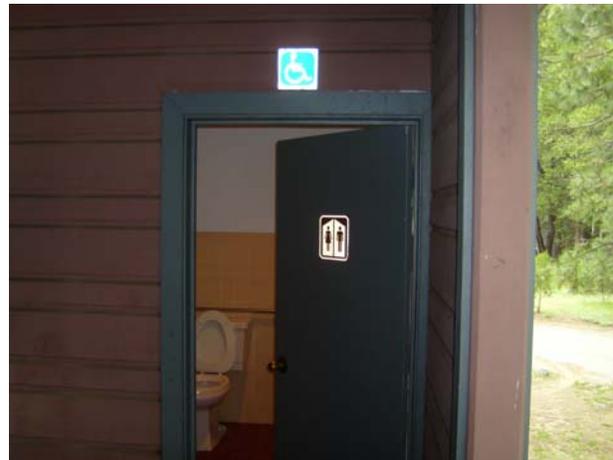
Hill's Studio – ISA in Incorrect Location

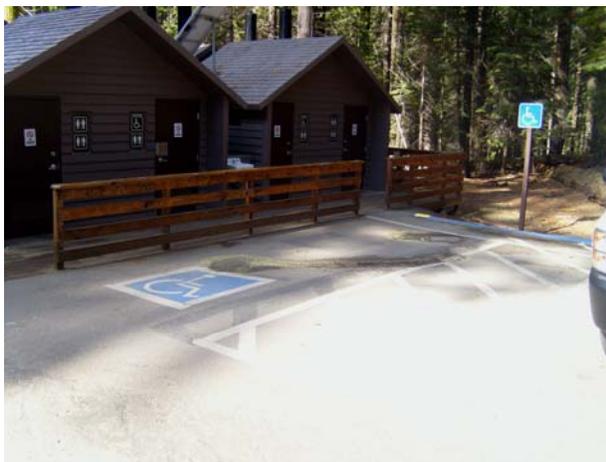
Mariposa Grove Trailhead – Waterless Restrooms and Parking

Item	Barrier	Action	Corrective Action
Mariposa Grove Trailhead and Visitor Area			
Information	Map dispenser is not on the accessible route.	Provide access to the map dispenser or move to an accessible location (ABA F 206.2.2).	Critical
Parking	Three additional parking spaces needed throughout the facilities.	Provide three more spaces including a van accessible space (ABA F 208).	Critical
Accessible Route	Thresholds and entrance area grate at museum require repair or replacement.	Bevel thresholds on route to and through the museum, replace grate (ABA F 206.2.2).	Important
ORAR	Obstructions in path of travel prevent access to Sequoia Forest Trail.	Provide an ORAR to the trailhead (PG T 204; PG T 304).	Important
Trailhead Sign	Sequoia Forest Trail. Inaccessible trail access point.	Install a compliant trailhead sign at an accessible location along the ORAR (PG T 221; PG T 321).	Important
ORAR	ORAR is not provided at the Grove Trailhead.	Provide an ORAR at the Grove Trailhead (PG T 204; PG T 304).	Important

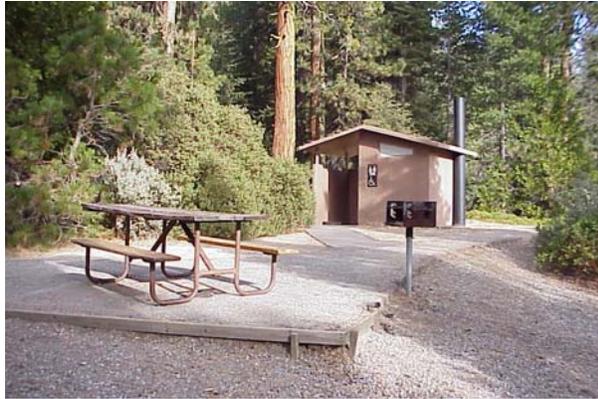
Mariposa Grove Picnic Area – Waterless Restroom and Picnic Area

Item	Barrier	Action	Corrective Action
Mariposa Grove Picnic Area			
Accessible Route	Parking area surface and route is uneven blacktop.	Repair slope, surface in parking area and route (ABA F206).	Important
Accessible Route	Route to waterless restroom is not accessible.	Provide an accessible route to the waterless restroom (ABA F206.2.2).	Critical
Parking	Designated parking not available.	Provide a van-accessible parking space and sign (ABA F208.2.4).	Important
Picnic Area	Accessible picnic area not provided.	Move grill to accessible picnic site; add an accessible picnic table (PG T 206; PG T 306).	Critical

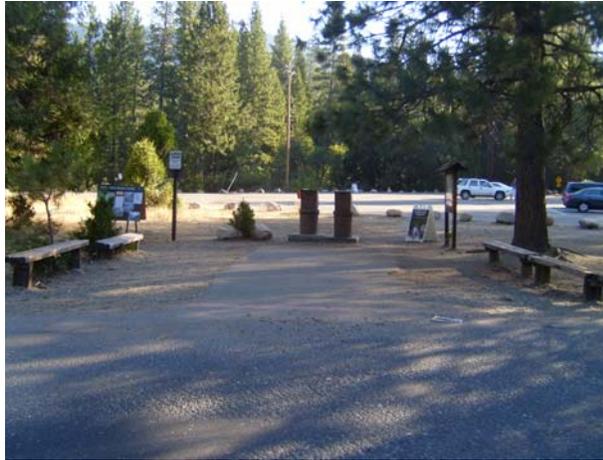
Mariposa Grove Shuttle Bus Stop – Benches and Waiting Area

Item	Barrier	Action	Corrective Action
Mariposa Grove Shuttle Bus Stop at the Wawona Store			
Accessible Route	Accessible route is needed from parking to the transit stop.	Establish an accessible route to connect site features (ABA 206.2.2).	Critical
Transit Stop	Accessible benches needed with clear ground space.	Provide an accessible transit stop with an accessible route; add two benches with companion seating space, one with an armrest, and accessible information (ABA 810.1; PG T313; PG T213.2.2).	Critical
Sign	Signs at the transit stop do not comply with text and finish standards.	Provide compliant signs at the transit stop (ABA F 216.3).	Critical

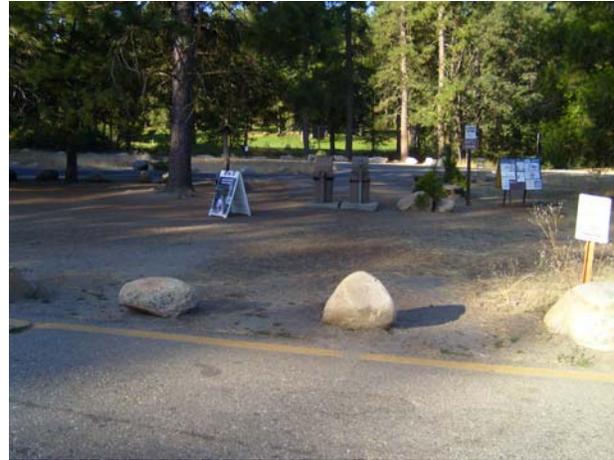
Mariposa Grove Shuttle Bus Stop – Access from Parking Lot

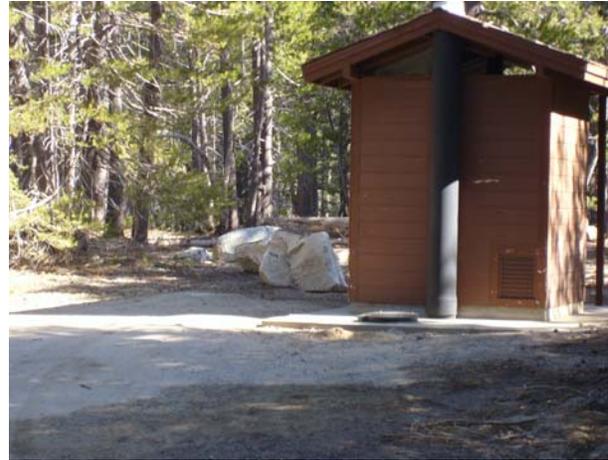
Ostrander Trailhead – Parking and Route to Waterless Restroom

Item	Barrier	Action	Corrective Action
Ostrander Lake Trailhead			
Parking	Designated parking is not provided at Trailhead.	Provide a van-accessible parking space and sign (ABA F 208.2.4).	Long Term
Trailhead Sign	Lack of compliant trailhead sign.	Install a compliant trailhead sign at an accessible location along the ORAR (PG T 221; PG T 321).	Long Term
Accessible Route	No accessible route exists to connect the facilities and parking.	Provide an ORAR that connects the trash receptacles to the current facilities (PG T309).	Long Term

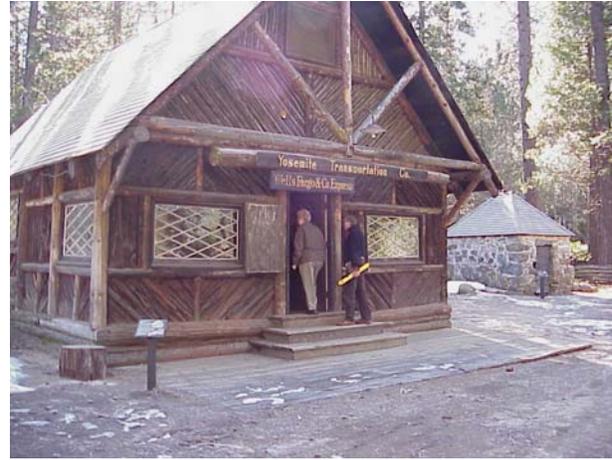
Pioneer Yosemite History Center – Wells Fargo Front Entrance

Item	Barrier	Action	Corrective Action
Pioneer Yosemite History Center			
ORAR	No accessible route connecting the program areas at the historic center.	Stabilize an ORAR to connect the areas of use (PG T 204; PG T 304).	Critical

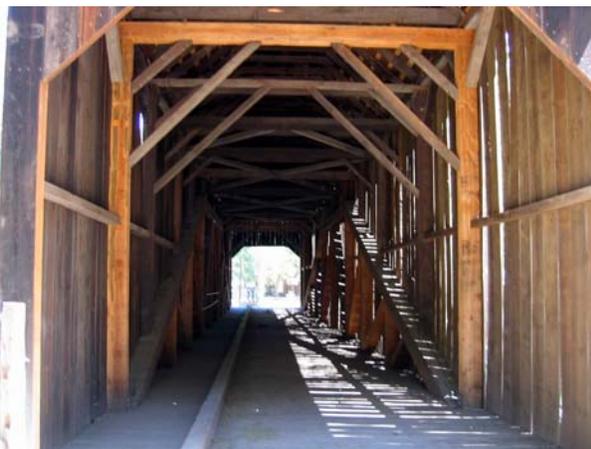
The bridge has a pedestrian route, but there are tread obstacles throughout due to the uneven floorboards. Some work is needed in order to remove the tread obstacles and to provide smooth access on both sides of the bridge.

Pioneer Yosemite History Center – Covered Bridge Access Route

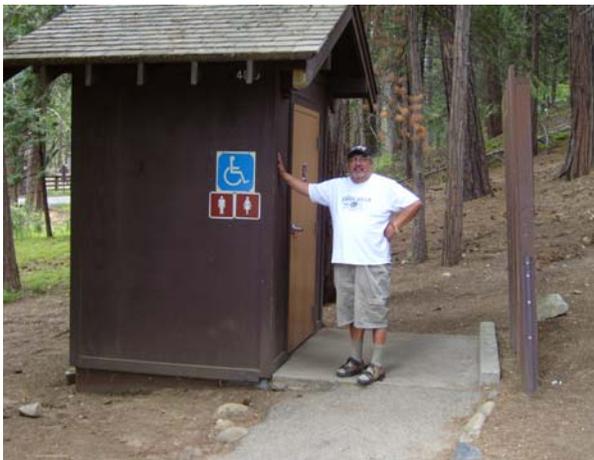
Pioneer Yosemite History – Waterless Restroom with Change in Level

Item	Barrier	Action	Corrective Action
Pioneer Yosemite History Center – Parking/Waterless Restroom/Picnic Area			
Parking	Two parking spaces are needed in the parking lot.	Add one standard accessible parking space and one van-accessible parking space (ABA F 208.2.4).	Critical
Waterless Restroom	Restroom not accessible. Lacks required clear space and mirror is too high.	Retrofit the waterless restroom to comply with ABA standards (ABA F 213).	Critical
Accessible Route	The route to and from the waterless restroom has excessive slopes, changes in level, and tread obstacles.	Repave a compliant accessible route from the picnic areas to the designated accessible waterless restroom (ABA F206.1).	Critical
Picnic Area	Accessible picnic table located too close to grill.	Move the accessible picnic table further away from the grill or replace with a standard picnic table (PG T308.2).	Long Term

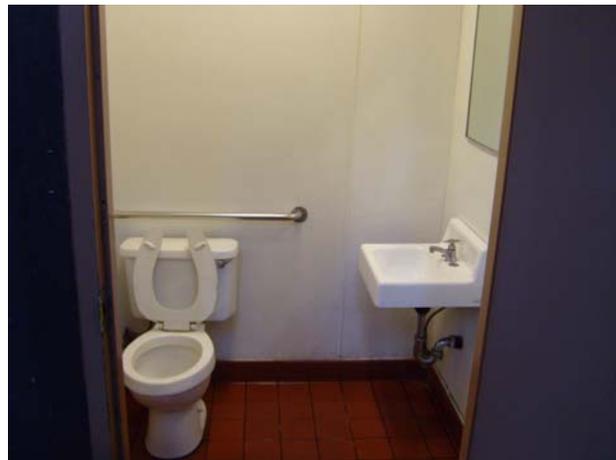
Pioneer Yosemite History Center – Inside Waterless Restroom

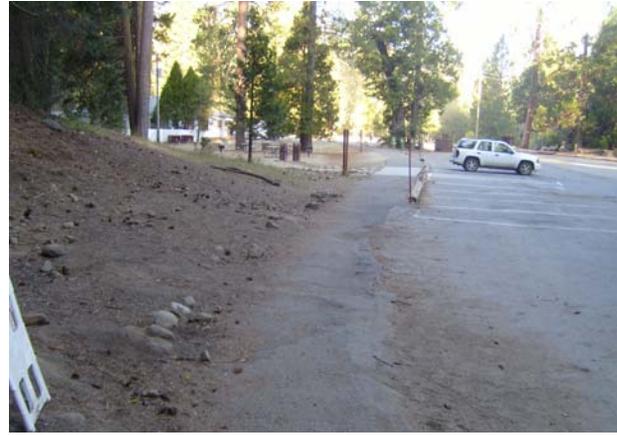
Pioneer Yosemite History Center – Accessible Route

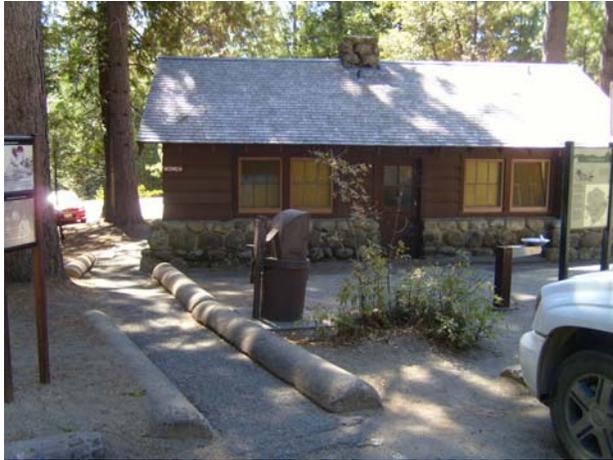
South Entrance – Restrooms

Item	Barrier	Action	Corrective Action
South Entrance Complex			
Accessible Route	Parking bumpers inhibit access to information and site features.	Reduce length of parking bumpers to allow access to the site features. (ABA F206.2.2).	Critical
Accessible Route	Route to restrooms is old and uneven.	Provide an accessible route to the restrooms (ABA F 206).	Critical
Parking	Lower parking lot lacks van-accessible space.	Provide a van-accessible parking space and sign. (ABA F 208.2.4).	Critical
Restrooms	Restrooms are not up to accessible standards.	Retrofit the restroom to comply with ABA standards. (ABA F 213).	Critical
Kiosk Buildings	Accessibility to the entrance kiosk is prevented by the structure's design.	Allow accessible communication by offering car side services to persons with disabilities on an as needed basis.	Important
Wayside Exhibit	Wayside exhibit and information boards are not on an accessible surface.	Move exhibits to be located along the accessible route (ABA F 206.2.2).	Critical

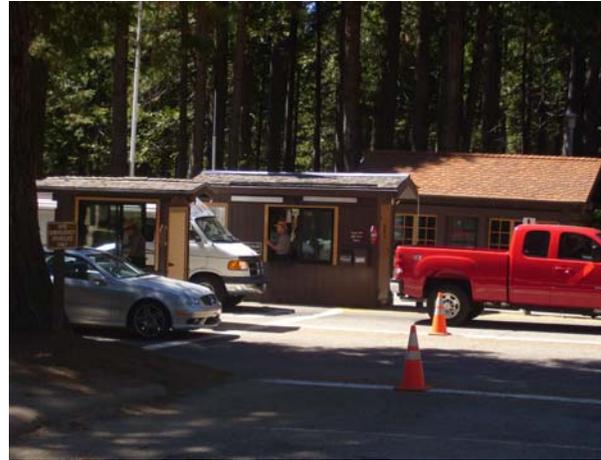
South Entrance – Entrance Kiosks

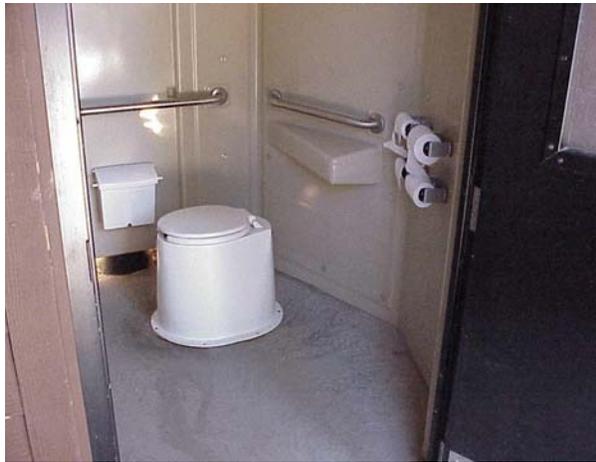
Summit Meadow – Waterless Restroom

Item	Barrier	Action	Corrective Action
Summit Meadow Parking and Waterless Restroom			
ORAR	An accessible route is needed from parking to waterless restroom.	Provide an accessible route to the waterless restroom. (PG T 204; PG T 304).	Critical
Parking	Site lacks accessible parking.	Provide a van-accessible parking space and sign. (ABA F 208.2.4).	Long Term
Trash Receptacle	Trash receptacles need to be relocated on an accessible route.	Relocate trash receptacles on an accessible route. (PG T209).	Long Term
Waterless Restroom	Toilet paper incorrectly positioned.	Relocate the toilet paper dispensers. (ABA F213).	Important

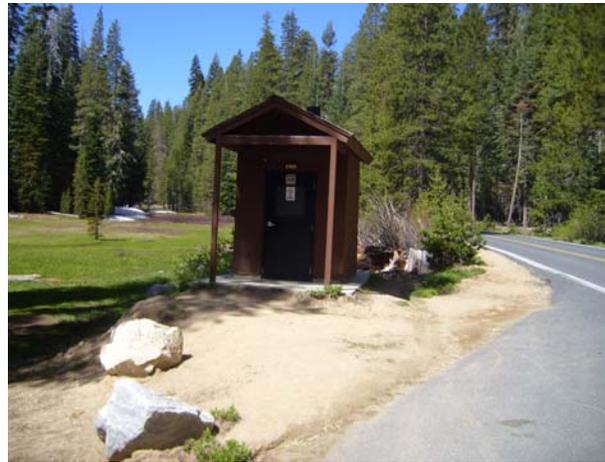
Summit Meadow – Route to Waterless Restroom

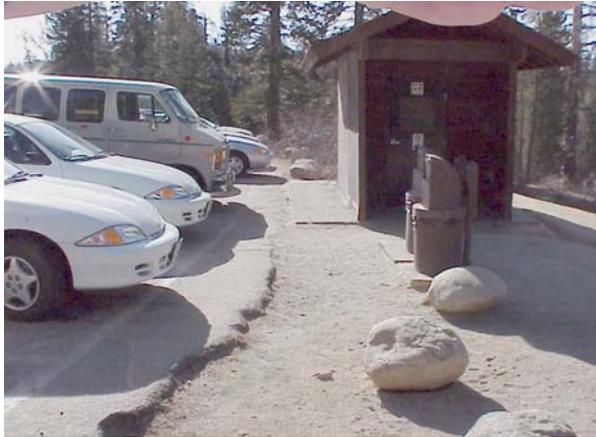
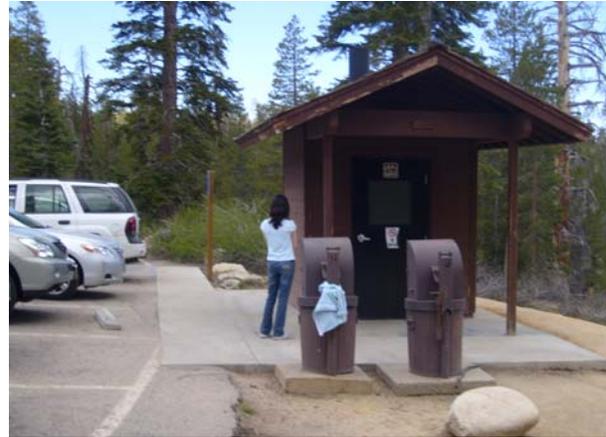
Taft Point and Sentinel Dome – Parking Lot and Waterless Restroom

Item	Barrier	Action	Corrective Action
Taft Point and Sentinel Dome Trailheads			
Waterless Restroom	Toilet paper dispenser is mounted on the incorrect wall.	Move toilet paper dispenser to the correct location. (ABA F 213).	Long Term
Trailhead	Provide an informative exhibit about the trail at an accessible location or install a new trailhead sign.	Provide an updated trailhead. (PG Advisory T321.2).	Long Term

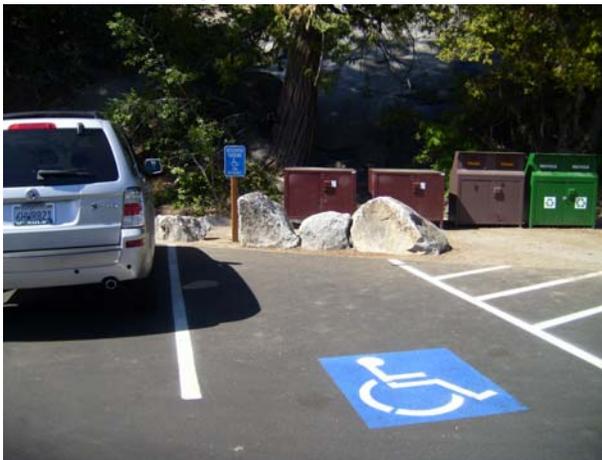
Tunnel View – Example of Non-Compliant Signage

Item	Barrier	Action	Corrective Action
Tunnel View			
Trailhead Signs	Lack of compliant trailhead signs.	Install a compliant trailhead sign at an accessible location (PG T 221; PG T 321).	Long Term
Accessible Parking Signs	Accessible parking signs do not meet the minimum height requirement.	Raise the signs to meet the 60" minimum height from ground surface to bottom of sign (ABA 502.6).	Long Term

Measures to ensure that this location meets accessible standards include the addition of a new trailhead sign in an accessible location, or the addition of an exhibit explaining the trail on an accessible route. Extending accessible parking signage to meet the minimum 60-inch height requirement should also be considered in both the upper and lower lot.

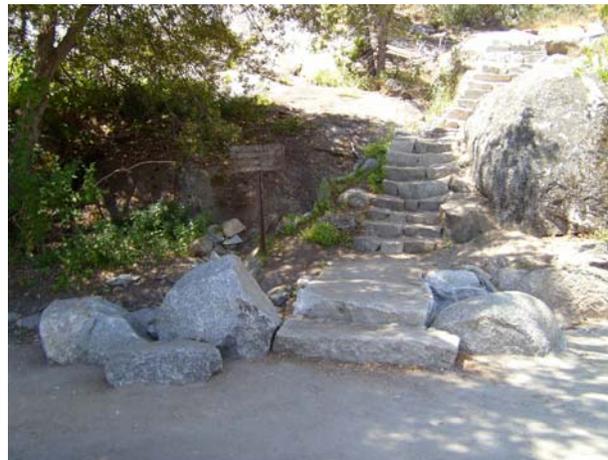
Tunnel View – Trailhead to Inspiration Point

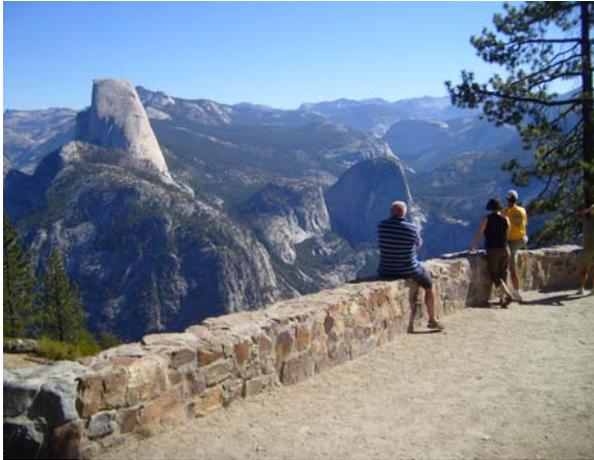
Washburn Point – Route to Lookout Point

This site is scheduled to be renovated in 2010 and will be improved by the creation of van-accessible parking, the addition of a curb cut, and accessible wayside exhibits.

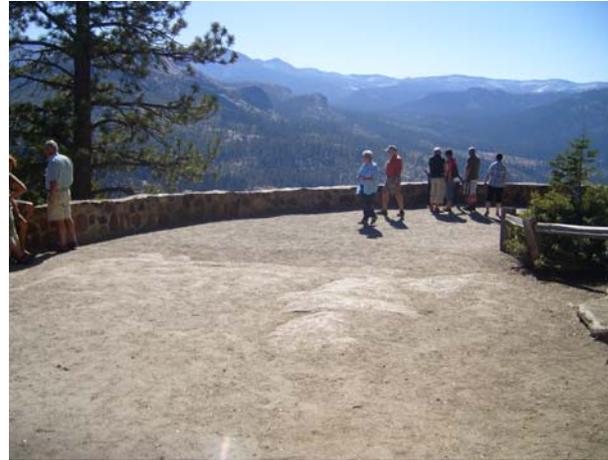
Washburn Point – Wayside, Loose-Sand Approach
