Self Evaluation and Transition Plan

Yosemite National Park

Accessibility Program

May 2010

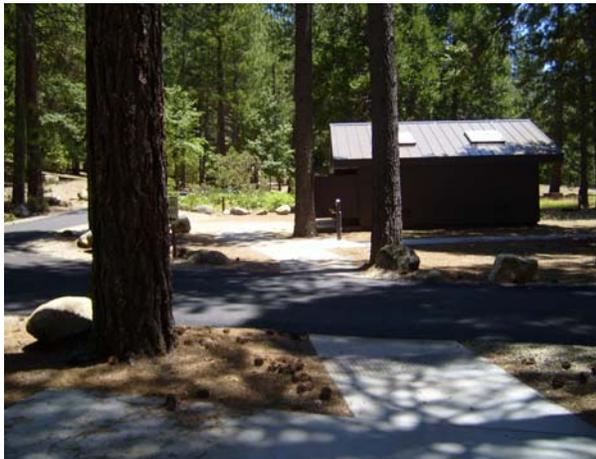
Wawona Campground – Loop C – Route to Restrooms

Item	Barrier	Action	Corrective Action
Wawona Campground			
Campsites	An additional three campsites are needed.	Provide three accessible campsites. (PG T218.2).	Critical
ORAR	Restroom building #4066 is not on an ORAR.	Provide an accessible ORAR to the restroom. (PG T 204; PG T 304).	Critical
Restrooms	Restroom building #4066 is not accessible.	Provide an accessible restroom facility with utility sink. (ABA F 213).	Critical

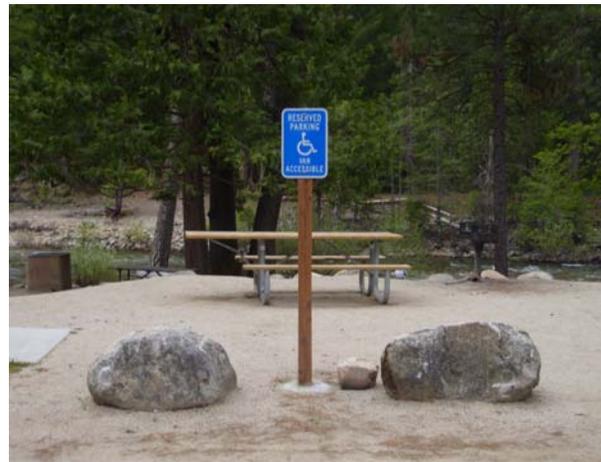
Wawona Day Use Picnic Area – Van Accessible Parking

A fully accessible picnic area has been installed as well as an ORAR from the waterless restroom to those facilities. Additional modifications will include a more defined van accessible parking space as well as an accessible route from that space to the facilities.

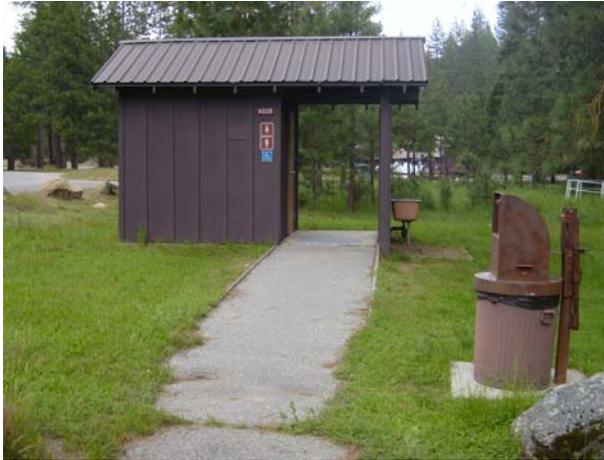
Wawona Horse Camp – Restroom and Utility Sink

Item	Barrier	Action	Corrective Action
Wawona Horse Camp			
ORAR	ORAR does not connect to utility sink and water spigot.	Provide an ORAR to connect all accessible site features (PG T 204; PG T 304).	Important
Campsite	Accessible campsites not provided.	Provide accessible campsites (PG T 218; PG T 318).	Critical
Vehicle and Trailer Site or RV Site	Vehicle and trailer site not designated.	Designate an accessible horse trailer and vehicle site using RV camping standards (PG T 218; PG T 318).	Long Term

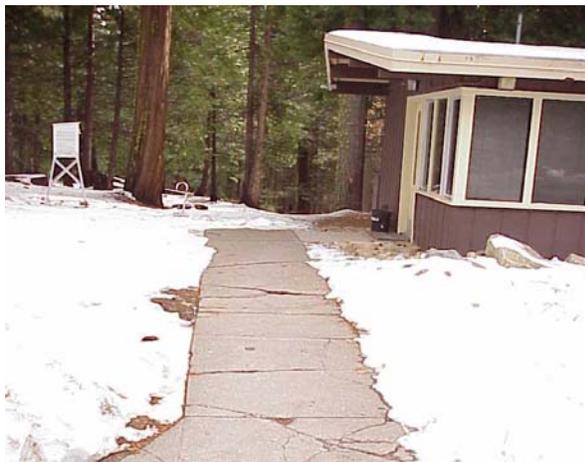
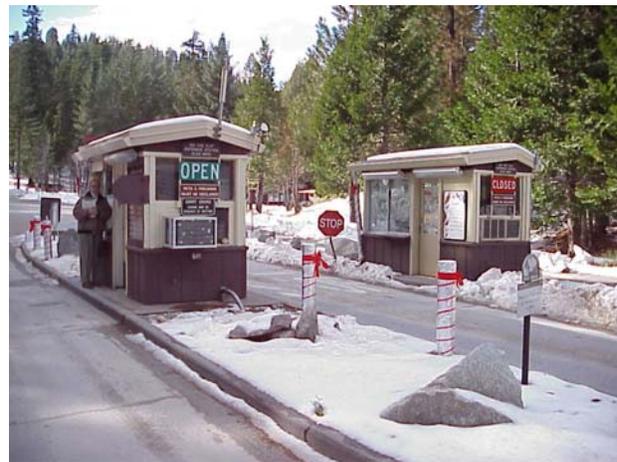
Big Oak Flat Entrance Station – Inaccessible Employee Area

Big Oak Flat Entrance Station – Kiosks

Item	Barrier	Action	Corrective Action
Big Oak Flat Entrance Station			
Kiosk Building	Accessibility to the entrance kiosk is prevented by the structure's design.	Replace inaccessible structure with new accessible kiosk.	Critical

The Big Oak Flat Entrance Station is being renovated and funds are obligated for the update of the site facilities. The Big Oak Flat Entrance Station renovation will enhance visitor accessibility and become the first barrier-free entrance kiosk for employees in the park. These improvements will allow employees and visitors with disabilities the chance to interact with a minimum of barriers.

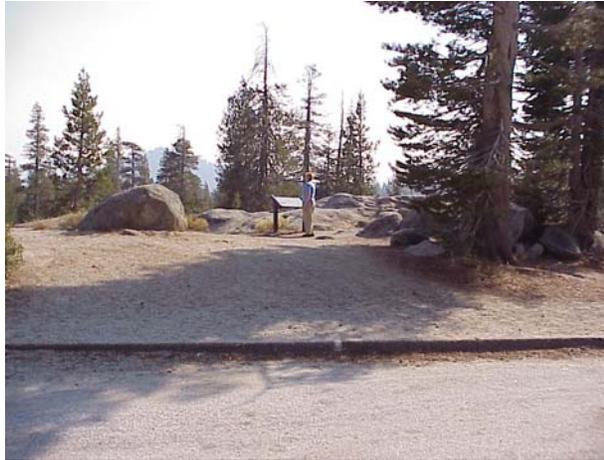
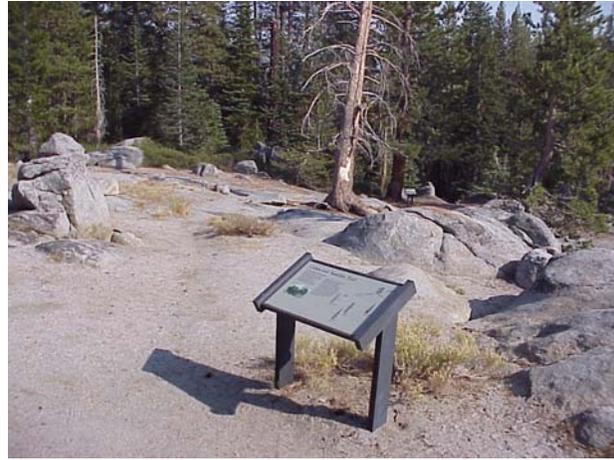
Cone-Bearing Trees Wayside – Route from Parking Lot

Cone-Bearing Trees Wayside – Exhibit

Item	Barrier	Action	Corrective Action
Cone Bearing Trees Wayside			
Wayside Exhibit	The six wayside exhibits are inaccessible.	Replace wayside with a compliant exhibit on the accessible route. (ABA F 216).	Long Term
Accessible Route	Accessible route not provided from parking to wayside exhibits.	Provide an accessible route connecting parking to the wayside exhibits. (ABA F 206.2.2).	Long Term

This site allows visitors to read and learn about various types of native pines. The site will be improved by placing the wayside exhibits along an accessible route. A new wayside exhibit is being completed with installation in an accessible location scheduled for summer 2010.

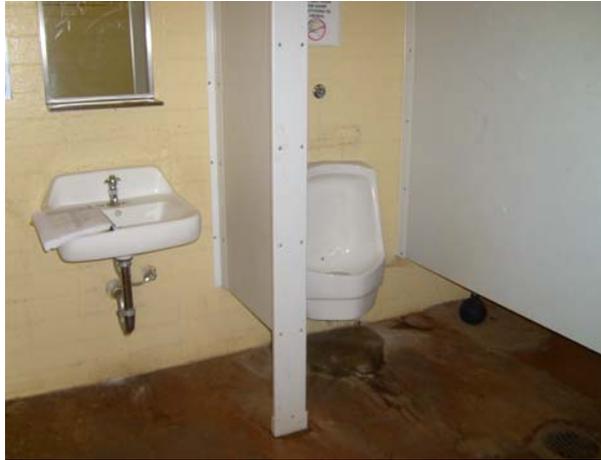
Crane Flat Campground – Men's Restroom

Item	Barrier	Action	Corrective Action
Crane Flat Campground			
ORAR	Accessible path of travel from campsites to comfort stations have not been established.	Provide an ORAR to comfort station #6040 serving accessible campsites (PG T 204; PG T 304).	Critical
Restrooms	Mirrors are too high.	Retrofit restrooms to comply with ABA standards (ABA F 213).	Critical
Water Source	The operating mechanisms for the water sources are not operable with one closed fist.	Provide accessible outside water spigots, handles and faucets (PG T 217; PG T 317).	Critical

An Outdoor Recreation Access Route (ORAR) will need to be created to allow access between the accessible campsites and restrooms. In addition, at least six more campsites need to be made accessible in order to meet requirements. An ORAR will also be needed in order to make the amphitheater accessible for the use of all visitors.

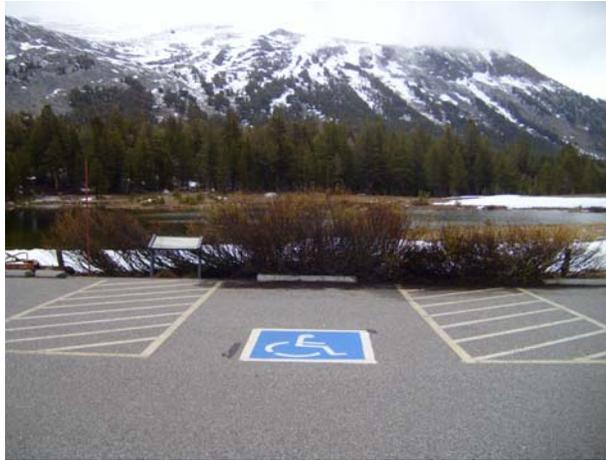
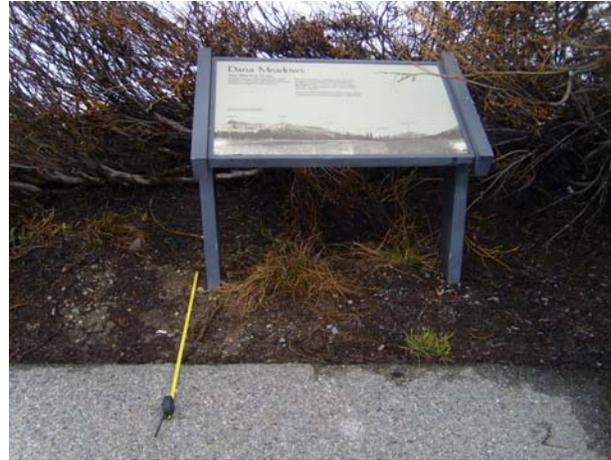
Dana Meadows Overlook – Parking Spaces and Wayside

Dana Meadows Overlook – Close-up of Wayside Exhibit

Item	Barrier	Action	Corrective Action
Dana Meadows Overlook and Wayside			
Accessible Route	Wayside exhibit is not located on an accessible route.	Pave or fill the ground surface to create accessible route from parking to exhibit. (ABA F 206.2.2).	Long Term
Parking	Van-accessible parking space not provided.	Provide a van-accessible parking space and sign. (ABA F 208.2.4).	Important
Wayside Exhibit	Wayside exhibit does not comply with standards for text size, contrast, and mounting height.	Provide an accessible exhibit at the wayside. (ABA F 216).	Long Term

This site provides viewing opportunities at the Dana Meadows area. The parking area already provides a standard accessible parking space with access aisles on both sides. The present wayside exhibit will be replaced with a compliant sign meeting access standards. The new wayside exhibit is being completed with installation scheduled for summer 2010.

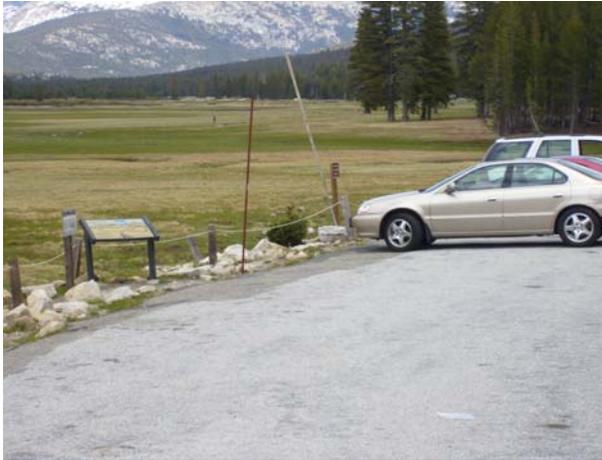
Endless Winter Wayside – Parking Slopes Toward Exhibit

This exhibit overlooks Tuolumne Meadows and Pothole Dome, and describes the life patterns of flora and fauna in the area. As with many waysides, this site needs an updated parking facility with an accessible space and a level surface. The exhibit will also need to be relocated on an accessible route. The wayside exhibit is scheduled for relocation during the summer 2010.

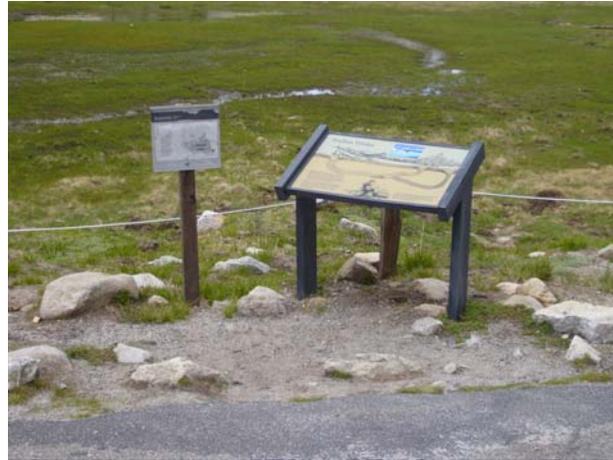
Endless Winter Wayside – Exhibit Inaccessible

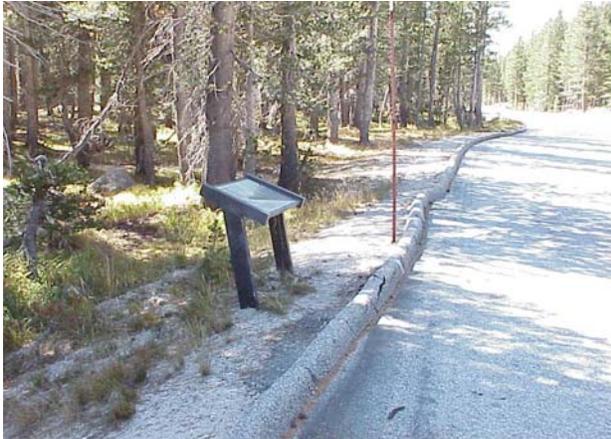
Ghost Forest Wayside – Inaccessible Due to Curb

Item	Barrier	Action	Corrective Action
Ghost Forest Wayside			
Accessible Route	Access to the wayside is prevented by a large curb between road and exhibit.	Move the exhibit to be accessible from the road or remove the barrier and add a pad around the exhibit. (ABA F 206.2.2).	Long Term
Parking	No accessible parking is provided at wayside.	Provide a van-accessible parking space (96" wide minimum with a 96" wide minimum access aisle) and sign. (ABA F 208.2.4).	Long Term

This site will be improved by creating a van-accessible parking space and making the exhibit accessible. This can be done by removing the curb barrier and creating an accessible pad at the exhibit, or by moving the exhibit to a level surface. A new wayside exhibit is being completed with installation scheduled for summer 2010.

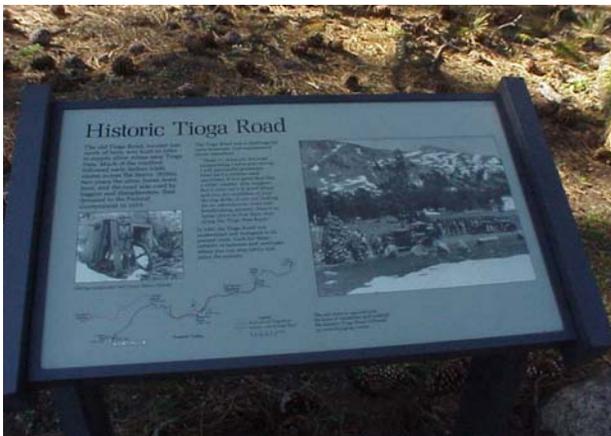
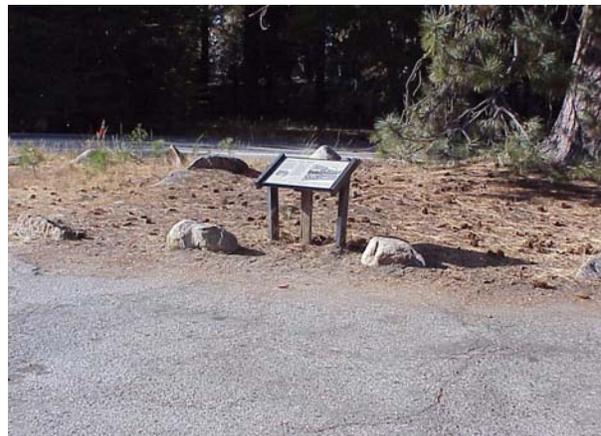
Gin Flat Interpretive Pullout – Wayside

Gin Flat Interpretive Pullout – Full View of Wayside

This site will be improved by adding a van-accessible parking space, improving the path of travel to the wayside exhibit, and adding an exhibit sign that complies with ABA standards.

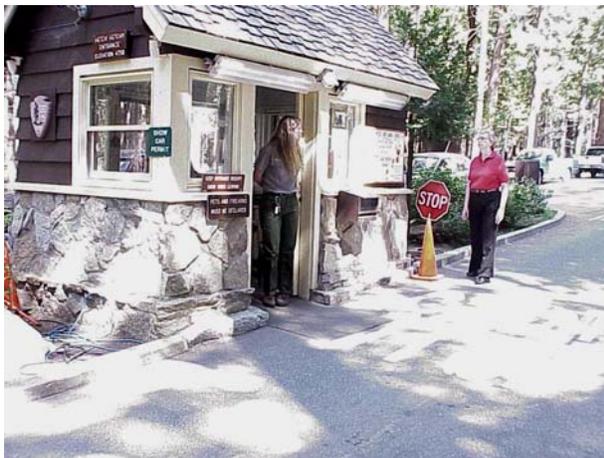
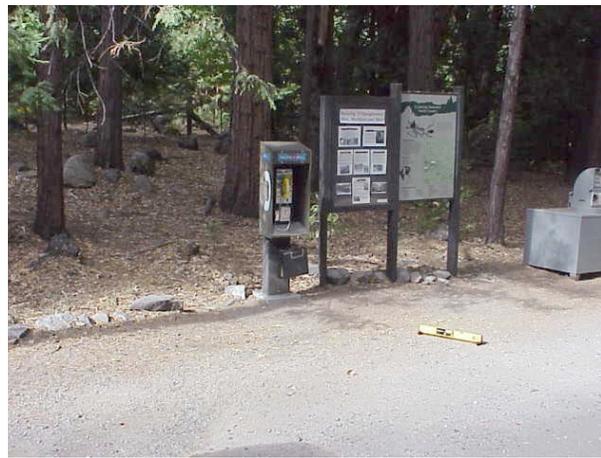
Hetch Hetchy Entrance Station – Close Up of Kiosk

Hetch Hetchy Entrance Station – Slope at Telephone

This site is comprised of the entrance kiosk, picnic area, information boards, parking area and pay phone. This site will be improved by the addition of a van-accessible parking space that connects to an accessible route serving all site features. The picnic table will be replaced with an accessible model, and the telephone and bulletin boards will be approachable on a level surface.

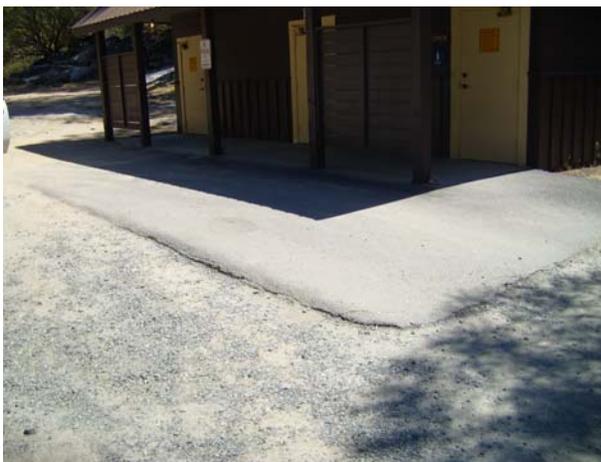
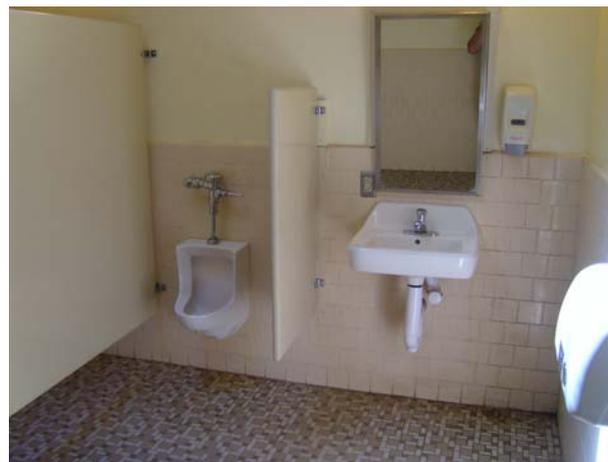
There is an accessible parking sign located in the gravel parking lot, but the sign should be moved closer to the restrooms for more direct access. The restrooms have been made accessible, but the door hardware and force required in opening the doors needs to be corrected. A change of level also exists between the parking area and the asphalt pad on which the restrooms are situated. Action to correct the change in level is required in order to create a barrier-free facility for all visitors.

Hetch Hetchy Day Use Parking and Restroom – Restroom Building and Asphalt Pad

Hetch Hetchy Day Use Parking and Restroom – View Inside Men's Restroom

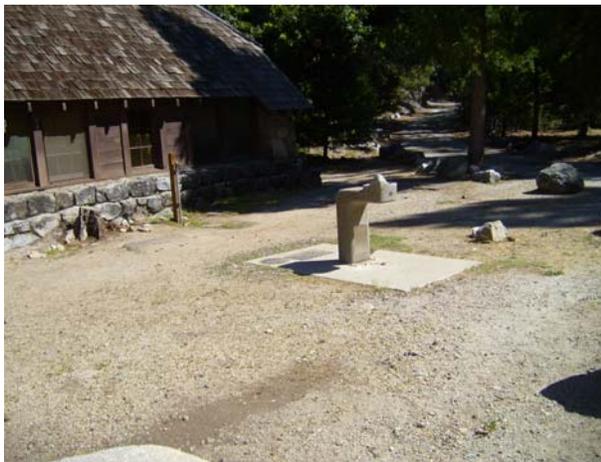
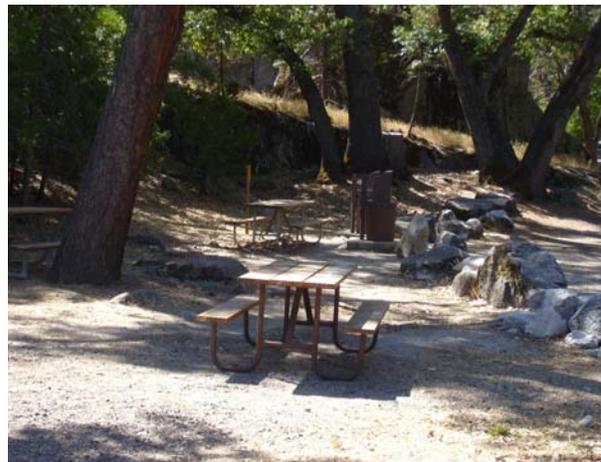
Hetch Hetchy Day Use Picnic Area and Restroom – Change in Level at Drinking Fountain

Hetch Hetchy Day Use Picnic Area and Restroom – Picnic Area

Item	Barrier	Action	Corrective Action
Hetch Hetchy Day Use Picnic Area and Restroom			
Parking	No van-accessible parking spaces provided.	Provide a van-accessible parking space and sign. (ABA F 208.2.4).	Critical

This site is currently in contracting for site rehabilitation and construction is anticipated to occur in the summer of 2010. The site will be improved through the addition of a van-accessible parking space that connects to an accessible route that will serve the restrooms, picnic areas and other features. The restrooms will be improved to meet ABA standards, as well as one of the two picnic areas.

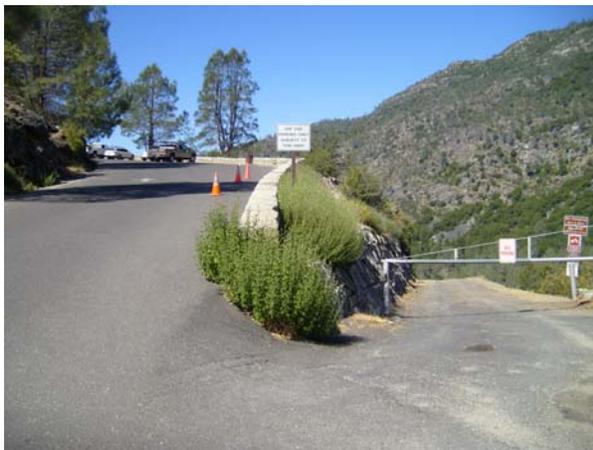
O’Shaughnessy Dam / Hetch Hetchy Reservoir and Picnic Area – Slope Past Dam Entrance Up to Parking Lot

Because of the steep terrain, extra care should be taken to provide a level van-accessible parking space near the dam and picnic area if possible.

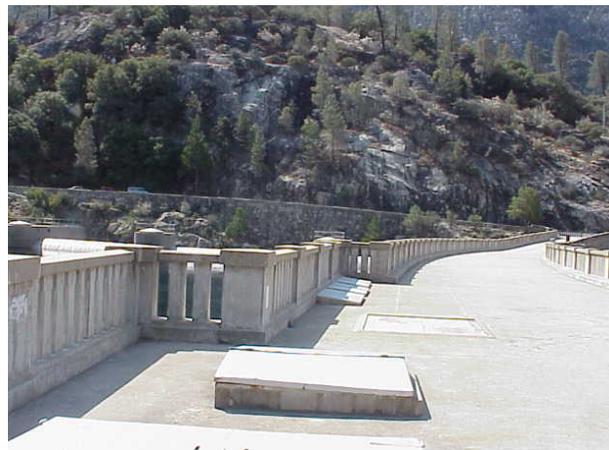
O’Shaughnessy Dam / Hetch Hetchy Reservoir and Picnic Area – View from Dam Access Road

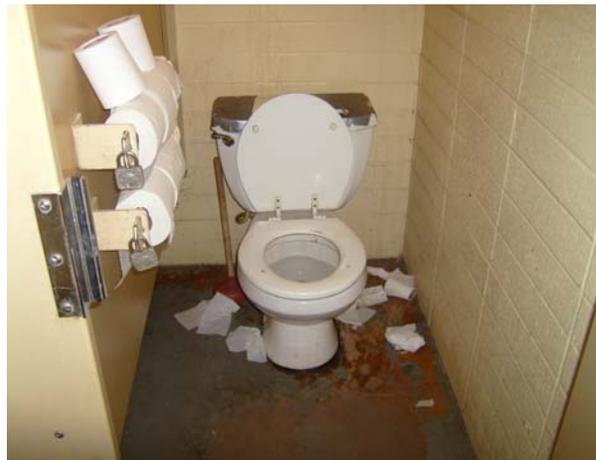
Hodgdon Meadow Campground – Inaccessible Restroom

Item	Barrier	Action	Corrective Action
Hodgdon Meadow Campground			
Restrooms	Restroom has many inaccessible features.	Retrofit or replace existing comfort station to meet accessible standards (ABA F 213).	Critical
Accessible Route	Accessible route and clear maneuvering space not provided at utility sink.	Provide an accessible route to the utility sink (ABA F 206.2.2).	Critical
Campsite	No accessible campsites are provided.	Provide accessible campsites. (PG T 218; PG T 318). Provide an accessible bear box, accessible grill (PG T 208; PG T 308), fire ring (PG T 207; PG T 307) and picnic table. (PG T 206; PG T 306). Provide an ORAR to connect accessible site features. (PG T 204; PG T 304).	Critical

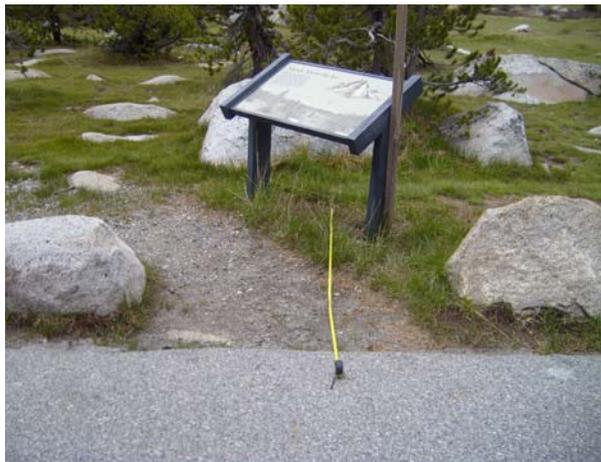
Islands Above the Ice Wayside – Non-Compliant Location

This site will be improved by adding a van-accessible parking space and adding an exhibit sign that complies with ADA standards at an accessible location. A new wayside exhibit is being completed with installation scheduled for summer 2010.

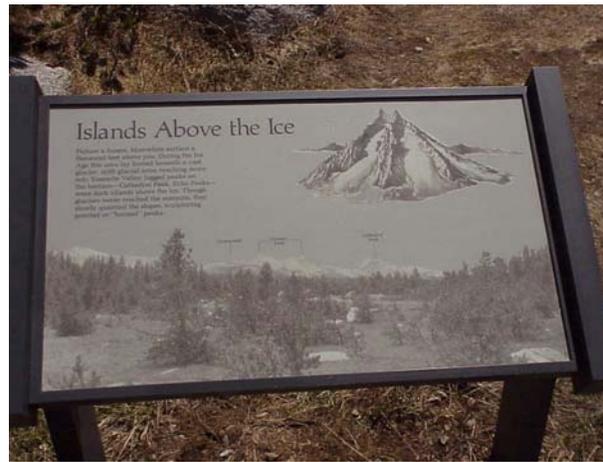
Islands Above the Ice Wayside – Image Contrast Too Low

Item	Barrier	Action	Corrective Action
Islands Above the Ice Wayside			
Wayside Exhibit	Exhibit does not comply with standards for contrast.	Replace sign with an accessible exhibit. (ABA F 216.3).	Long Term

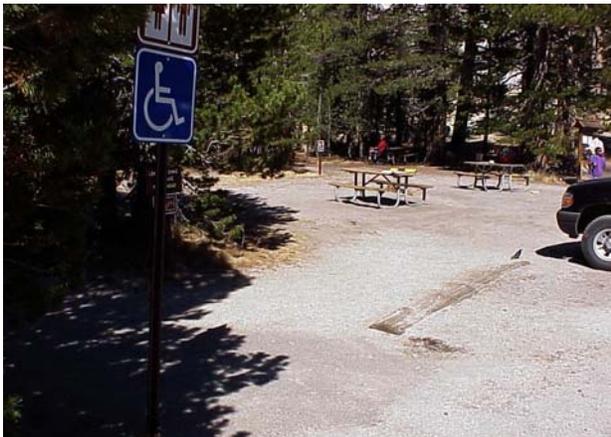
Lembert Dome/Dog Lake Picnic Area and Trailhead – Parking and Access Route to Picnic Area

Item	Barrier	Action	Corrective Action
Lembert Dome and Dog Lake Picnic Area and Trailhead			
Accessible Route	Route to picnic area from parking area is uncompacted sand, which is not an accessible surface material.	Provide an accessible route to the waterless restroom; picnic area and trailhead sign. (ABA F 206.2.2).	Critical
Transit Stop	The existing transit stop is inaccessible.	Provide an accessible transit stop on the accessible route; add a bench with companion seating space and accessible information. (ABA 810.1).	Critical

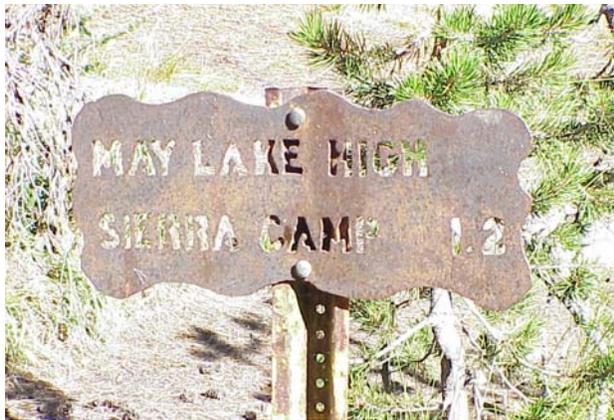
May Lake Trailhead, Old Tioga Road – Trailhead sign

This site will be improved by the addition of a van-accessible parking space and a compliant trailhead sign.

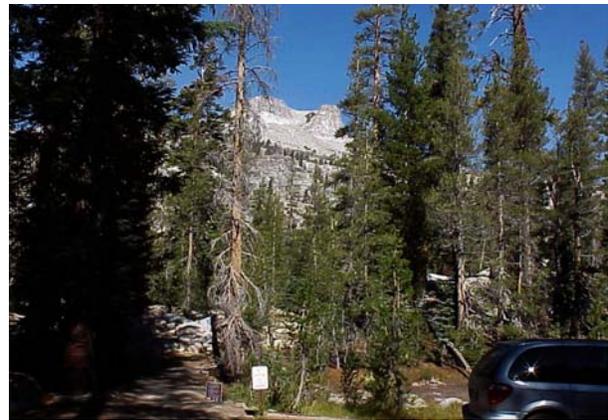
May Lake Trailhead, Old Tioga Road – Beginning of Trail

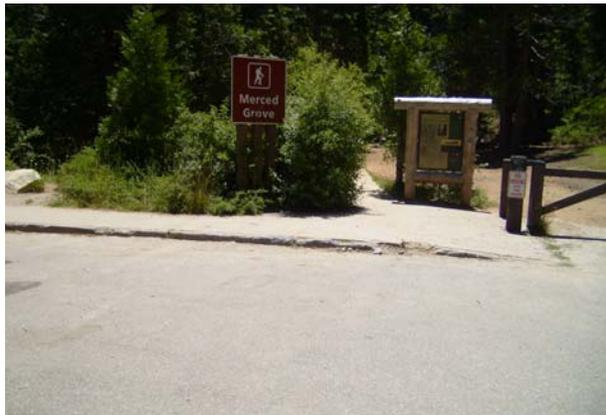
Merced Grove Trailhead – Parking and Trail information

Item	Barrier	Action	Corrective Action
Merced Grove Trailhead			
Merced Grove Trailhead	The accessible space is completely faded away and old.	Repaint the parking and include a van accessible space. (ABA F208.2.4).	Important
Merced Grove Trailhead	The sidewalk from parking to the waterless restroom is overgrown and does not meet clearance standards.	Trim back the vegetation to allow an 80-inch minimum height clearance. (PG T 322.1).	Long Term

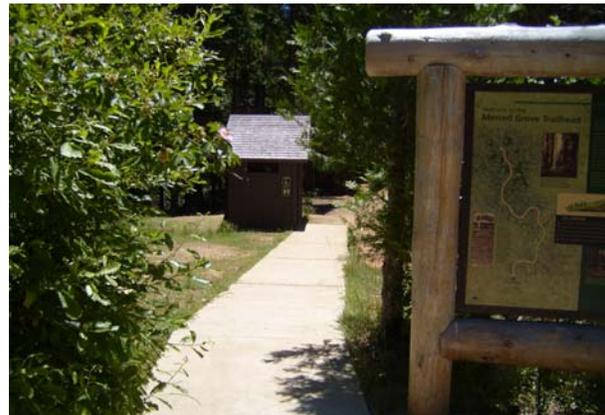
Merced Grove Trailhead – Path to Toilets

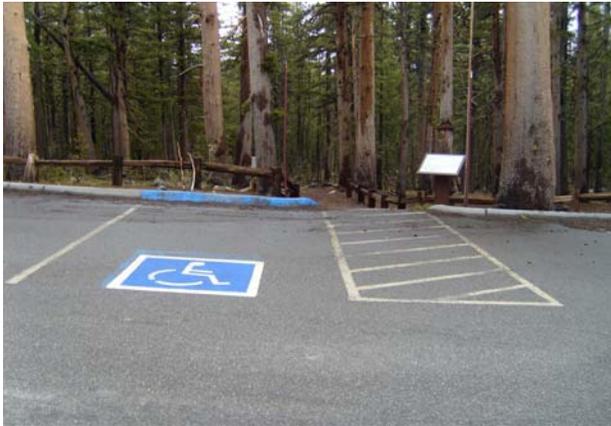
Mono/Parker Passes Trailhead – Designated Parking

Item	Barrier	Action	Corrective Action
Mono Pass and Parker Pass Trailhead			
Parking	A van-accessible parking space is needed at the waterless restroom	Provide a van-accessible parking space and sign. (ABA F 208.2.4).	Critical
Parking	Parking lot has excessive slope in front of trailhead and waterless restroom that exceeds accessibility standards.	Repave the parking area to create a level surface with accessible spaces in the appropriate locations. (ABA F208.3.1; PG T318.2.4).	Critical
Parking	A van-accessible parking space is needed near the trailhead.	Provide a van-accessible parking space and sign. (ABA F 208.2.4).	Critical
Sign	A sign is needed on the road to direct visitors to the area.	Install a compliant highway sign. (NPS Best Practice).	Long Term
Trailhead Sign	Lack of compliant trailhead sign.	Install a compliant trailhead sign at an accessible location along the ORAR. (PG T 221; PG T 321).	Long Term

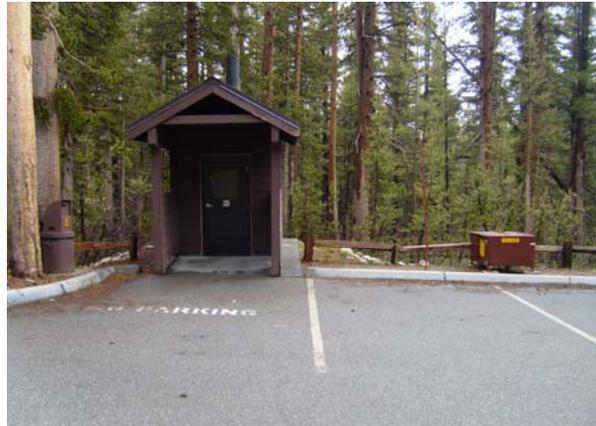
Mono/Parker Passes Trailhead – Waterless Restroom

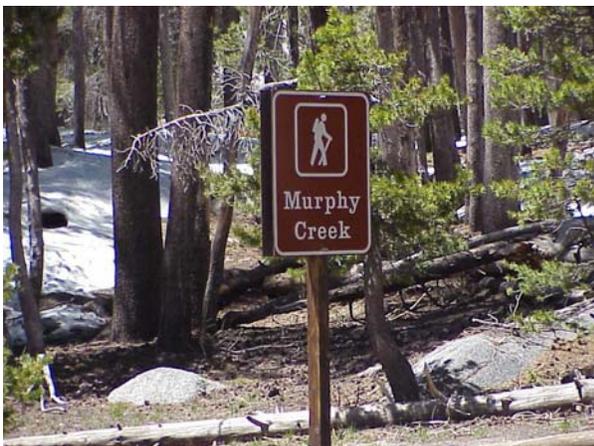
Murphy Creek Picnic Area – Sign on Highway

The site will be improved by the addition of a van-accessible parking space and an accessible route to the waterless restroom and phone. The parking area is covered in gravel and creates a change in level with the path leading to the waterless restroom. Paving and striping of the parking area is suggested. The highway sign should be upgraded with an ISA placard to indicate to drivers that the site offers accessibility.

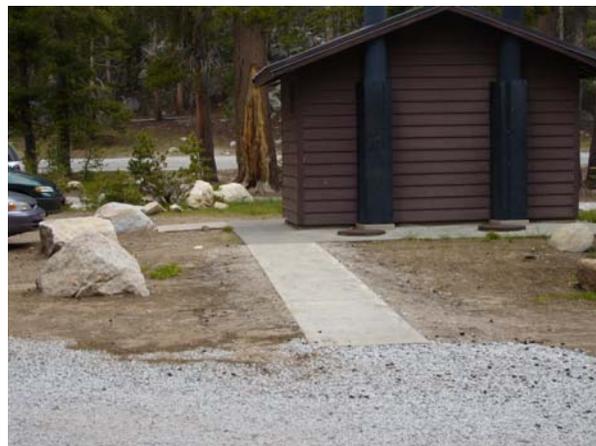
Murphy Creek Picnic Area – Paved Access

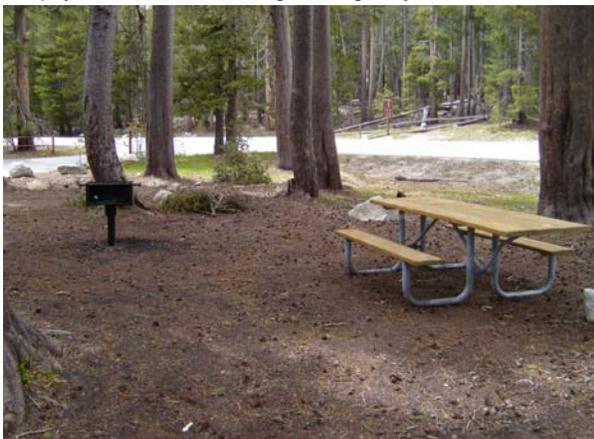
Murphy Creek Picnic Area – Accessible Picnic Area

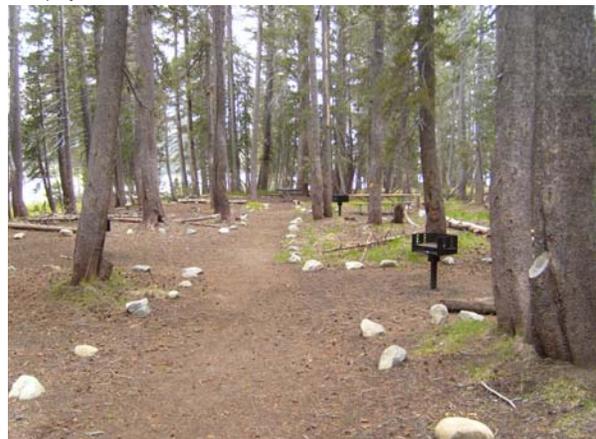
Murphy Creek Picnic Area – Sites Connected by an ORAR

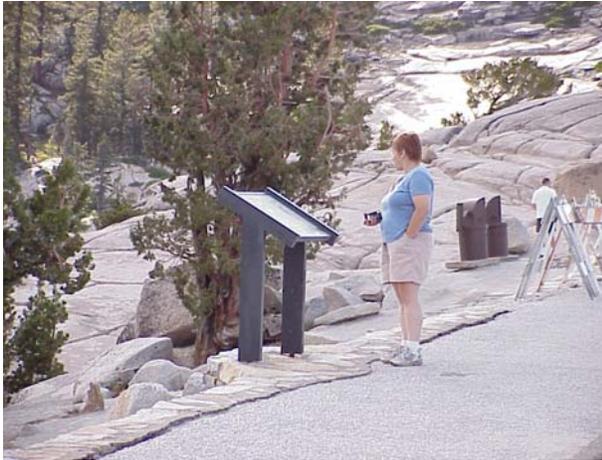
Olmsted Point Scenic Overlook – Before Renovation

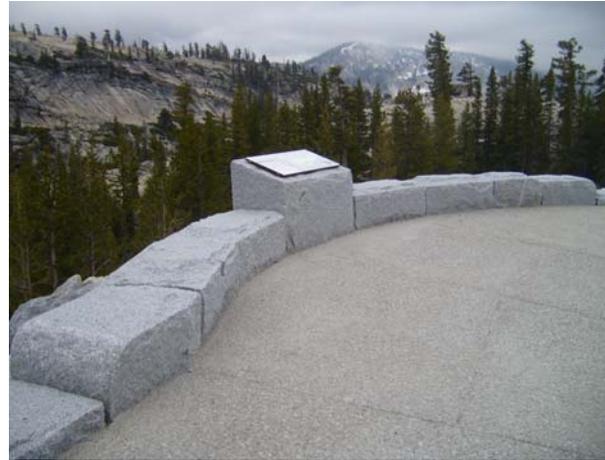
Olmsted Point Scenic Overlook – Renovated Accessible Area

Olmsted Point is one of the park’s premier scenic lookouts and has seen extensive modifications and barrier removal. The viewing area has been updated to include fully accessible exhibits, clear viewsheds, access ways, and a tactile map. Accessible parking has been provided as well as an area for tour bus parking. The only recommendation the Plan suggests for enhanced accessibility is the designation of a van-accessible parking space. Olmsted Point, as well as Tunnel View, is an excellent example of how barrier-free design provides practical and aesthetic viewing opportunities for all park visitors. These locations should be the standard for all future park projects.

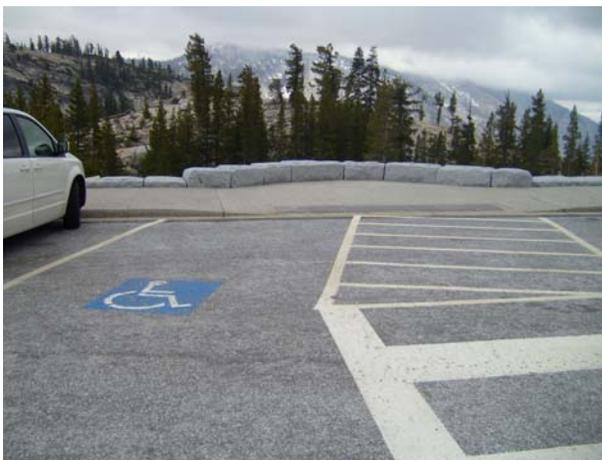
Olmsted Point Scenic Overlook – Accessible Parking Space

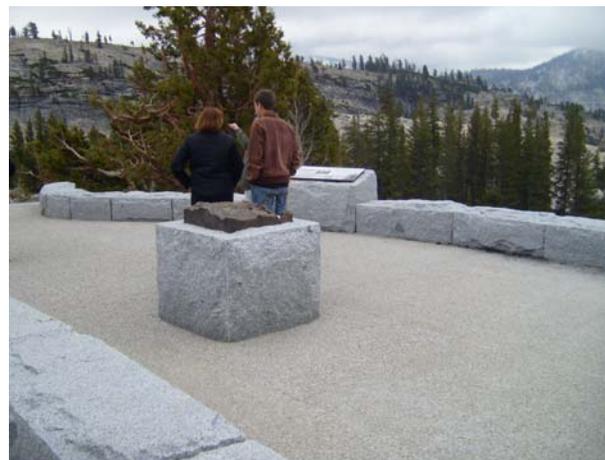
Olmsted Point Scenic Overlook – Tactile Map and Exhibit

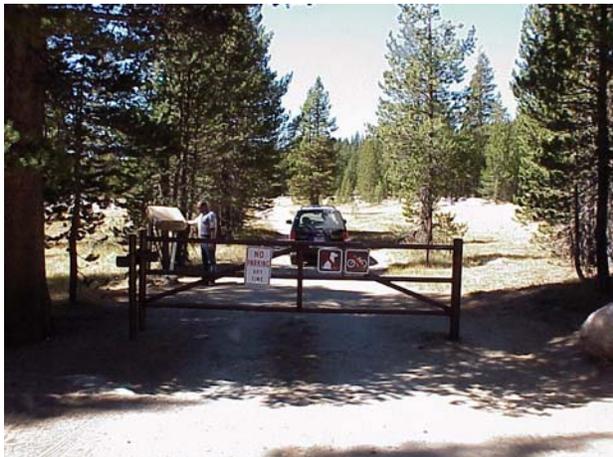
Parsons Lodge and Soda Springs – Gate from Lembert Dome to Parsons Lodge

Item	Barrier	Action	Corrective Action
Parsons Lodge and Soda Springs			
Parking	Parking lot is not paved and has no designated spaces.	Pave accessible parking spaces and connect to accessible route. Provide a van-accessible parking space and sign. (ABA F 208.2.4).	Long Term
Accessible route	Route from parking to lodge is inaccessible.	Provide an accessible route from parking to lodge. (ABA F 206.2.2).	Long Term
Accessible Route	Route to the gate is inaccessible. Provide an accessible pullout and an accessible route to the gate.	Provide an accessible pullout and an accessible route to the gate. (ABA F 206.2.2).	Long Term
Gate	Gate lacks clear maneuvering space.	Provide clear maneuvering space to open and close gate. (ABA 404).	Long Term
Accessible Route	The entrance to the lodge is inaccessible and demonstrates stairs and a steep path.	Build a ramp (ABA 405) and modify the path of travel to provide an accessible route. (ABA F 208.2.2).	Long Term

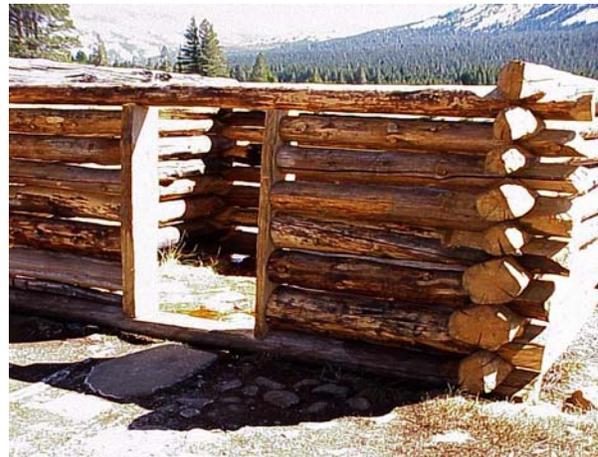
Parsons Lodge and Soda Springs – Historical Structure

steep slope, will be made accessible, if possible, by the addition of a ramp and improved path of travel.

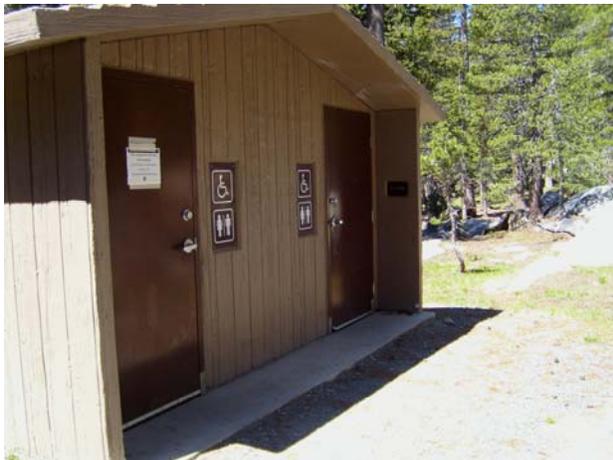
Porcupine Flat Campground – Inaccessible Entry to Vault Toilet

The campground will be improved by the addition of two accessible tent campsites and one accessible RV campsite. RVs are limited to 24 feet in length and trailers to 20 feet. Access to the waterless restrooms will be improved to and from the accessible sites.

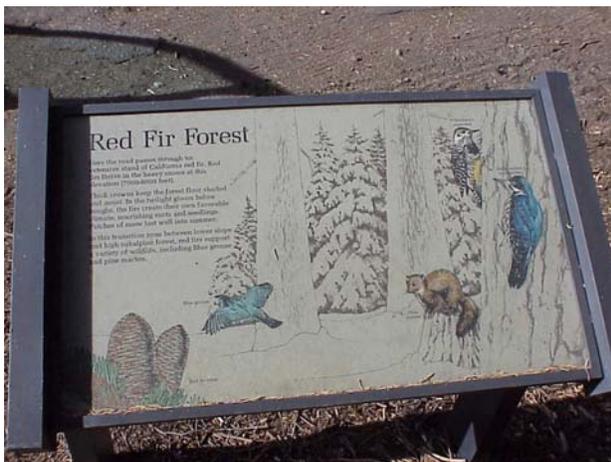
Red Fir Forest Wayside – Wayside Exhibit

This small pullout will be made accessible by relocating the wayside exhibit so that it faces the highway and is along an accessible route rather than up a hill. The area is too small to provide a van-accessible space. The program access goals attained by the physical alterations to this site will include enhanced access to the wayside exhibit.

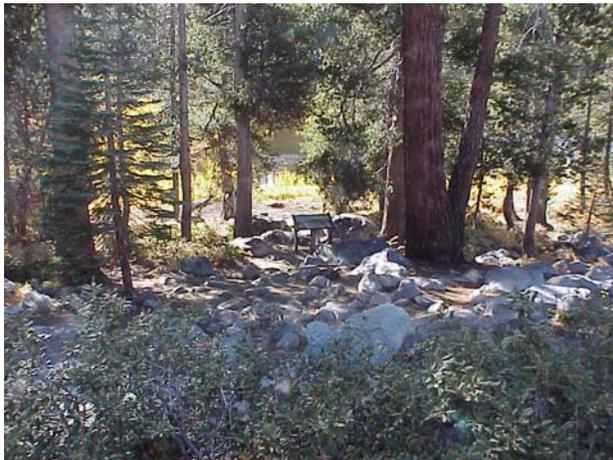
Siesta Lake Wayside – Exhibit Location

Item	Barrier	Action	Corrective Action
Siesta Lake Wayside			
Accessible Route	Accessible route does not connect all of the site features.	Construct an asphalt access route between vehicle parking and the bikeway. (ABA F 206.2.2).	Long Term
Wayside Exhibit	Wayside exhibit is not located on an accessible surface.	Move exhibits to be located along the accessible route. (ABA F 206.2.2).	Long Term

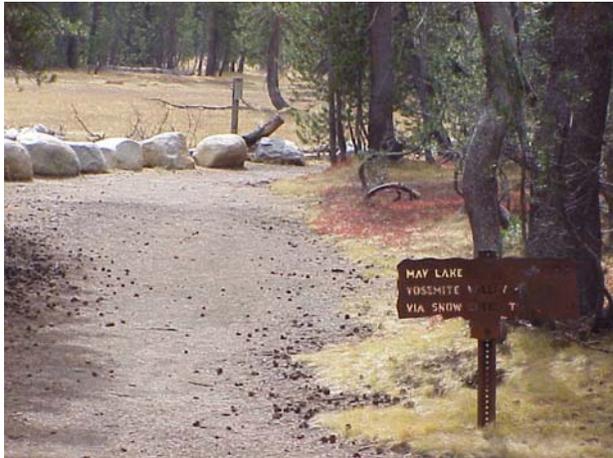
Sunrise Parking and Trailheads – Trailhead Sign

Item	Barrier	Action	Corrective Action
Sunrise Trailhead and Parking			
Sign	A sign is needed on the road to direct visitors to the area.	Install a compliant highway sign (NPS Best Practices).	Long Term
Parking	The parking area lacks van-accessible spaces.	Provide a van-accessible parking space and sign (ABA F 208.2.4).	Critical
Trailhead Sign	Lack of compliant trailhead sign.	Install a compliant trailhead sign at an accessible location along the ORAR (PG T 221; PG T 321).	Long Term
ORAR	ORAR is not provided to the trailhead.	Provide an ORAR from parking to trailhead (PG T 204; PG T 304).	Long Term
Waterless Restroom	Vault toilet lacks restroom sign and is on an elevated concrete pad.	Provide a smooth transition from ORAR to waterless restroom entrance. Post the ISA on restroom building. (ABA 206.2.2).	Critical

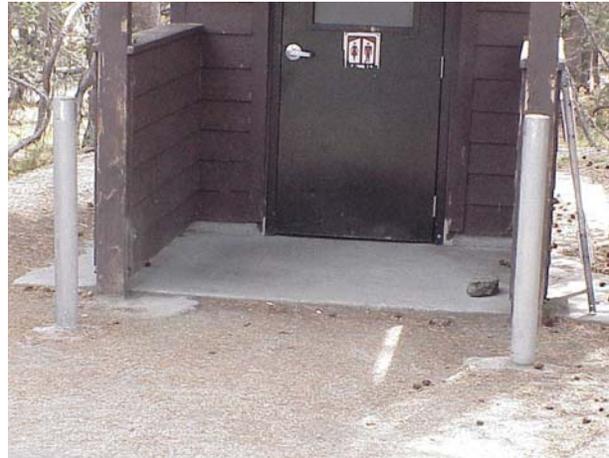
Sunrise Parking and Trailheads – Close Up of Waterless Restroom

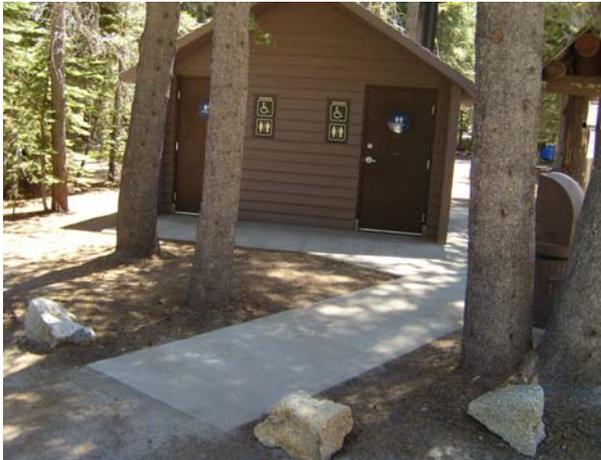
Tamarack Flat Campground – Vault Toilet

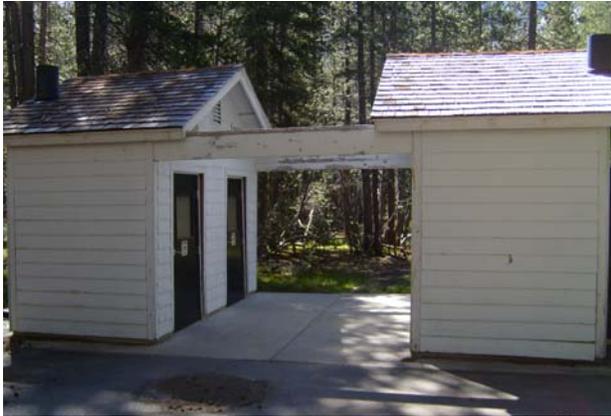
Tenaya Lake East End Beach – Waterless Restrooms

Access to the site will be improved by the addition of van-accessible parking, an accessible beach route and an ORAR to the picnic area. The vault toilet facilities will be modified to provide full accessibility. There are currently 10 tables in three picnic areas, in which none provides accessibility.

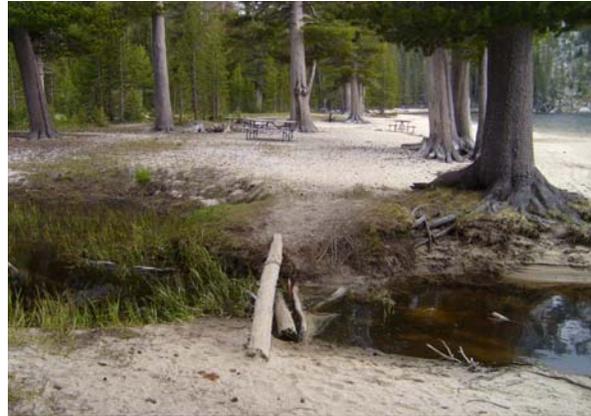
Tenaya Lake East End Beach – Improved Access to Picnic Area

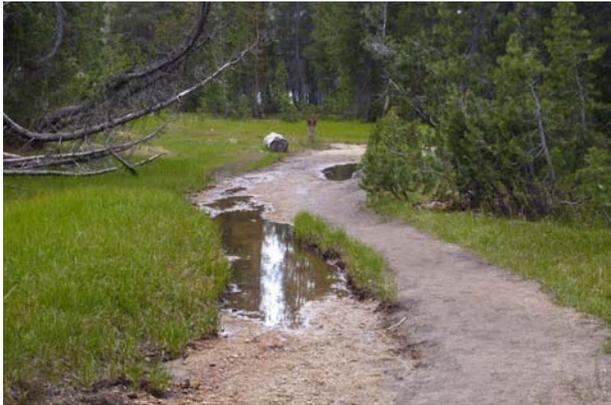
Tenaya Lake East End Beach – Access Route to Picnic Area

Item	Barrier	Action	Corrective Action
Tenaya Lake East End Beach			
Parking	Site lacks accessible van parking.	Provide a van-accessible parking space and sign. (ABA F 208.2.4).	Critical
Beach Access	An access route is not provided to the beach.	Provide a stable, firm, and slip-resistant route to the beach. (PG T 205; PG T 305).	Important
Waterless Restrooms	Waterless restrooms lack restroom sign, entrance is inaccessible, and toilet paper is out of reach.	Post ISA on the left side of the outside door, provide an accessible entrance and move toilet paper dispenser in the accessible stall. (ABA F 213).	Critical
Picnic Tables	Accessible picnic tables not provided at picnic area.	Provide an accessible picnic table on an accessible route. (PG T 206; PG T 306).	Critical

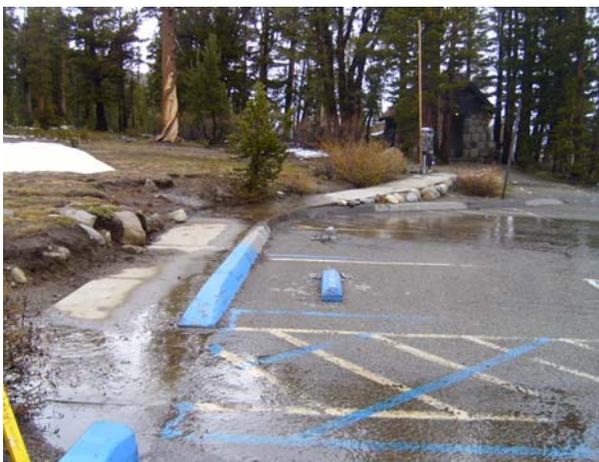
The complex has been improved by the addition of an accessible route between the parking lot and the accessible restroom. These additions have greatly improved accessibility when compared to its previous situation. The parking lot has a slope greater than 2% and will need to be made level, and a van-accessible parking space added.

Tioga Pass Entrance Complex – Parking

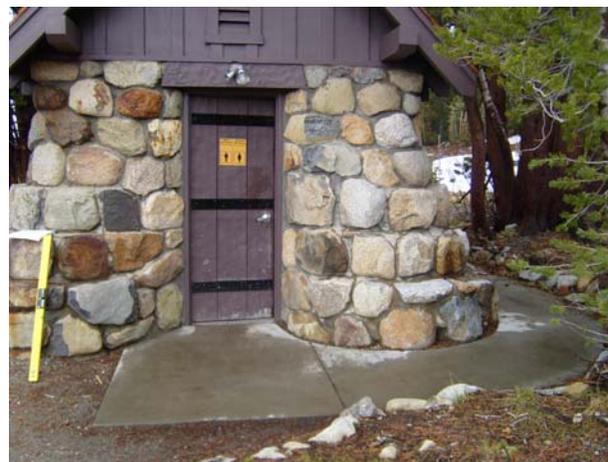
Tioga Pass Entrance Complex – Waterless Restroom

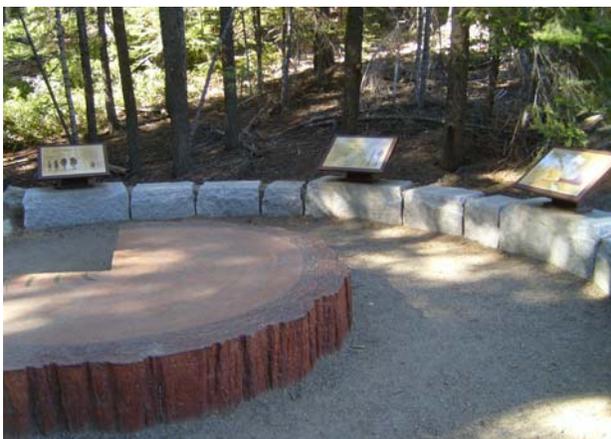
Tuolumne Grove Trailhead – Wayside Exhibits

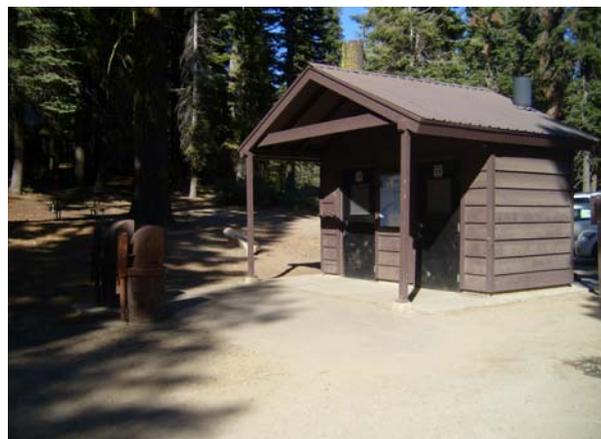
Tuolumne Grove Trailhead – Access to Waterless Restroom

This site will be improved with the addition of a van-accessible parking space connected by an accessible route to the waterless restroom. Minor changes will be made at the waterless restroom. In addition, a compliant trailhead sign will be added.

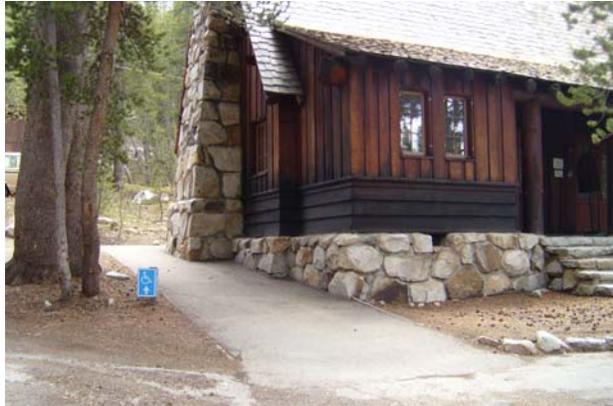
Tuolumne Visitor Center – Front of Visitor Center Showing Steep Wheelchair Access Route to Back

Item	Barrier	Action	Corrective Action
Tuolumne Visitor Center			
Accessible Route	Route from rear parking to visitor center rear entrance is excessively sloped.	Create an accessible route from parking to visitor center (ABA F 206.2.2).	Critical
Back Door	The back door on the accessible route requires excessive force to open.	Readjust or replace the door to achieve proper operation force. (ABA 404.2.9).	Critical

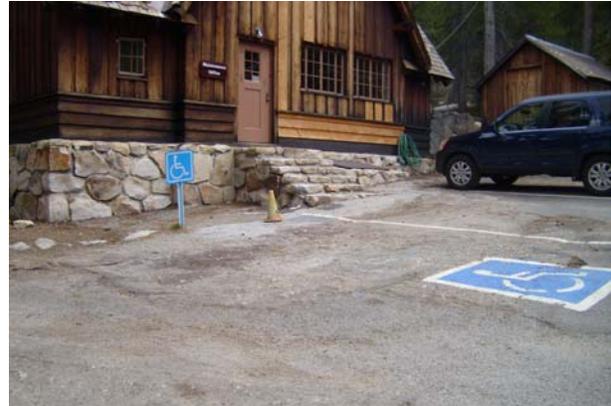
Tuolumne Visitor Center – Non-Compliant Slope at Parking

Item	Barrier	Action	Corrective Action
Tuolumne Visitor Center			
Accessible Route	Route is needed from parking to restrooms.	Create an accessible route from parking to restrooms. (ABA F 206.2.2).	Critical
Parking	A van-accessible parking space is needed at the restrooms.	Provide a van-accessible parking space and sign. (ABA F 208.2.4).	Critical
Restrooms	Restrooms not up to accessibility standards.	Retrofit restrooms to comply with ABA standards. (ABA F 213).	Critical
Sign	A sign is needed at the front of the visitor center to direct visitors to the accessible path of travel to rear of building.	Post a compliant directional sign with an ISA placard to show the route to the accessible entrance. (ABA F 216.3).	Critical
Transit Stop	The existing transit stop bench needs to be relocated onto the cement.	Provide an accessible transit stop on the accessible route. (ABA 810.1).	Critical
Pay Telephone	Telephone courtesy shelf is too high.	Lower the courtesy shelf. (ABA F 217).	Critical

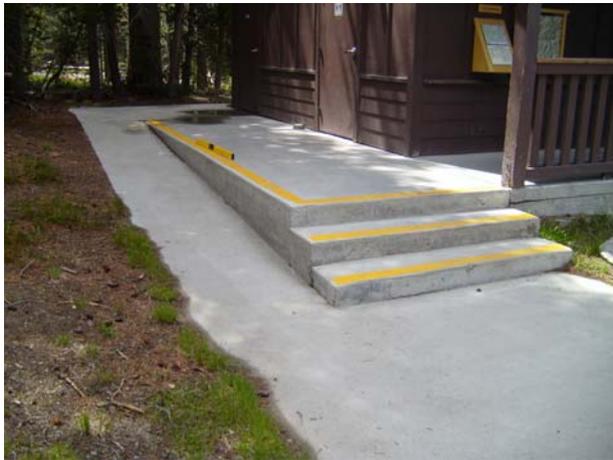
Tuolumne Meadows Wilderness Center – Ramp with No Railings

The facility will be improved by the addition of two accessible parking spaces with one being a van accessible parking space, the creation of an accessible route to the building by modifying the ramp to meet ABA standards, minor alterations to the restroom, and the creation of an accessible transit stop.

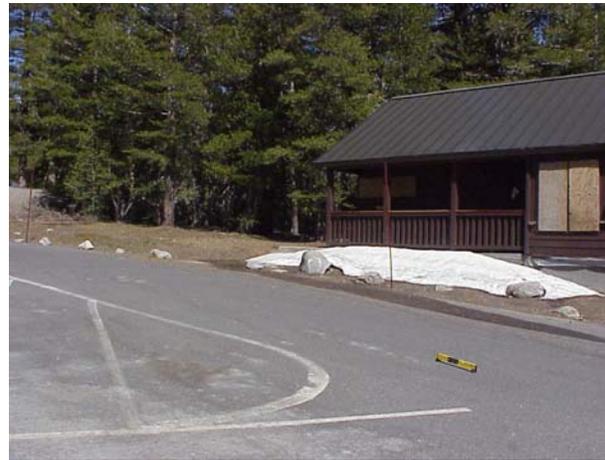
Tuolumne Meadows Wilderness Center – Slope of Parking Lot

Item	Barrier	Action	Corrective Action
Tuolumne Wilderness Center			
Parking	Accessible parking is not provided.	Add at least two accessible spaces and a van-accessible space (ABA F 208.2.4).	Critical
Ramp	Ramp has slope >5% and rises 16 inches. Requires handrails.	Provide compliant ramp with continuous handrails on both sides (ABA F 405).	Critical

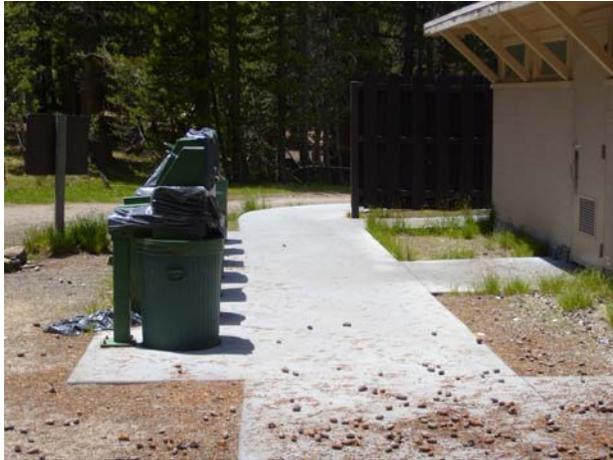
Tuolumne Meadows Campground – Accessible Route to Restroom # 3023

Restrooms #3023 and #3077 have undergone accessible route improvements and renovation should be continued to provide accessibility throughout the facilities.
