Self Evaluation and Transition Plan

Yosemite National Park

Accessibility Program

May 2010

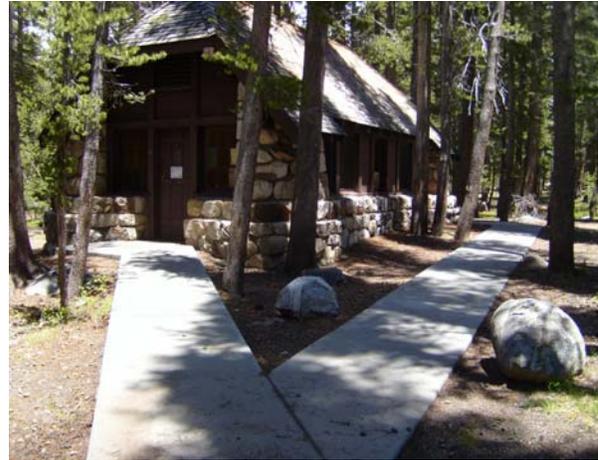
Tuolumne Meadows Campground – Accessible Route to Restroom # 3077

Restrooms #3023 and #3077 have undergone accessible route improvements and renovation should be continued to provide accessibility throughout the facilities.

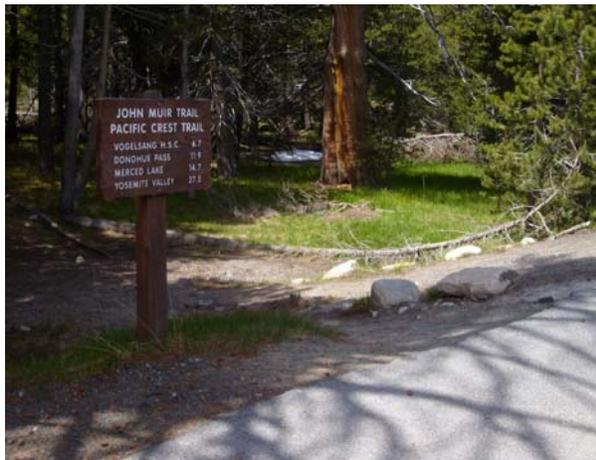
Tuolumne Lodge Parking Lot: Link to Pacific Crest Trail – From Parking Lot to Beginning of Trail

Item	Barrier	Action	Corrective Action
Tuolumne Lodge Parking Lot: Link to Pacific Crest Trail			
Parking	Additional accessible parking spaces required for ABA compliance.	Provide 4-5 accessible spaces and a van-accessible parking space and sign. (ABA F 208.2.4).	Critical
ORAR	An ORAR is needed from parking to trailhead.	Provide an ORAR from parking to trailhead. (PG T 204; PG T 304).	Long Term
Trailhead Sign	Lack of compliant trailhead sign.	Install a compliant trailhead sign at an accessible location along the ORAR. (PG T 221; PG T 321).	Long Term

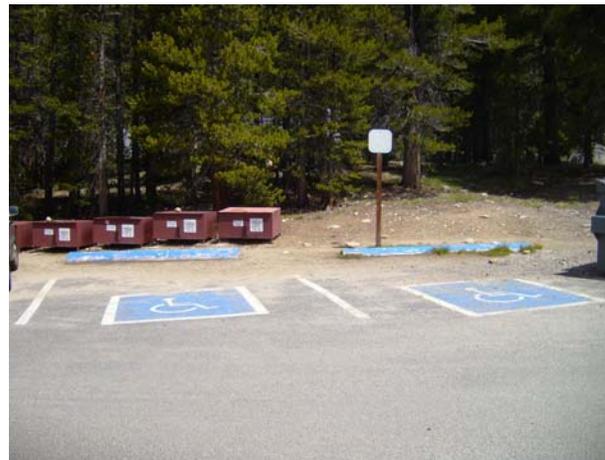
The parking lot lacks the required accessible spaces needed and so three additional spaces need to be provided near the trailhead and bus stop with at least one being van-accessible.

Tuolumne Lodge Parking Lot: Link to Pacific Crest Trail – Accessible Spaces

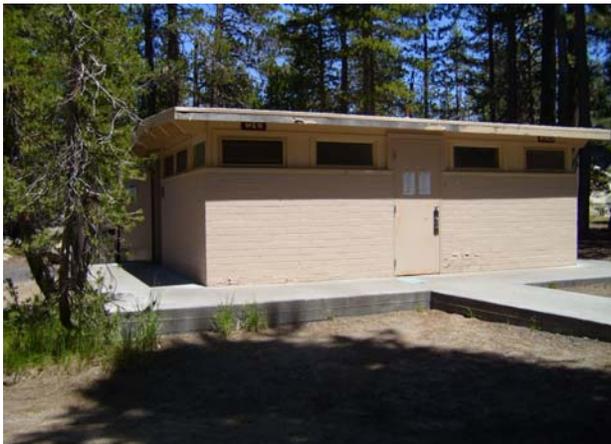
White Wolf Campground – Access to the Restroom

Item	Barrier	Action	Corrective Action
White Wolf Campground			
ORAR	ORAR not provided to pay telephone and information board.	Provide an ORAR to connect accessible areas. (PG T 204; PG T 304).	Long Term
Pay Telephone	Accessible pay telephone not provided.	Provide an accessible pay telephone on the ORAR. (ABA F 217).	Long Term
Accessible Route	Access is not provided to utility sink at restroom #6253.	Provide an accessible route with clear maneuvering space at the utility sink. (ABA F 206.2.2).	Important
ORAR	An ORAR is needed from the accessible sites to and in the amphitheater.	Provide an ORAR to connect accessible areas. (PG T 204; PG T 304).	Important
Amphitheater	There are no wheelchair seating spaces in the amphitheater.	Disperse wheelchair seating spaces and companion seating on the ORAR throughout the amphitheater. (ABA F 221).	Important
Benches	Accessible benches not provided in amphitheater.	Provide accessible benches. (PG T 213; PG T 313).	Important

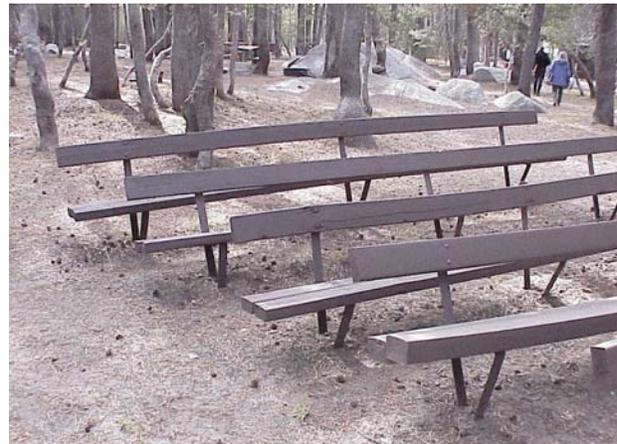
White Wolf Campground Amphitheater – No Accessible Seating

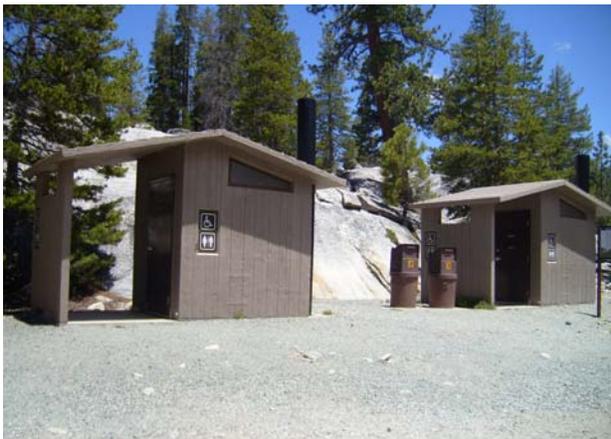
Yosemite Creek Campground – Waterless Restroom

This campground contains campsites suitable for tent camping and is not suitable for RV use. Access will be improved by providing clear space at the fee collection pole, relocating information boards to an ORAR and providing an ORAR to the waterless restrooms and pay telephone. Outdoor Developed Areas Guidelines require that at least four campsites be made accessible and be connected by an ORAR to the above mentioned facilities.

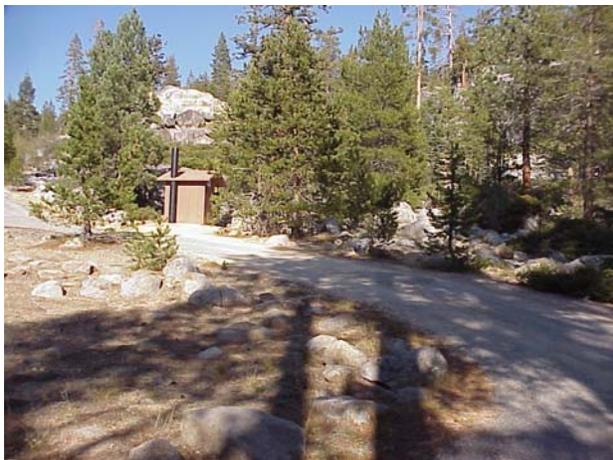
Yosemite Creek Picnic Area – Access Route to Waterless Restroom

This picnic area will be improved by providing accessible tables and grills, a van-accessible space close to the waterless restroom, and providing an accessible route between the parking space, waterless restrooms, and accessible picnic area. Completion of these accessibility updates is expected by the end of 2010.

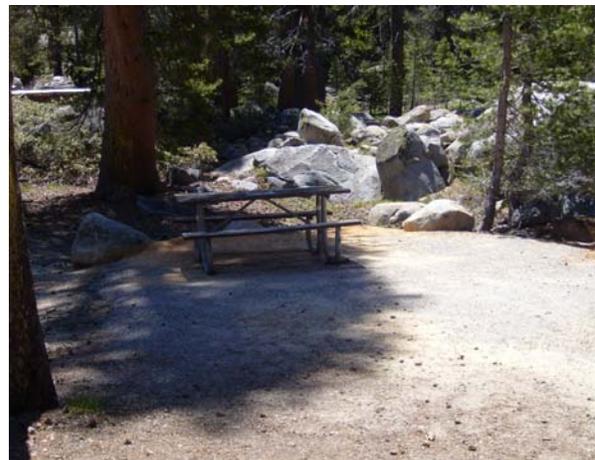
Yosemite Creek Picnic Area – Non-Accessible Table
