Merced Wild and Scenic River Values Draft Baseline Conditions Report

Prepared by ESA for the
National Park Service, Yosemite National Park

**DRAFT MERCED WILD AND SCENIC RIVER
OUTSTANDINGLY REMARKABLE VALUES
RIVER VALUES BASELINE CONDITIONS REPORT**

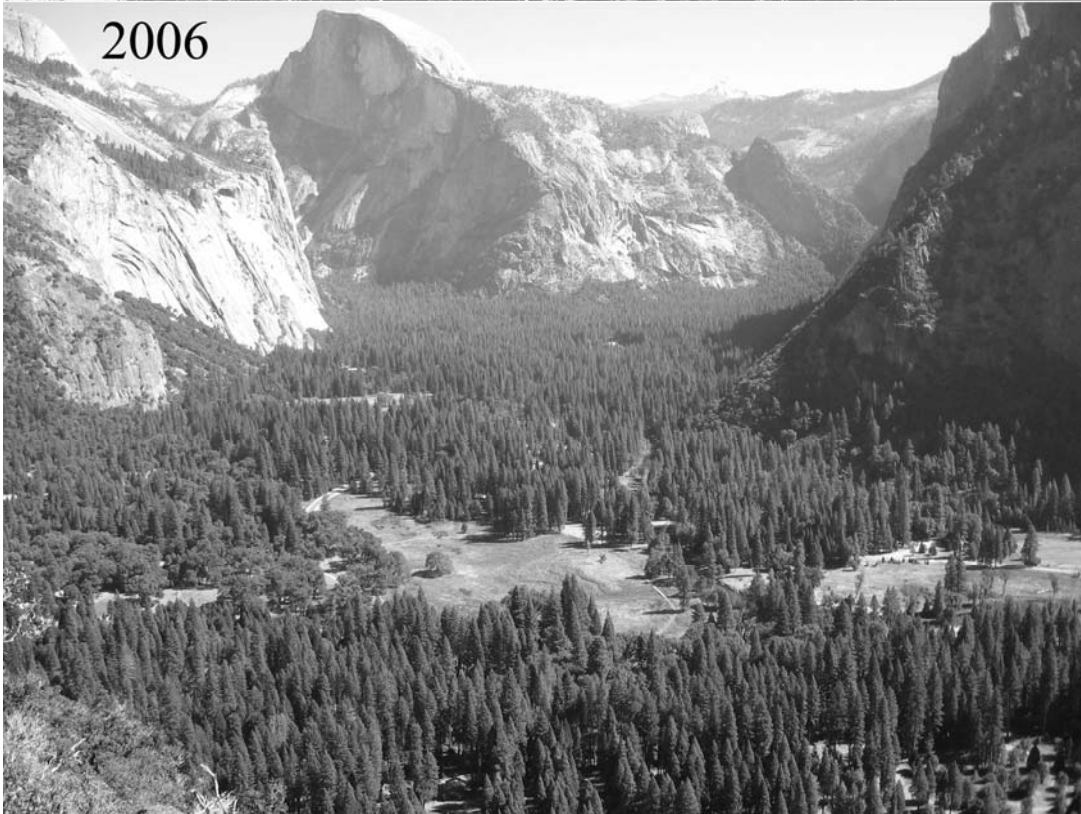
1899

2006

SOURCE: Cooper and Wolf, 2008

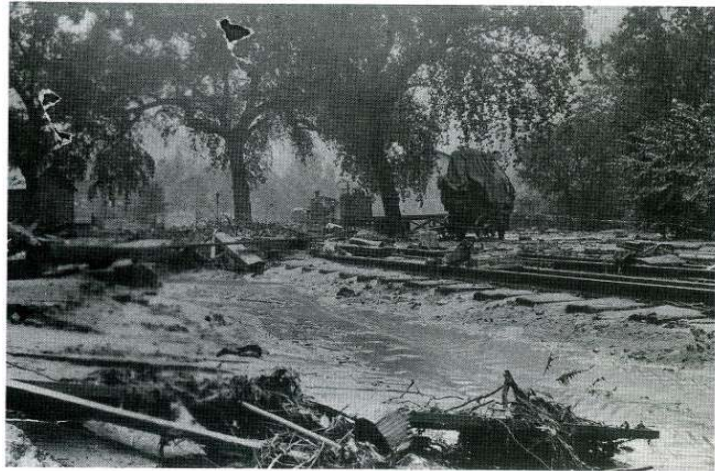
Another impact on the valley oak population at the time of designation was the loss of overbank flooding in the El Portal floodplain (see **Photo 2.1-6**). Construction of the Yosemite Valley Railroad terminus in El Portal and the El Portal Road (Highway 140), and subsequent road repairs after regular flood events, effectively blocked flooding throughout the population, except during very large flood events. Flooding rejuvenates riparian systems, creating a dynamic system and depositing nutrients. Prior to this construction, and long before designation of the river, the valley oak population likely had a robust understory, with flooding typically occurring every one to five years (Howard 1992).

Looking east at the results of the August 13, 1913 cloudburst and flood from the vicinity of the present Standard Oil Co. plant in El Portal.
Jim Law collection

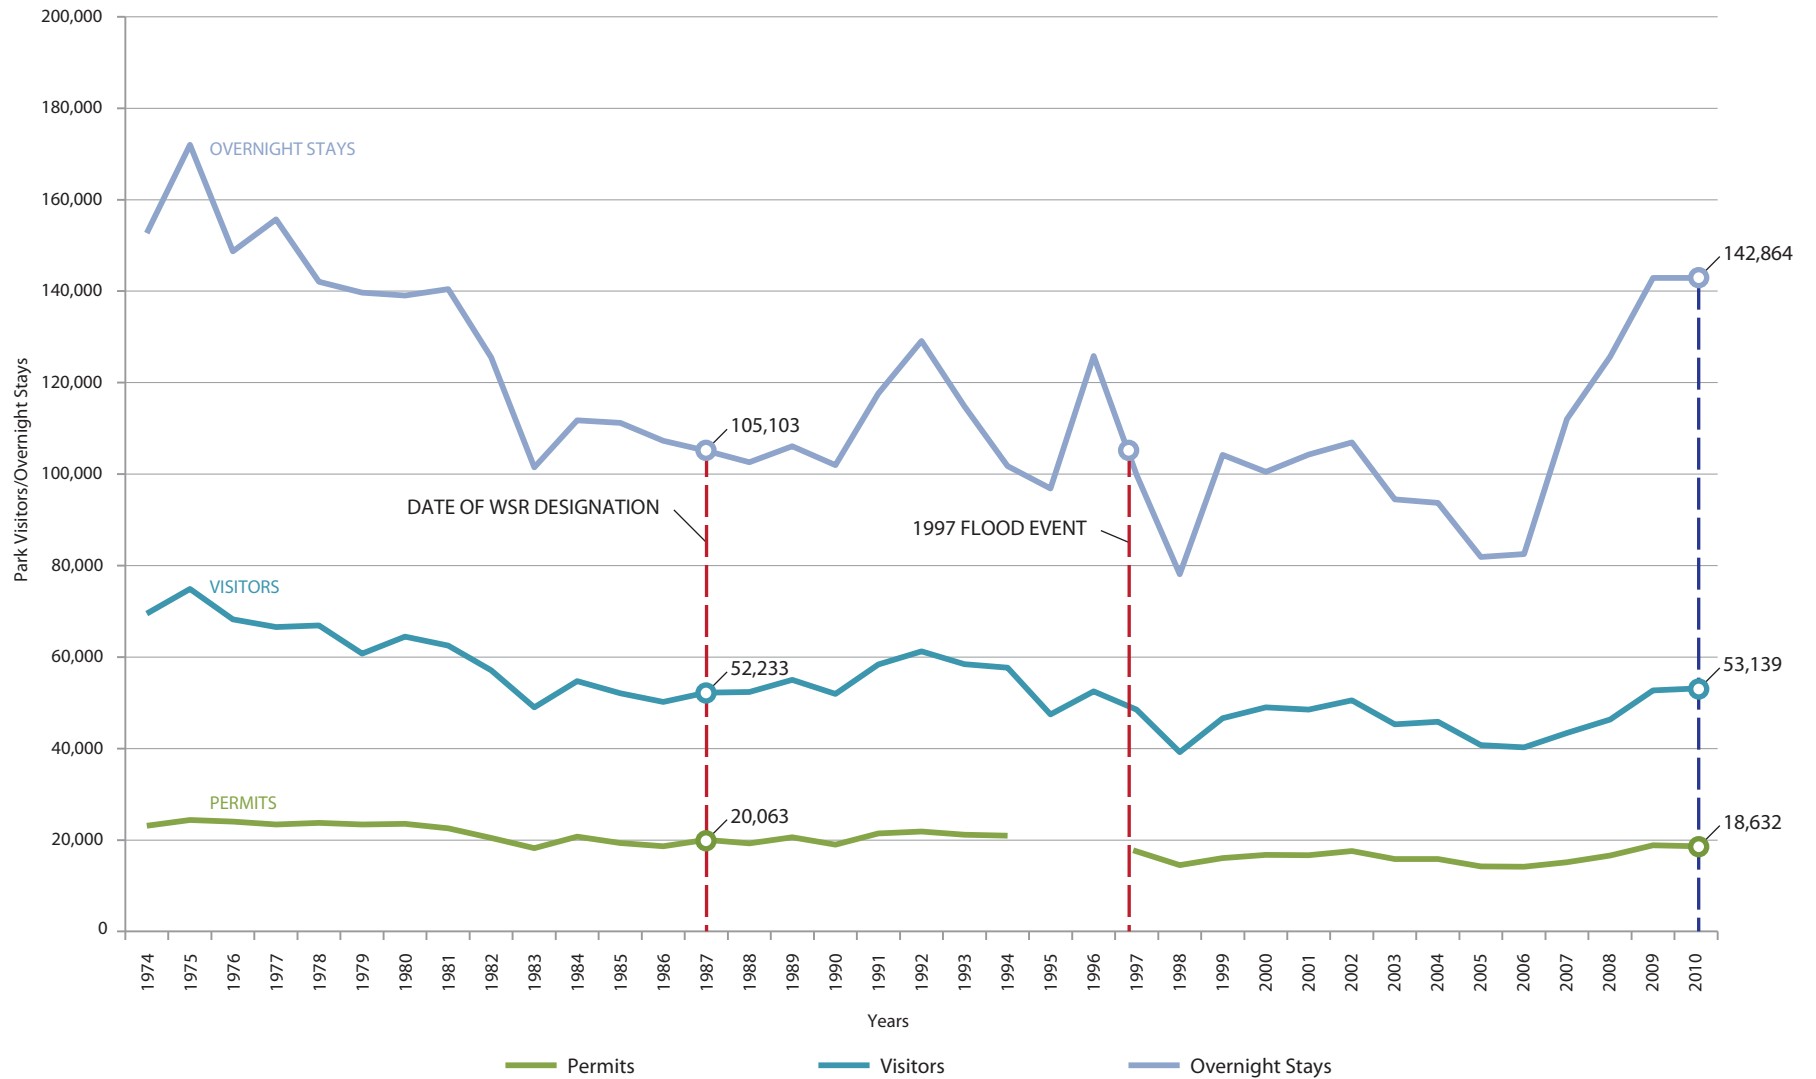
Yosemite Wilderness Permits, Visitation and Overnight Use (1974-2010)

NOTE: Visitation counts do not include day use visitors to the Yosemite backcountry.
No permit data available for 1995 and 1996.
