Merced Wild and Scenic River:

Cultural Resources & Historic Properties – Two Case Studies

David Humphrey
Park Historical Landscape Architect
Yosemite National Park

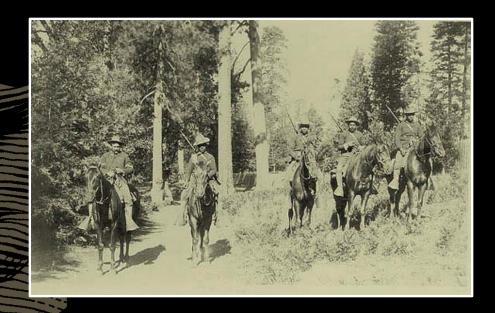
Camp A.E. Wood - Cavalry Camp - Wawona

Typical threats & disturbances

- Construction of park infrastructure
- Ongoing visitor use
- Surface erosion
- Vegetation growth
- Fuel buildup

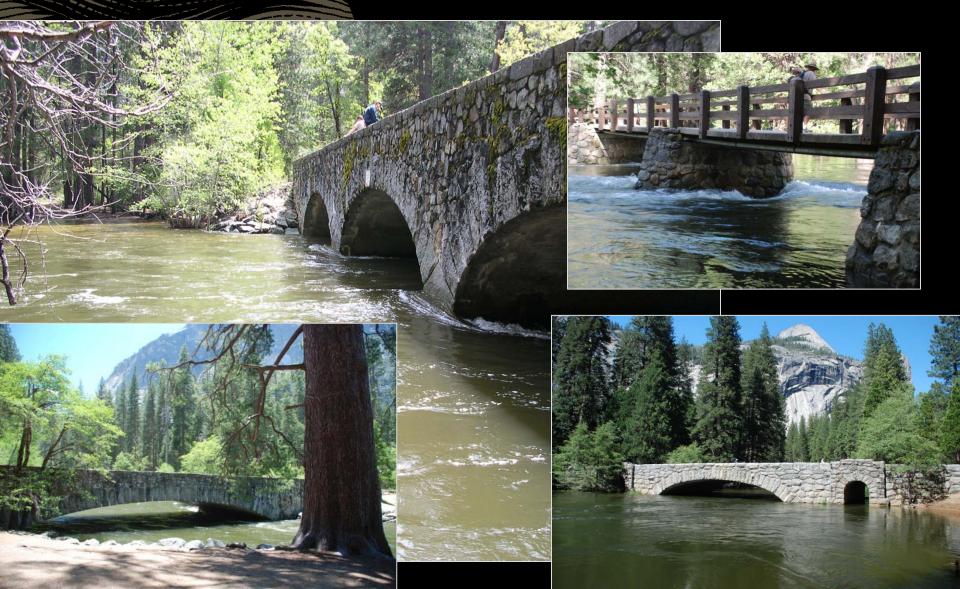
Historic Bridges and managing free flowing condition

1 Log Bridges

The earliest bridges were built of large logs and primarily used as footbridges. Simple queen post trusses were used for crossing short spans with heavier loads.

This 3-panel bridge over Yosemite Creek was a modification of the king post truss with a horizontal chord for reinforcement.

2 Wawona Covered Bridge

A covered bridge protects the interior wooden thats system from decay. The 1868 open deck bridge at Wawona was covered in 1878 and remains the only covered bridge in Yosemite. Outside the park but close to the boundary there was another covered bridge across the South Fork Toulumme River.

3 Timber Truss Bridges

As spans grew longer and vehicle weights increased, more complex truss systems were employed Such hindges spanned across Yosemile Croek and the Marced River in Yosemile Valley. Also the old Cascade Creek Bridge built in 1907 was "limber truss construction."

4 Steel Truss Bridges

More expensive than wooden trusses, steel bridges were much more dutable and could carry heavier loads. The second Sentinel Bridge - an early representative of this group. Was erected in 1879 as an iron truss. Built in 1915, the old El Capitan Bridge was a combined timber and steel truss system.

5 Reinforced Concrete Bridges

By 1920, concrete bridges had made their appearance on the Valley floor. Over time, most of them were replaced, like the Old Stonernan Bridge & the Old Sentinel Bridge. One of the earliest concrete origos was erected in 1921 at Happy lists. The original concrete railing was later replaced by a Mission 68 railing.

Old Happy Isles Bridge 1921

6 Early Rustic Concrete Bridges

By facing three simple reinforced concrete bridges at Bridalveil Falls with stone, the military set the precedent for rustic bridge design in 1913.
