An overview of the research project: Merced River Restoration in Yosemite Valley

A cooperative agreement between
UC Santa Barbara and the National Park Service

Merced River Riparian Corridor Restoration in Yosemite Valley

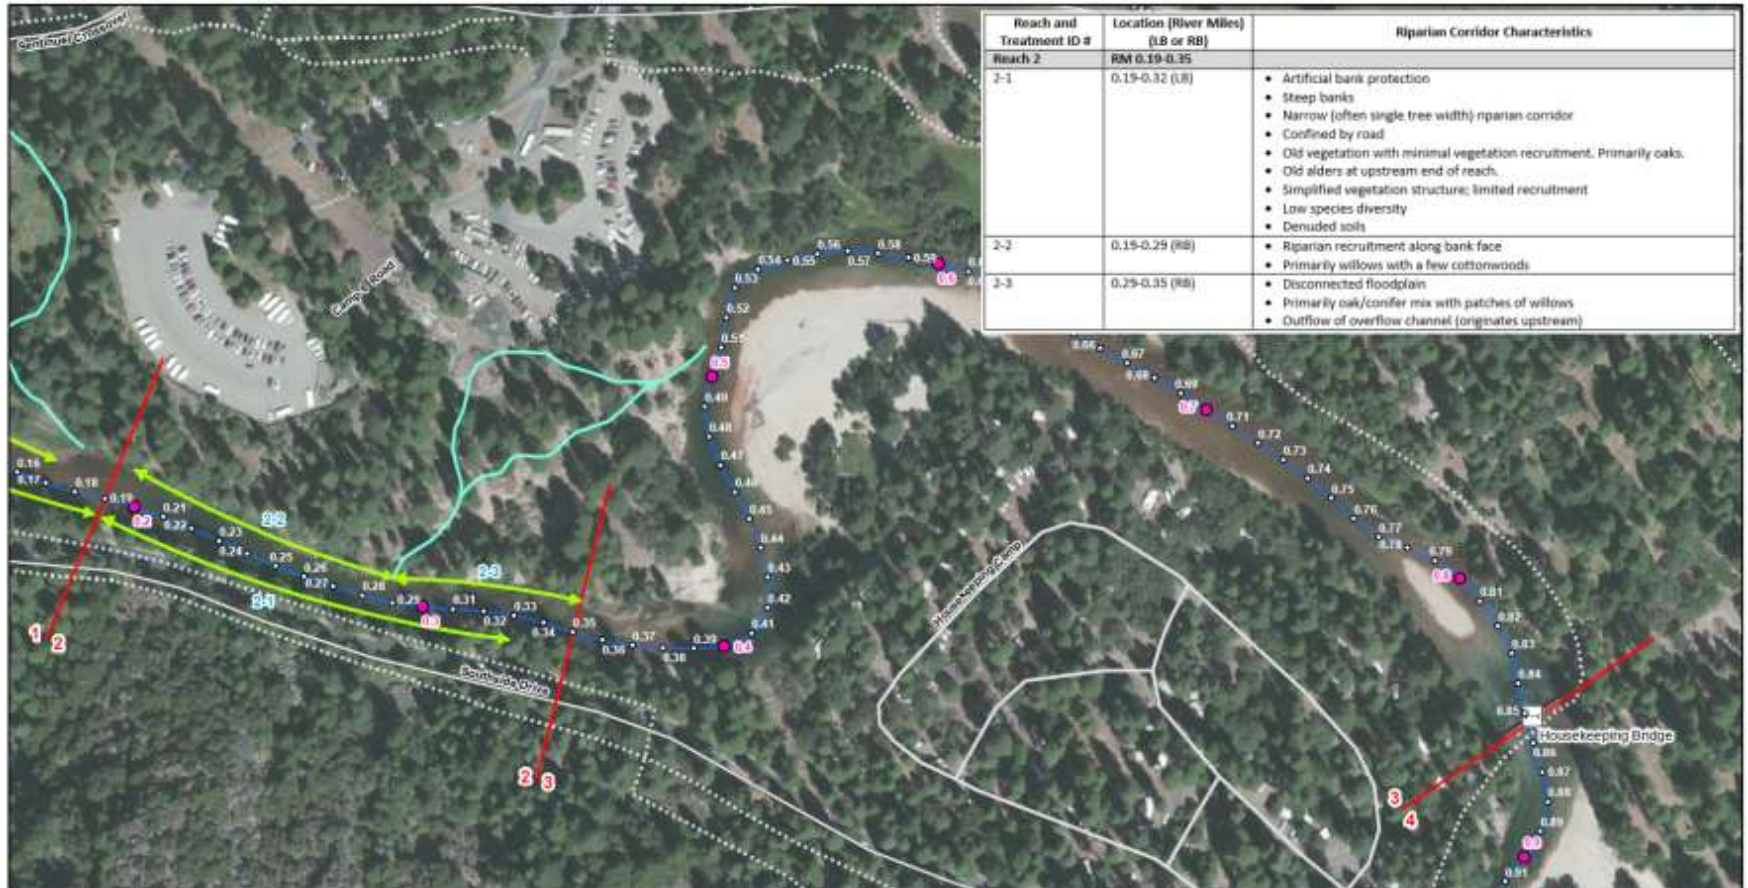
Example of riparian corridor assessment information:

<p>Map Features</p> <ul style="list-style-type: none"> Bridge Compground Picnic Area Waterfall Primary Rd Secondary/Local Rd Trail Reach Breaks Historic High Flow Channel 	<p>Riparian Corridor Assessment Features</p> <ul style="list-style-type: none"> Riparian Corridor Assessment Segment with ID number 	<p>Yosemite Valley Merced River Restoration Project</p> <p>Riparian Corridor Assessment</p> <p>Map 2 of 7</p>

From Merced River Riparian Corridor Restoration Concept Designs, March 2016

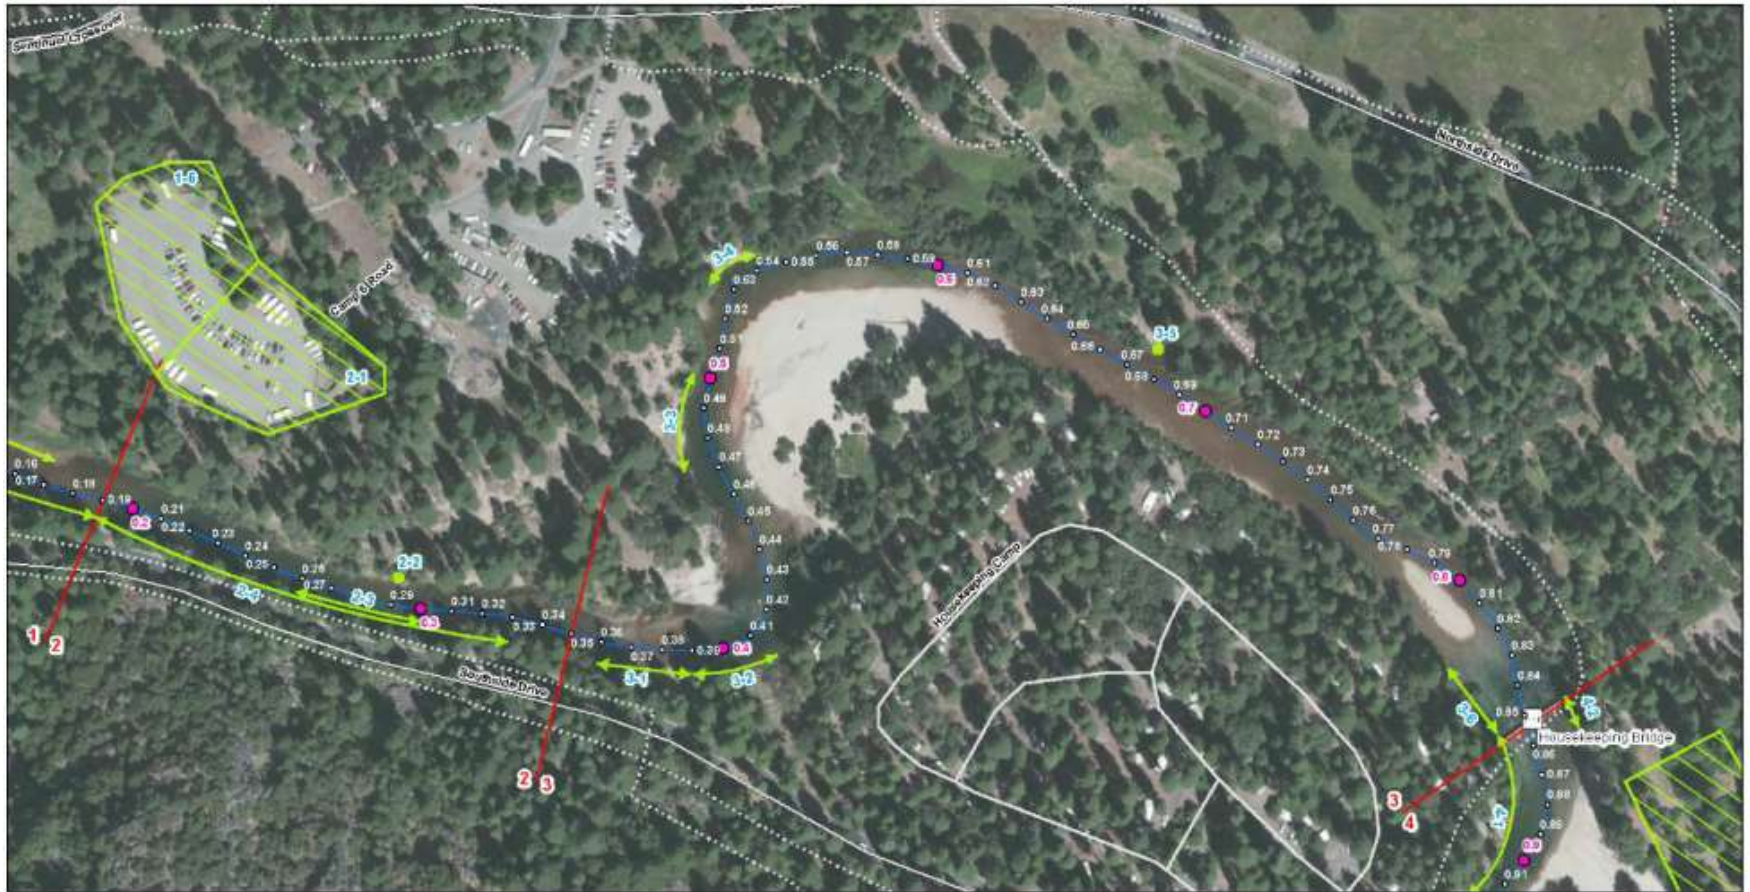
Example map providing general guidance and location of treatment types and sites:

<p>Map Features</p> <ul style="list-style-type: none"> Bridge Campground Picnic Area Waterfall Primary Rd Secondary/Local Rd Trail Reach Breaks 	<p>Restoration Treatment Features</p> <ul style="list-style-type: none"> Treatment ID Number Restoration Treatment Location 	<p>Yosemite Valley Merced River Restoration Project</p> <p>Reach and Treatment ID</p> <p>Map 2 of 7</p>

From *Merced River Riparian Corridor Restoration Concept Designs*, March 2016

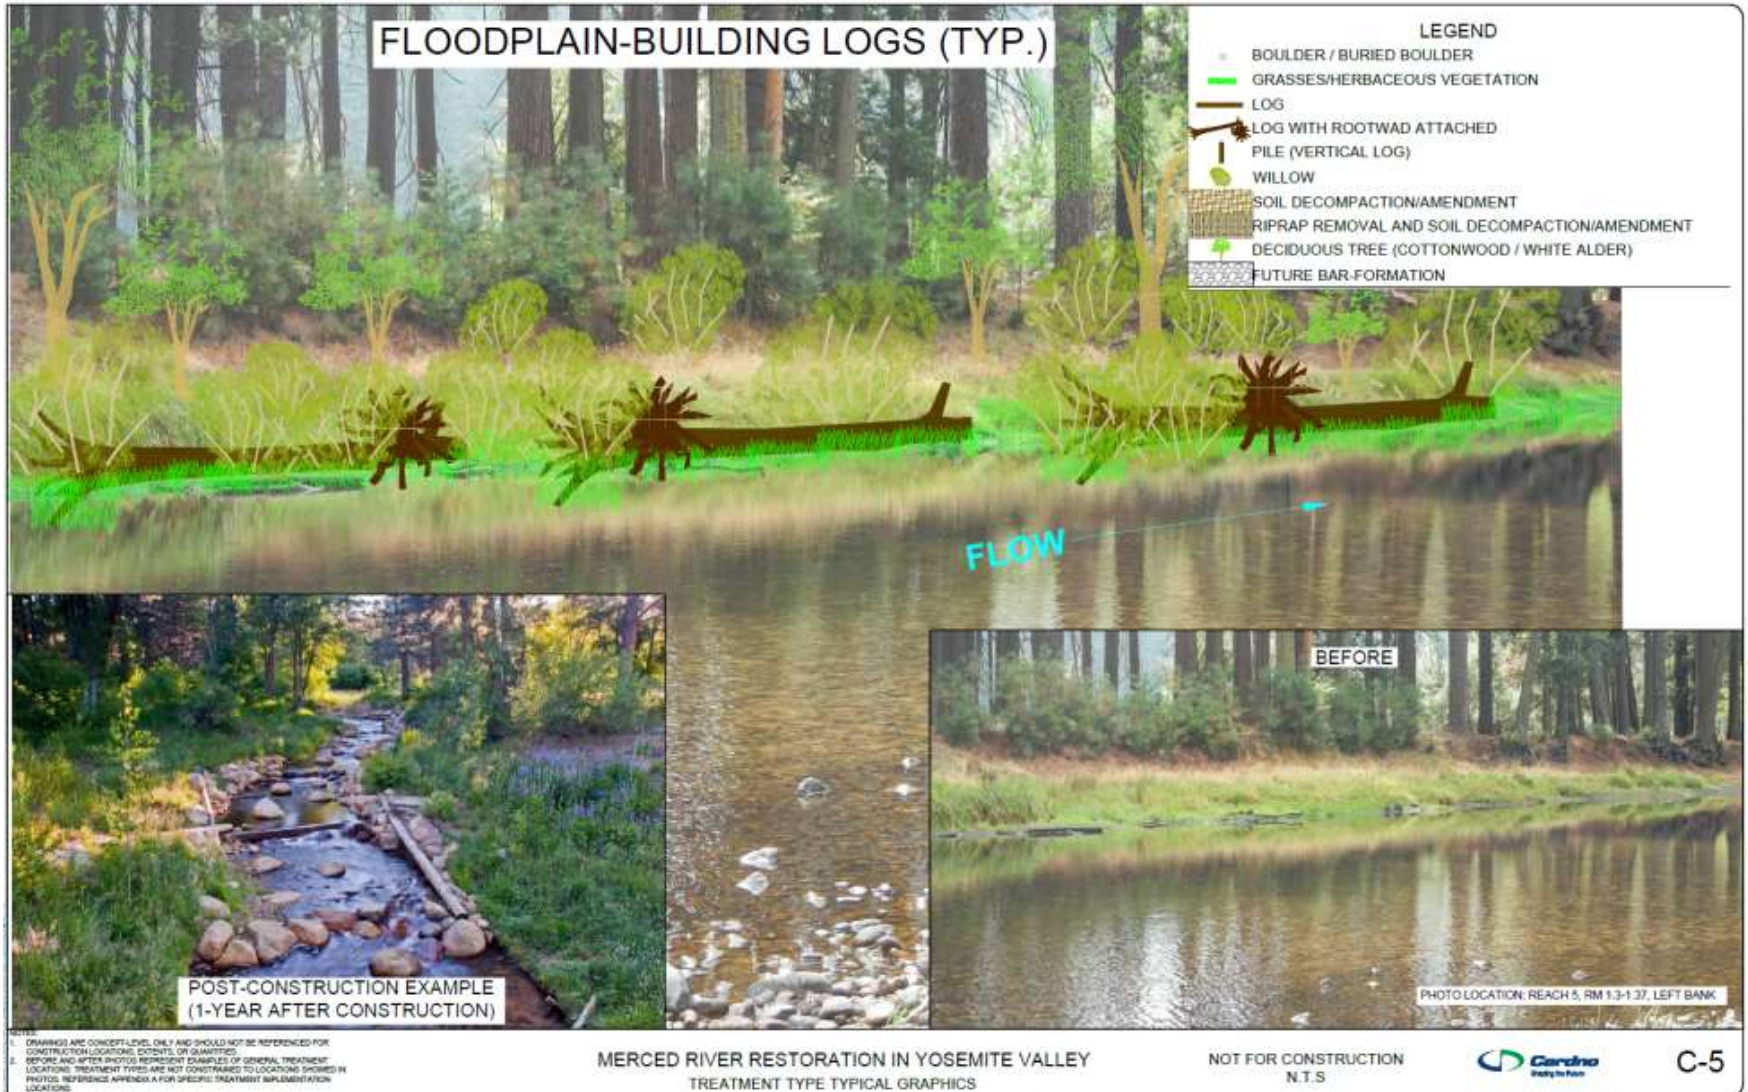
Example of treatment type typical graphic:

From Merced River Riparian Corridor Restoration Concept Designs, March 2016
