Investigation and hazard assessment of the 2003 and 2007 Staircase Falls rock falls, Yosemite National Park, California, USA

G. F. Wieczorek¹, G. M. Stock², P. Reichenbach³, J. B. Snyder⁴, J. W. Borchers⁵, and J. W. Godt⁶

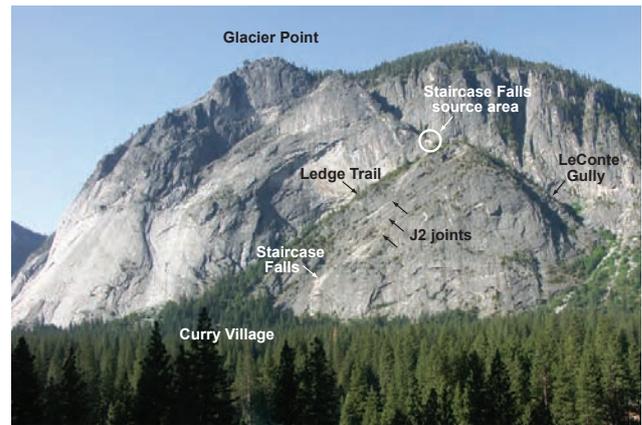
Fig. 2. Western portion of Glacier Point showing Staircase Falls rock-fall detachment area (circled) and path of Staircase Falls and abandoned Ledge Trail along eastward dipping J2 joint sets (see Table 1 for joint orientation data). Cliff faces exhibit influence of vertical regional joints weathered back along J1 exfoliation joints, which are present on nearly all visible rock surfaces.

The Staircase Falls rock-fall detachment area is below and west of Glacier Point, on the eastern edge of LeConte Gully and immediately above Staircase Falls (Figs. 1, 2). The detachment area is at an elevation of 1770 m, 555 m above the floor of Yosemite Valley. Prior to 2003, there were no documented observations of historic rock fall activity from this detachment area, but accumulations of rock debris and a lack of trees on a prominent ledge ~ 20 m below the detachment area suggest earlier (pre-1850) rock-fall activity from the site. The active rock-fall detachment surface is on the upper northeast side of a jointed, weathered bedrock fin that projects out ~ 28 m to the northwest from the eastern edge of LeConte Gully (Fig. 3). Here, Staircase Creek, which originates on the rim of Yosemite Valley near Glacier Point, turns

sharply out of LeConte Gully and flows around the bedrock fin to reach the top of Staircase Falls (Figs. 2, 3).

LeConte Gully (Fig. 2) are controlled by these regional-scale joints, which intersect nearly all others. Joint J2 is a pervasive ledge-forming discontinuity below Glacier Point with steep dips of approximately 30° to the east (Fig. 2). This orientation is similar to the set of discontinuities that form the stair “treads” of Staircase Falls and the broad ledge carrying the abandoned “Ledge Trail” (Fig. 2). Also prominent are sheeting (J1) joints, also known as exfoliation joints, which form parallel to topographic surfaces (e.g., Matthes, 1930; Bahat et al., 1999; Martel, 2006). J1 joints have strongly influenced cliff retreat back from the original joint-controlled surfaces, exposing with time the inclined steps of Staircase Falls (Huber, 1987). Overburden depth can affect spacing and openness of joints, particularly J1 sheeting joints; the cliff faces below Glacier Point, particularly areas with topographic complexity (e.g., bedrock features that project out from the mean cliff surface), possess joints that are wider and more hydrologically conductive than those joints deeper below the ground surface.

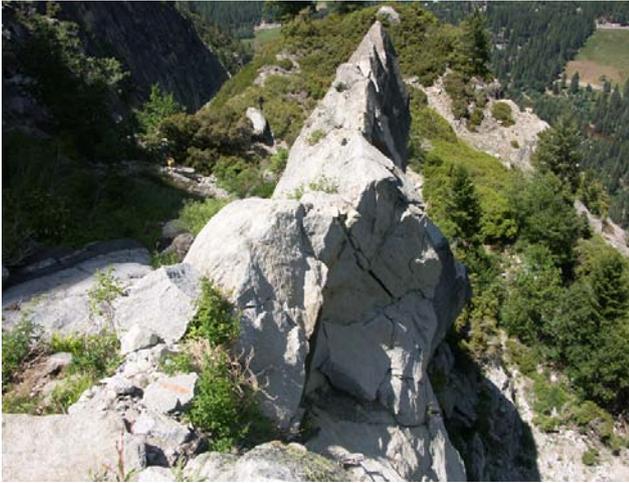
Fig. 3. Staircase Falls rock-fall detachment area, showing narrow projecting bedrock fin. 2003 and 2007 rock falls occurred from center-right side of fin. Floor of Yosemite Valley 555 m below is in upper right of photograph. Staircase Creek flows down left (south-west) side of fin before turning sharply right (northeast) around the base of fin to top of Staircase Falls.

Subsequent observation of the detachment area in April 2004 revealed additional potentially unstable rock in the form of a fractured, jointed, and moderately weathered bedrock fin (Fig. 3). We estimated the volume of potentially unstable rock remaining at the detachment area, in the form of the narrow bedrock fin (Fig. 3), to be $\sim 350\text{ m}^3$. Only a few meters of rock separate the Staircase Creek channel in LeConte Gully from the active detachment surface of the Staircase Falls source area (Fig. 3).

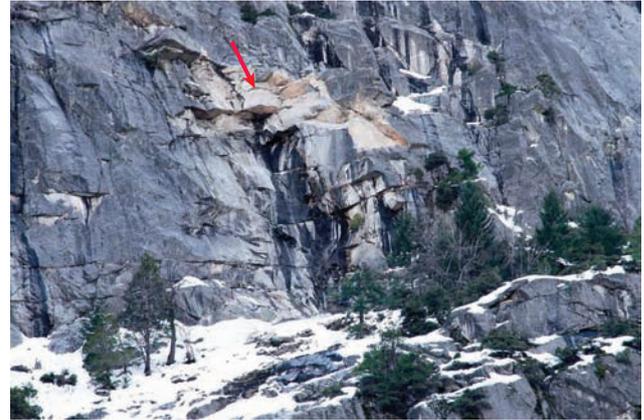
Fig. 4. Photograph of Staircase Falls rock-fall detachment area taken 21 days after 26 December 2003 event, showing light colored joint-controlled detachment surfaces. Rock debris impacted snow-covered ledge immediately below source area, and then fell $\sim 745\text{ m}$ down joint-controlled ledges to Yosemite Valley floor. Note heavy dark drainage paths below detachment area indicating water flow through joints. Overhanging rectangular block in center left of photograph (marked by red arrow) fell during 9 June 2007 rock fall. (Photo by Dan Horner, NPS).

of the Staircase Falls source area taken 21 days after the 26 December 2003 rock fall showed water streaming from joints below the source area (Fig. 4). Water discharging from the source area is adequate to support perennial hydrophytic vegetation. Each failure from the Staircase Falls detachment area decreases the width of the bedrock fin between LeConte Gully and Staircase Creek, potentially increasing infiltration from Staircase Creek through the fin, and also permitting winter ice to form deeper in the cliff face. Each failure thus accelerates joint weathering in this fin, increasing the probability of future rock falls from this location.

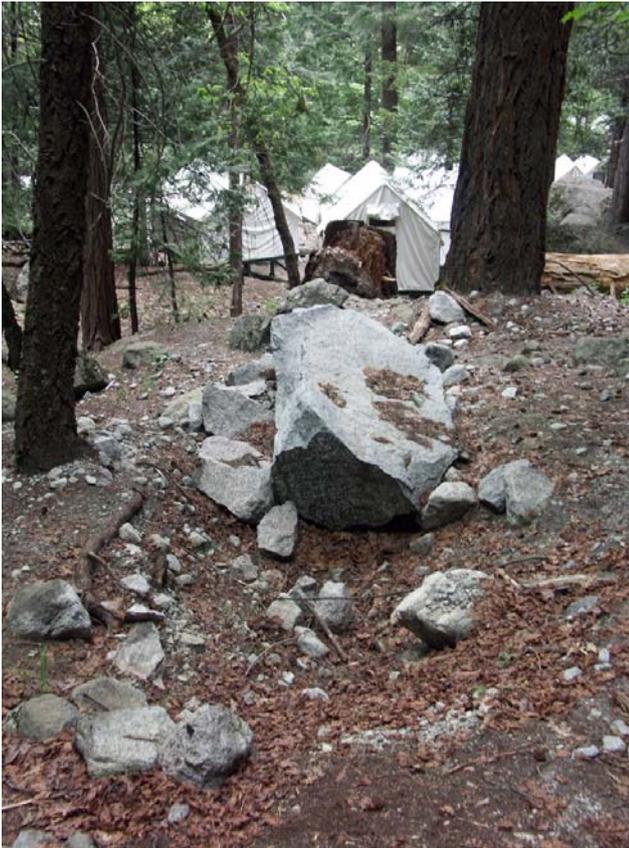
Fig. 5. Part of rock-fall deposit from 26 December 2003 Staircase Falls rock fall. 4 m^3 (11 metric tons) block landed $\sim 120\text{ m}$ beyond base of cliff, leaving prominent impact crater.
