HISTORIC RESOURCE STUDY

WAR IN THE PACIFIC NATIONAL HISTORICAL PARK
Guam

by
Erwin N. Thompson

U.S. Department of the Interior / National Park Service

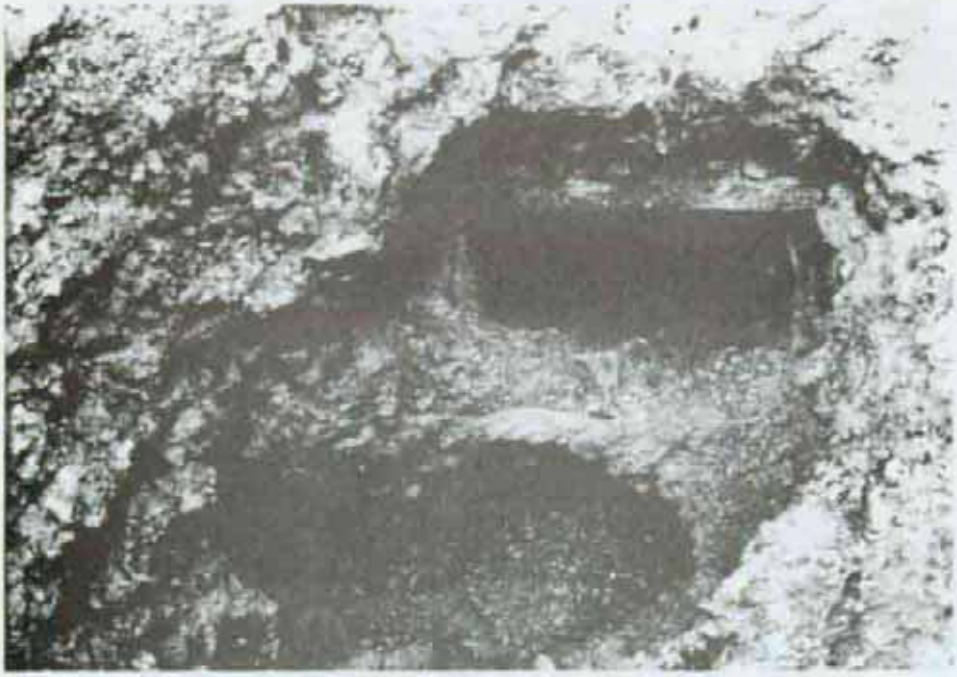
No. 29. Japanese pillbox, Adelup Point, 1984

No. 30. Japanese pillbox. On the east side of Adelup Point, outside the boundaries of the National Park. This fortification has been described as a "dual" pillbox, having two rooms (one large and one quite small), each with a gun embrasure. The cliff parallel to the westernmost embrasure has been chiseled out to increase the field of fire. A concrete observation port remains on top. As with No. 29, the pillbox played no direct role in the W-Day landings. It is recommended that it, too, be identified on any trail guides for Adelup Point. This is an excellent example of an essentially undamaged and completed Japanese pillbox.

No. 30. Japanese pillbox, Adelup Point, 1984

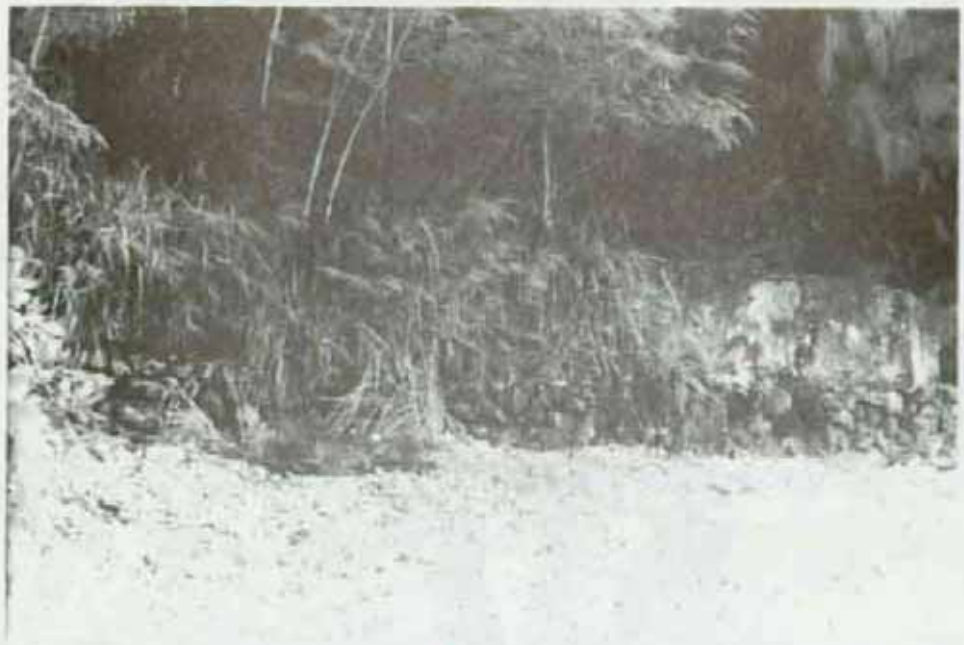
Site 33

No. 33. Seawall, Asan Beach, 1984

No. 33. Seawall, Asan

inches in height. (The original wall was about 440 feet in length.) The writer suspects that the wall existed before 1941, when the U.S. government funded maintenance of the road. The wall is subject to potential storm damage. It is recommended that the seawall not be interpreted onsite. Parking on Marine Drive in this area is extremely dangerous.

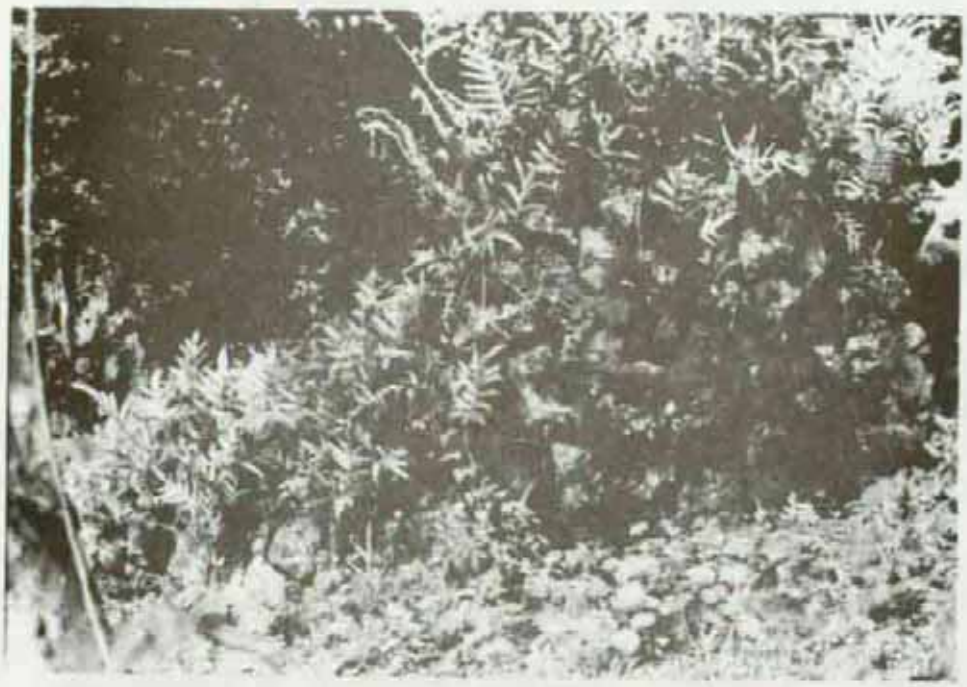
No. 63. Japanese rock and concrete wall, Asan Point, above crevices in cliff behind wall, below

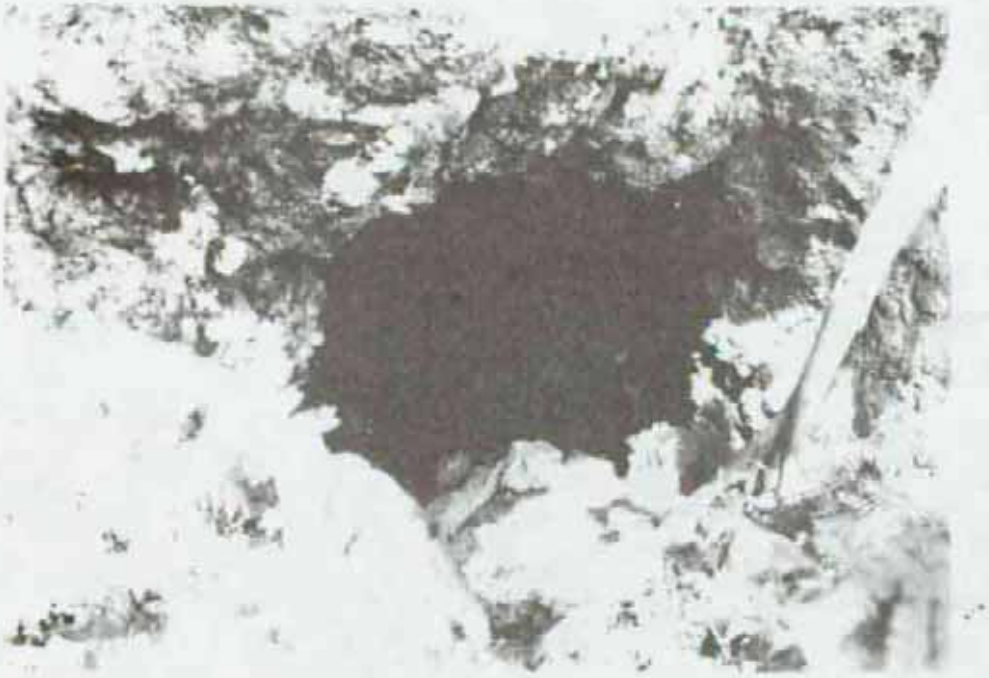
No. 106. Japanese tunnel, Asan Point, 1984

No. 106. Japanese tunnel. This Chamorro-built (forced labor) tunnel is the sole surviving Japanese defense structure on the east side of Asan Point. The large cave is easily accessible to visitors. Like all tunnels, rock rubble gathers on the floor and as a matter of visitor safety must be regularly checked. Interpretation, on- or off-site, should be developed for this tunnel and all of Asan Point.

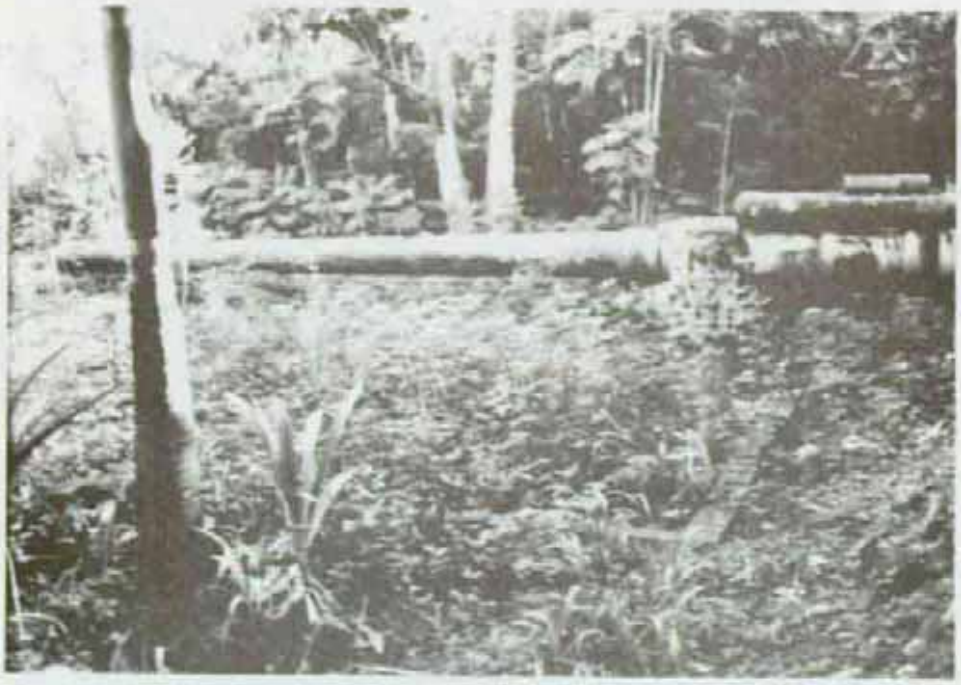
No. 60. Gun No. 1, Piti, 1984

Gun No. 1 (east) is emplaced behind a low, rectangular concrete wall. Guns Nos. 2 and 3 (middle and west) are emplaced in earthen revetments. The ammunition and personnel caves are no longer extent on the surface. Gun No. 2 has been partly knocked from its base plate and its breech end is buried in the earth. Gun No. 3 has one of its two cylinders lying on the ground. Some time in the past, two of the guns acquired a coat of silver paint. This could be replaced with a more appropriate color. Vegetation grows profusely within the emplacements, requiring cyclic clearing. A thicket of tangantangan blocks the view of the harbor and ocean. By climbing the short distance to the top of the ridge, a good view of the west is obtained.

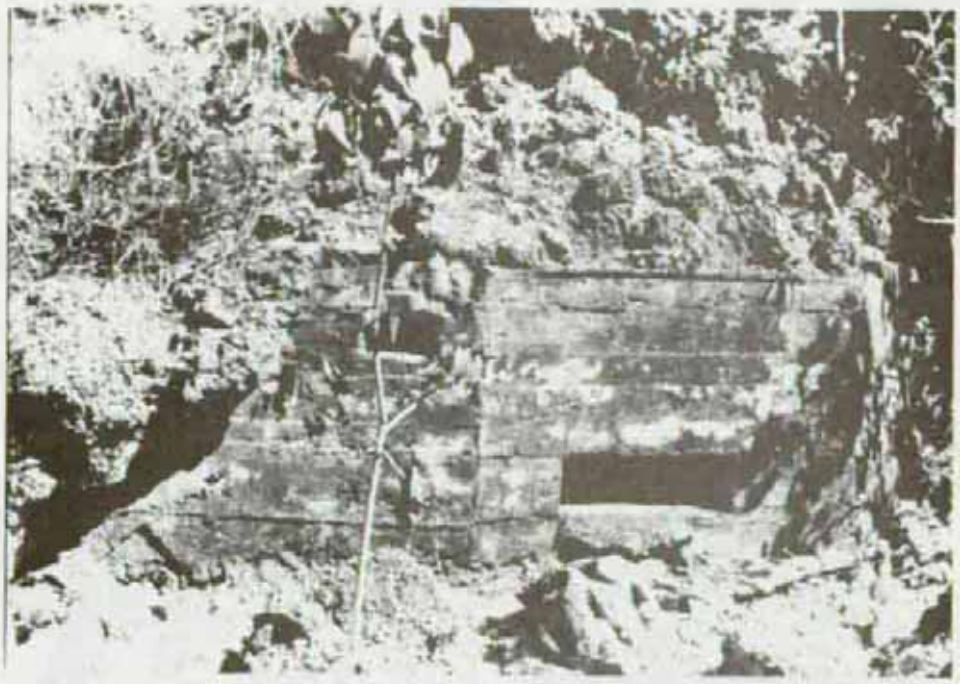
No. 2. Japanese pillbox, Apaca Point, Agat 1984

No. 2. Japanese pillbox. This combination reinforced-concrete and limestone-cliff pillbox is on the south side of Apaca Point. The Japanese took advantage of natural crevices in the limestone and closed them up with a concrete wall having one automatic weapon embrasure and one rifle port. The interior is readily accessible via another crevice at the rear. The pillbox is in good condition and is an interesting exhibit in place here on the north flank of the Agat landing beaches.

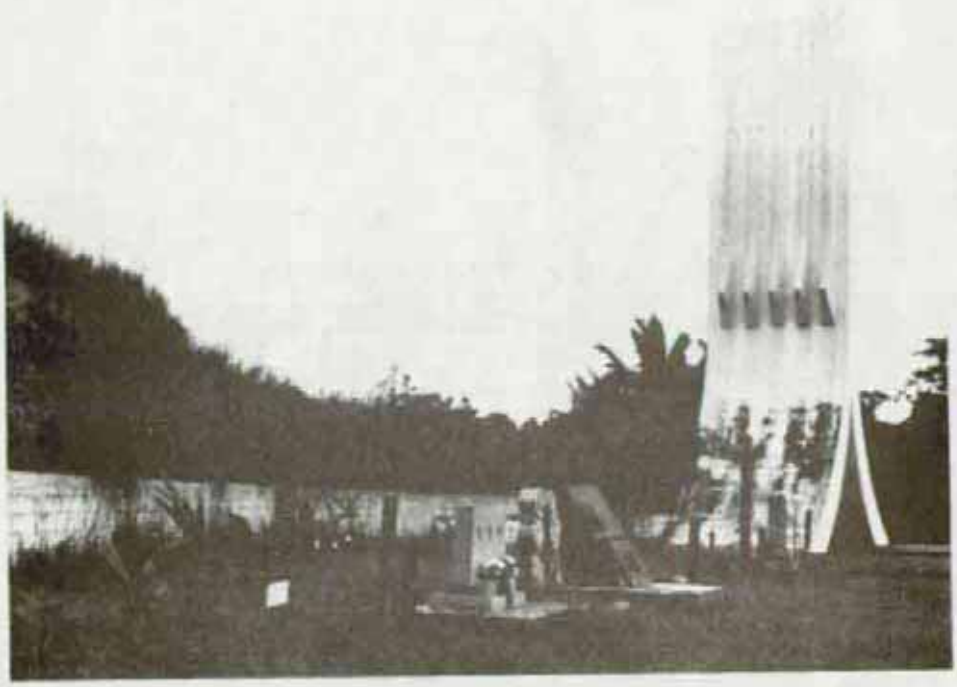
Memorial Tower, Mataguac Hill, 1984

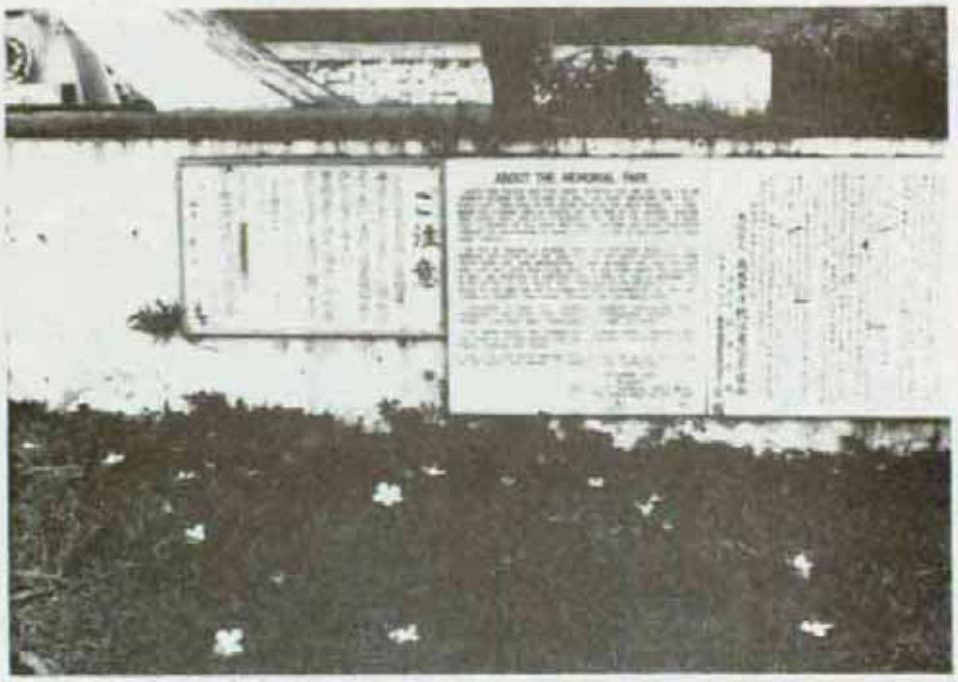
Interpretation at Mataguac Hill, 1984

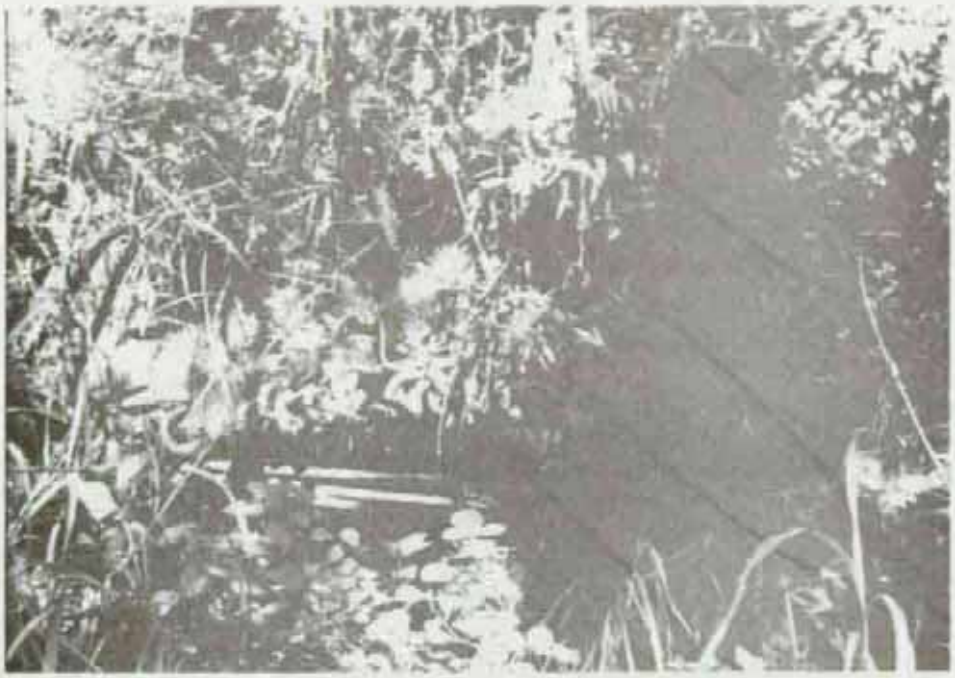
Japanese 20cm gun battery, Dungcas Beach

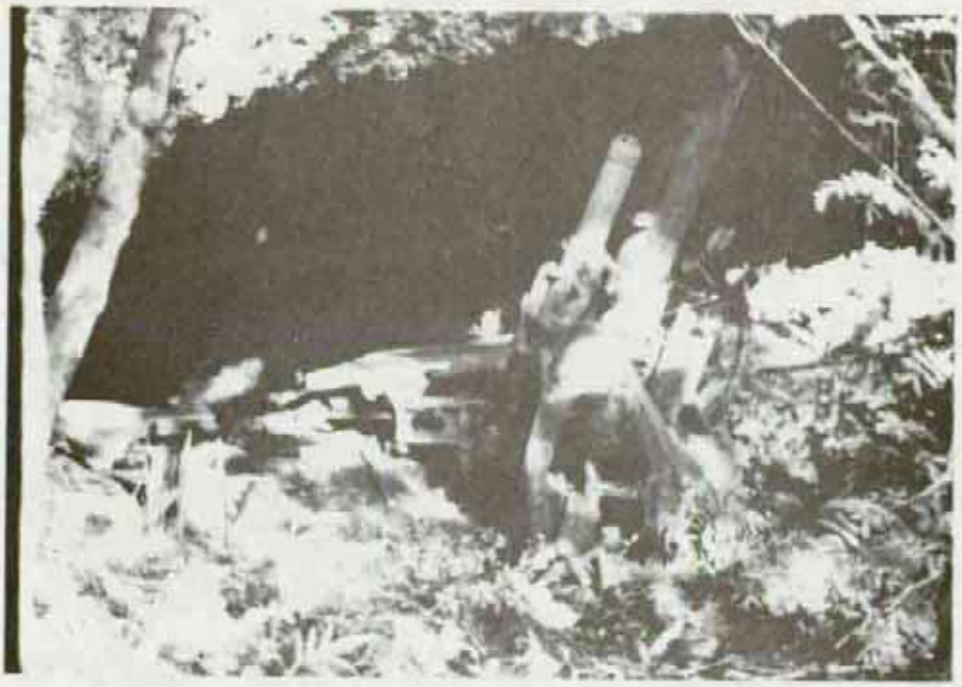
Japanese 20cm, two-gun battery, Dungcas Beach, 1984
