Historic Structure Report for

BUILDING 125 (PAINT SHOP) CHARLESTOWN NAVY YARD

Boston National Historical Park
Boston, Massachusetts

December 2003

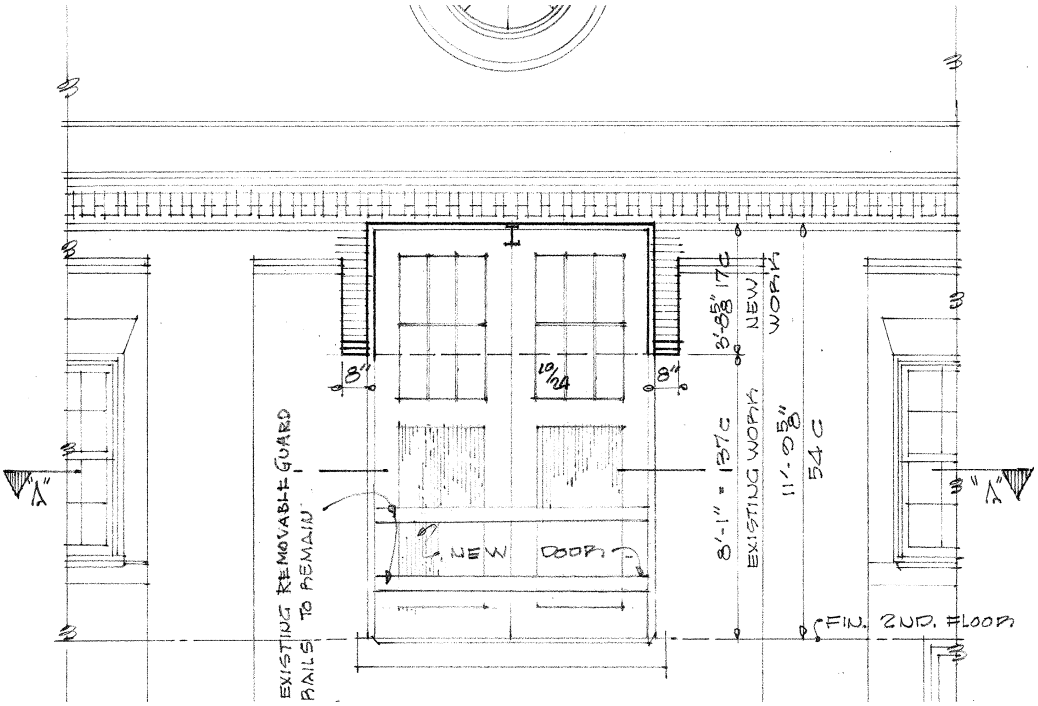
The archives contain a drawing dated July 16, 1952 for increasing the height of the shipping door by four feet and installing a new crane beam to improve loading into the second floor. Apparently this work was done about this time, or at least by November of 1955 when the change is first seen in a photograph. The door head, which was originally aligned with the adjacent windows and comfortably centered in its recessed brick panel, was raised (awkwardly) to the underside of the brick corbel above. Corbelled brick brackets were added to each side of the door head, probably in an attempt to resolve the architectural problem. The work included a new trolley beam raised more than three feet to ll ft. 9in. above the floor.

Figure 19: Drawing of new shipping door (1952). The door head originally aligned with the adjacent windows.

10. The shipping door on the second floor was enlarged in 1952, and the result was very unfortunate for the proportions of the main facade. It is recommended that the original masonry opening be restored, but restoration of the original wooden door would probably not be desirable for the future interior use of the second floor, so the opening might be filled instead with a window.

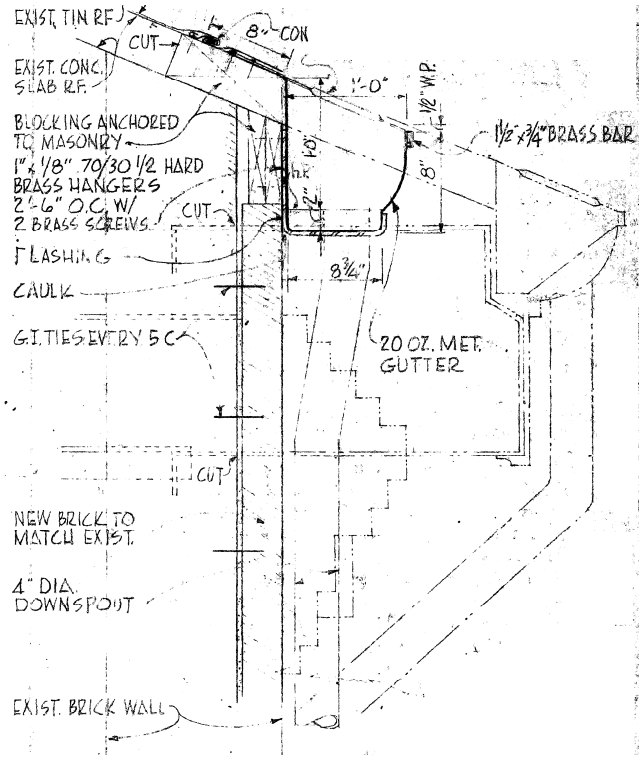
> "The cornices, gutters and roofs have been repaired on numerous occasions and further repairs are not economically wise. This deteriorated condition has made complete rehabilitation mandatory and further delay will only result in excessive maintenance and repair costs."[5]

Figure 21: Detail from drawing calling for the removal of original brick and metal cornice (2/19/1962).

11. The replication of the missing original eave and pediment trim should be a long-term goal. Its removal in the 1960's was a major loss to the architectural character of the building. But this work would be for aesthetic reasons only, and may not be possible within a near term project of limited funds.

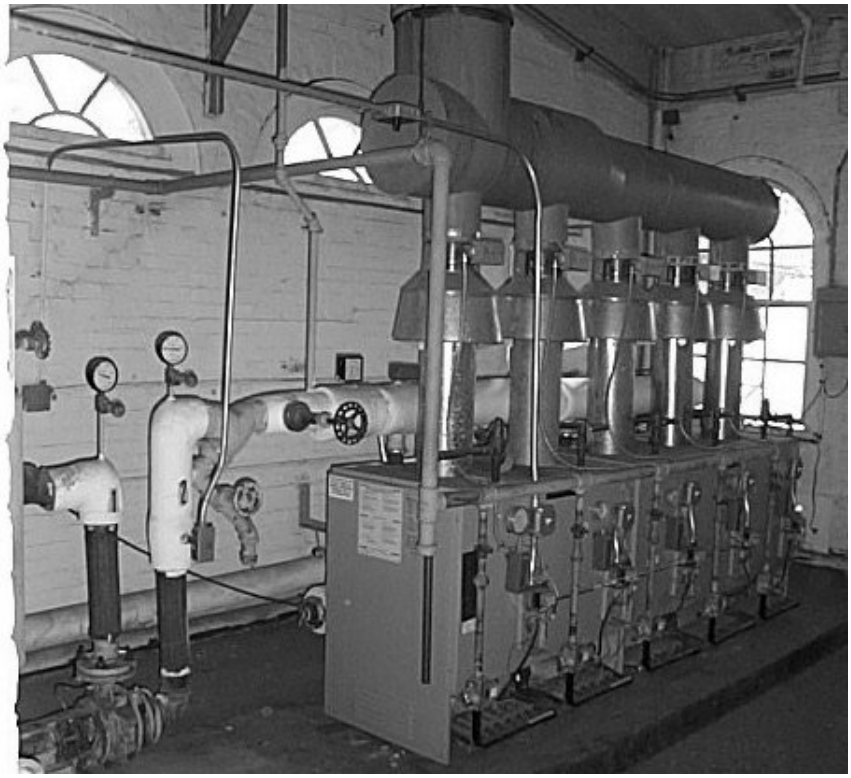
Figure 41: View to northwest in Room 107, the boiler room. Since this space was originally constructed as a shower room, the west wall windows were built as shown with fixed transoms only. (1/15/03)
