Building Number: 36

Original Name: **Maintenance Shop**

Est. Year of Construction: **1953**

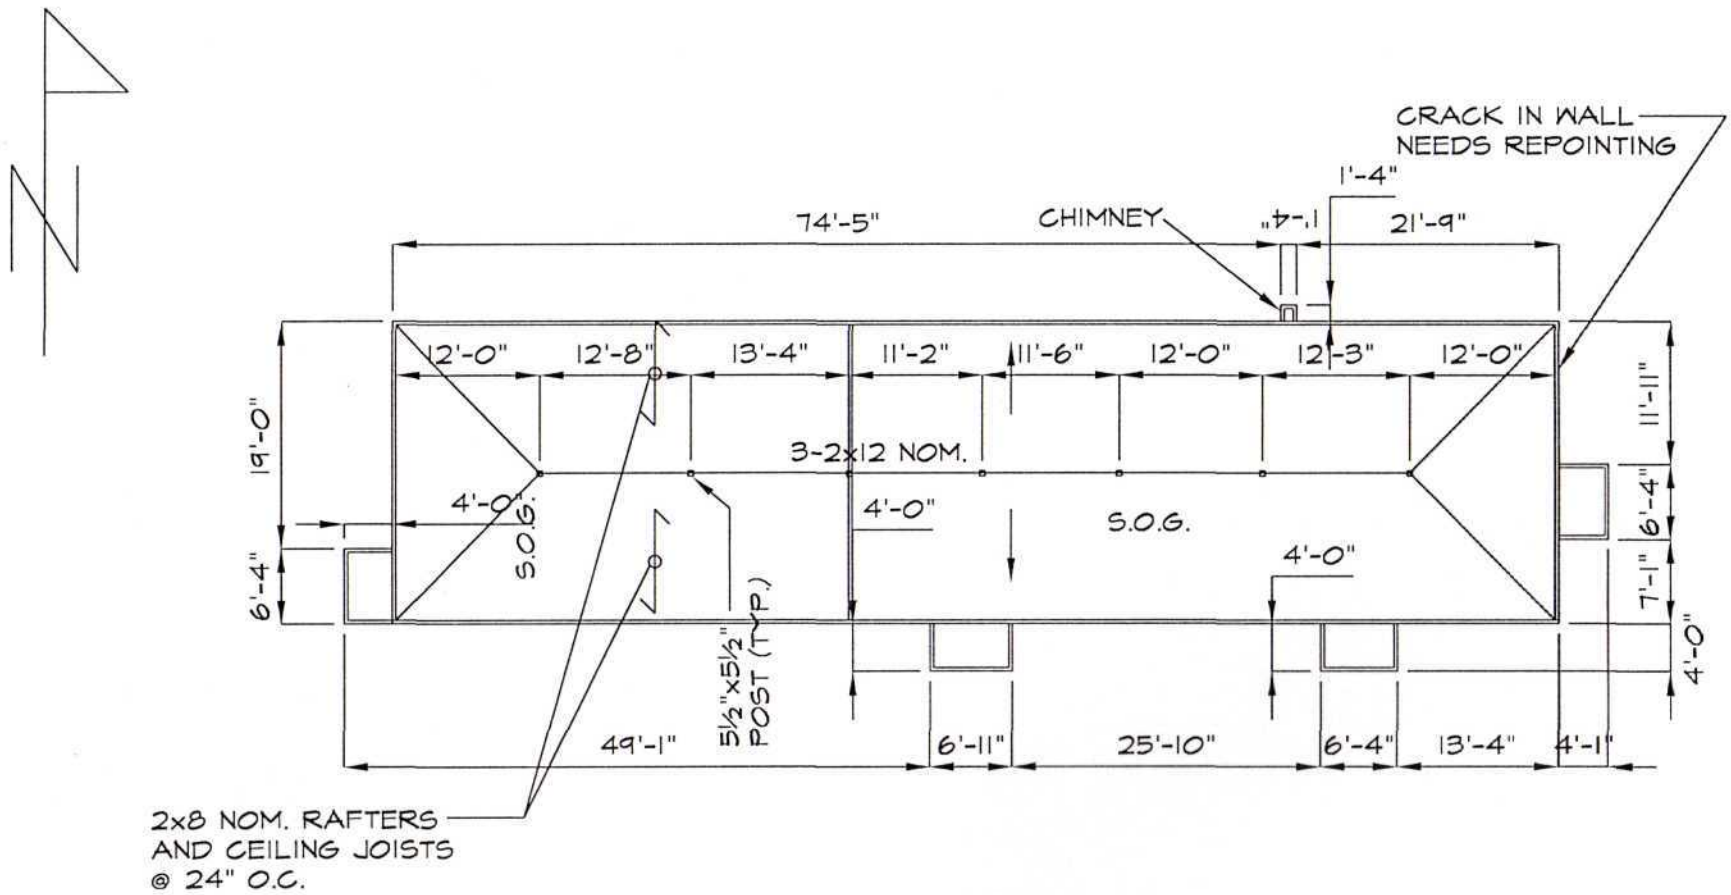
36

1. 8" CMU WALLS w/ 8"x16" PILLASTERS AT COLUMNS.
2. THE WALLS MUST BE WATERPROOFED AND THERE ARE SOME CRACKS THAT MUST BE REPOINTED.
