DECEMBER 1999 DATA

WR: Western Region
YOSE: Yosemite NP

ROUTE: 500 VALLEY LOOP ROAD TOTAL LENGTH: 12.46 Miles

AUGUST 2003 DATA

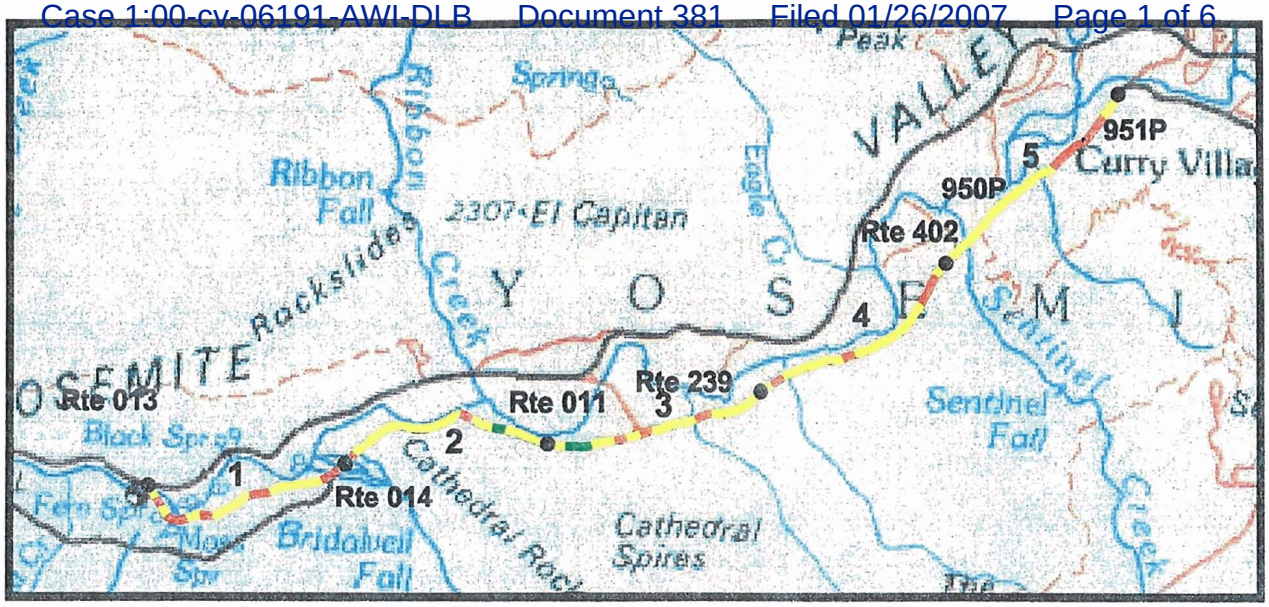
Section Number	1	2	3	4	5
Section Length (mi)	1.00	1.00	1.00	1.00	1.00
AADT	3316	3316	3316	3761	3761
SADT	4767	4767	4767	5193	5193
ADT Date	1994	1994	1994	1994	1994
Cross Section Information					
Number of Lanes	2	2	2	2	2
Paved Width (ft)	22	22	22	22	22
Lane Width (ft)	11	11	11	11	11
Shoulder Width (ft)	2	2	2	2	2
Roadway Condition Information					
PCR (Pavement Condition Rating)	66	69	69	69	68
Roughness Index	50	63	60	57	62
SCR (Surface Condition Rating)	77	73	75	77	72
Alligator Cracking	100	100	100	100	100
Rutting Index	71	66	69	74	76
Patching Index	100	100	100	100	100
Transverse Cracking	92	91	92	93	89
Longitudinal Cracking	99	99	98	97	95

COMMENTS:
MP 0.00 Begin at Rte 013
MP 0.12 Pic #3460 - Typical Pavement Section
MP 0.91 Intersection right (014)
MP 2.35 Intersection left (011)
MP 2.55 Intersection left (239)
MP 4.03 Intersection left (402)
MP 4.35 Intersection left (950)

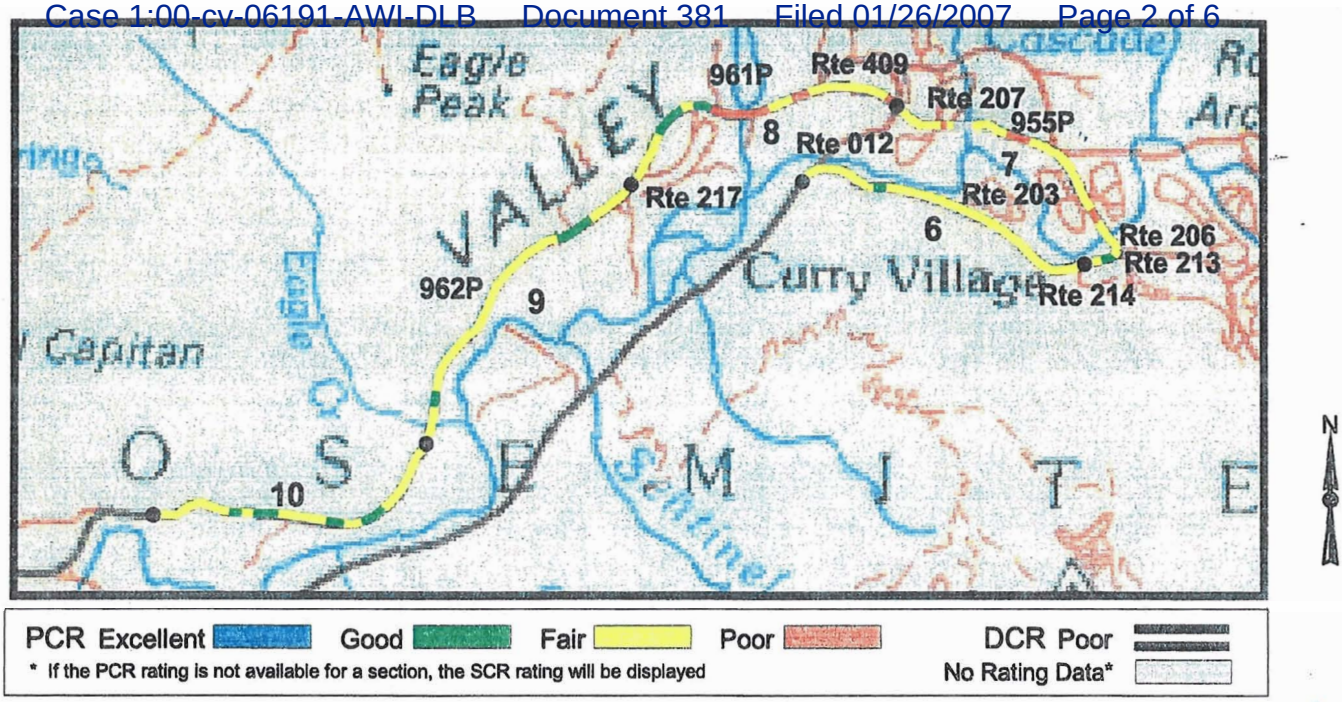
Section Number	6	7	8	9	10
Section Length (mi)	1.00	1.00	1.00	1.00	1.00
AADT	3761	3761	3761	3761	3761
SADT	5193	5193	5193	5193	5193
ADT Date	1994	1994	1994	1994	1994
Cross Section Information					
Number of Lanes	2	2	2	2	2
Paved Width (ft)	22	22	22	22	22
Lane Width (ft)	11	11	11	11	11
Shoulder Width (ft)	2	2	2	2	2
Roadway Condition Information					
PCR (Pavement Condition Rating)	72	64	69	81	79
Roughness Index	54	47	57	66	65
SCR (Surface Condition Rating)	84	75	78	91	89
Alligator Cracking	100	100	100	100	100
Rutting Index	79	68	72	85	82
Patching Index	100	100	100	100	100
Transverse Cracking	95	92	93	98	99
Longitudinal Cracking	99	100	99	100	99

COMMENTS:
MP 5.08 Intersection left (012)
MP 5.67 Intersection left (203)
MP 6.08 Intersection right (214)
MP 6.08 Intersection right (206, 213)
MP 6.52 Intersection right (955)
MP 6.83 Intersection right (207)
MP 6.94 Intersection left (012)
MP 6.96 Intersection right (409)
MP 7.62 Intersection left (961)
MP 7.64 Intersection right (961)
MP 7.92 Intersection left (217)
MP 9.60 Intersection right (962)
MP 9.70 Intersection right (962)

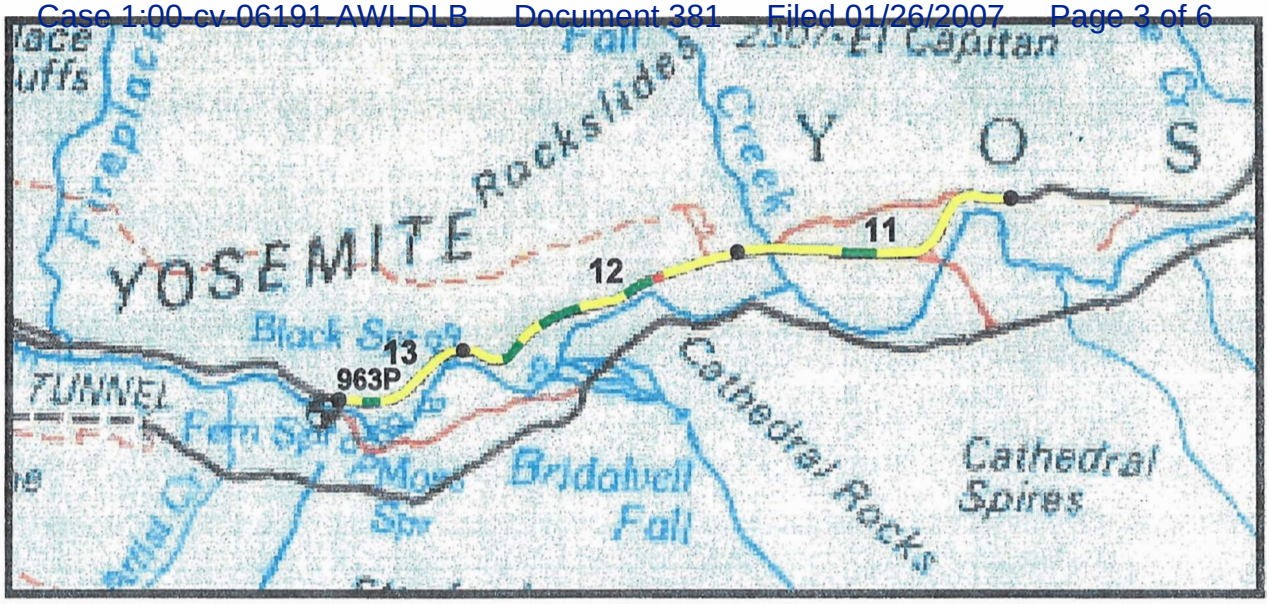
Section Number	11	12	13		
Section Length (mi)	1.00	1.00	0.46		
AADT	3761	3761	3761		
SADT	5193	5193	5193		
ADT Date	1994	1994	1994		
Cross Section Information					
Number of Lanes	2	2	2		
Paved Width (ft)	22	22	22		
Lane Width (ft)	11	11	11		
Shoulder Width (ft)	2	2	2		
Roadway Condition Information					
PCR (Pavement Condition Rating)	80	78	81		
Roughness Index	66	69	78		
SCR (Surface Condition Rating)	89	84	83		
Alligator Cracking	100	100	100		
Rutting Index	83	74	76		
Patching Index	100	100	100		
Transverse Cracking	98	98	98		
Longitudinal Cracking	99	98	97

COMMENTS:
MP 10.37 Intersection left (011)
MP 10.45 Intersection left (011)
MP 12.21 Intersection left (963)
MP 12.46 End at Rte 013

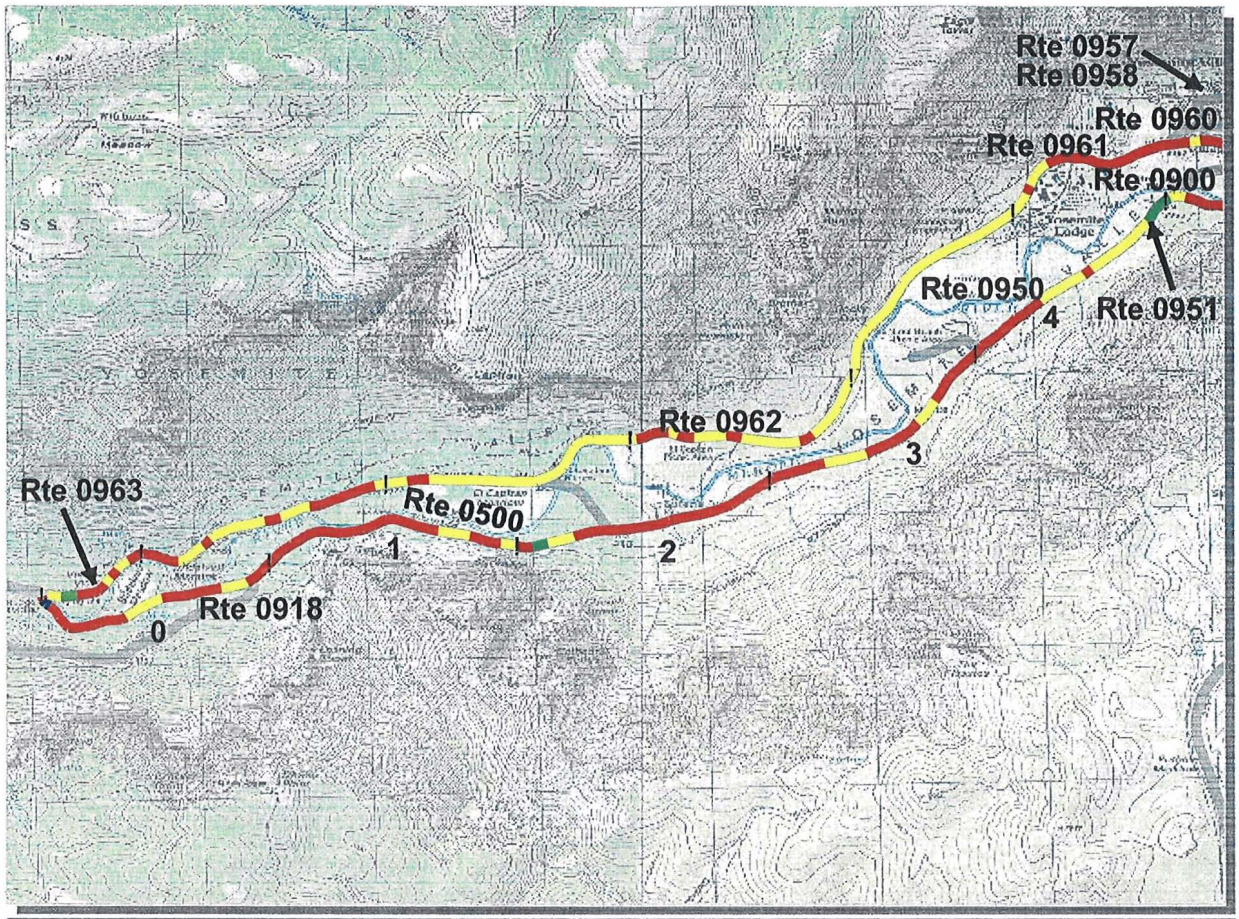
Section Number	0	1	2	3	4
Section Length (mi)	1.00	1.00	1.00	1.00	1.00
AADT	**				
SADT	**				
ADT Date	**				
Cross Section Information					
Number of Lanes	2	2	2	2	2
Paved Width (ft)	24	21	21	19	20
Lane Width (ft)	12	10	10	9	10
Shoulder Width (ft)	0	4	2	3	3
Roadway Condition Information					
PCR (Pavement Condition Rating)	42	35	39	45	57
RCI (Roughness Condition Index)	57	66	62	65	75
SCR (Surface Condition Rating)	31	17	23	32	51
Alligator Cracking Index	62	82	62	69	85
Rutting Index	54	37	46	56	64
Patching Index	94	90	94	95	97
Tranverse Cracking Index	98	95	97	97	98
Longitudinal Cracking Index	97	92	97	96	97

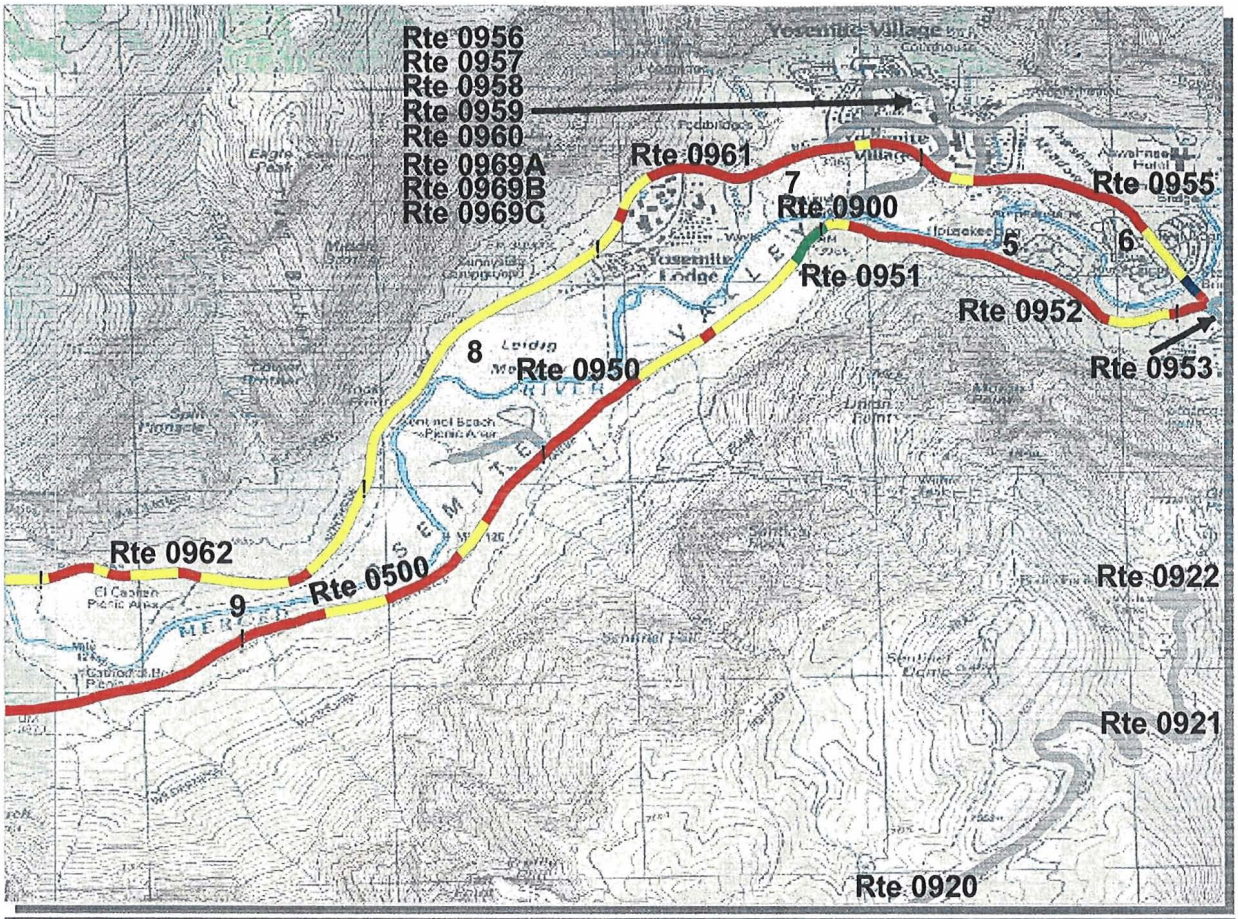
Section Number	5	6	7	8	9
Section Length (mi)	1.00	1.00	1.00	1.00	1.00
AADT	**				
SADT	**				
ADT Date	**				
Cross Section Information					
Number of Lanes	2	2	2	2	2
Paved Width (ft)	23	20	20	20	21
Lane Width (ft)	11	10	11	11	11
Shoulder Width (ft)	0	0	0	3	0
Roadway Condition Information					
PCR (Pavement Condition Rating)	37	40	44	70	64
RCI (Roughness Condition Index)	69	55	71	73	73
SCR (Surface Condition Rating)	20	33	31	69	58
Alligator Cracking Index	45	70	90	98	96
Rutting Index	58	54	43	73	64
Patching Index	93	94	96	99	99
Tranverse Cracking Index	99	98	96	98	98
Longitudinal Cracking Index	97	97	96	99	98

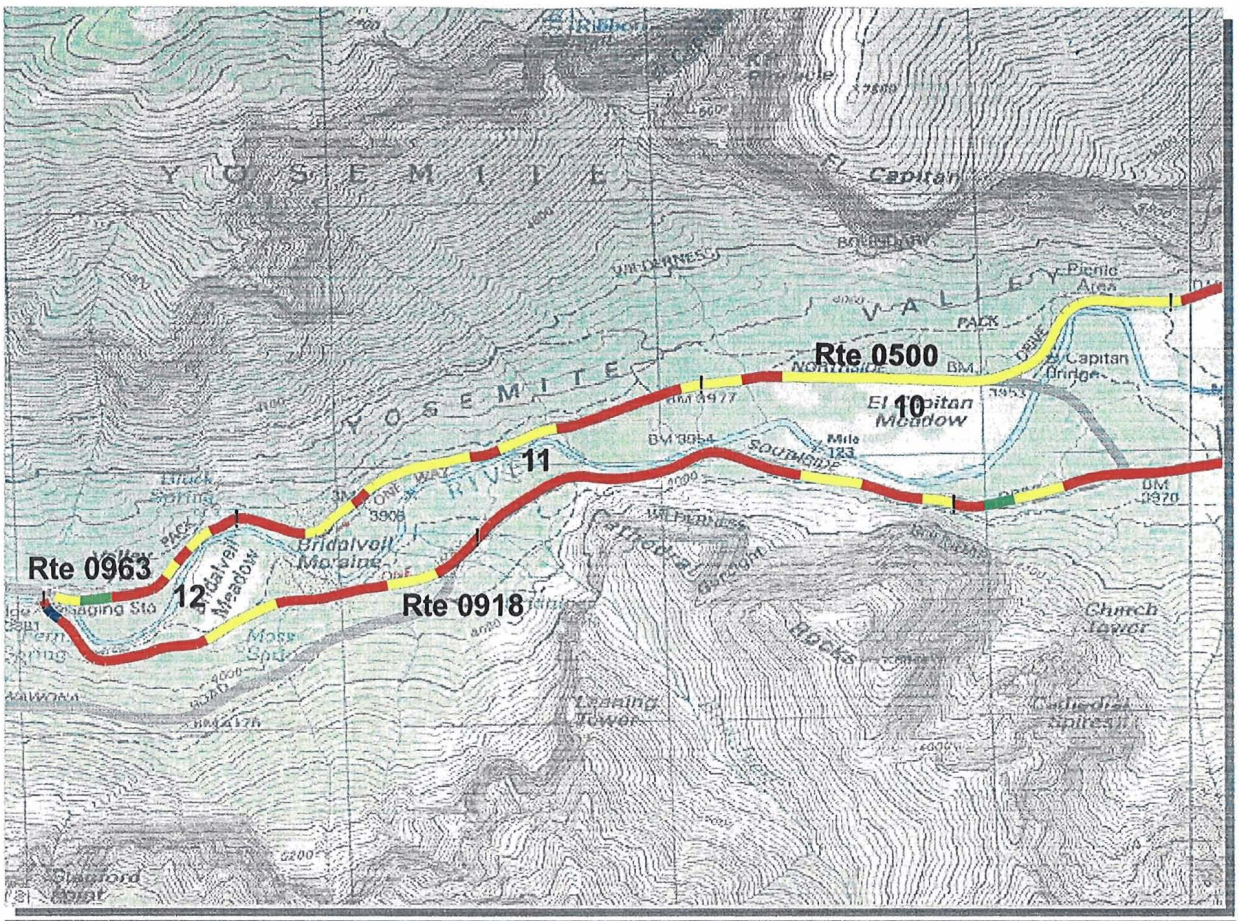
Section Number	10	11	12		
Section Length (mi)	1.00	1.00	0.45		
AADT	**				
SADT	**				
ADT Date	**				
Cross Section Information					
Number of Lanes	2	2	2		
Paved Width (ft)	20	20	21		
Lane Width (ft)	10	10	11		
Shoulder Width (ft)	0	0	0		
Roadway Condition Information					
PCR (Pavement Condition Rating)	69	56	56		
RCI (Roughness Condition Index)	73	77	84		
SCR (Surface Condition Rating)	67	43	39		
Alligator Cracking Index	99	94	82		
Rutting Index	70	50	55		
Patching Index	98	97	99		
Tranverse Cracking Index	98	98	99		
Longitudinal Cracking Index	99	98	98
